(54) **COMPOSITE REPAIR FOR PIPES**
(75) Inventor: **Barton E. Bennett**, Mishawaka, IN (US)
(73) Assignee: **Odyssian Technology, LLC**, South Bend, IN (US)
(*) Notice: Subject to any disclaimer, the term of this patent is extended or adjusted under 35 U.S.C. 154(b) by 93 days.

A repair assembly is provided for repairing a pipe that in one embodiment includes a layer of thermoplastic material substantially surrounding the pipe in an area needing repair; a heating element located to provide heat to the layer of thermoplastic material; and an overpress at least partially surrounding the pipe and the layer of thermoplastic material. The layer of thermoplastic material may be configured as a sleeve surrounding the pipe, and the sleeve may be configured in two semicylindrical halves with longitudinal seams where the semicylindrical halves meet. The seams extend generally parallel to a longitudinal axis of the pipe, and the sleeve may further include outwardly extending flanges along the edges of the semicylindrical halves at the seams.

COMPOSITE REPAIR FOR PIPES

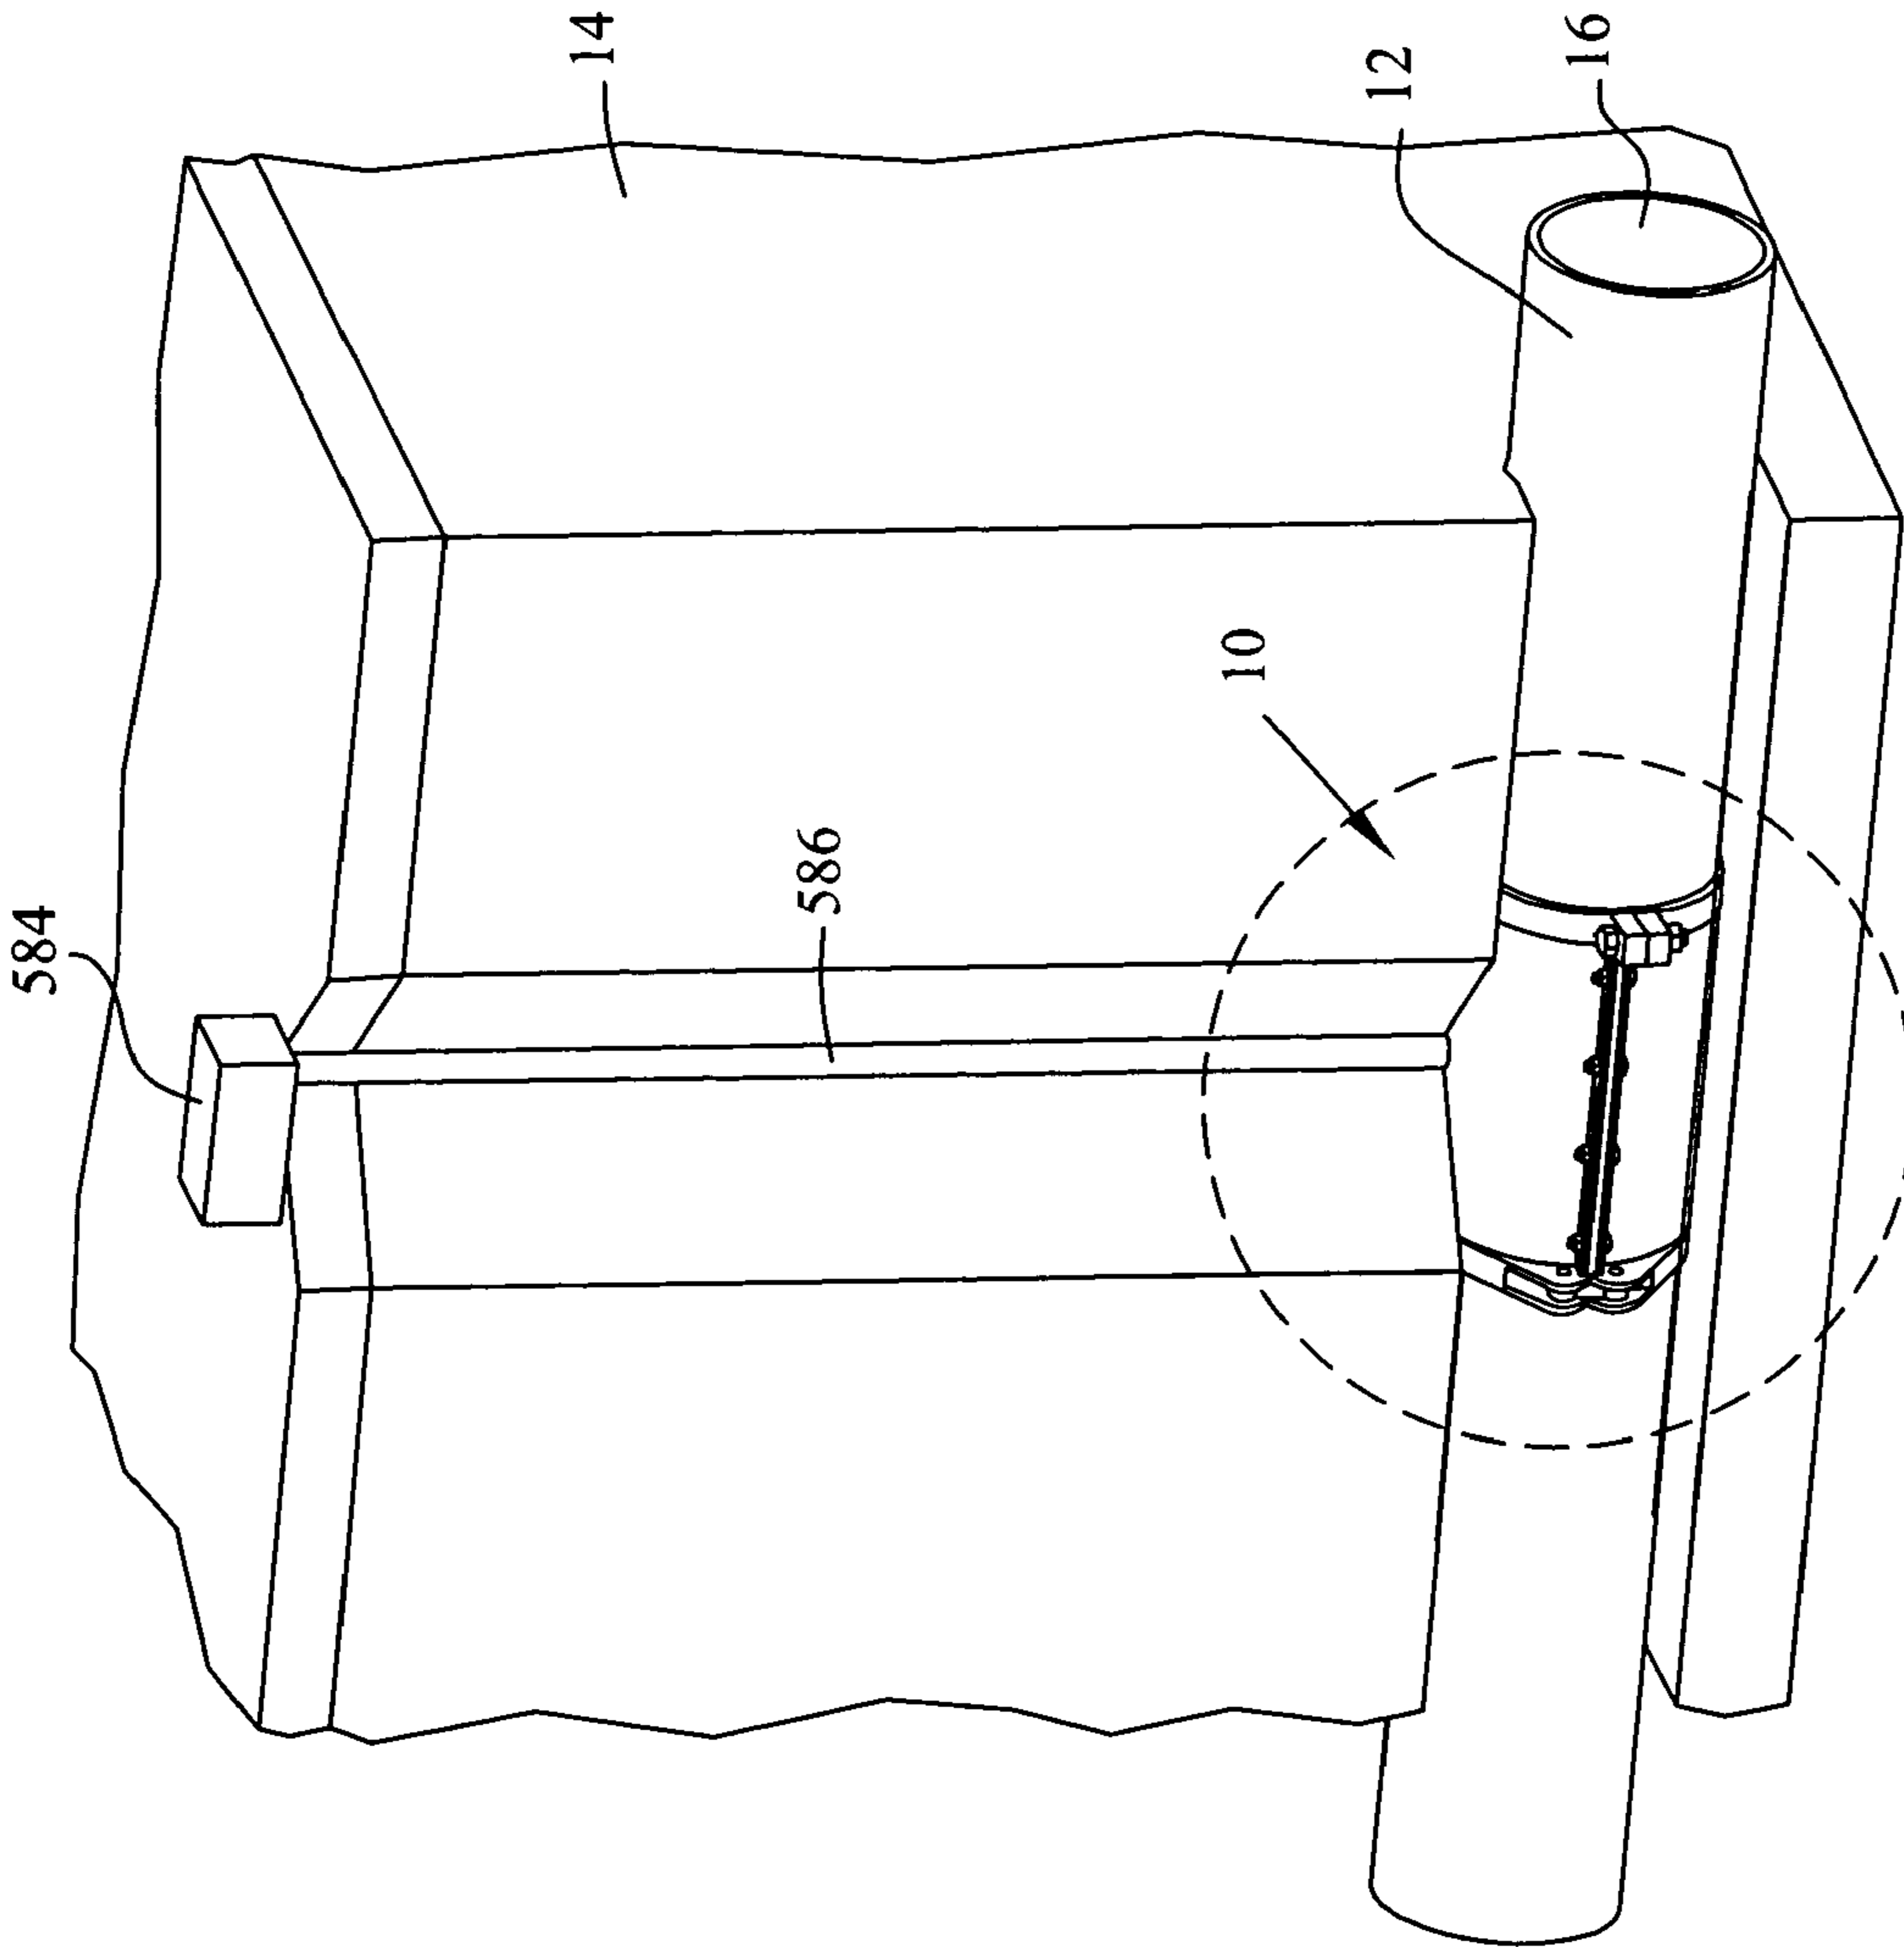
FIG. 1 is a perspective view of one embodiment of a repair assembly of the present invention as installed on a pipe at a site in the field;

Now referring to FIGS. 1 and 1A, a composite repair assembly, generally indicated as 10, is shown for a field installation repair. Composite repair assembly 10 is installed on a pipe or pipeline 12, which is mounted in or under the ground 14. Pipe 12 includes an internal passageway 16 through which a material (not shown) to be transported through pipe 12 is contained. Composite repair assembly 10 may be used to prepare a localized defect or damaged area 18 of pipe 12 (see FIG. 3). Pipe 12 may be manufactured from most known and commercially available pipe materials including steel or other metals, or plastic pipe, such as high-density polyethylene.

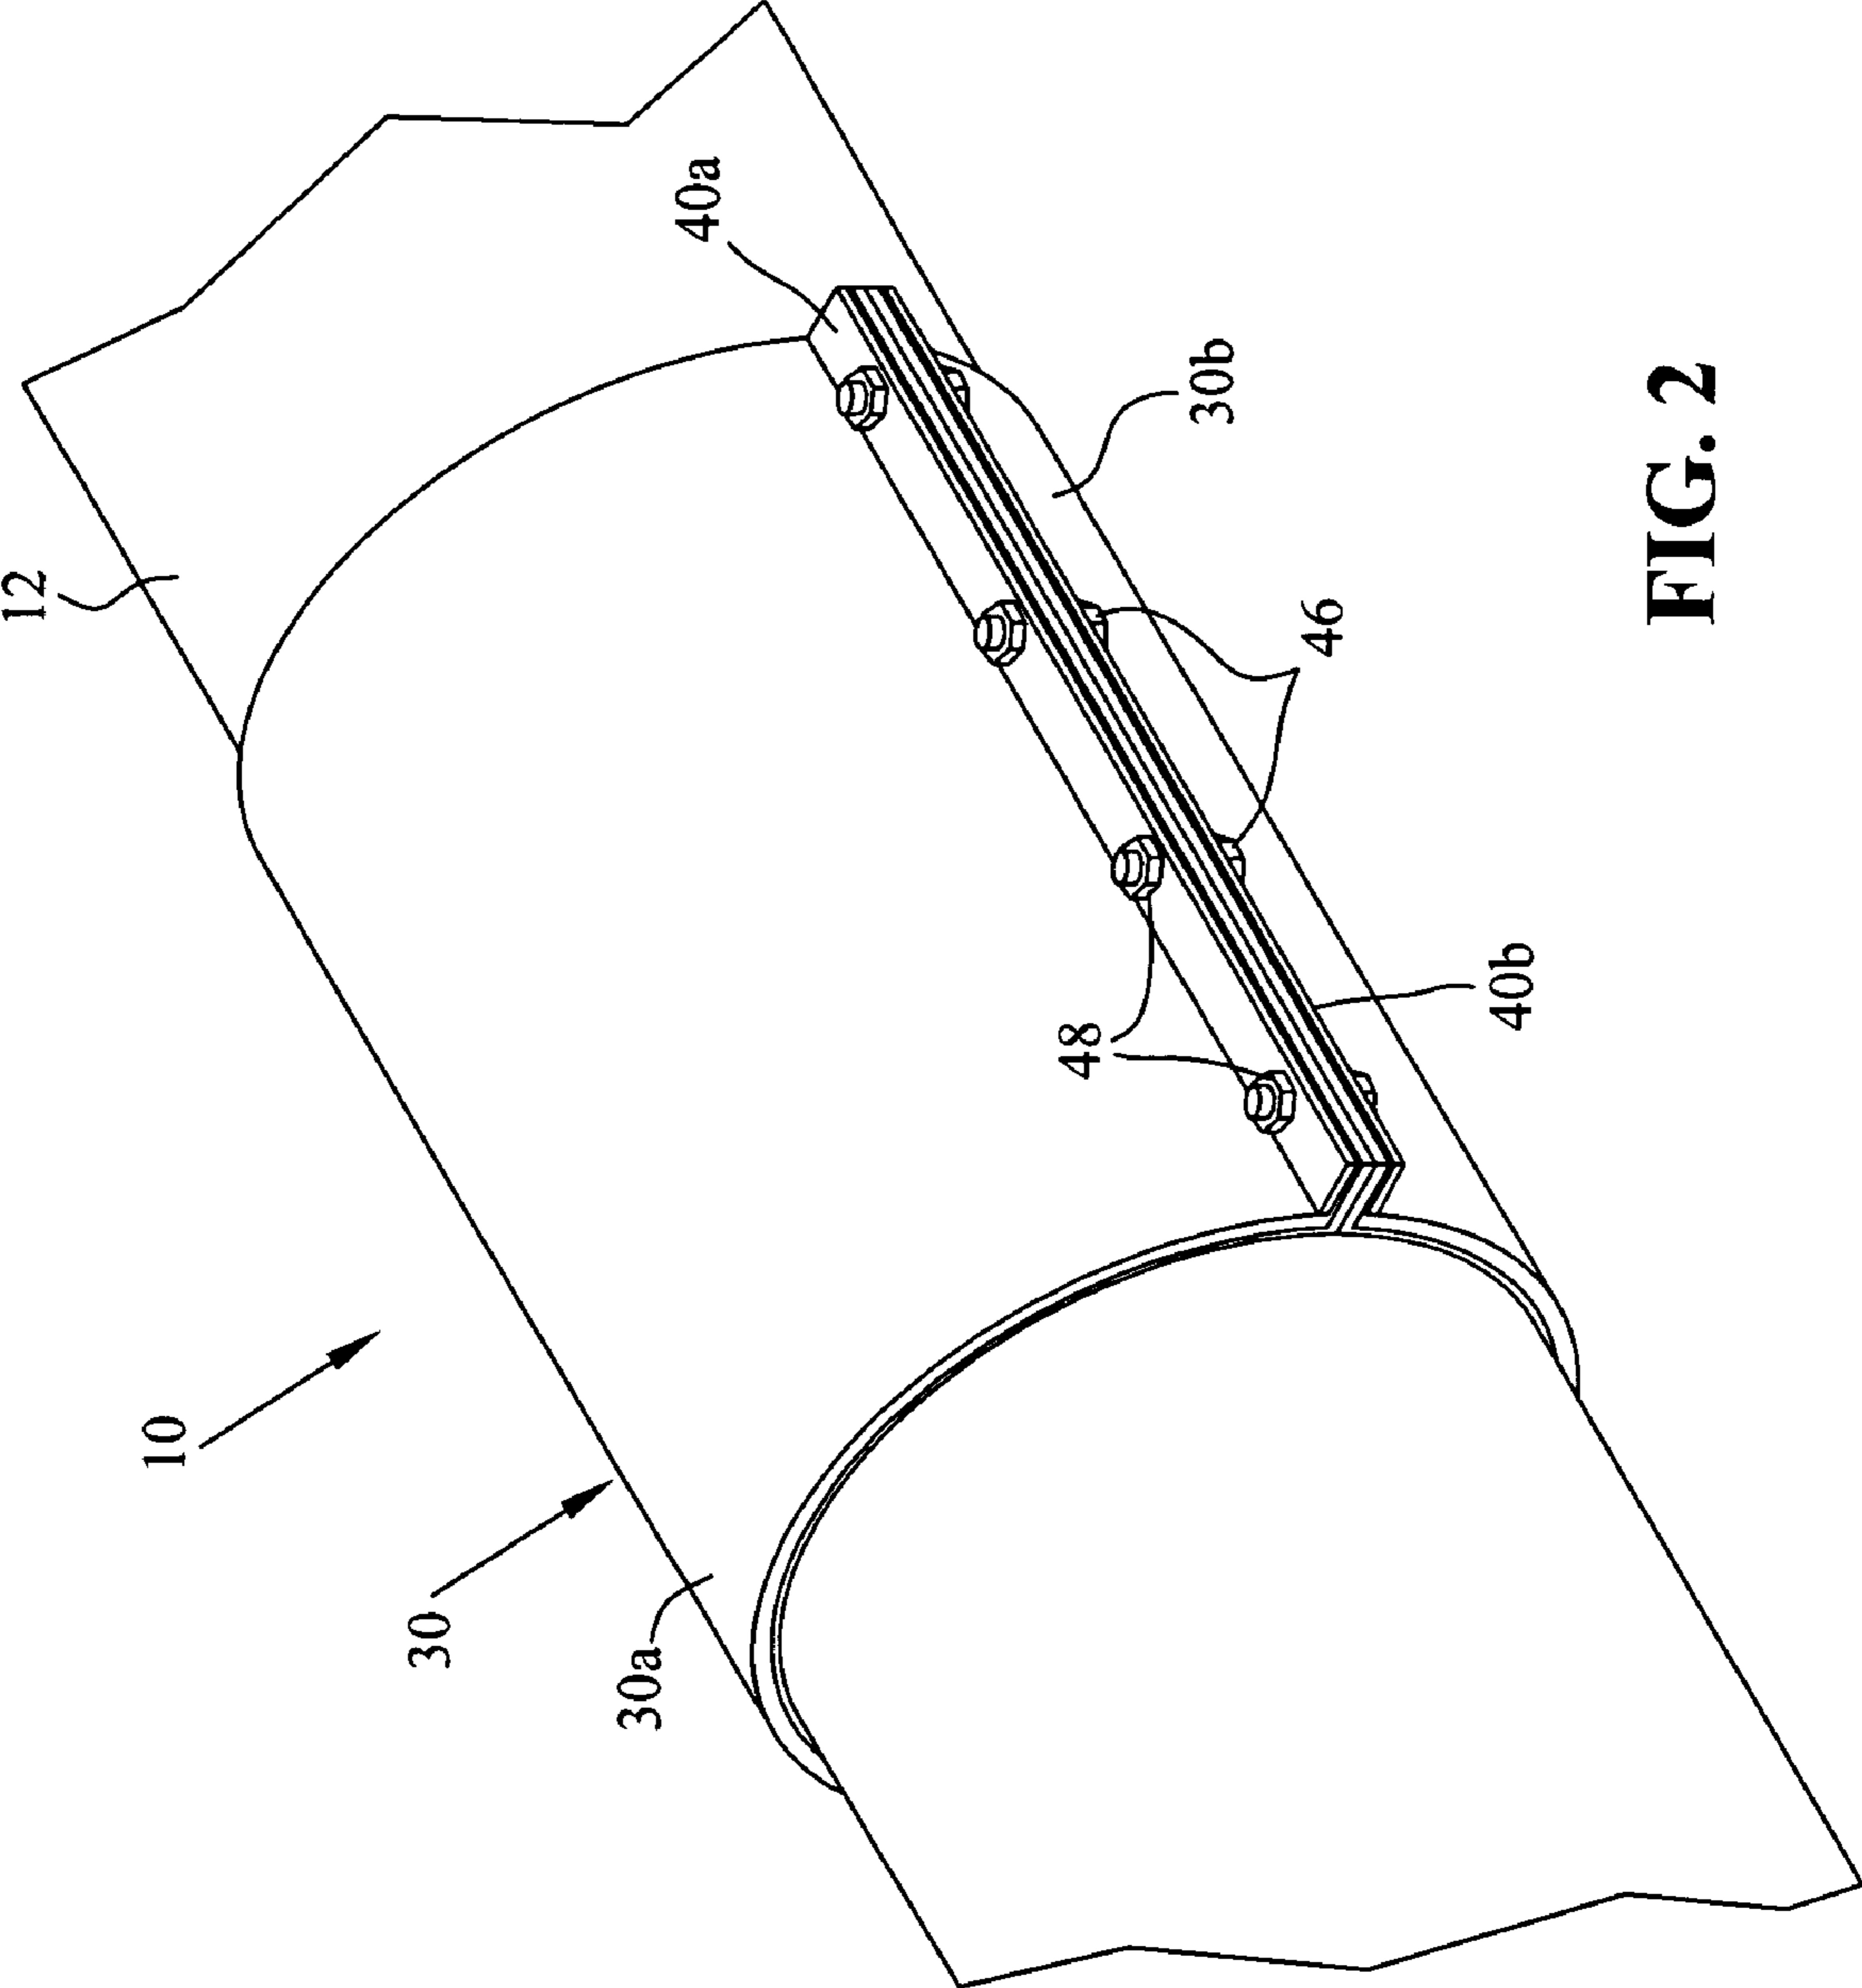
FIG. 2 is a perspective view of the repair assembly removed from the ground;

Now referring to FIGS. 2-4, in this embodiment, composite repair assembly 10 includes a layer of thermoplastic material, generally indicated as 20, and includes two semicylindrical halves of thermoplastic material 20a and 20b, as best shown in FIG. 3. Outwardly extending flanges 22a and 22b are provided along longitudinally extending respective side edges of halves 20a and 20b. Flanges 20a and 20b include a number of holes 24 for receipt of fasteners. As used herein,

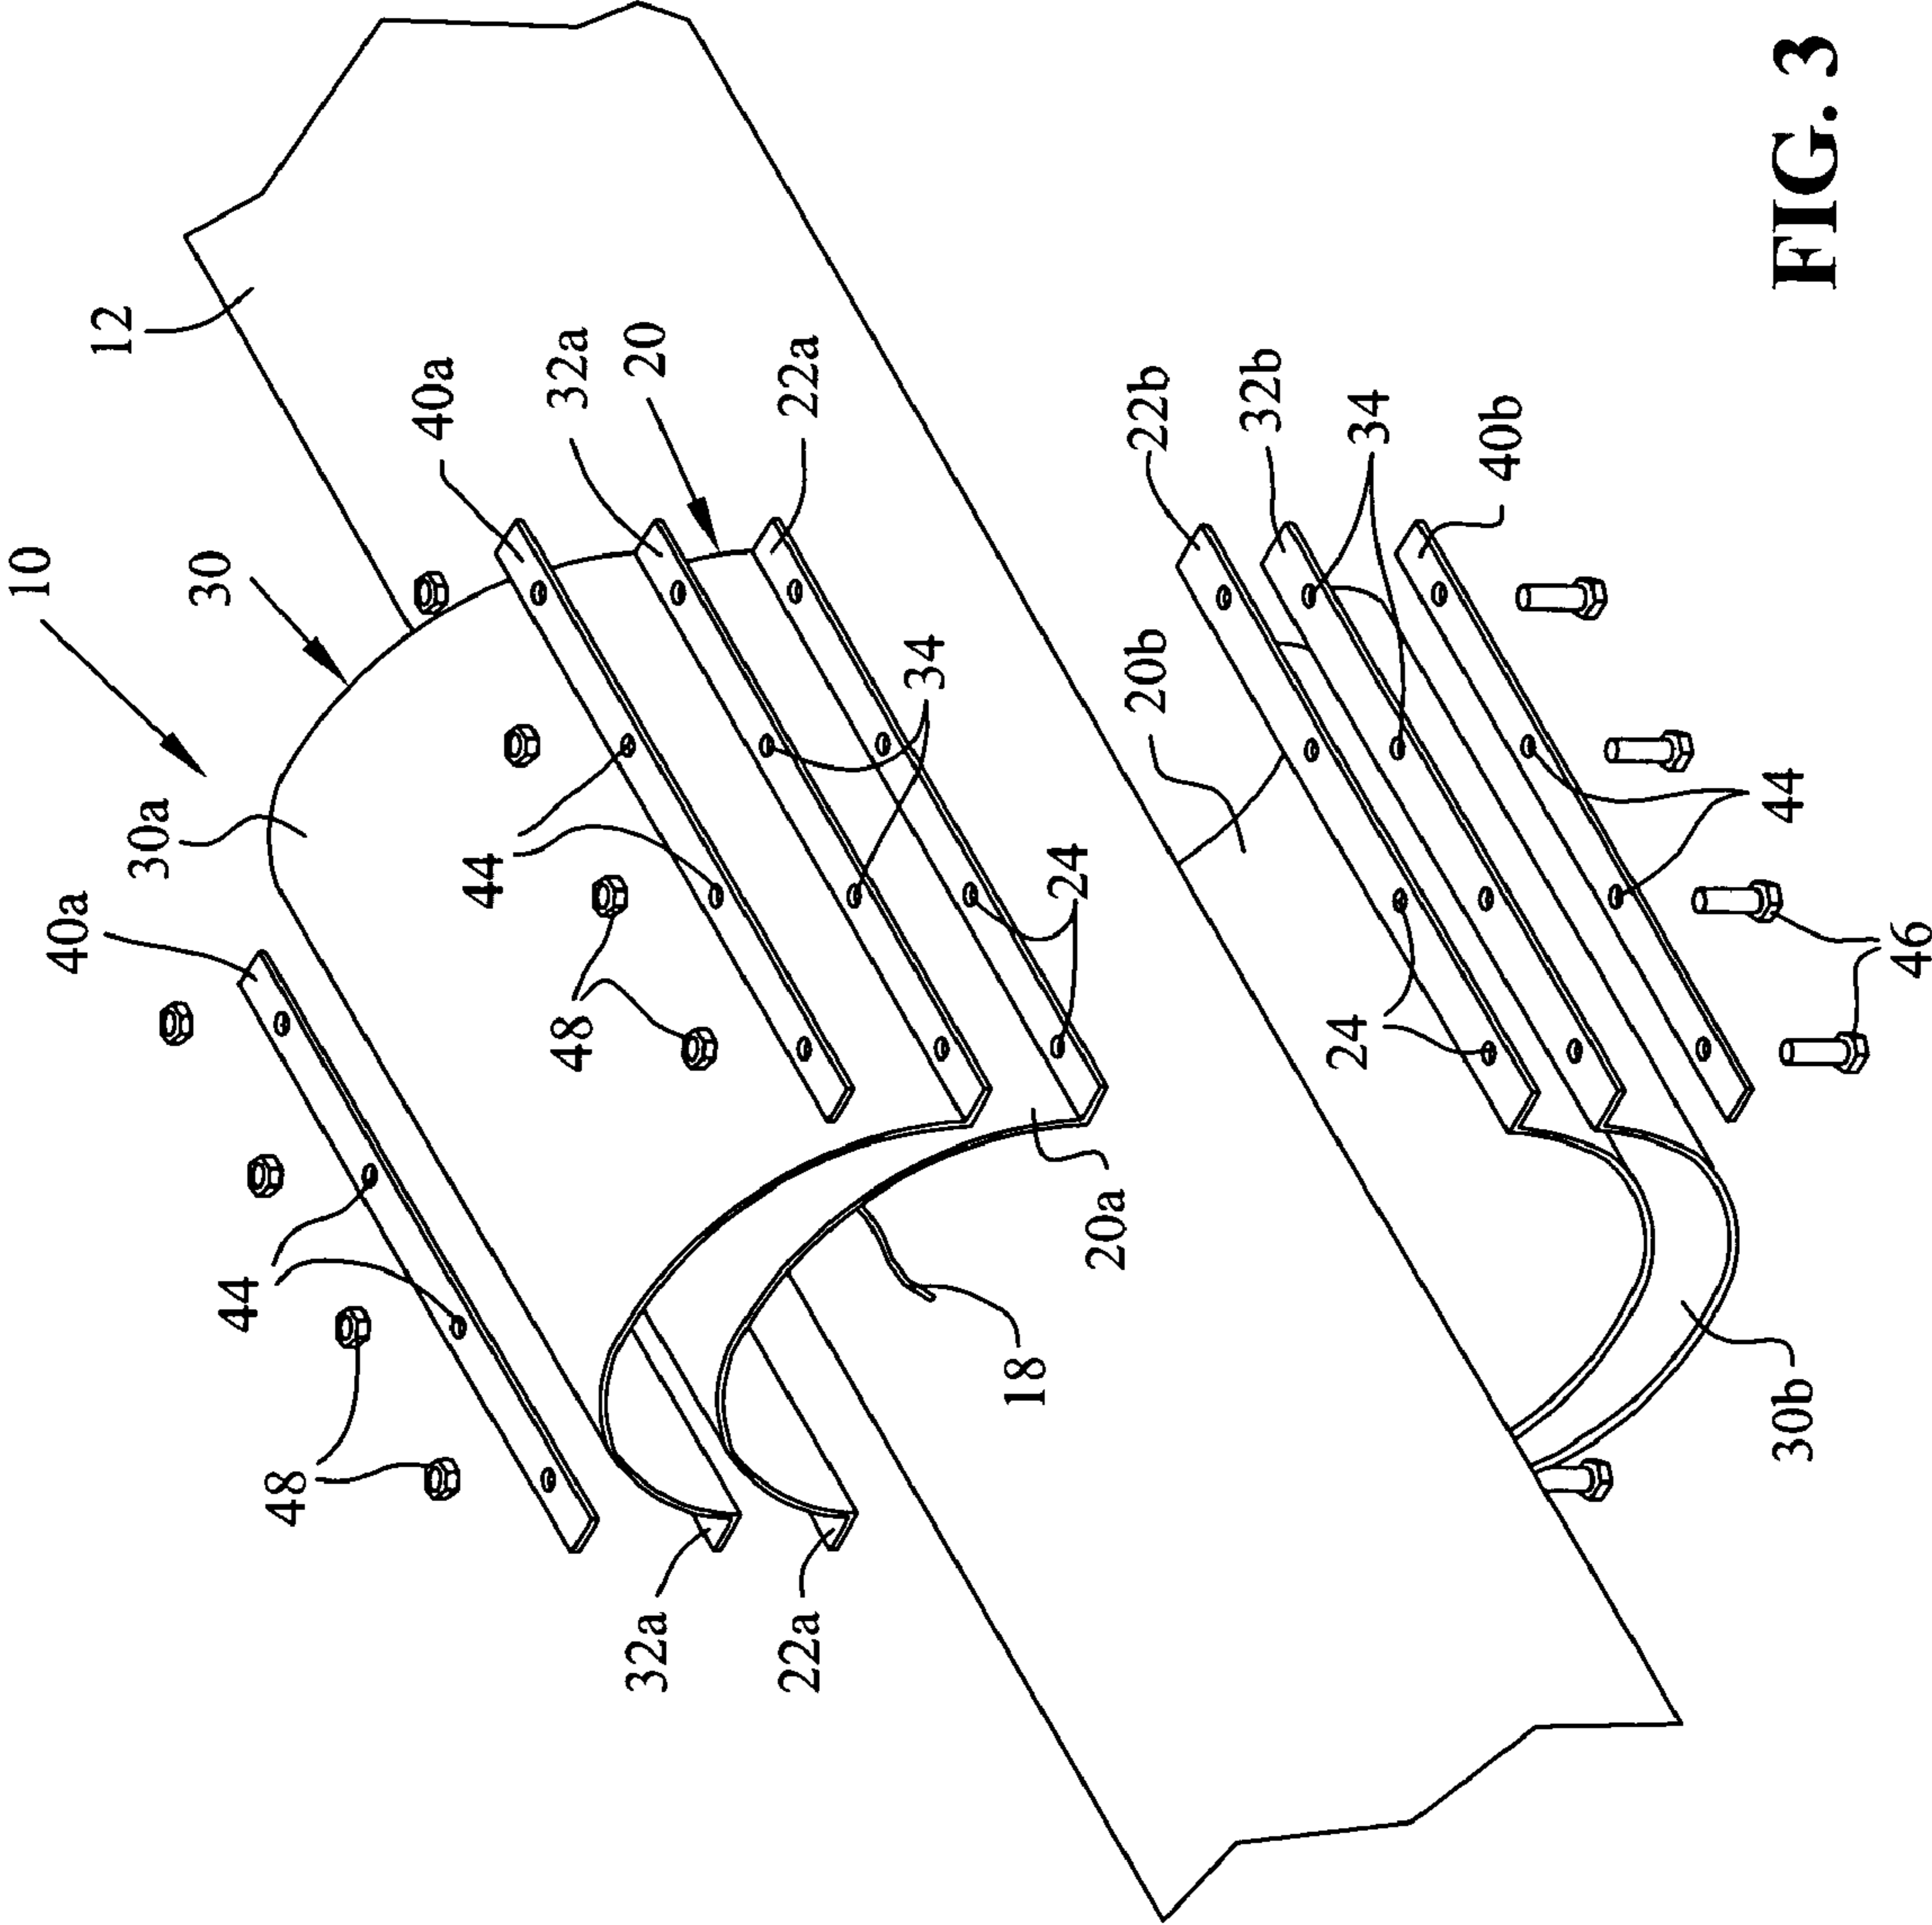
FIG. 3 is an exploded perspective view of the repair assembly of FIG. 2;

Composite repair assembly **10** also includes an overpress, generally indicated as **30**, which in this embodiment includes two semicylindrical halves **30a** and **30b**. As with the layer of thermoplastic material **20**, overpress **30** also includes outwardly extending flanges **32a** and **32b** along respective longitudinally extending side edges of halves **30a** and **30b**. Flanges **32a** and **32b** include holes **34** for receipt of fasteners. Overpress **30** may be manufactured from a light gauge aluminum or other metal that is designed primarily to provide compression to the thermoplastic layer of material **20**, as opposed to providing the structural strength for the repair of pipe **12**.

Composite repair assembly **10** also includes reinforcement members **40a** and **40b** having holes **44**, as well as bolts or fasteners **46** and nuts **48**. It should be appreciated that reinforcement members **40a** and **40b** should be sufficiently strong to hold flanges **22a**, **22b** and **32a**, **32b** together without significant bending or distortion upon heating and cooling. In addition, it should be appreciated that reinforcement members **40a** and **40b** may take on other suitable configurations including, but not limited to, washers or other intermittent members.

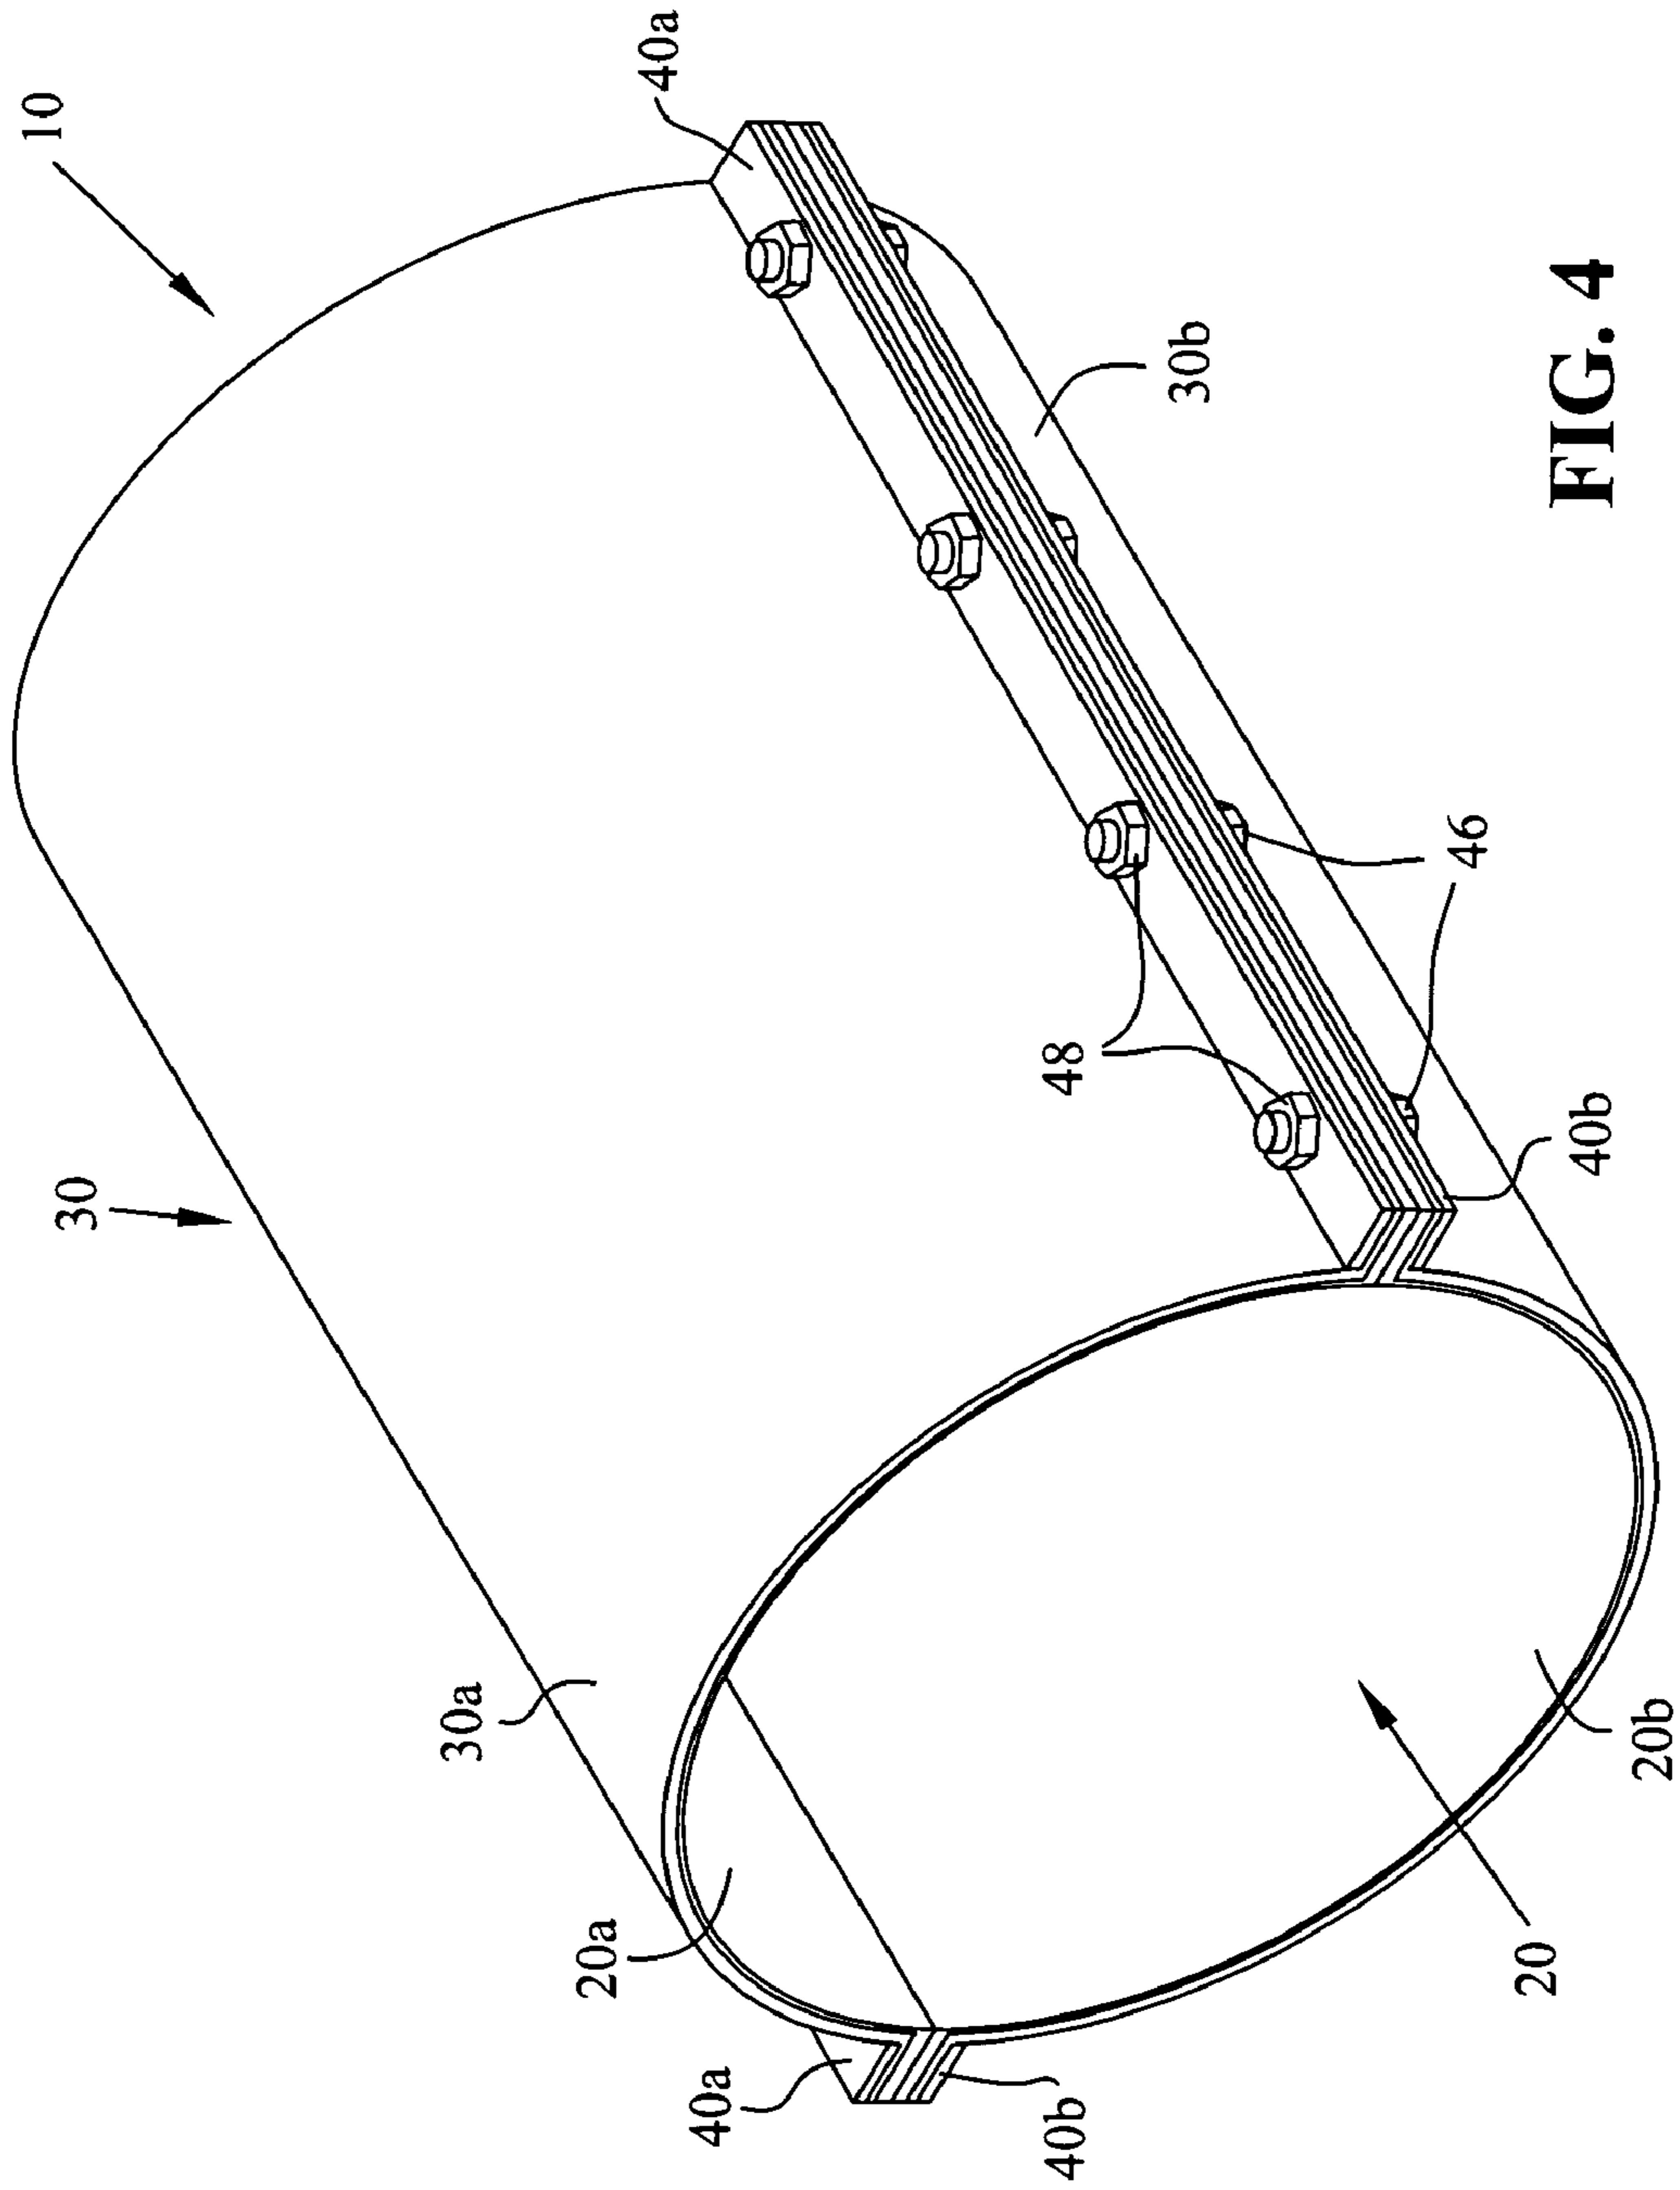
FIG. 4 is a perspective view of the repair assembly of FIG. 2 removed from the pipe;

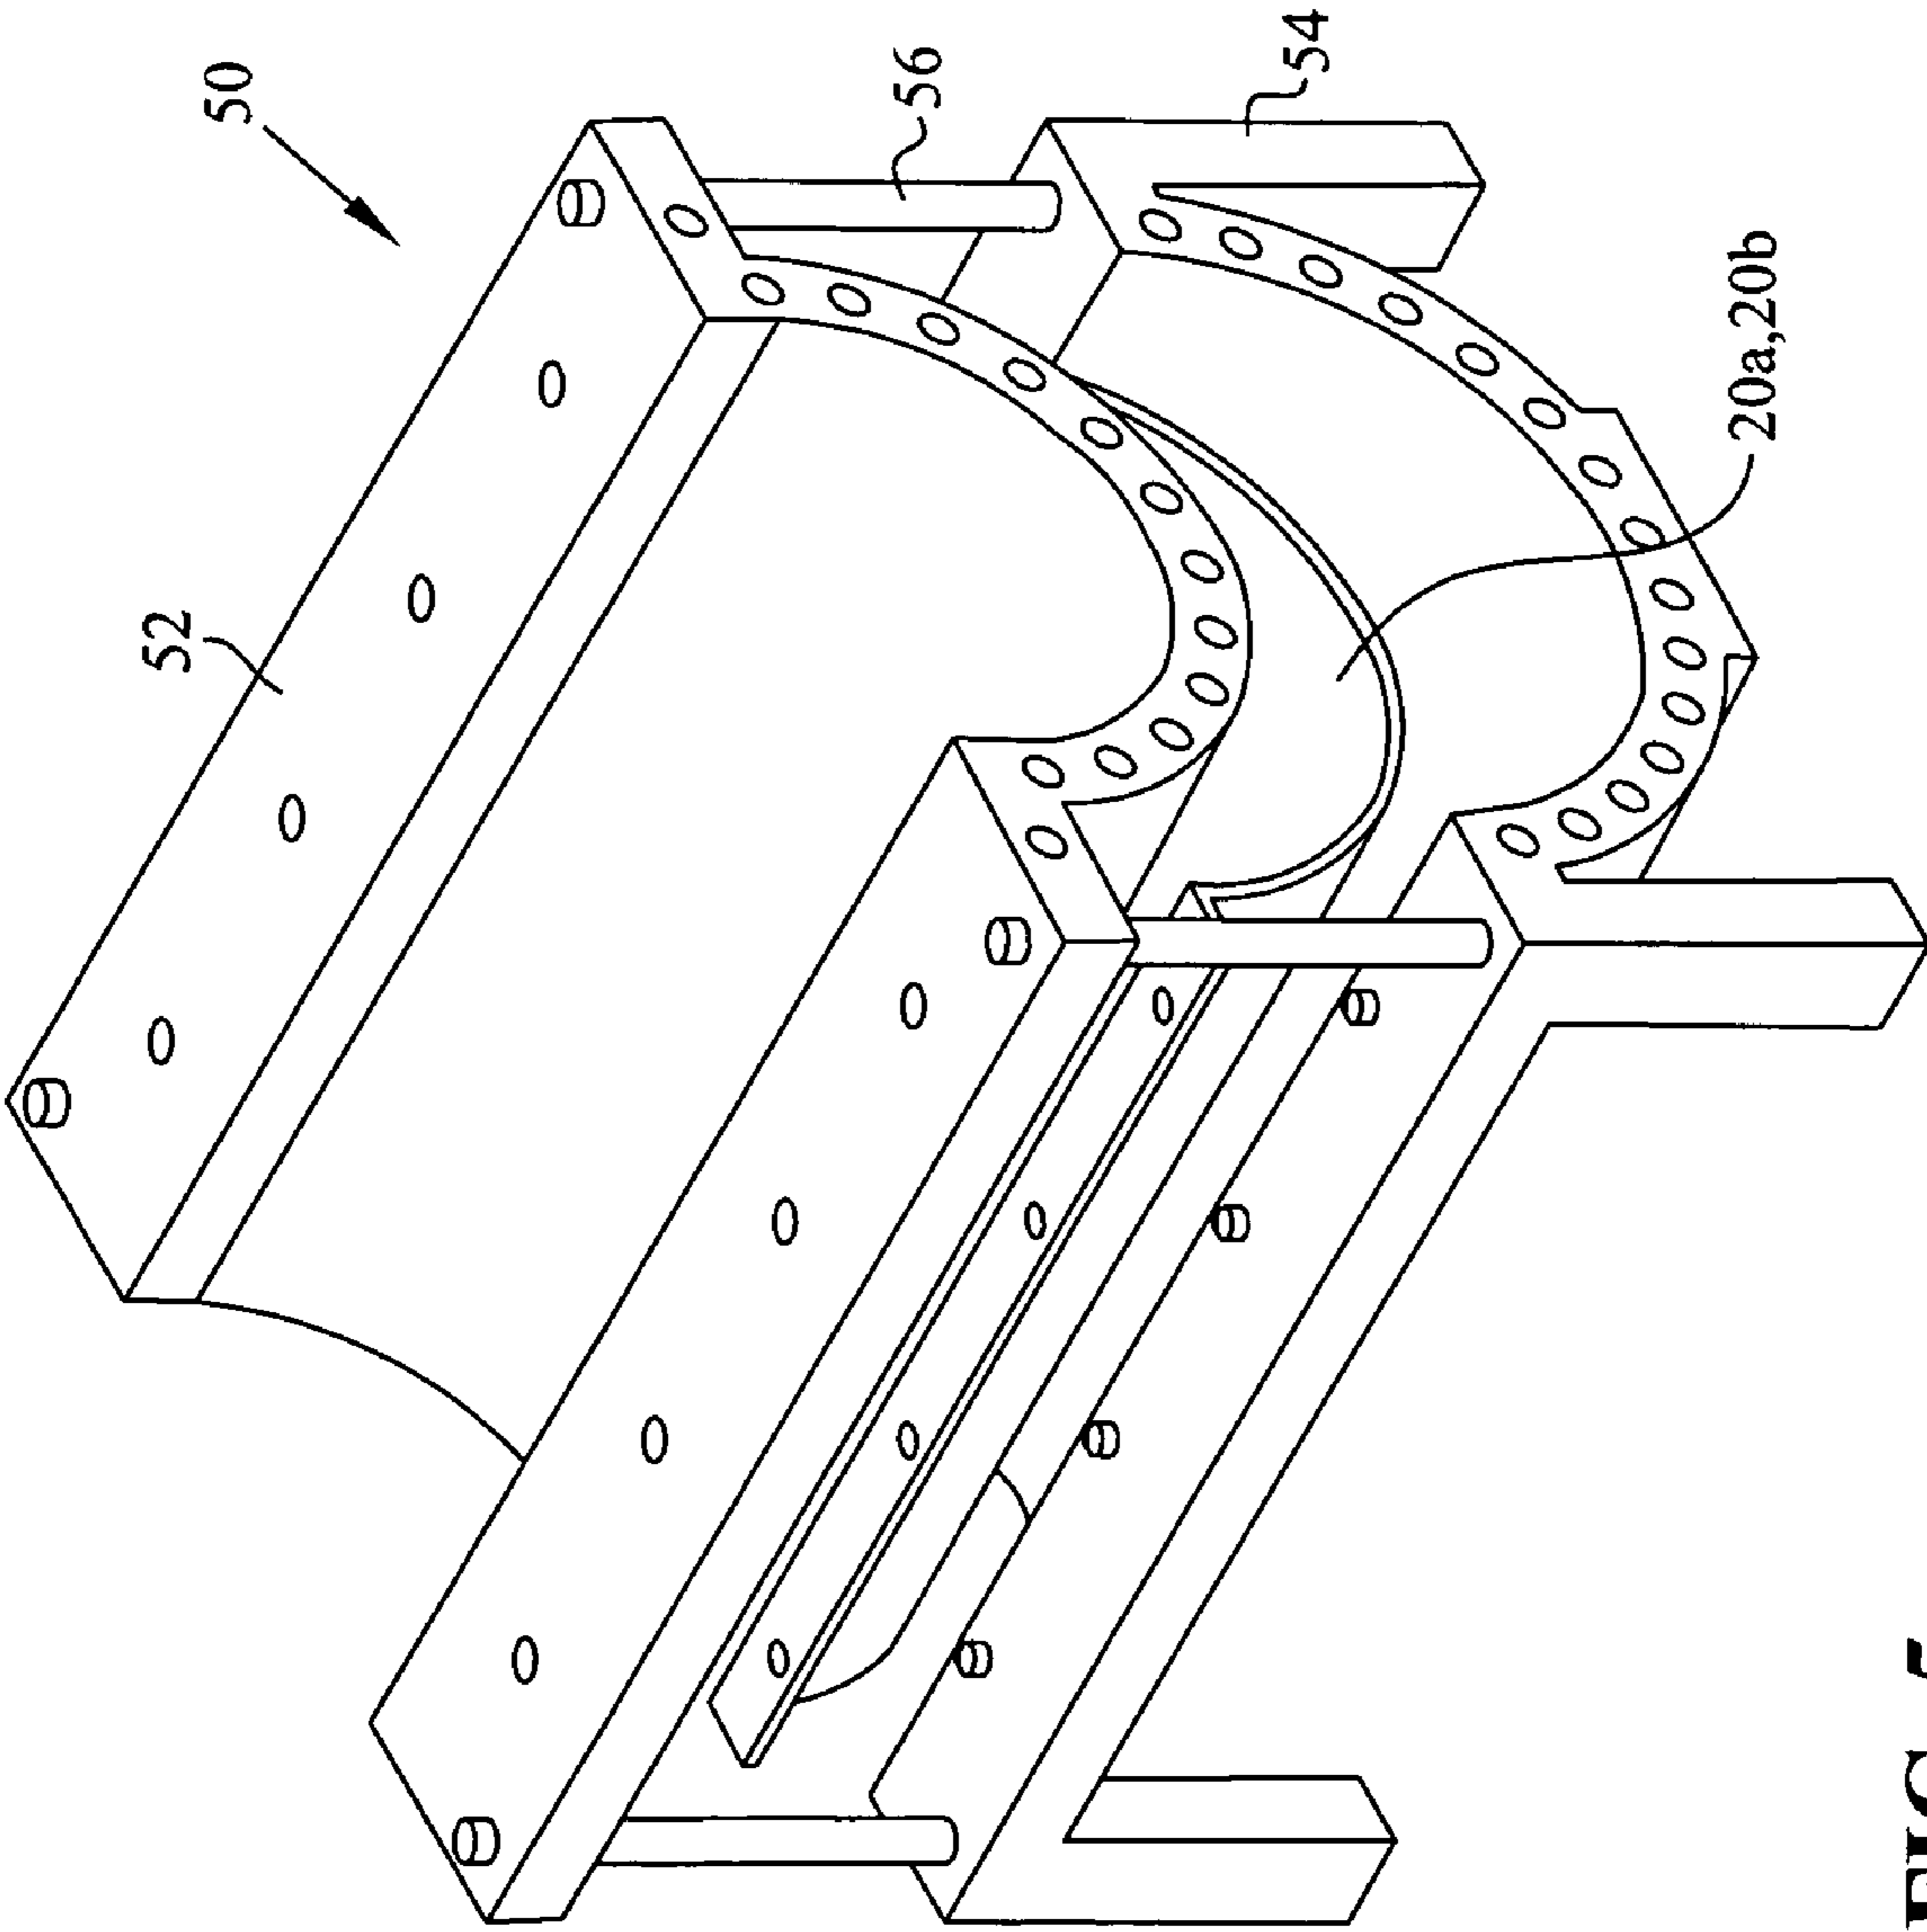
FIG. 5 is a perspective view of one-half of a composite molded sleeve and mold for making the sleeve for use in the repair assembly of FIG. 2;
