(54) **COMPOSITE REPAIR FOR PIPES**
(75) Inventor: **Barton E. Bennett**, Mishawaka, IN (US)
(73) Assignee: **Odyssian Technology, LLC**, South Bend, IN (US)
(*) Notice: Subject to any disclaimer, the term of this patent is extended or adjusted under 35 U.S.C. 154(b) by 93 days.

A repair assembly is provided for repairing a pipe that in one embodiment includes a layer of thermoplastic material substantially surrounding the pipe in an area needing repair; a heating element located to provide heat to the layer of thermoplastic material; and an overpress at least partially surrounding the pipe and the layer of thermoplastic material. The layer of thermoplastic material may be configured as a sleeve surrounding the pipe, and the sleeve may be configured in two semicylindrical halves with longitudinal seams where the semicylindrical halves meet. The seams extend generally parallel to a longitudinal axis of the pipe, and the sleeve may further include outwardly extending flanges along the edges of the semicylindrical halves at the seams.

COMPOSITE REPAIR FOR PIPES

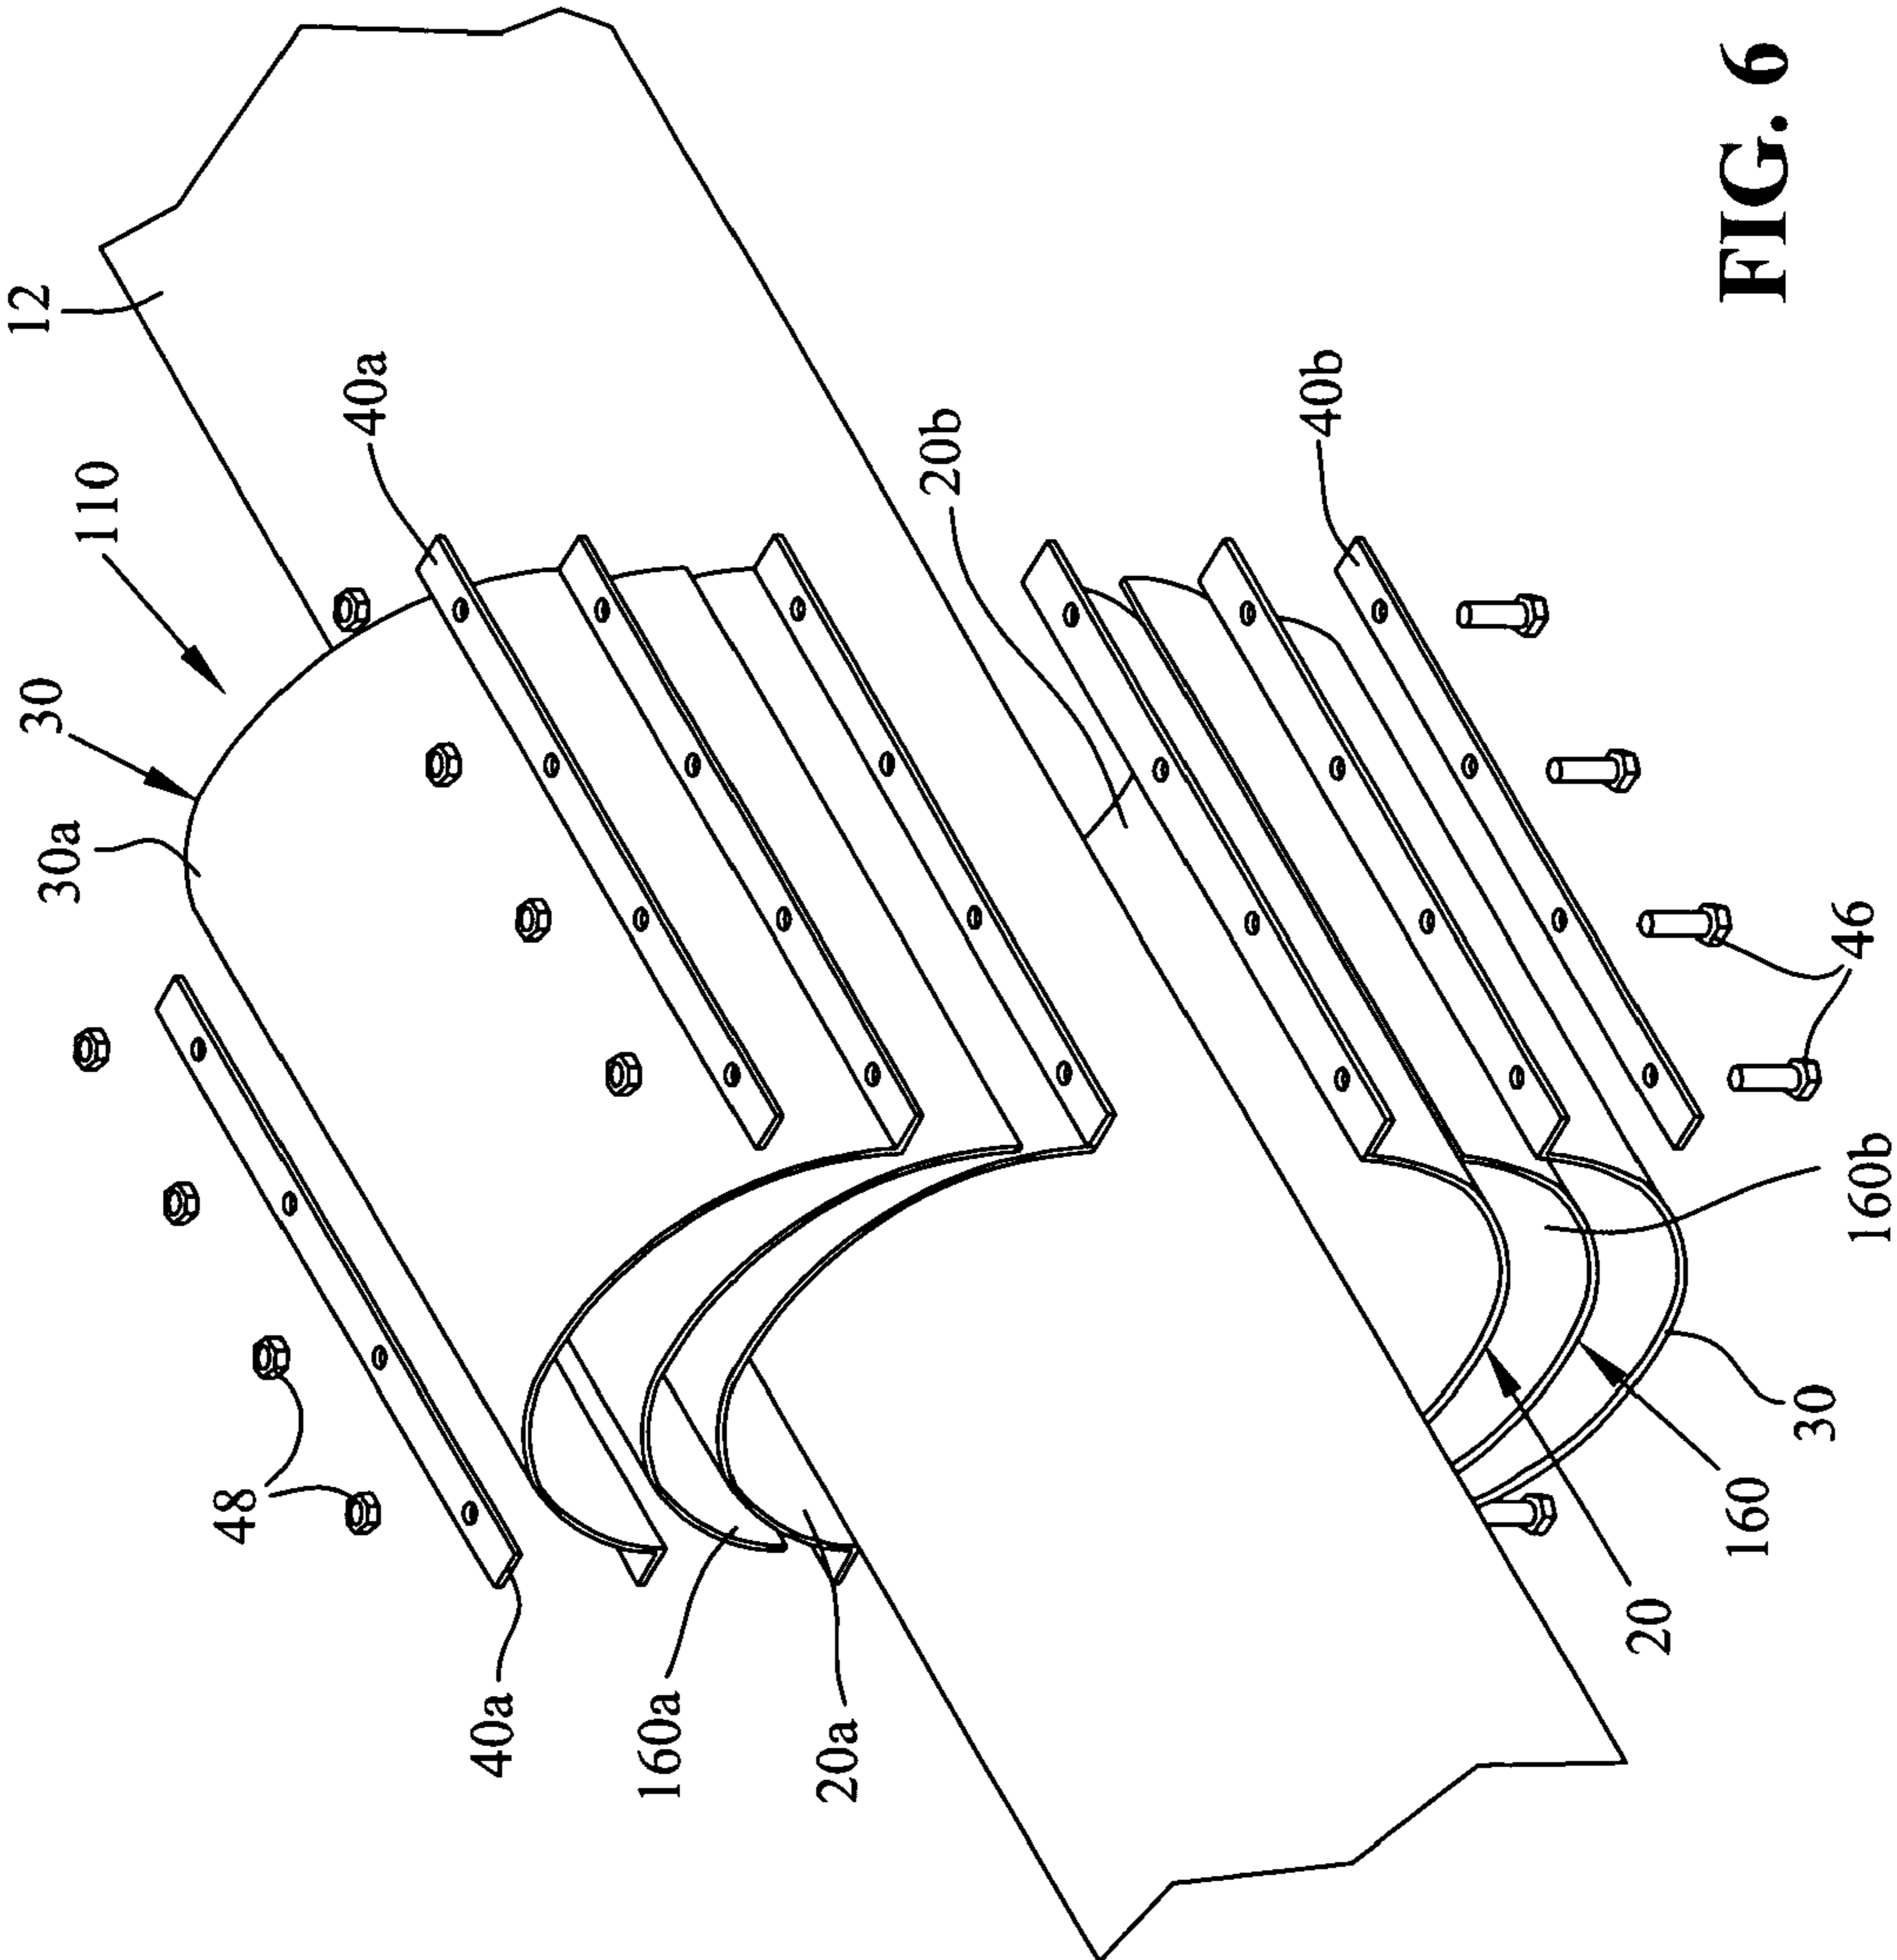
FIG. 6 is an exploded perspective view of an alternate embodiment repair assembly including a layer of material having a high coefficient of thermal expansion;

Referring now to FIGS. **6** and **7**, an alternate embodiment composite repair assembly is shown generally as **110**. Repair assembly **110** is configured to repair an area in pipe **12** and similar to composite repair assembly includes thermoplastic material layer **20** having semicylindrical halves **20a** and **20b**; overpress **30** having semicylindrical halves **30a**, **30b**; and reinforcement members **40a**, **40b**. In addition, composite repair assembly **110** also includes a layer of high Coefficient of Thermal Expansion (CTE) material, generally indicated as **160**. In this embodiment, layer **160** of high CTE material has two semicylindrical portions **160a** and **160b**. It should be appreciated that layer of high CTE material **160** may be provided independently of layer **20** and overpress **30** or alternately, may be preattached to one or the other. Each half **160a**, **160b** may be attached to the respective semicylindrical half **20a**, **20b** or **30a**, **30b** using an adhesive, tape, hook and loop fasteners or other known ways of attachment. Layer **160** is preferably a rubberized or elastomeric material, including, but not limited to, rubber, Neoprene®, fluorocarbon, or fluorosilicon.

In installation and operation, the composite repair assembly **110** functions similarly to composite repair assembly **10**; however, layer of high CTE material **160** provides additional compression on layer of thermoplastic material **20** to provide enhanced sealing. Since layer **160** has a high coefficient of thermal expansion, when the repair assembly is heated, layer **160** will tend to expand more than either layer of thermoplastic material **20** or overpress **30**. Accordingly, as overpress **30** restricts outward expansion of layer **160**, layer **160** will tend to expand inwardly thereby pushing thermoplastic layer **20** even tighter about pipe **12** when heated to provide a better seal around area **18**. When the heat is removed, thermoplastic layer **20** will harden in the compressed state around pipe **12**.

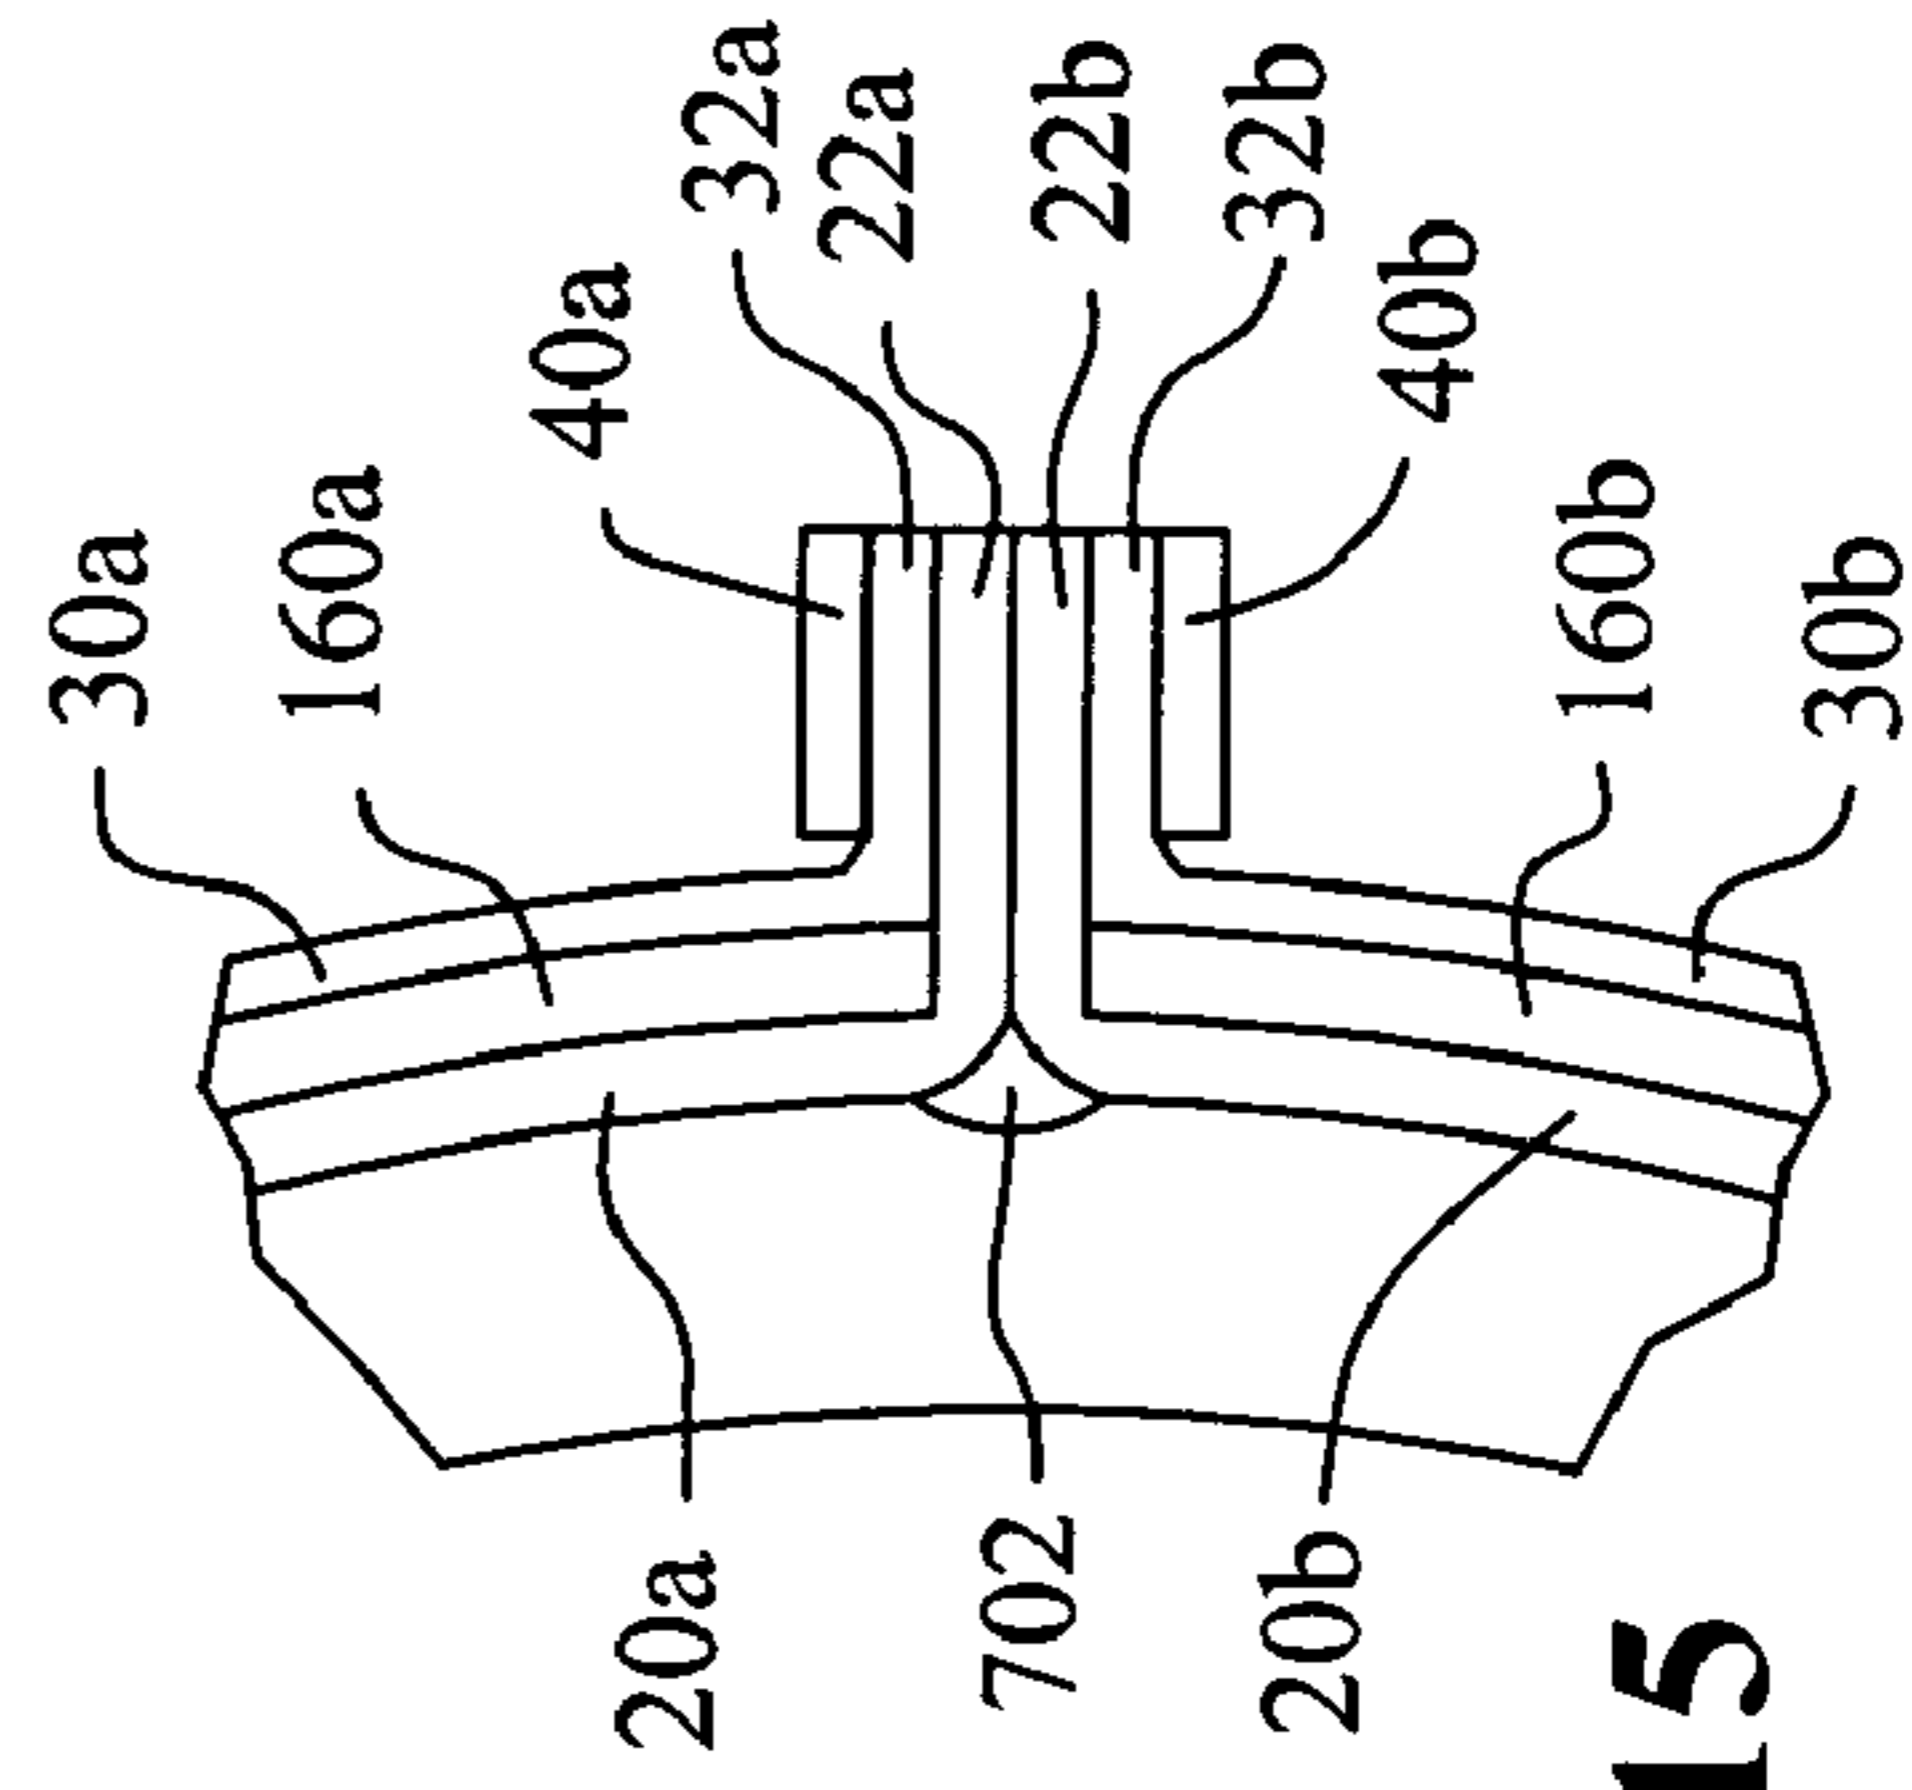
FIG. 15 is an end view of a portion of a composite repair assembly showing a sealing insert for use with the composite repair; and

Referring now to FIG. **15**, an optional sealing insert or sealing member **702** is provided. Sealing member **702** can be positioned along the inside diameter of the seam created by the joining of semicylindrical thermoplastic halves **20a** and **20b** and adjacent flanges **22a**, **22b**. As shown in FIG. **15**, the seam area between semicylindrical halves **20a** and **20b** may result in a recess that could possibly lead to a leak path of the repair. Accordingly, sealing member **702** may be placed at this juncture to enhance the sealing. The cross-sectional configuration of sealing member **702** in the embodiment shown has a generally triangular top end configured to be received in the gap between halves **20a** and **20b** and a rounded or flat head; however, it should be appreciated that any suitable configuration may be employed. Sealing member **702** may be manufactured from a similar material as thermoplastic layer **20** or may also be manufactured from high CTE material as is used to make layer **160**. One skilled in the art will recognize that other materials may also be used to provide sealing member **702**.

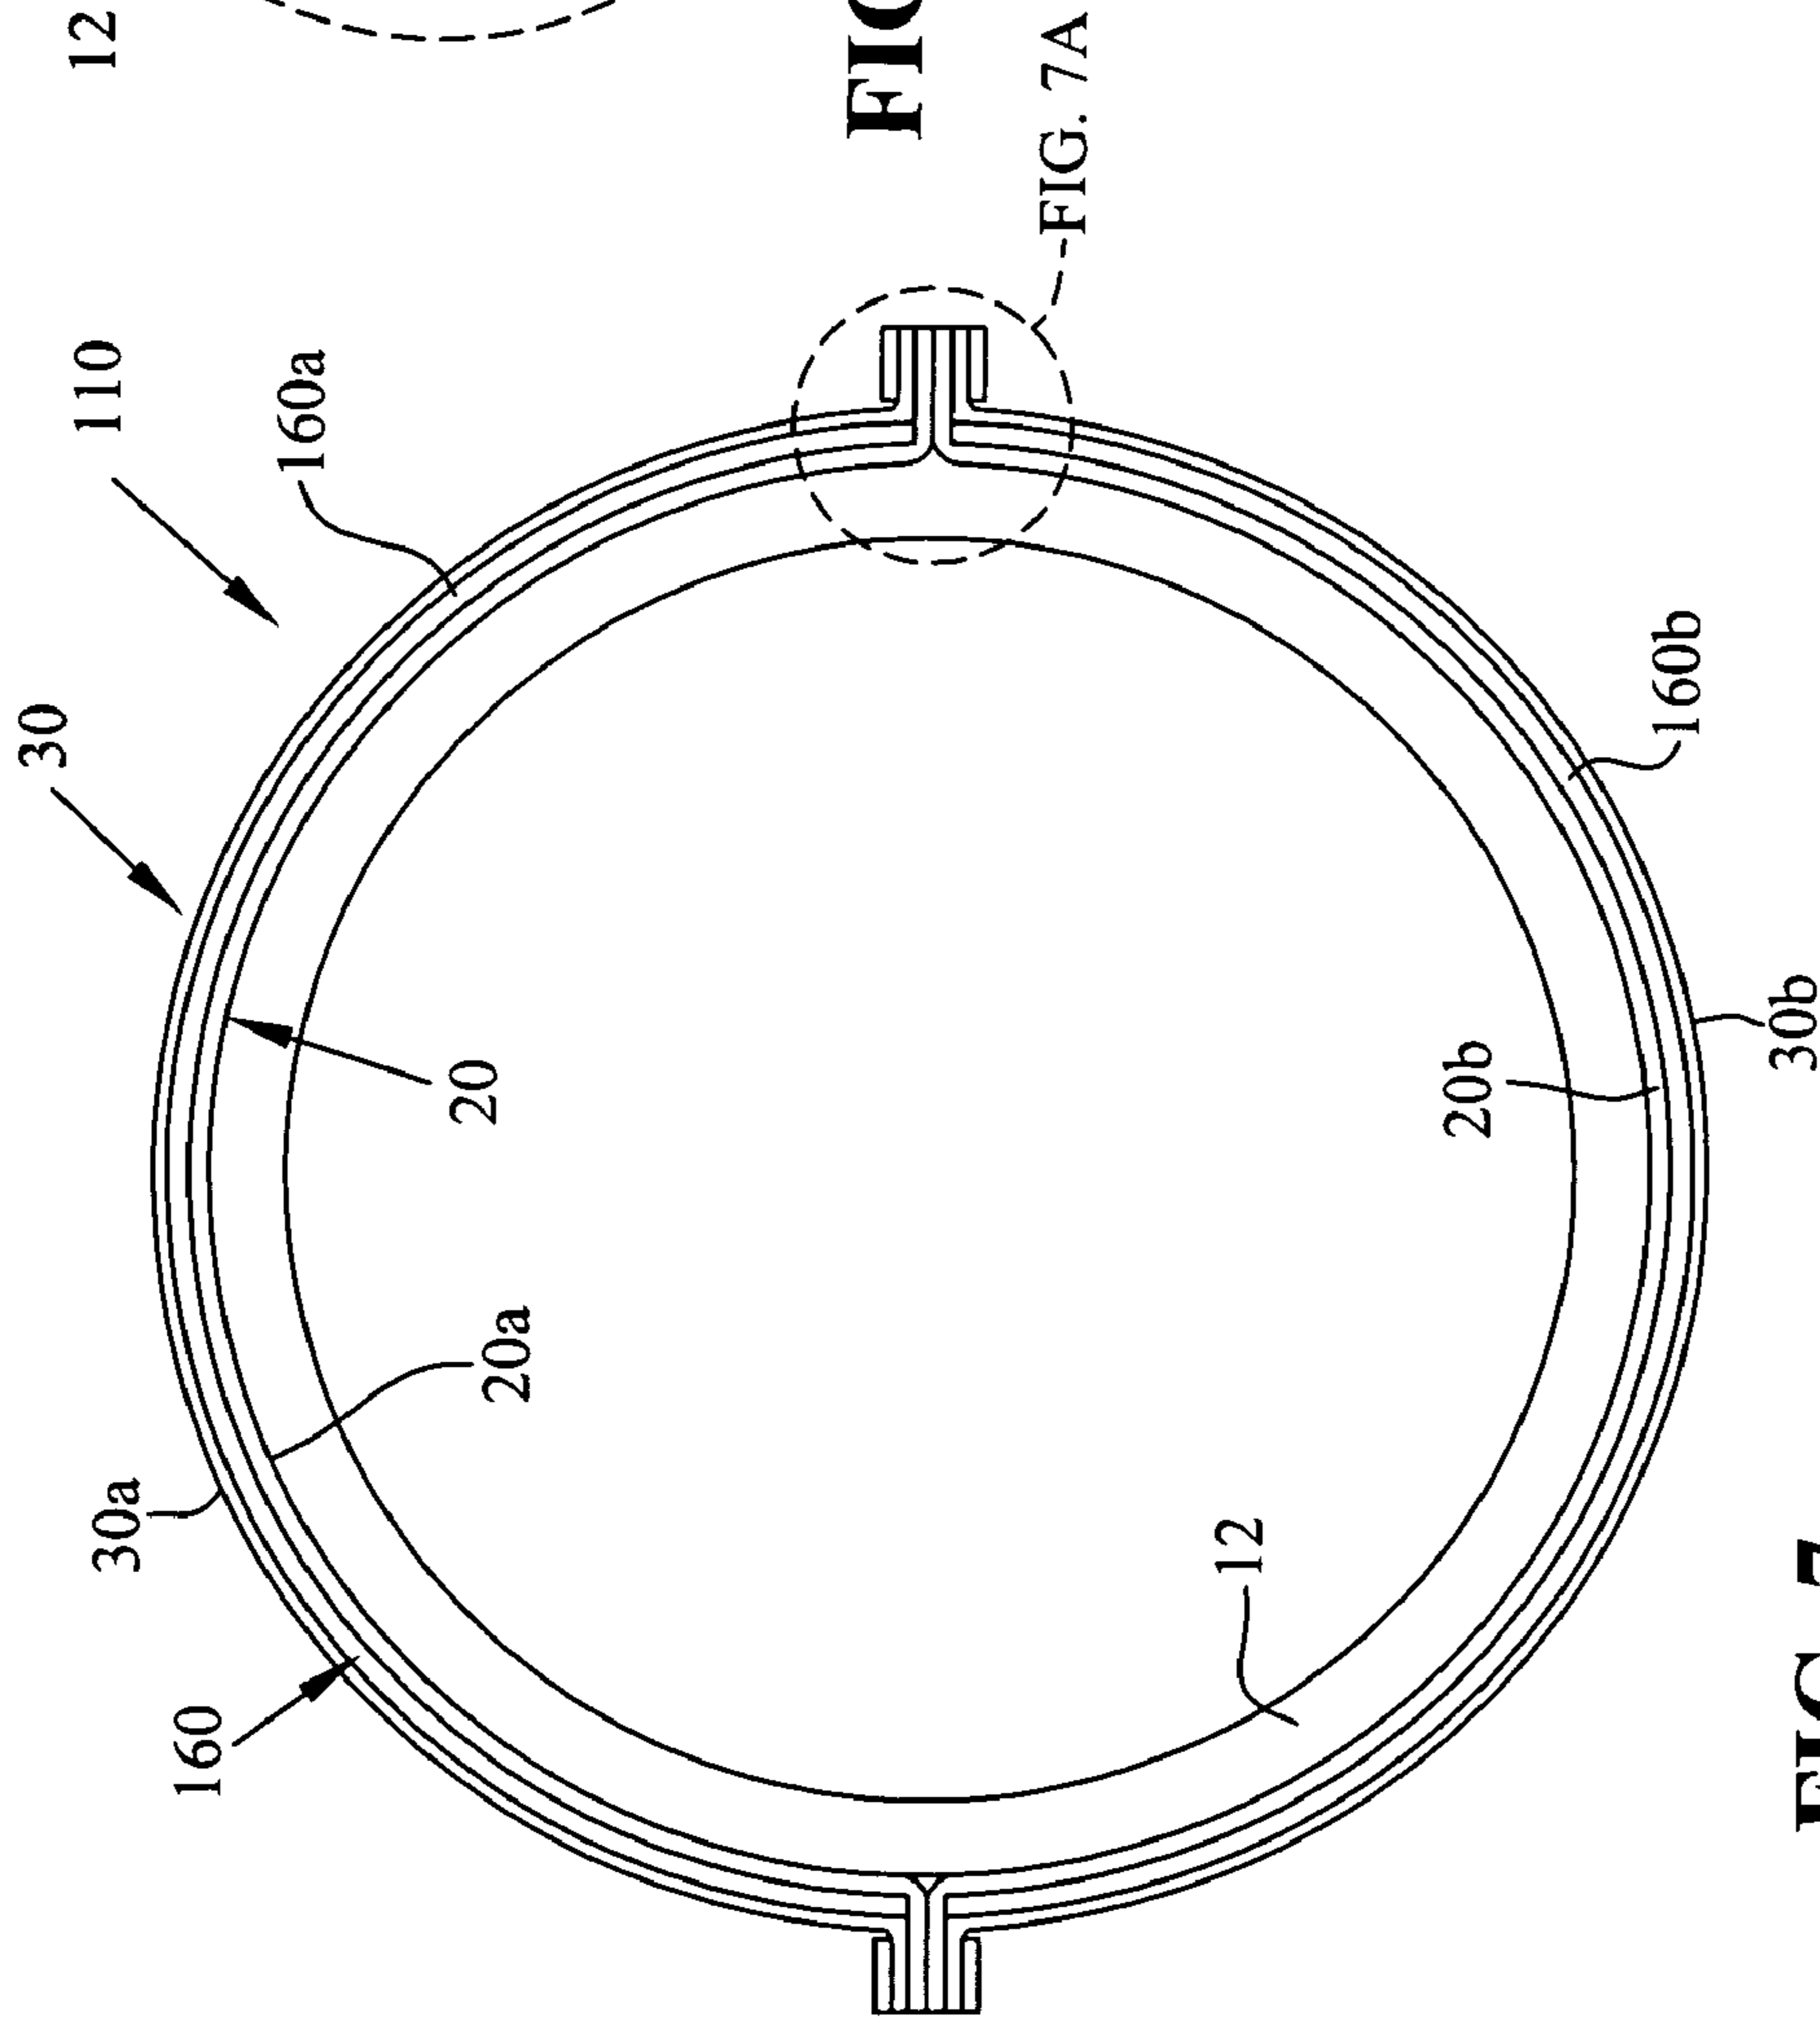
FIG. 7 is an end view of the repair assembly of FIG. 6;

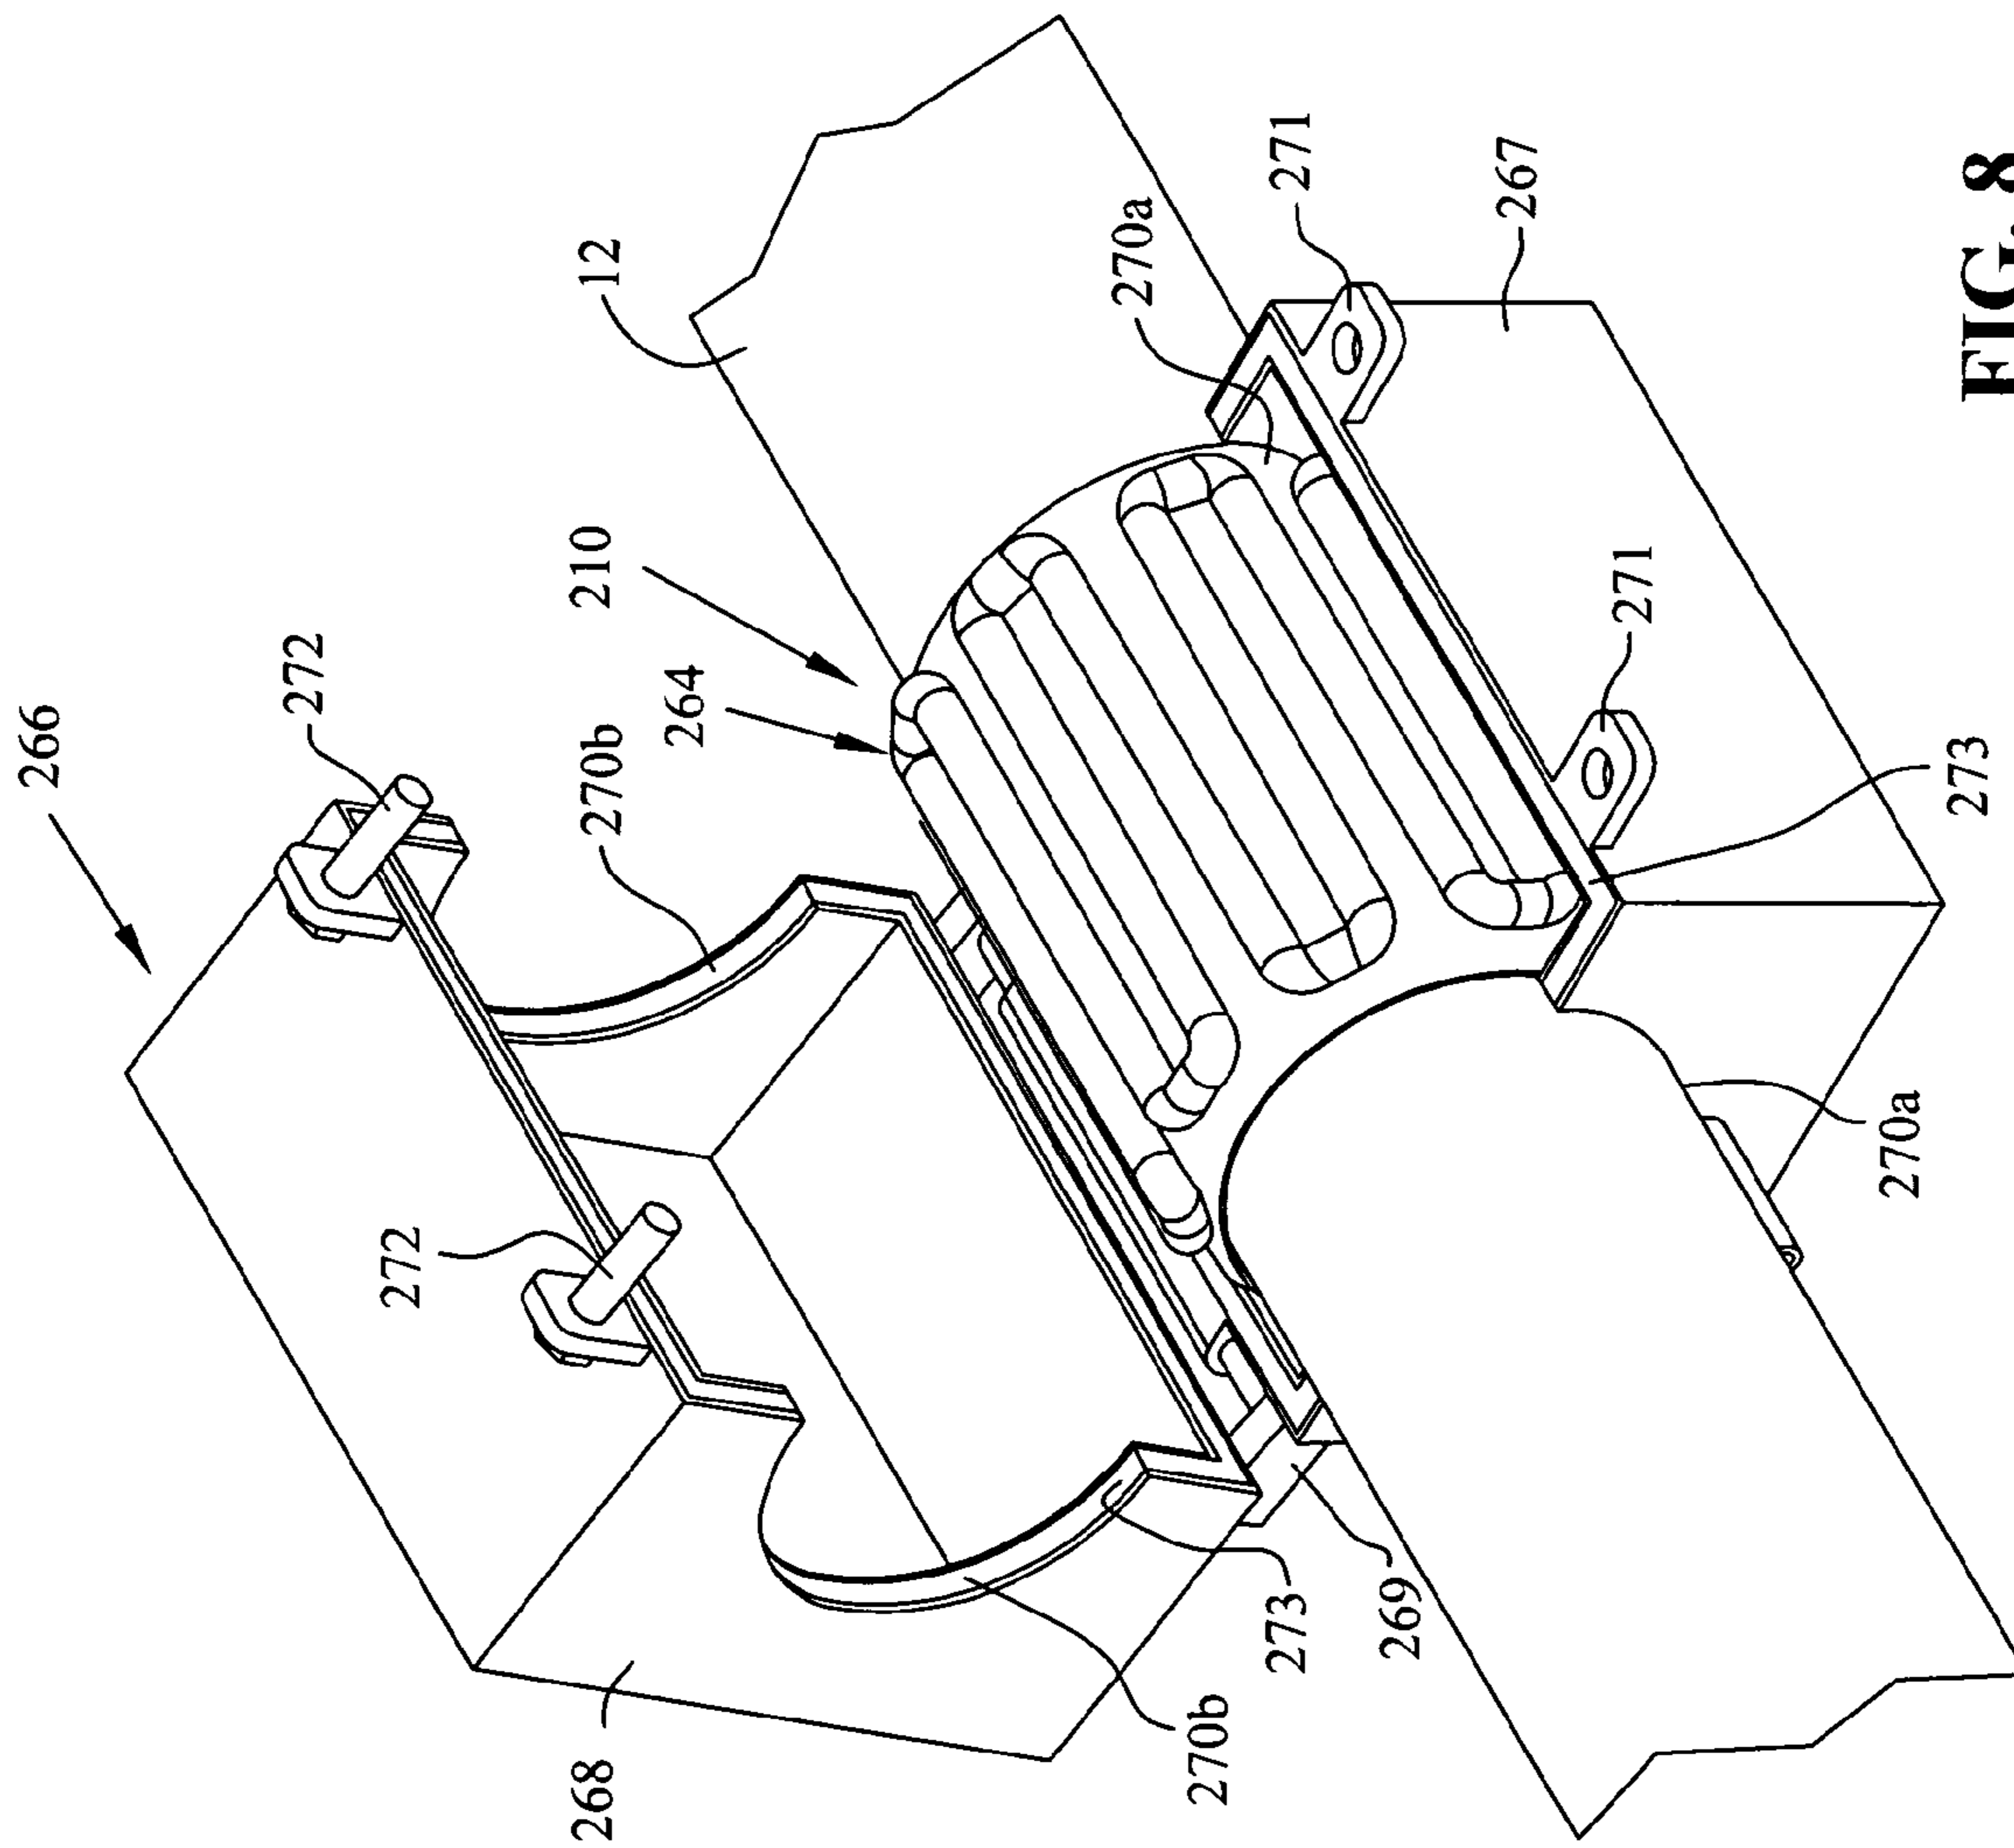
FIG. 8 is a perspective view of another embodiment of a repair assembly including an external heating assembly and heating container shown with the container in an open position;

Now referring to FIG. **8**, an alternate composite repair assembly, generally indicated as **210**, is shown and can include the components of either repair assembly **10** or repair assembly **110**, and in addition, includes a heating element(s) or source, generally indicated as **264**. Heating element **264** is provided in a sinusoidal configuration in the embodiment shown and may contain a fluid, such as hot oil, that provides and transfers heat to composite repair assembly **210**. It should be appreciated that other configurations and types of heating elements may be used with the present assembly as discussed above. Composite repair assembly **210** also includes a hot box/thermo-insulating container, generally indicated as **266**, for holding the heat in composite repair assembly **210** and pipe **12** until the repair is complete. In the embodiment shown, hot box **266** includes a bottom portion **267**, a top portion **268** and a hinged connection **269** connecting bottom portion **267** and top portion **268**. Bottom portion **267** and top portion **268** each include semicircular openings **270a** and

270*b*, which form circular openings when hot box 266 is closed to allow pipe 12 and composite repair assembly 210 to be received in the hot box. Hot box 266 also includes mating latching or securing mechanisms 271 and 272, respectively, on bottom portion 267 and top portion 268. Latching mechanisms 271 and 272 may comprise pin and hasp mechanisms or other known securing and locking mechanisms. Also, both bottom portion 267 and top portion 268 of hot box 266 include a layer of insulating material 273 to hold heat in the composite repair assembly during the heating step. As is known and appreciated by one skilled in the art, heating element 264 is connected to a mechanism and source for providing heat to element 264, such as a resistive element, or combusive heat.

Once the repair is completed and the layer of thermoplastic material has sealed area 18 in pipe 12, heating element 264 and hot box 266 may be removed, or alternately, left in place in case the need arises to reheat the repair assembly, to further compress or better seal thermoplastic layer 20 about area 18.

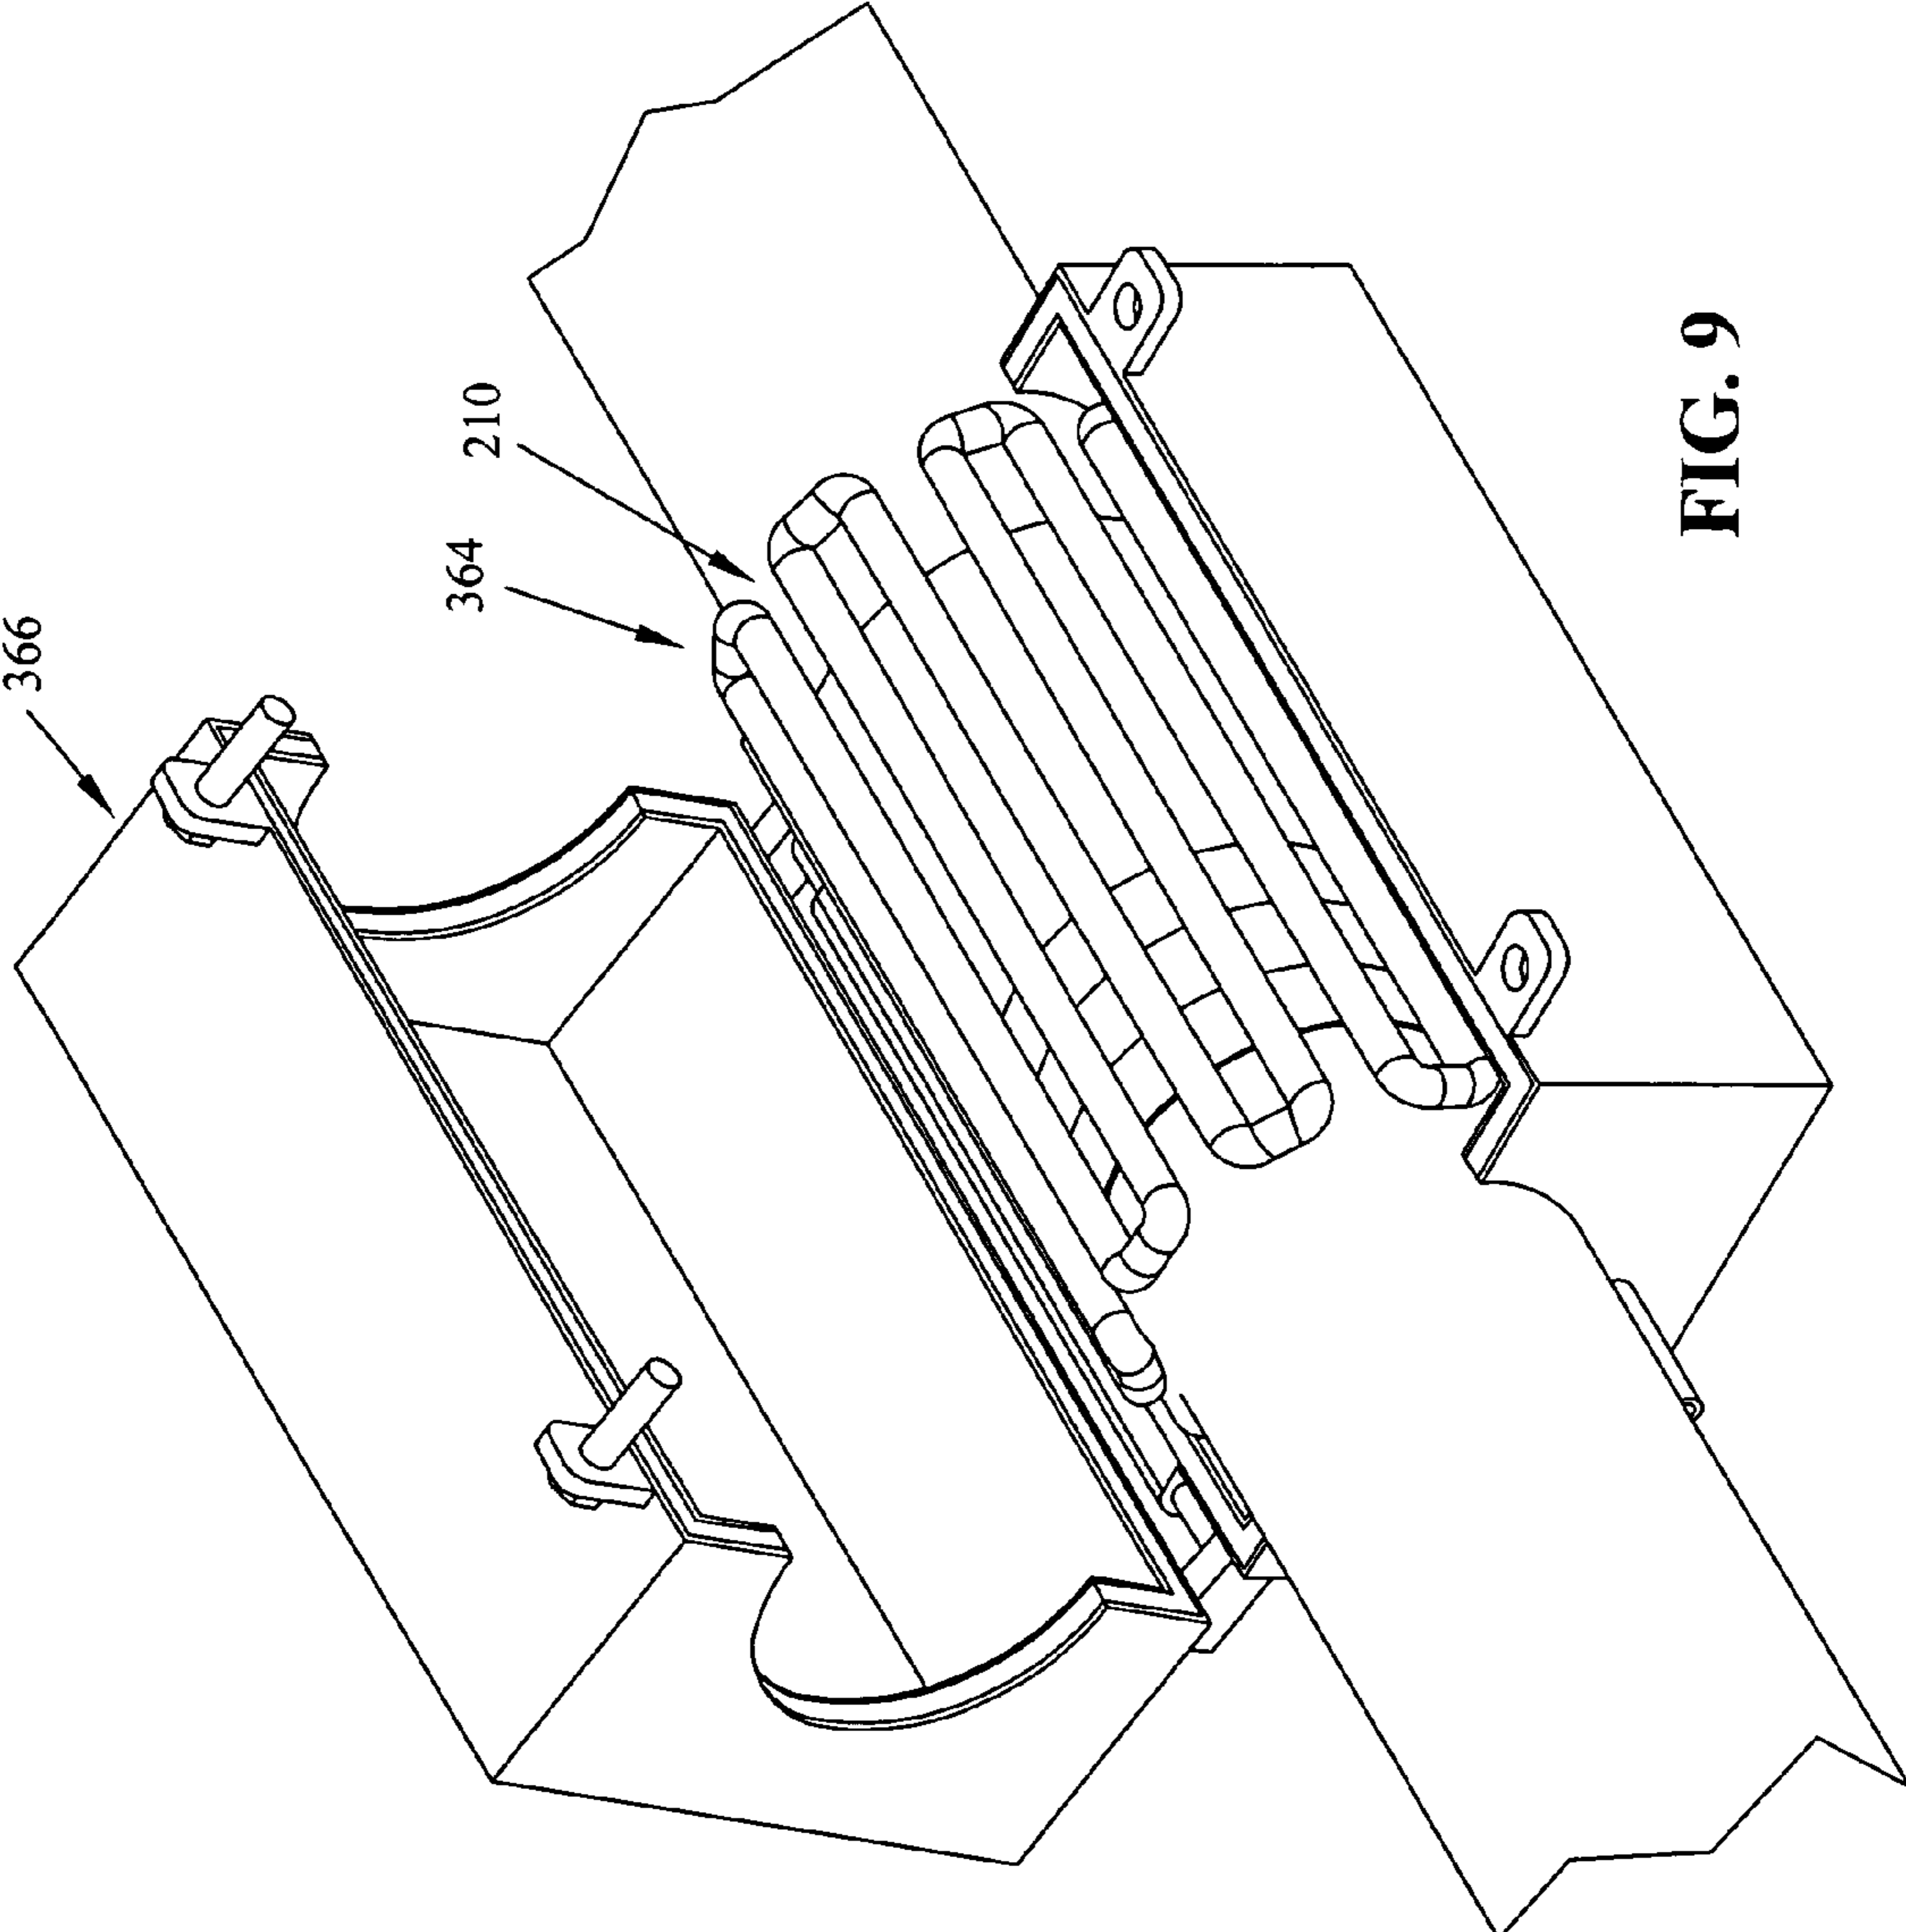
FIG. 9

Now referring to FIG. 9, an alternate embodiment heating mechanism, generally indicated as 364, is shown, along with an alternate embodiment hot box, generally indicated as 366. Heating element 364 and hot box 366 are similar in most respects to heating element 264 and hot box 266, respectively, except that heating element 364 is elongated so that it extends past the ends of the composite repair assembly 210. This is to ensure uniform heating throughout the entirety of composite repair assembly 210 and layer of thermoplastic material 20.
