(54) **COMPOSITE REPAIR FOR PIPES**
(75) Inventor: **Barton E. Bennett**, Mishawaka, IN (US)
(73) Assignee: **Odyssian Technology, LLC**, South Bend, IN (US)
(*) Notice: Subject to any disclaimer, the term of this patent is extended or adjusted under 35 U.S.C. 154(b) by 93 days.

A repair assembly is provided for repairing a pipe that in one embodiment includes a layer of thermoplastic material substantially surrounding the pipe in an area needing repair; a heating element located to provide heat to the layer of thermoplastic material; and an overpress at least partially surrounding the pipe and the layer of thermoplastic material. The layer of thermoplastic material may be configured as a sleeve surrounding the pipe, and the sleeve may be configured in two semicylindrical halves with longitudinal seams where the semicylindrical halves meet. The seams extend generally parallel to a longitudinal axis of the pipe, and the sleeve may further include outwardly extending flanges along the edges of the semicylindrical halves at the seams.

COMPOSITE REPAIR FOR PIPES

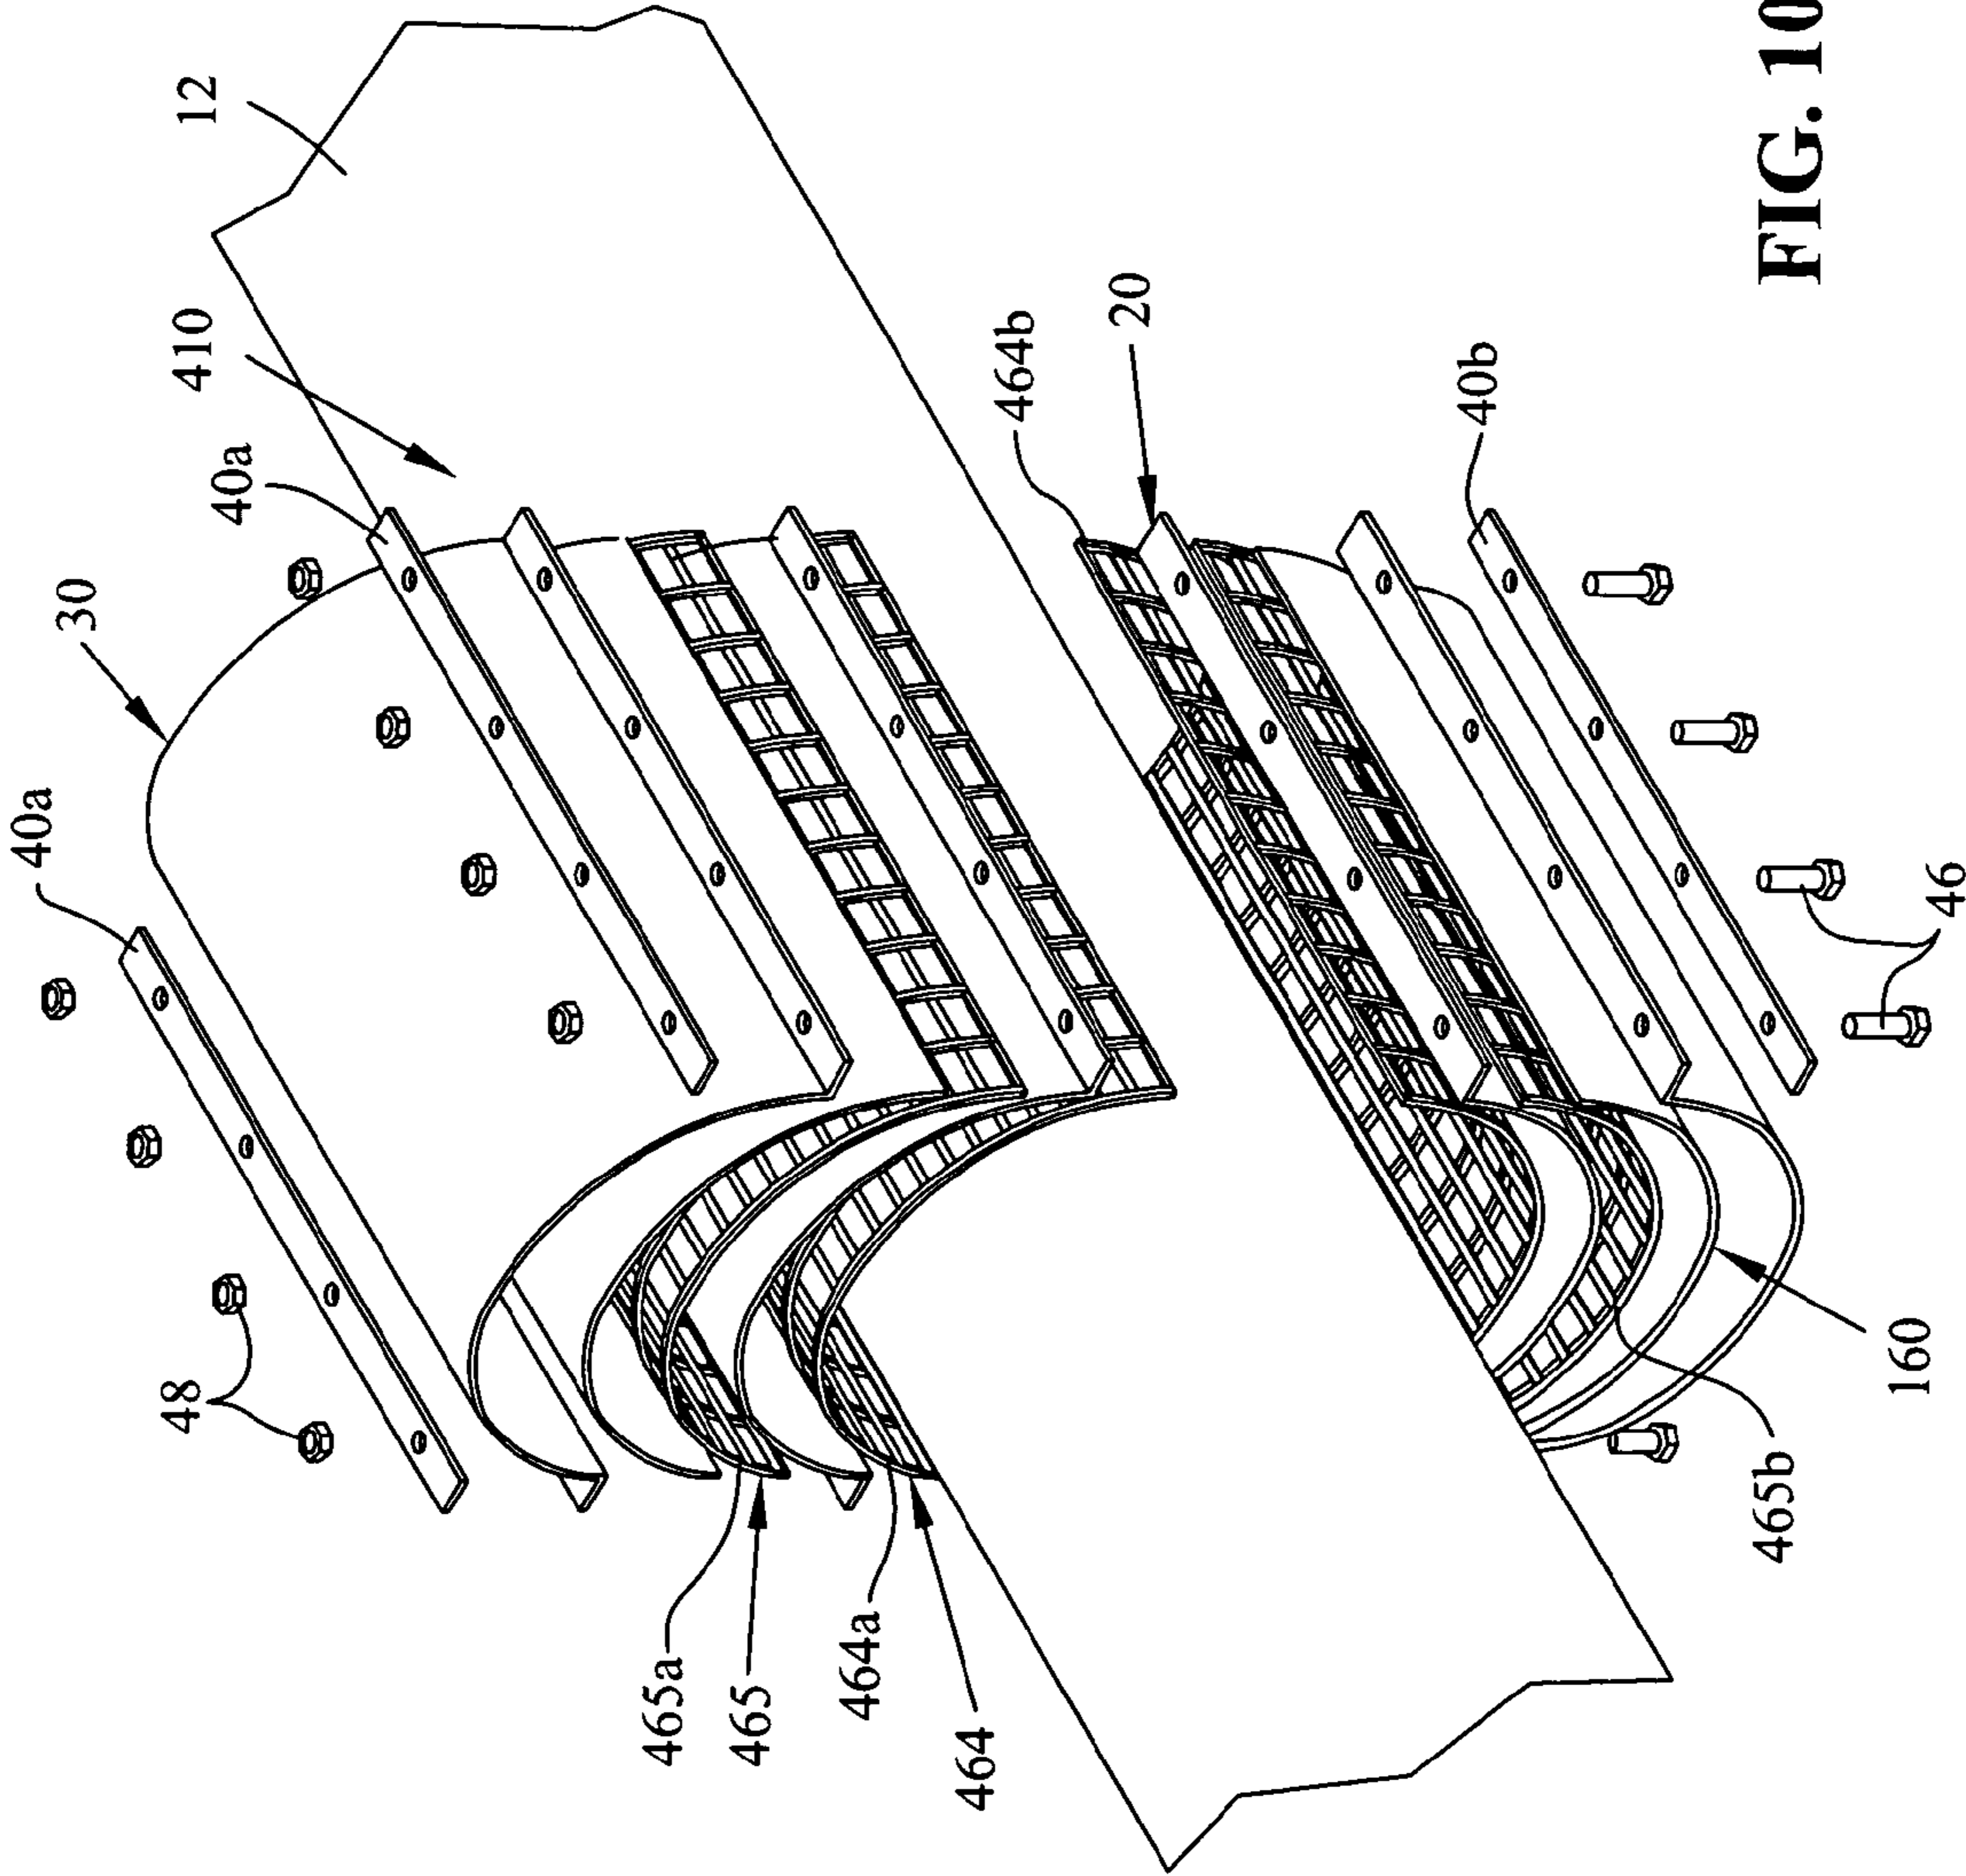
FIG. 10 is a perspective view of another embodiment of a repair assembly and heating assembly in accordance with the subject invention;

Now referring to FIG. 10, yet another alternate embodiment composite repair assembly is shown, generally indicated as 410. Composite repair assembly 410 is similar in most respects to composite repair assembly 110, with the exception that composite repair assembly 410 includes dual layers of heating elements, generally indicated as 464 and 465. In the embodiment shown, heating element 464 is provided in two semicylindrical halves 464*a*, 464*b*, and heating element 465 is also provided in two semicylindrical halves 465*a*, 465*b*. Heating elements 464 and 465 are further provided in a wire mesh configuration of resistive heating elements, which may be nickel chromium as discussed above. The heating elements 464 and 465 may be of an alternate configuration such as a single strand wire form, or any configuration suitable for providing heat to the thermoplastic material. As is well known and appreciated by one skilled in the art, heating elements 464 and 465 are connected to a source of electrical power (not shown) with wires or other electrical connectors (not shown).

Composite repair assembly 410 is assembled and used similar to other composite repair assemblies discussed above; however, heating element 464 is placed between layer of thermoplastic material 20 and pipe 12, and heating element 465 is placed between thermoplastic layer 20 and layer of high CTE material 160. Accordingly, heating element 464 may be used to preheat pipe 12. As will be appreciated by one skilled in the art, the in ground installation of pipe 12 may result in pipe 12 and area 18 being at a low temperature, especially in the winter months of cold climates. As such, in order for thermoplastic layer 20 to be heated and properly flow around pipe 12, it may be necessary to preheat the pipe. Accordingly, heating element 464 may be activated before activating heating element 465. The placement of heating element 465 allows it to provide heat to both thermoplastic layer 20 and layer 160 of high CTE material, thereby providing expansion of layer 160 and compression of layer 20 as discussed above. It should be appreciated that heating element 465 may be placed to the exterior of layer 160 or even to

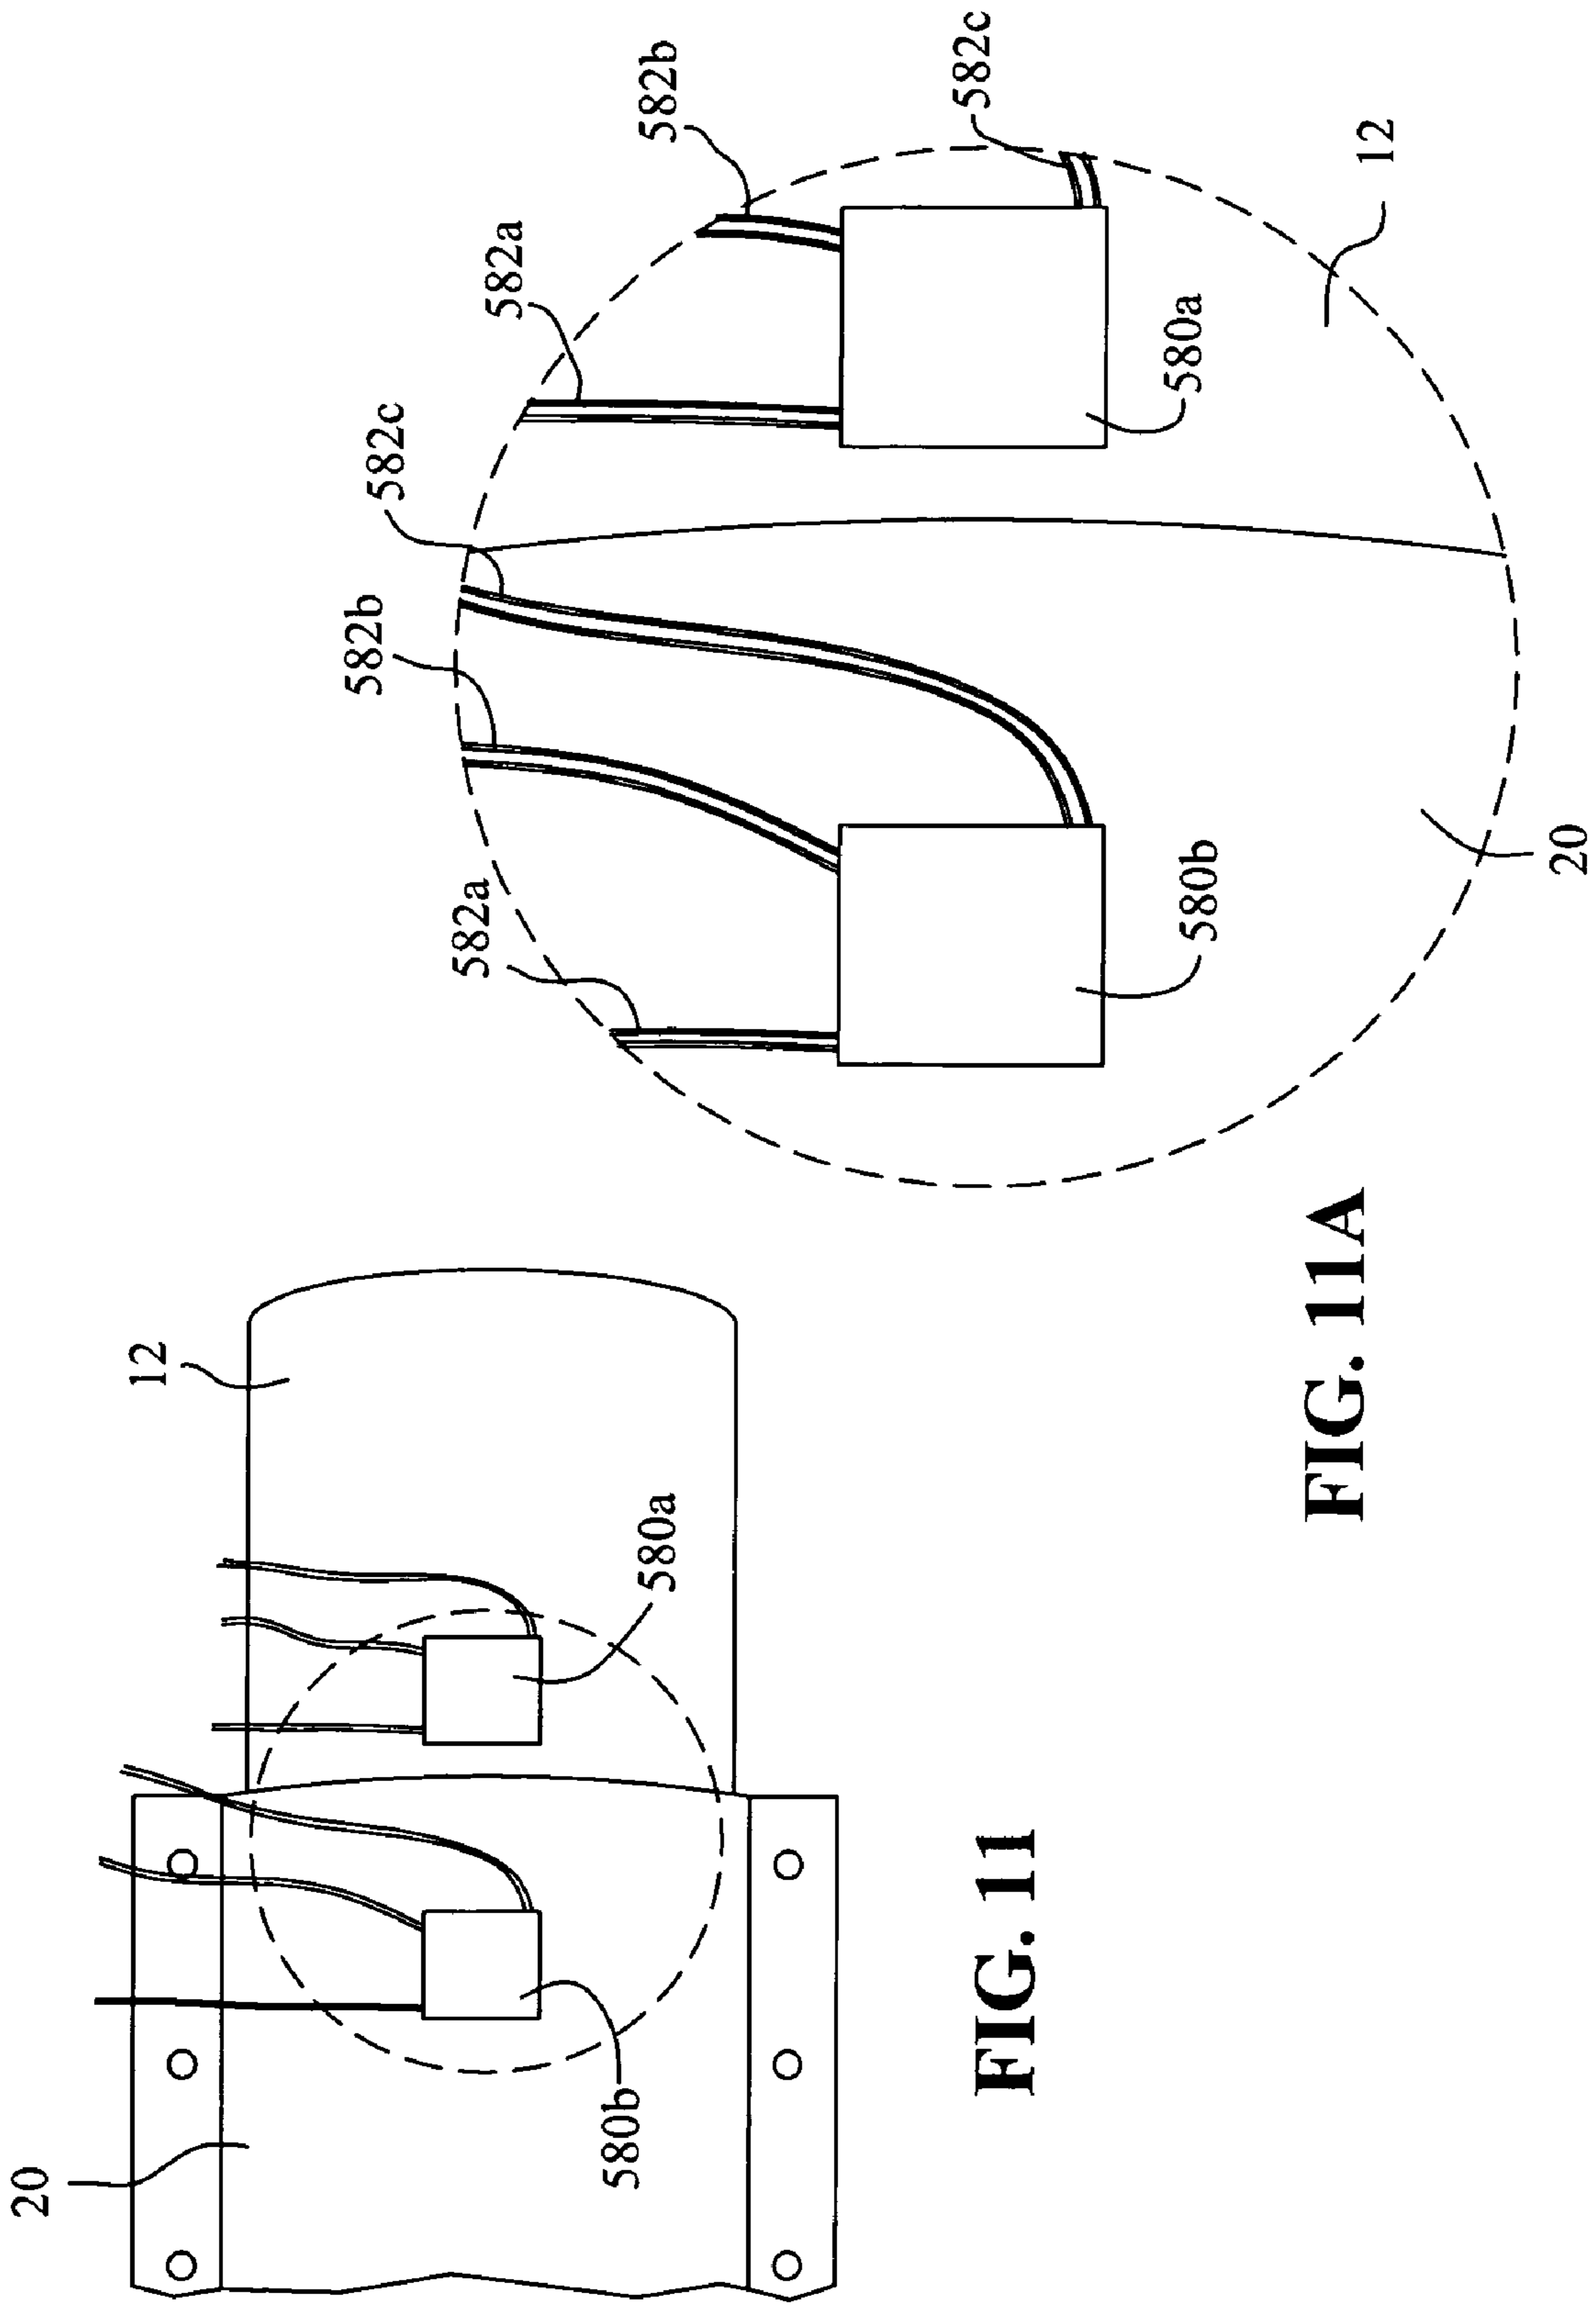
FIG. 11 is a plan view of a repair made in accordance with the subject invention and further including strain gauge sensors;

Now referring to FIGS. 11-14, the composite repair assemblies of the present invention may be provided with sensors to monitor and verify the integrity of the repair. In this embodiment, a pair of strain gauge sensors 580*a* and 580*b* is provided. Strain gauge sensor 580*a* is attached to pipe 12, while strain gauge sensor 580*b* is attached to thermoplastic layer 20. Electrical wires or connectors 582*a-c* are provided for electrical connection of the strain gauge sensors to a microprocessor or control device 584 (FIG. 1). Also as shown in FIG. 1, a conduit 586 is provided to route electrical wires 582*a-c* from strain gauge sensors 580*a* and 580*b* to microprocessor 584. Also, as shown in FIGS. 12-14, a sensor boot, generally indicated as 588, may be included to provide environmental protection to the repair assemblies, strain gauges, and to provide a secondary containment structure that houses sensors within the cavity for detection of leakage of the composite repair. In the embodiment shown, sensor boot 588 is provided in two halves, including a bottom portion 590, a top portion 592, and a hinge 593 connecting portions 590 and 592. Portions 590 and 592 may be provided with semicircular openings 594*a*, 594*b*, respectively, to form a circular opening to allow the sensor boot to encompass and receive pipe 12, when the boot is closed about the pipe. Sensor boot 588 may also include a seal member 595 to provide a seal between the top and bottom portions as well as with pipe 12.

In operation, strain gauge sensors 580*a* and 580*b* can be used to monitor the integrity of the repair. If the strain in strain gauge sensor 580*b* attached to thermoplastic layer 20 significantly changes relative to the strain detected in strain gauge sensor 580*a*, which is attached to pipe 12, then this could be an indication that the integrity of the repair may be compromised. In other words, if thermoplastic layer 20 is expanding or relaxing at a rate greater than anticipated relative to pipe 12, then this may be an indication that either the composite repair has lost its seal or its structural reinforcement provided by thermoplastic layer 20 around area 18. Acceptable values of strain in sensor 580*b* can be programmed into microprocessor controller 584, and if the strain readings exceed allowed design constraints, the microprocessor can actuate an alarm to be sounded or send a signal warning about the failure or potential failure of the repair.

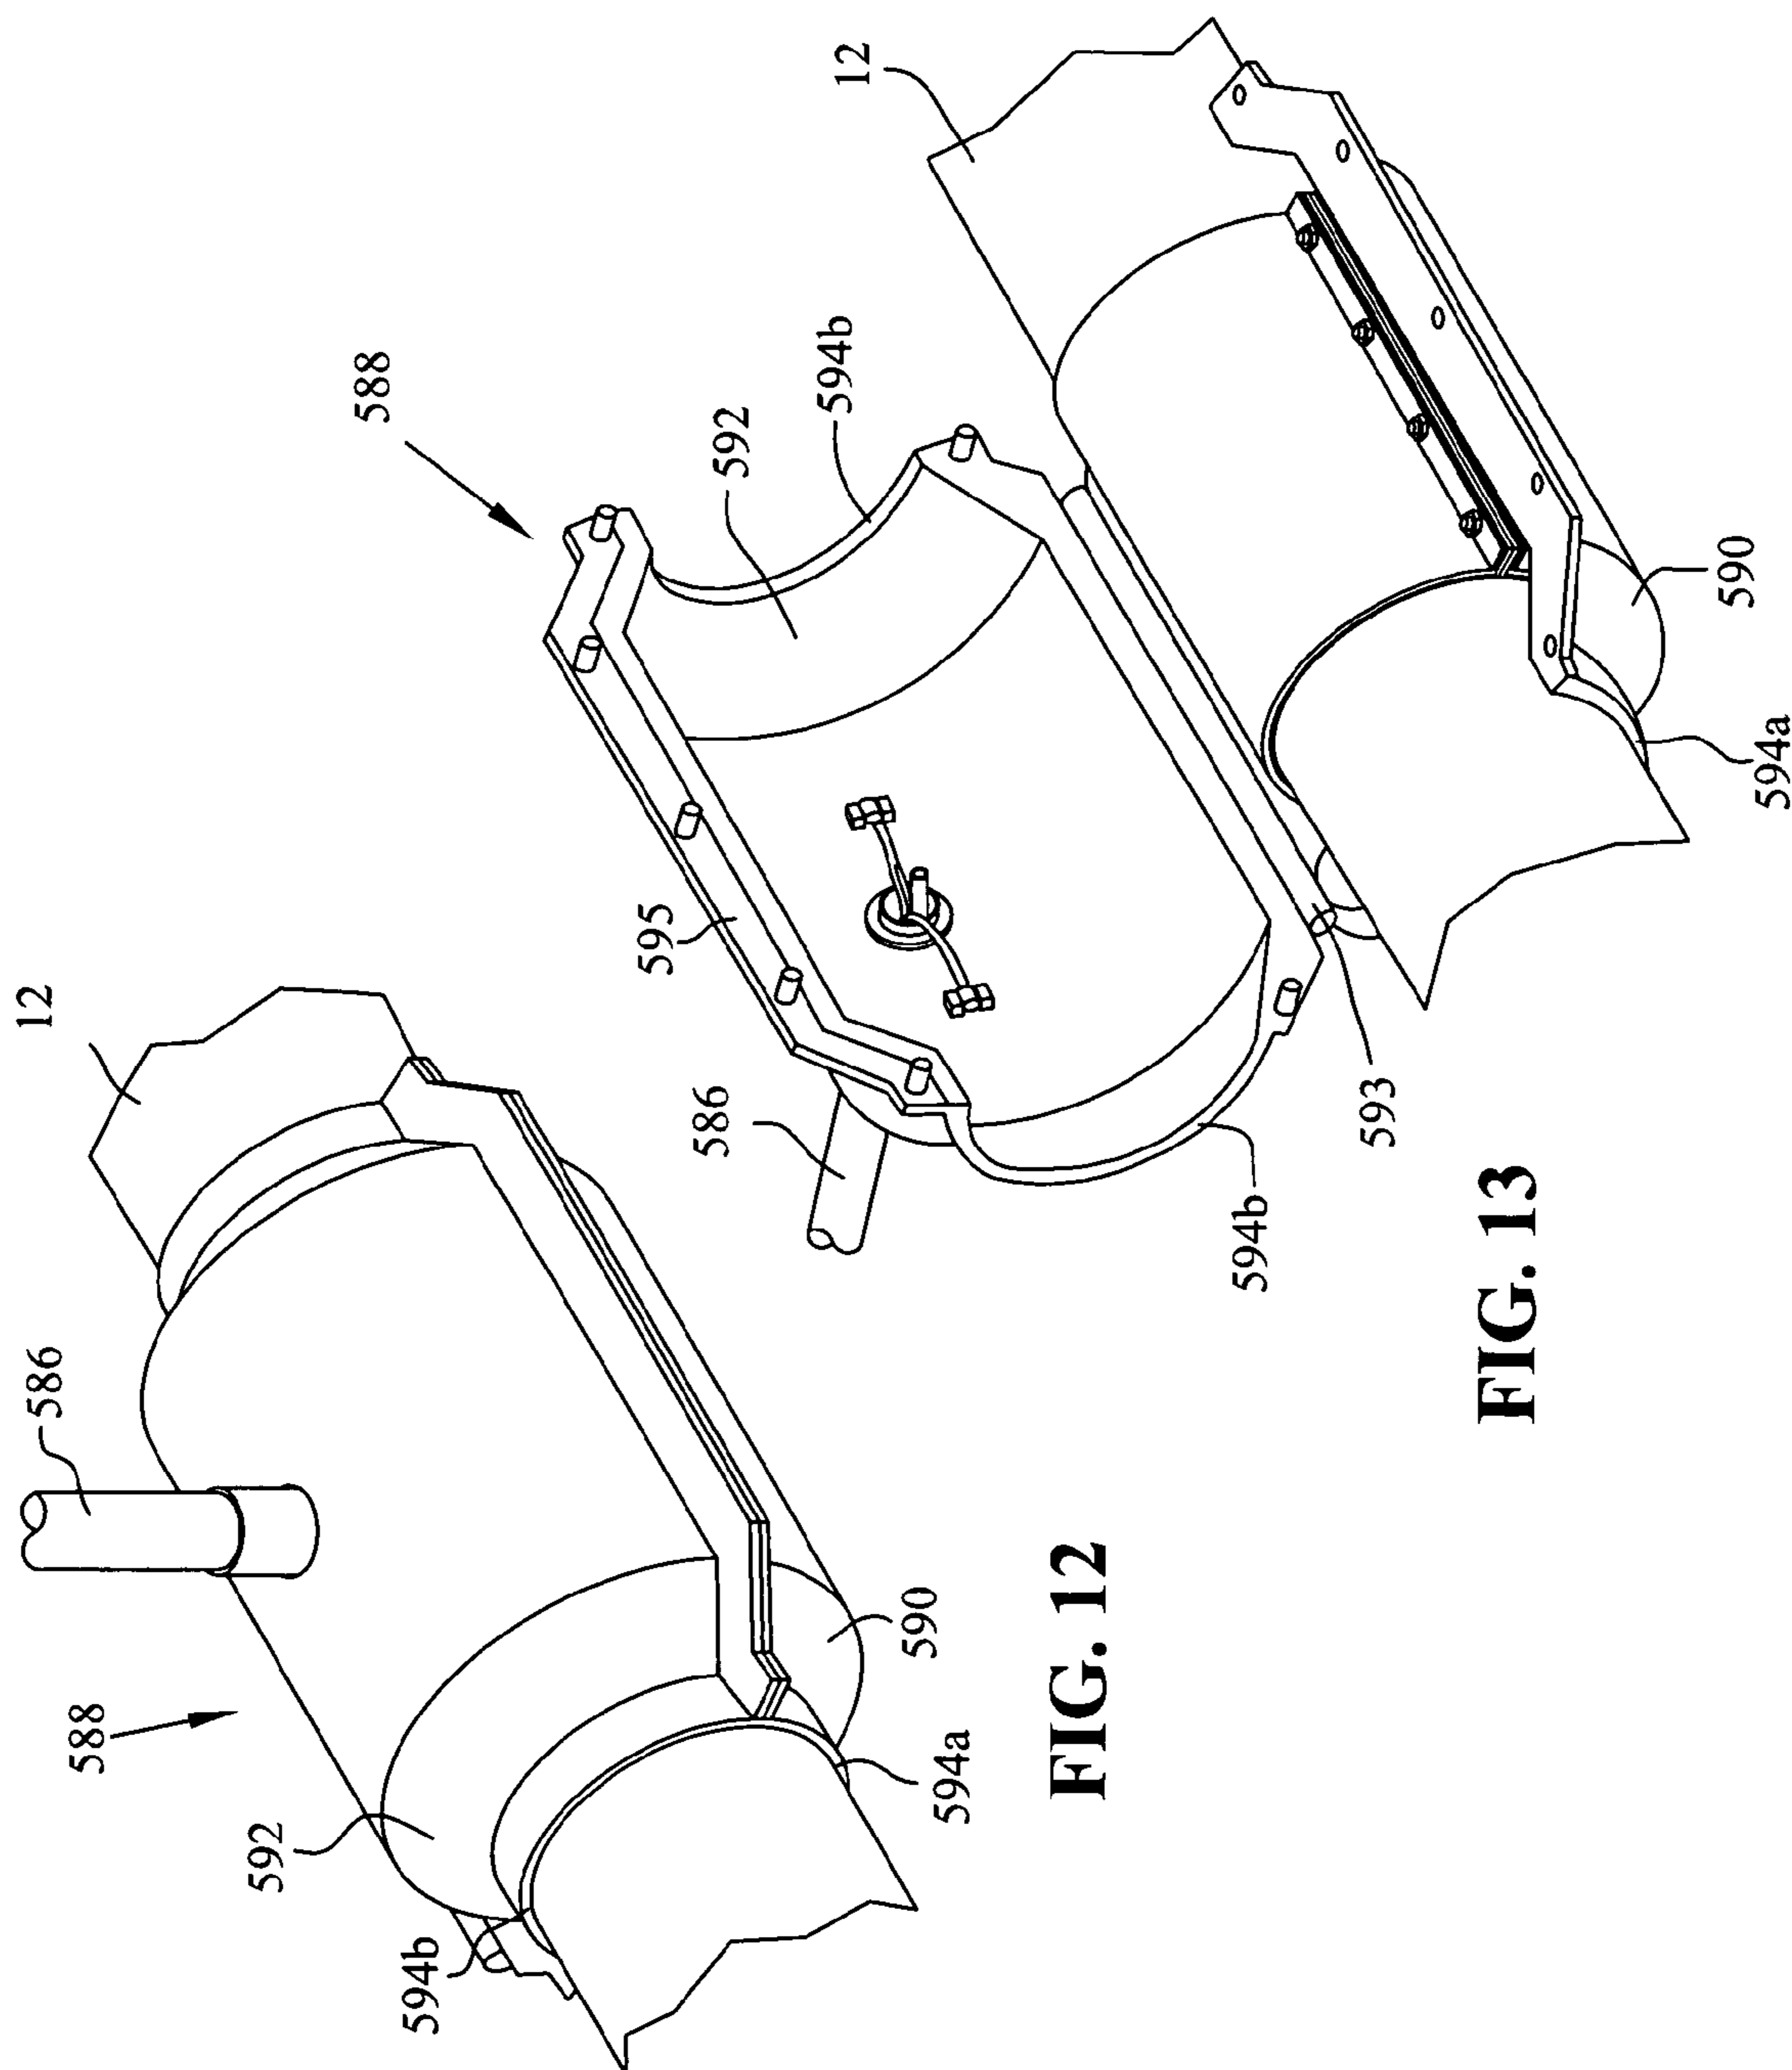
FIG. 12 is a perspective view of a sensor boot covering the strain gauge sensors of FIG. 11, sealing and providing a secondary containment structure having leak detection sensors in the space between the pipe repair and boot walls;

FIG. 13 is a perspective view of the composite repair assembly and sensor boot of FIG. 12 with the boot in an open position;

In addition, with the disclosed assembly, sensor boot 588 can be used to assist in detecting any substance leaking from or into the repair. For instance, sensors 596*a* and 596*b* may be natural gas sensors if pipe 12 is carrying natural gas to sense if any gas is leaking through the composite repair. Gas tube 599 is provided to introduce oxygen or other known gas atmosphere into the sensor boot so that the sensors can detect a change in the known atmosphere due to a leak. It should also be appreciated that the gas sensors may be located external to the boot, wherein the gas tube could be used to draw atmo-

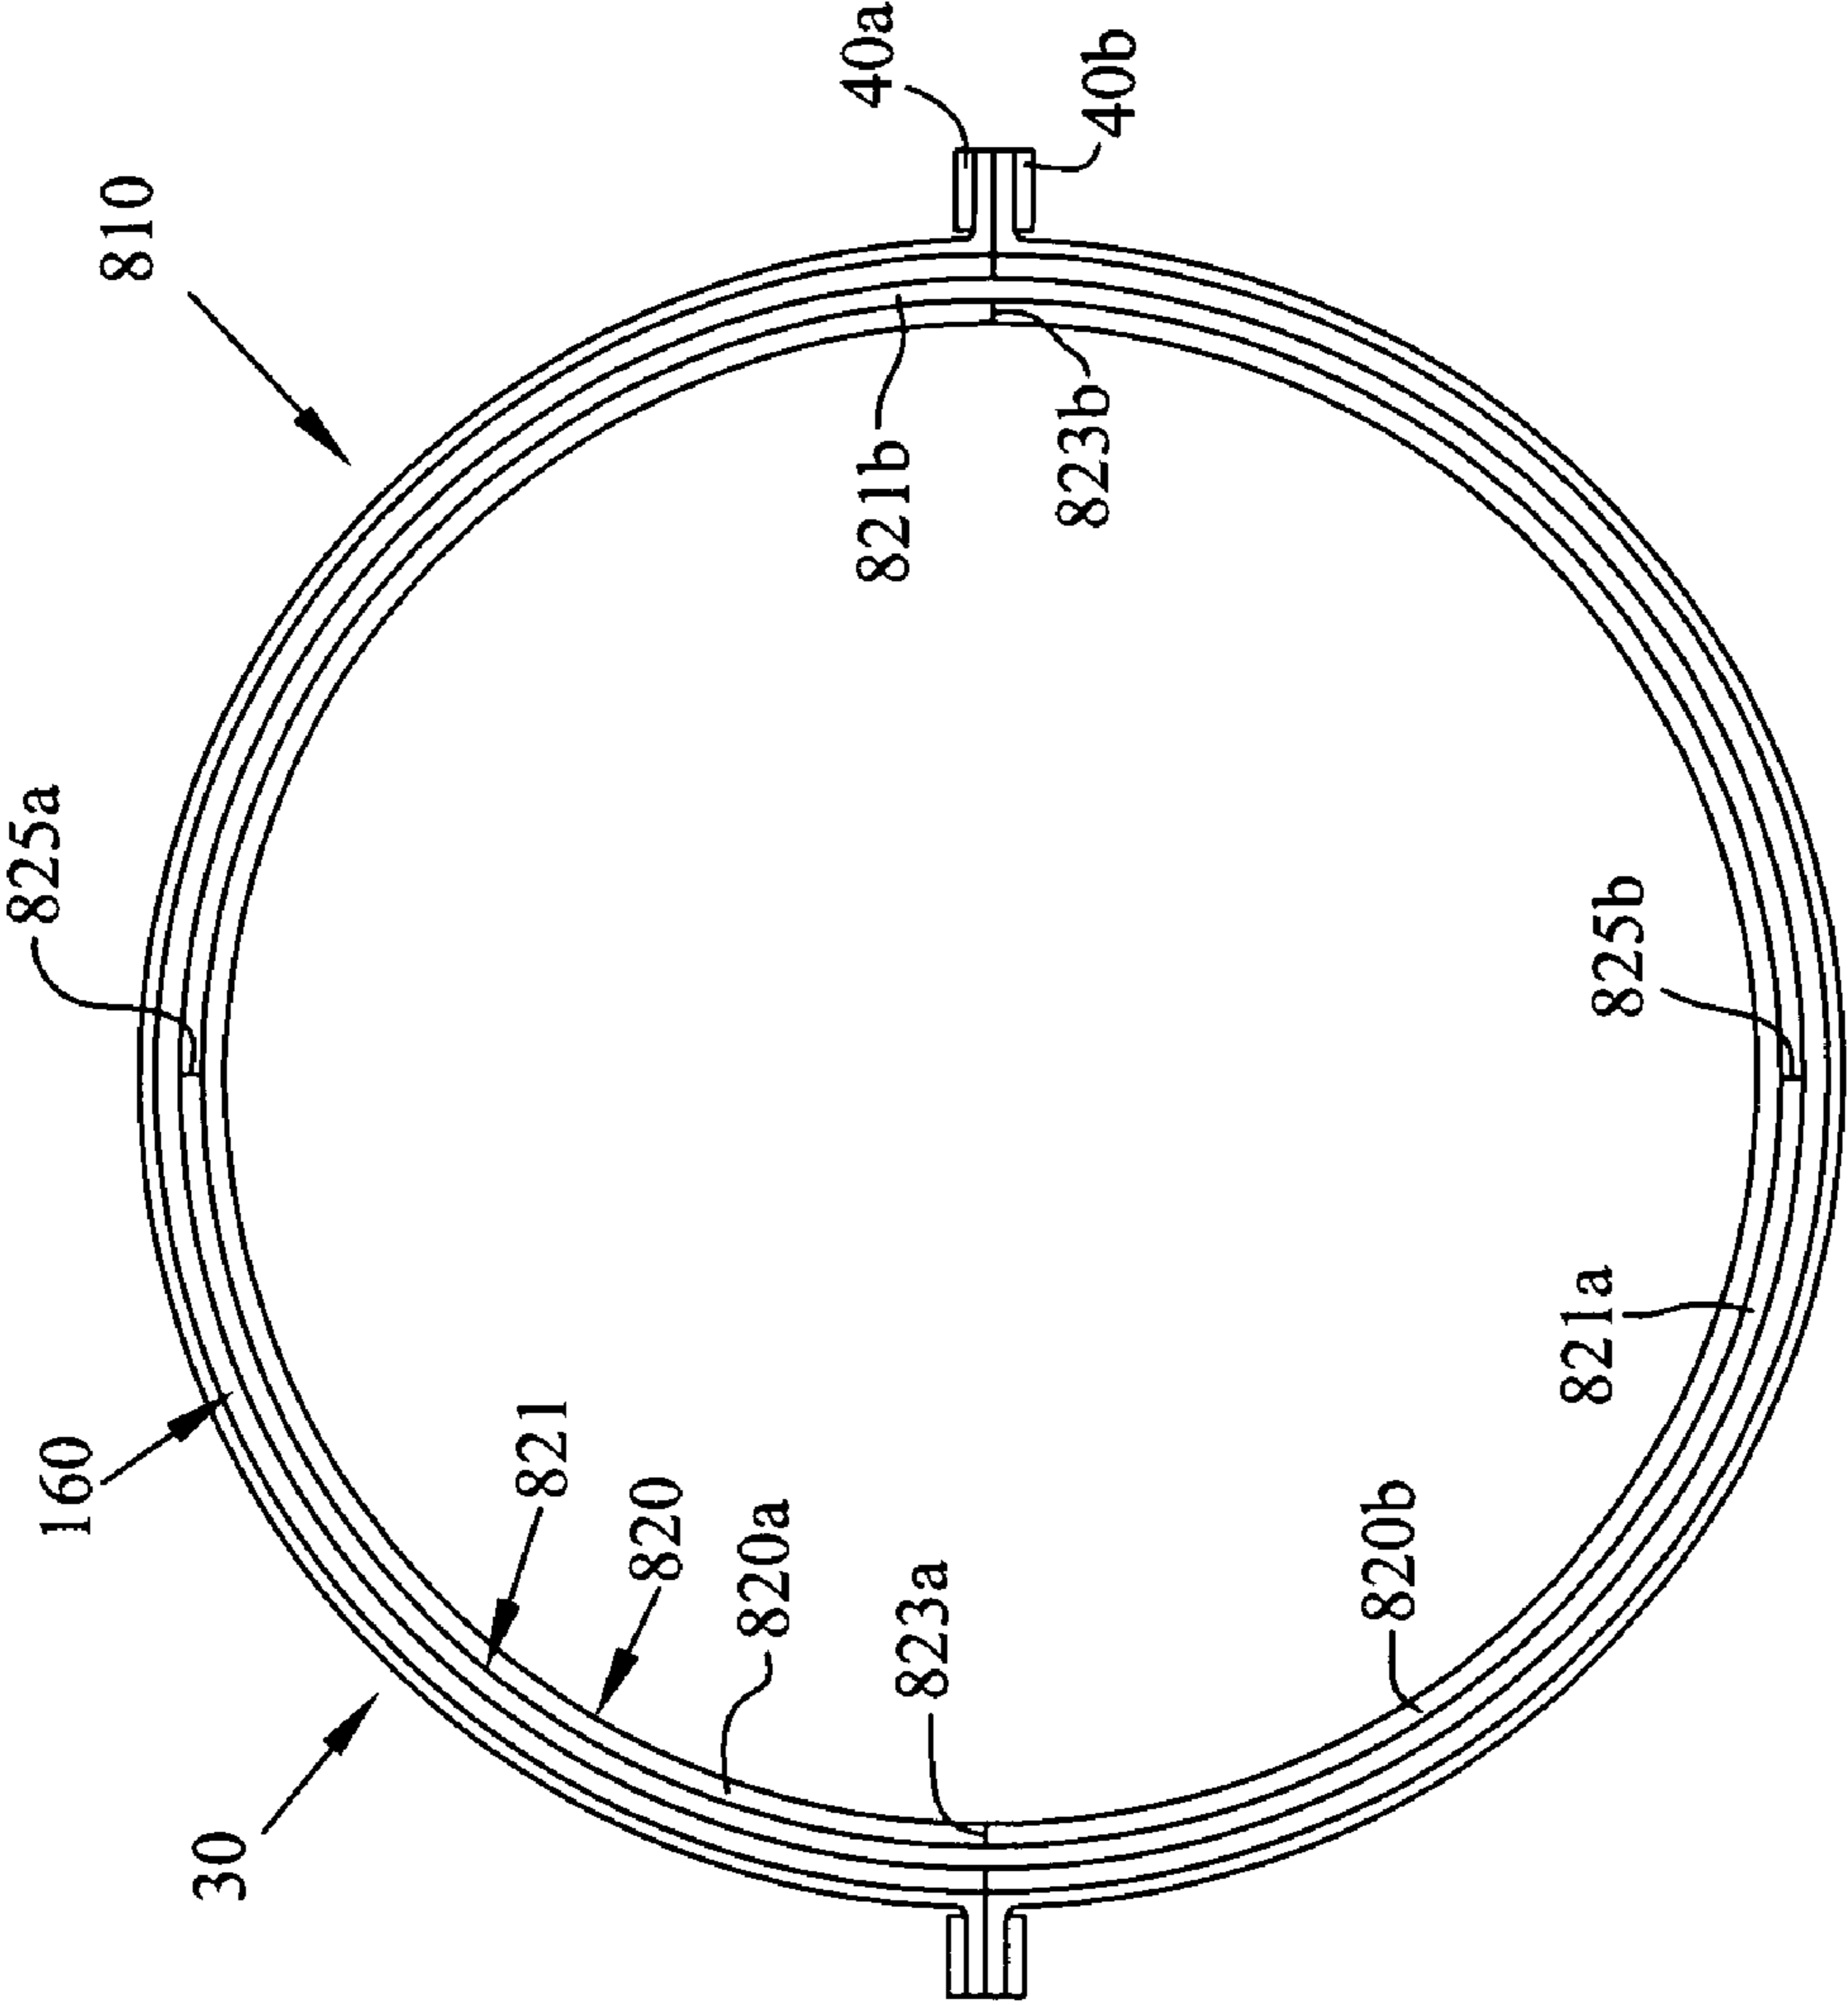
FIG. 16 is an end view of an alternate embodiment composite repair assembly including two layers of thermoplastic composite repair material, with the pipe removed for clarity.

Now referring to FIG. **16**, yet another alternate embodiment composite repair assembly is generally indicated as **810**. Composite repair assembly **810** is somewhat similar to composite repair assembly **110**; however, repair assembly **810** includes two layers of thermoplastic material, generally indicated as **820** and **821**. Both layers **820** and **821** are provided in two semicylindrical halves **820a**, **820b** and **821a** and **821b**, respectively. Unlike layer **20**, however, thermoplastic layers **820** and **821** do not include outwardly extending flanges, but do have longitudinally extending seams **823a**, **823b** between halves **820a** and **820b**, and longitudinally extending seams **825a**, **825b** between halves **821a** and **821b**. As is evident in FIG. **16**, seams **825a** and **825b** are rotationally offset approximately 90° from seams **823a** and **823b**.

As should be appreciated, the dual layer of thermoplastic material can be used to provide enhanced resistance to deformation from any pressure or release through area **18** in pipe **12**. Additionally, seams **823a**, **823b** and **825a**, **825b** are rotationally offset from one another to prevent having a localized area with a continuous leak path and to increase the resistance to deformation as compared to the seams being aligned with one another. It is preferable that the seams be offset at least 45° from one another. In addition, it should be readily apparent to one skilled in the art, that additional layers of thermoplastic material may also be used with this embodiment and it is recommended that the seams of any additional layers also be rotationally offset from seams **823a**, **823b** and **825a**, **825b**.
