(10) **Patent No.:** **US 8,153,922 B2**
(45) **Date of Patent:** **Apr. 10, 2012**

- (54) **INSERT WELD REPAIR**
- (75) Inventor: **Philip R. Belanger**, Acton, ME (US)
- (73) Assignee: **United Technologies Corporation**,
Hartford, CT (US)

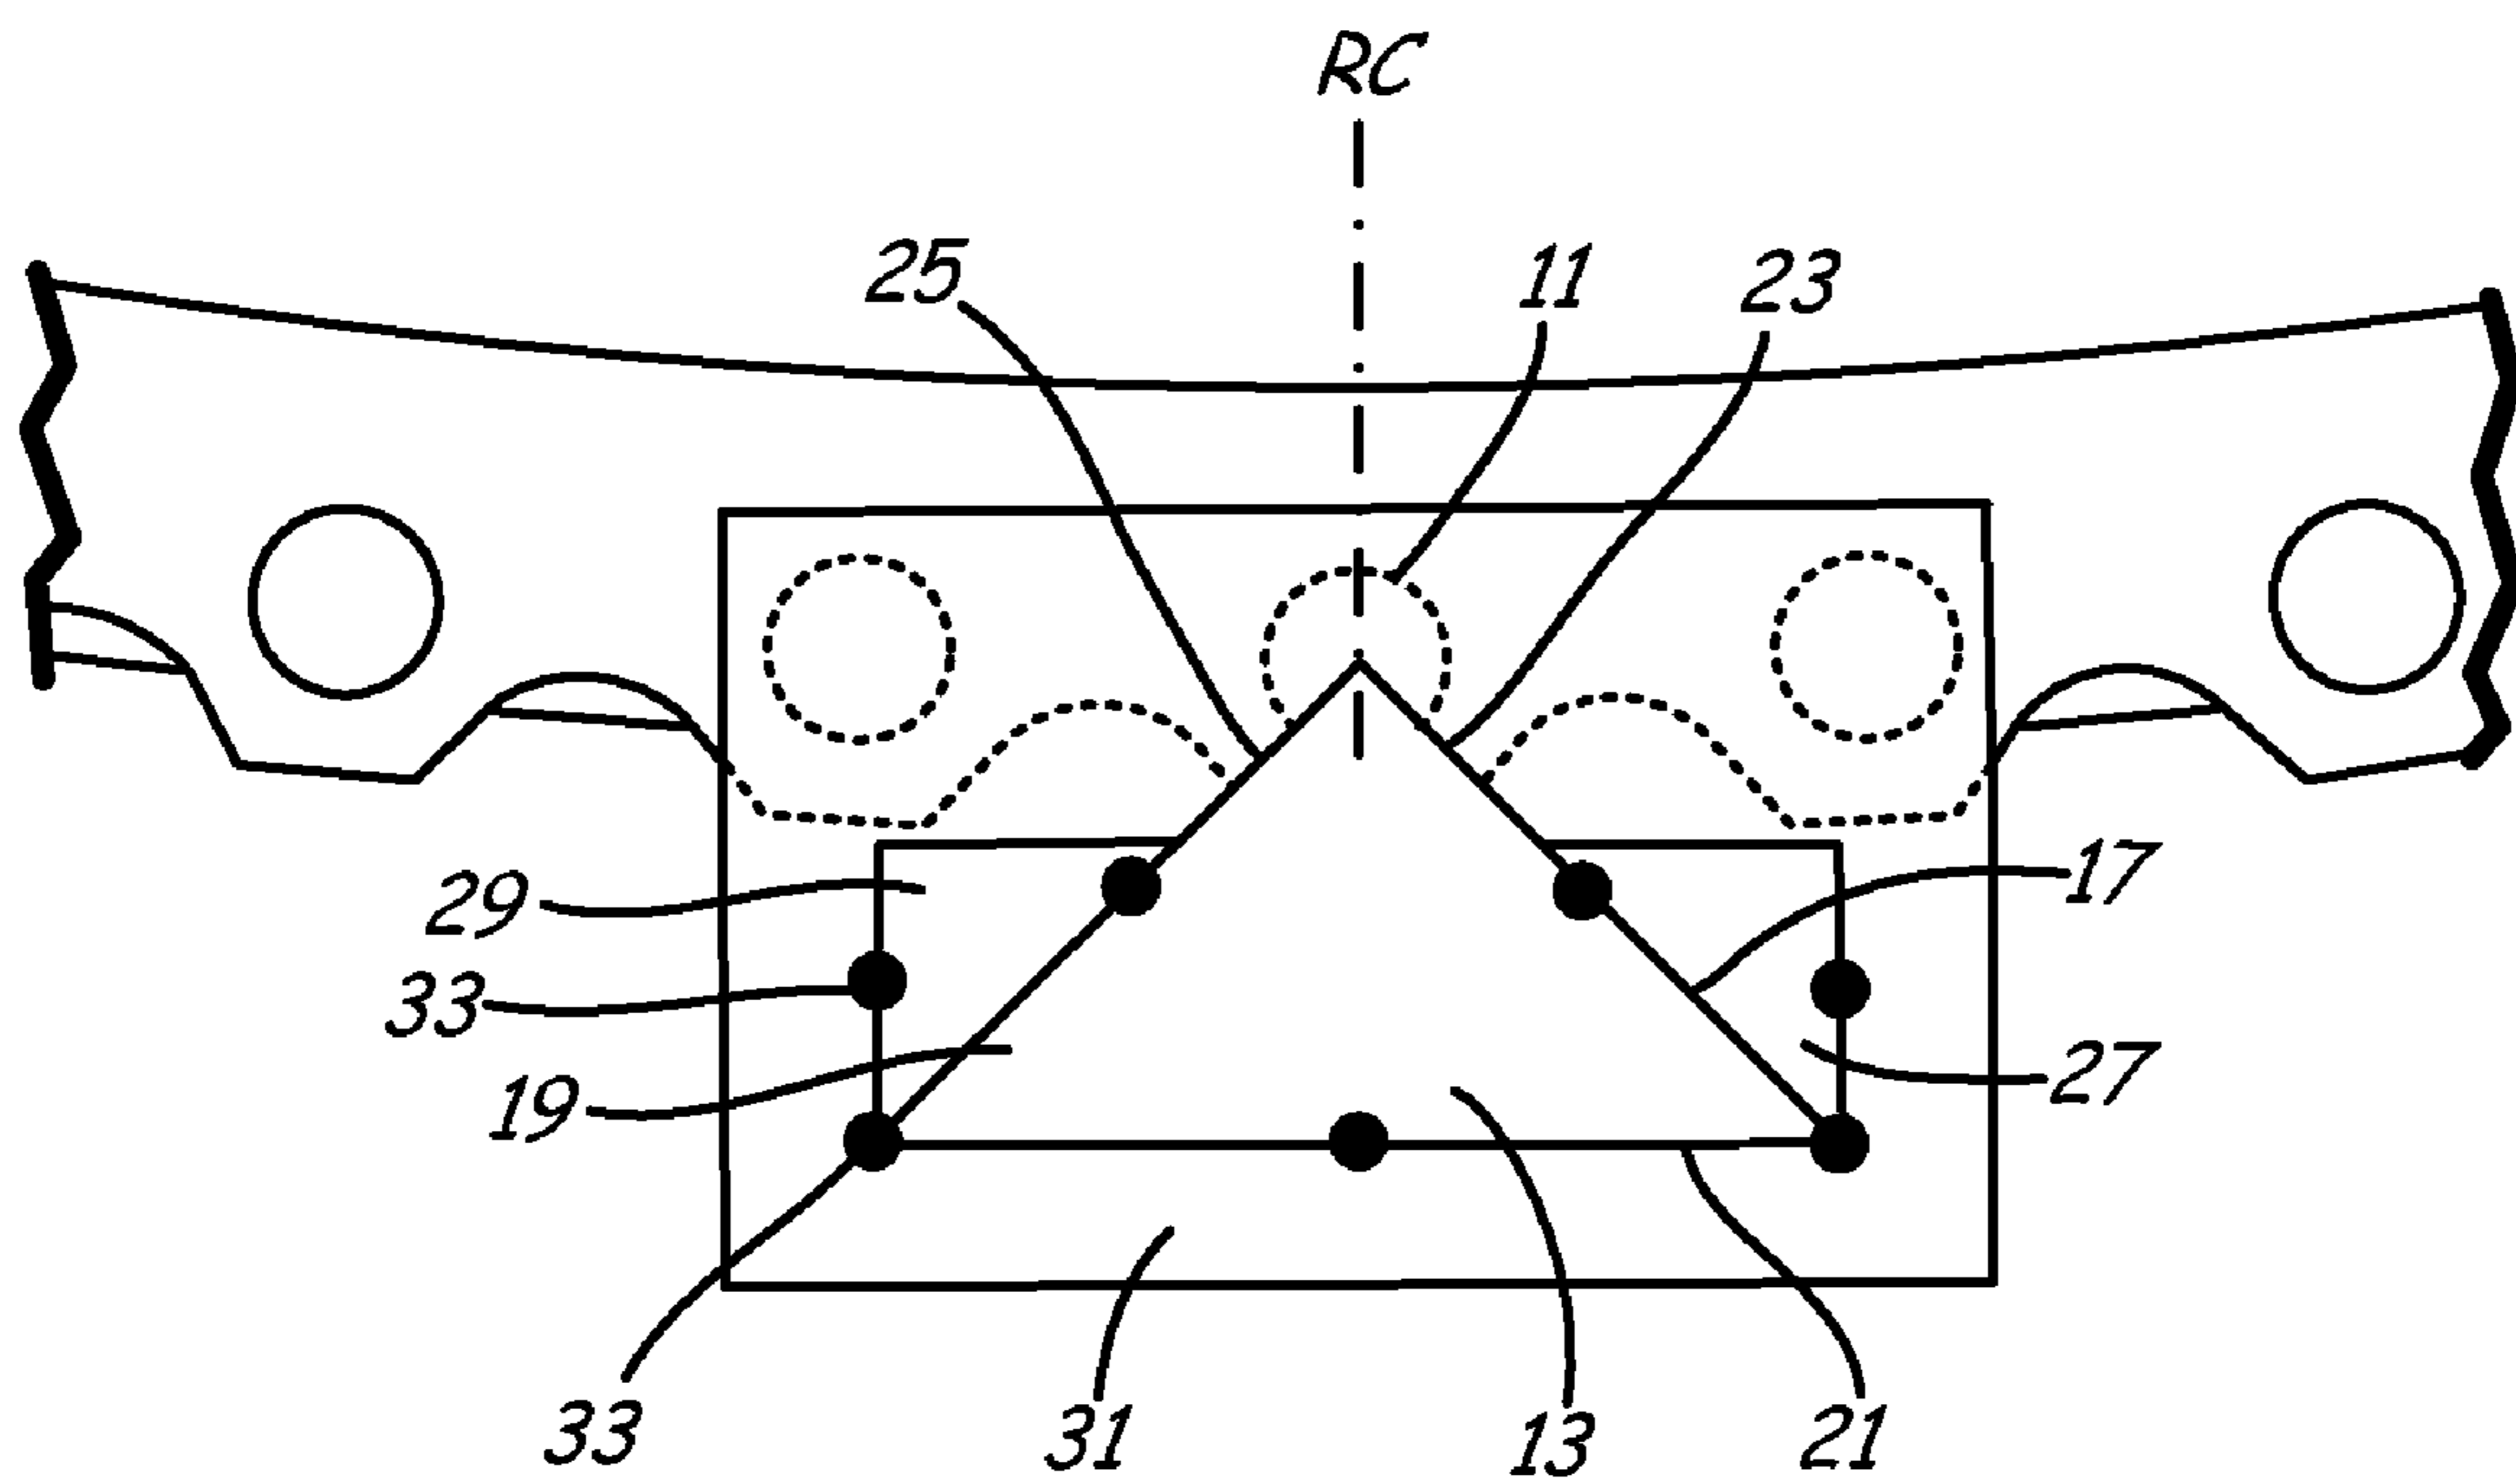
FIG. 1
(PRIOR ART)

FIG. 1 is a plan view of a prior art repair for a hole utilizing a wedge and multiple run off plates.

There are many techniques known in the art for repairing larger diameter holes, such as bolt holes about 0.30" or greater in diameter. As shown in FIG. 1, in one such prior art repair, an area on a line about 45° on either side of the radial center line RC of hole 11 is removed. This material is then replaced with wedge 13 constructed of a similar material as the base material of the part being repaired. Wedge 13 contains at least two sides 17, 19 that are at approximately 90 degrees to one another. The remaining geometry of the wedge is not critical to the repair, and the remaining side(s) 21, can be of varying shapes and angles. This approximately perpendicular corner is inserted into the area of removed base material, the corner mating with edges 23, 25 of the base material left on the part. Wedge 13 is surrounded by three runoff plates 27, 29, and 31. Additionally, a backing plate may be used in the repair. Thus, five separate pieces are required to initiate the repair. Wedge 13 and run off plates 27, 29, and 31 are attached by tack welds 33 prior to initiating the repair. The multiple run off plates 37, 29, and 31 are small and difficult to assemble about wedge 13.

In the prior art repair, wedge 13 is welded into place with welds that are approximately 45 degrees from the original base material. In this configuration, the welds move the weld material (the weld zone with depleted material properties) outboard of the highest stressed areas at the hole location. This allows the raw material of the replacement wedge (with base materials properties) to remain in the highest stressed areas. The highest stressed areas surrounding the hole are located approximately 90 degrees from one another. This repair works well for holes down to about 0.30 inches in diameter, but on smaller holes the wedge becomes so small that the weld used to retain the wedge extends into the highest stressed areas of the flange. Prior to this invention, repairs to smaller diameter holes (i.e., holes having a diameter of about 0.30" or less) on flanges were viewed as being unrepairable. Thus, a repair for smaller holes was needed.

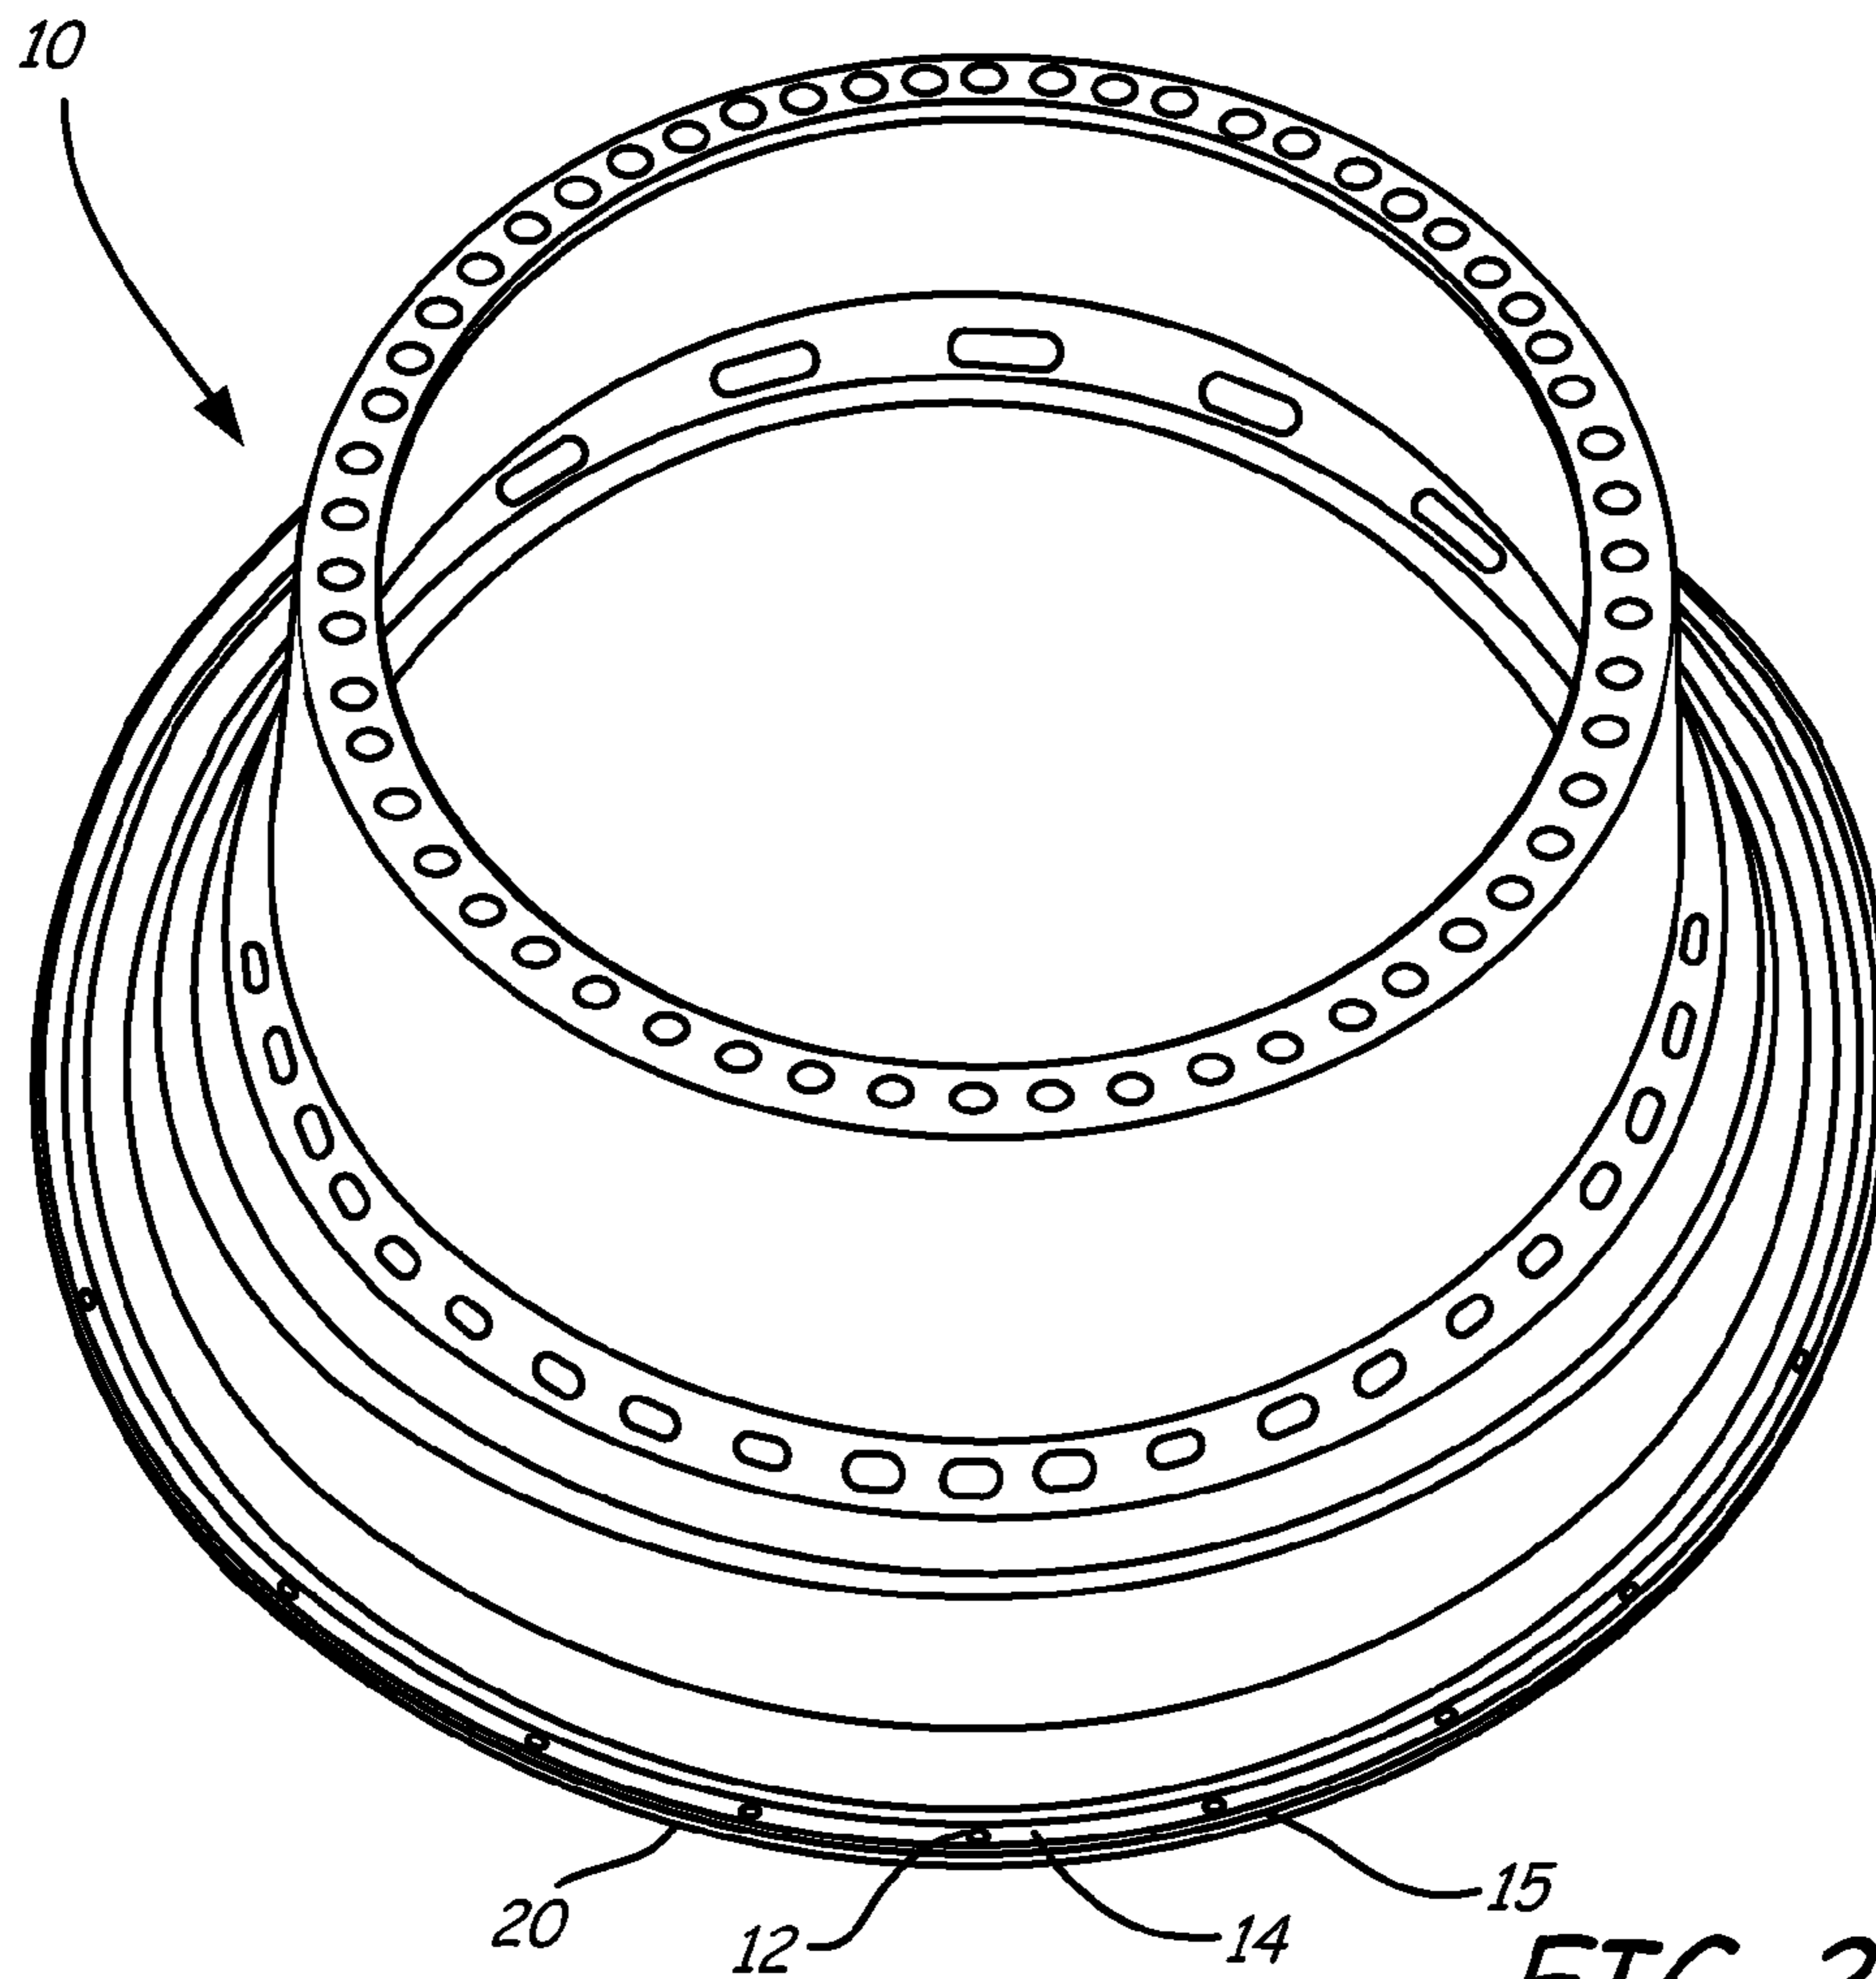
FIG. 2 is a perspective view of a forward inner nozzle support of a dual annular combustor configuration of a high pressure turbine.

FIG. 2 is a perspective view of a forward inner nozzle support 10 of a dual annular combustor (DAC) of a higher

pressure turbine. The nozzle support **10** contains a series of small diameter holes **12** circumferentially spaced about an outer diameter flange **14**. Holes **12** are apertures used to receive small diameter pins or bolts for additional parts that are mounted to the flange. FIG. 2A is a closeup view of the nozzle support **10** illustrating a crack **16** at one small diameter hole **12** on flange **14**. Cracks **16** typically emanate from the holes **12** in an outward radial direction. In the past, cracks **16** in small diameter holes **12** of nozzle support **10** were unrepairable.

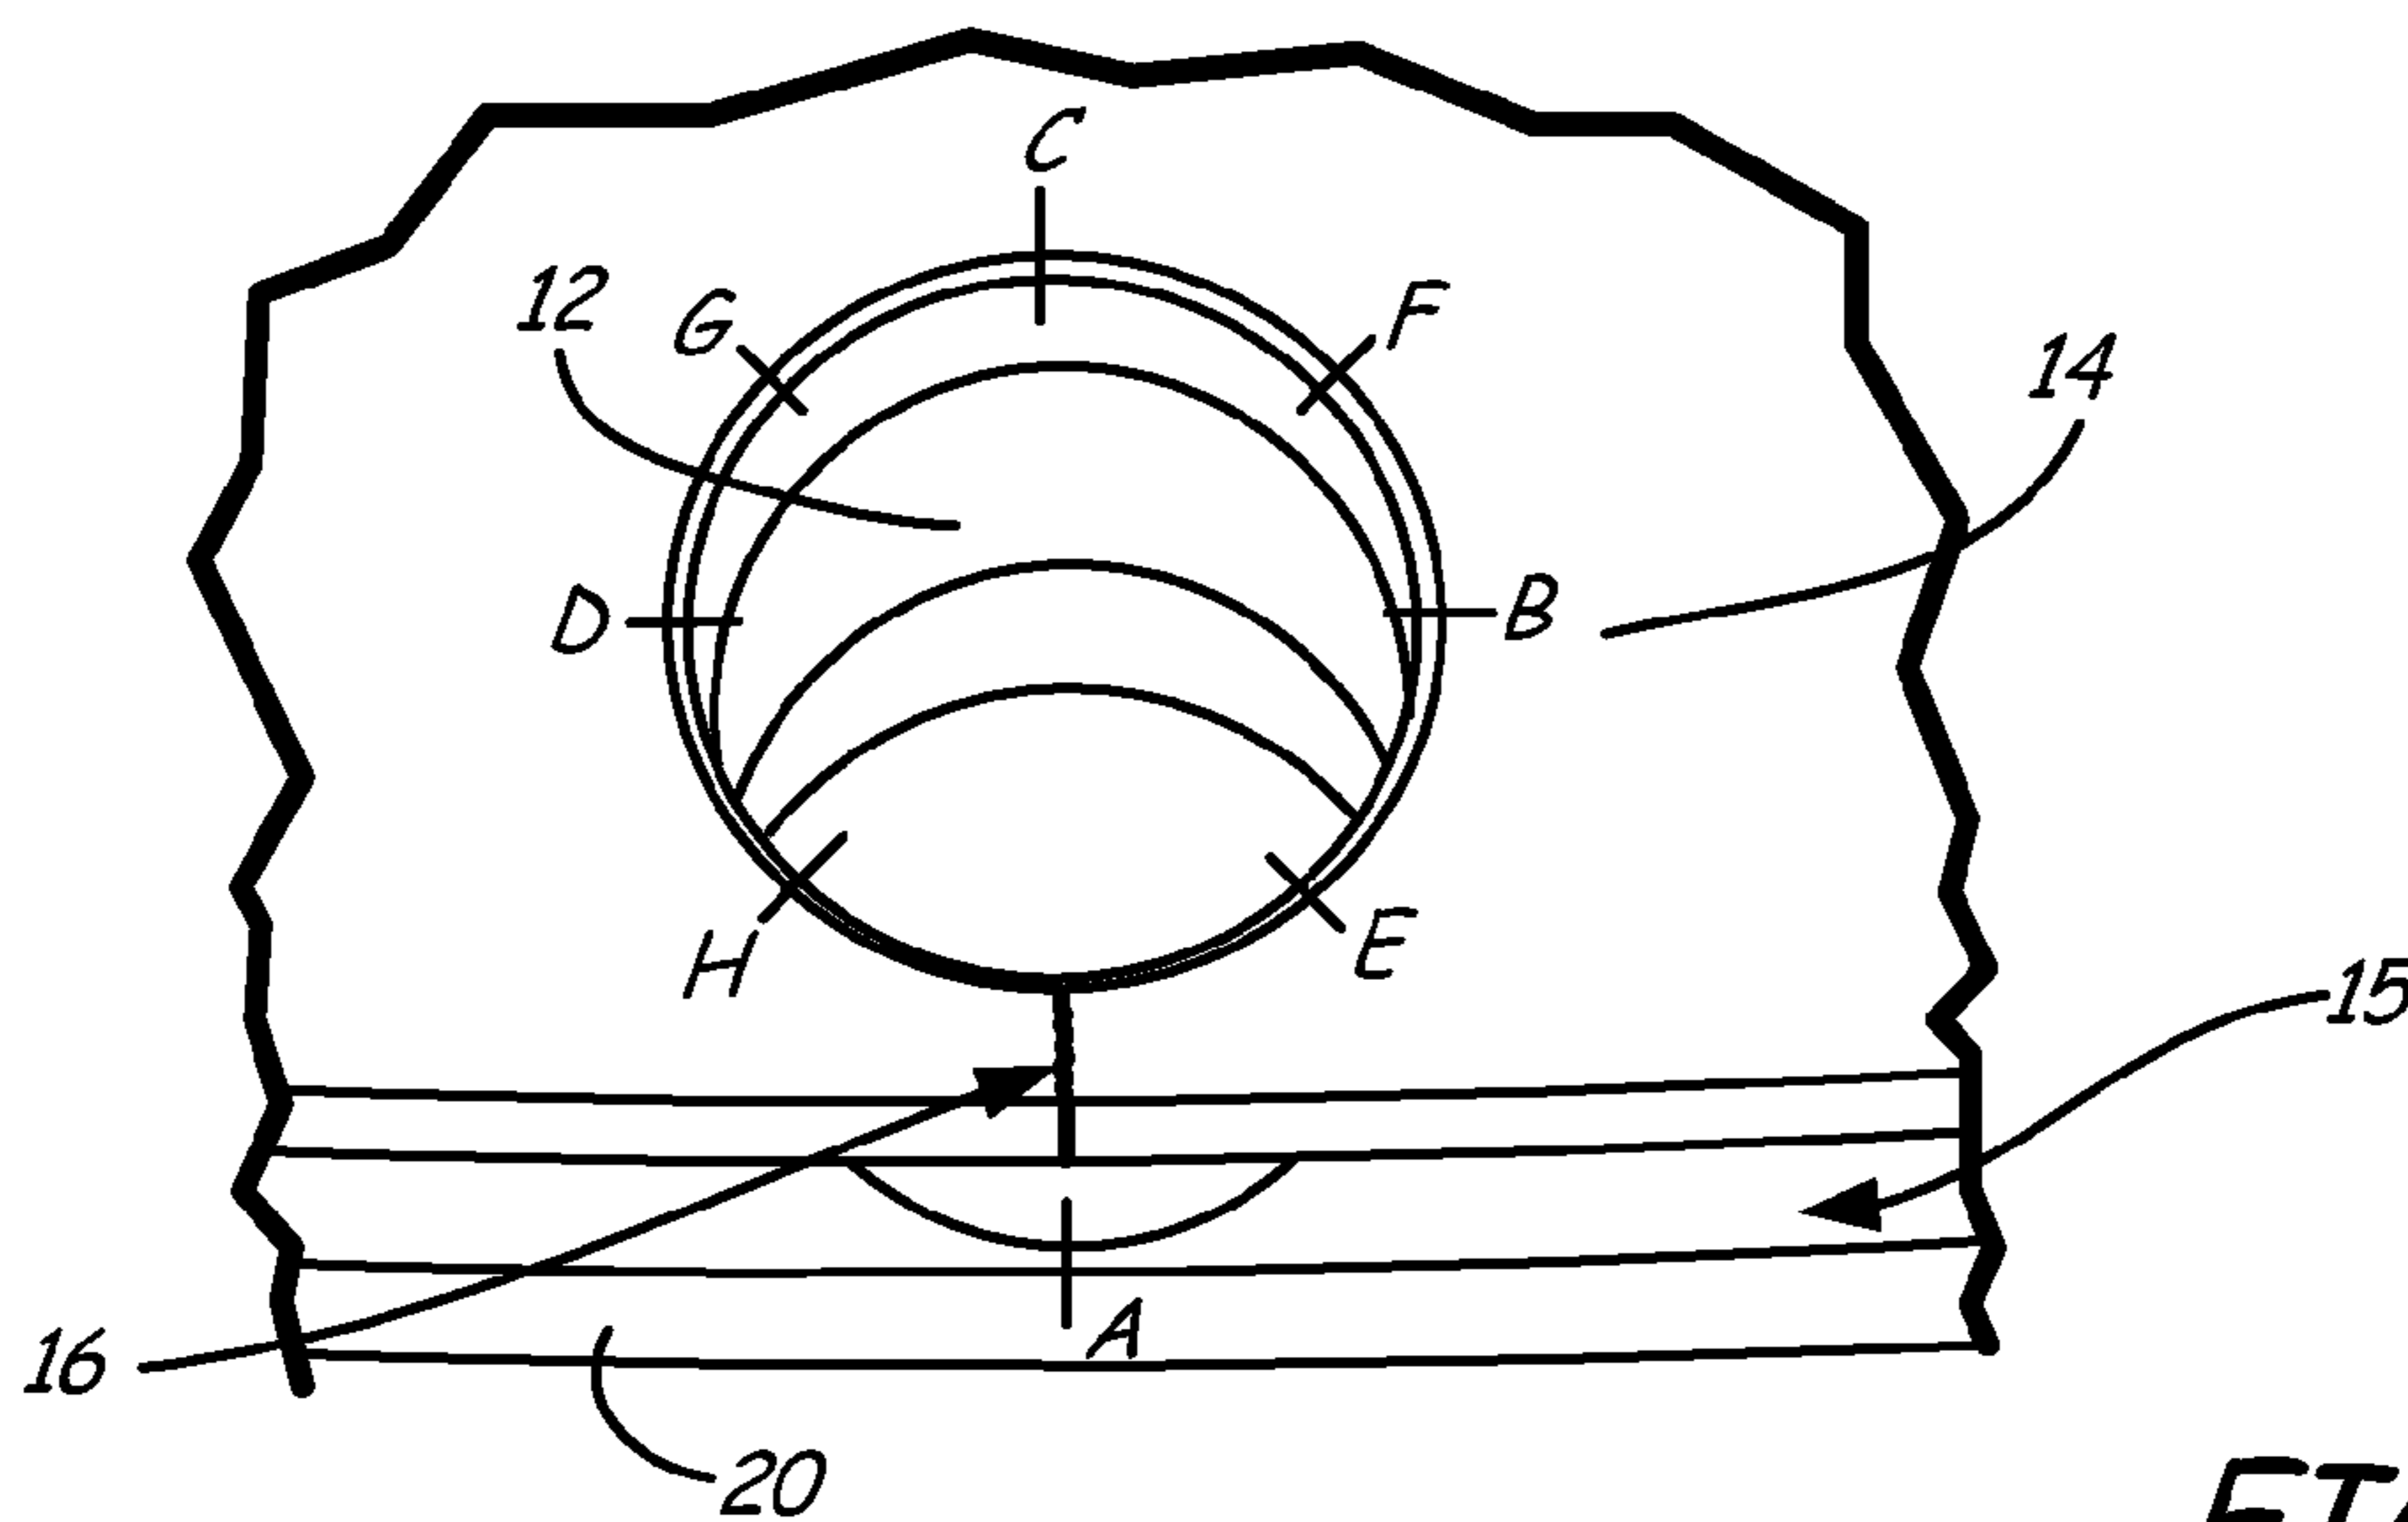
FIG. 2A is a magnification of an area of the perspective view of the nozzle support illustrating a crack at one of the flange bolt holes.

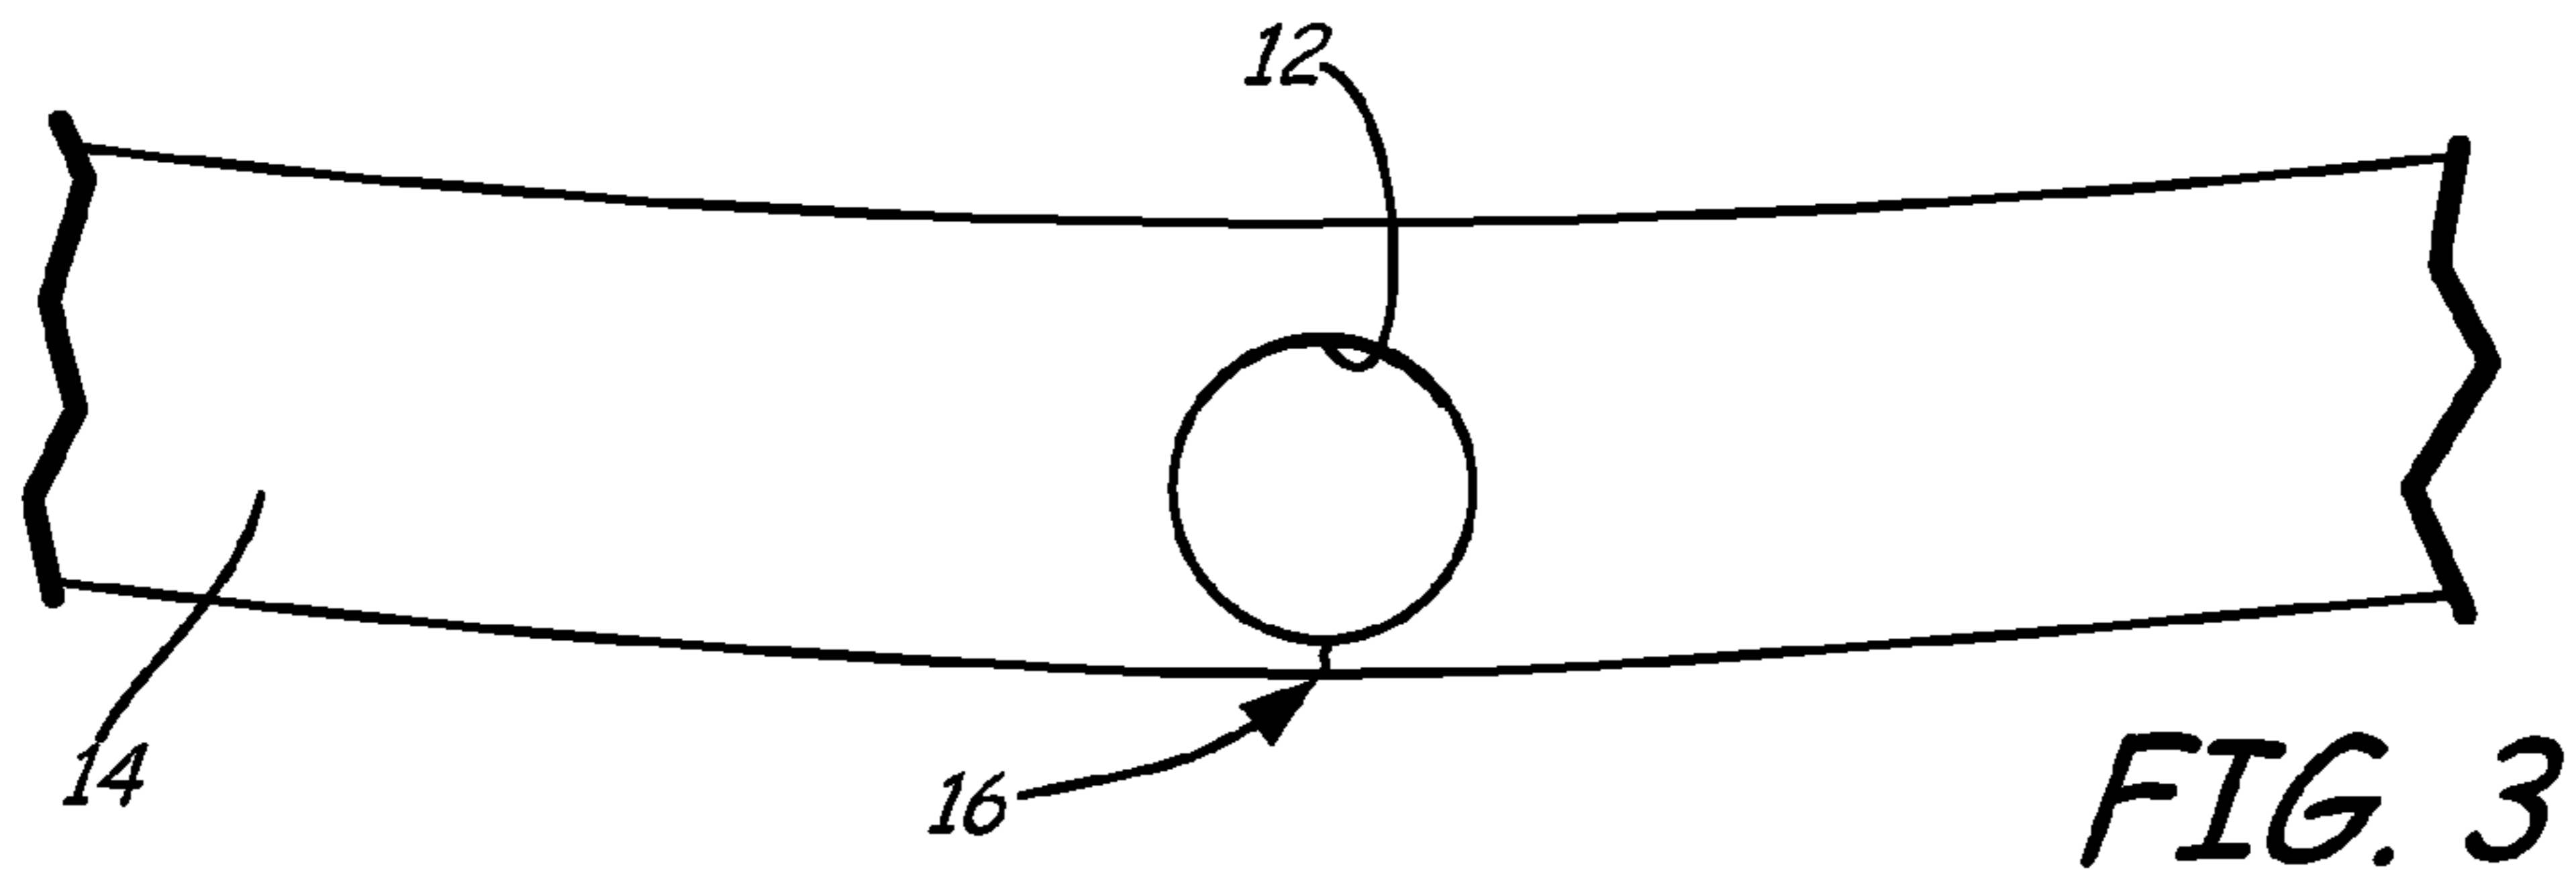
FIG. 3 is a plan view illustrating a defect adjacent an aperture on a flange.

FIG. 3 is a plan view illustrating defect **16** adjacent hole **12** on flange **14**. Hole **12** is an aperture through flange **14** which is capable of receiving a pin or bolt to fasten another object to the nozzle support **10**. In the embodiment illustrated, hole **12** is circular, although other aperture profiles are envisioned. Hole **12** is a small diameter aperture, less than about 0.30 inches in diameter, which was previously unrepairable when a defect was detected adjacent the aperture.

Flange **14** is constructed from a heat resistant base material. The base material is a super alloy, such as a nickel base or cobalt based superalloy, or other alloys common in the gas turbine industry. Examples of alloys include Inconel7 718 (IN718), IN617, IN625, Ti 6Al 4V and other titanium alloys, Al 6061 and 4043, Waspaloy, Astroloy, Udimet7 500, and HA230. Crack **16** is the result of thermal stress that often emanates from hole **12** to the outer surface of flange **14**.

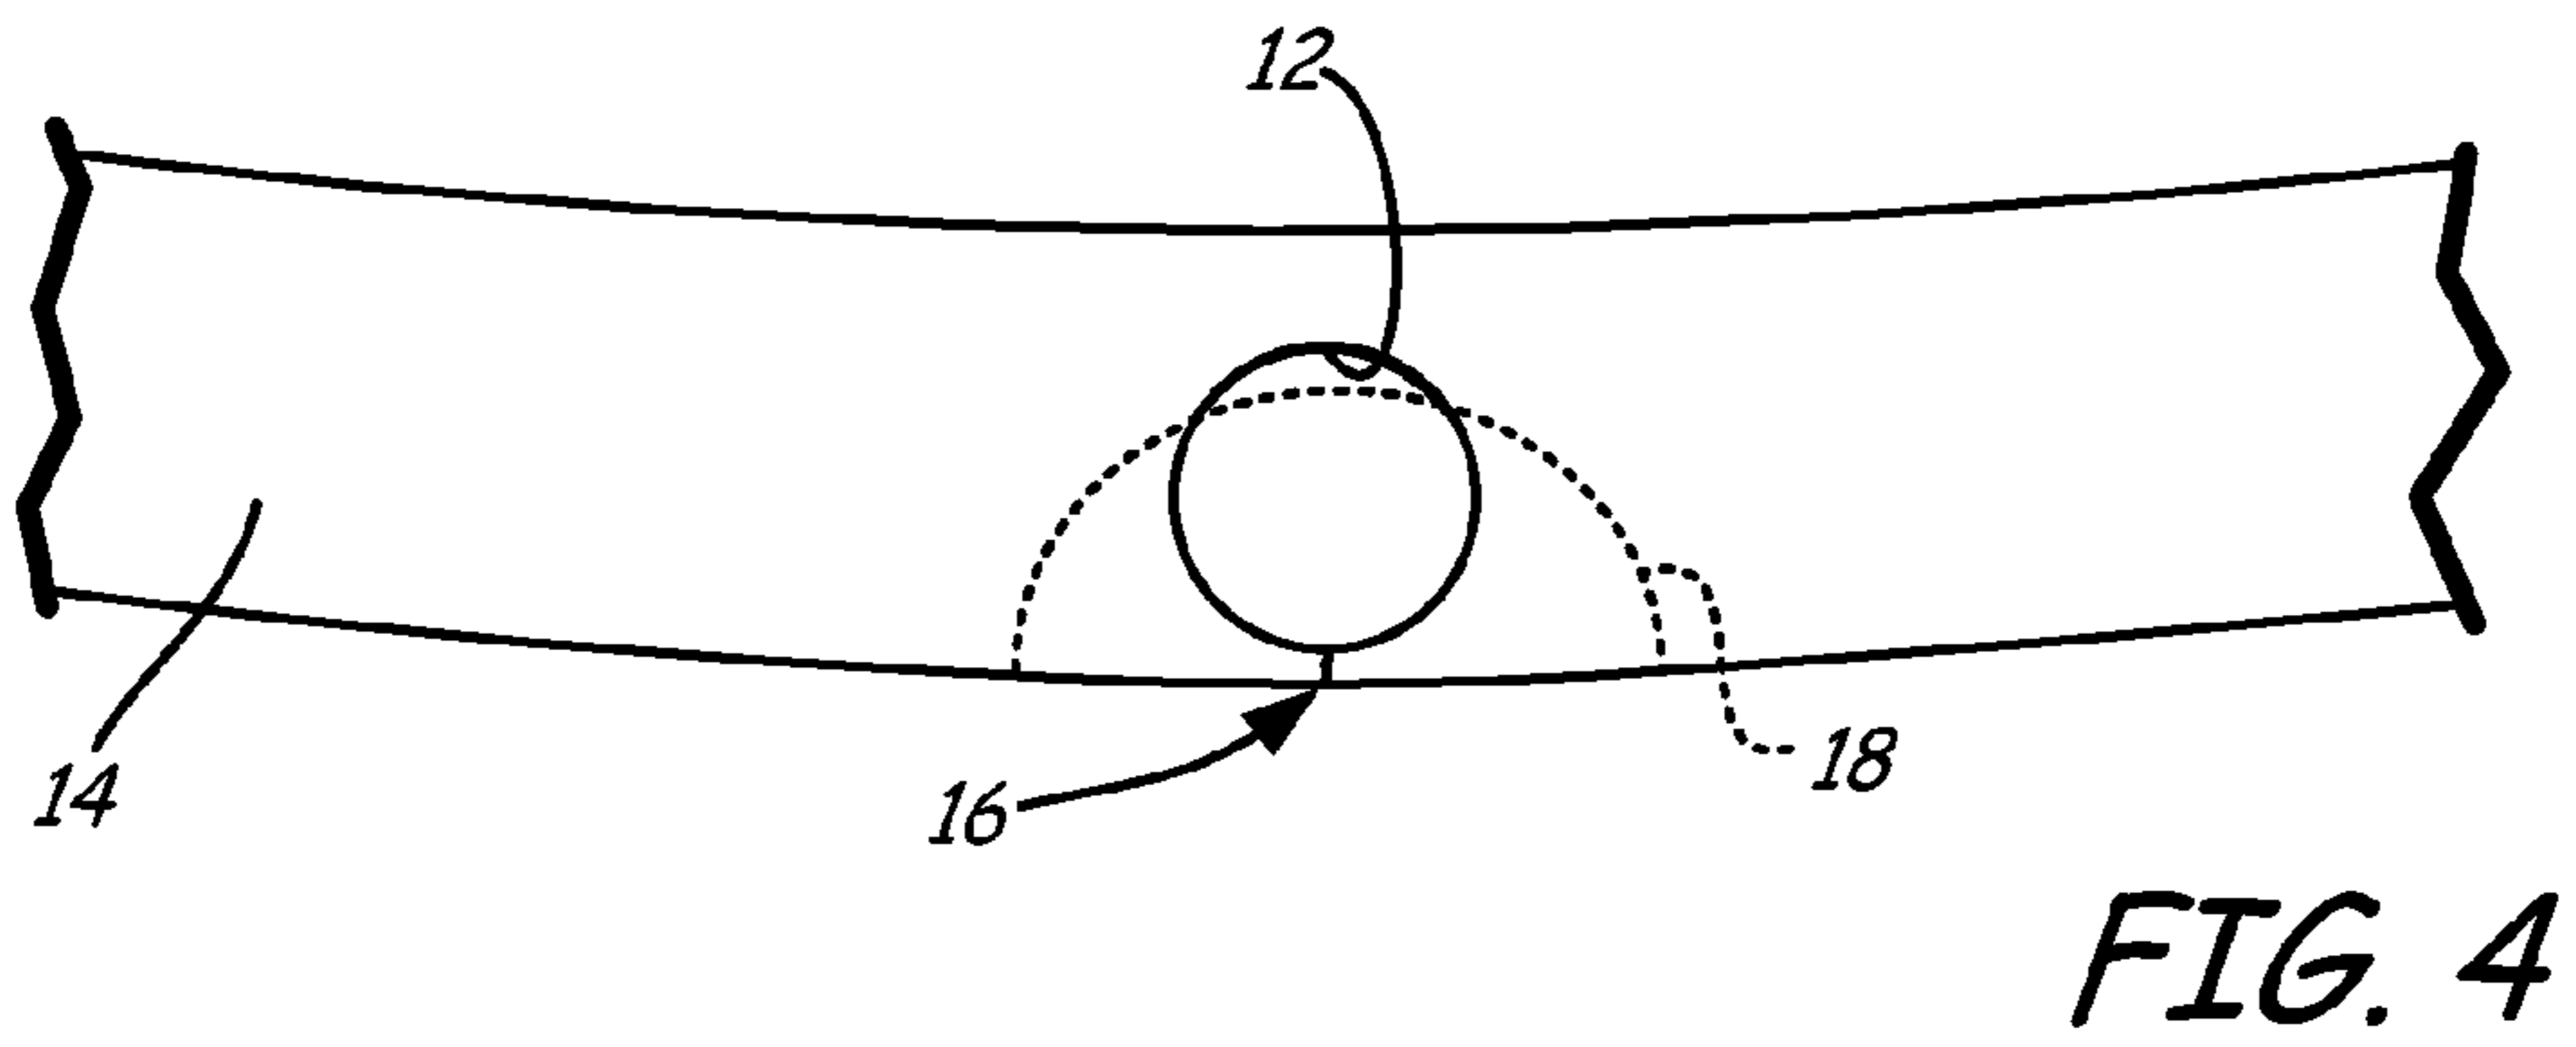
FIG. 4 is a plan view illustrating a portion of the flange to be removed.

FIG. 4 is a plan view illustrating a portion **18** of flange **14** to be removed. Portion **18** of flange **14** is extracted by common techniques known to those of skill in the art for material removal, such as laser cutting or machining. Portion **18** is to be removed in a parabola centered about an axis that runs through the diameter of hole **12**, without completely removing the hole **12**. The material is removed by cutting perpendicular to the top surface of flange **14**. Removing material in the shape of a parabola or similar shape removes the defect and provides an attachment surface outside the high stress zones which are adjacent hole **12**. Typically, the position of a hole located nearest the outer edge of the flange, or perpendicular to the outer edge, as well as areas offset 90 degrees, 180 degrees, and 270 degrees therefrom, contain the highest stresses (See A, B, C, and D, respectively, FIG. 2A). Creating a repair where the weld seams fall between these areas (at approximately 45 degrees, 135 degrees, 225 degrees, and 315 degrees) moves the welds out of high stress zones surrounding the hole **12** (See E, F, G, and H, of FIG. 2A). Moving the weld out of the high stress zones surrounding the hole **12** is similar to what occurs when large holes are repaired as described above. This assures good fatigue life for the repaired part.

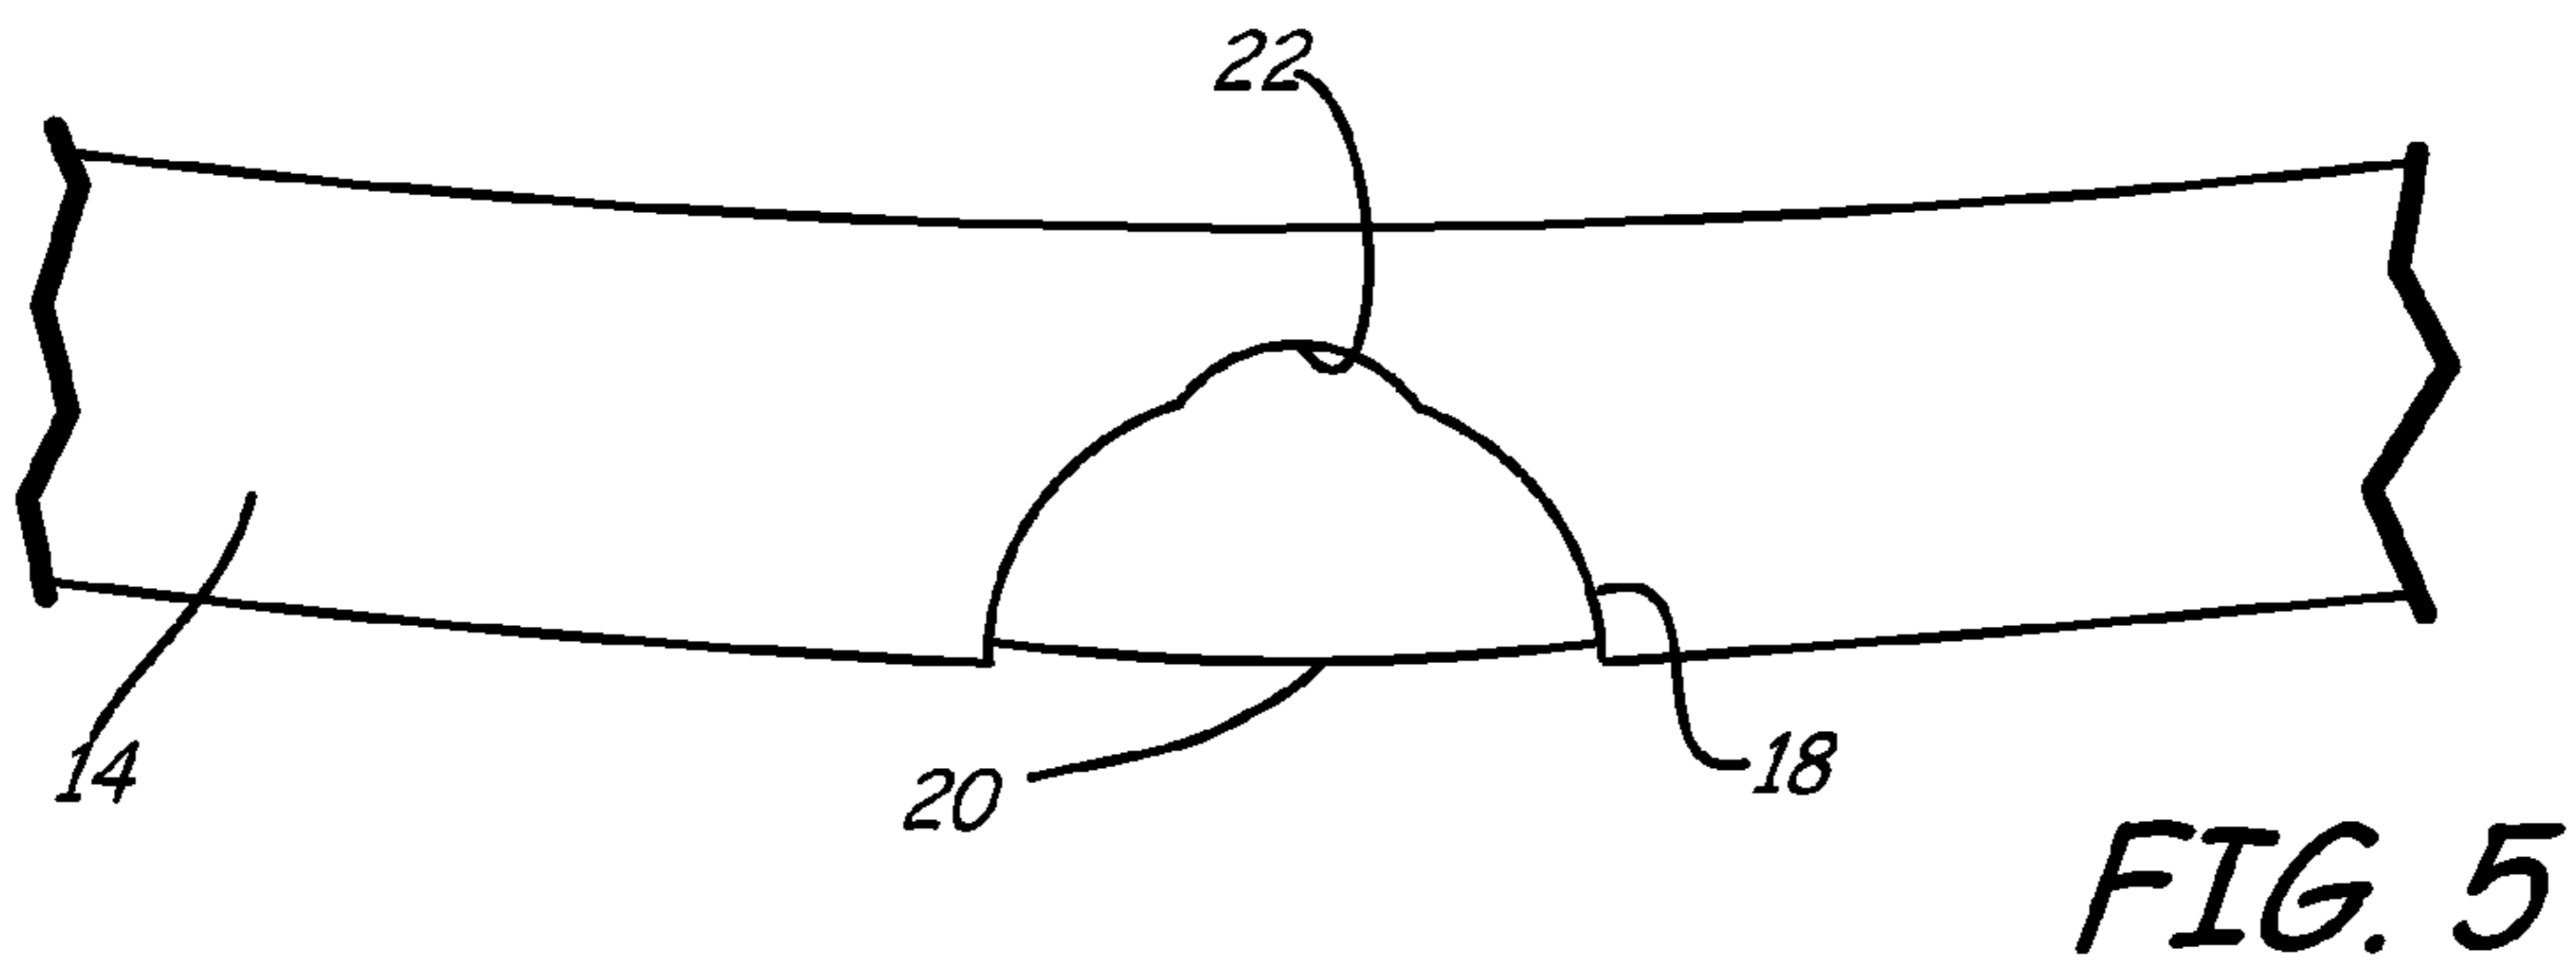
FIG. 5 is a plan view illustrating the portion of the flange removed and a parallel flange.

FIG. 5 is a plan view illustrating portion **18** of flange **14** removed, which reveals lower flange **20**. With portion **18** removed, only a small arc **22** of the hole **12** is left. The remaining arc **22** acts as a guide and locator for finishing the repair to assure that the repaired hole is nominally placed in the same position on flange **14** as the original hole **12**. Lower flange **20** is a parallel structure to flange **14**, and a slot **15** exists between the two flanges **14** and **20**, which run circumferentially around the base of the forward inner nozzle support (See FIGS. 2 and 2A).
