(10) **Patent No.:** **US 8,153,922 B2**
(45) **Date of Patent:** **Apr. 10, 2012**

- (54) **INSERT WELD REPAIR**
- (75) Inventor: **Philip R. Belanger**, Acton, ME (US)
- (73) Assignee: **United Technologies Corporation**,
Hartford, CT (US)

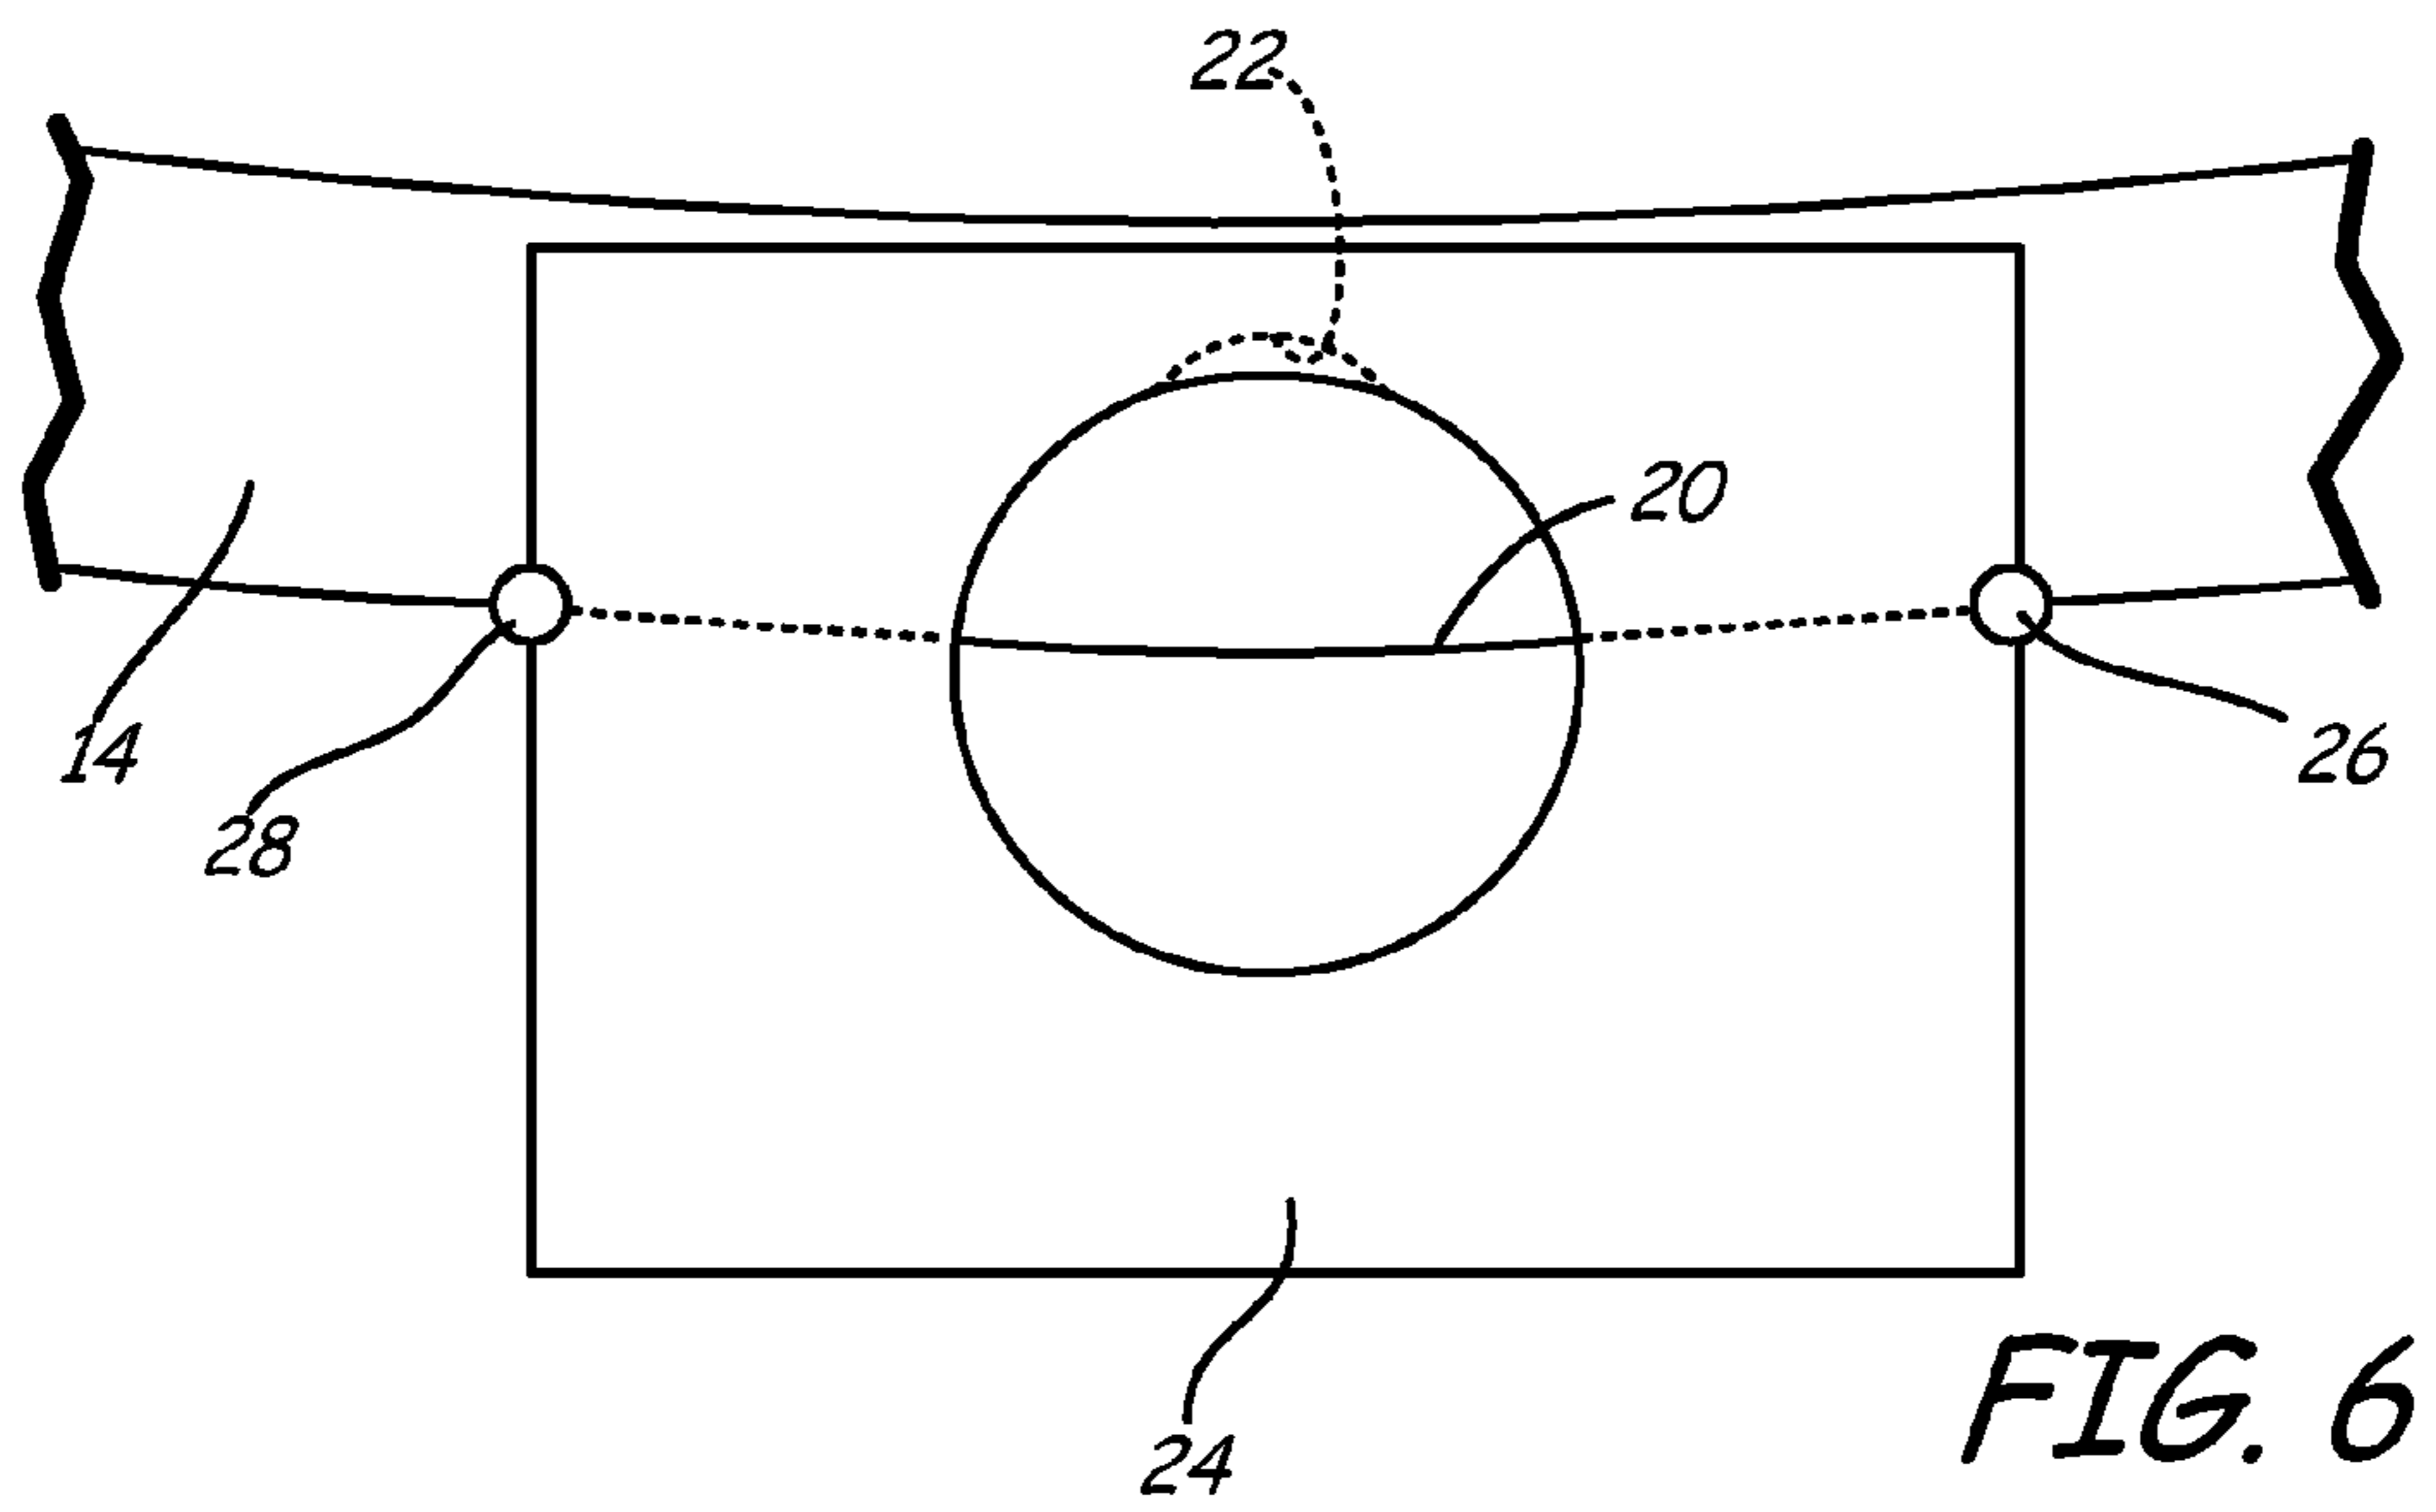
FIG. 6 is a plan view illustrating a combination runoff and top plate tacked to the flange.

FIG. 6 is a plan view illustrating a combination plate **24** (i.e., combination runoff and top plate) attached to flange **14**. Combination plate **24** is attached to flange **14** by placing tack welds **26**, **28** where the edges of combination plate **24** meet the outer edge of flange **14**. Tack welds **26**, **28** hold combination plate **24** temporarily in place. Also, tack welds can be easily removed later, without damaging flange **14**, to remove combination plate **24**. Combination plate **24** may be fabri-

cated from the same material as the base material of flange **14**, or a material that has consistent metallurgical properties. In embodiments, combination plate **24** has a central portion removed that reveals lower flange **20**, and covers arc **22**. In alternate embodiments (not illustrated), combination plate **24** does not cover arc **22**.

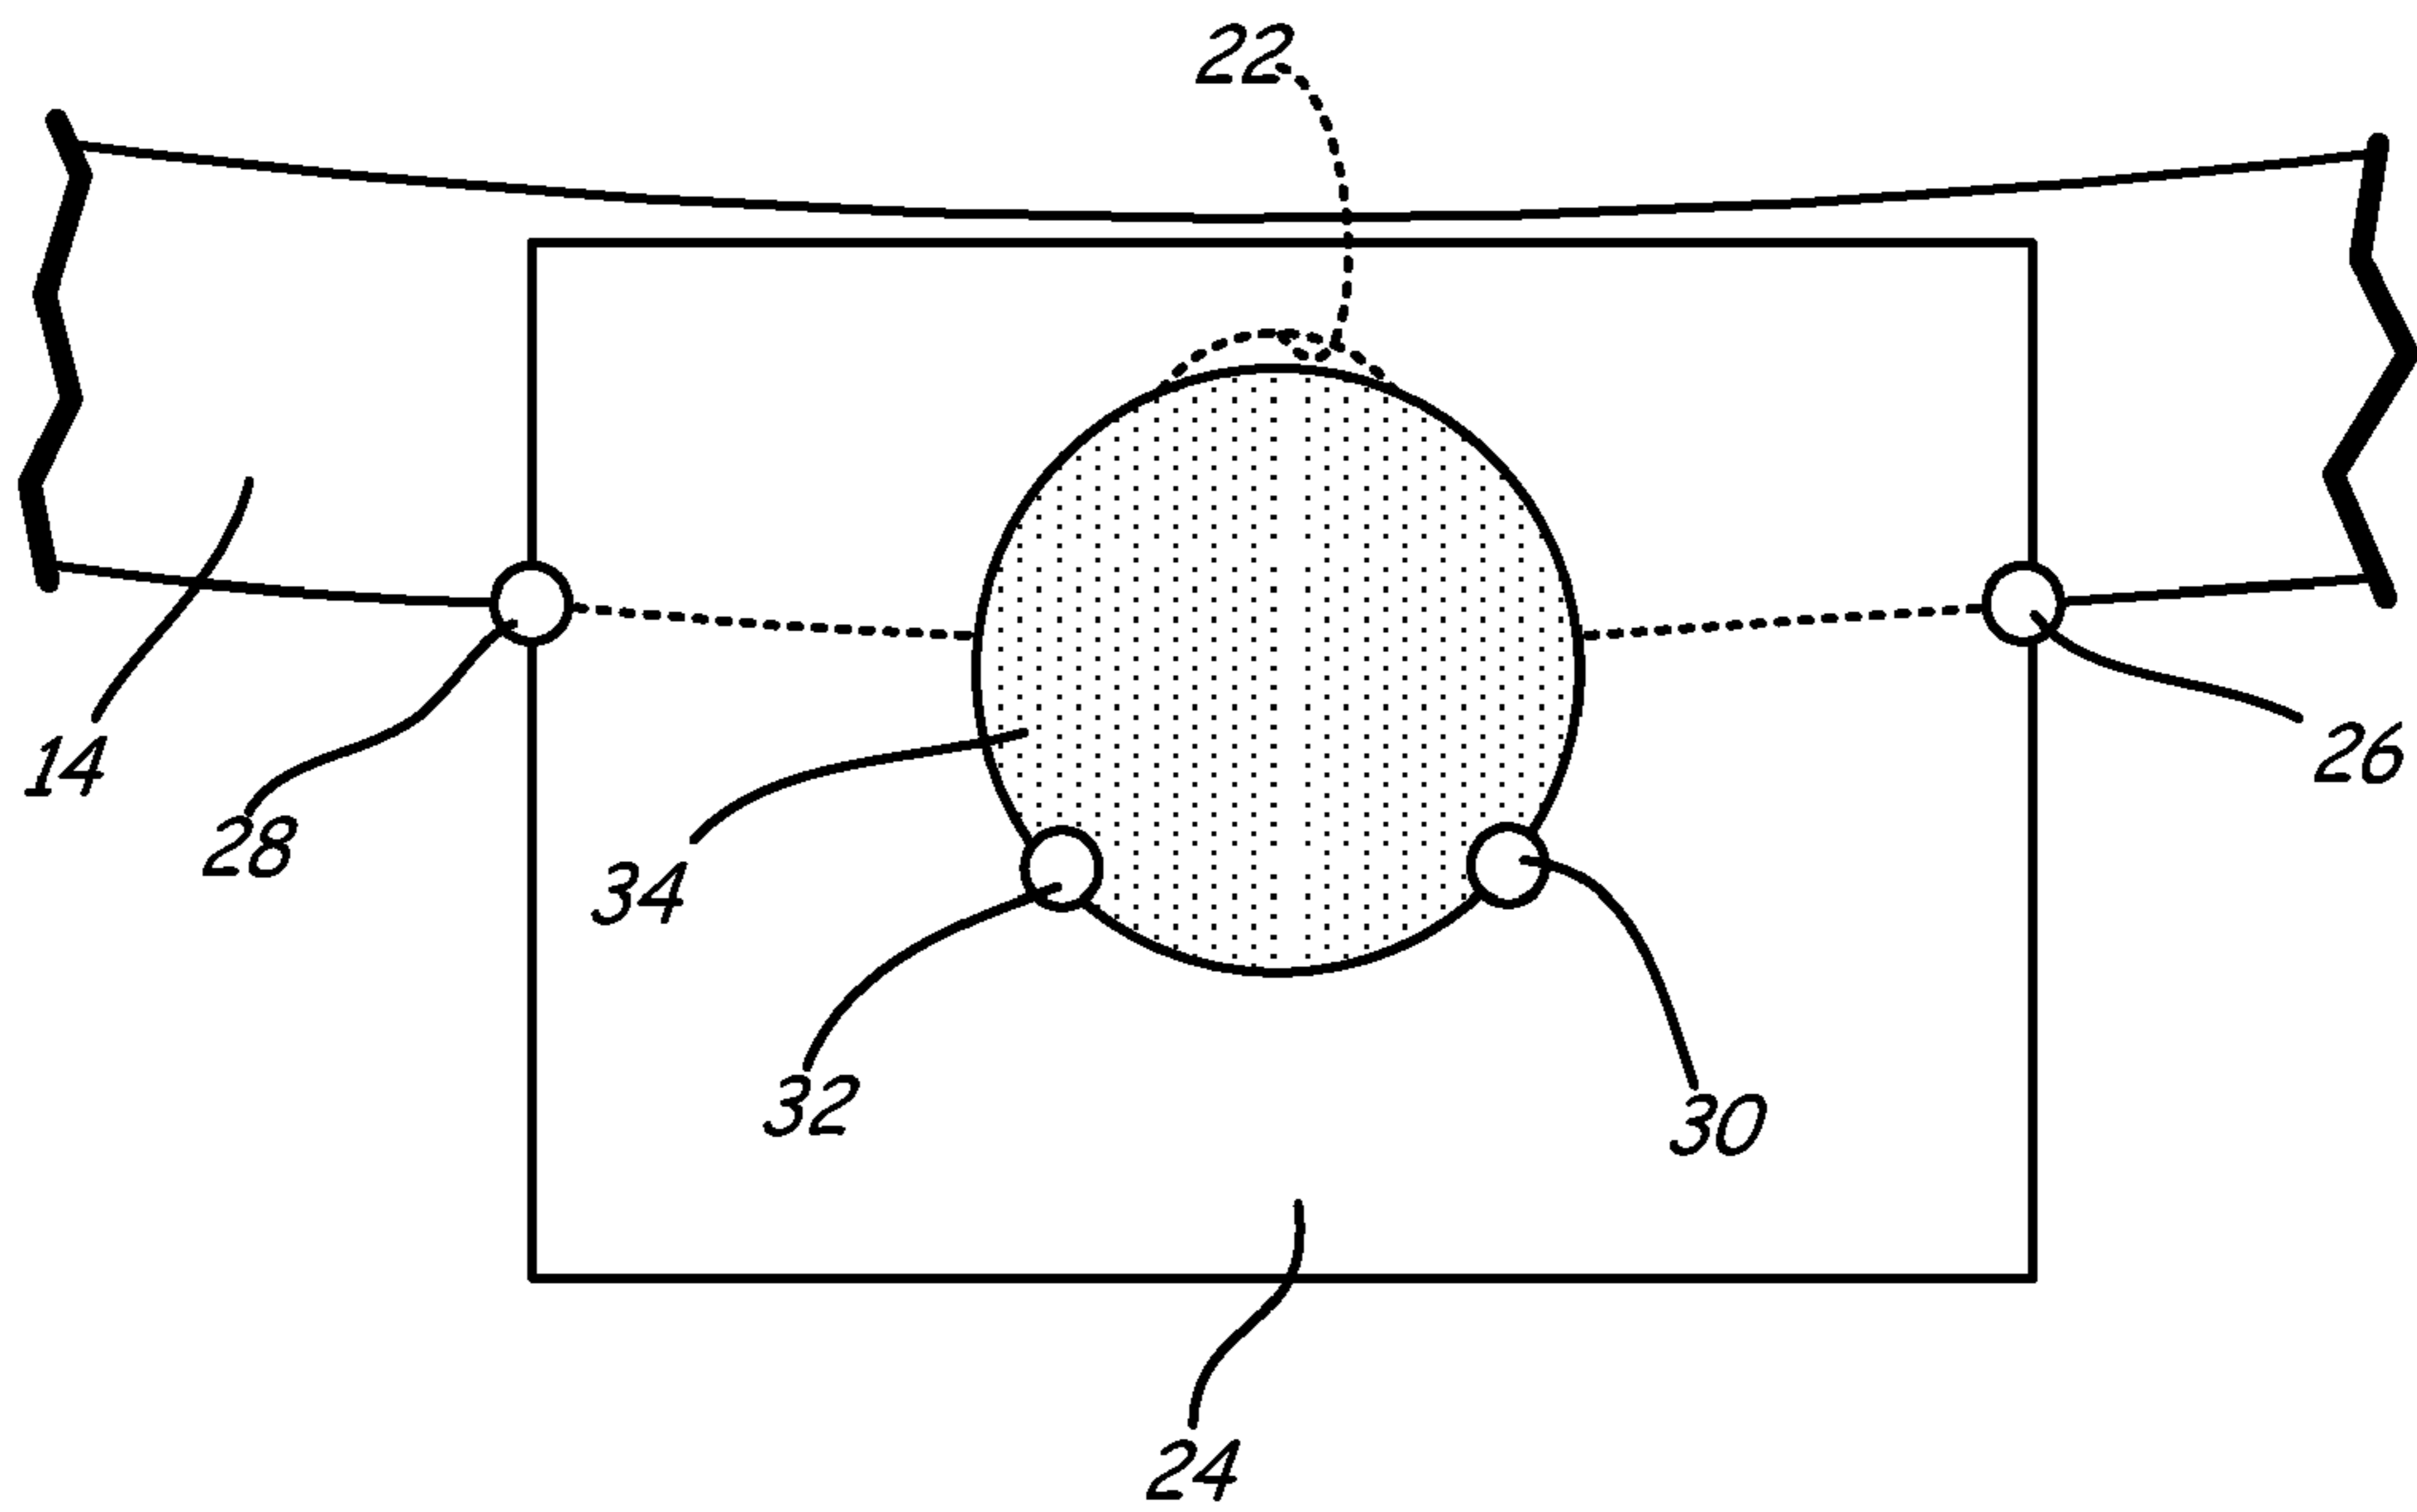
FIG. 7 is a plan view illustrating a biscuit insert tacked to the combination plate.

FIG. 7 is a plan view illustrating insert **34** attached to the combination plate **24** via tack welds **30**, **32**, which hold the insert **34** in place until the final welding process occurs. Insert **34** is a plug of material that is preferably the same material as, or contains the same metallurgical properties as, that of the base material of flange **14**. Insert **34** is sized to be positioned against the edge of portion **18** of flange **14** previously removed (see FIG. 4), as well as mate with the profile of the aperture in combination plate **24**. In the embodiment illustrated, insert **34** is circular. Although illustrated as circular, insert **34** may be elliptical, biscuit shaped, or have an arced portion that matches the profile of the removed material **18** of flange **14**. When the weld is complete, tack welds **30**, **32** will be incorporated into the final repair weld.

In embodiments, combination plate **24** is larger than the diameter of the hole **12** being repaired. In embodiments, combination plate **24** has a length (measurements of the sides generally parallel to the outer edge of flange **14**) of at least two times the diameter of the original hole **12** (FIG. 2), and has a width (measurements of the sides generally perpendicular to the outer edge of flange **14**) of at least two times the diameter of hole **12**. The aforementioned dimensions of combination plate **24** assure good support for insert **34**, and allow for locating tack welds **26**, **28** an adequate distance from the repair weld(s) around insert **34**.

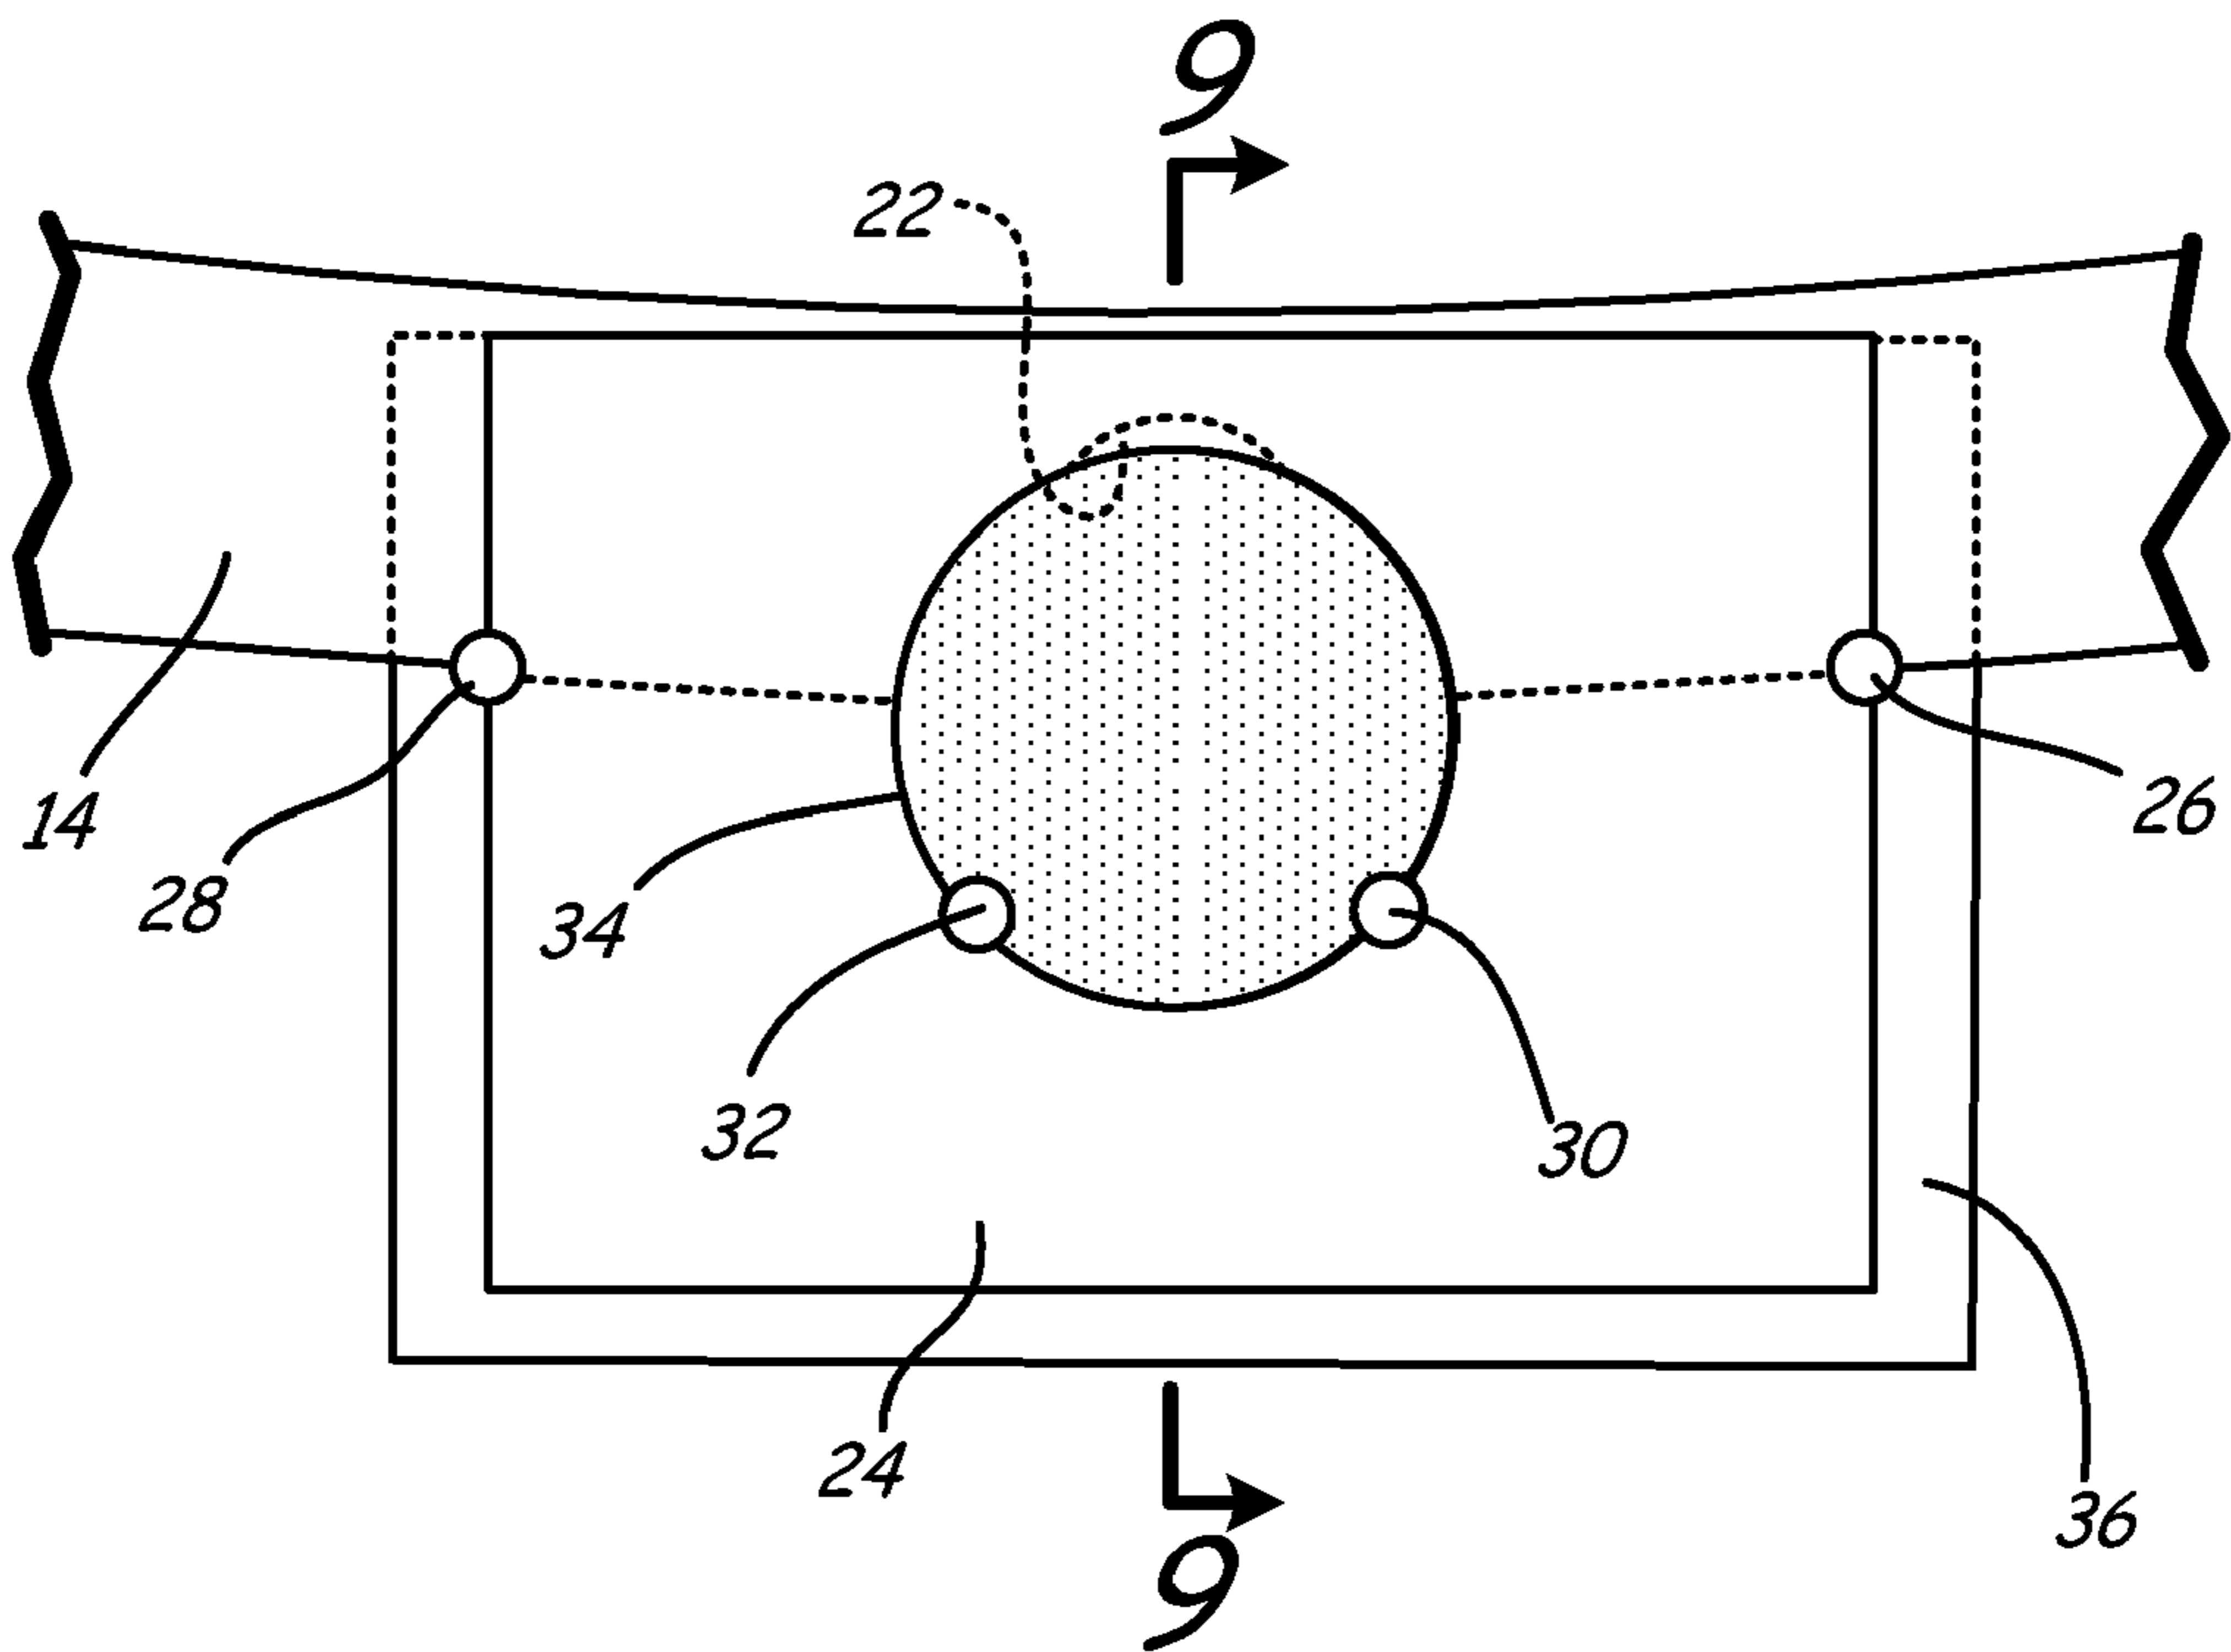
FIG. 8 is a plan view illustrating a backing plate placed below the combination plate and insert.

FIG. 8 is a plan view illustrating backing plate **36** placed below combination plate **24** and insert **34**. Backing plate **36** may be fabricated from a similar metal that is used to construct combination plate **24** and insert **34**. In alternate embodiments, backing plate **36** is constructed from a different metal, or a heat resistant material such as ceramic. In FIG. 8, backing plate **36** is illustrated as containing larger dimensions than combination plate **24**, but backing plate **36** may be smaller in size than combination plate **24** so long as the backing plate **36** covers the area underneath where the repair weld is to be made. When backing plate **36** is larger than combination plate **24**, backing plate **36** protects adjacent areas from weld run off or spatter, as well as protects lower flange **20** from penetration of the electron beam or similar welding source.

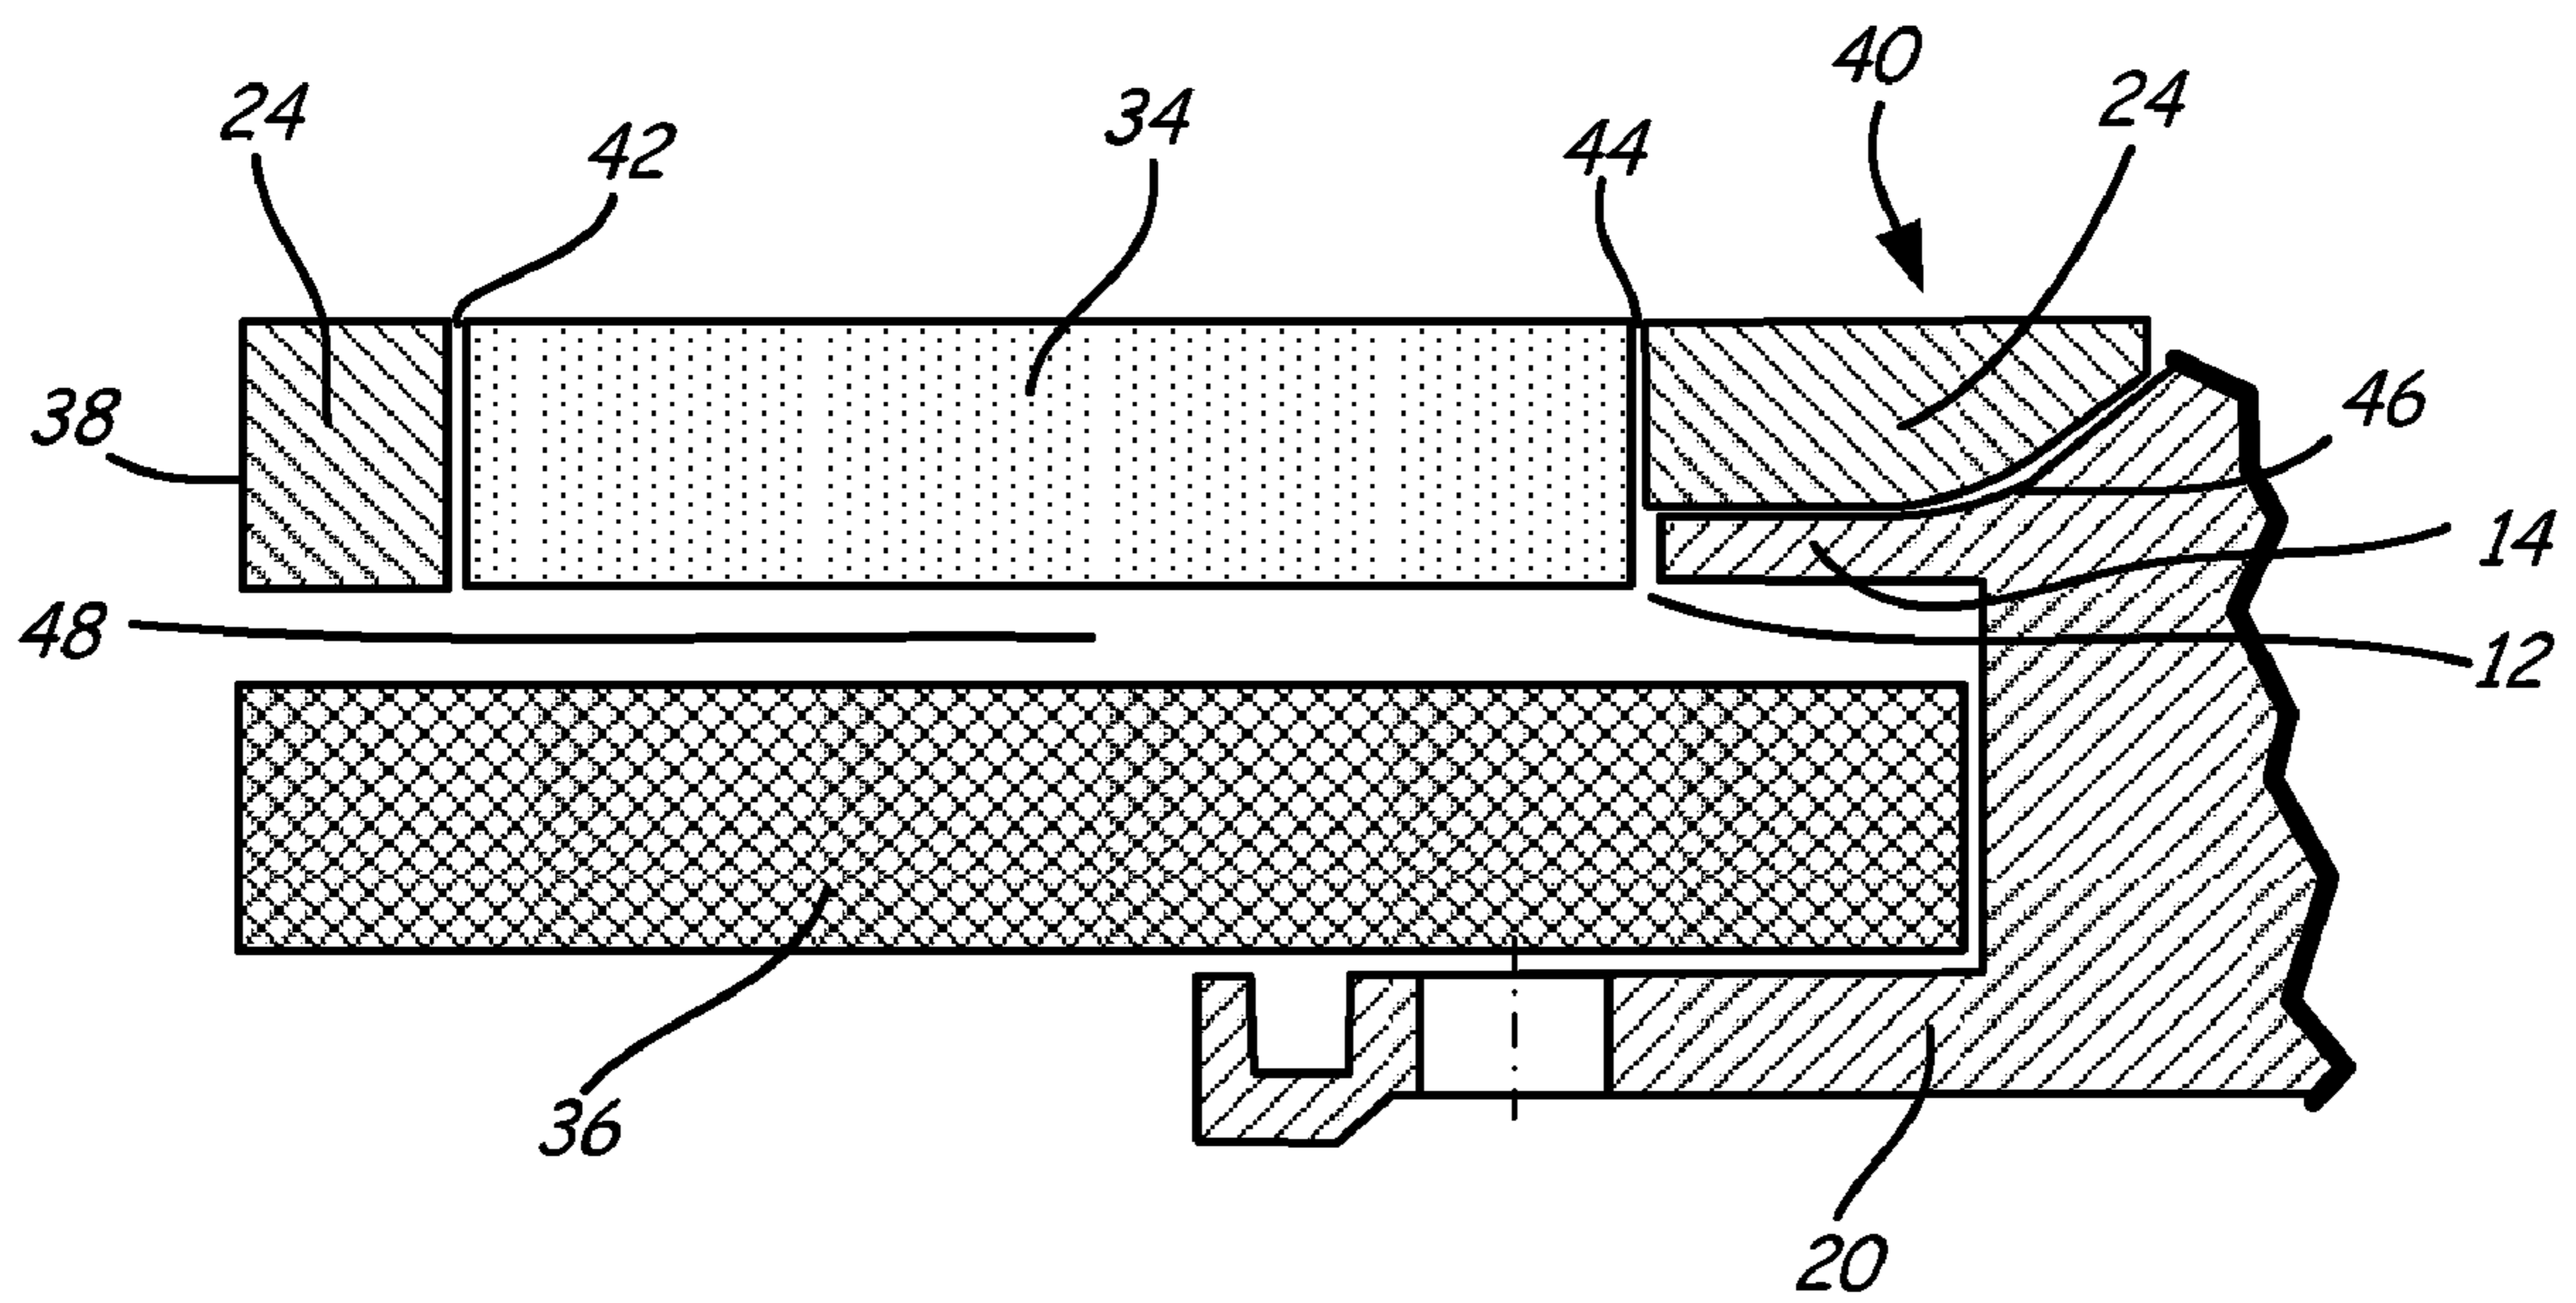
FIG. 9 is a cross-sectional elevation view of the bolt hole repair apparatus for refabrication of the flange of the nozzle support illustrated in FIG. 7.

FIG. 9 is a cross-sectional elevation view of the bolt hole repair apparatus for refabrication of flange **14** illustrated in FIG. 8. In this view, the remaining portion of the base material of flange **14** is visible. Also illustrated are insert **34**, combination plate **24**, and backing plate **36**. Insert **34** is a thickness that is approximately equivalent to the thickness of the rear edge **38** of combination plate **24**, which is also approximately equivalent to the thickness of the front end **40** of combination plate **24** added to thickness of the remnant of hole **12** left on flange **14**. Small clearance gaps **42**, **44** exist between insert **34** and plate **24**. The clearance allows for the easy insertion of insert **34** into the aperture contained in combination plate **24**. Clearance gaps **42**, **44** will cease to exist as the material from insert **34** and combination plate **24** fuse together during the repair weld.

Front end **40** of combination plate **24** is contoured to mate with remaining surface **46** of flange **14** and hole **12**. Although flange **14** is illustrated in this view as containing a radius, other geometries of the contour are envisioned including bevels, chamfers, rabbets, dados, or stepped notches, the geometry of the contour depending on the geometry of the base

material left on flange 14. Insert 34 and combination plate 24 contain more material than the thickness of the material removed from flange 14 so that insert 34 can be machined to the appropriate size after the weld repair has been completed.

The part illustrated in FIG. 9 is a section of nozzle support 10 of FIG. 2. Nozzle support 10 contains two flanges, flange 14 which is to be repaired, and a lower flange 20. Lower flange 20 and flange 14 are spaced close together, and a typical spacing is less than about 0.25 inches. Backing plate 36 is placed between flange 14 and lower flange 20, and protects the lower flange 20 from any slag, spatter, or similar byproduct resulting from the welding process.

In a typical prior art welding repair utilizing a backing plate, the weld must penetrate through the repair portions to assure a good weld. In such repairs, the backing plate is placed directly behind the weld to adsorb the residual energy from the weld, which allows the backing plate to fuse to the repair. Then, after the repair, the backing plate must be removed. The relatively small distance between flange 14 and lower flange 20 makes such a removal difficult.

Thus, in this invention, an air gap 48 is left between the top surface of backing plate 36 and the bottom surfaces of insert 34, combination plate 24, and the remaining portion of flange 14. In embodiments, air gap 48 is about 0.10 inches or less, which assures that the excess energy from the weld beam is adsorbed, but is far enough from the bottom edge of the repair pieces (insert 34, combination plate 24, and flange 14) to assure that backing plate 36 does not become fused to the repair pieces. Utilizing combination plate 24 to provide a good weld, while separating the repair pieces from the backing plate 36 via air gap 48, assures that a good, structurally sound weld repair can be obtained. Backing plate 36 should be large enough to cover the clearance gaps 42, 44 between the combination plate 24 and the edges of the insert all the way around the edge of insert 34. The thickness of backing plate 36 is less than the distance between flange 14 and lower flange 20 so that air gap 48 exists as shown.

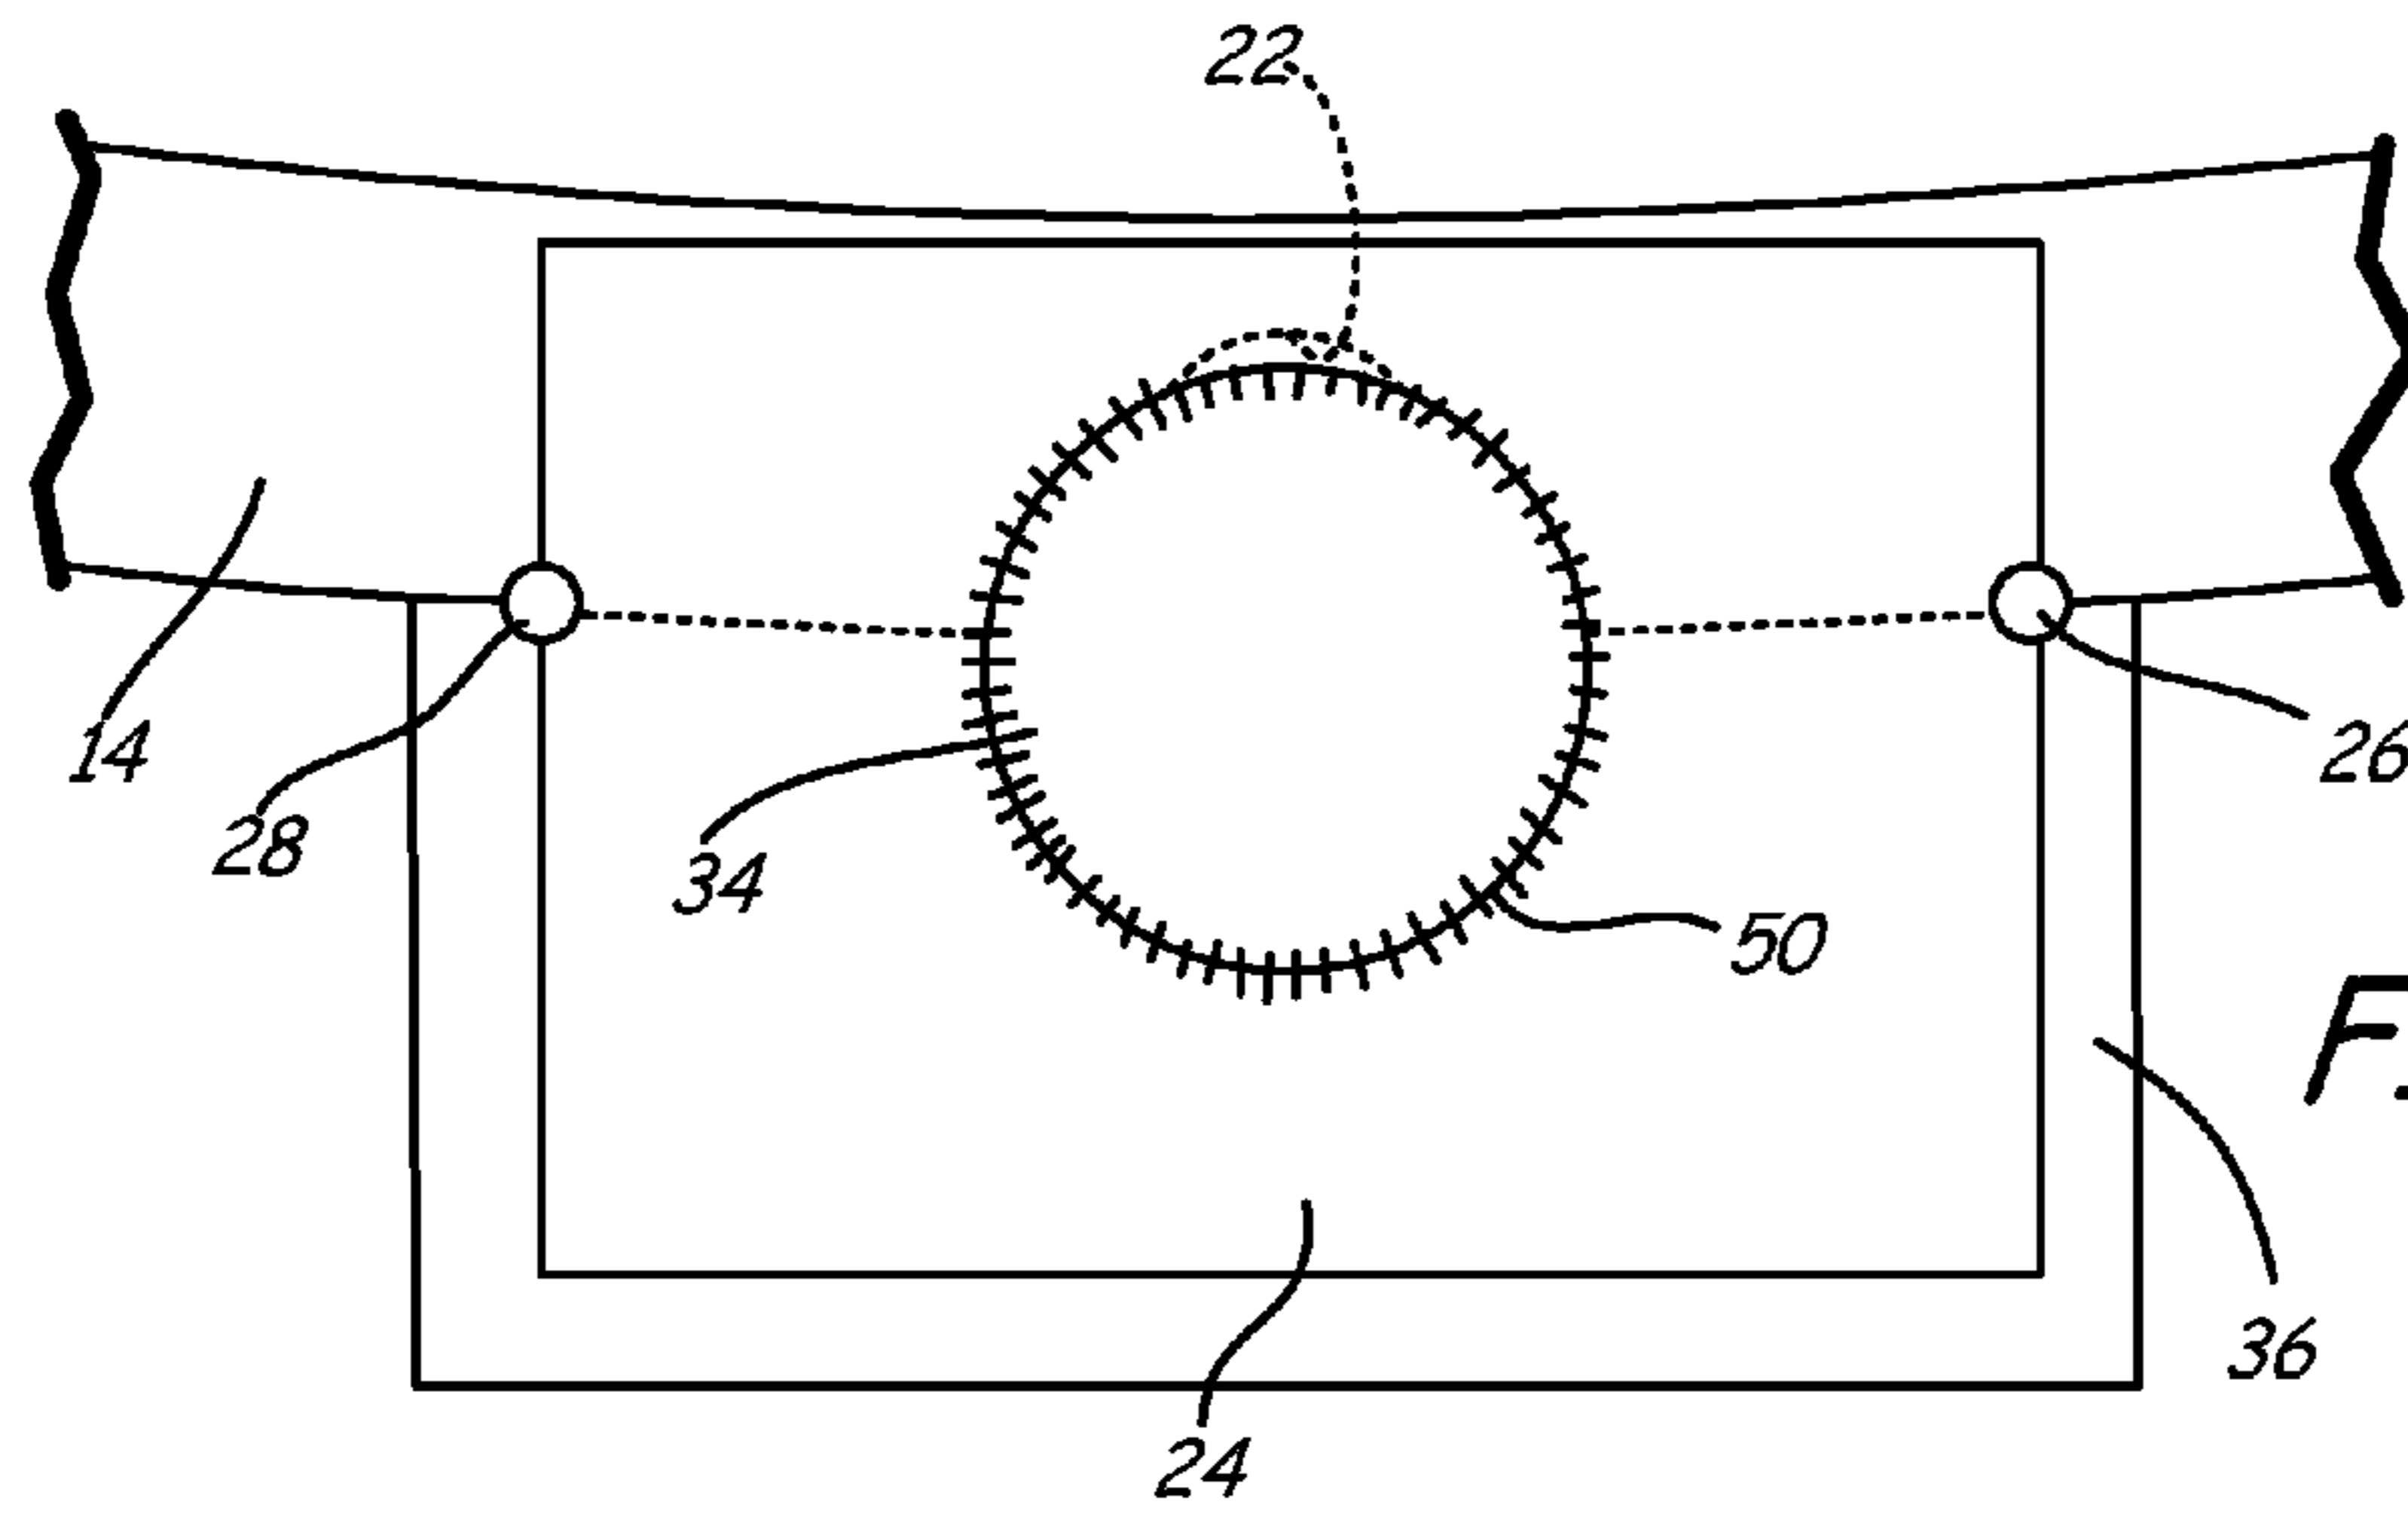
FIG. 10 is a plan view illustrating a completed weld between the insert, combination plate, and flange with the backing plate still in place.

FIG. 10 is a plan view illustrating a completed weld 50 between insert 34 and combination plate 24. Insert 34 is welded into place by a process such as electronic beam welding. Electronic beam welding (EBW) uses a narrow beam of high velocity, high energy electrons to generate the heat necessary to create a weld in a metal work piece. Special equipment is used to focus the electron beam in a vacuum chamber, and the kinetic energy of the electrons is converted to heat energy as it strikes the metal. The welds created by EBW are characteristically deep and narrow with a very small heat affected zone and low distortion. The current repair moves the weld seams out of the high stress areas surrounding the hole 12. The weld seams are left in the low stress areas of the flange 14.

EBW is typically autogenous, that is, does not require a filler material. Thus, a tight fit of insert 34 with the remaining base material and combination plate 24 will occur as the pieces fuse together during the welding process without the addition of a filler material. Weld 50 is a butt weld joining insert 34, base material of flange 14, and combination plate 24 together. While weld 50 is done from the top of insert 34, the weld extends around the entire perimeter of insert 34 and throughout the entire thickness of insert 34.

EBW can leave depressions in the parts welded. Thus, ensuring that insert 34 and combination plate 24 are thicker than the original thickness of flange 14 allows for the melting and fusing of material from the respective top sides of insert 34 and combination plate 24 to flow down and fill in the weld against the base material of flange 14. Thus, when material is
