(10) **Patent No.:** **US 8,153,922 B2**
(45) **Date of Patent:** **Apr. 10, 2012**

- (54) **INSERT WELD REPAIR**
- (75) Inventor: **Philip R. Belanger**, Acton, ME (US)
- (73) Assignee: **United Technologies Corporation**,
Hartford, CT (US)

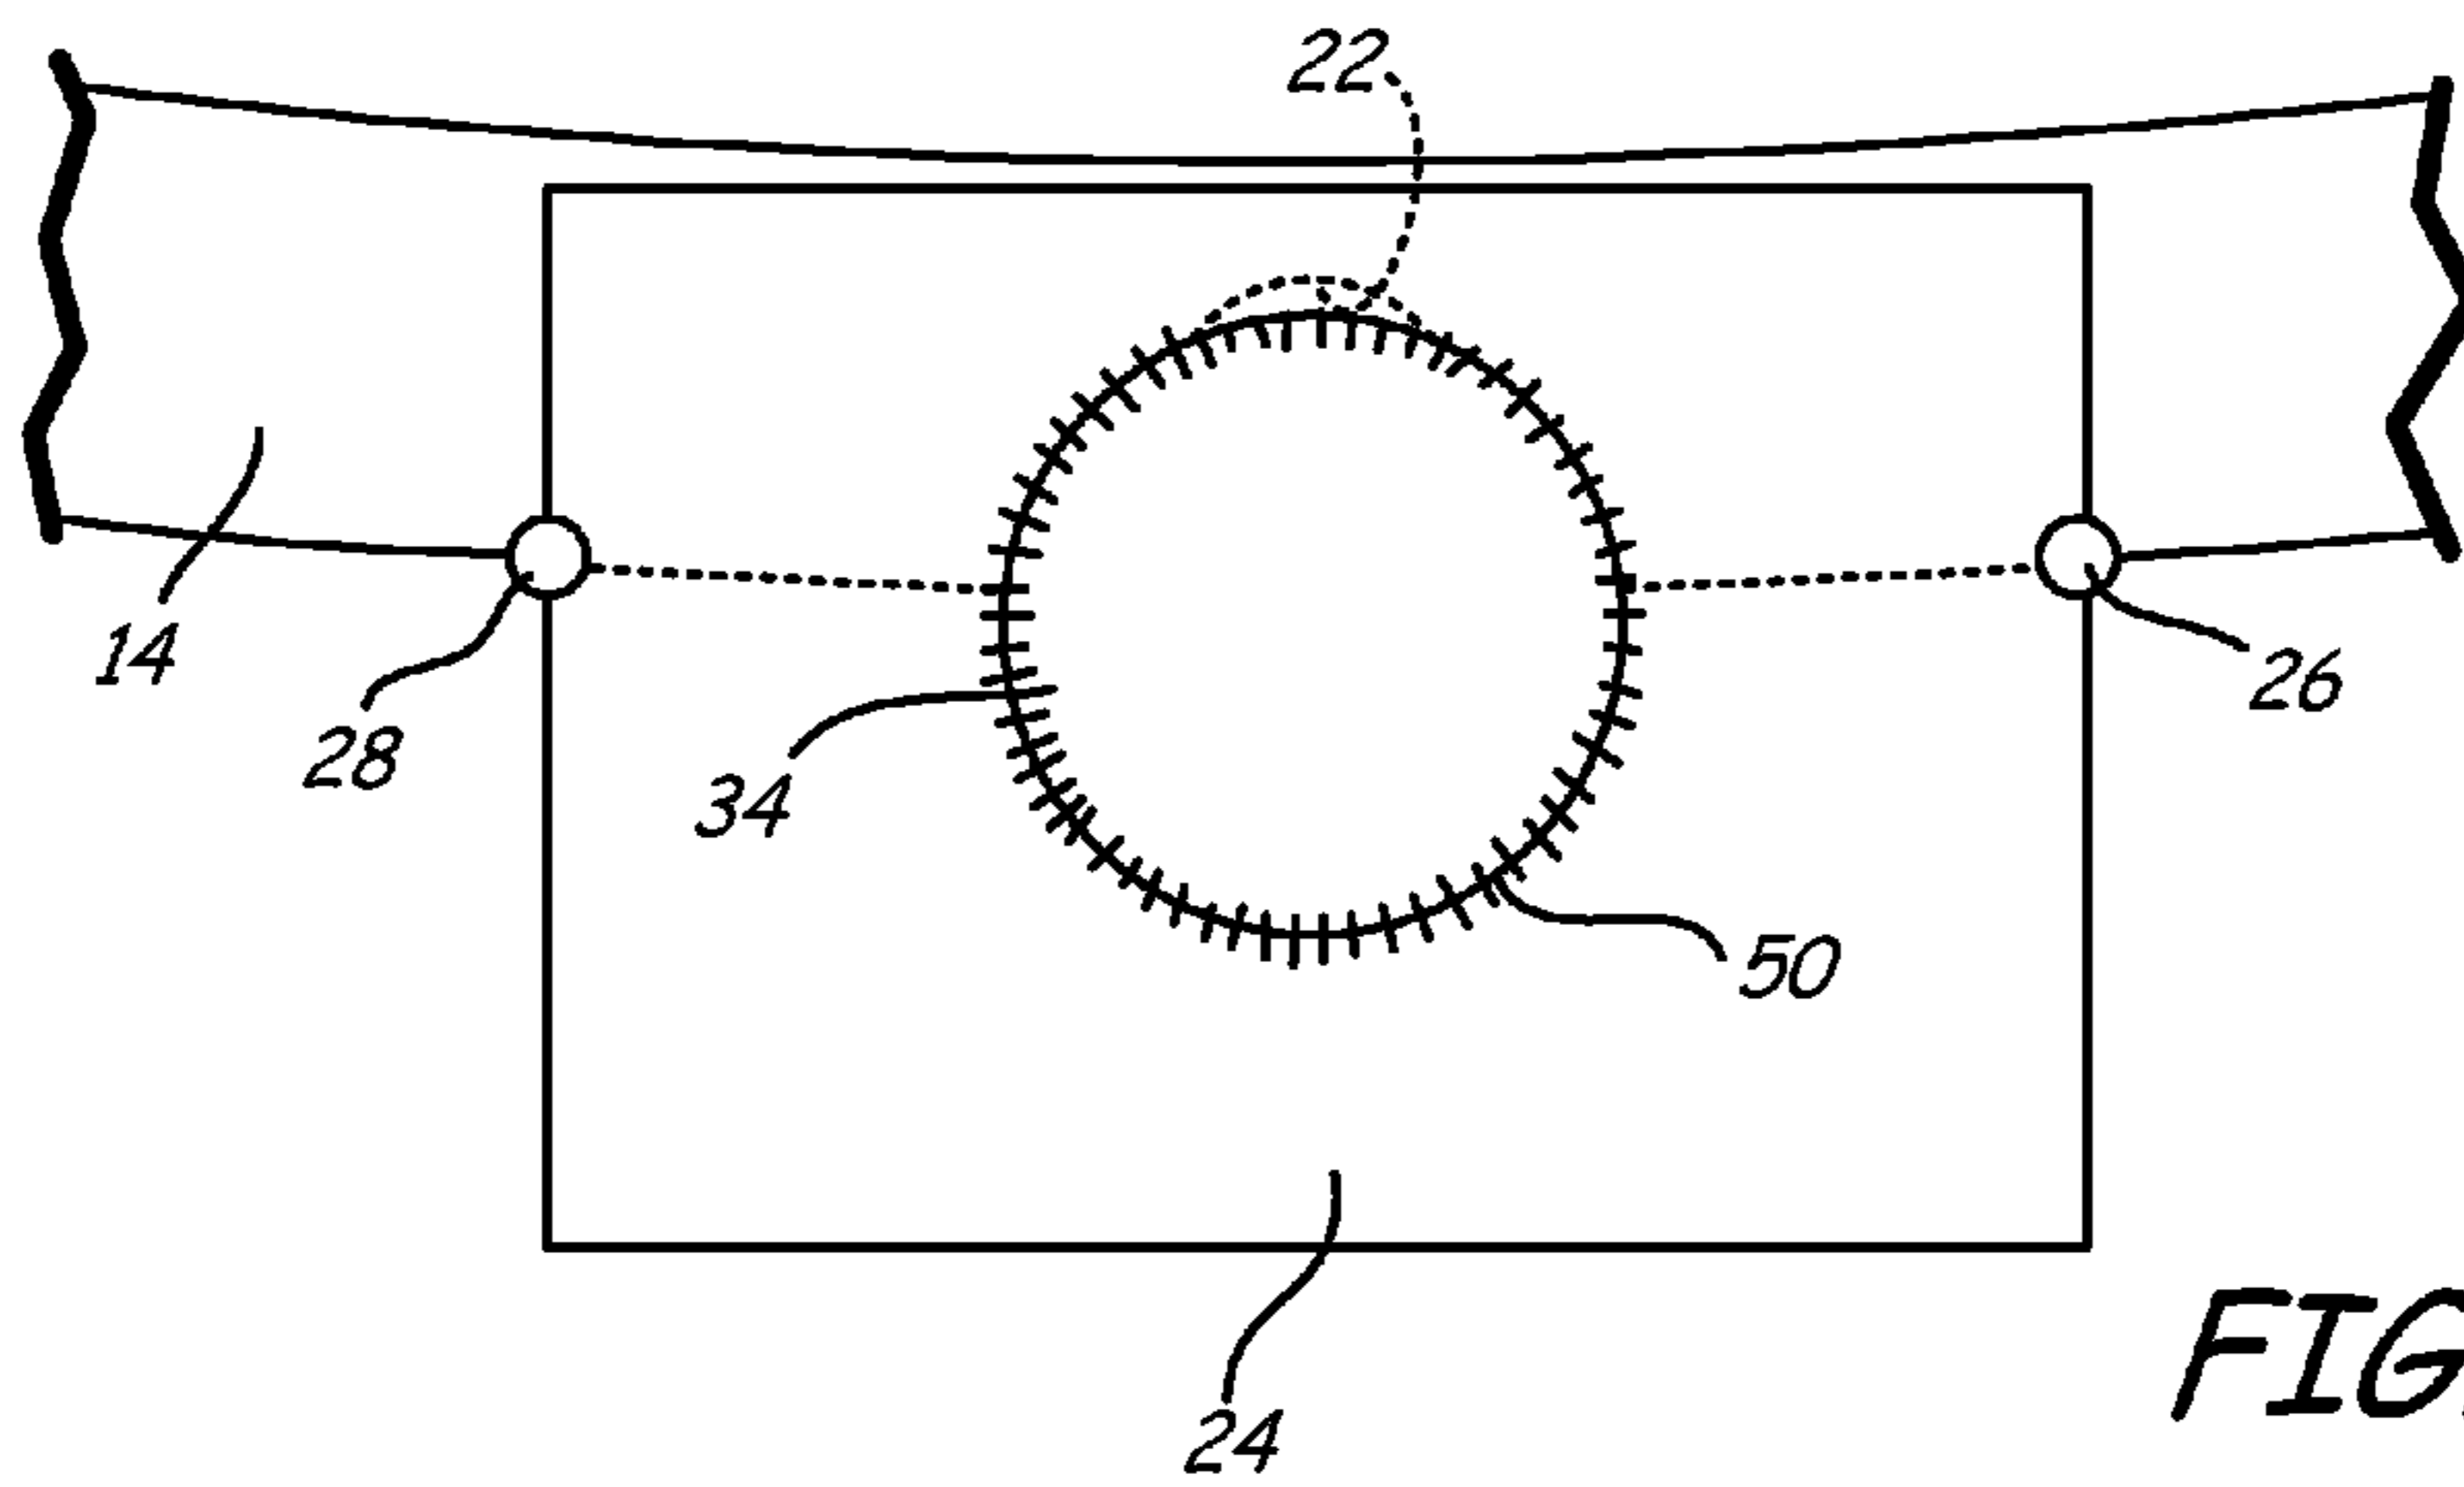
FIG. 11 is a plan view illustrating the completed weld with the backing plate removed.

FIG. 11 is a plan view illustrating completed weld 50 with backing plate 36 removed. Since backing plate 36 does not become fused to the repair pieces (insert 34, combination plate 24, and flange 14), after weld 50 has been completed, backing plate 36 may simply be pulled out from the repaired part. There is no need to use material removal equipment, such as grinders or similar machines to remove backing plate 36. Backing plate 36 may be reused as there will be minimal damage to the top surface as it will not contain removal scars associated with plates that become fused during the welding process.

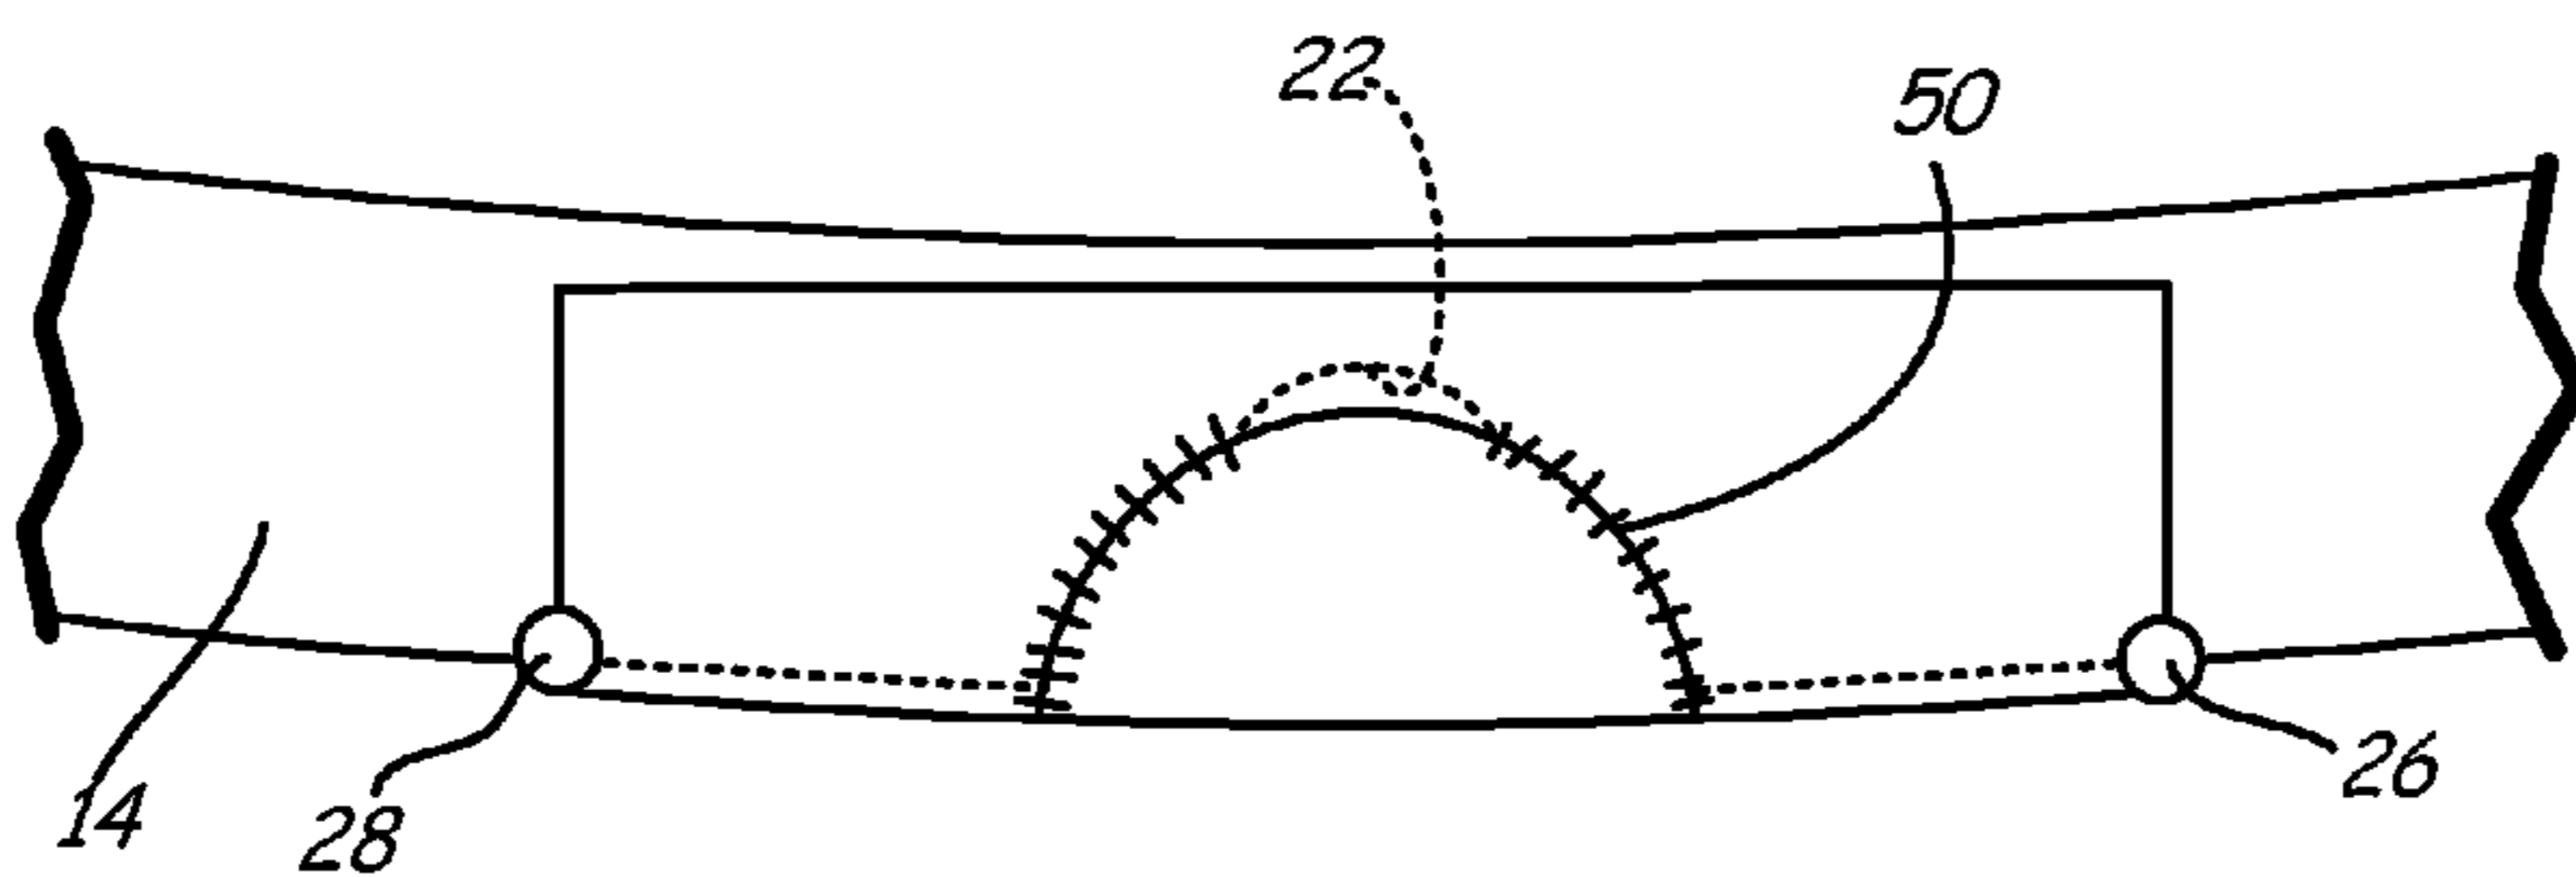
FIG. 12 is a plan view illustrating the completed weld with a portion of the combination plate and insert removed.

FIG. 12 is a plan view illustrating completed weld 50 with portions of combination plate 24 and insert 34 removed. Combination plate 24 and insert 34 are cut along a path that substantially follows the outer profile of flange 14. A mill, laser, or similar material removal machine is used to cut combination plate 24 and insert 34. A nominal amount of material of combination plate 24 and insert 34 may remain after an initial cut to ensure that the cutting process does not affect the integrity of the original flange profile.

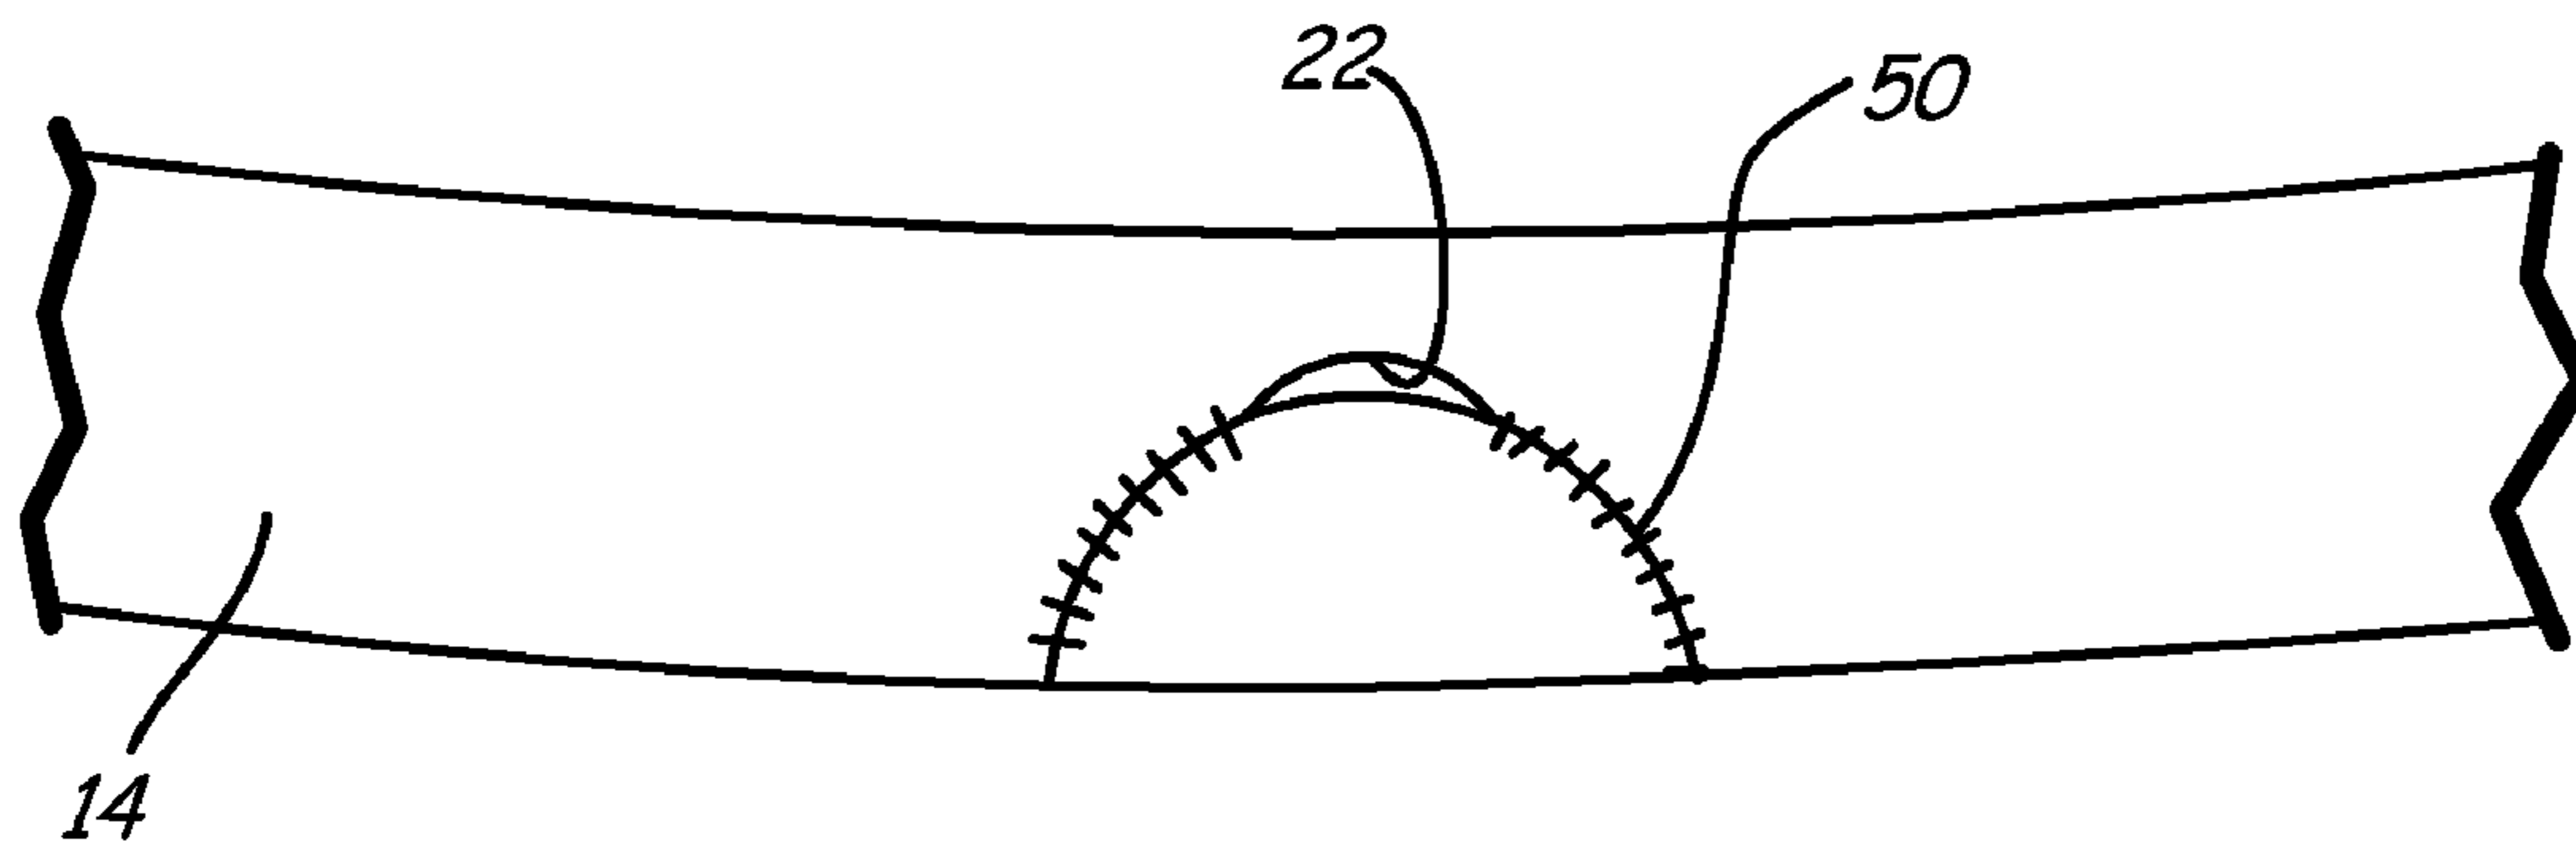
FIG. 13 is a plan view illustrating the combination plate and insert removed to produce the original flange profile.

FIG. 13 is a plan view illustrating combination plate 24 removed to produce the original profile of flange 14. To remove combination plate 24, first tack welds 26, 28 are detached from flange 14. Next, a mechanized process such as machining is utilized to remove combination plate 24 and excess material from insert 34 until the original profile of the top surface of flange 14 is obtained. After combination plate 24 is removed, arc 22 of the original aperture in flange 14 is again visible. Weld 50 will also be machined on the top and bottom surfaces to obtain nominally the same surfaces of flange 14 as those prior to the repair. Finally, the outer edge of flange 24 is machined to obtain substantially the same profile and outer diameter as the profile prior to the repair.

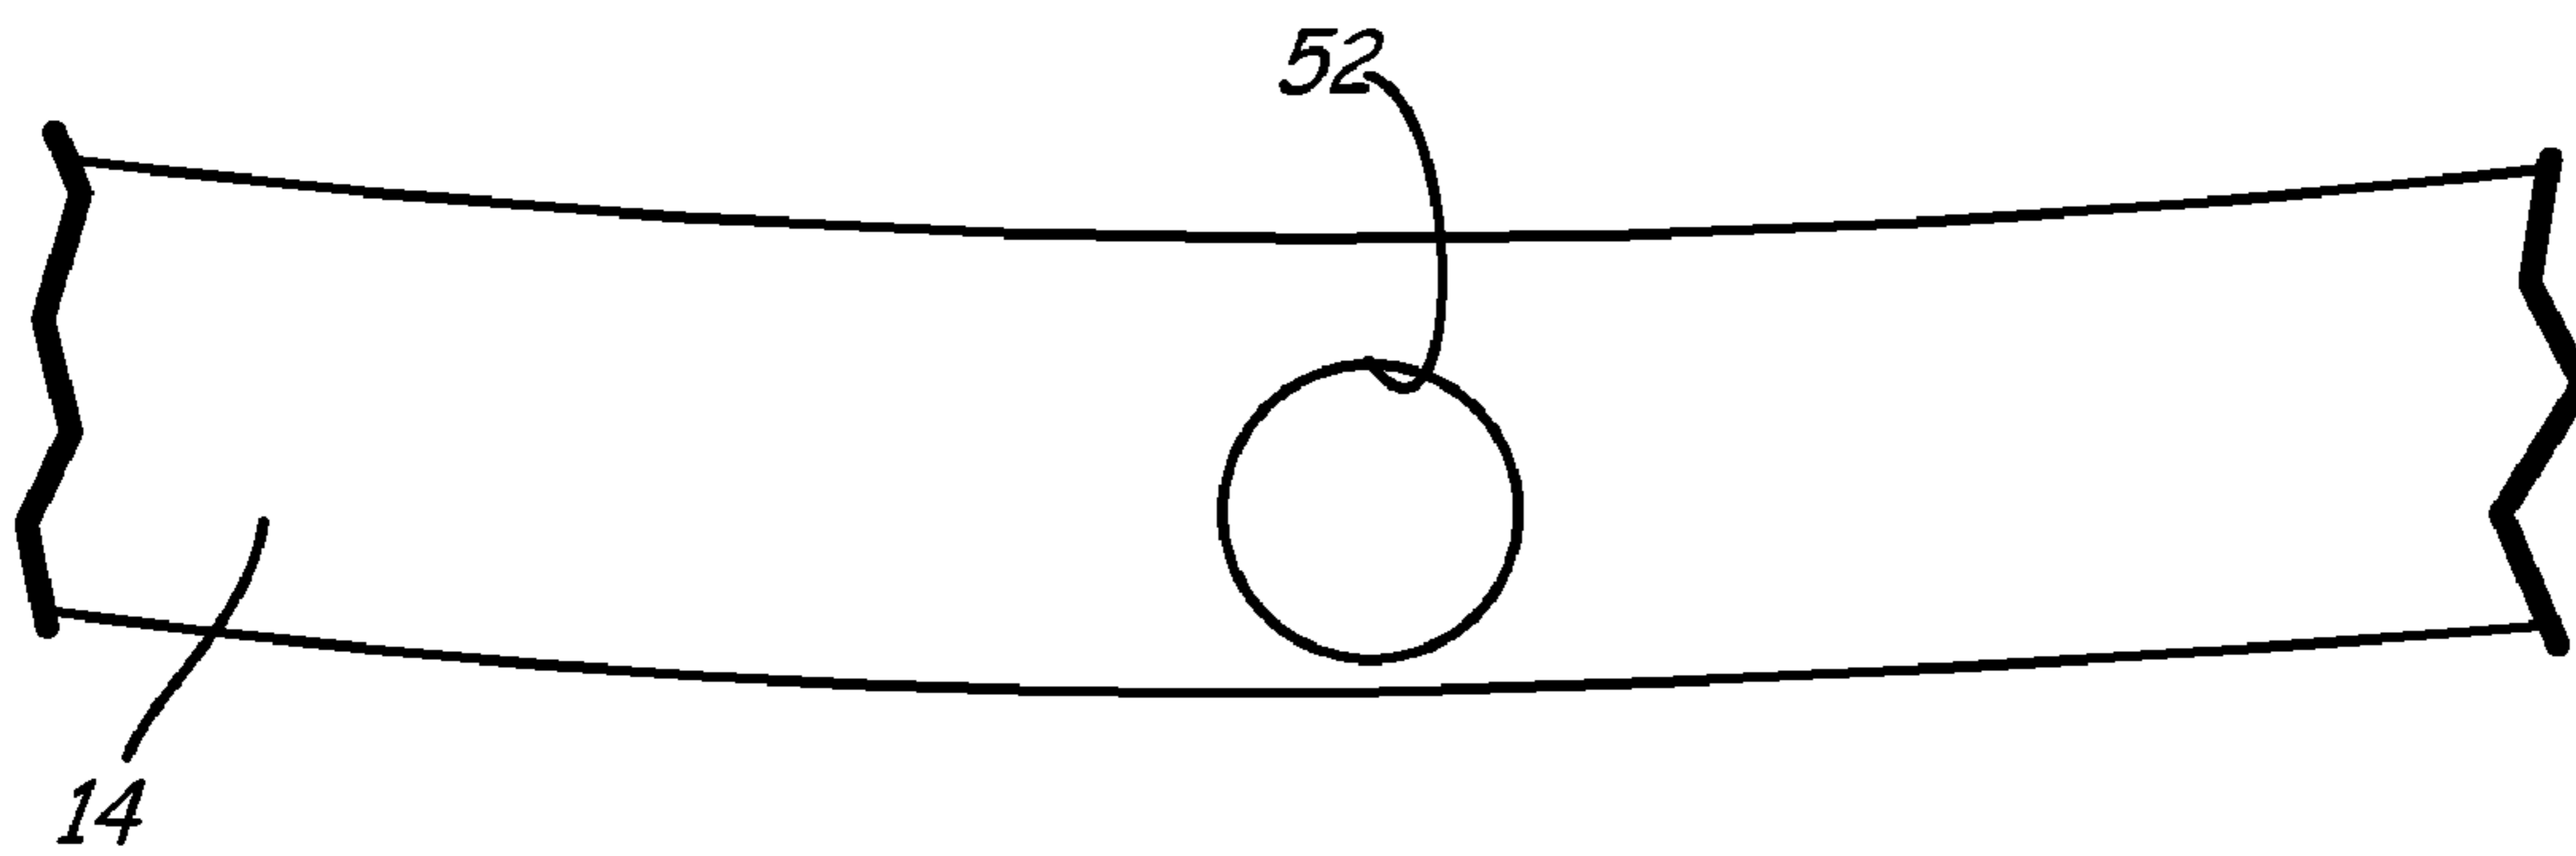
FIG. 14 is a plan view illustrating the complete repair with a new aperture in the flange.

FIG. 14 is a plan view illustrating the complete repair with a new hole 52 in flange 14. After the flange profile has been nominally obtained, an aperture is machined in the flange to

create nominally the same hole **12** that existed prior to the repair. Arc **22** is used as a guide to machine hole **52** to assure the location is nominally the same as prior to the repair. In an alternate embodiment, the hole in lower flange **20** (See FIGS. **2A** and **9**) is used as a guide to create hole **52** in flange **14**.
