(10) **Patent No.:** **US 8,215,454 B2**
(45) **Date of Patent:** **Jul. 10, 2012**

(54) **LUBRICATION SYSTEM WITH TOLERANCE FOR REDUCED GRAVITY**

(73) Assignee: **United Technologies Corporation**, Hartford, CT (US)

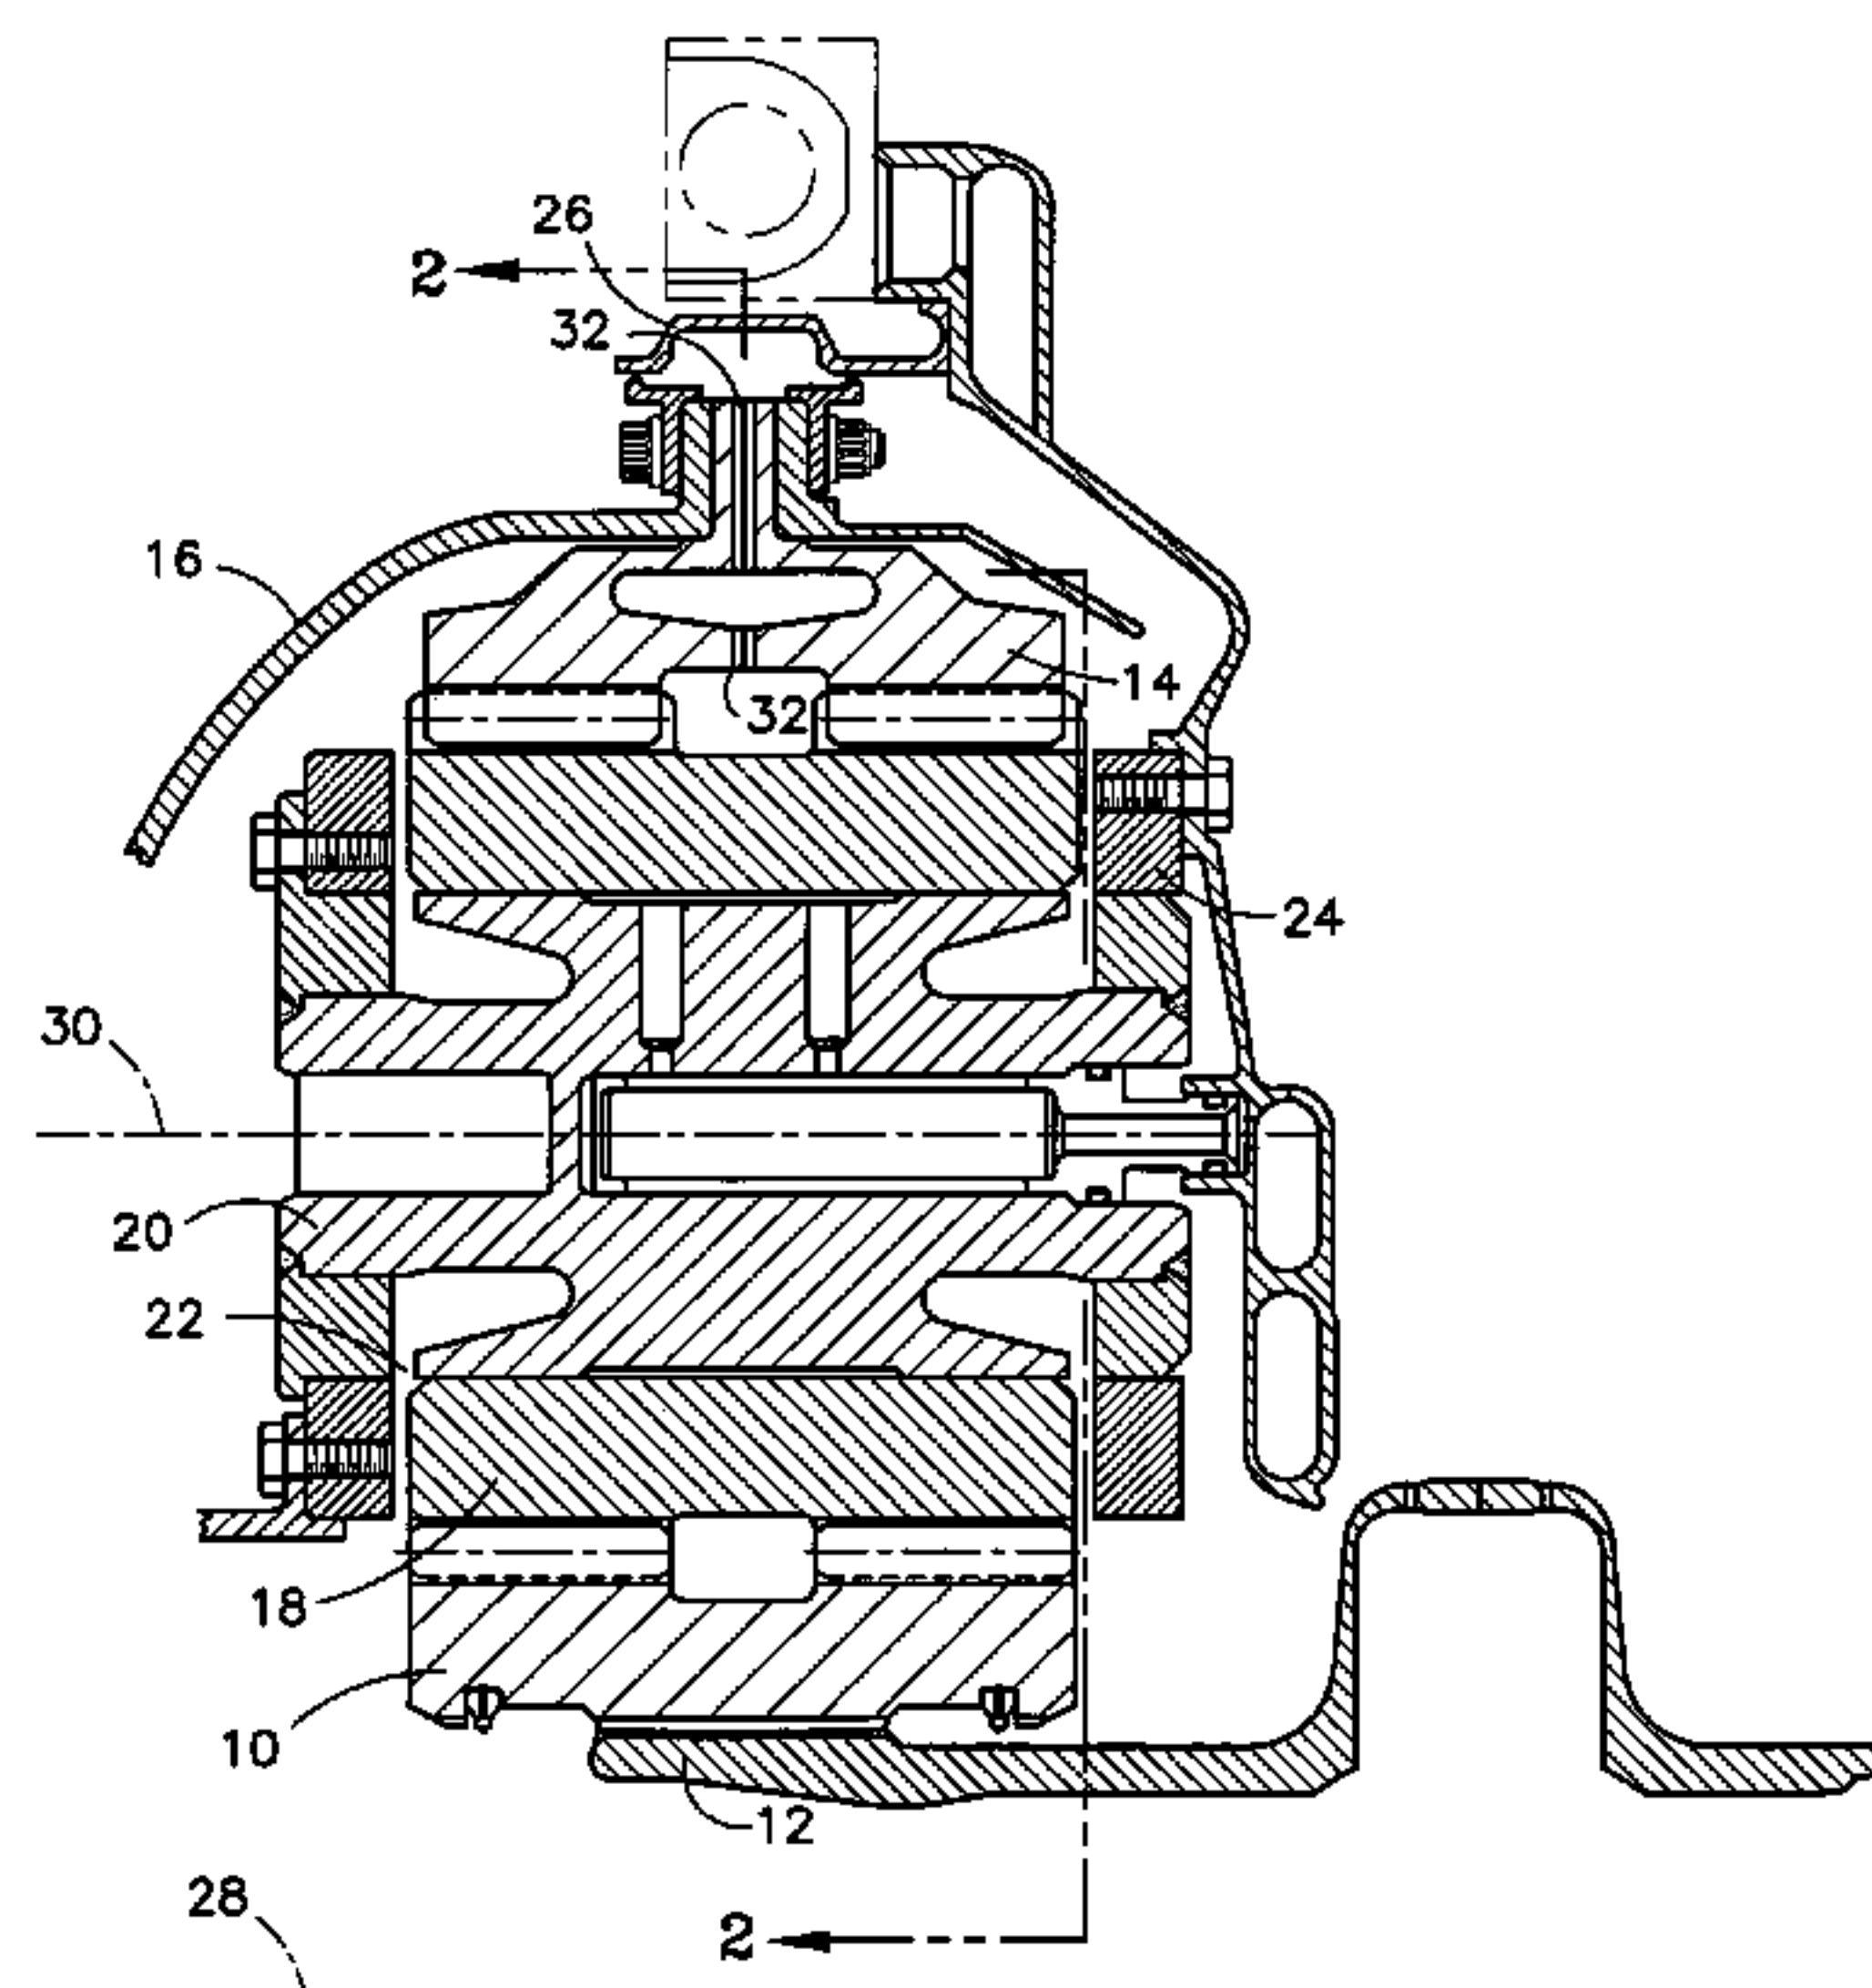
FIG. 1 is a cross sectional side elevation view of a gear train configured as a star system and useful in an aircraft gas turbine engine.

Referring to FIGS. 1 and 2, a reduction gear train suitable for use in an aircraft gas turbine engine includes a sun gear 10 driven by a sun gear (input) shaft 12, a ring gear 14 radially outboard of the sun gear and connected to a ring gear (output) shaft 16, and a set of intermediate gears 18 radially intermediate and meshing with the sun and ring gears. Each intermediate gear circumscribes a journal pin 20. A thin, replenishable film of lubricant, not shown, occupies a small annular space 22 between each intermediate gear and its journal pin to support the intermediate gear. This arrangement is referred to as a journal bearing. The journal pins are all supported by a carrier 24. The carrier interconnects the journal pins with each other and, by doing so, also interconnects the intermediate gears to each other. A lubricant recovery gutter 26 circumscribes the ring gear.

In the gear train shown in FIGS. 1 and 2, the sun and ring gears are each rotatable about an axis 28. The carrier is non-rotatable even though the individual intermediate gears are each rotatable about their respective axes 30. Such a system is referred to as a star system. As seen best in FIG. 2, the input and output shafts counterrotate. Lubricant flows through the gear system to support the intermediate gears 18 on the journal pins 20 and to lubricate and cool the gear teeth. The used lubricant expelled by the gear train enters the gutter 26 by various paths, which include lubricant slots 32.

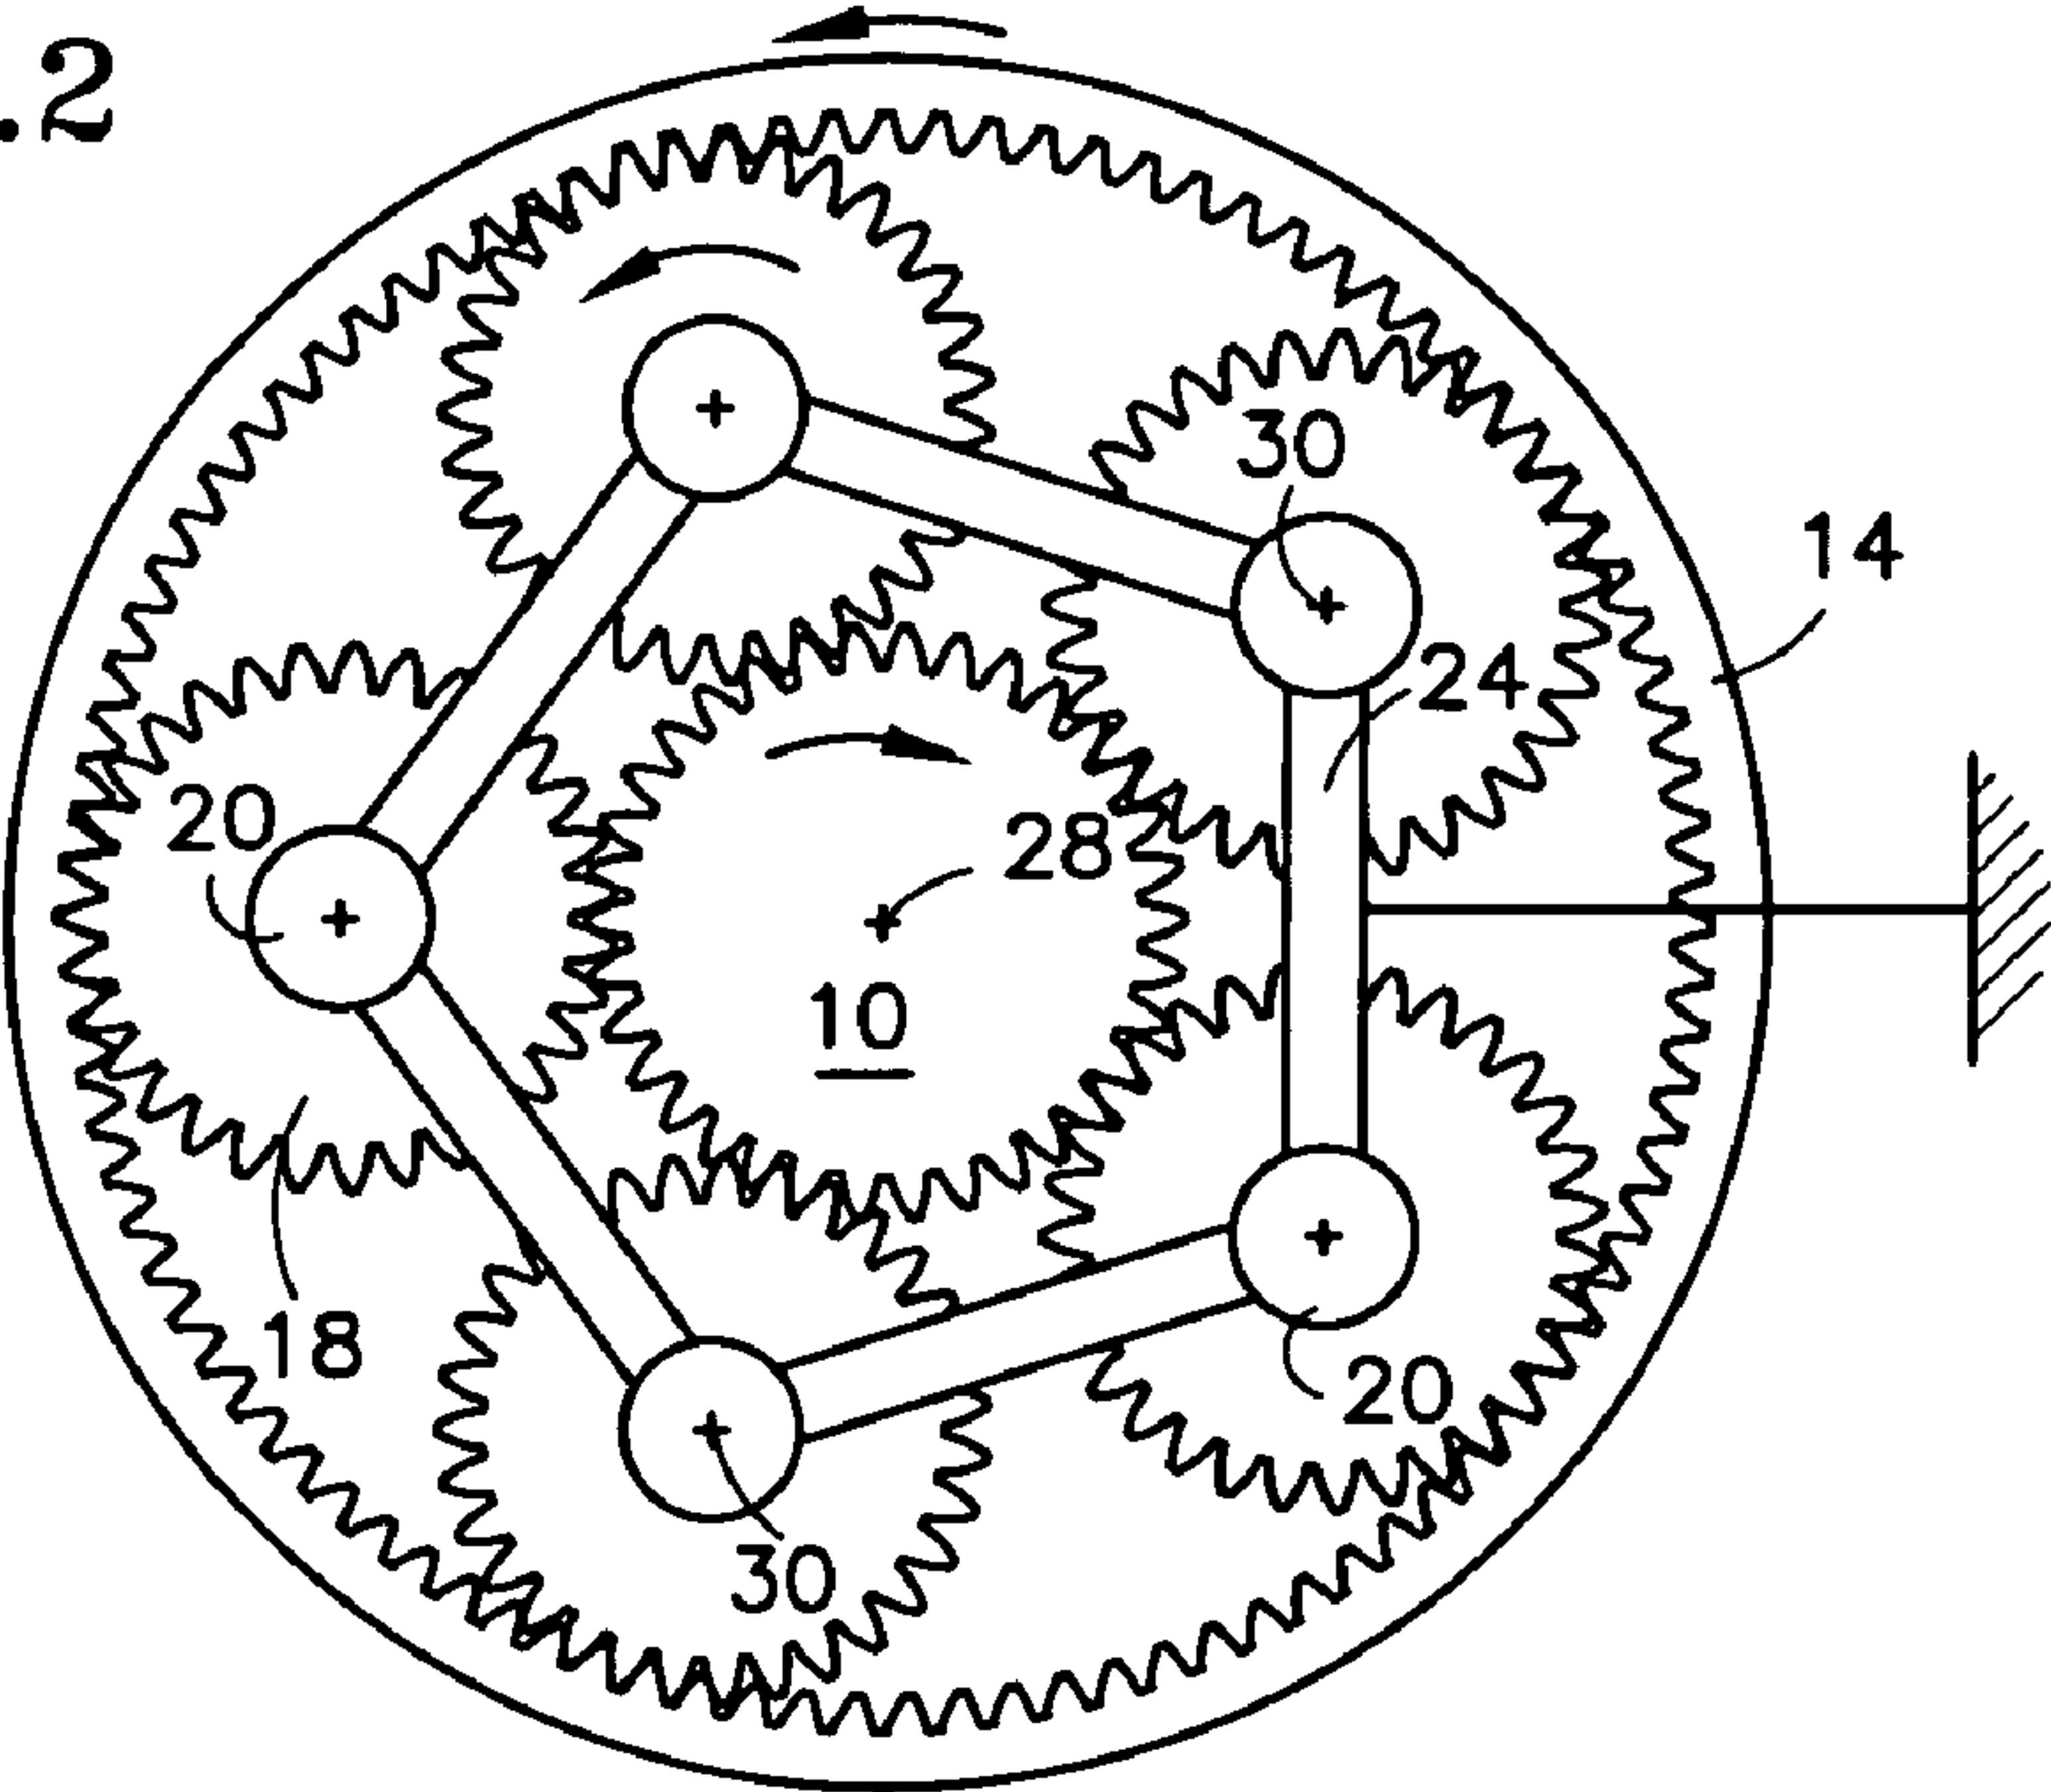
FIG.2

FIG. 2 is a schematic view in the direction 2-2 of FIG. 1.

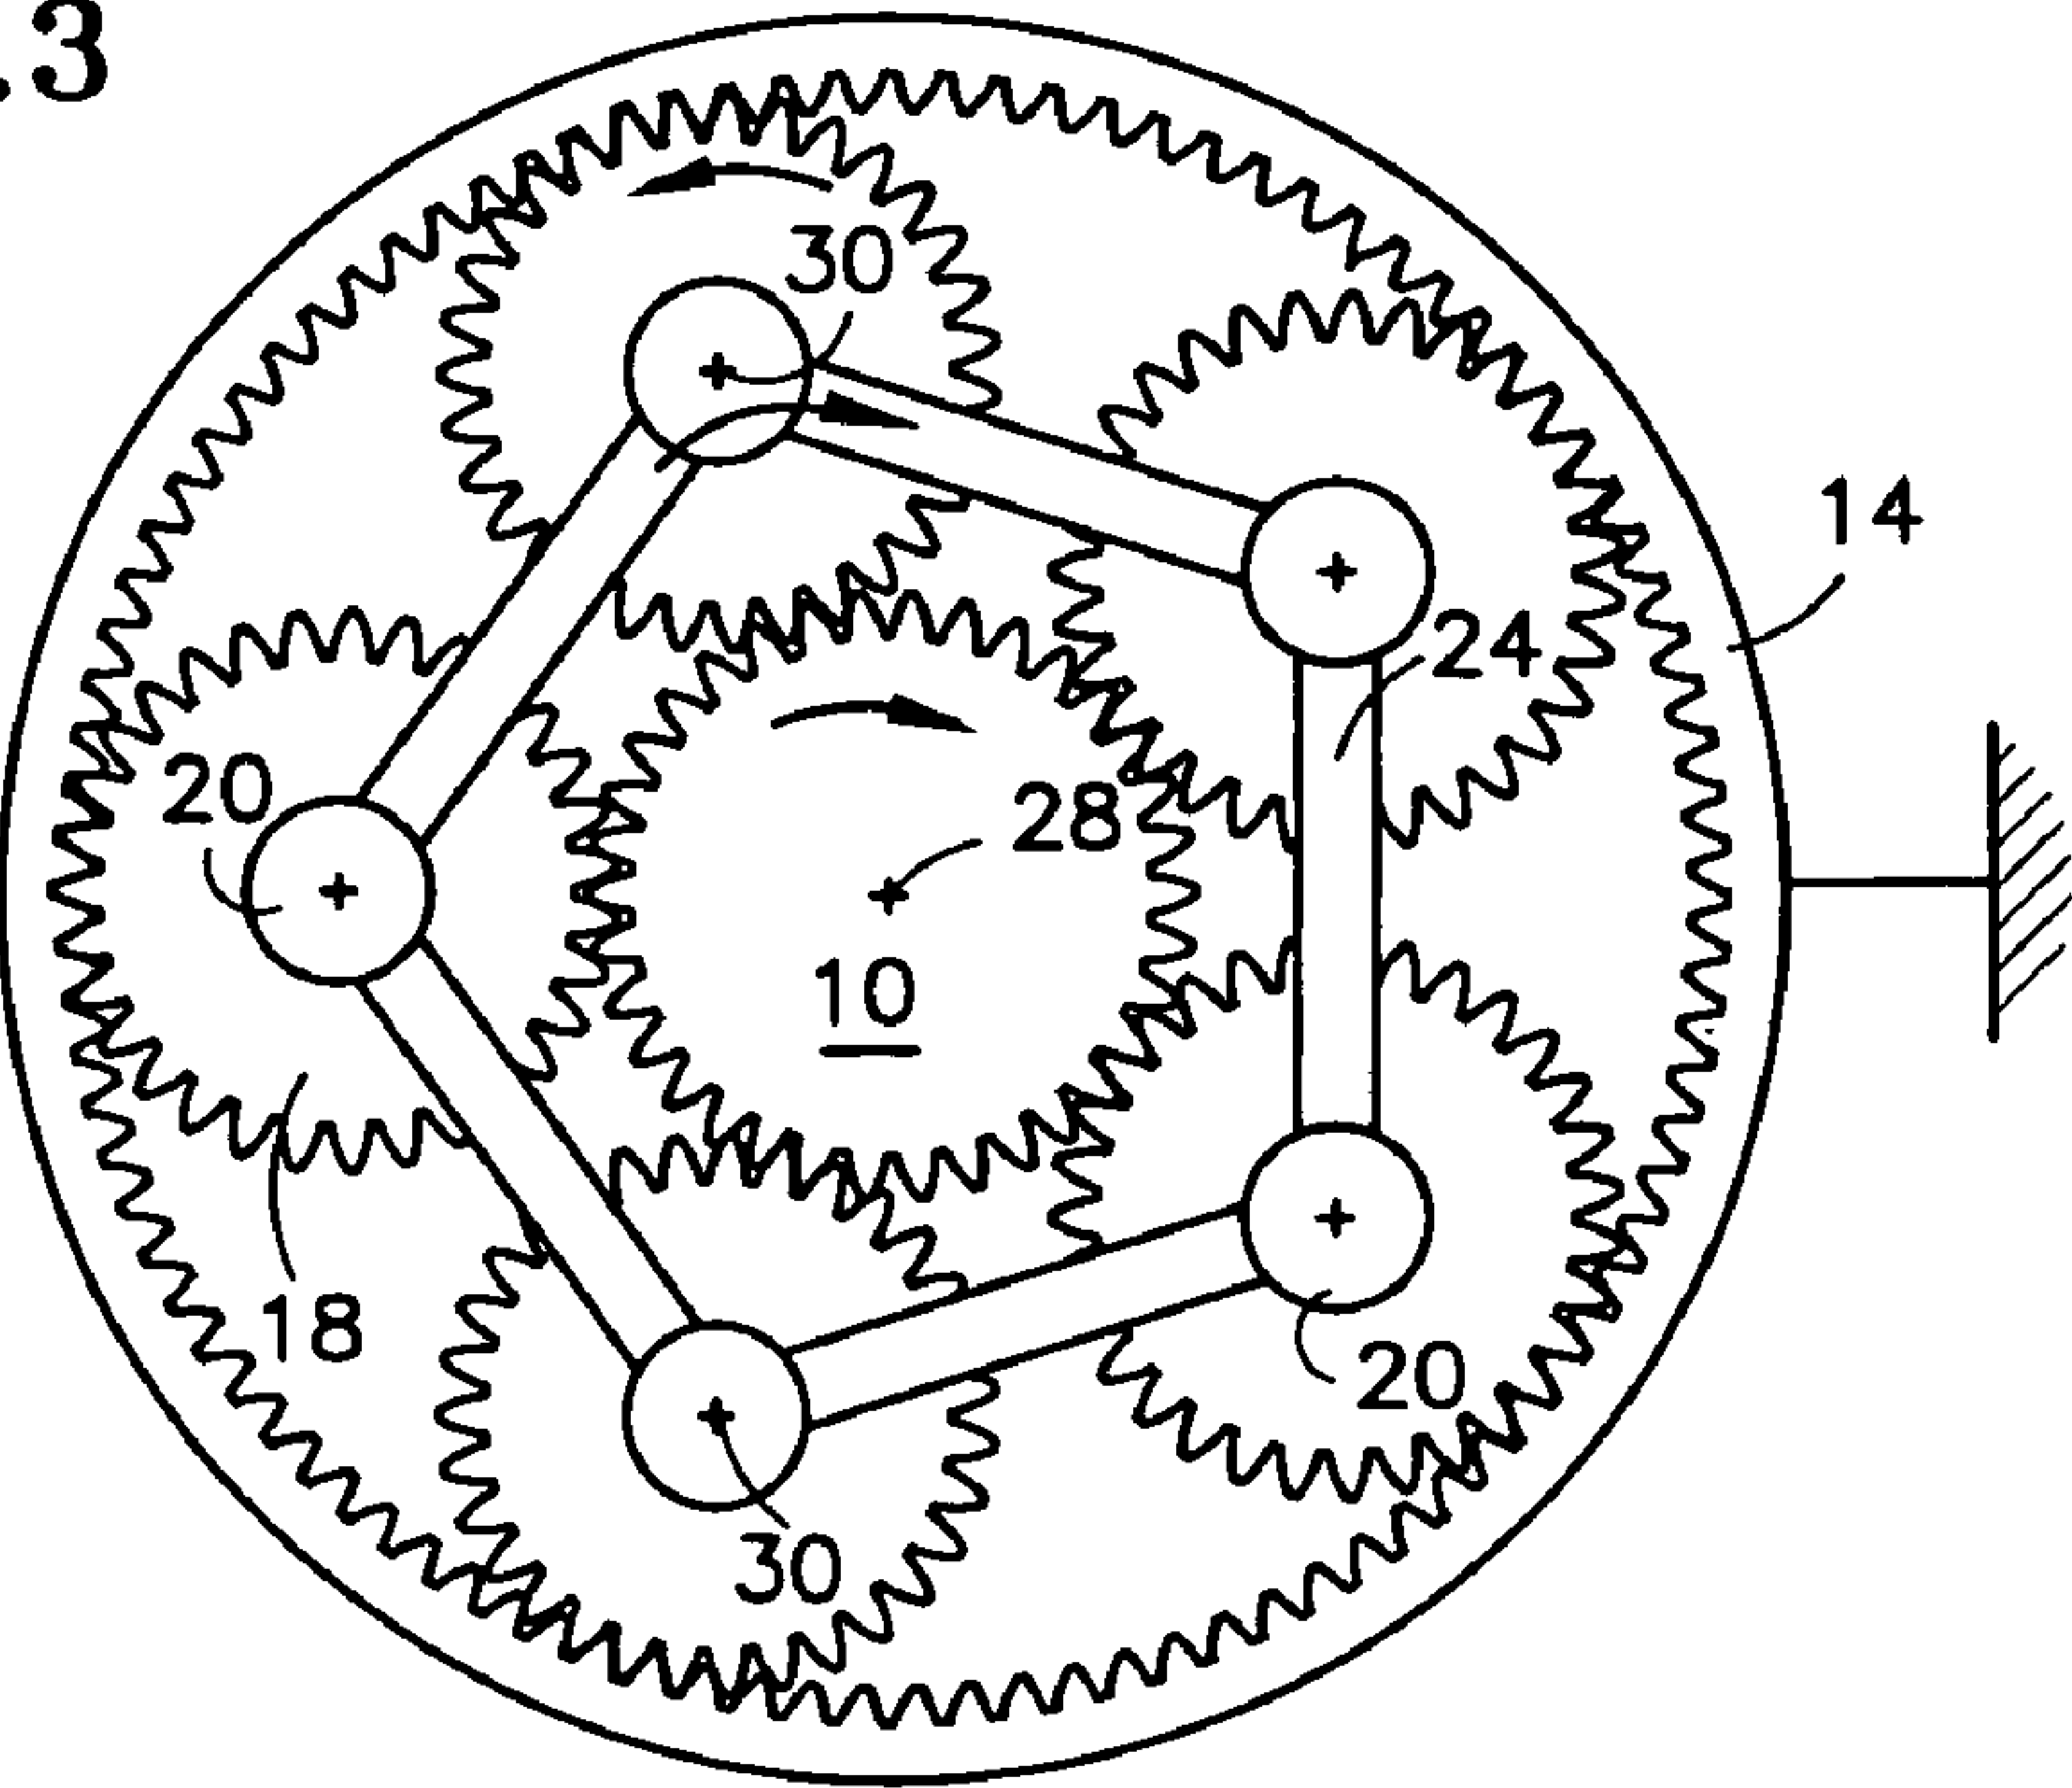
FIG.3

FIG. 3 is a schematic view similar to FIG. 2 illustrating a gear train configured as a planetary system.

Alternatively, as seen in FIG. 3, the sun gear and carrier are rotatable about the axis 28. The ring gear is nonrotatable. The carrier is connected to an output shaft. Such a system is referred to as a planetary system. The input and output shafts co-rotate as indicated in FIG. 3. Finally, all three components may be rotatable about axis 28 so that dual output shafts connected to the carrier and the ring gear counterrotate with respect to each other.

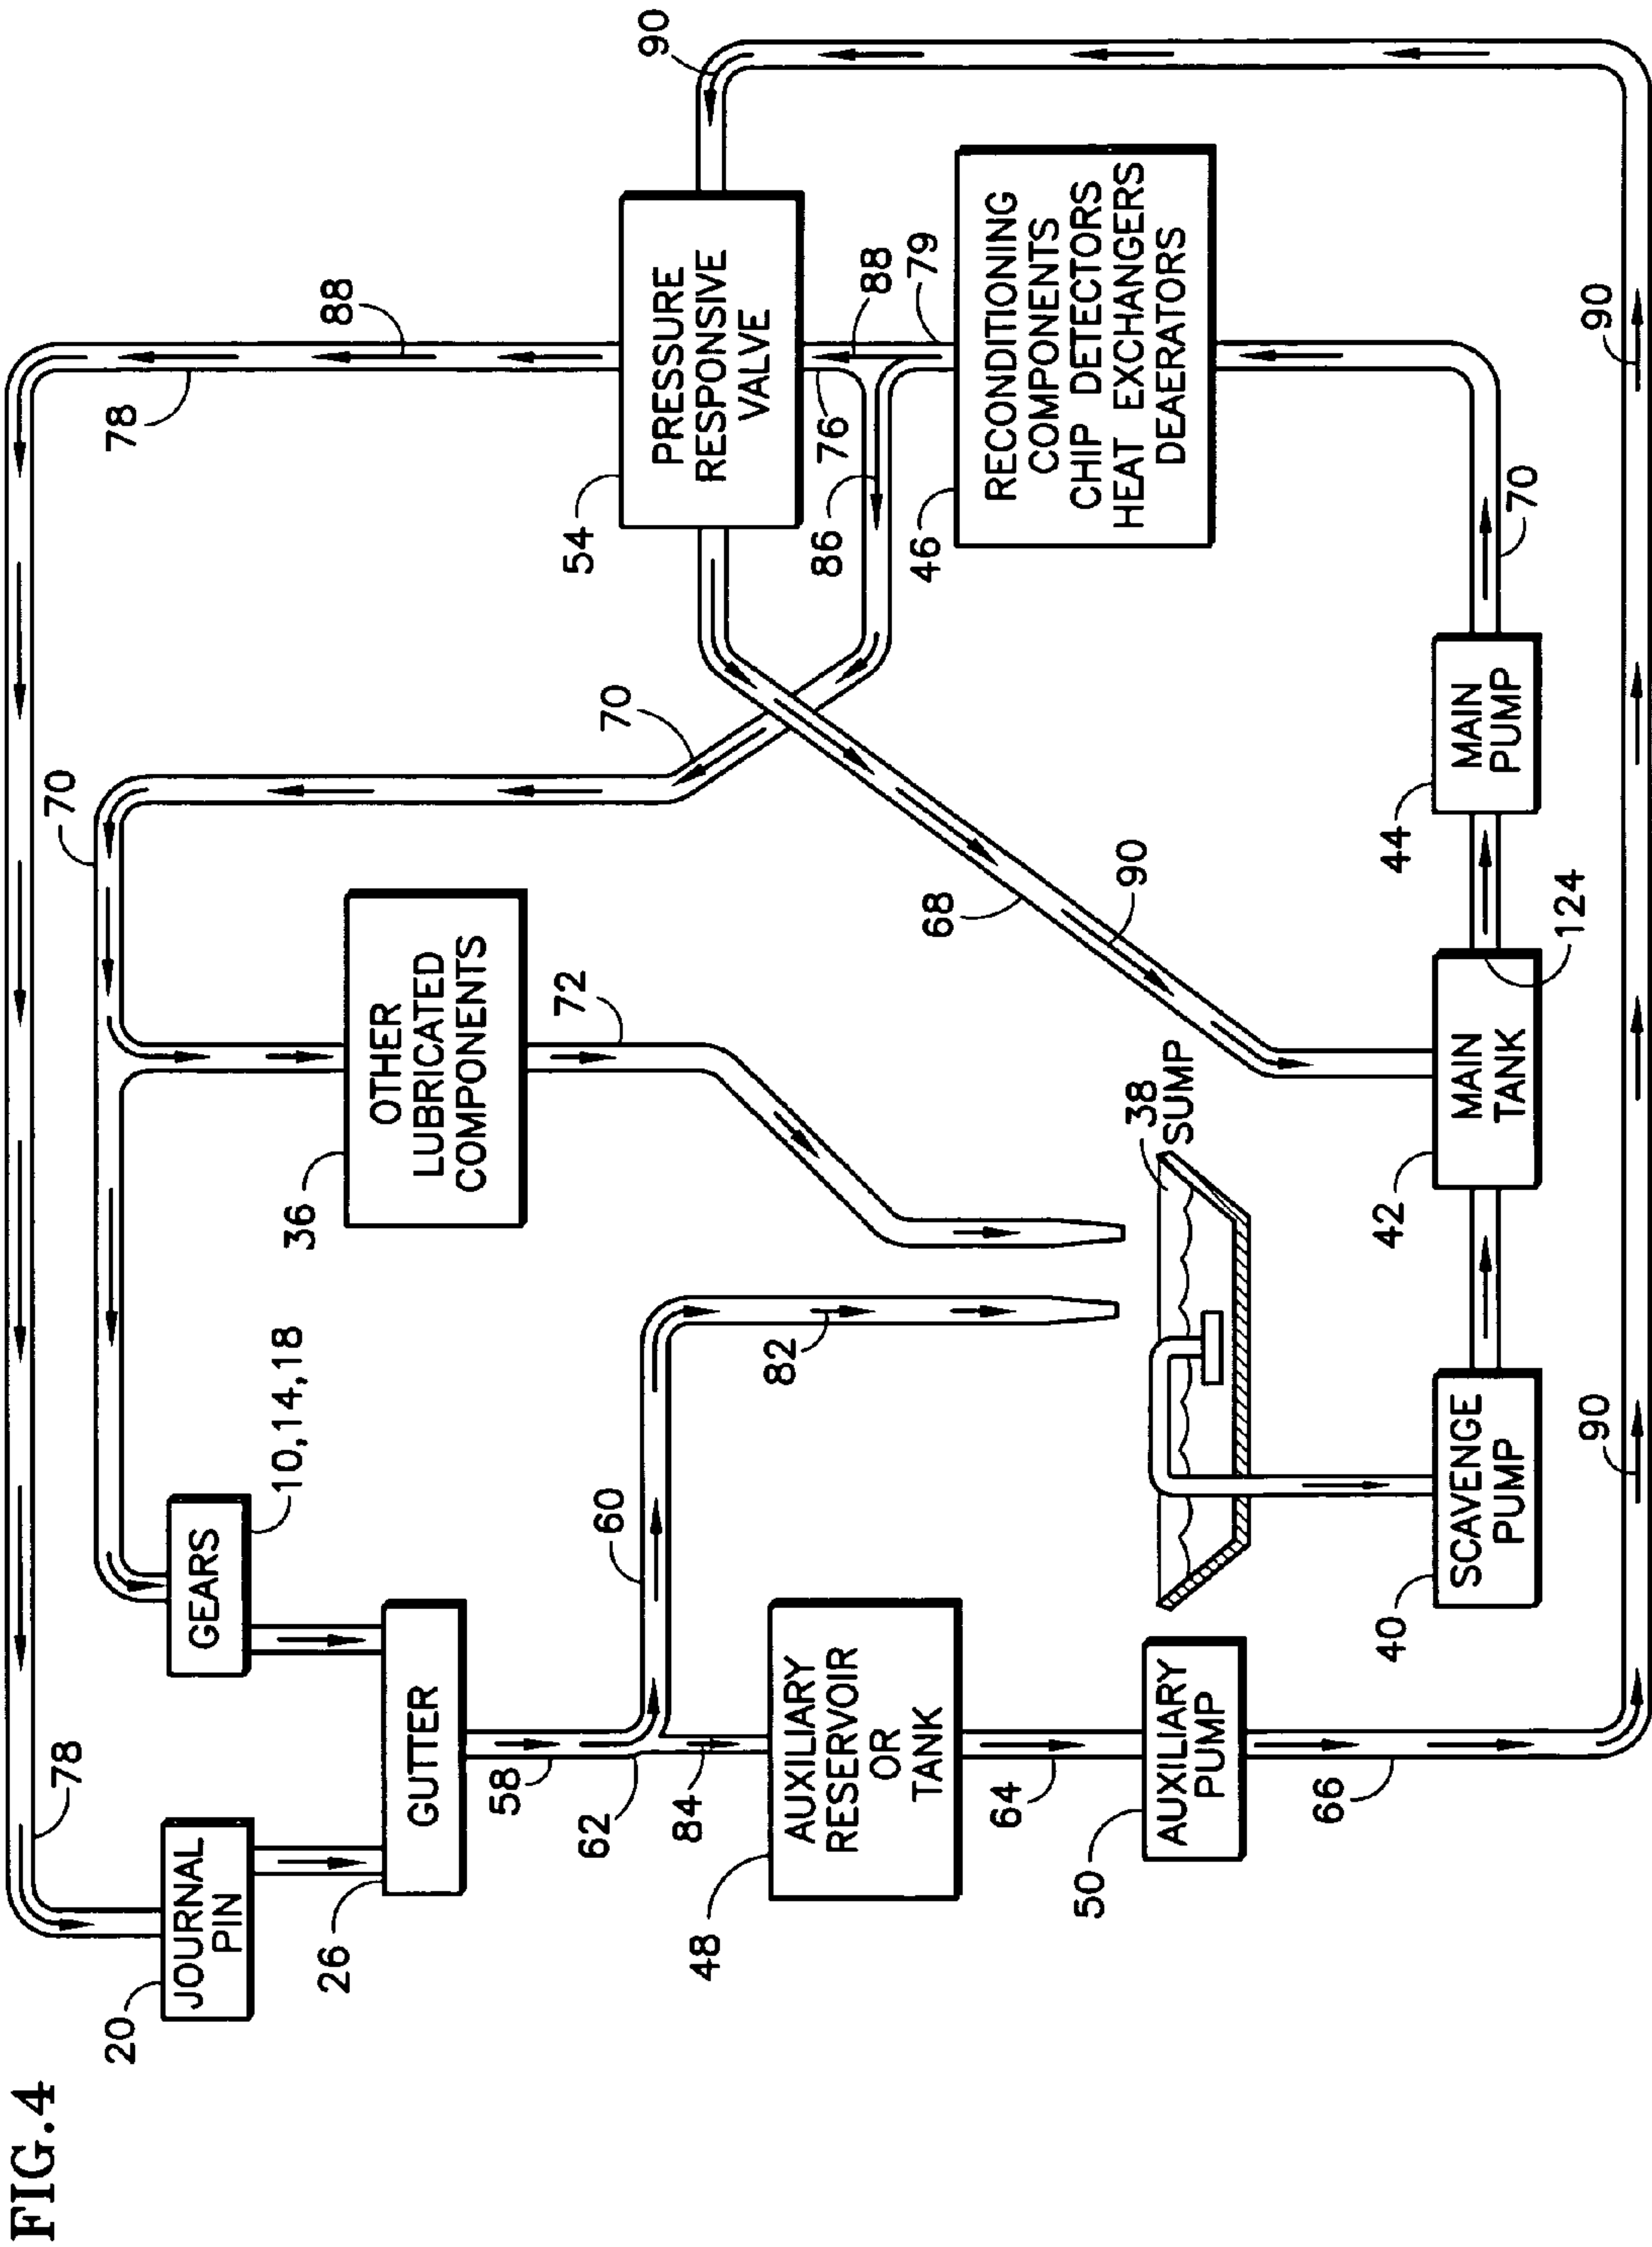
FIG. 4 is a schematic diagram showing a lubrication system in a normal state of operation, i.e. with the lubricant pressure at a normal level.

FIG. 4 schematically shows the relevant components of the above described gear train (gears 10, 14, 18, journal pin 20 and gutter 26), other engine components 36 requiring lubrication, and a lubrication system suitable for use with the gear train. The lubrication system includes a main system whose

components include a sump **38**, a scavenge pump **40** for scavenging lubricant from the sump, a main tank **42** for receiving lubricant from the scavenge pump, a main pump **44** for pumping lubricant from the main tank, and various lubricant reconditioning components such as chip detectors, heat exchangers and deaerators, collectively designated **46**. The lubrication system also includes an auxiliary system whose components include an auxiliary lubricant tank or reservoir **48** and an auxiliary pump **50**. The lubrication system also includes a pressure responsive valve **54**.

An auxiliary tank supply conduit **58** extends from the gutter **26** to the auxiliary tank **48**. The gutter serves as a source of lubricant for the tank. A main bypass line **60** branches from the supply conduit at a junction **62** and extends to the sump **38**. An auxiliary tank discharge conduit **64** extends from the auxiliary tank to the auxiliary pump. An auxiliary pump discharge line **66** extends from the auxiliary pump to the pressure responsive valve. A main tank return line **68** extends from the valve **54** to the main lubricant tank **42**. A lubricant delivery pathway **70** extends from the main pump **44** through the various lubricant reconditioning components **36** and ultimately to the gears **10**, **14**, **18** and other components **46**. A lubricant return pathway **72** extends from the components to the sump **38**. A portion **76** of the delivery pathway **70** leads to the pressure responsive valve **54**. A journal pin delivery line **78** extends from the valve to the journal pins **20**.

During normal operation, rotation of the gears expels lubricant radially outwardly, and with a high tangential velocity, into the lubricant recovery gutter **26**. The supply conduit **58**, which branches substantially tangentially off the gutter as seen in FIGS. **7** and **8**, captures the expelled lubricant. A large portion **82** of the lubricant flows through the main bypass line **60** and returns to the sump **38**. A smaller portion **84** of the lubricant flows into the auxiliary tank **48** to establish or replenish a reserve quantity of lubricant therein. The auxiliary pump **50** pumps lubricant from the tank to the pressure responsive valve **54**. Concurrently, the scavenge pump **40** extracts lubricant from the sump **38** and delivers it to the main tank **42**. The main pump **44** pumps the lubricant from the tank to the reconditioning components **46**. Most of the reconditioned lubricant **86** then flows to the gears **10**, **14**, **18** and other components **36**. The remainder **88** of the lubricant flows to the pressure responsive valve. The valve, responding to normal pressure in the lubrication system, directs this remaining lubricant **88** to the journal pins and directs reserve lubricant **90** (received from the auxiliary pump) to the main tank **42**.

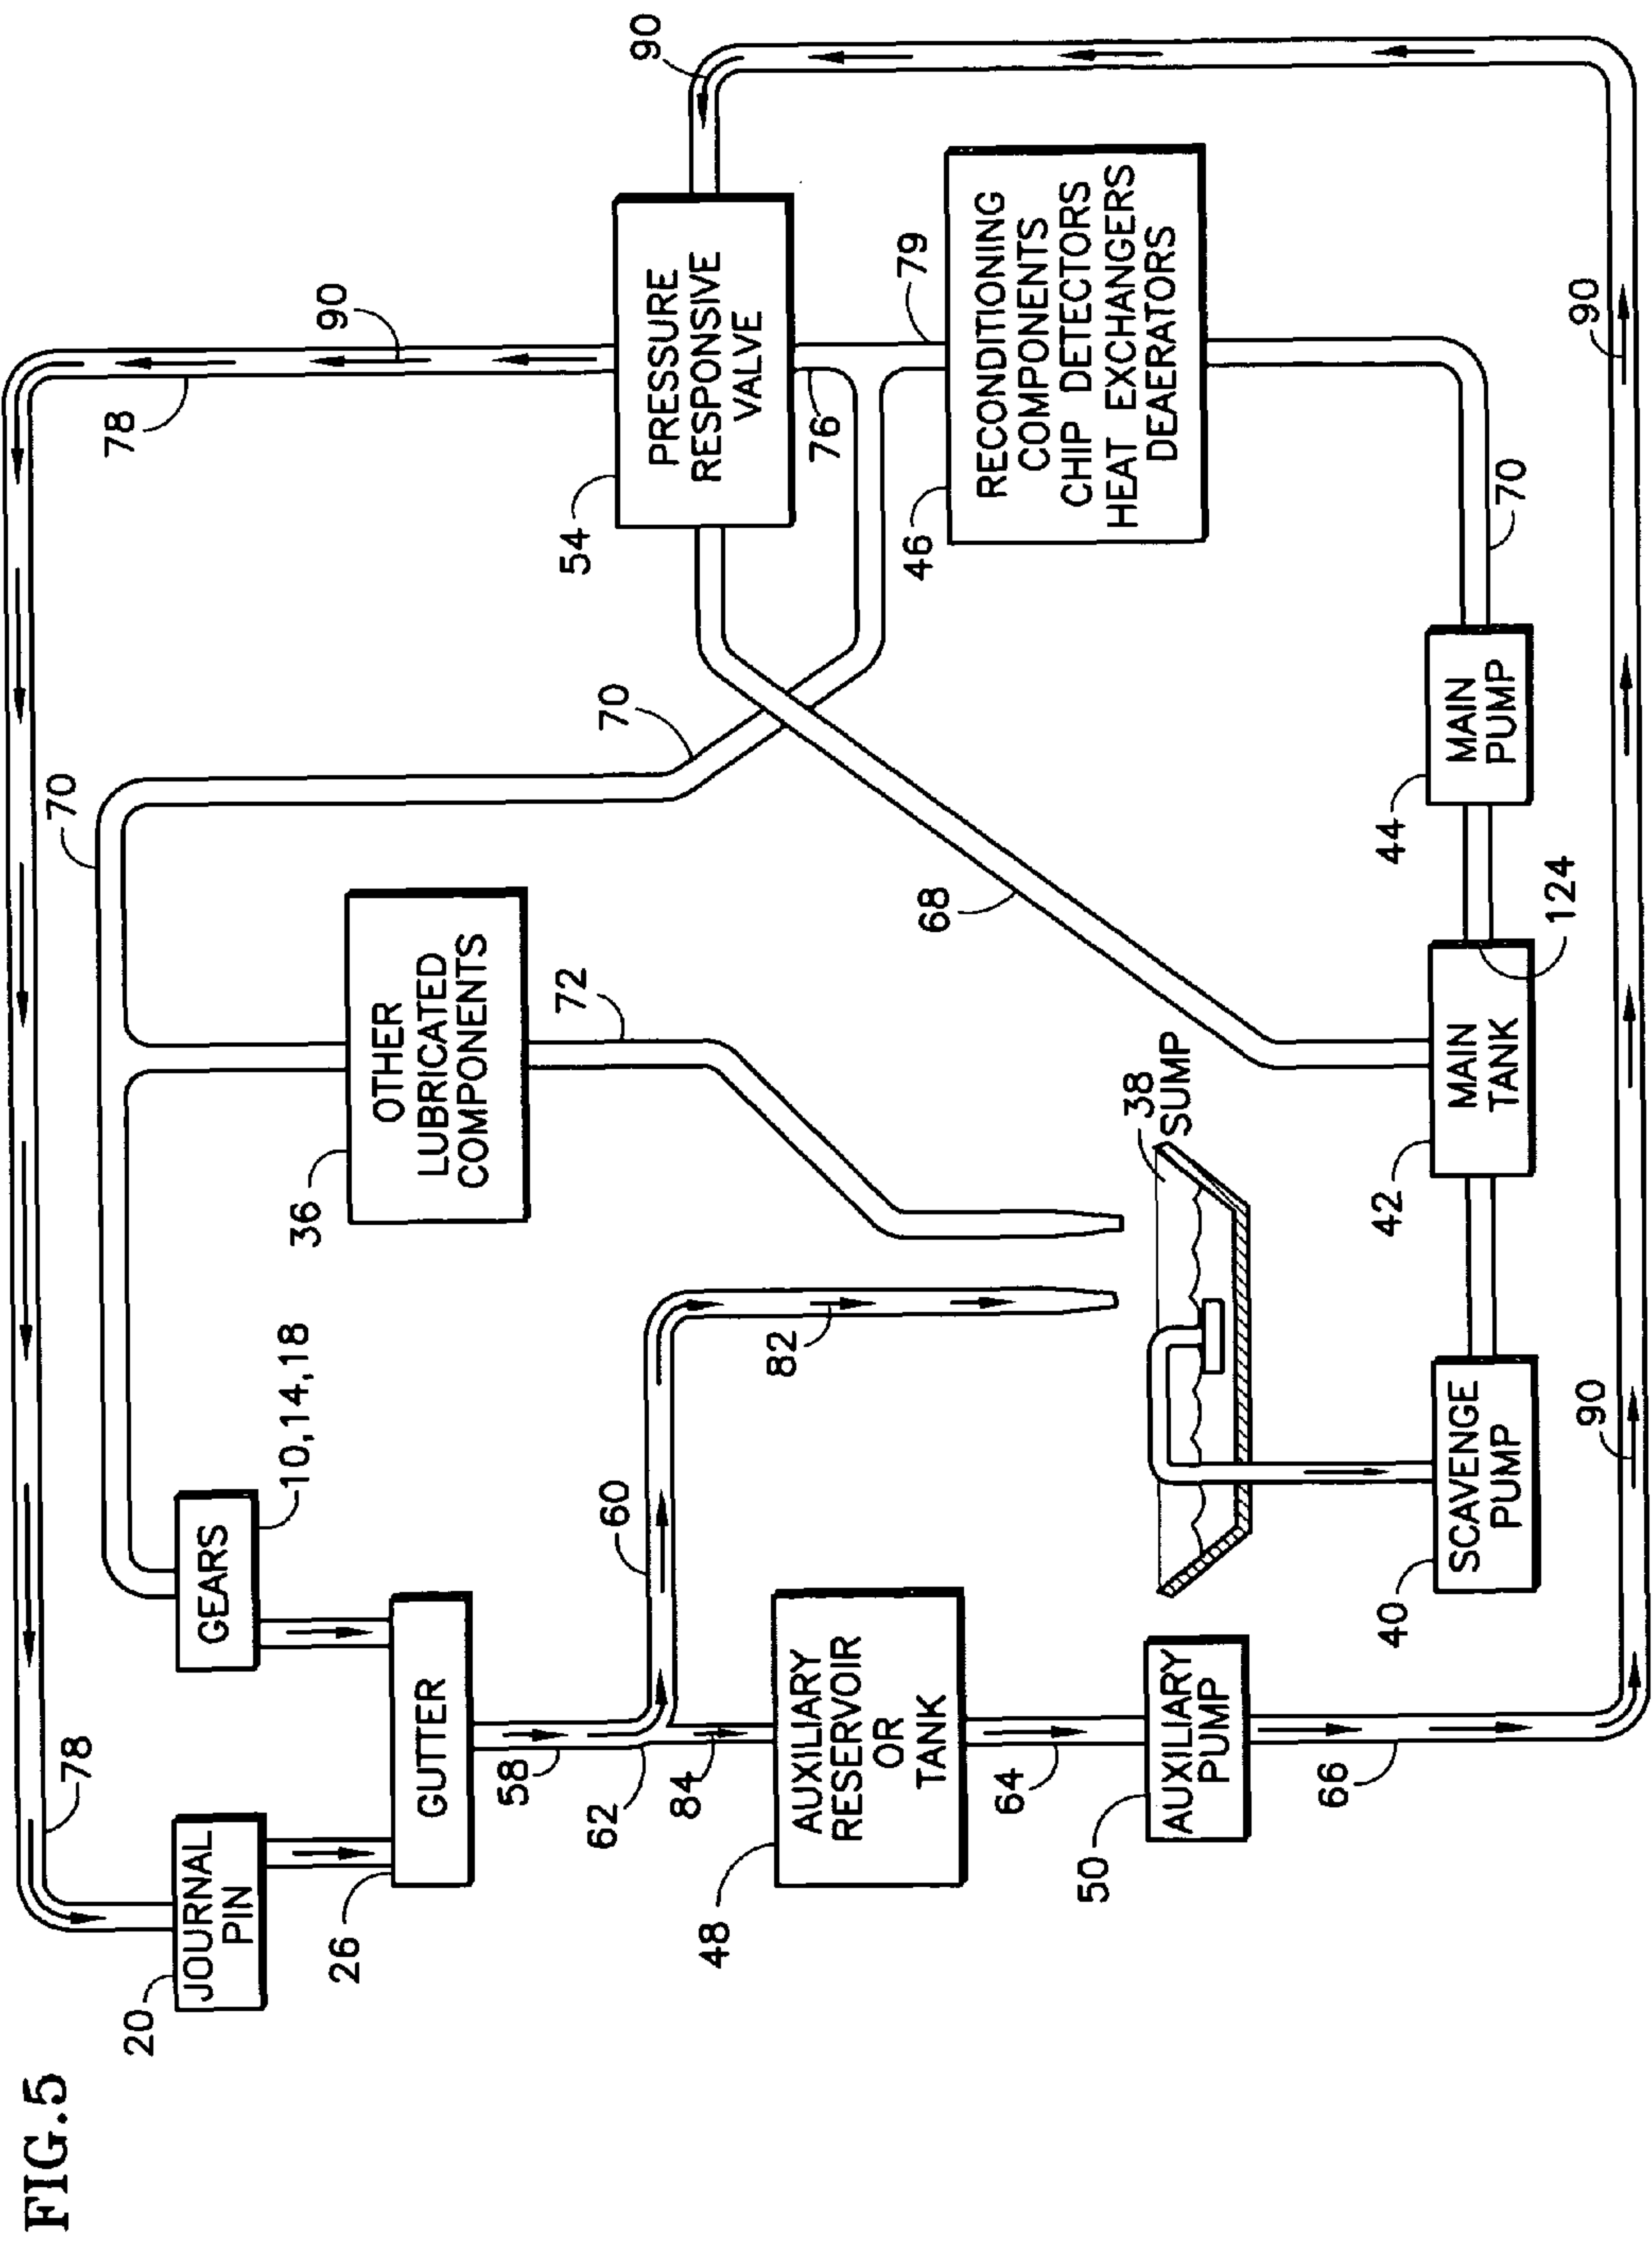
FIG. 5 is a schematic diagram showing the lubrication system of FIG. 4 shortly after the onset of an abnormal state of operation, i.e. with the lubricant pressure lower than a normal level.

Referring now to FIG. **5**, immediately after the onset of abnormal operation (e.g. due to a severe leak, clog or malfunction of a system component) the lubricant pressure drops

such that an unsatisfactorily reduced quantity of lubricant flows through the lubricant delivery pathway **70**. In response to the abnormally low pressure, the pressure responsive valve **54** shunts the reserve lubricant **90** received from the auxiliary pump to the journal pins **20** to ensure that the pins receive lubricant, at least temporarily. The gear system at first continues to expel a large quantity of lubricant into the gutter. As with normal operation, a large portion **82** of the lubricant flows through the main bypass line **60** and returns to the sump **38**. A smaller portion **84** of the lubricant flows to the auxiliary tank to at least partially replenish the lubricant being withdrawn by the auxiliary pump.
