(10) **Patent No.:** **US 8,215,454 B2**
(45) **Date of Patent:** **Jul. 10, 2012**

(54) **LUBRICATION SYSTEM WITH TOLERANCE FOR REDUCED GRAVITY**

(73) Assignee: **United Technologies Corporation**, Hartford, CT (US)

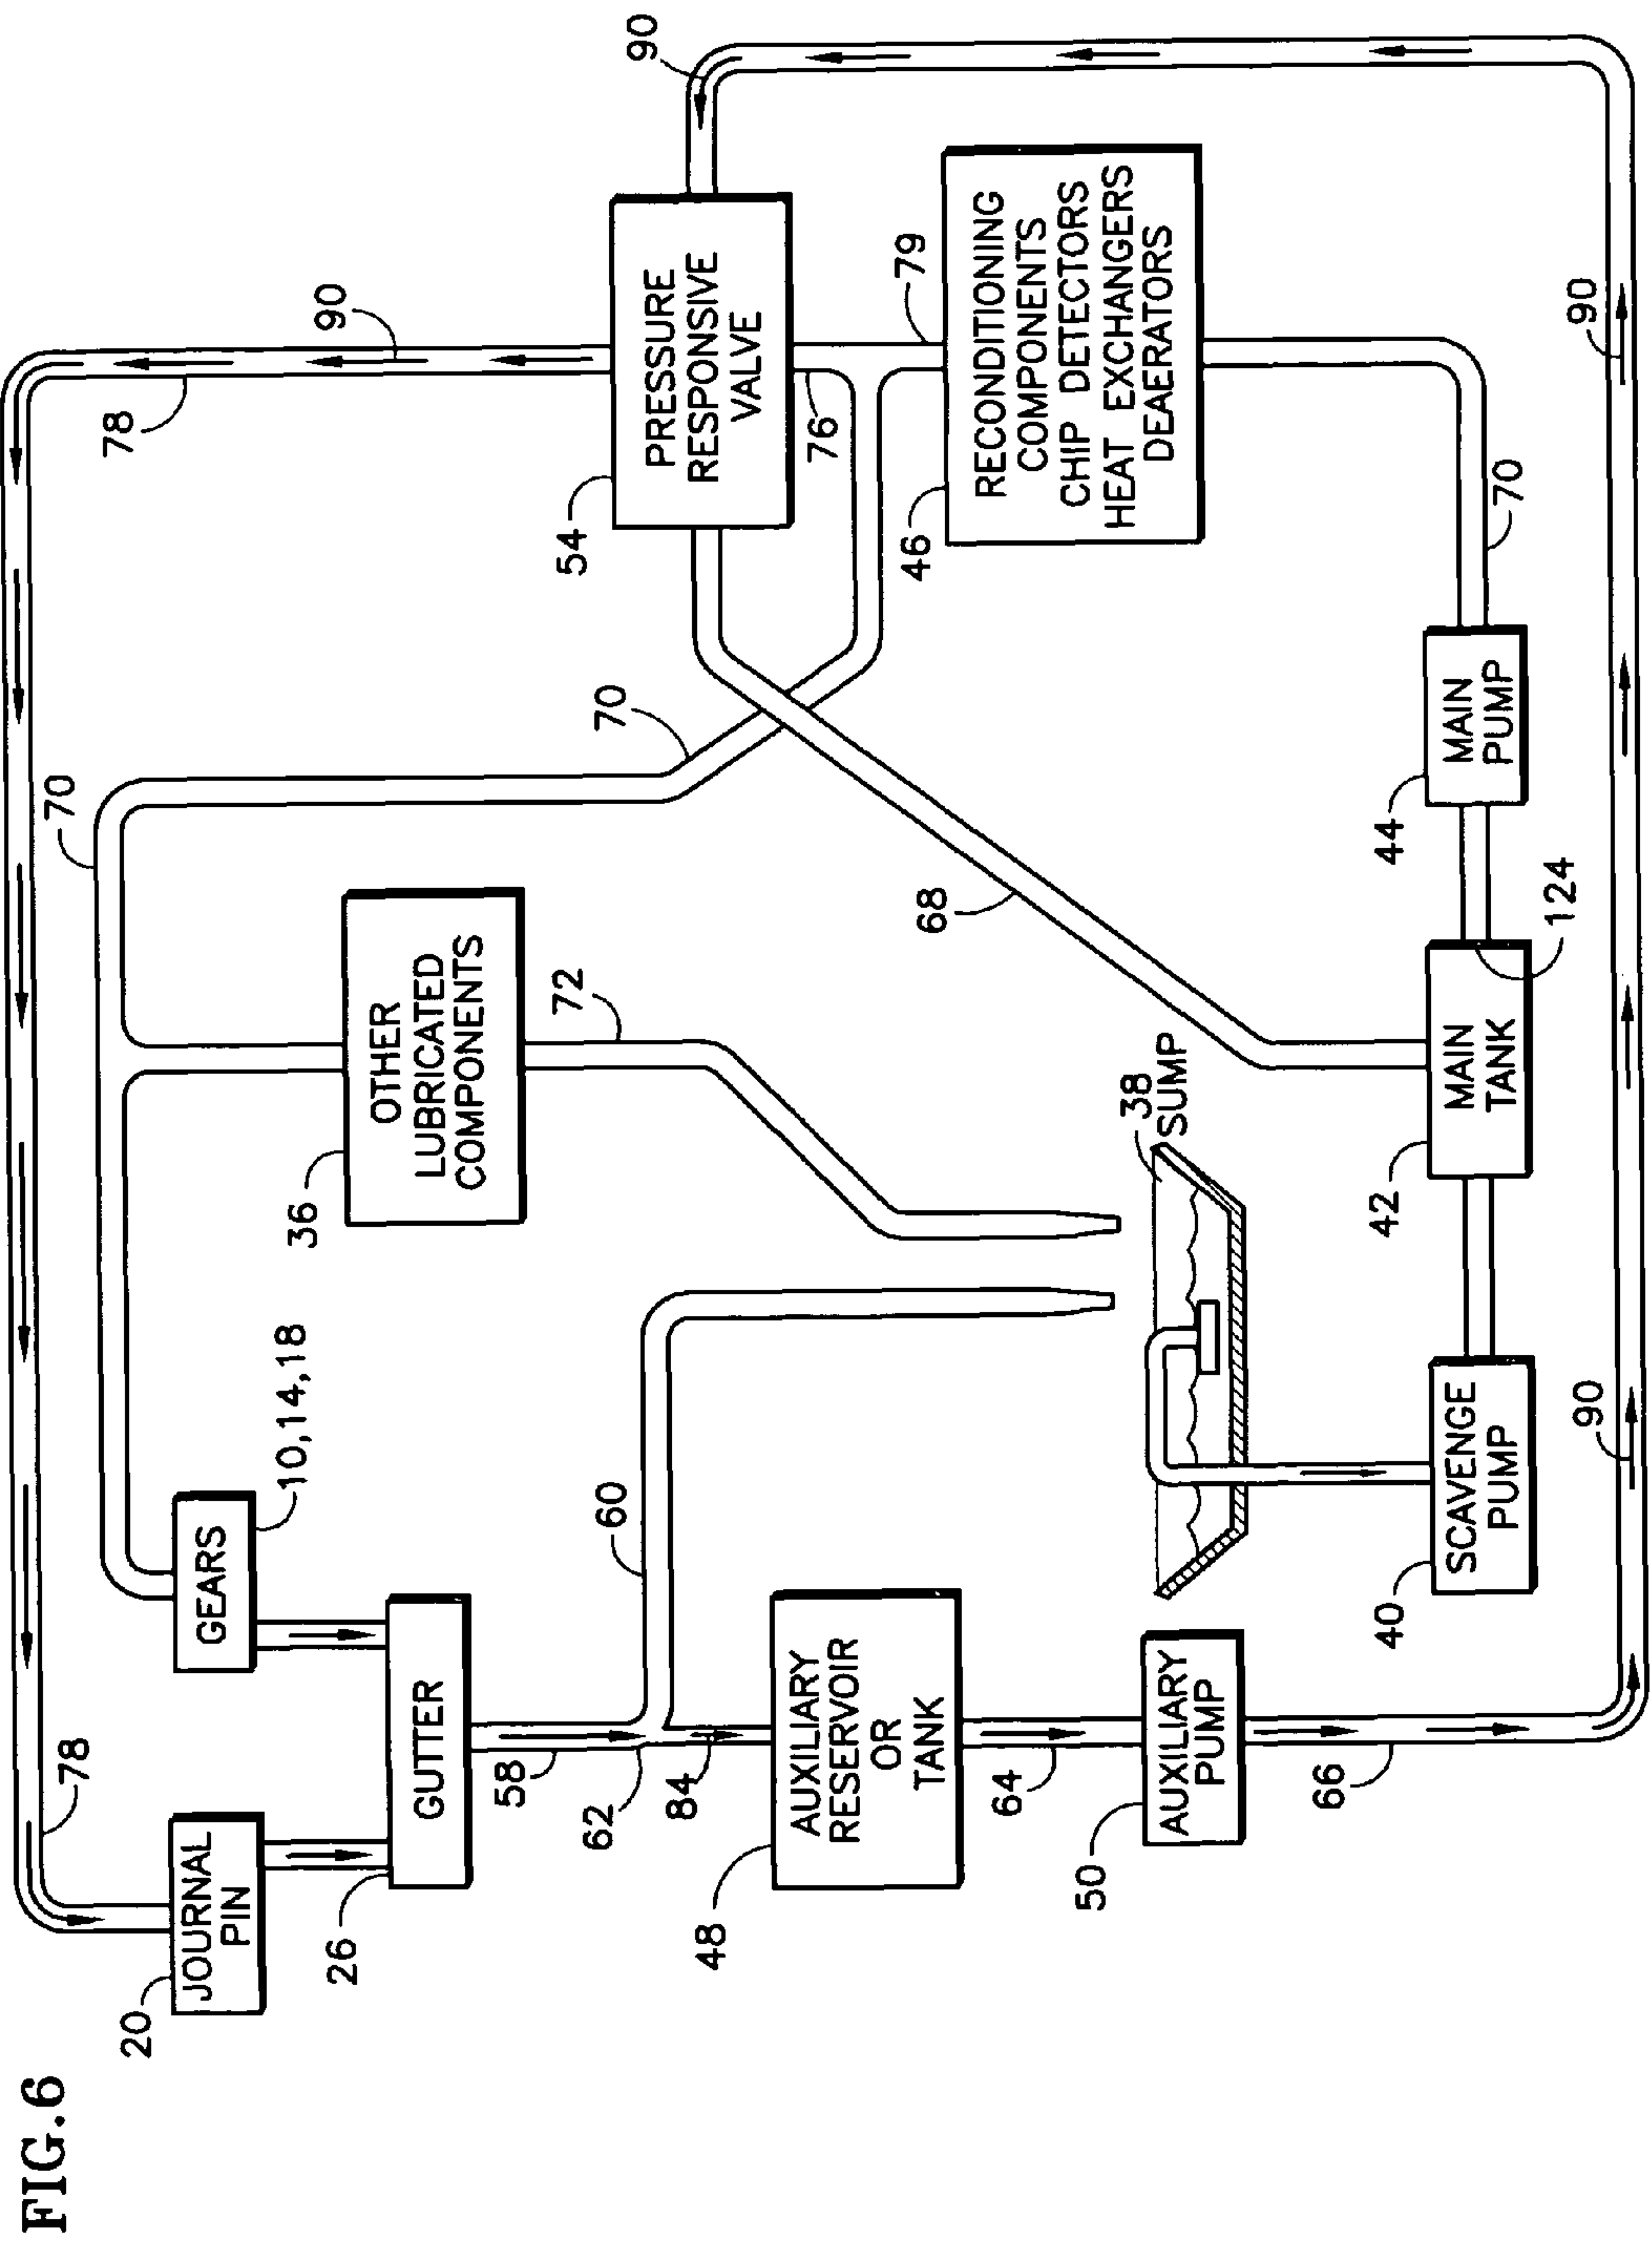
FIG. 6 is a schematic diagram similar to FIG. 5 showing the lubrication system at a later time.

If the abnormally low lubricant pressure persists, the system reaches the state shown in FIG. **6**. The quantity of lubricant circulating through the system is small enough that little or no lubricant backs up from the auxiliary tank and enters the main bypass line **60**. Instead, nearly all of the limited quantity of lubricant flows to the auxiliary pump **50** and eventually back to the journal pins **20**. This state of operation persists until the tank **48** is depleted and the flow rate from the gutter **26** is insufficient to replenish it.

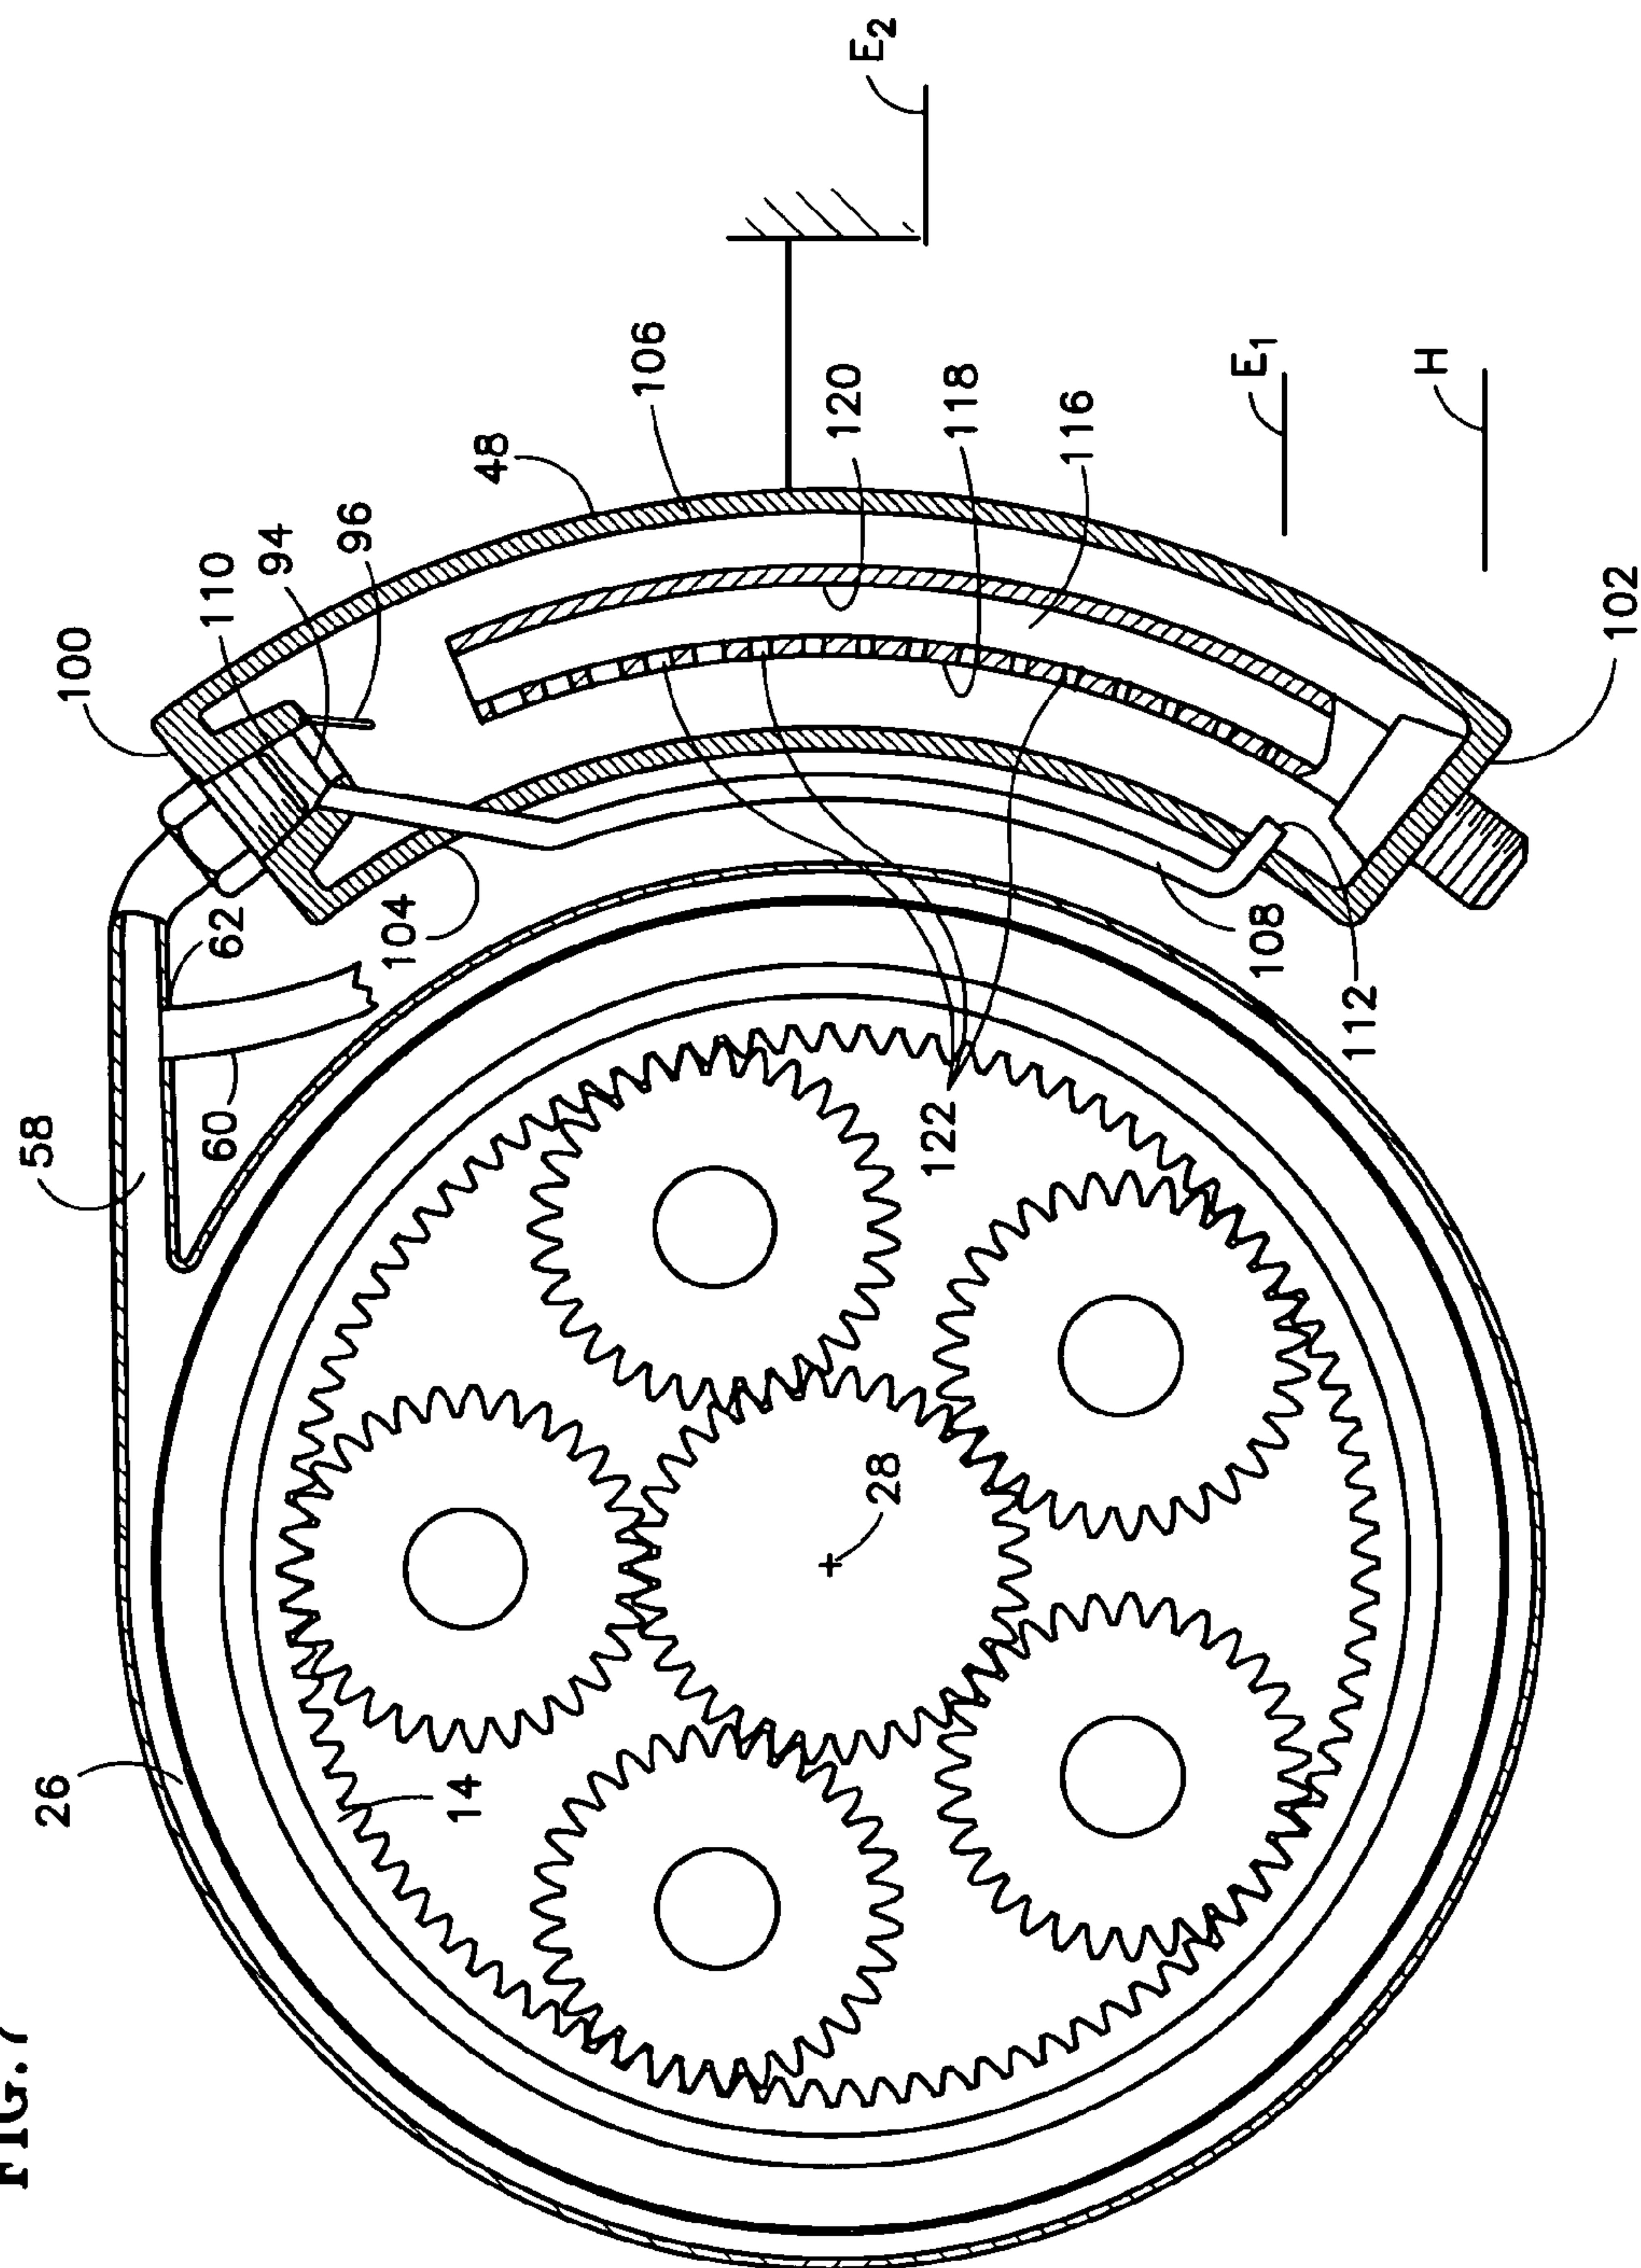
FIG. 7 is a schematic view showing an auxiliary lubricant tank with a bypass conduit and a discharge conduit for accommodating reduced-G operation.

FIG. **7** illustrates the ring gear **14**, gutter **26** and supply conduit **58**, which extends substantially tangentially from the gutter. The main bypass line **60** branches from the supply conduit at the junction **62** upstream of a conduit outlet **94**. An optional valve such as flapper valve **96** regulates lubricant flow from the outlet. The valve may be loaded, for example by a spring, to its closed position. The auxiliary tank **48** is mounted to a nonrotatable mechanical ground. The tank has a top **100**, a bottom **102** and an arcuate profile with radially inner and outer boundaries **104**, **106**. A reduced-G bypass line **108** branches from the conduit downstream of the junction **62** and upstream of the conduit outlet **94**. The bypass line has an inlet **110**, and an outlet **112** inside the auxiliary tank. The outlet **112** is at a first elevation, E_1 , preferably near the bottom of the tank.

The system also includes an auxiliary tank discharge conduit **116**. The discharge conduit **116** has an arcuate profile with radially inner and outer boundaries **118**, **120**. A portion of the conduit resides within the tank. The resident portion has an opening along the conduit inner boundary for allowing lubricant transfer between the tank and the conduit. The opening may take any convenient form. For example the opening may be a single opening such as a hole or a slot extending along the conduit. The illustrated opening is an array of perforations **122**. The perforations may all have the same area, however, as explained below, it may be desirable for the area of the individual perforations to decrease, or at least not increase, with decreasing elevation. The opening, whatever form it takes, is at least partially at a second elevation E_2 higher than the first elevation E_1 . For example, in the illustrated, perforated variant, at least some of the perforations are higher than E_1 .

As used herein, "elevation" refers to distance or height above a reference height H no higher than the bottom of the tank **48** when the system is in the orientation seen in FIG. 7, i.e. an orientation representative of the engine or aircraft being on level ground or in straight and level flight.

During normal positive-G operation (G approximately equal to 9.8 m/sec./sec.) with normal lubricant pressure, lubricant enters the auxiliary tank, principally by way of the outlet **94**, although some lubricant may enter the tank by flowing through the bypass line **108** and its outlet **112**. During normal positive-G operation with abnormally low lubricant pressure, the valve **96**, if present, may close so that lubricant still flowing through the conduit **58** enters the tank by way of the bypass line **108**. Either way, the lubricant exits the tank through the auxiliary tank discharge conduit **116** after first passing through the opening represented by perforations **122**.

During reduced-G operation, particularly zero-G or negative-G, the lubricant pressure may be low enough that a reduced quantity of lubricant (including no lubricant) flows through the supply conduit **58**. The low lubricant pressure may result from a malfunction in the lubrication system or it may occur because the reduced-G's have lifted lubricant away from the outlet **124** of the main tank (FIG. 4) in a system that is otherwise fully functional. The flapper valve **96**, if present, closes. Lubricant still circulating in the system is impelled through supply conduit **58** as a result of the tangential velocity imparted to the lubricant by the rotation of the gears. That lubricant enters the tank by way of the bypass line **108** and its outlet **112**. For negative-G operation, the lubricant will migrate toward the top of the tank. However because the array of perforations **122** is at least partially at an elevation E_2 higher than outlet elevation E_1 , the lubricant can enter the discharge conduit **116** by way of the perforations **122**. Because the lubricant migrates toward the top of the tank during negative-G operation, there will be a tendency for the auxiliary pump **50** to extract air from the bottom of the tank rather than lubricant from the top of the tank. This tendency can be partially counteracted if the perforations **122** are of decreasing area with decreasing elevation. The lubricant is encouraged to enter the discharge conduit partly because of the negative-G's and partly due to suction created by the auxiliary pump **50**. Because the conduit is arcuate, the lubricant will tend to accumulate along the radially outer boundary **120** of the conduit so that it can be extracted by the pump **50**. For zero-G operation, the system operates similarly except that the lubricant will tend to float and will not be able to enter the conduit as readily.

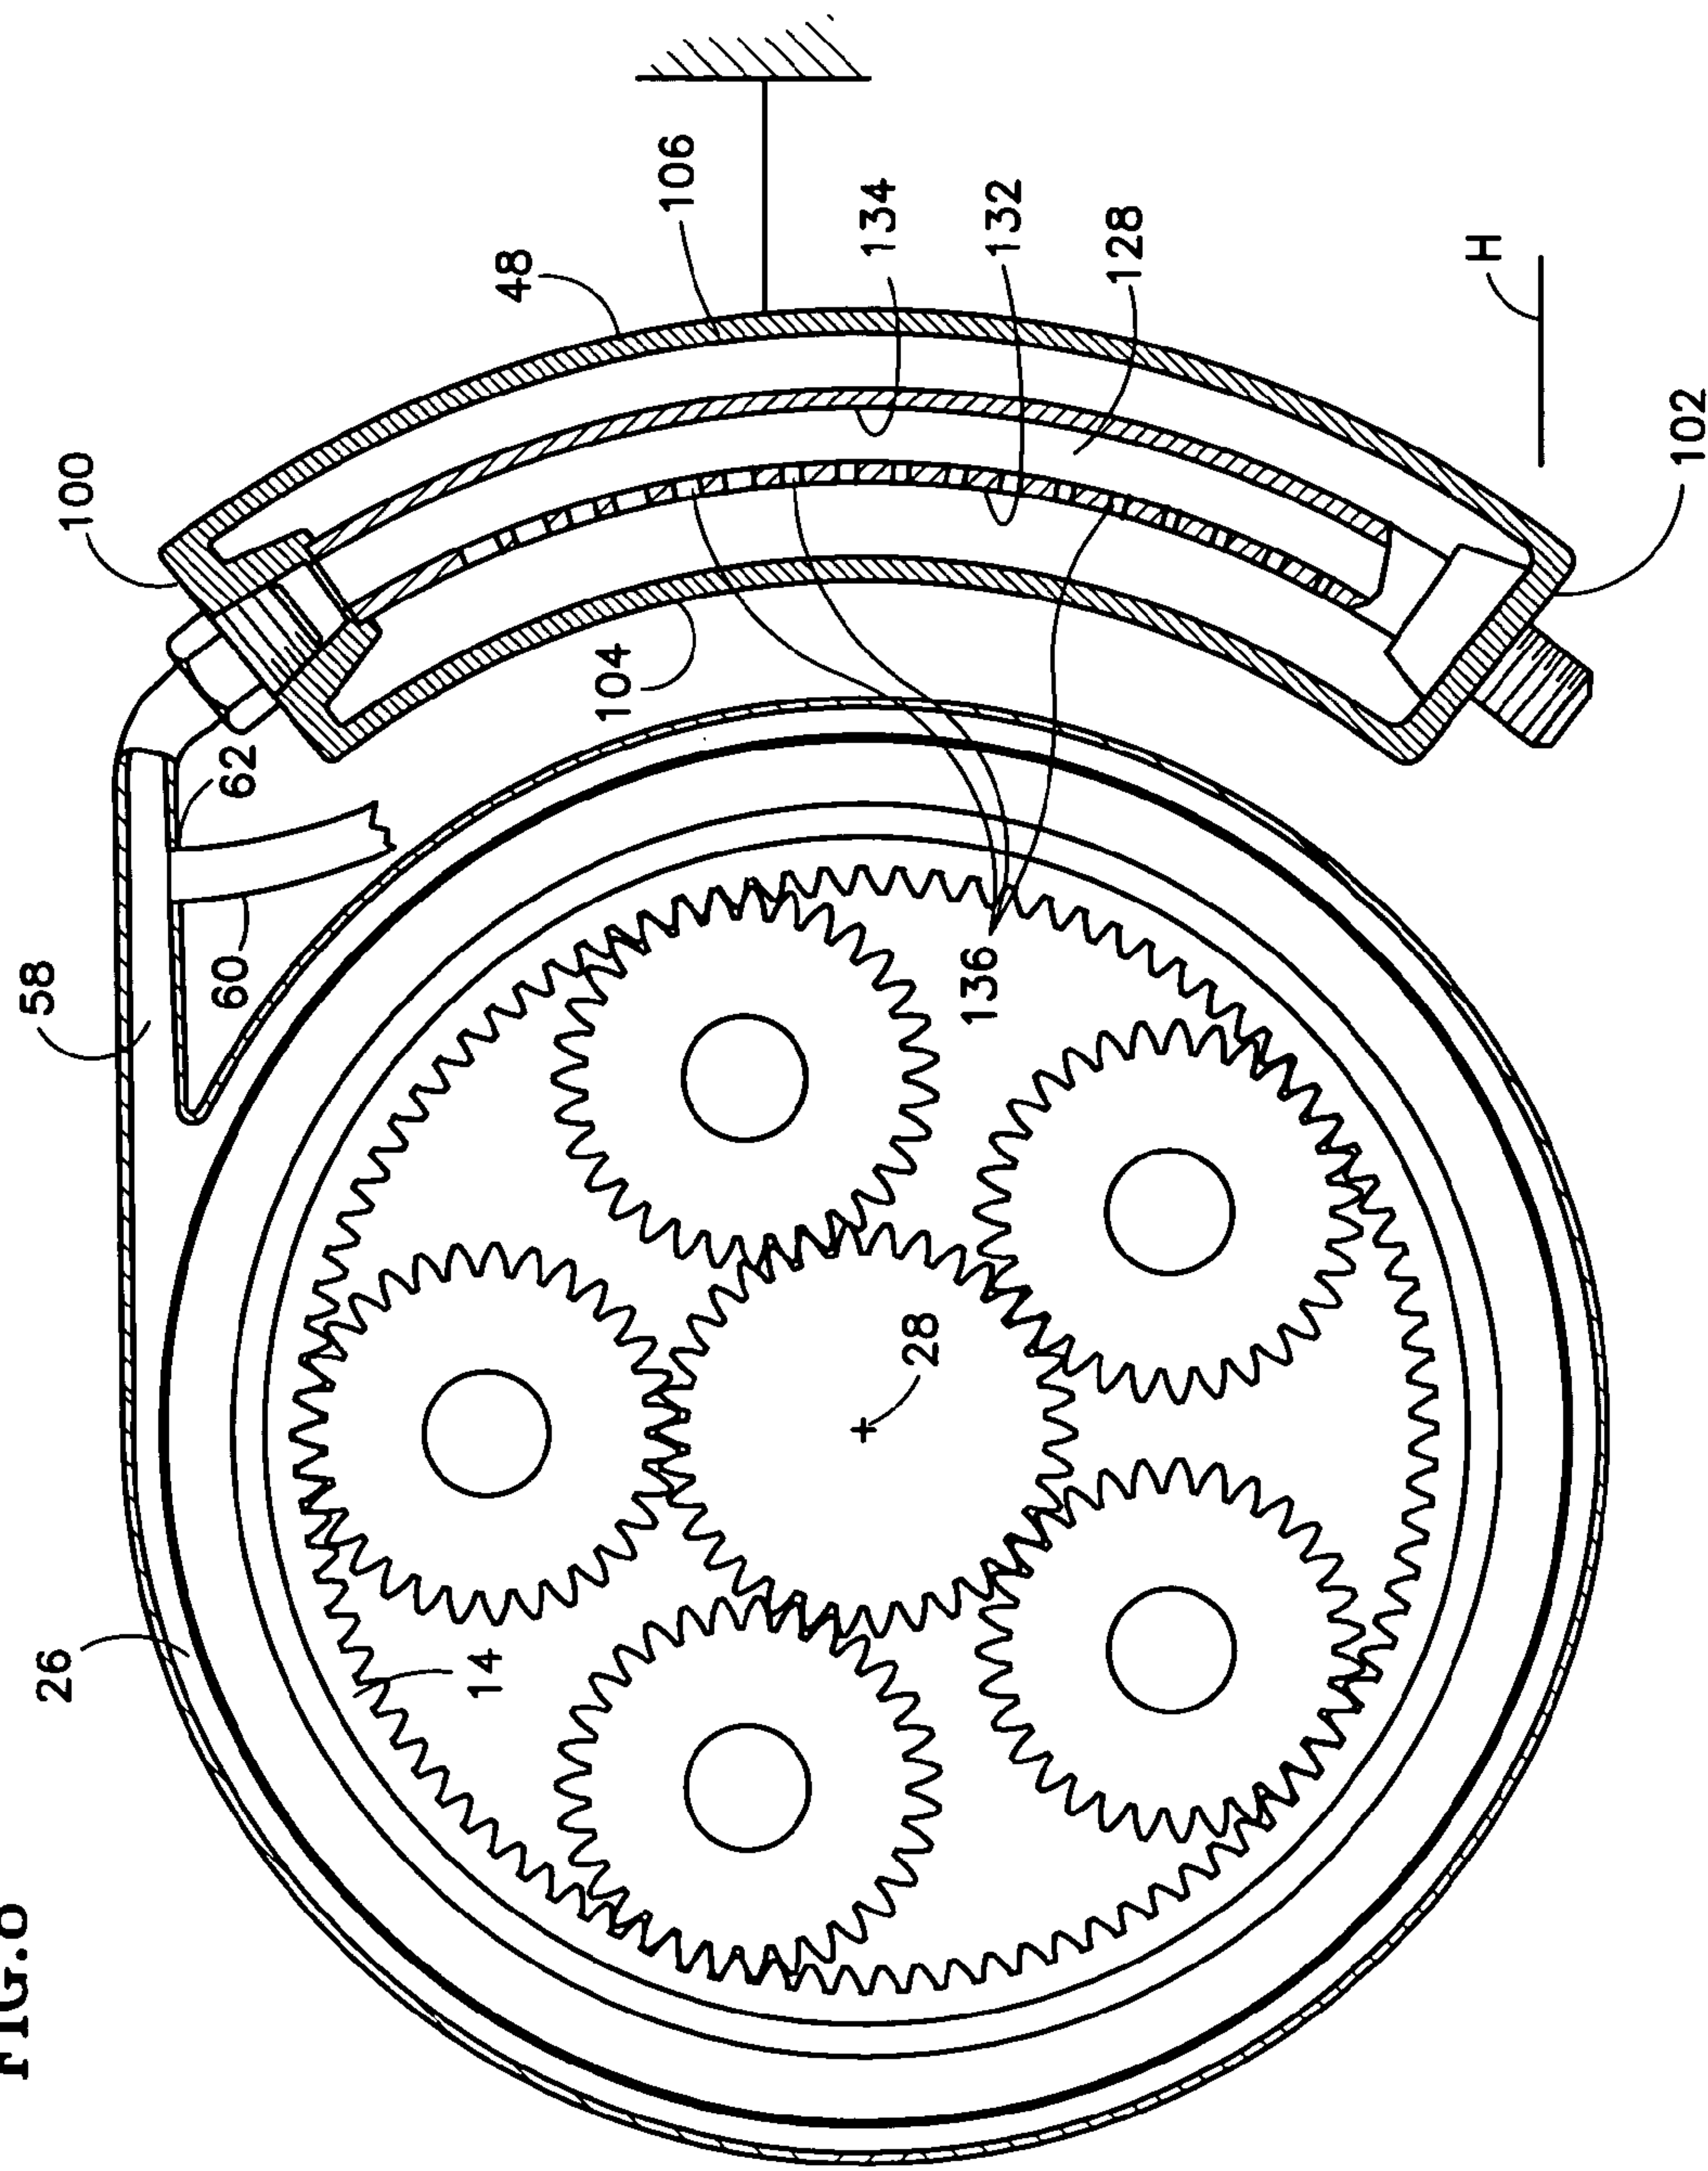
FIG. 8 is a schematic view showing an auxiliary lubricant tank with a continuous conduit extending through the tank without interruption for accommodating reduced-G operation.

FIG. 8 illustrates the ring gear **14**, gutter **26** and supply conduit **58**, which extends substantially tangentially from the gutter. The main bypass line **60** branches from the conduit at the junction **62**. The auxiliary tank **48** is mounted to a nonrotatable mechanical ground. The tank has a top **100**, a bottom **102** and an arcuate profile with radially inner and outer boundaries **104**, **106**.

The system also includes an auxiliary tank discharge conduit **128**. The discharge conduit may be a component physically distinct from the supply conduit **58** and connected thereto by a fitting or other appropriate connection as shown. Alternatively, the discharge conduit may be an integral extension or continuation of the supply conduit **58**, with the interface between the conduits **58**, **128** being, for example, at the location where the continuous conduit penetrates into the auxiliary tank **48**. The conduit extends continuously and without interruption through the tank.

The discharge conduit **128** has an arcuate profile with radially inner and outer boundaries **132**, **134**. A portion of the discharge conduit resides within the tank. The resident por-

tion has an opening along the conduit inner boundary for allowing lubricant transfer between the tank and the conduit. The opening may take any convenient form. For example the opening may be a single opening such as a hole or a slot extending along the conduit. The illustrated opening is an array of perforations **136**. The perforations may all have the same area. However, as explained above, it may be desirable for the area of the individual perforations to decrease, or at least not increase, with decreasing elevation in order to reduce the tendency for the pump **50** to extract air rather than lubricant during negative-G operation.

As used herein, "elevation" refers to distance or height above a reference height H no higher than the bottom of the tank **48** when the system is in the orientation seen in FIG. 8, i.e. an orientation representative of the engine or aircraft being on level ground or in straight and level flight.

During normal positive-G operation (G approximately equal to 9.8 m/sec./sec.) with normal lubricant pressure, lubricant delivered by supply conduit **58** flows through the perforations to establish a reserve quantity of lubricant in the auxiliary tank **48**. Excess lubricant flows through the discharge conduit **128** to the auxiliary pump **50** (FIG. 4). During positive-G operation with abnormally low lubricant pressure, the quantity of lubricant circulating through the lubrication system is typically reduced relative to the normal quantity (in the limit, the reduced quantity may be zero). The reduced quantity flows into the discharge conduit and adds to residual lubricant in the tank and/or flows through the discharge conduit to the auxiliary pump.

During reduced-G operation, particularly zero-G or negative-G, the lubricant pressure may be low enough that a reduced quantity of lubricant (including no lubricant) flows through the supply conduit **58**. The low lubricant pressure may result from a malfunction in the lubrication system or it may occur because the reduced-G's have lifted lubricant away from the outlet **124** of the main tank (FIG. 4) in a system that is otherwise fully functional. Lubricant still circulating in the system is impelled through supply conduit **58** as a result of the tangential velocity imparted to the lubricant by the rotation of the gears. That lubricant flows from the supply conduit **58** into the discharge conduit **128**. For negative-G operation, any lubricant already in the tank migrates toward the top of the tank. The perforations **136** admit this lubricant to the discharge conduit to augment any lubricant arriving from the supply conduit **58**. The lubricant in the tank is encouraged to enter the discharge conduit partly because of the negative-G's and partly due to suction created by the auxiliary pump **50**. Because the conduit is arcuate, the lubricant will tend to accumulate along the radially outer boundary **134** of the conduit so that it can be extracted by the pump **50**. For zero-G operation, the system operates similarly except that the lubricant will tend to float and will not be able to enter the conduit as readily.
