(10) **Patent No.:** **US 8,215,454 B2**  
(45) **Date of Patent:** **Jul. 10, 2012**

(54) **LUBRICATION SYSTEM WITH TOLERANCE FOR REDUCED GRAVITY**

(73) Assignee: **United Technologies Corporation**, Hartford, CT (US)

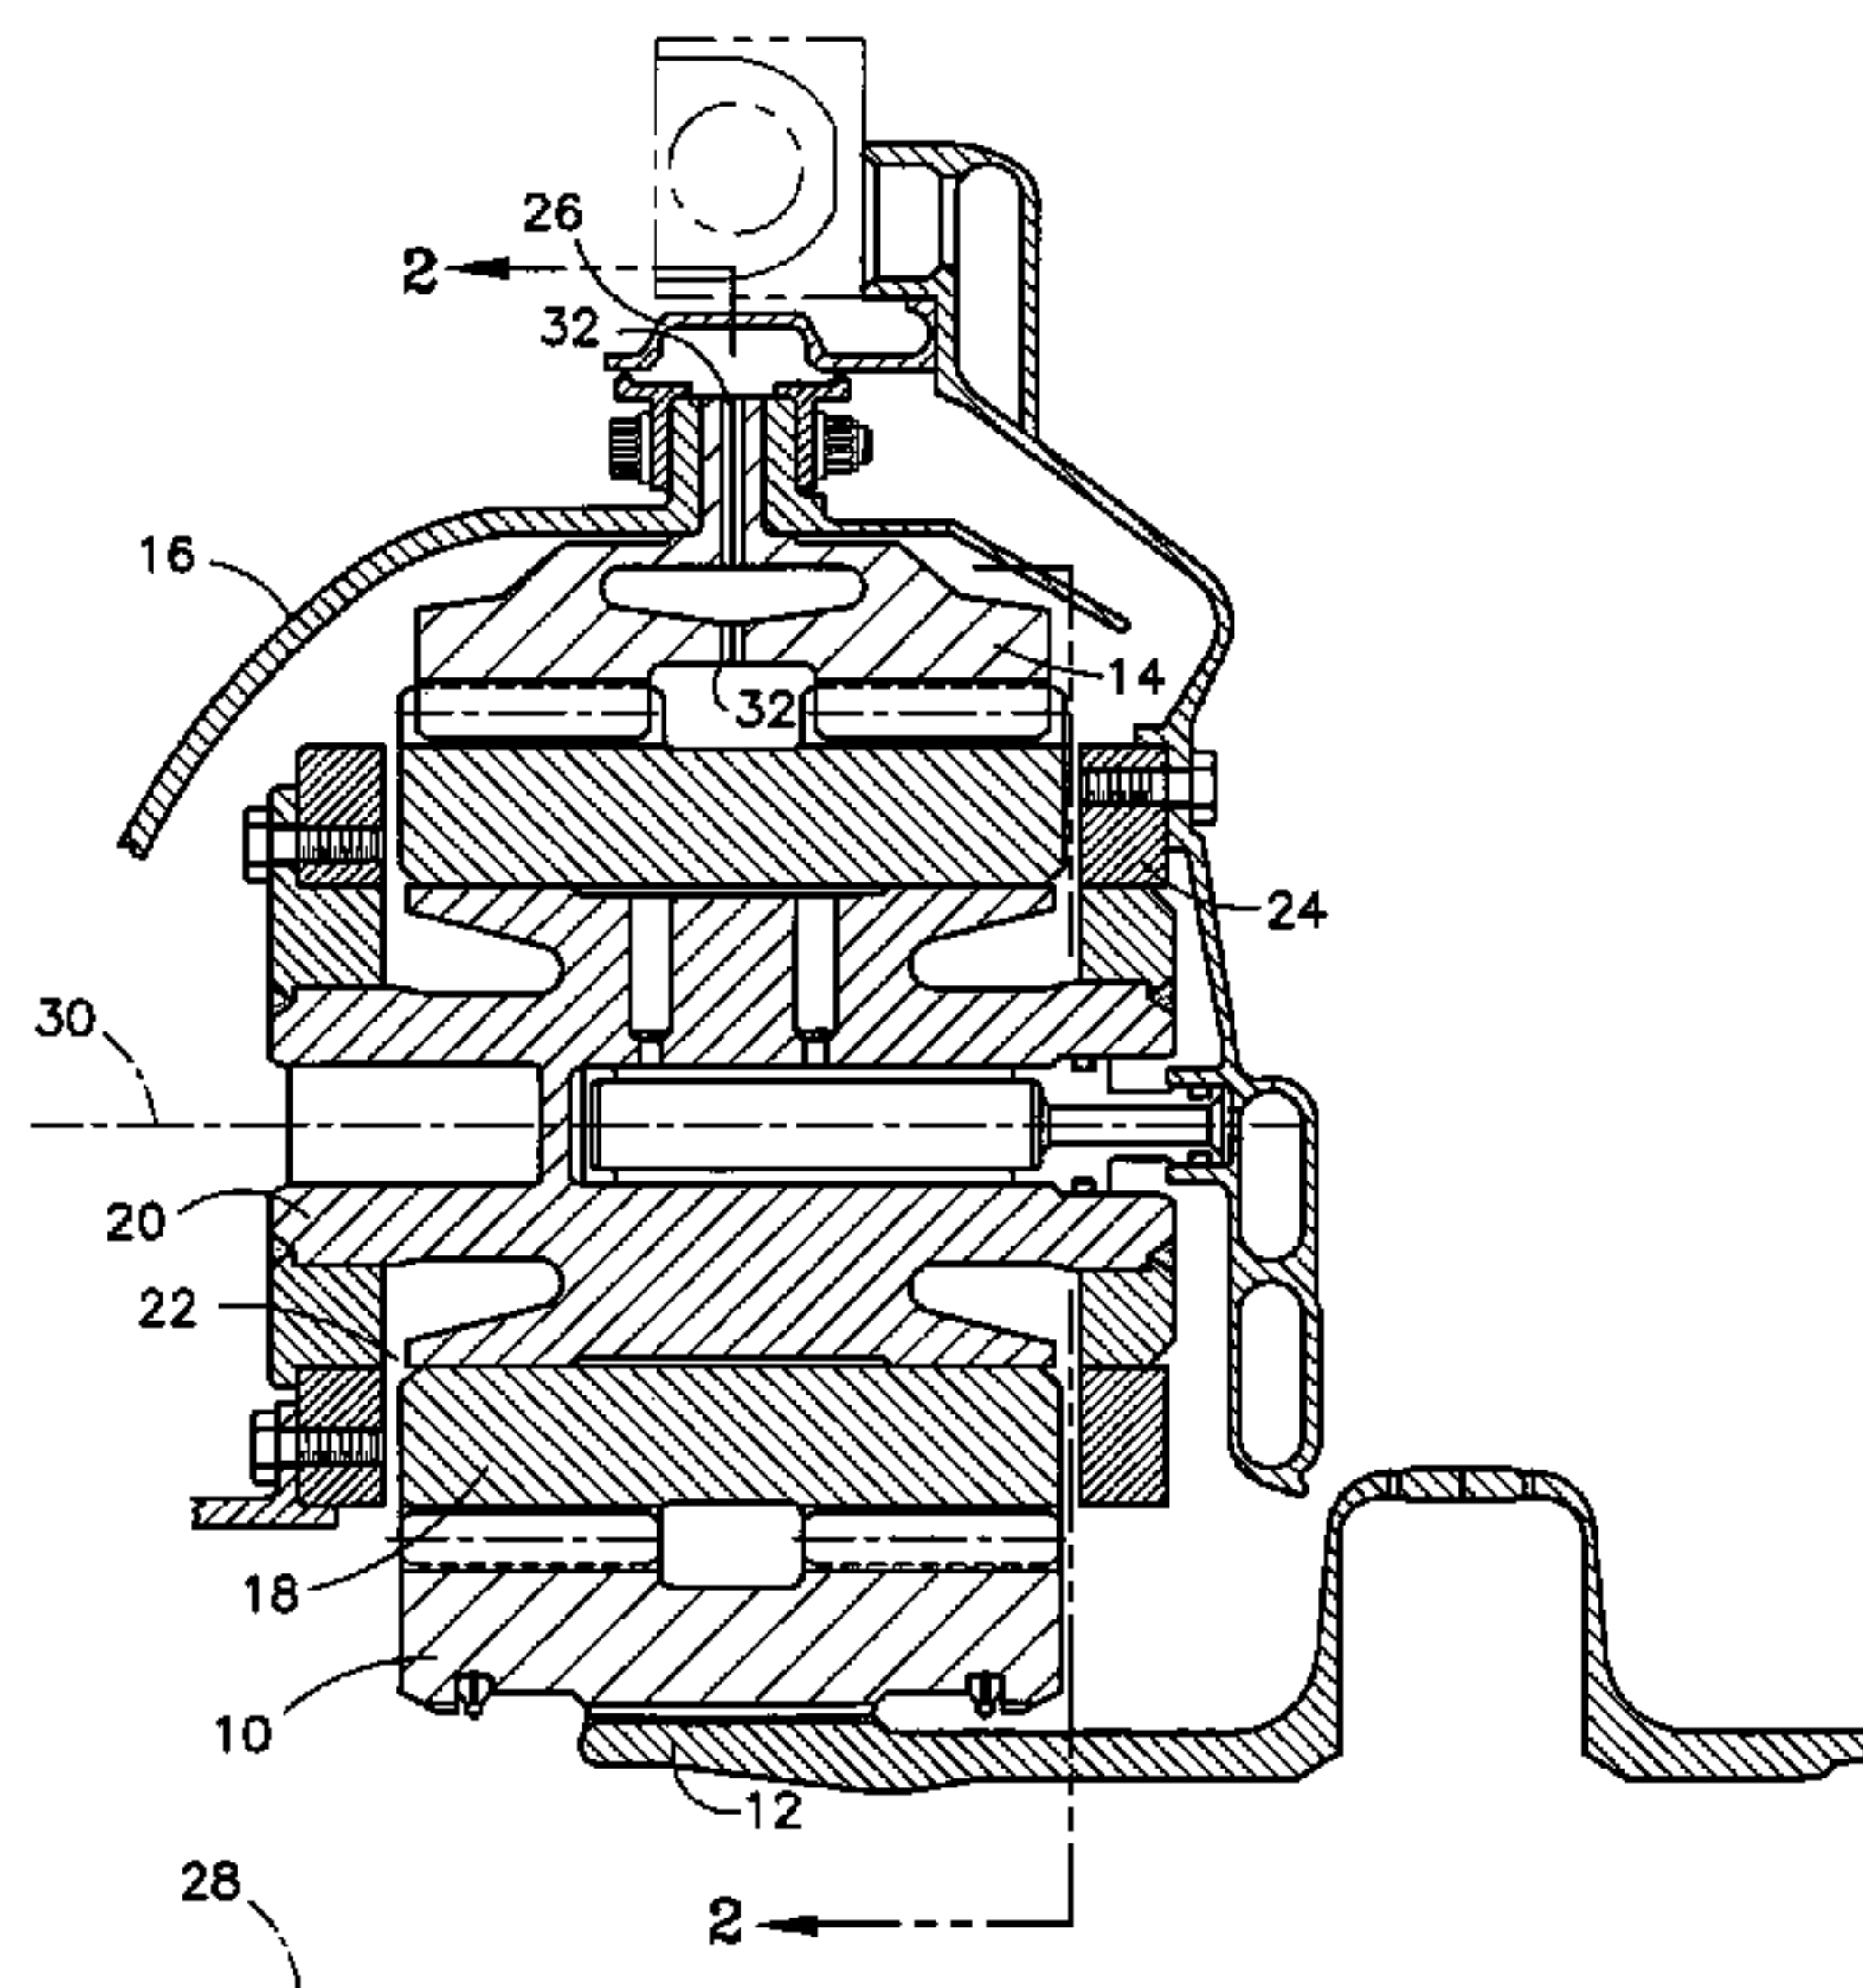
A lubrication system includes an auxiliary lubricant tank **48**, a supply conduit **58** extending from a source of lubricant **26** to the auxiliary lubricant tank. A reduced-G bypass line **108** branches from the conduit and enters the auxiliary tank at a first elevation  $E_1$ . The system also includes an auxiliary tank discharge conduit **116**, a portion of which resides within the tank. The resident portion has an opening **122** at least partially at a second elevation  $E_2$  higher than the first elevation.

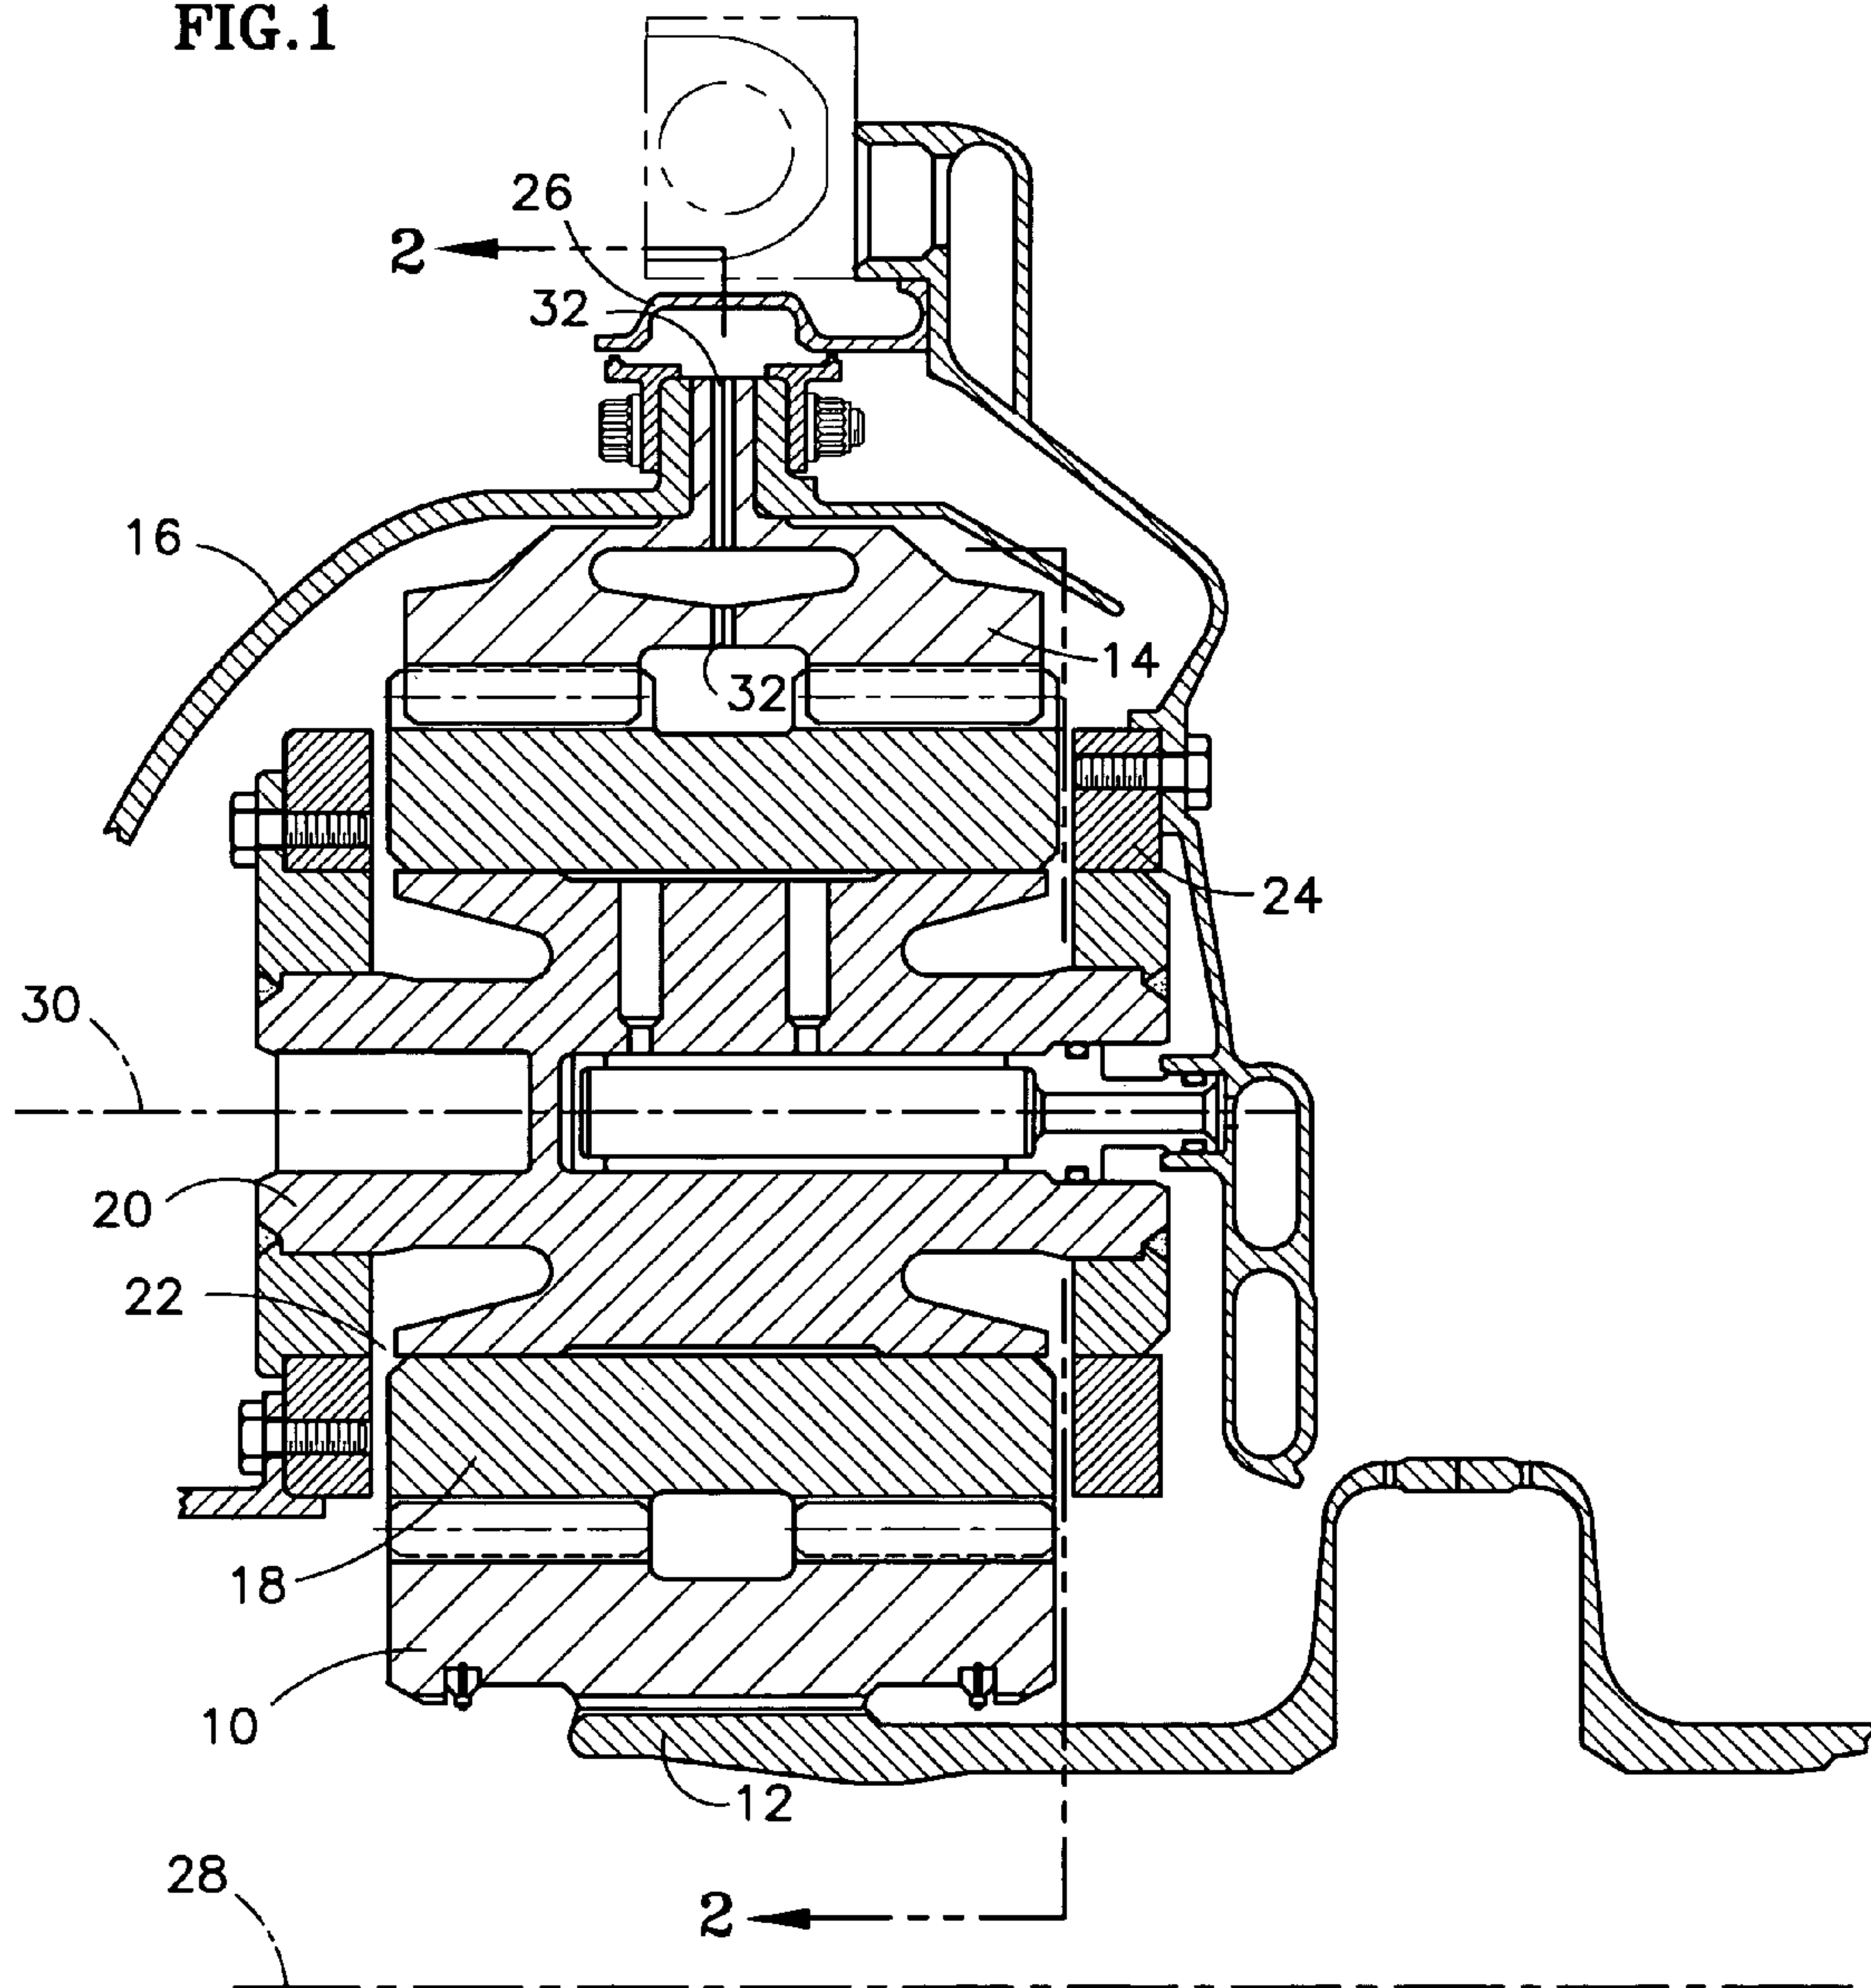
FIG. 1 is a cross sectional side elevation view of a gear train configured as a star system and useful in an aircraft gas turbine engine.

Referring to FIGS. 1 and 2, a reduction gear train suitable for use in an aircraft gas turbine engine includes a sun gear 10 driven by a sun gear (input) shaft 12, a ring gear 14 radially outboard of the sun gear and connected to a ring gear (output) shaft 16, and a set of intermediate gears 18 radially intermediate and meshing with the sun and ring gears. Each intermediate gear circumscribes a journal pin 20. A thin, replenishable film of lubricant, not shown, occupies a small annular space 22 between each intermediate gear and its journal pin to support the intermediate gear. This arrangement is referred to as a journal bearing. The journal pins are all supported by a carrier 24. The carrier interconnects the journal pins with each other and, by doing so, also interconnects the intermediate gears to each other. A lubricant recovery gutter 26 circumscribes the ring gear.

In the gear train shown in FIGS. 1 and 2, the sun and ring gears are each rotatable about an axis 28. The carrier is non-rotatable even though the individual intermediate gears are each rotatable about their respective axes 30. Such a system is referred to as a star system. As seen best in FIG. 2, the input and output shafts counterrotate. Lubricant flows through the gear system to support the intermediate gears 18 on the journal pins 20 and to lubricate and cool the gear teeth. The used lubricant expelled by the gear train enters the gutter 26 by various paths, which include lubricant slots 32.

Many of the engine components, including the gears 10, 14, 18 are able to tolerate lubricant starvation for brief intervals of time. However the journal pins 20 are far less tolerant of lubricant starvation. Accordingly, whether the gear system is configured as a star, a planetary or with all three gears rotatable, it is desirable to ensure that lubricant flows to the journal pins, at least temporarily under all conditions. The temporary lubricant supply allows time for normal operation to resume or for the engine to be shut down before significant damage can occur.

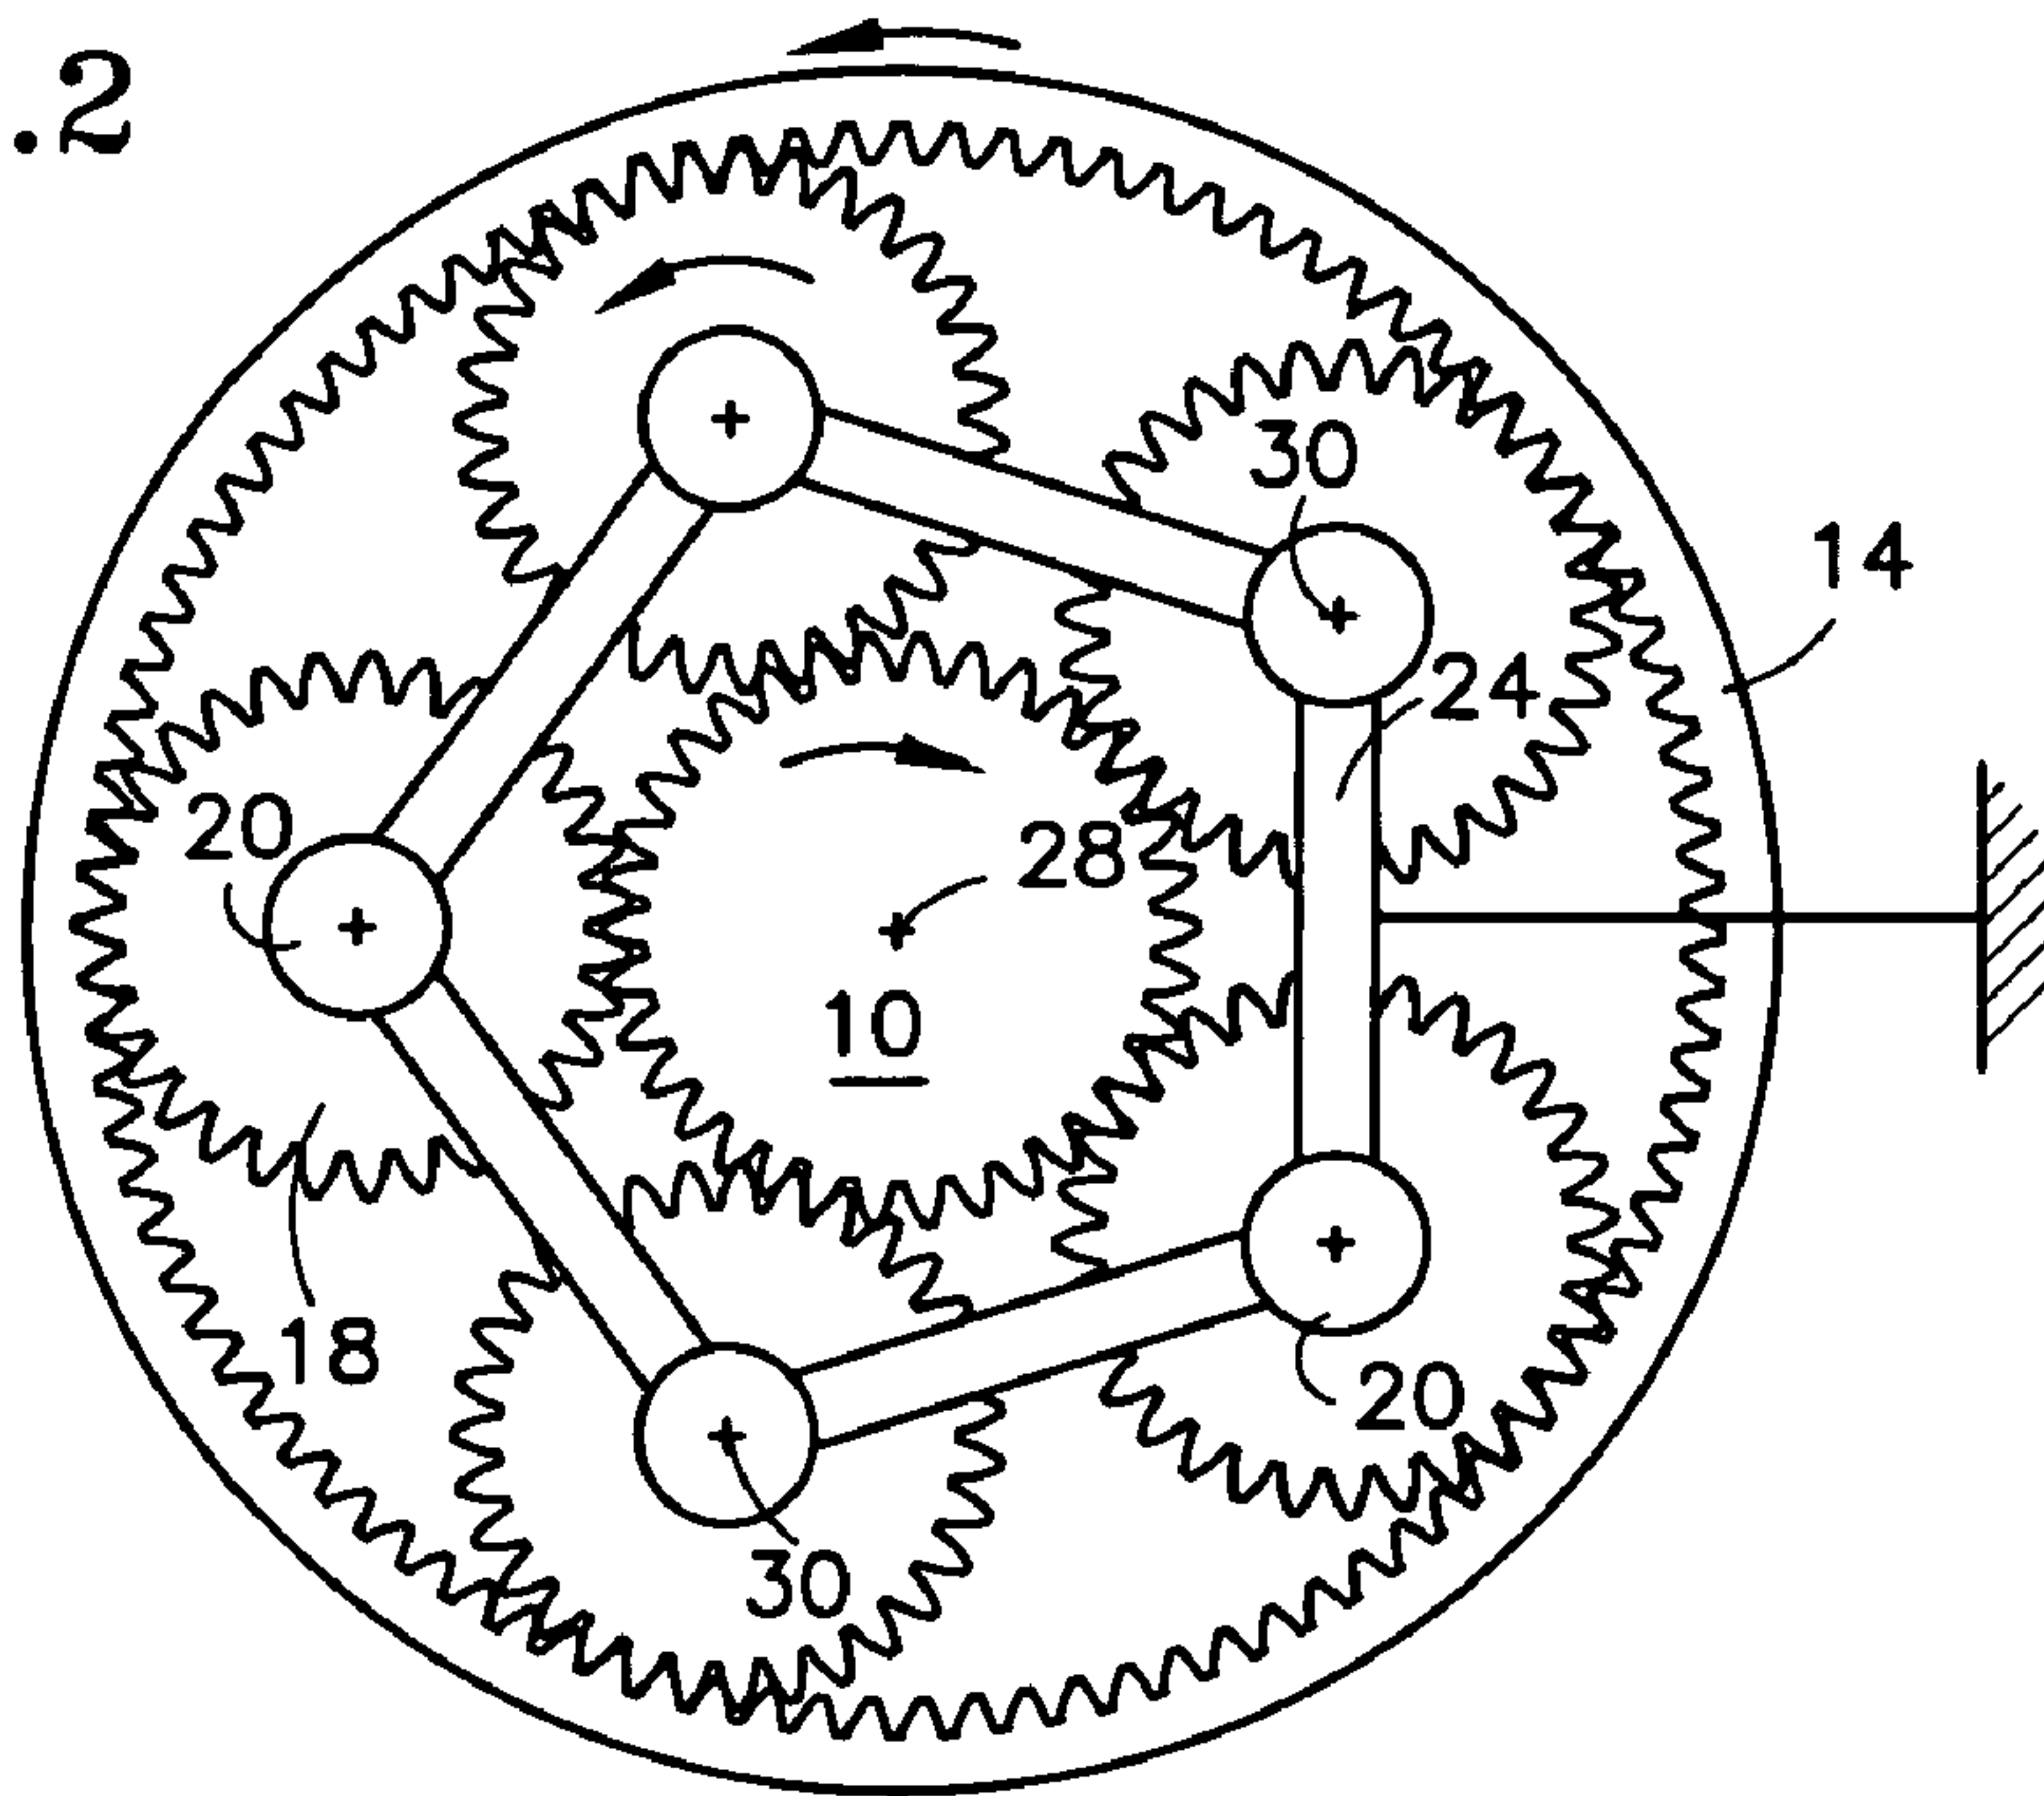
FIG. 2 is a schematic view in the direction 2-2 of FIG. 1.

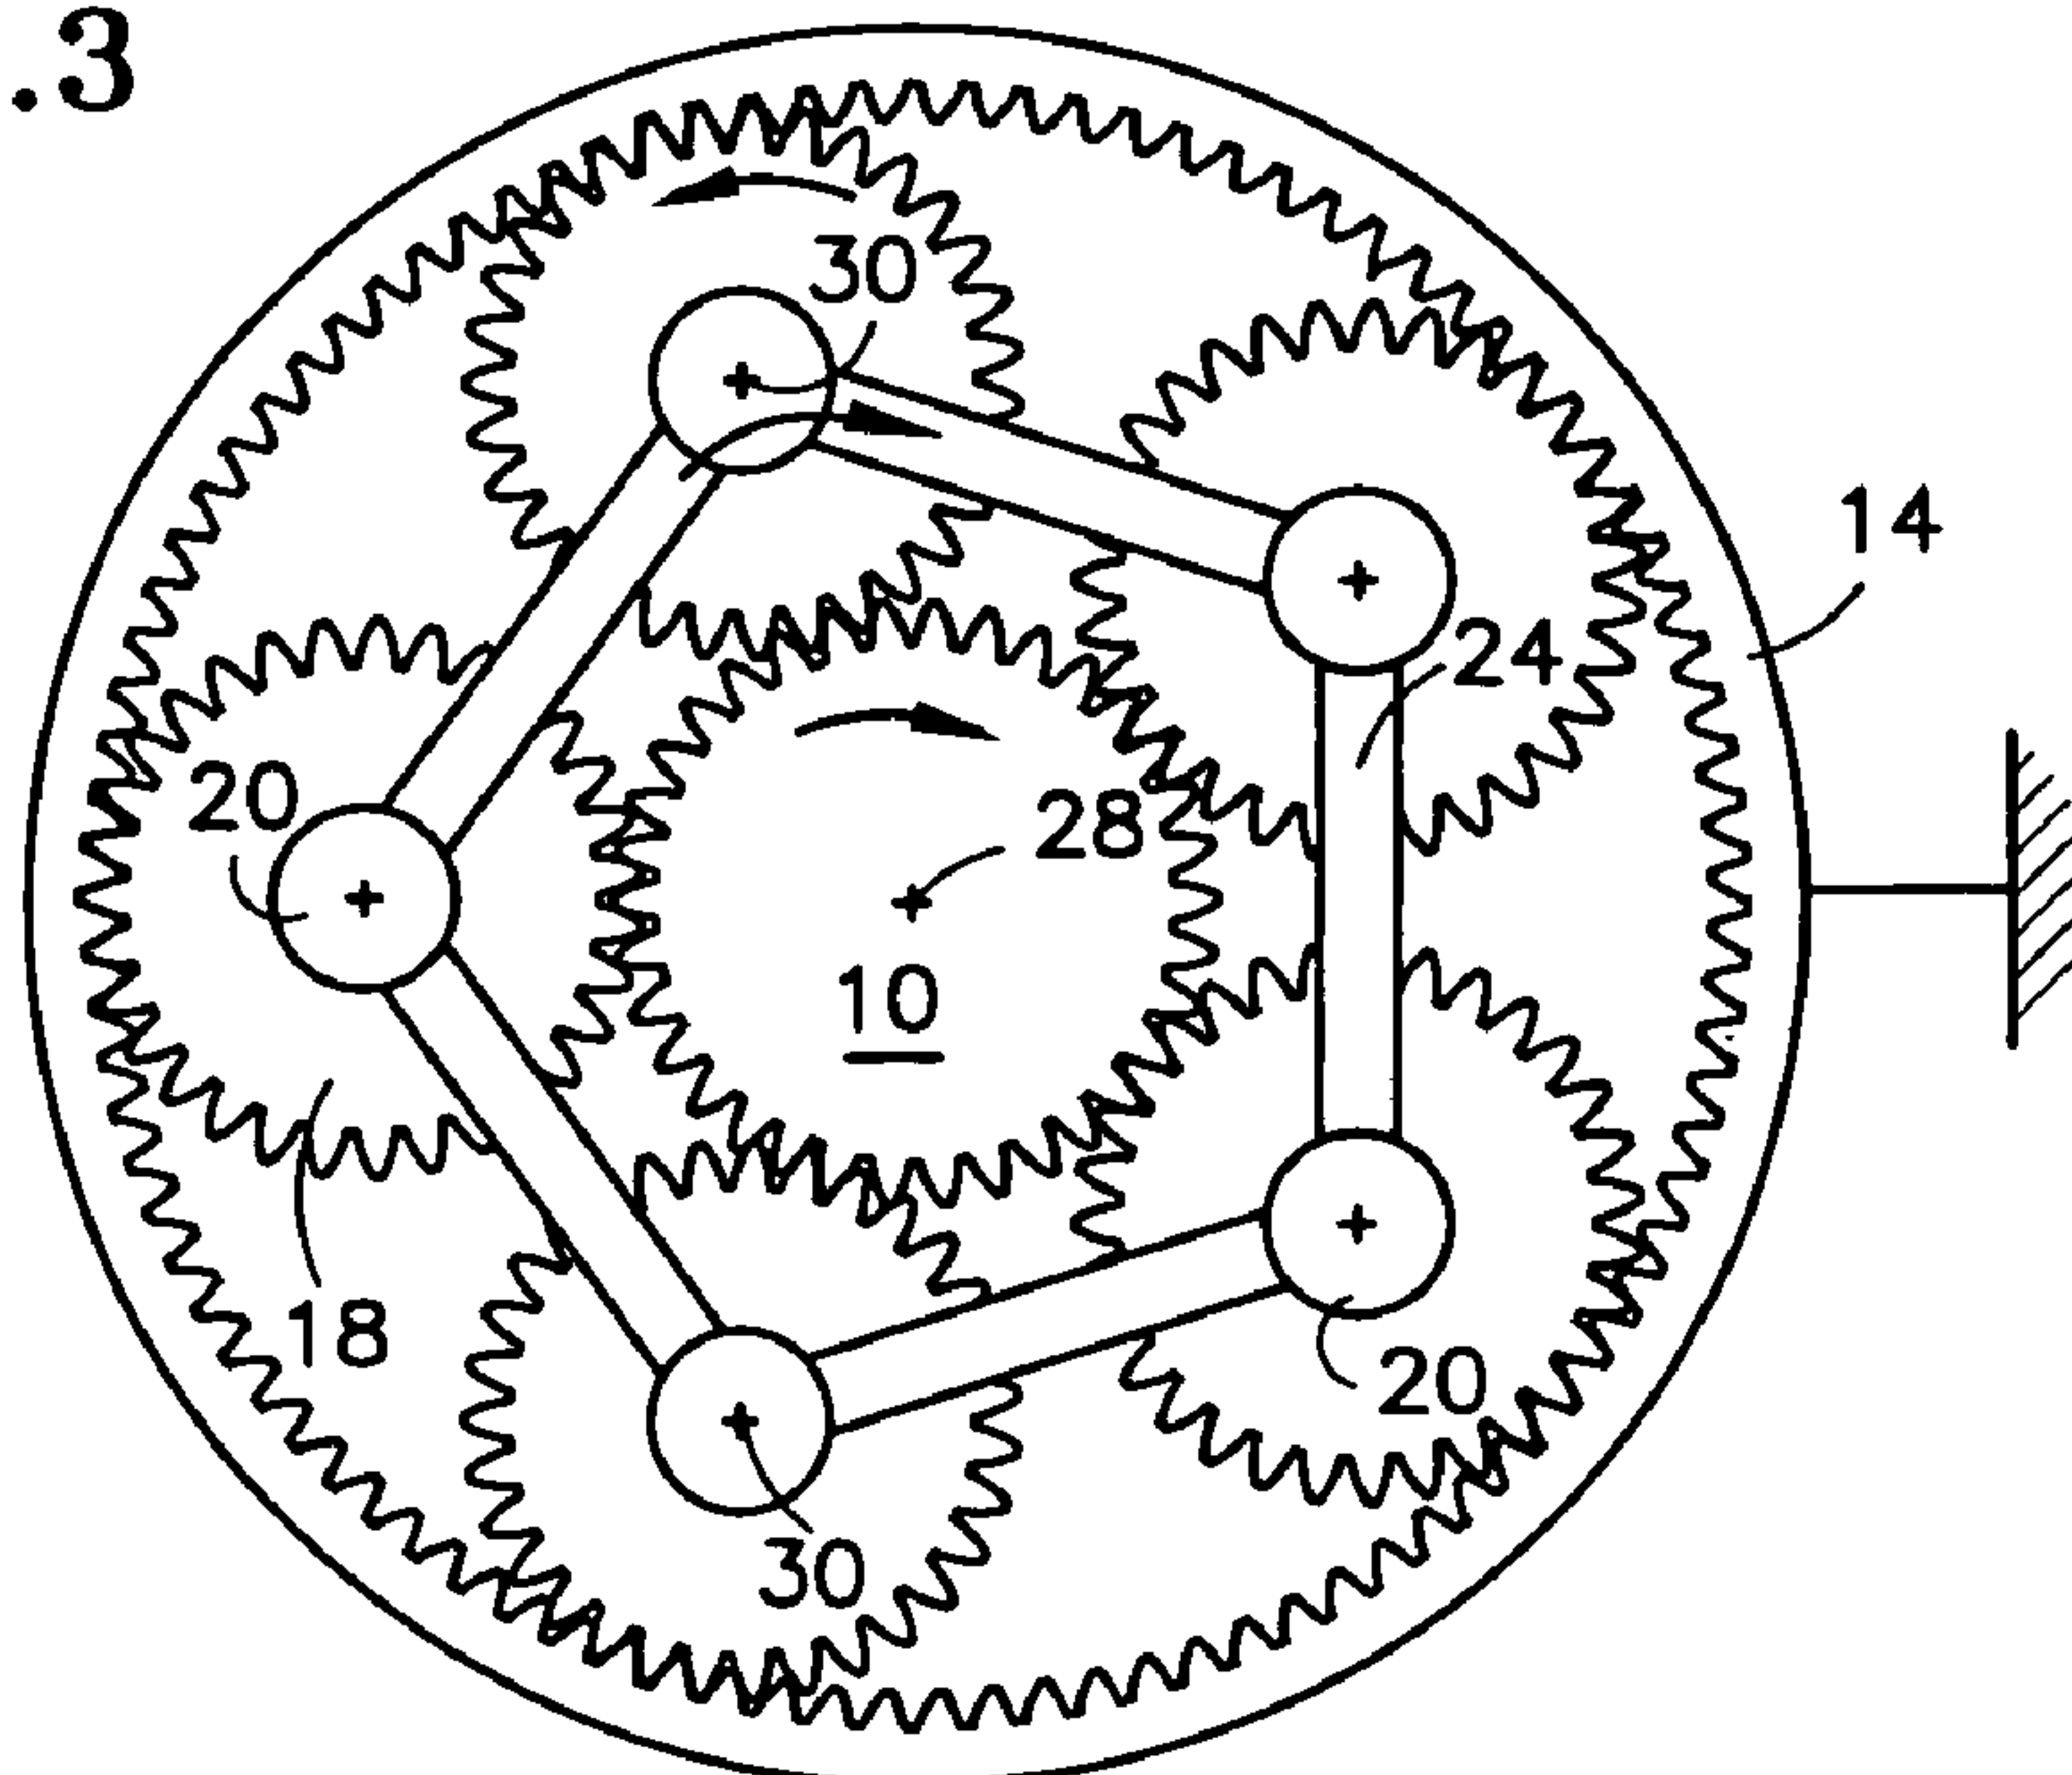
FIG. 3 is a schematic view similar to FIG. 2 illustrating a gear train configured as a planetary system.

Alternatively, as seen in FIG. 3, the sun gear and carrier are rotatable about the axis 28. The ring gear is nonrotatable. The carrier is connected to an output shaft. Such a system is referred to as a planetary system. The input and output shafts co-rotate as indicated in FIG. 3. Finally, all three components may be rotatable about axis 28 so that dual output shafts connected to the carrier and the ring gear counterrotate with respect to each other.

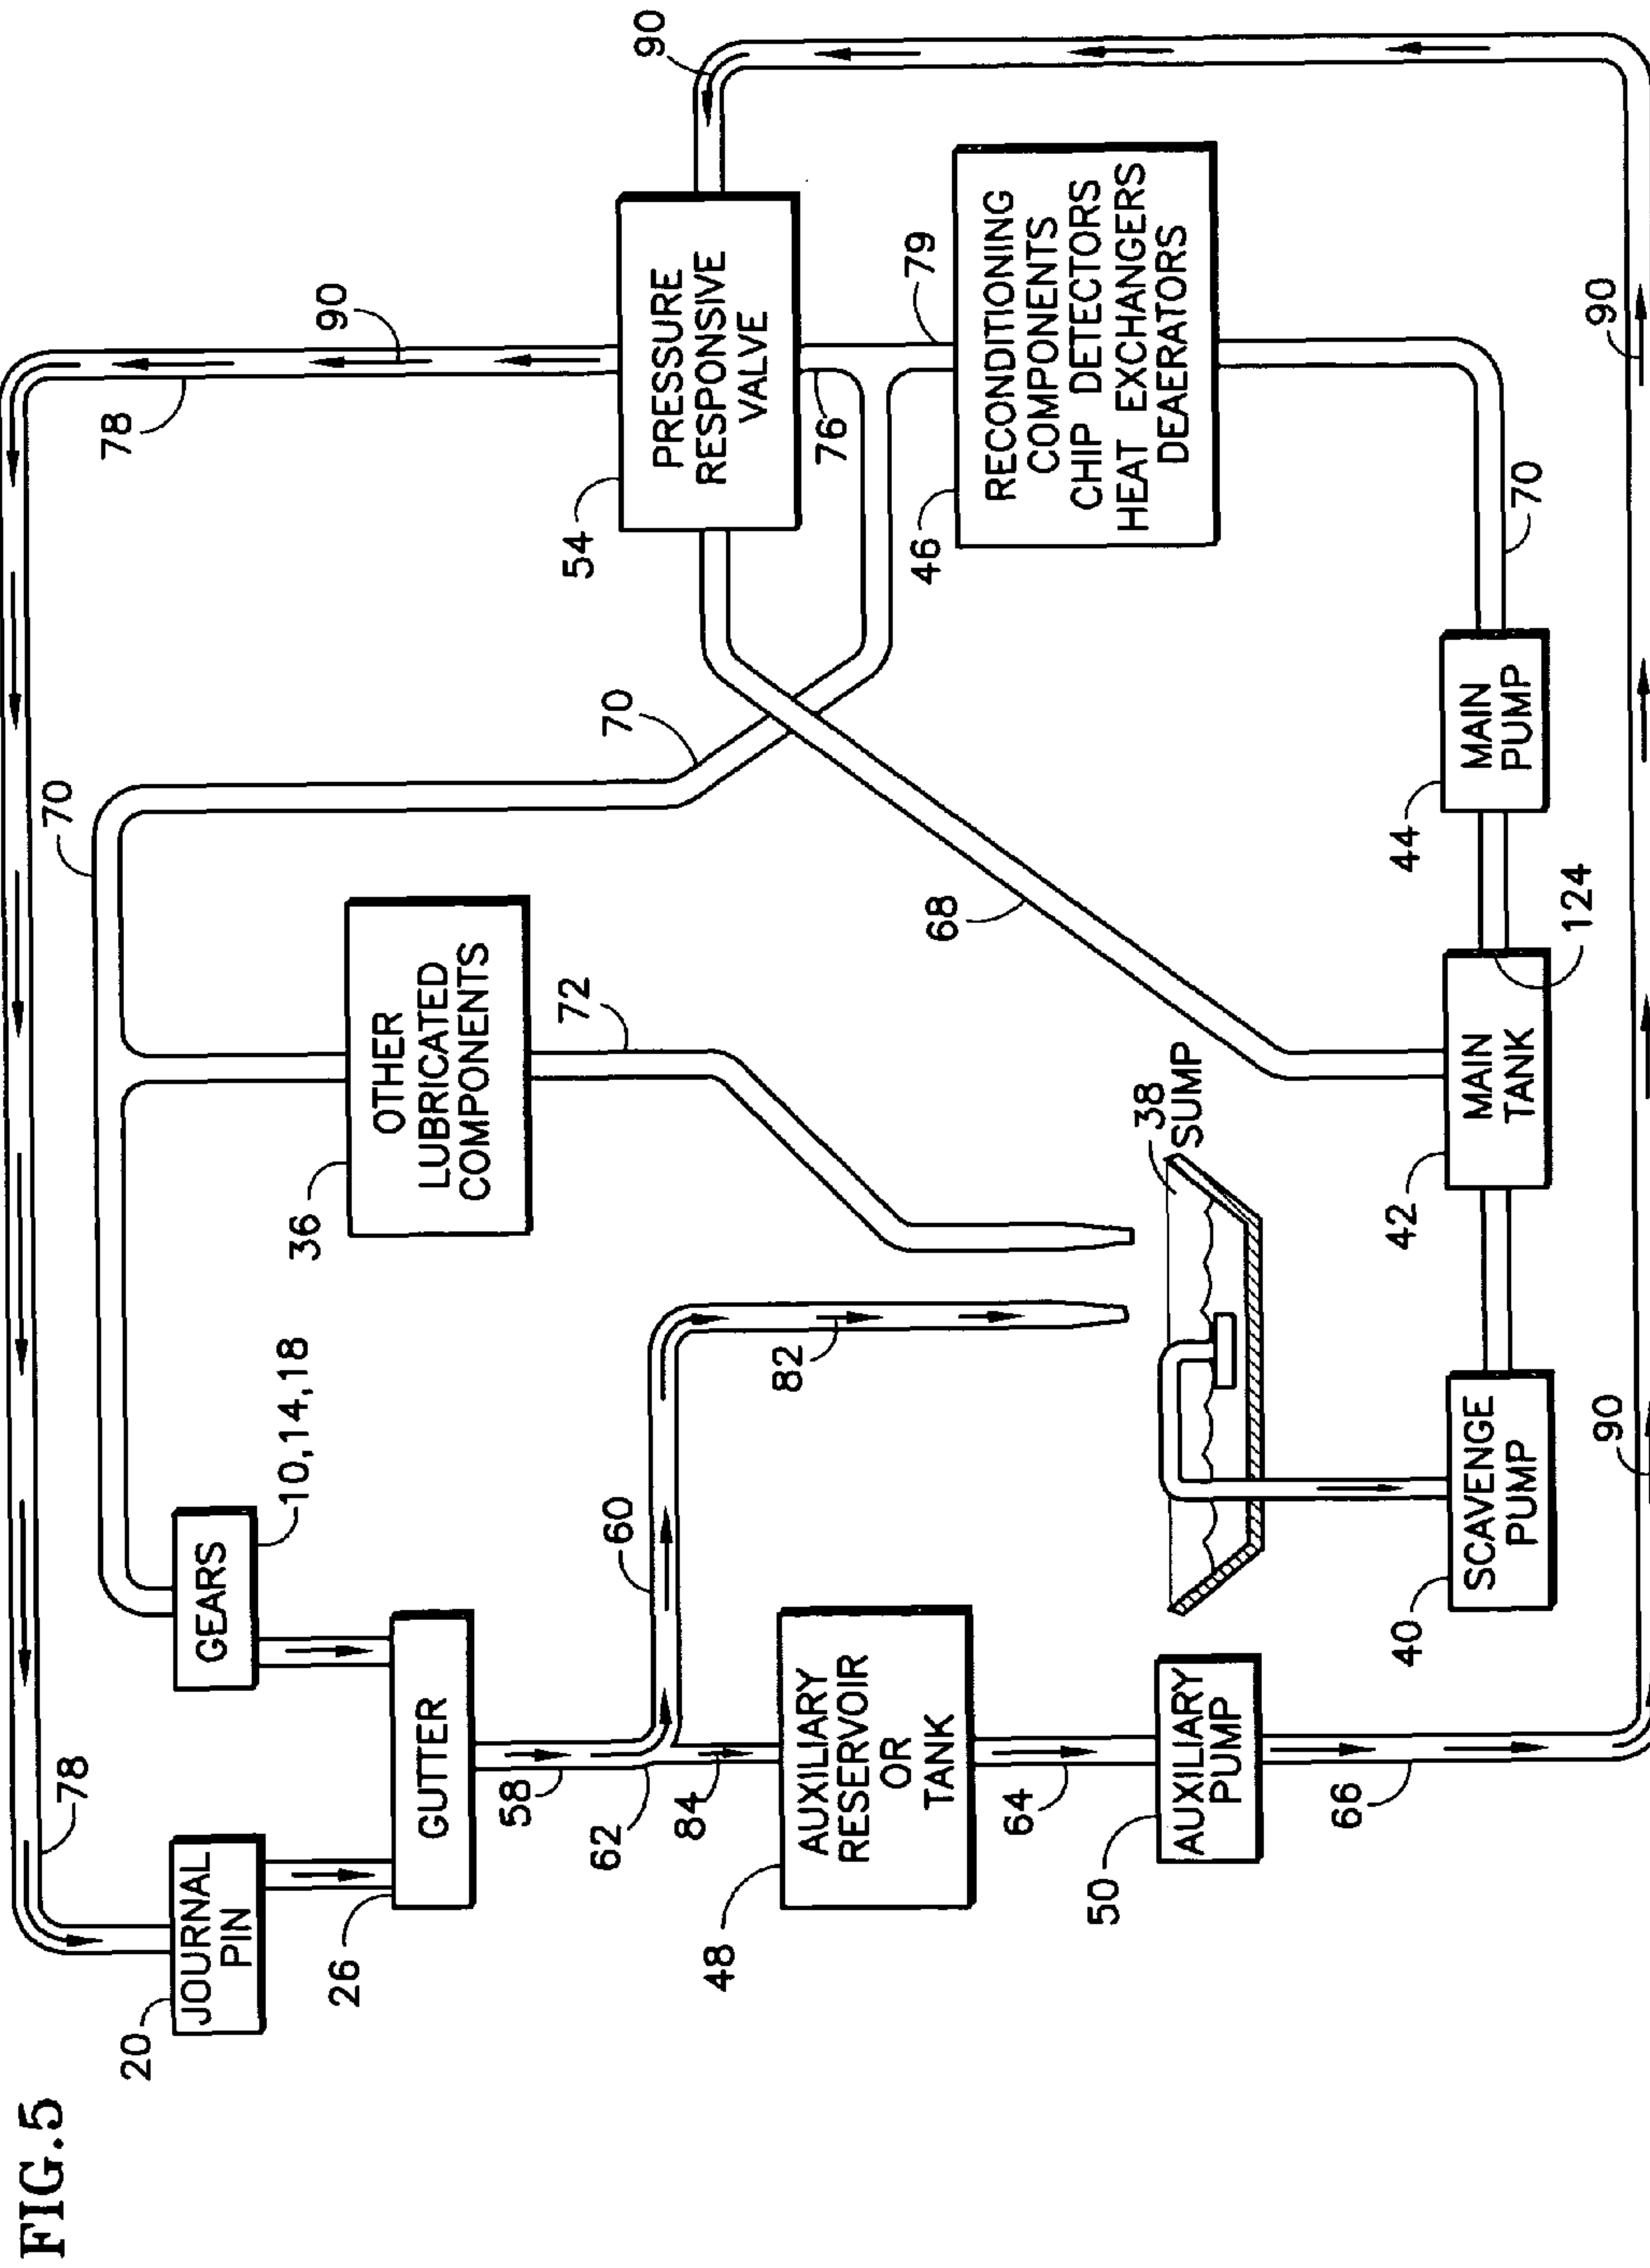
FIG. 4 is a schematic diagram showing a lubrication system in a normal state of operation, i.e. with the lubricant pressure at a normal level.

FIG. 4 schematically shows the relevant components of the above described gear train (gears 10, 14, 18, journal pin 20 and gutter 26), other engine components 36 requiring lubrication, and a lubrication system suitable for use with the gear train. The lubrication system includes a main system whose

components include a sump **38**, a scavenge pump **40** for scavenging lubricant from the sump, a main tank **42** for receiving lubricant from the scavenge pump, a main pump **44** for pumping lubricant from the main tank, and various lubricant reconditioning components such as chip detectors, heat exchangers and deaerators, collectively designated **46**. The lubrication system also includes an auxiliary system whose components include an auxiliary lubricant tank or reservoir **48** and an auxiliary pump **50**. The lubrication system also includes a pressure responsive valve **54**.

An auxiliary tank supply conduit **58** extends from the gutter **26** to the auxiliary tank **48**. The gutter serves as a source of lubricant for the tank. A main bypass line **60** branches from the supply conduit at a junction **62** and extends to the sump **38**. An auxiliary tank discharge conduit **64** extends from the auxiliary tank to the auxiliary pump. An auxiliary pump discharge line **66** extends from the auxiliary pump to the pressure responsive valve. A main tank return line **68** extends from the valve **54** to the main lubricant tank **42**. A lubricant delivery pathway **70** extends from the main pump **44** through the various lubricant reconditioning components **36** and ultimately to the gears **10**, **14**, **18** and other components **46**. A lubricant return pathway **72** extends from the components to the sump **38**. A portion **76** of the delivery pathway **70** leads to the pressure responsive valve **54**. A journal pin delivery line **78** extends from the valve to the journal pins **20**.

During normal operation, rotation of the gears expels lubricant radially outwardly, and with a high tangential velocity, into the lubricant recovery gutter **26**. The supply conduit **58**, which branches substantially tangentially off the gutter as seen in FIGS. **7** and **8**, captures the expelled lubricant. A large portion **82** of the lubricant flows through the main bypass line **60** and returns to the sump **38**. A smaller portion **84** of the lubricant flows into the auxiliary tank **48** to establish or replenish a reserve quantity of lubricant therein. The auxiliary pump **50** pumps lubricant from the tank to the pressure responsive valve **54**. Concurrently, the scavenge pump **40** extracts lubricant from the sump **38** and delivers it to the main tank **42**. The main pump **44** pumps the lubricant from the tank to the reconditioning components **46**. Most of the reconditioned lubricant **86** then flows to the gears **10**, **14**, **18** and other components **36**. The remainder **88** of the lubricant flows to the pressure responsive valve. The valve, responding to normal pressure in the lubrication system, directs this remaining lubricant **88** to the journal pins and directs reserve lubricant **90** (received from the auxiliary pump) to the main tank **42**.

Although the above described system is satisfactory during normal-G operation, it may be desirable to extend such satisfactory operability to reduced-G conditions irrespective of whether the lubricant pressure is normal (FIG. **4**) or is abnormally low (FIGS. **5** and **6**). Reduced-G conditions include positive-G conditions materially less than 9.8 meters/sec./sec., particularly when such conditions result in an inability of the main lubricant system to satisfy the lubrication requirements of the gears, journal pins and other components requiring lubrication. Reduced-G conditions also include non-positive-G conditions, i.e. zero-G and negative-G conditions. Reduced-G conditions can arise from aircraft maneuvers and/or aircraft orientation.
