(10) **Patent No.:** **US 8,215,454 B2**  
(45) **Date of Patent:** **Jul. 10, 2012**

(54) **LUBRICATION SYSTEM WITH TOLERANCE FOR REDUCED GRAVITY**

(73) Assignee: **United Technologies Corporation**, Hartford, CT (US)

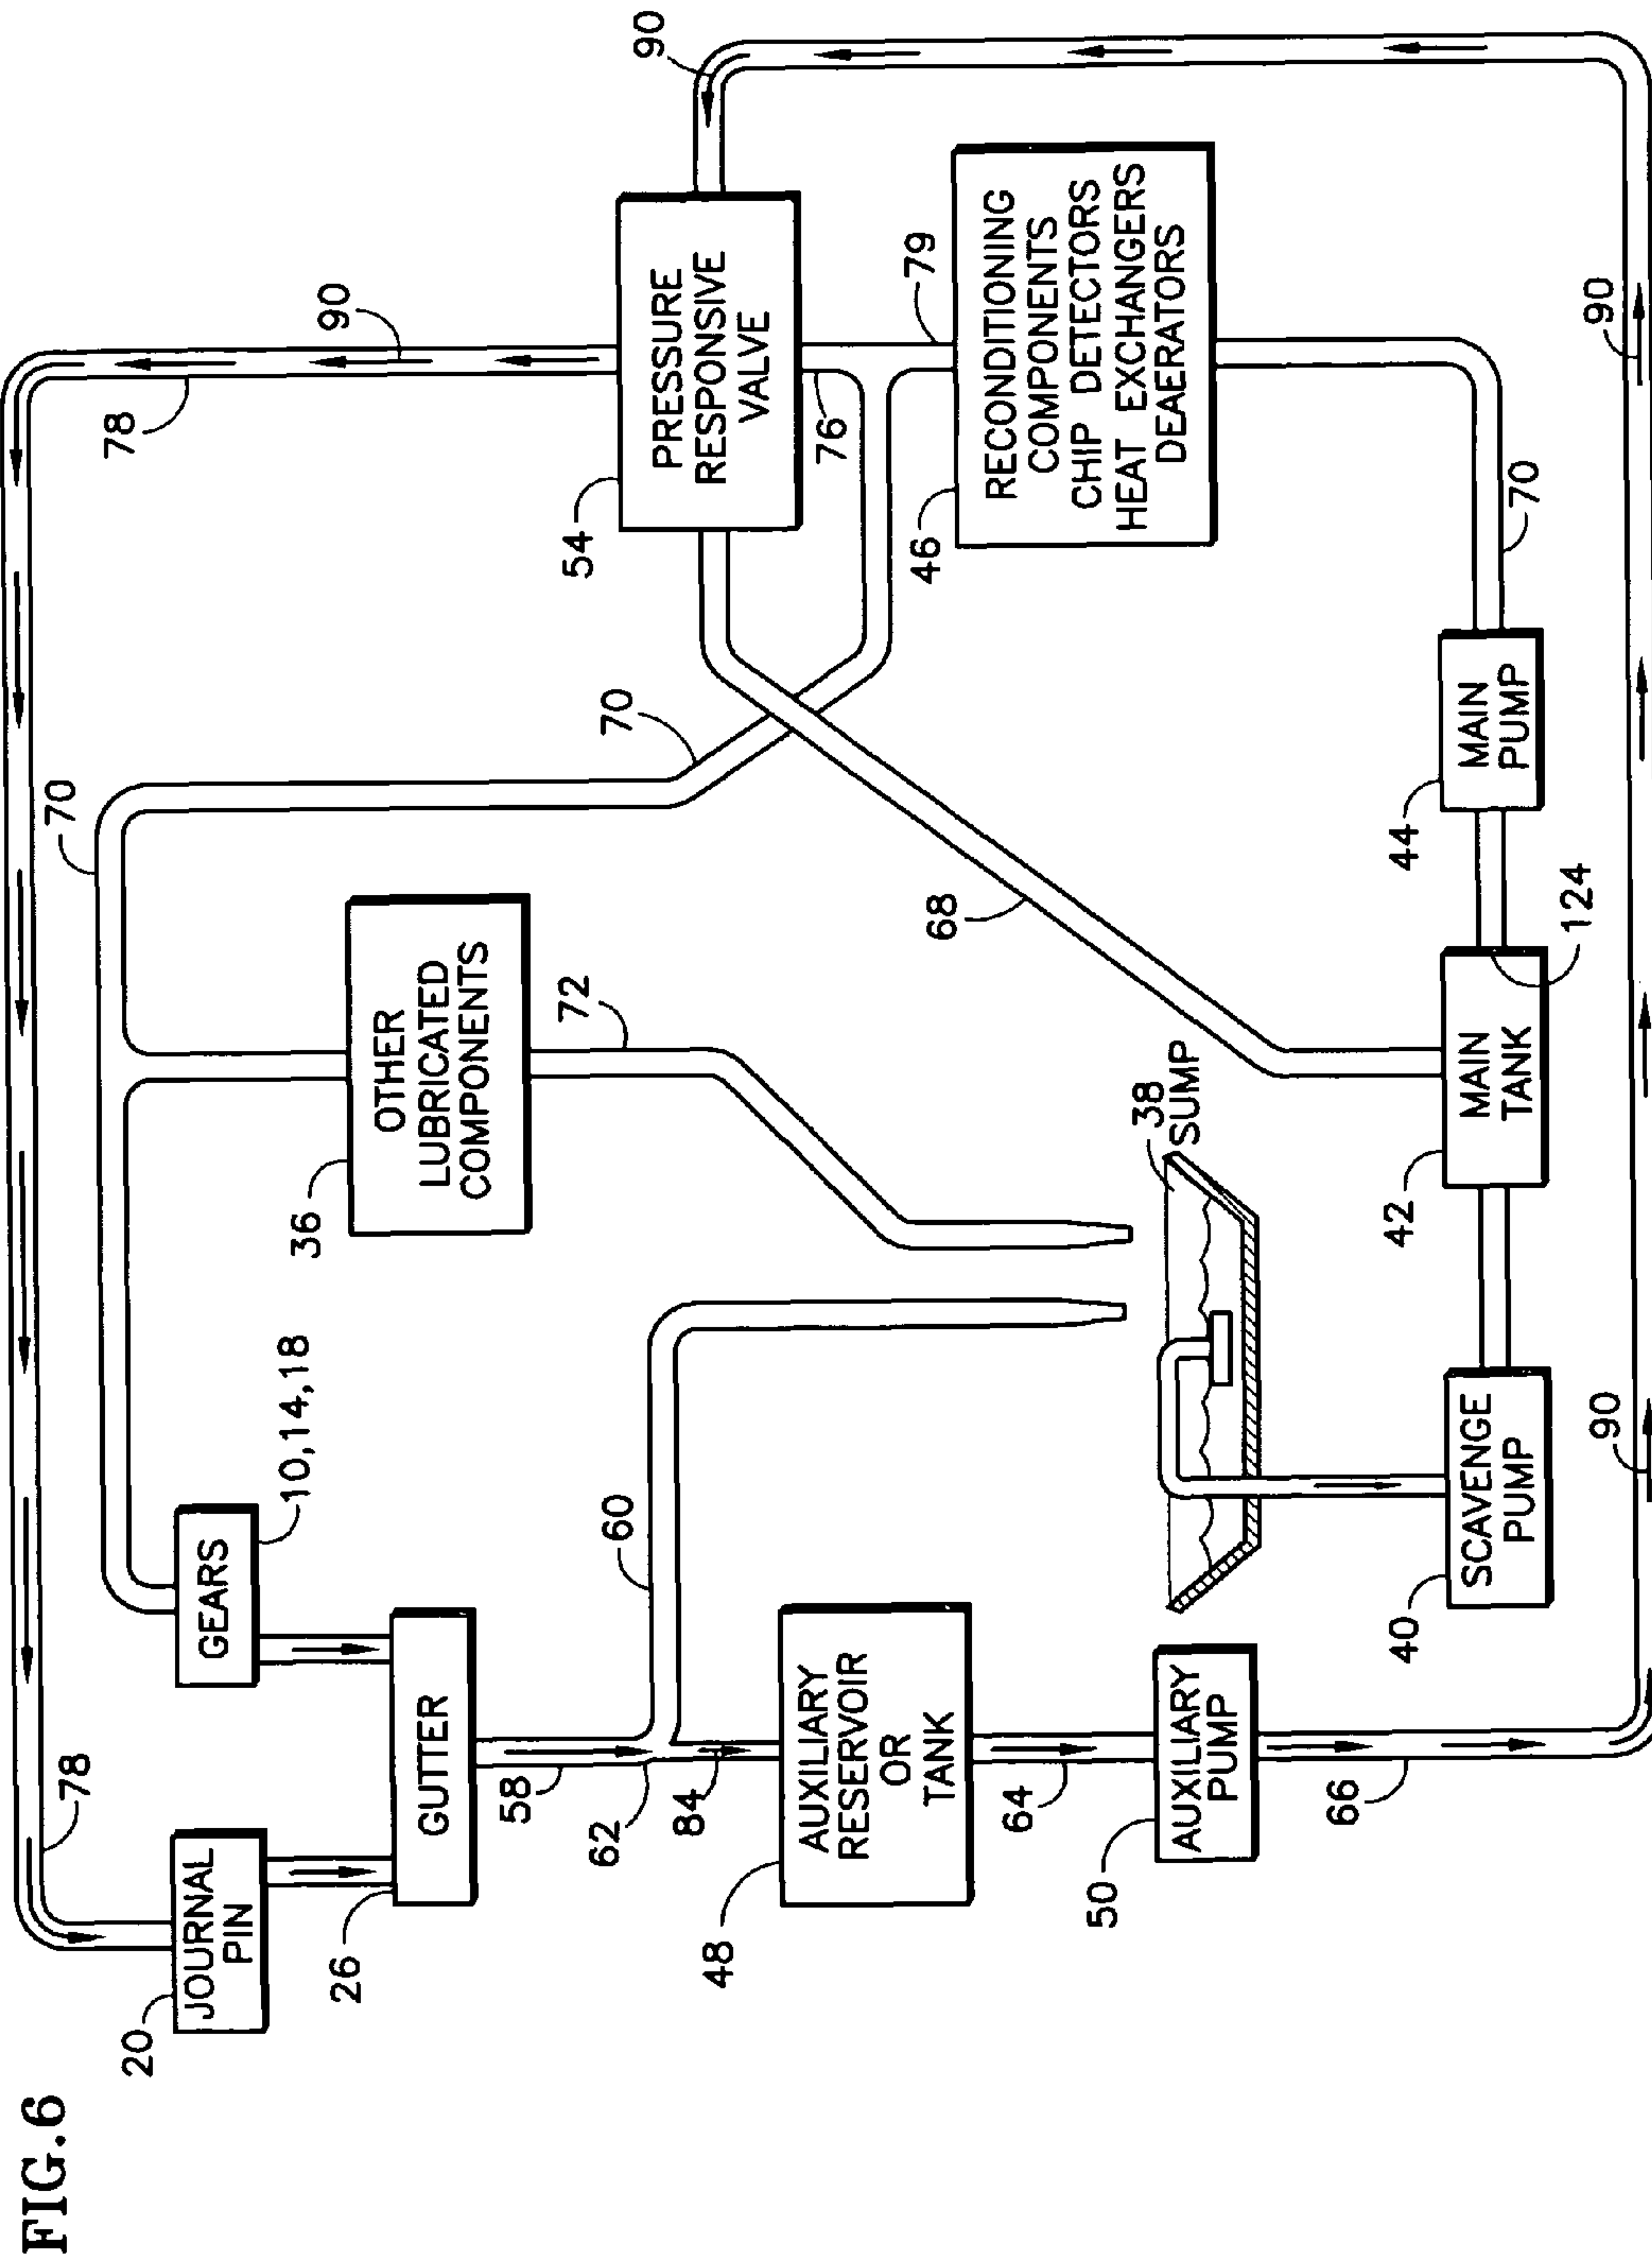
FIG. 5 is a schematic diagram showing the lubrication system of FIG. 4 shortly after the onset of an abnormal state of operation, i.e. with the lubricant pressure lower than a normal level.

Referring now to FIG. **5**, immediately after the onset of abnormal operation (e.g. due to a severe leak, clog or malfunction of a system component) the lubricant pressure drops

such that an unsatisfactorily reduced quantity of lubricant flows through the lubricant delivery pathway **70**. In response to the abnormally low pressure, the pressure responsive valve **54** shunts the reserve lubricant **90** received from the auxiliary pump to the journal pins **20** to ensure that the pins receive lubricant, at least temporarily. The gear system at first continues to expel a large quantity of lubricant into the gutter. As with normal operation, a large portion **82** of the lubricant flows through the main bypass line **60** and returns to the sump **38**. A smaller portion **84** of the lubricant flows to the auxiliary tank to at least partially replenish the lubricant being withdrawn by the auxiliary pump.
