(10) **Patent No.:** **US 8,252,376 B2**
(45) **Date of Patent:** **Aug. 28, 2012**

(54) **METHOD FOR RESTORING THE MICROSTRUCTURE OF A TEXTURED ARTICLE AND FOR REFURBISHING A GAS TURBINE BLADE OR VANE**

(73) Assignee: **Siemens Aktiengesellschaft**, München (DE)

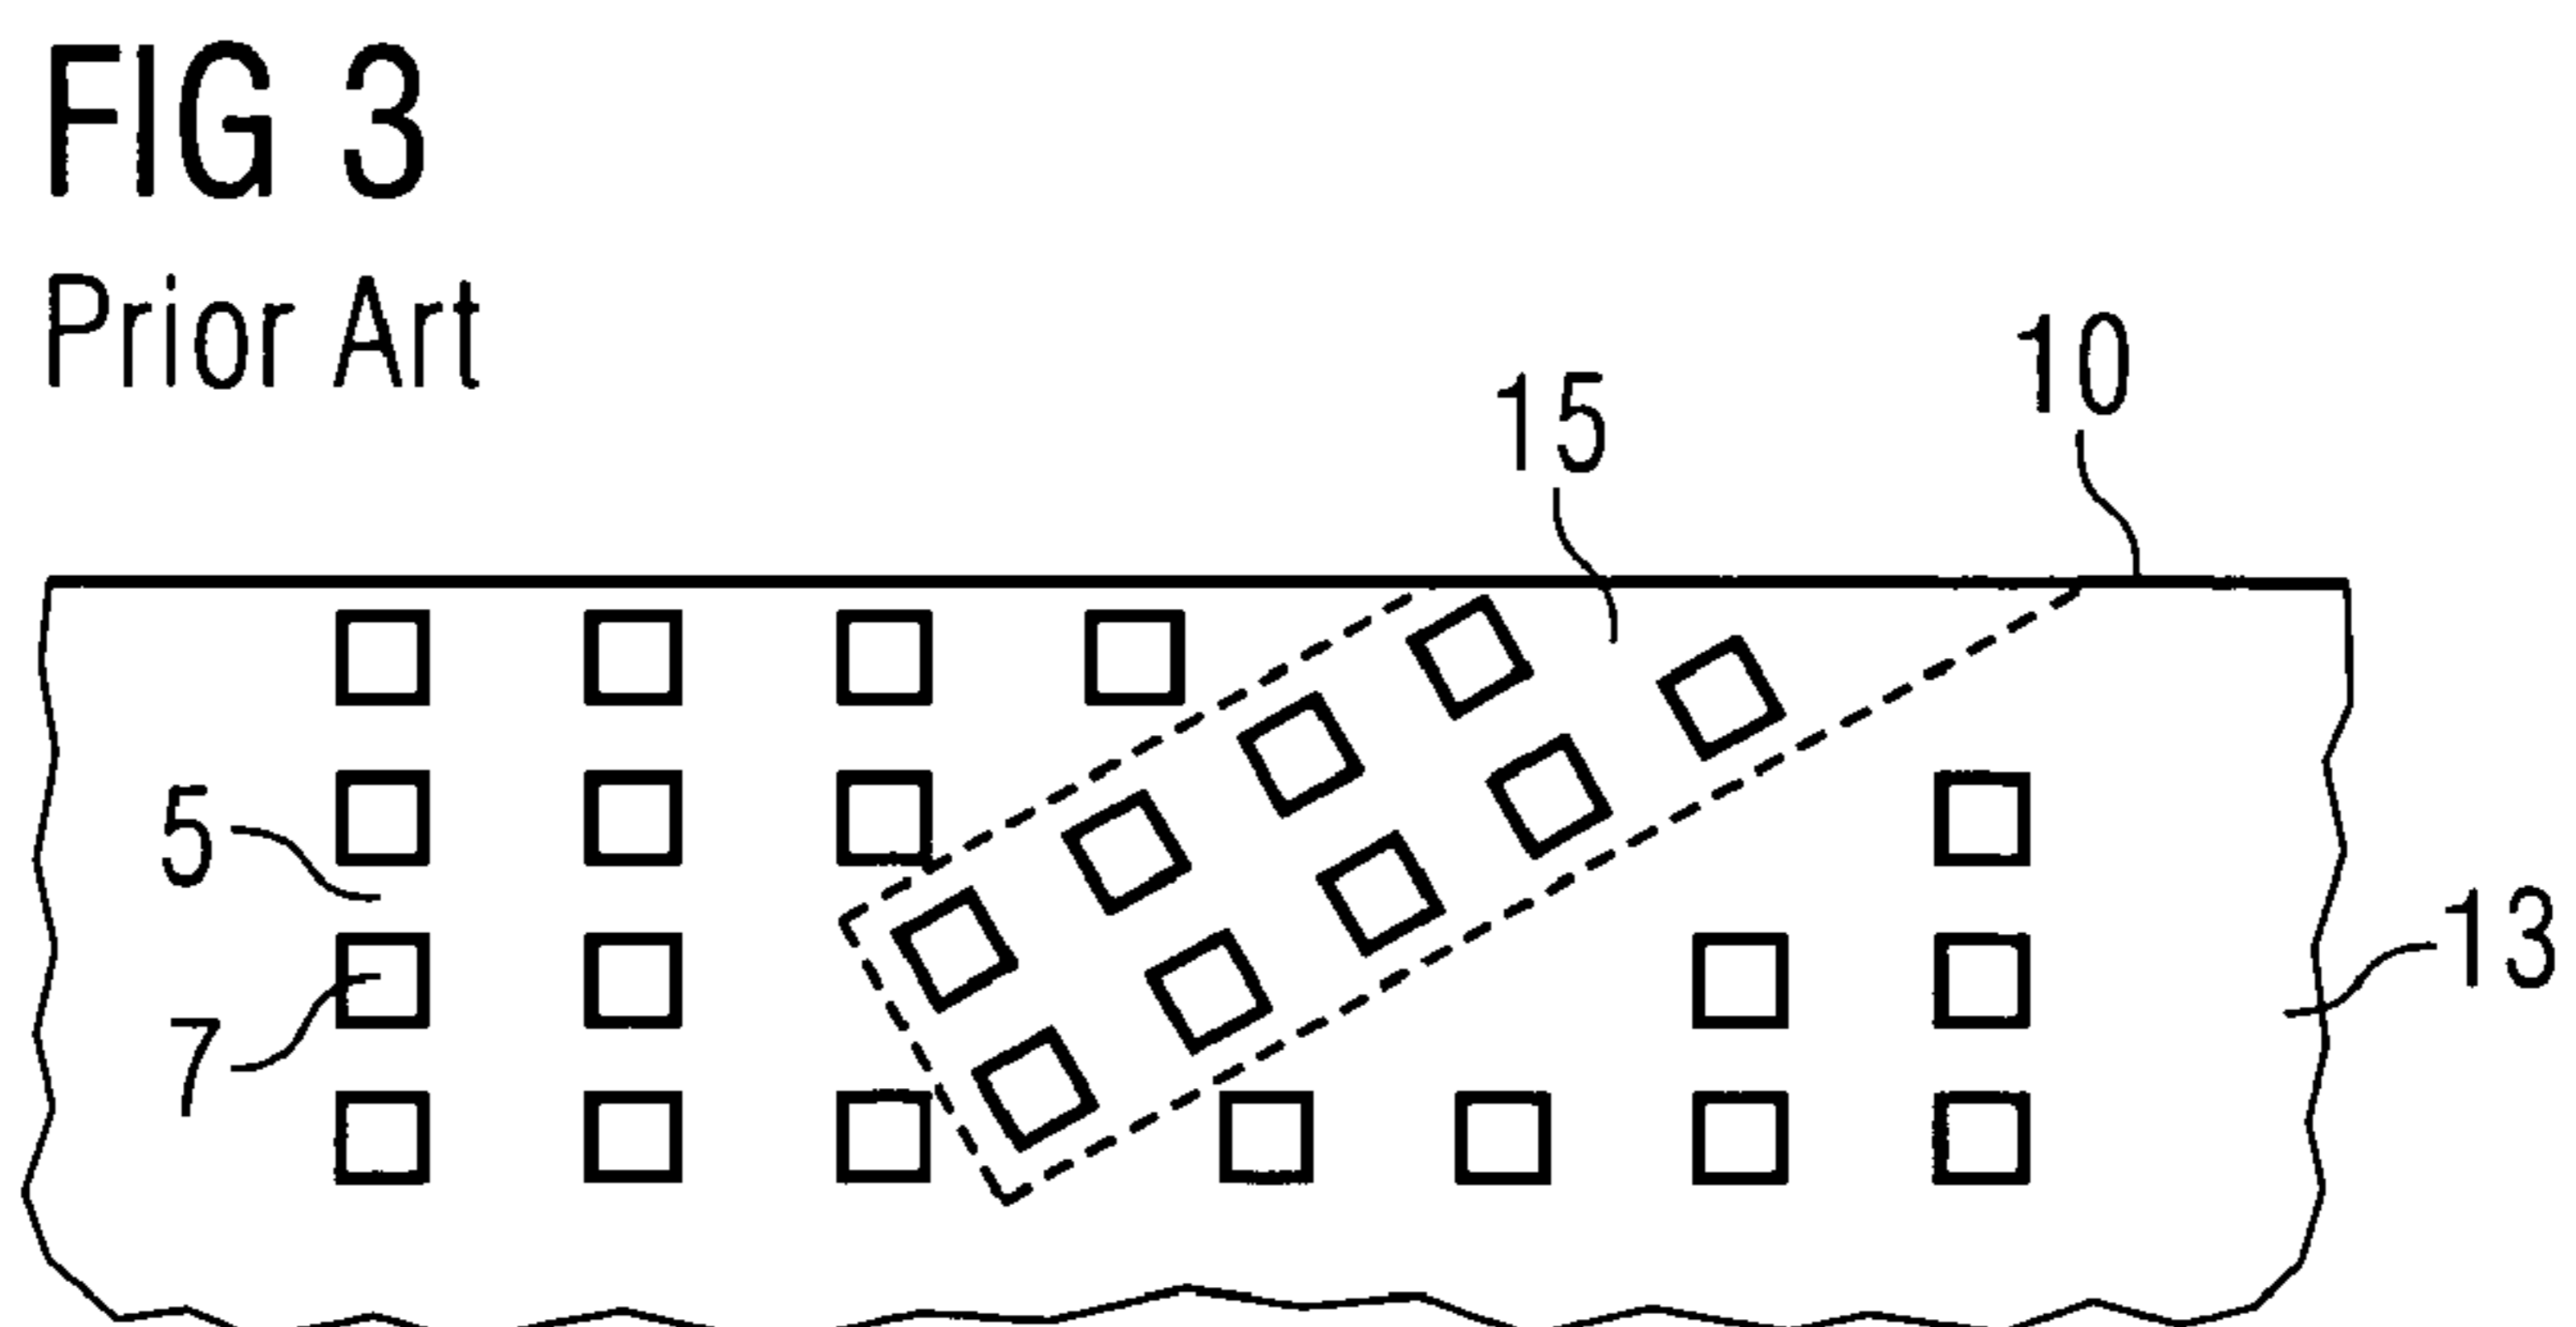
FIG. 4 shows a gas turbine blade.

A gas turbine blade 21 made from a single crystal nickel-based superalloy is shown in FIG. 4. The body 23 of the blade 21 is coated with a corrosion protective coating 29. On the protective coating 29, a thermal barrier coating 31 is placed. After a certain time period of operation, the blade 23 needs to be refurbished because the coating system is at least partially worn off by oxidation, corrosion and erosion.

The thermal barrier coating 31 and/or the protective coating 29 is removed by chemical and/or mechanical stripping, e.g. by grinding. During this procedure of mechanical strip-

ping often a surface damaged surface rim is generated, usually with a depth of 20 μm from the surface.

The surface coating 11 is deposited on the remainder of the protective coating 29, thereby closing the complete surface of the body 23. Subsequently the solution heat treatment is applied, as described above. After the heat treatment, the surface coating 11, the protective coating 29 and the thermal barrier coating 31 are removed by mechanical stripping and chemical treatment and a new protective coating as well as a new thermal barrier coating are provided.

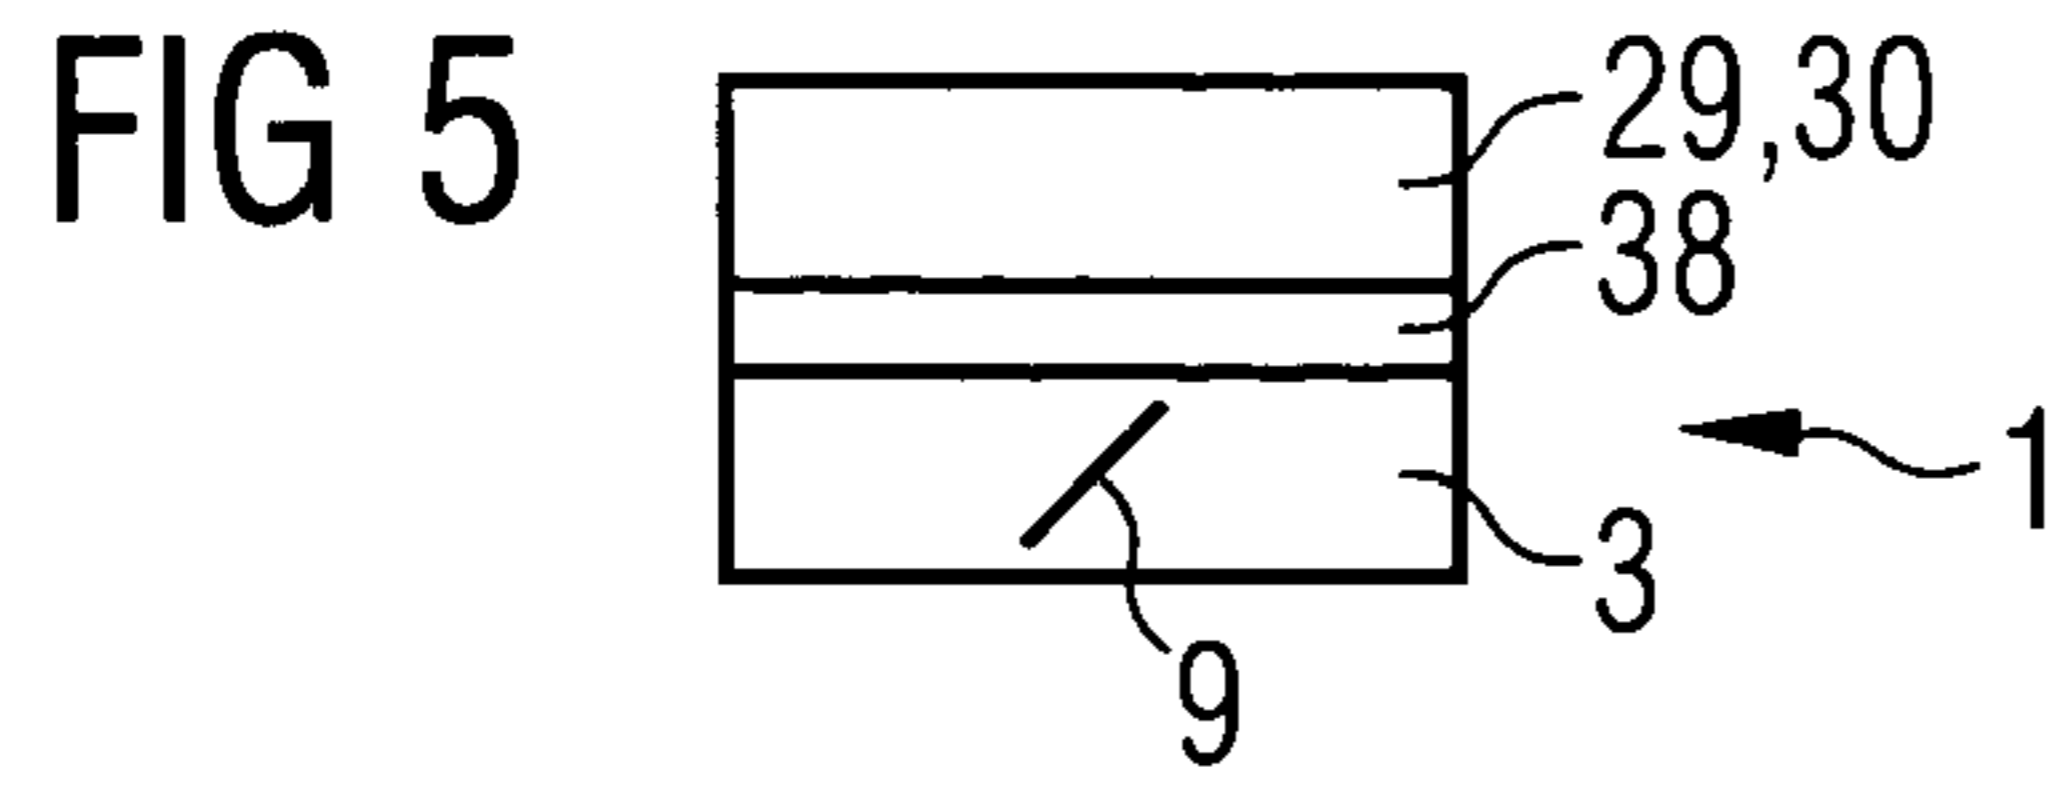
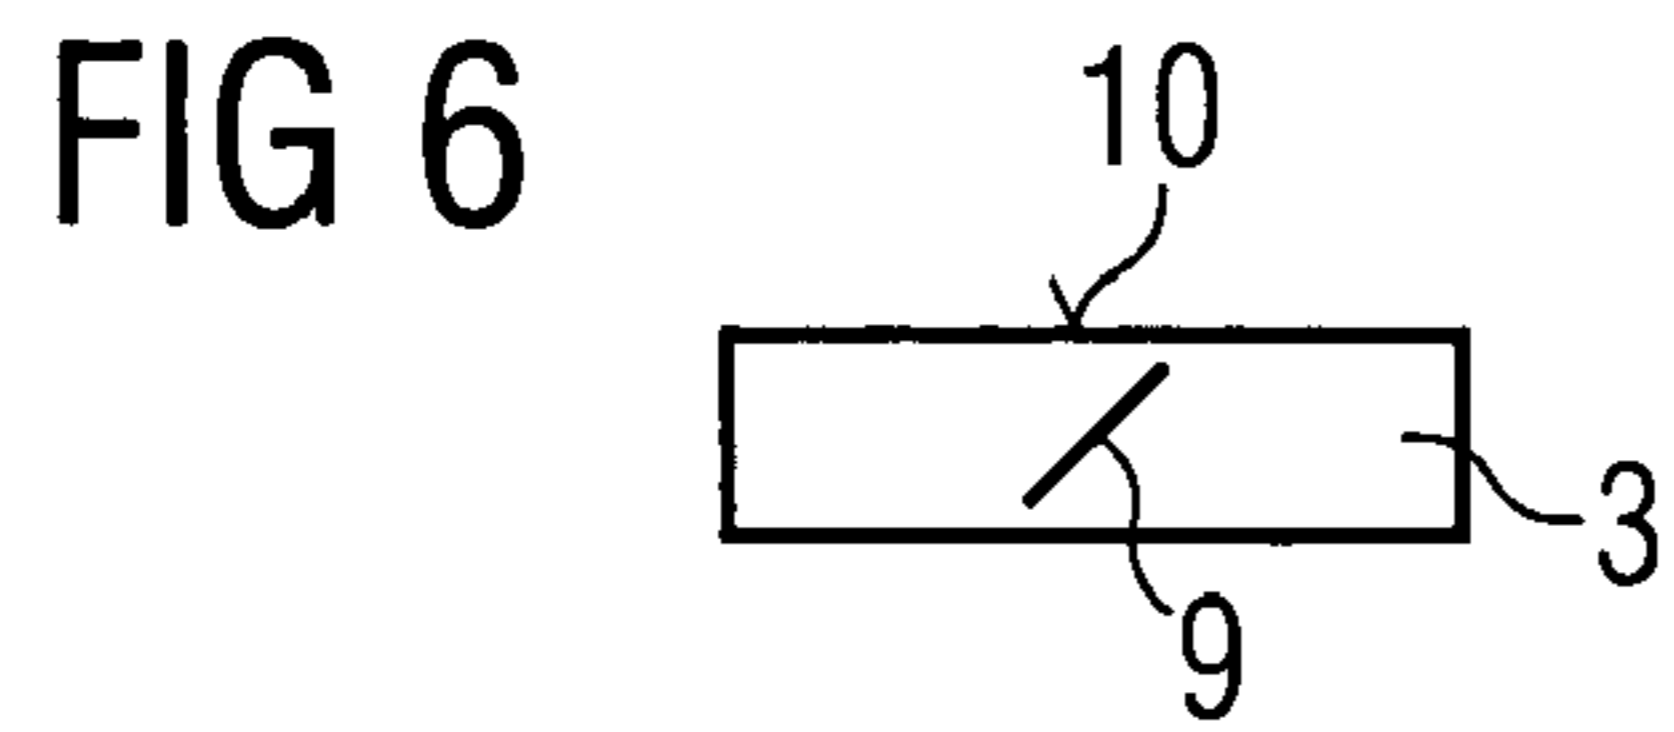
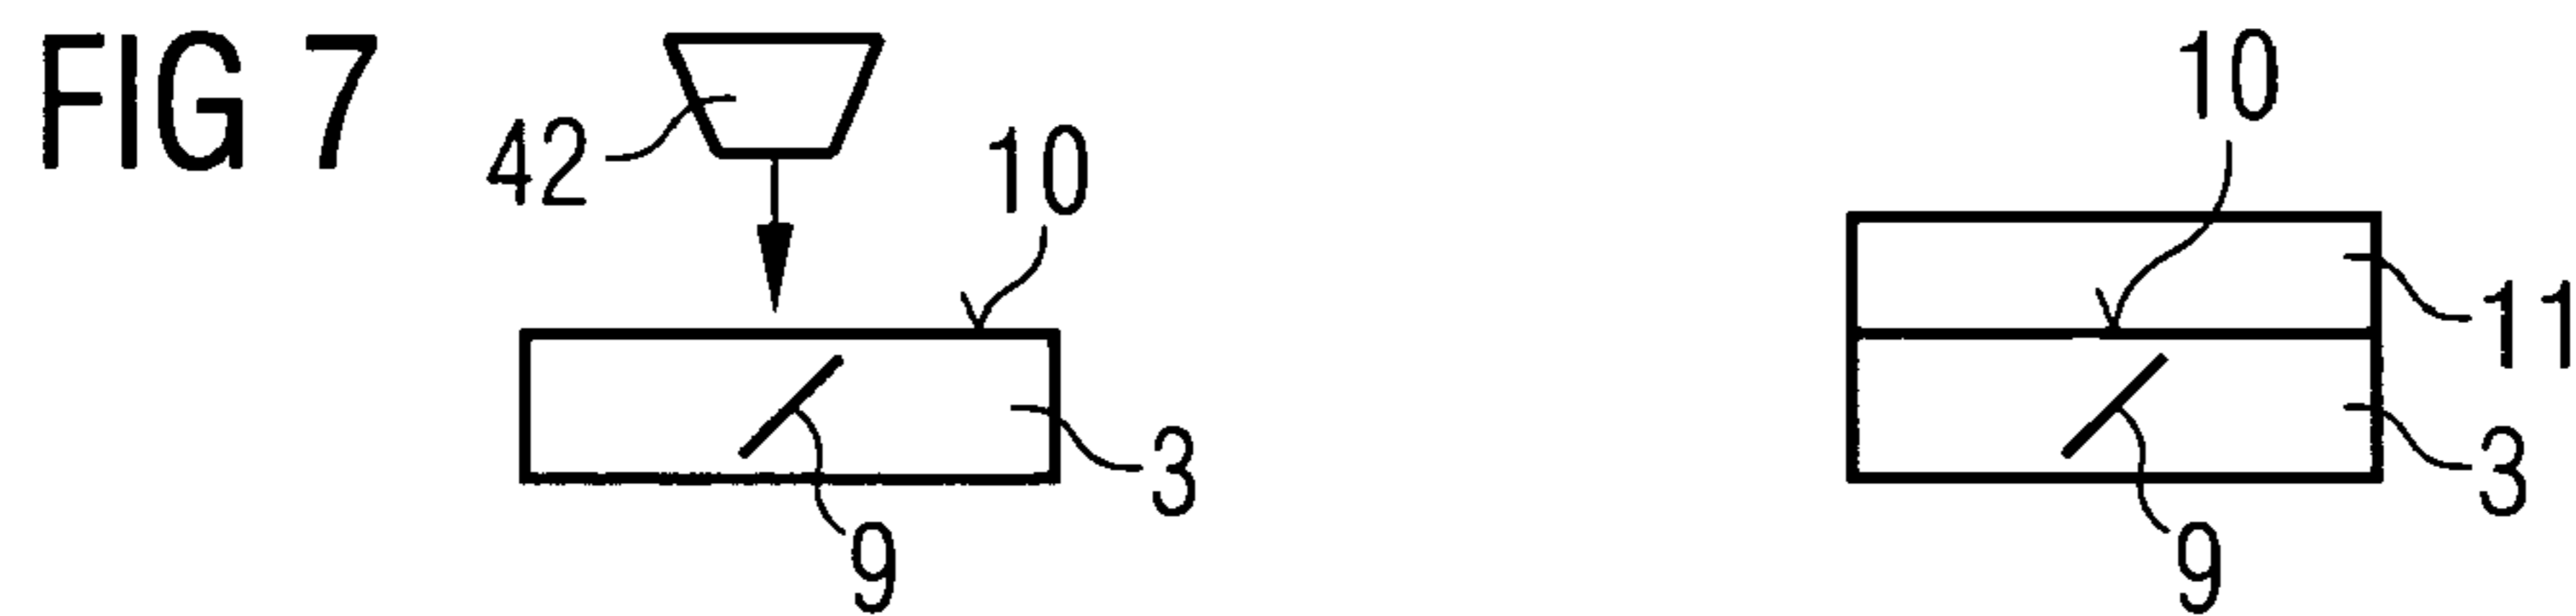
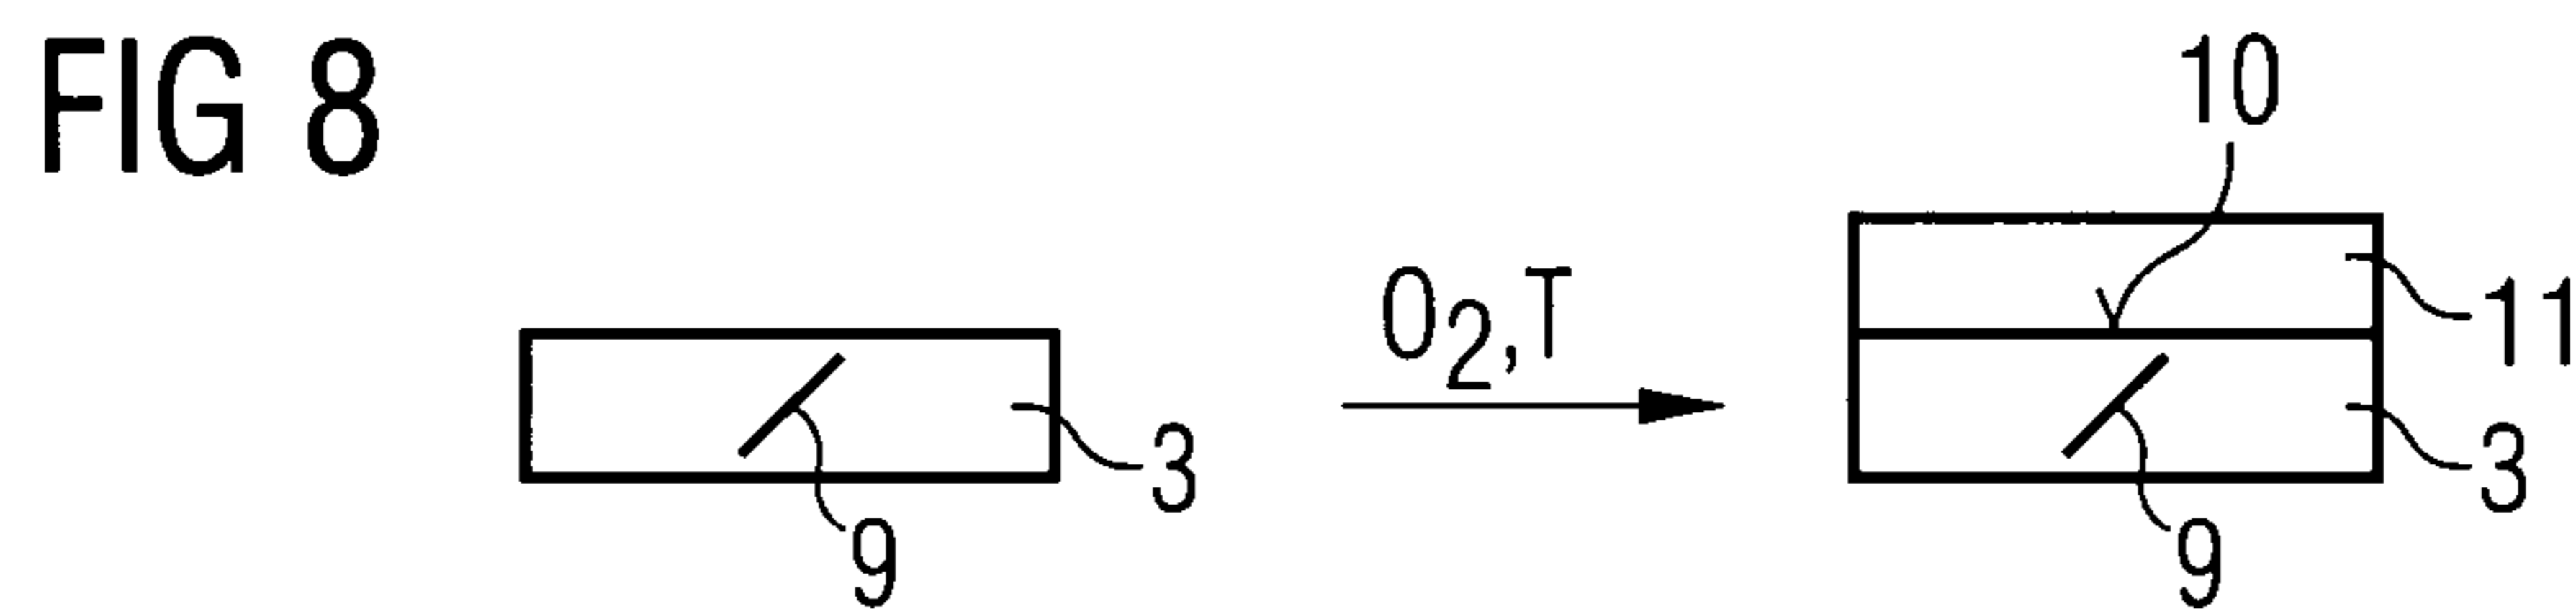
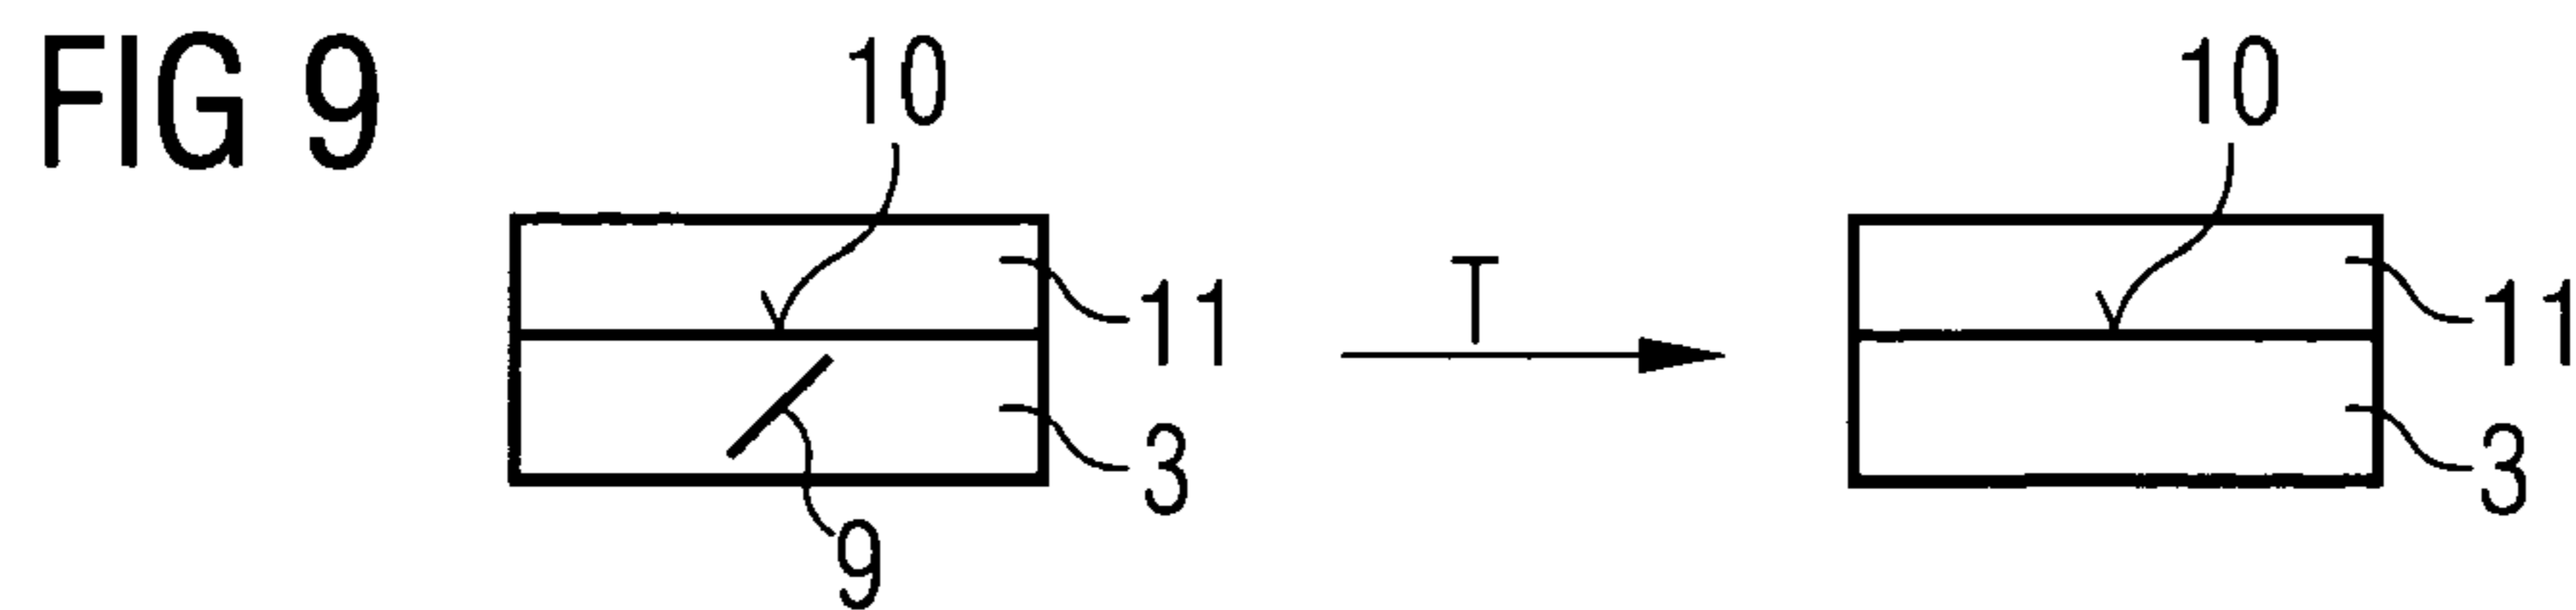
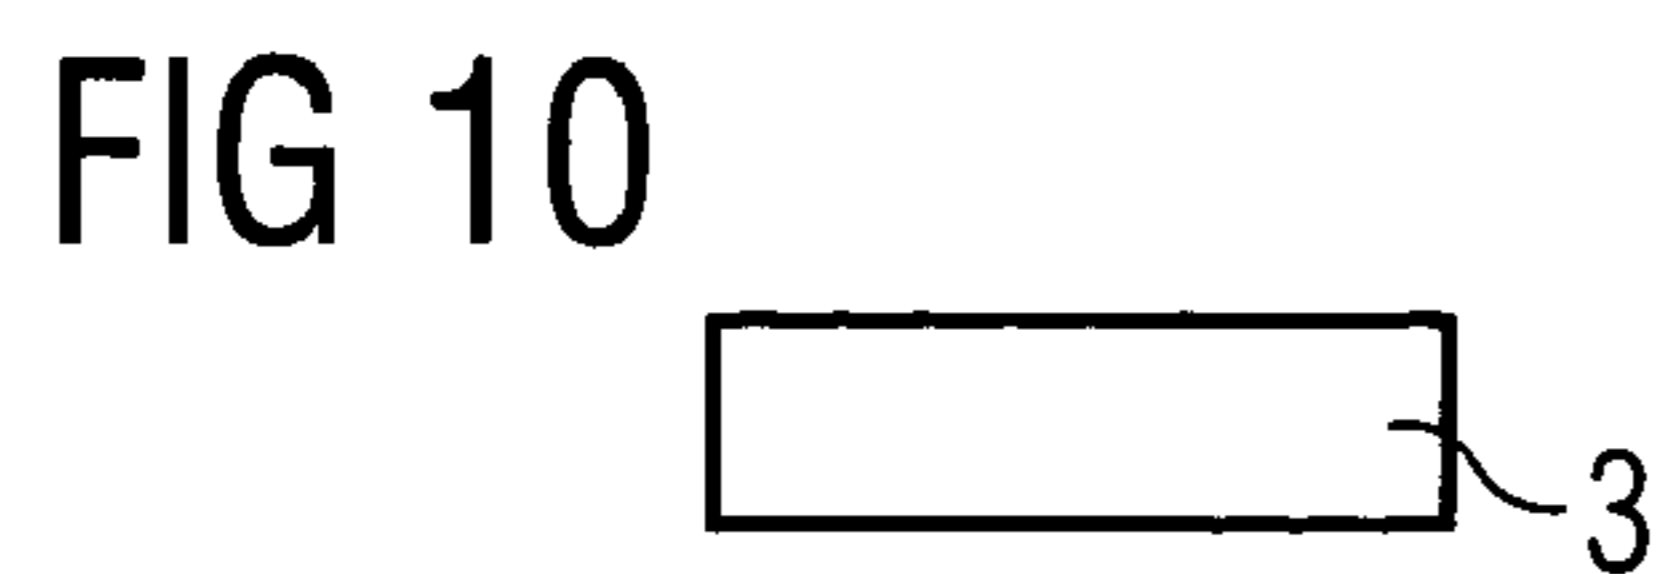
FIG. 5 to 11 show several steps of an embodiment of the inventive method.

FIGS. 5 to 11 show schematically the steps of restoring the microstructure of a textured article and/or the refurbishing of a textured article.

FIG. 5 shows the article 1 with the body 3 having a dislocation accumulation 9. On the body 3 there is e.g. a layer 38 with corrosion products on which the protective layer 29 and thermal barrier coating 30 is laying.

In a first step of the inventive method the protective layer 29, the thermal barrier coating 30 and the corrosion products in the layer 38 are removed (FIG. 6).

Secondly, on the surface 10 of the body 3 the surface coating 11 is applied by a coating apparatus 42 (FIG. 7). Different kinds of coating apparatus or processes can be used.

The surface coating 11 can also be applied by oxidising the body 3 at higher temperatures HT (FIG. 8) in an atmosphere with oxygen O_2 .

The article with the surface coating 11 according to FIG. 7, 8 is now applied to a solution heat treatment as indicated in FIG. 9. The thermal stable surface coating 11 is maintained during the hole solution heat treatment.

FIG. 10 shows the article 1 with his body 3 after the solution heat treatment and removal of the surface coating 11. No grain boundary inside the single crystal or no additional grain boundary inside the directionally solidified article 1, especially in the surface rim is present.

A new protective layer 29 and a new thermal barrier coating 30 can now be applied again on the body 3 of the article 1 (FIG. 11).

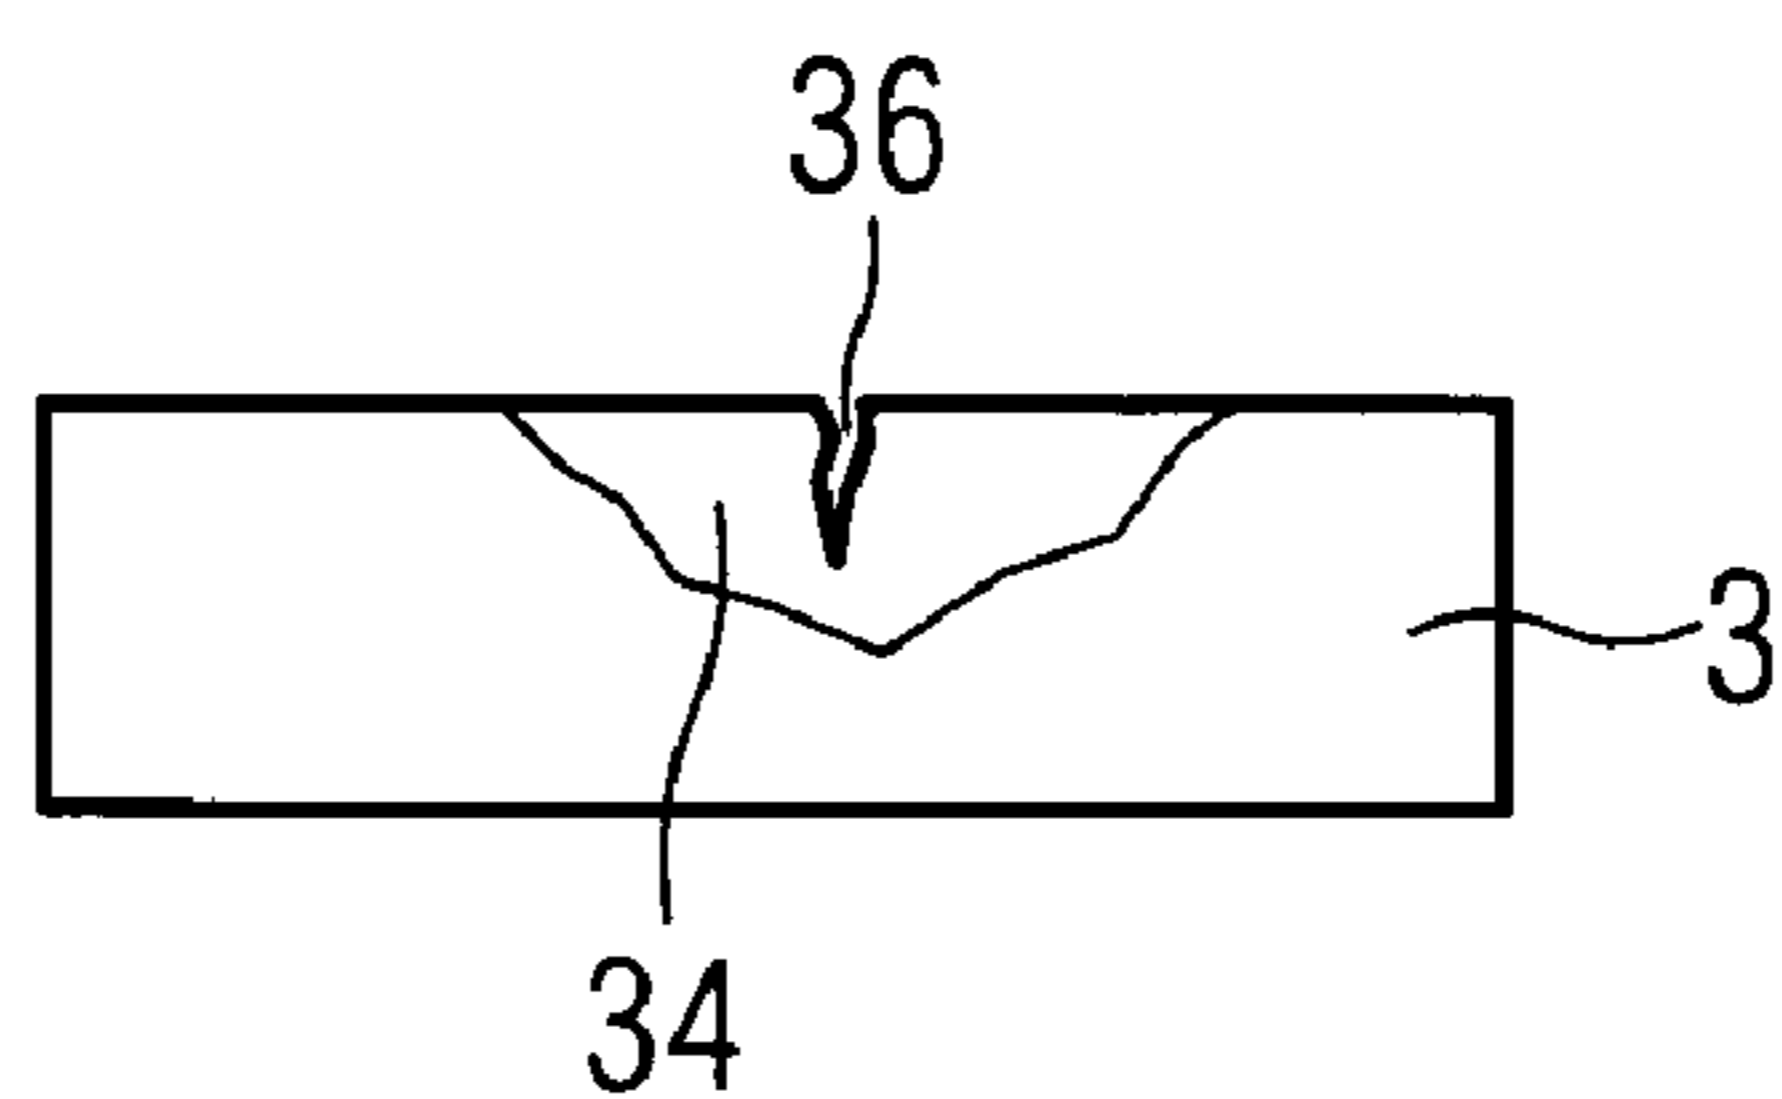
FIG 12

FIG. 12 shows an application of the inventive method.

FIG. 12 shows a further application example of the method of the invention.

The substrate 3 may have a crack 36 or relatively large regions 34 comprising defective material. However, for the substrate 3 to be reused, it is necessary for the crack 36 or the regions 34 comprising defective material no longer to be present.

This is achieved, for example, by soldering up the crack 36 or by removing a region 34 which surrounds the crack 36. The region 34 is, for example, built up by build-up welding, resulting in a newly built-up region 39.

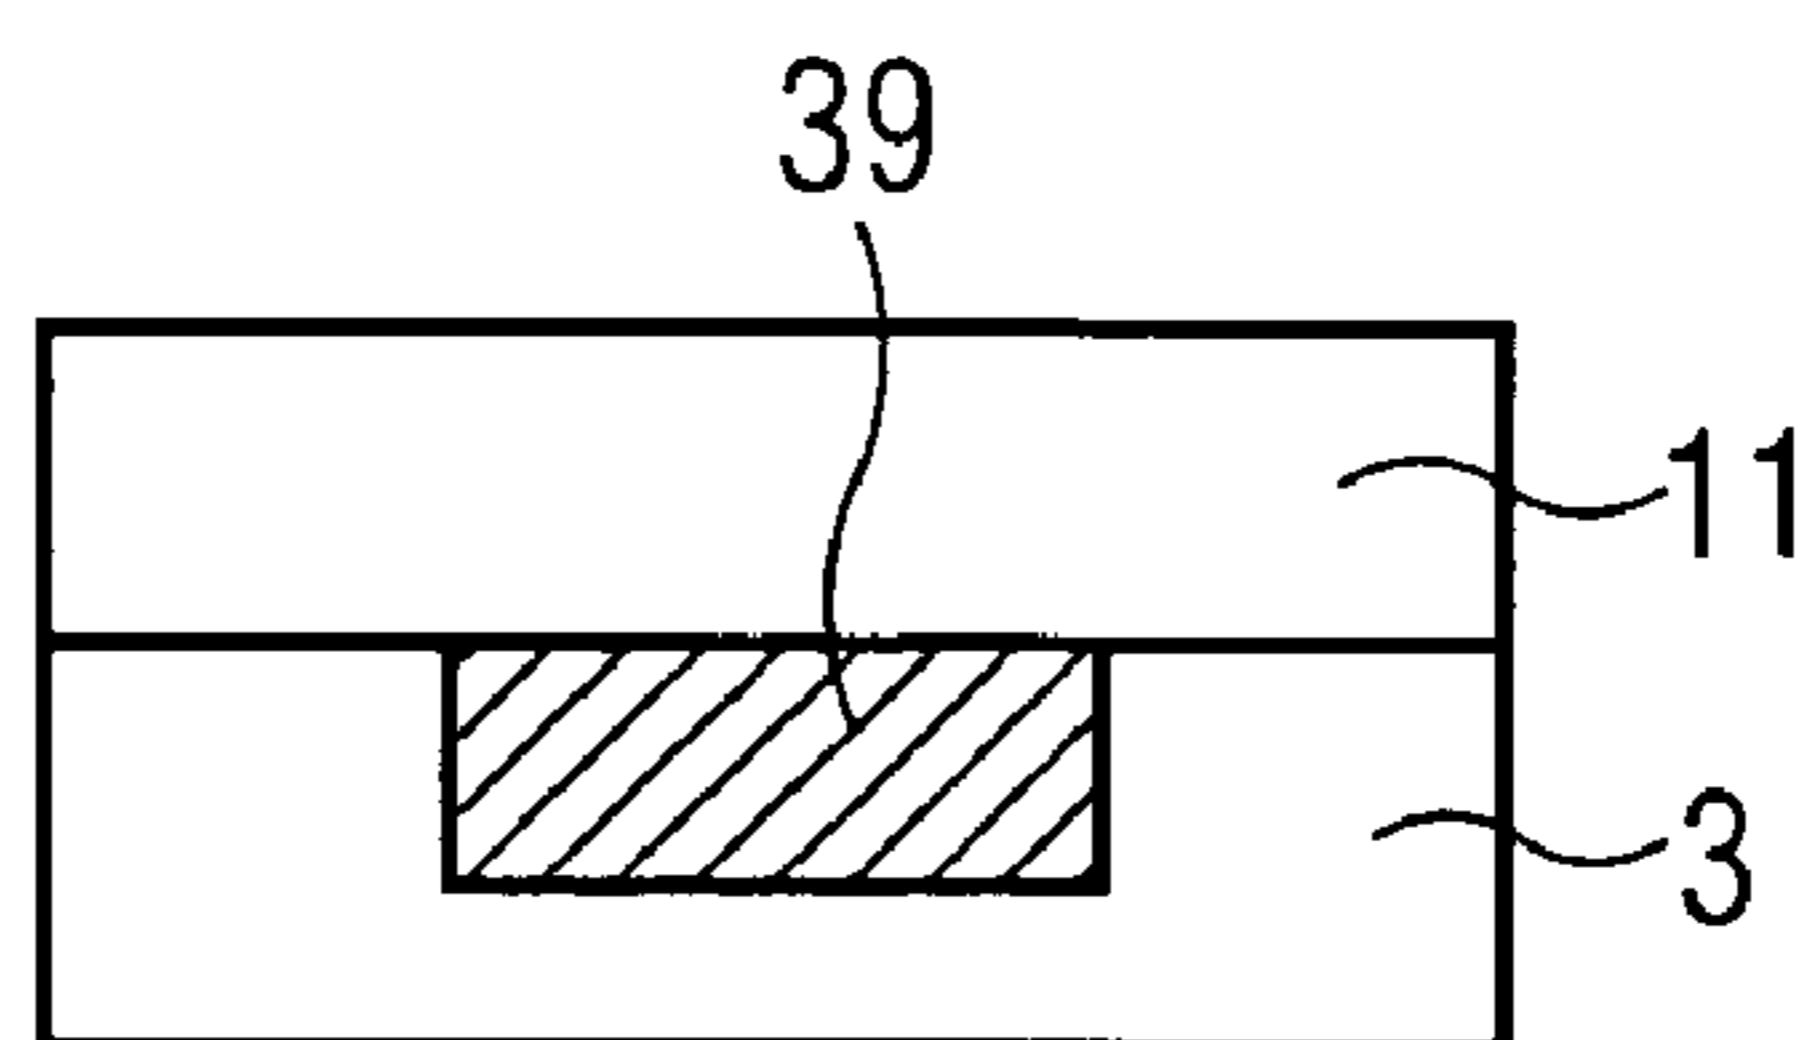
FIG 13

FIG. 13 shows a further application of the inventive method.

The surface layer 11 may also extend over these newly built-up regions 39 (FIG. 13) in which new material has been newly added, for example by build-up welding or in which a crack 36 has been filled with solder or weld metal.

The solution heat treatment or another heat treatment which will lead to recrystallization is then carried out using a component as shown in FIG. 13.
