(10) **Patent No.:** **US 8,300,171 B2**
(45) **Date of Patent:** **Oct. 30, 2012**

(54) **REPAIRING STRUCTURE OF LIQUID CRYSTAL DISPLAY AND REPAIRING METHOD THEREOF**

(73) Assignee: **Chunghwa Picture Tubes, Ltd.**,
Taoyuan (TW)

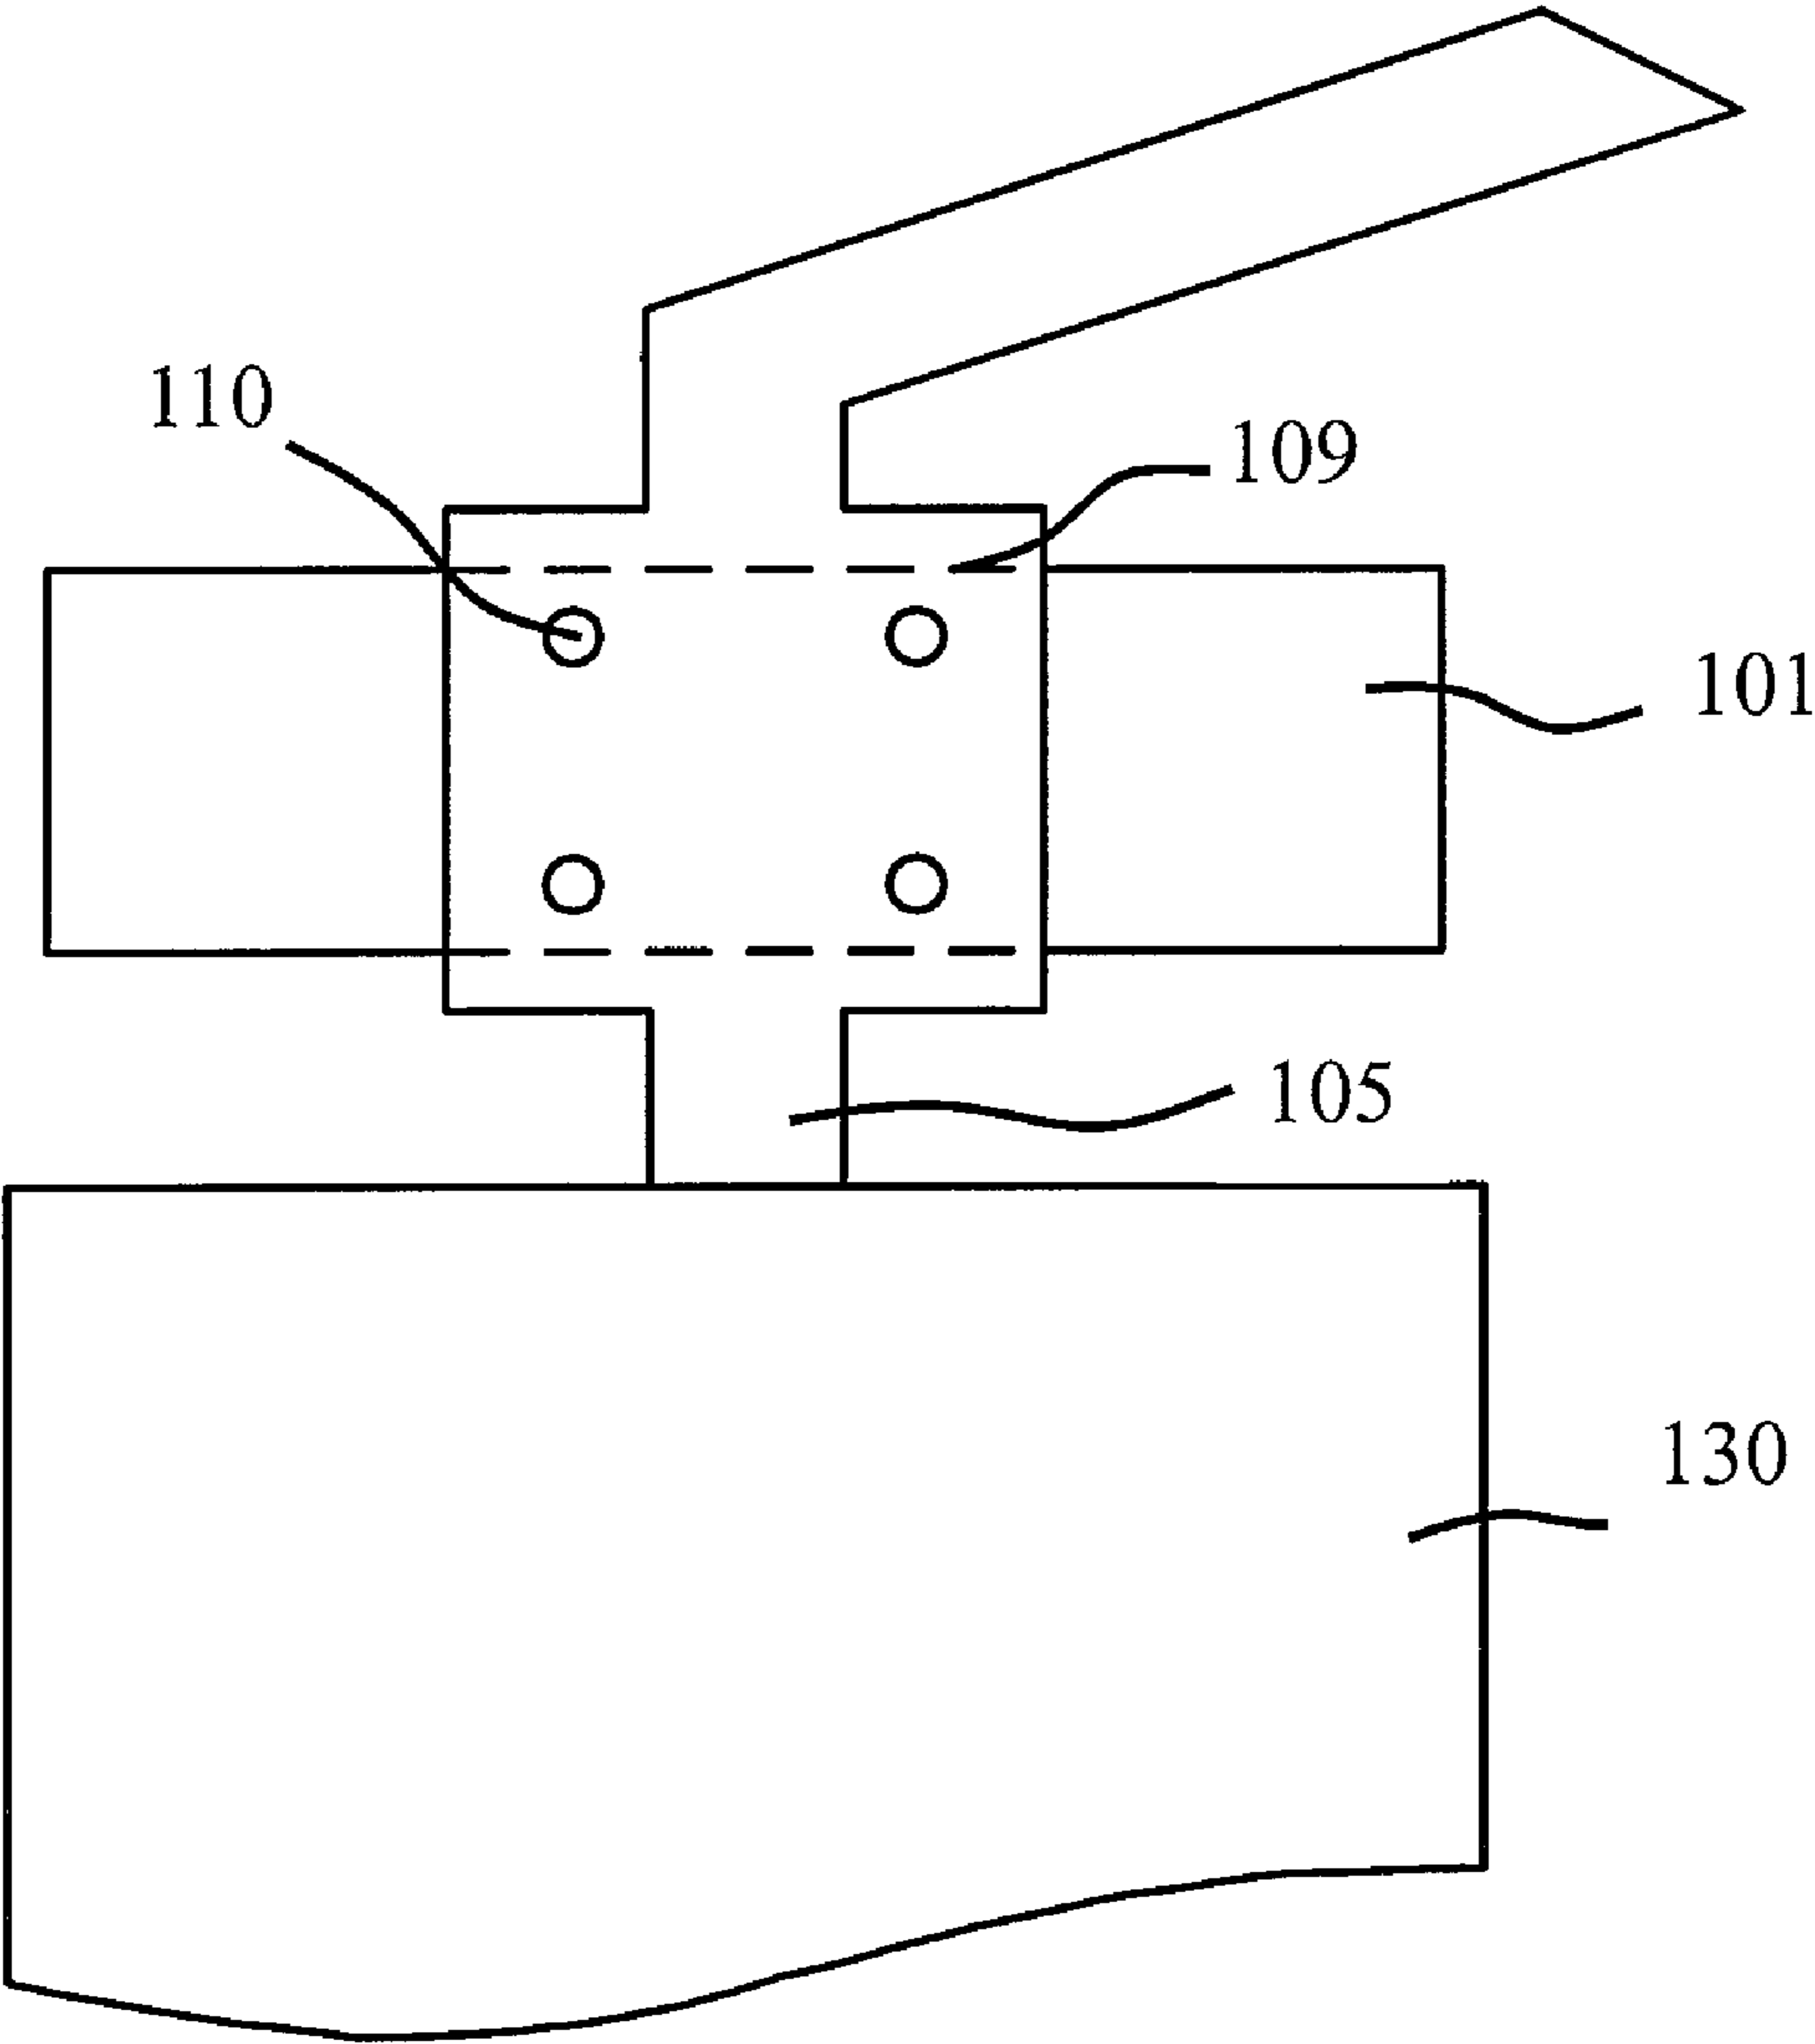
FIG .1 (RELATED ART)

FIG. 1 is a schematic structural view of a repairing method of a data line of a display in the prior art.

In order to solve the above problems, in a structure layout of a current TFT LCD, a plurality of annular repairing line structures is usually disposed around the array, which achieves a repairing effect through a laser welding manner, thereby increasing the yield of the panels and saving the fabrication cost. Referring to FIG. 1, when a data line **105** in a pixel region **130** is broken, a crossing region **109** between the data line **105** to be repaired and the repairing line **101** is dotted and welded by using the laser, so as to enable the data line **105** to be electrically connected to the repairing line **101**, such that an electrical signal is delivered between the two wires. Particularly, during the repairing process, 4 welding points **110** around the crossing region **109** are selected to be repaired by using the laser, and a diameter range of the welding points **110** is approximately 3 μm -5 μm . However, the repairing method of the line defect still has disadvantages, for example, too many welding points exist, such that a repairing time is too long, and the welding points are too small, so that

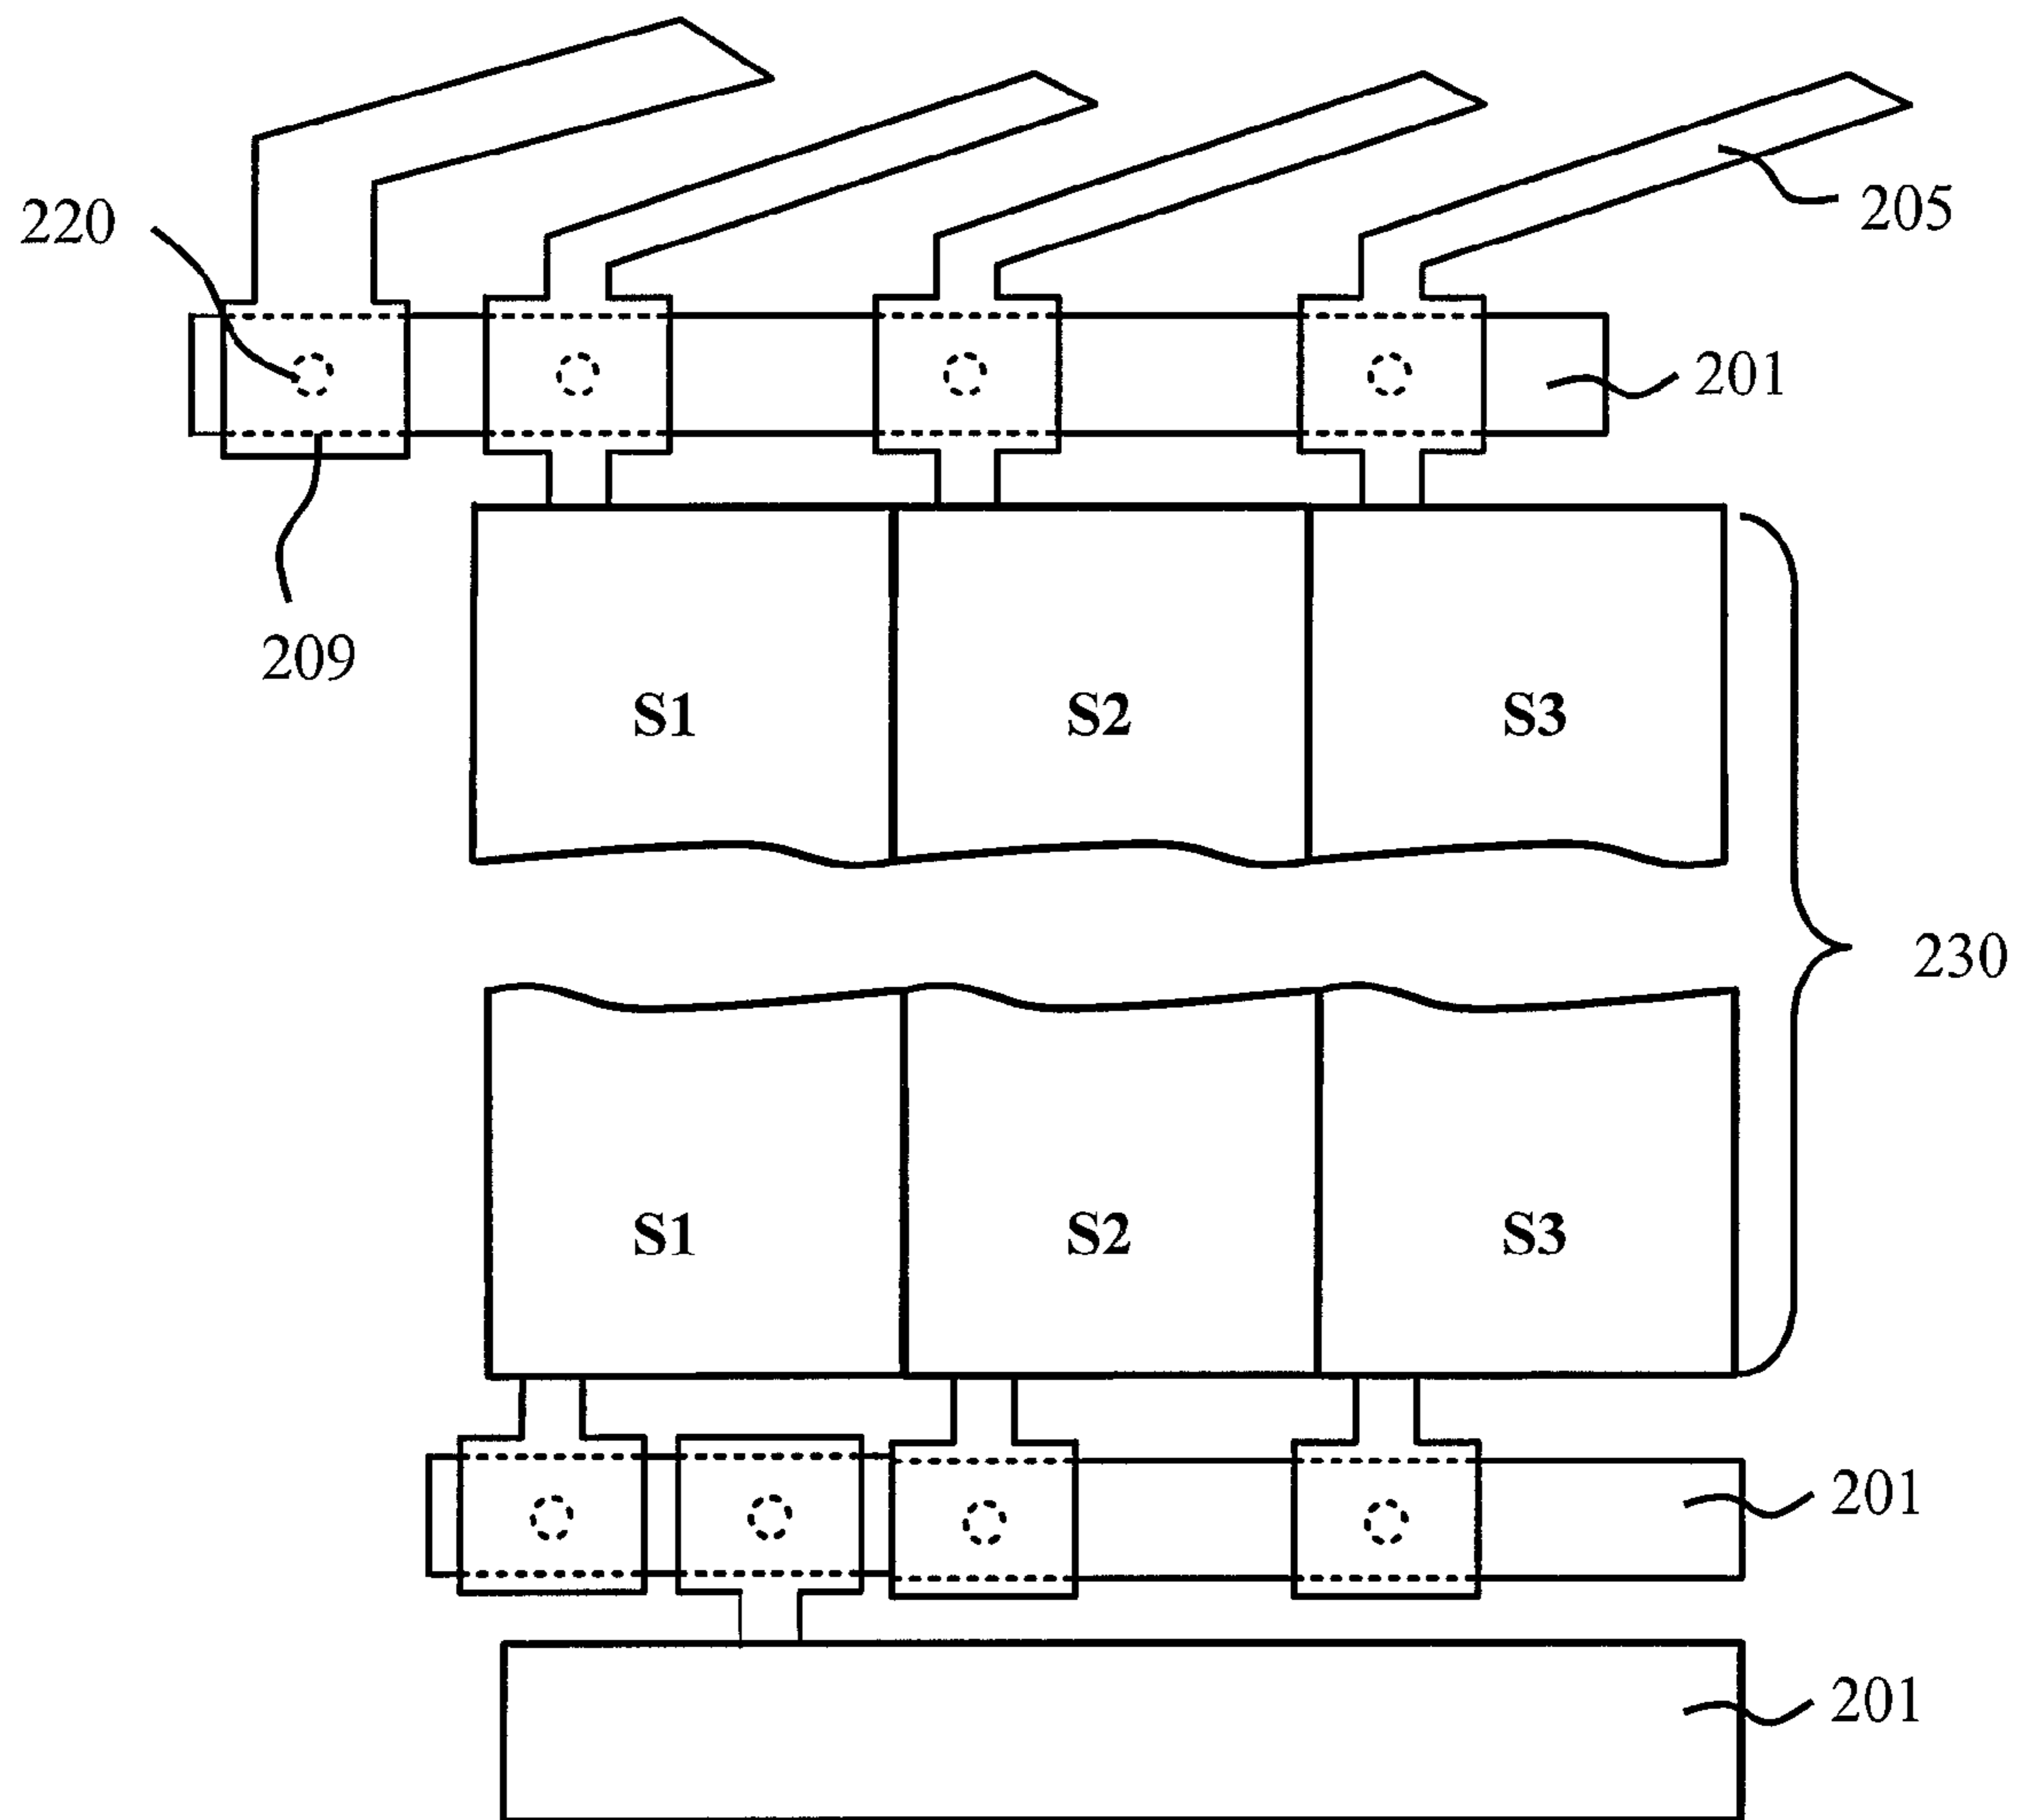
FIG. 2 is a schematic structural view of a repairing method of a data line of a display according to an embodiment of the present invention.

In the repairing method of an LCD, when a first conductive layer is a repairing line, and a second conductive layer is a data line, the method may be applied to repairing the defective data line. FIG. 2 is a schematic structural view of a repairing method of a data line of an LCD according to an embodiment of the present invention. Referring to FIG. 2, a display panel includes a plurality of data lines 205 and a plurality of repairing lines 201. The data lines 205 are connected to a pixel region 230. Each of the repairing lines 201 spans across at least one data line 205. The data line 205 and the corresponding repairing line 201 have a crossing region 209 where they are overlapped with each other, and a round opening 220 is designed at a central position of the repairing line 201.

If the data line 205 in the pixel region 230 has certain defects, the data line 205 may be repaired by using the repairing structure. A laser power is provided, and at the crossing

regions 209 between the defective data line 205 and the repairing lines 201 located on two ends thereof, the insulating layer 203 above the opening 220 of each repairing line 201 is penetrated by the laser power, such that the defective data line 205 is electrically connected to the repairing lines 201, and the electrical signal is delivered between the two conductive layers. Any defective data line 205 spans across at least two repairing lines 201, and the welding area is larger than that of the prior art, such that an impedance value at the position is reduced, and it is not necessary to weld four points at each repairing region, thereby greatly reducing the repairing time.

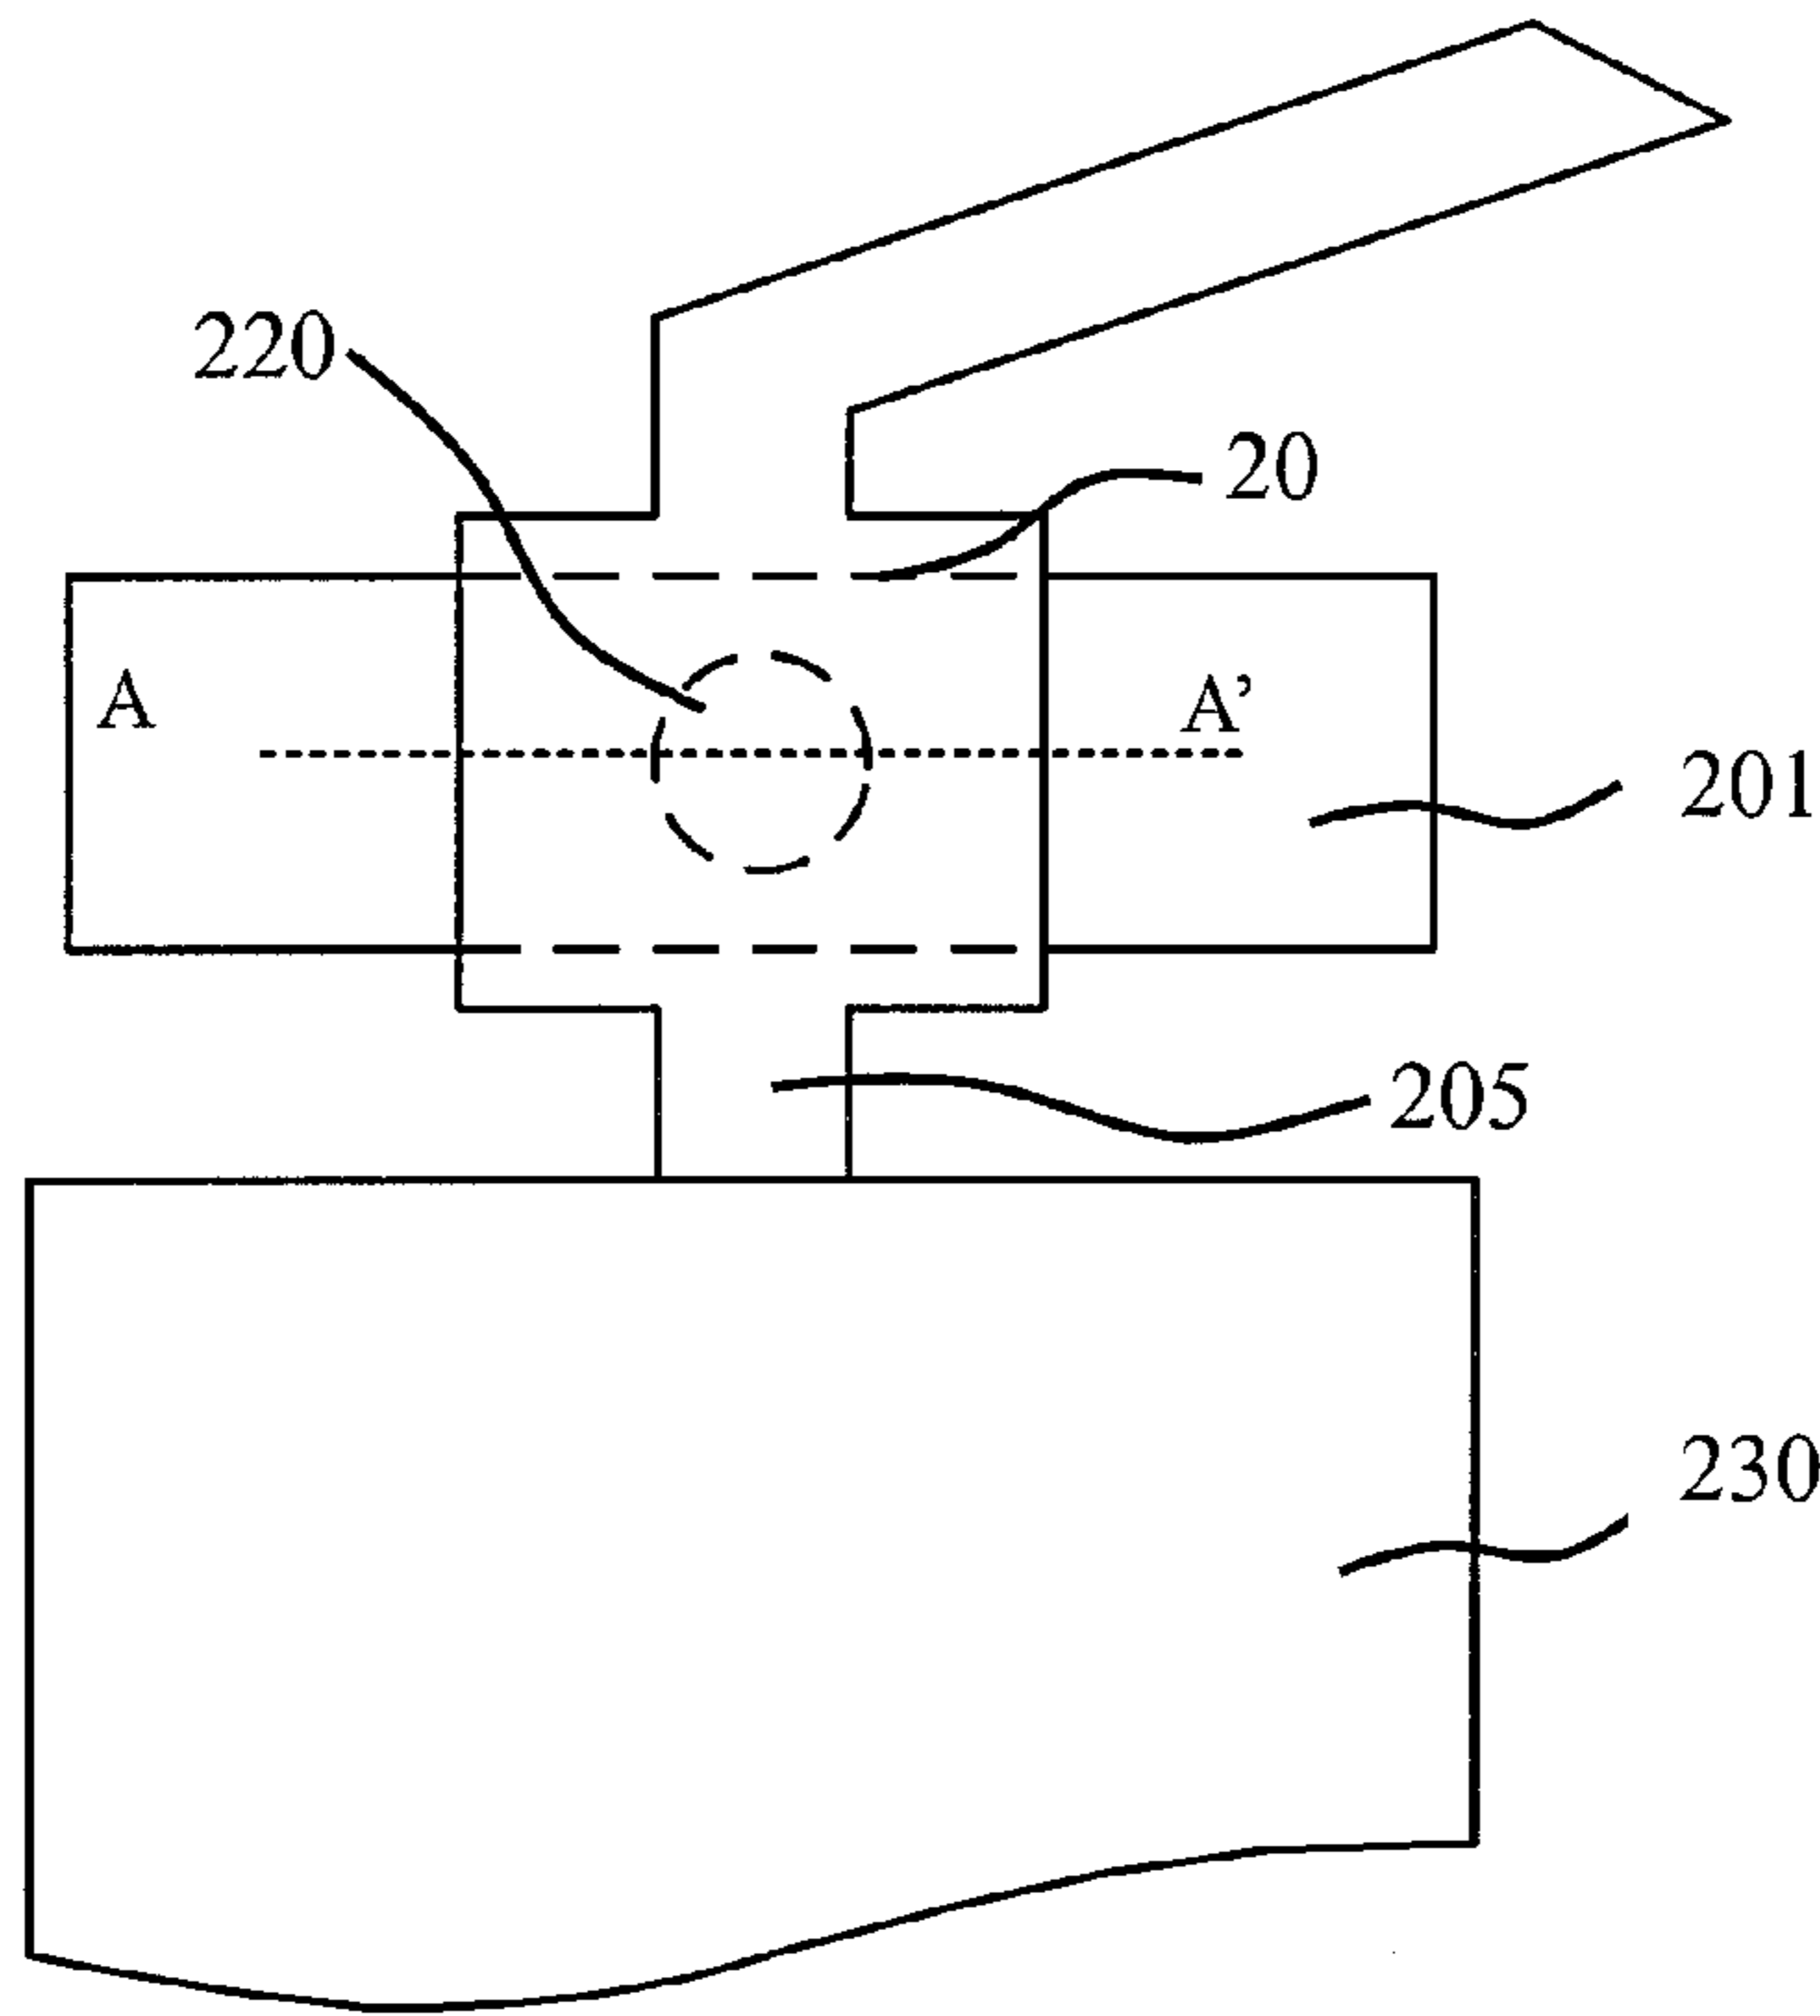
FIG. 3A is a partially enlarged view of a repairing structure of a data line of FIG. 2.

FIG. 3A is a partially enlarged view of a repairing structure of a data line according to the above embodiment, and FIG. 3B is a schematic cross-sectional view of FIG. 3A, taken along a section line of A-A'. Referring to FIGS. 3A and 3B, the repairing structure of the data line includes: a repairing line 201 with an opening 220, an insulating layer 203 located on the repairing line 201 and covering the opening 220, a data line 205 located on the insulating layer 203, a protective layer 207 located on the data line 205, and a crossing region 209 located at a position where the repairing line 201 and the data line 205 are overlapped, in which the opening 220 is located on the crossing region 209 of the repairing line 201. When the insulating layer 203 above the opening 220 is penetrated, the repairing line 201 is electrically connected to the data line 205, such that an electrical signal is delivered between the two wire layers.

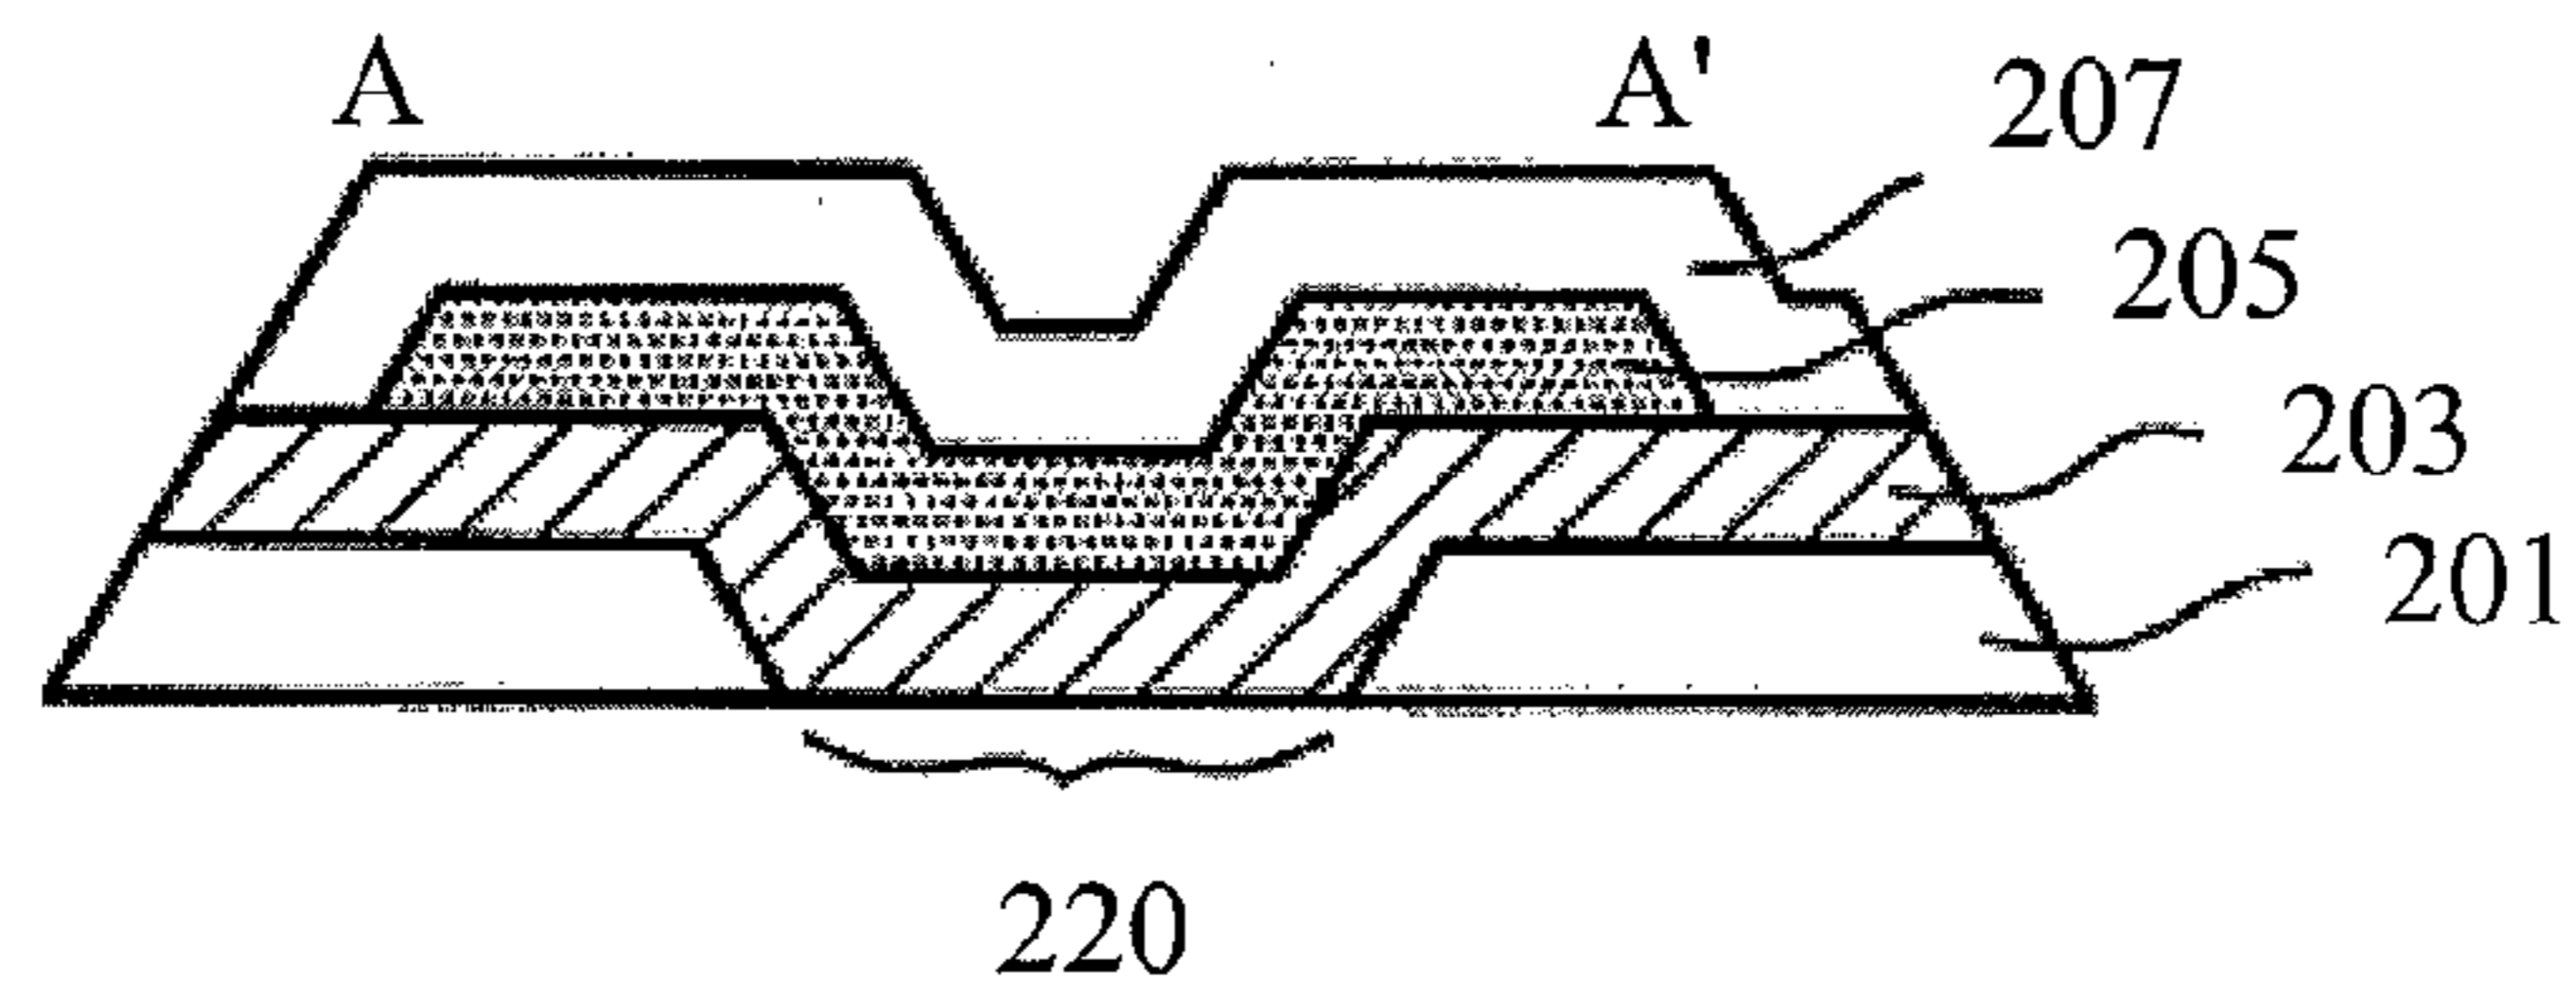
FIG. 3B is a schematic cross-sectional view of FIG. 3A, taken along a section line of A-A'.

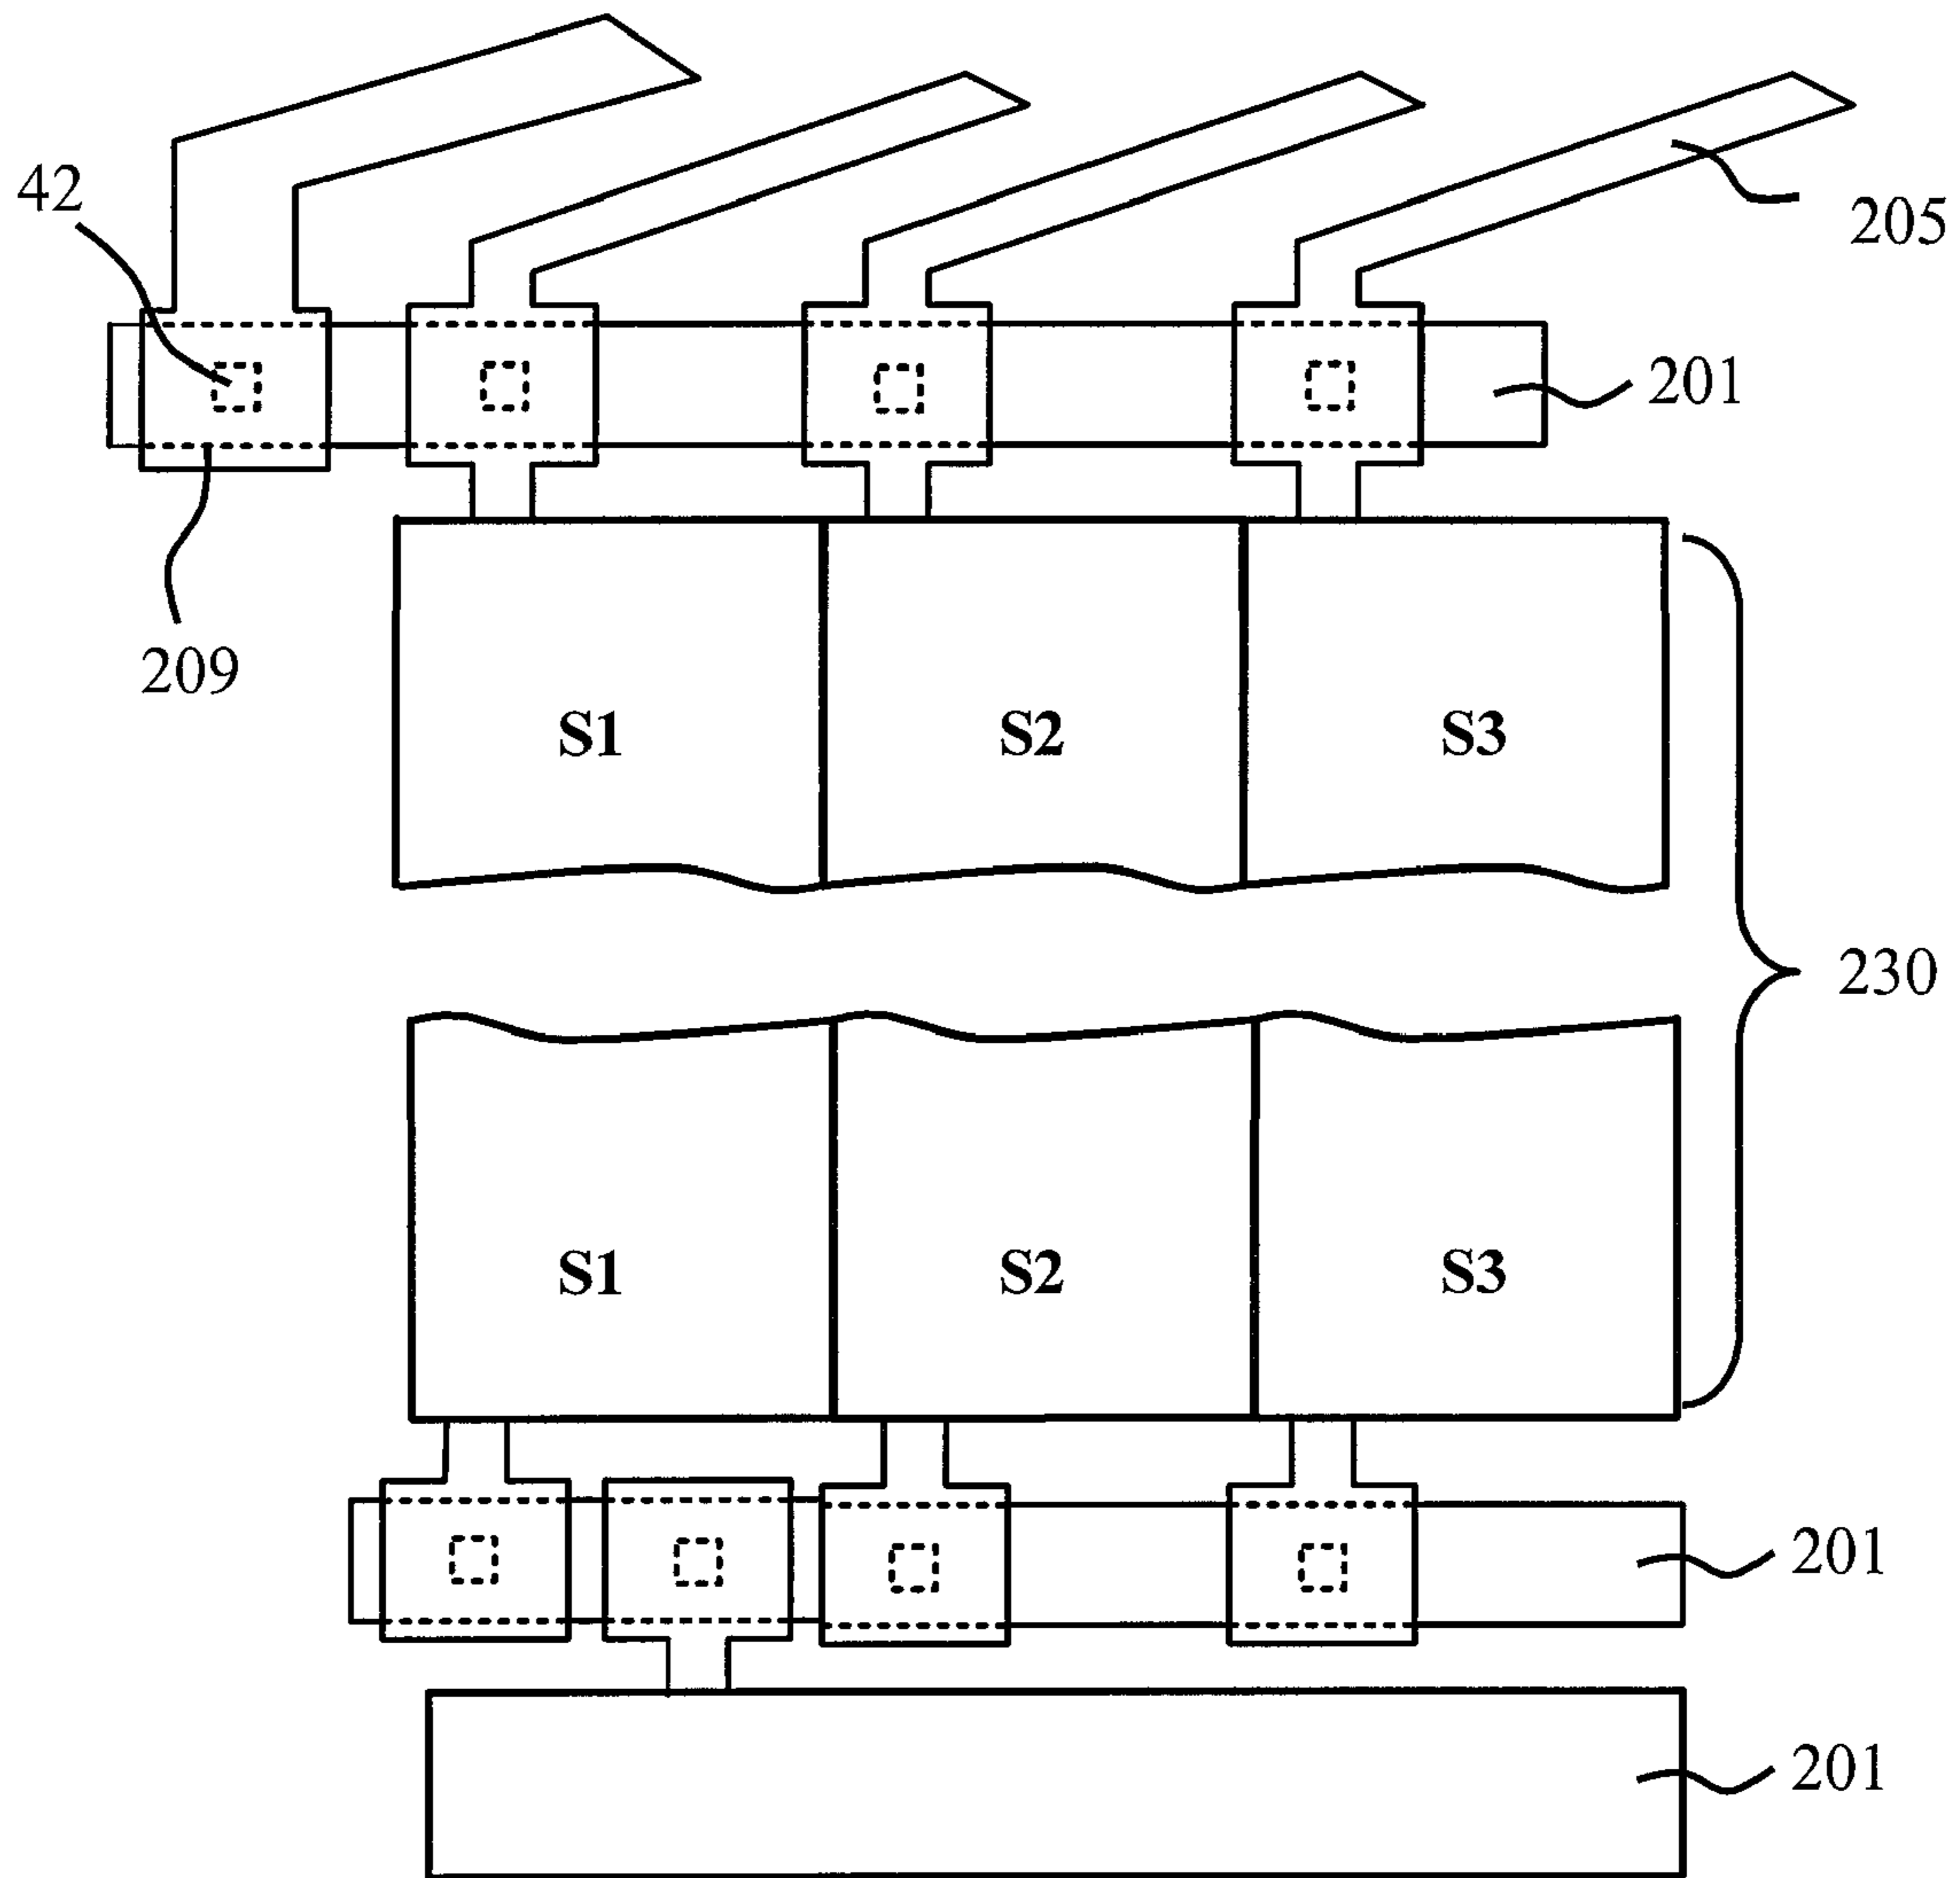
FIG .4

FIG. 4 is a schematic structural view of a repairing method of a data line of a display according to another embodiment of the present invention.

FIG. 4 is a schematic structural view of a repairing method of a data line of a display according to another embodiment of the present invention. Referring to FIG. 4, a display panel includes a plurality of data lines 205 and a plurality of repairing lines 201. The data lines 205 are connected to a pixel region 230. Each of the repairing lines 201 spans across at least one data line 205. The data line 205 and the corresponding repairing line 201 have a crossing region 209 where they are overlapped with each other. A square opening 420 is designed at a central position of the repairing line 201, which is used for laser melting when the defective data line 205 is repaired subsequently. Referring to FIGS. 3A and 3B, in the repairing structure, various patterns of the opening may be designed according to users' different demands.

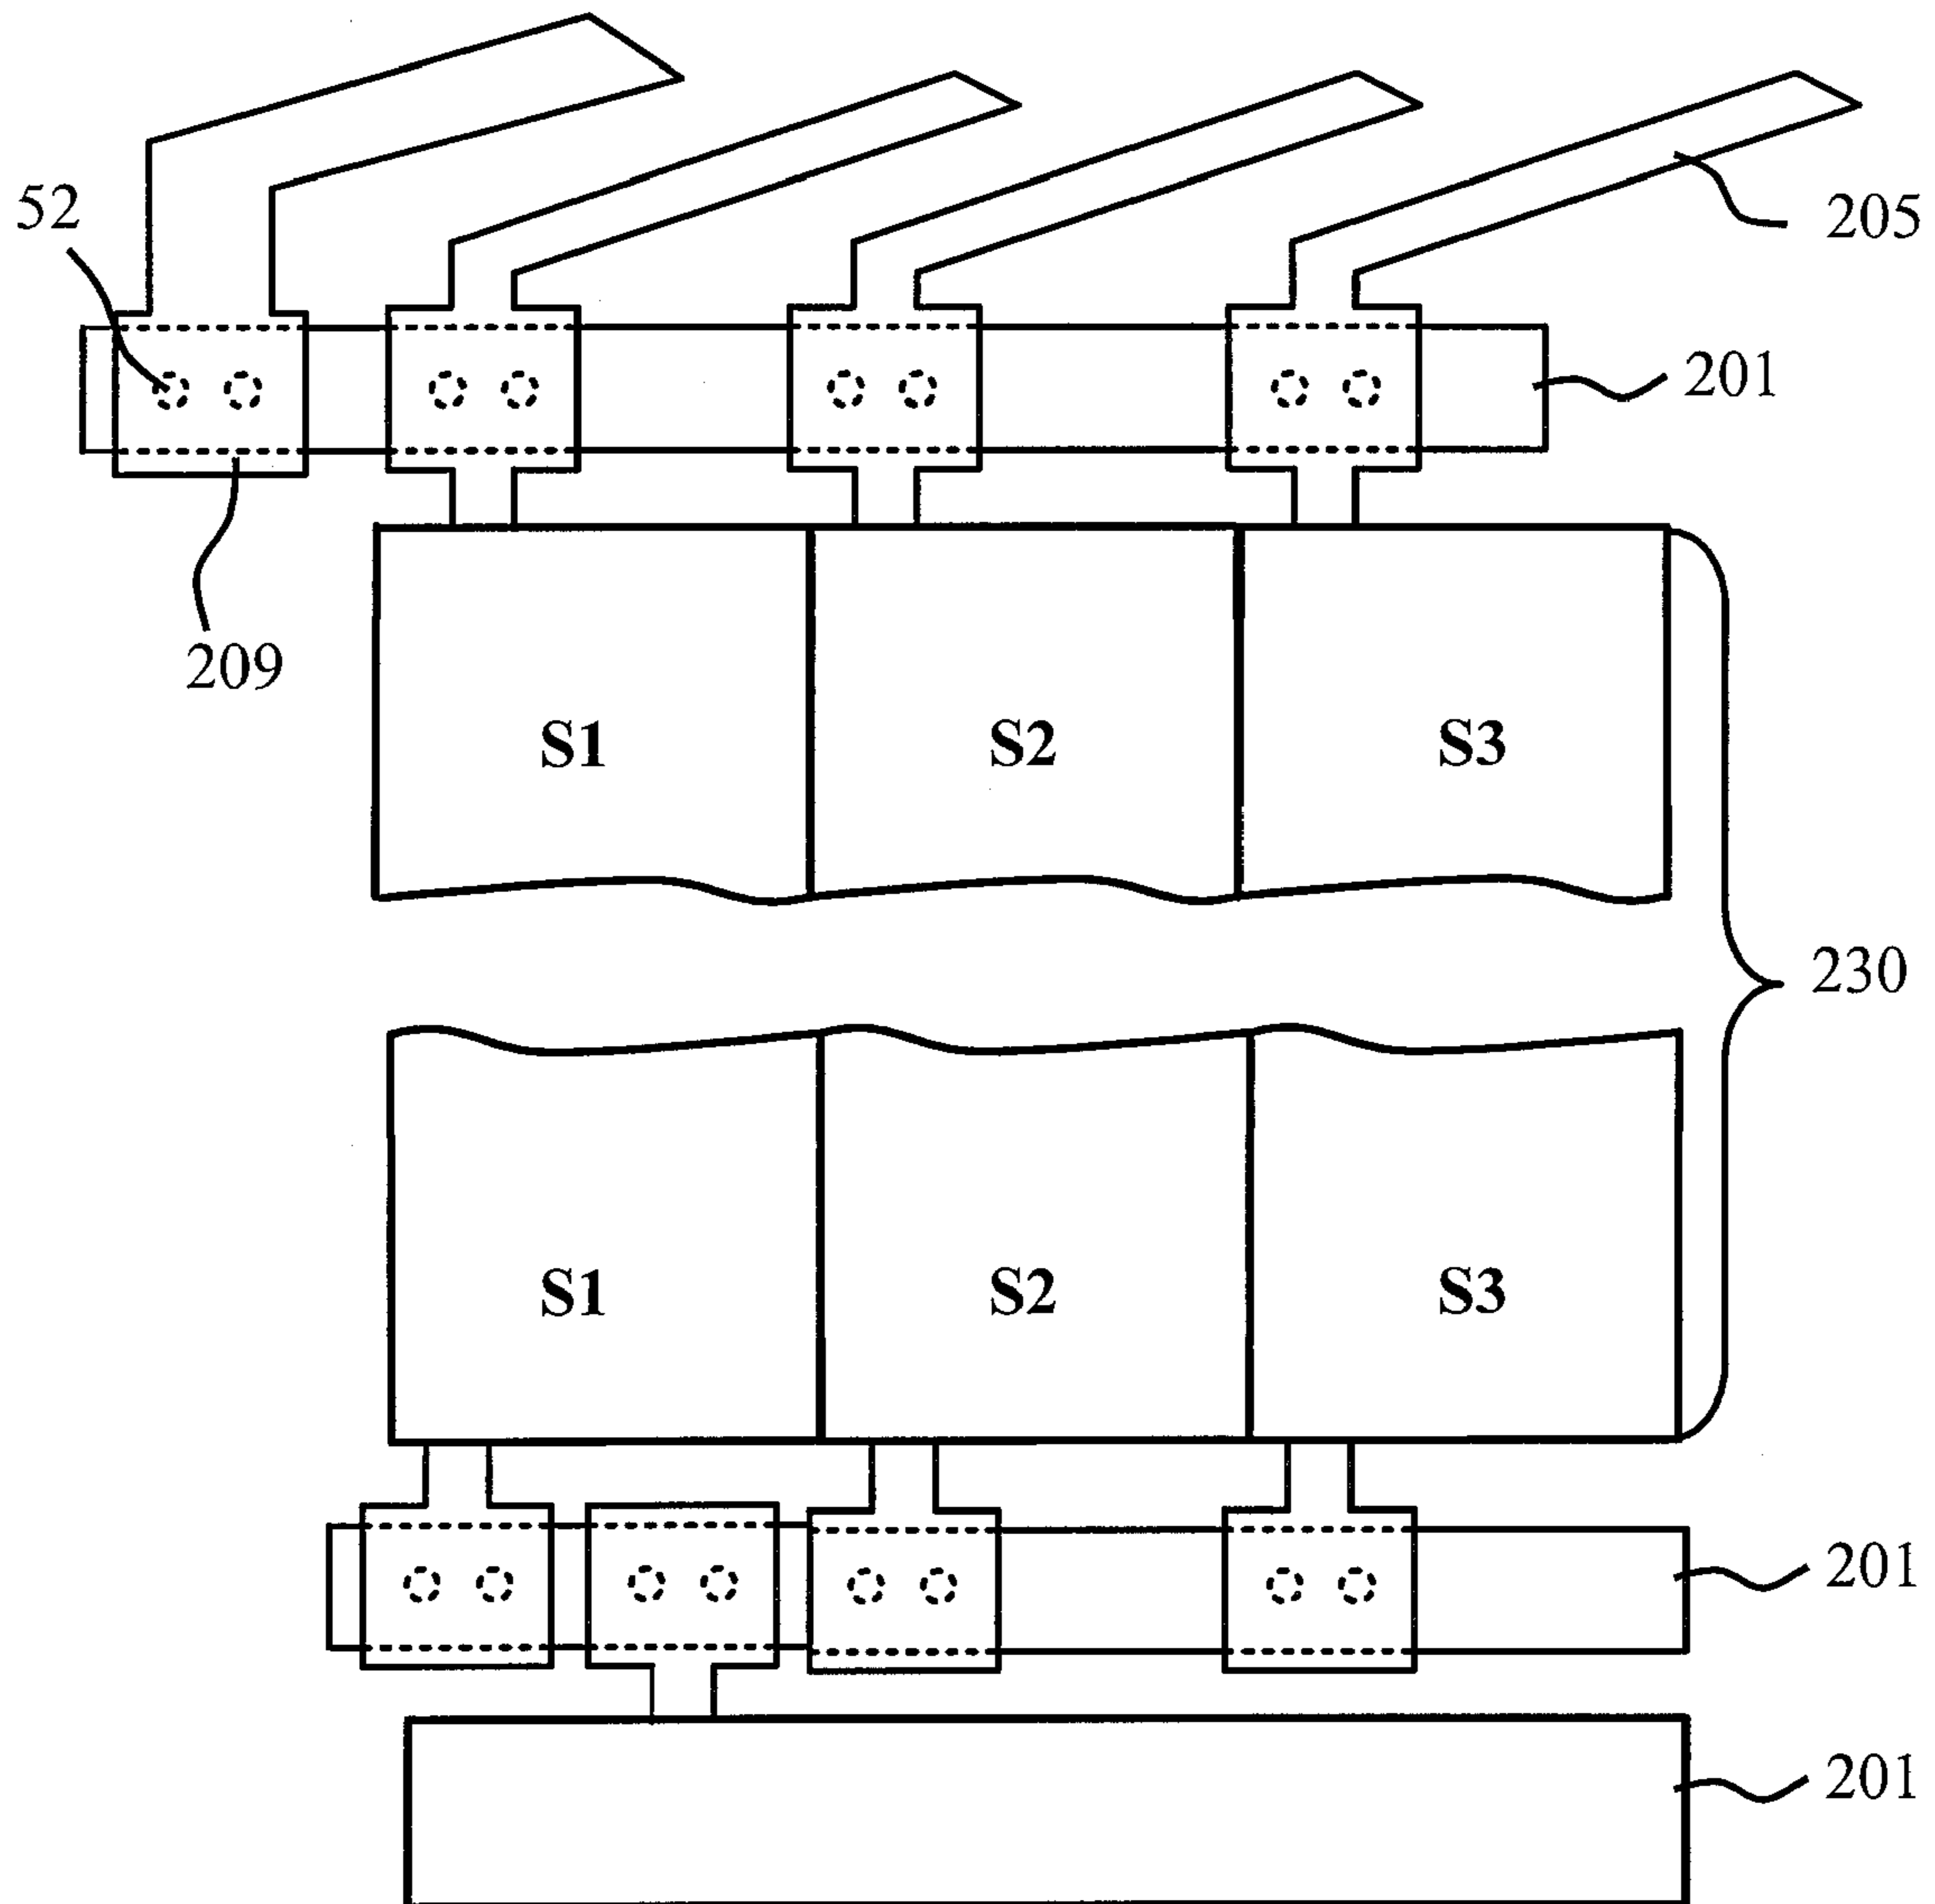
FIG .5

FIG. 5 is a schematic structural view of a repairing method of a data line of a display according to another embodiment of the present invention.

FIG. 5 is a schematic structural view of a repairing method of a data line of a display according to another embodiment of the present invention. Referring to FIG. 5, a display panel includes a plurality of data lines 205 and a plurality of repairing lines 201. The data lines 205 are connected to a pixel region 230. Each of the repairing lines 201 spans across at least one data line 205. The data line 205 and the corresponding repairing line 201 have a crossing region 209 where they are overlapped with each other. Two round openings 520 are designed at a central position of the repairing line 201, which are used for laser melting when the defective data line 205 is repaired subsequently. Referring to FIGS. 3A and 3B, such repairing structure mainly aims at preventing a repairing failure. If the welding fails for the first time, the remaining opening 520 can be still used for welding, thereby increasing the yield and lowering the cost.
