(10) **Patent No.:** **US 8,329,074 B2**
(45) **Date of Patent:** **Dec. 11, 2012**

(54) **DEVICE AND METHOD FOR REPAIRING MORTAR JOINTS BETWEEN CHIMNEY TILES**

(73) Assignee: **Merediths' Inc.**, Richmond, IN (US)

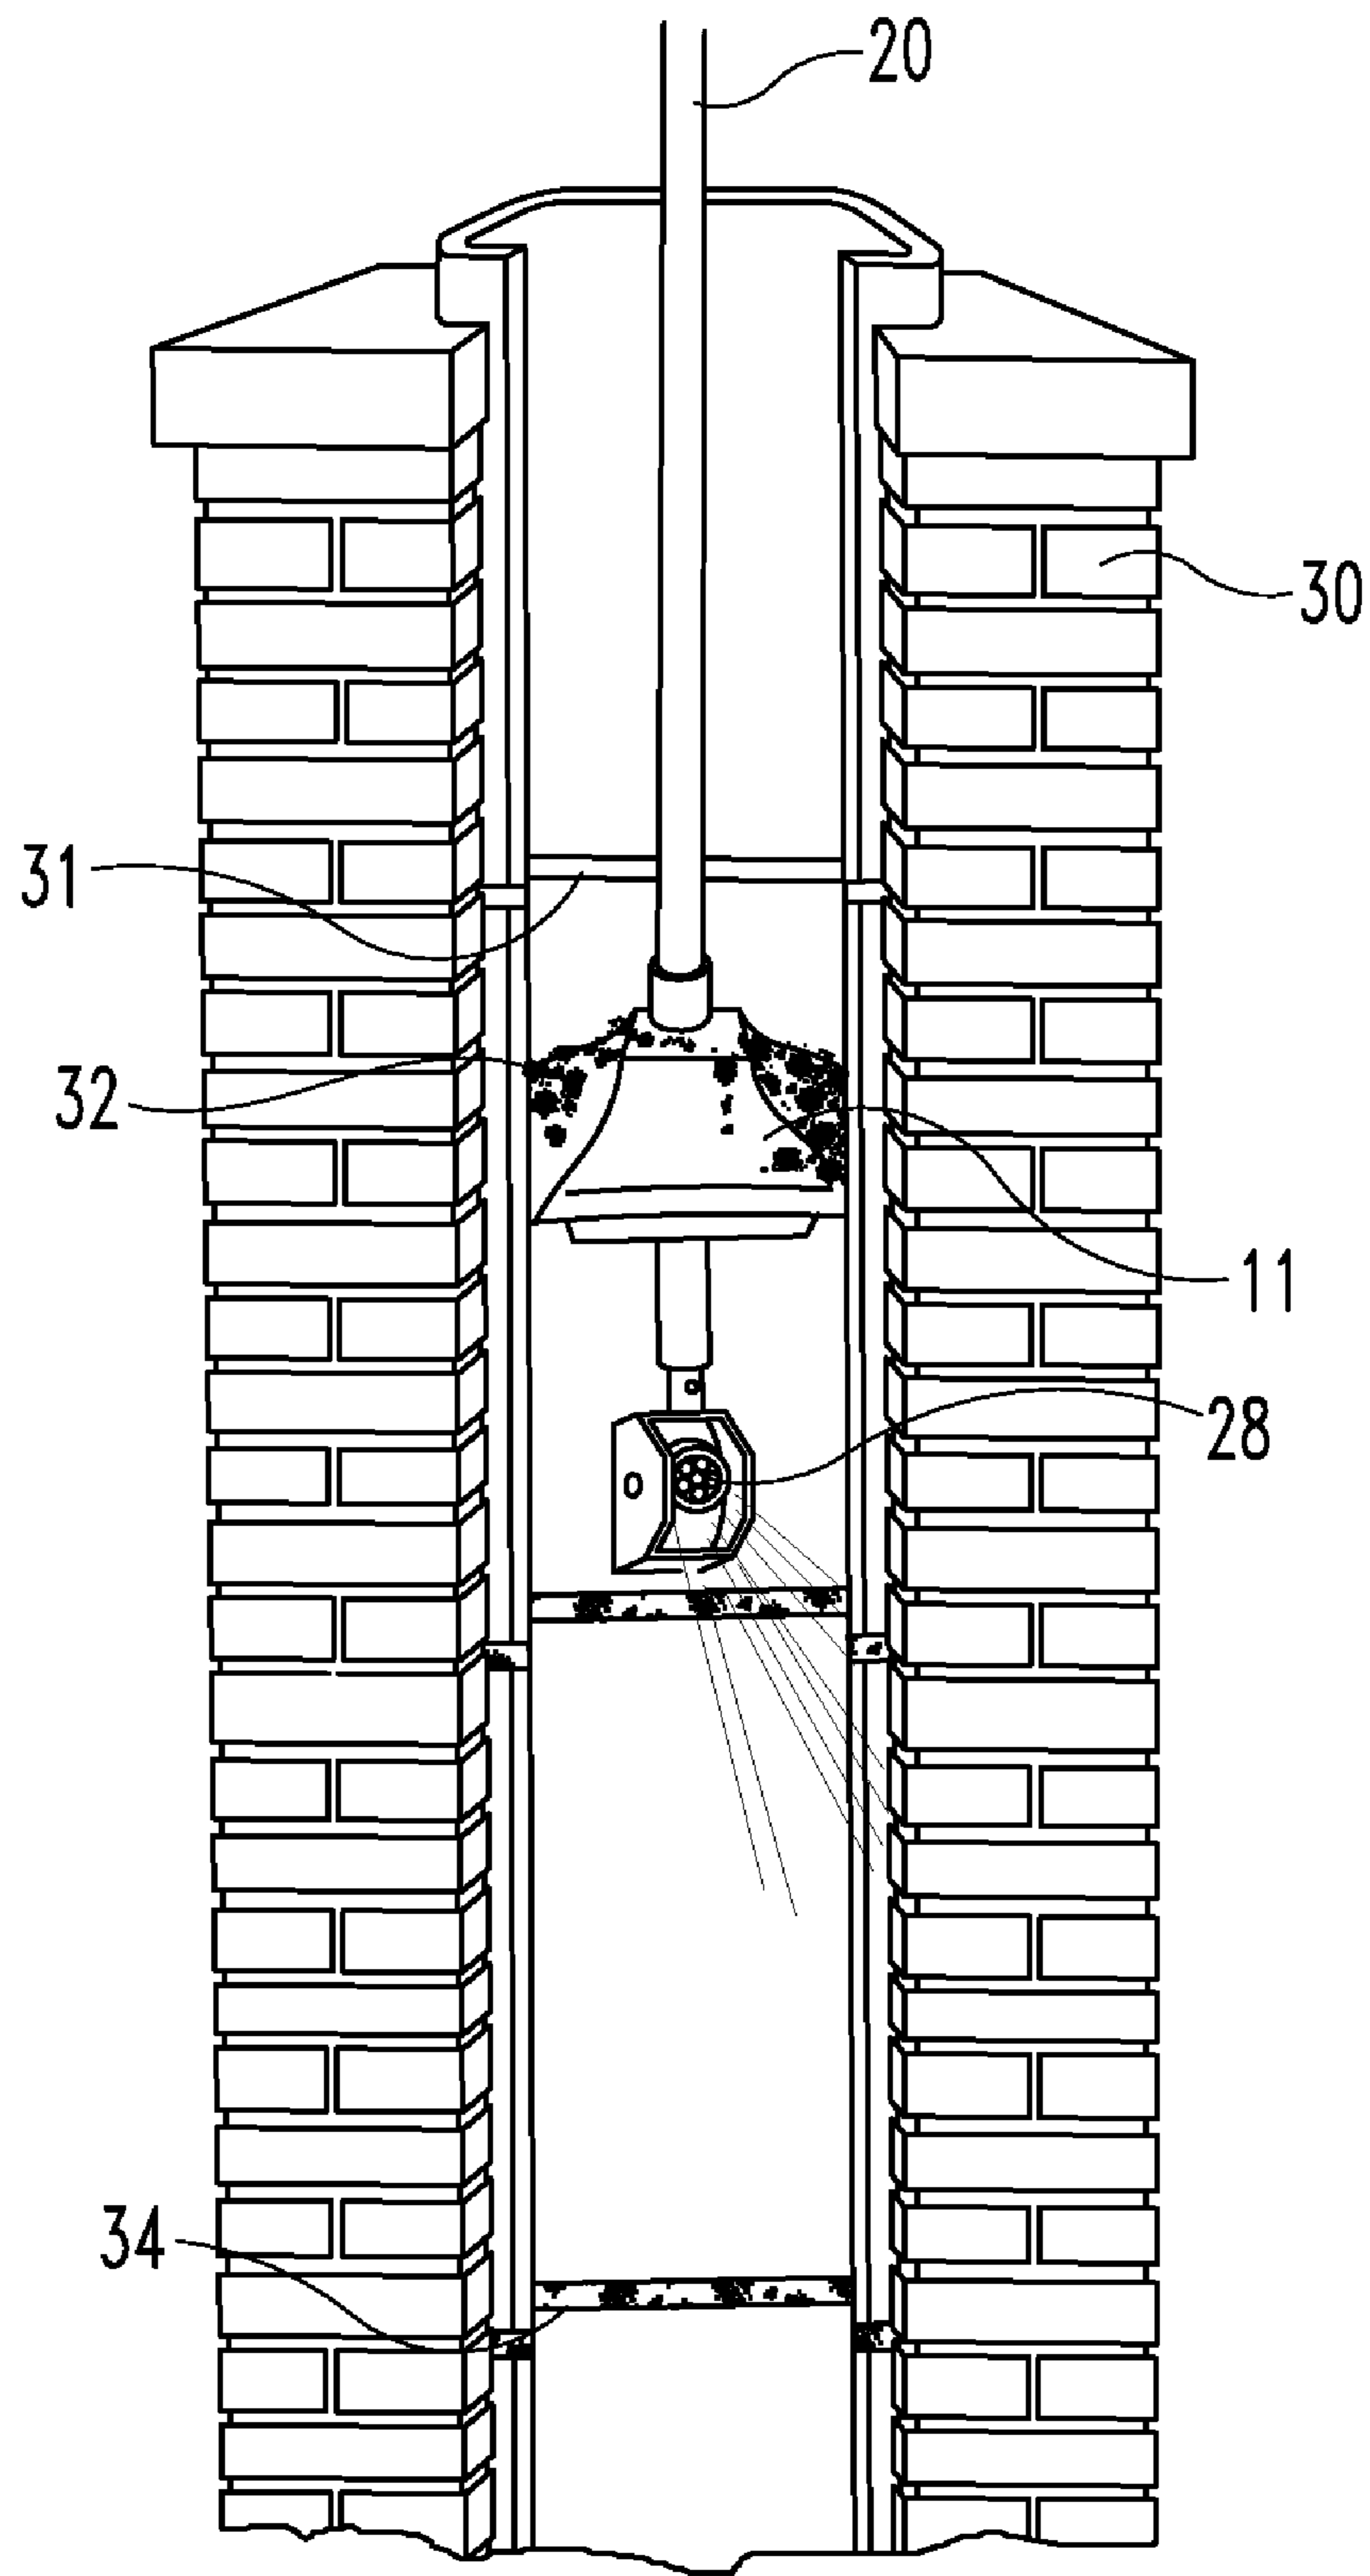
Fig. 1

FIG. 1 shows a perspective view of the inventive tool being used for the inventive method, according to one embodiment.

Referring now to the drawings, FIG. 1 shows a perspective view of the inventive tool being used for the inventive method, according to one embodiment. Plunger assembly 11 is positioned in chimney by using rod 20 to push the plunger assembly and camera 28 into the chimney. Repair material 32, which may be mortar or another chimney-repair material, has been provided on plunger assembly 11 so that the plunger may push the material into chimney joints 31. A repaired joint 34 results.

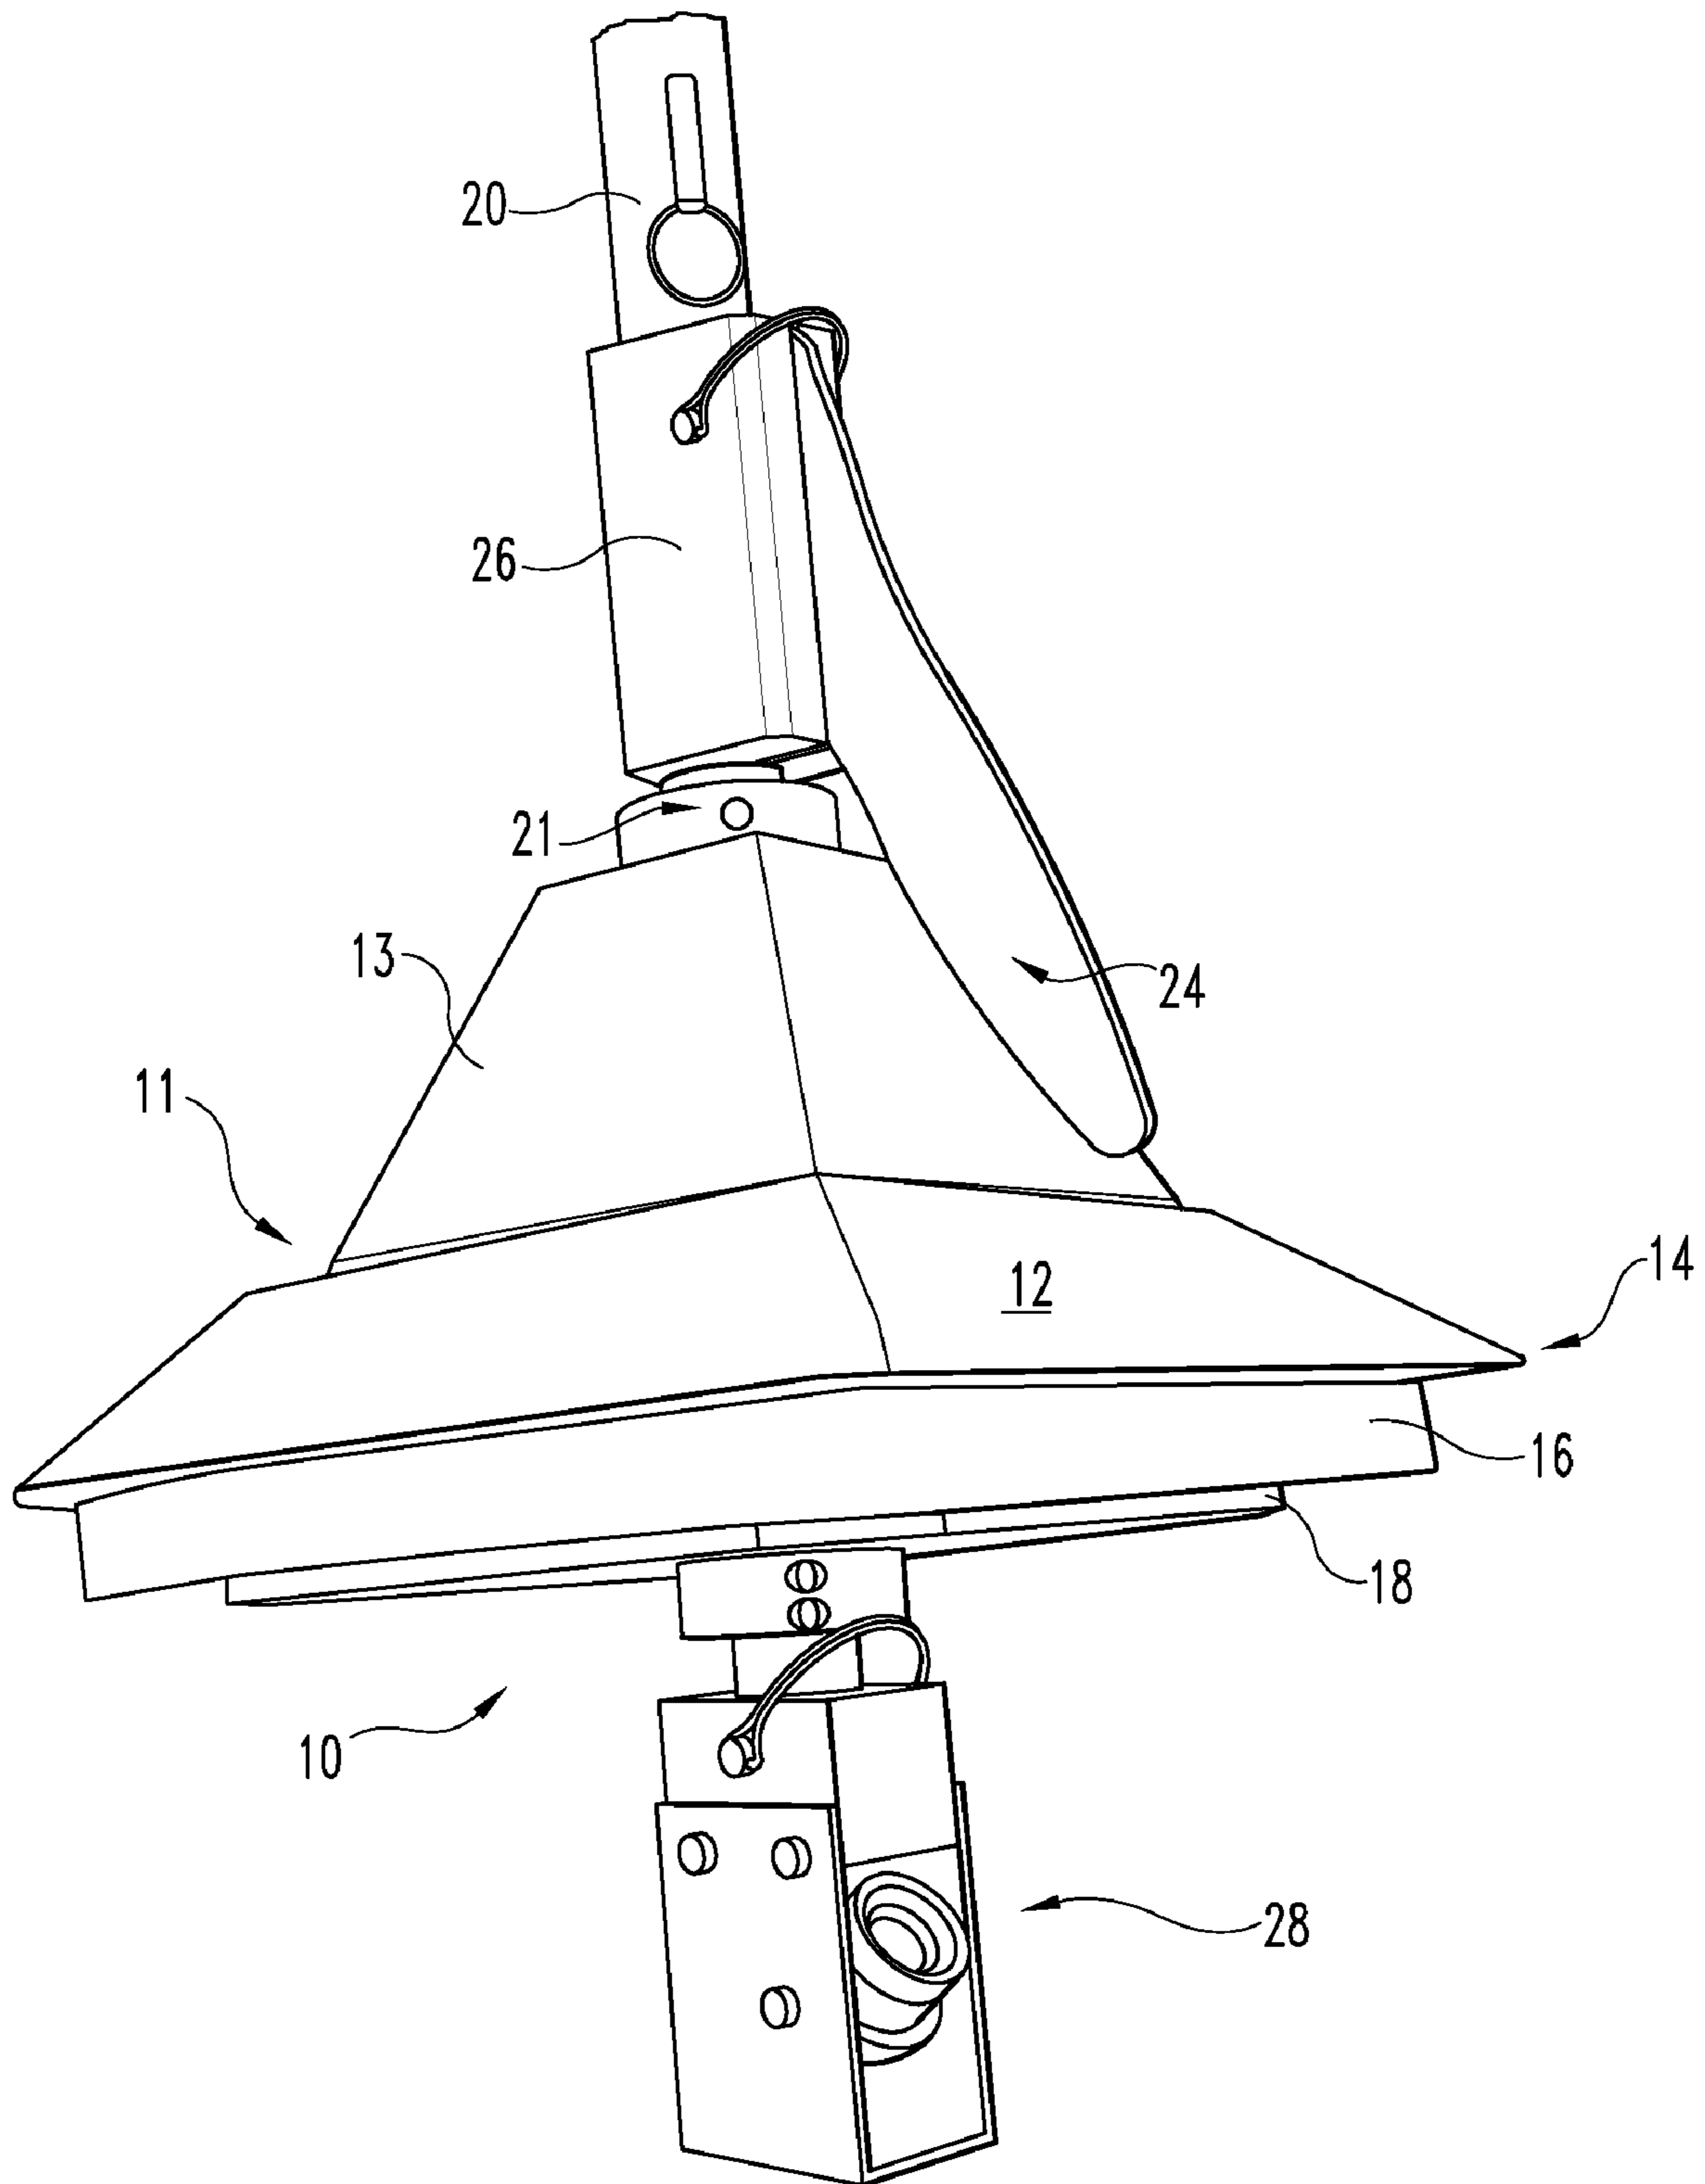
Fig. 2

FIG. 2 shows a perspective view of the inventive tool, according to one embodiment.

FIG. 2 shows a perspective view of the inventive tool, according to one embodiment. Plunger/camera assembly 10 includes a plunger assembly 11 that is sized to be slightly larger than the interior of a chimney flue to be treated. Plunger assembly 11 has a plunger blade 12 that slopes to a rim 14 to direct mortar or another repair material to the flue surface when mortar is dropped onto the plunger from above. Plunger blade support plate 16 lends rigidity and support to plunger blade 12.

Plunger assembly 11 is mounted on rod 20 which extends both above and below the assembly. As indicated above, a sleeve may be provided to facilitate rotation of the rod through plunger 10 without turning the plunger.

A spreader paddle 24 is mounted to rod 20. Spreader paddle 24 is fixed to rod 20 such that rotation of rod 20 additionally rotates spreader paddle 24.

A camera 28 is provided on rod 20 below plunger 11. The camera may be in a fixed orientation (although generally rotatable), or it may be capable of being maneuvered to view higher or lower when desired. Camera 28 is also preferably fixed to rod 20 such that rotation of rod 20 rotates camera 28.

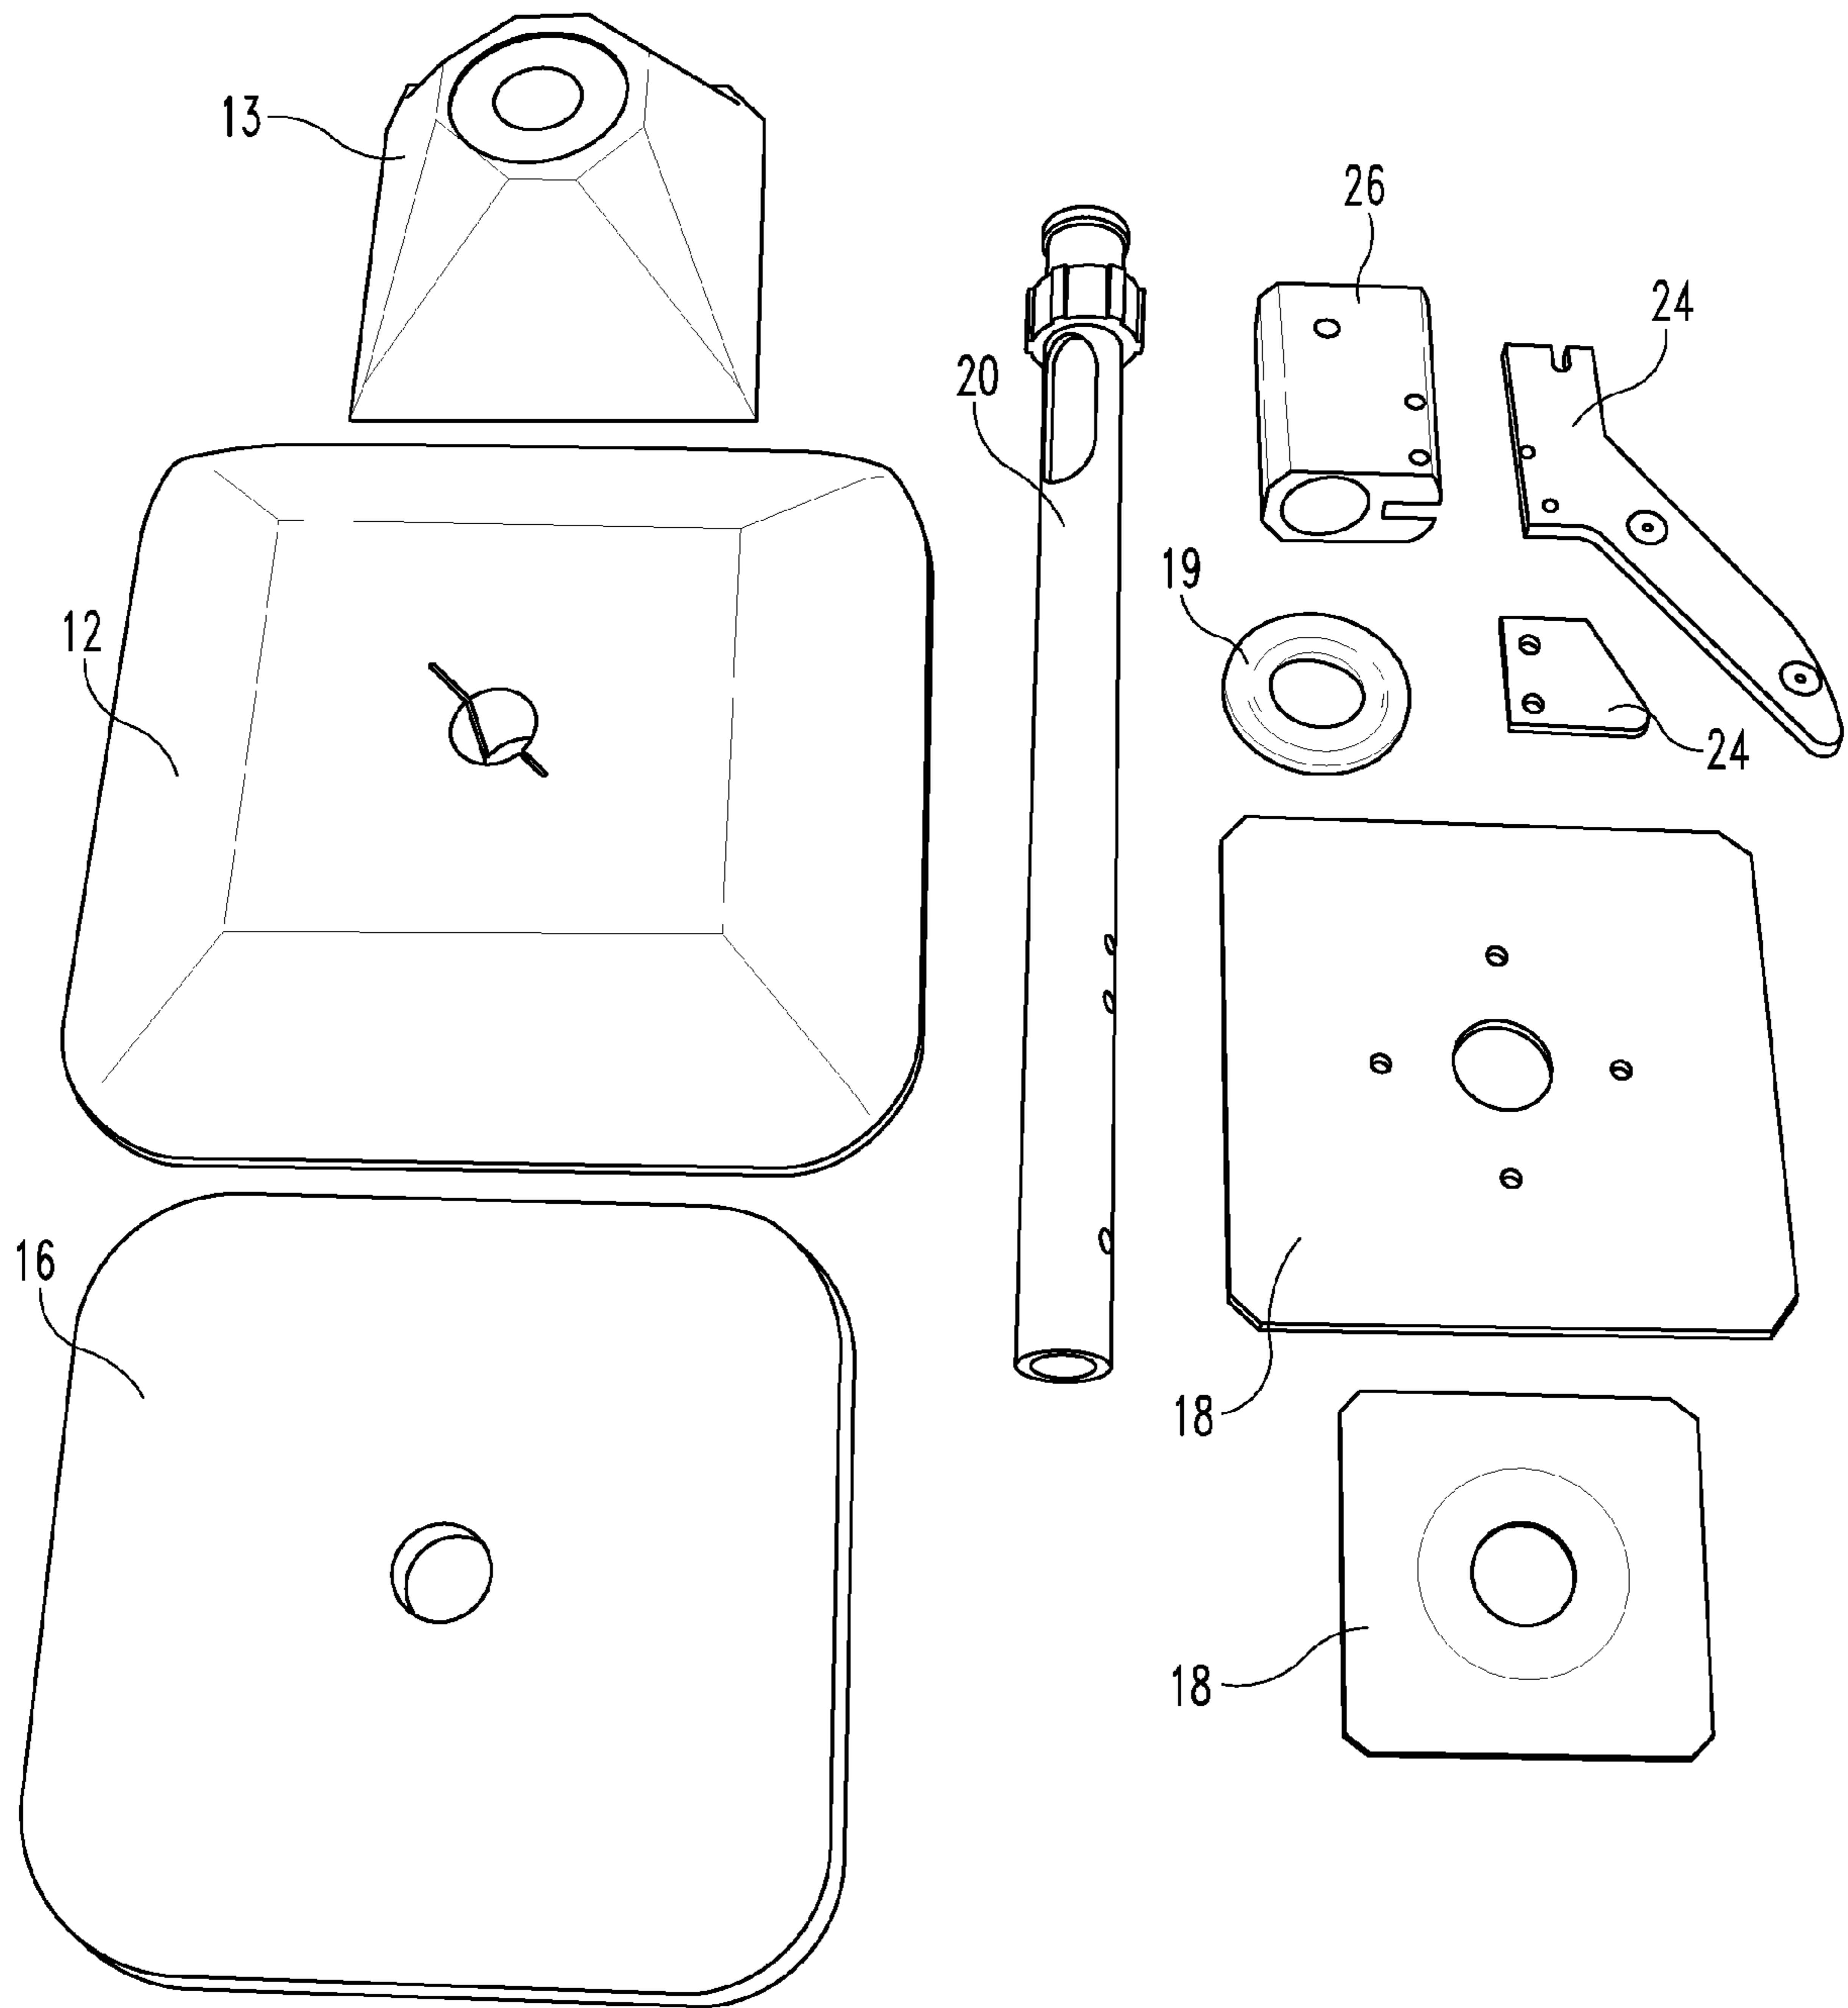
Fig. 3

FIG. 3 shows the components of the plunger assembly of the inventive tool, according to one embodiment.

FIG. 3 shows the components of the plunger assembly of the inventive tool, according to one embodiment. Plunger head 13, plunger blade 14, plunger blade support plate 16, spreader head 26, spreader paddle 24, retainer ring 19, and retainer plates 18 are shown, as is rod 20.

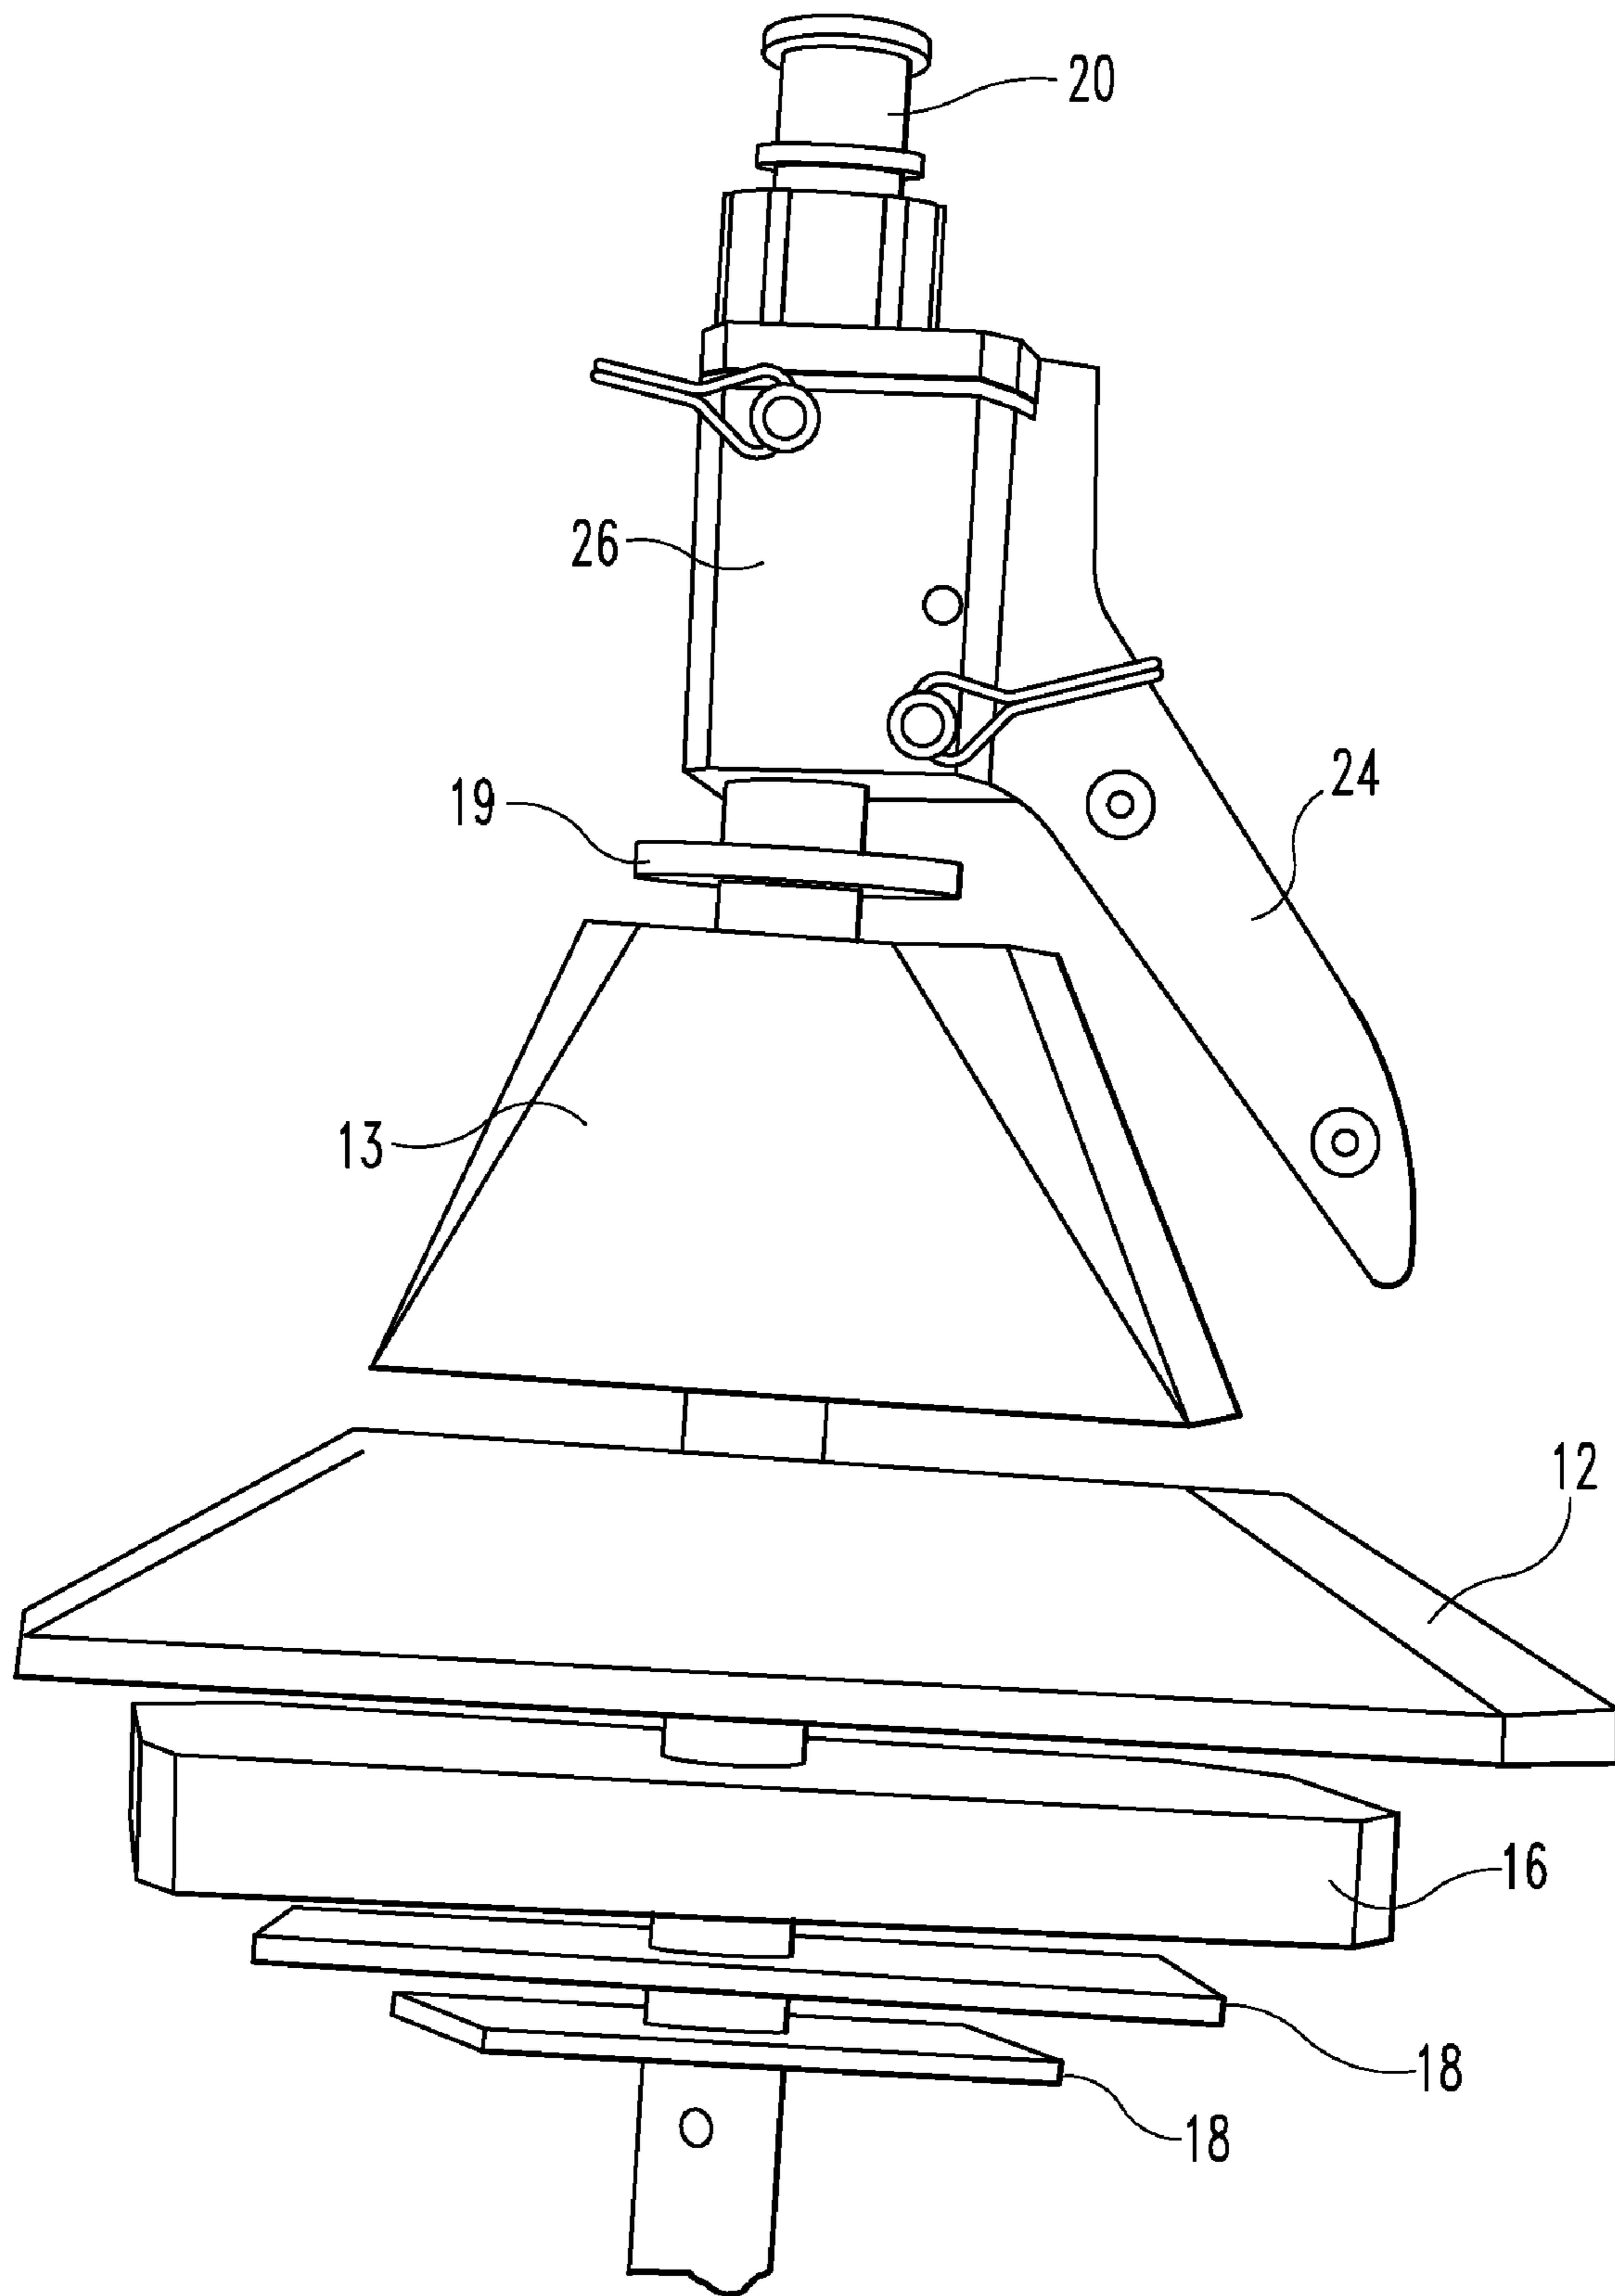
Fig. 4

FIG. 4 shows a semi-exploded view of the plunger assembly of the inventive tool, according to one embodiment.

FIG. 4 shows a semi-exploded view of the plunger assembly of the inventive tool, according to one embodiment. Spreader head 26 holds spreader paddle 24 on rod 20 such that rotation of the rod correspondingly rotates the spreader paddle. Retainer ring 19 and retainer plates 18 hold plunger head 13, plunger blade 14, and plunger blade support plate 16 in place on the rod. A lock nut or locking screw 21 may be used to hold the pieces in place. A sleeve (not illustrated) may be used to isolate the plunger assembly so that rotation of the rod does not result in rotation of the plunger assembly.

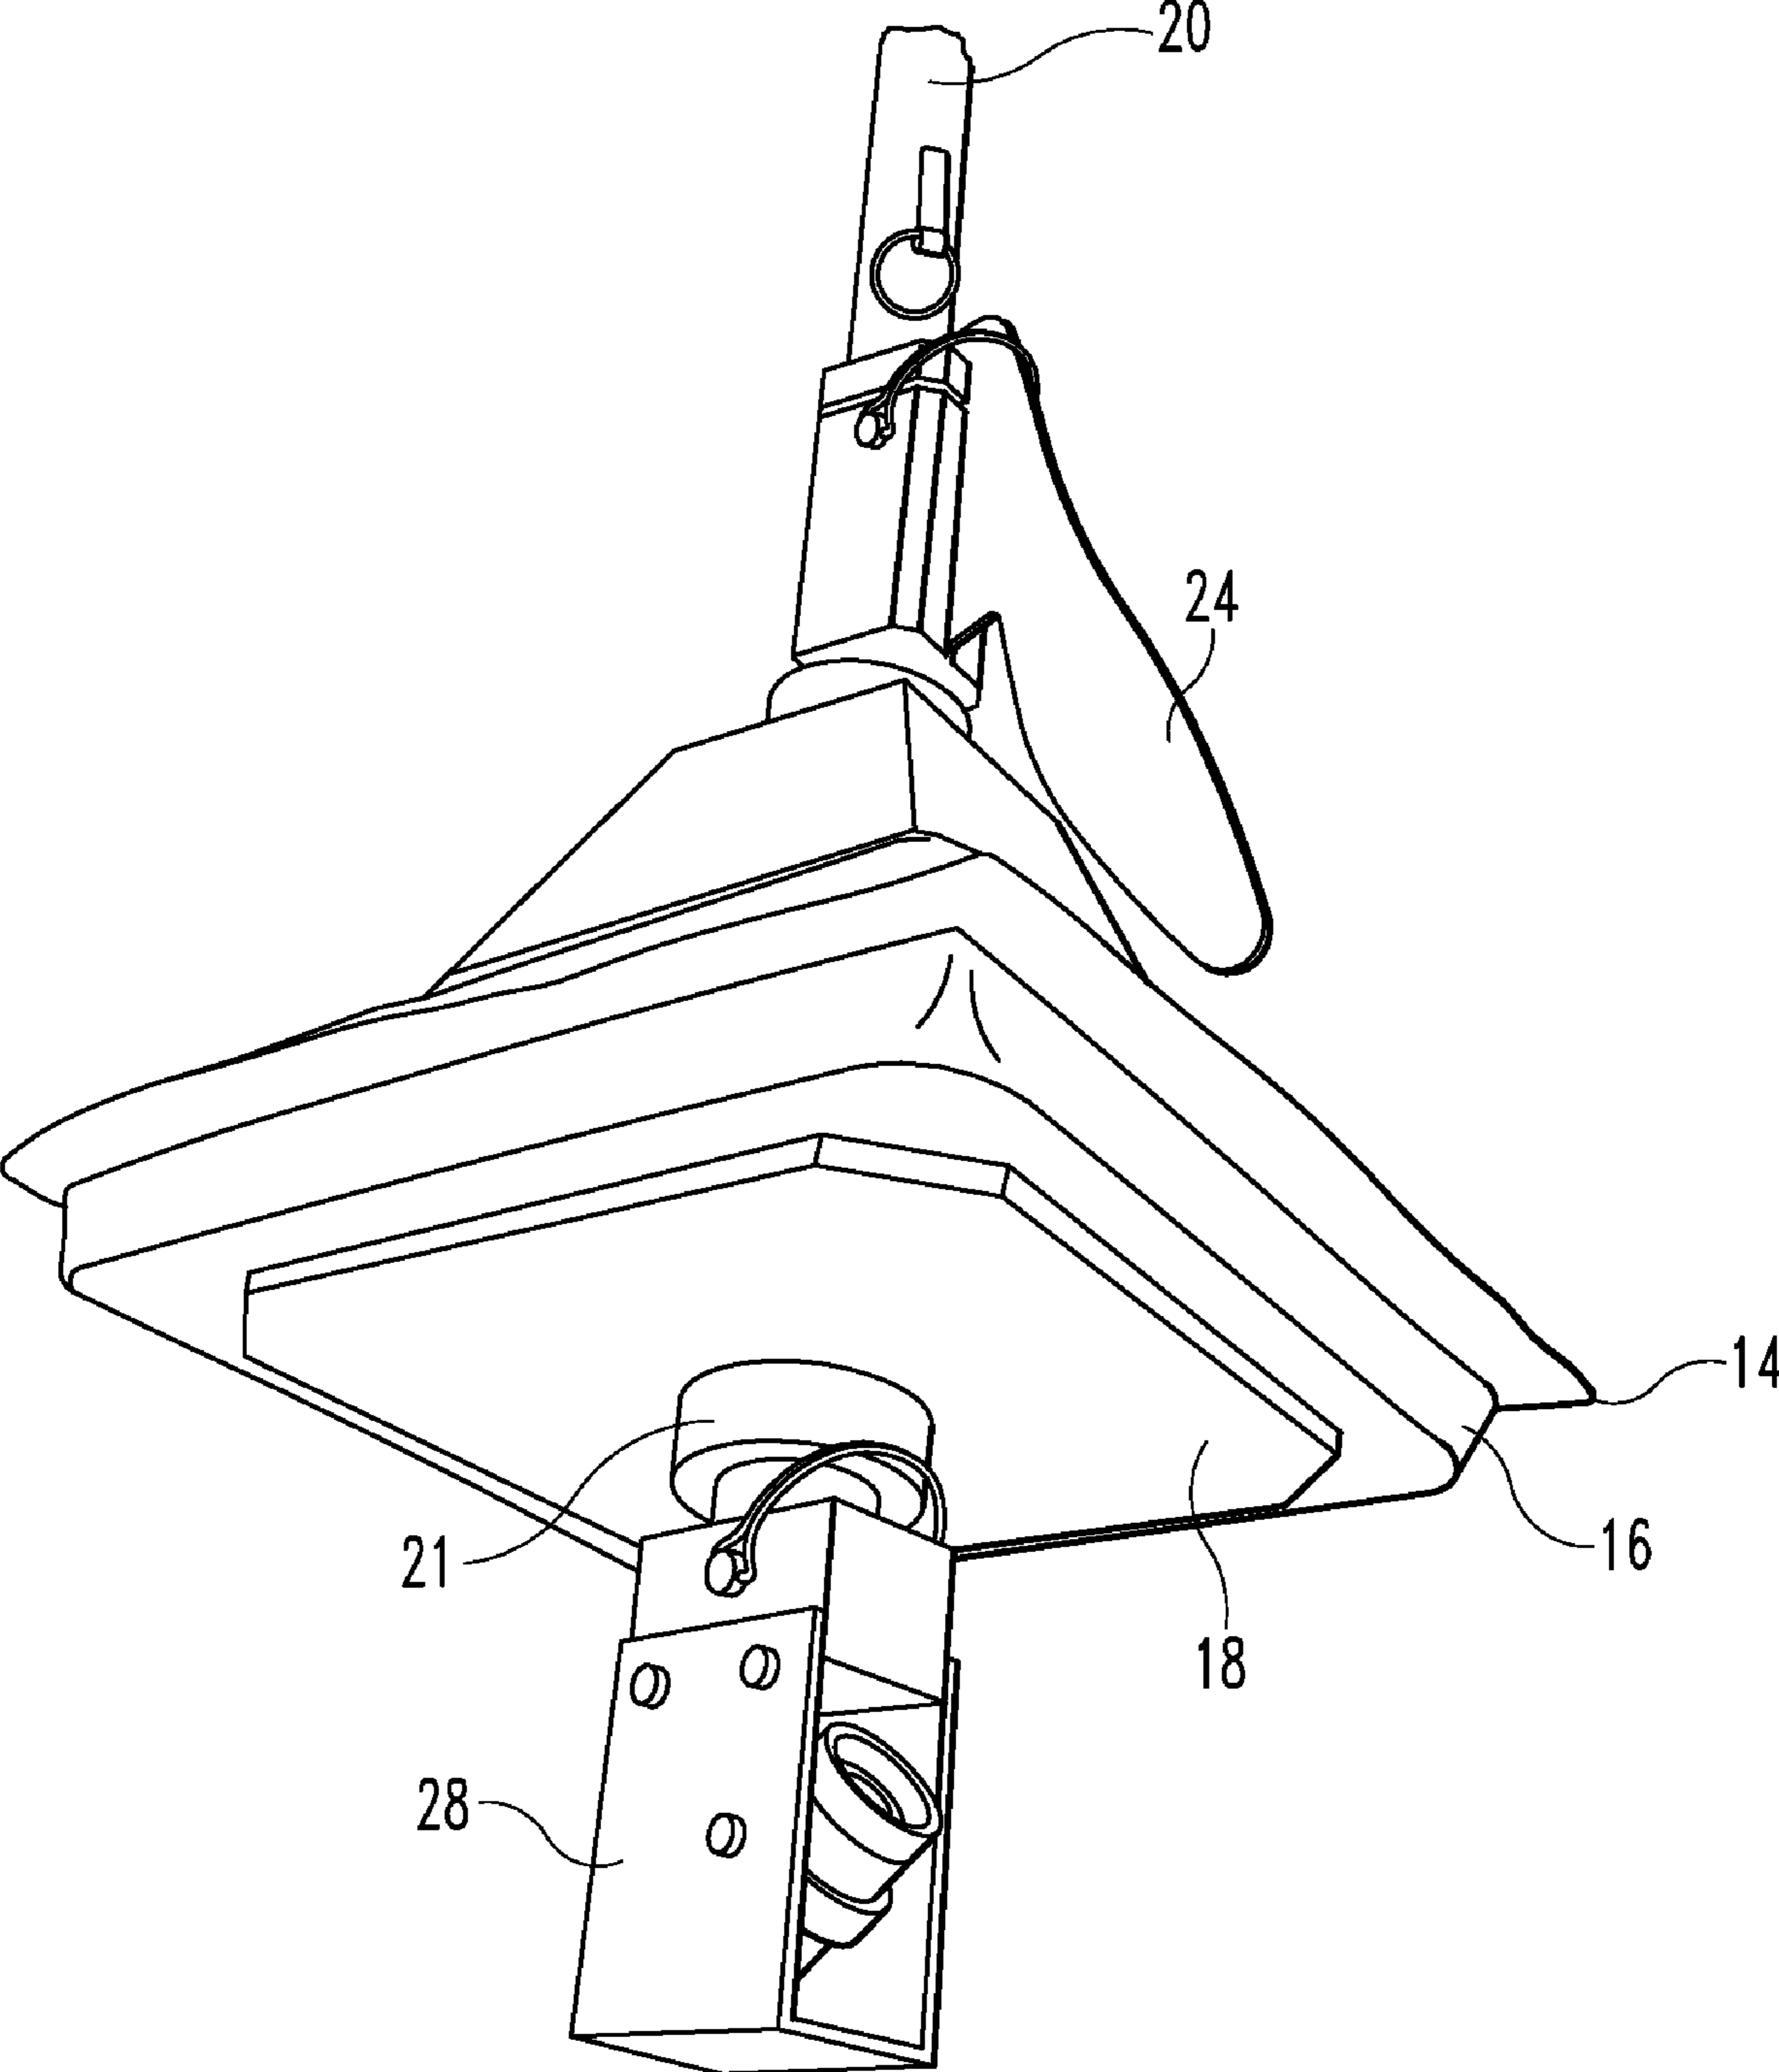
Fig. 5

FIG. 5 shows a perspective view of the inventive tool, according to one embodiment.

FIG. 5 shows a perspective view of the inventive tool, according to one embodiment. Rod 20 holds spreader blade 24 above plunger assembly 11 and camera 28.

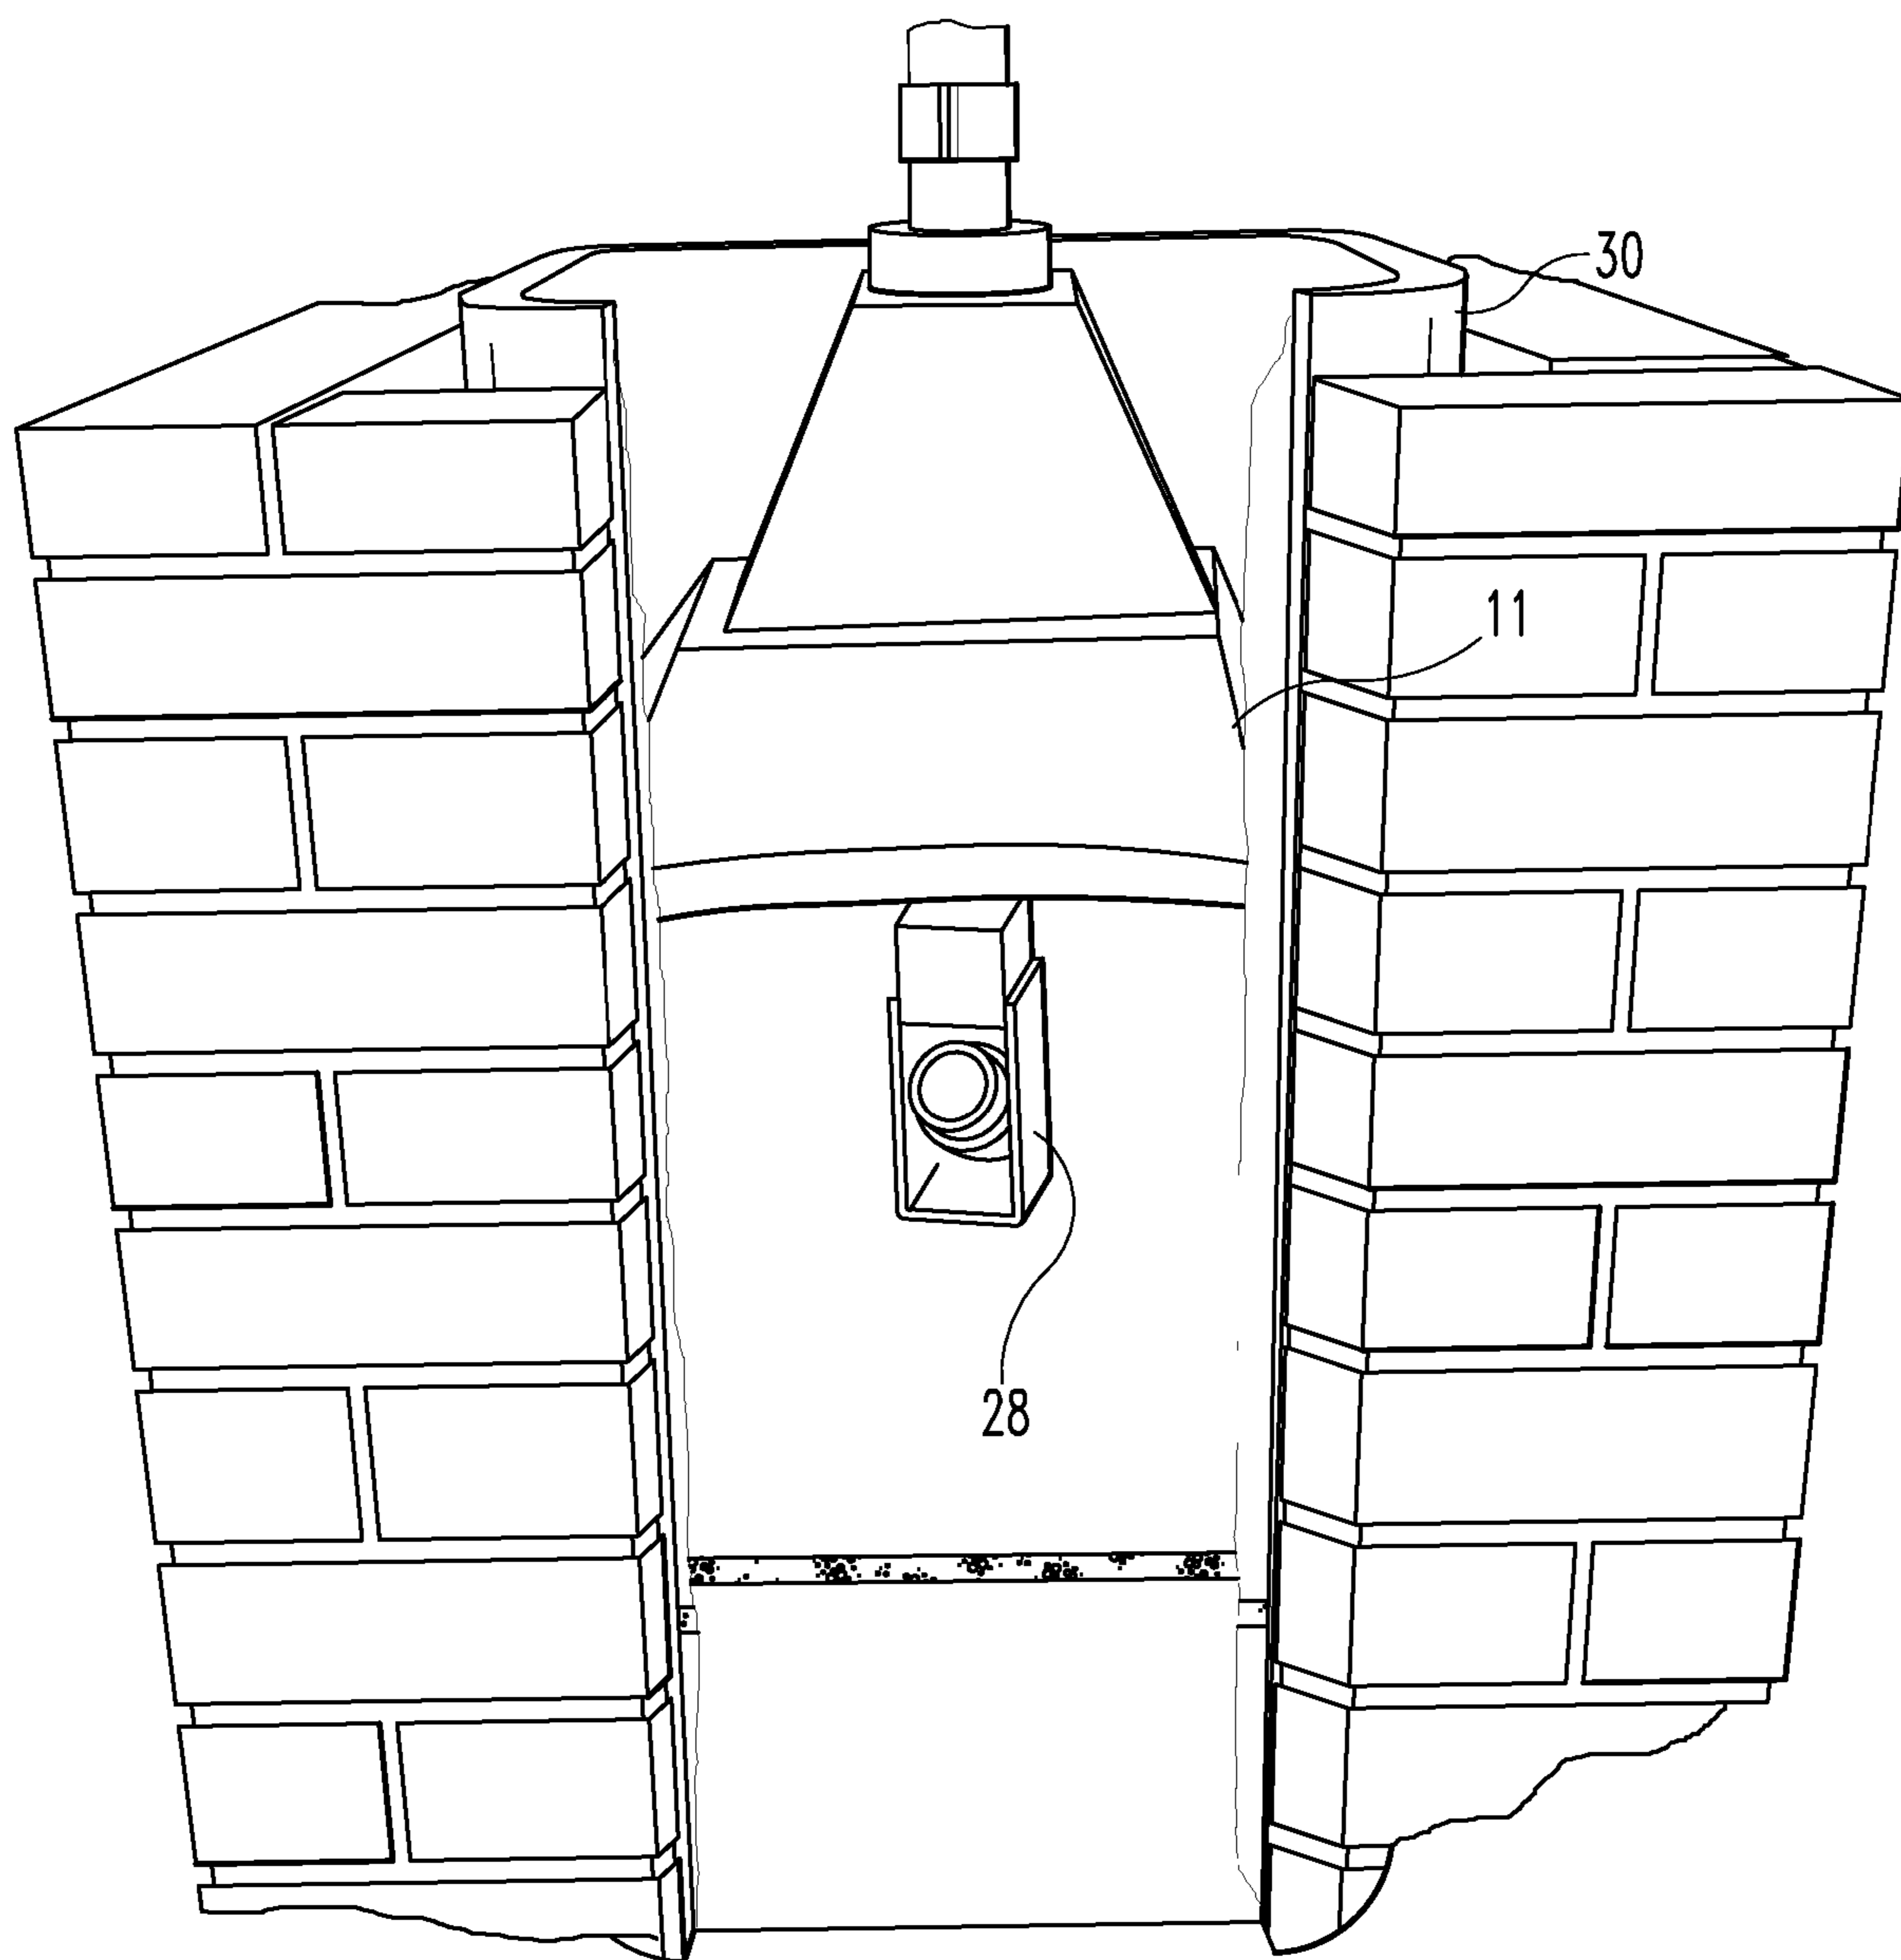
Fig. 6

FIG. 6 shows a perspective view of the inventive tool in a chimney (in partial section), according to one embodiment.

FIG. 6 shows a perspective view of the inventive tool in a chimney (shown in partial section, with the front part of the chimney cut away), according to one embodiment. Plunger assembly 11 is positioned so as to receive mortar from above and to be pulled upward to push mortar into joint 30.
