(10) **Patent No.:** **US 8,329,074 B2**
(45) **Date of Patent:** **Dec. 11, 2012**

(54) **DEVICE AND METHOD FOR REPAIRING MORTAR JOINTS BETWEEN CHIMNEY TILES**

(73) Assignee: **Merediths' Inc.**, Richmond, IN (US)

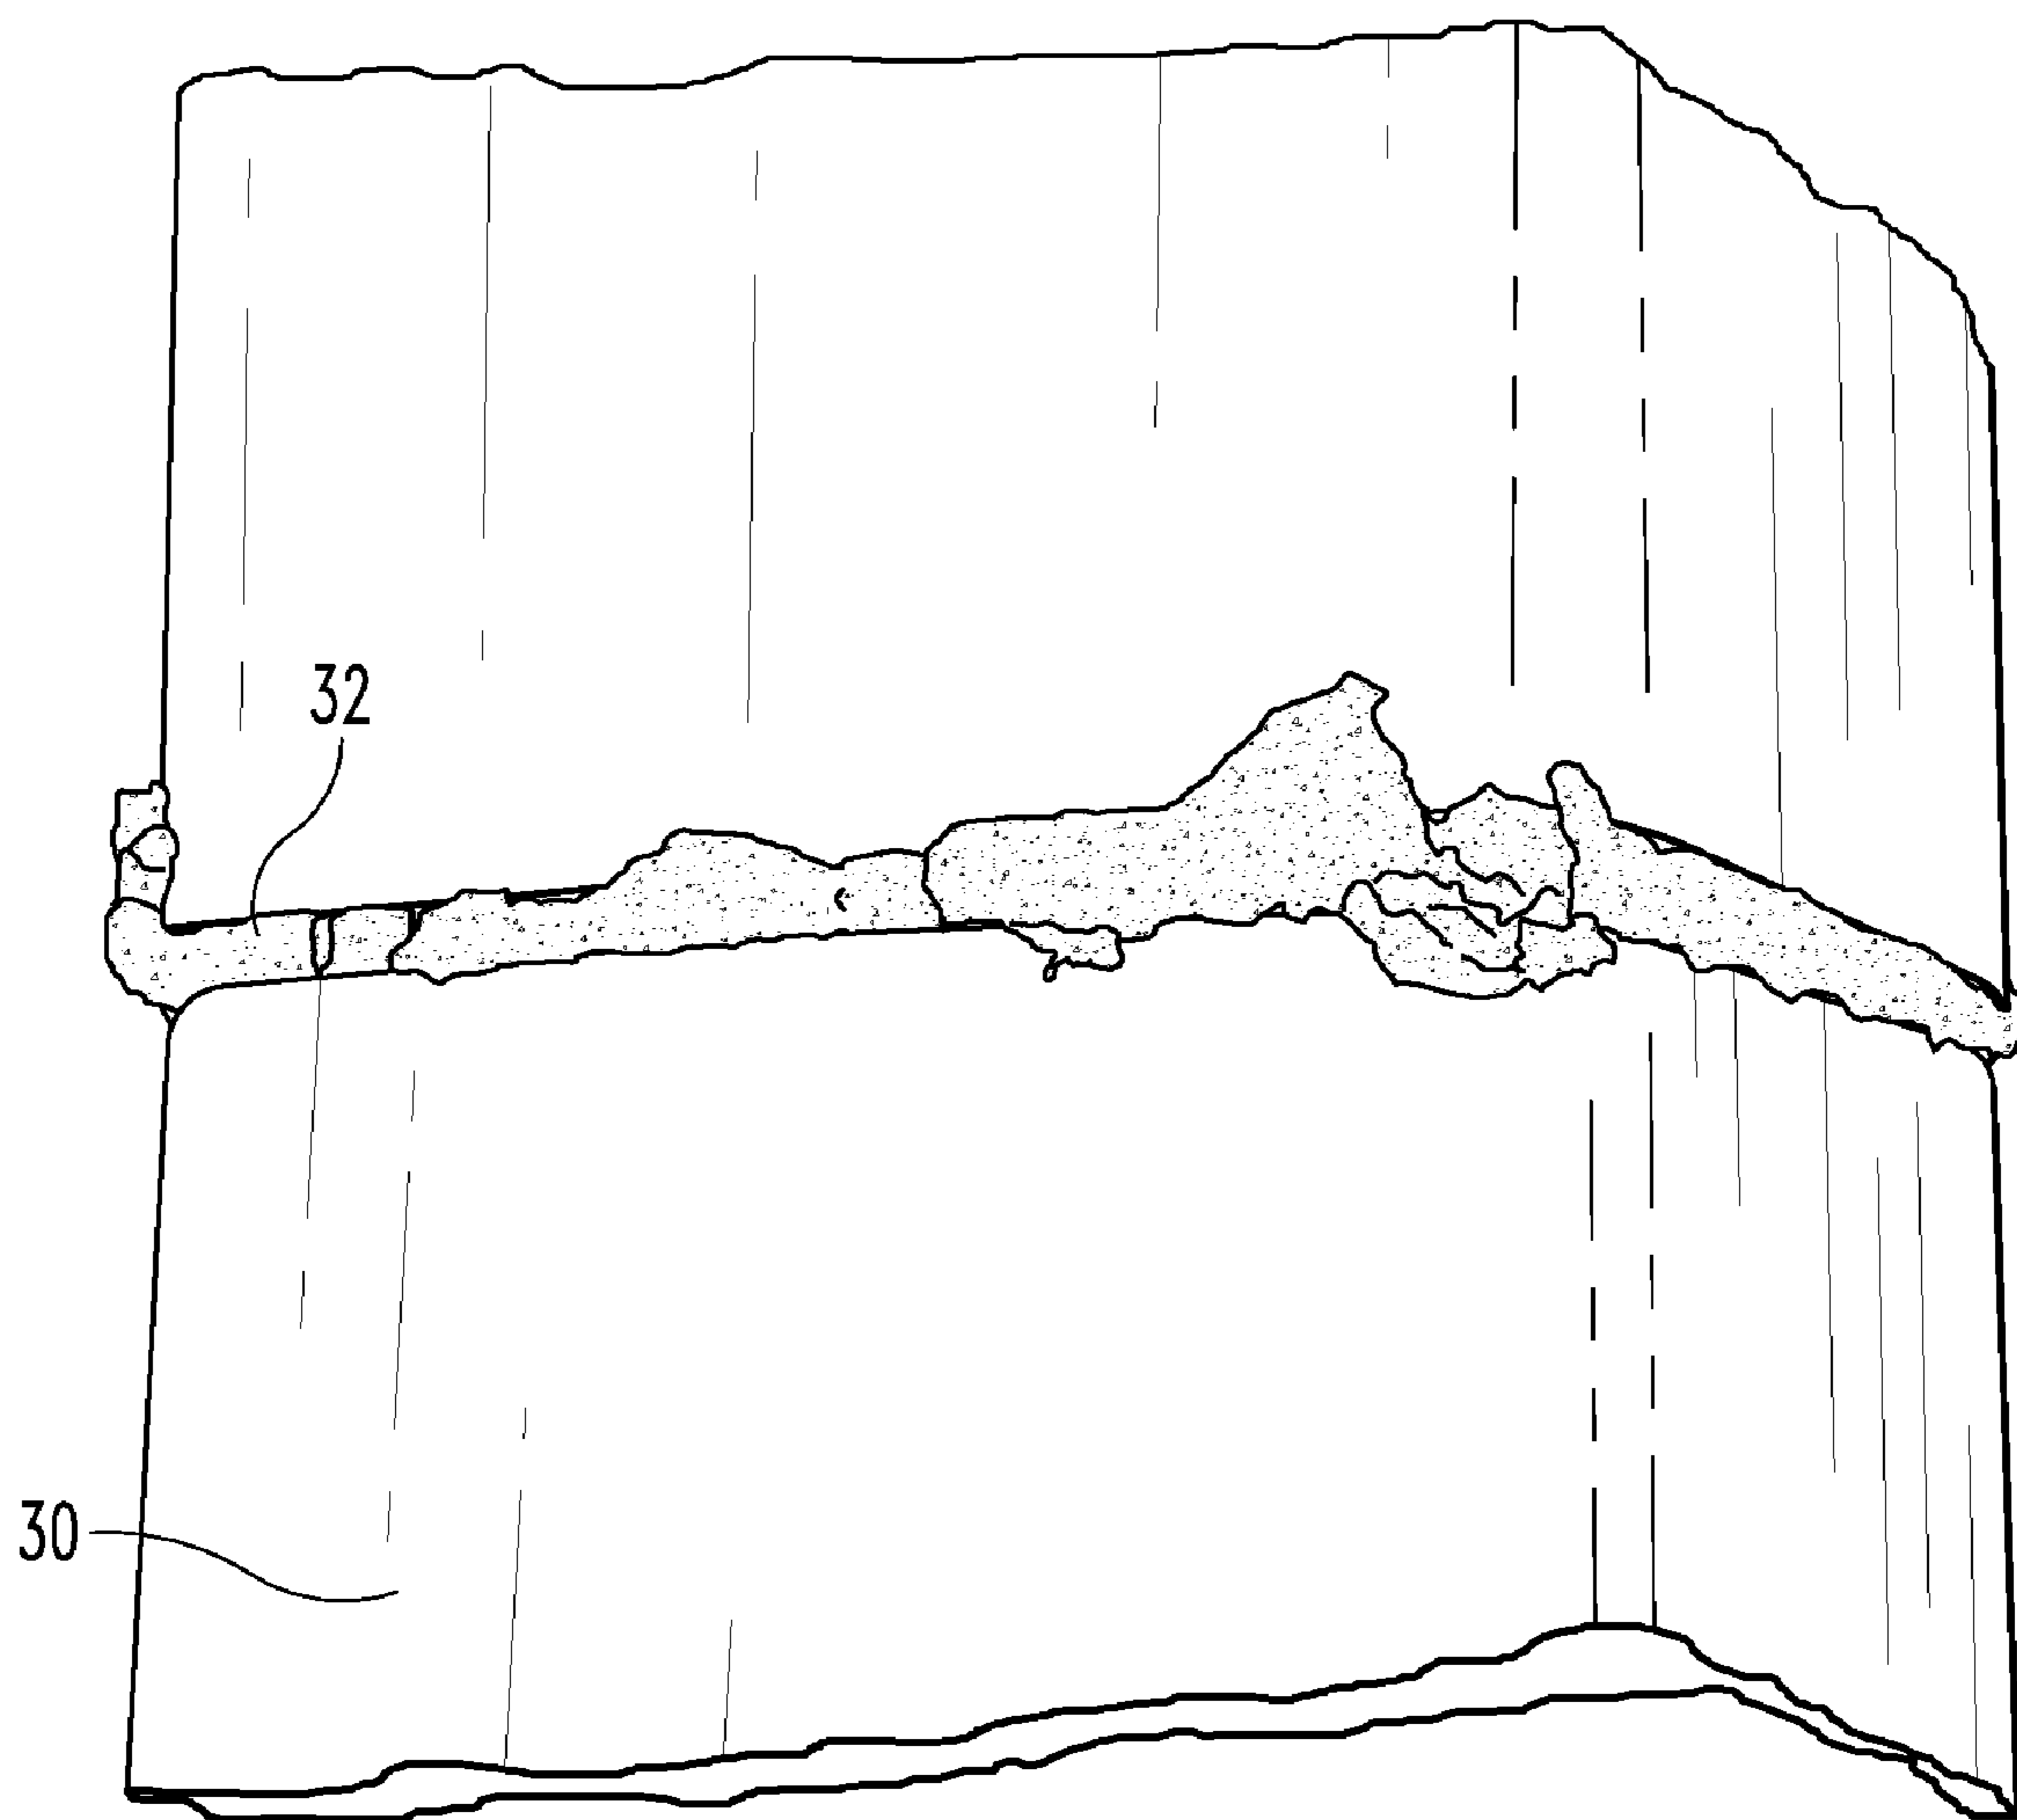
Fig. 7

FIG. 7 shows an exterior view of a chimney joint filled with mortar after being repaired by the inventive tool according to the inventive method, according to one embodiment.

FIG. 7 shows an exterior view of a chimney joint filled with mortar after being repaired by the inventive tool according to the inventive method. Mortar or other repair material 32 fills the joint in the repaired chimney 30.
