US008402633B2

(54) **METHOD FOR REPAIRING SELF-PIERCING RIVETED WORKPIECES**

(73) Assignee: **GM Global Technology Operations LLC**, Detroit, MI (US)

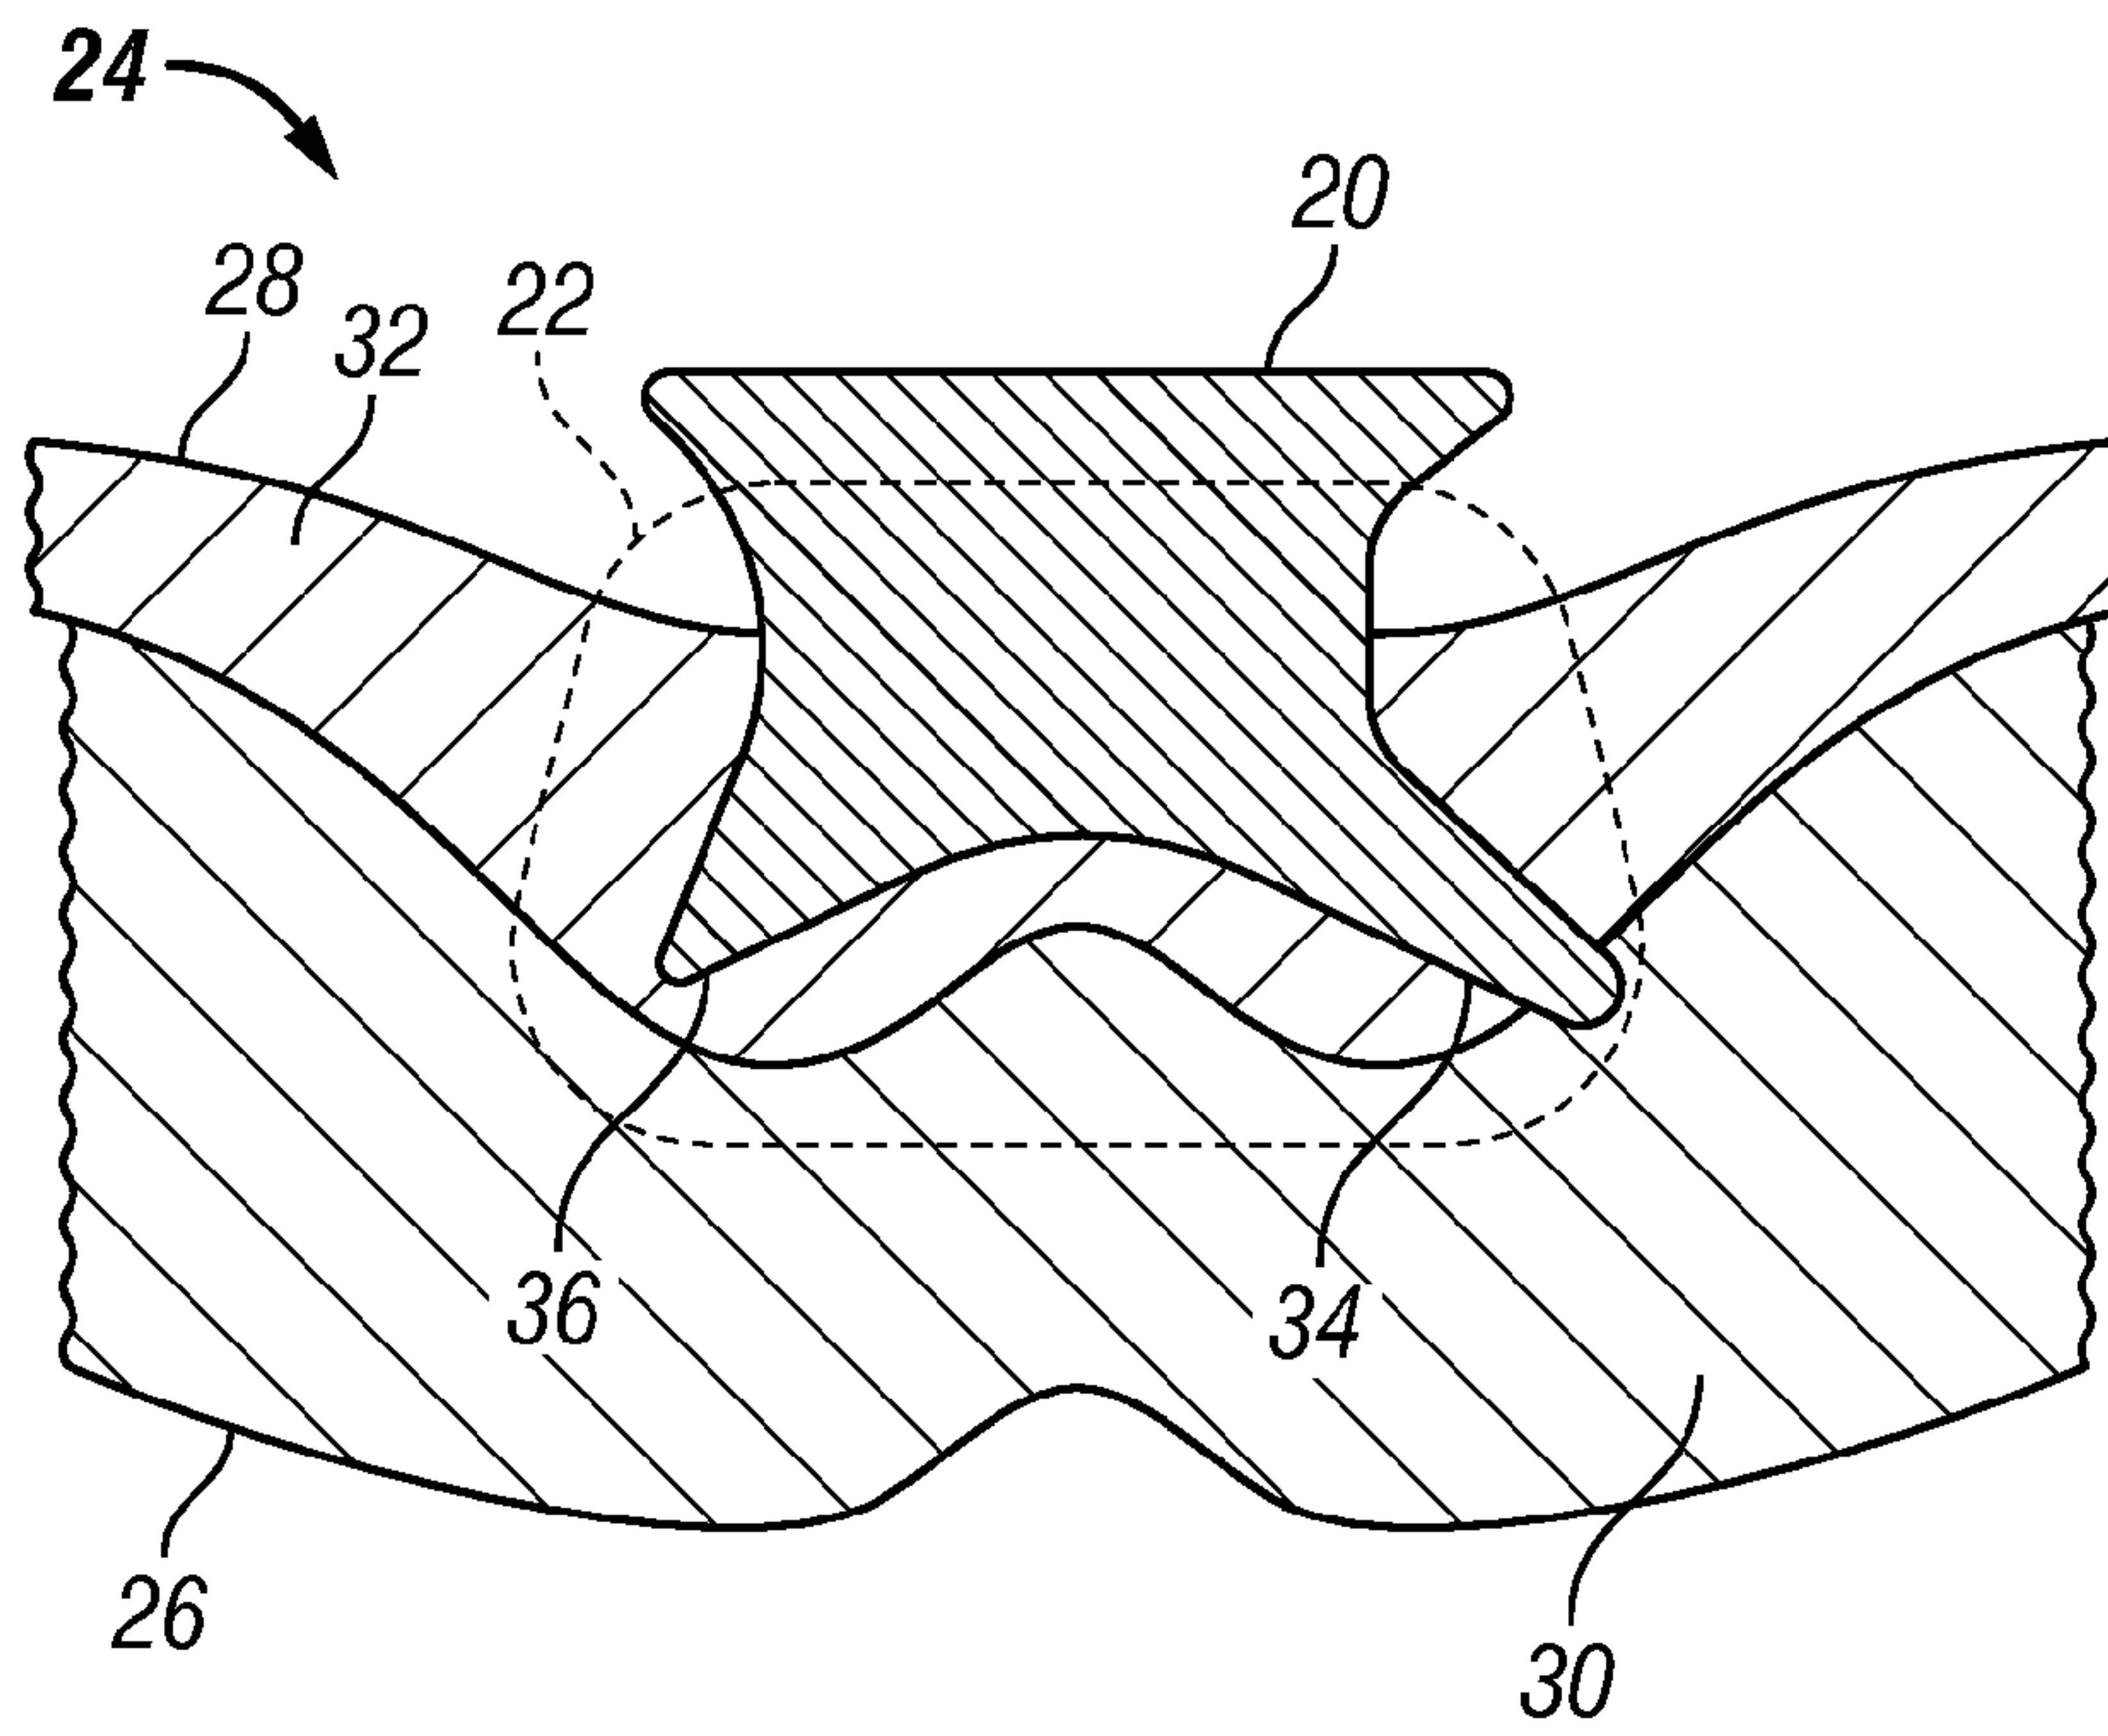
FIG. 1 is a simplified cross-sectional view of an improperly-installed-self-piercing rivet and a discrepant joint formed thereby in a workpiece;

FIG. 1 is a simplified cross-sectional view of an improperly-installed-self-piercing rivet 20 and a discrepant joint 22 formed thereby in a workpiece 24. Workpiece 24 is a metal structure having a first side 26 and a second side 28. Workpiece 24 may be joined with other workpieces (not shown) to construct any desirable structure. Examples of such structures include, but are not limited to, aircraft fuselages, ship hulls, and structural components on automobiles.

Workpiece 20 is comprised of a first metal member 30 and a second metal member 32. First metal member 30 and second metal member 32 are generally planar members that have overlapping portions which are riveted together with self-piercing rivets. As illustrated, improperly-installed-self-piercing rivet 20 has only partially penetrated through second metal member 32. A first upset portion 34 has penetrated completely through second metal member 32 and has partially penetrated through first metal member 30. First upset portion 34 is curved in a manner that engages first metal member 30 and that mechanically joins first metal member 30 to second metal member 32. However, a second upset portion 36 has not penetrated completely through second metal member 32 and therefore does not mechanically join second metal member 32 with first metal member 30.

The failure of second upset portion 36 to engage with first metal member 30 causes the joint to be discrepant. Various methods of repairing discrepant joints will be discussed below.

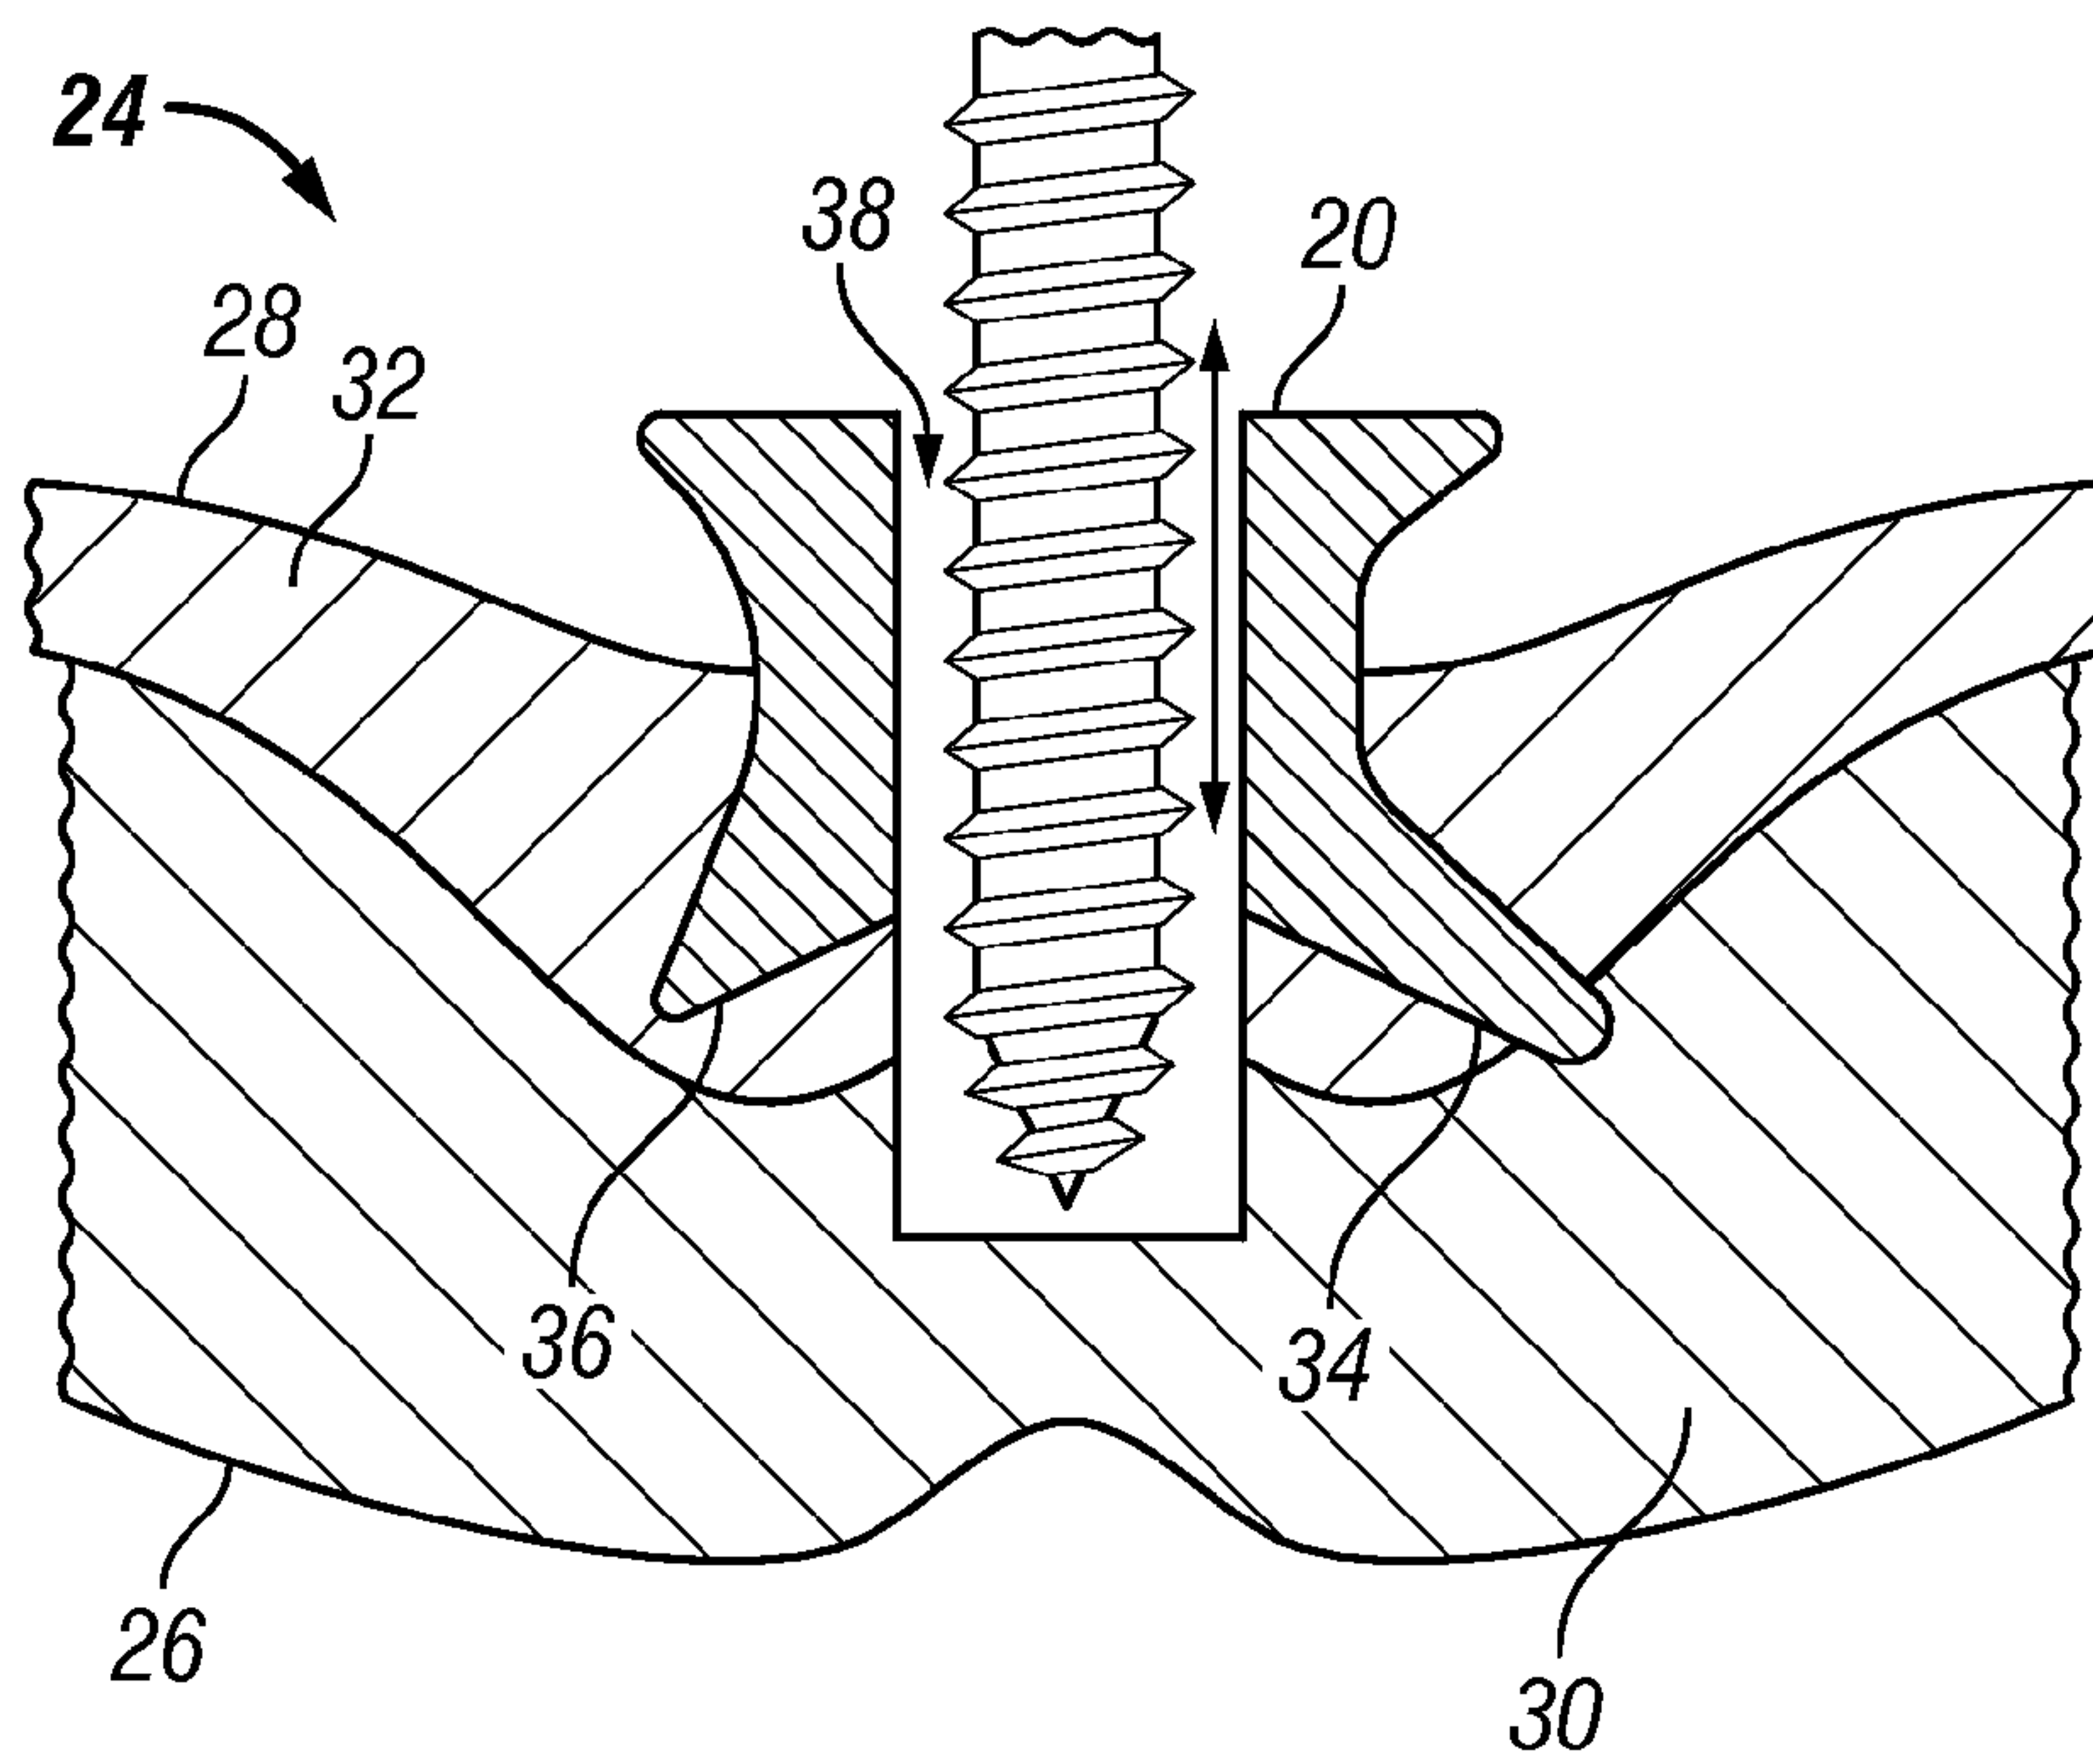
FIG. 2 is a simplified cross-sectional view illustrating drilling a hole in the improperly-installed-self-piercing rivet that extends through a portion of the workpiece;

FIG. 2 is a simplified cross-sectional view illustrating drilling a hole 38 in improperly-installed-self-piercing rivet 20 that extends through a portion of workpiece 24. In the illustrated example, hole 38 is drilled through an approximate center of improperly-installed-self-piercing rivet 20. In other examples, hole 38 may be drilled through any suitable portion of improperly-installed-self-piercing rivet 20, and at any suitable angle. Hole 38 extends completely through improperly-installed-self-piercing rivet 20, completely through second metal member 32 and partially through first metal member 30.

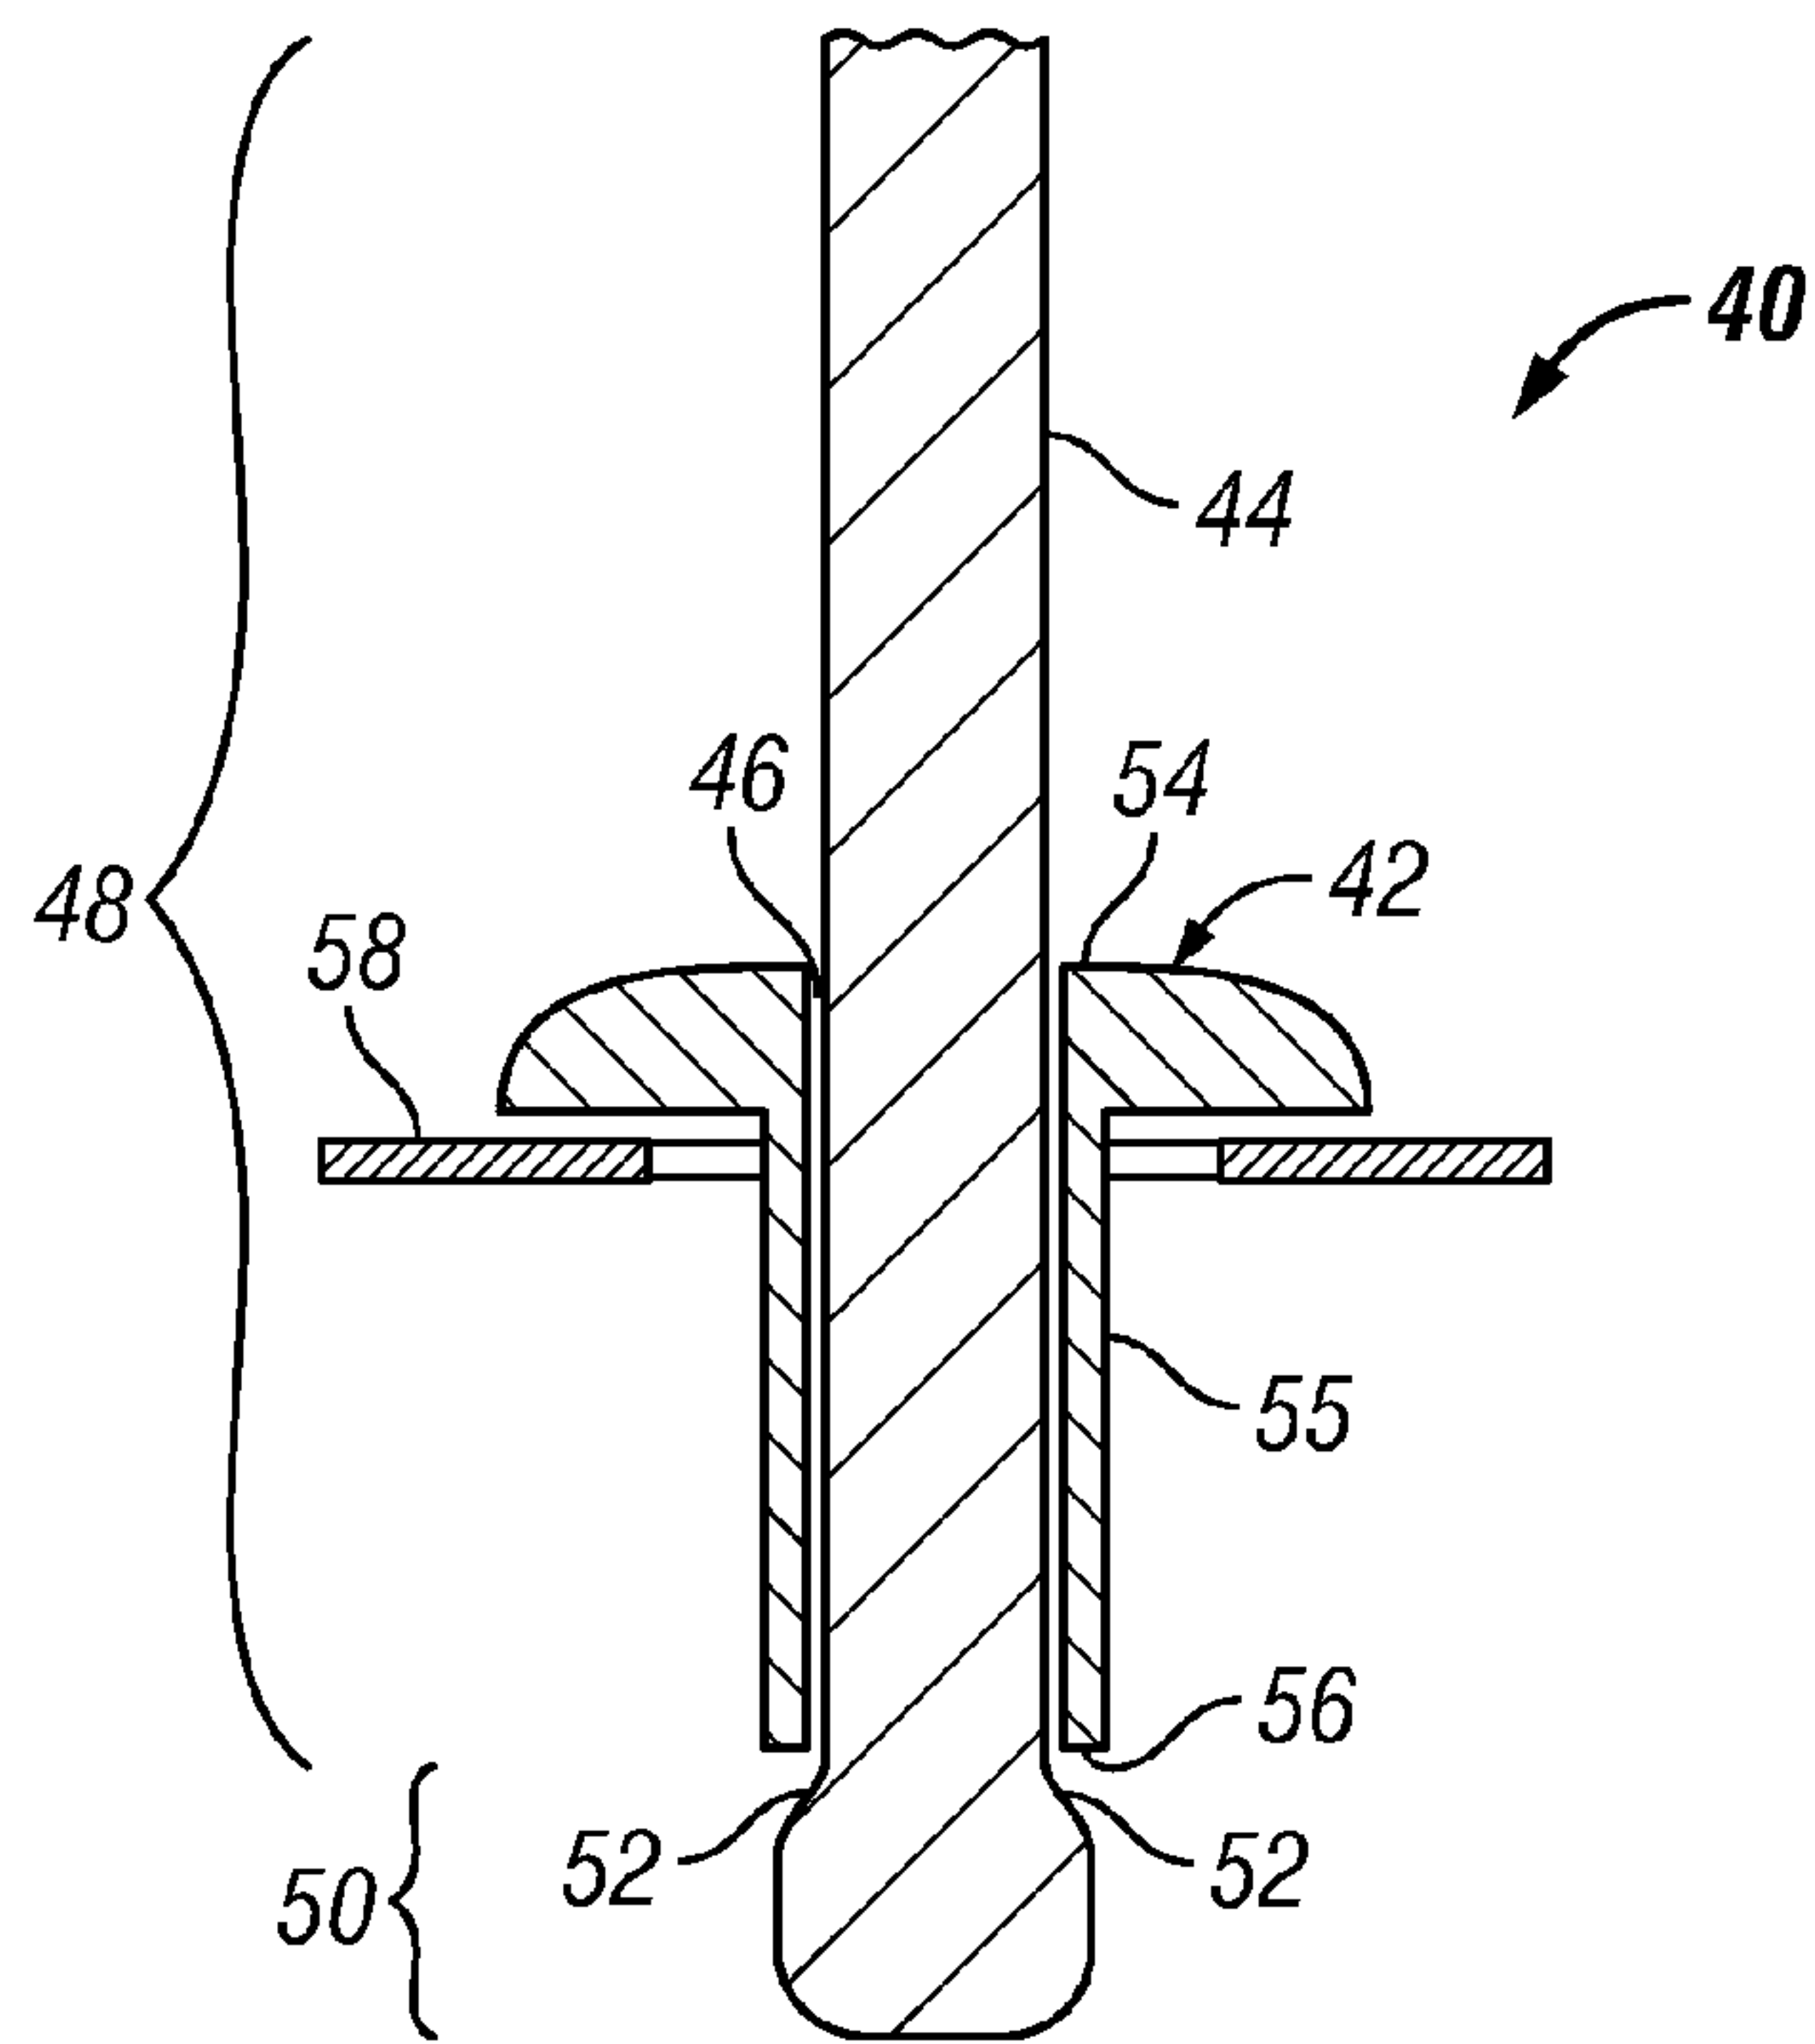
FIG. 3 is a simplified cross-sectional view illustrating a blind rivet assembly including a blind rivet and a mandrel;

FIG. 3 is a simplified cross-sectional view illustrating a blind rivet assembly 40 (also referred to herein as a repair rivet) including a blind rivet 42 and a mandrel 44. A hole 46 extends longitudinally completely through blind rivet 42. Hole 46 is configured to receive a shaft portion 48 of mandrel 44 and to permit mandrel 44 to slide inwardly and outwardly with respect to blind rivet 42. Mandrel 44 includes a head portion 50 having a diameter that is larger than a diameter of shaft portion 48. An upper area 52 of head portion 50 is configured to meet shaft portion 48 at an obtuse angle.

Blind rivet 42 includes a head portion 54, a shaft portion 55, and an annular end portion 56. Head portion 50 of mandrel 44 has a larger diameter than annular end portion 56 and is therefore obstructed from movement into hole 46. A sealant 58, in the form of a washer, is placed around an outer portion of shaft portion 55. Sealant 58 may be made of any suitable material, including, but not limited to, metal, rubber and polymeric materials. In some embodiments, sealant 58 may be an adhesive and in other embodiments, sealant 58 may be a bonding material that is configured to be cured through the application of heat, ultra-violet light, or by other means.

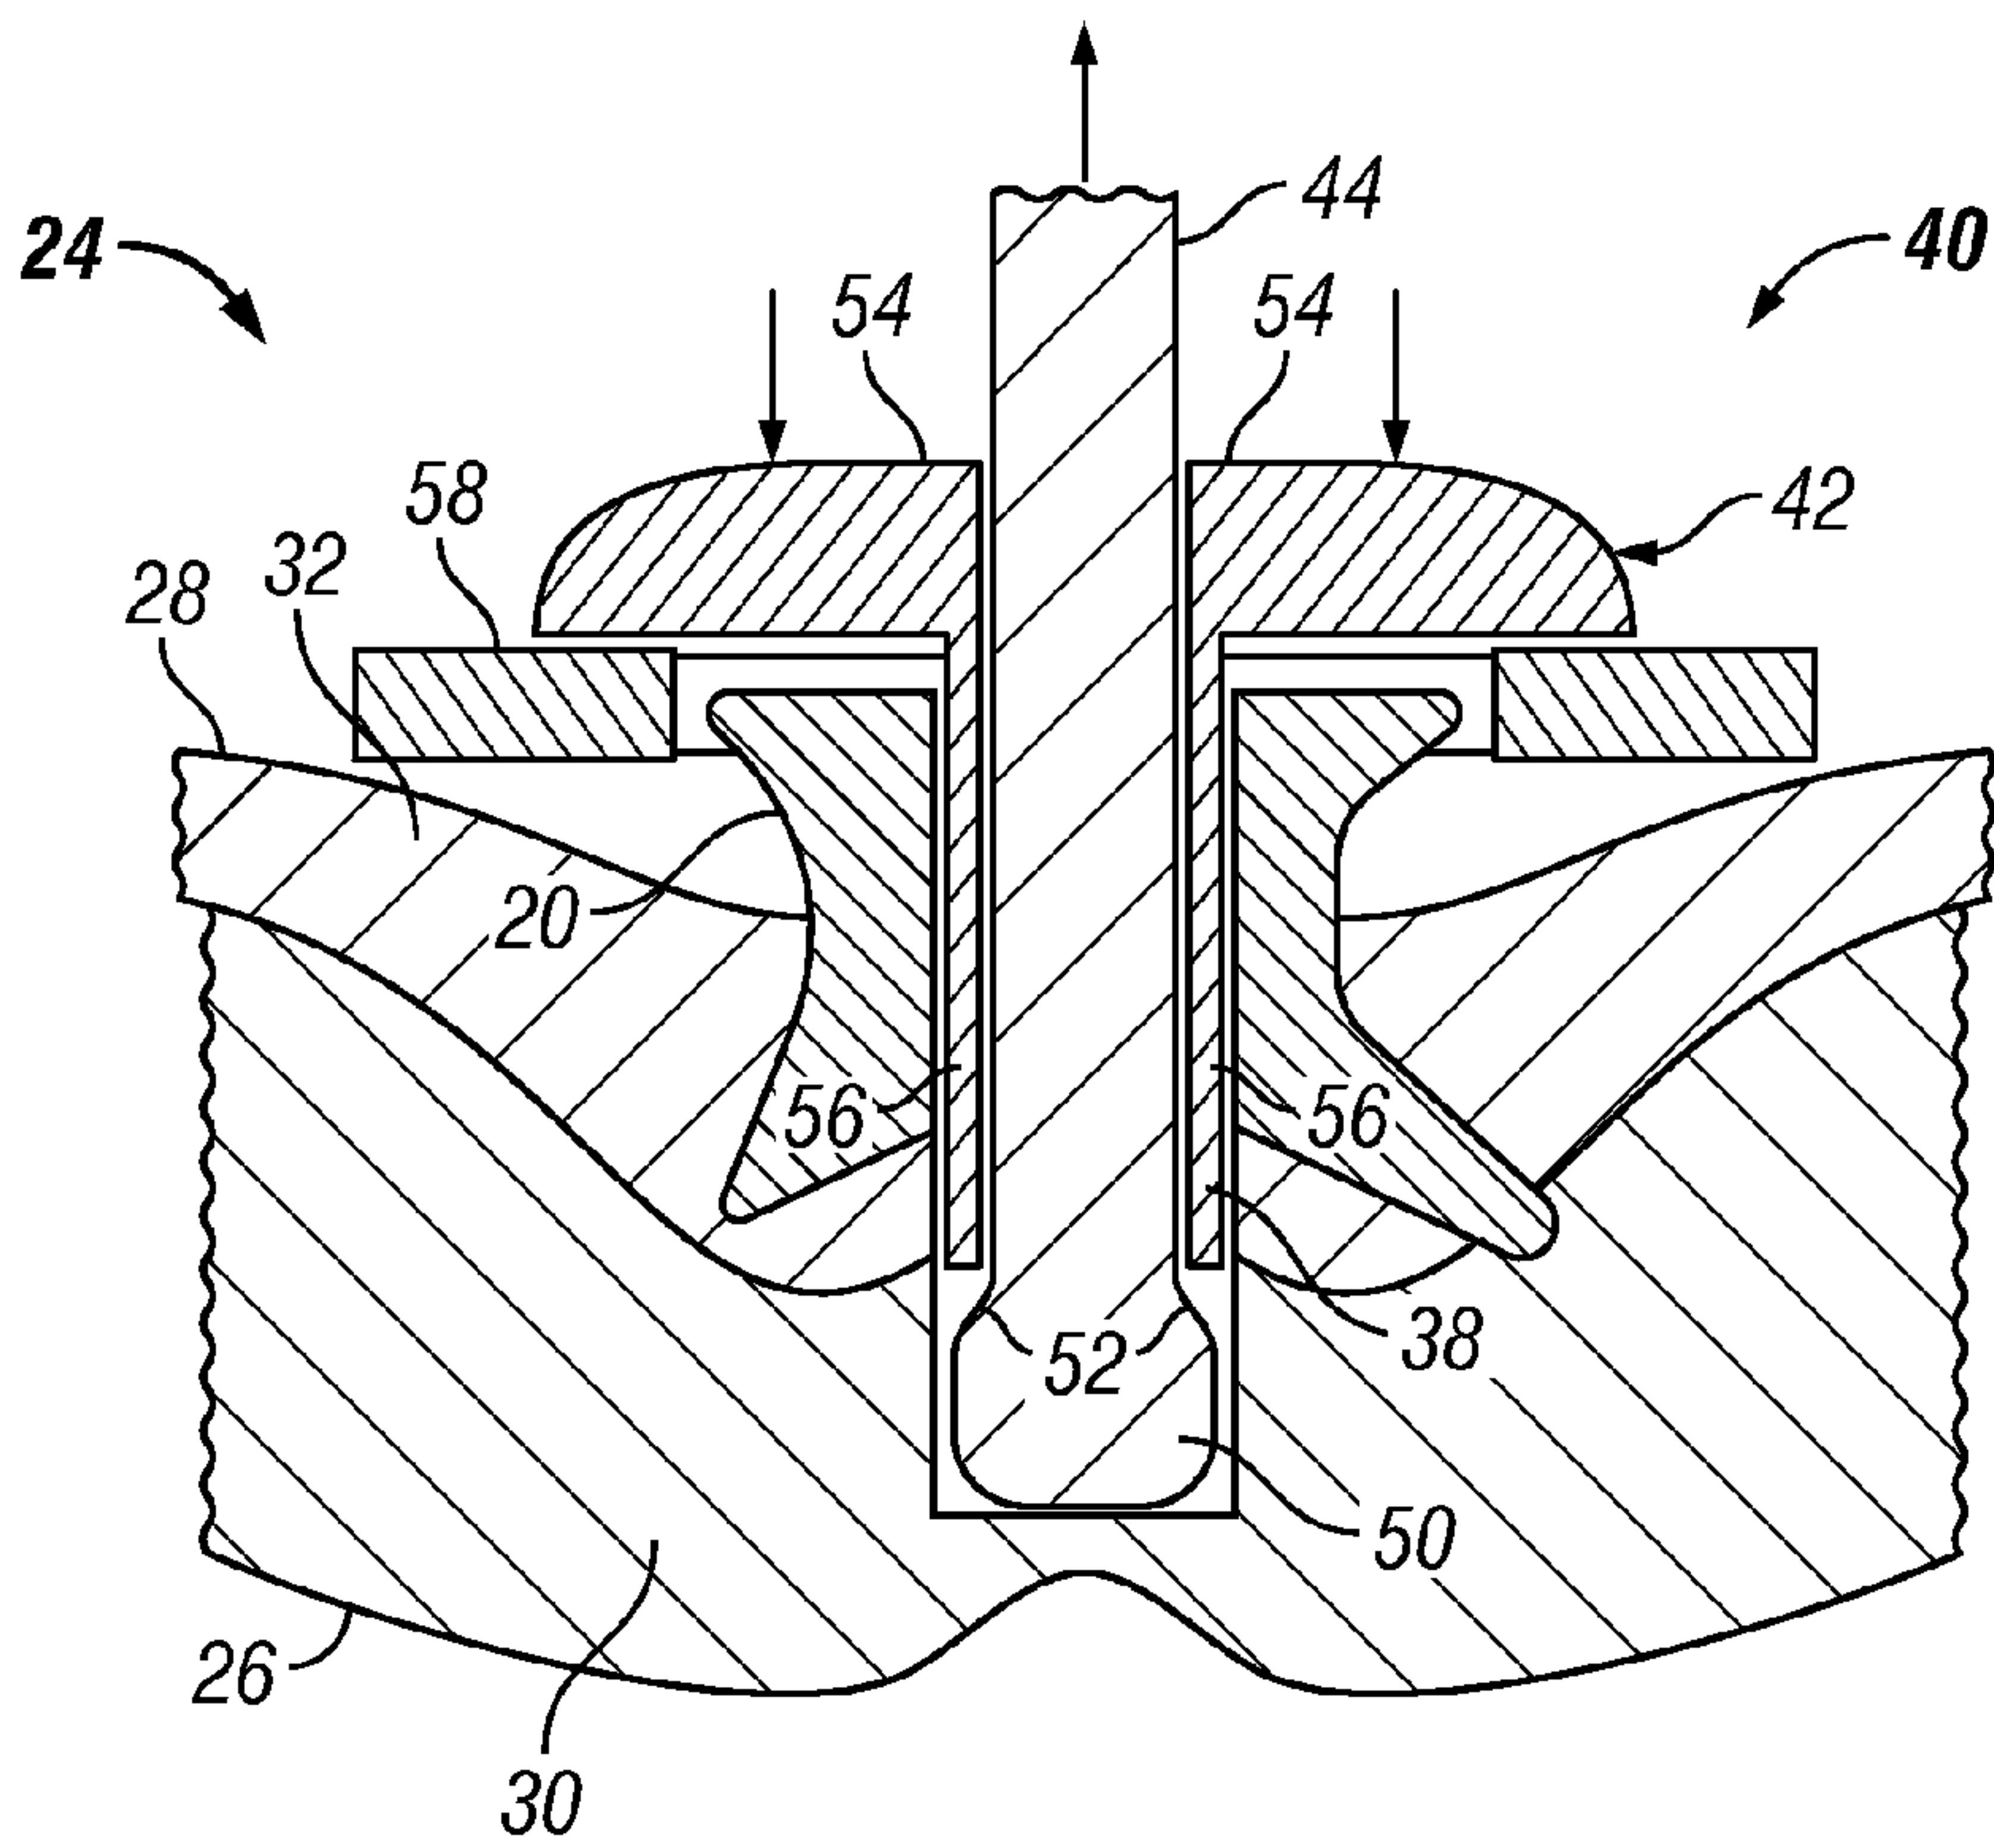
FIG. 4 is a simplified cross-sectional view illustrating insertion of the blind rivet assembly into the hole and pulling on the mandrel;

FIG. 4 is a simplified cross-sectional view illustrating insertion of blind rivet assembly 40 into hole 38 and pulling on mandrel 44. As illustrated, blind rivet assembly 40 is sized to extend far into hole 38 by a distance that permits annular end portion 56 to reside within first metal member 30. Mandrel 44 is pulled in an upward direction as a downward or bracing force is applied on head portion 54. This combination of forces drives the angled upper portion of head 52 into annular end portion 56.

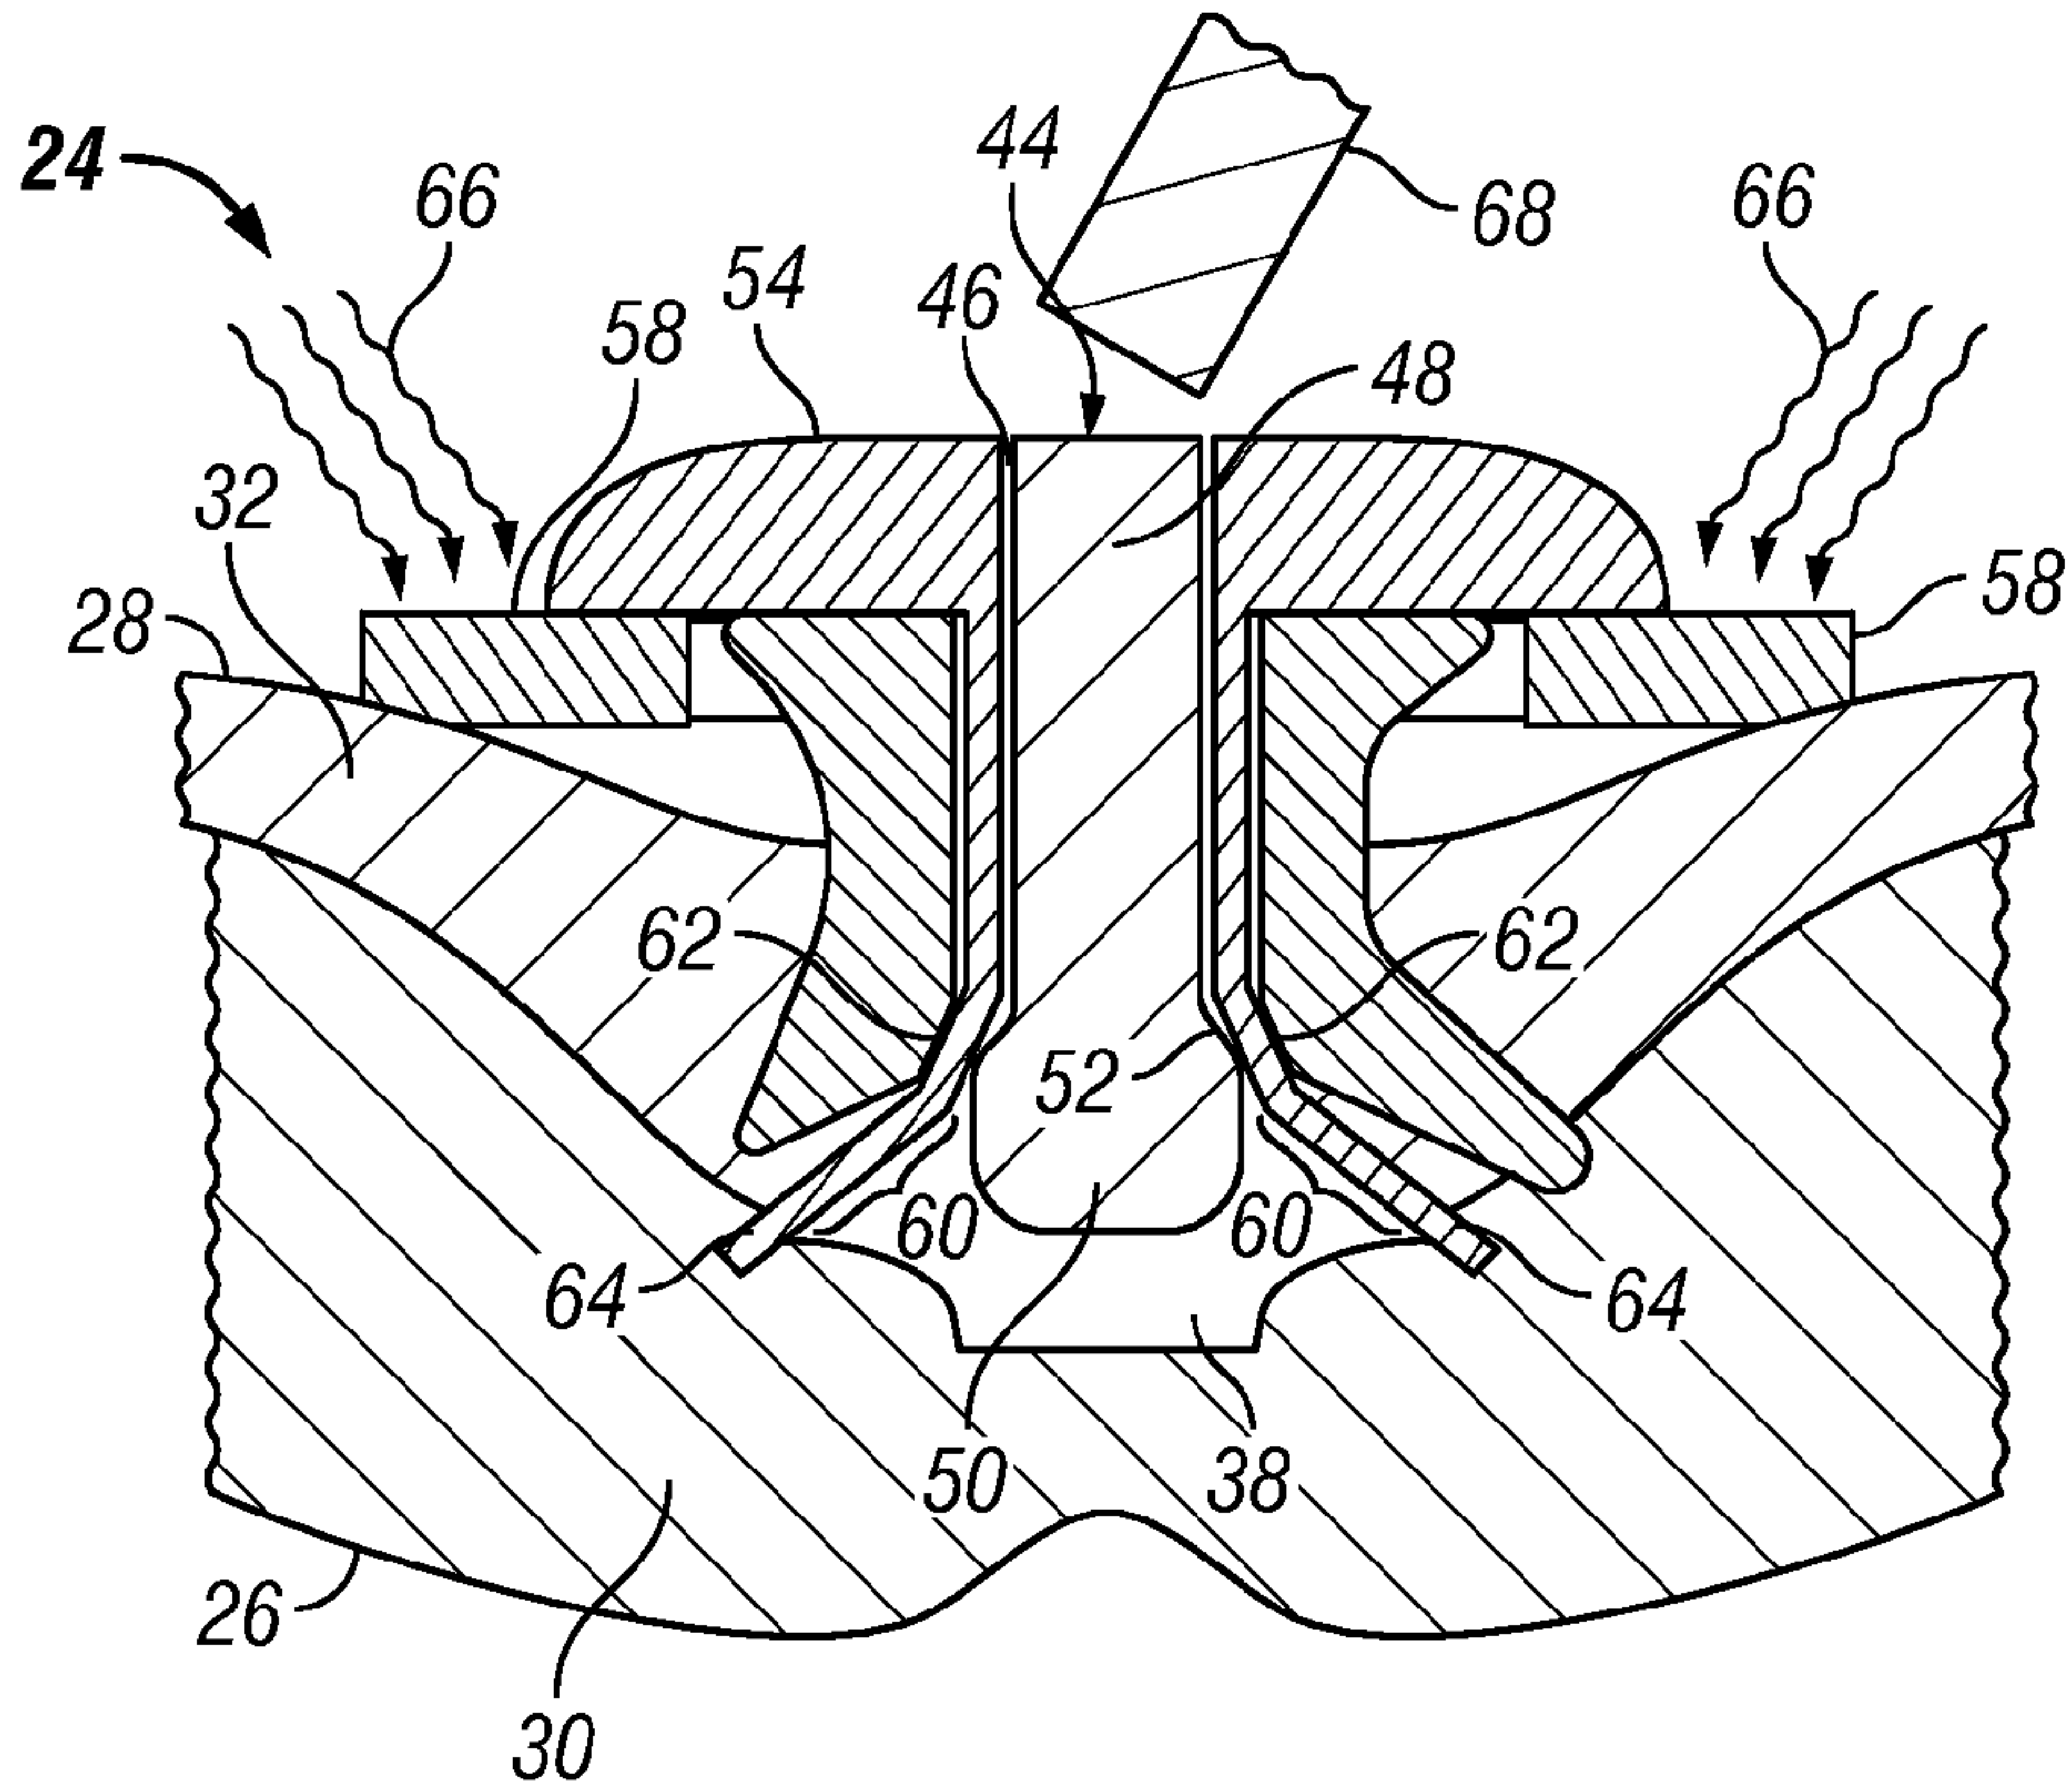
FIG. 5 is a simplified cross-sectional view illustrating the creation of an upset portion of the blind rivet and engagement of the upset portion with the workpiece and with the improperly-installed-self-piercing rivet;

FIG. 5 is a simplified cross-sectional view illustrating the creation of an upset portion 60 of blind rivet 42 and engagement of upset portion 60 with workpiece 24 and with improperly-installed-self-piercing rivet 20. Head portion 50 of mandrel 44 has been driven upwards into hole 46 in blind rivet 42 causing the annular end portion to rupture and form upset portions 60. Upset portion 60 engages with improperly-installed-self-piercing rivet 20 at engagement area 62 and with first metal member 30 at engagement area 64. In this manner, upset portion 60 strengthens the connection between first metal member 30 and second metal member 32, thus repairing the discrepant joint. It should be understood that the illustration, and in particular, upset portion 60, has been exaggerated for the purposes of illustration.

The force acting downwardly on head portion 54 of blind rivet 42 has driven blind rivet 42 further into workpiece 24. This, in turn, has permitted sealant 58 to compress against second side 28 to form a water tight seal around blind rivet 42. Additionally, sealant 58 is cured by the application of heat energy 66 to sealant 58. A top portion 68 has been severed from shaft portion 48. As a result, an upper surface of the remaining portion of mandrel 44 is generally flush with an upper end of head portion 54 of blind rivet 42. Top portion 68 may be severed by any suitable means including, but not limited to, the use of bolt cutters, wire cutters, a blow torch or any other tool effective to cut through mandrel 44.
