US008402633B2

(54) **METHOD FOR REPAIRING SELF-PIERCING RIVETED WORKPIECES**

(73) Assignee: **GM Global Technology Operations LLC**, Detroit, MI (US)

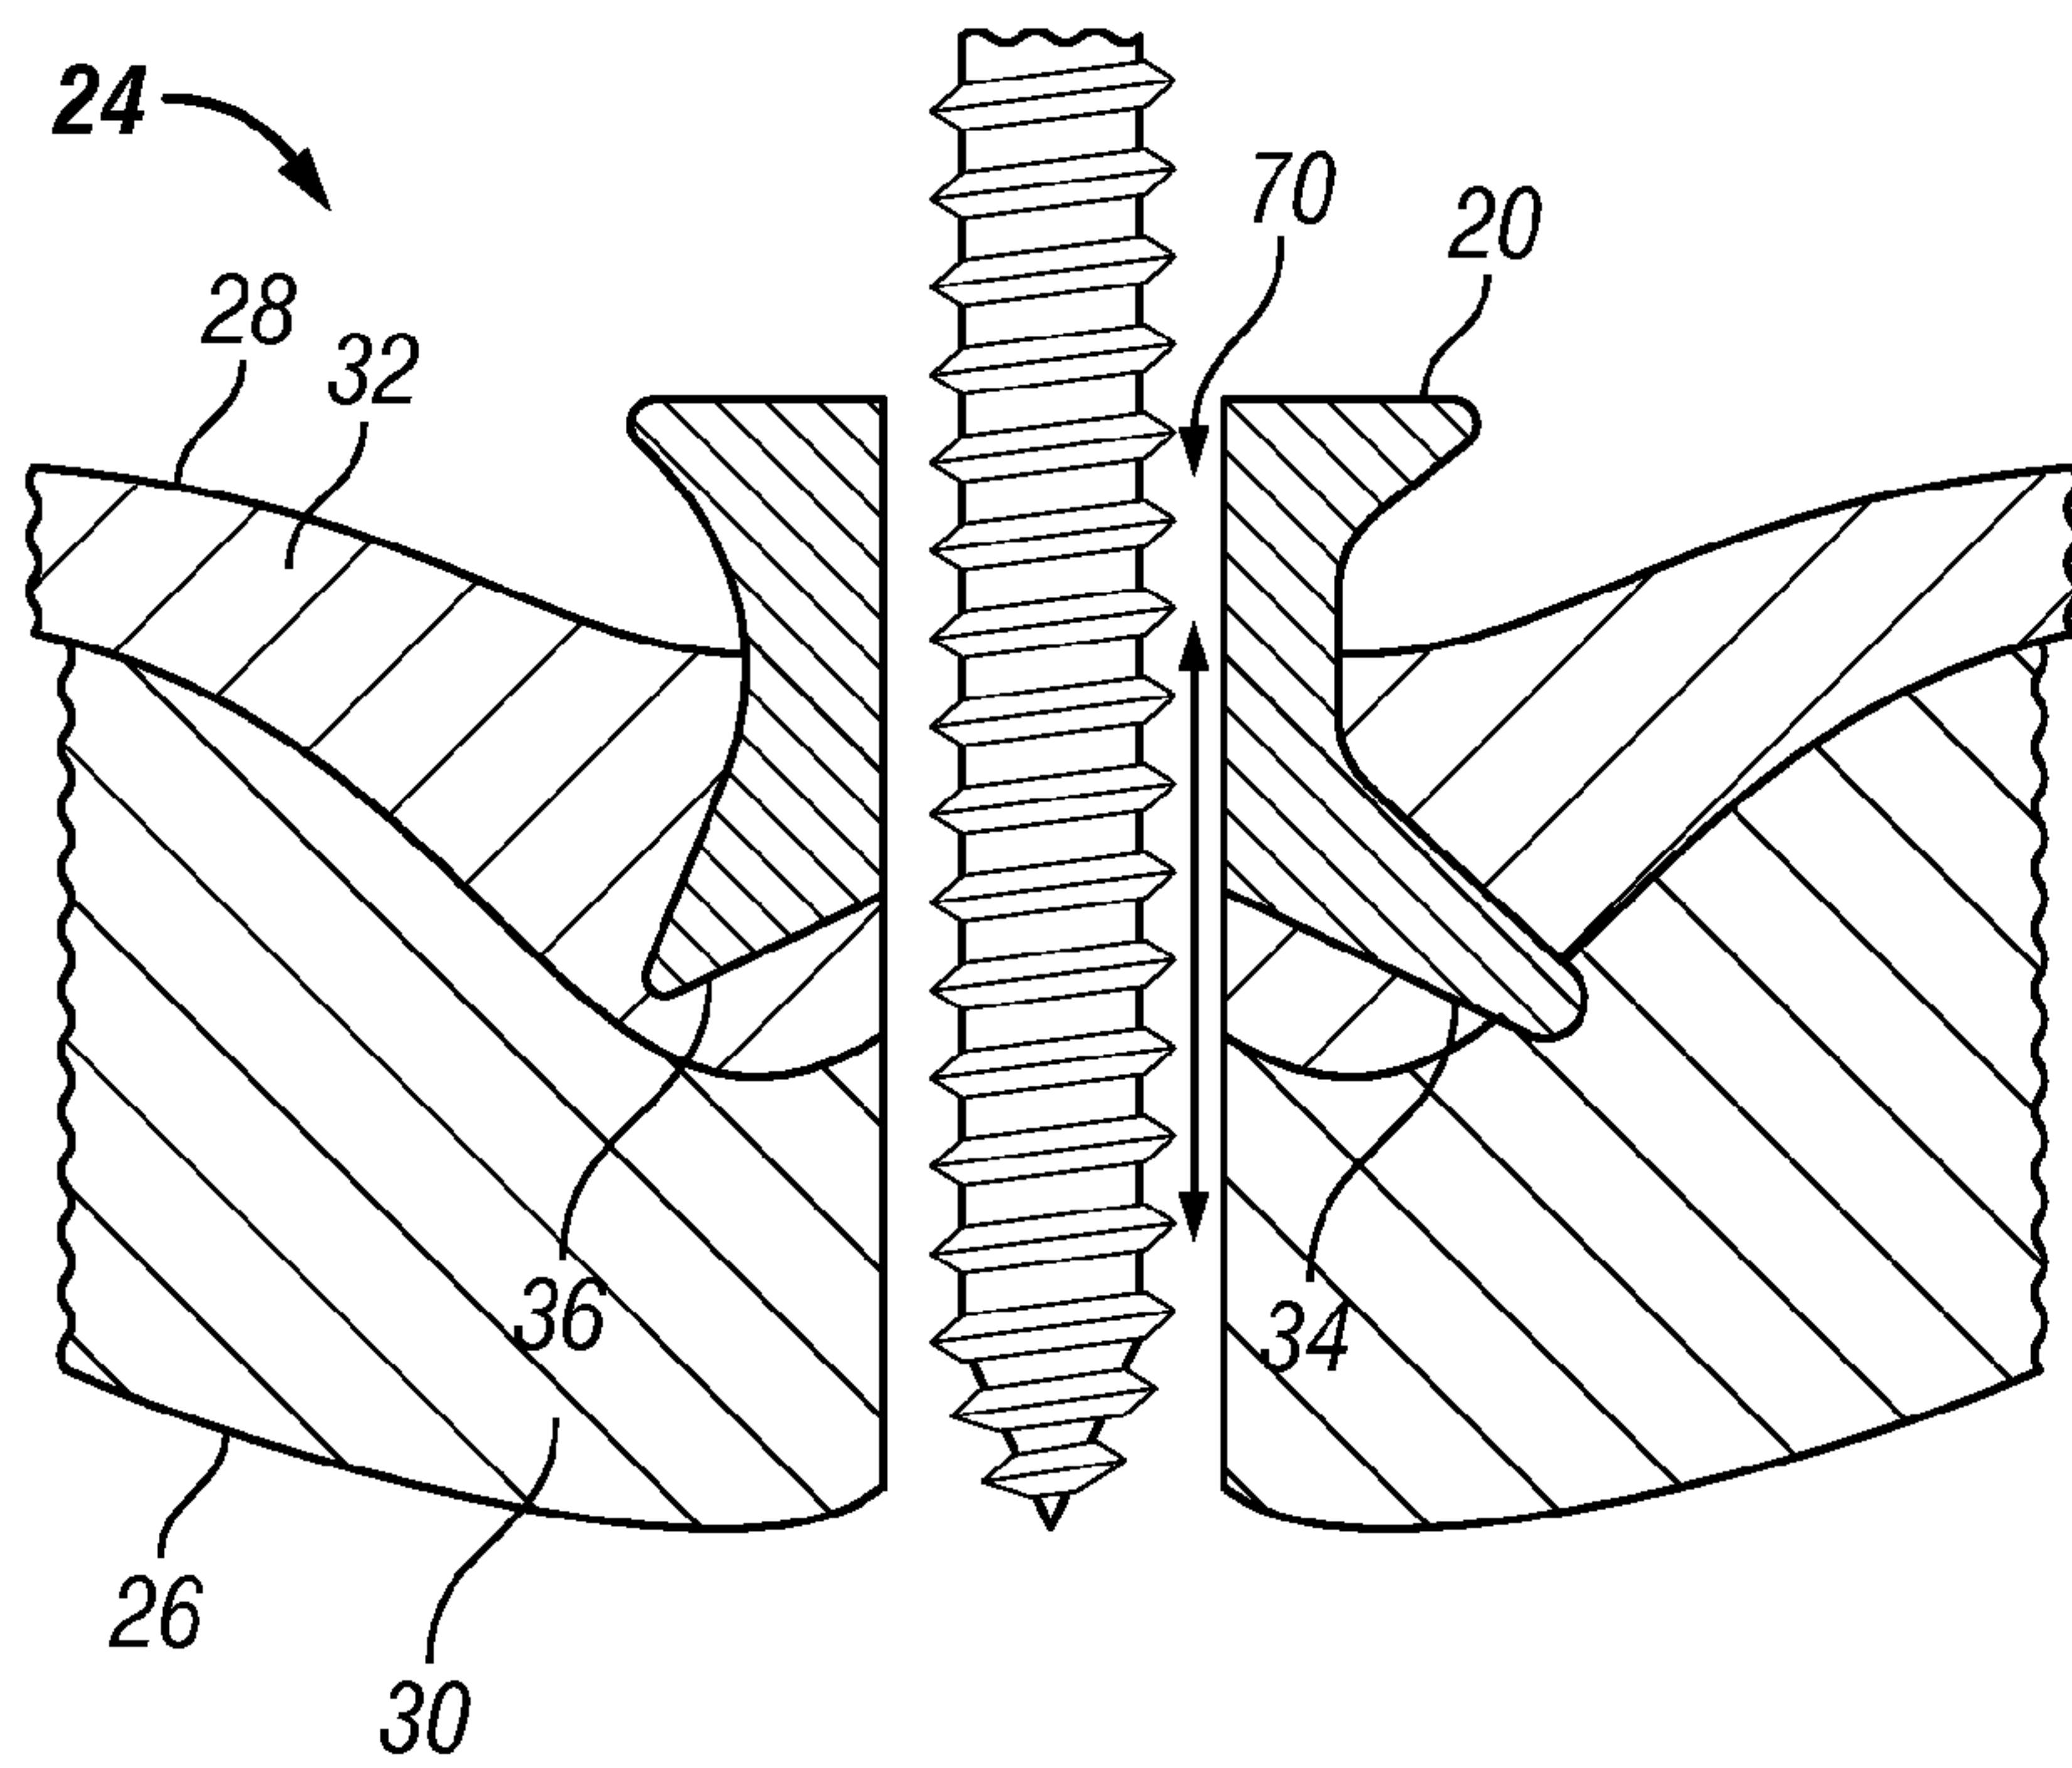
FIG. 6 is a simplified cross-sectional view illustrating drilling a hole in the improperly-installed-self-piercing rivet that extends completely through the workpiece;

FIG. 6 is a simplified cross-sectional view illustrating drilling a hole 70 in improperly-installed-self-piercing rivet 20 that extends completely through workpiece 24. In the illustrated example, hole 70 is drilled through the center of improperly-installed-self-piercing rivet 20. In other examples, hole 70 may be drilled through any suitable portion of improperly-installed-self-piercing rivet 20, and at any suitable angle. Hole 70 extends completely through improperly-installed-self-piercing rivet 20, completely through second metal member 32 and completely through first metal member 30.

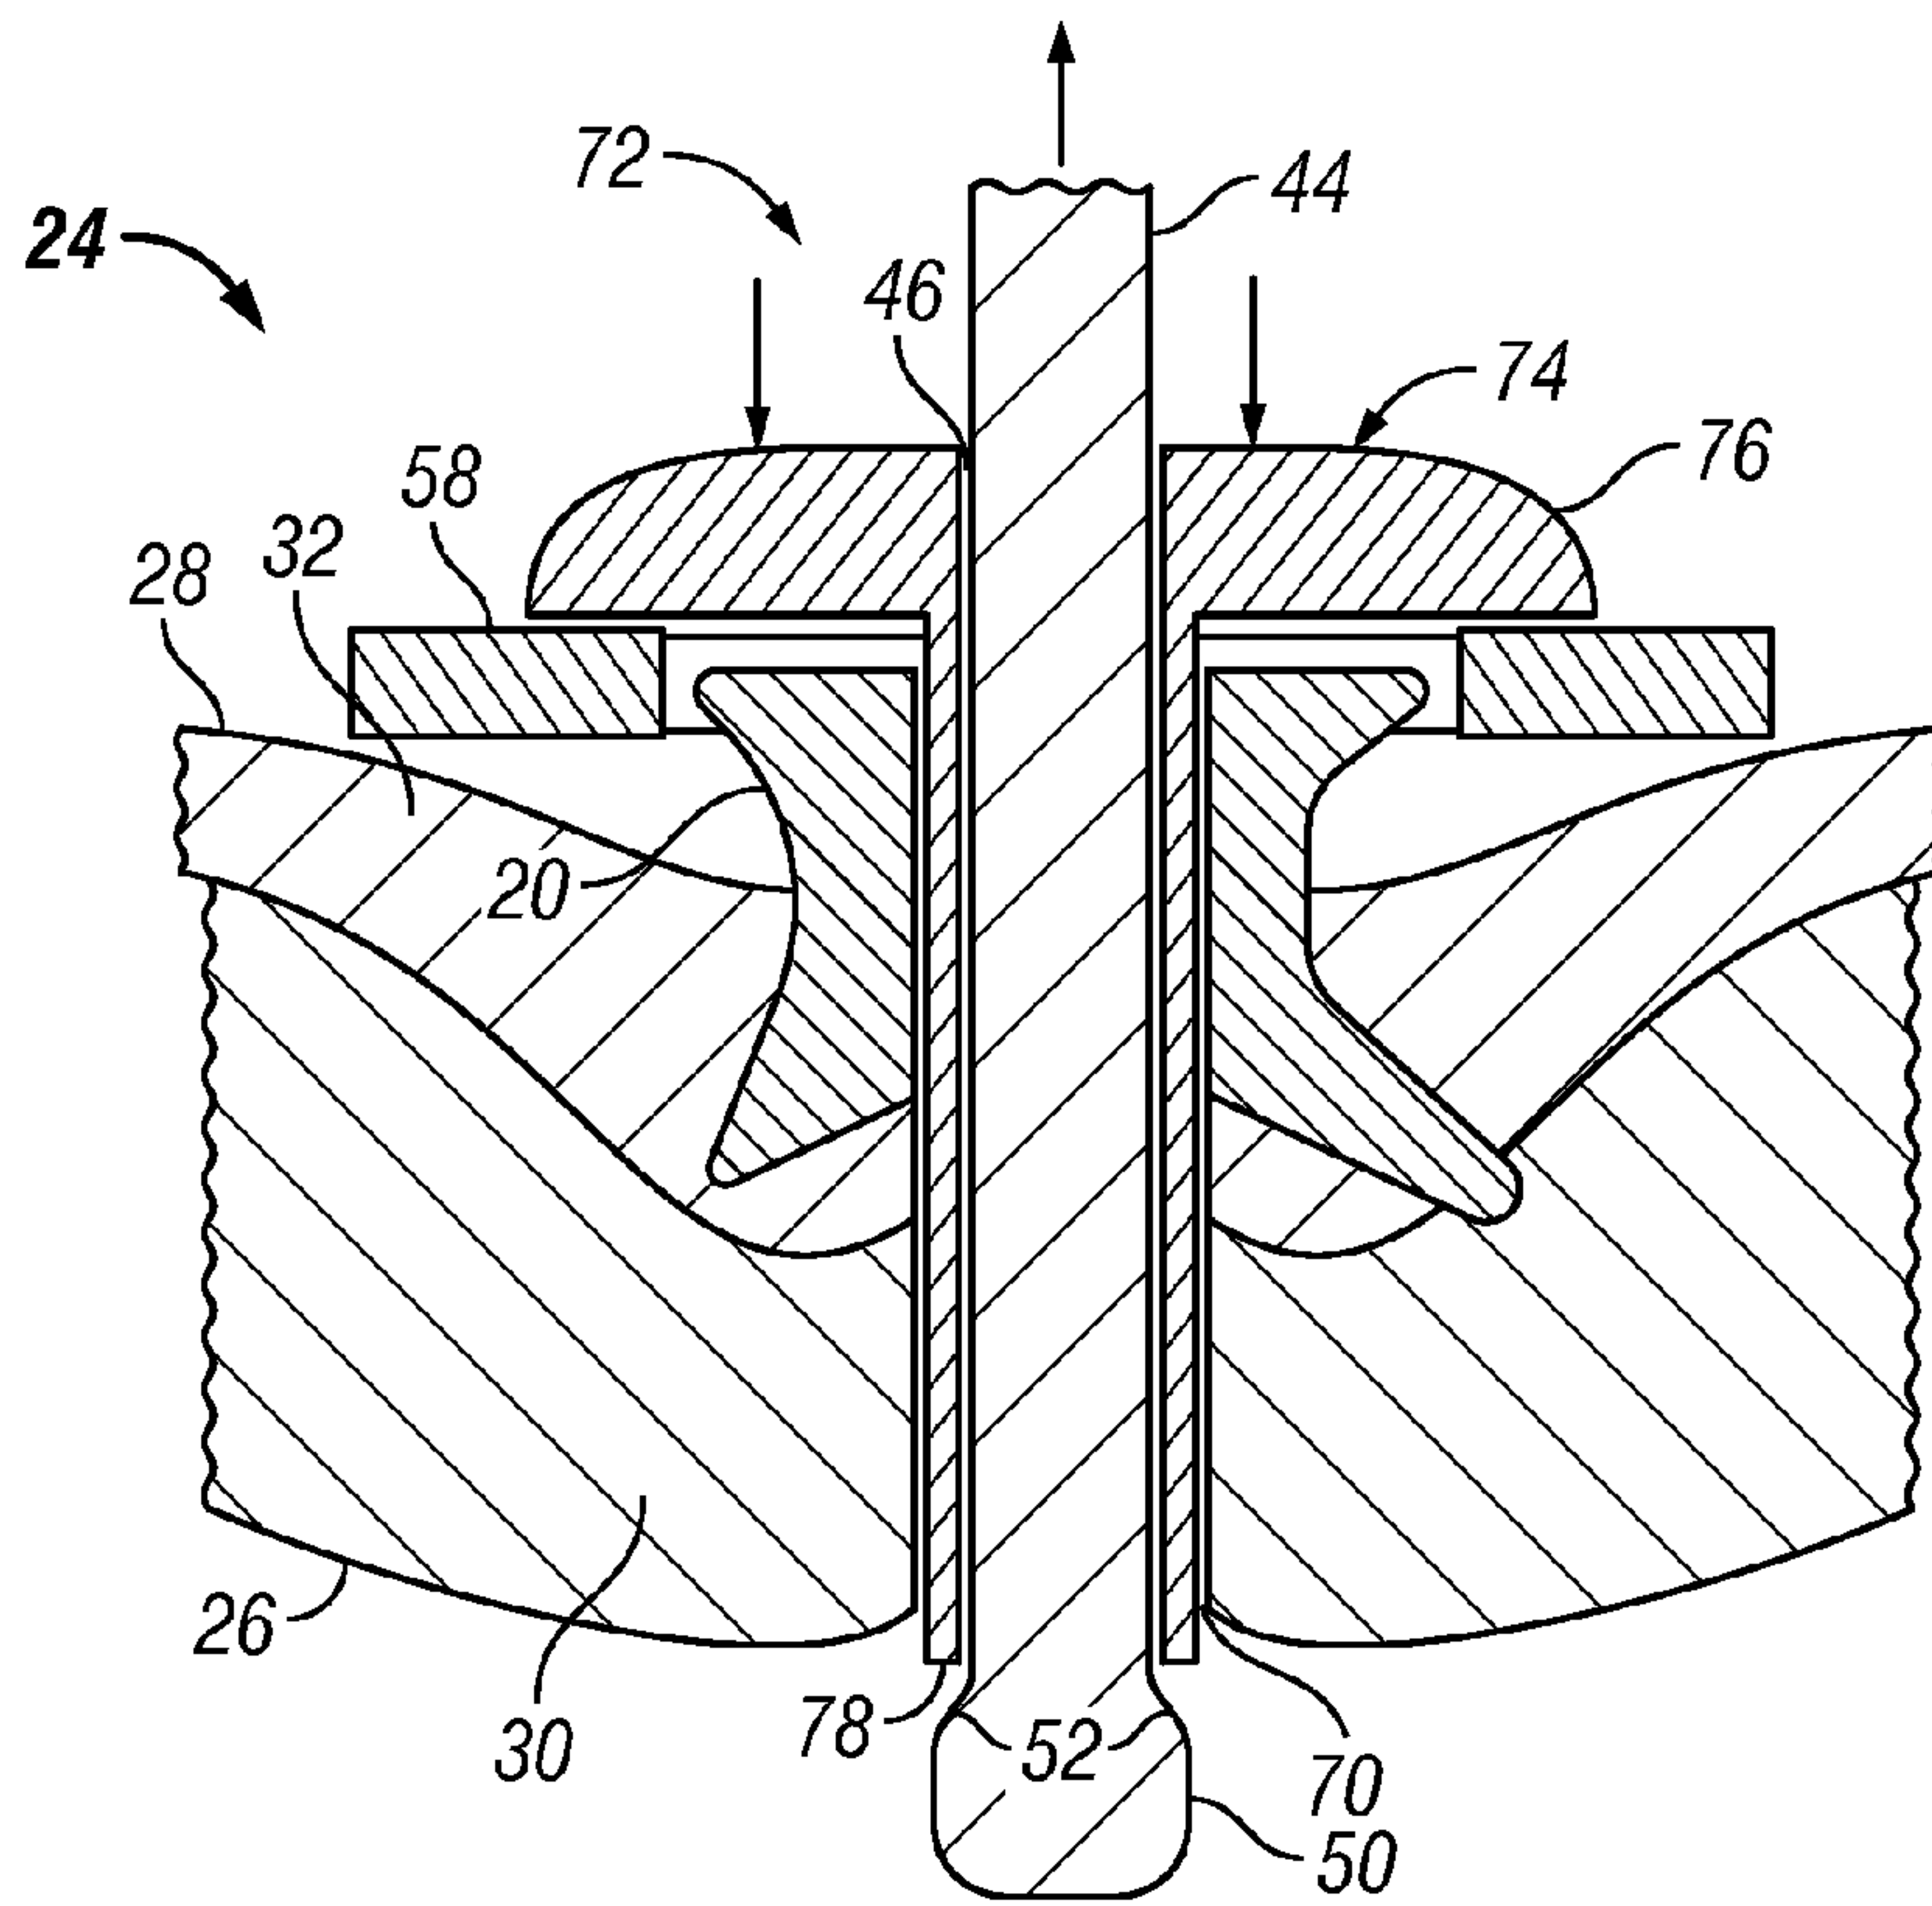
FIG. 7 is a simplified cross-sectional view illustrating insertion of the blind rivet assembly into the hole and pulling on the mandrel;

FIG. 7 is a simplified cross-sectional view illustrating insertion of a blind rivet assembly 72 into hole 70 and pulling on mandrel 44. Blind rivet assembly 72 is very similar to blind rivet assembly 40, the only difference being that blind rivet assembly 72 includes a blind rivet 74 that has a length that permits it to extend completely through hole 70 and protrude beyond first side 26 of first metal member 30. Blind rivet 74 includes a head portion 76 and an annular end portion 78. Mandrel 44 is pulled in an upward direction while a downward or bracing force is applied in a downward direction on

head 76. This combination of forces causes head portion 50 of mandrel 44 to push in an upward direction against annular end portion 78. Upper portions 52 of head portion 50 engage annular end portion 78. Upper portions 52 are angled and act as a camming surface forcing annular end portion 78 to expand in an outward direction. When mandrel 44 is pulled hard enough, annular end portion 78 will rupture and form an upset portion of blind rivet 74.

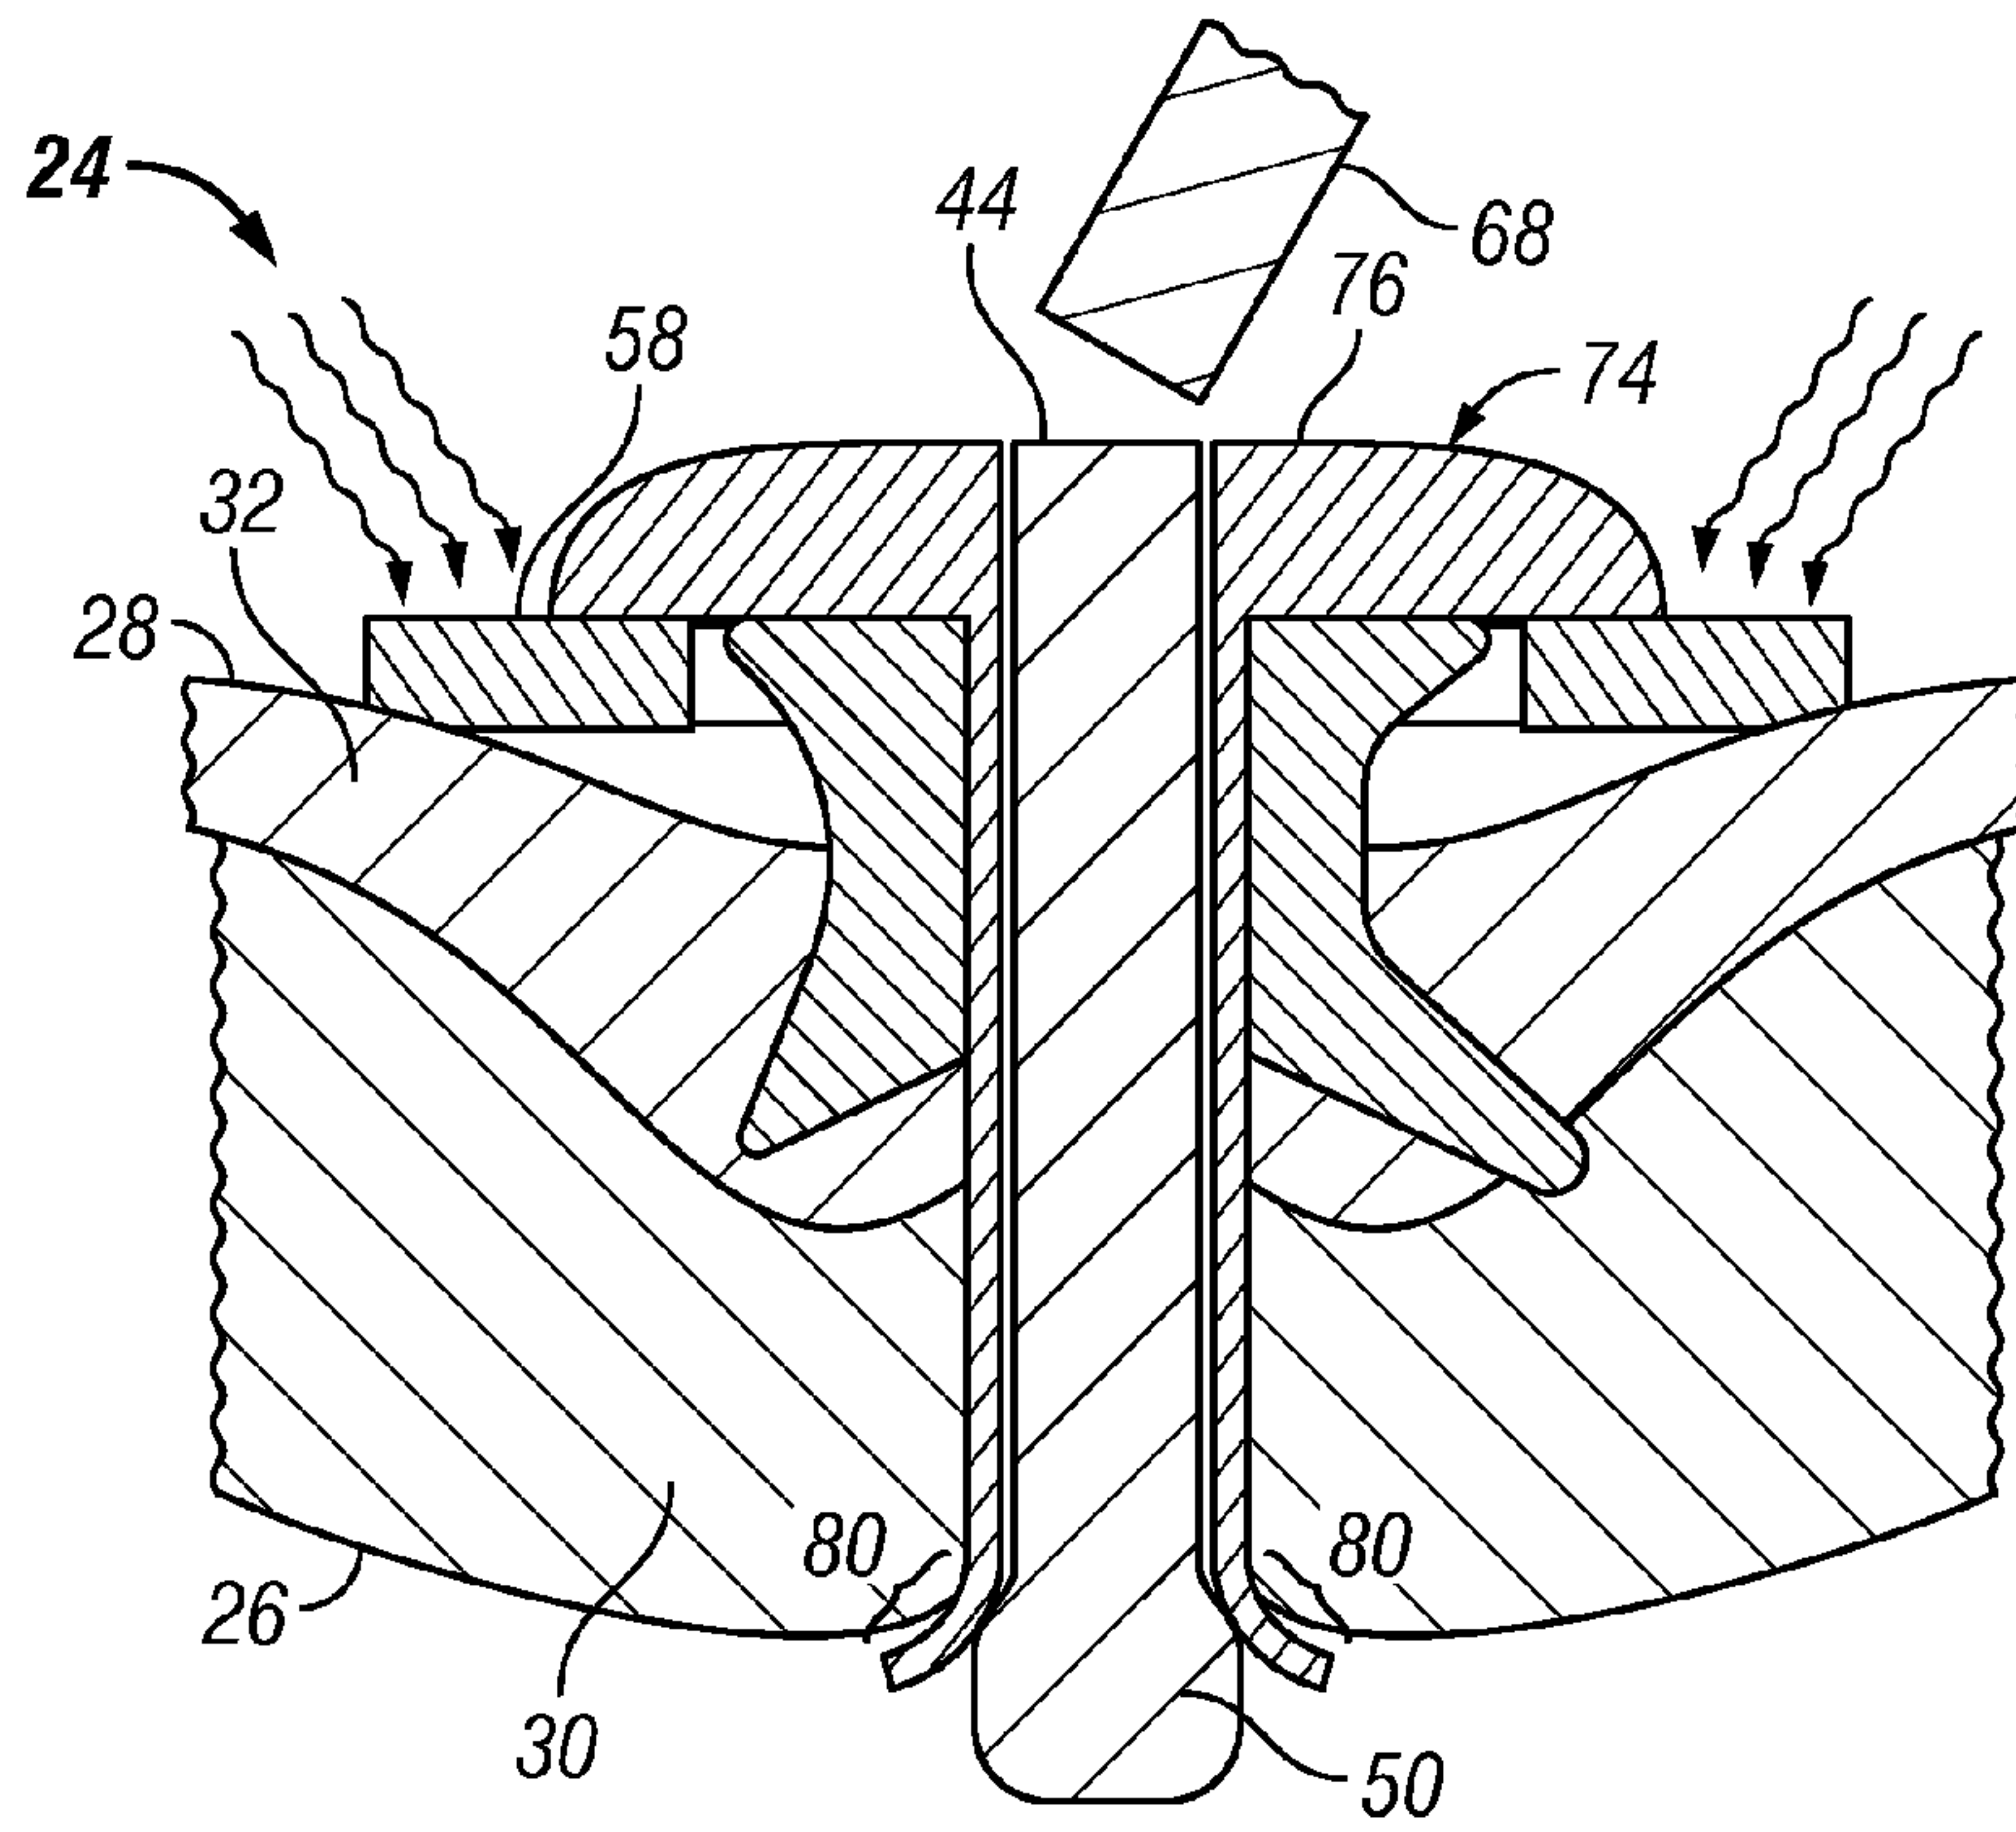
FIG. 8 is a simplified cross-sectional view illustrating the creation of an upset portion of the blind rivet and engagement of the upset portion with an external surface of the workpiece;

FIG. 8 is a simplified cross-sectional view illustrating the creation of an upset portion 80 of blind rivet 74 and engagement of upset portion 80 with first side 26 of workpiece 24. As illustrated, upset portion 80 has bent in a generally outward direction with respect to a longitudinal axis of mandrel 44. The curvature of upset portion 80 has caused upset portion 80 to engage first side 26 and to exert an upward force on first metal member 30. An underside of head portion 76 similarly pushes down on second metal member 32 through engagement with improperly-installed-self-piercing rivet 20. The combination of the upward force acting on first metal member 30 and the downward force acting on second metal member 32 places workpiece 24 in compression and effectively repairs the discrepant joint.

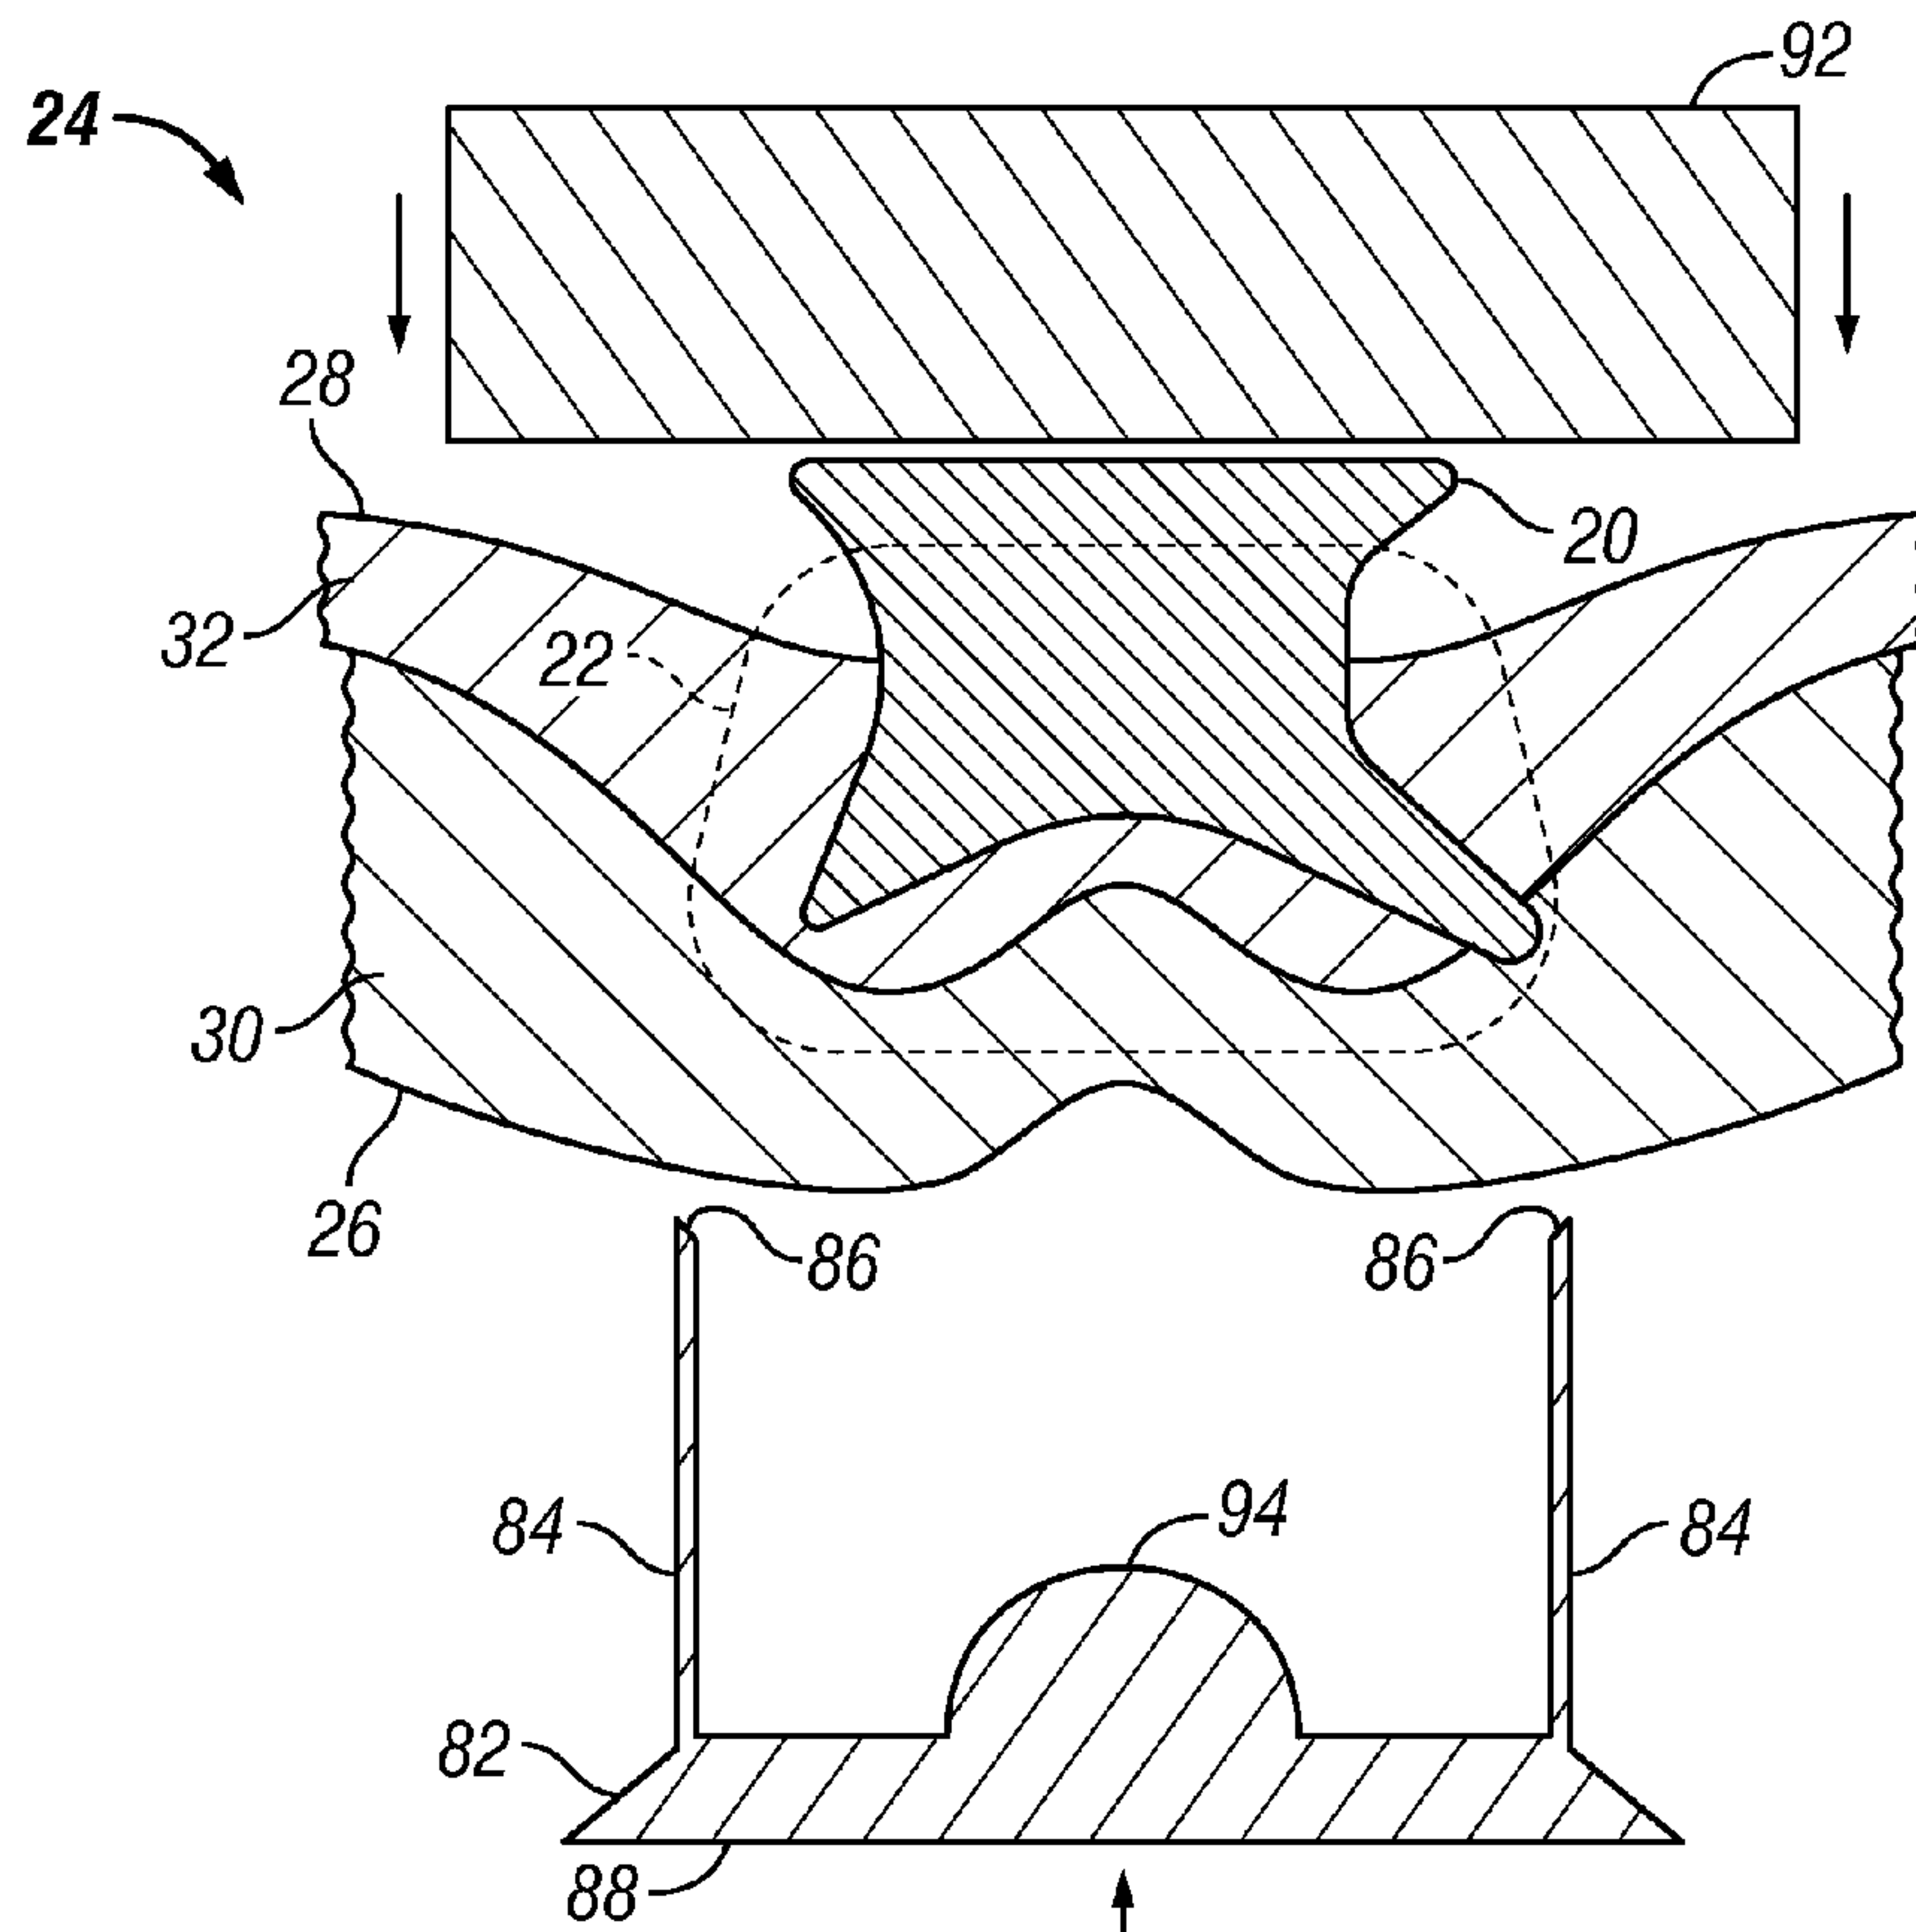
FIG. 9 is a simplified cross-sectional view illustrating the positioning of a self-piercing rivet at the discrepant joint and aligning it with the improperly-installed-self-piercing rivet;

FIG. 9 is a simplified cross-sectional view illustrating the positioning of a self-piercing rivet 82 at discrepant joint 22 and aligning it with improperly-installed-self-piercing rivet 20. Self-piercing rivet 82 includes a generally cylindrical shaft portion 84 having sharpened annular end 86, a head portion 88 and a protrusion 94. Sharpened annular end 86 is configured to pierce through workpiece 24 when a sufficient force is applied on head portion 88.

Self-piercing rivet 82 is positioned against first side 26 of workpiece 24 at a location that is opposite to, and which aligns with, improperly-installed-self-piercing rivet 20. As illustrated, shaft portion 84 has an inner diameter that exceeds an outer diameter of improperly-installed-self-piercing rivet 20. Consequently, when self-piercing rivet 82 is driven into workpiece 24, a portion of shaft portion 84 will generally surround improperly-installed-self-piercing rivet 20.

A die 92 is positioned against improperly-installed-self-piercing rivet 20 and will brace or push improperly-installed-self-piercing rivet 20 in a downward direction as a punch or other tool applies an upward force on head portion 88 of self-piercing rivet 82.

Self-piercing rivet 82 also includes a protrusion 94 protruding from head portion 88 in the same direction as shaft portion 84. When self-piercing rivet 82 is driven into a metal member, protrusion 94 causes the metal material of the workpiece to move or flow away from protrusion 94 and towards an inner wall of shaft portion 84. This, in turn, causes shaft portion 84 to deform and form upset portions that curve away from protrusion 94. The curvature of the upset portions results in mechanical engagement with work piece.

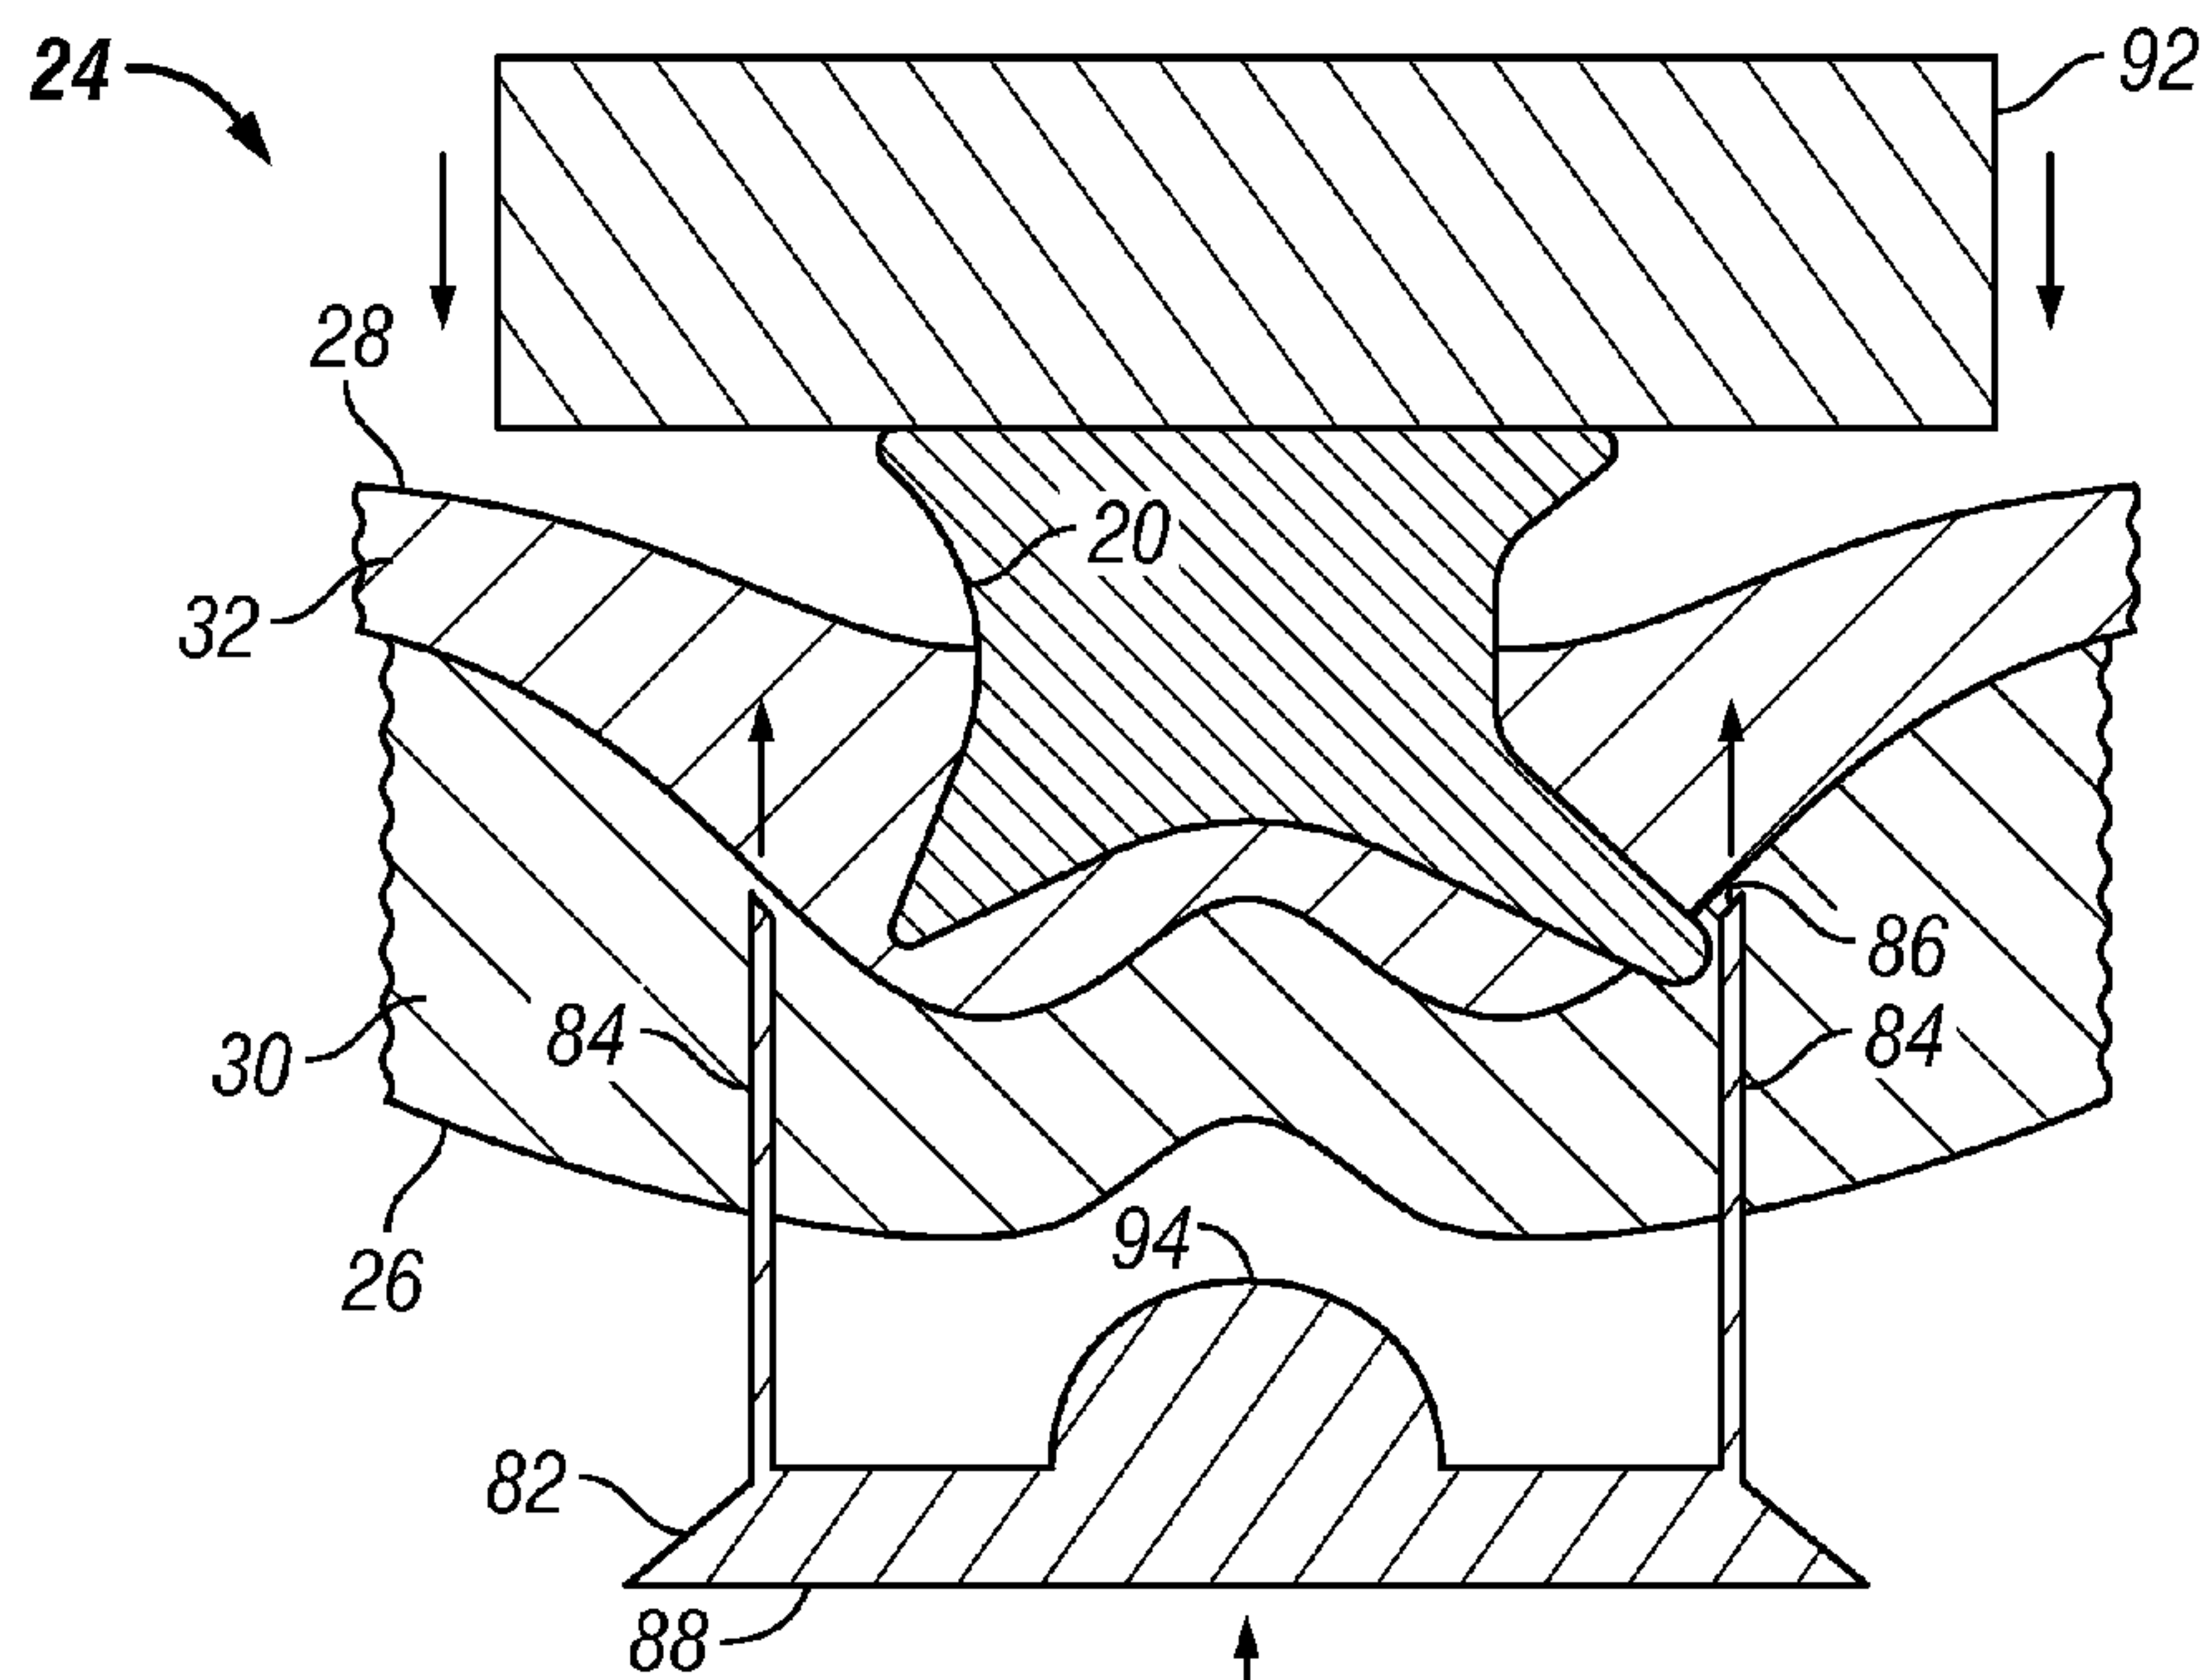
FIG. 10 is a simplified cross-sectional view illustrating an early stage of driving the self piercing rivet into the discrepant joint;

FIG. 10 is a simplified cross-sectional view illustrating an early stage of driving self-piercing rivet 82 into the discrepant joint. Die 92 compresses against a top side of improperly-installed-self-piercing rivet 20 while a punch (not shown) drives self-piercing rivet 82 into workpiece 24. At the stage illustrated in FIG. 10, protrusion 94 has not yet made contact with workpiece 24 and shaft portion 84 is driving straight in to workpiece 24.
