(10) **Patent No.:** **US 8,418,560 B2**
(45) **Date of Patent:** **Apr. 16, 2013**

(54) **COMPOSITE FIBER WAVE INSPECTION SYSTEM AND METHOD**

(73) Assignee: **General Electric Company**, Niskayuna, NY (US)

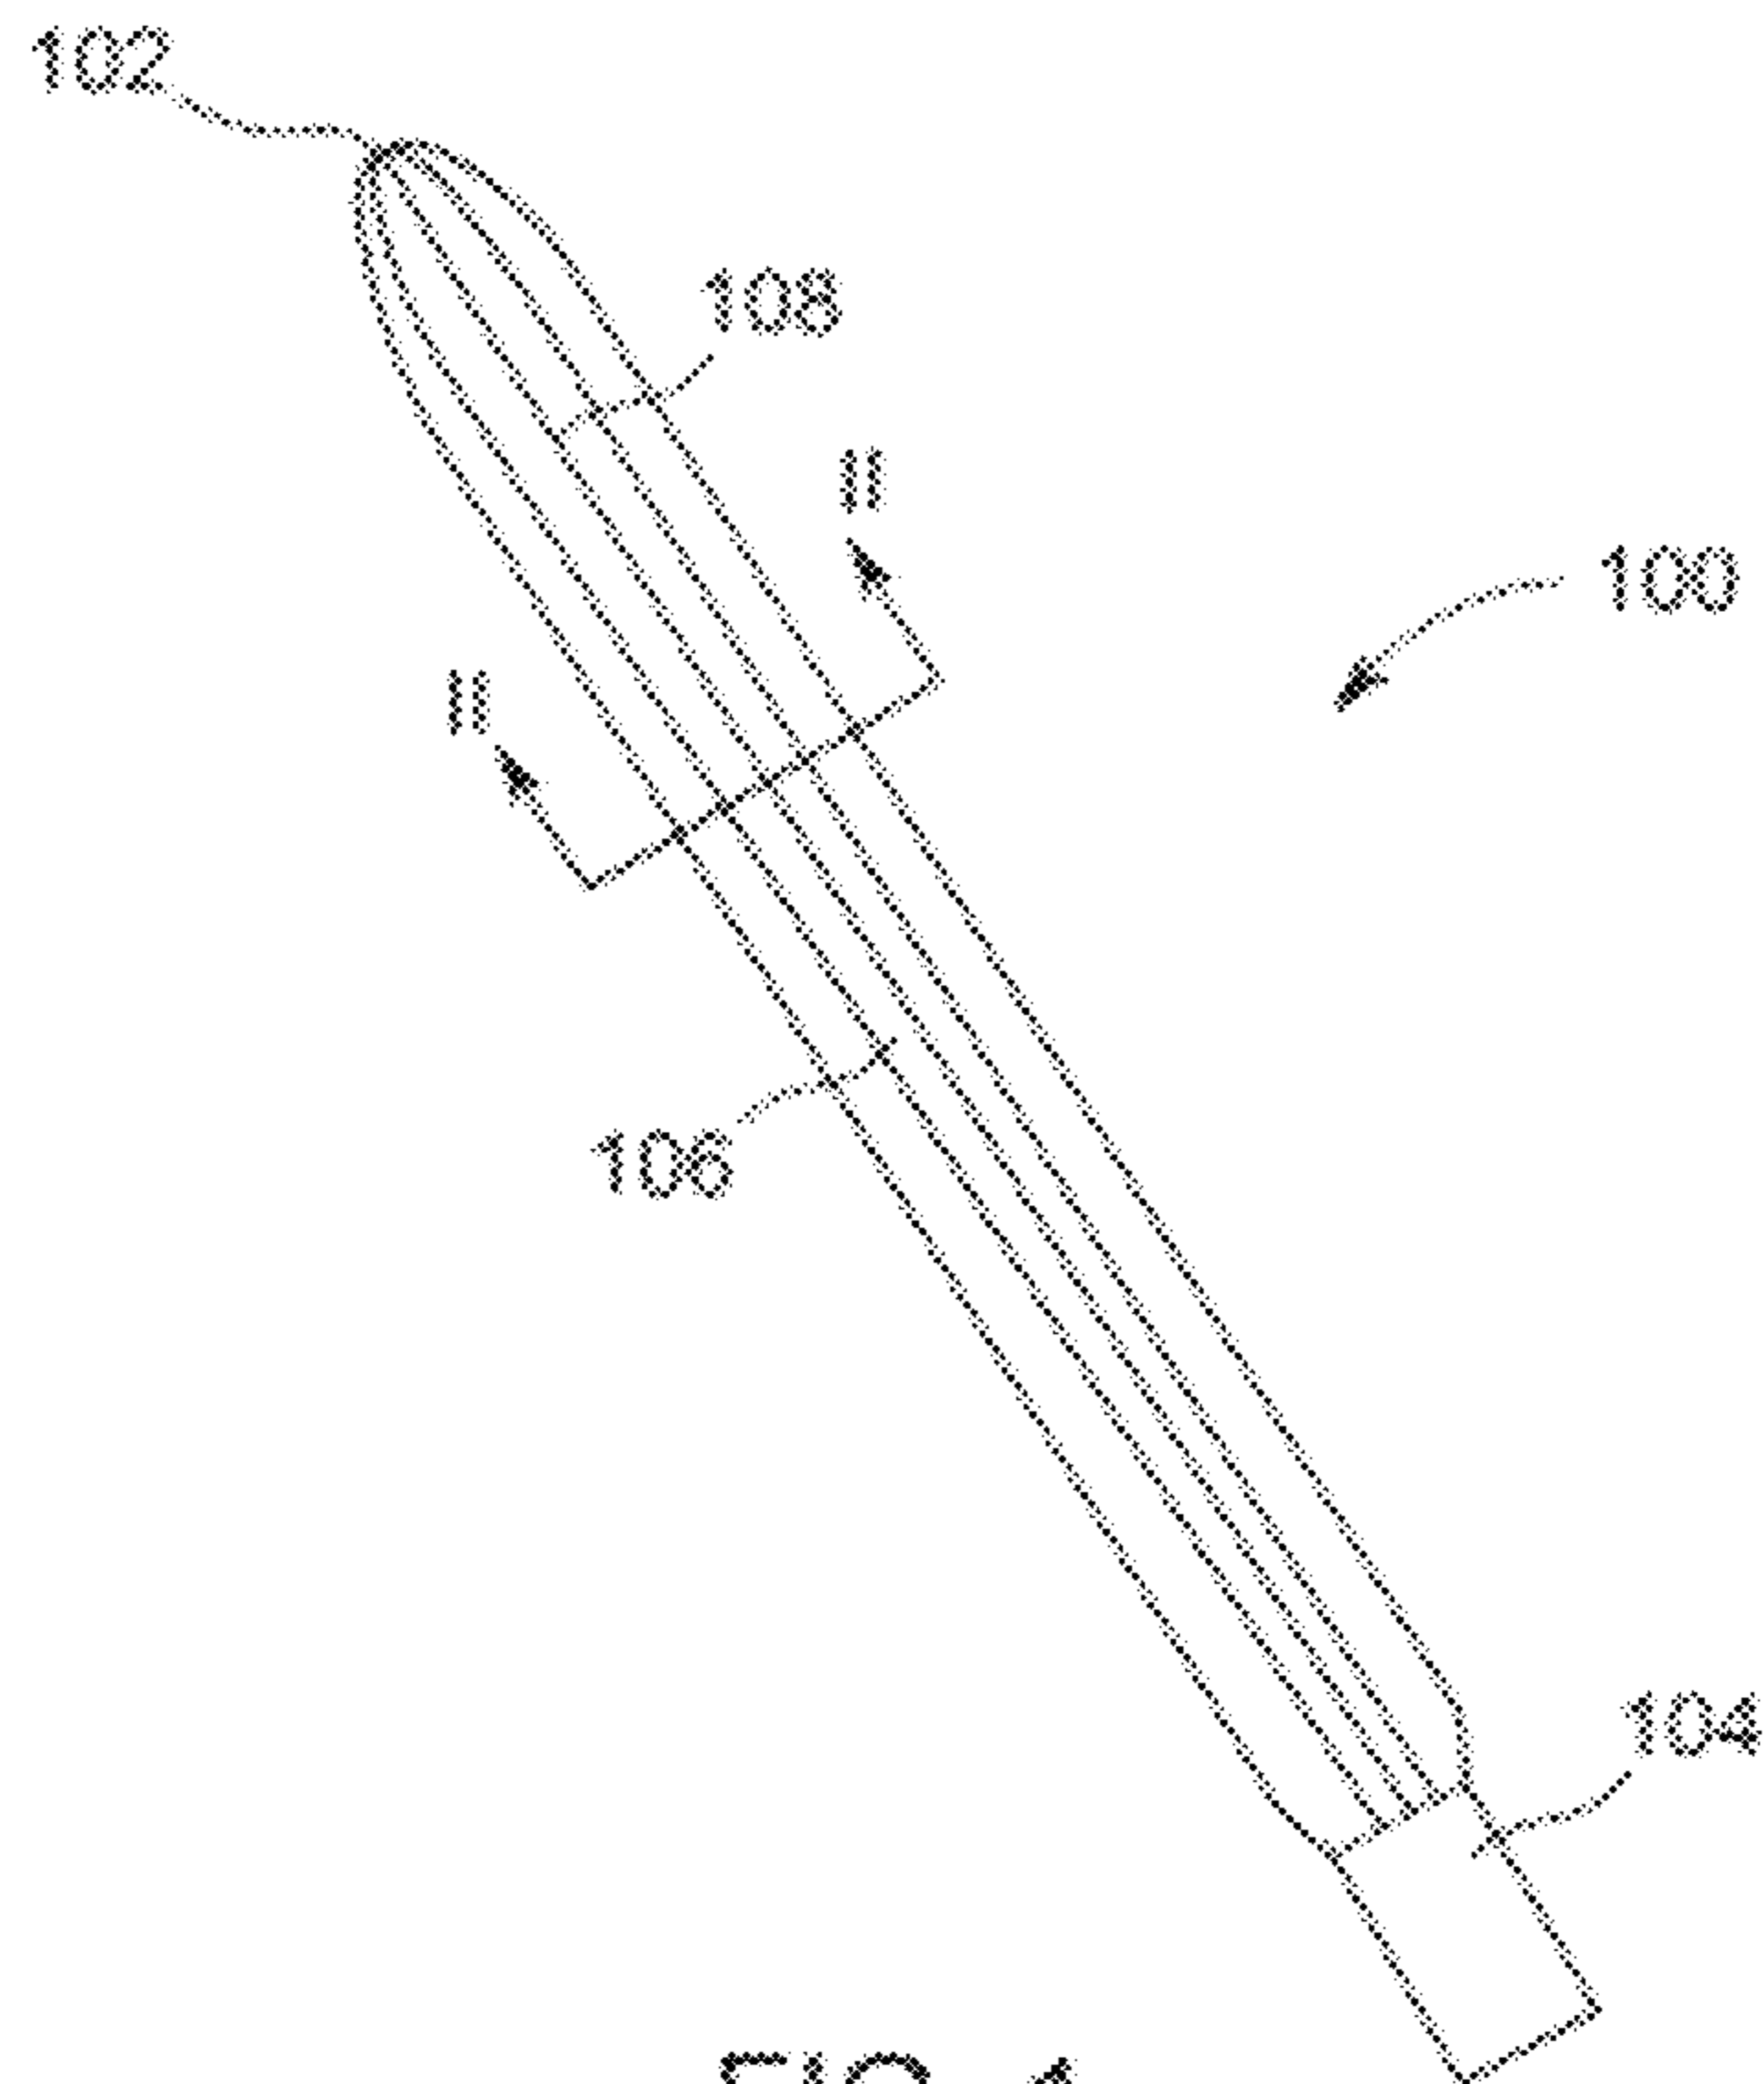
FIG. 1
(PRIOR ART)

FIG. 1 is a schematic view of a wind turbine blade.

A typical wind turbine blade is constructed of layers of an outer skin supported by a primary spar. For example, and as illustrated in FIGS. 1-3, a wind turbine blade **100** has a turbine tip **102** and an opposing turbine root **104**. Extending between the tip **102** and the root **104** are a spar cap **106** and a shear web **108**. The shear web **108** serves as the main structural support within a turbine blade **100**. The spar cap **106** is a glass portion running the length of the turbine blade coincident with the shear web **108** and it serves to take the tensile load of the blade **100**.

The wind turbine blade 100 schematically depicted in FIGS. 1-3 includes as a skeleton an internal shear web 108, a spar cap 106, and a core material section 112. Layers of material are applied over the skeleton of the wind turbine blade 100 to form the shells 105a, 105b. Some areas of the shells 150a, 105b have more matrixed layers than other areas. For example, there are more matrixed layers at the leading edge 114 of the wind turbine blade than are at the trailing edge 116.

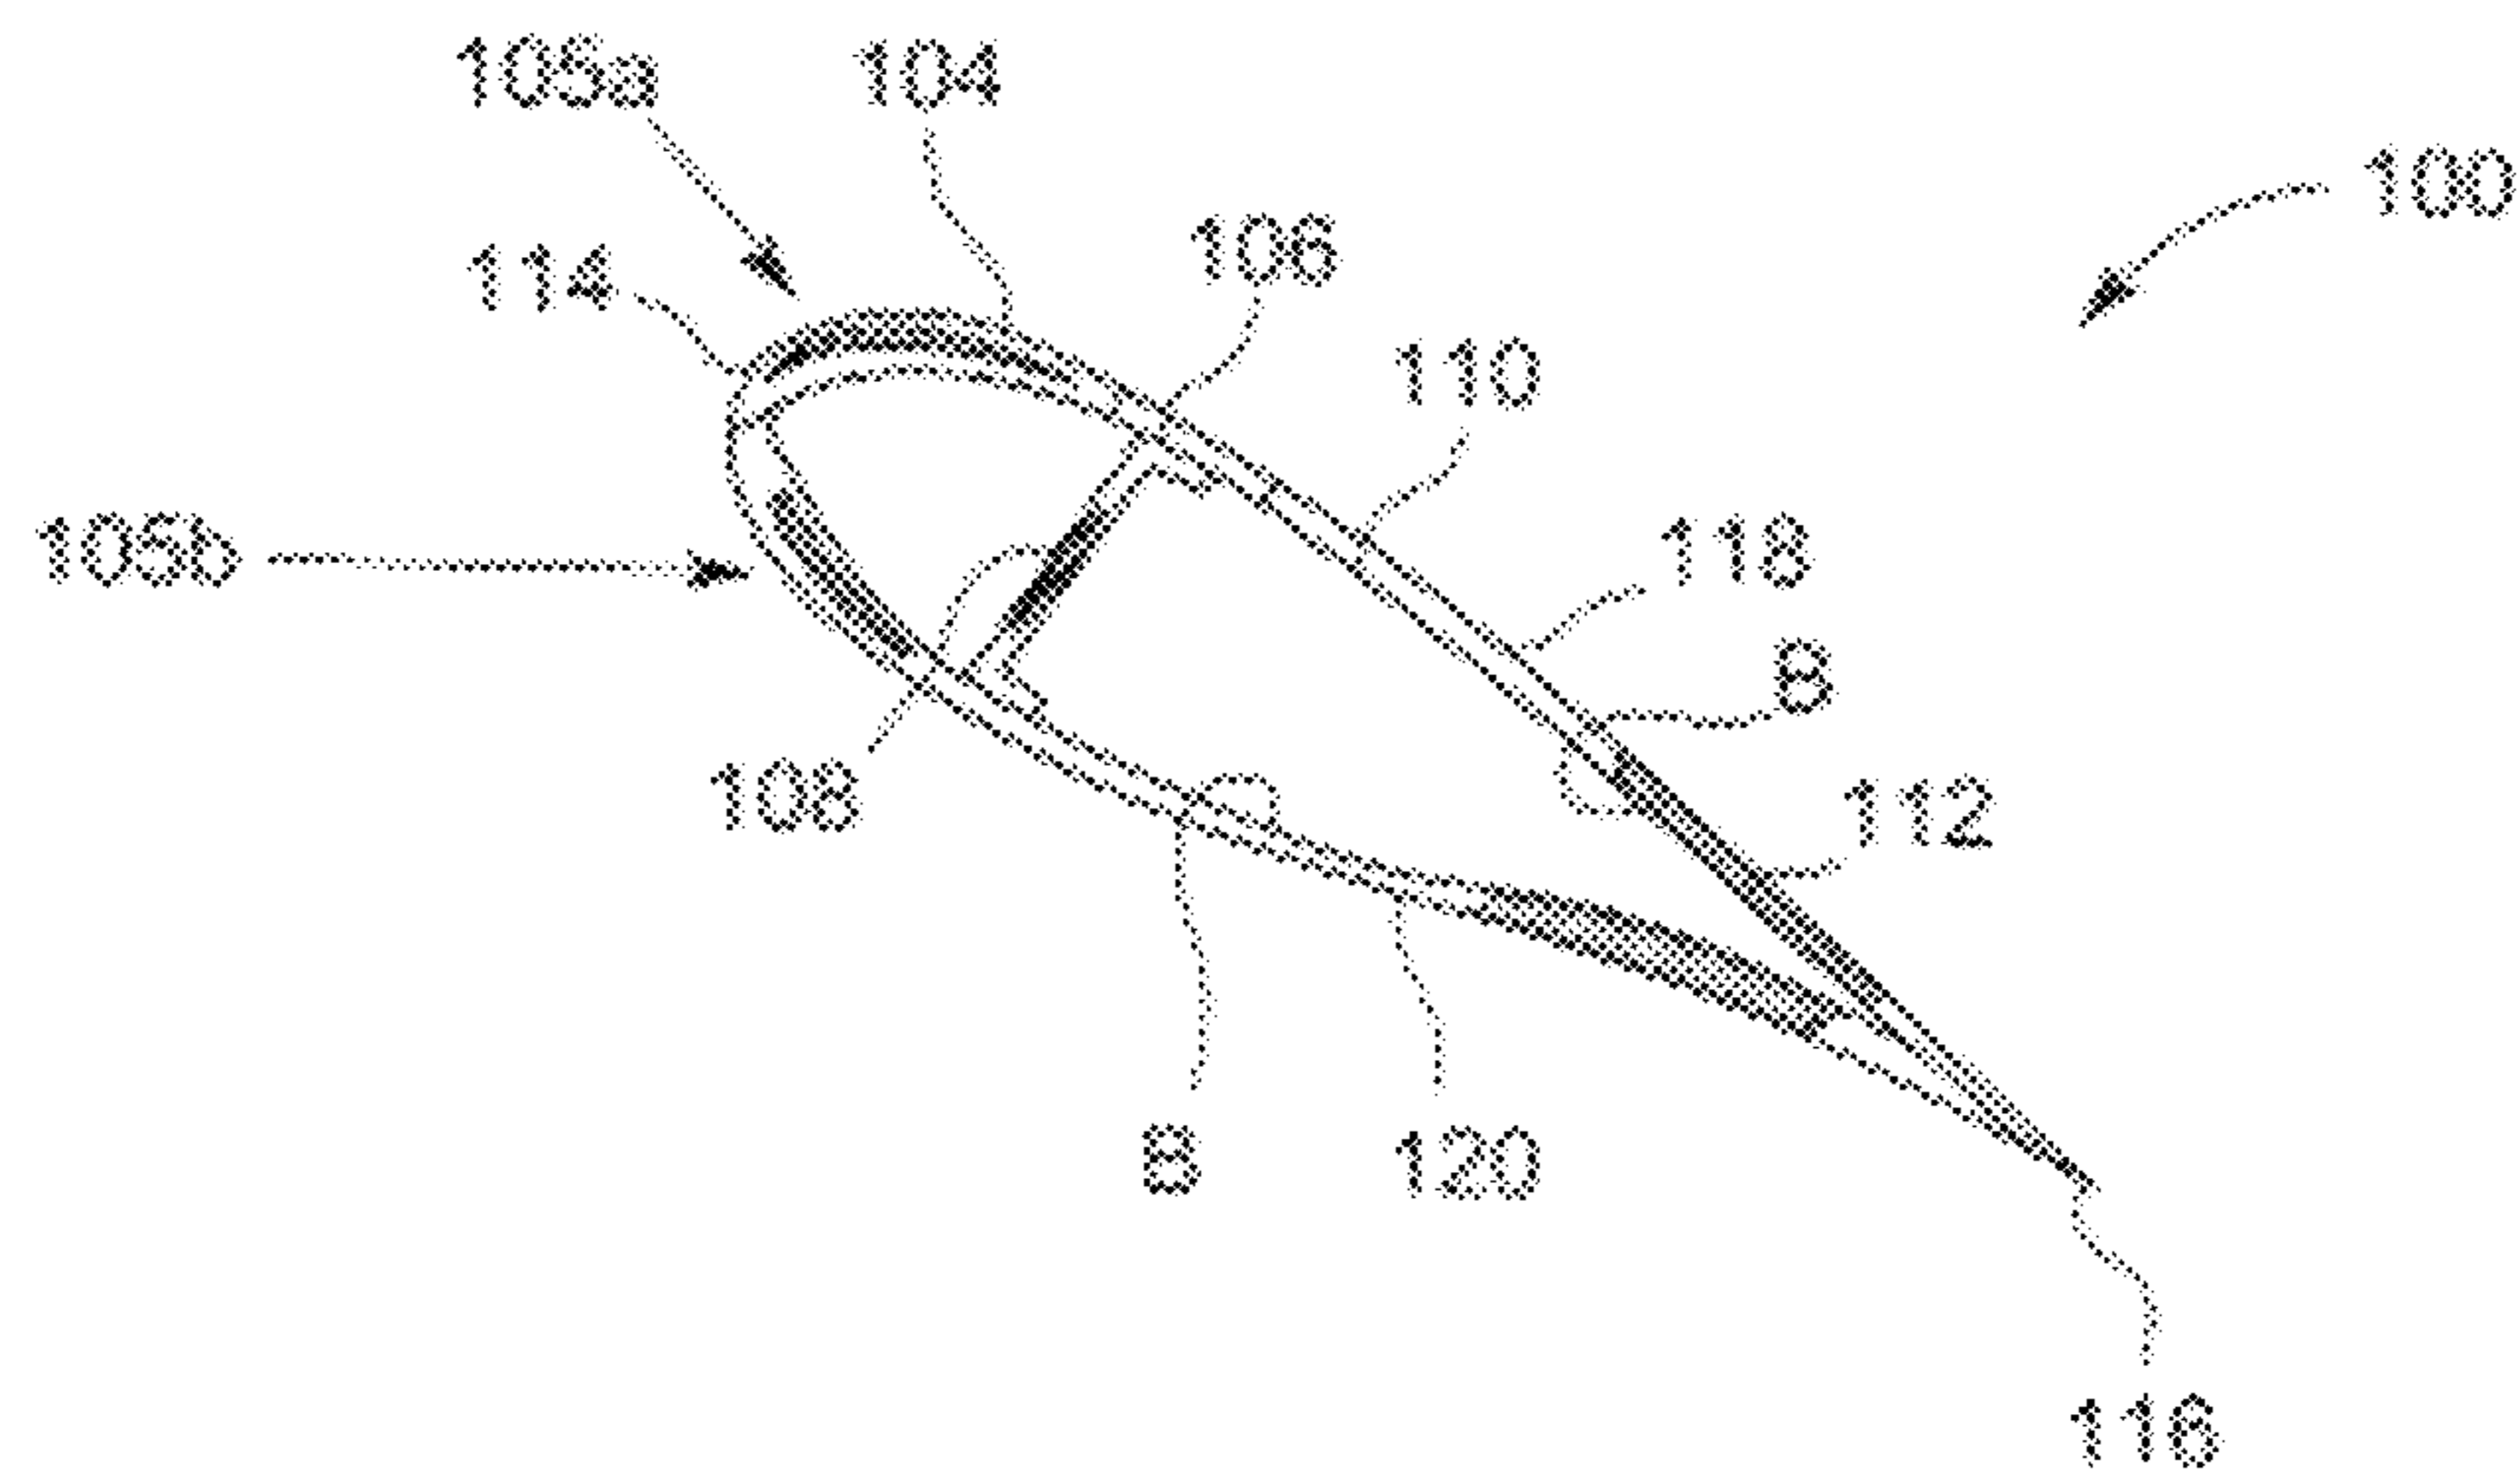
FIG. 2
(PRIOR ART)

FIG. 2 is a partial schematic view of a wind turbine blade.

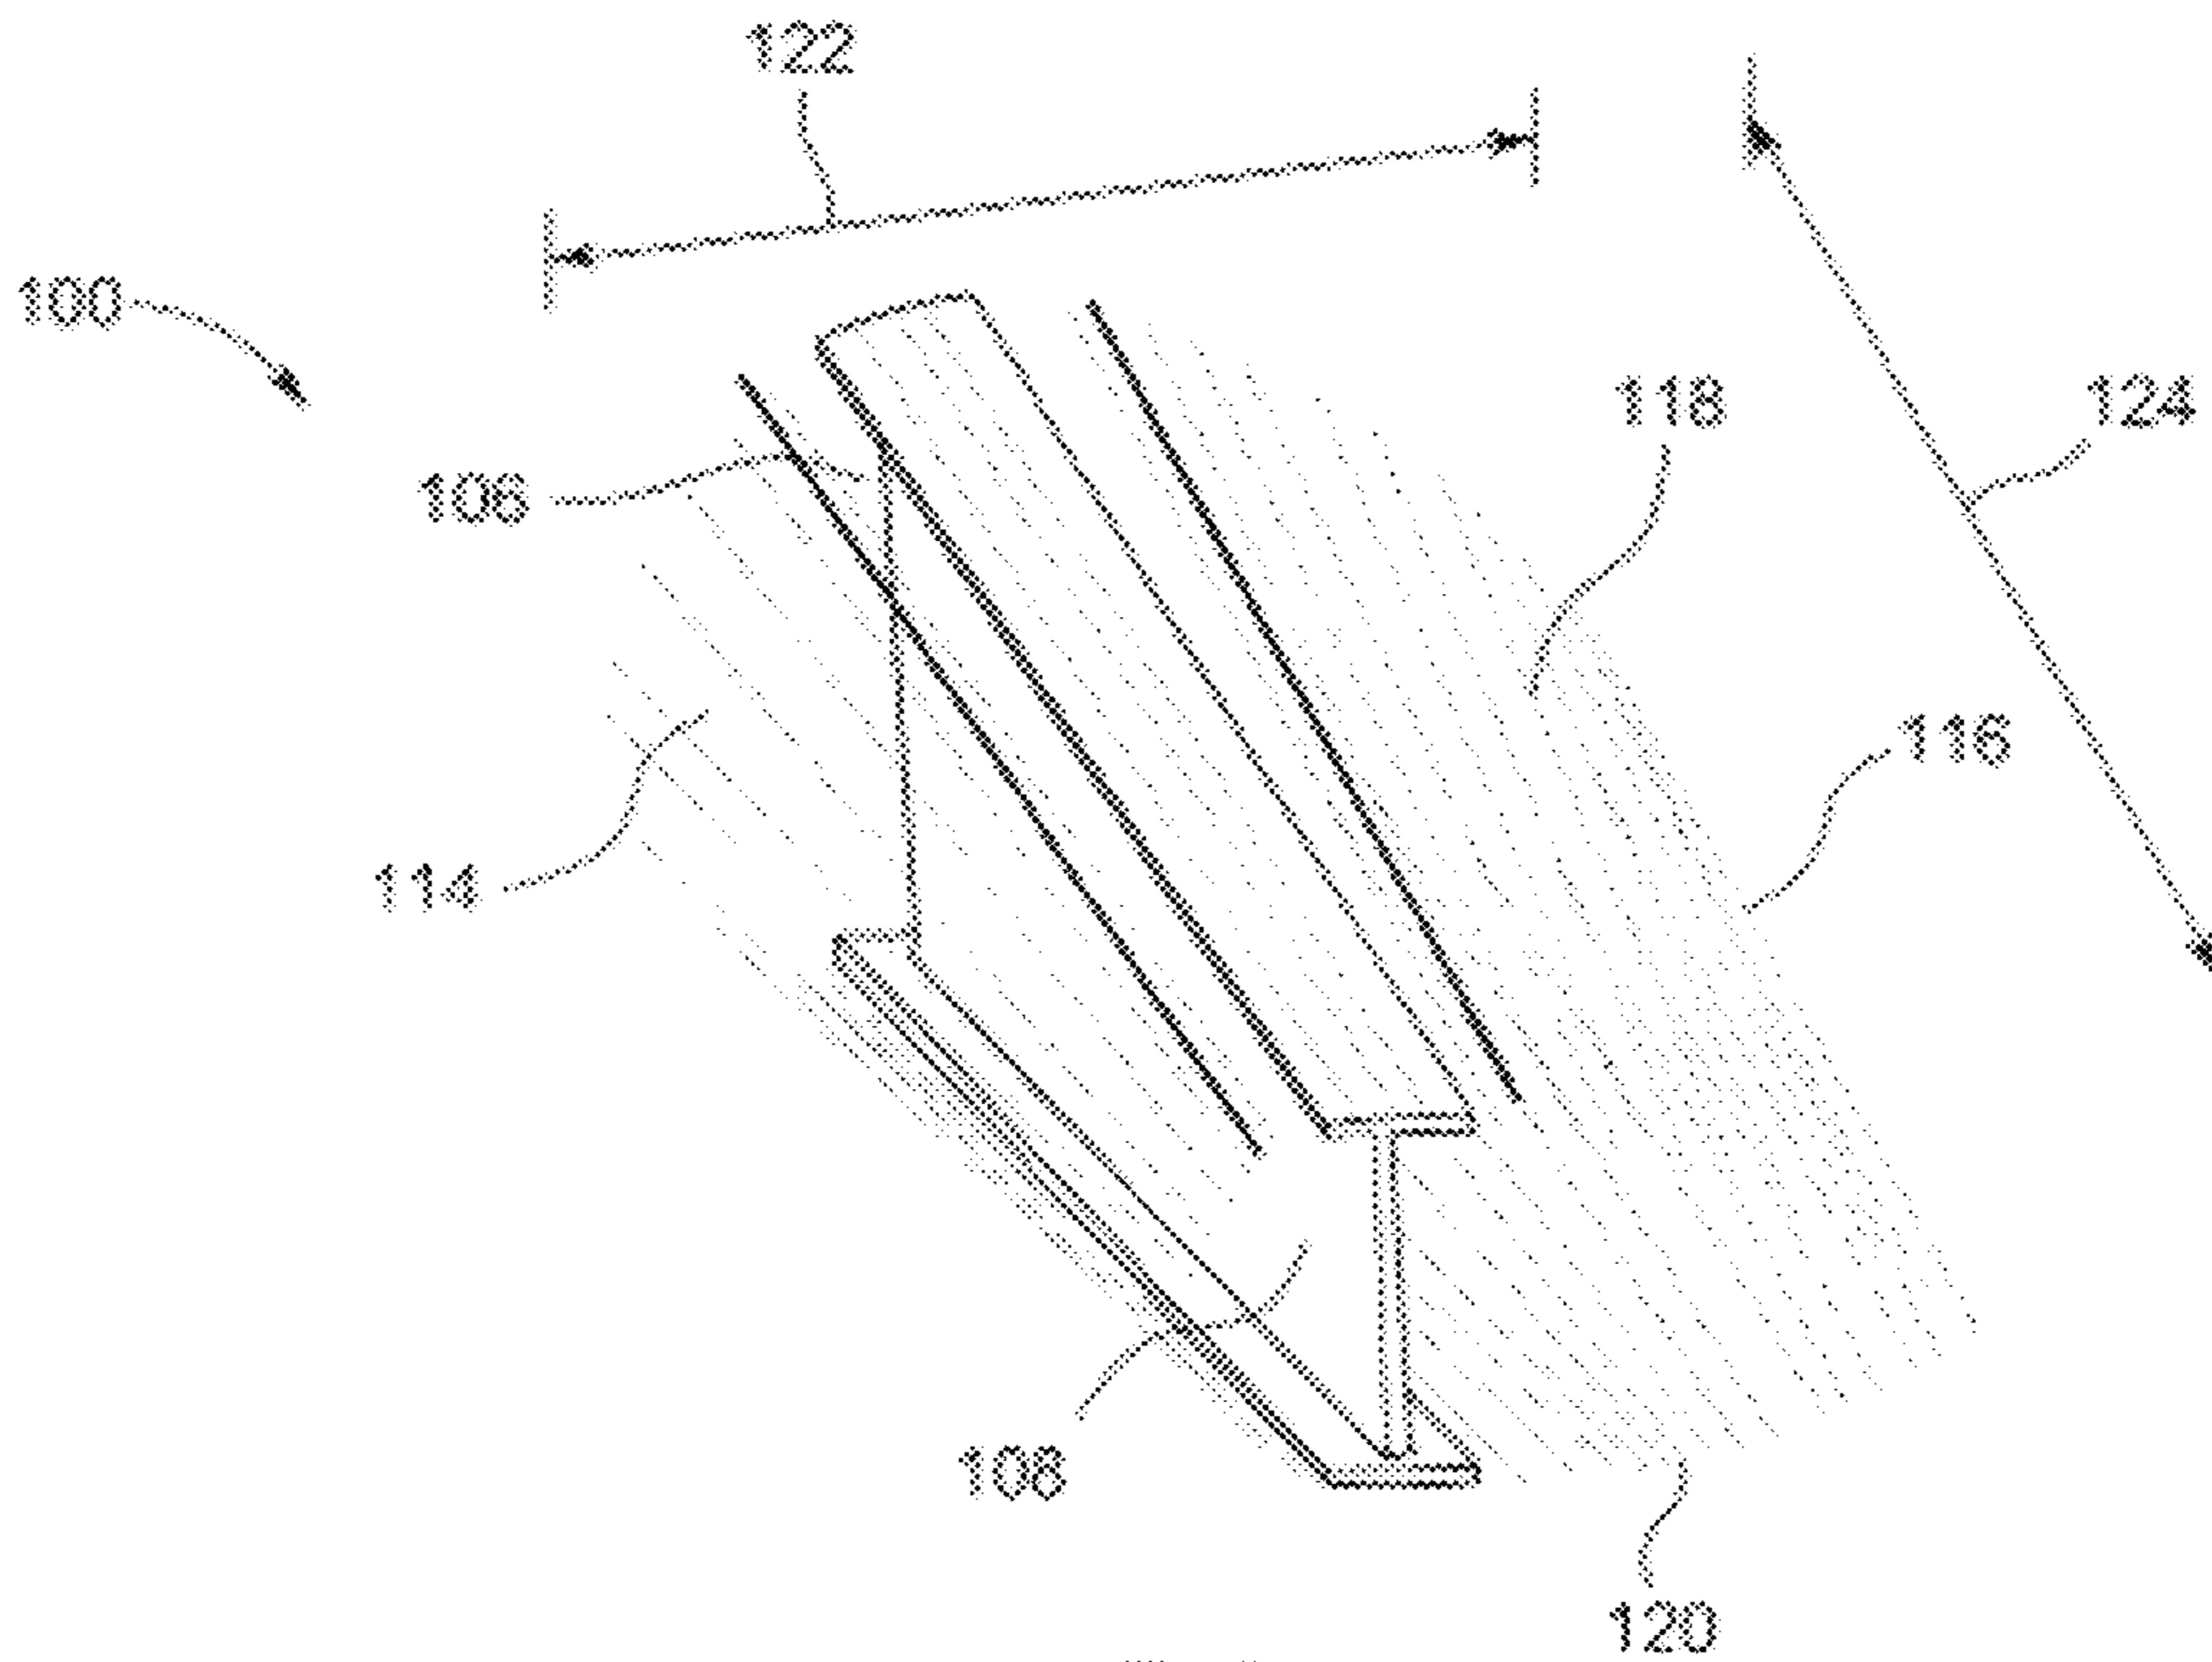
FIG. 3
(PRIOR ART)

FIG. 3 is a schematic view of an internal shear web, a spar cap and a core material section of a wind turbine blade.

The wind turbine blade 100 includes a suction surface 118 and an opposing pressure surface 120. The layers of material making up the two shells are applied in a chord-wise direction 122. The direction of the spar cap 106 and the shear web 108 is called the span-wise direction 124.

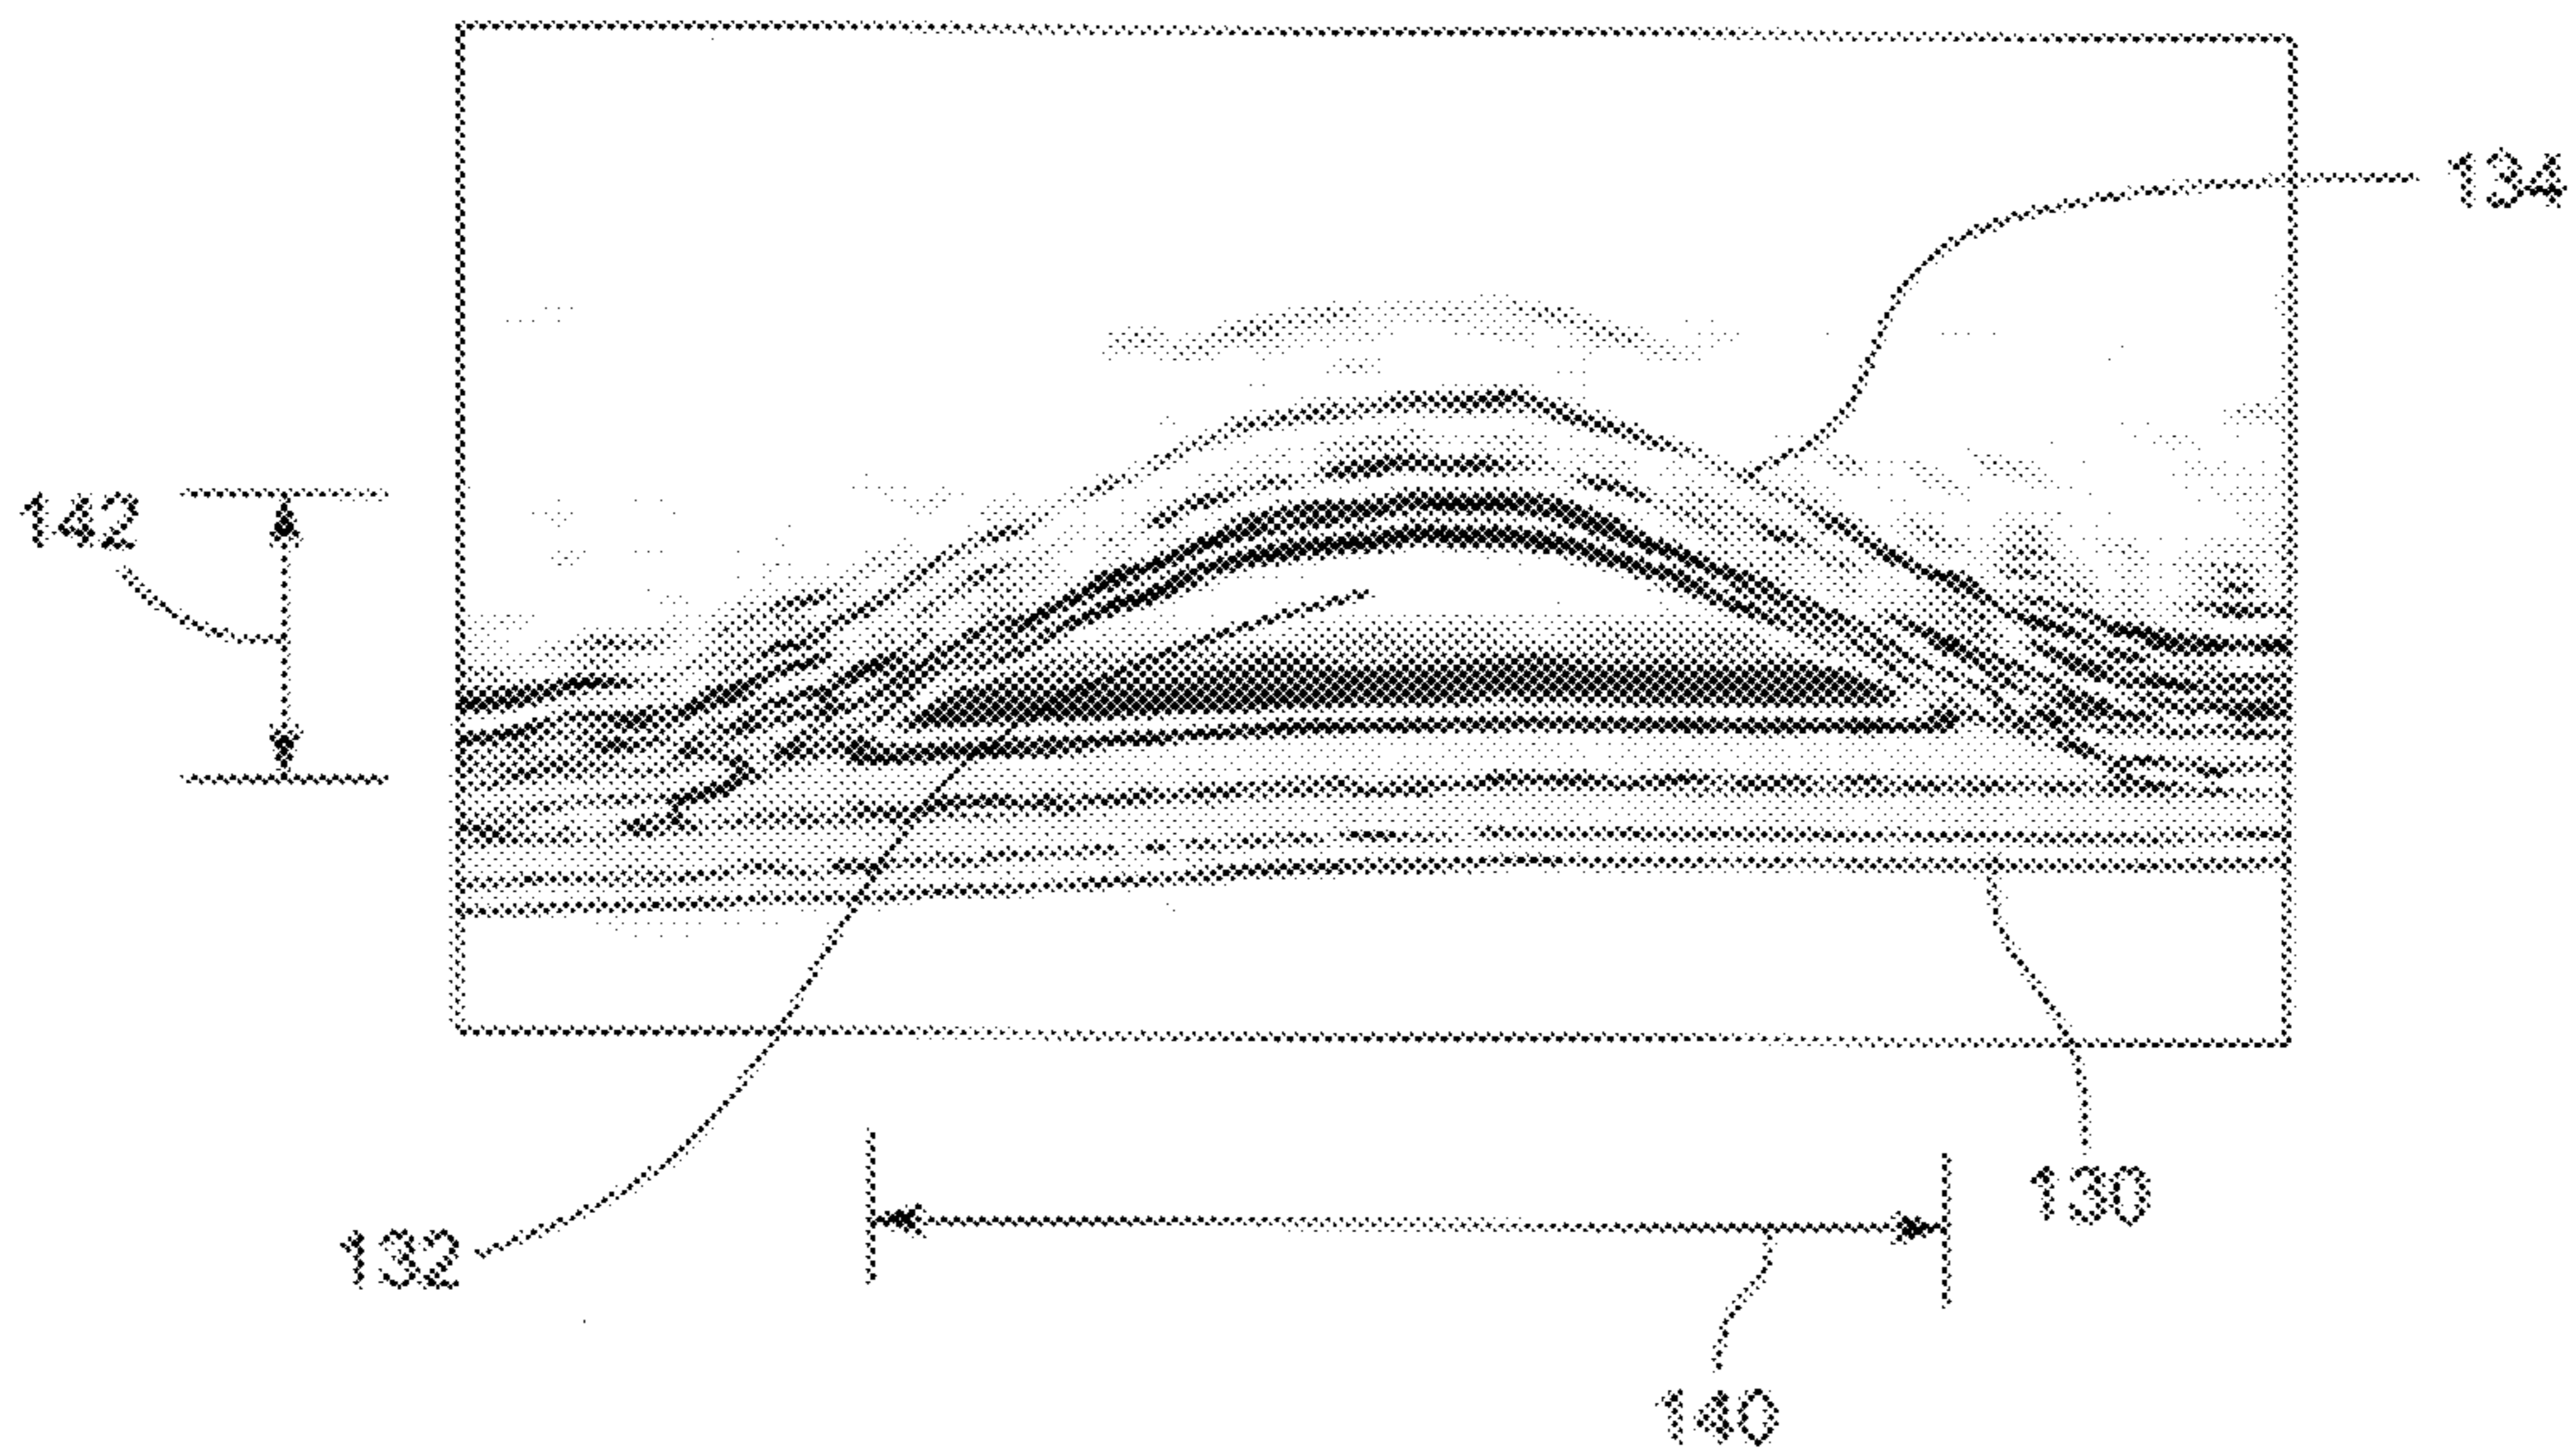
FIG. 4 is an ultrasound image of a defect within layers of a wind turbine blade.

FIG. 4 illustrates a portion of an image slice taken with an ultrasound machine. The ultrasound machine may include a plurality of phased array probes capable of generating a cross-sectional image without mechanical scanning or it may include a single element probe with a mechanical scanning mechanism. The image slice shows a plurality of shell layers 130 located at a lower extent in the image. Further, a defect

132 is shown above the layers 130. Finally, affected layers 134 are shown overlaying the defect 132. An internal length L_o 140 of the defect 132 can be measured from the scanned image. Further, an internal height a_i 142 of the defect 132 can be measured from the scanned image.

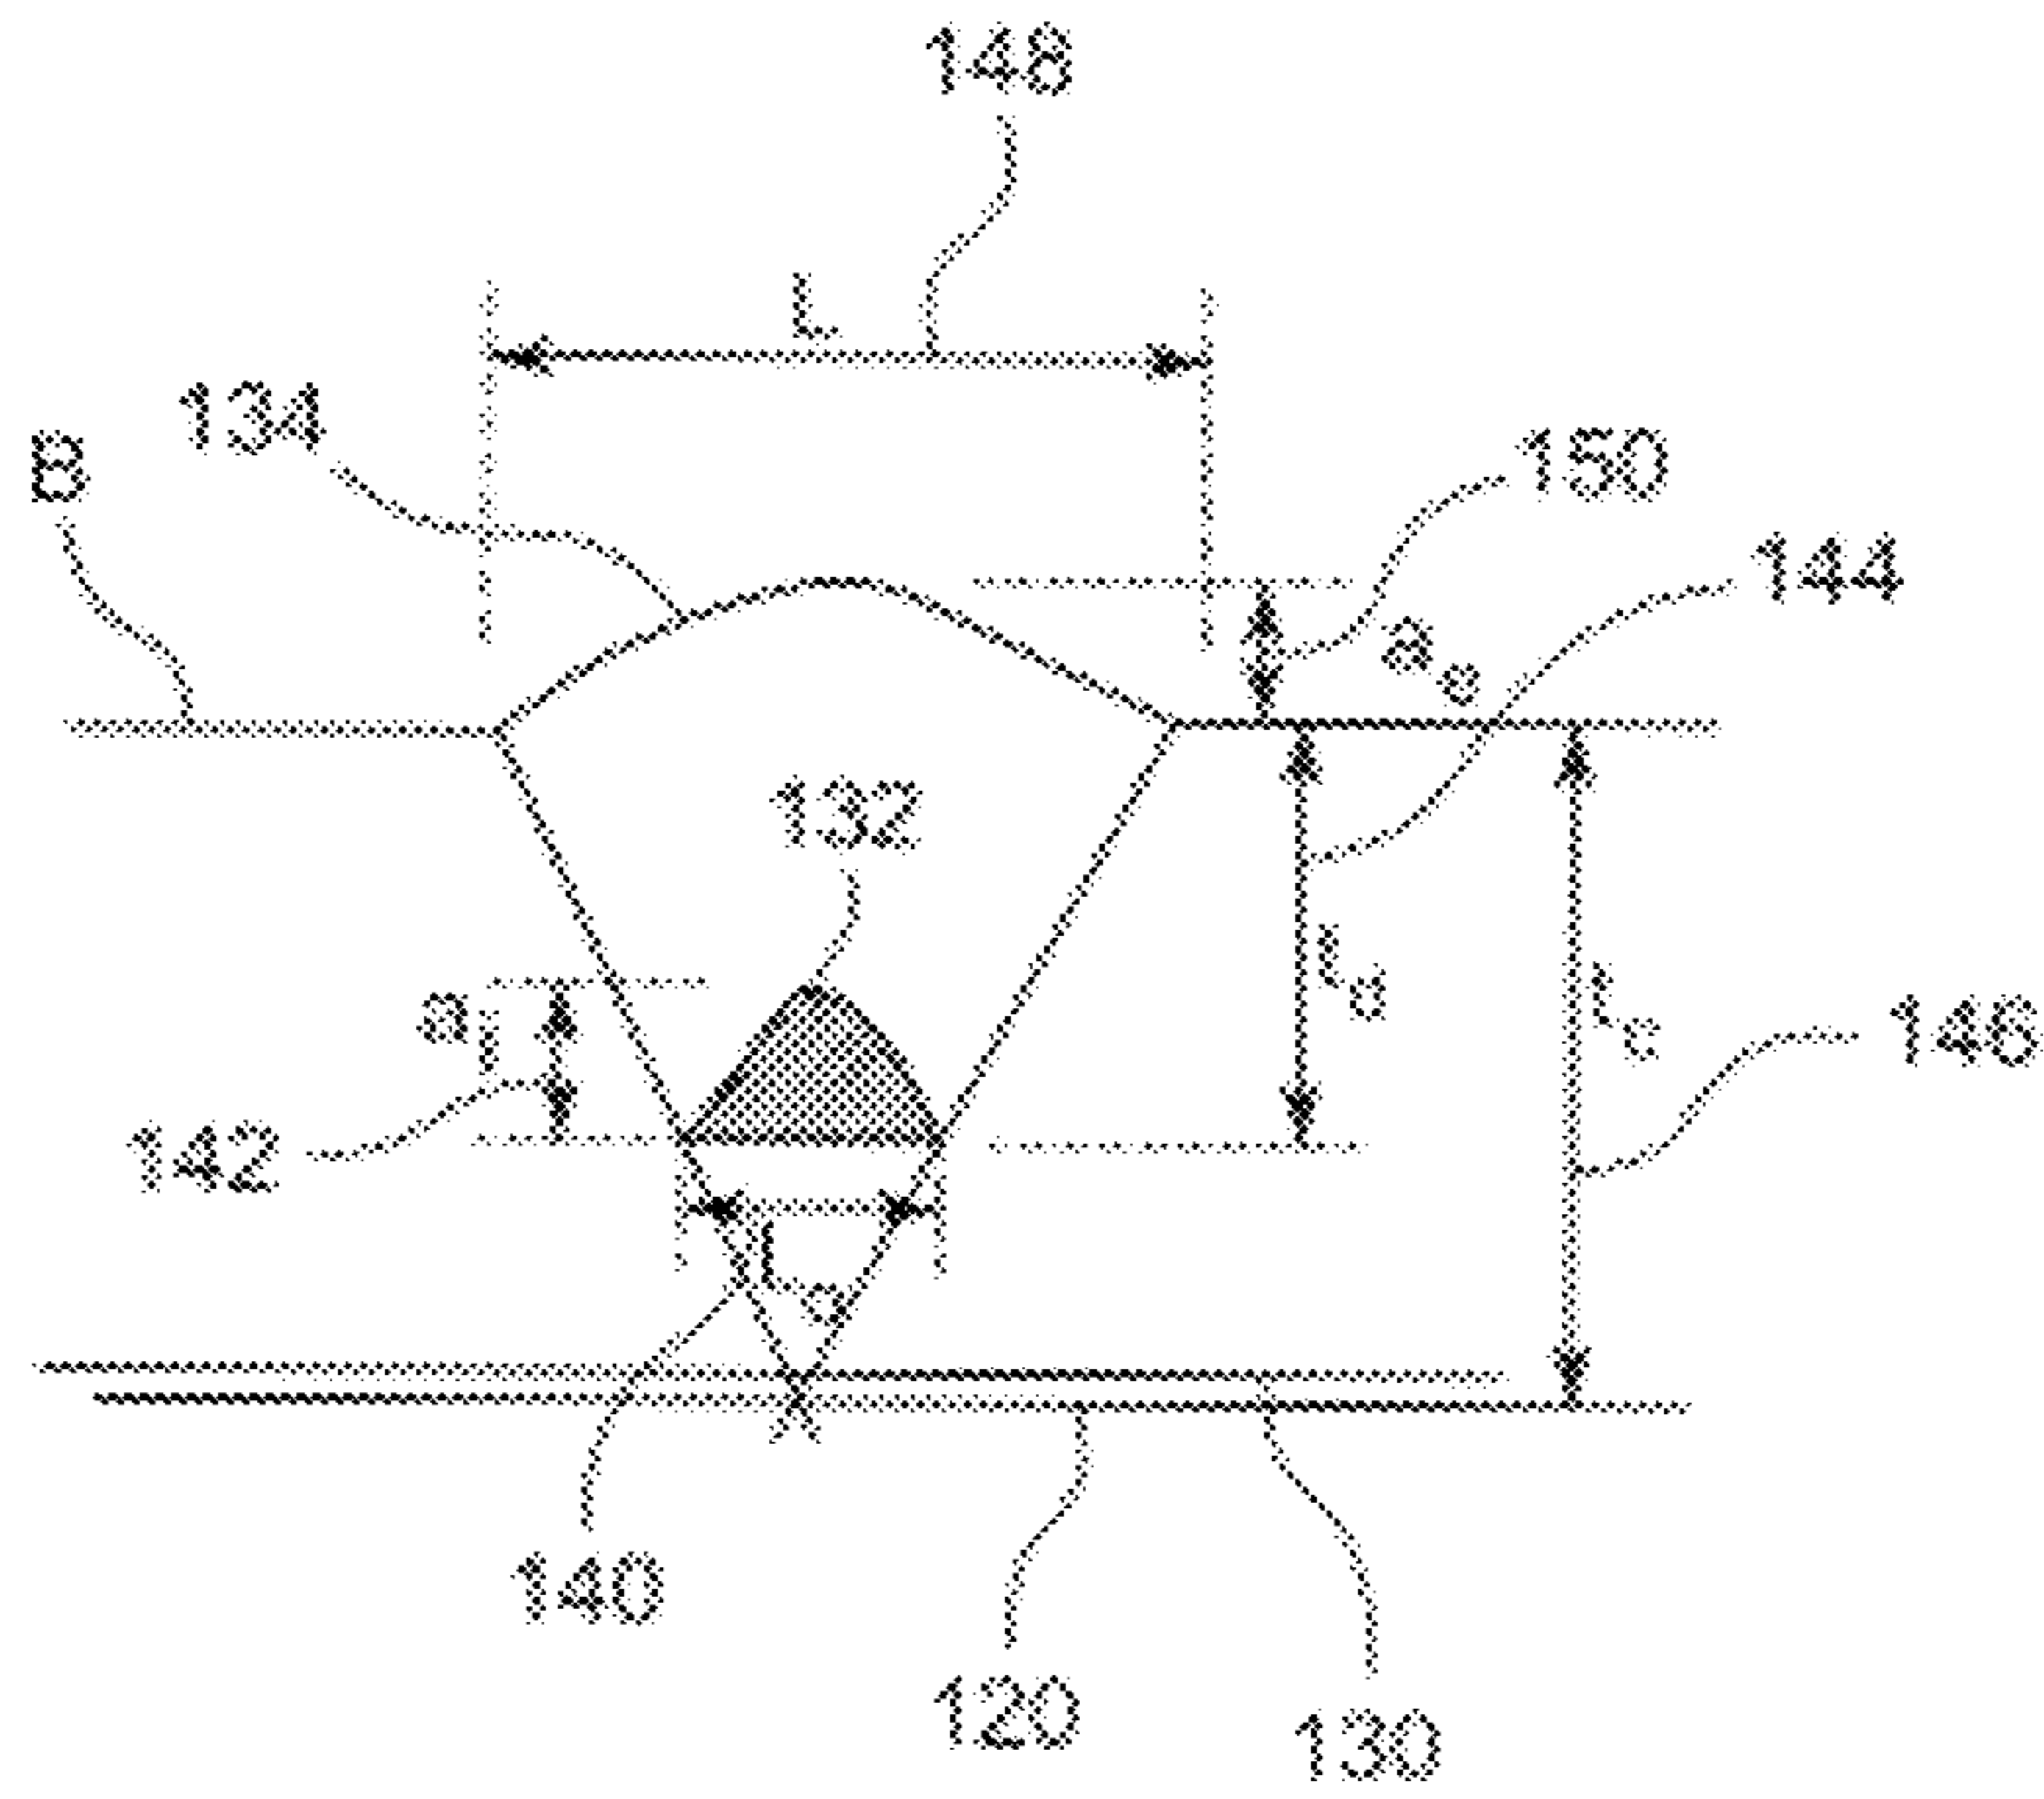
FIG. 5 is a schematic view of a defect within layers of a wind turbine blade.

FIG. 5 illustrates schematically a defect 132 located at a position between the surface B and the pressure surface 120 of a layered object, such as the wind turbine blade 100 (FIGS. 1-3). It should be appreciated that the defect 132 can be located in shell 105b as illustrated or in shell 105a and the surface opposing the surface B can be suction surface 118. Through non-destructive imaging, the defect 132 can be imaged and its length L_o 140 and its height a_i 142 can be ascertained. Further, either through manual or other visual inspection the external length L 148 and the external height a_e 150 of the defect 132 can also be ascertained. For example, known visual inspection techniques include running a hand along surface B to detect an anomaly, using a flashlight to create a shadow effect from a bulge, or looking at an edge of the blade once the shell is decanted from the mold to look for a wave in the fiber plies. The external length L 148 and the external height a_e 150 are essentially the extent to which the outer affected layers 134 remain affected by the defect 132.

Further measurements can also be made of other parameters of the defect 132. For example, measurements can be taken of the thickness t_c 146 of the layered object at the location of the defect 132 as well as the depth t_d 144 within the layered object at which the defect 132 occurs.

The ratio t_d/t_c is an important ratio in considering the theoretical strength of a layered object, such as the wind turbine blade 100. Where a defect can be found within the layered object affects the ultimate strength such an object has. One reason for this is that layers above the defect, the affected layers 134, are bulged out of plane from unaffected layers 130 located beneath the defect. This bulging out of plane causes the individual layers to have a lessened individual strength, and the combined strength of the bulging out of plane layers is lessened as a group.

For example, suppose the ratio t_d/t_c is 1, or said a different way, the defect 132 is located at the second surface 116, then a certain percentage of layers, namely 100%, may be affected by the defect 132. Instead, if the ratio t_d/t_c is 0.5, or the defect 132 is located in the middle of the layered object, then only 50% of the layers may be affected by the defect 132. Thus, for a ratio t_d/t_c of 0.5, the strength of the layered object will be greater than for a ratio t_d/t_c of 1.

Another ratio of importance is the ratio of the internal height a_i to the total thickness t_c at which the defect 132 is found. It has been discovered that when the ratio a_i/t_c increases toward 1, the strength of the layered object decreases.
