(10) **Patent No.:** **US 8,418,560 B2**
(45) **Date of Patent:** **Apr. 16, 2013**

(54) **COMPOSITE FIBER WAVE INSPECTION SYSTEM AND METHOD**

(73) Assignee: **General Electric Company**, Niskayuna, NY (US)

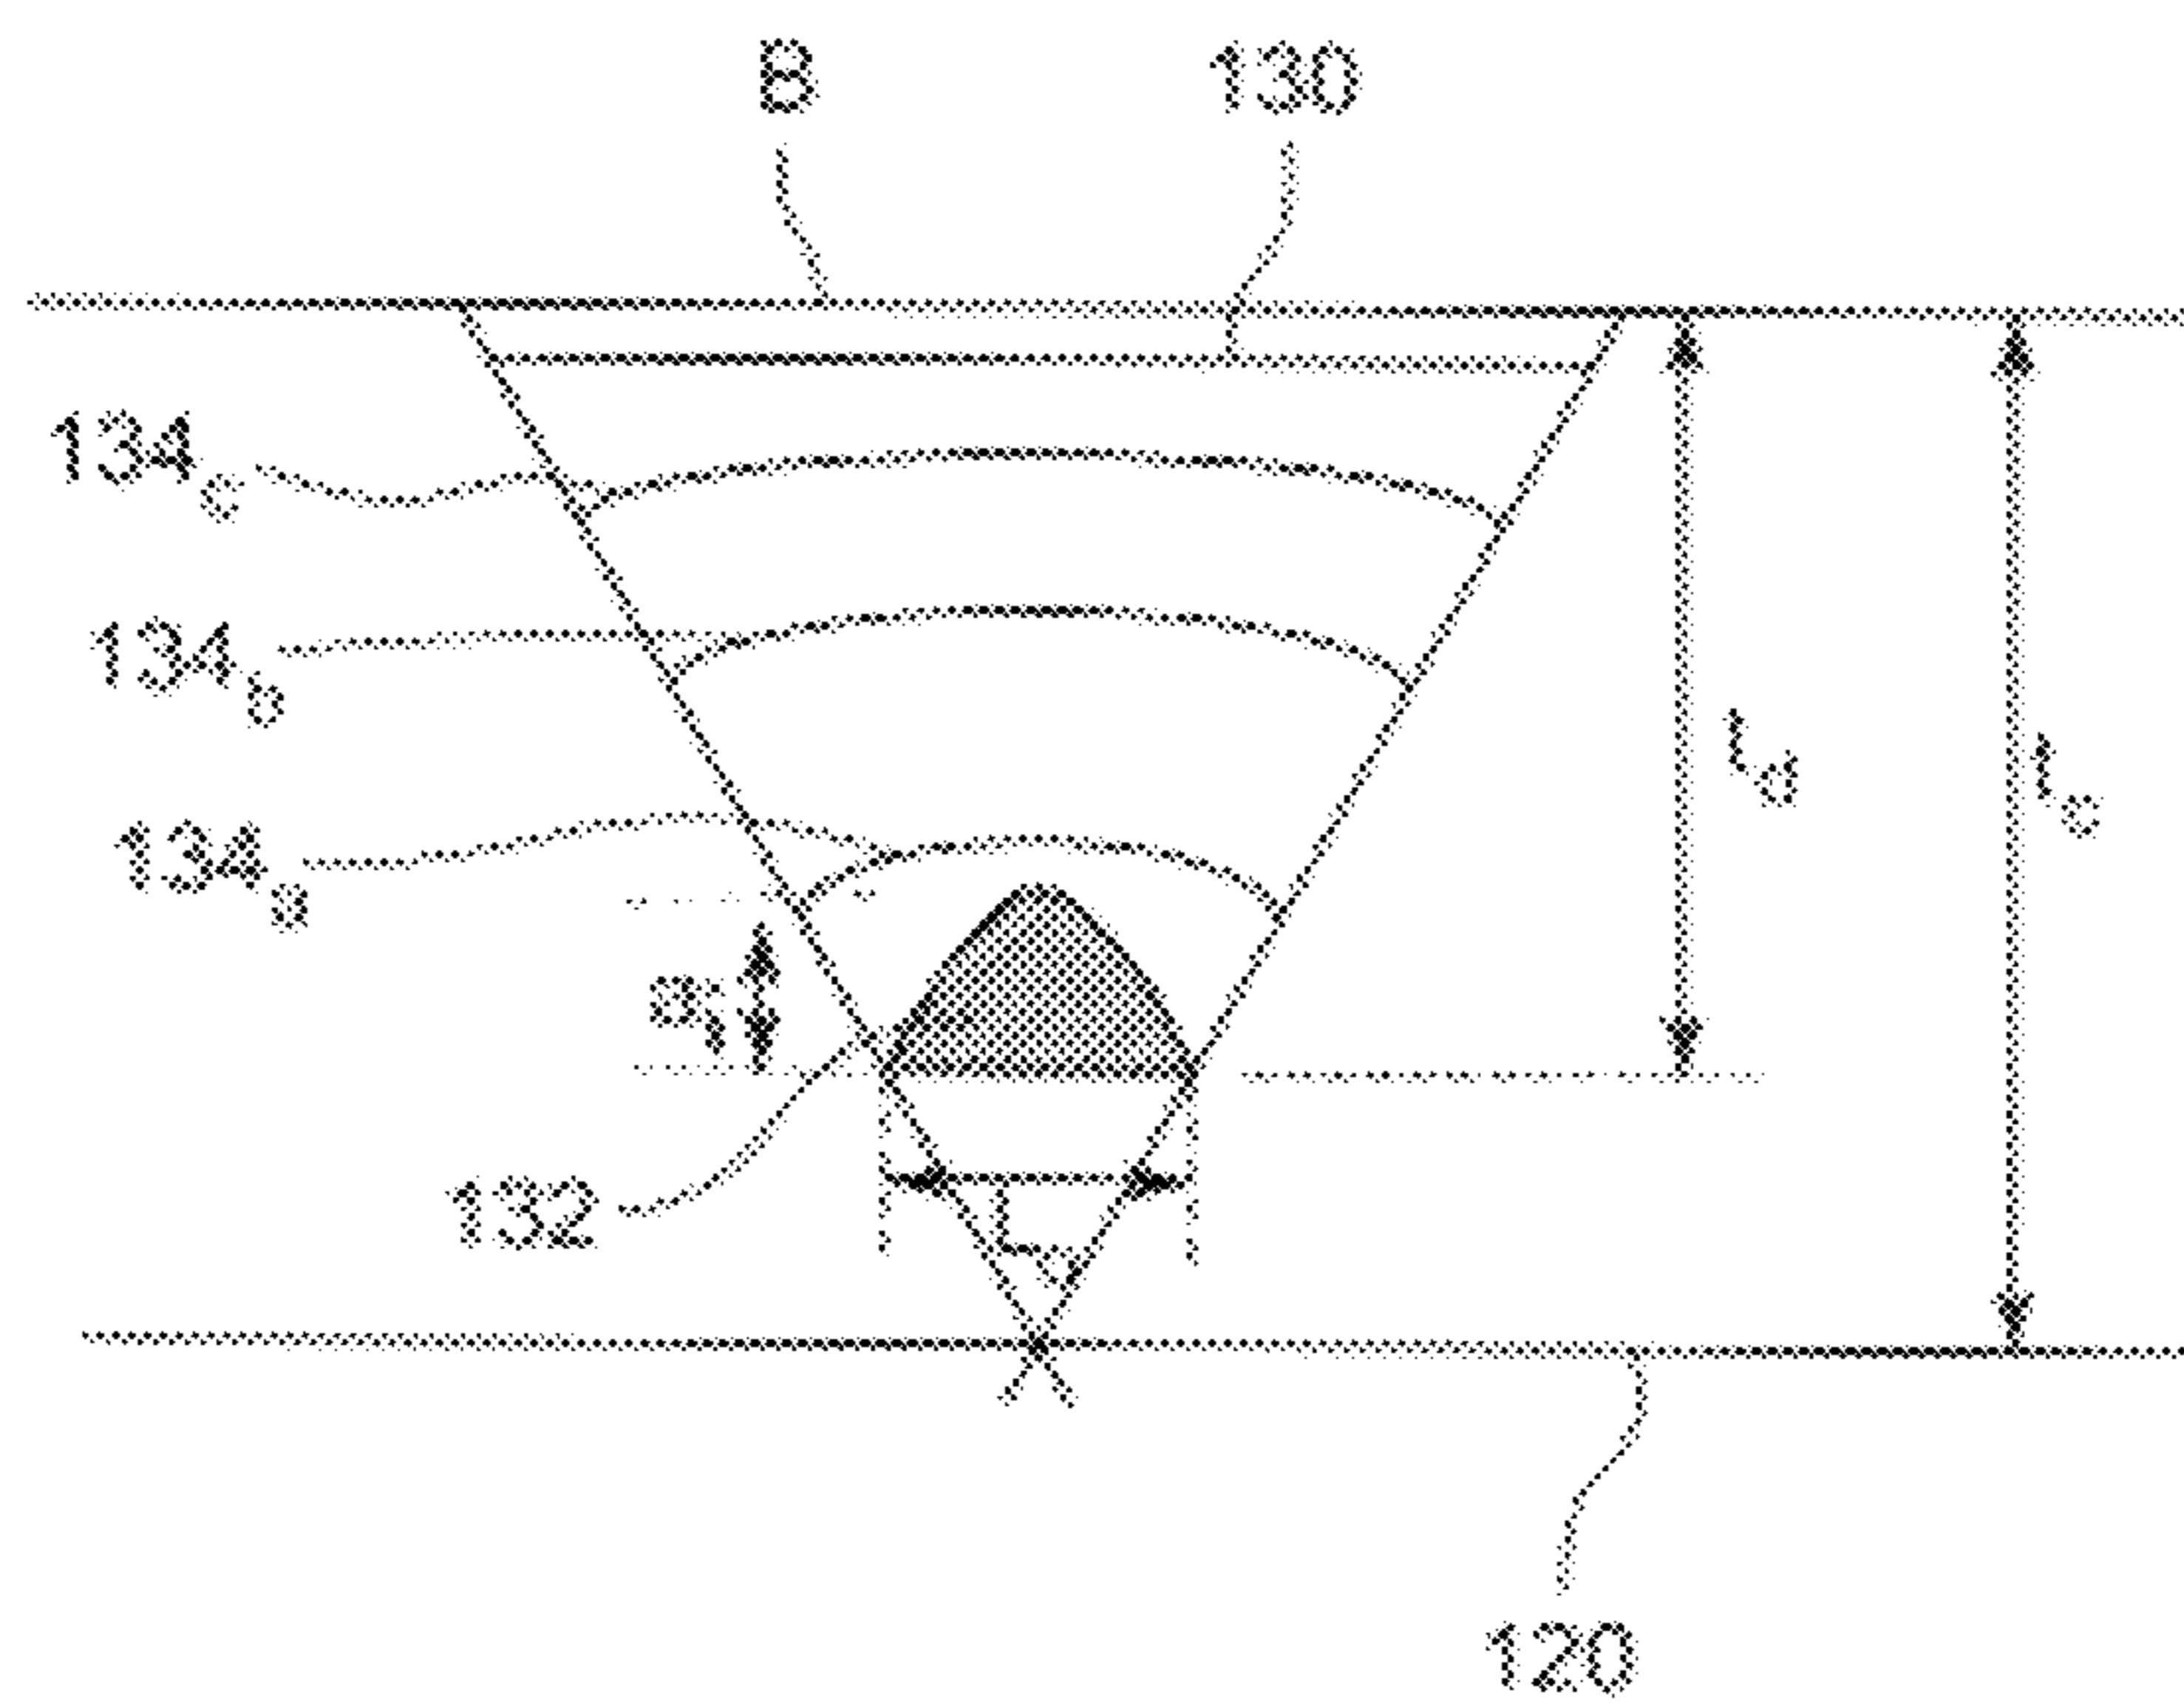
FIG. 6 is a schematic view of a defect, invisible from external detection, within layers of a wind turbine blade.

It should be appreciated that the defect 132 could be at such a depth, or located at such a place within the layered object that there are no externally visible signs of the defect 132. As illustrated in FIG. 6, a defect 132 is located between a first surface 114 and a second surface 116 of a layered object, such as a wind turbine blade 100. Affected layers are located between the defect 132 and the first surface 114. Specifically, affected layers 134_a, 134_b, and 134, are shown located between the defect 132 and the first surface 114.

The amount to which the affected layers are affected diminishes as the distance from the defect 132 increases. Specifically, the height of the bulge of each affected layer decreases with increasing distance, while the length of the bulge of each affected layer increases with increasing distance. Thus, the height of the affected layer 134_a is greater than the height of the affected layer 134_b, which in turn is

greater than the height of the affected layer 134_c. Eventually, the bulging is completely dissipated and unaffected layers 130 commence between the layer 134, and the first surface 114. Thus, the defect 132 is not visible externally and would go undetected using conventional inspection techniques. Using inspection techniques according to embodiments of the invention, however, such a defect 132 as illustrated in FIG. 5 would be detectable.

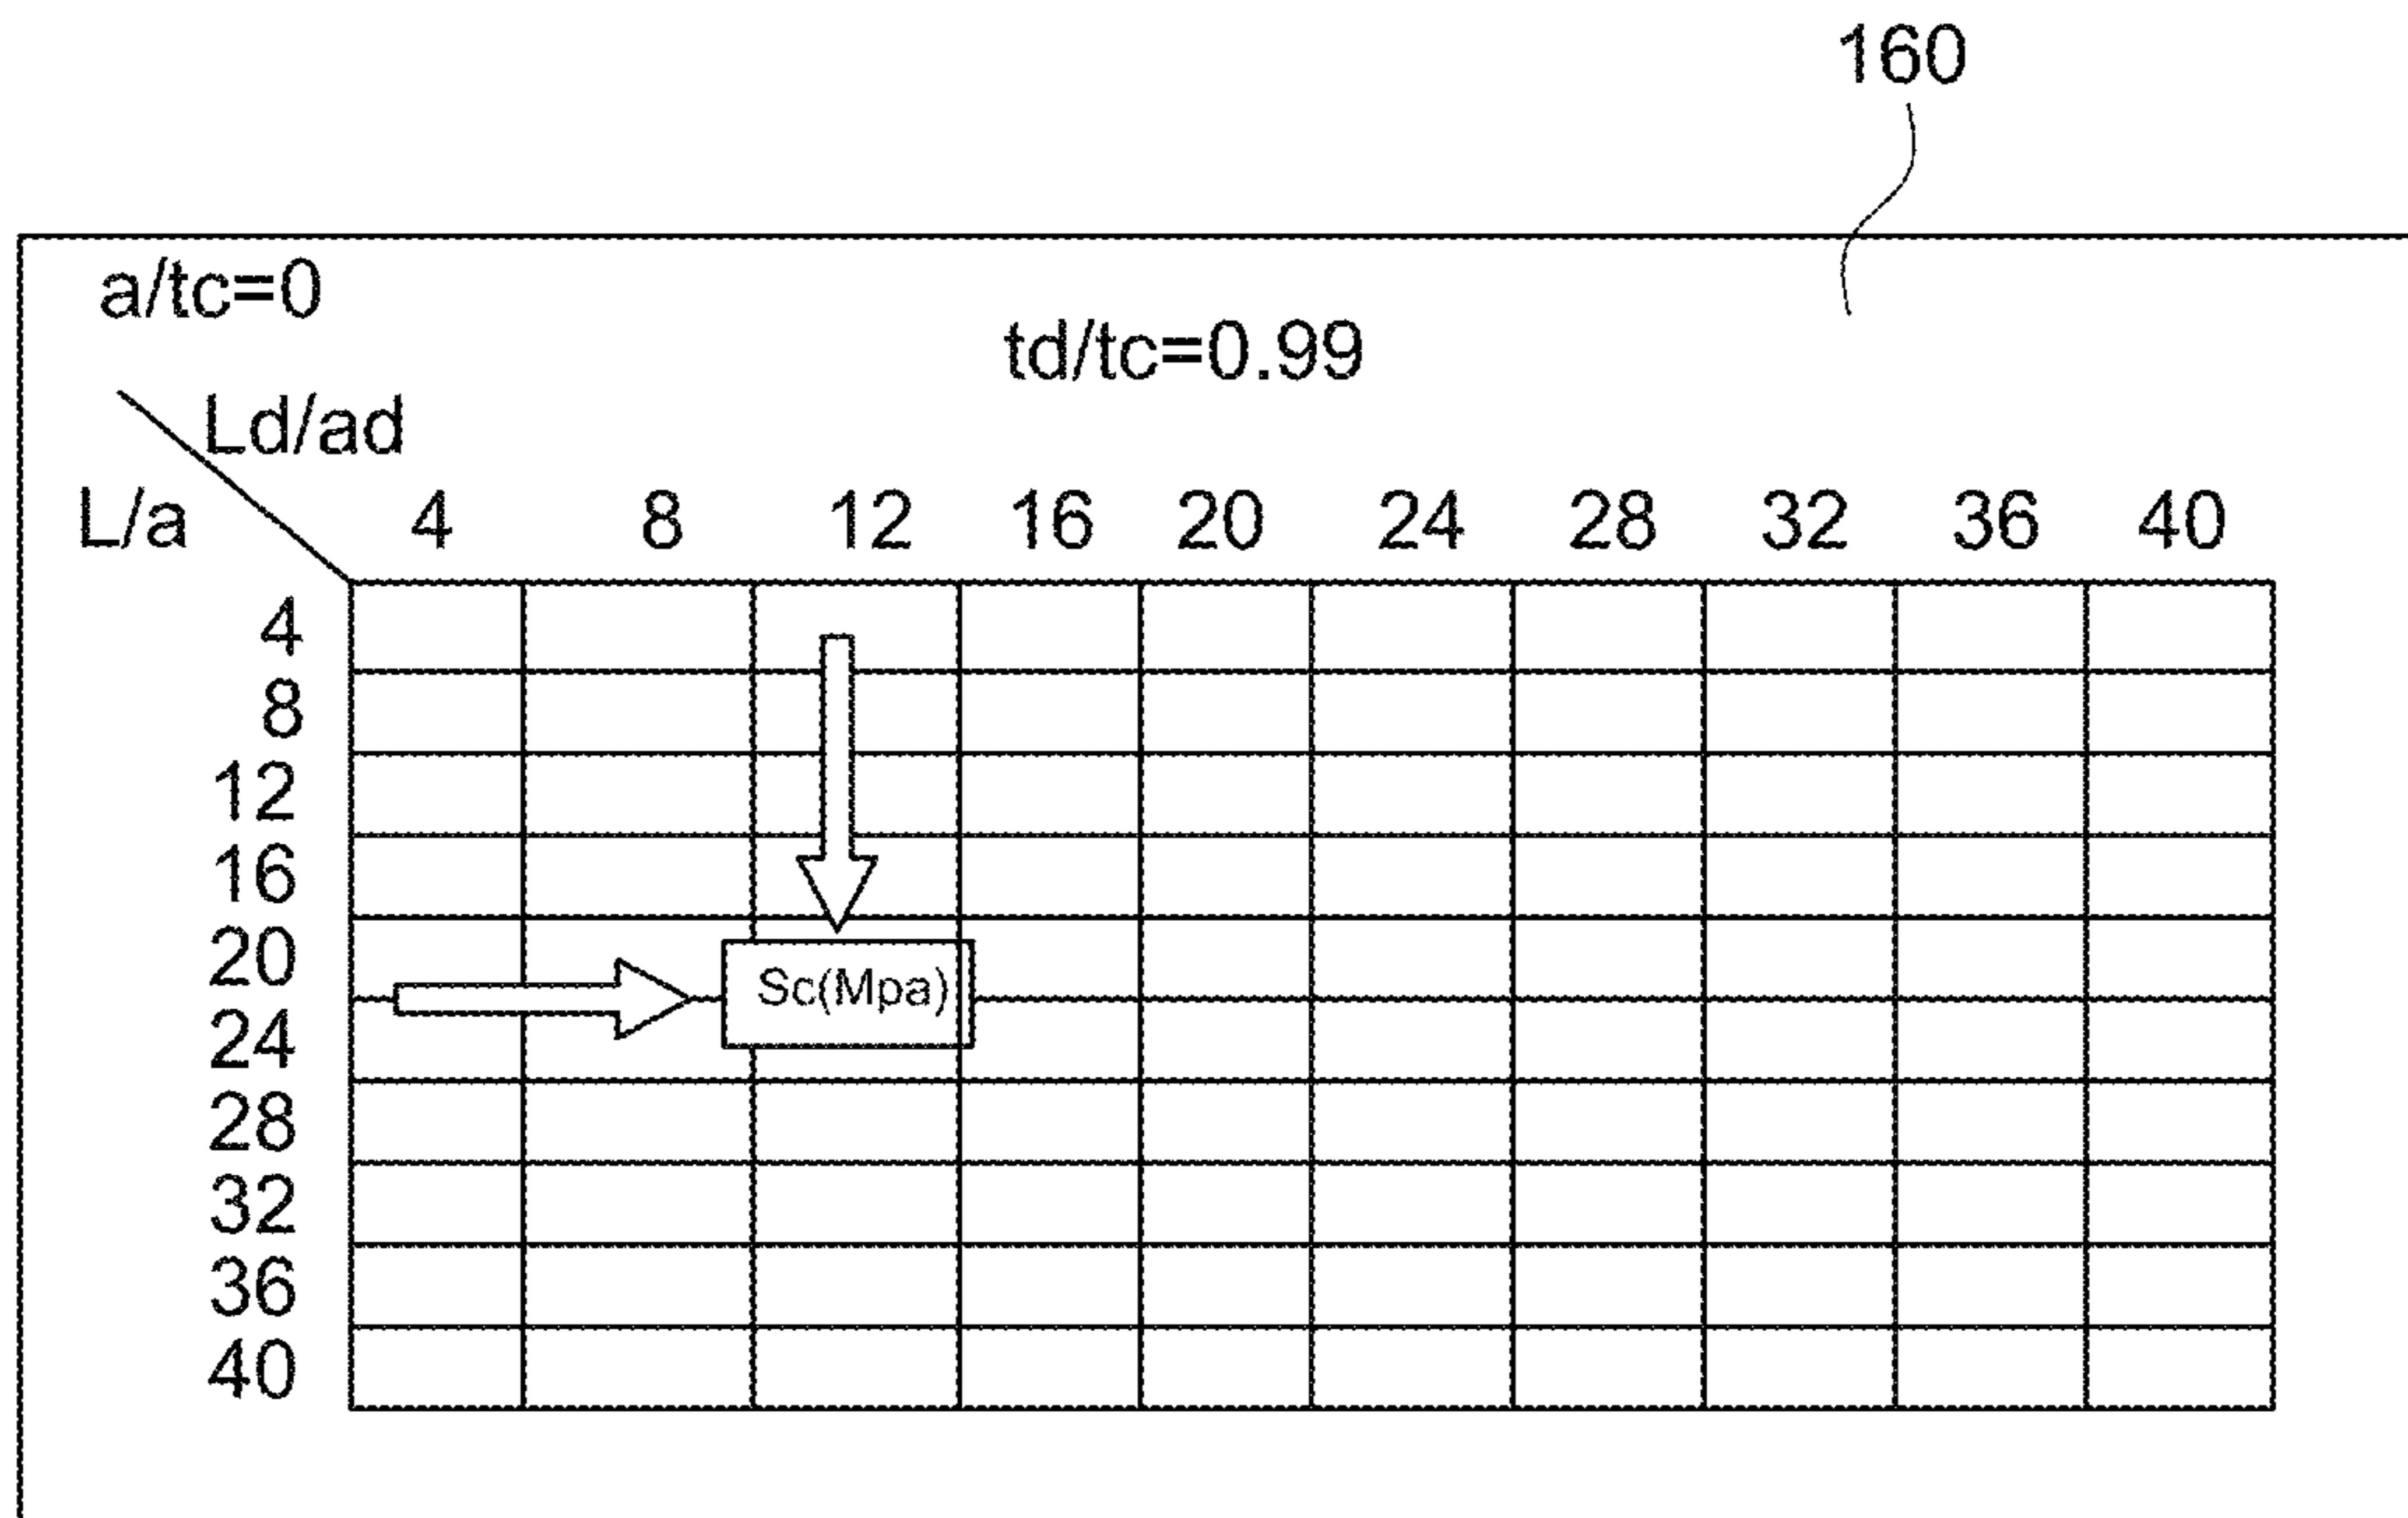
FIG. 7 is an exemplar of a look-up table for determining the mechanical strength of a wind turbine blade in accordance with an embodiment of the invention.

Once the measurements of the various parameters and aspects of the defect are taken, a look-up table 160 is utilized. The look-up table 160 of FIG. 7 provides strength profiles for, in addition to the external aspect ratio L/a_e , various internal parameters, including the internal aspect ratio L_o/a_i ; the ratio of depth of the defect relative to the thickness of the layered object in the plane of the defect (t_d/t_c); and, the ratio of the height of the defect to the thickness of the layered object in the plane of the defect (a_i/t_c). The ratios are synchronized on the look-up table 160 by location on the blade 100 from the tip 102 to the root 104. Specifically, the ratios are synchronized in one meter increments from tip 102 to root 104 in the span-wise direction 124.

Next, at Step **210**, a strength profile of the layered object can be formulated by ascertaining the amount to which the layered object's strength has been compromised by the defect. This can be accomplished through the use of a look-up table, such as the look-up table **160**.

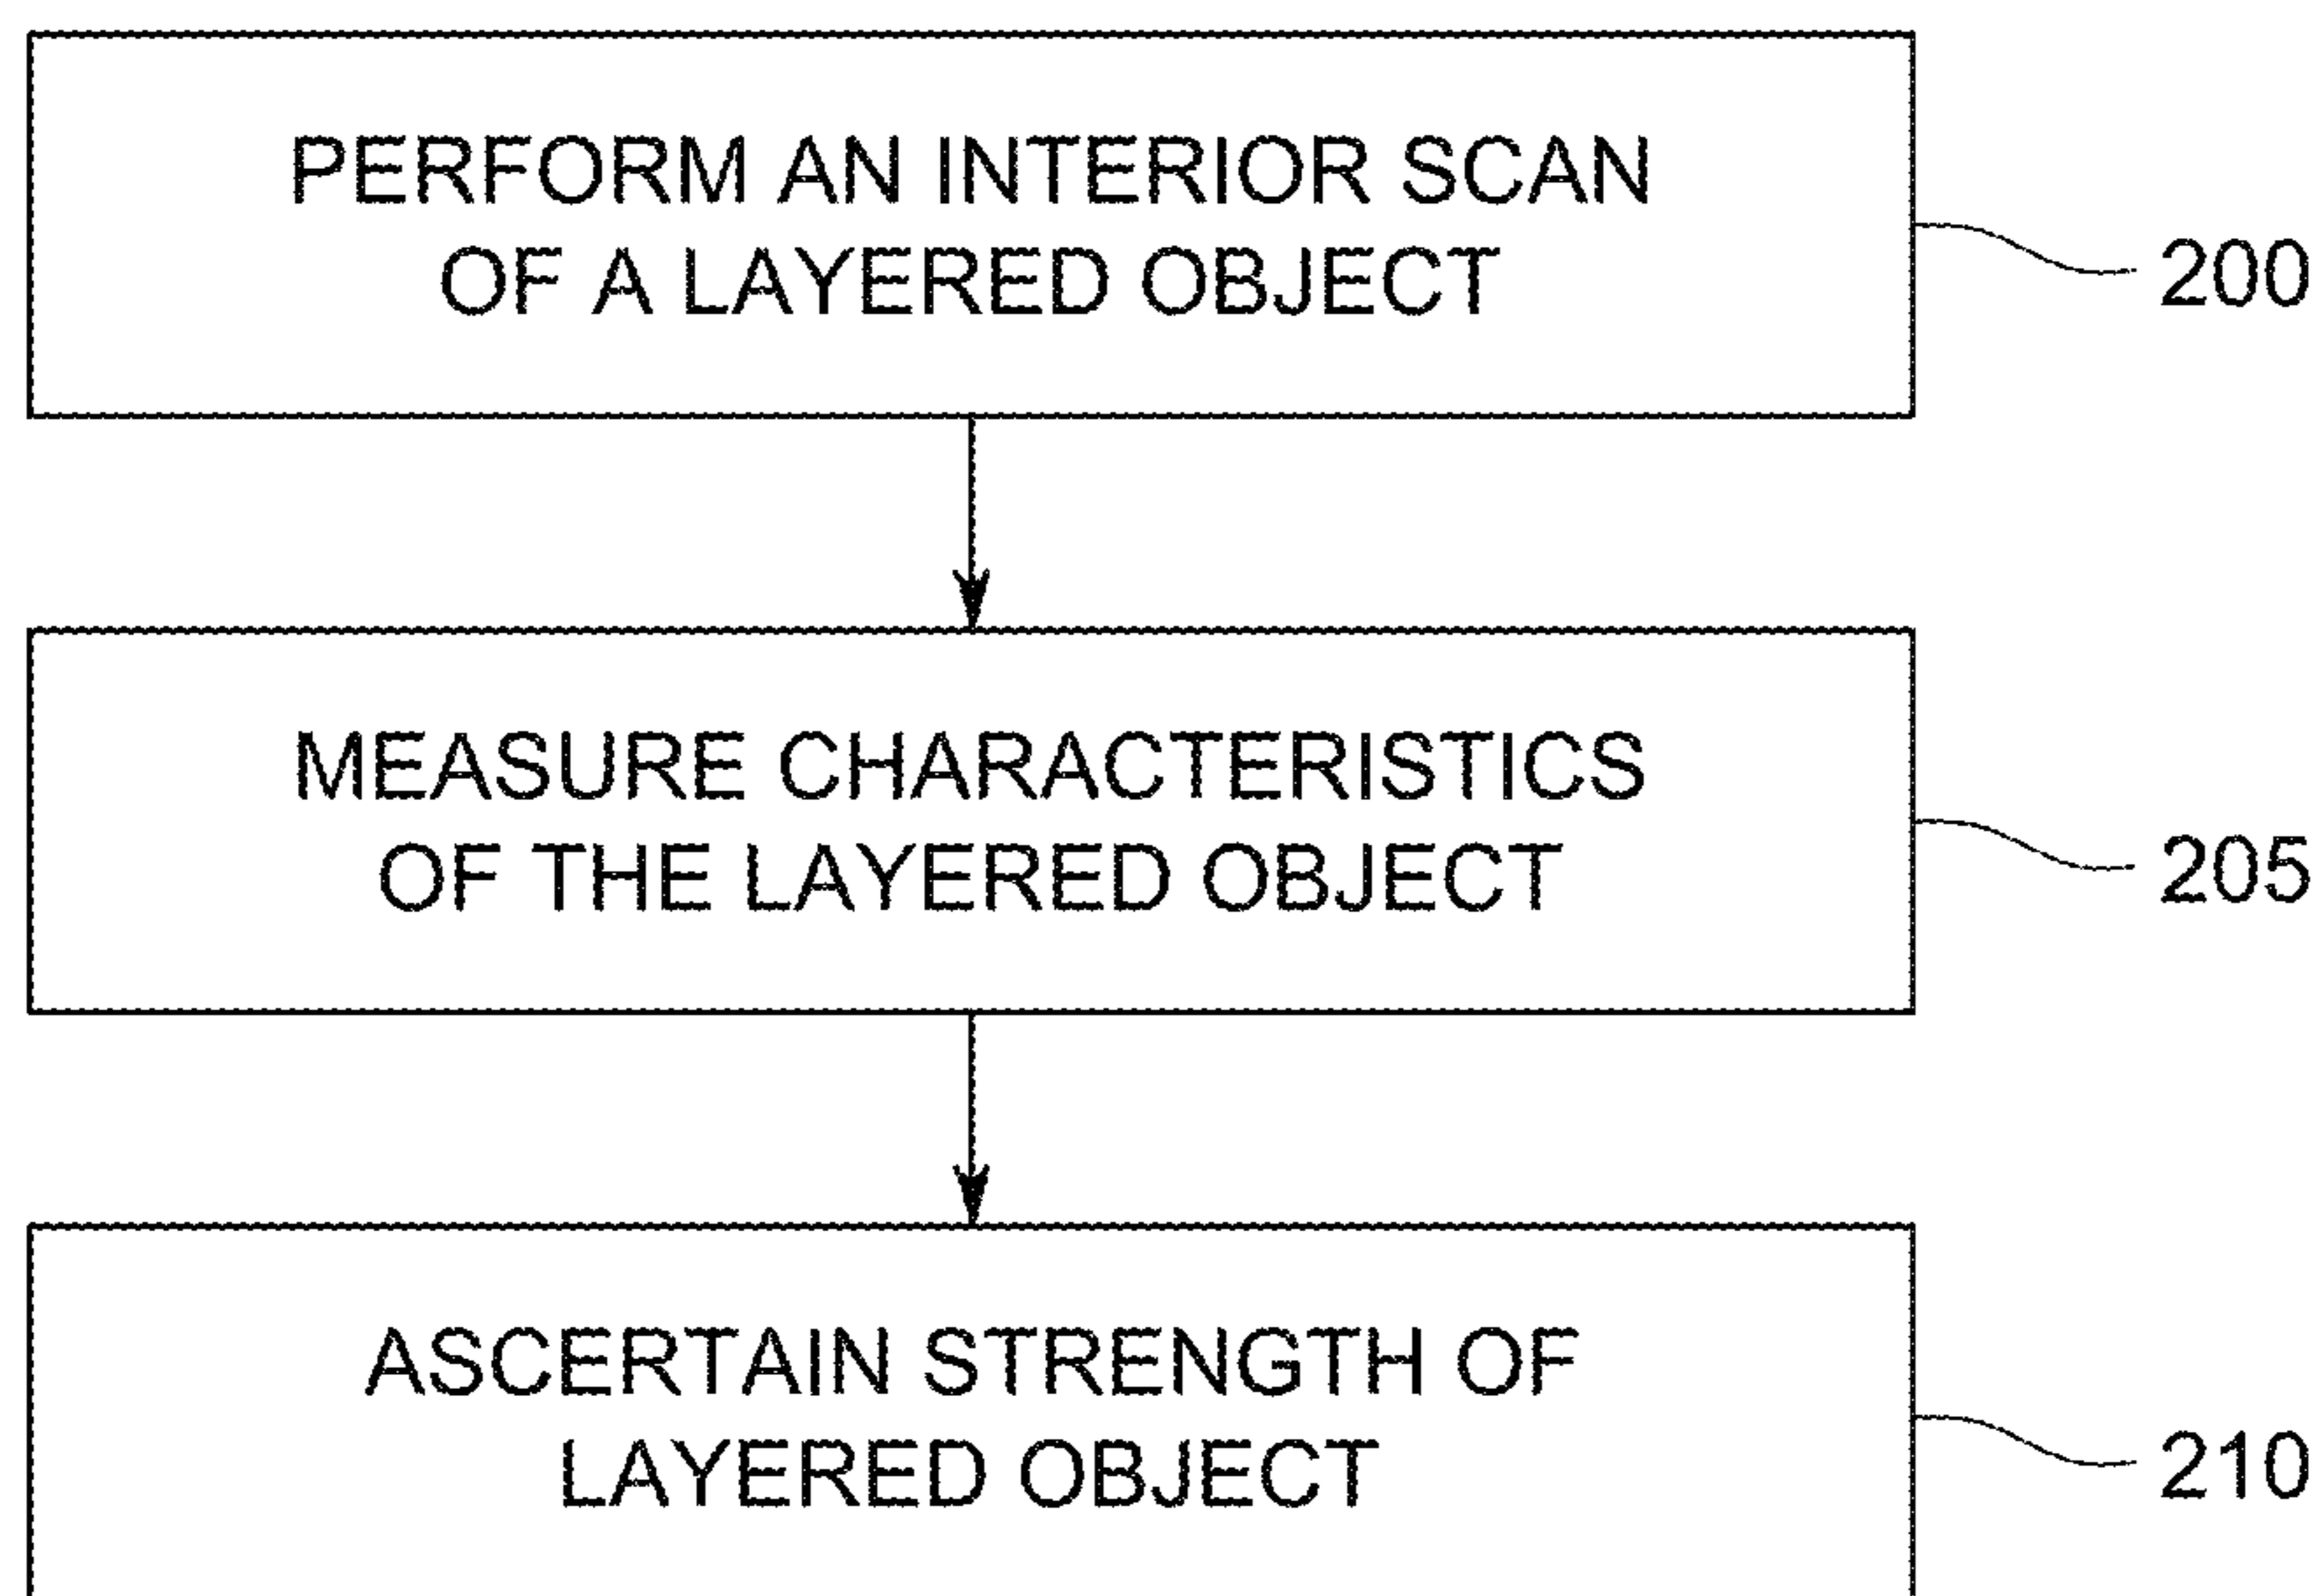
FIG. 8 is a process diagram illustrating a method of inspecting for defects within a turbine blade in accordance with one embodiment.

With reference to FIG. 8, a method of inspecting a layered object is described. At Step 200, a scan of an interior portion of a layered object is performed. The scan may be performed by any number of non-destructive imaging techniques capable of obtaining images of a plurality of planes throughout an object. Embodiments of the invention include ultrasound imaging, x-ray computed tomography imaging, and laminographic imaging.

Next, at Step 205, measurements are taken from the scanned images of various parameters located in the images. For example, if a defect is located in an image, the defect parameters of an external aspect ratio L/a_e , an internal aspect ratio L_o/a_i , the ratio of depth of the defect relative to the thickness of the layered object in the plane of the defect (t_d/t_c), and, the ratio of the height of the defect to the thickness of the layered object in the plane of the defect (a_i/t_c) can be taken. The equipment used may include an ultrasonic instrument capable of high resolution encoded scans. There are different techniques used for the acquisition of data, depending on the section of the blade to be inspected. This may require several chord-wise 122 and span-wise 124 scans that are then stitched together in an analytical software. There are several equip-
