(10) **Patent No.:** **US 8,480,164 B2**
(45) **Date of Patent:** **Jul. 9, 2013**

(54) **FRONTAL STRUCTURE OF VEHICLE**

(73) Assignee: **Honda Motor Co., Ltd.**, Tokyo (JP)

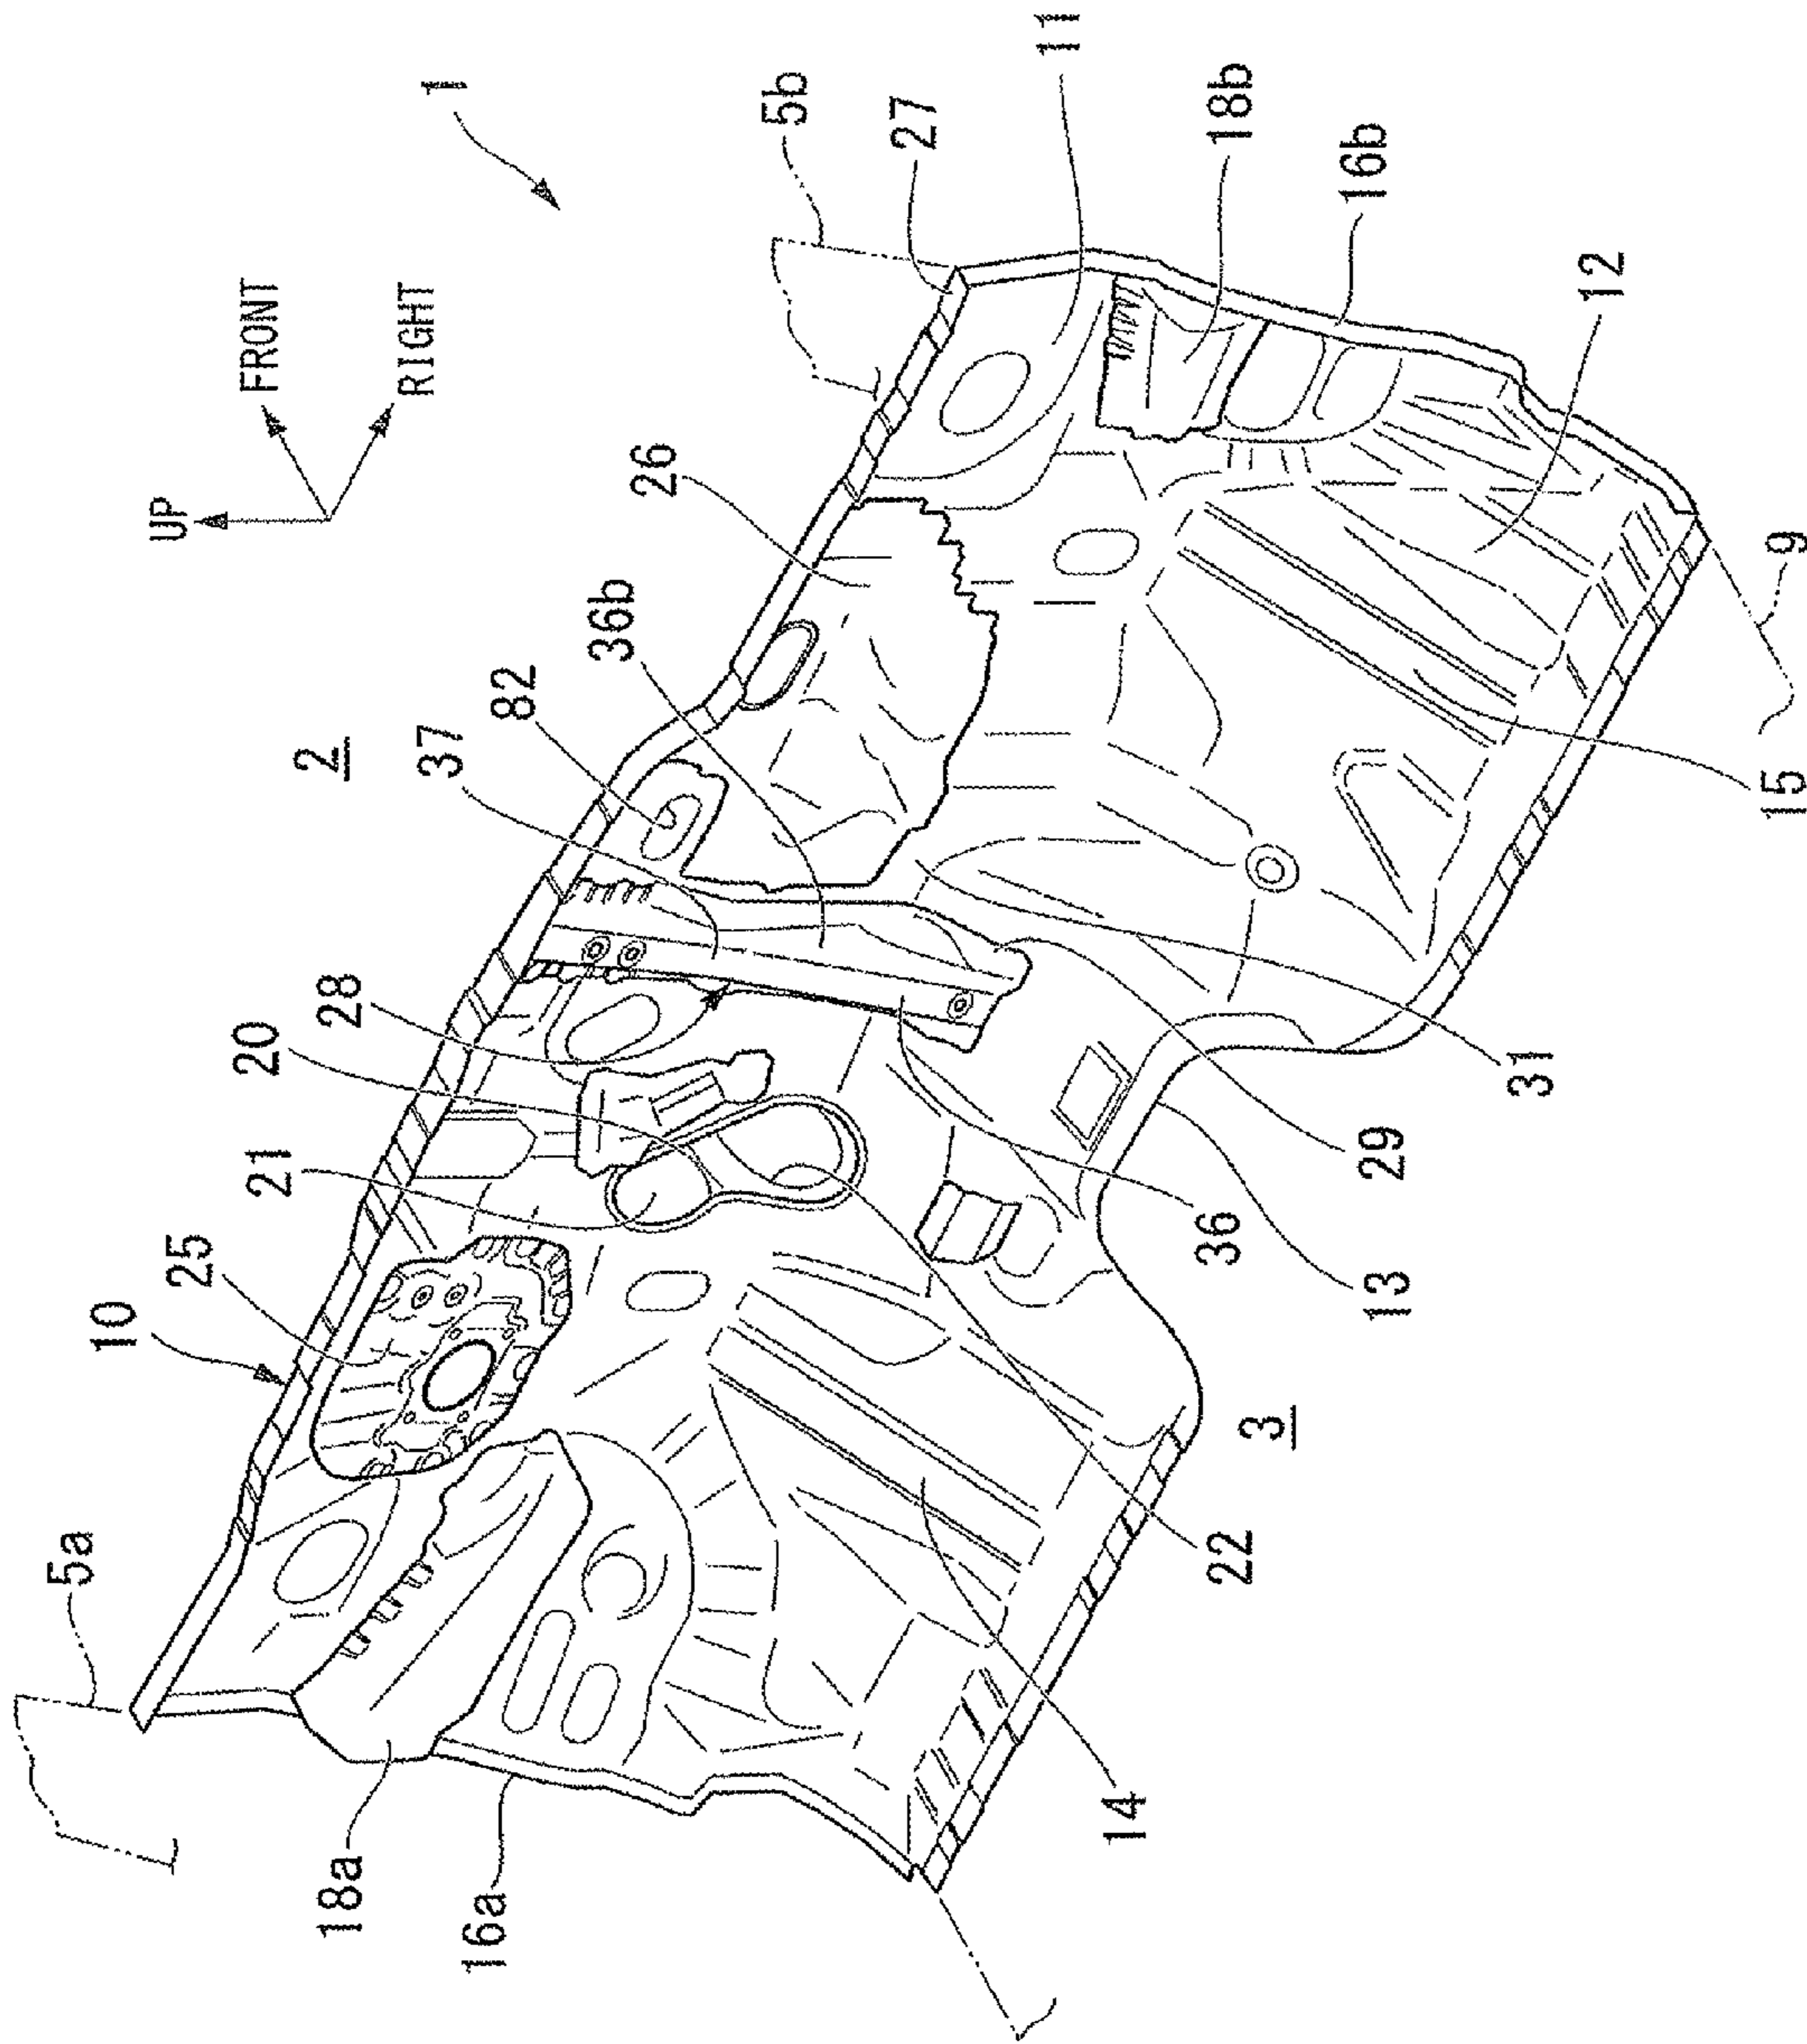
FIG. 1 is a perspective view of a dashboard lower section according to a first embodiment of the present invention seen from a cabin side.

FIG. 1 is a perspective view of a dashboard lower section seen from a cabin side. FIG. 2 is a planar view of a dashboard lower section seen from a cabin side.

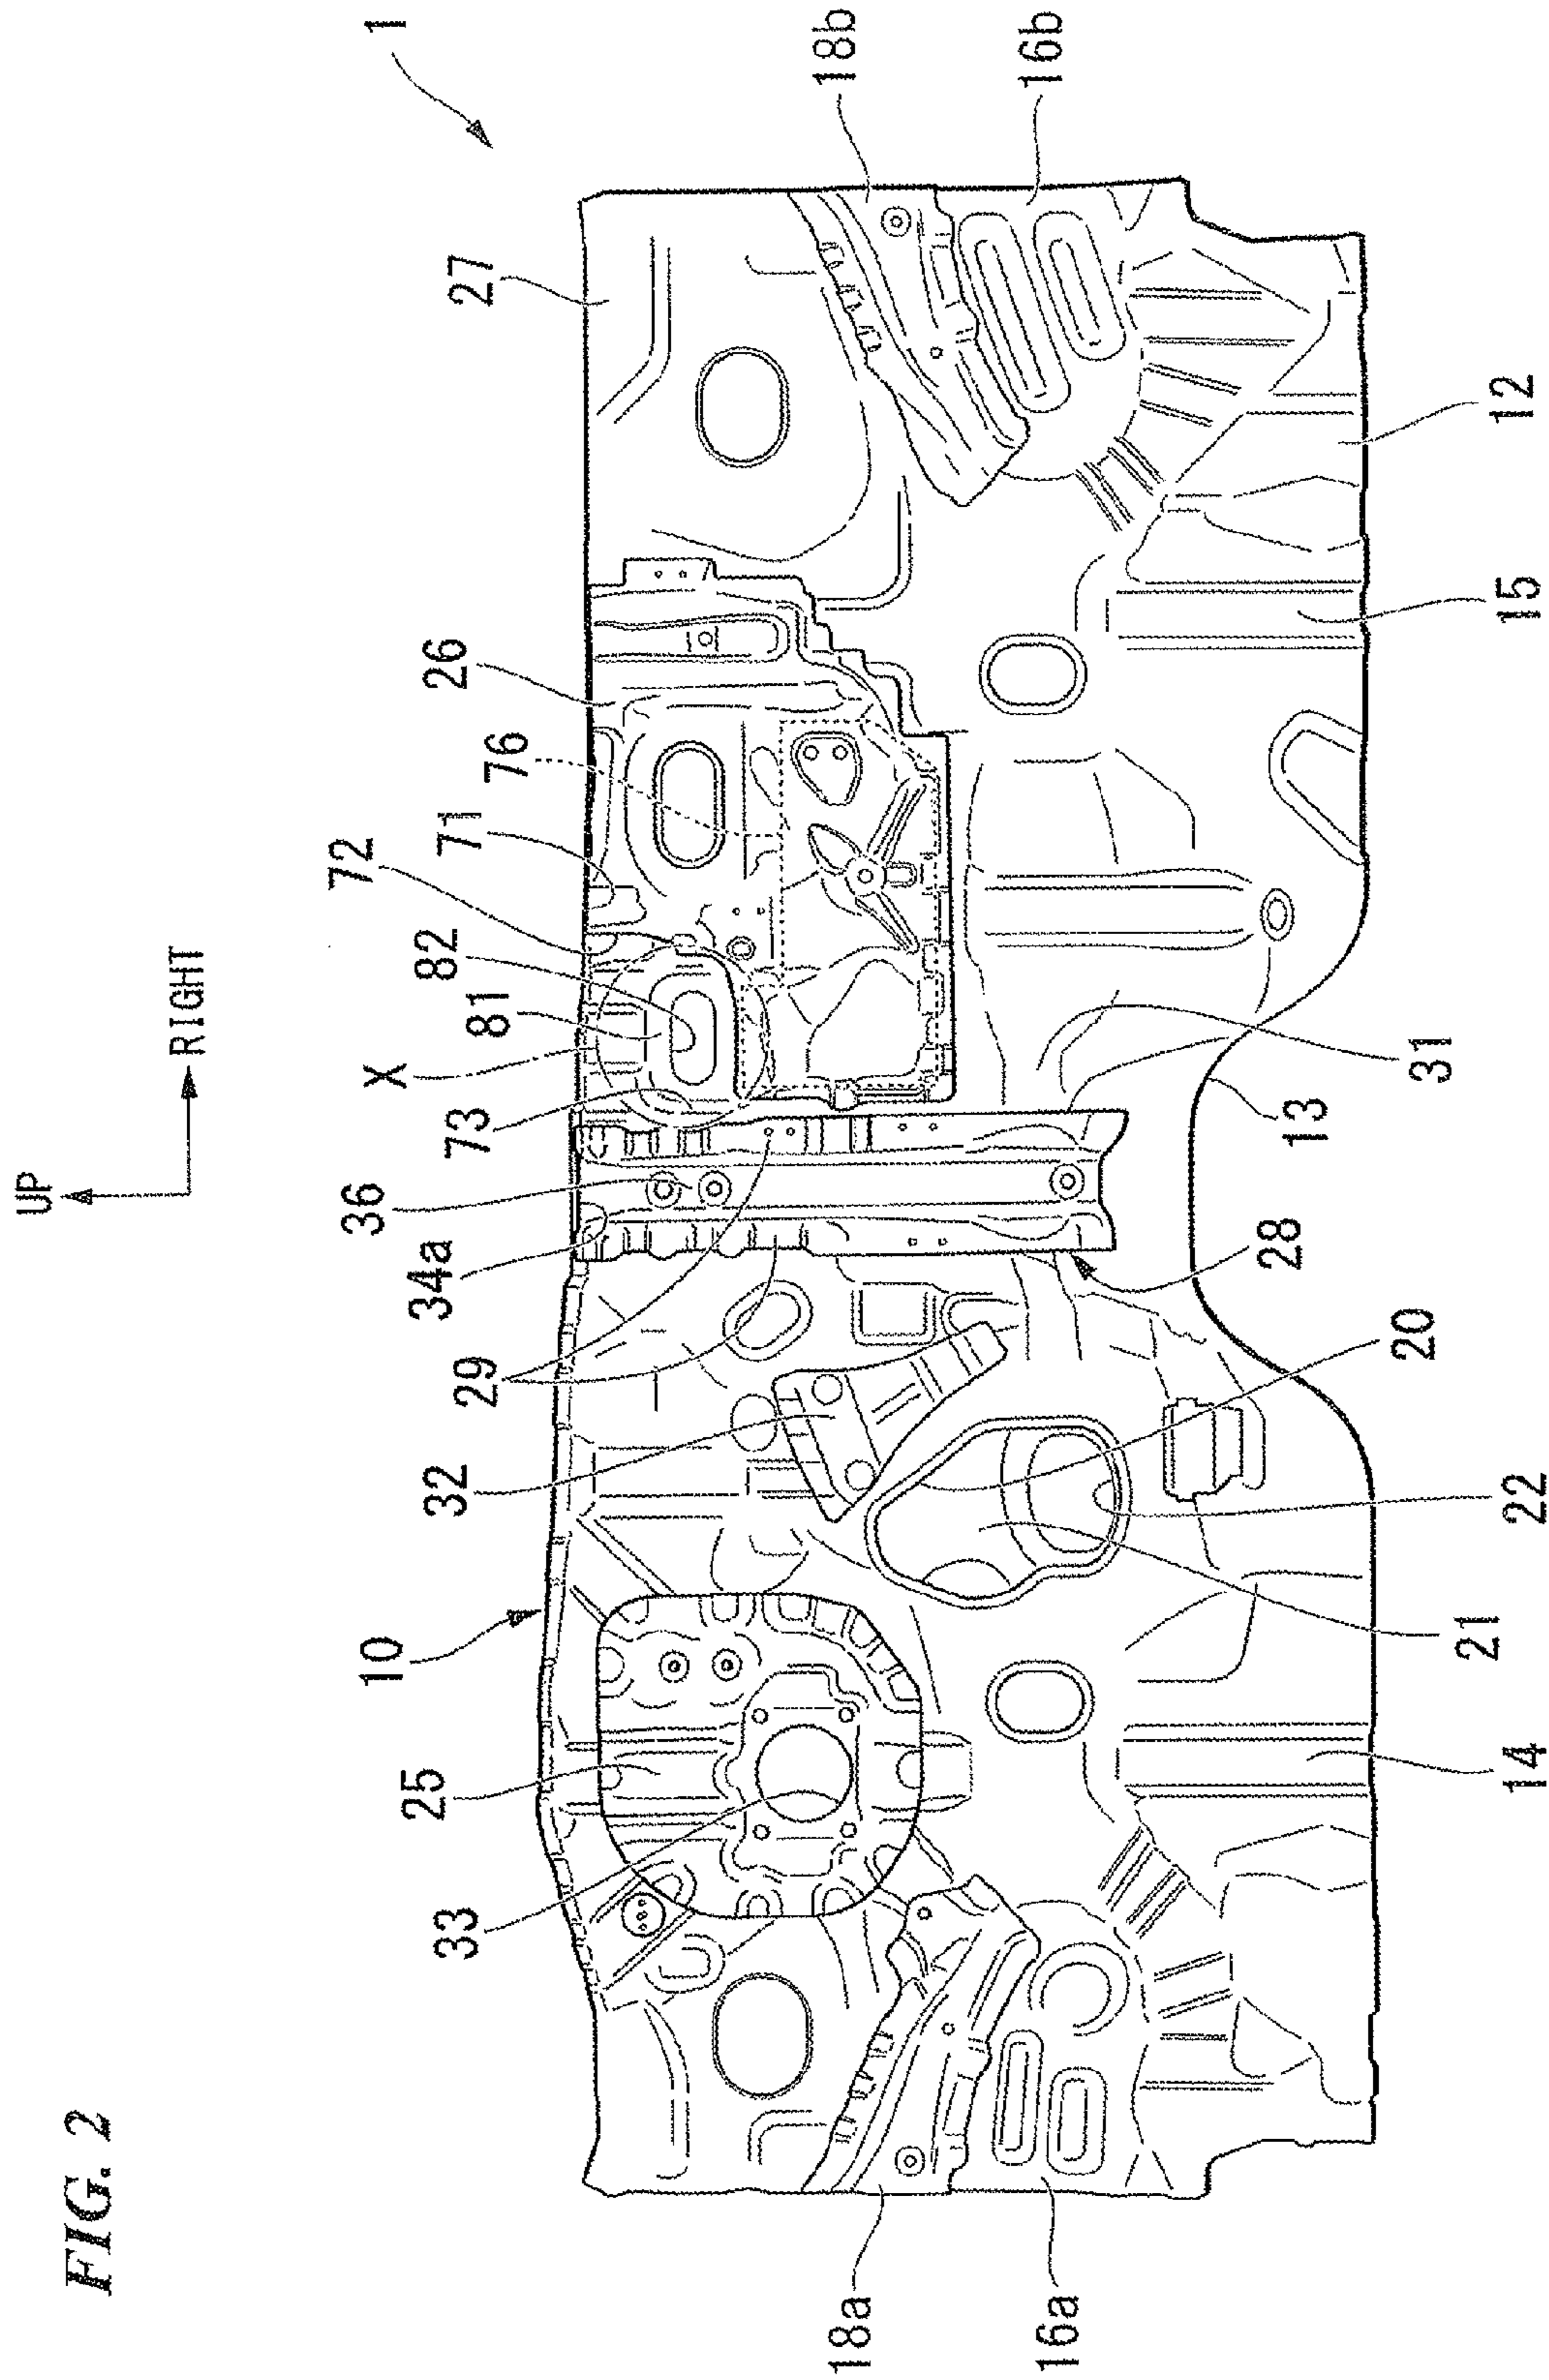
FIG. 2 is a planar view of a dashboard lower section according to a first embodiment of the present invention seen from a cabin side.

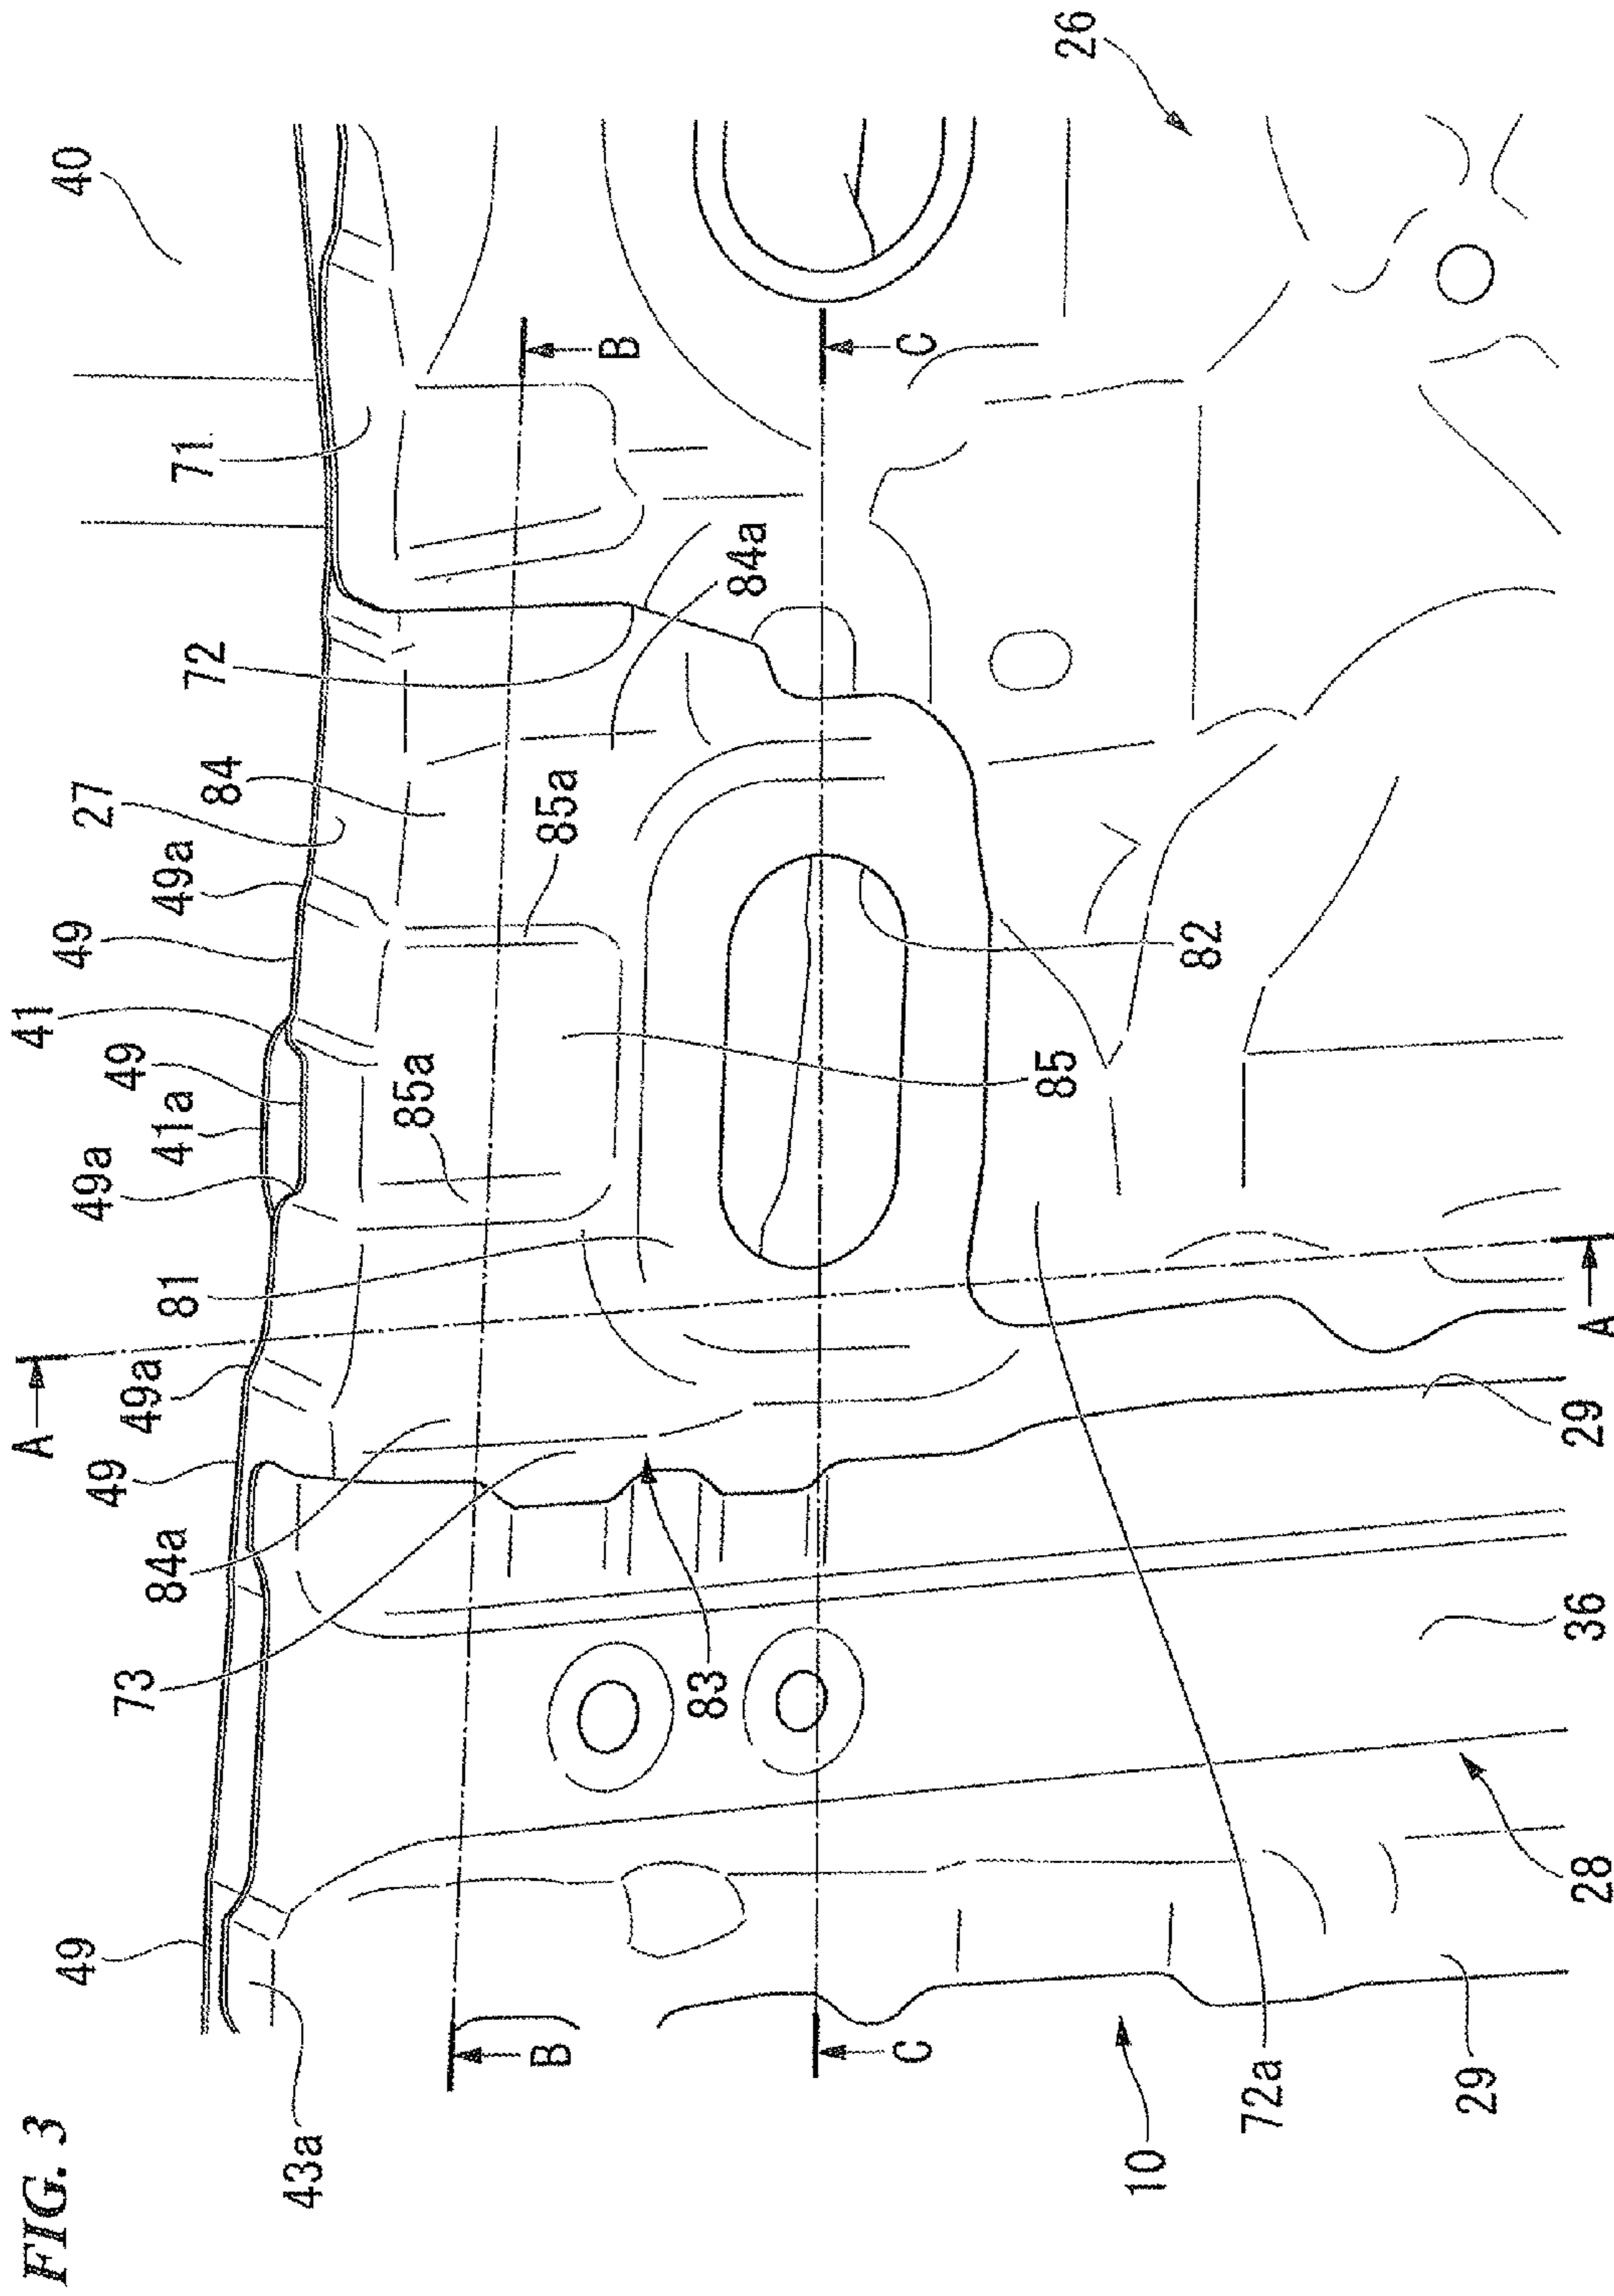
FIG. 4 is a cross sectional view along line A-A of FIG. 3.

FIG. 3 is an enlarged view of part X in FIG. 2. FIG. 4 is a cross sectional view along line A-A of FIG. 3. FIG. 5 is a cross sectional view along line B-B of FIG. 3. FIG. 6 is a cross sectional view along line C-C of FIG. 3.

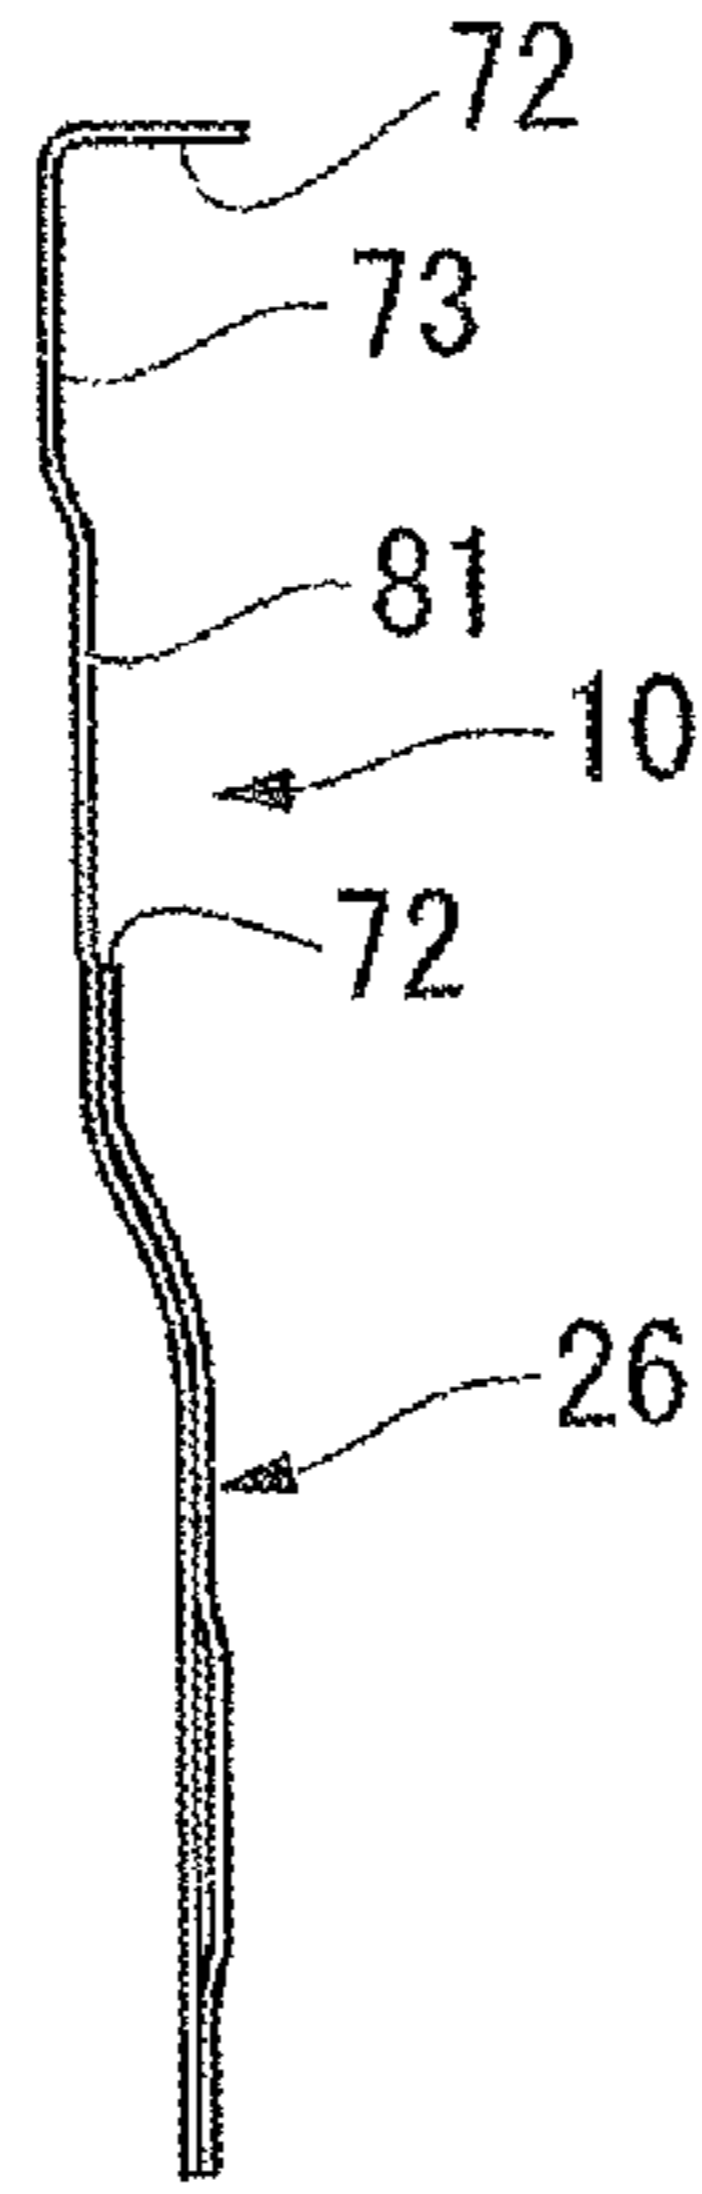
FIG. 5

As shown in FIGS. 3-6, a boot attachment surface 81 is formed at the exposed part 73 of the dashboard lower section 10. The boot attachment surface 81 is formed at approximately the entire lower half of the exposed part 73. The boot attachment surface 81 protrudes towards the cabin 3 side. An opening part 82 for an air conditioner is formed at a major portion of a central part of the boot attachment surface 81. In other words, the boot attachment surface 81 and the opening part 82 for an air conditioner are formed between the center frame 28 and the damping material fixing panel 26.

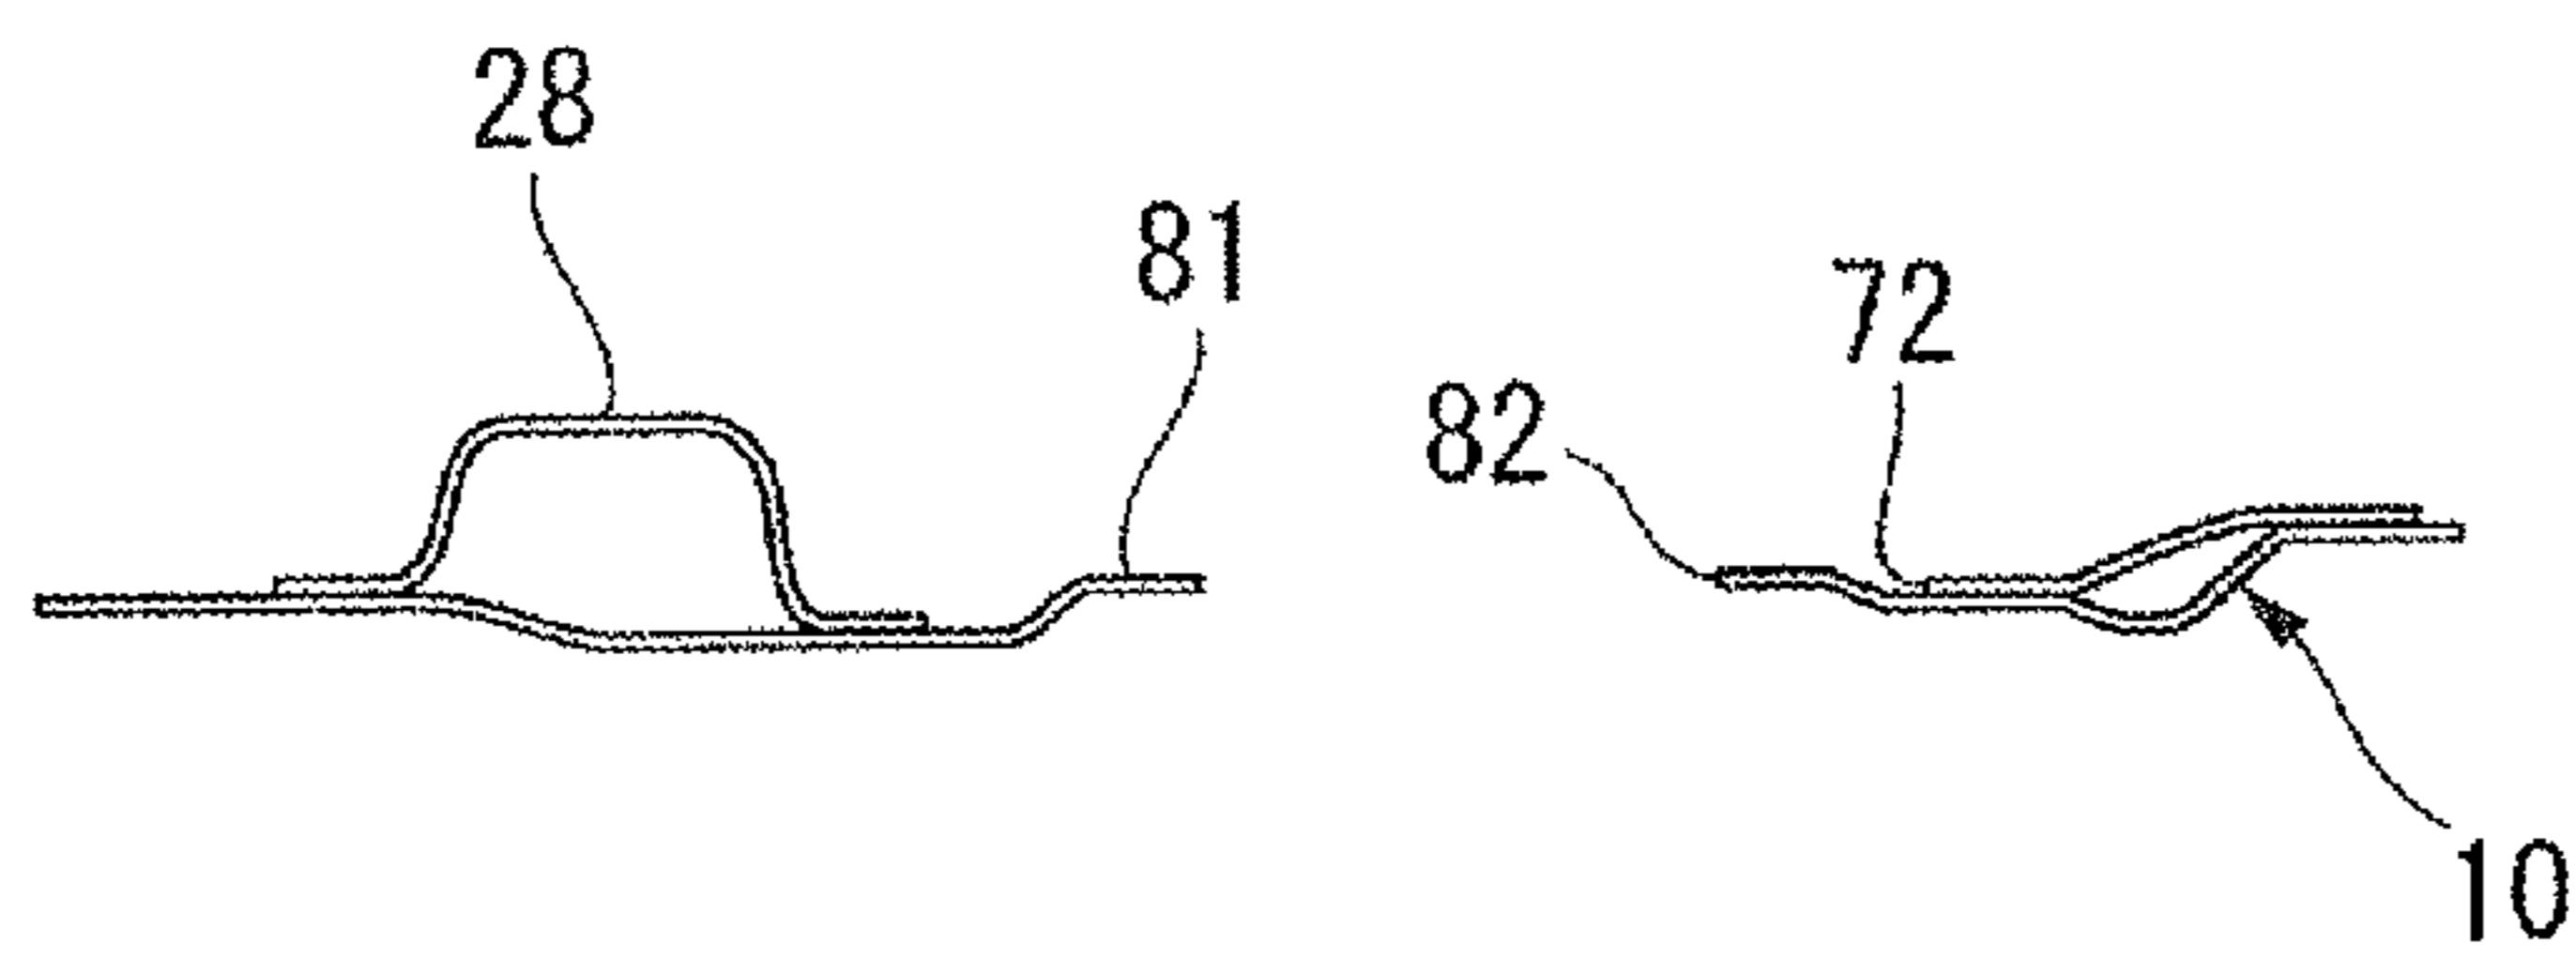
FIG. 7

As shown in FIGS. 7-9, the air conditioning piping 92 is passed through the opening part 82 for an air conditioner formed on the dashboard lower section 10. The air conditioning piping 92 is included in the air conditioning unit 91. The air conditioning unit 91 is a cooling cycle equipment including a non-diagrammed compression device, a condenser, a blower, and an evaporator 94. The air conditioning piping 92 connects the compressor, the condenser, and the evaporator 94. In other words, the interior of the air conditioning piping 92 is a refrigerant gas flow channel.

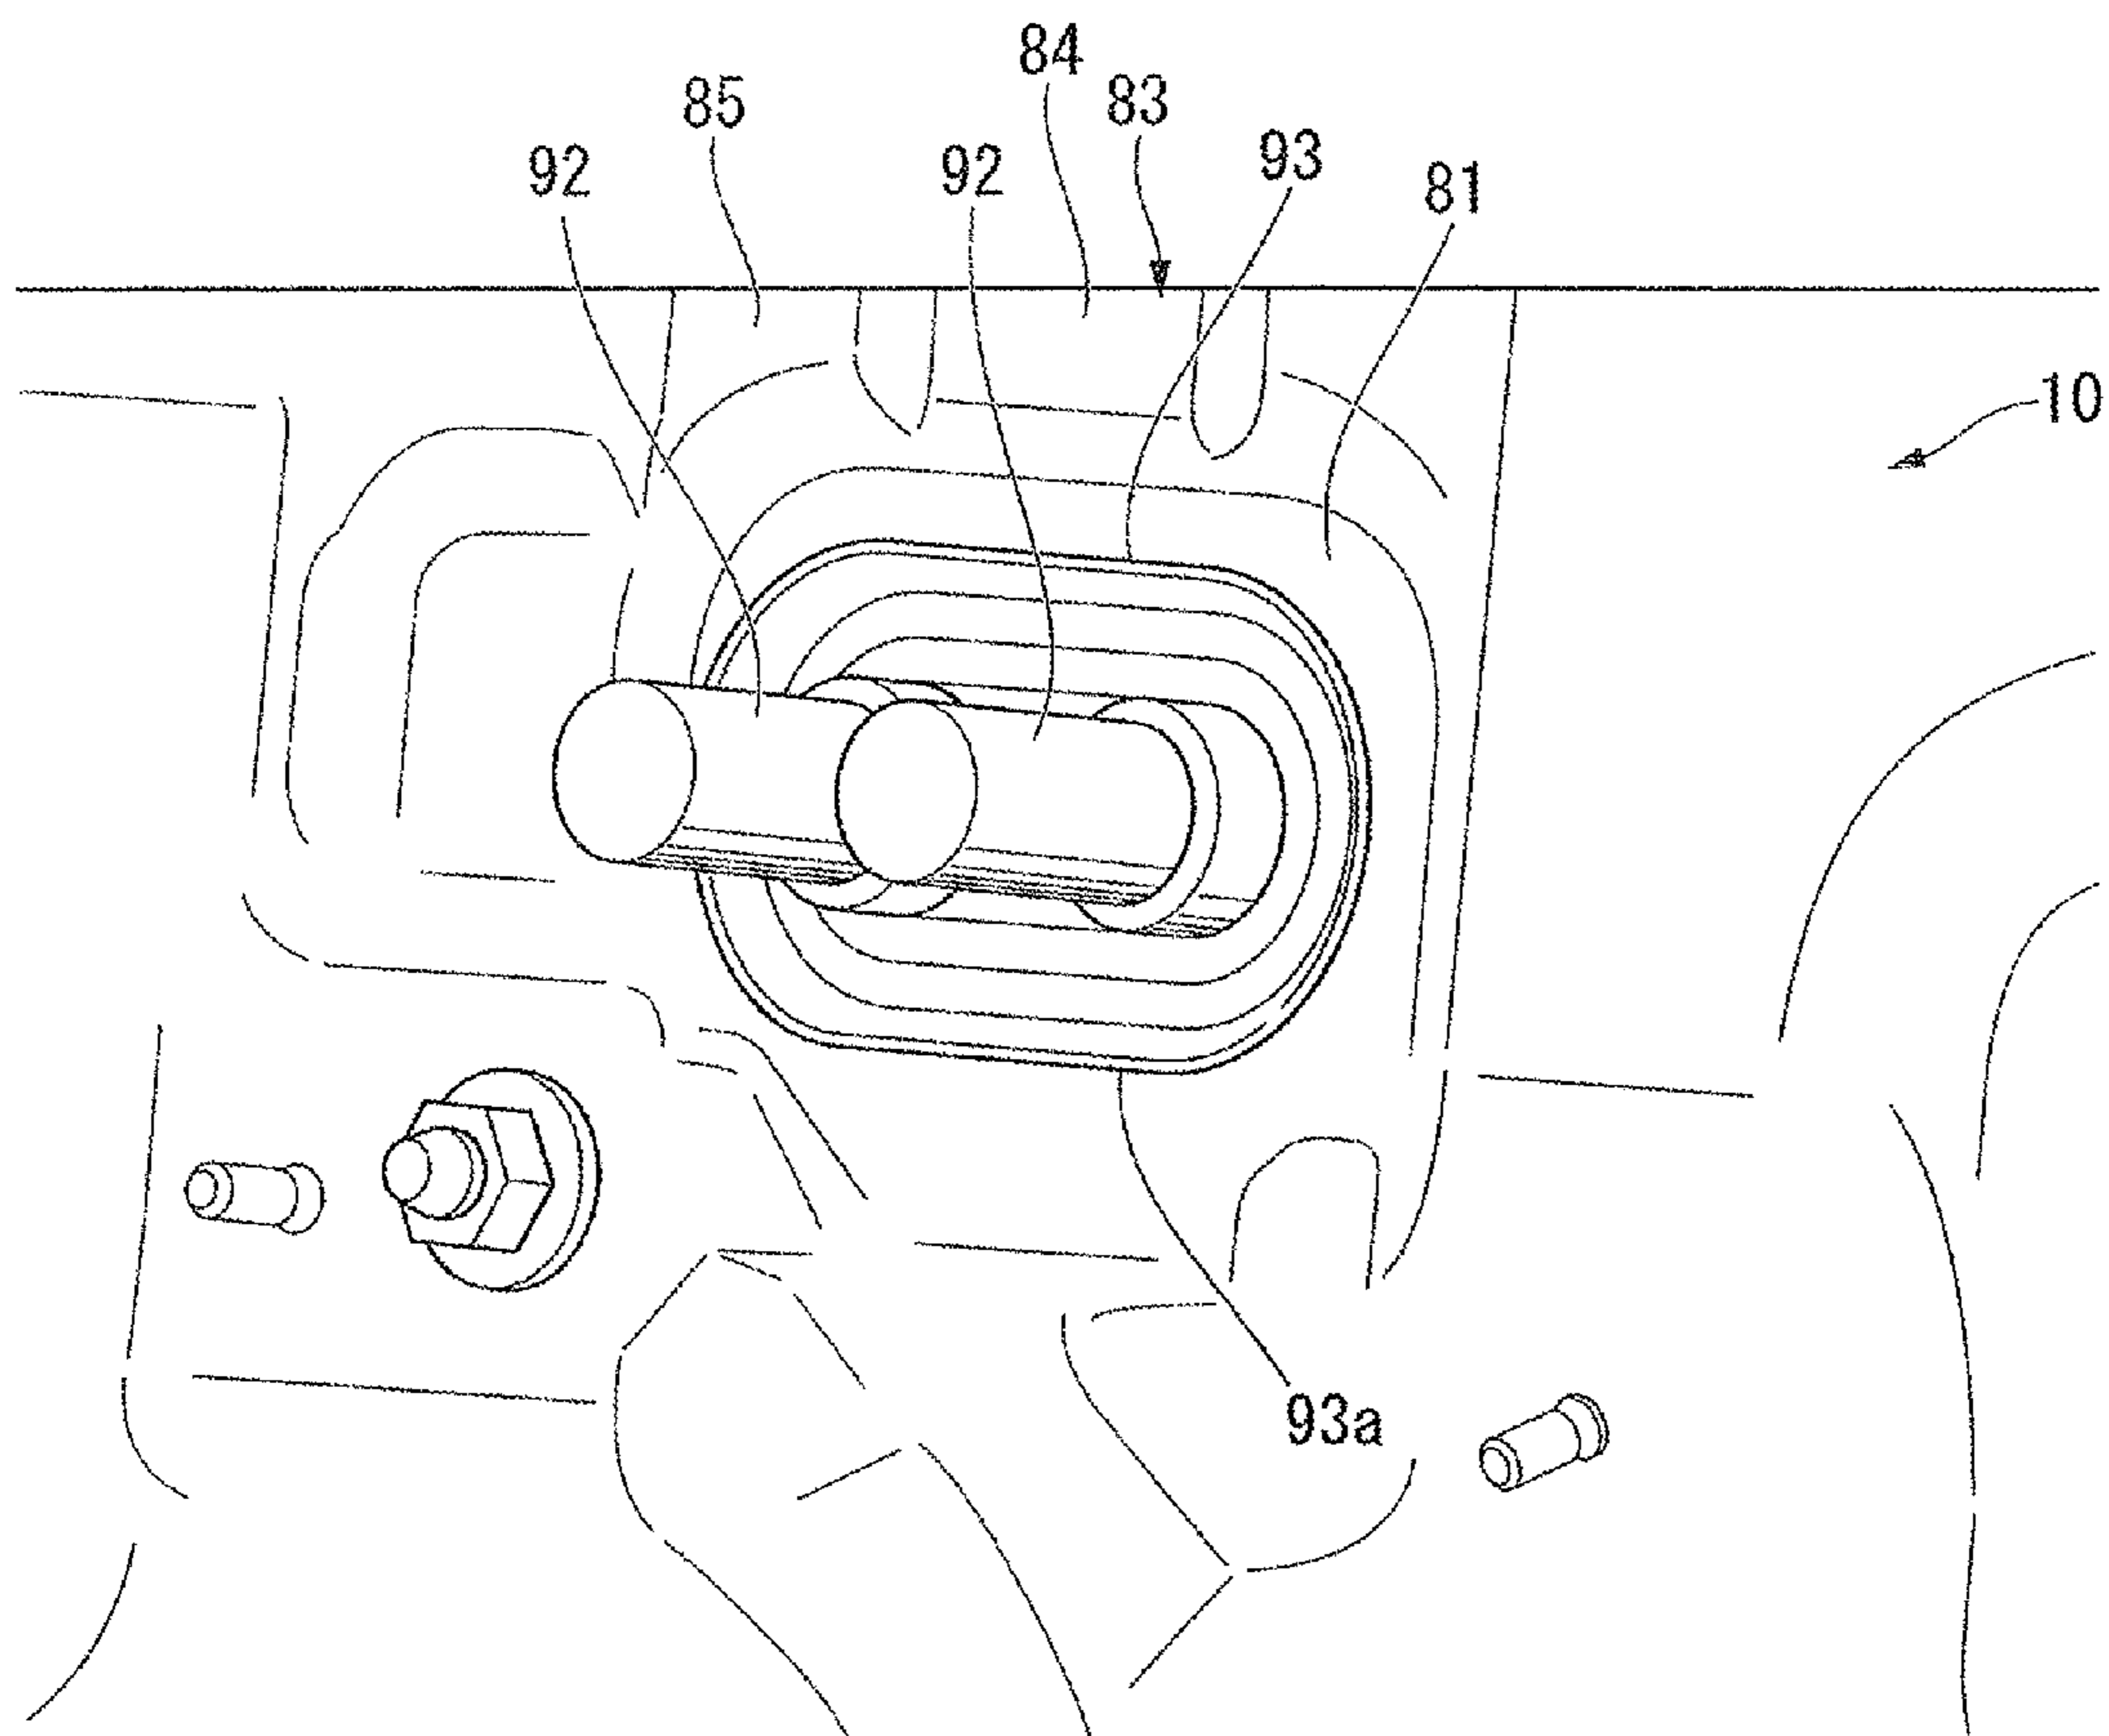
FIG. 8 is a perspective view of a boot attachment surface according to a first embodiment of the present invention seen from a cabin side.

FIG. 7 is a perspective view of a boot attachment surface seen from an engine room side. FIG. 8 is a perspective view of a boot attachment surface seen from a cabin side. FIG. 9 is a cross sectional view along line D-D of FIG. 8.

In addition, as shown in detail in FIGS. 8 and 9, the bent section 27 of the dashboard lower section 10 is connected to the front glass supporting panel 42 via the dashboard upper section 40. The front glass supporting panel 42 is formed by applying a pressing operation and the like to a planar metallic component. The front glass supporting panel 42 includes a longitudinal wall 43 formed on a same plane as the longitudinal wall 11 of the dashboard lower section 10.
