(10) **Patent No.:** **US 8,480,164 B2**
(45) **Date of Patent:** **Jul. 9, 2013**

(54) **FRONTAL STRUCTURE OF VEHICLE**

(73) Assignee: **Honda Motor Co., Ltd.**, Tokyo (JP)

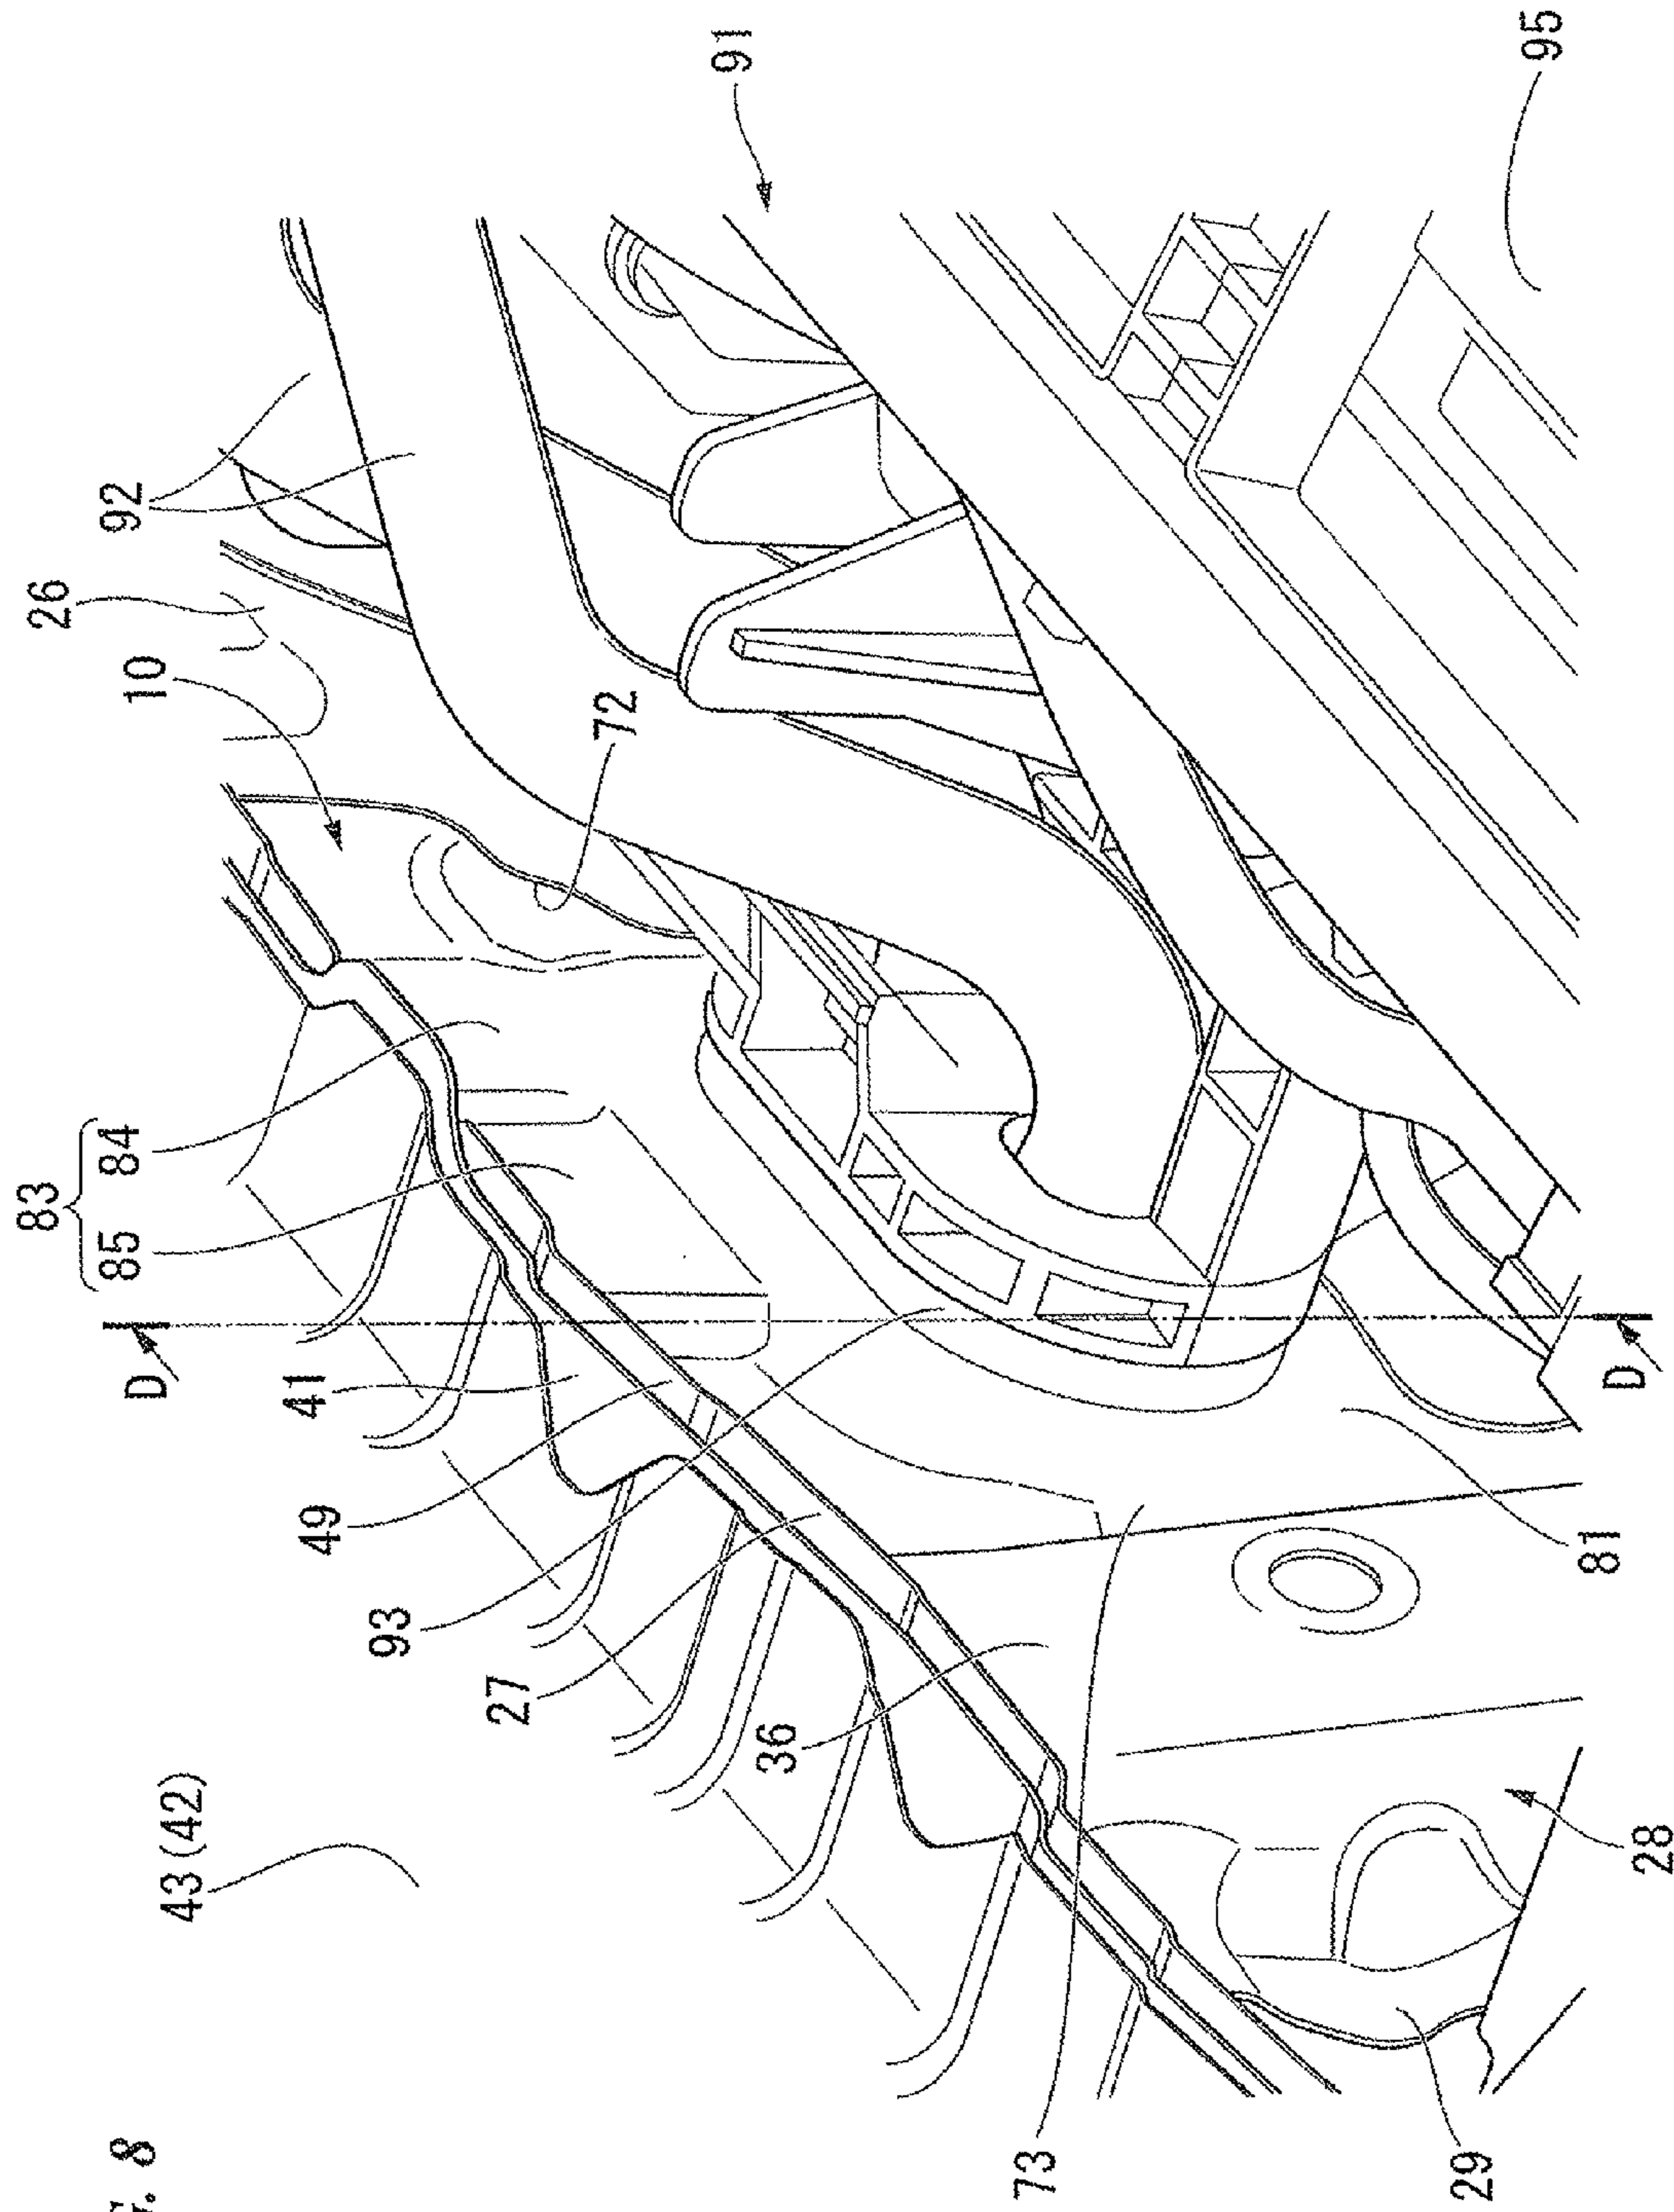
FIG. 9 is a cross sectional view along line D-D of FIG. 8.

In addition, as shown in detail in FIGS. 8 and 9, the bent section 27 of the dashboard lower section 10 is connected to the front glass supporting panel 42 via the dashboard upper section 40. The front glass supporting panel 42 is formed by applying a pressing operation and the like to a planar metallic component. The front glass supporting panel 42 includes a longitudinal wall 43 formed on a same plane as the longitudinal wall 11 of the dashboard lower section 10.

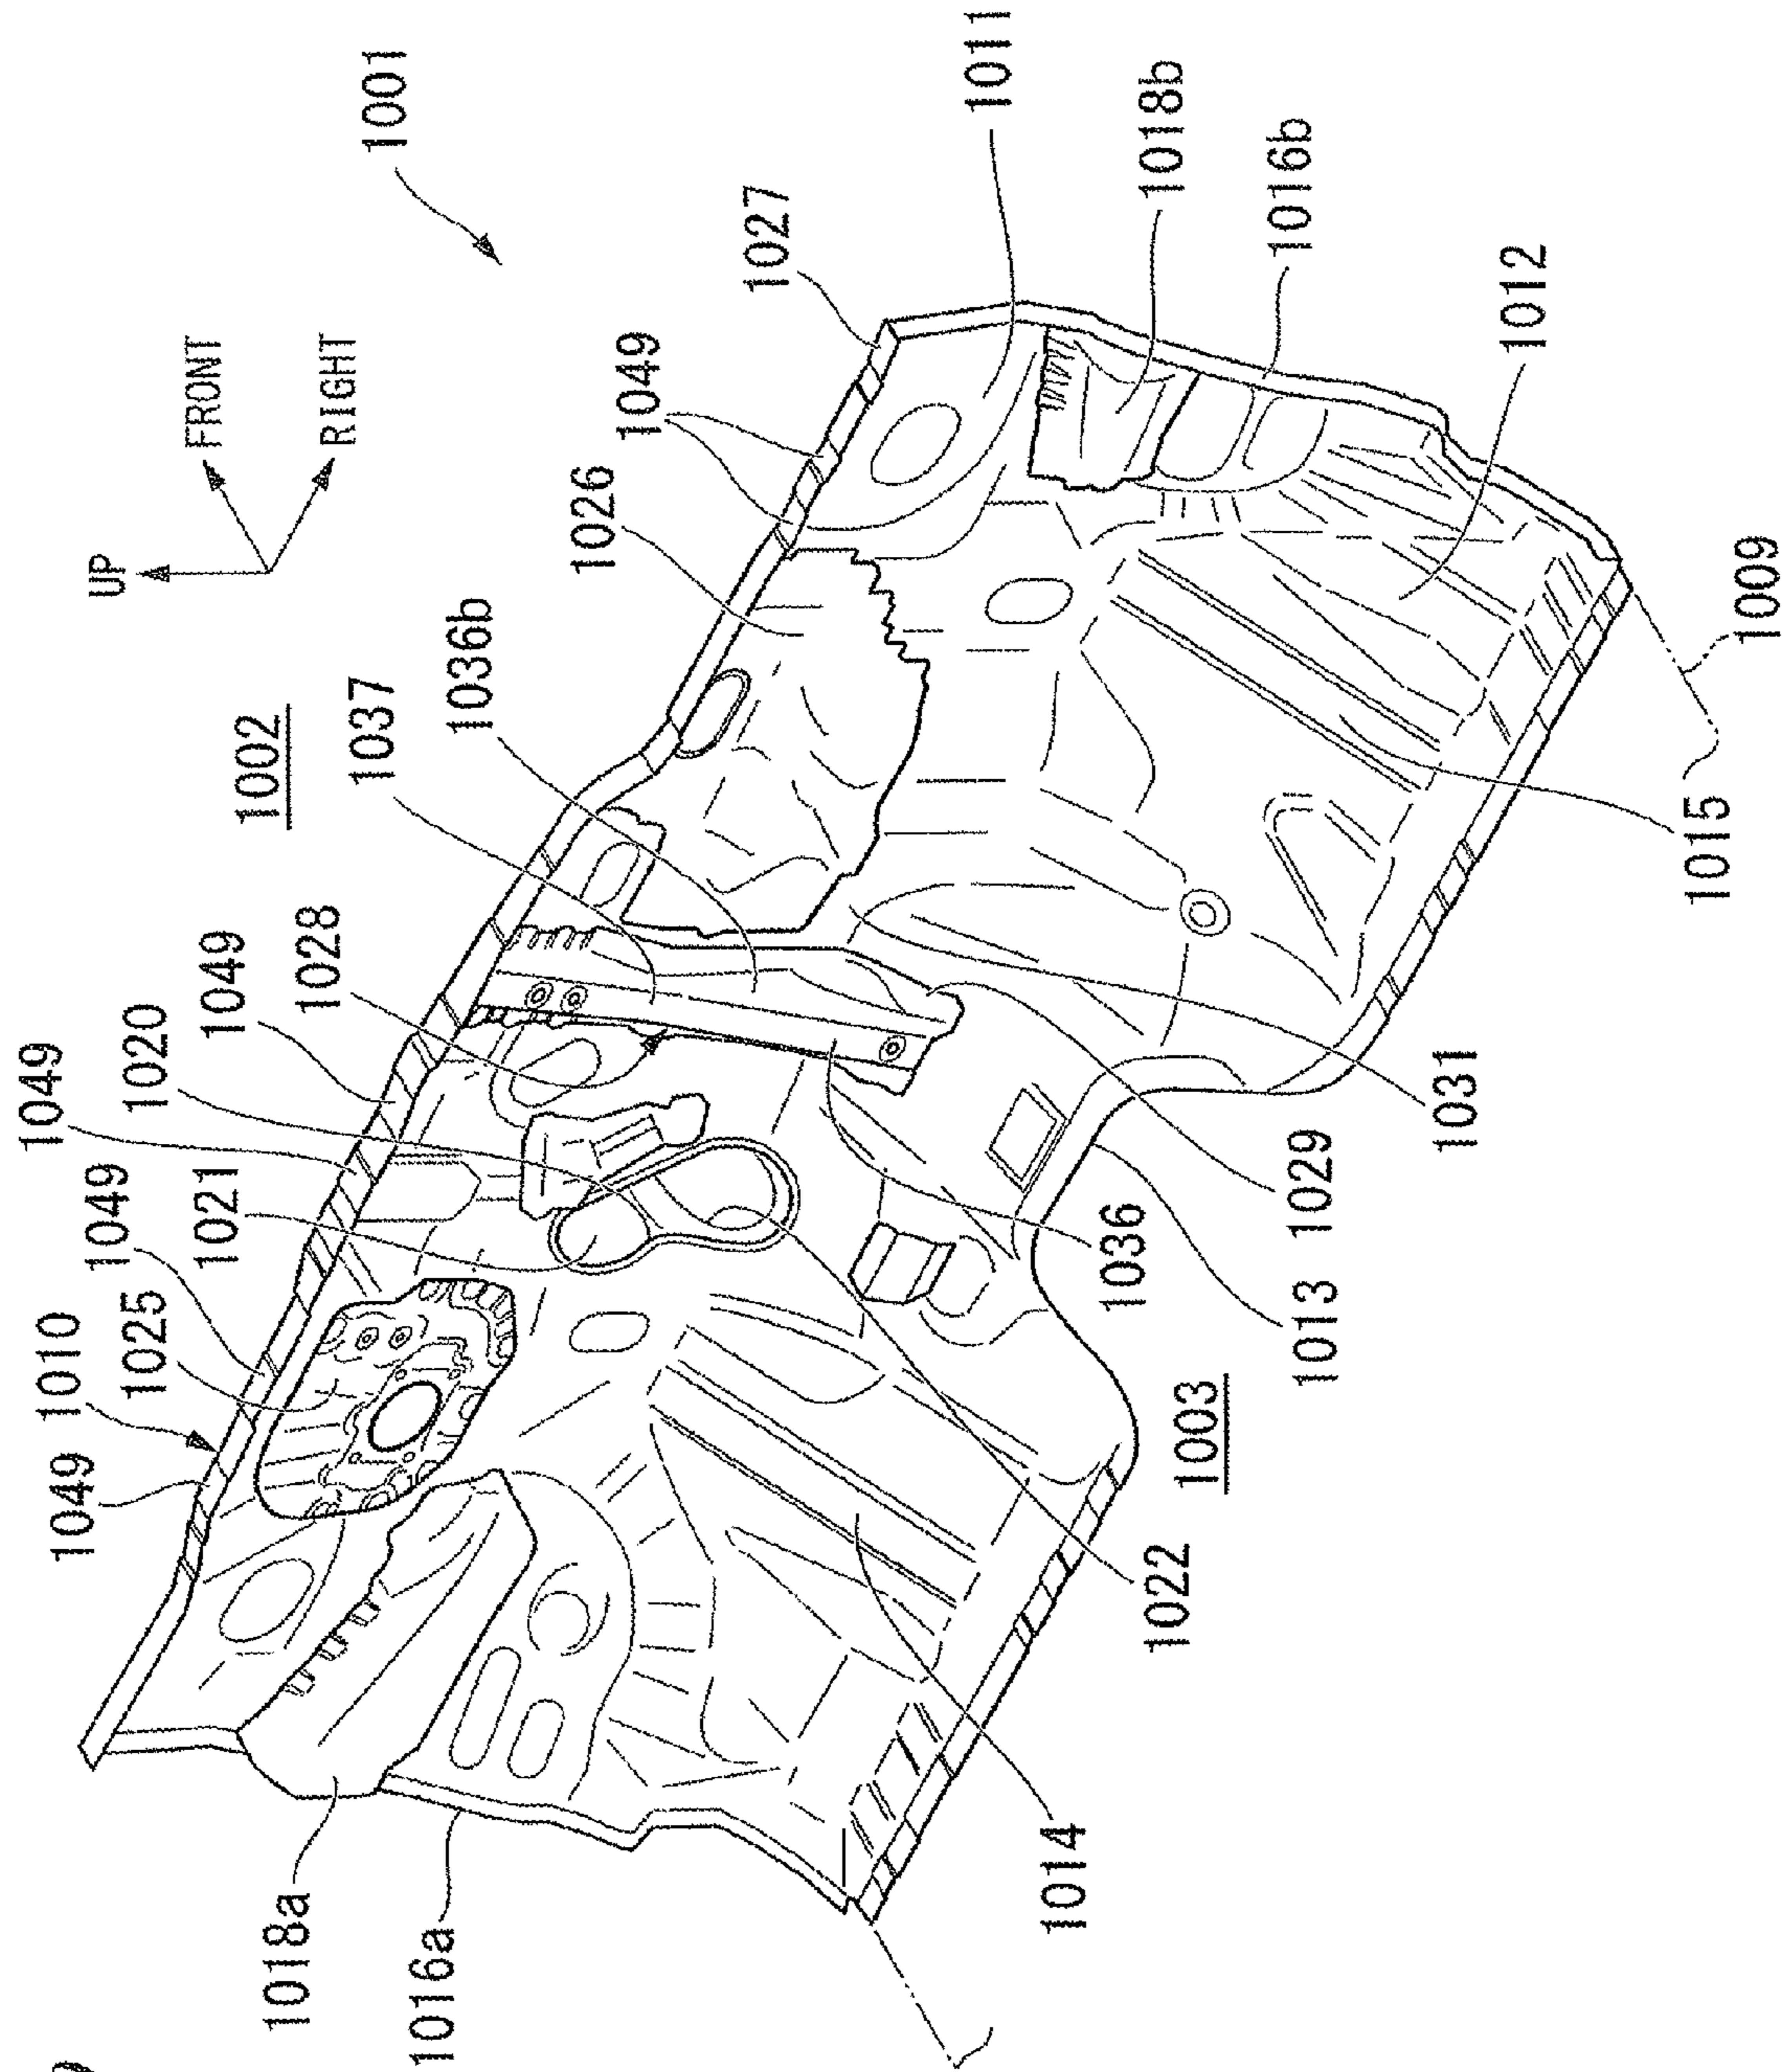
FIG. 10 is a perspective view of a dashboard lower section according to a second embodiment of the present invention seen from a cabin side.

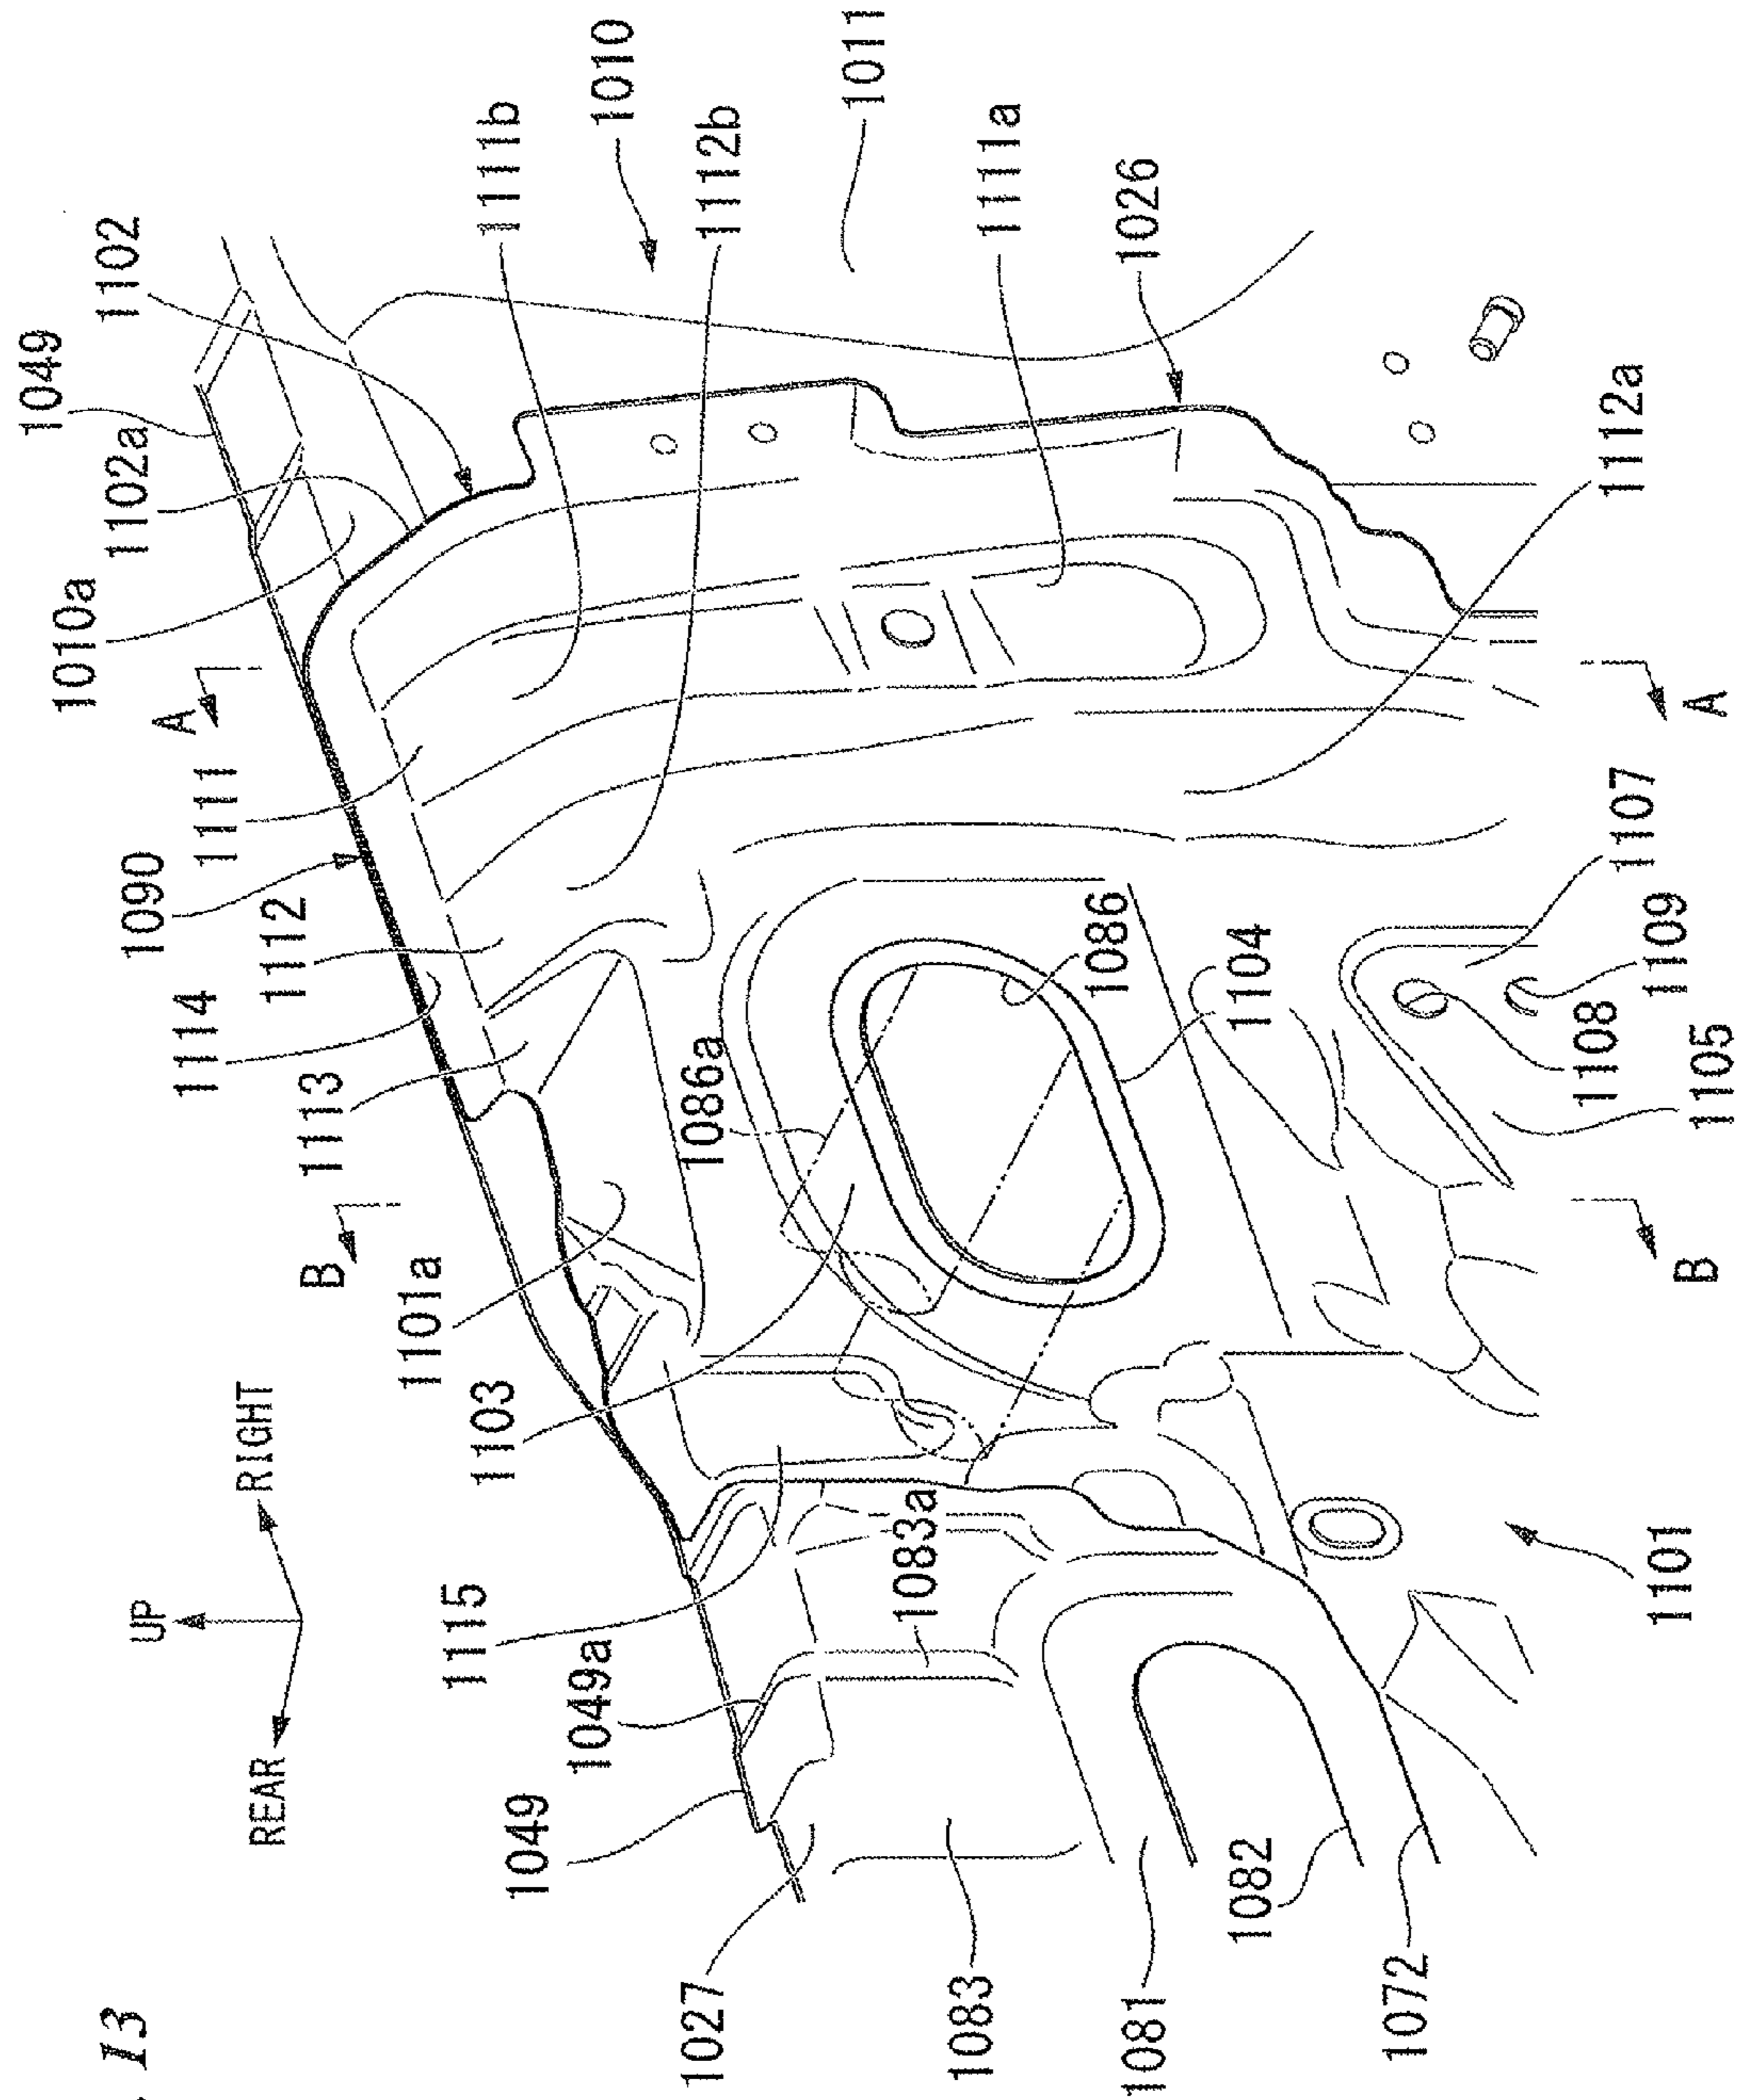
FIG. 13 is a perspective of a main part of a damping panel according to a second embodiment of the present invention.

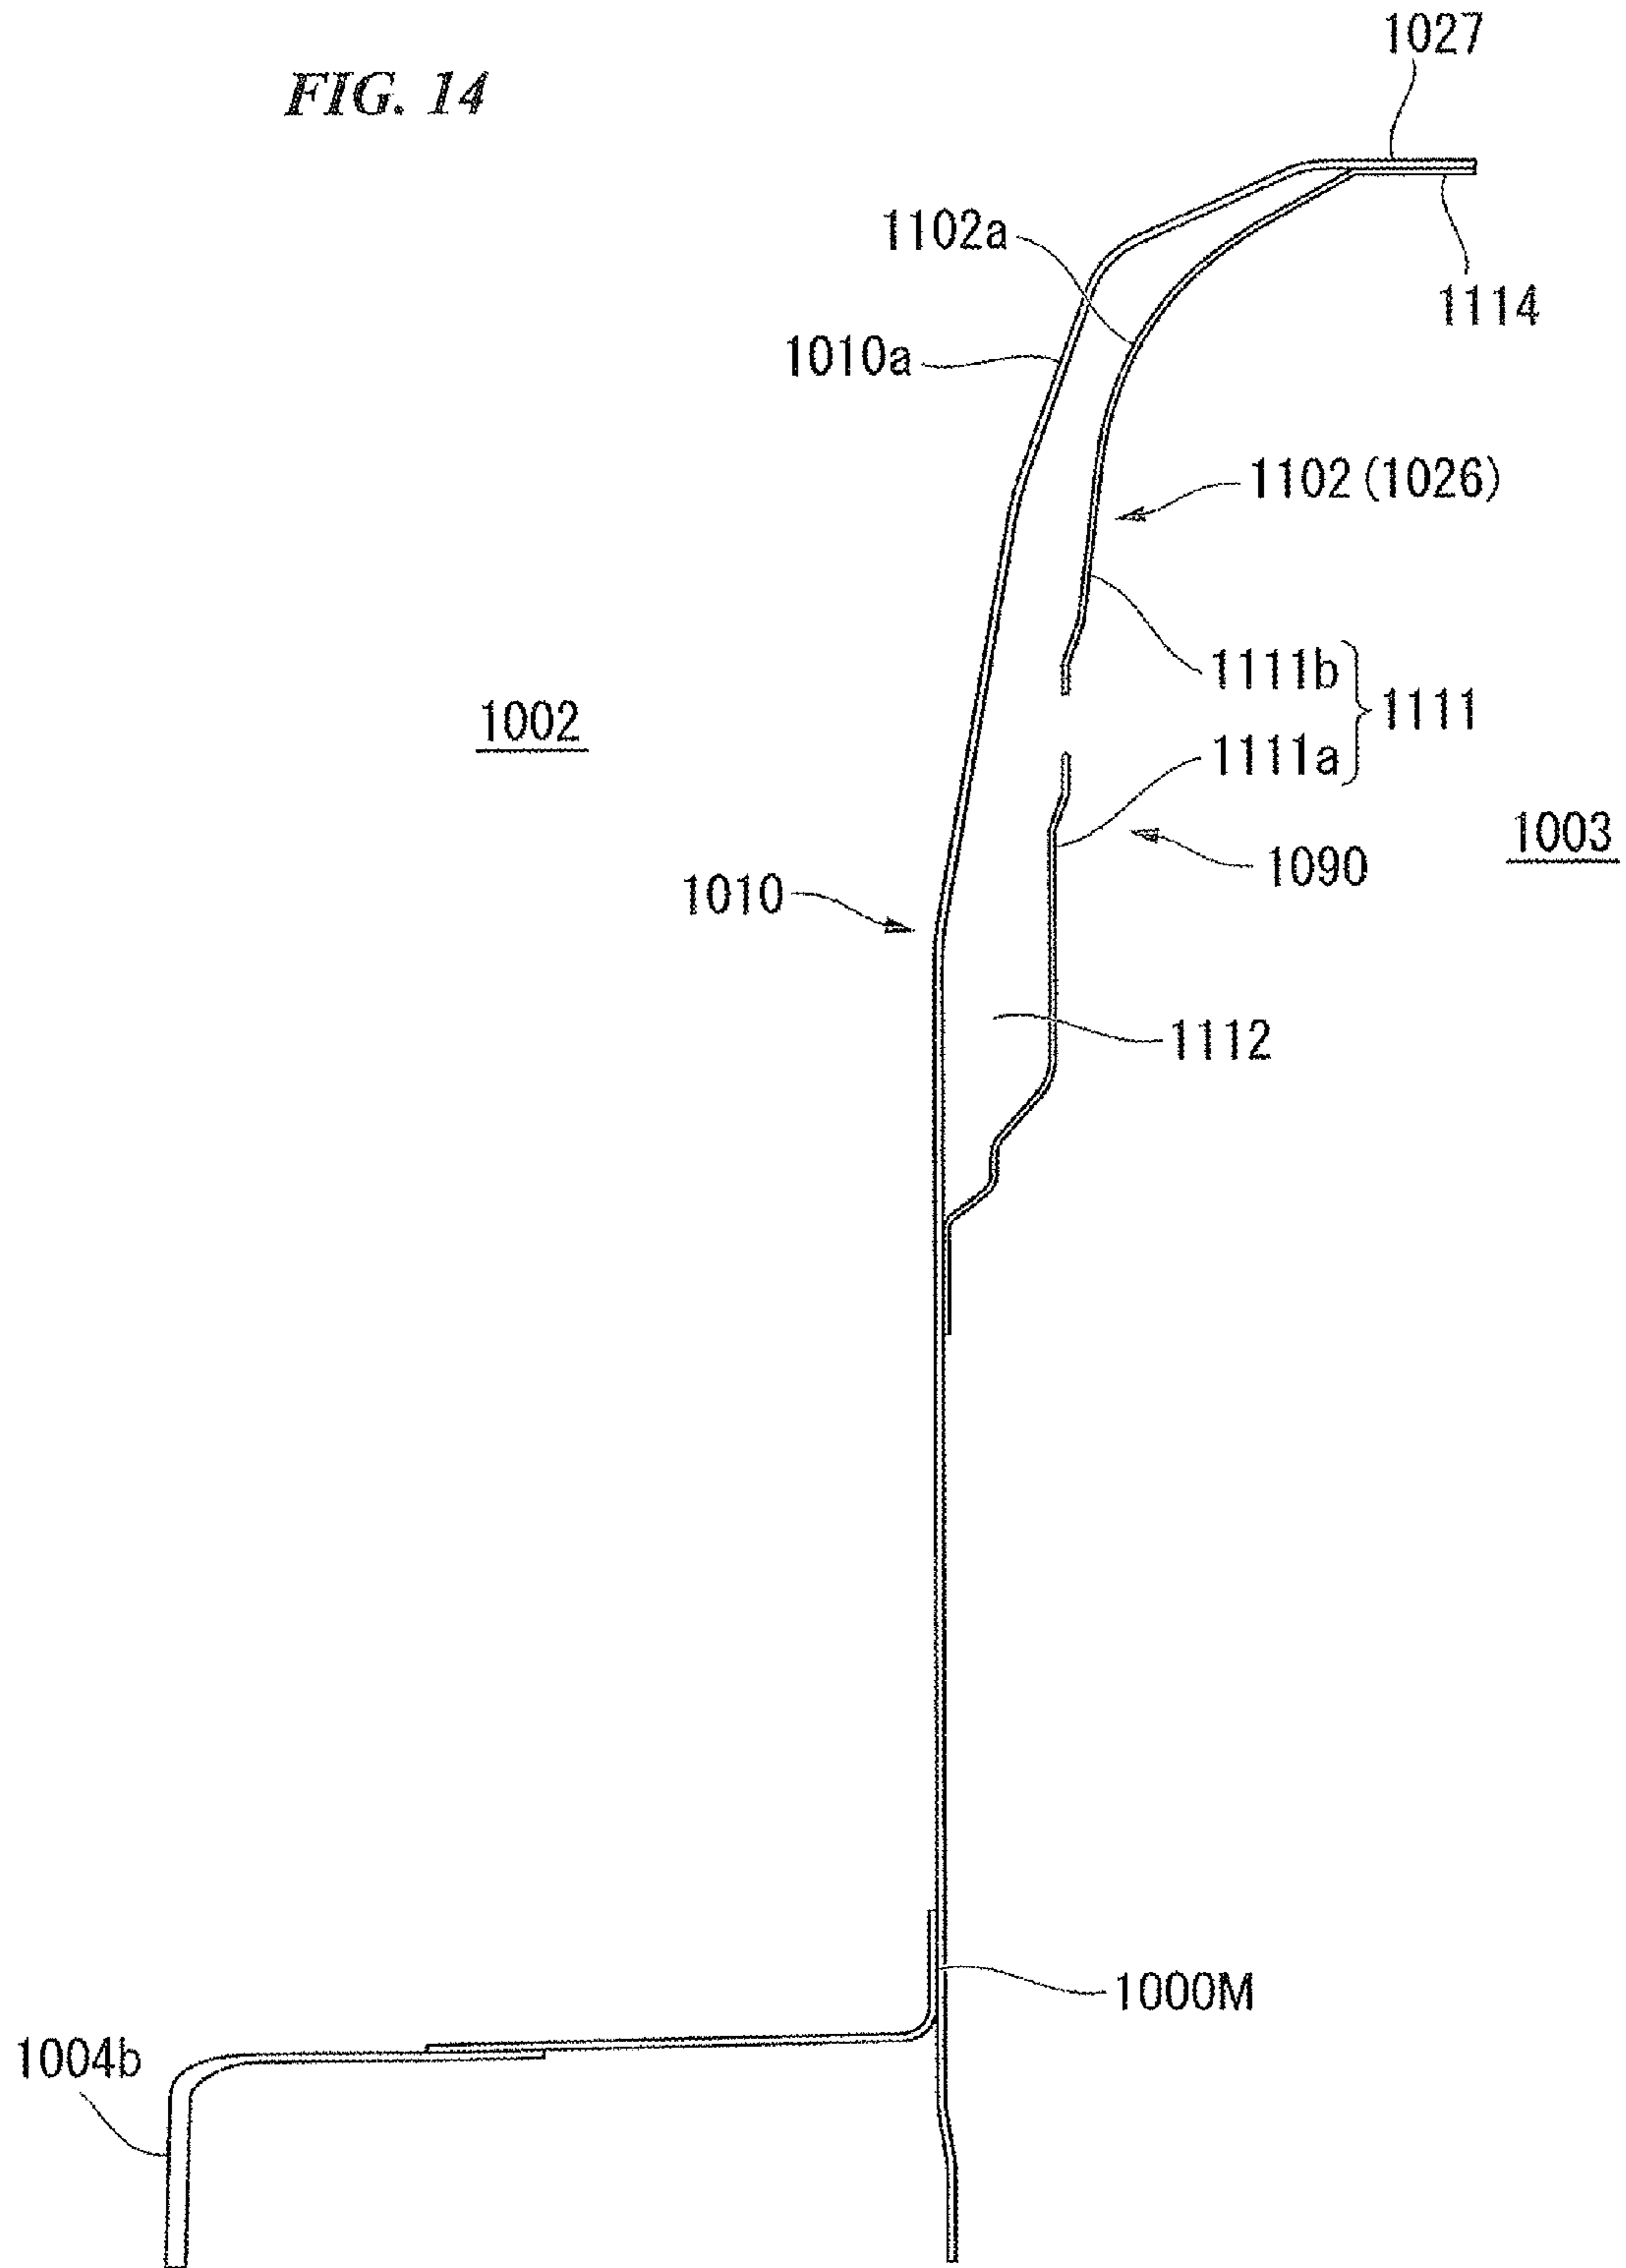
FIG. 15 is a cross sectional view along line B-B of FIG. 13.

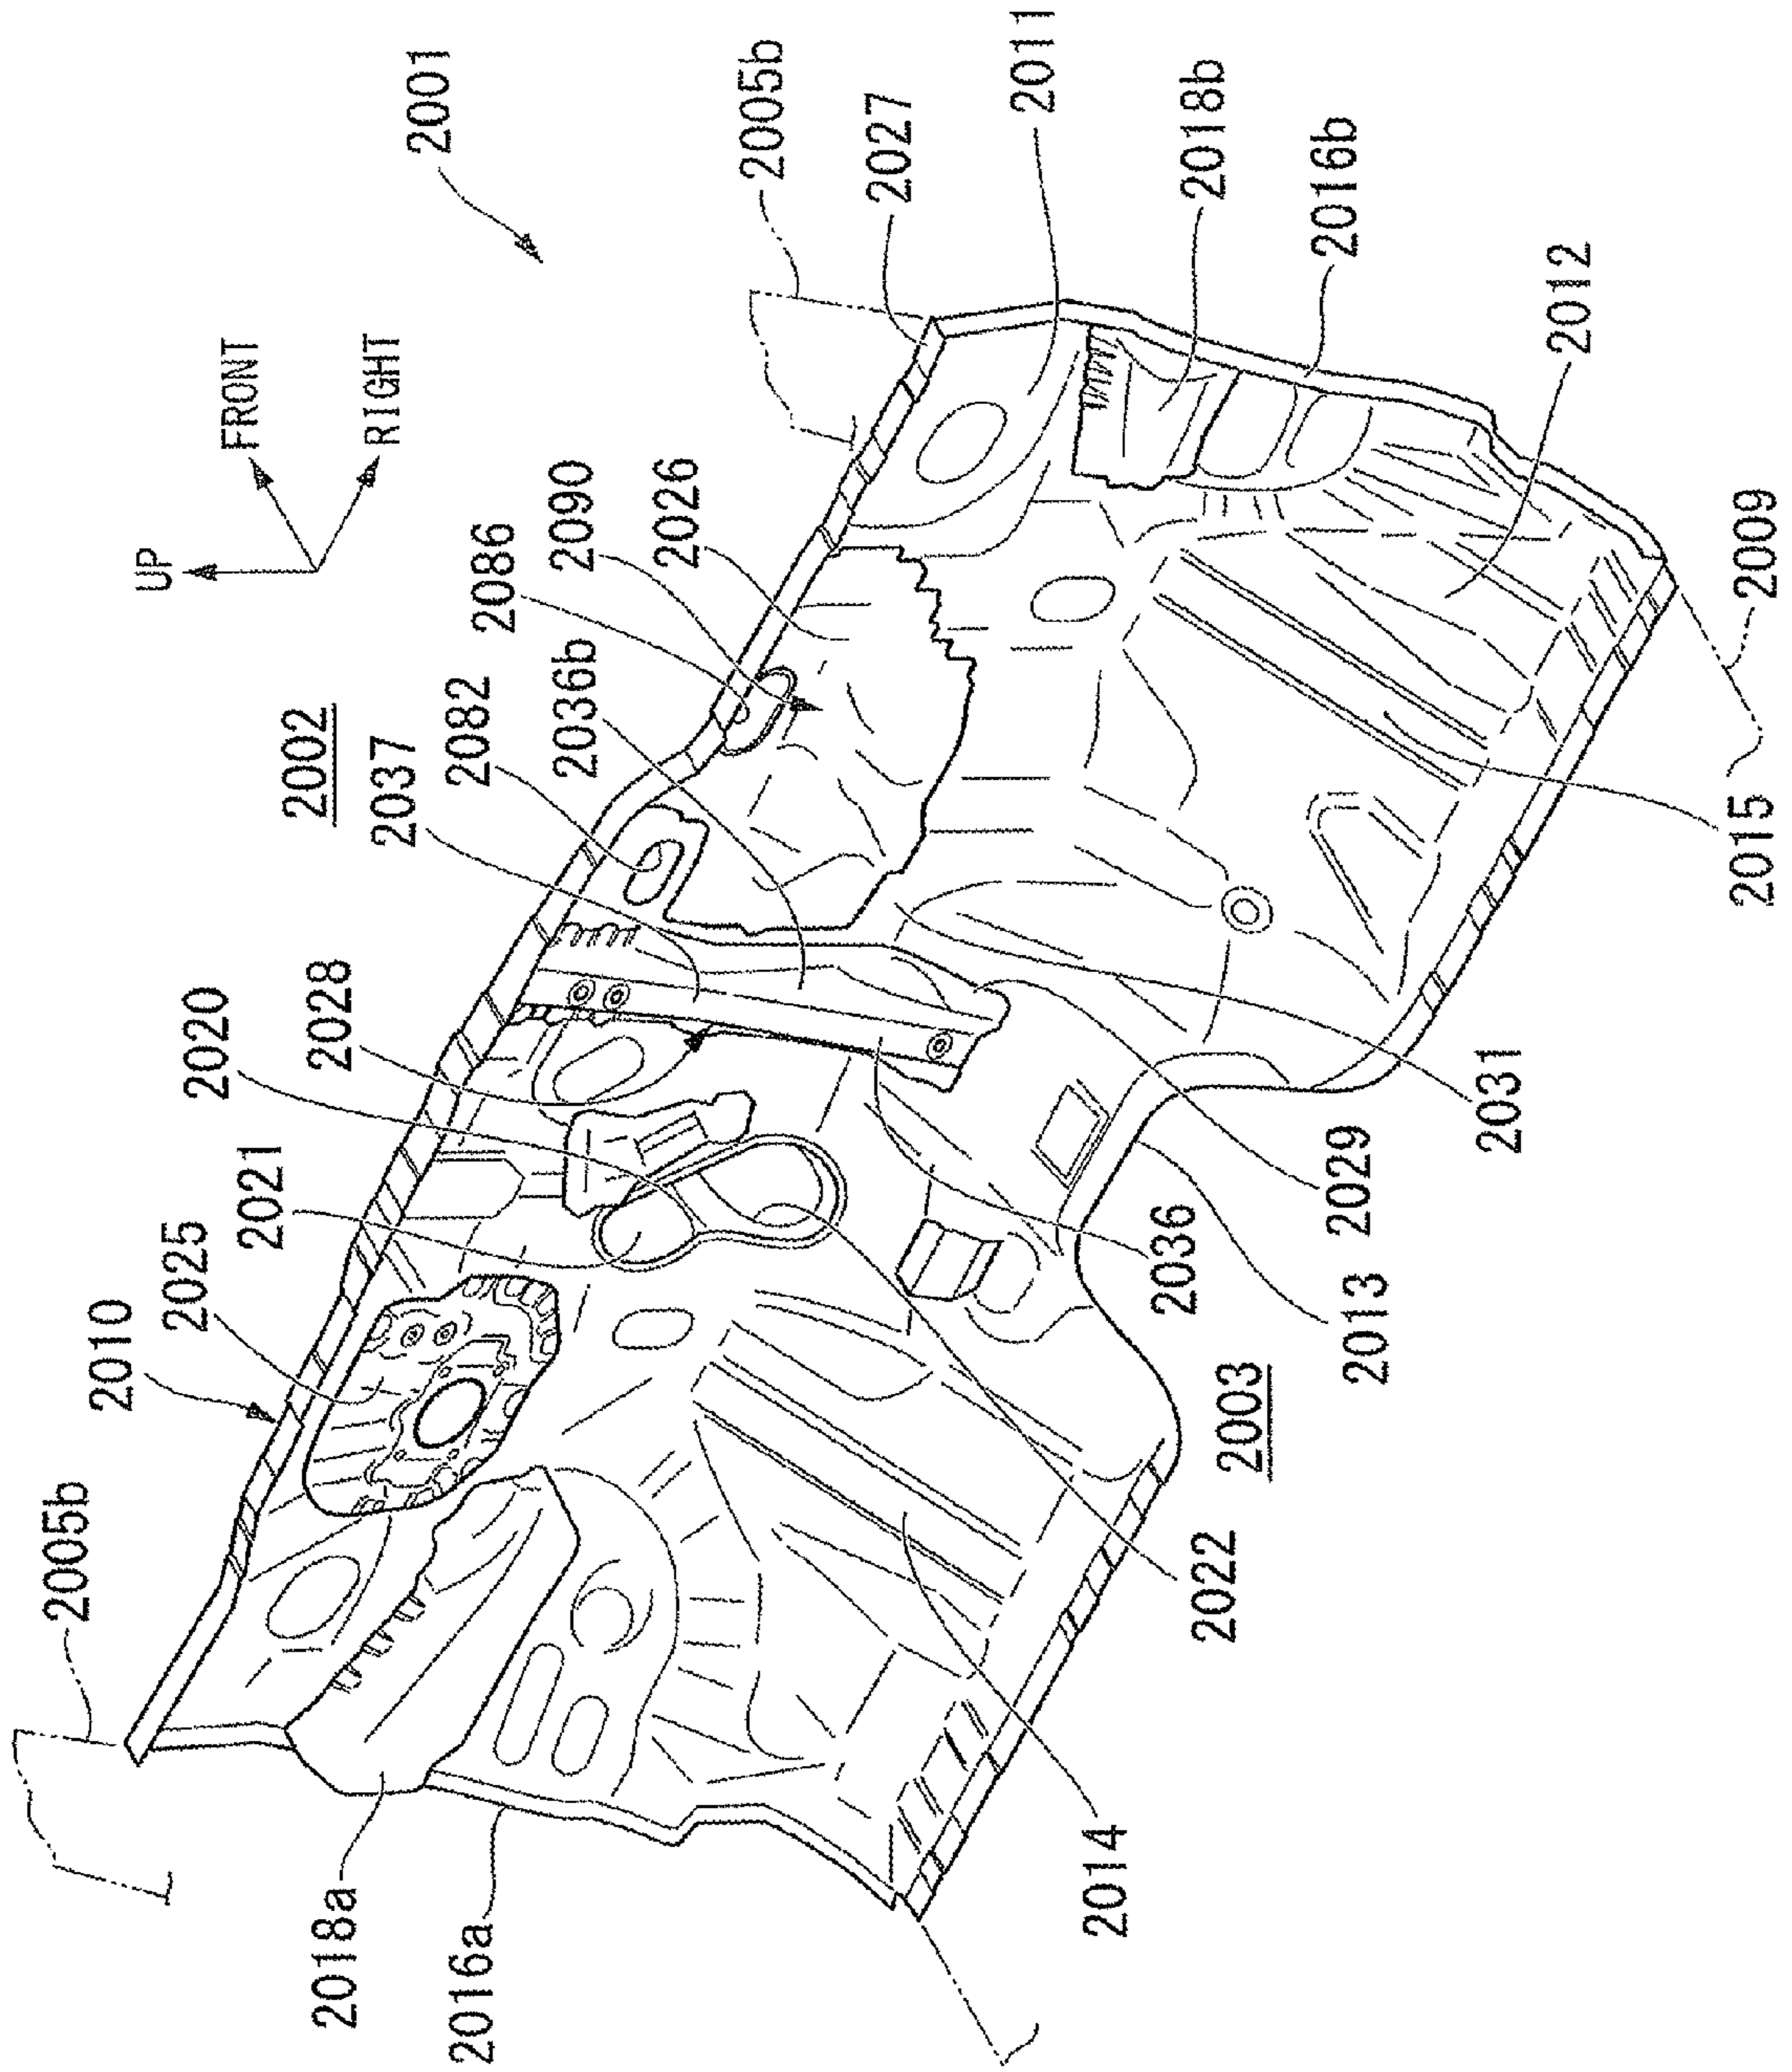
FIG. 16 is a perspective view of a dashboard lower section according to a third embodiment of the present invention seen from a cabin side.

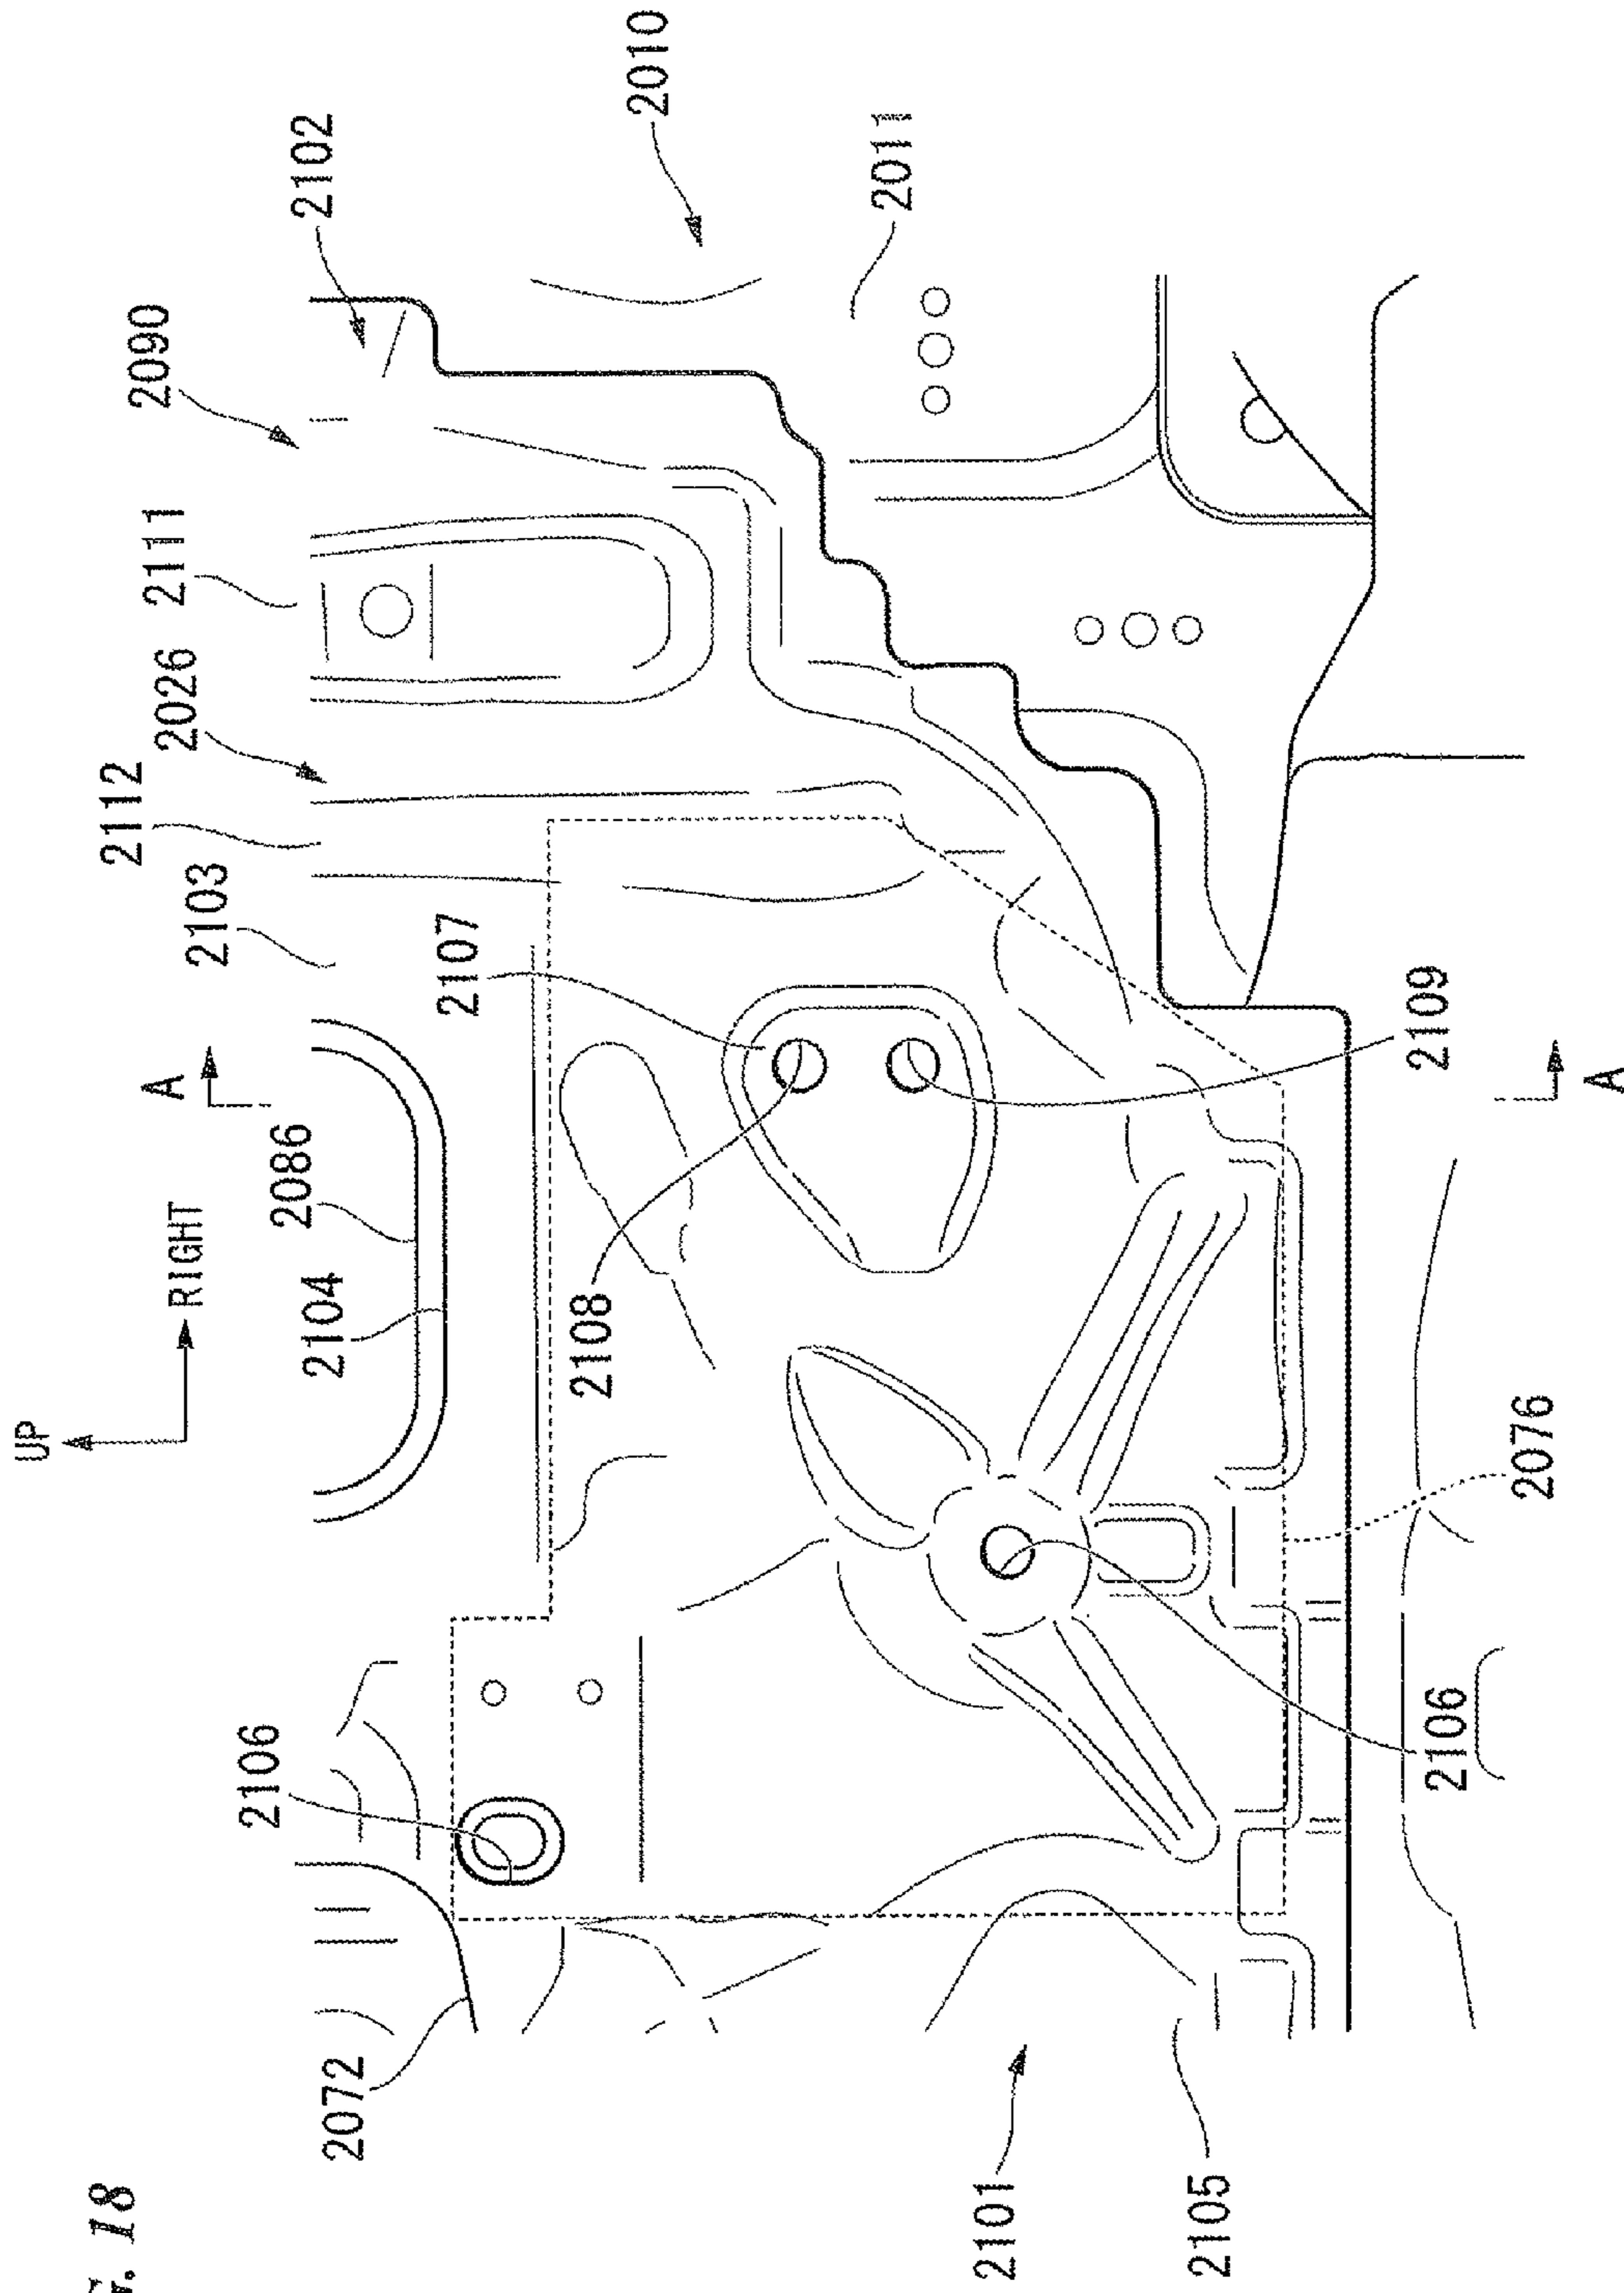
FIG. 18 is a planar view of a damping panel according to a third embodiment of the present invention.
