(10) **Patent No.:** **US 8,480,164 B2**
(45) **Date of Patent:** **Jul. 9, 2013**

(54) **FRONTAL STRUCTURE OF VEHICLE**

(73) Assignee: **Honda Motor Co., Ltd.**, Tokyo (JP)

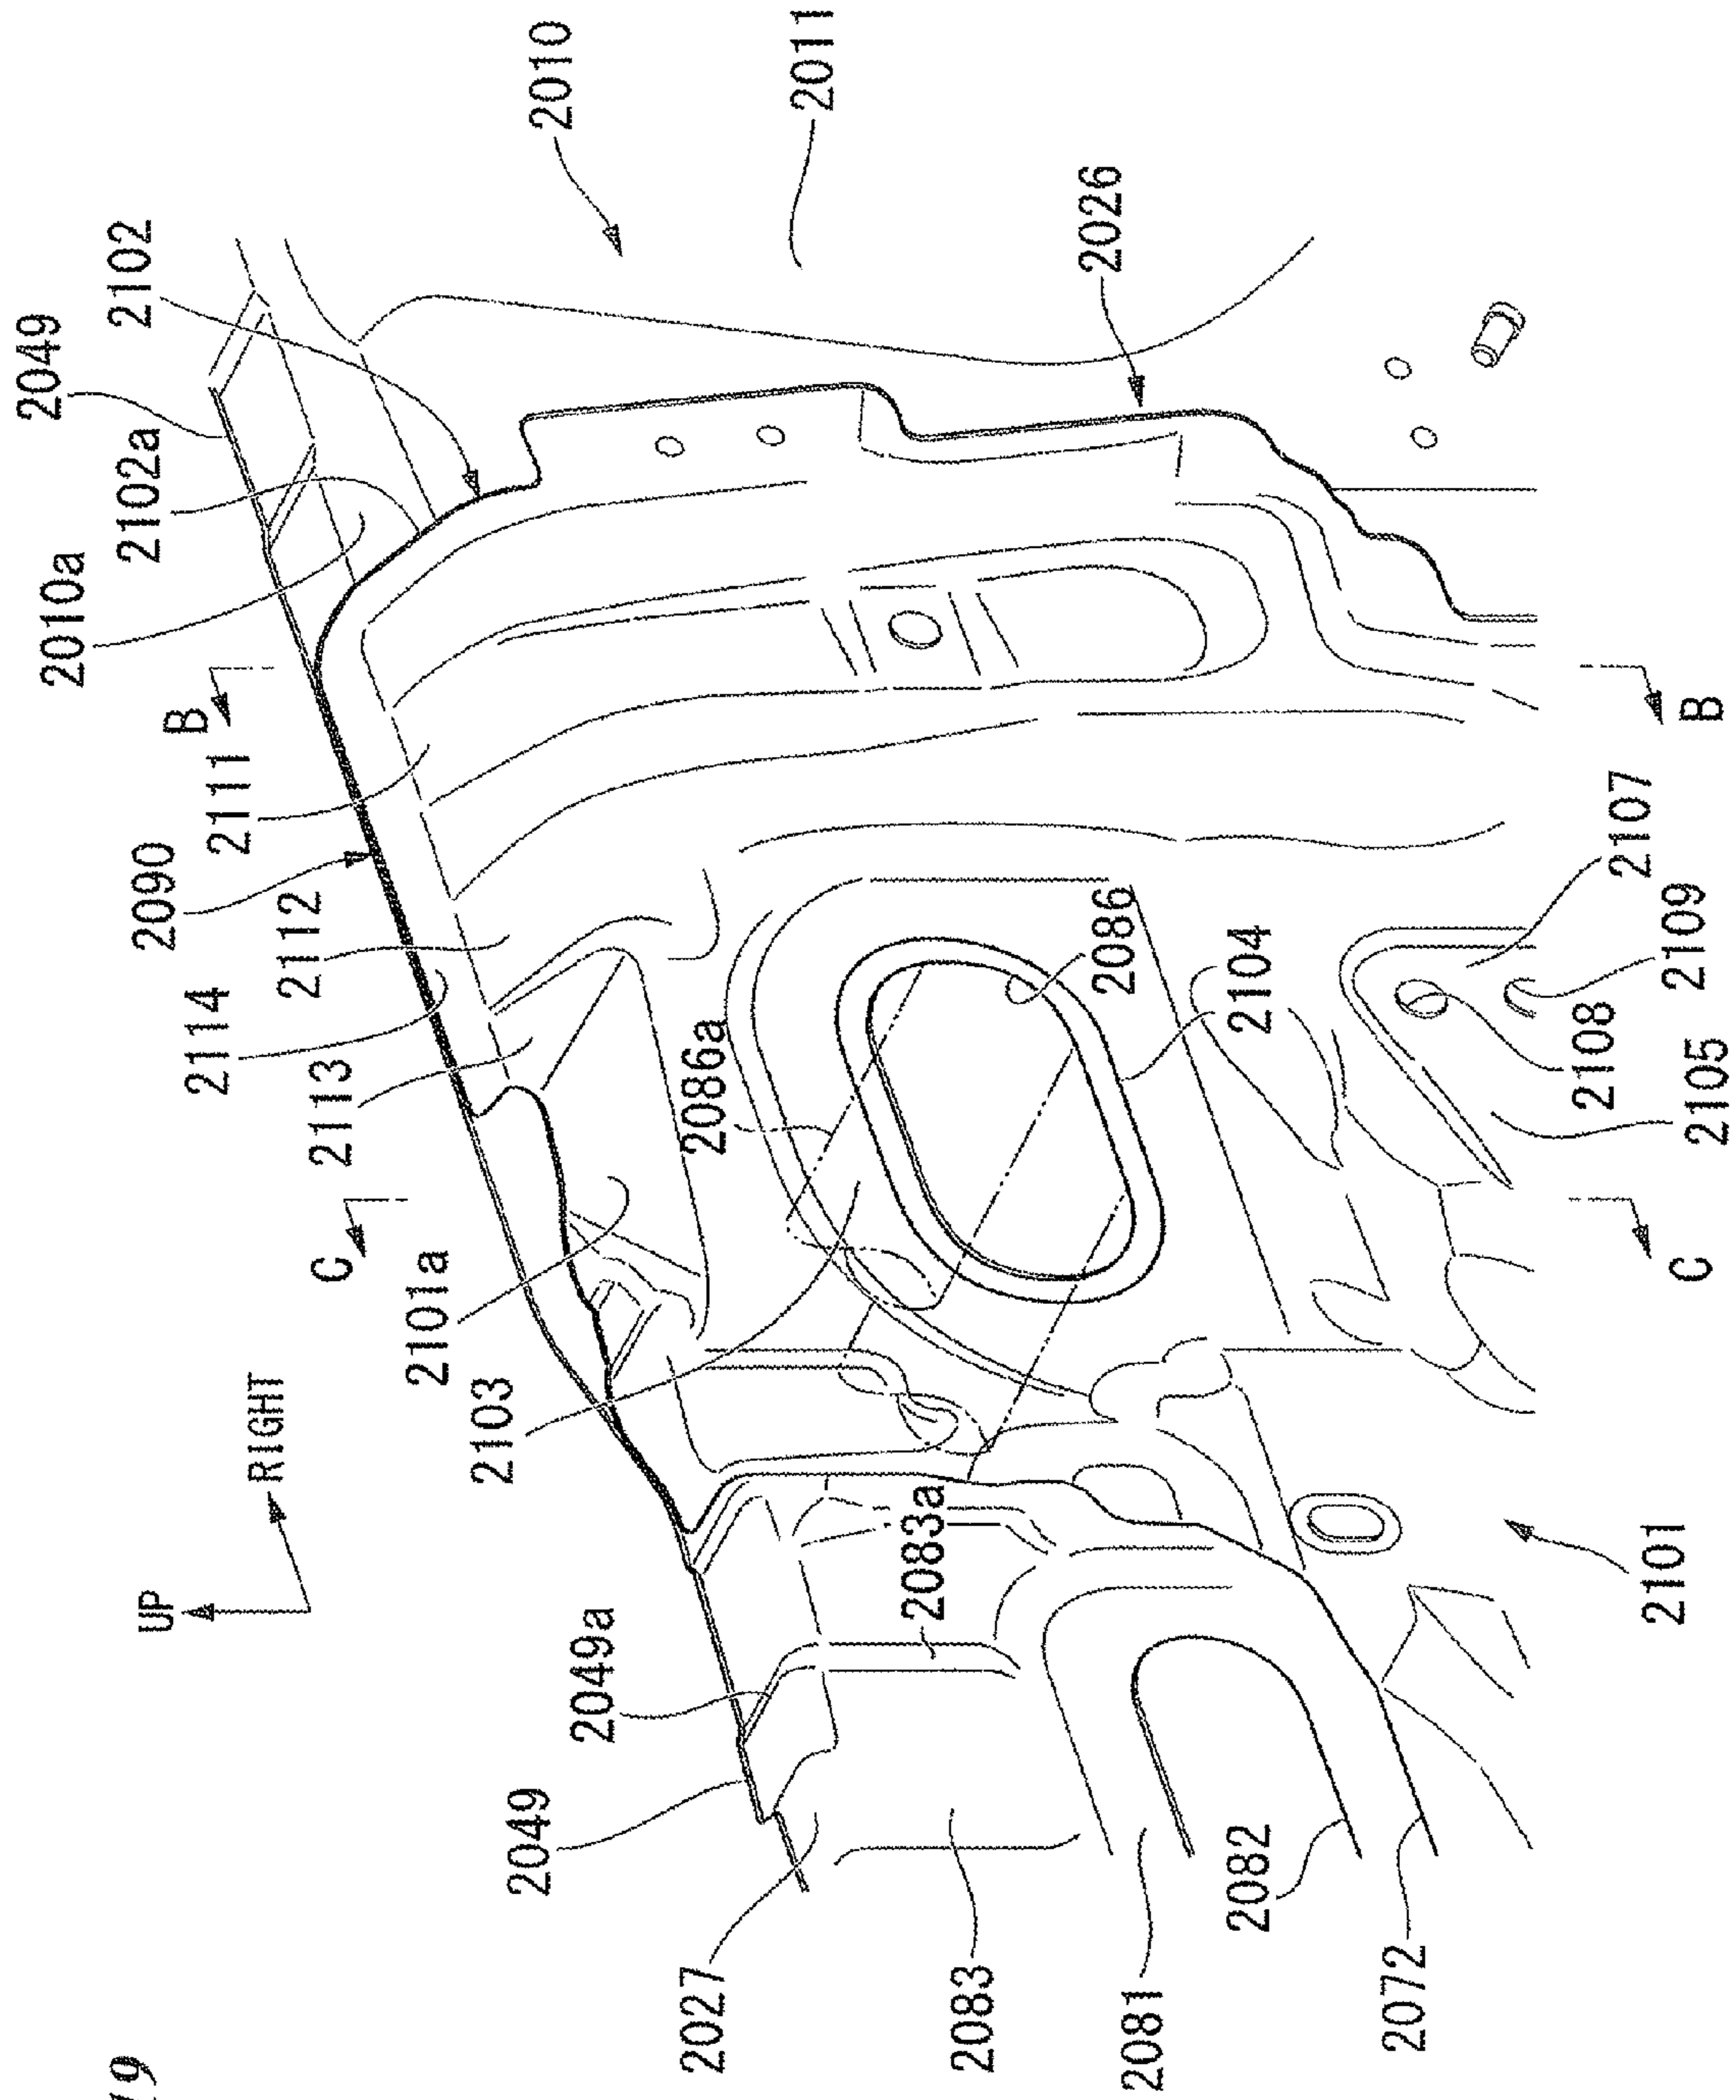
FIG. 19 is a perspective view of a main part of a damping panel according to a third embodiment of the present invention.
