US008517148B2

(10) **Patent No.:** **US 8,517,148 B2**
(45) **Date of Patent:** ***Aug. 27, 2013**

(54) **LUBRICATION SYSTEM WITH TOLERANCE FOR REDUCED GRAVITY**

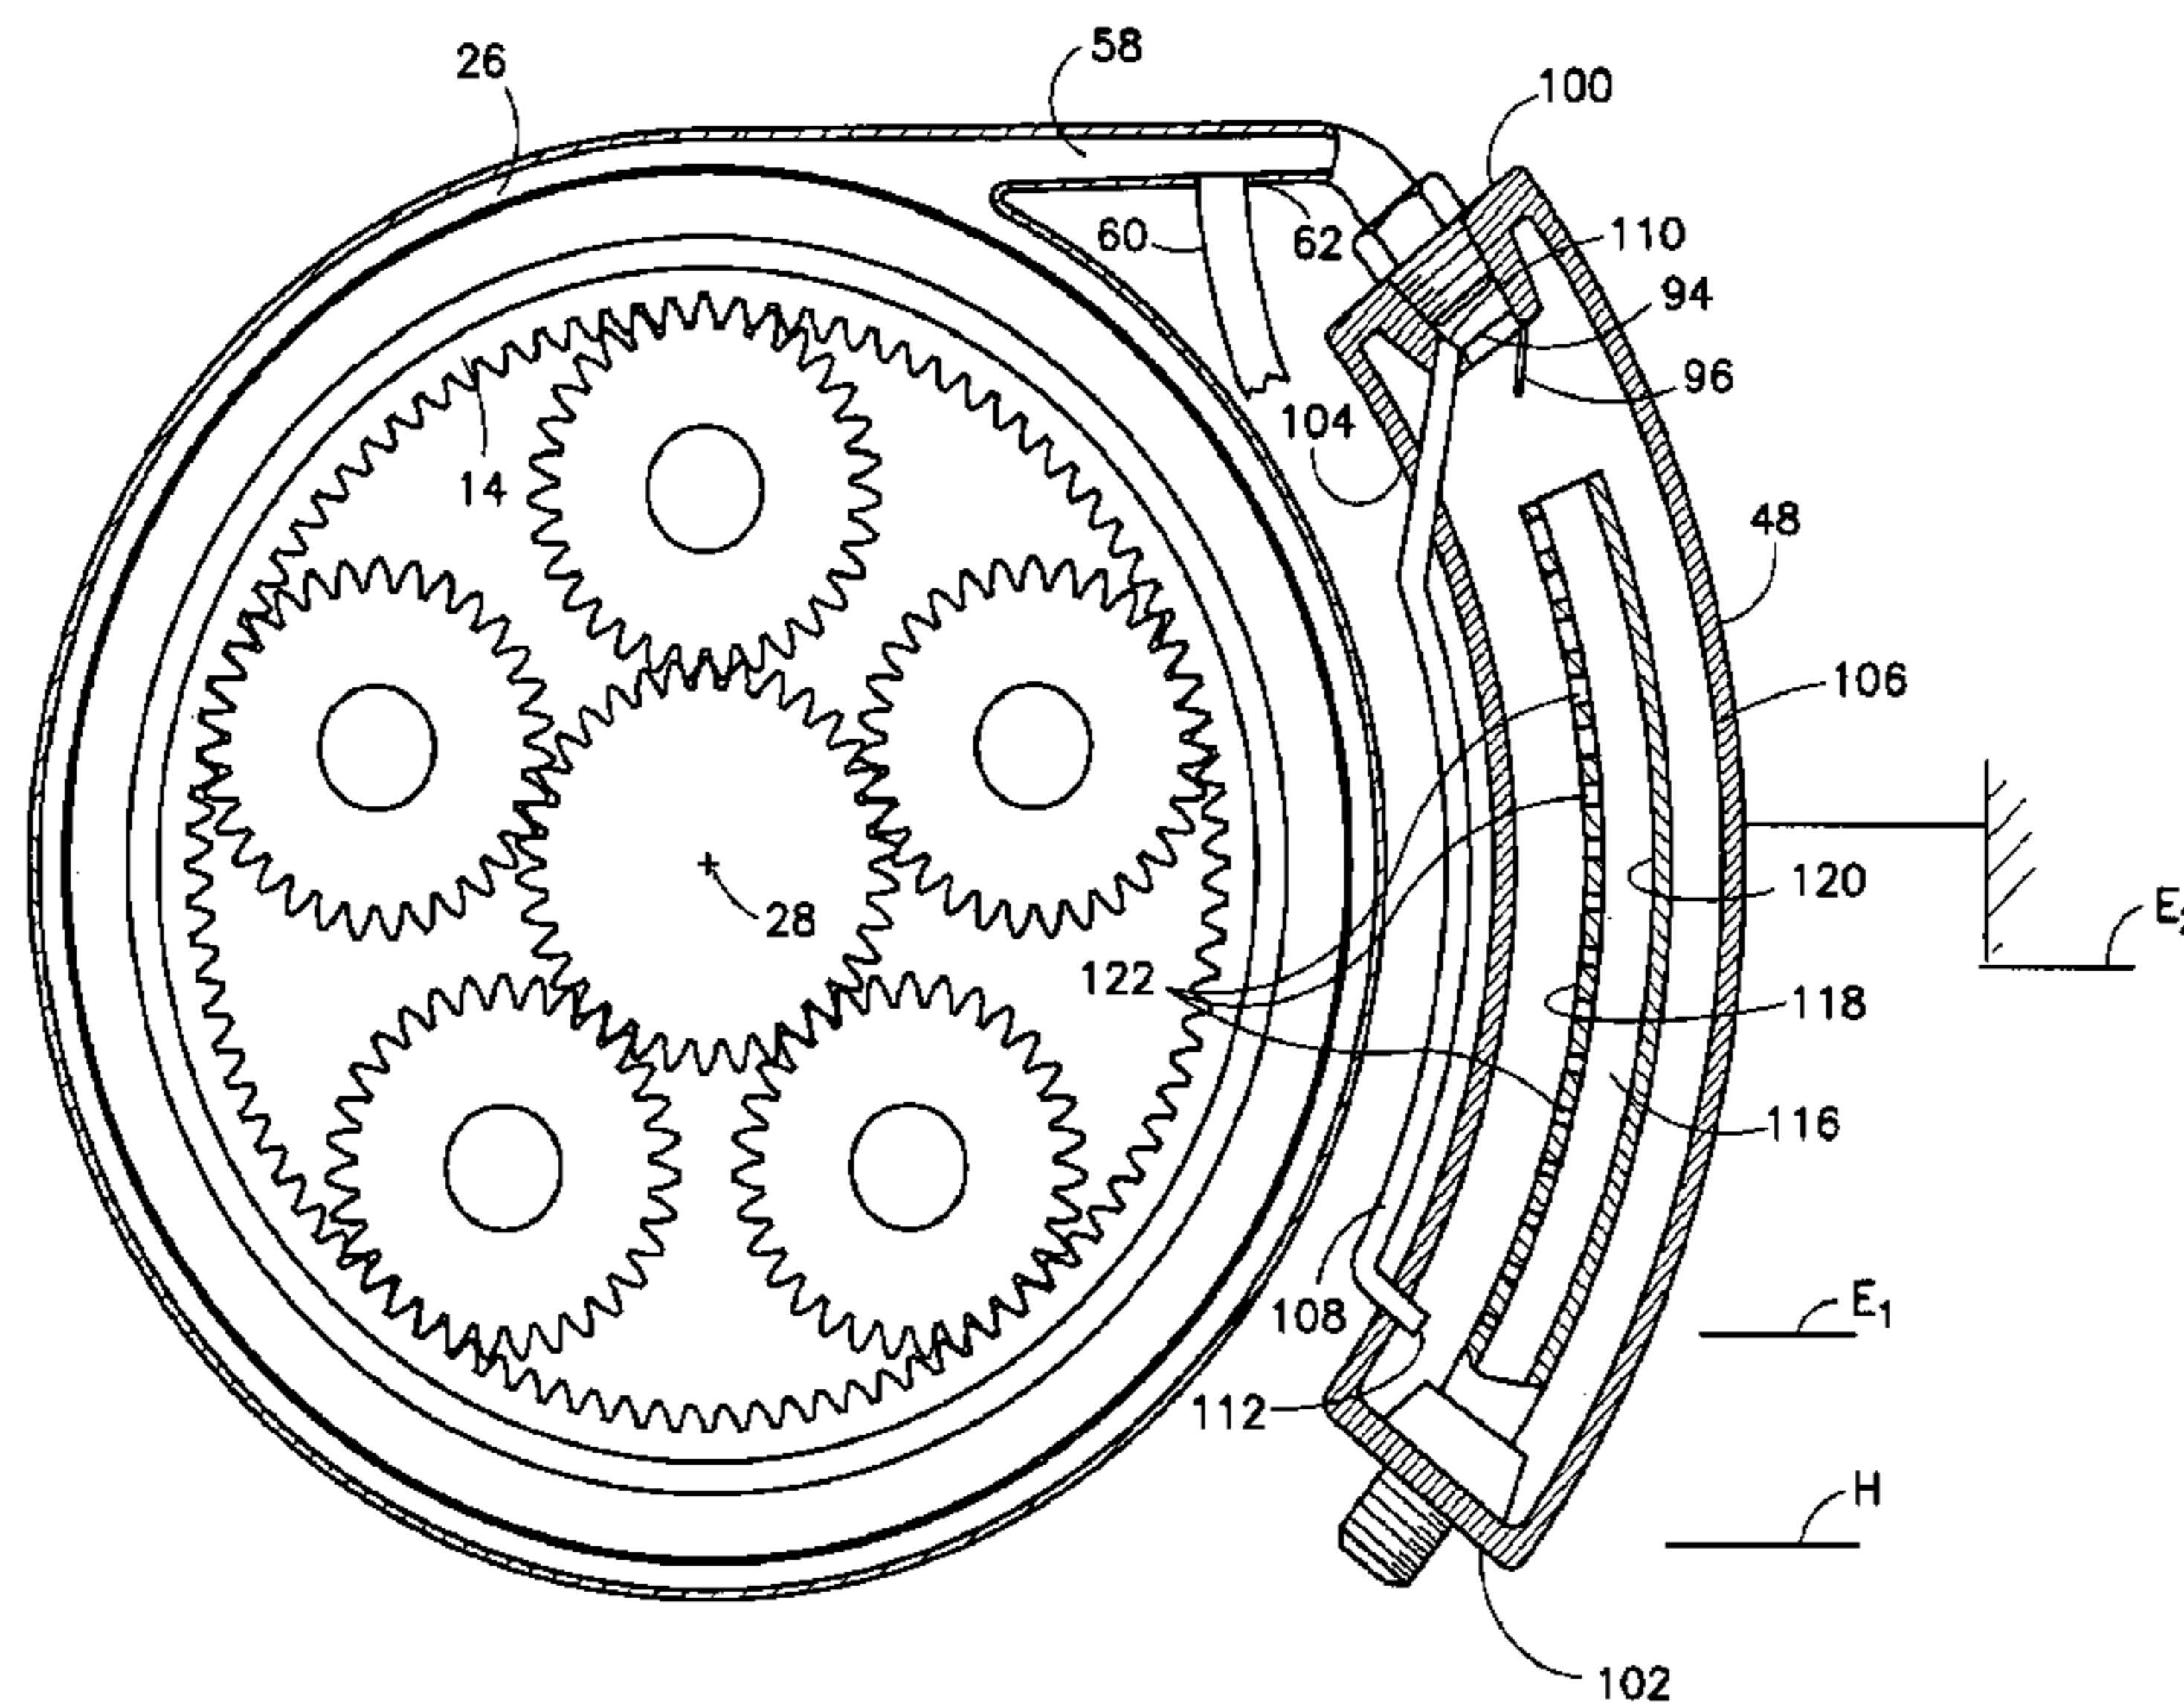
A lubrication system includes an auxiliary lubricant tank **48**, a supply conduit **58** extending from a source of lubricant **26** to the auxiliary lubricant tank. A reduced-G bypass line **108** branches from the conduit and enters the auxiliary tank at a first elevation E_1 . The system also includes an auxiliary tank discharge conduit **116**, a portion of which resides within the tank. The resident portion has an opening **122** at least partially at a second elevation E_2 higher than the first elevation.

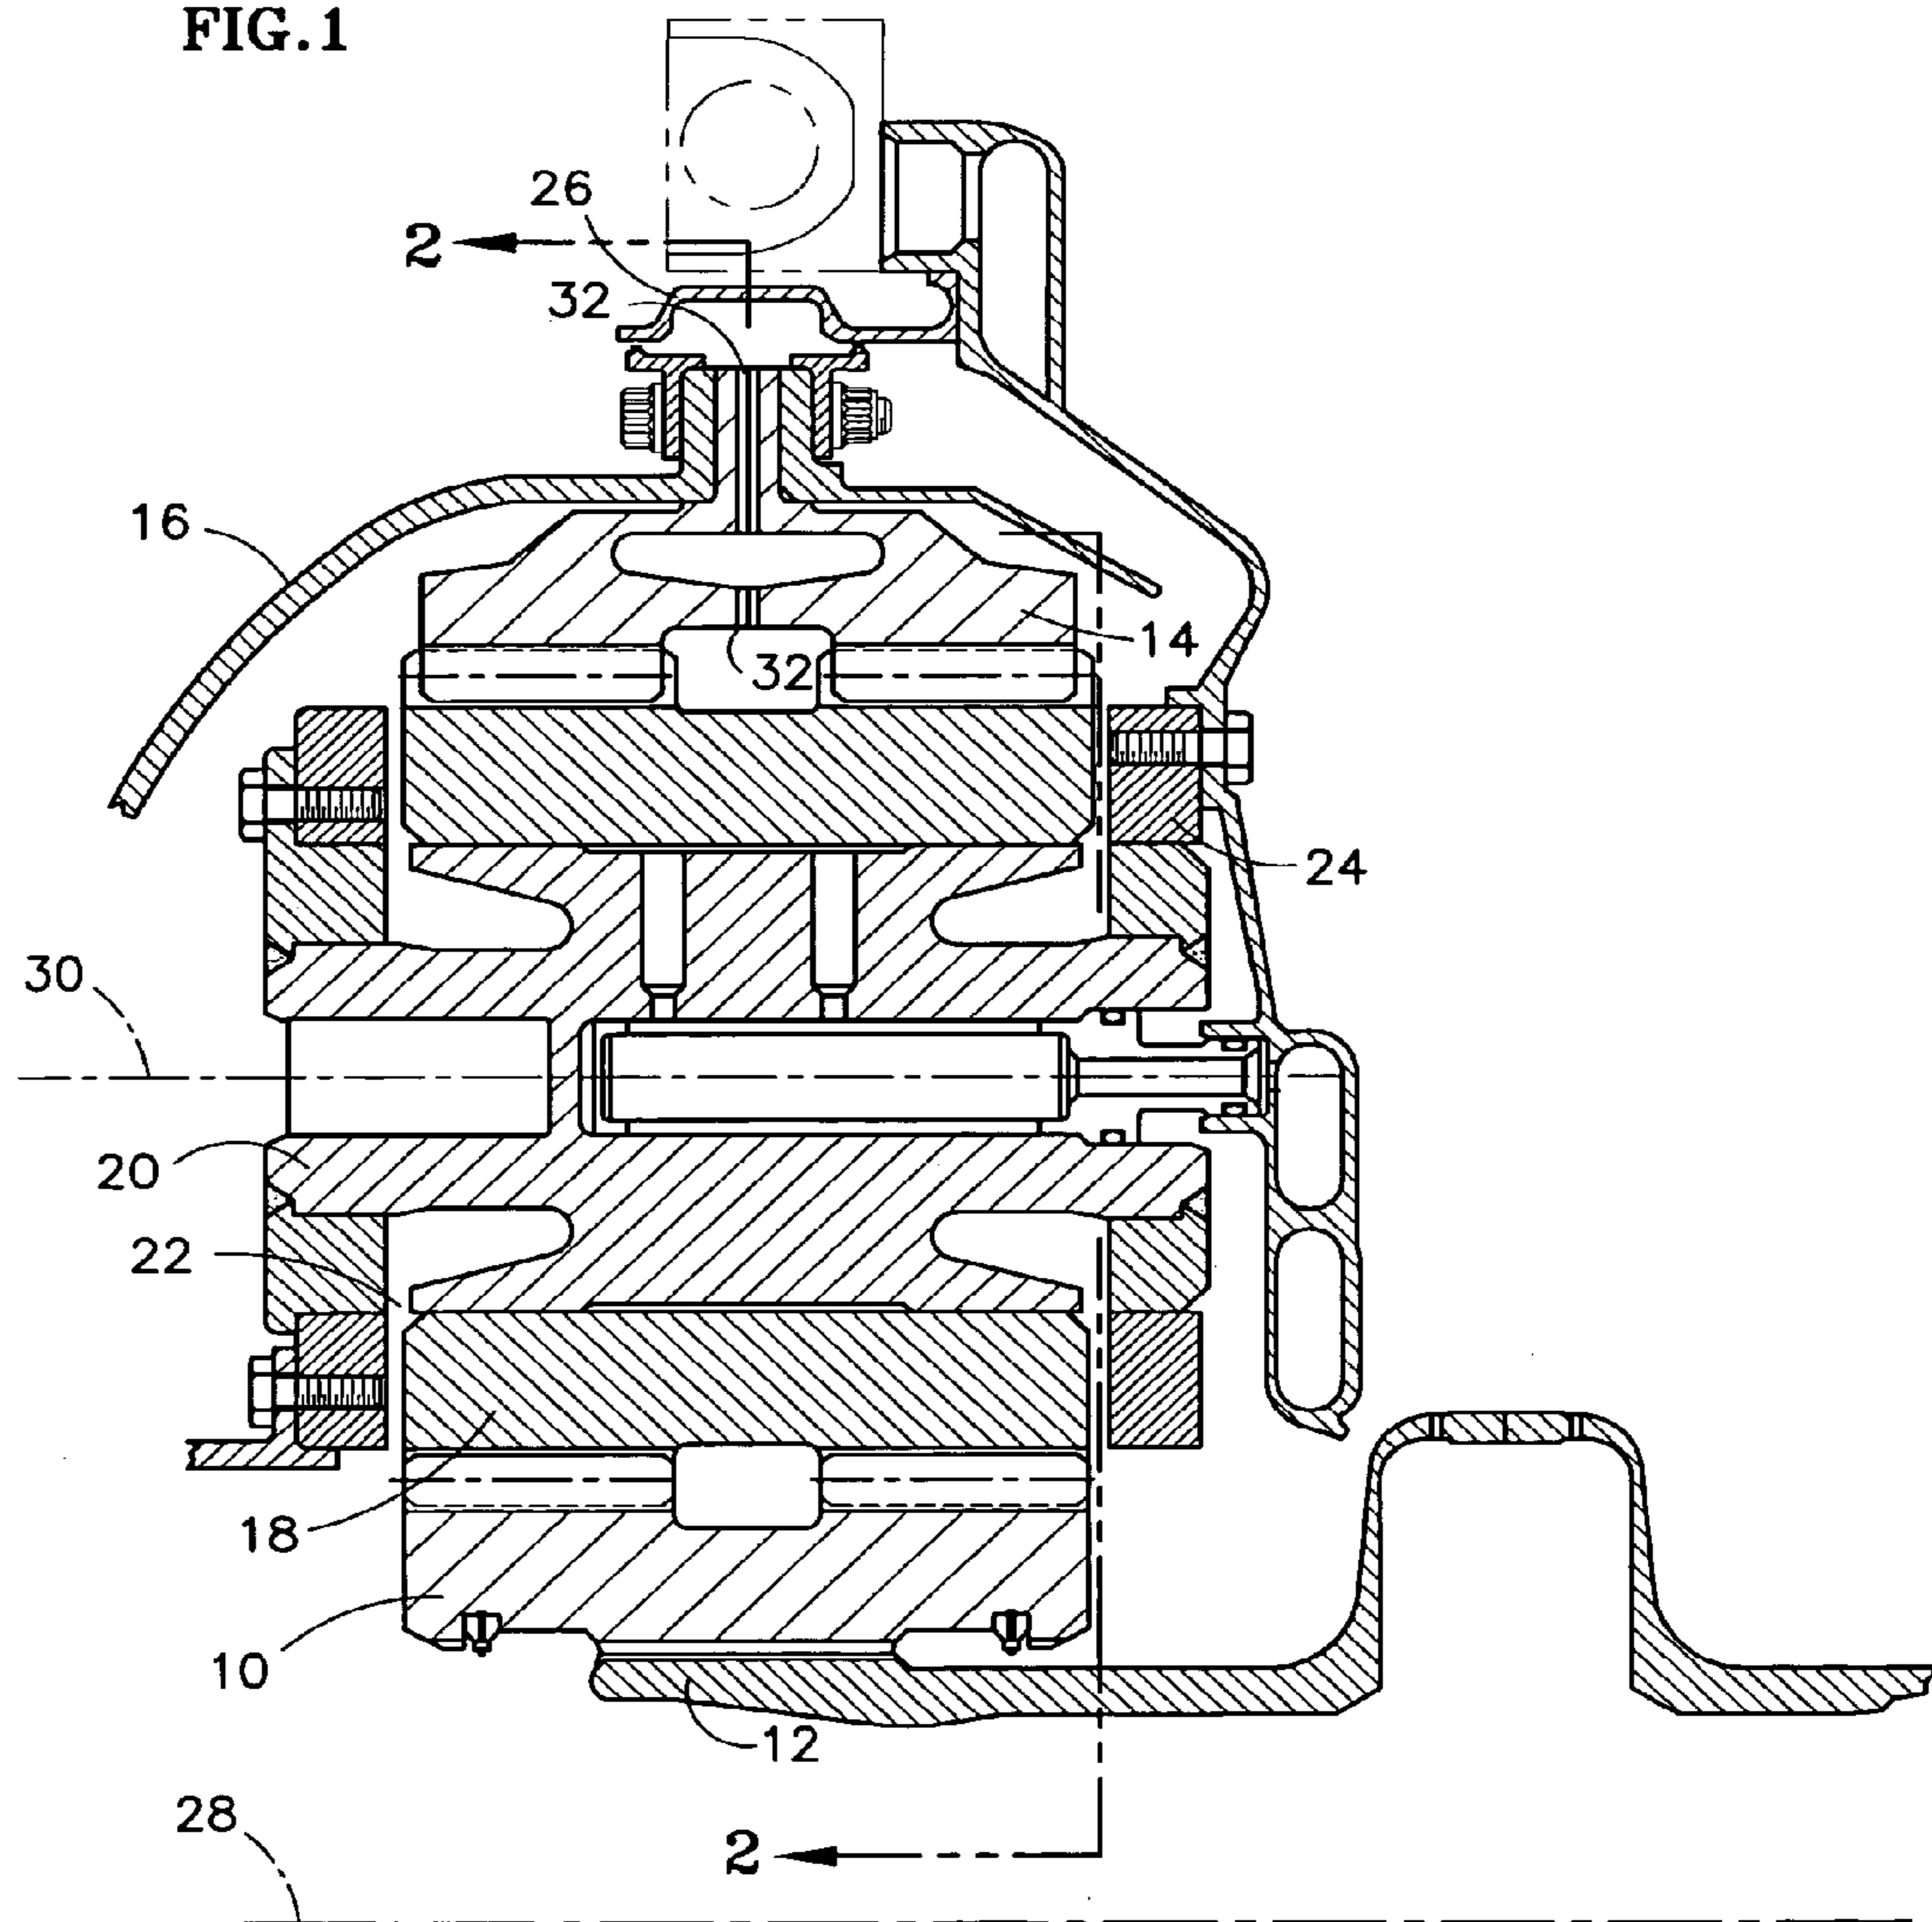
FIG. 1 is a cross sectional side elevation view of a gear train configured as a star system and useful in an aircraft gas turbine engine.

Referring to FIGS. 1 and 2, a reduction gear train suitable for use in an aircraft gas turbine engine includes a sun gear 10 driven by a sun gear (input) shaft 12, a ring gear 14 radially outboard of the sun gear and connected to a ring gear (output) shaft 16, and a set of intermediate gears 18 radially intermediate and meshing with the sun and ring gears. Each intermediate gear circumscribes a journal pin 20. A thin, replenishable film of lubricant, not shown, occupies a small annular space 22 between each intermediate gear and its journal pin to support the intermediate gear. This arrangement is referred to as a journal bearing. The journal pins are all supported by a carrier 24. The carrier interconnects the journal pins with each other and, by doing so, also interconnects the intermediate gears to each other. A lubricant recovery gutter 26 circumscribes the ring gear.

In the gear train shown in FIGS. 1 and 2, the sun and ring gears are each rotatable about an axis 28. The carrier is non-rotatable even though the individual intermediate gears are each rotatable about their respective axes 30. Such a system is referred to as a star system. As seen best in FIG. 2, the input and output shafts counterrotate. Lubricant flows through the gear system to support the intermediate gears 18 on the journal pins 20 and to lubricate and cool the gear teeth. The used lubricant expelled by the gear train enters the gutter 26 by various paths, which include lubricant slots 32.

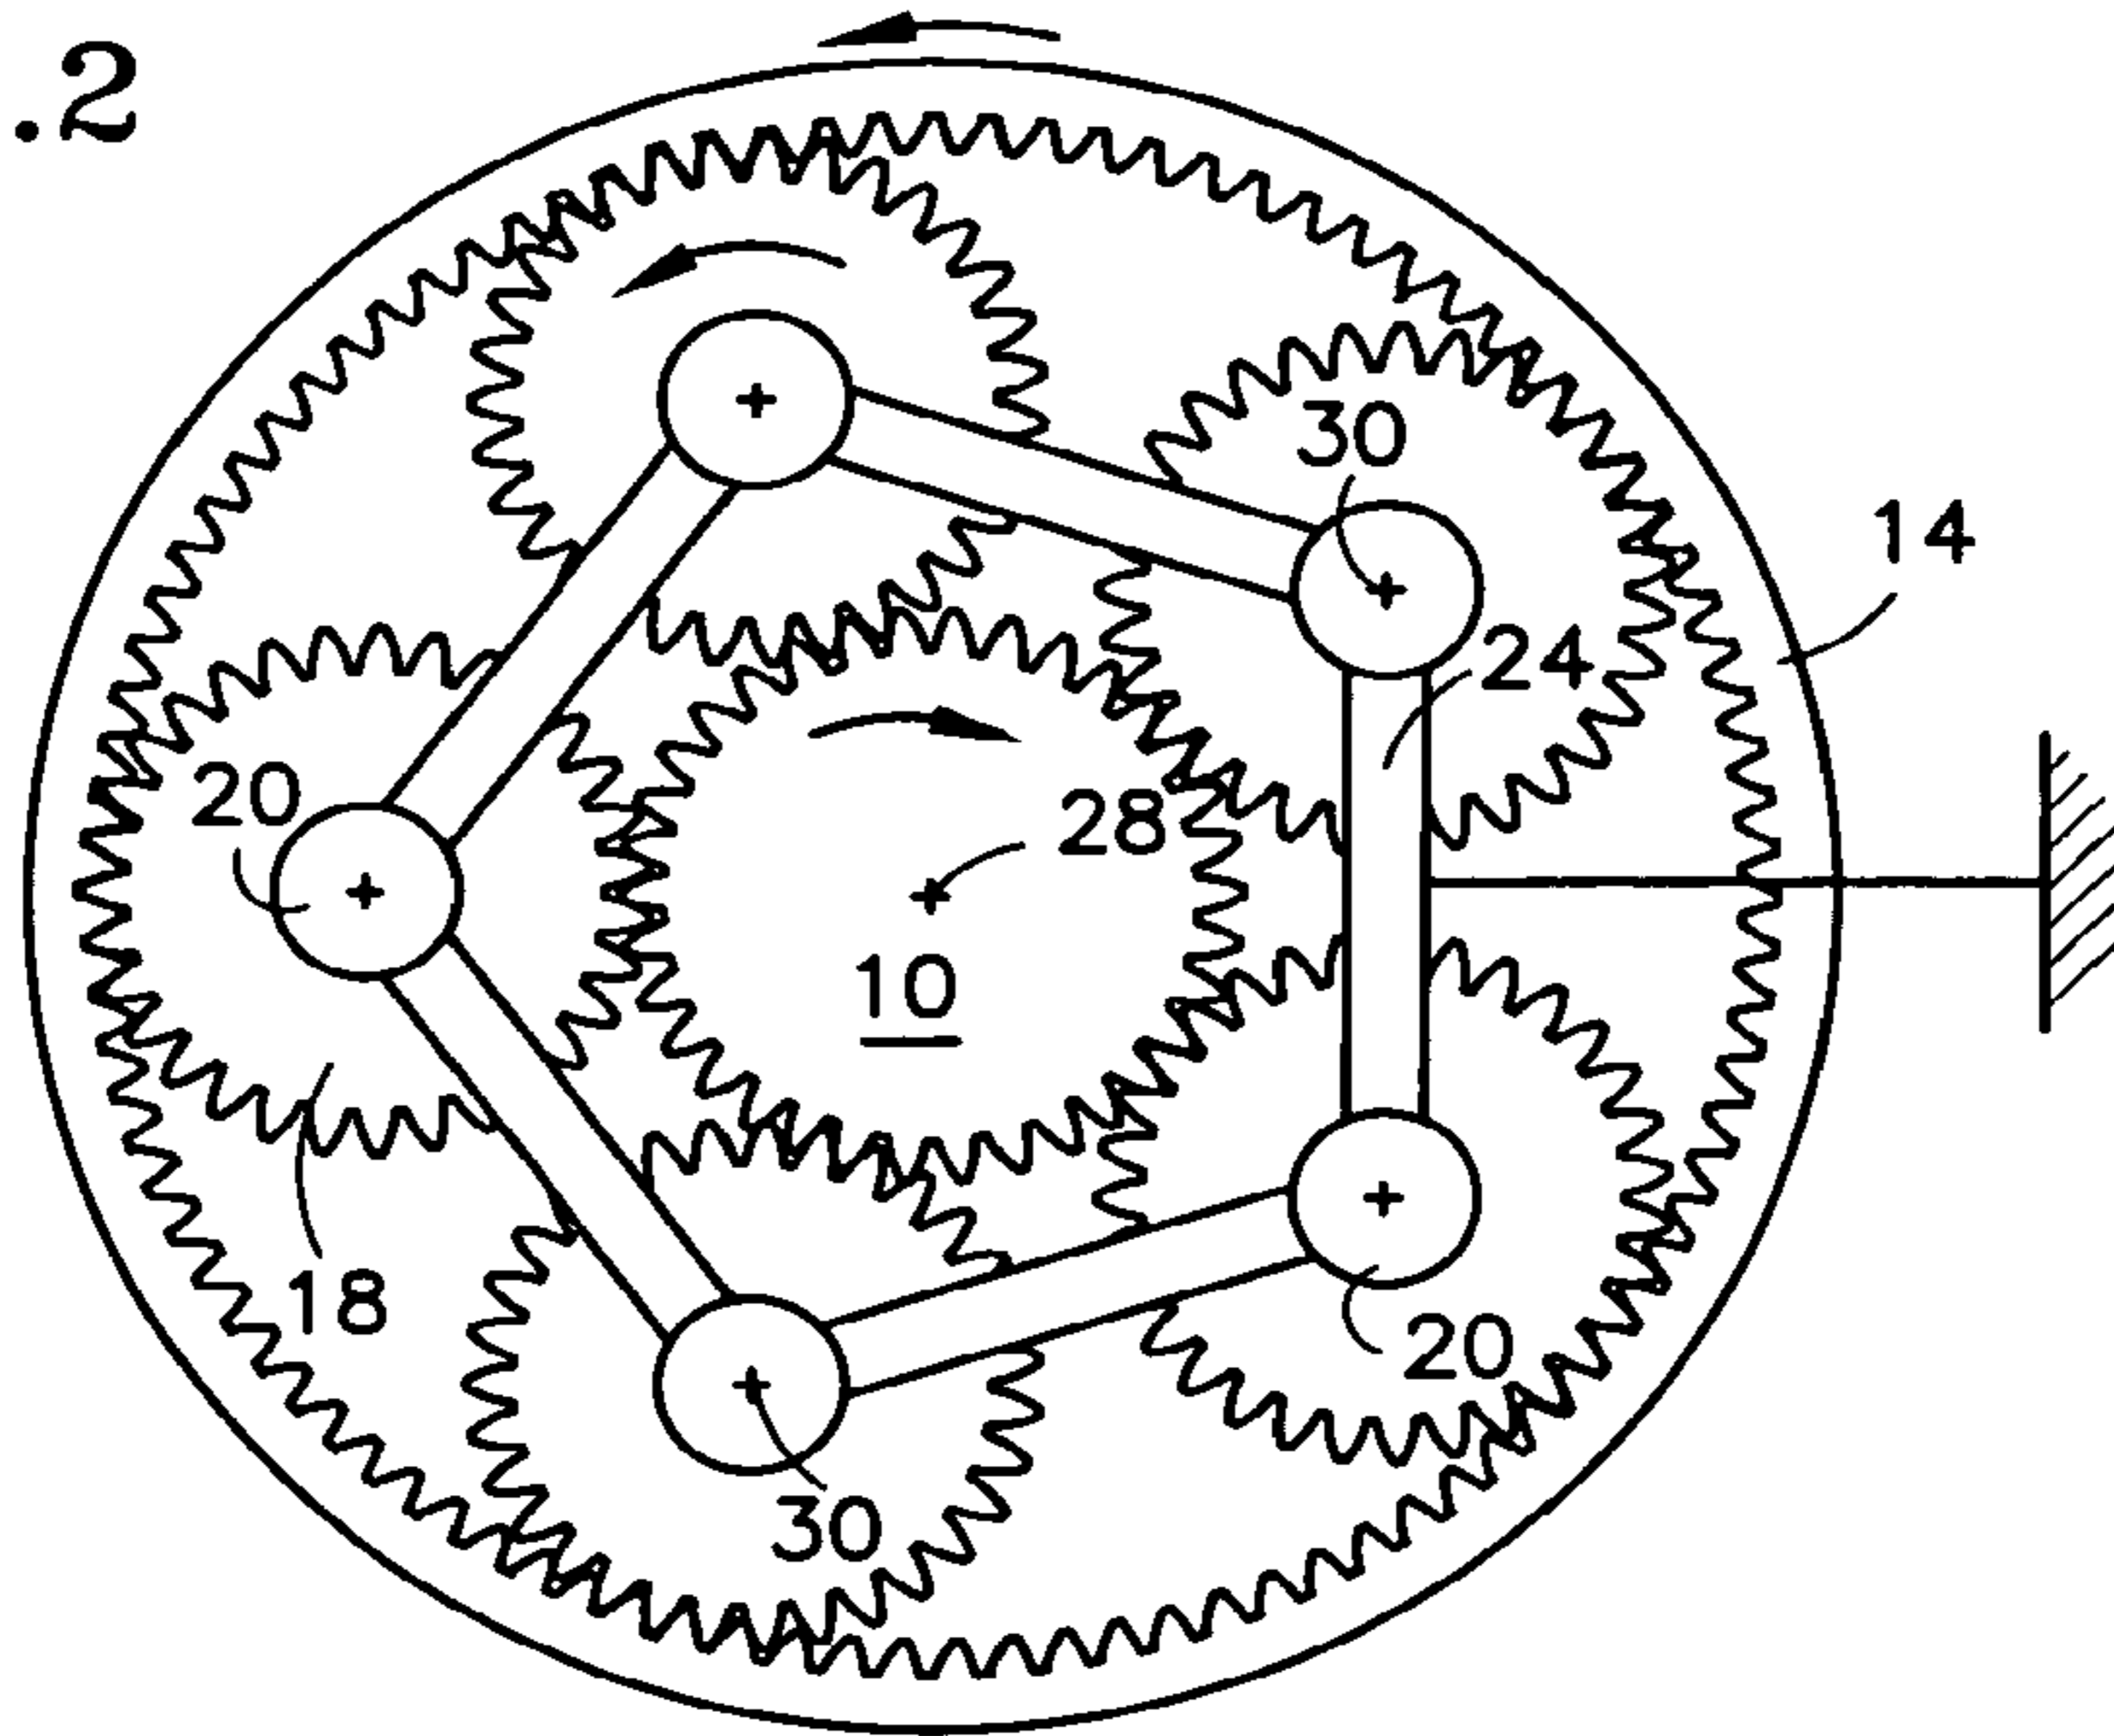
FIG. 2 is a schematic view in the direction 2-2 of FIG. 1.

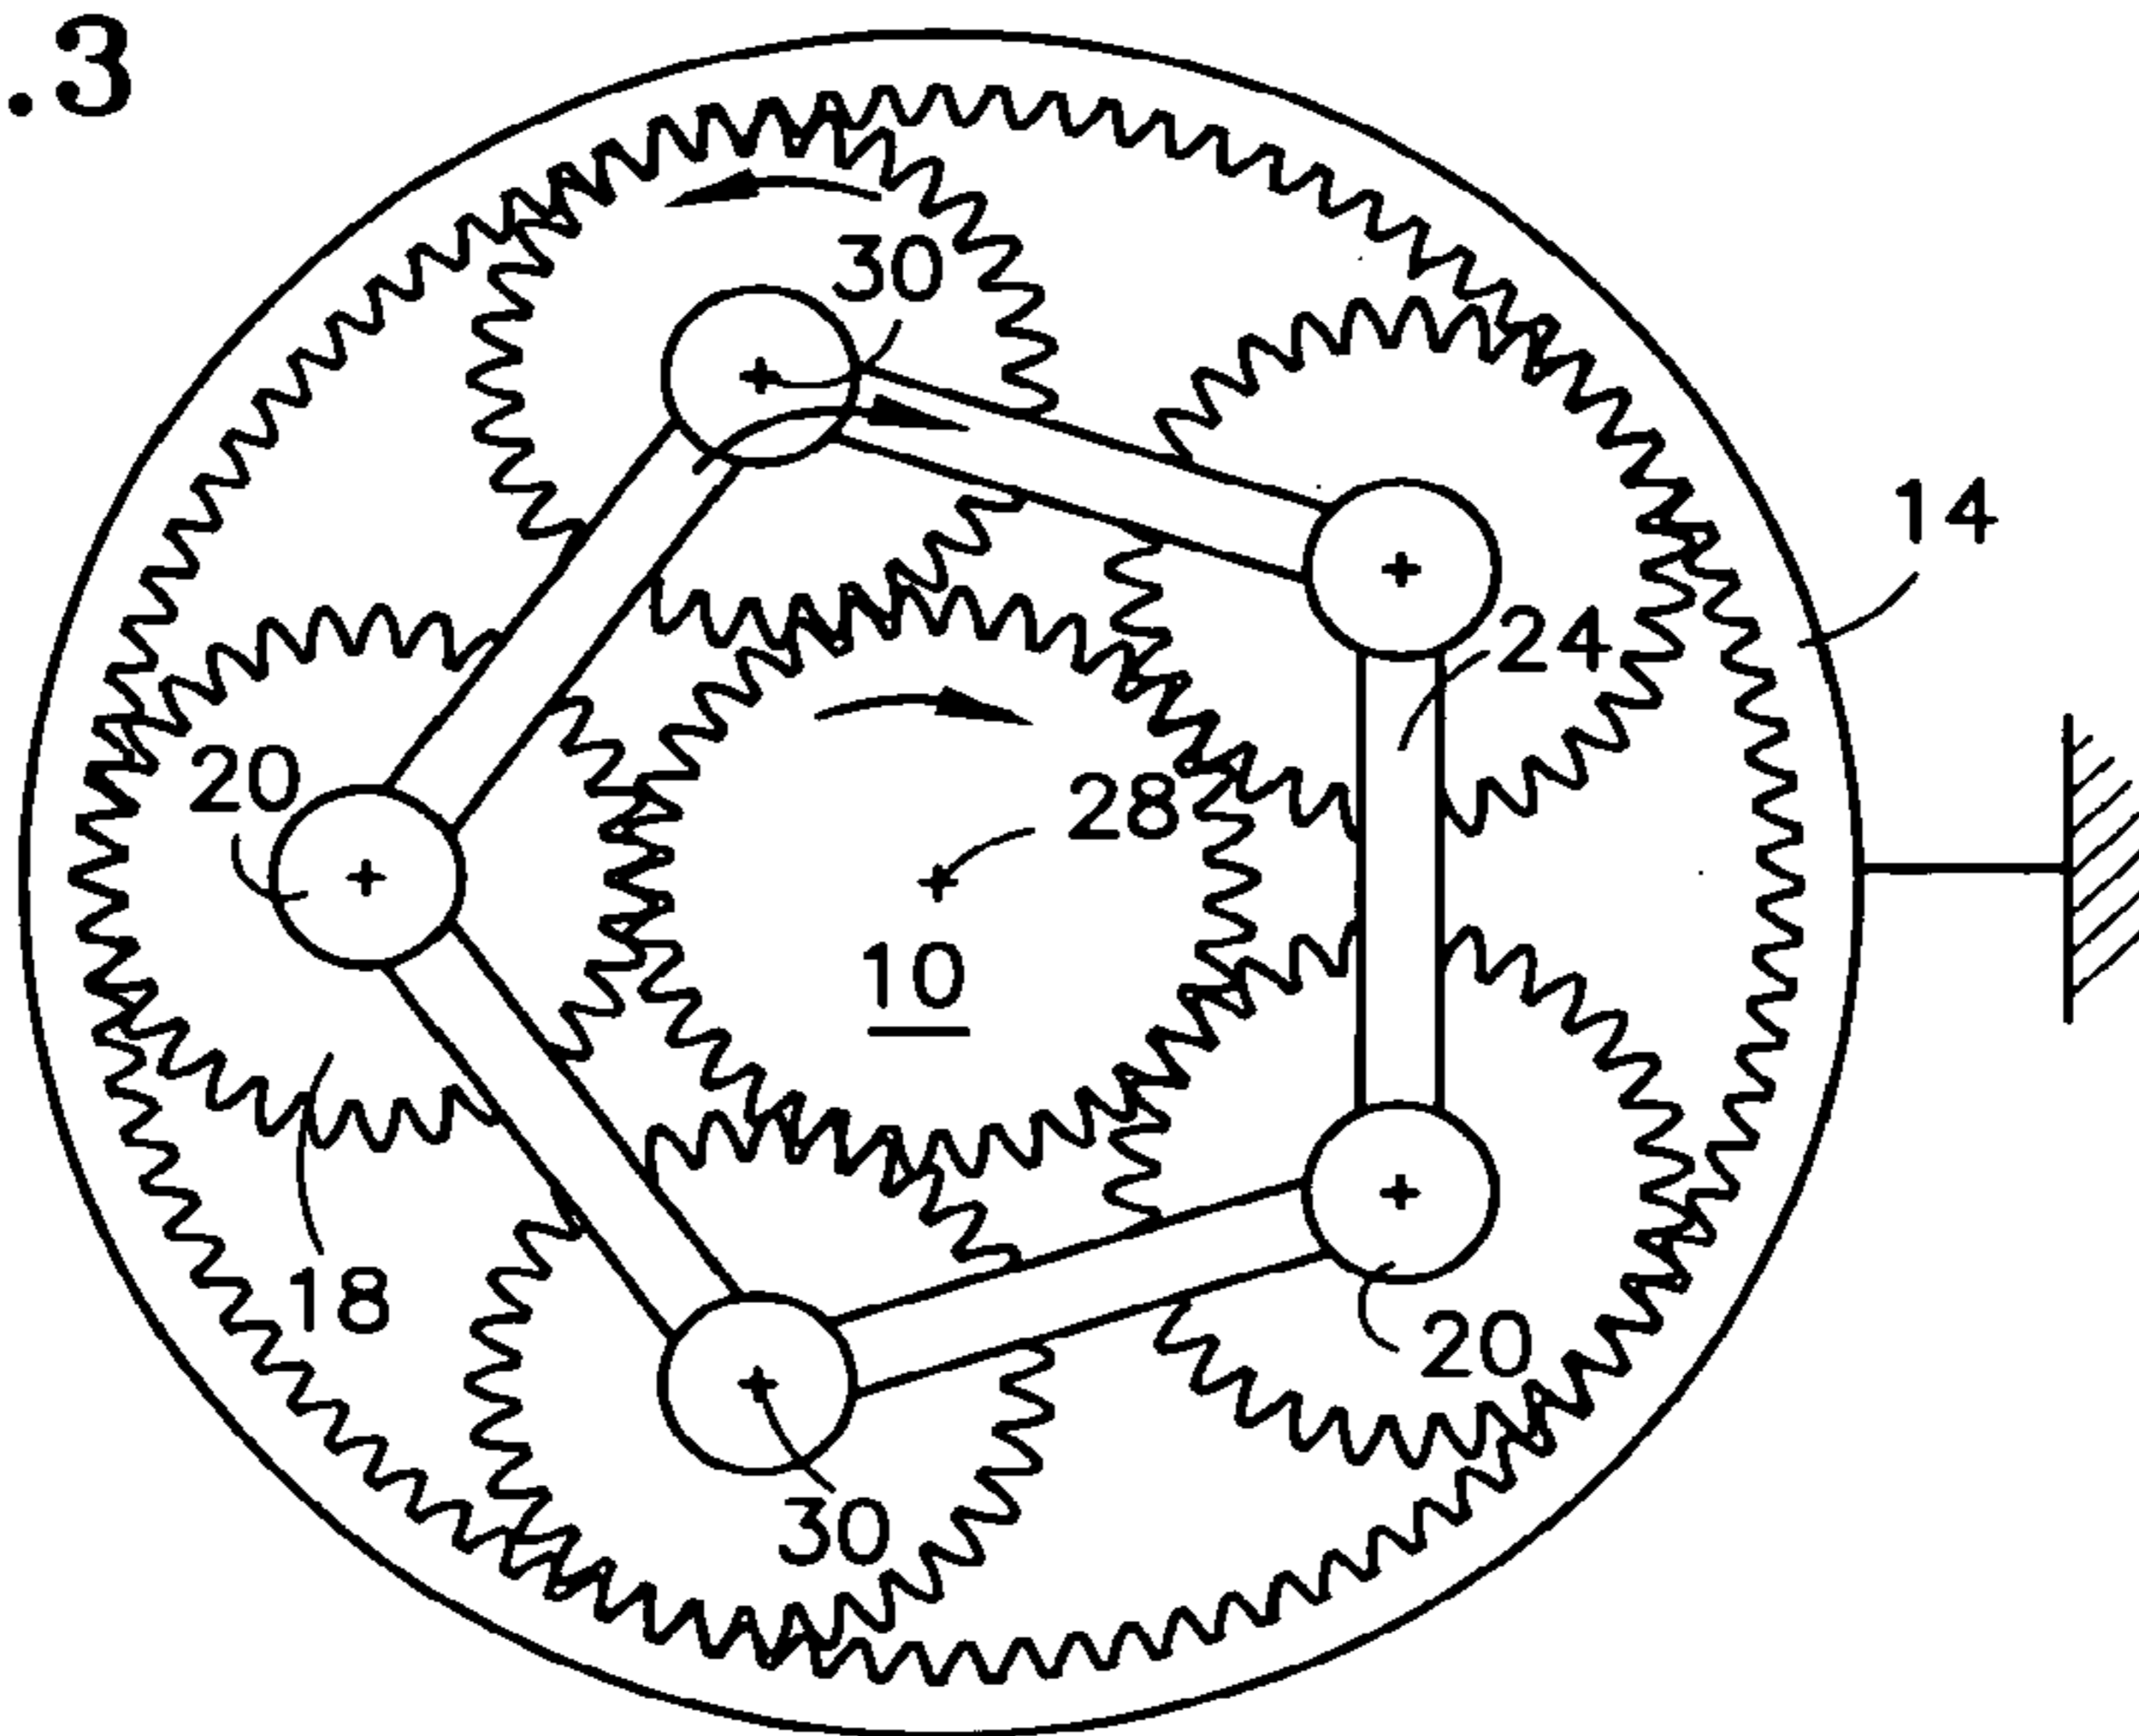
FIG. 3 is a schematic view similar to FIG. 2 illustrating a gear train configured as a planetary system.

Alternatively, as seen in FIG. 3, the sun gear and carrier are rotatable about the axis 28. The ring gear is nonrotatable. The carrier is connected to an output shaft. Such a system is referred to as a planetary system. The input and output shafts co-rotate as indicated in FIG. 3. Finally, all three components may be rotatable about axis 28 so that dual output shafts connected to the carrier and the ring gear counterrotate with respect to each other.

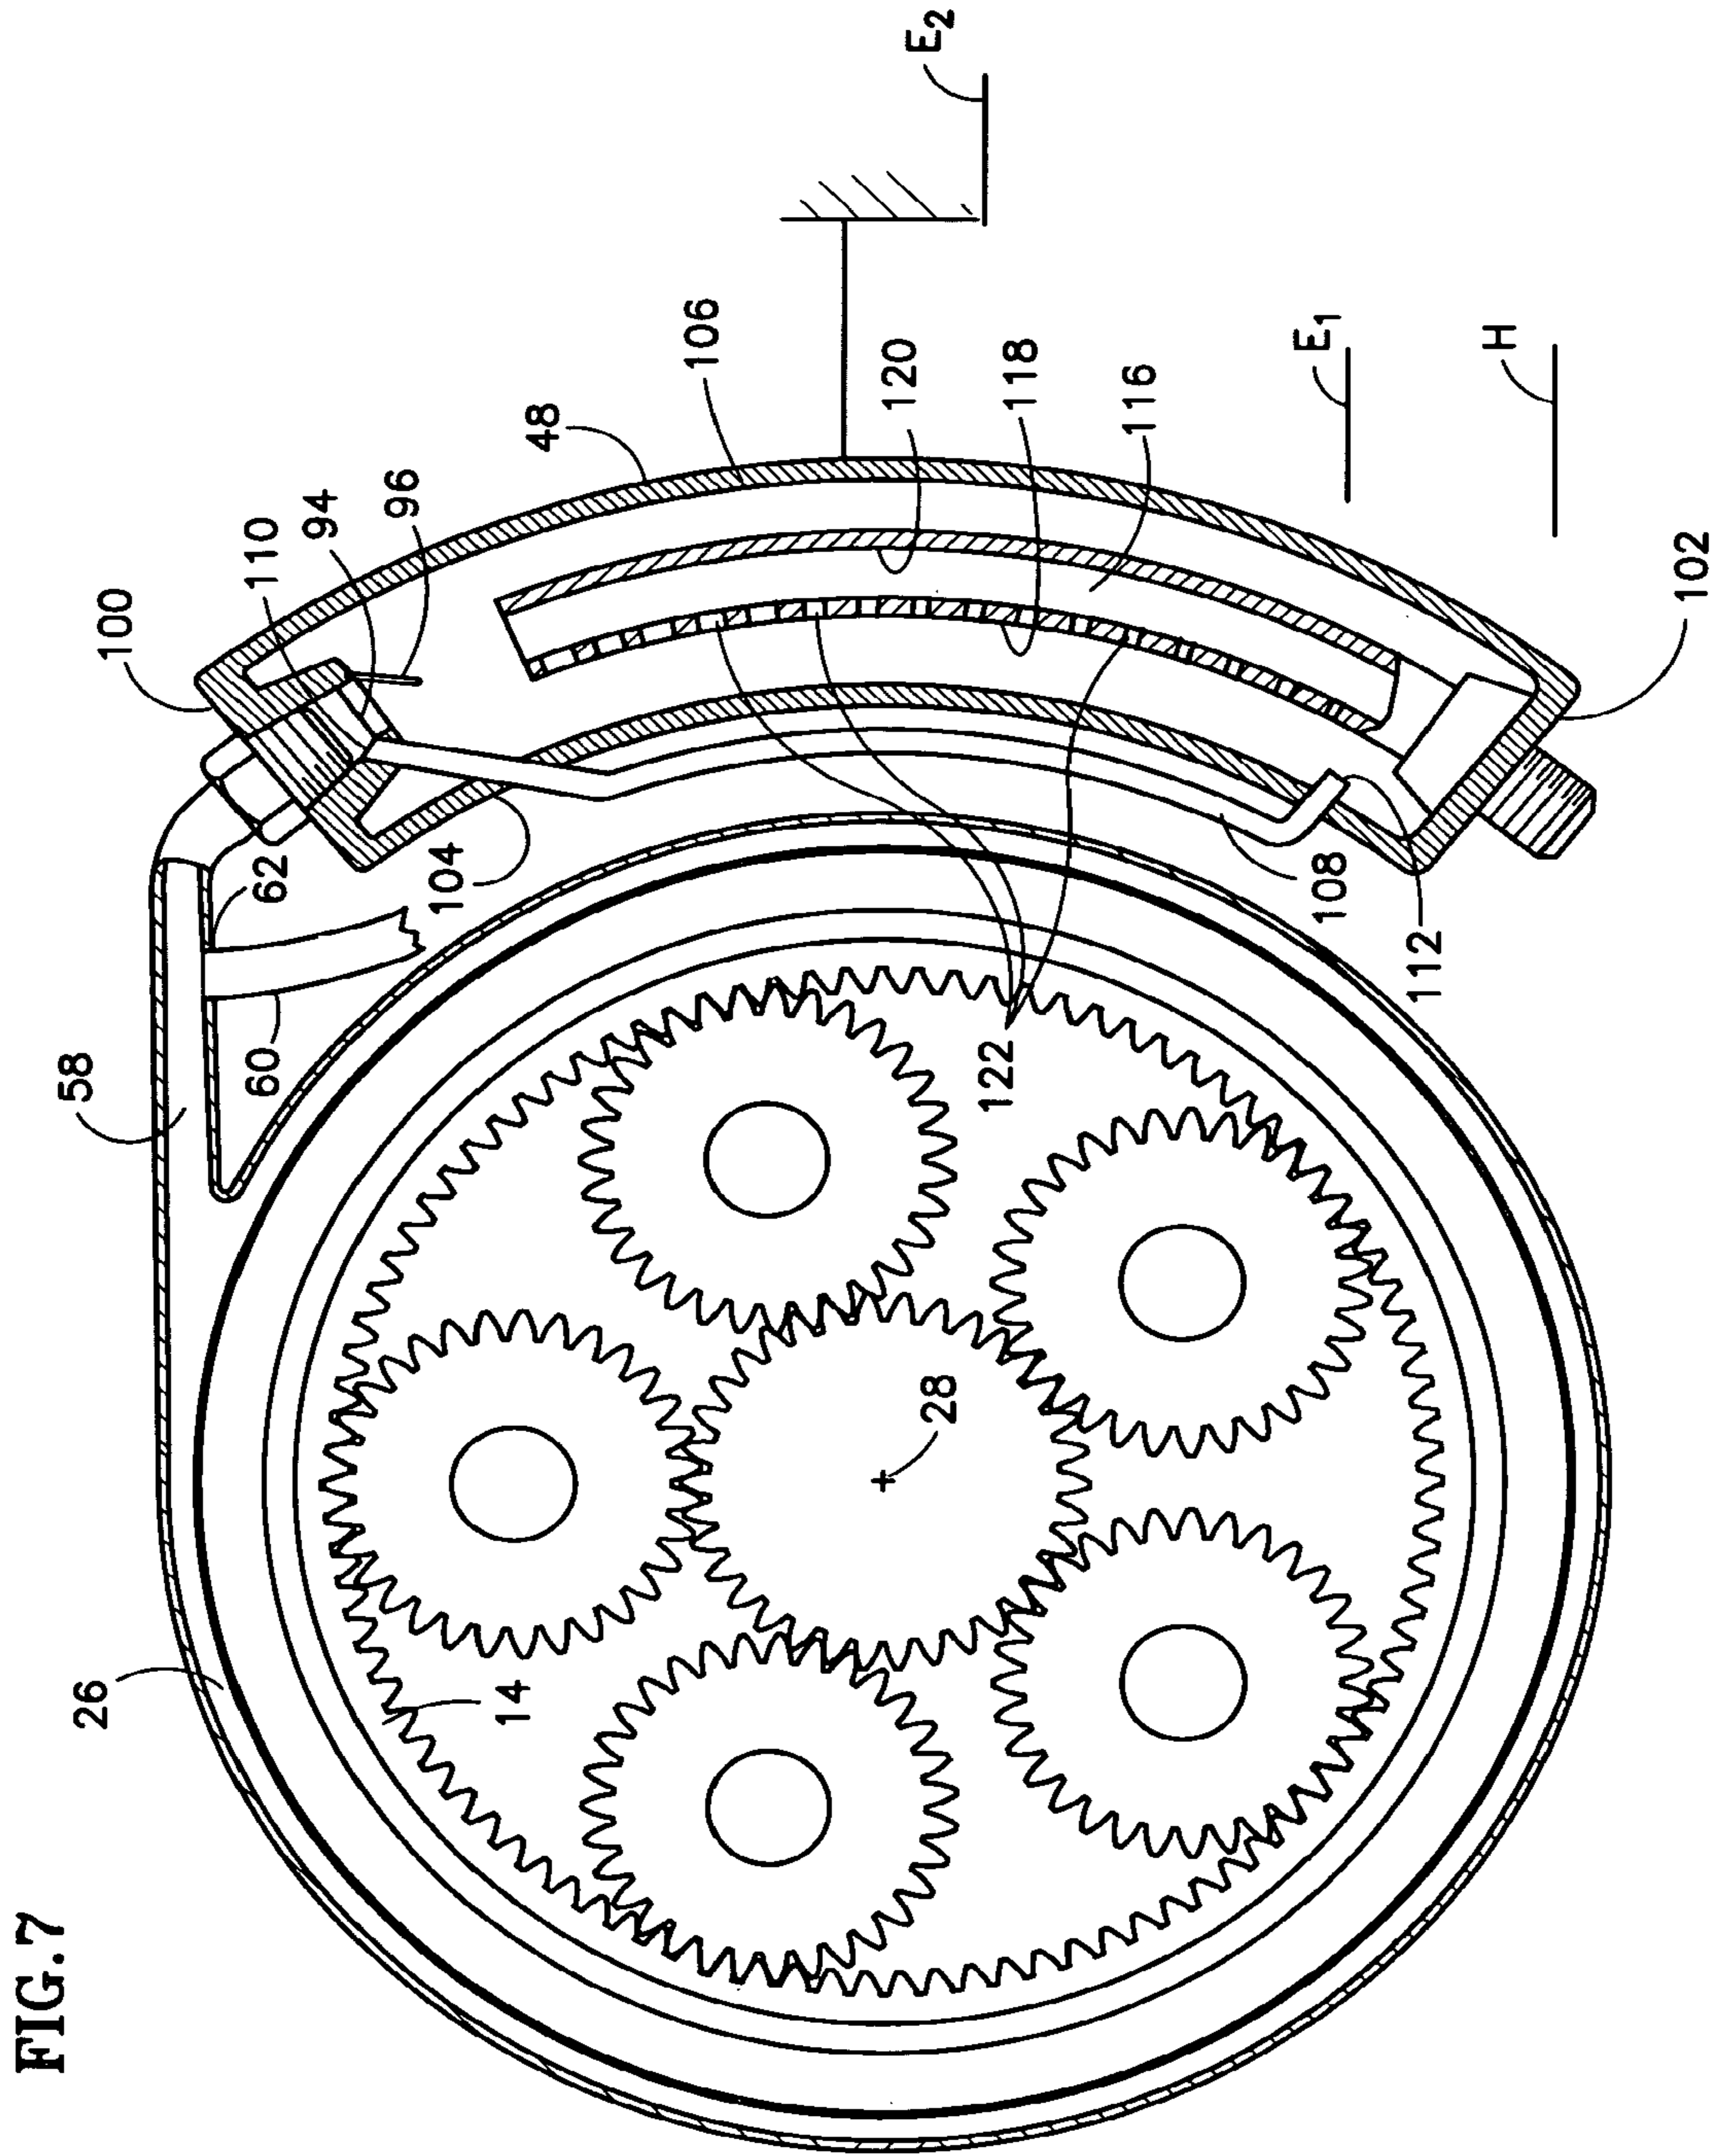
FIG. 4 is a schematic diagram showing a lubrication system in a normal state of operation, i.e. with the lubricant pressure at a normal level.

FIG. 5 is a schematic diagram showing the lubrication system of FIG. 4 shortly after the onset of an abnormal state of operation, i.e. with the lubricant pressure lower than a normal level.

FIG. 6 is a schematic diagram similar to FIG. 5 showing the lubrication system at a later time.

FIG. 4 schematically shows the relevant components of the above described gear train (gears 10, 14, 18, journal pin 20 and gutter 26), other engine components 36 requiring lubri-

cation, and a lubrication system suitable for use with the gear train. The lubrication system includes a main system whose components include a sump **38**, a scavenge pump **40** for scavenging lubricant from the sump, a main tank **42** for receiving lubricant from the scavenge pump, a main pump **44** for pumping lubricant from the main tank, and various lubricant reconditioning components such as chip detectors, heat exchangers and deaerators, collectively designated **46**. The lubrication system also includes an auxiliary system whose components include an auxiliary lubricant tank or reservoir **48** and an auxiliary pump **50**. The lubrication system also includes a pressure responsive valve **54**.

An auxiliary tank supply conduit **58** extends from the gutter **26** to the auxiliary tank **48**. The gutter serves as a source of lubricant for the tank. A main bypass line **60** branches from the supply conduit at a junction **62** and extends to the sump **38**. An auxiliary tank discharge conduit **64** extends from the auxiliary tank to the auxiliary pump. An auxiliary pump discharge line **66** extends from the auxiliary pump to the pressure responsive valve. A main tank return line **68** extends from the valve **54** to the main lubricant tank **42**. A lubricant delivery pathway **70** extends from the main pump **44** through the various lubricant reconditioning components **36** and ultimately to the gears **10**, **14**, **18** and other components **46**. A lubricant return pathway **72** extends from the components to the sump **38**. A portion **76** of the delivery pathway **70** leads to the pressure responsive valve **54**. A journal pin delivery line **78** extends from the valve to the journal pins **20**.

During normal operation, rotation of the gears expels lubricant radially outwardly, and with a high tangential velocity, into the lubricant recovery gutter **26**. The supply conduit **58**, which branches substantially tangentially off the gutter as seen in FIGS. **7** and **8**, captures the expelled lubricant. A large portion **82** of the lubricant flows through the main bypass line **60** and returns to the sump **38**. A smaller portion **84** of the lubricant flows into the auxiliary tank **48** to establish or replenish a reserve quantity of lubricant therein. The auxiliary pump **50** pumps lubricant from the tank to the pressure responsive valve **54**. Concurrently, the scavenge pump **40** extracts lubricant from the sump **38** and delivers it to the main tank **42**. The main pump **44** pumps the lubricant from the tank to the reconditioning components **46**. Most of the reconditioned lubricant **86** then flows to the gears **10**, **14**, **18** and other components **36**. The remainder **88** of the lubricant flows to the pressure responsive valve. The valve, responding to normal pressure in the lubrication system, directs this remaining lubricant **88** to the journal pins and directs reserve lubricant **90** (received from the auxiliary pump) to the main tank **42**.

Referring now to FIG. **5**, immediately after the onset of abnormal operation (e.g. due to a severe leak, clog or malfunction of a system component) the lubricant pressure drops such that an unsatisfactorily reduced quantity of lubricant flows through the lubricant delivery pathway **70**. In response to the abnormally low pressure, the pressure responsive valve **54** shunts the reserve lubricant **90** received from the auxiliary pump to the journal pins **20** to ensure that the pins receive lubricant, at least temporarily. The gear system at first continues to expel a large quantity of lubricant into the gutter. As with normal operation, a large portion **82** of the lubricant flows through the main bypass line **60** and returns to the sump **38**. A smaller portion **84** of the lubricant flows to the auxiliary tank to at least partially replenish the lubricant being withdrawn by the auxiliary pump.

If the abnormally low lubricant pressure persists, the system reaches the state shown in FIG. **6**. The quantity of lubricant circulating through the system is small enough that little or no lubricant backs up from the auxiliary tank and enters the main bypass line **60**. Instead, nearly all of the limited quantity of lubricant flows to the auxiliary pump **50** and eventually back to the journal pins **20**. This state of operation persists until the tank **48** is depleted and the flow rate from the gutter **26** is insufficient to replenish it.
