US008517148B2

(10) **Patent No.:** **US 8,517,148 B2**
(45) **Date of Patent:** ***Aug. 27, 2013**

(54) **LUBRICATION SYSTEM WITH TOLERANCE FOR REDUCED GRAVITY**

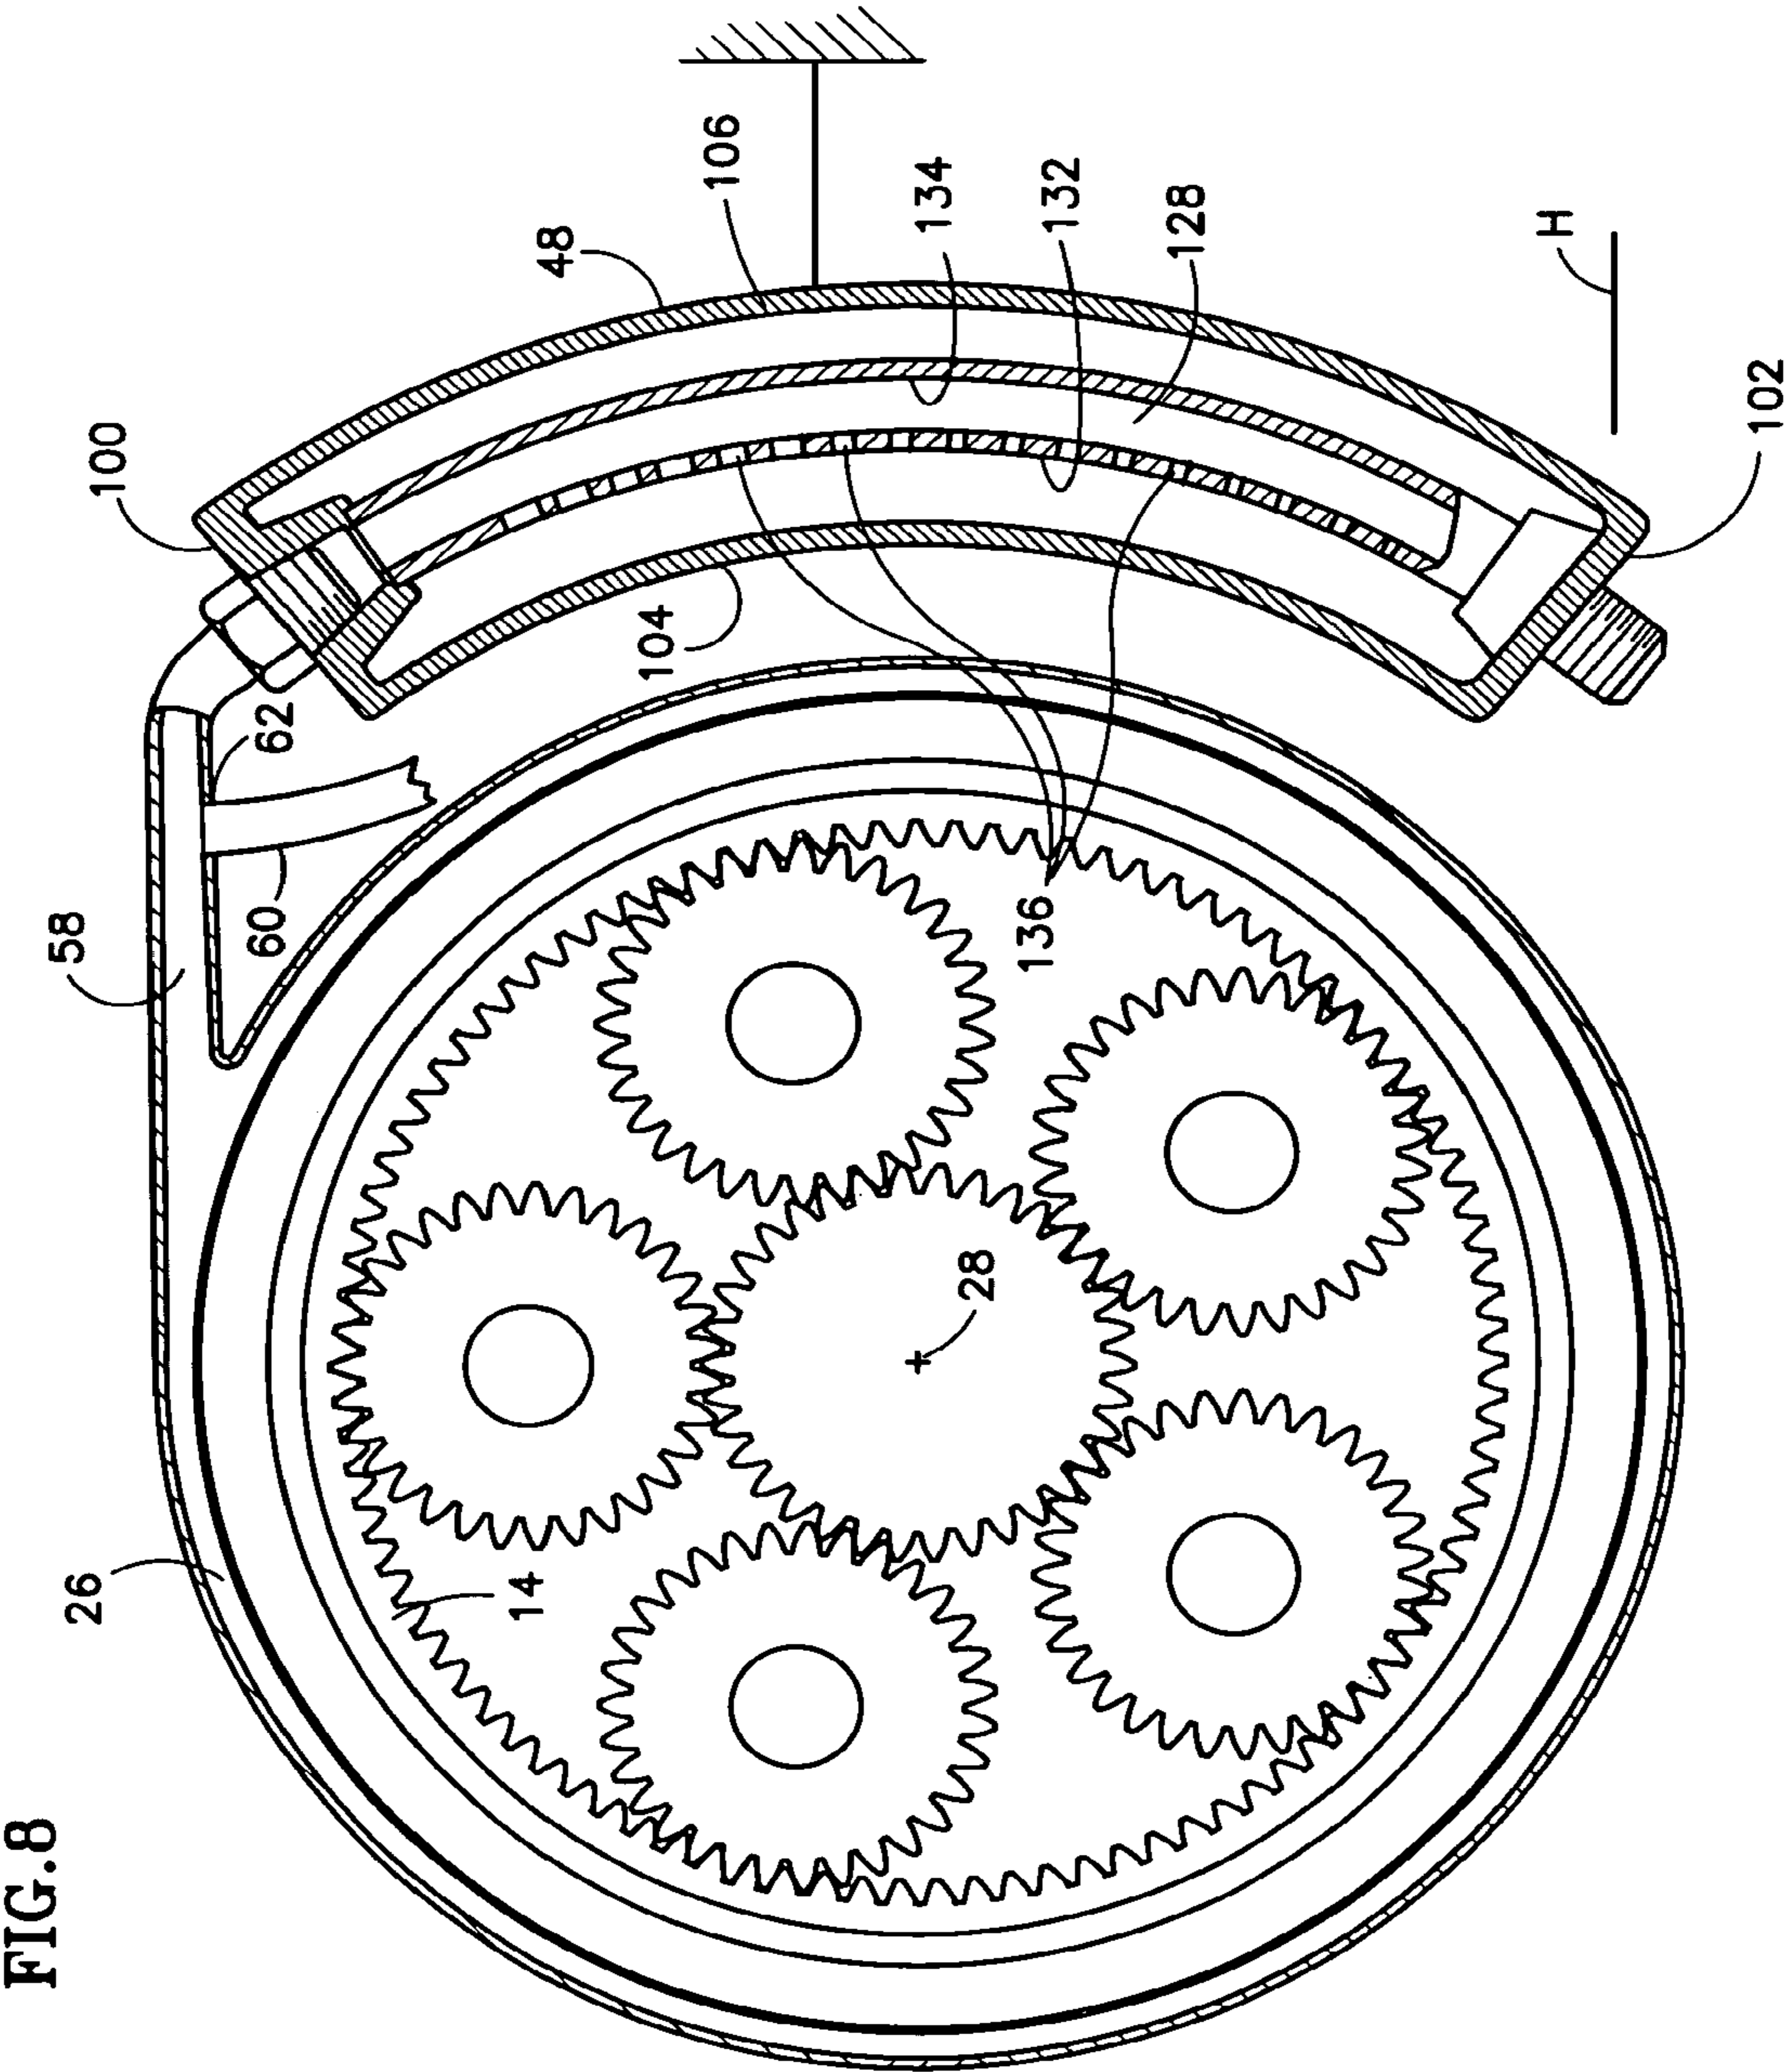
FIG. 7 is a schematic view showing an auxiliary lubricant tank with a bypass conduit and a discharge conduit for accommodating reduced-G operation.

FIG. 8 is a schematic view showing an auxiliary lubricant tank with a continuous conduit extending through the tank without interruption for accommodating reduced-G operation.

FIG. **7** illustrates the ring gear **14**, gutter **26** and supply conduit **58**, which extends substantially tangentially from the gutter. The main bypass line **60** branches from the supply conduit at the junction **62** upstream of a conduit outlet **94**. An optional valve such as flapper valve **96** regulates lubricant flow from the outlet. The valve may be loaded, for example by a spring, to its closed position. The auxiliary tank **48** is mounted to a nonrotatable mechanical ground. The tank has a top **100**, a bottom **102** and an arcuate profile with radially inner and outer boundaries **104**, **106**. A reduced-G bypass line **108** branches from the conduit downstream of the junction **62** and upstream of the conduit outlet **94**. The bypass line has an inlet **110**, and an outlet **112** inside the auxiliary tank. The outlet **112** is at a first elevation, E_1 , preferably near the bottom of the tank.

The system also includes an auxiliary tank discharge conduit **116**. The discharge conduit **116** has an arcuate profile with radially inner and outer boundaries **118**, **120**. A portion of the conduit resides within the tank. The resident portion has an opening along the conduit inner boundary for allowing lubricant transfer between the tank and the conduit. The opening may take any convenient form. For example the opening may be a single opening such as a hole or a slot extending along the conduit. The illustrated opening is an array of perforations **122**. The perforations may all have the same area, however, as explained below, it may be desirable for the area of the individual perforations to decrease, or at least not increase, with decreasing elevation. The opening, whatever form it takes, is at least partially at a second elevation E_2

FIG. 8 illustrates the ring gear **14**, gutter **26** and supply conduit **58**, which extends substantially tangentially from the gutter. The main bypass line **60** branches from the conduit at the junction **62**. The auxiliary tank **48** is mounted to a nonrotatable mechanical ground. The tank has a top **100**, a bottom **102** and an arcuate profile with radially inner and outer boundaries **104**, **106**.

The system also includes an auxiliary tank discharge conduit **128**. The discharge conduit may be a component physically distinct from the supply conduit **58** and connected thereto by a fitting or other appropriate connection as shown. Alternatively, the discharge conduit may be an integral extension or continuation of the supply conduit **58**, with the interface between the conduits **58**, **128** being, for example, at the location where the continuous conduit penetrates into the auxiliary tank **48**. The conduit extends continuously and without interruption through the tank.

The discharge conduit **128** has an arcuate profile with radially inner and outer boundaries **132**, **134**. A portion of the discharge conduit resides within the tank. The resident portion has an opening along the conduit inner boundary for allowing lubricant transfer between the tank and the conduit. The opening may take any convenient form. For example the opening may be a single opening such as a hole or a slot extending along the conduit. The illustrated opening is an array of perforations **136**. The perforations may all have the same area. However, as explained above, it may be desirable for the area of the individual perforations to decrease, or at least not increase, with decreasing elevation in order to reduce the tendency for the pump **50** to extract air rather than lubricant during negative-G operation.
