US008517148B2

(10) **Patent No.:** **US 8,517,148 B2**
(45) **Date of Patent:** ***Aug. 27, 2013**

(54) **LUBRICATION SYSTEM WITH TOLERANCE FOR REDUCED GRAVITY**

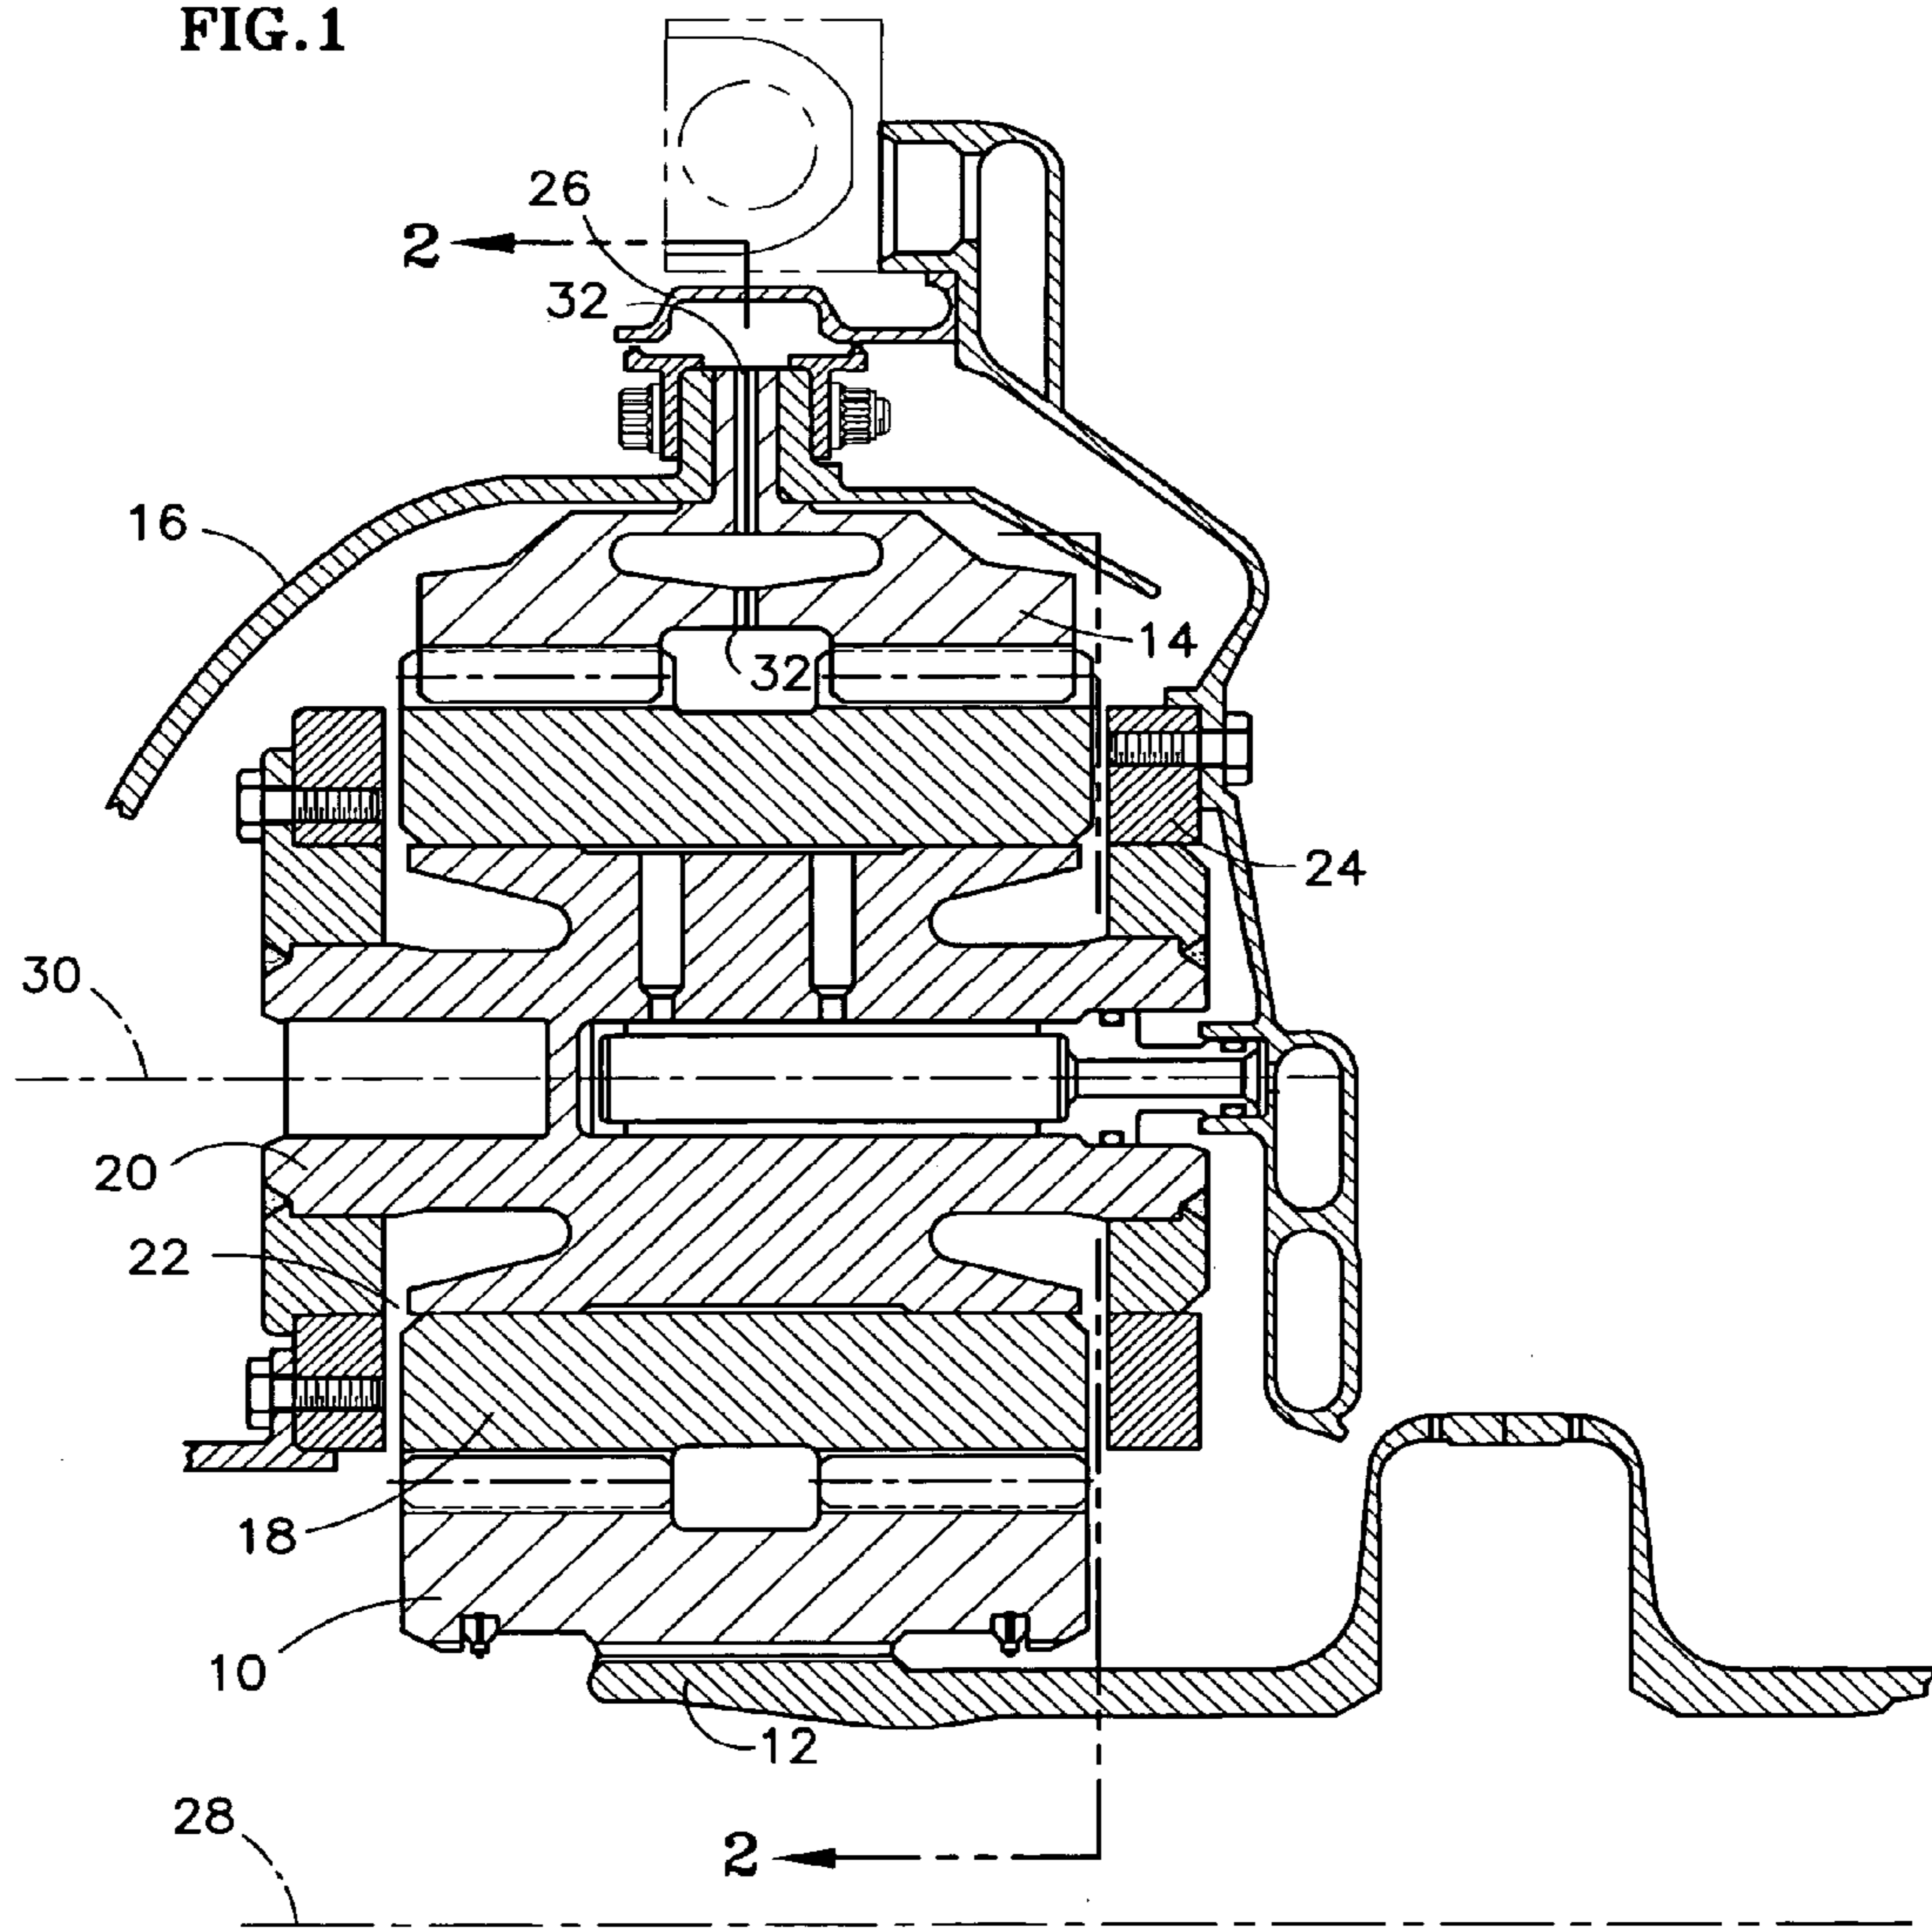
FIG. 1 is a cross sectional side elevation view of a gear train configured as a star system and useful in an aircraft gas turbine engine.

Referring to FIGS. 1 and 2, a reduction gear train suitable for use in an aircraft gas turbine engine includes a sun gear 10 driven by a sun gear (input) shaft 12, a ring gear 14 radially outboard of the sun gear and connected to a ring gear (output) shaft 16, and a set of intermediate gears 18 radially intermediate and meshing with the sun and ring gears. Each intermediate gear circumscribes a journal pin 20. A thin, replenishable film of lubricant, not shown, occupies a small annular space 22 between each intermediate gear and its journal pin to support the intermediate gear. This arrangement is referred to as a journal bearing. The journal pins are all supported by a carrier 24. The carrier interconnects the journal pins with each other and, by doing so, also interconnects the intermediate gears to each other. A lubricant recovery gutter 26 circumscribes the ring gear.

In the gear train shown in FIGS. 1 and 2, the sun and ring gears are each rotatable about an axis 28. The carrier is non-rotatable even though the individual intermediate gears are each rotatable about their respective axes 30. Such a system is referred to as a star system. As seen best in FIG. 2, the input and output shafts counterrotate. Lubricant flows through the gear system to support the intermediate gears 18 on the journal pins 20 and to lubricate and cool the gear teeth. The used lubricant expelled by the gear train enters the gutter 26 by various paths, which include lubricant slots 32.

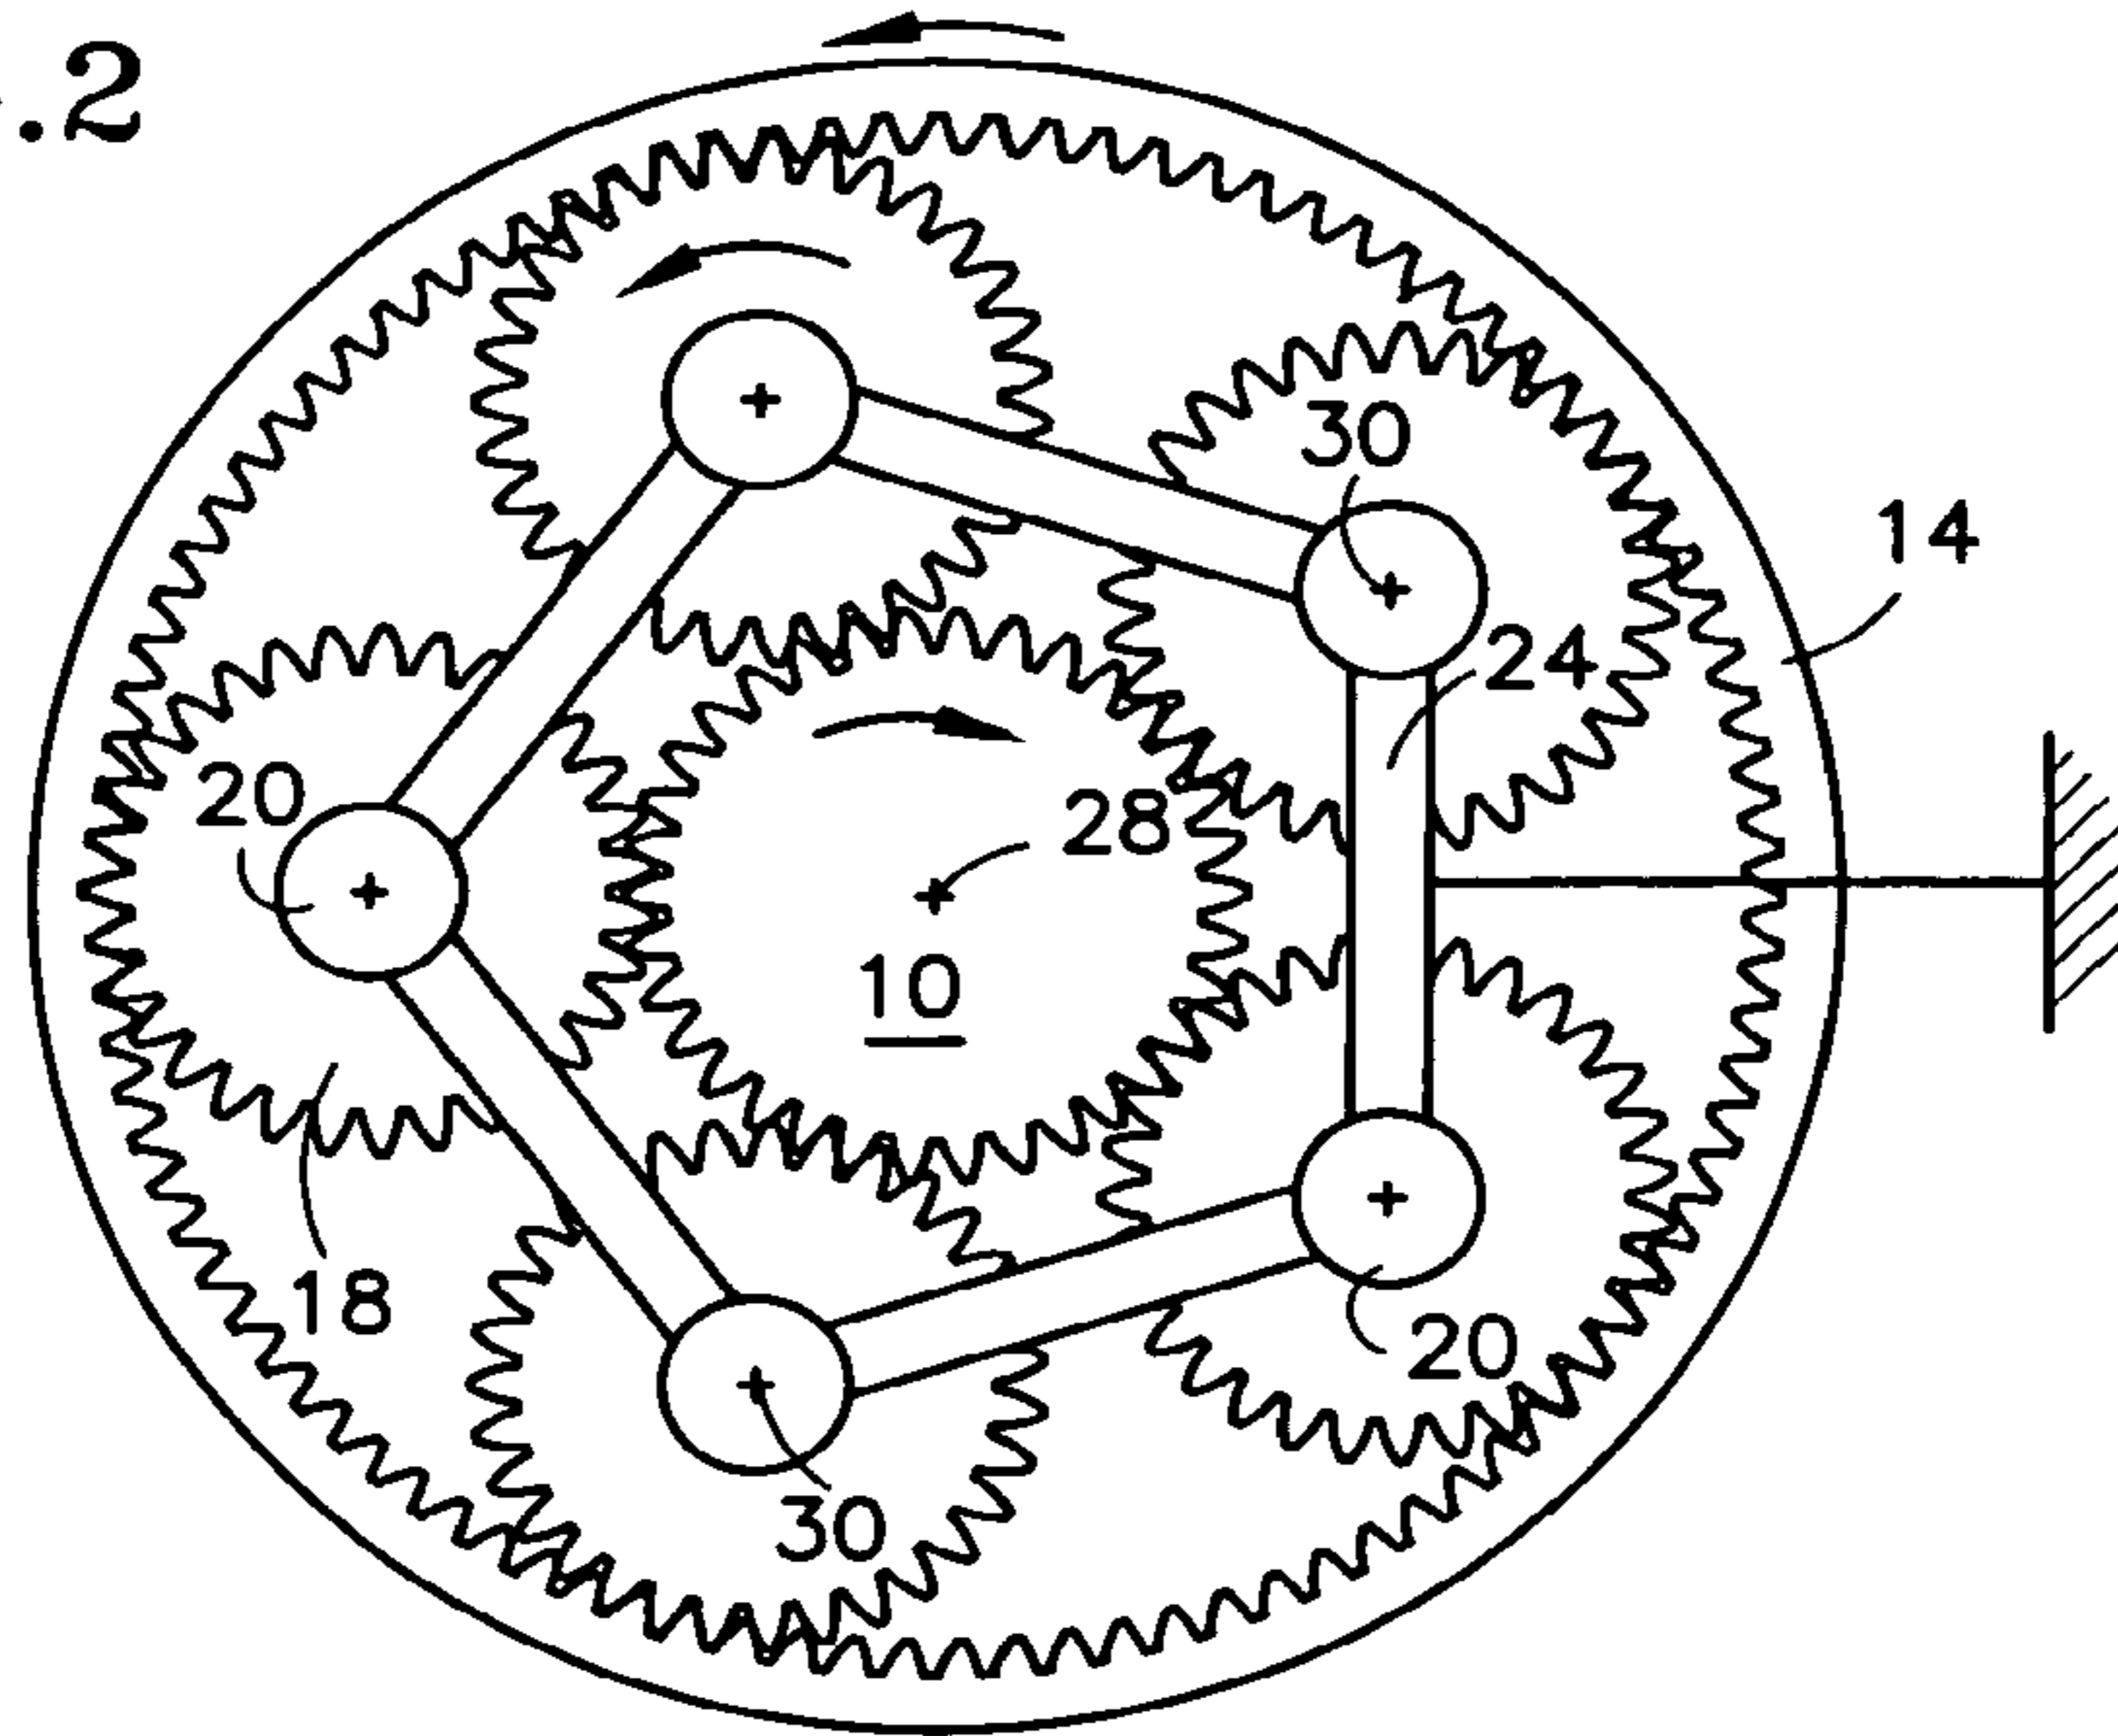
FIG. 2 is a schematic view in the direction 2-2 of FIG. 1.

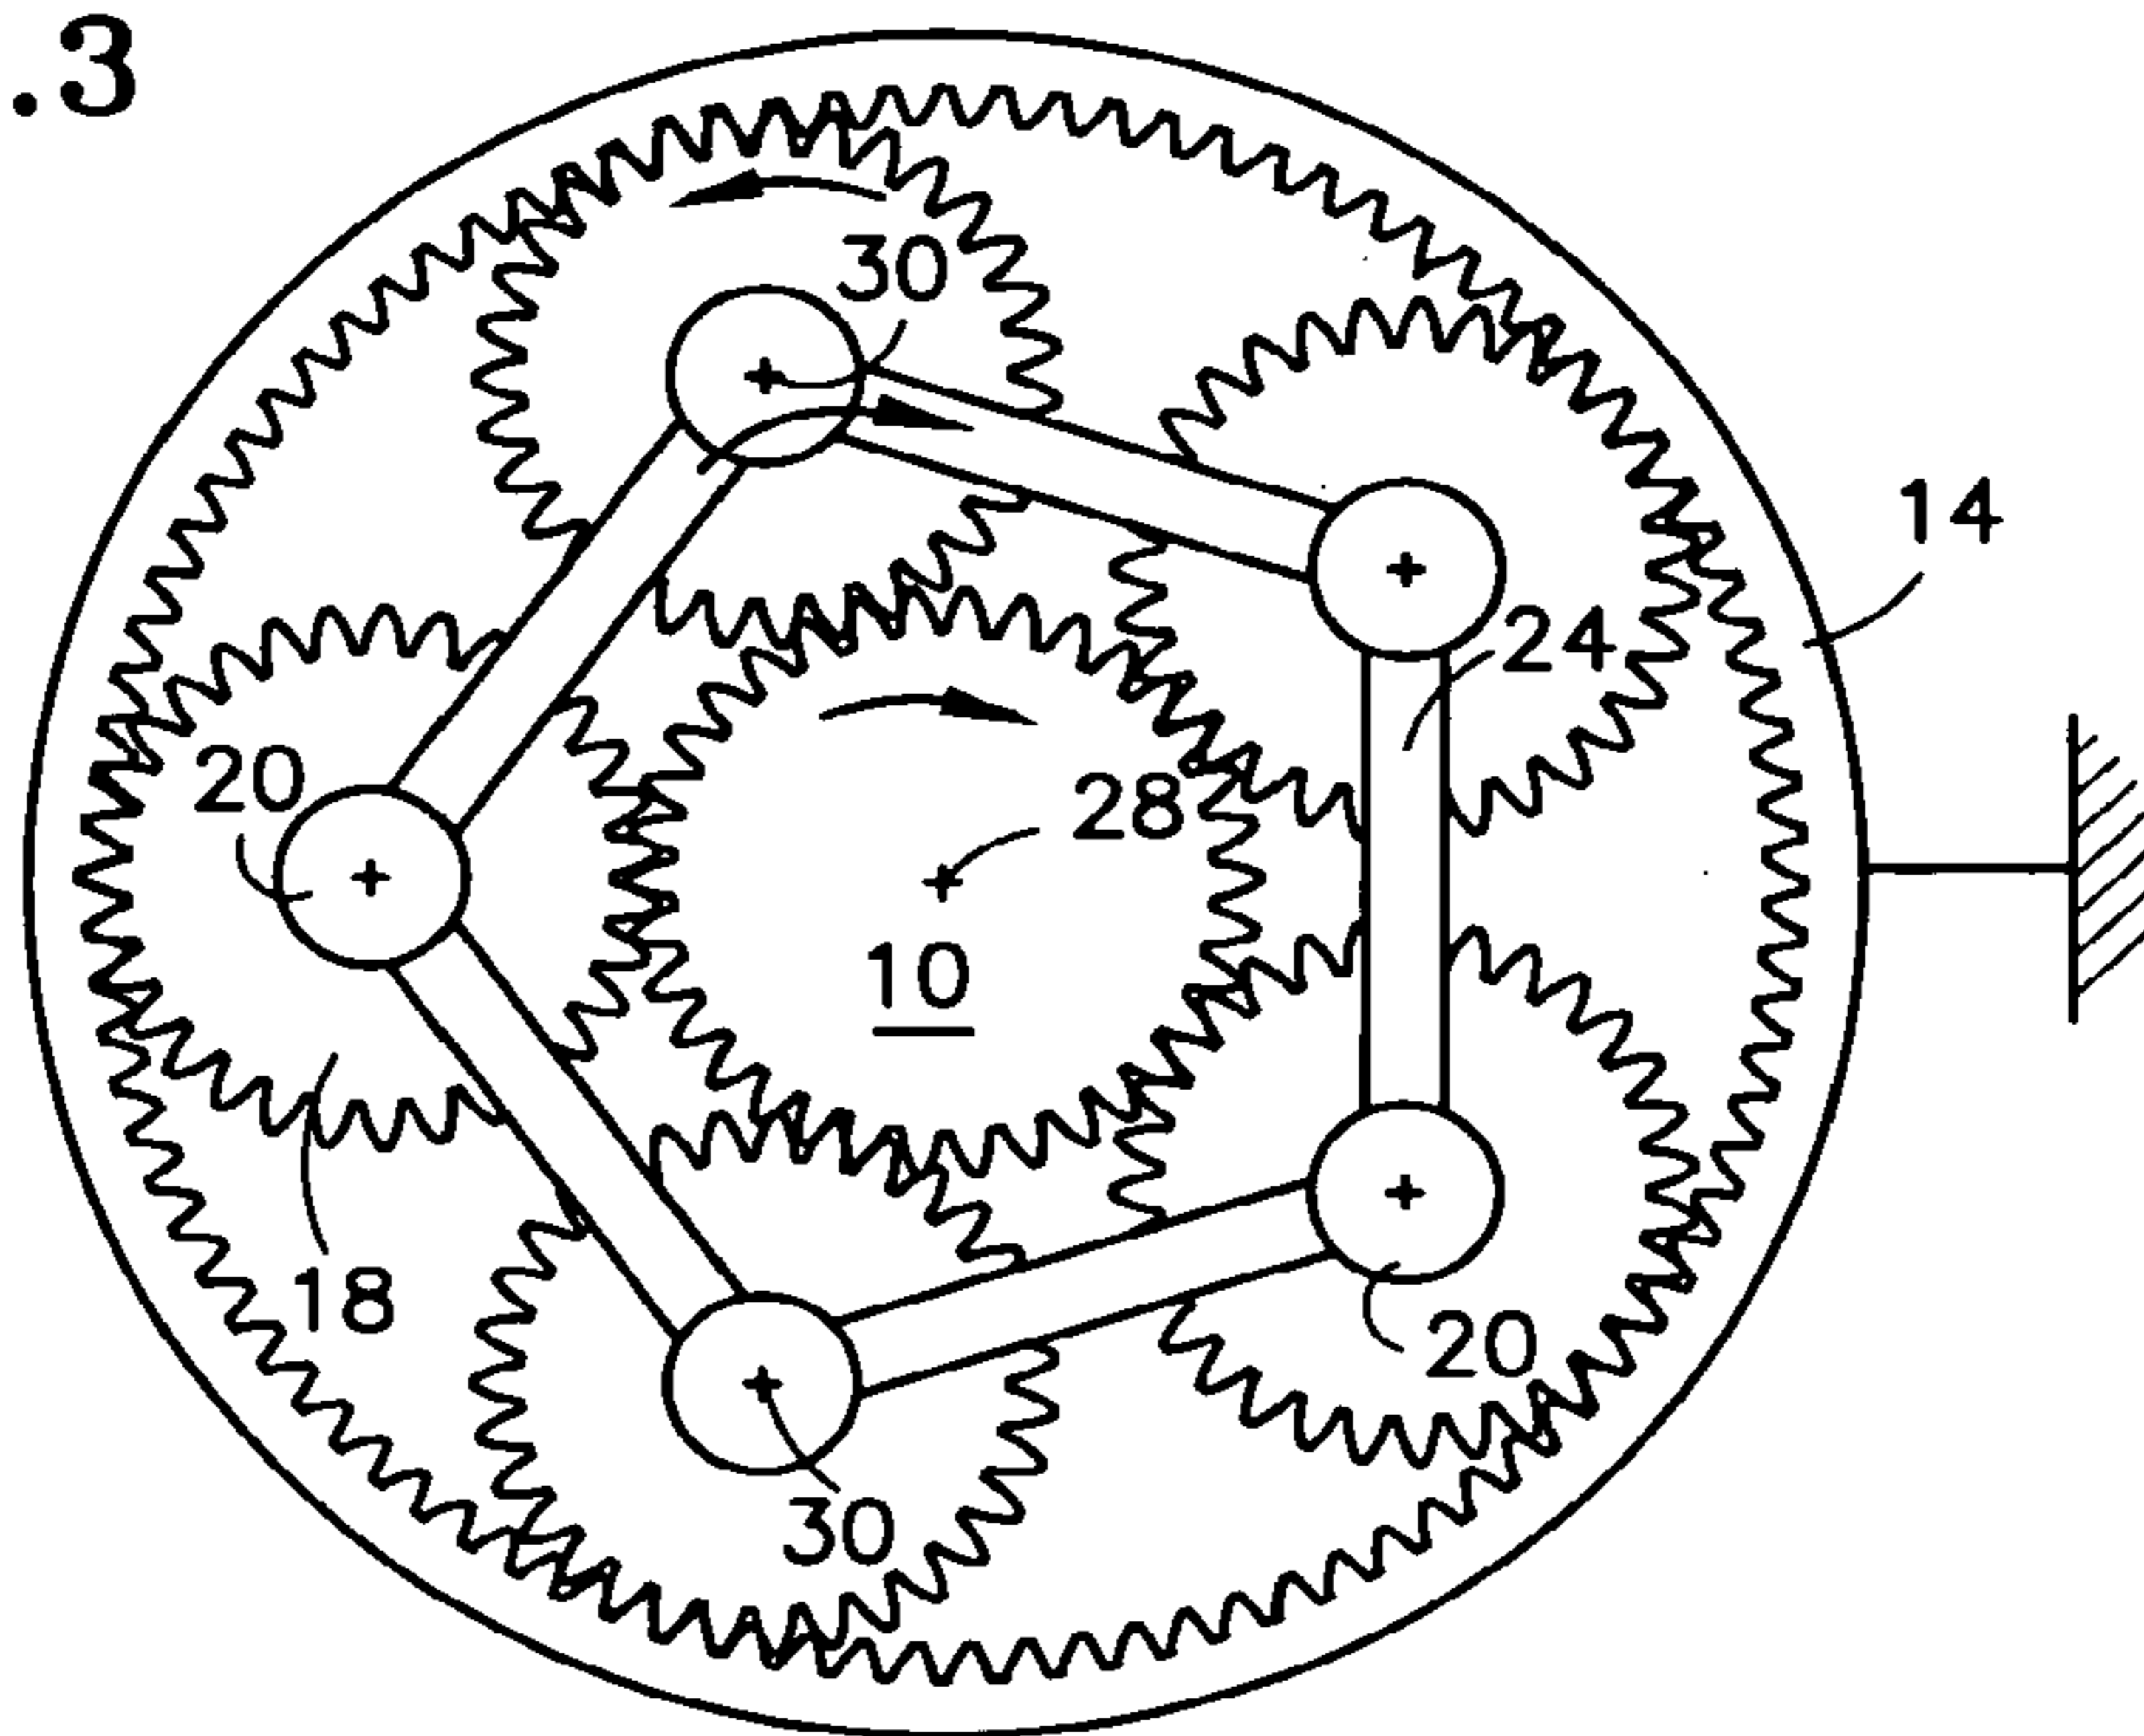
FIG. 3 is a schematic view similar to FIG. 2 illustrating a gear train configured as a planetary system.

Alternatively, as seen in FIG. 3, the sun gear and carrier are rotatable about the axis 28. The ring gear is nonrotatable. The carrier is connected to an output shaft. Such a system is referred to as a planetary system. The input and output shafts co-rotate as indicated in FIG. 3. Finally, all three components may be rotatable about axis 28 so that dual output shafts connected to the carrier and the ring gear counterrotate with respect to each other.

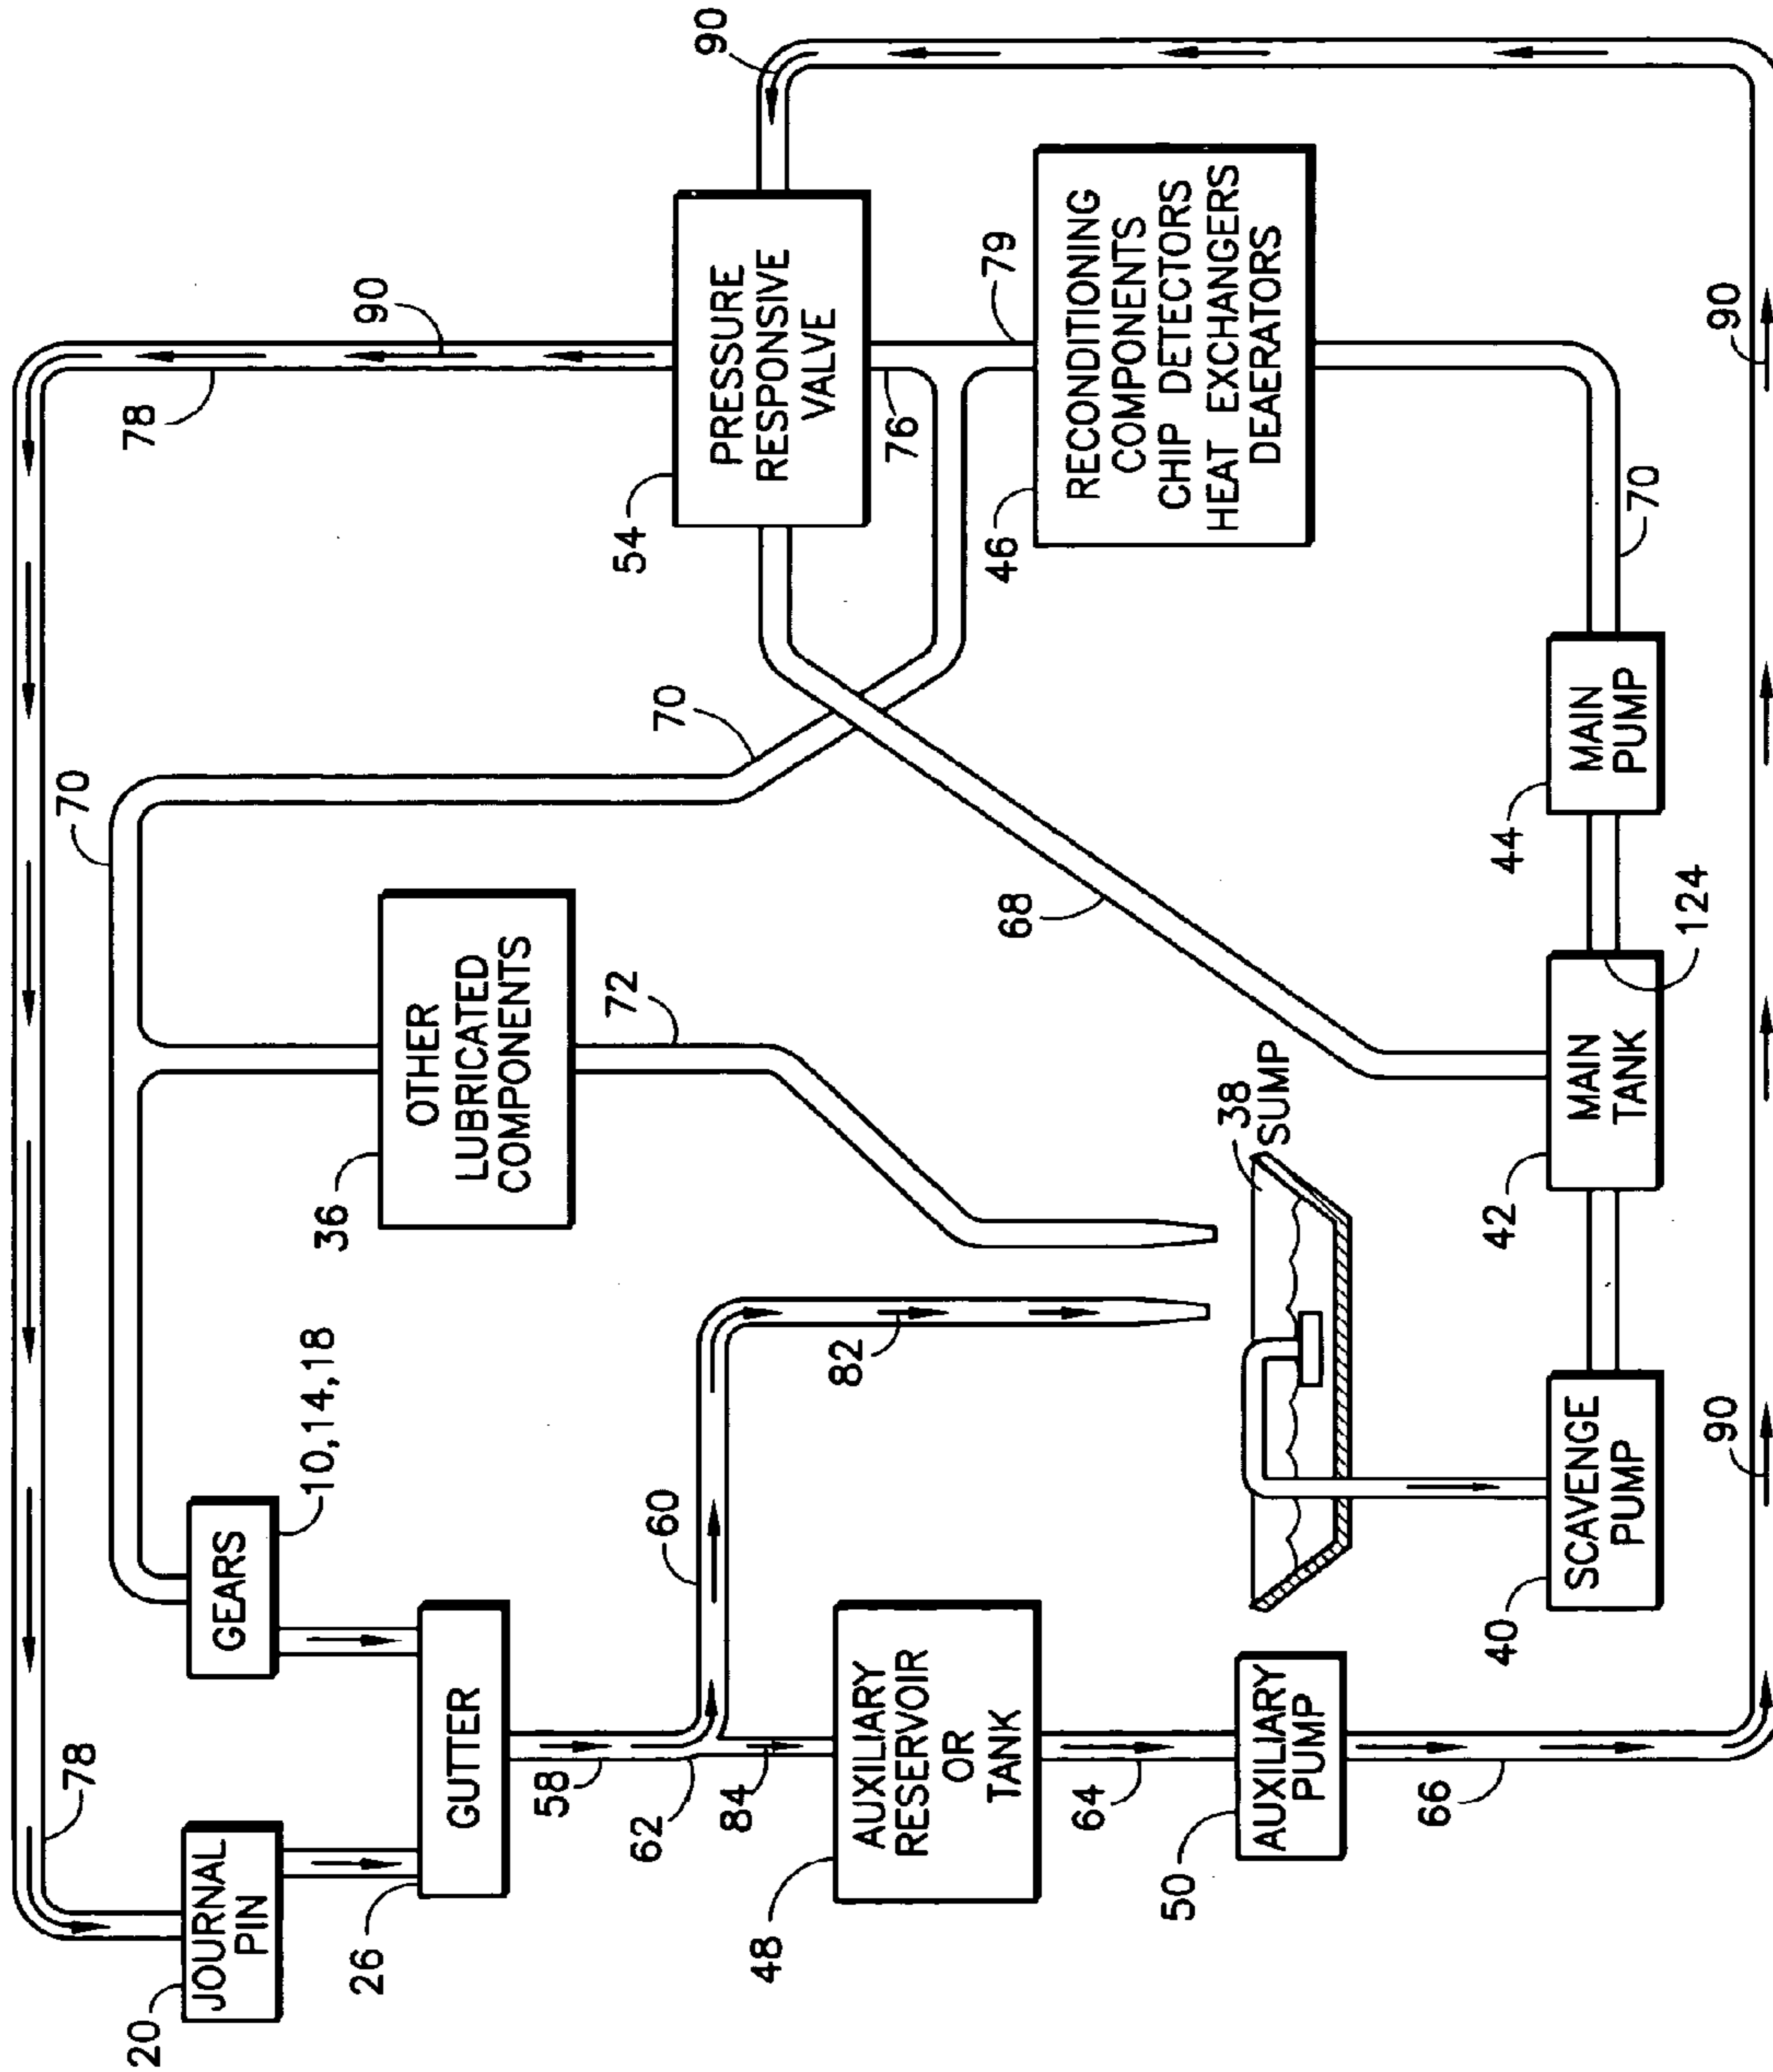
FIG. 4 is a schematic diagram showing a lubrication system in a normal state of operation, i.e. with the lubricant pressure at a normal level.

FIG. 4 schematically shows the relevant components of the above described gear train (gears 10, 14, 18, journal pin 20 and gutter 26), other engine components 36 requiring lubri-

cation, and a lubrication system suitable for use with the gear train. The lubrication system includes a main system whose components include a sump **38**, a scavenge pump **40** for scavenging lubricant from the sump, a main tank **42** for receiving lubricant from the scavenge pump, a main pump **44** for pumping lubricant from the main tank, and various lubricant reconditioning components such as chip detectors, heat exchangers and deaerators, collectively designated **46**. The lubrication system also includes an auxiliary system whose components include an auxiliary lubricant tank or reservoir **48** and an auxiliary pump **50**. The lubrication system also includes a pressure responsive valve **54**.

An auxiliary tank supply conduit **58** extends from the gutter **26** to the auxiliary tank **48**. The gutter serves as a source of lubricant for the tank. A main bypass line **60** branches from the supply conduit at a junction **62** and extends to the sump **38**. An auxiliary tank discharge conduit **64** extends from the auxiliary tank to the auxiliary pump. An auxiliary pump discharge line **66** extends from the auxiliary pump to the pressure responsive valve. A main tank return line **68** extends from the valve **54** to the main lubricant tank **42**. A lubricant delivery pathway **70** extends from the main pump **44** through the various lubricant reconditioning components **36** and ultimately to the gears **10**, **14**, **18** and other components **46**. A lubricant return pathway **72** extends from the components to the sump **38**. A portion **76** of the delivery pathway **70** leads to the pressure responsive valve **54**. A journal pin delivery line **78** extends from the valve to the journal pins **20**.

During normal operation, rotation of the gears expels lubricant radially outwardly, and with a high tangential velocity, into the lubricant recovery gutter **26**. The supply conduit **58**, which branches substantially tangentially off the gutter as seen in FIGS. **7** and **8**, captures the expelled lubricant. A large portion **82** of the lubricant flows through the main bypass line **60** and returns to the sump **38**. A smaller portion **84** of the lubricant flows into the auxiliary tank **48** to establish or replenish a reserve quantity of lubricant therein. The auxiliary pump **50** pumps lubricant from the tank to the pressure responsive valve **54**. Concurrently, the scavenge pump **40** extracts lubricant from the sump **38** and delivers it to the main tank **42**. The main pump **44** pumps the lubricant from the tank to the reconditioning components **46**. Most of the reconditioned lubricant **86** then flows to the gears **10**, **14**, **18** and other components **36**. The remainder **88** of the lubricant flows to the pressure responsive valve. The valve, responding to normal pressure in the lubrication system, directs this remaining lubricant **88** to the journal pins and directs reserve lubricant **90** (received from the auxiliary pump) to the main tank **42**.

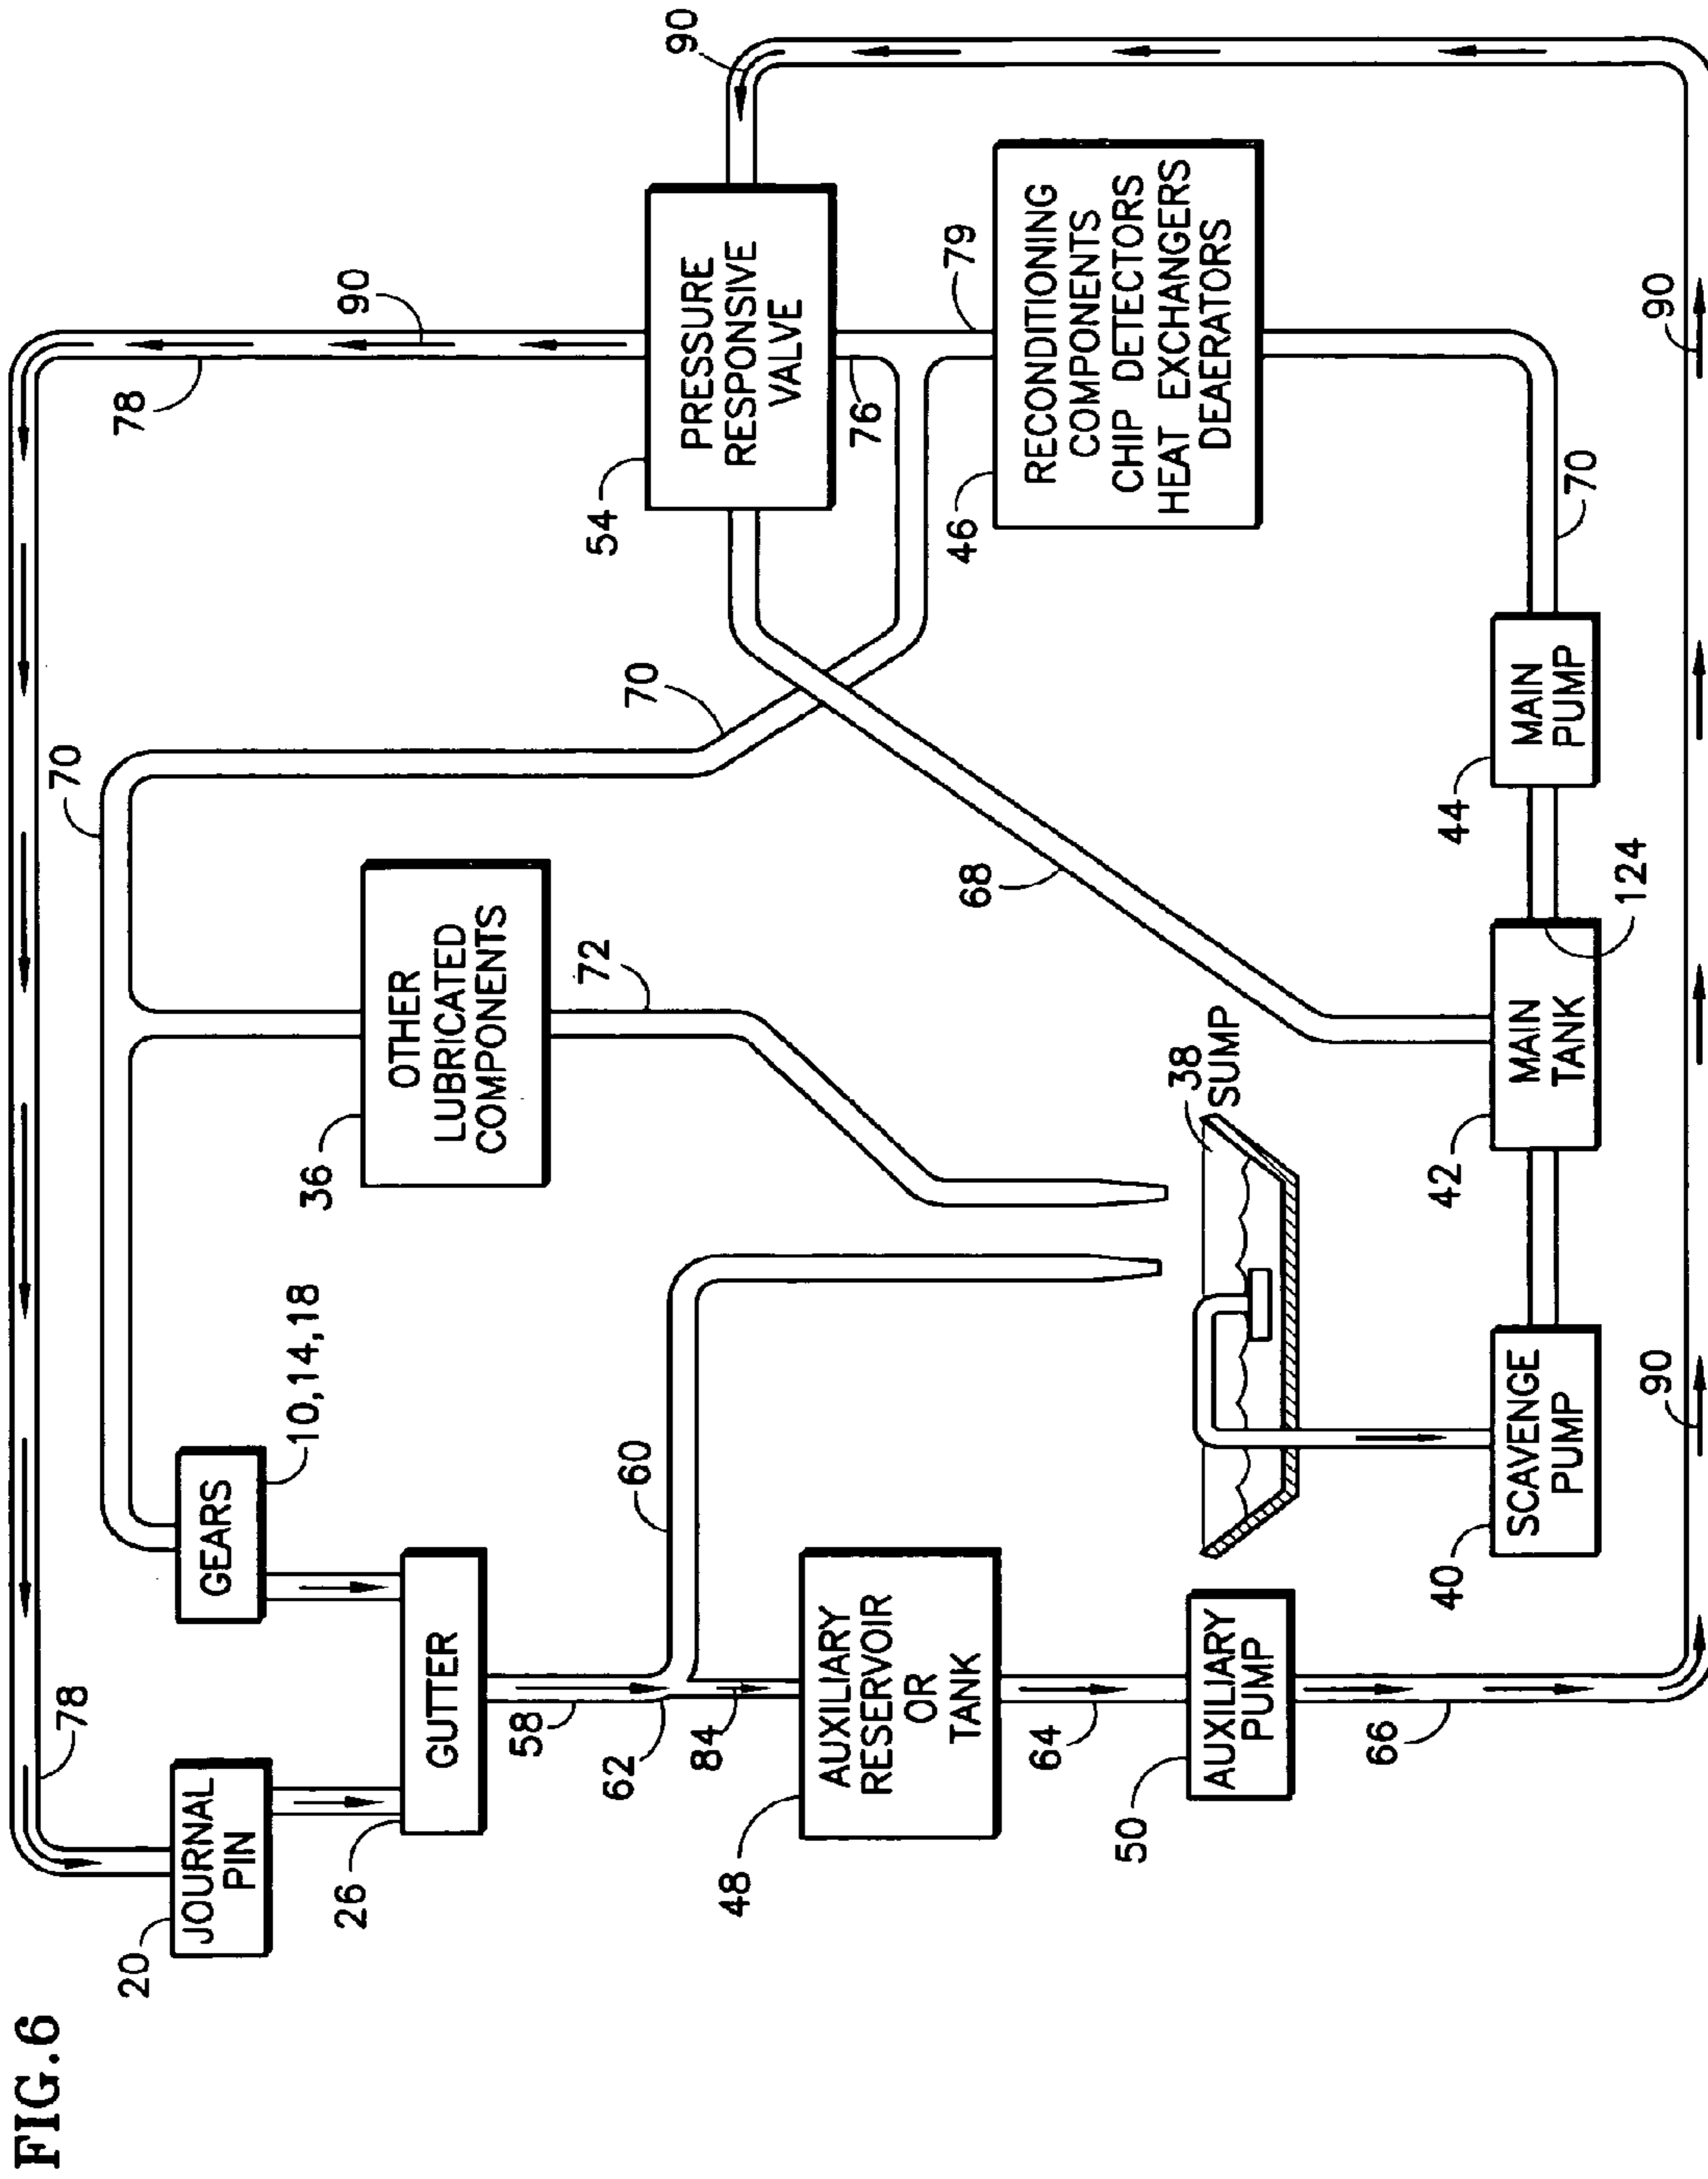
FIG. 5 is a schematic diagram showing the lubrication system of FIG. 4 shortly after the onset of an abnormal state of operation, i.e. with the lubricant pressure lower than a normal level.

Referring now to FIG. **5**, immediately after the onset of abnormal operation (e.g. due to a severe leak, clog or malfunction of a system component) the lubricant pressure drops such that an unsatisfactorily reduced quantity of lubricant flows through the lubricant delivery pathway **70**. In response to the abnormally low pressure, the pressure responsive valve **54** shunts the reserve lubricant **90** received from the auxiliary pump to the journal pins **20** to ensure that the pins receive lubricant, at least temporarily. The gear system at first continues to expel a large quantity of lubricant into the gutter. As with normal operation, a large portion **82** of the lubricant flows through the main bypass line **60** and returns to the sump **38**. A smaller portion **84** of the lubricant flows to the auxiliary tank to at least partially replenish the lubricant being withdrawn by the auxiliary pump.
