US008517148B2

(10) **Patent No.:** **US 8,517,148 B2**
(45) **Date of Patent:** ***Aug. 27, 2013**

(54) **LUBRICATION SYSTEM WITH TOLERANCE FOR REDUCED GRAVITY**

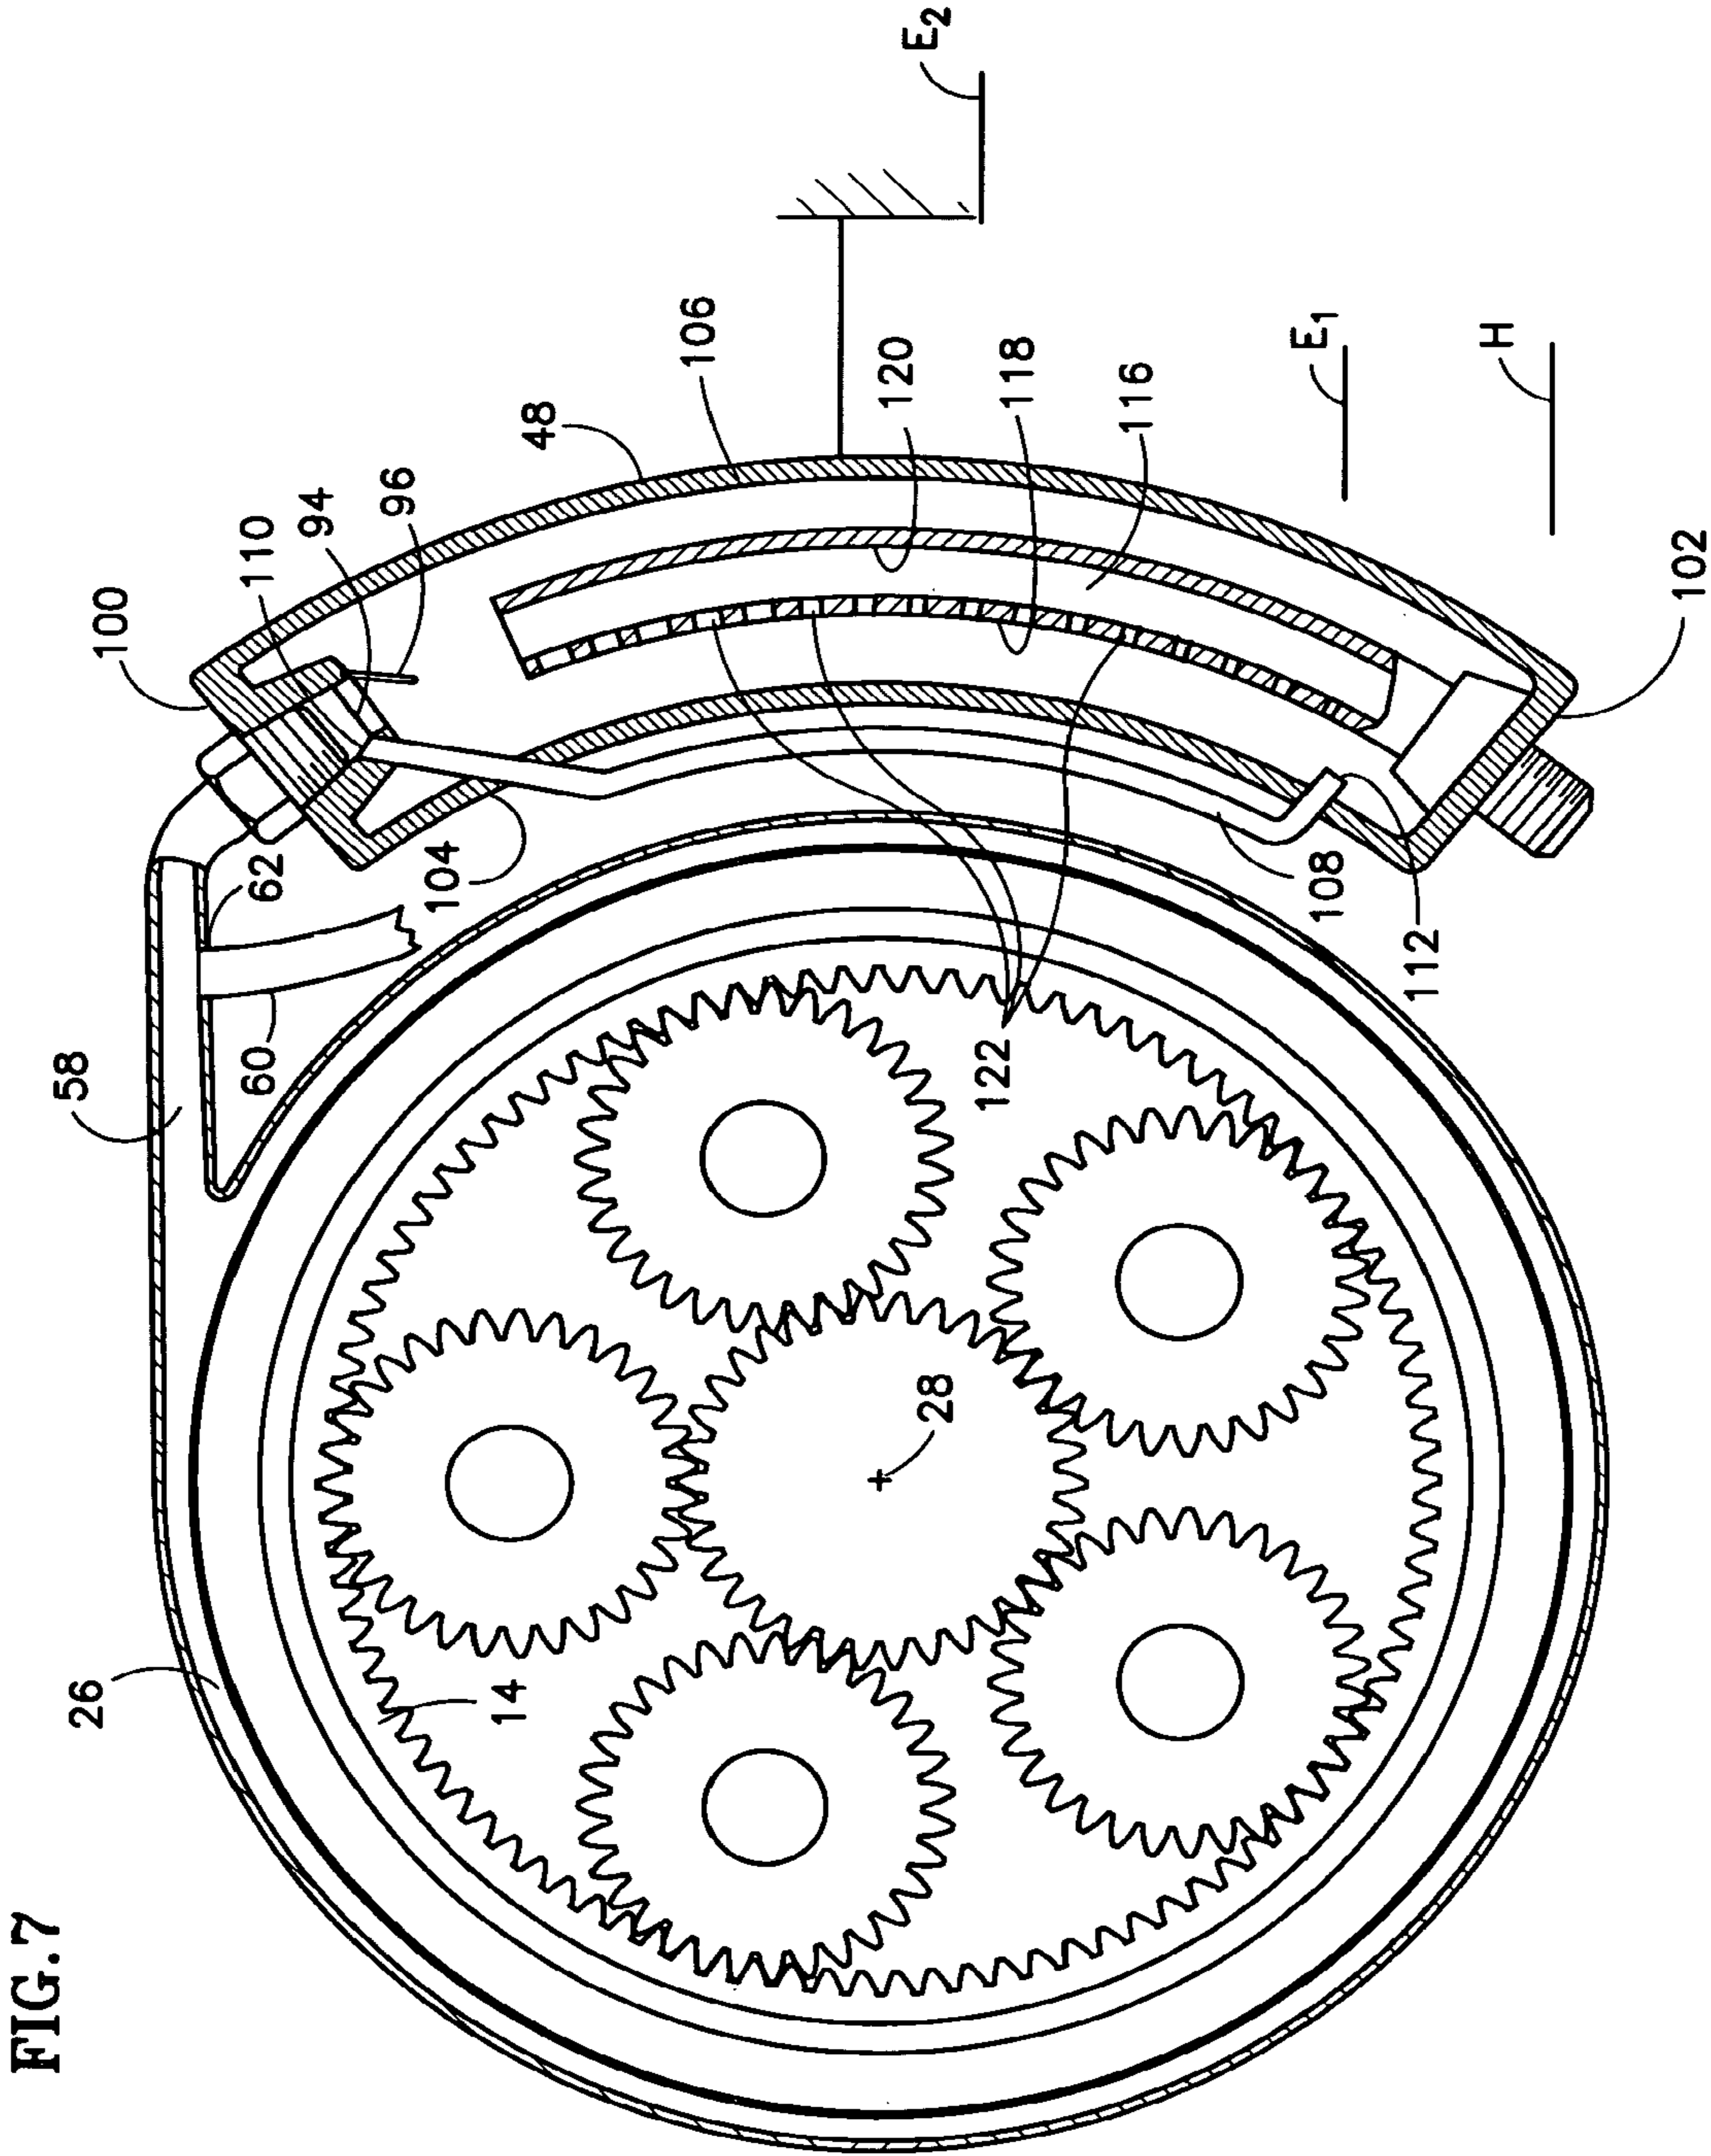
FIG. 6 is a schematic diagram similar to FIG. 5 showing the lubrication system at a later time.

If the abnormally low lubricant pressure persists, the system reaches the state shown in FIG. **6**. The quantity of lubricant circulating through the system is small enough that little or no lubricant backs up from the auxiliary tank and enters the main bypass line **60**. Instead, nearly all of the limited quantity of lubricant flows to the auxiliary pump **50** and eventually back to the journal pins **20**. This state of operation persists until the tank **48** is depleted and the flow rate from the gutter **26** is insufficient to replenish it.

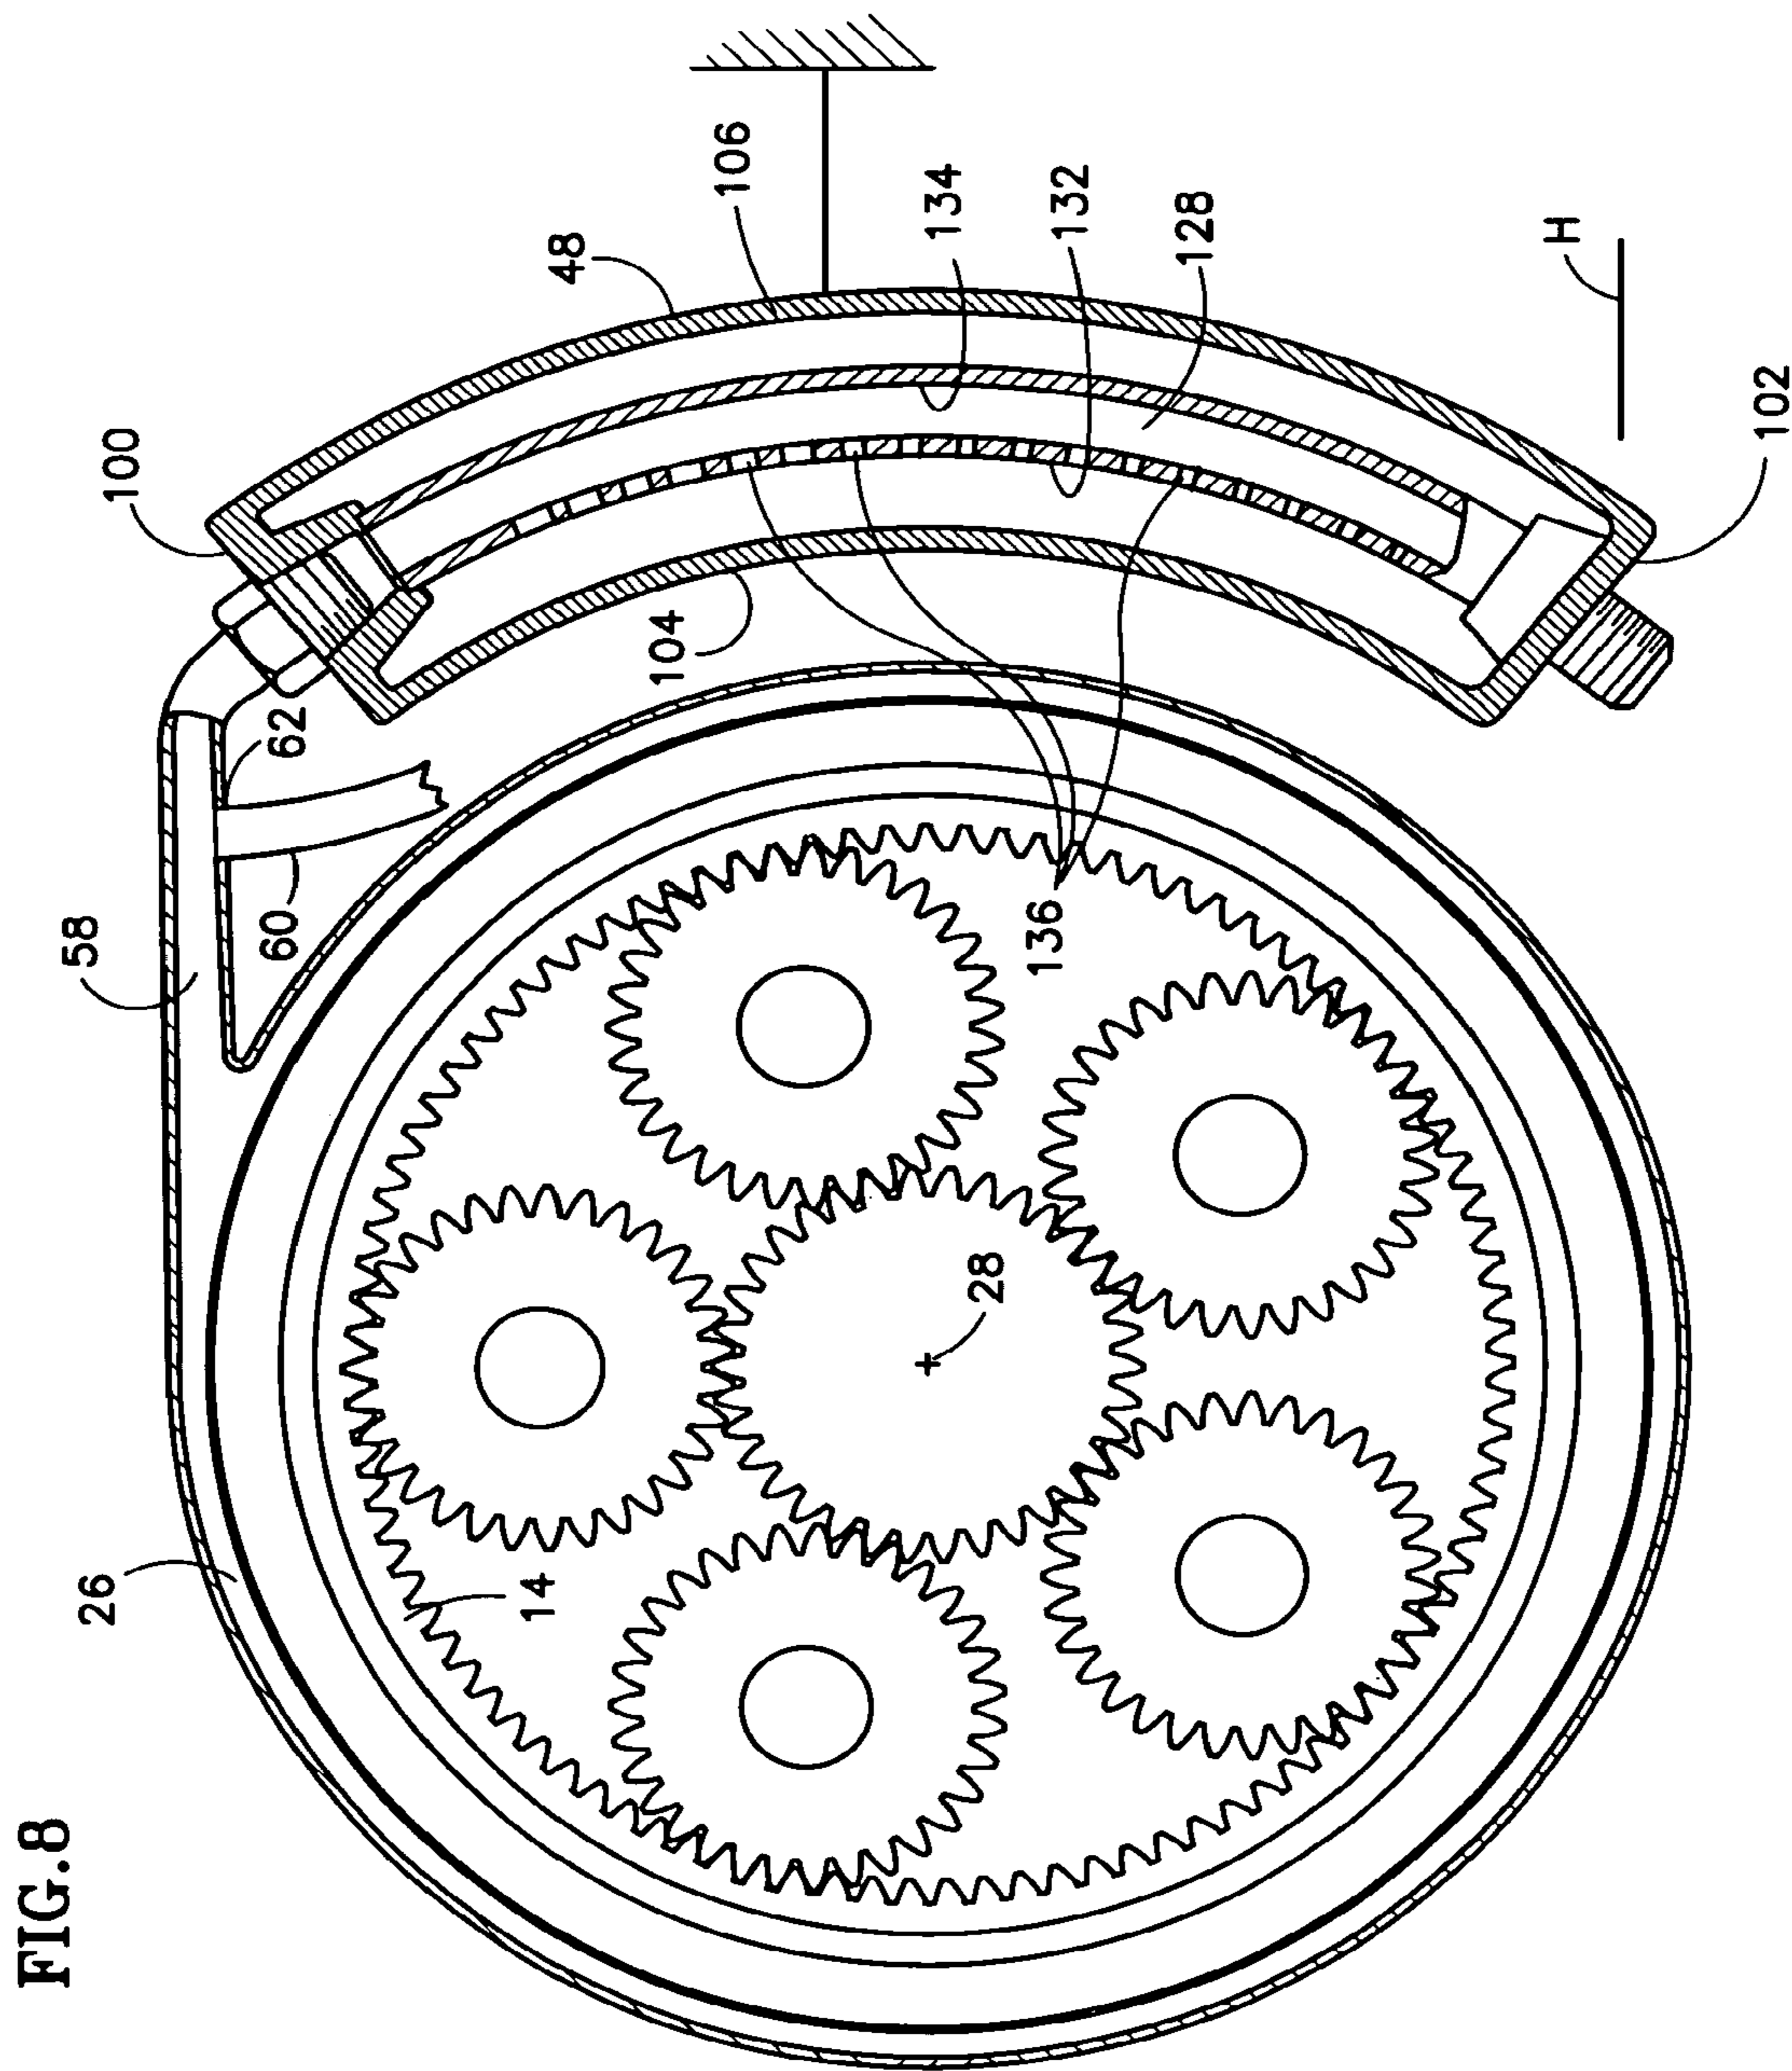
FIG. 7 is a schematic view showing an auxiliary lubricant tank with a bypass conduit and a discharge conduit for accommodating reduced-G operation.

FIG. **7** illustrates the ring gear **14**, gutter **26** and supply conduit **58**, which extends substantially tangentially from the gutter. The main bypass line **60** branches from the supply conduit at the junction **62** upstream of a conduit outlet **94**. An optional valve such as flapper valve **96** regulates lubricant flow from the outlet. The valve may be loaded, for example by a spring, to its closed position. The auxiliary tank **48** is mounted to a nonrotatable mechanical ground. The tank has a top **100**, a bottom **102** and an arcuate profile with radially inner and outer boundaries **104**, **106**. A reduced-G bypass line **108** branches from the conduit downstream of the junction **62** and upstream of the conduit outlet **94**. The bypass line has an inlet **110**, and an outlet **112** inside the auxiliary tank. The outlet **112** is at a first elevation, E_1 , preferably near the bottom of the tank.

The system also includes an auxiliary tank discharge conduit **116**. The discharge conduit **116** has an arcuate profile with radially inner and outer boundaries **118**, **120**. A portion of the conduit resides within the tank. The resident portion has an opening along the conduit inner boundary for allowing lubricant transfer between the tank and the conduit. The opening may take any convenient form. For example the opening may be a single opening such as a hole or a slot extending along the conduit. The illustrated opening is an array of perforations **122**. The perforations may all have the same area, however, as explained below, it may be desirable for the area of the individual perforations to decrease, or at least not increase, with decreasing elevation. The opening, whatever form it takes, is at least partially at a second elevation E_2

higher than the first elevation E_1 . For example, in the illustrated, perforated variant, at least some of the perforations are higher than E_1 .

As used herein, "elevation" refers to distance or height above a reference height H no higher than the bottom of the tank **48** when the system is in the orientation seen in FIG. 7, i.e. an orientation representative of the engine or aircraft being on level ground or in straight and level flight.

During normal positive-G operation (G approximately equal to 9.8 m/sec./sec.) with normal lubricant pressure, lubricant enters the auxiliary tank, principally by way of the outlet **94**, although some lubricant may enter the tank by flowing through the bypass line **108** and its outlet **112**. During normal positive-G operation with abnormally low lubricant pressure, the valve **96**, if present, may close so that lubricant still flowing through the conduit **58** enters the tank by way of the bypass line **108**. Either way, the lubricant exits the tank through the auxiliary tank discharge conduit **116** after first passing through the opening represented by perforations **122**.

During reduced-G operation, particularly zero-G or negative-G, the lubricant pressure may be low enough that a reduced quantity of lubricant (including no lubricant) flows through the supply conduit **58**. The low lubricant pressure may result from a malfunction in the lubrication system or it may occur because the reduced-G's have lifted lubricant away from the outlet **124** of the main tank (FIG. 4) in a system that is otherwise fully functional. The flapper valve **96**, if present, closes. Lubricant still circulating in the system is impelled through supply conduit **58** as a result of the tangential velocity imparted to the lubricant by the rotation of the gears. That lubricant enters the tank by way of the bypass line **108** and its outlet **112**. For negative-G operation, the lubricant will migrate toward the top of the tank. However because the array of perforations **122** is at least partially at an elevation E_2 higher than outlet elevation E_1 , the lubricant can enter the discharge conduit **116** by way of the perforations **122**. Because the lubricant migrates toward the top of the tank during negative-G operation, there will be a tendency for the auxiliary pump **50** to extract air from the bottom of the tank rather than lubricant from the top of the tank. This tendency can be partially counteracted if the perforations **122** are of decreasing area with decreasing elevation. The lubricant is encouraged to enter the discharge conduit partly because of the negative-G's and partly due to suction created by the auxiliary pump **50**. Because the conduit is arcuate, the lubricant will tend to accumulate along the radially outer boundary **120** of the conduit so that it can be extracted by the pump **50**. For zero-G operation, the system operates similarly except that the lubricant will tend to float and will not be able to enter the conduit as readily.
