(54) **METHOD FOR REFURBISHING PTAL COATING TO TURBINE HARDWARE REMOVED FROM SERVICE**

A method of repairing damaged airfoils. The method comprises the steps of stripping thermal barrier coatings from the airfoil. After the coatings are removed, cracks are removed from the airfoil. Cracks that appear in the bond coat area over the airfoil fillet portion are removed by locally grit blasting the fillet portion of the airfoil. This operation also results in locally removing the bond coating from the fillet portion. Cracks and other damage sustained by the airfoil tip are removed and replaced by welding superalloy material. The airfoil then may be cleaned by thermal etching. The airfoil is then placed in a plating tool permitting preferential plating of airfoil areas from which plating has been removed. After plating, the airfoil is then heat treated to diffuse the platinum coating with the superalloy substrate materials. The diffusion heat treated airfoil is aluminided by any aluminiding process, forming a PtAl coating.

**METHOD FOR REFURBISHING PTAL
COATING TO TURBINE HARDWARE
REMOVED FROM SERVICE**

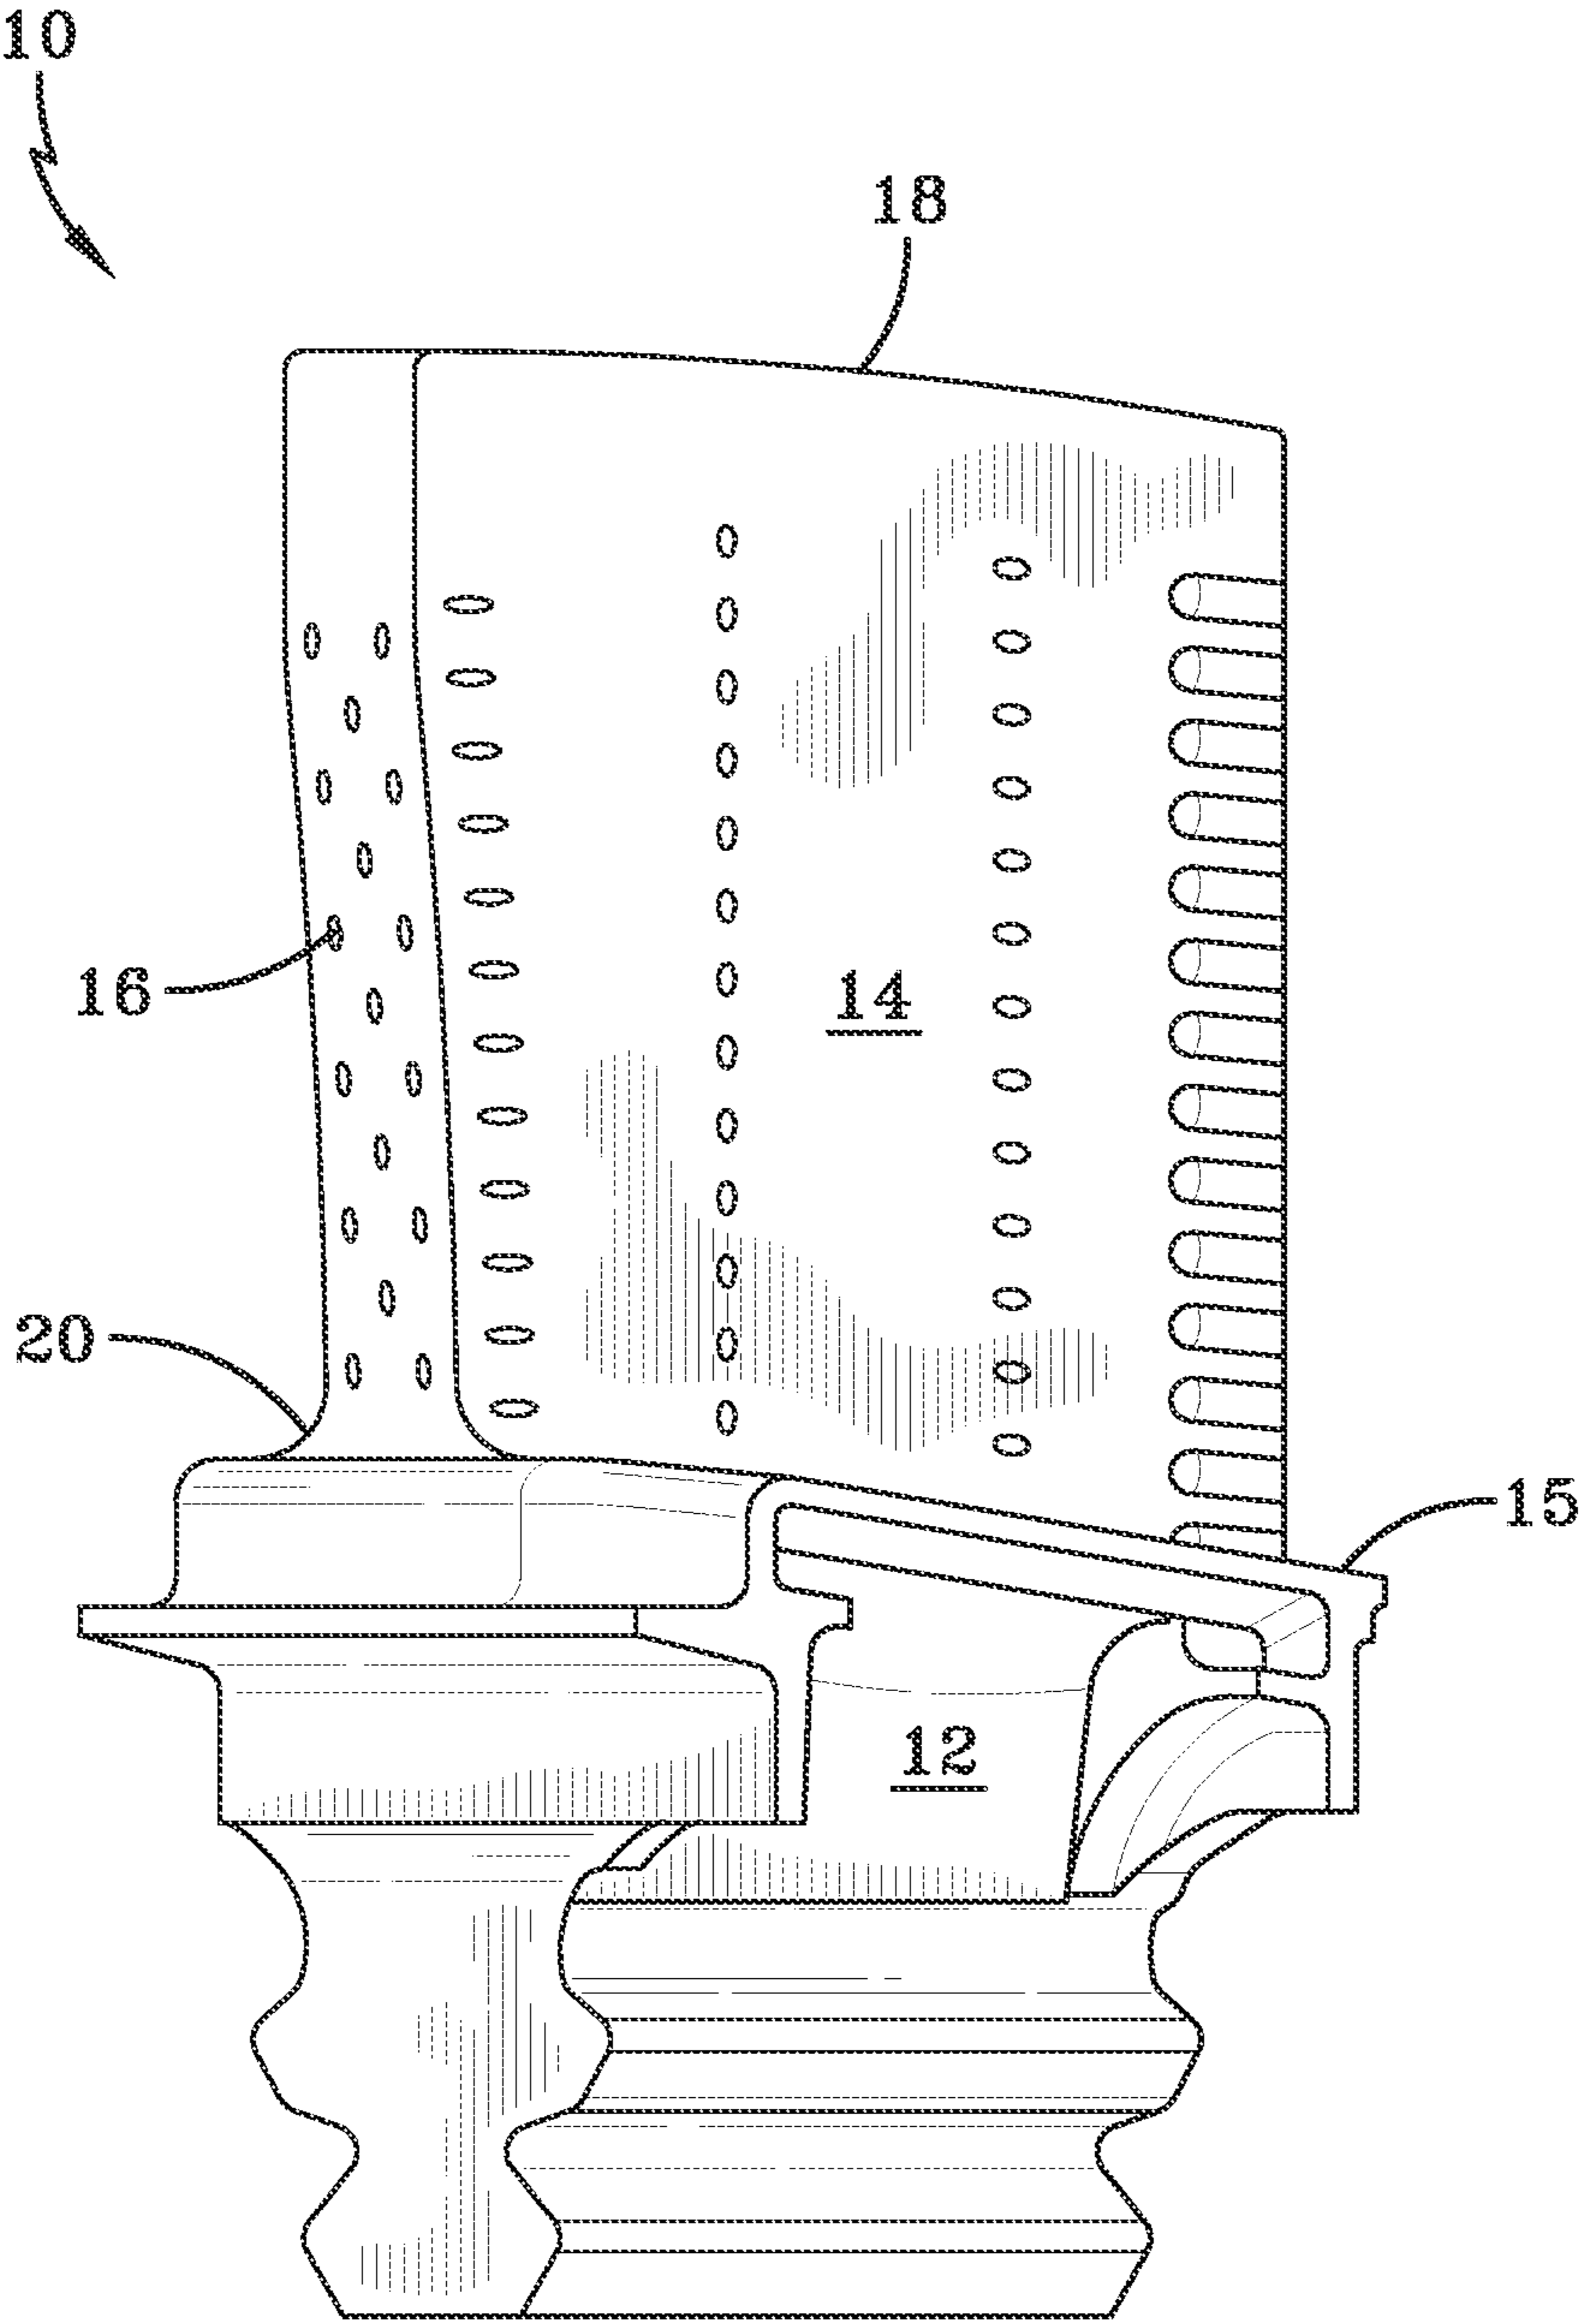
FIG-1

FIG. 1 depicts a high pressure turbine blade as an exemplary airfoil that may be removed from service for repair.

FIG. 1 depicts one type of airfoil, a high pressure turbine blade 10 that may be repaired by the current process. A typical high pressure turbine blade 10 includes a dovetail portion 12, an airfoil portion 14, a platform 15 separating airfoil portion 14 from dovetail portion 12, a tip portion 18 at an end of blade 10 opposite dovetail portion 12 and a fillet radius region 20 that provides a transition between platform 15 and airfoil portion 14. Also shown are cooling channels 16 that are fabricated into a high pressure turbine blade. Minimum wall thicknesses are established between the outer surface of the airfoil portion 14 and the cooling channels 16.

High pressure turbine airfoil 10 is coated with a bond coat, such as a PtAl coating that covers platform 15 on the airfoil portion side 14, fillet radius 20, airfoil portion 14 and tip portion 18. Dovetail portion 12 and the dovetail side of platform 15 usually is not coated with a coating. Overlying the bond coat in the tip portion 18 and at least an upper portion of the airfoil portion is a thermal barrier coating that improves the thermal performance of blade 10. Airfoils removed from service, such as high pressure turbine airfoil 10, typically sustain damage in tip portion 18 and in fillet radius 20. Tip portion damage may be from a number of mechanisms including FOD and wear from contact with mating shrouds, while damage in the fillet radius 20 may be cracks in the plating as the result of stresses resulting from rotation at elevated temperatures of operation.

Current methods of repair require removal of coatings from blade 10, removal of the damaged material in tip portion 18, replacement of the damaged material in tip portion 18, removal of cracks from fillet radius 20 and reapplication of coating(s). As discussed previously, removal of coatings is accomplished by a chemical removal process that may result in removal of too much material, resulting in thinning of blade 10 that causes walls that are too thin, so that the blade must be scrapped.

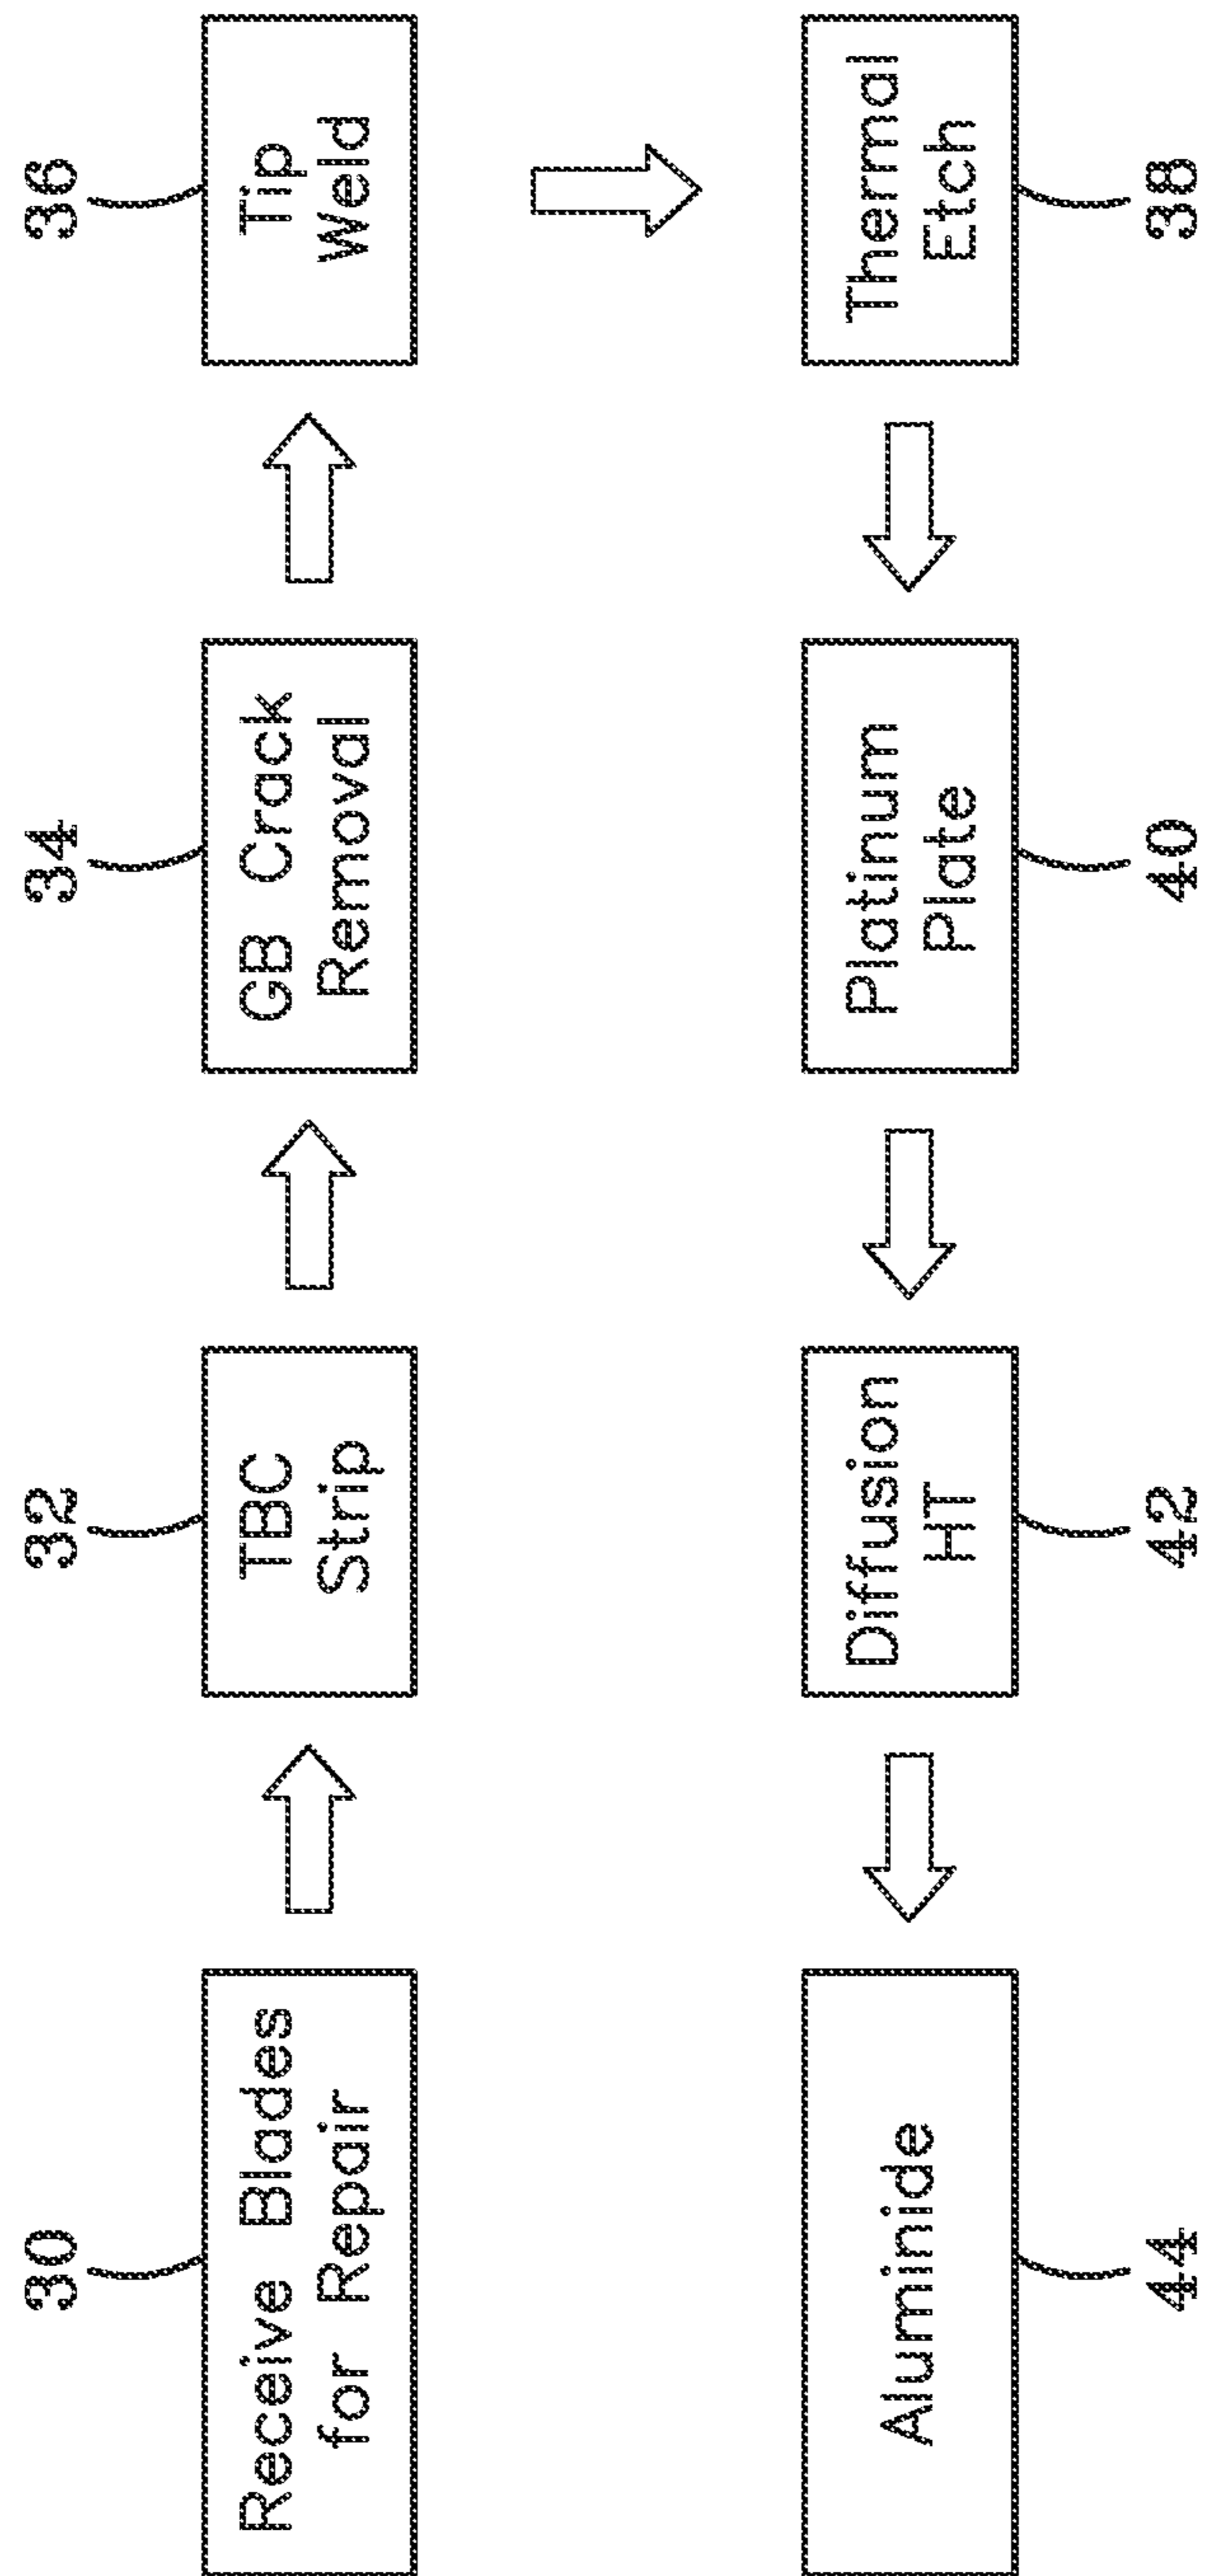
FIG-2

FIG. 2 is a flow chart of the repair process of the present invention.

Referring now to FIG. 2, which is a flow chart of the present method, the method comprises the steps of inspecting blades removed from service and receiving damaged blades for repair 30. Then, thermal barrier coatings are stripped from the airfoil 32 using conventional methods for removing TBCs. The airfoils are again inspected for damage. This inspection, which further identifies and characterizes damage, may be a visual inspection or a penetrant inspection, which is well suited to identify tight cracks, or both. Cracks are then removed from the airfoil by grit blasting 34. Cracks usually appear in the bond coat area over fillet radius 20 of the airfoil, as this region is exposed to very high stresses. The cracks are removed by locally grit blasting fillet radius 20 of the airfoil to remove cracks from fillet radius 20. This operation also usually results in locally removing the bond coating from

fillet radius 20. Cracks and other foreign-object induced damage may be sustained by tip portion 18. The damage in this area usually requires removal of tip portion 18. The airfoil tip portion is then provided with replacement superalloy material by welding or other metal replacement processes 36. If damage does not require removal and replacement of tip material and damage is restricted to cracks in tip portion 18, cracks may be removed by locally grit blasting tip portion 18. The airfoil may then be thermally etched 38. Platinum may then be plated 40 over the airfoil where the bond coat was locally removed by an electrolytic plating process. This plating includes plating the replacement airfoil tip portion 18 or exposed airfoil portion substrate as well as fillet radius 20. The localized plating is accomplished by minimally adding additional plating to airfoil portions that were not aggressively grit blasted, but more fully plating those portions that were aggressively grit blasted, or tip portions 18 that required removal and replacement of material. The airfoil is then diffusion heat treated 42 to diffuse the platinum coating with the superalloy substrate materials. The diffusion heat treated airfoil is then aluminided by any aluminiding process 44, although a standard vapor phase aluminiding process is preferred.

After the platinum is applied, the platinum-coated blade may be removed from the fixture and processed in accordance with the procedure set forth above and in FIG. 2.

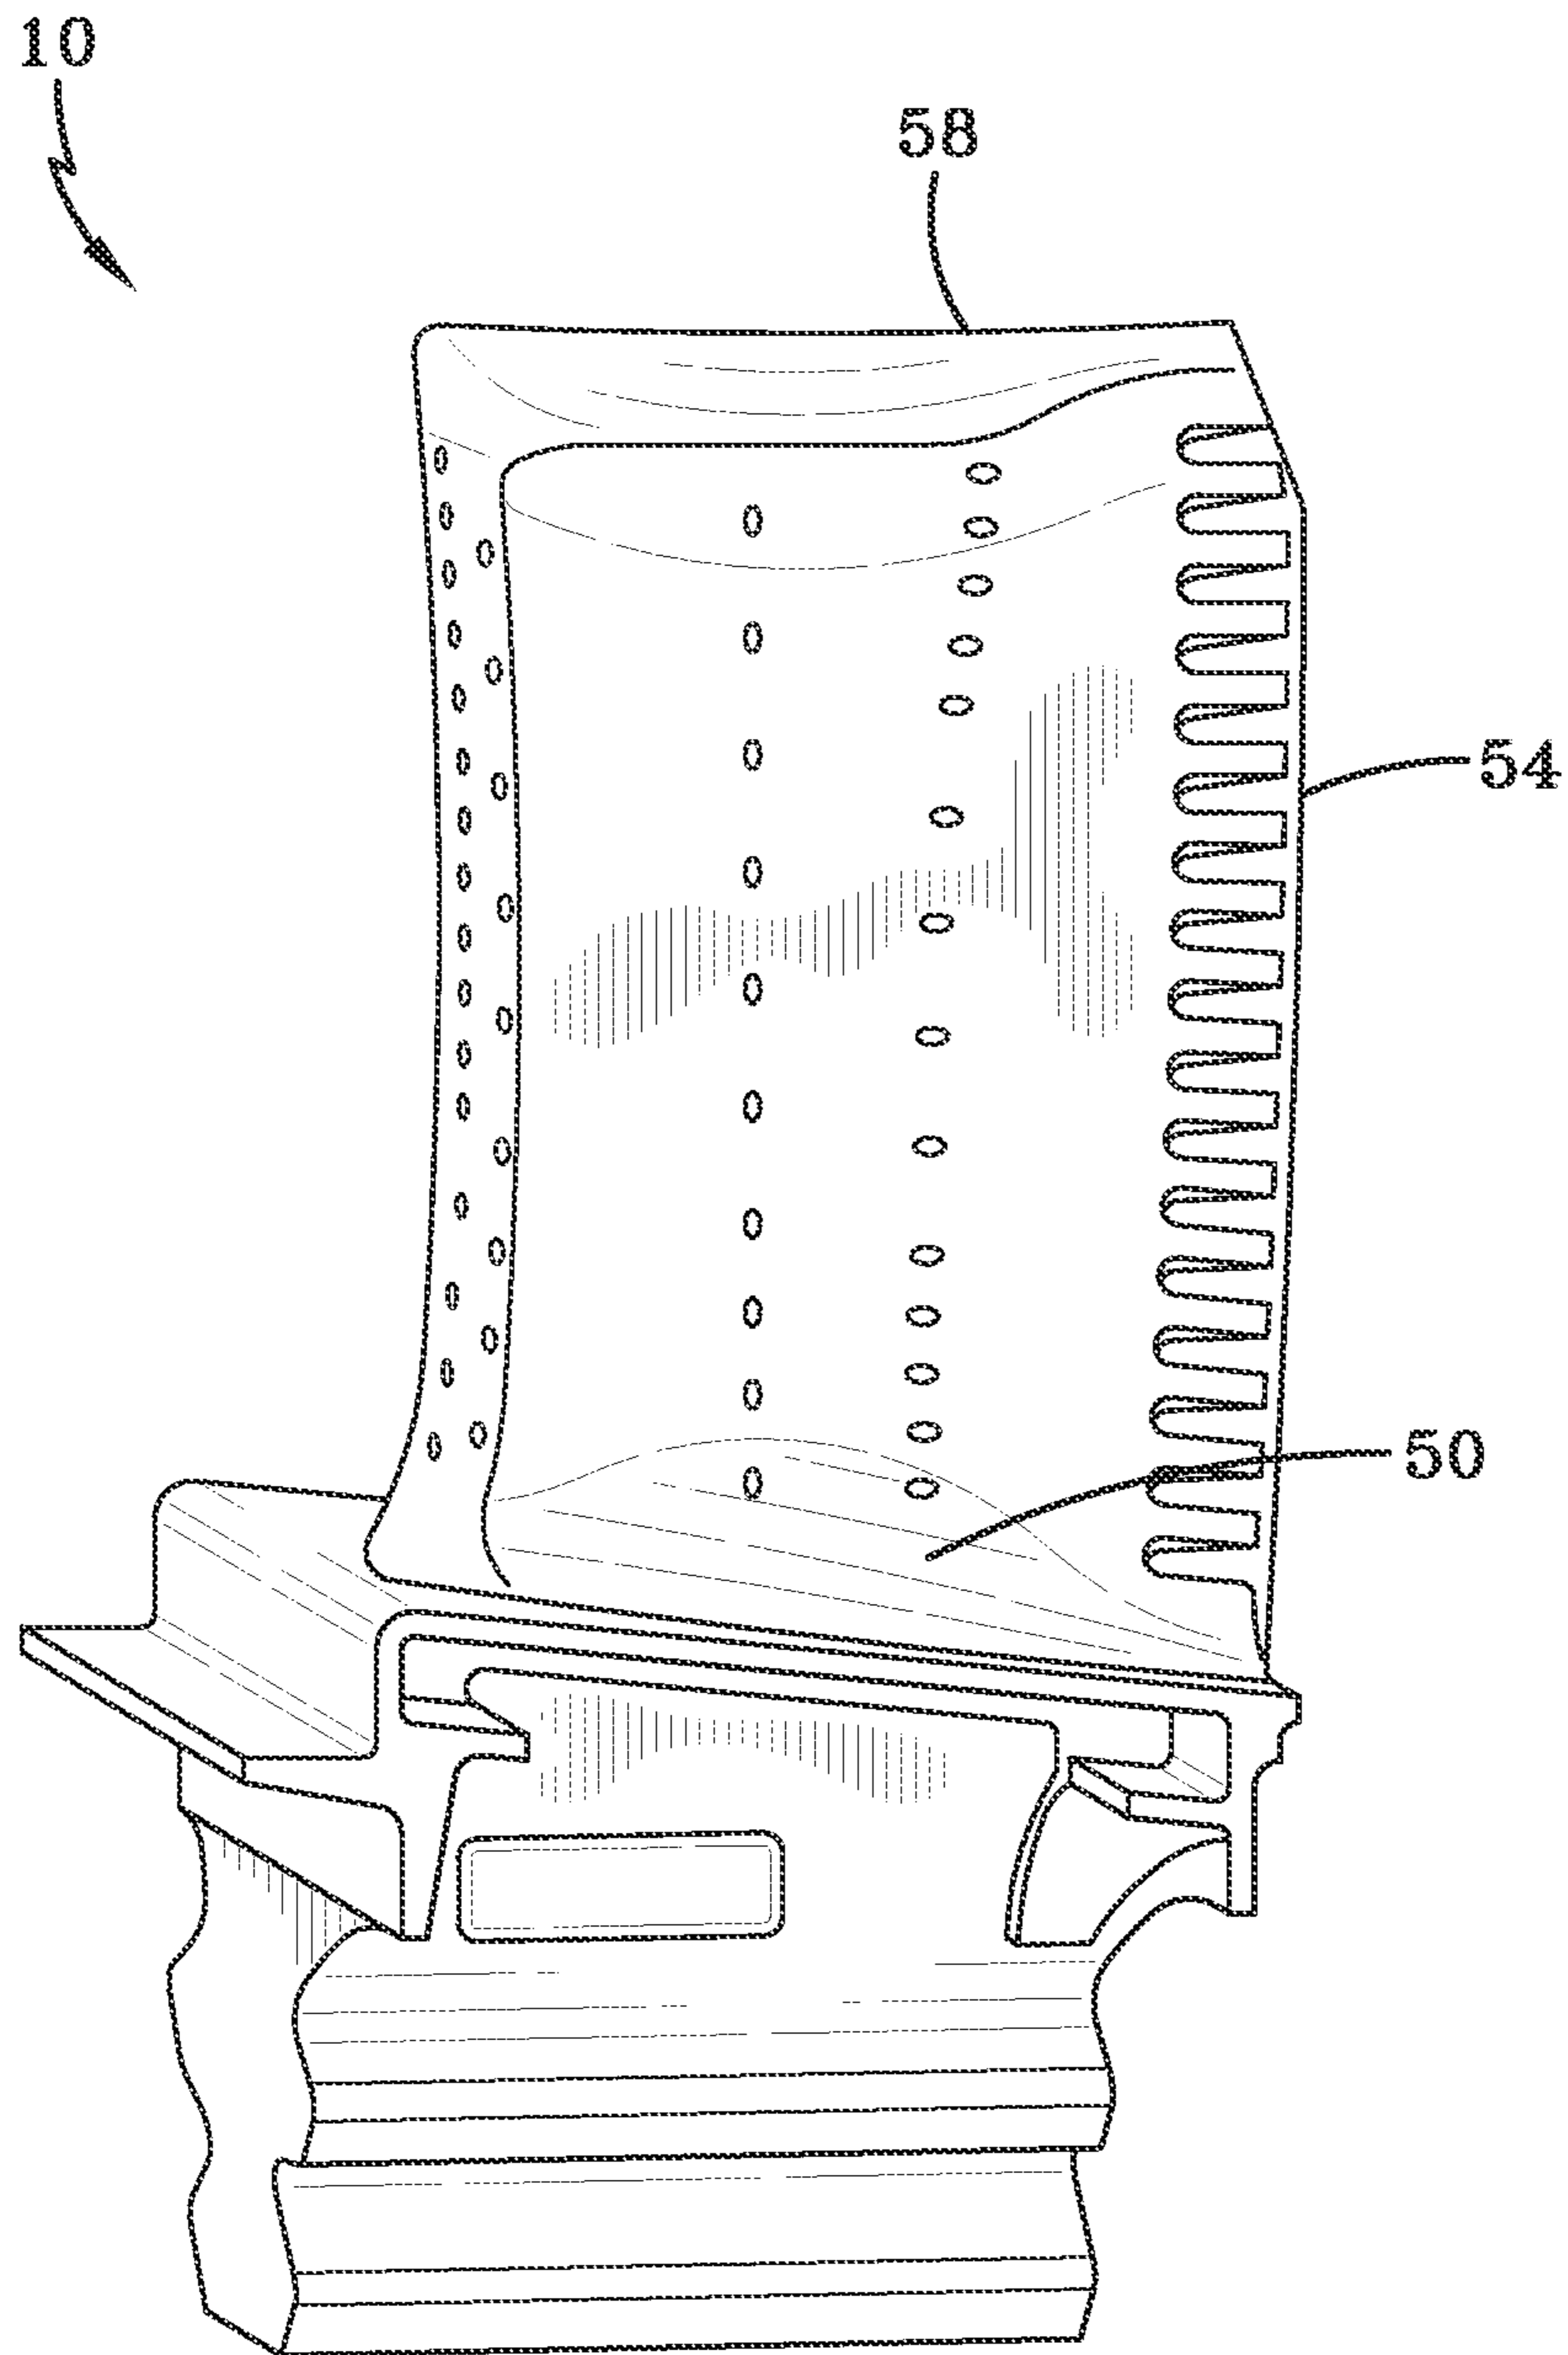
FIG-3

FIG. 3 depicts a high pressure turbine blade from which damaged regions have been removed.

FIG. 3 depicts a high pressure turbine blade 10 from which damaged regions have been removed in accordance with the present invention. TBCs were removed from blade 10 by standard removal methods. One standard method immerses the airfoil in an inorganic hydroxide bath having a high concentration of alkali or alkaline earth hydroxide at an elevated temperature for a time sufficient to effect detachment of the thermal barrier coating for removal from the substrate and bond coat. The airfoil then optionally can be immersed in a water bath to remove any remaining thermal barrier coating. This process affects thermal barrier coating removal without detectable damage to the substrate or any bond coat which may be present. The fillet radius 50 was then aggressively grit blasted to remove cracks that may have developed in this region during service. Grit blasting may be targeted to a specific region, here fillet radius 50. Grit blasting accomplishes the removal of any bond coats, such as PtAl, which may be present in fillet radius 50. After removal of bond coats, the exposed substrate material is inspected to assure that any defects, typically hairline cracks, are removed from fillet radius 50, although frequently the cracks have not yet propagated into the substrate material.

In FIG. 3, the blade tip, which usually is damaged as a result of normal operation in a turbine engine, is removed by a machining operation. The blade tip is then restored by a tip weld repair and contour machining, as is well known in the art. As will be apparent to one skilled in the art, initial inspection of the tip may disclose insufficient damage to require tip portion 58 removal and superalloy replacement. However for about 80% or more of blades removed from service, tip removal and tip replacement by weld repair is required without the necessity for grit blasting of the tip.

While grit blasting of fillet radius 50 may be focused to remove bond coating, the grit blasting currently cannot be focused so as not to affect the bond coat in adjacent airfoil portion 54. So, airfoil portion 54 depicted in FIG. 3 may be hard-masked with a masking material that will protect adjacent airfoil portion 54 from the aggressive grit blasting prior to accomplishing the grit blasting. Without the protection afforded by the hard masking, grit blasting may be sufficiently intense to undesirably remove all plating in airfoil portion 54 as well as expose superalloy material producing wall thinning that can result in scrapping of the airfoil. So prior to the aggressive grit blasting, airfoils surfaces, and in

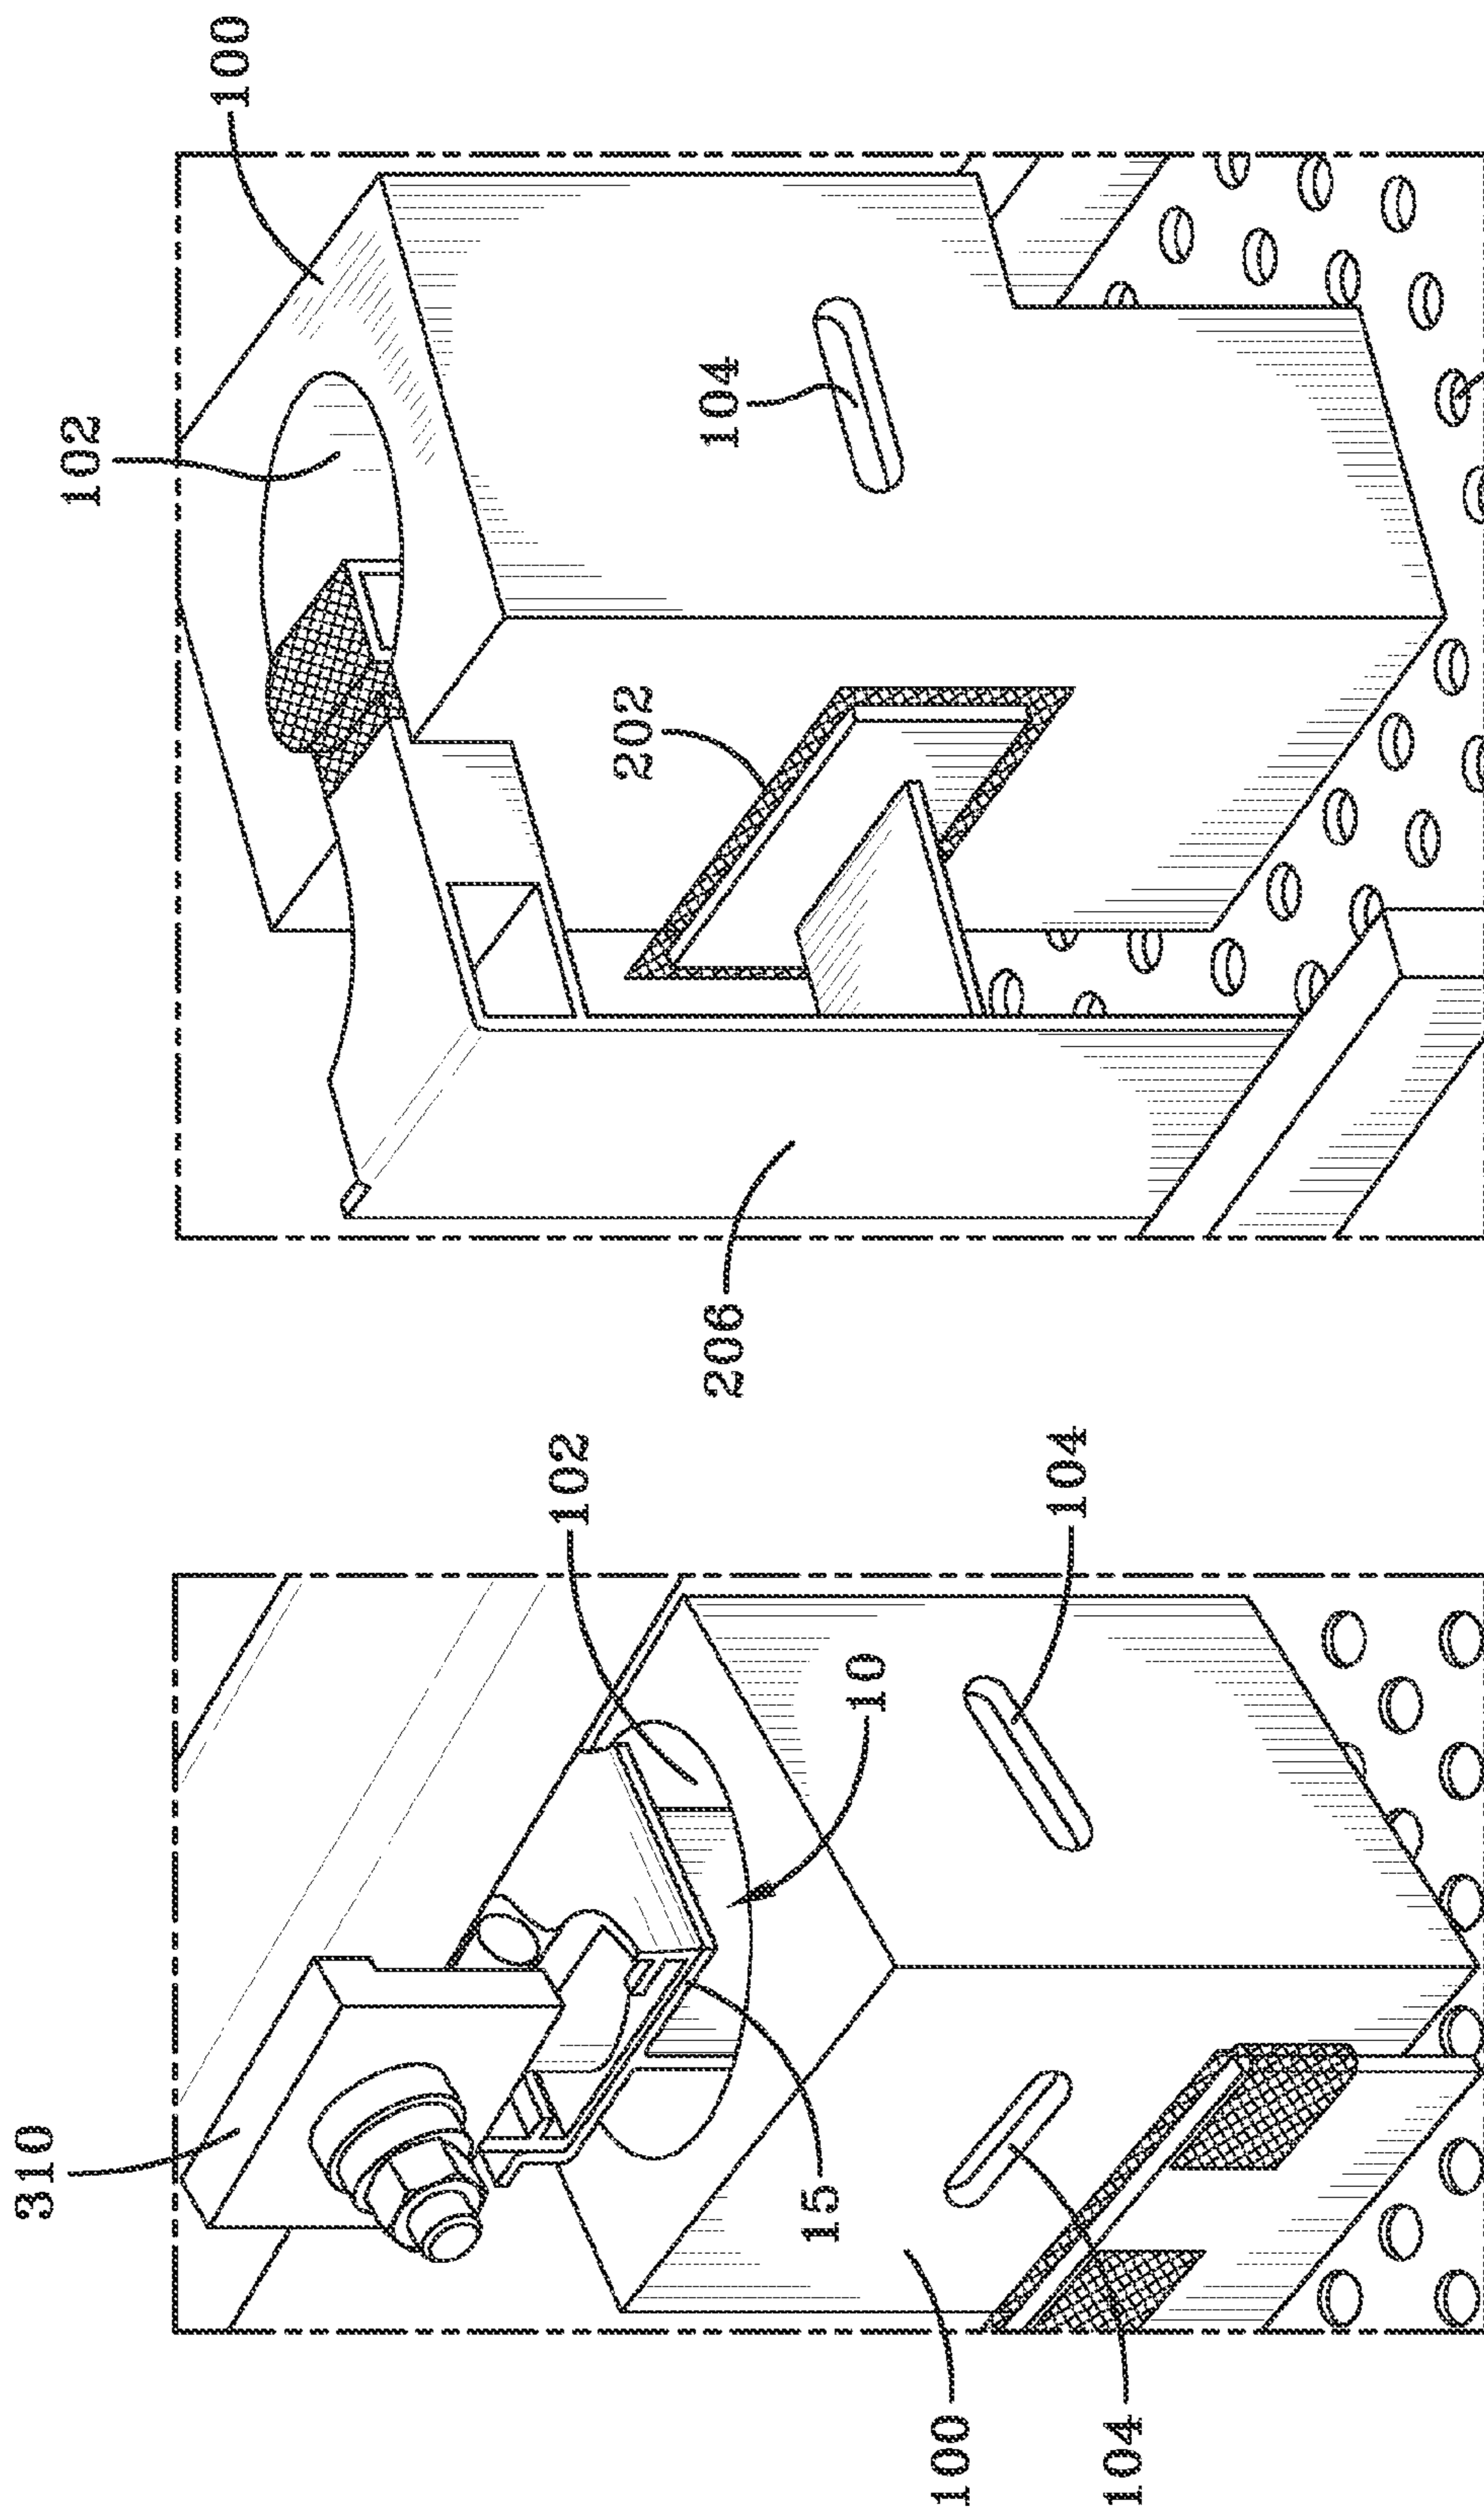
FIG-4

FIG. 4 depicts a plating tool having a high pressure turbine blade inserted therein.

FIG. **4** depicts a high pressure turbine blade **10** inserted into a plating tool **100**. In its broadest manifestation, a plating tool comprises a non-conductive fixture **101**, FIG. **6**. The fixture has a first end, an opposed second end and a periphery extending 360° between the first end and the second end. The first end includes a cavity extending into an interior of the fixture. There is at least one opening or slot **104** in the periphery of the fixture providing fluid communication between the cavity and an exterior. This opening permits electrolytic fluid to circulate freely between the cavity and exterior so that electrolytic fluid on the interior does not become depleted during plating operations. At least one mesh screen is positioned adjacent a surface located within the interior of the cavity and forms part of the anode. As used herein, "anode" means the bottom half of the non-conductive fixture, including openings therein, as well as any mesh screens, that form a part of the platform circuit, which screens control current flow, and hence plating deposition, to the workpiece. The non-conductive fixture impedes current flow except through its openings, where current may flow unimpeded from the anode to the workpiece or cathode. The amount of plating deposited on the workpiece is governed by the current flow and the resulting current density. Preferably, the surface to be plated is located on a workpiece that is inserted into the interior of the cavity

Referring again to FIG. **4**, blade **10** is assembled to a first fixture **310** that maintains the blade in an inverted position with the tip portion **58** positioned downward and the dovetail portion facing upward and attached to fixture **310**. Plating tool **100** is fabricated of a soft, machinable plastic block. Kynar®, a polyvinylidene fluoride (PVDF) available from Arkema, Inc, King of Prussia, Pa. is a preferred plastic block. FIG. **5** depicts a view of plating tool **100** at an orientation 180° from the view of FIG. **4**, but without a high pressure turbine blade inserted therein. FIG. **6** depicts plating tool **100** rotated 90° counterclockwise of FIG. **4** and with no high pressure turbine blade inserted therein. As will become evident, plating tool **100** is design-specific for each type of airfoil and is engine specific. Thus a high pressure turbine blade will require a different plating tool than a low pressure turbine blade, and a high pressure turbine blade from an engine for a Boeing 747 aircraft, such as a GE-90, will require a different plating tool than a high pressure turbine blade from an engine for a Boeing 737 aircraft.

FIG. **6** clearly shows a cavity **102** substantially centered in plating tool **100**. Cavity **102** is also visible in FIGS. **4** and **5**. Also visible in FIG. **6** is a fillet radius plating mesh screen **200**. Fillet radius plating mesh screen **200** has a convex shape formed to carefully mirror the concave shape of fillet radius **50** when high pressure turbine blade **50** is assembled into cavity **102** as depicted in FIG. **4**. FIGS. **4**, **5**, and **6** show plating tool assembled onto a perforated table **300**, which table may be movable so that plating solution can be brought up to the position of blade platform **15** when assembled as shown in FIG. **4**, by lowering the table into the plating solution.

As is most clearly evident in FIG. **7**, which is side view of plating tool **100** of FIG. **4**, a circulation slot **104** is formed in the side of plating tool **100**. A circulation slot **104** exists on each face of plating tool **100**, as also shown in FIGS. **4**, **5** and **6**. Once plating tool **100** is immersed into a plating solution, circulation slots **104** provide access into the cavity **102** so that plating solution can circulate from the exterior of plating tool **100** into cavity **102**, and around the airfoil, which prevents the plating solution within cavity **102** from becoming depleted adjacent to blade tip portion **18**, which blade tip is positioned within cavity **102** adjacent to circulation slot **104**.

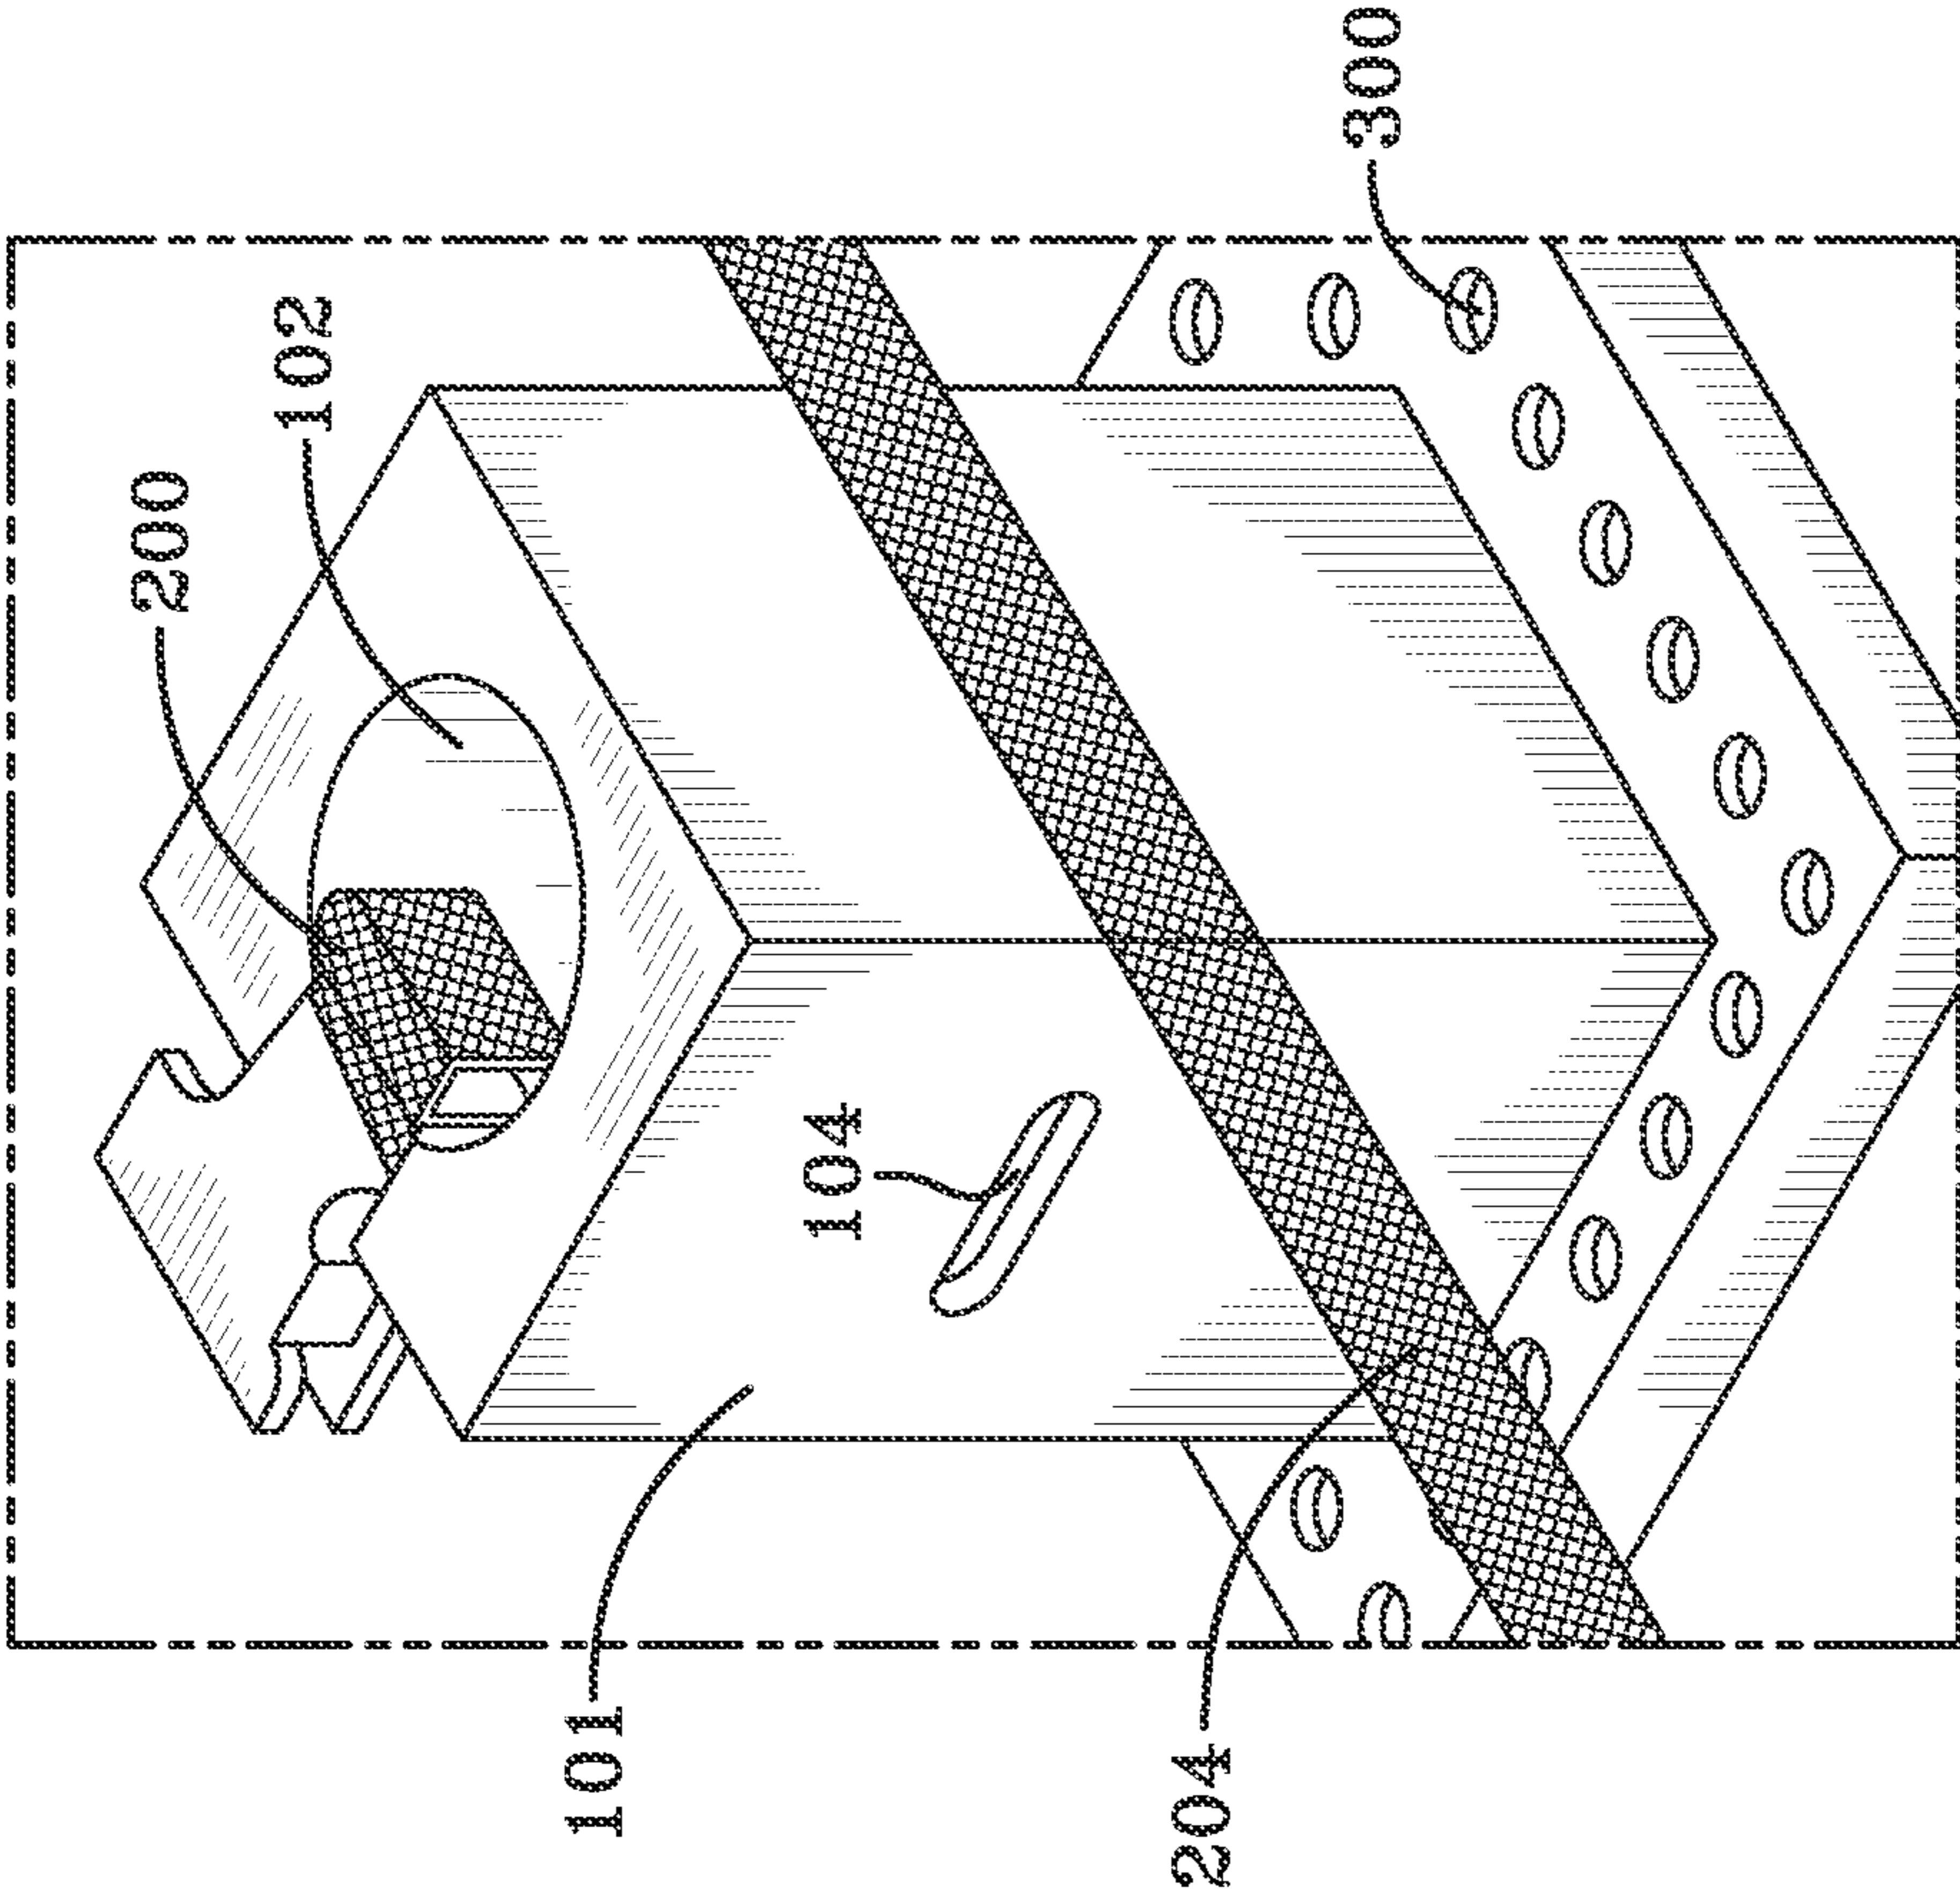
FIG-5

FIG. 5 is a view of the plating tool of FIG. 4 viewed 180° from FIG. 4, but with no blade inserted therein.

FIG. 5 and FIG. 6 depict mesh screen 202 and 204 respectively. As depicted in FIG. 5, mesh screen 202 adjacent tip portion is held in place by second fixture 206, which fixture also provides an electrical connection to fillet radius plating mesh screen 200. FIG. 6 also shows mesh screen 204. Since a plurality of plating tools may be assembled to perforated table 300 simultaneously, mesh screen 204 may extend across the plurality of plating tools 100 and adjacent to a plurality of circulation slots 104 so that a plurality of airfoils may be plated simultaneously.
