(54) **METHOD FOR REFURBISHING PTAL COATING TO TURBINE HARDWARE REMOVED FROM SERVICE**

A method of repairing damaged airfoils. The method comprises the steps of stripping thermal barrier coatings from the airfoil. After the coatings are removed, cracks are removed from the airfoil. Cracks that appear in the bond coat area over the airfoil fillet portion are removed by locally grit blasting the fillet portion of the airfoil. This operation also results in locally removing the bond coating from the fillet portion. Cracks and other damage sustained by the airfoil tip are removed and replaced by welding superalloy material. The airfoil then may be cleaned by thermal etching. The airfoil is then placed in a plating tool permitting preferential plating of airfoil areas from which plating has been removed. After plating, the airfoil is then heat treated to diffuse the platinum coating with the superalloy substrate materials. The diffusion heat treated airfoil is aluminided by any aluminiding process, forming a PtAl coating.

**METHOD FOR REFURBISHING PTAL
COATING TO TURBINE HARDWARE
REMOVED FROM SERVICE**

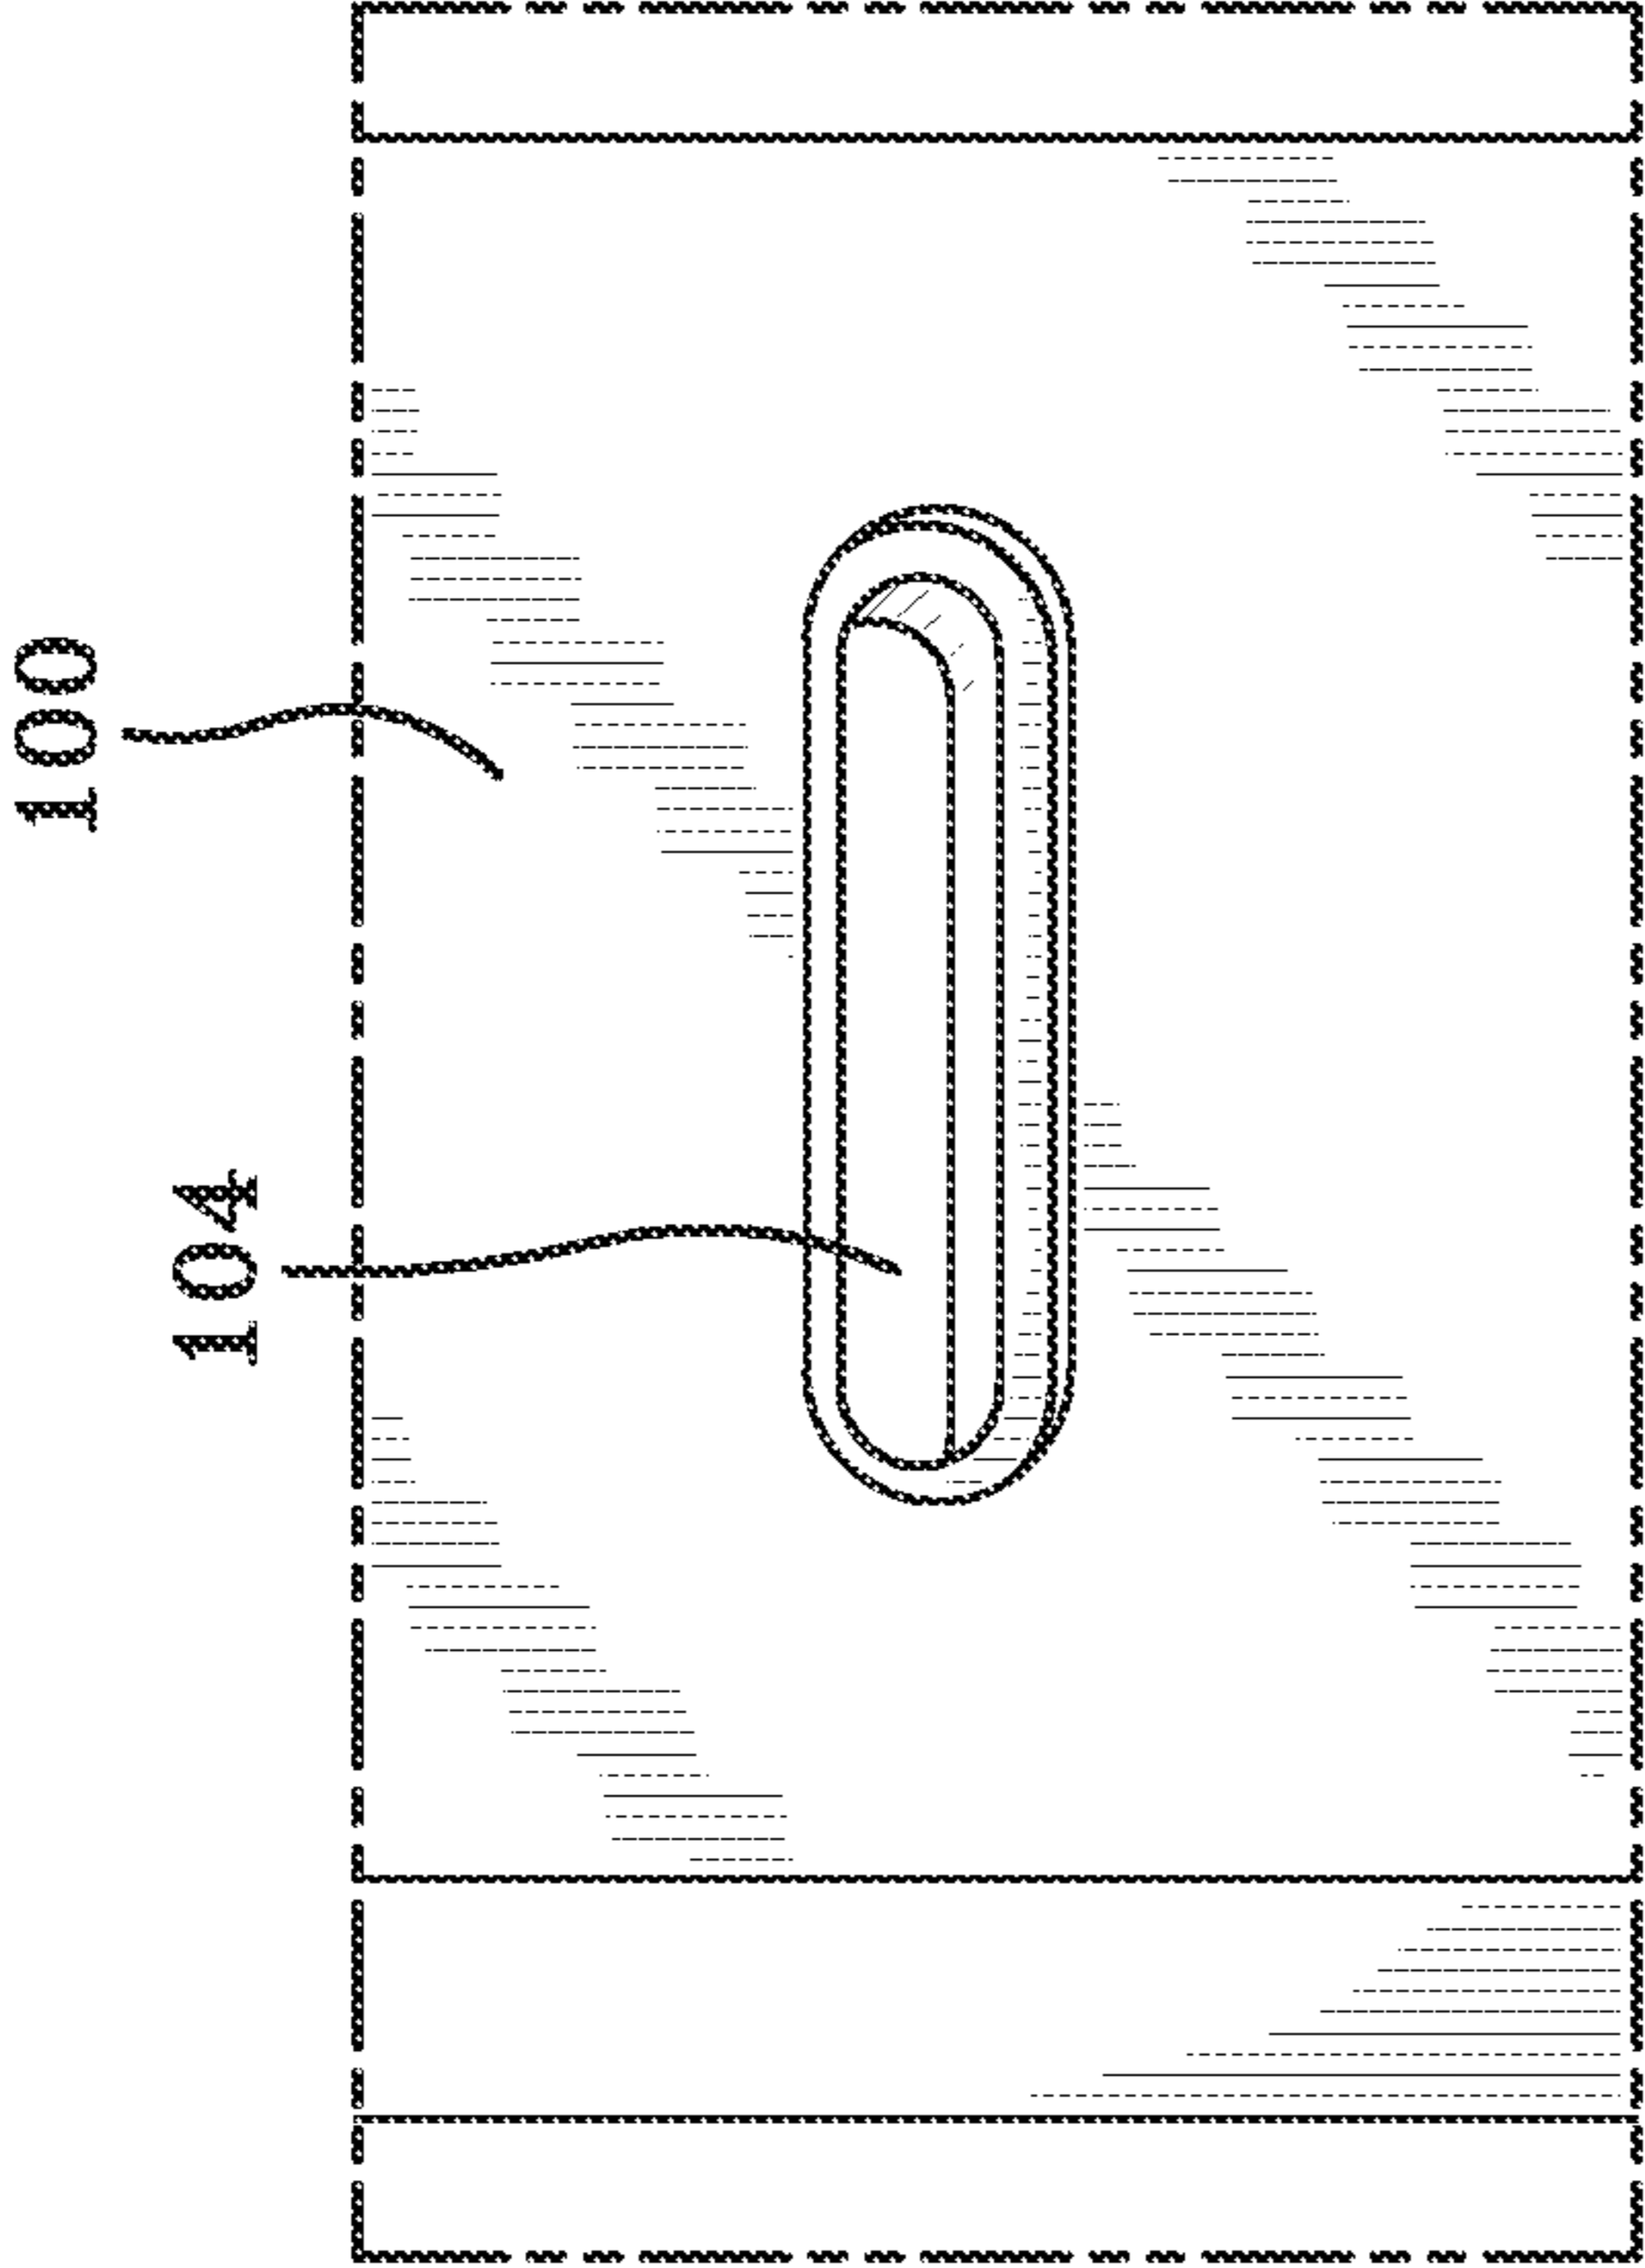
FIG. 6 is a view of the plating tool of FIG. 4 viewed 90° counterclockwise from FIG. 4, but with no blade inserted therein.

FIG. 7 is a view of a side of the plating tool of FIG. 4, clearing disclosing a circulation slot.

As is most clearly evident in FIG. **7**, which is side view of plating tool **100** of FIG. **4**, a circulation slot **104** is formed in the side of plating tool **100**. A circulation slot **104** exists on each face of plating tool **100**, as also shown in FIGS. **4**, **5** and **6**. Once plating tool **100** is immersed into a plating solution, circulation slots **104** provide access into the cavity **102** so that plating solution can circulate from the exterior of plating tool **100** into cavity **102**, and around the airfoil, which prevents the plating solution within cavity **102** from becoming depleted adjacent to blade tip portion **18**, which blade tip is positioned within cavity **102** adjacent to circulation slot **104**.

FIG. **6** clearly shows a cavity **102** substantially centered in plating tool **100**. Cavity **102** is also visible in FIGS. **4** and **5**. Also visible in FIG. **6** is a fillet radius plating mesh screen **200**. Fillet radius plating mesh screen **200** has a convex shape formed to carefully mirror the concave shape of fillet radius **50** when high pressure turbine blade **50** is assembled into cavity **102** as depicted in FIG. **4**. FIGS. **4**, **5**, and **6** show plating tool assembled onto a perforated table **300**, which table may be movable so that plating solution can be brought up to the position of blade platform **15** when assembled as shown in FIG. **4**, by lowering the table into the plating solution.
