(10) **Patent No.:** **US 8,661,667 B2**
(45) **Date of Patent:** **Mar. 4, 2014**

(54) **HINGE ARM REPAIR**

This invention relates generally to gas turbine engines and, more particularly, to the repair of a hinge arm of a nacelle access door hinge assemblies.

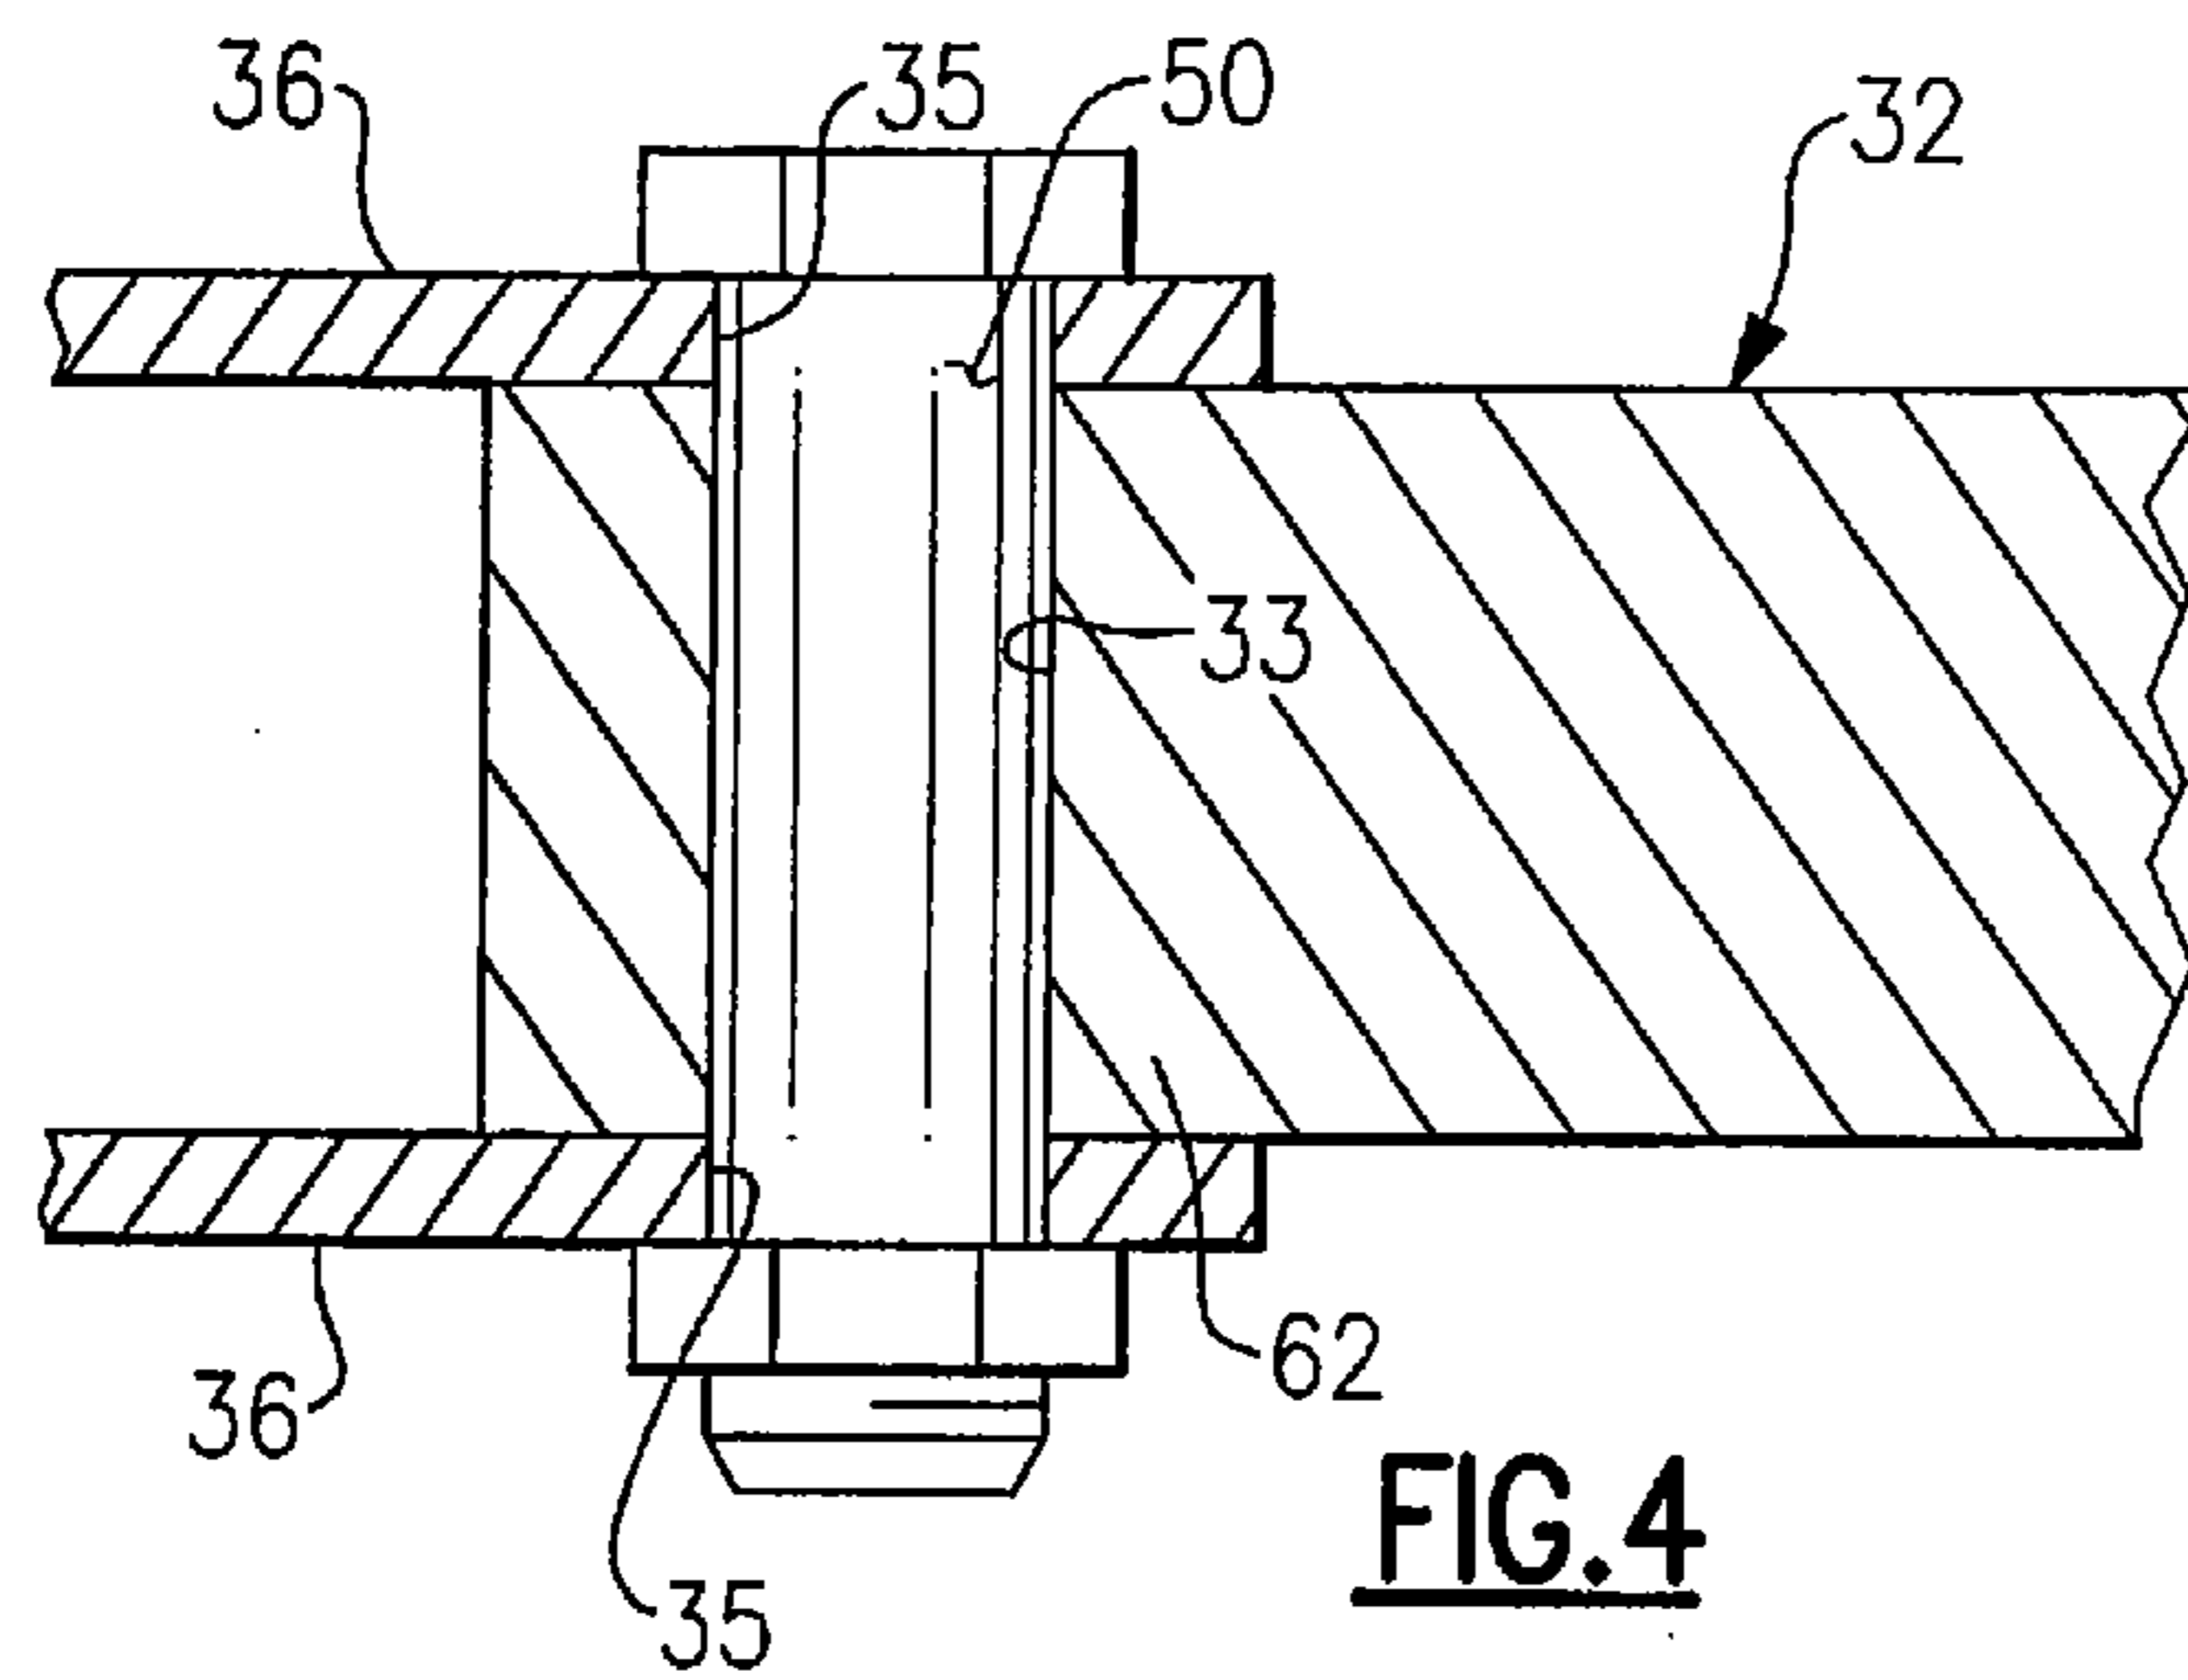
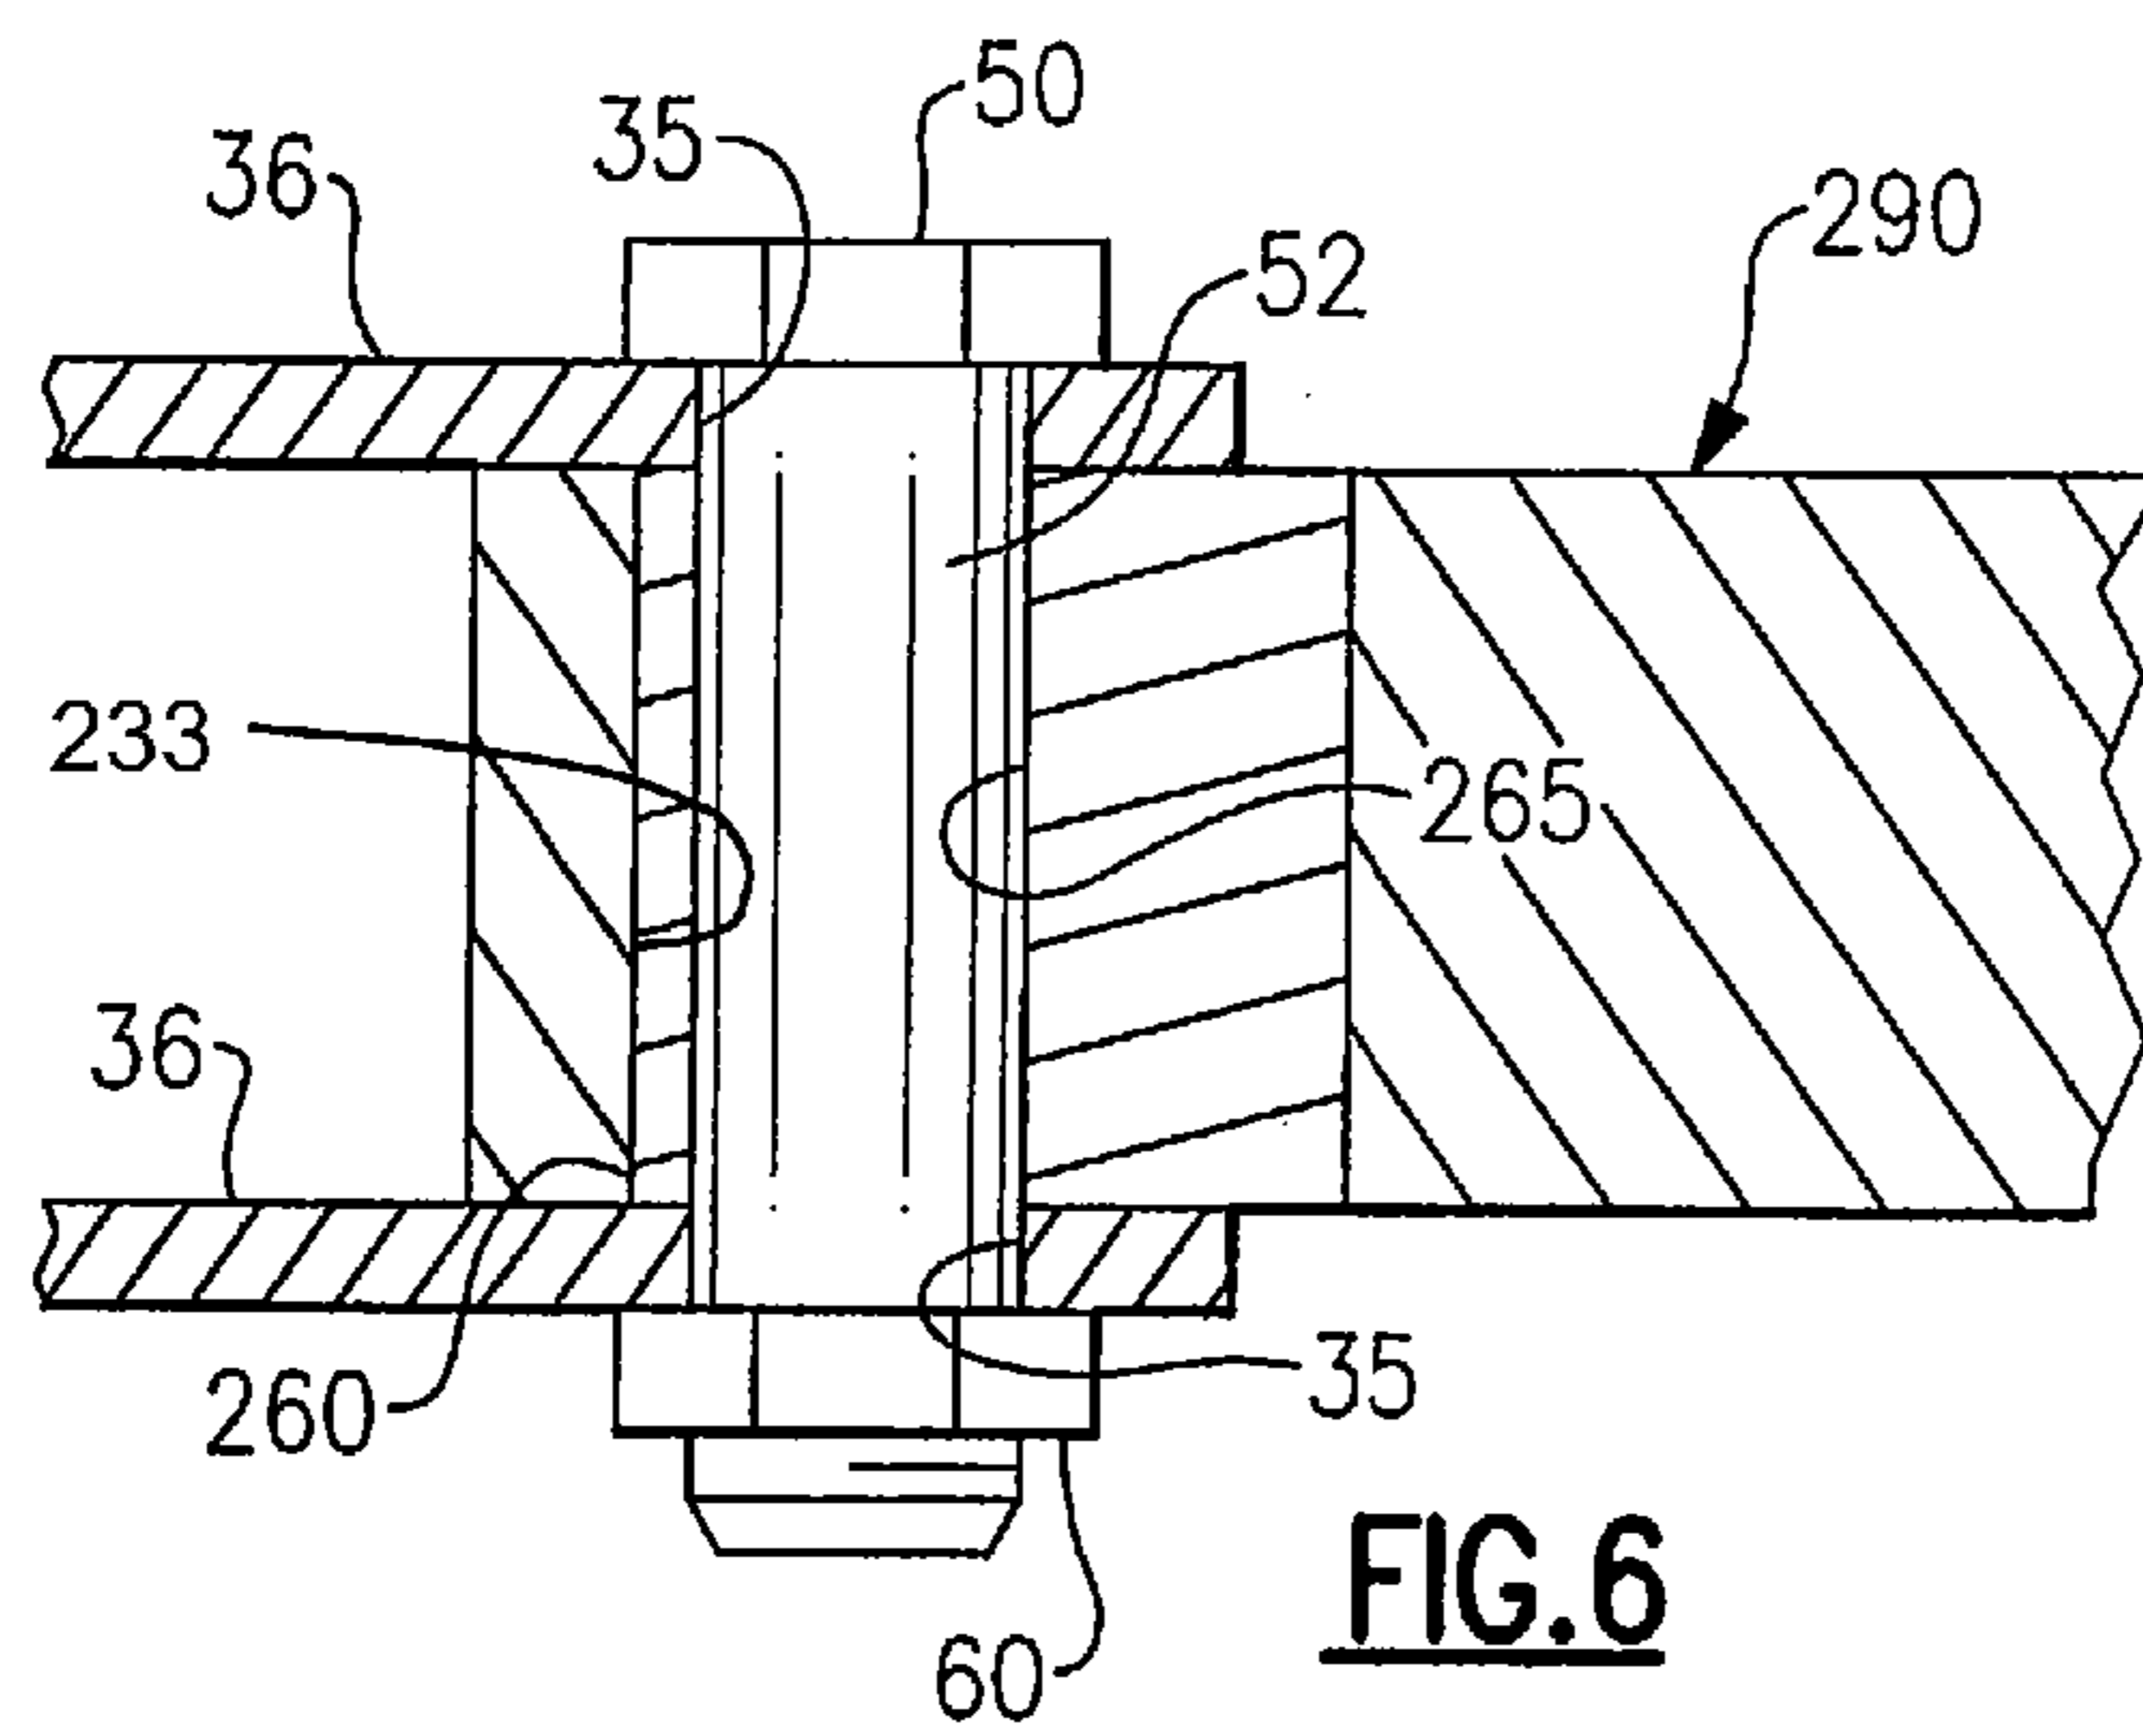
FIG. 3 is an exploded side elevation view of an exemplary embodiment of an access door and an associated hinge assembly;

FIG. 4 is a sectioned side elevation view of an exemplary embodiment of a portion of a hinge assembly pre-repair;

FIG. 6 is a sectioned side elevation view of an exemplary embodiment of a repaired hinge assembly;

Referring now to FIGS. 3 and 4, in particular, there is depicted in an exploded view an access door **20** that in a closed position covers the access opening **25** through the body of the nacelle **130**. The access door **20** is mounted to the nacelle **130** by a pair of hinge assemblies **30**. A pair of latches **40** may be mounted on the inside of the access door **20** along the side of the access door **20** from the access door is hinged. Although the access door **20** as depicted in FIG. 3 is supported for pivotal movement on a pair of hinge assemblies **30**, it is to understood that in some applications, depending primarily upon the size and weight of the access door, the access door may be supported by a single hinge assembly or by two or more than two hinge assemblies.

Each hinge assembly **30** includes a hinge arm **32** mounted to the access door **20** to the structure of the access door **20** on the inside surface of the access door **20**, a bracket **34** mounted to the body of the nacelle **130** on the inside of the nacelle **130**, and a pair of pivot arms **36**. The bracket **34** is secured to the nacelle **130** by bolts **54**. Each of the pivot arms **36** is pivotally mounted at one end to the bracket **34** and, in assembly, is pivotally mounted at its other end, i.e. its distal end, to the hinge arm **32**. Each of the pivot arms **36** has a hole **35** passing through its distal end for receiving a hinge pin.

The hinge arm **32** includes a base plate **38** by which the hinge arm may be secured to the structure of the access door **20**, for example by bolts **52**. The hinge arm **32** has a hole **33** passing through the distal end **62** of the hinge arm **32**. When the hinge assembly **30** is assembled, the distal end **62** of the hinge arm **32** is inserted between distal ends of the paired pivot arms **36** with the respective pin receiving holes **35** and the pin receiving hole **33** aligned and with a hinge pin **50** inserted through the aligned holes **33**, **35**.

As noted previously, in conventional practice the various parts of the hinge assemblies are made of aluminum, a light weight material that has a relatively high specific strength corrected for density. However, aluminum is prone to wear. Consequently, over time in service, the hinge pin wears against the bore of the hole **33** in the distal end of the hinge arm **32**, which results in the hole **33** becoming enlarged. Typically, the primary area of wear is on the distal side of the hole **33** which results in a thinning of the strap portion **38** of

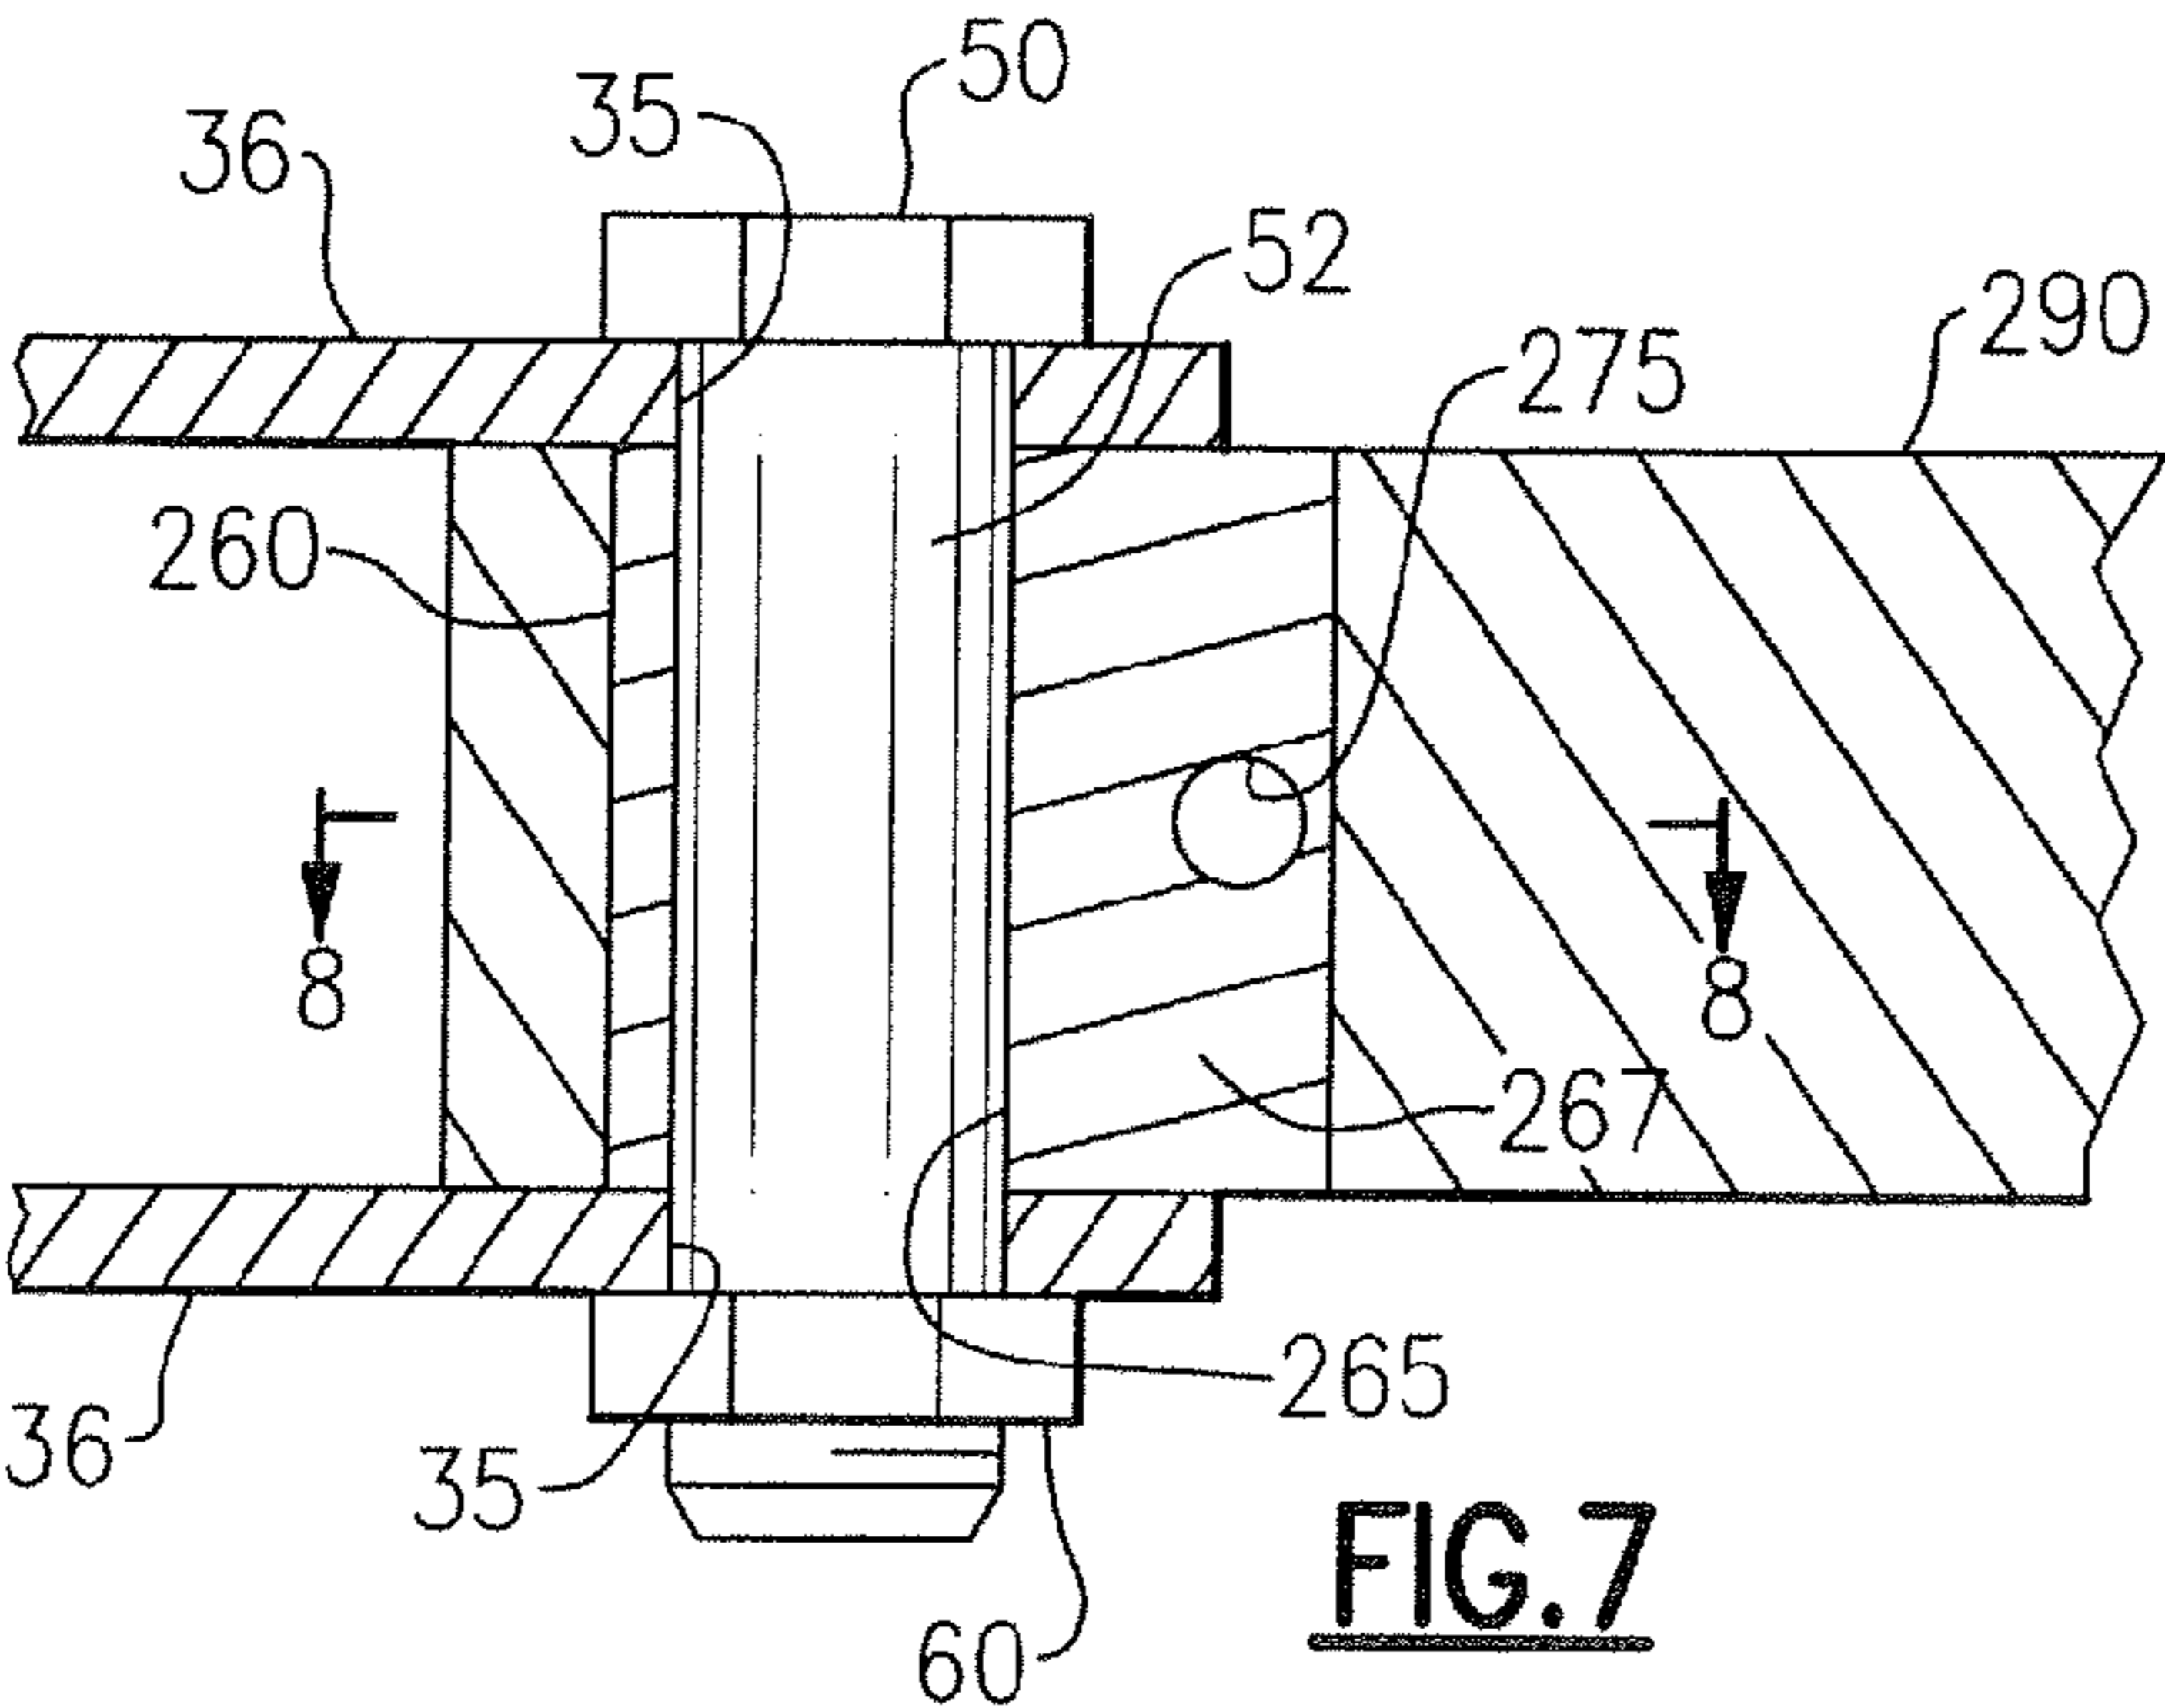
FIG. 7 is a sectioned side elevation view of another exemplary embodiment of a repaired hinge assembly;

Referring now to FIGS. 7-8, to provide additional assurance that the keyed bushing 260 will not "back out" of the hole 233, the key 267 may be staked to the repaired hinge arm 232 after being positioned within the keyway 255. For example, a staking hole 275 may be drilled transversely into the side 272 of the repaired hinge arm 232 so as to extend through the key 267 and the keyway 255. A staking pin 274 may be inserted into the staking hole 275 so as to extend through the key 267 and the keyway 255 thereby locking the keyed bushing 262 into place and preventing the key 267, and therefore the keyed bushing 260, from backing out. In an embodiment, the staking pin 274 has a shaft that may be sized relative to the staking hole 275 to provide a press fit between the staking pin 274 and the staking hole 275 when the staking pin 274 is inserted into the staking hole 275, such as illustrated in FIG. 8A. In an embodiment, the staking pin 274 may

To reinstall the repaired hinge arm 290 into service, the base plate of the hinge arm is remounted to the inside structure of the access door and the distal end of the repaired hinge arm 290 is reinserted between the pair of pivot arms 36 as illustrated in FIGS. 6 and 7. With the bore 265 of the keyed bushing 260 in the repaired hinge arm 290 aligned with the holes 35 in the respective pivot arms 36, a hinge pin 50 is inserted through the aligned holes. The hinge pin 50 may be a bolt having a shaft 52 having a threaded distal end adapted to receive a threaded nut 60 for locking the hinge pin 50 in place. The portion of the shaft 52 of the hinge pin 50 in contact with the inside bore of the keyed bushing 262 is unthreaded and has a shaft diameter that is sized relative to the inside diameter of the bore through the keyed bushing 262 to provide a proper clearance, i.e. not too loose and not too tight, between the hinge pin 50 and the bore through the keyed bushing 262. The amount of clearance desired is a design consideration and is within the skill of a person of ordinary skill in the art.

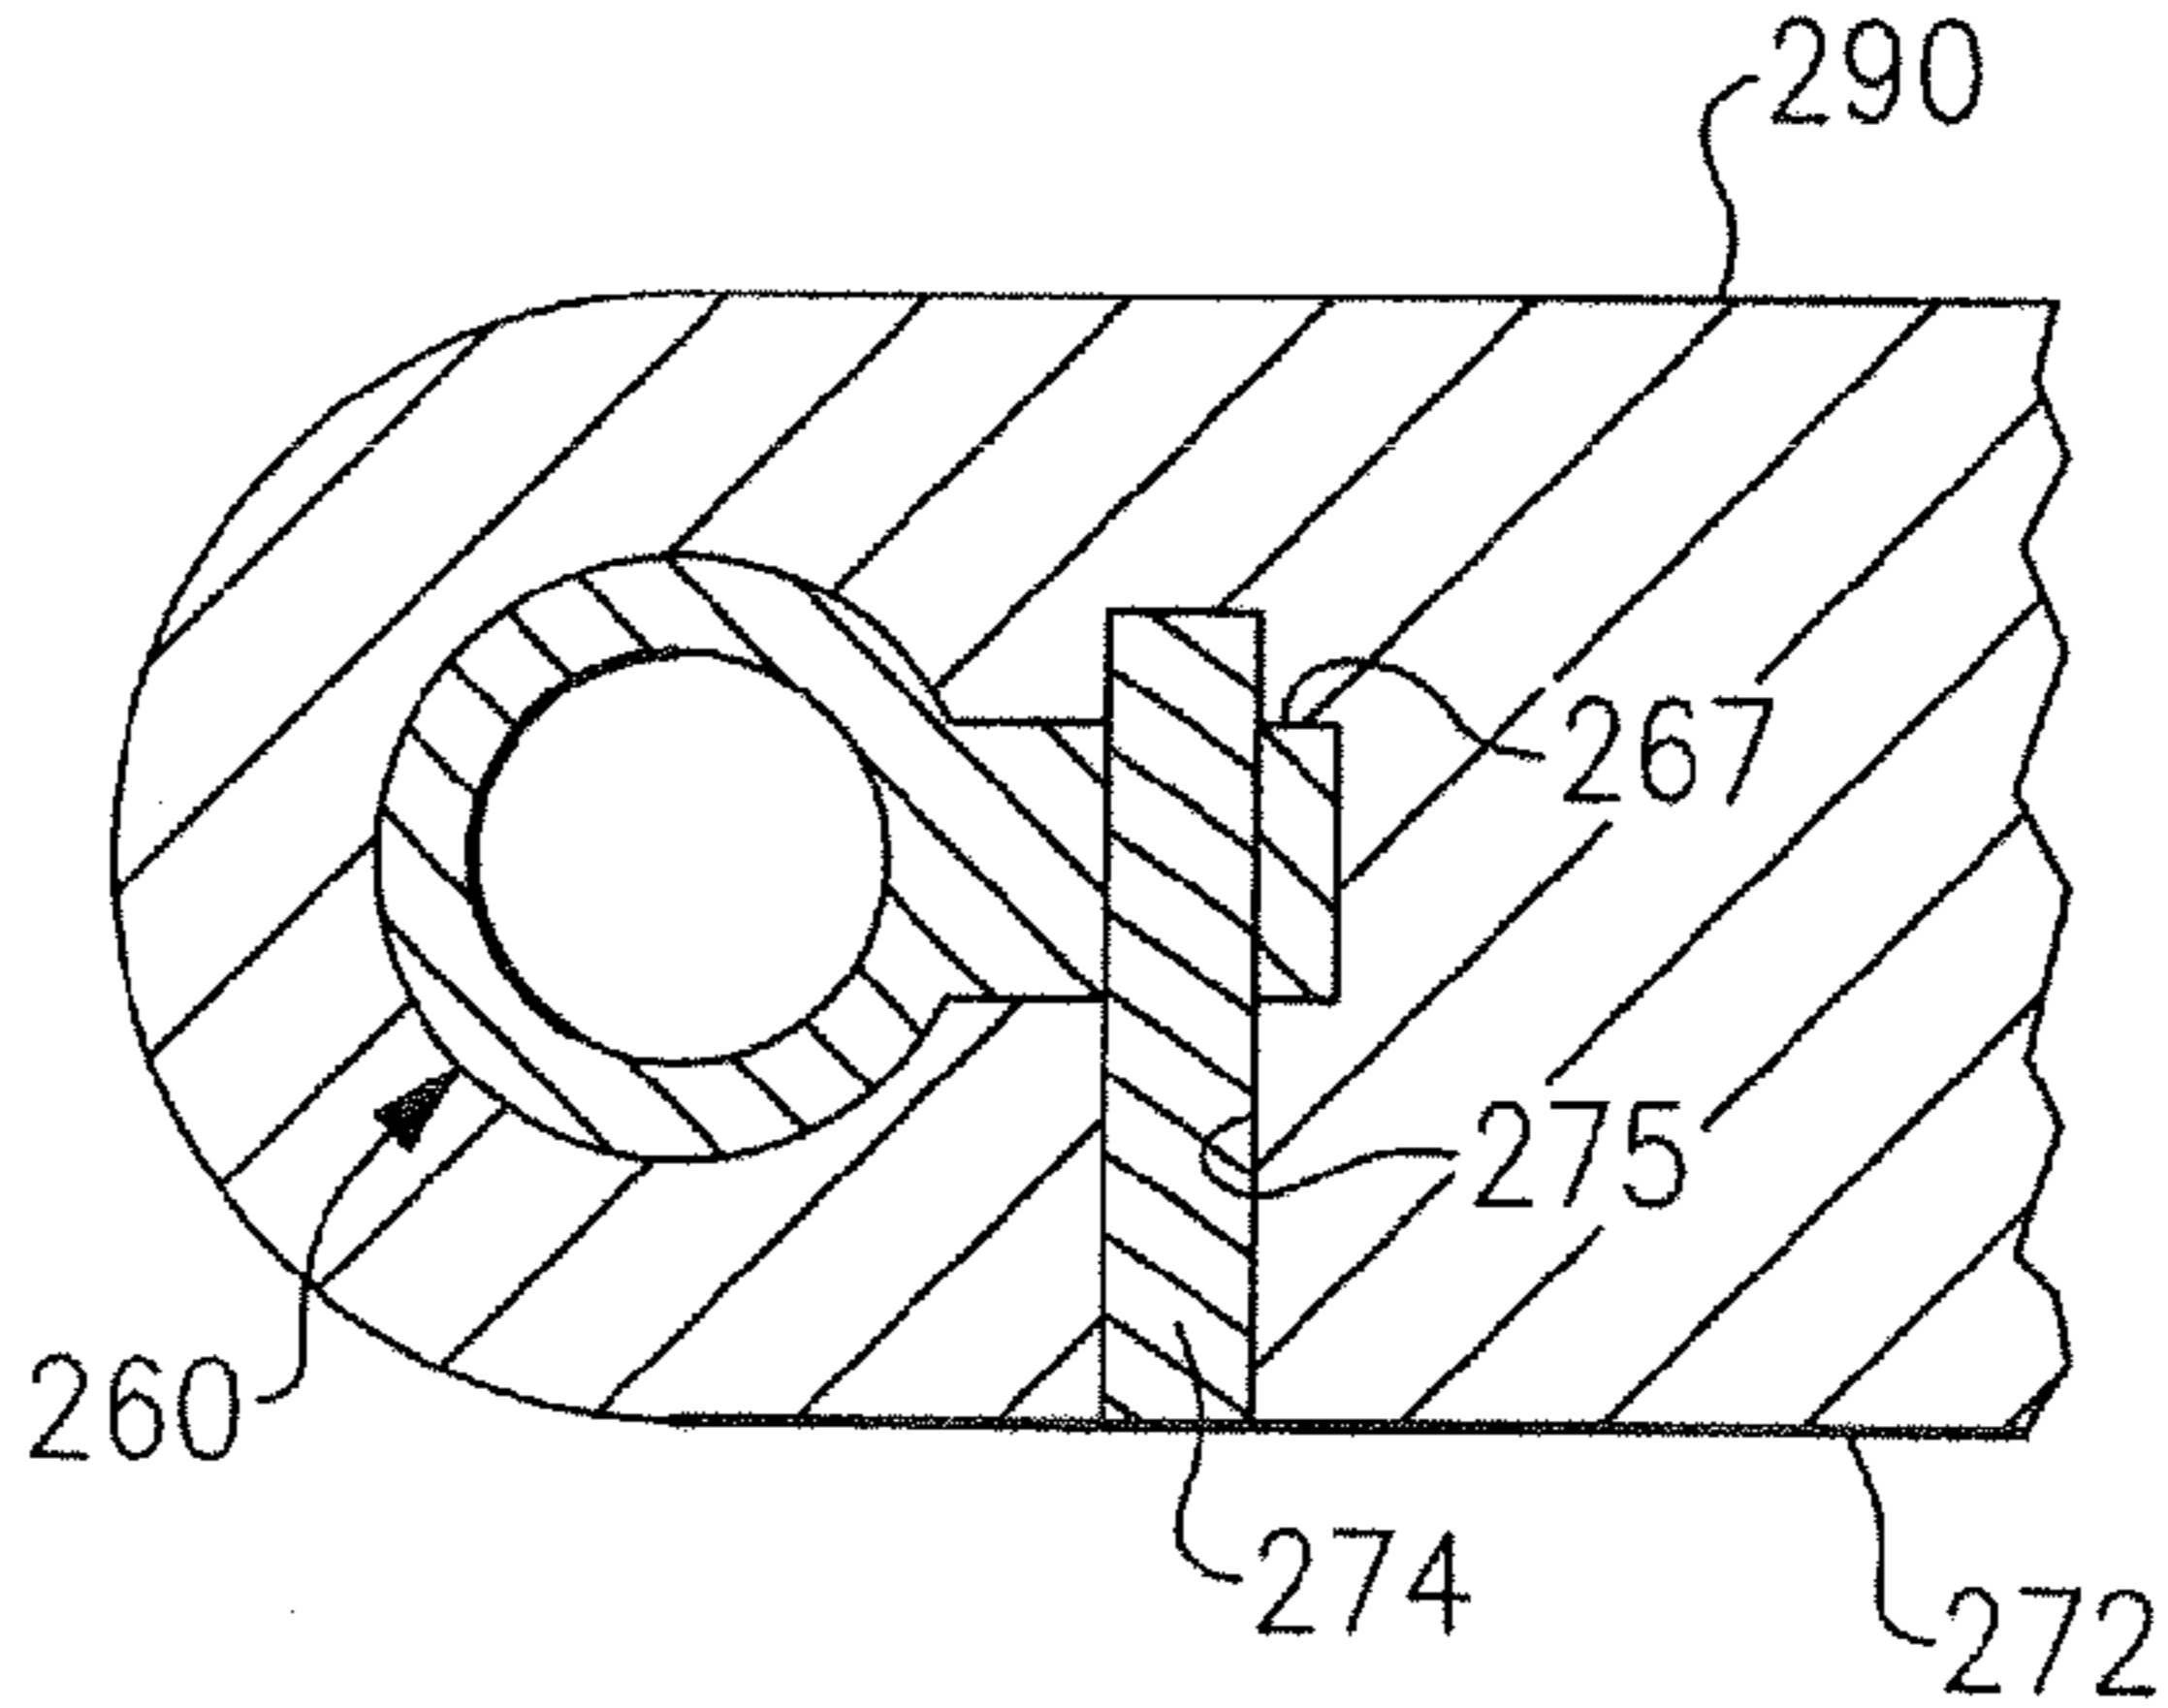
FIG. 8A is a plan view of the repaired hinge assembly of FIG. 7 taken along line 8-8; and

be secured into the staking hole 275 by application of a retaining compound, such as for example Loctite 635 marketed by Henkel Aerospace, alone or in conjunction with the use of a press fit. In an embodiment, the staking pin 274 may be secured in the staking hole 275 by a threaded connection therebetween. For example, the portion of the staking hole 275 on the far side of the keyway 255 and the distal end of the staking pin 274 may be threaded whereby the staking pin 274 may be screwed into the lock hole 275, such as illustrated in FIG. 8B. With the key 267 being held within the keyway 255, either by press-fit or by locking with a staking pin, rotation of the repaired hinge arm 232 relative to the keyed bushing 260 is prevented.

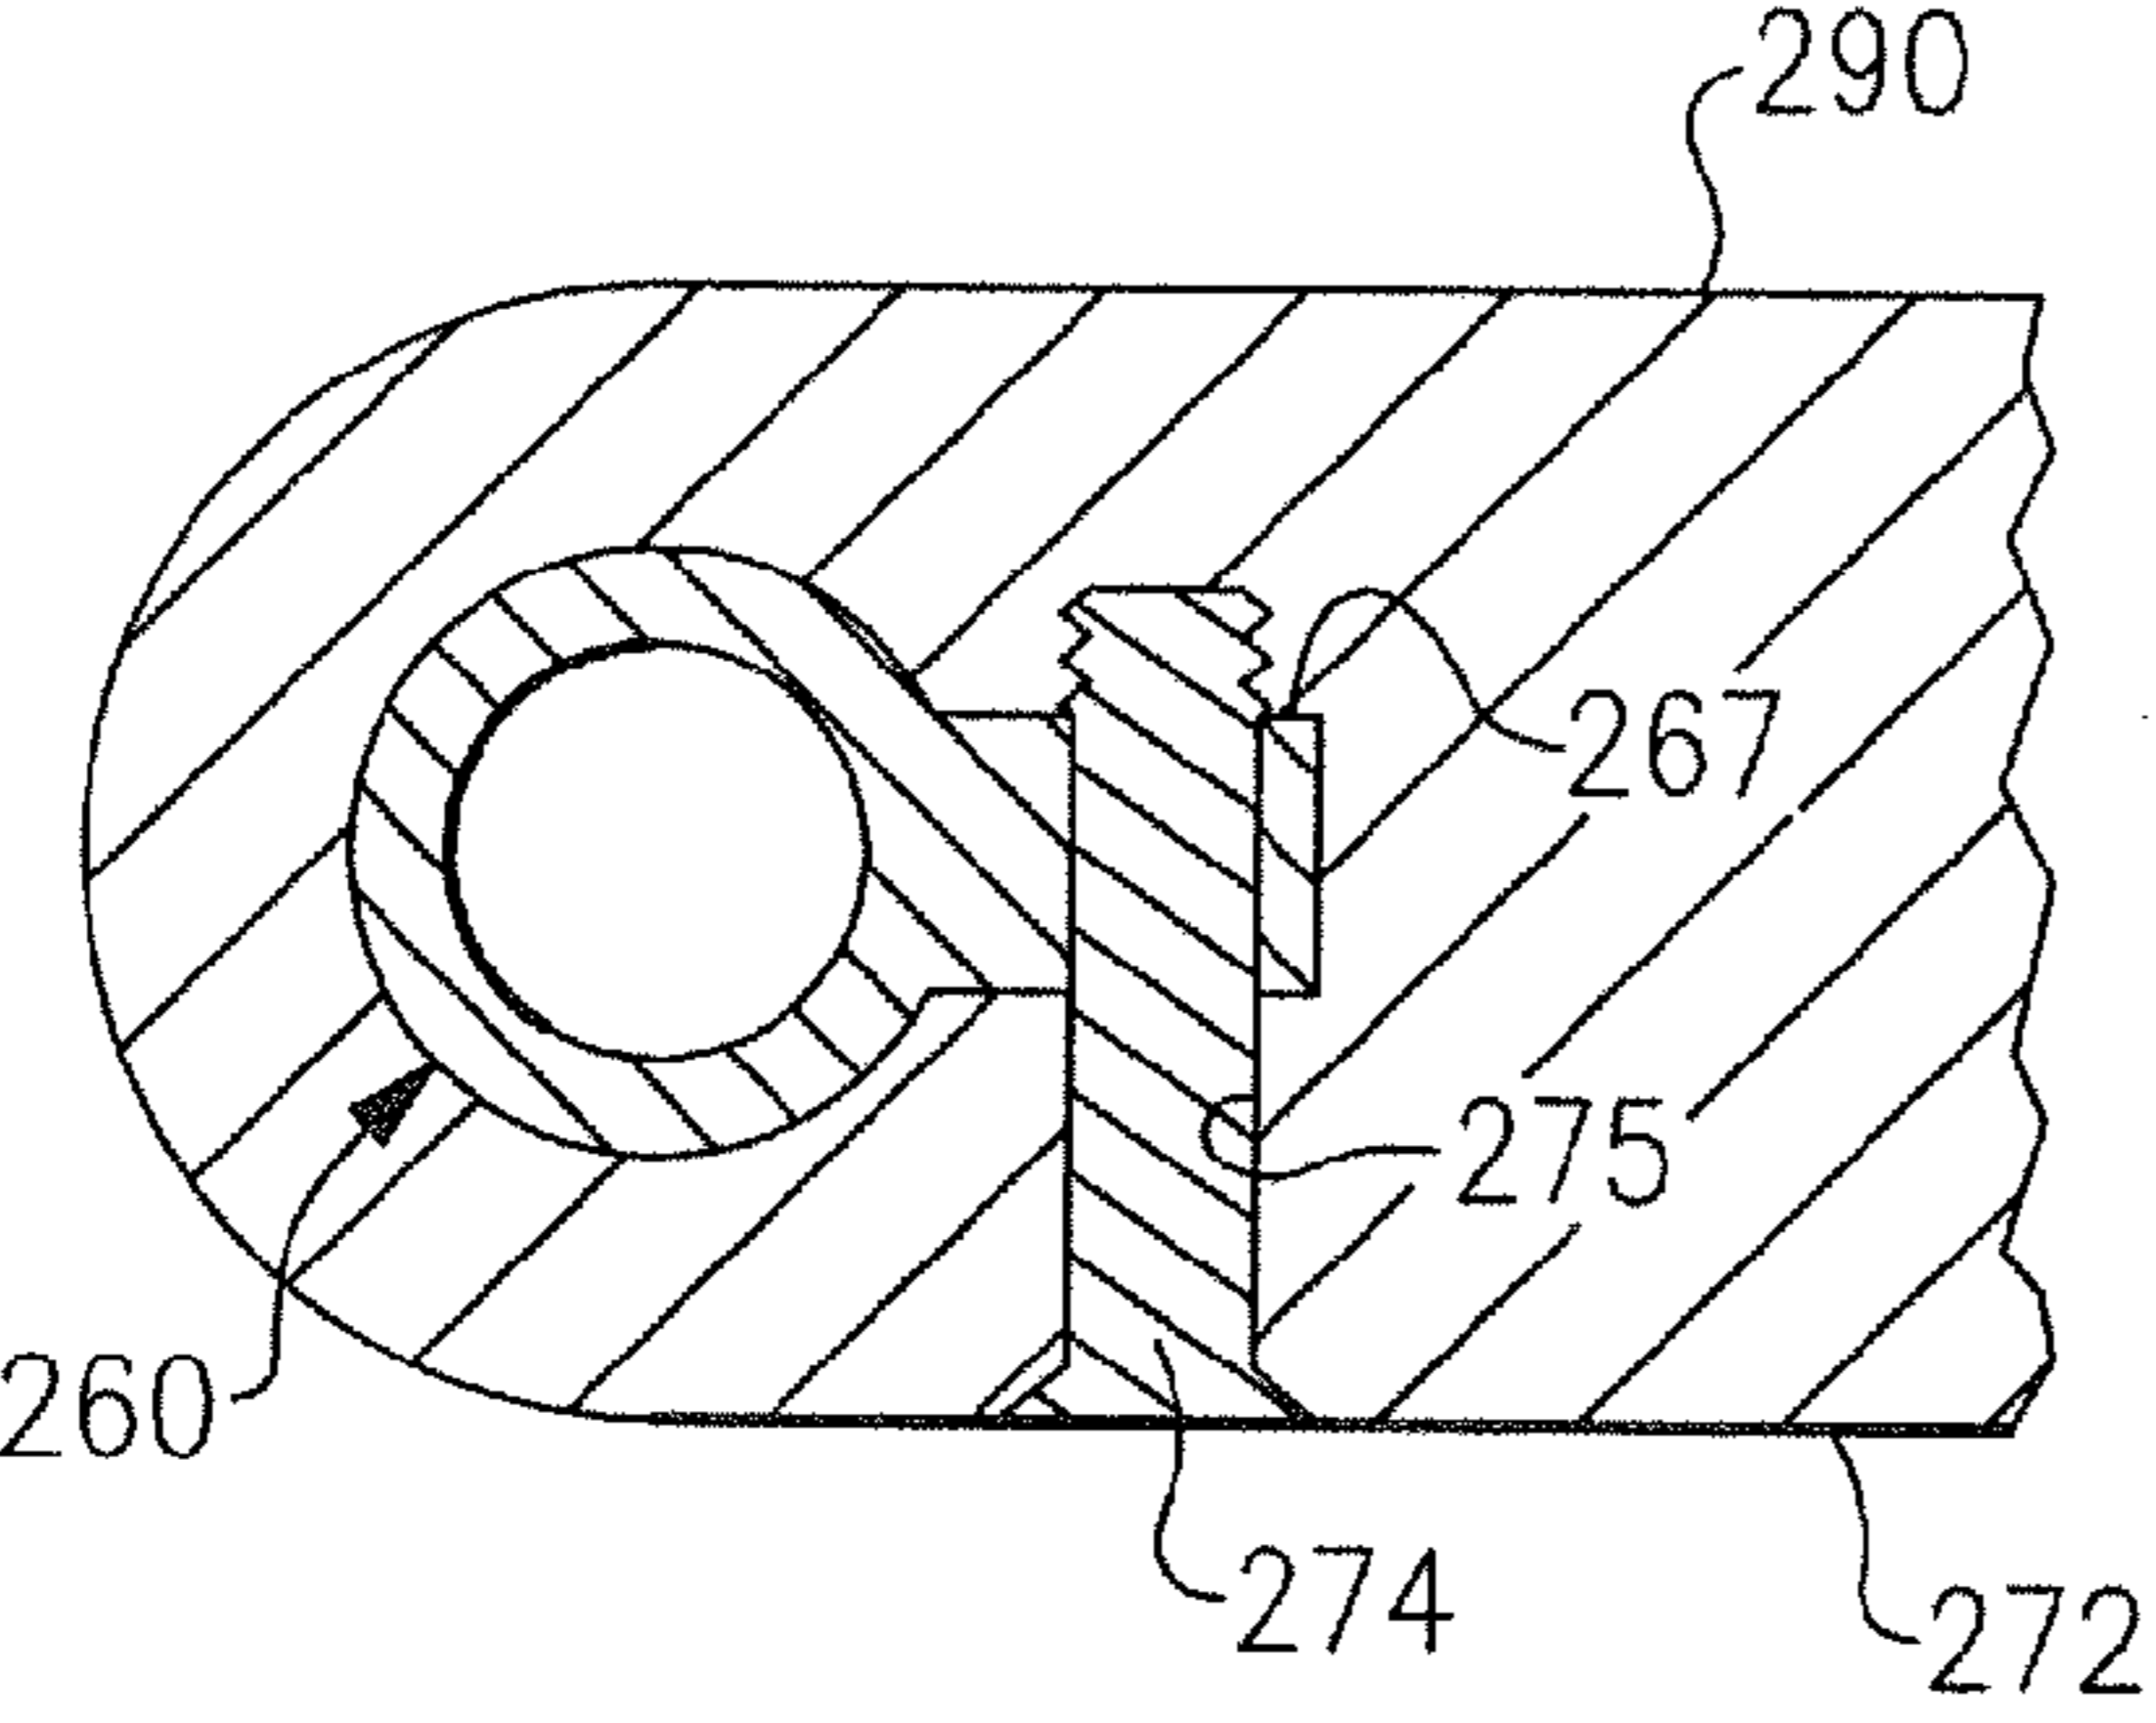
FIG. 8B is a plan view of another embodiment of the repaired hinge assembly of FIG. 7 taken along line 8-8.
