(10) **Patent No.:** **US 8,661,667 B2**
(45) **Date of Patent:** **Mar. 4, 2014**

(54) **HINGE ARM REPAIR**

(73) Assignee: **United Technologies Corporation**,
Hartford, CT (US)

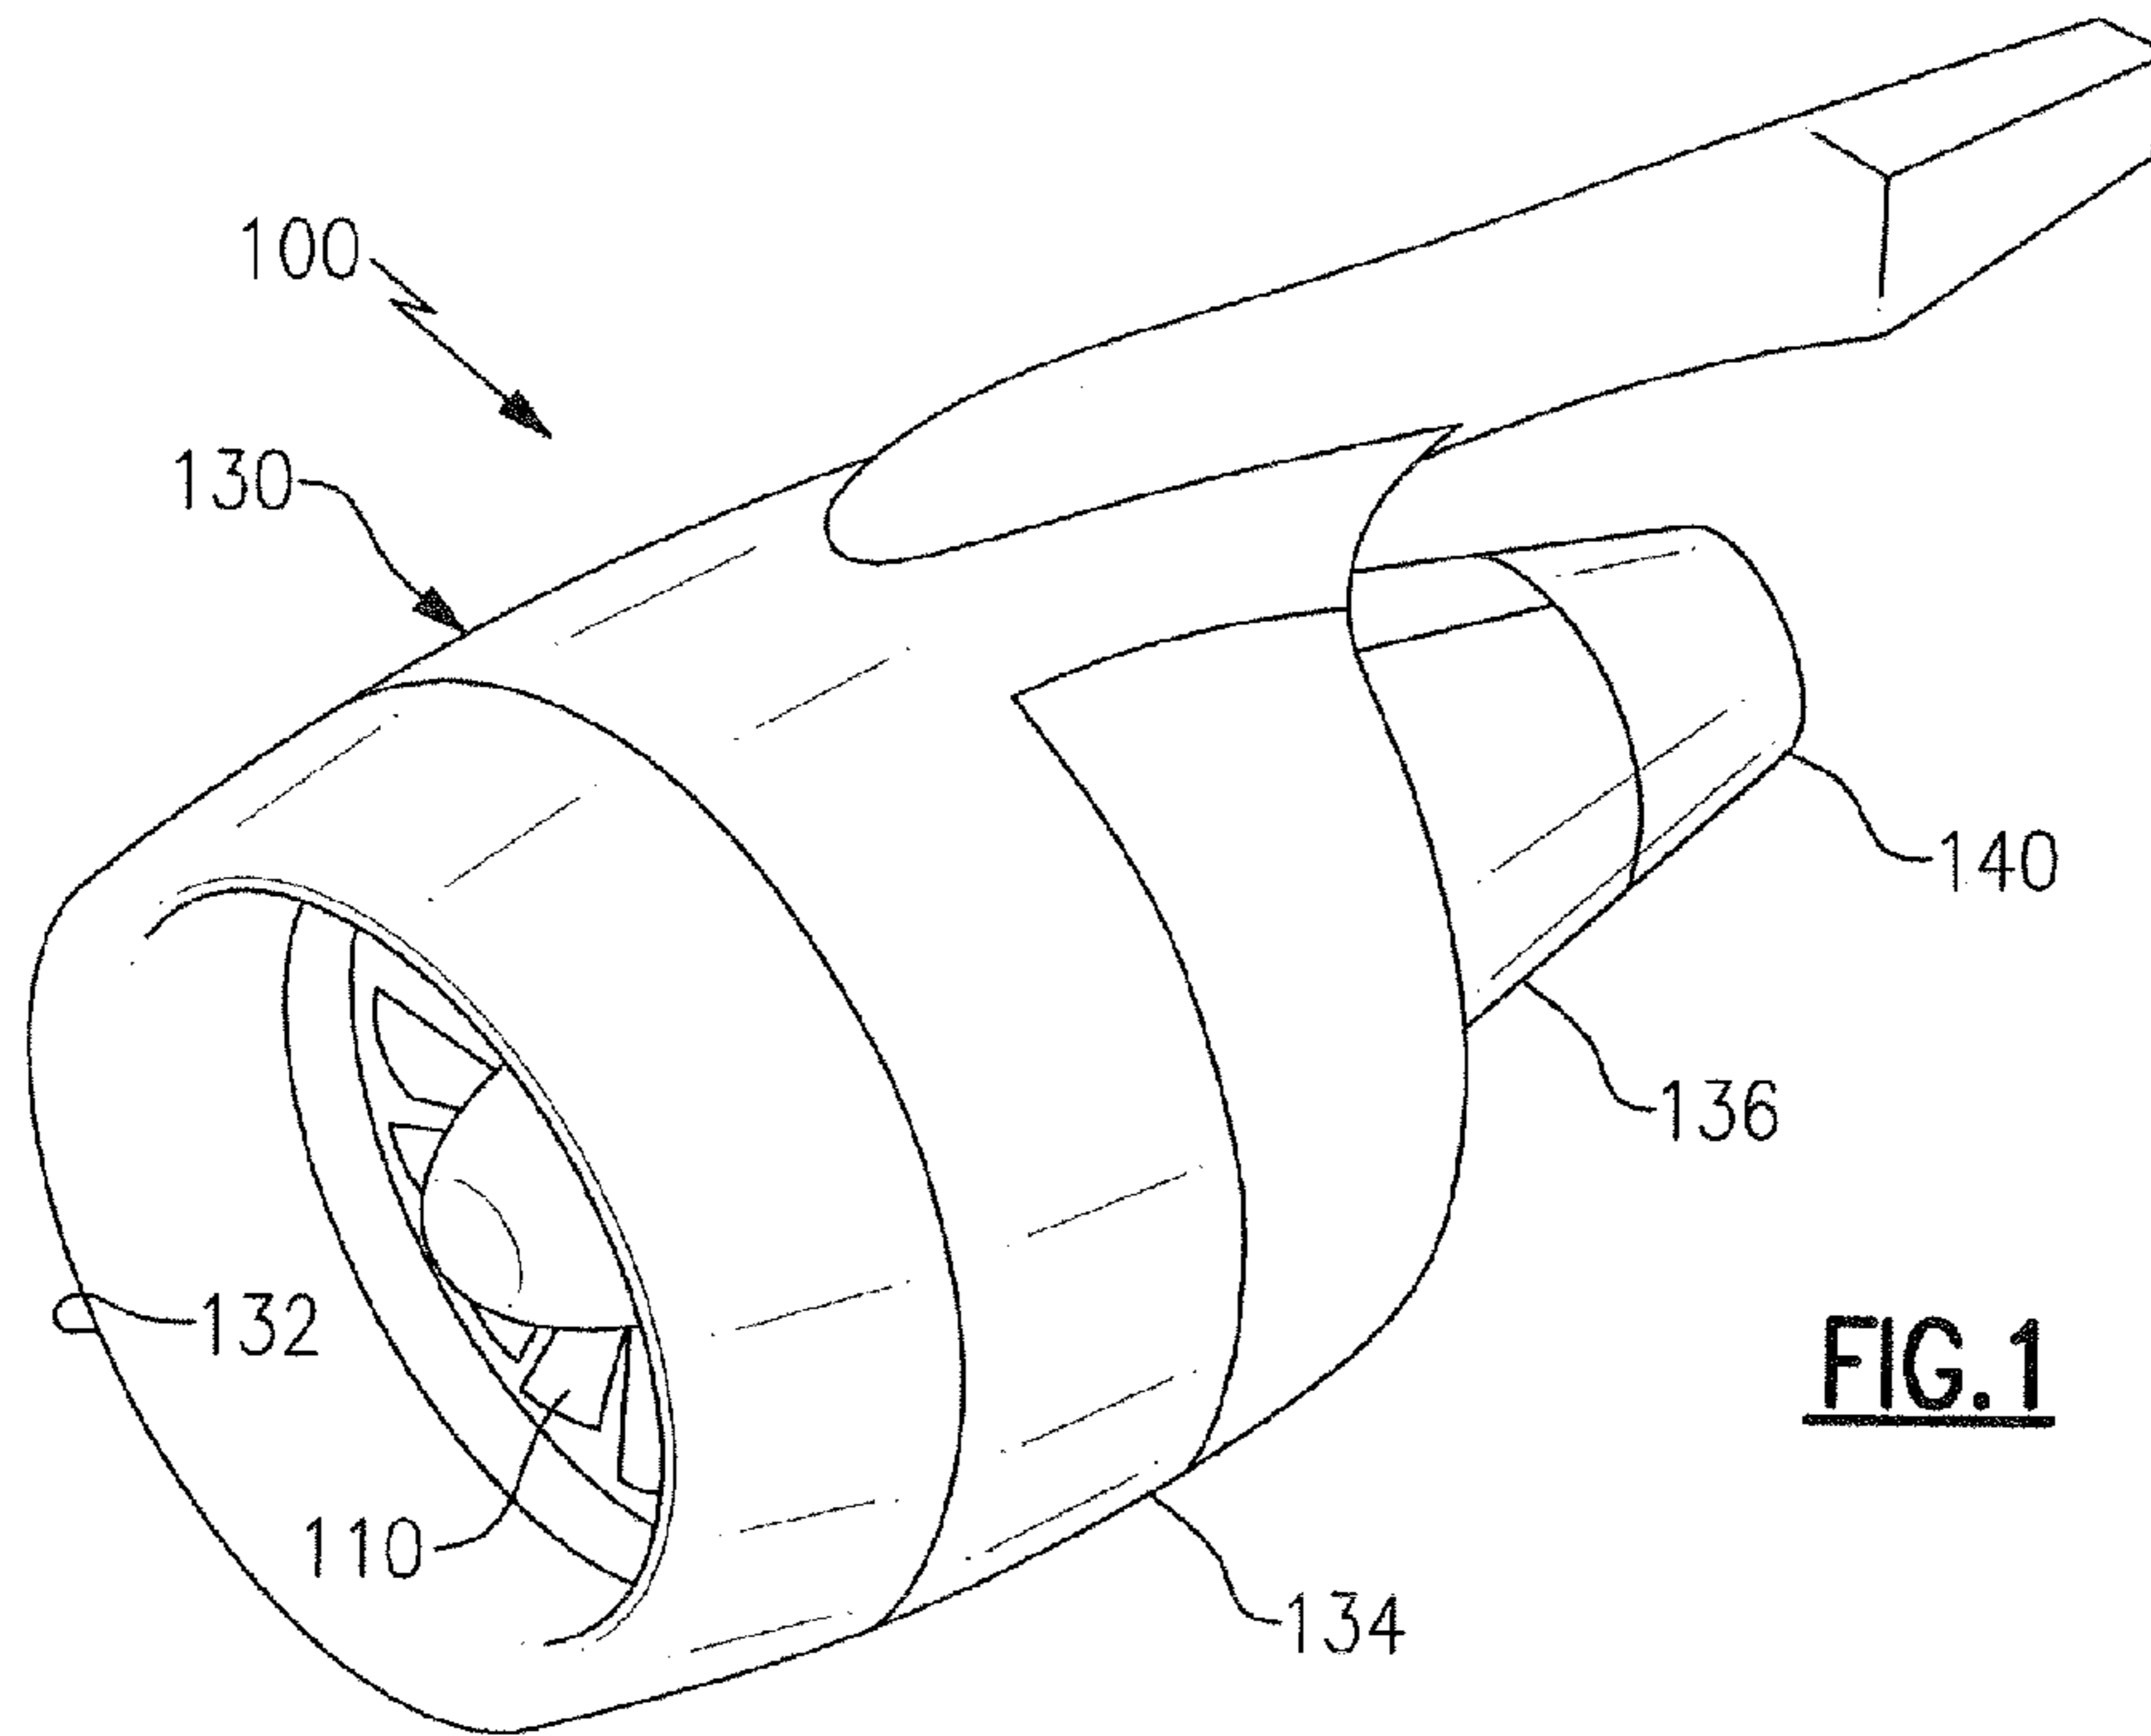
FIG. 1 is a perspective view of an exemplary embodiment of a turbofan gas turbine engine;

Referring initially to FIGS. 1 and 2 of the drawing, an exemplary embodiment of a turbofan gas turbine engine,

designated generally as **100**, is shown. The turbofan gas turbine engine **100** includes, from fore-to-aft, a fan **110**, a compressor module (not shown) a combustor module (not shown), a turbine module (not shown), and an exhaust nozzle **140**. A nacelle **130** forms a housing or wrap that surrounds the gas turbine engine **100** to provide an aerodynamic housing about the gas turbine engine. In the turbofan gas turbine engine **100** depicted in the drawings, the nacelle **130** includes, from fore to aft, the engine inlet **132**, the fan cowl **134**, the engine core cowl **136** and the primary exhaust nozzle **140**.

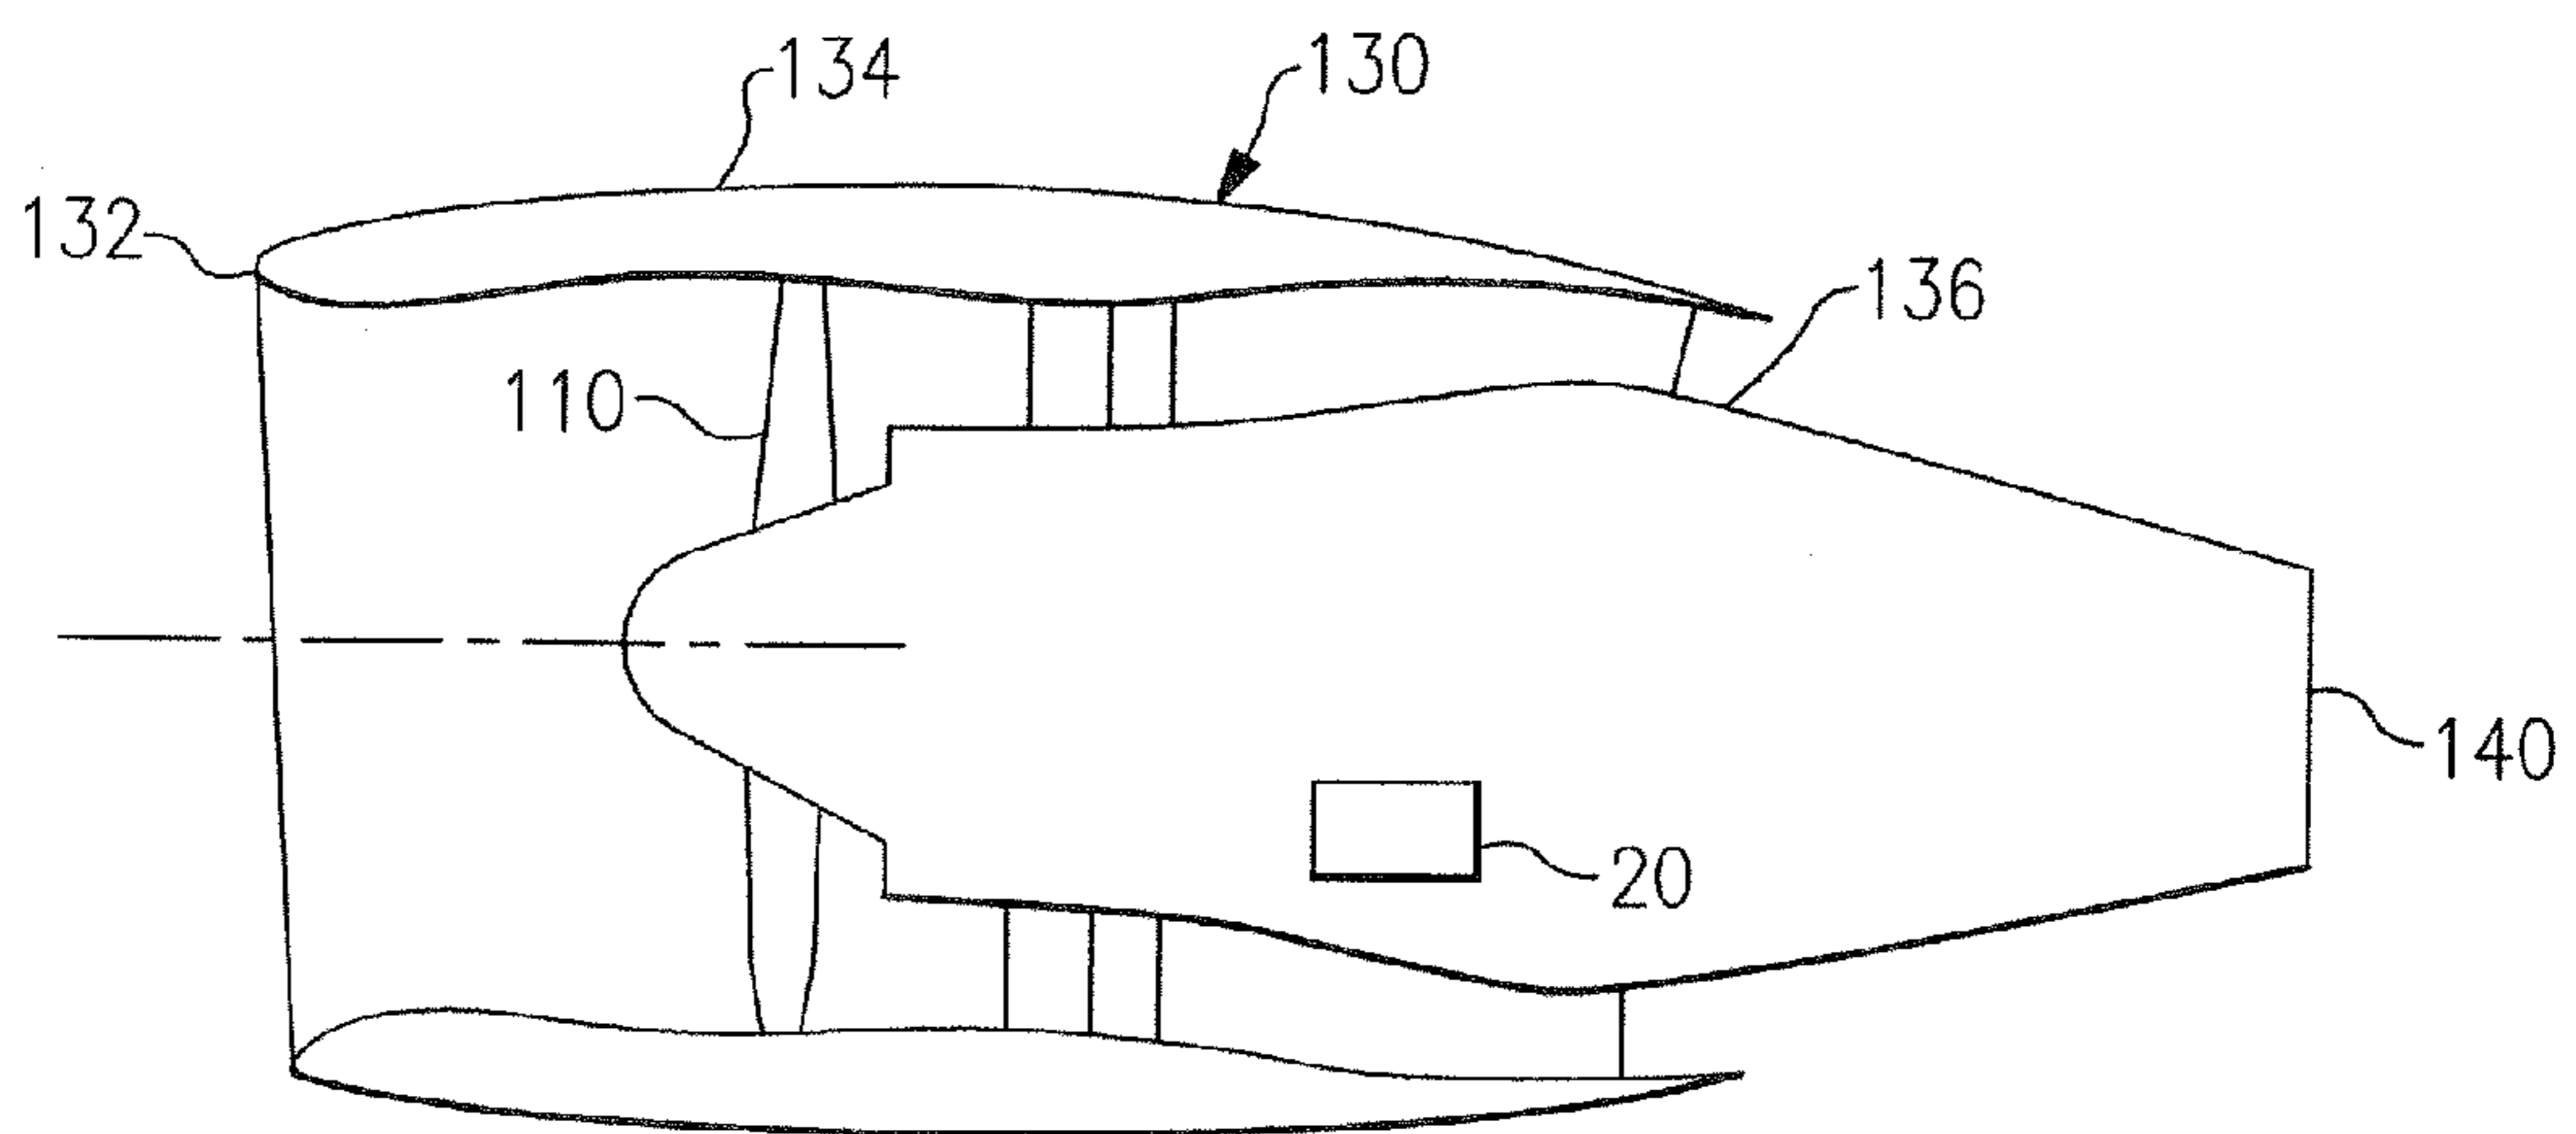
FIG. 2 is a schematic view of a longitudinal section of the exemplary embodiment of the turbofan gas turbine engine of FIG. 1;

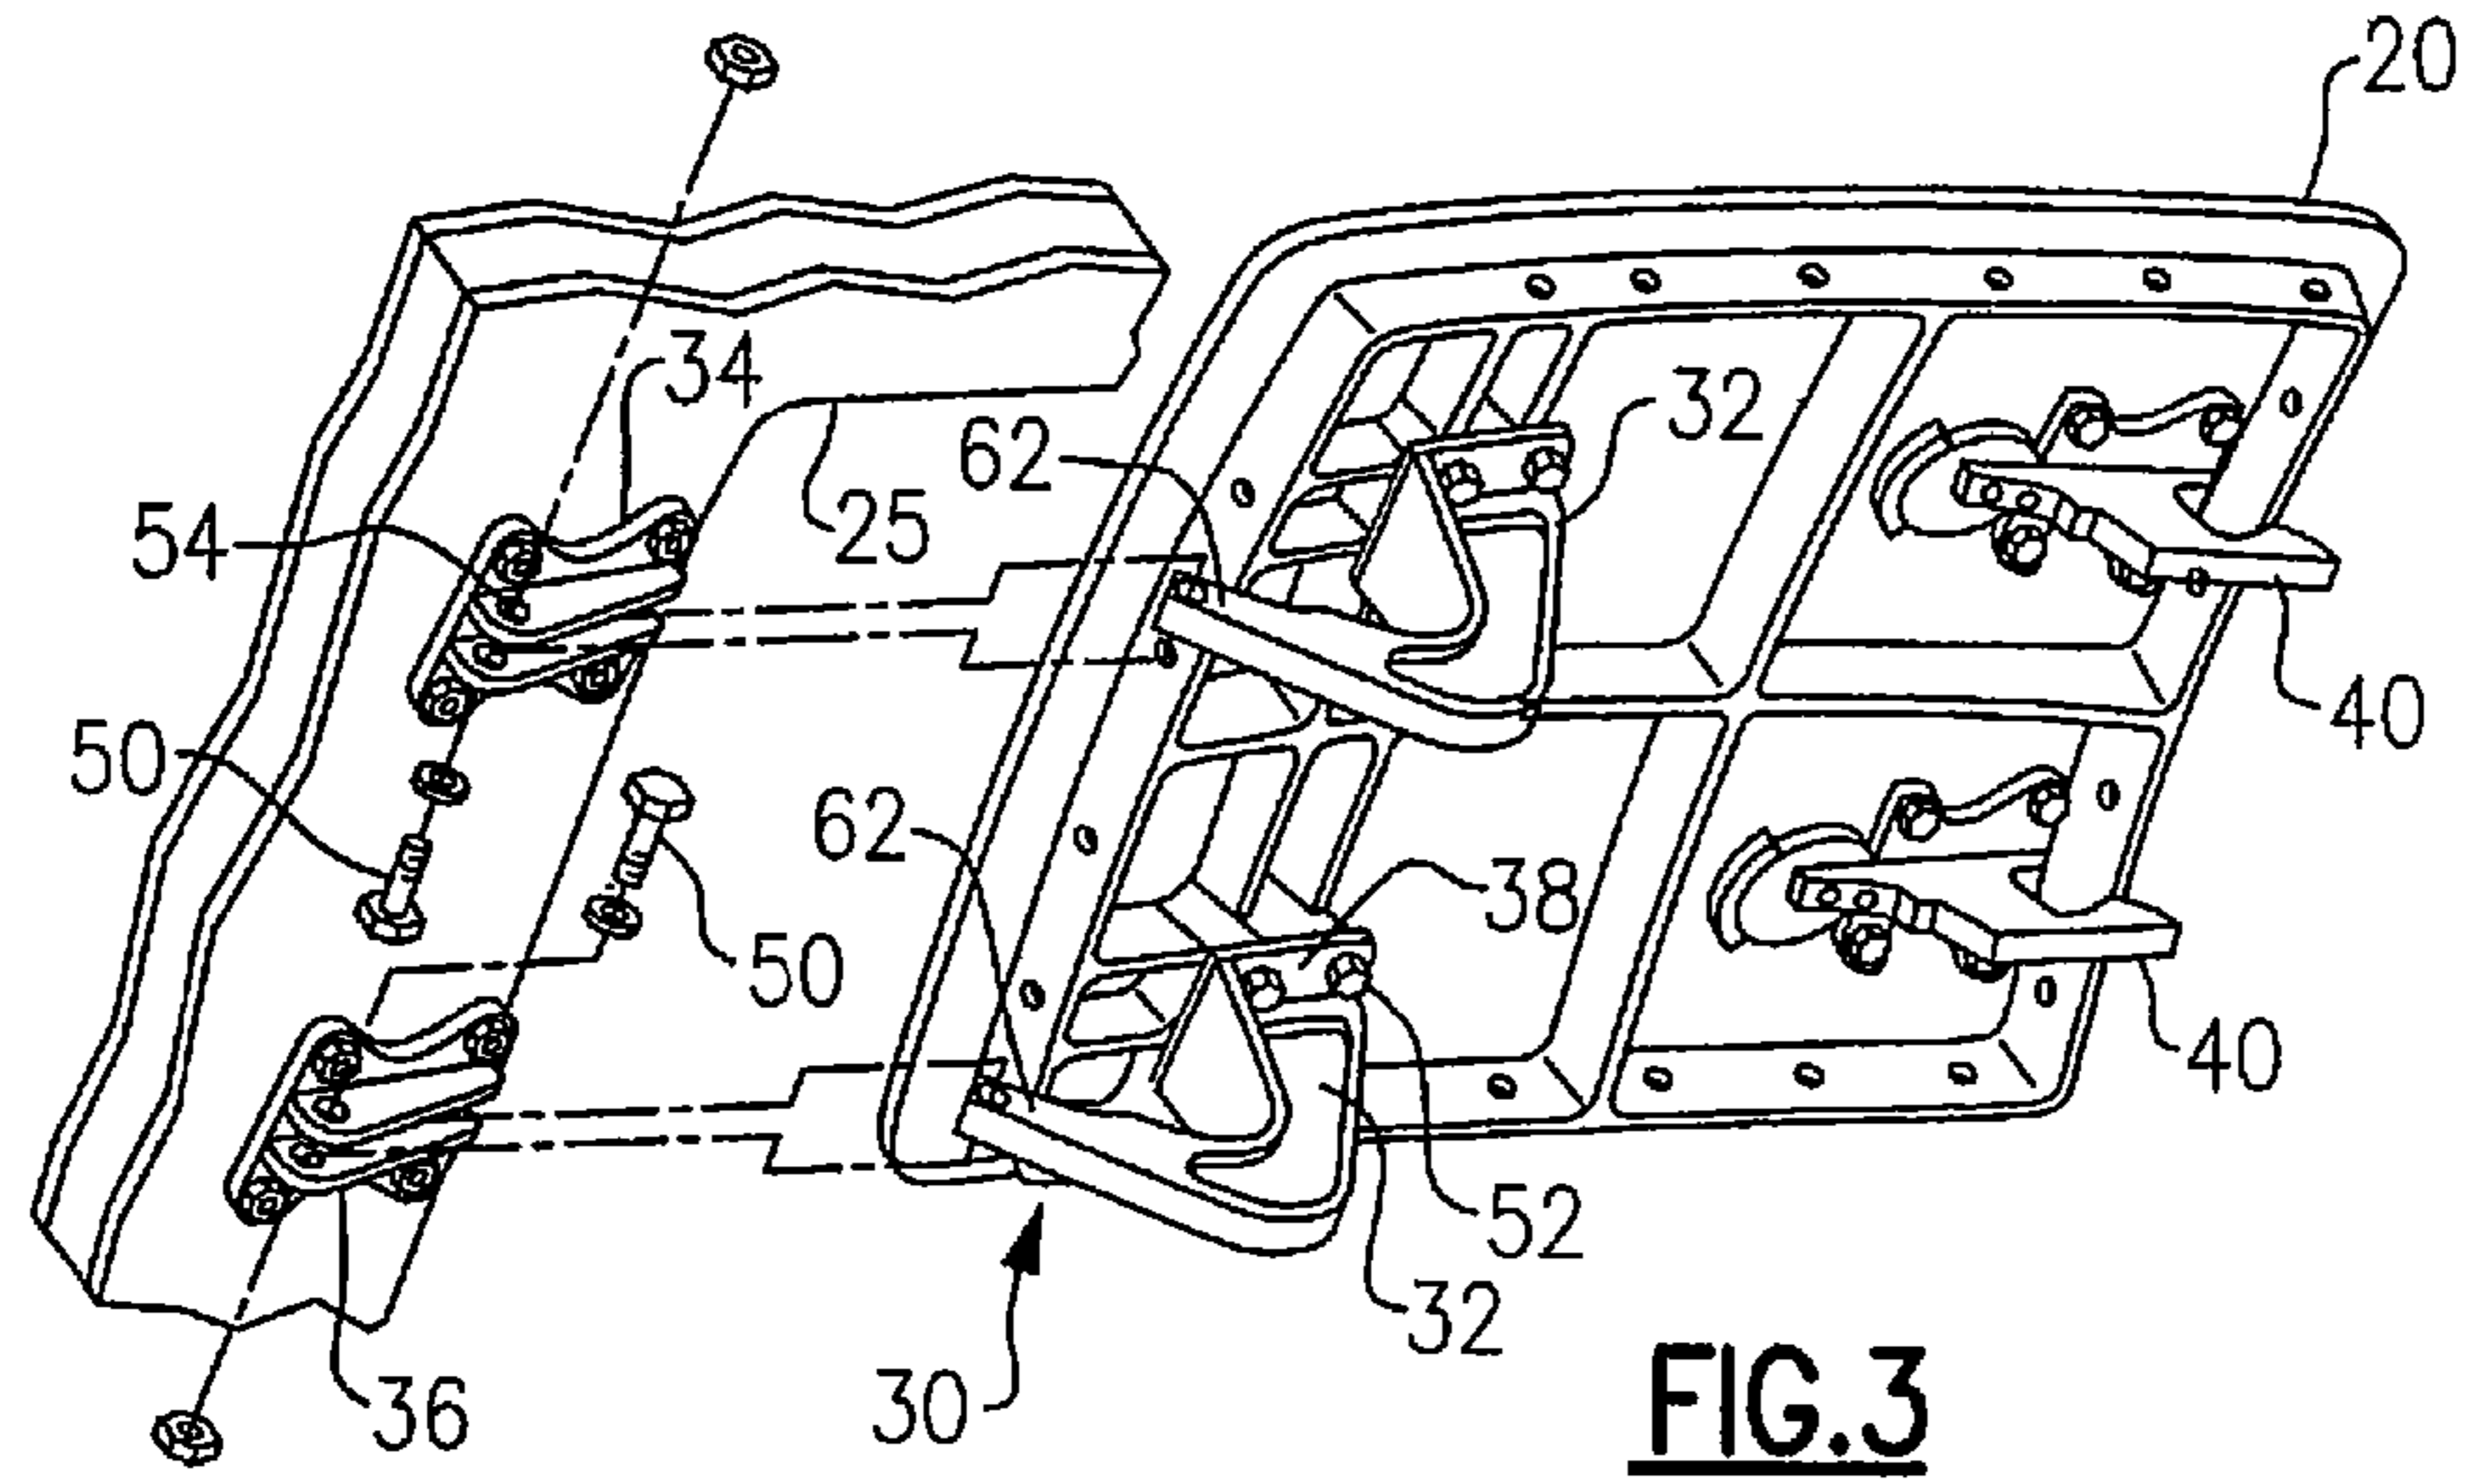
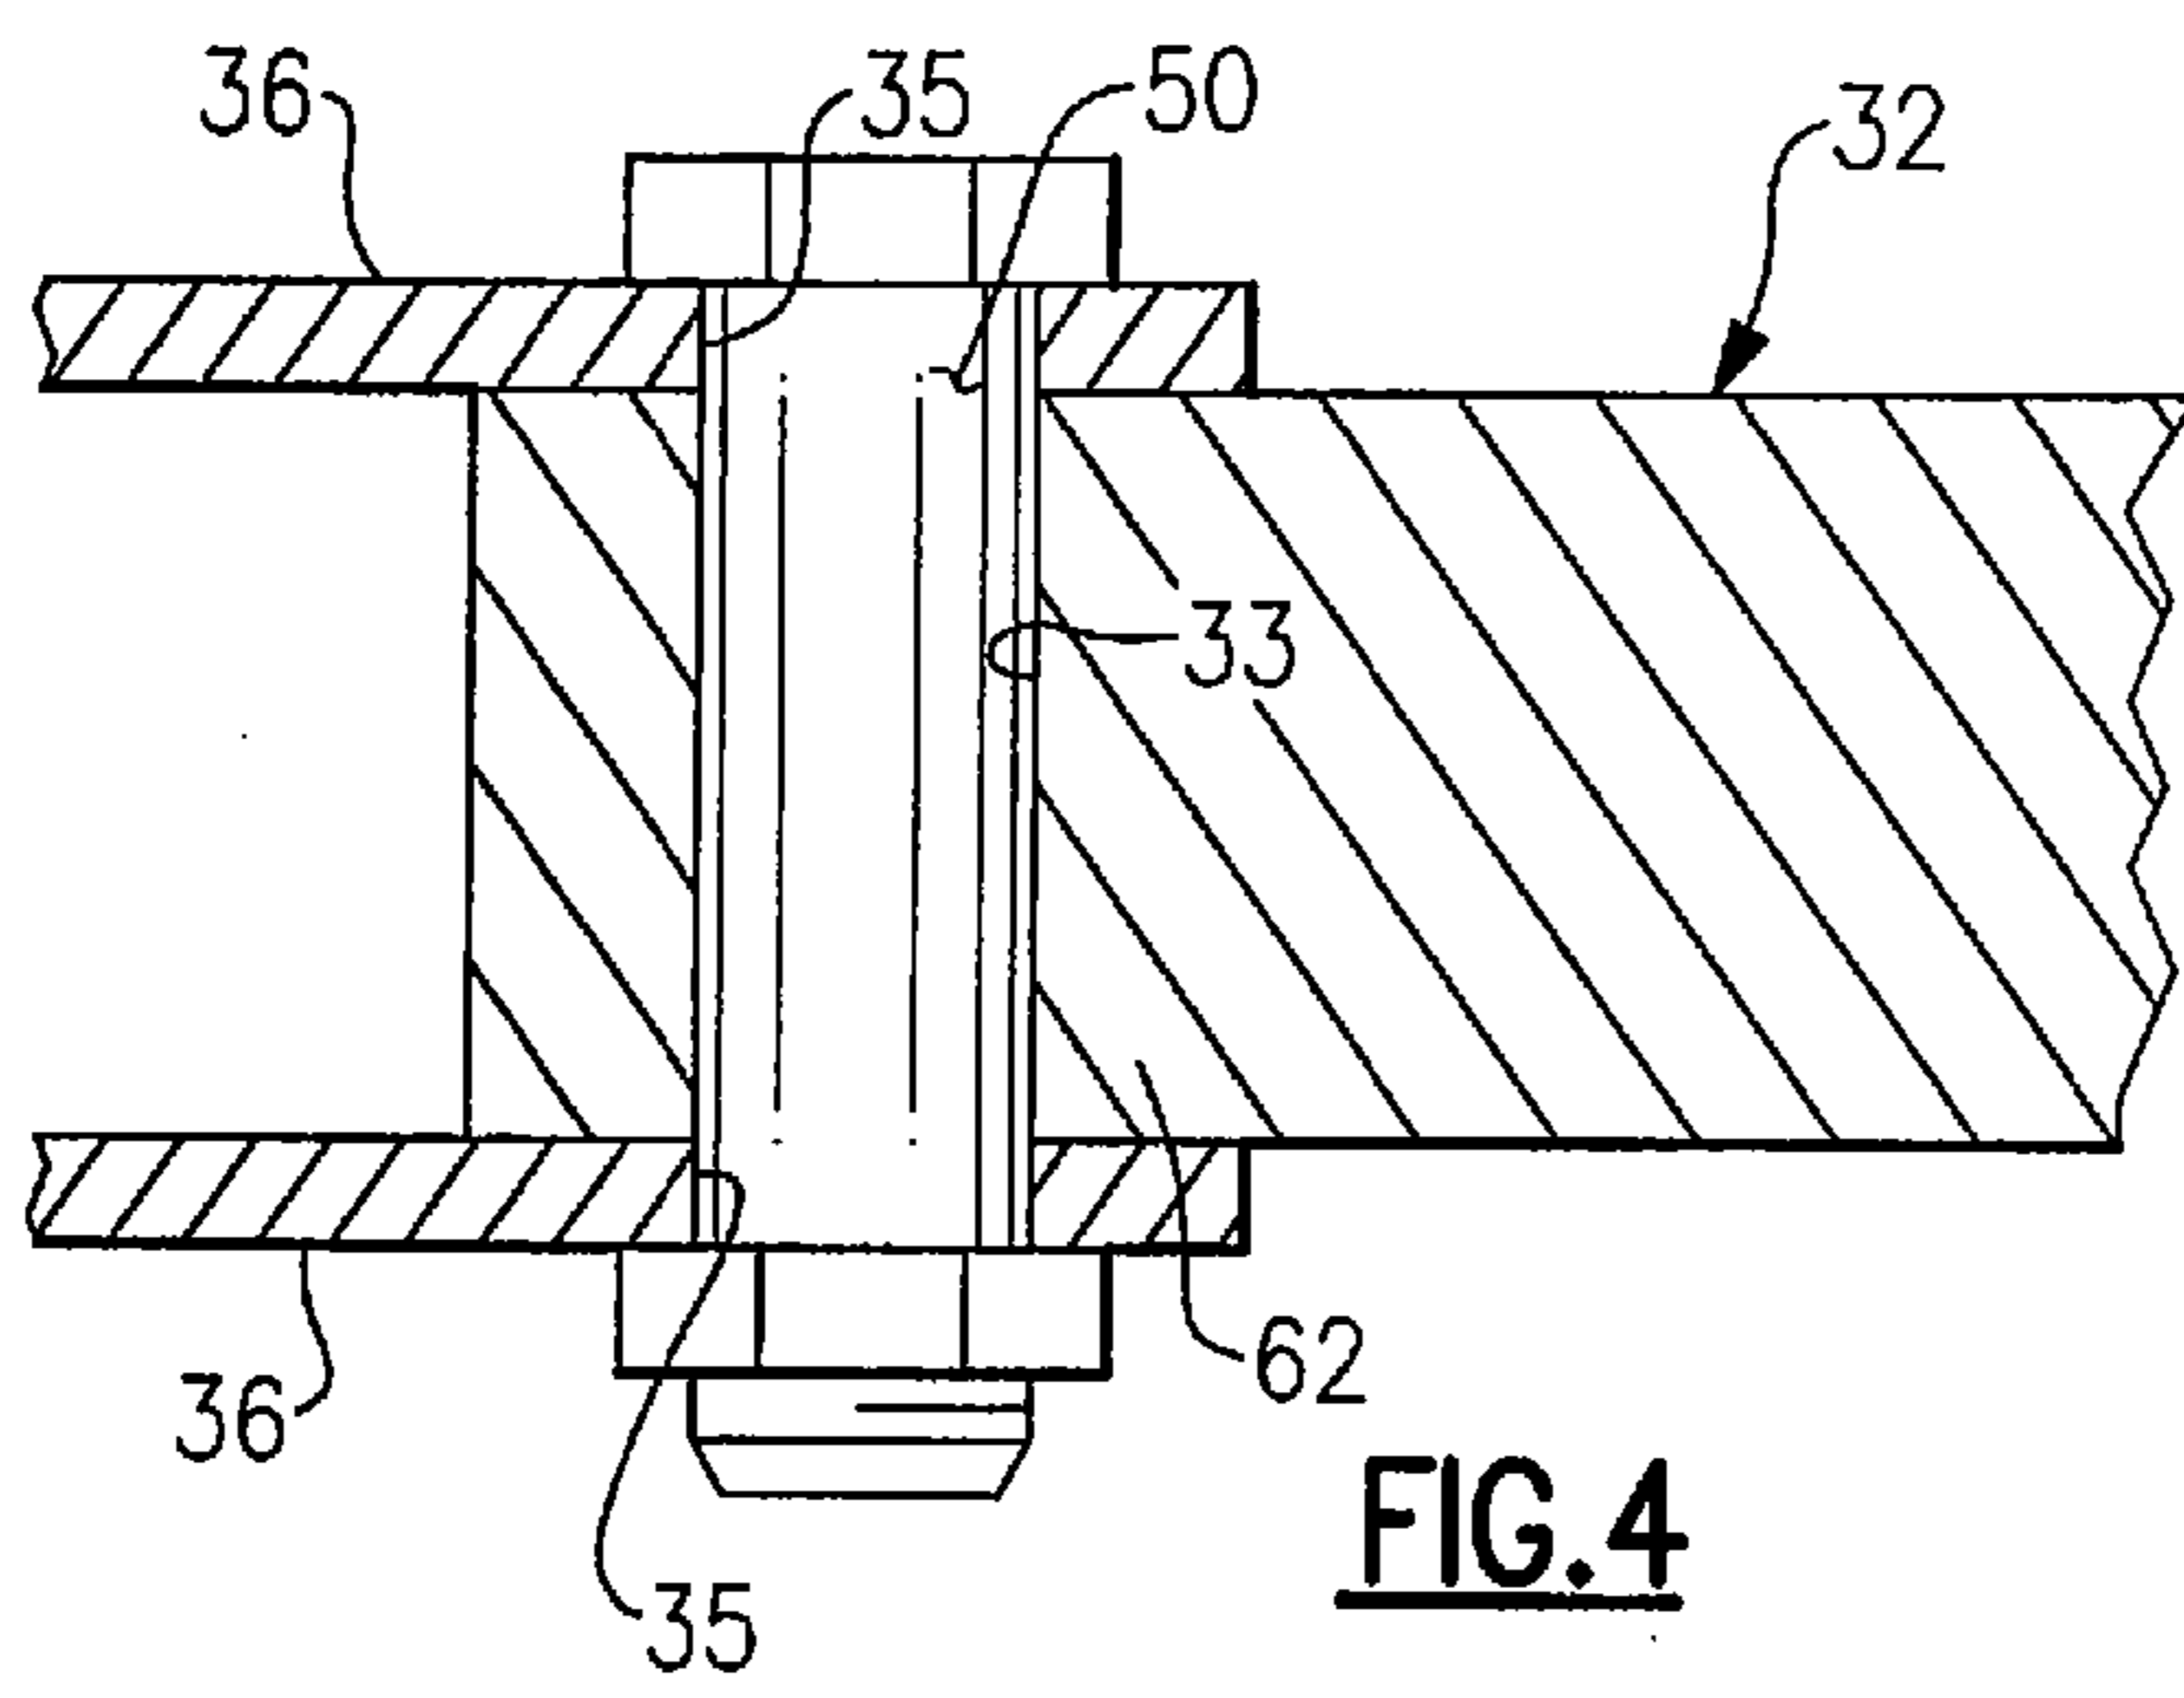
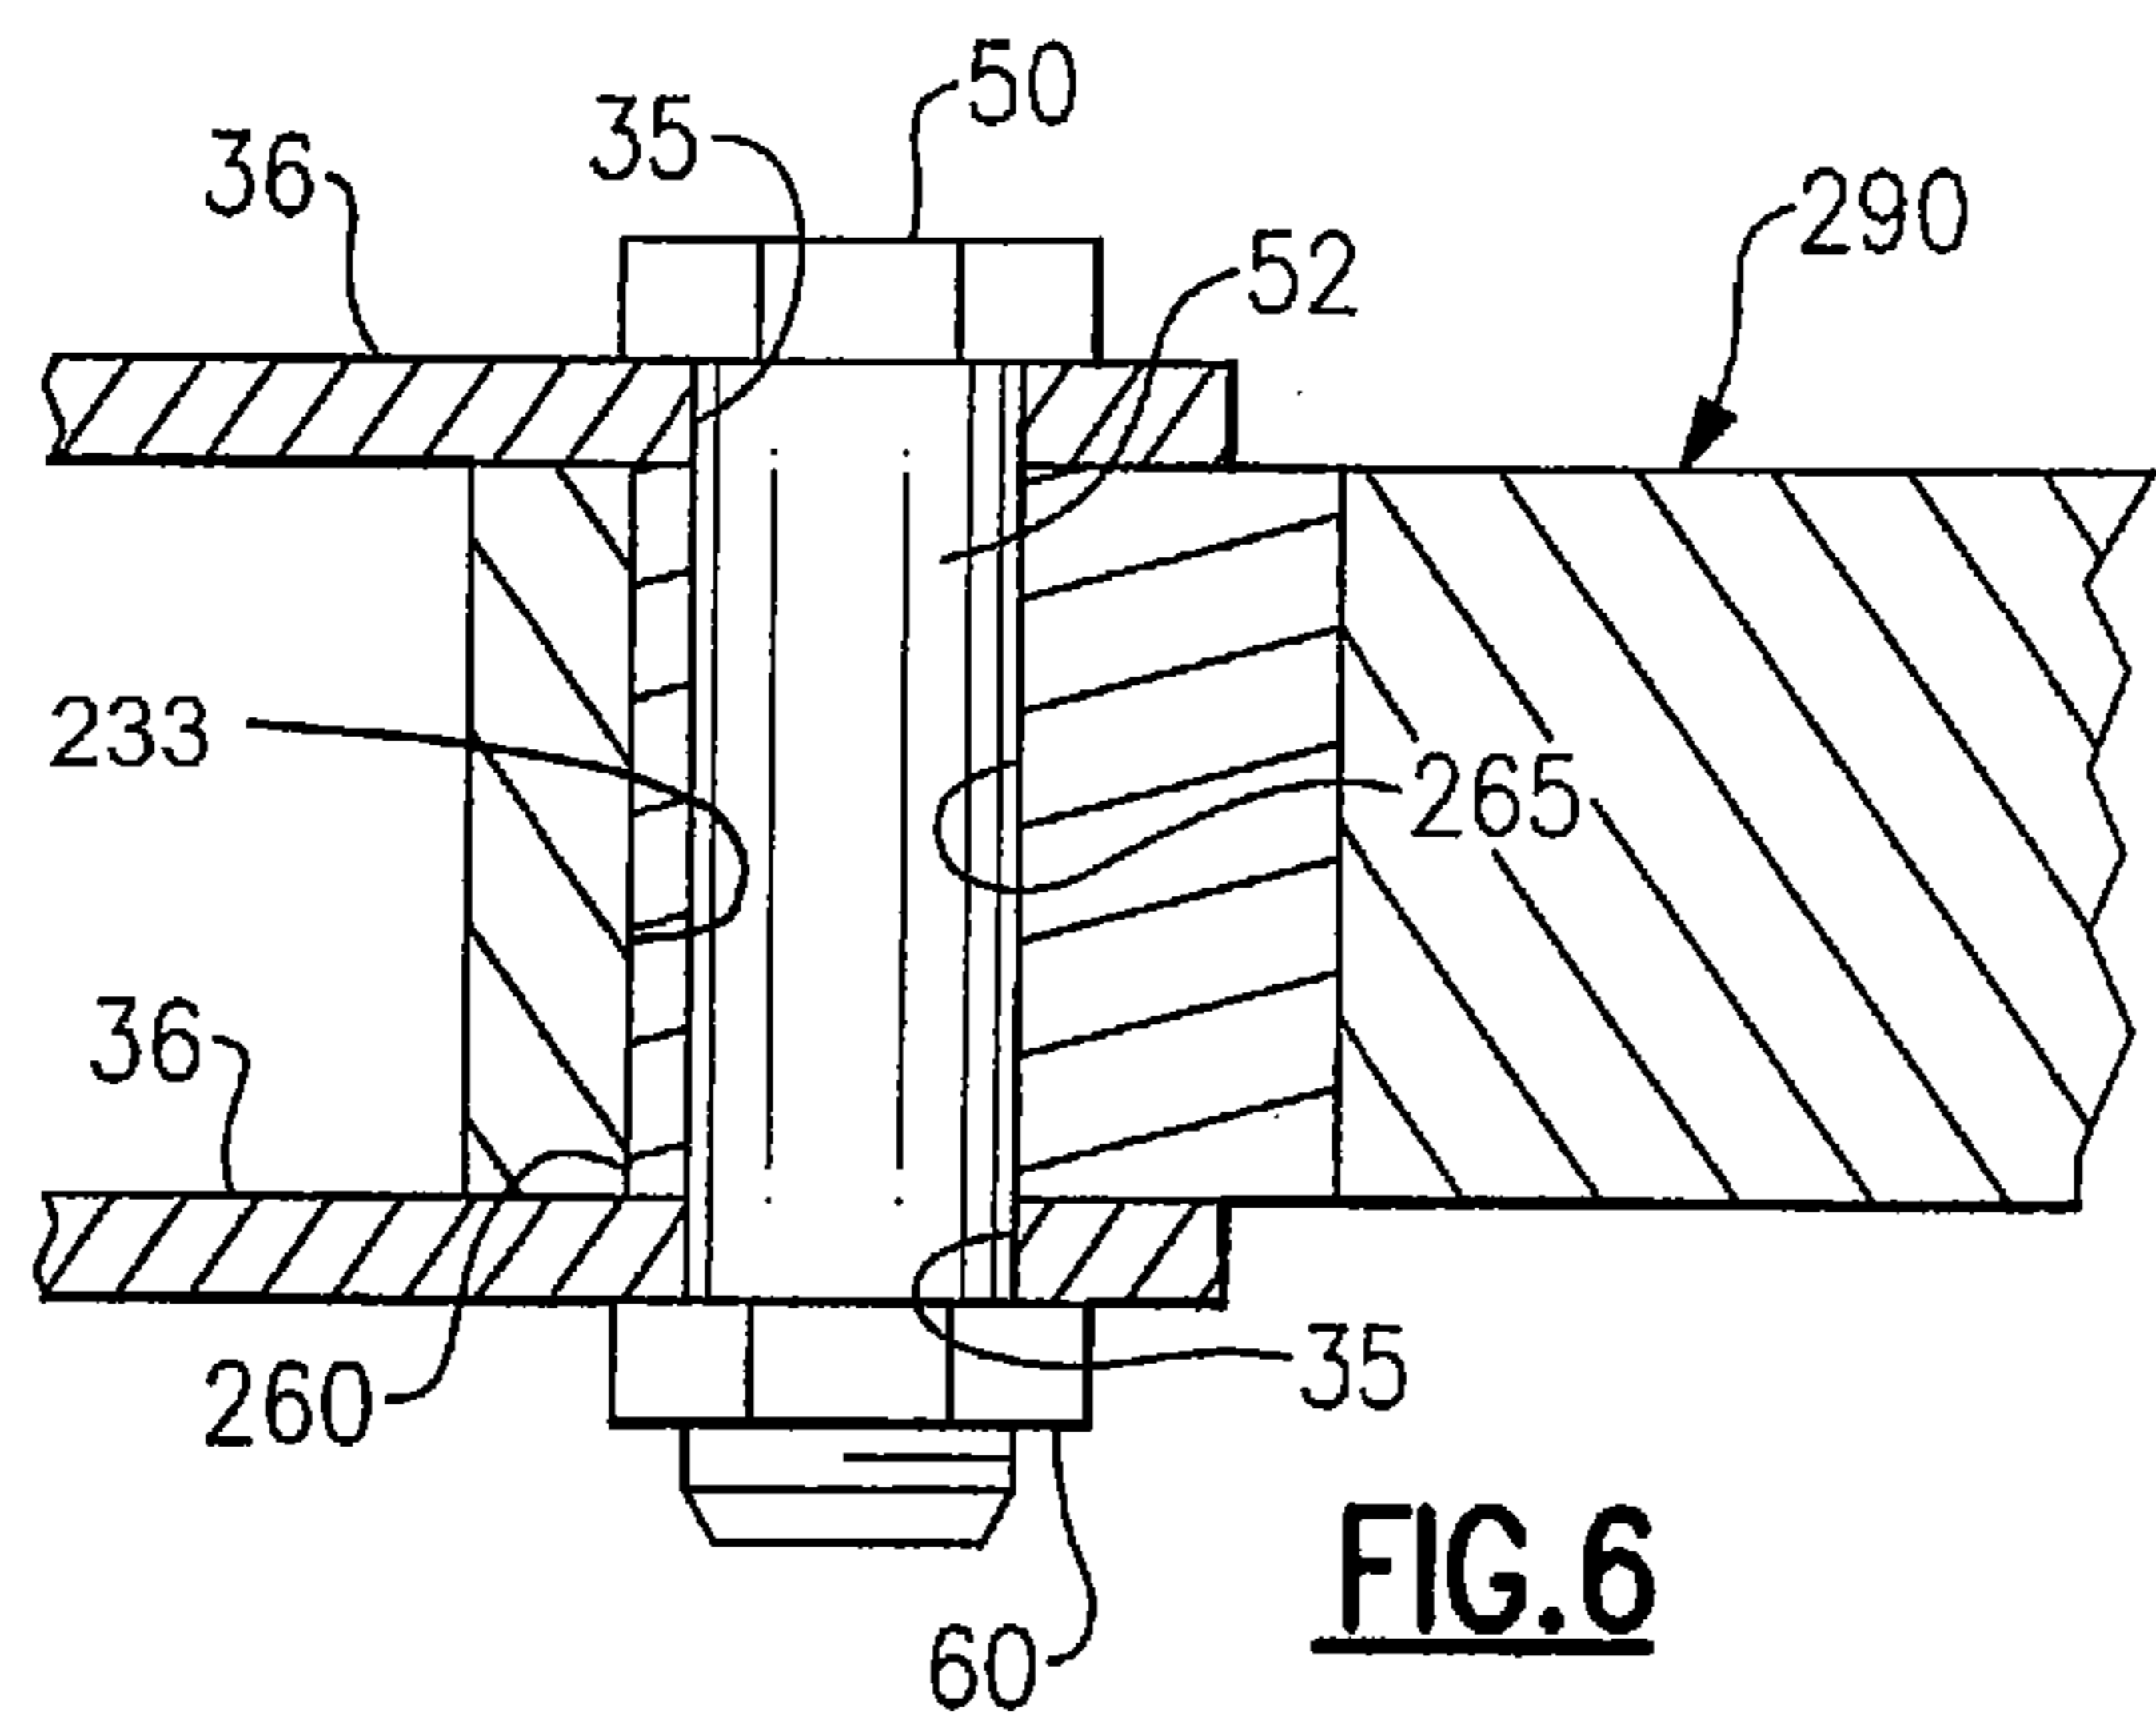
FIG. 3 is an exploded side elevation view of an exemplary embodiment of an access door and an associated hinge assembly;

FIG. 4 is a sectioned side elevation view of an exemplary embodiment of a portion of a hinge assembly pre-repair;

FIG. 6 is a sectioned side elevation view of an exemplary embodiment of a repaired hinge assembly;

Referring now to FIGS. 3 and 4, in particular, there is depicted in an exploded view an access door **20** that in a closed position covers the access opening **25** through the body of the nacelle **130**. The access door **20** is mounted to the nacelle **130** by a pair of hinge assemblies **30**. A pair of latches **40** may be mounted on the inside of the access door **20** along the side of the access door **20** from the access door is hinged. Although the access door **20** as depicted in FIG. 3 is supported for pivotal movement on a pair of hinge assemblies **30**, it is to be understood that in some applications, depending primarily upon the size and weight of the access door, the access door may be supported by a single hinge assembly or by two or more than two hinge assemblies.

Each hinge assembly **30** includes a hinge arm **32** mounted to the access door **20** to the structure of the access door **20** on the inside surface of the access door **20**, a bracket **34** mounted to the body of the nacelle **130** on the inside of the nacelle **130**, and a pair of pivot arms **36**. The bracket **34** is secured to the nacelle **130** by bolts **54**. Each of the pivot arms **36** is pivotally mounted at one end to the bracket **34** and, in assembly, is pivotally mounted at its other end, i.e. its distal end, to the hinge arm **32**. Each of the pivot arms **36** has a hole **35** passing through its distal end for receiving a hinge pin.

The hinge arm **32** includes a base plate **38** by which the hinge arm may be secured to the structure of the access door **20**, for example by bolts **52**. The hinge arm **32** has a hole **33** passing through the distal end **62** of the hinge arm **32**. When the hinge assembly **30** is assembled, the distal end **62** of the hinge arm **32** is inserted between distal ends of the paired pivot arms **36** with the respective pin receiving holes **35** and the pin receiving hole **33** aligned and with a hinge pin **50** inserted through the aligned holes **33**, **35**.

As noted previously, in conventional practice the various parts of the hinge assemblies are made of aluminum, a light weight material that has a relatively high specific strength corrected for density. However, aluminum is prone to wear. Consequently, over time in service, the hinge pin wears against the bore of the hole **33** in the distal end of the hinge arm **32**, which results in the hole **33** becoming enlarged. Typically, the primary area of wear is on the distal side of the hole **33** which results in a thinning of the strap portion **38** of
