(10) **Patent No.:** **US 8,661,667 B2**
(45) **Date of Patent:** **Mar. 4, 2014**

(54) **HINGE ARM REPAIR**

(73) Assignee: **United Technologies Corporation**,
Hartford, CT (US)

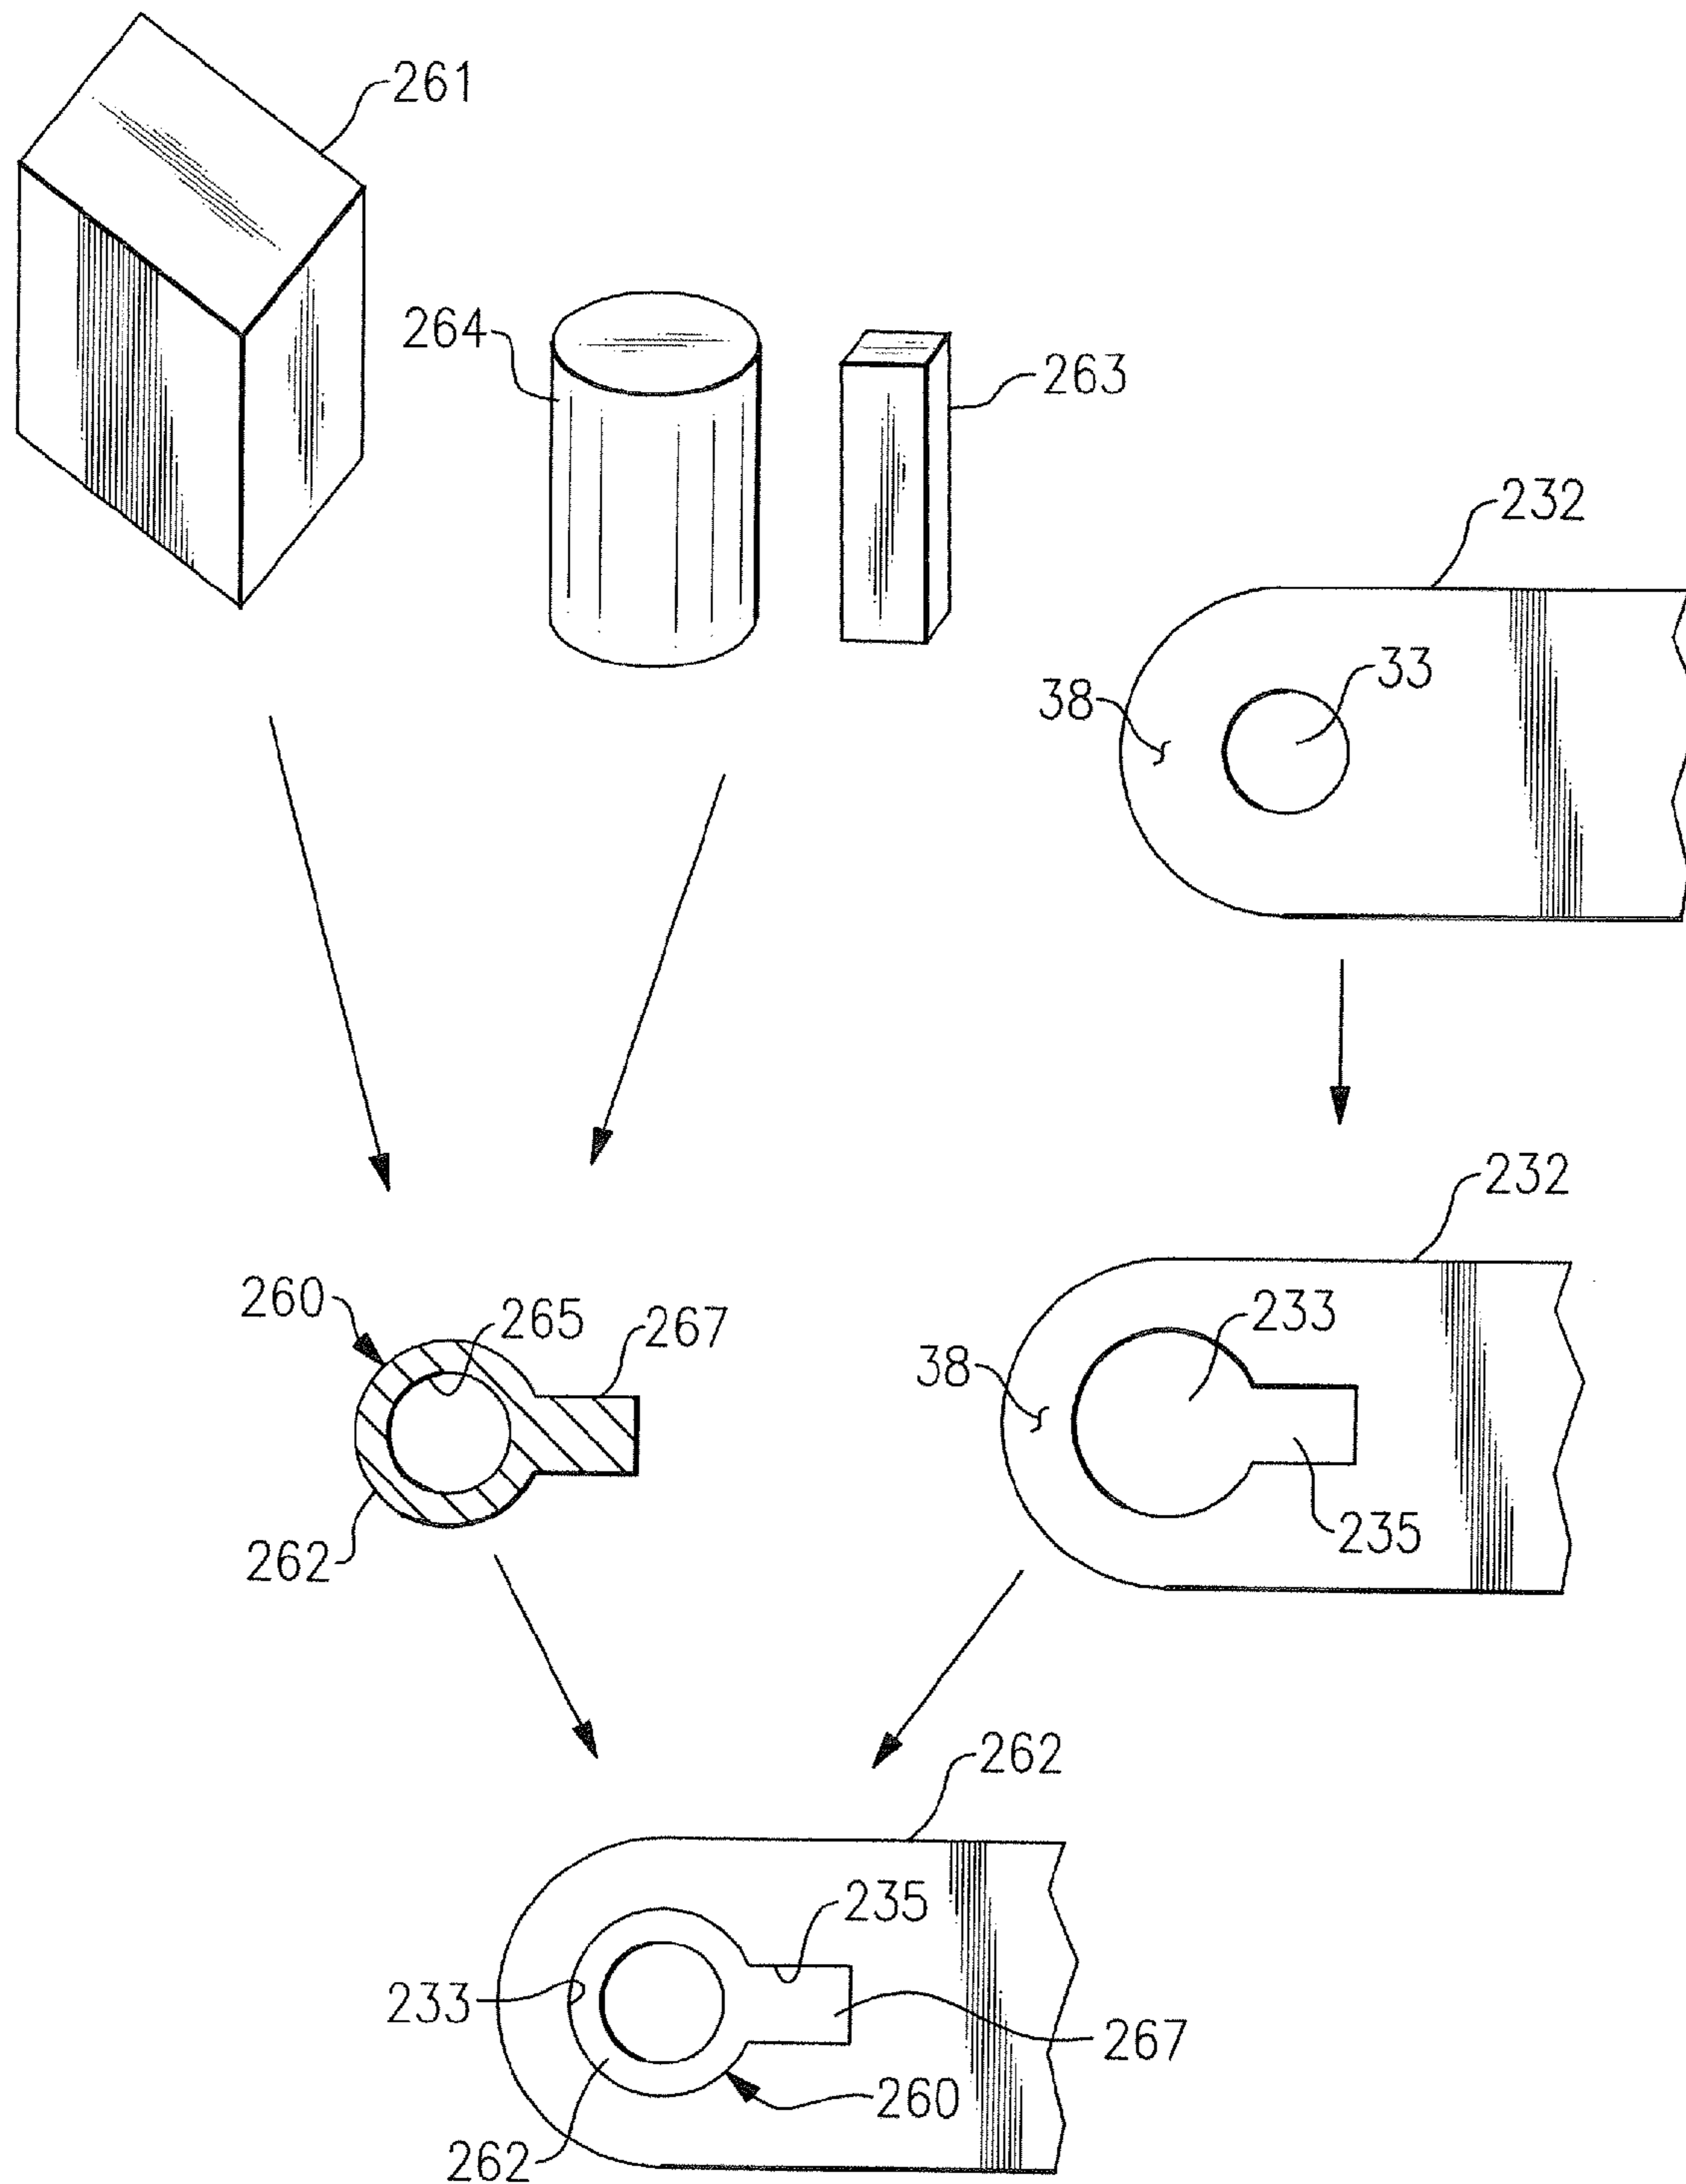
FIG.5

FIG. 5 is a schematic illustration of an exemplary embodiment of a process of repair an access door hinge in accordance with the invention;

Referring now to FIGS. 5-8 in particular, the repair of a hinge assembly according to the method disclosed herein is illustrated in FIG. 5 and embodiments of a hinge assembly repaired in accordance with the method disclosed herein are illustrated in FIGS. 6, 7, 8A and 8B. To repair a worn hinge arm 232, the hinge arm 232 is disassembled from hinge assembly and the hole 33 through the worn hinge arm 232 is redrilled to form a new hole 233 that has a larger bore diameter than the original hole 33. The larger bore of the new hole 233 is sized to accommodate a bushing to be inserted the hole 233, which will be discussed in further detail later herein. Additionally, a keyway 235 is machined into the bore wall of the hole 233 away from the strap portion 38. Forming the keyway 235 in the strap portion 38 should be avoided as doing so could, in some applications, weaken the strap portion 38 to the point that the strap portion 38 is susceptible to eventual structural failure. The keyway 235 extends coaxially with the bore along the entire axial extent of the hole 233 through the hinge arm and extends radially outwardly from the bore of the hole 233 into the hinge arm 232 on the side of the hole 233 opposite the strap portion 38 at the distal end of the hinge arm 232.

A keyed bushing 260 is inserted in the overbored hole 233 and the keyway 235. The keyed bushing 260 comprises a cylindrical body 262 having a key 267 extending axially along one side of the cylindrical body 262 and projecting radially outward from the cylindrical body 262. The keyed bushing 260 may be machined from a solid block 261 of aluminum material or prepared by fabricating, for example by welding, an aluminum stake 263 to a solid rod 264 of aluminum material. If formed by welding, heat treatment of the welded unit is done separate from the hinge arm, thereby maintaining the parent material properties of the hinge arm. A bore 265 is drilled axially through the machined or fabricated bushing blank to accommodate a hinge pin. It is to be understood that the bore 265 may be drilled either before or after the bushing is installed into the hinge arm under repair.

The outer diameter of the cylindrical body 262 of the bushing 260 is sized relative to the bore diameter of the bore 265 of the new hole 233 and the key 267 is sized relative to the keyway 235 associated with the new hole 233 to provide a press-fit relationship between the cylindrical body 262 of the keyed bushing 260 and the bore 265 and between the respective sides of the key 267 with the abutting surfaces of the keyway 235. The press-fit relationship serves to prevent the keyed bushing 260 from "backing out" of the bore 265 of the new hole 233 after the repaired hinge arm 290 is returned to service.

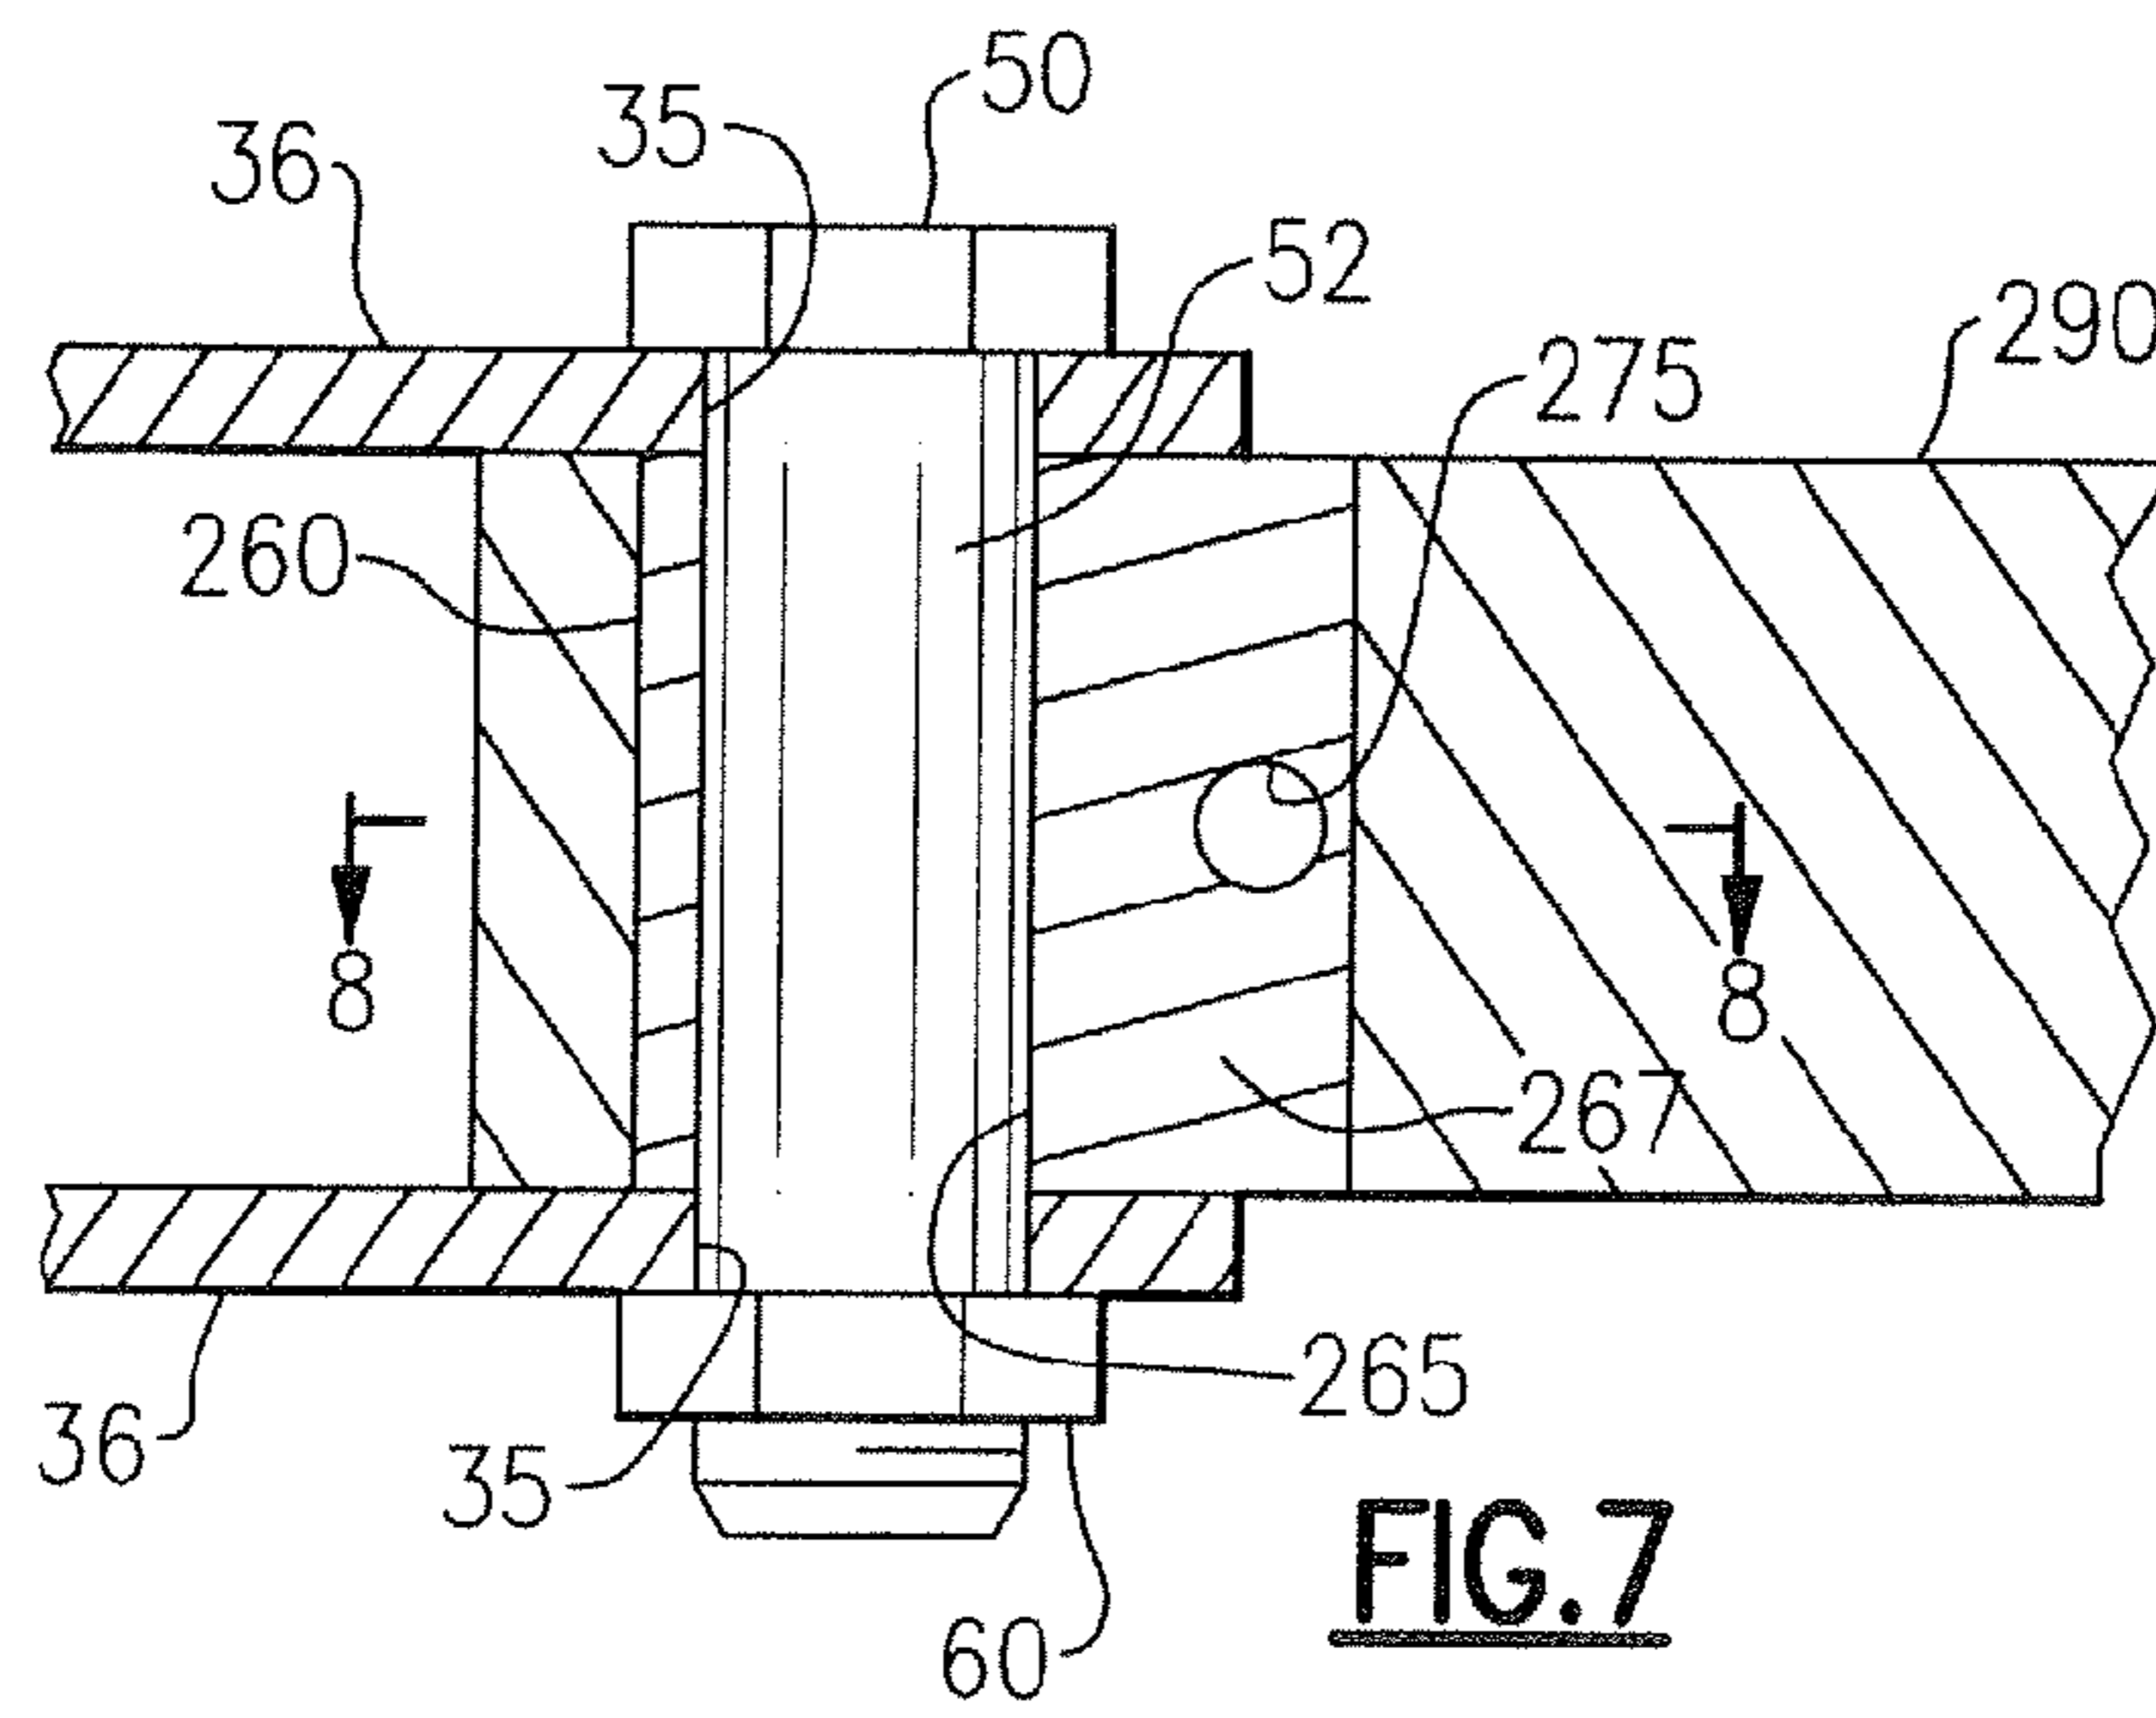
FIG. 7 is a sectioned side elevation view of another exemplary embodiment of a repaired hinge assembly;

Referring now to FIGS. 7-8, to provide additional assurance that the keyed bushing 260 will not "back out" of the hole 233, the key 267 may be staked to the repaired hinge arm 232 after being positioned within the keyway 255. For example, a staking hole 275 may be drilled transversely into the side 272 of the repaired hinge arm 232 so as to extend through the key 267 and the keyway 255. A staking pin 274 may be inserted into the staking hole 275 so as to extend through the key 267 and the keyway 255 thereby locking the keyed bushing 262 into place and preventing the key 267, and therefore the keyed bushing 260, from backing out. In an embodiment, the staking pin 274 has a shaft that may be sized relative to the staking hole 275 to provide a press fit between the staking pin 274 and the staking hole 275 when the staking pin 274 is inserted into the staking hole 275, such as illustrated in FIG. 8A. In an embodiment, the staking pin 274 may

be secured into the staking hole 275 by application of a retaining compound, such as for example Loctite 635 marketed by Henkel Aerospace, alone or in conjunction with the use of a press fit. In an embodiment, the staking pin 274 may be secured in the staking hole 275 by a threaded connection therebetween. For example, the portion of the staking hole 275 on the far side of the keyway 255 and the distal end of the staking pin 274 may be threaded whereby the staking pin 274 may be screwed into the lock hole 275, such as illustrated in FIG. 8B. With the key 267 being held within the keyway 255, either by press-fit or by locking with a staking pin, rotation of the repaired hinge arm 232 relative to the keyed bushing 260 is prevented.

To reinstall the repaired hinge arm 290 into service, the base plate of the hinge arm is remounted to the inside structure of the access door and the distal end of the repaired hinge arm 290 is reinserted between the pair of pivot arms 36 as illustrated in FIGS. 6 and 7. With the bore 265 of the keyed bushing 260 in the repaired hinge arm 290 aligned with the holes 35 in the respective pivot arms 36, a hinge pin 50 is inserted through the aligned holes. The hinge pin 50 may be a bolt having a shaft 52 having a threaded distal end adapted to receive a threaded nut 60 for locking the hinge pin 50 in place. The portion of the shaft 52 of the hinge pin 50 in contact with the inside bore of the keyed bushing 262 is unthreaded and has a shaft diameter that is sized relative to the inside diameter of the bore through the keyed bushing 262 to provide a proper clearance, i.e. not too loose and not too tight, between the hinge pin 50 and the bore through the keyed bushing 262. The amount of clearance desired is a design consideration and is within the skill of a person of ordinary skill in the art.

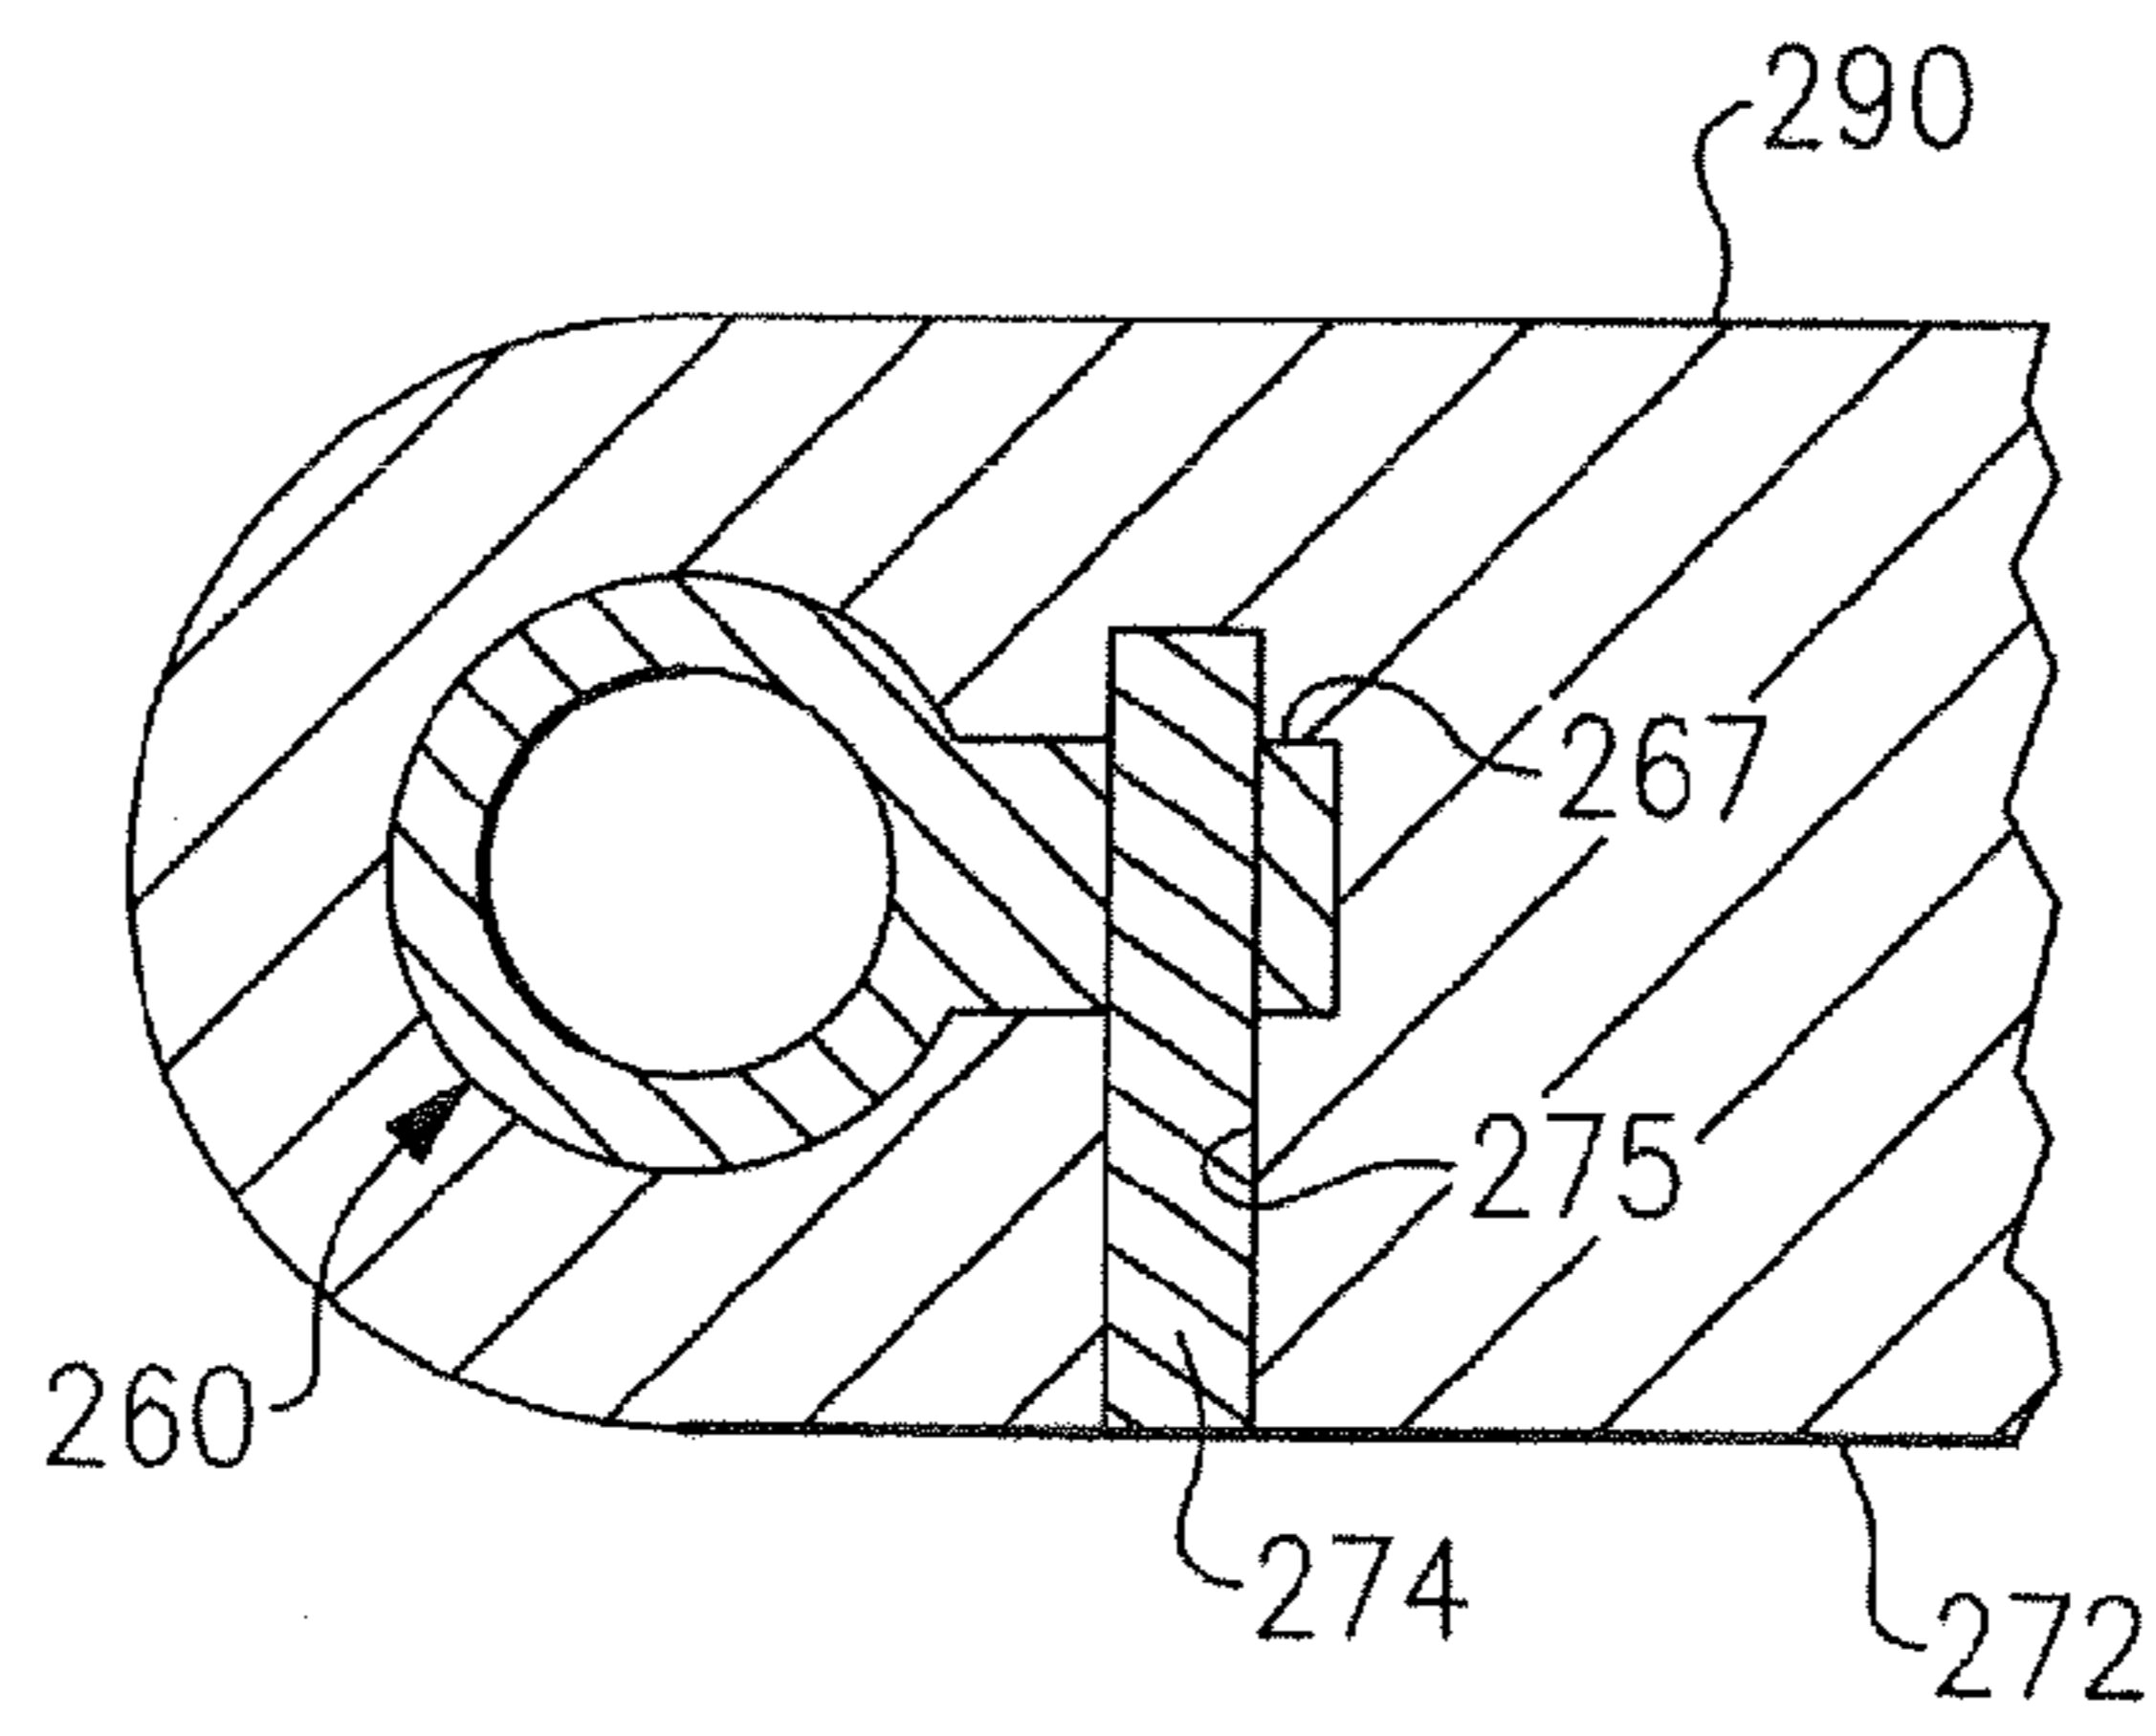
FIG. 8A is a plan view of the repaired hinge assembly of FIG. 7 taken along line 8-8; and

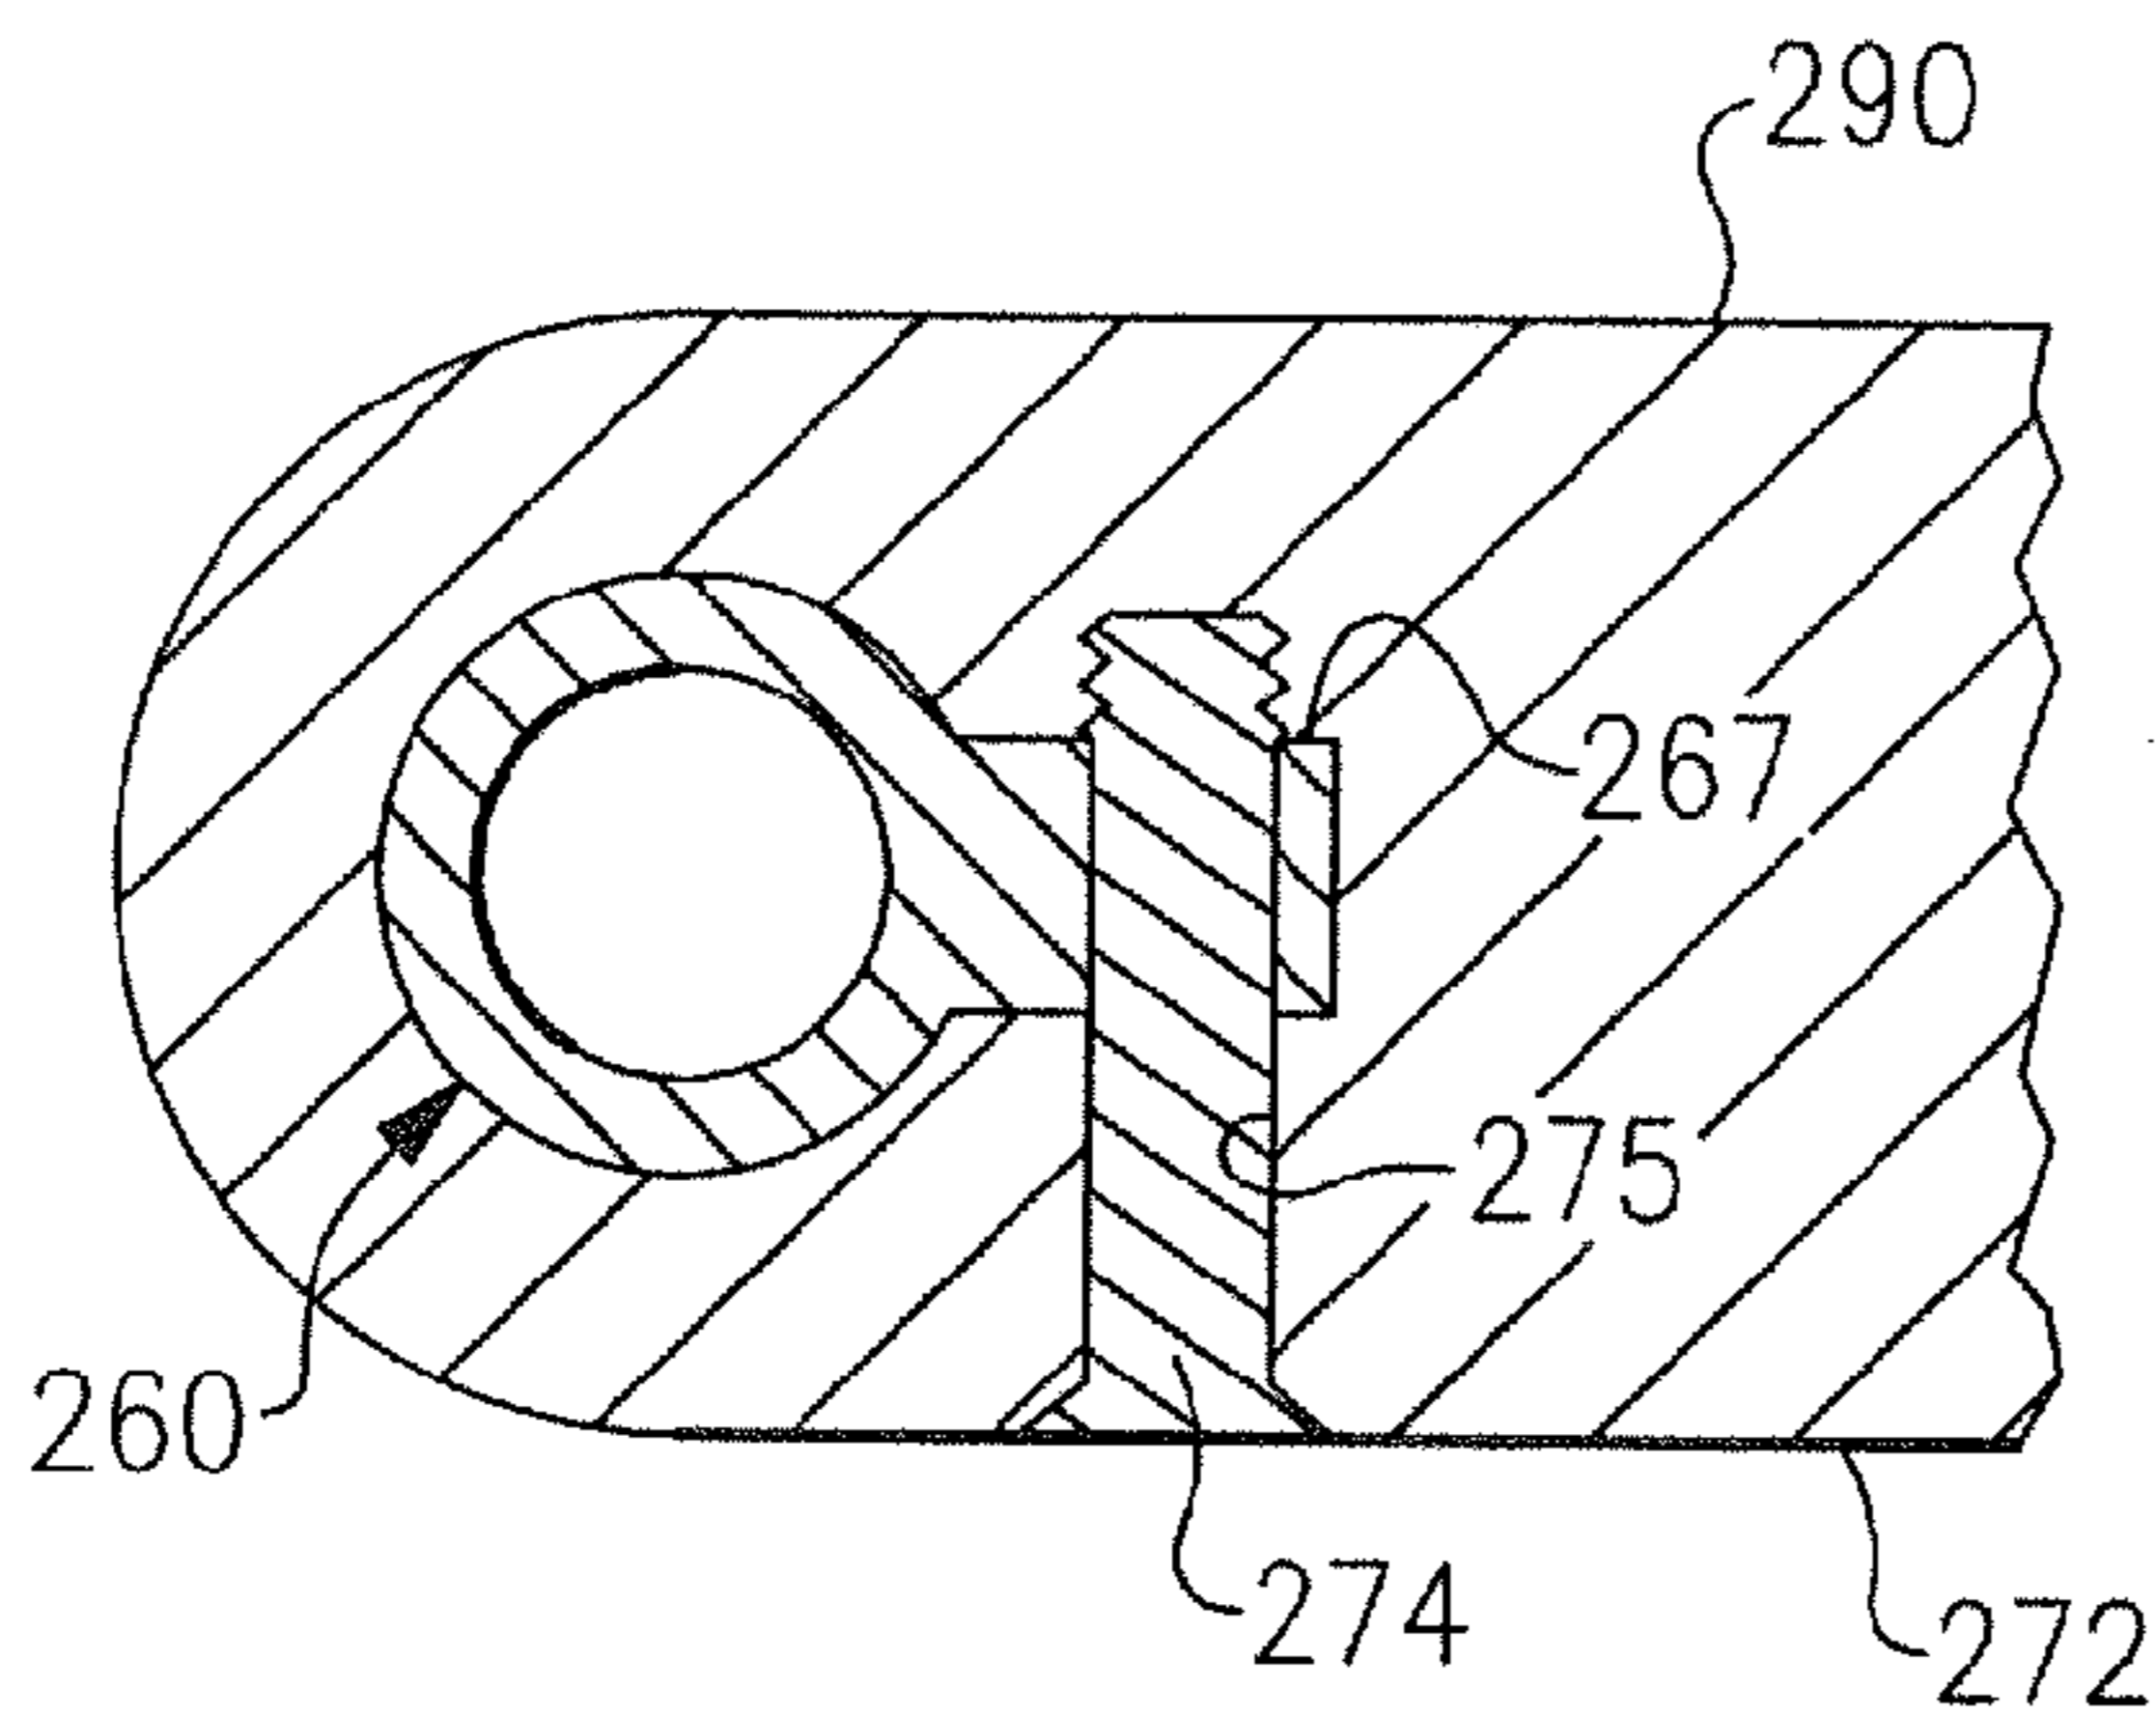
FIG. 8B is a plan view of another embodiment of the repaired hinge assembly of FIG. 7 taken along line 8-8.
