(10) **Patent No.:** **US 8,695,527 B2**
(45) **Date of Patent:** **Apr. 15, 2014**

(54) **GLAZING EROSION INDICATOR**

(73) Assignee: **Airbus Operations Limited**, Bristol (GB)

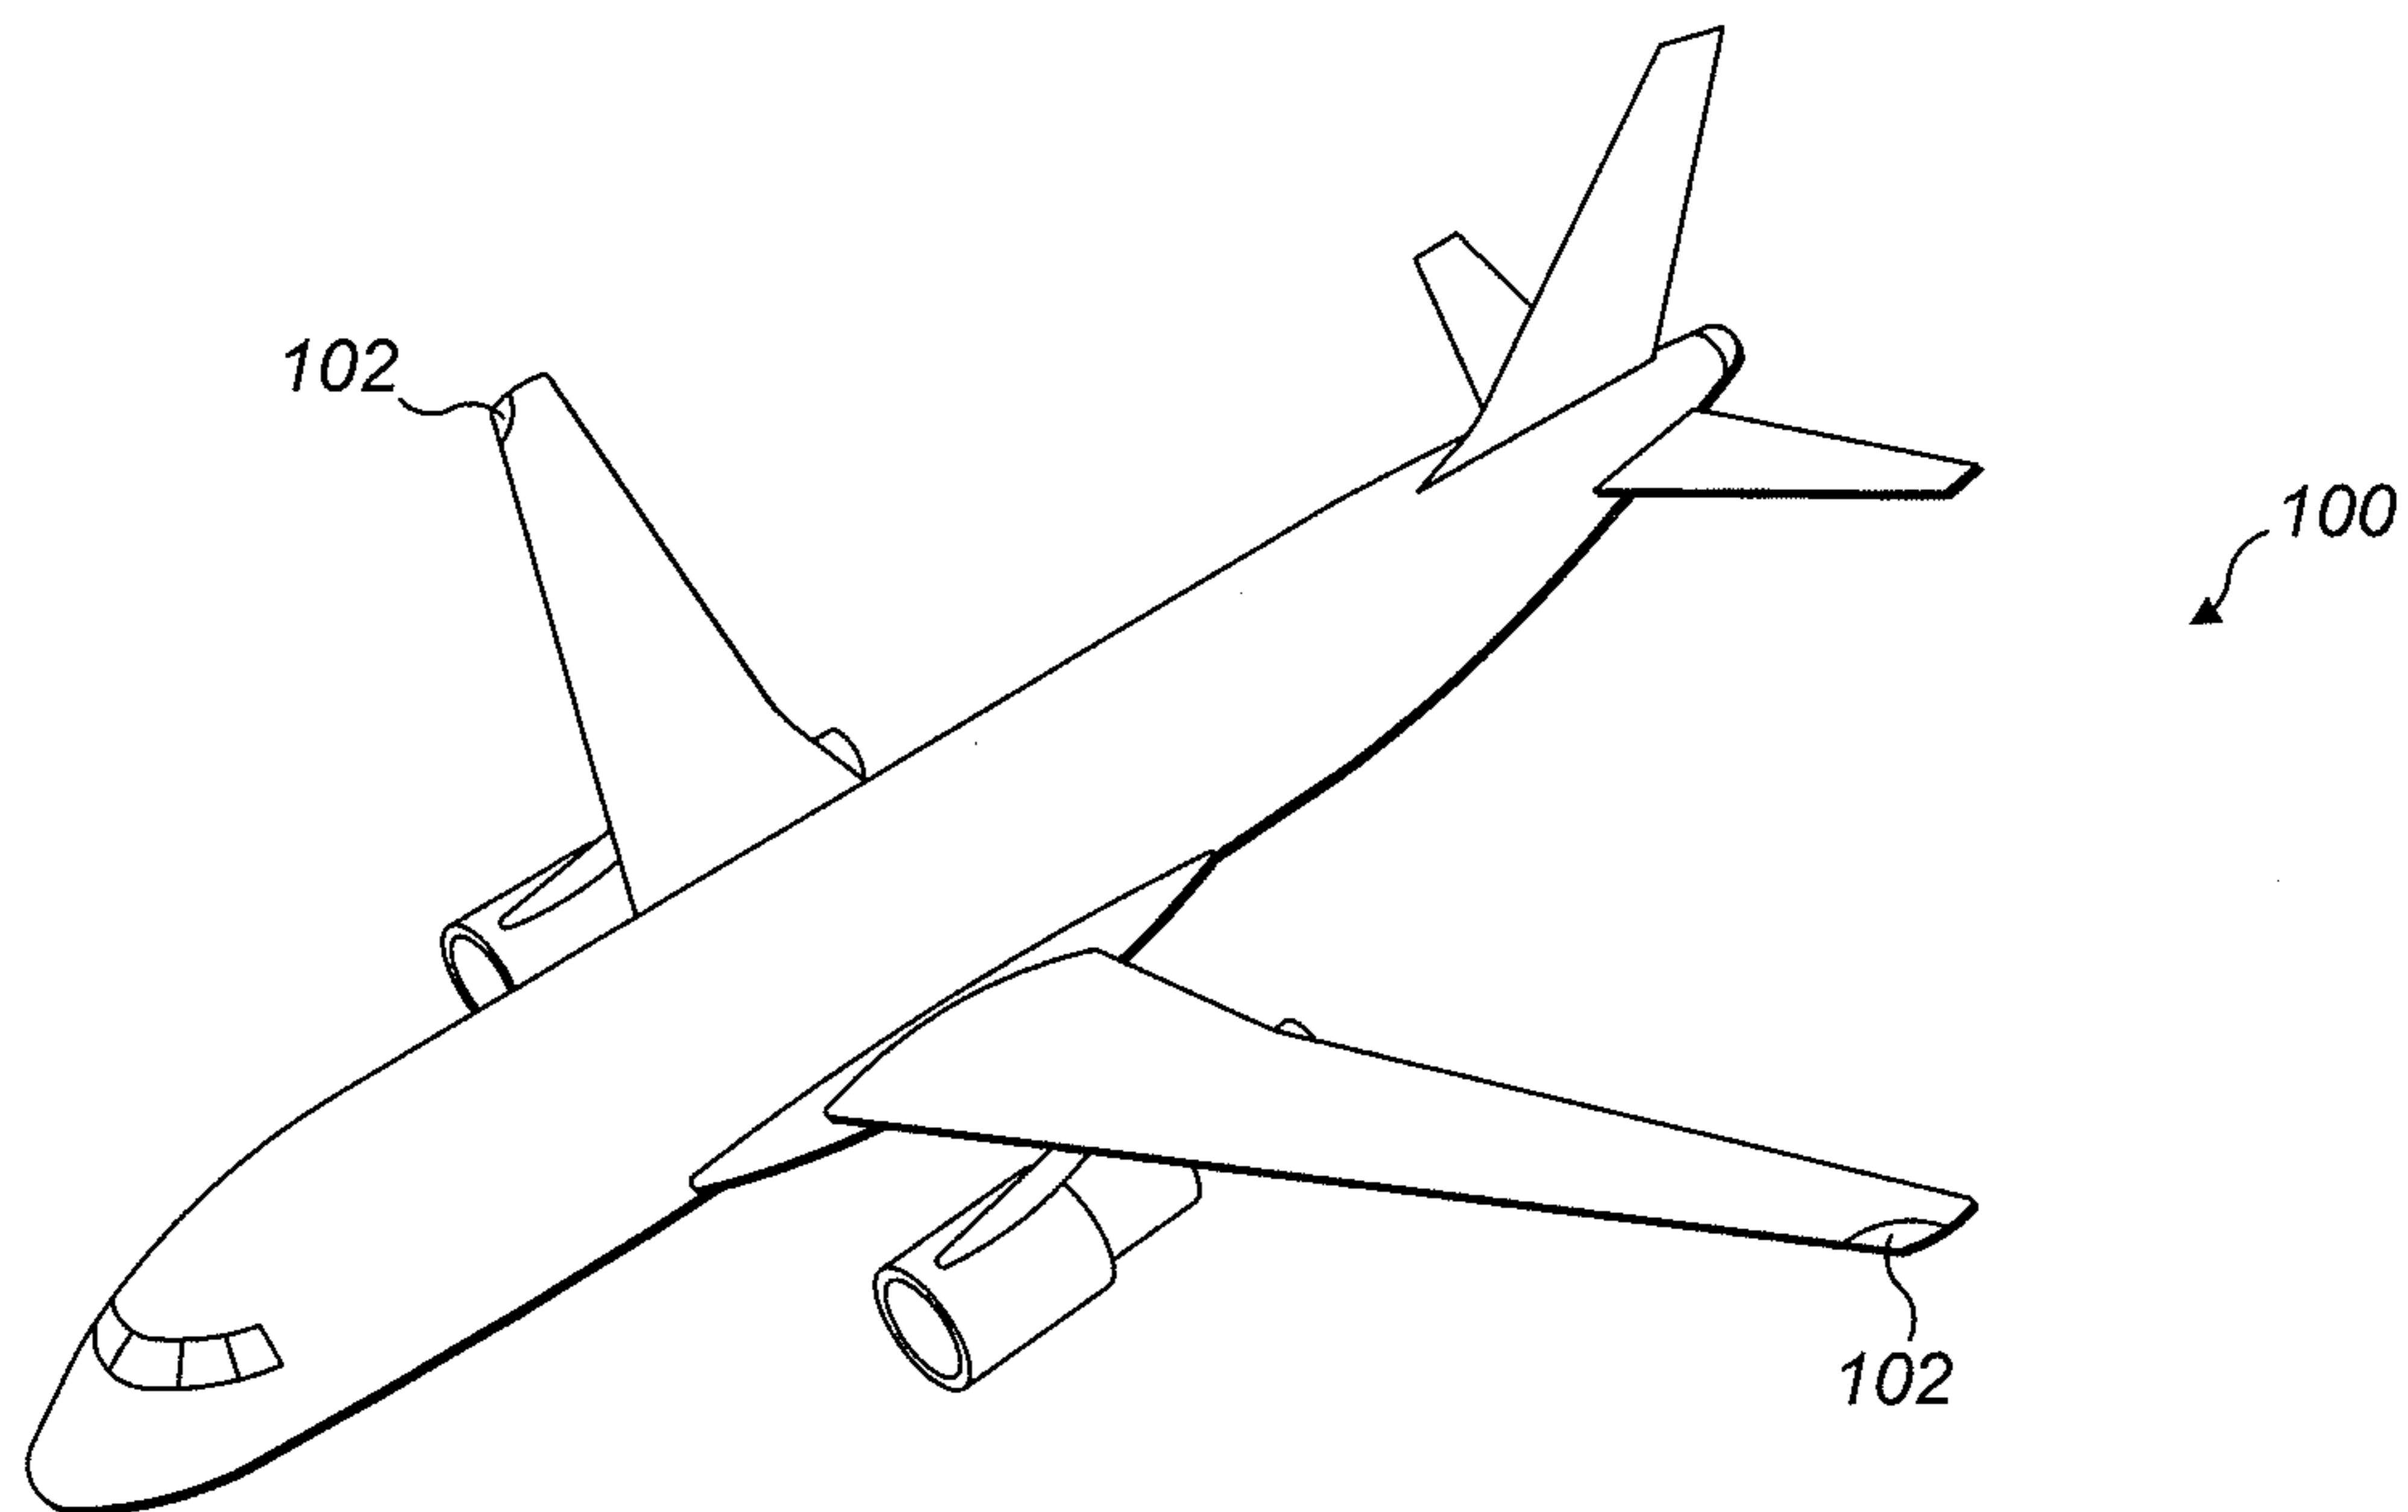
FIG. 1 is a perspective view of an aircraft comprising a wear indicator in accordance with the present invention;

Turning to FIG. 1, there is provided an aircraft **100** comprising forward facing lights **102**.

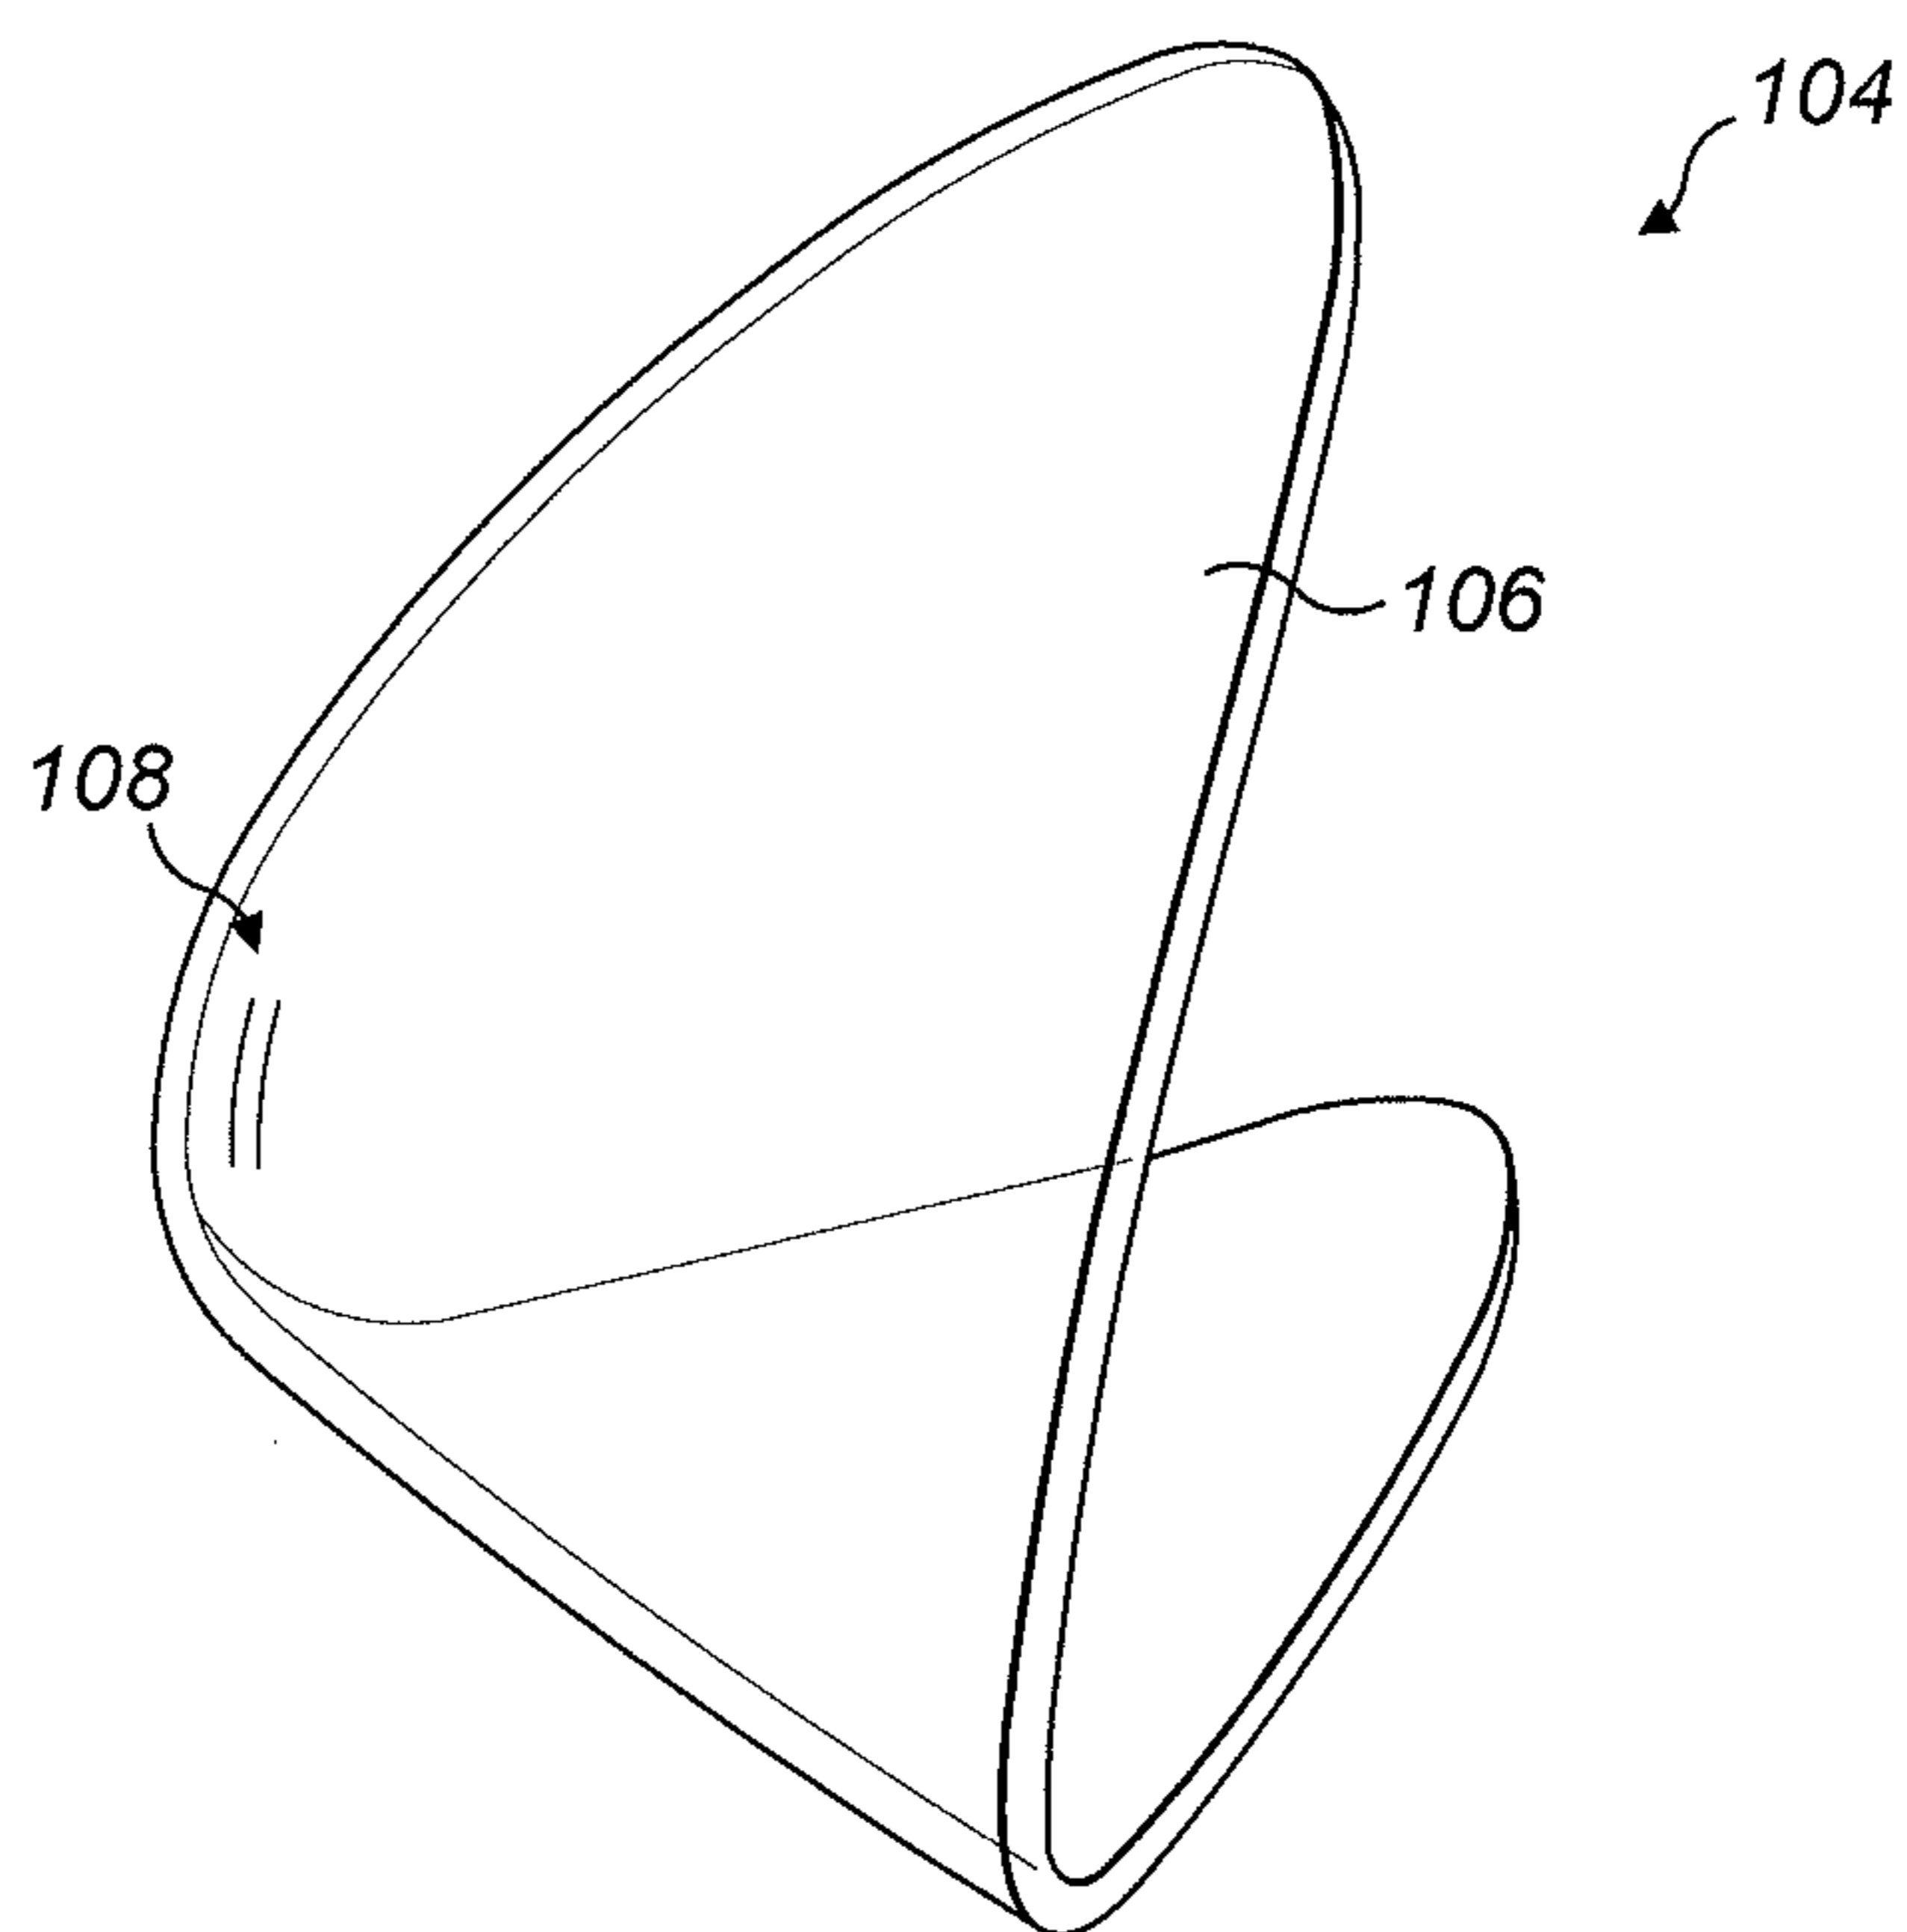
FIG. 2 is a perspective view of an aircraft glazing component comprising a wear indicator in accordance with the present invention;

Turning to FIG. 2, each light comprises a glazing component **104** having a curved body **106** constructed from a transparent material such as polycarbonate. The body **106** is provided with a visual wear indicator **108** provided on an interior face and comprising a pair of parallel, straight offset lines. The wear indicator **108** is positioned on a part of the body which covers a lamp, and not any part which may be backed by mounting formations or backing plates etc. In other words, the indicator is positioned to be in the path of the emitted light of the aircraft light arrangement. The indicator is positioned near the centre of the body **106** so that it is easily visible to ground staff. It will be noted that the wear indicator **108** is

positioned near the foremost point of the body **106** in use; i.e. the position of the highest amount of wear and erosion.

By providing two offset parallel straight lines, as erosion occurs, the lines will eventually become blurred. Therefore, the ground crew can be informed that once they cannot distinguish the two lines, erosion has increased to a level at which the glazing component **104** needs to be replaced. Preferably the lines are less than 10 mm apart.

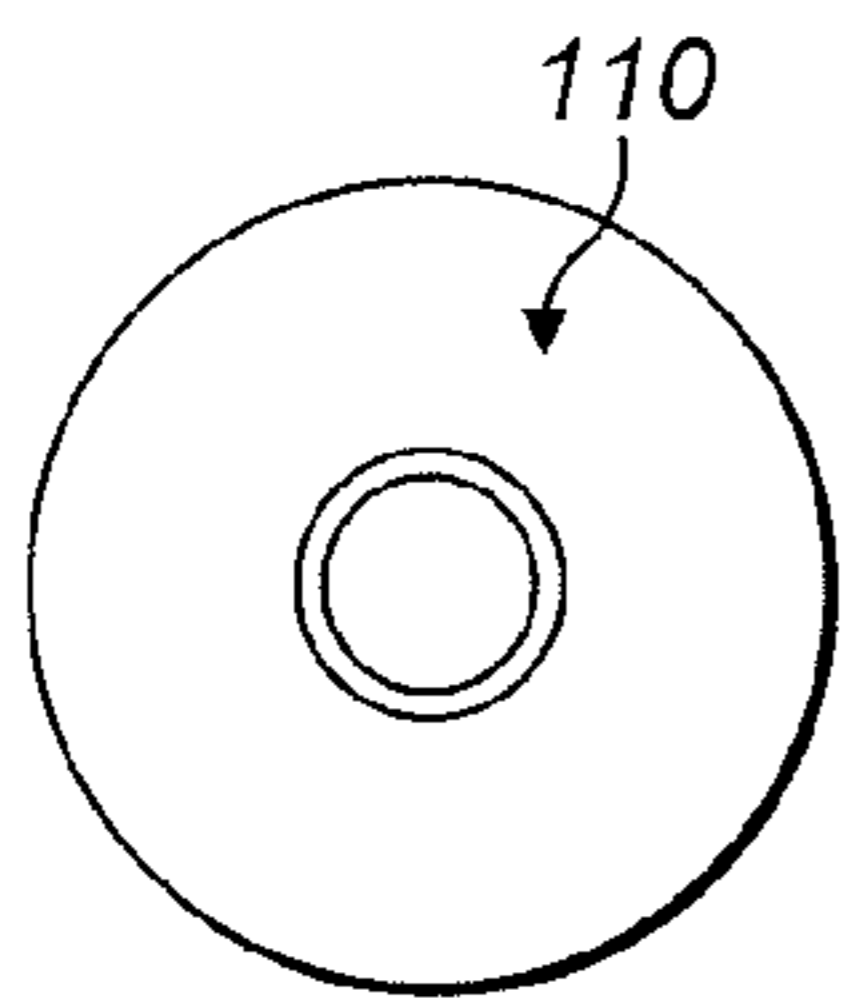
FIG. 3a

Turning to FIGS. **3a** to **3d**, there are shown several variations on the visual wear indicator **108**. In FIG. **3a**, a visual wear indicator **110** is provided comprising two concentric circles, the boundary between which will be blurred as erosion occurs. A similar arrangement is shown in FIG. **3b** in which a wear indicator **112** comprises a filled-in circle surrounded by a space circular boundary. An advantage of the wear indicator **112** is that it is more visible in use than the wear indicator **110**.

FIGS. 3a to 3d are example wear indicators;

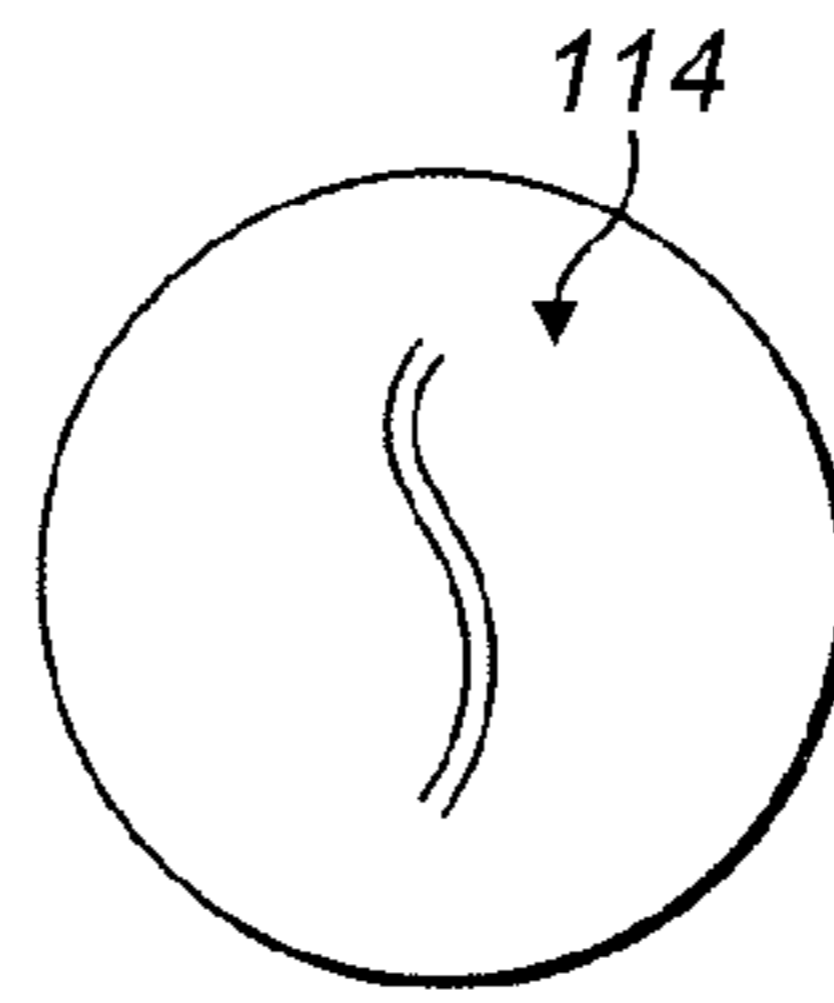
FIG. 3c

FIG. **3c** shows a wear indicator **114** comprising two spaced curved lines which work in a similar fashion to the wear indicator **108**. Finally, FIG. **3d** shows a wear indicator **116** which comprises text in the form of the word "pass" which gradually becomes obscured as erosion takes place. The text is of a similar shade/texture as eroded glazing. Therefore, once the word "pass" is no longer visible, the component fails the test and should be replaced.

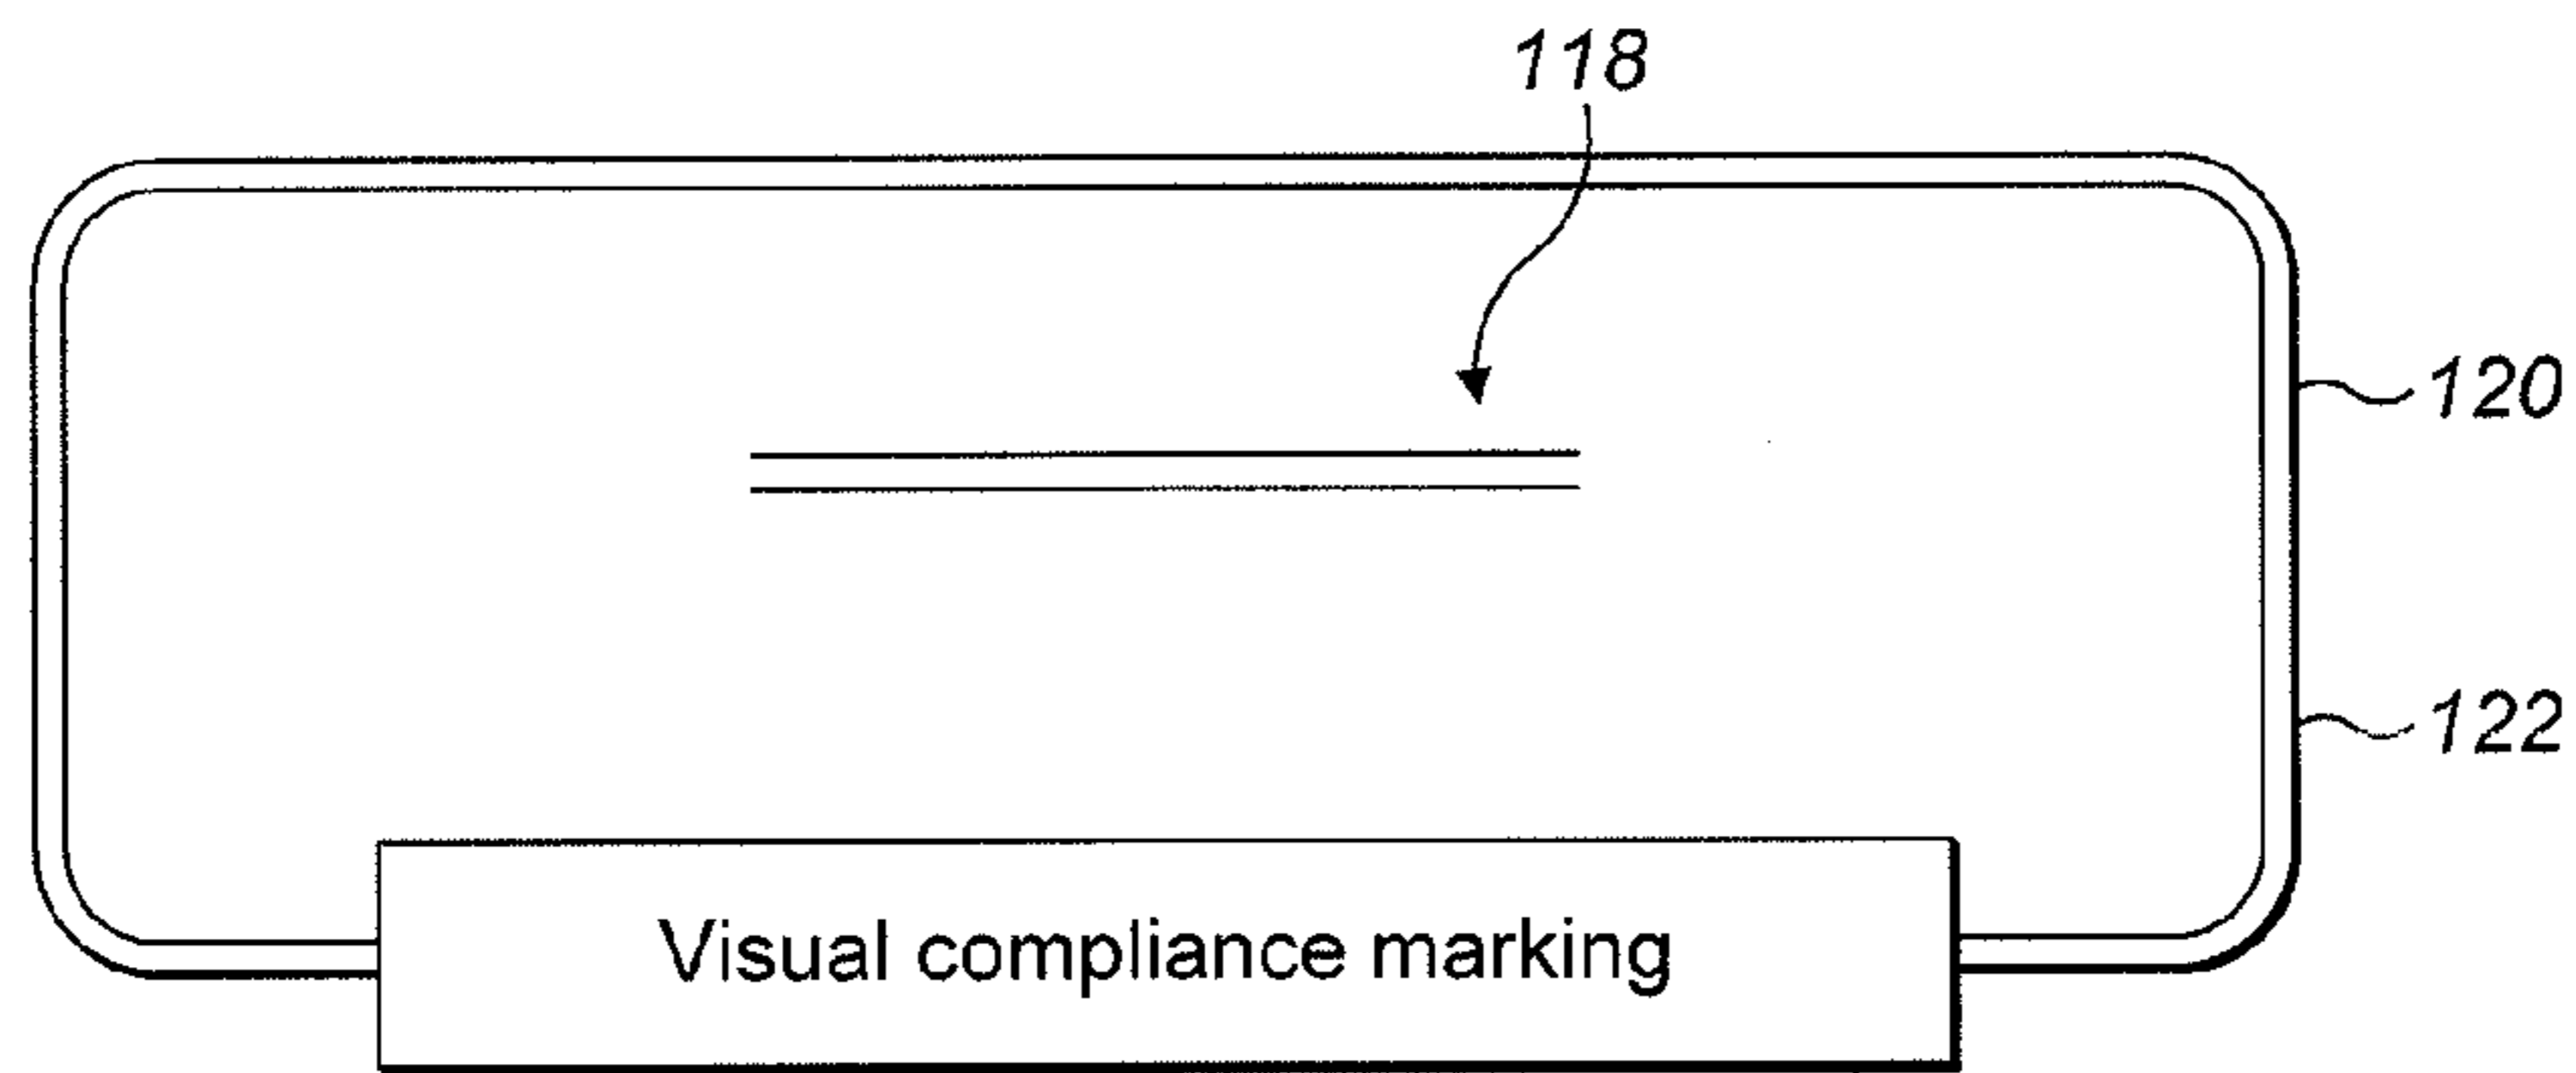
FIG. 4 is a view of a wear indicator comprising a location indicator; and

Turning to FIG. **4**, there is shown a wear indicator **118** similar to wear indicator **108**. The wear indicator **118** is surrounded by a location indicator **120** comprising a border **122** and a label **124**. The location indicator **120** is designed so as to be more prominent than the wear indicator **118** such that it is always visible, even when the visual wear indicator **118** itself has become obscured by erosion.

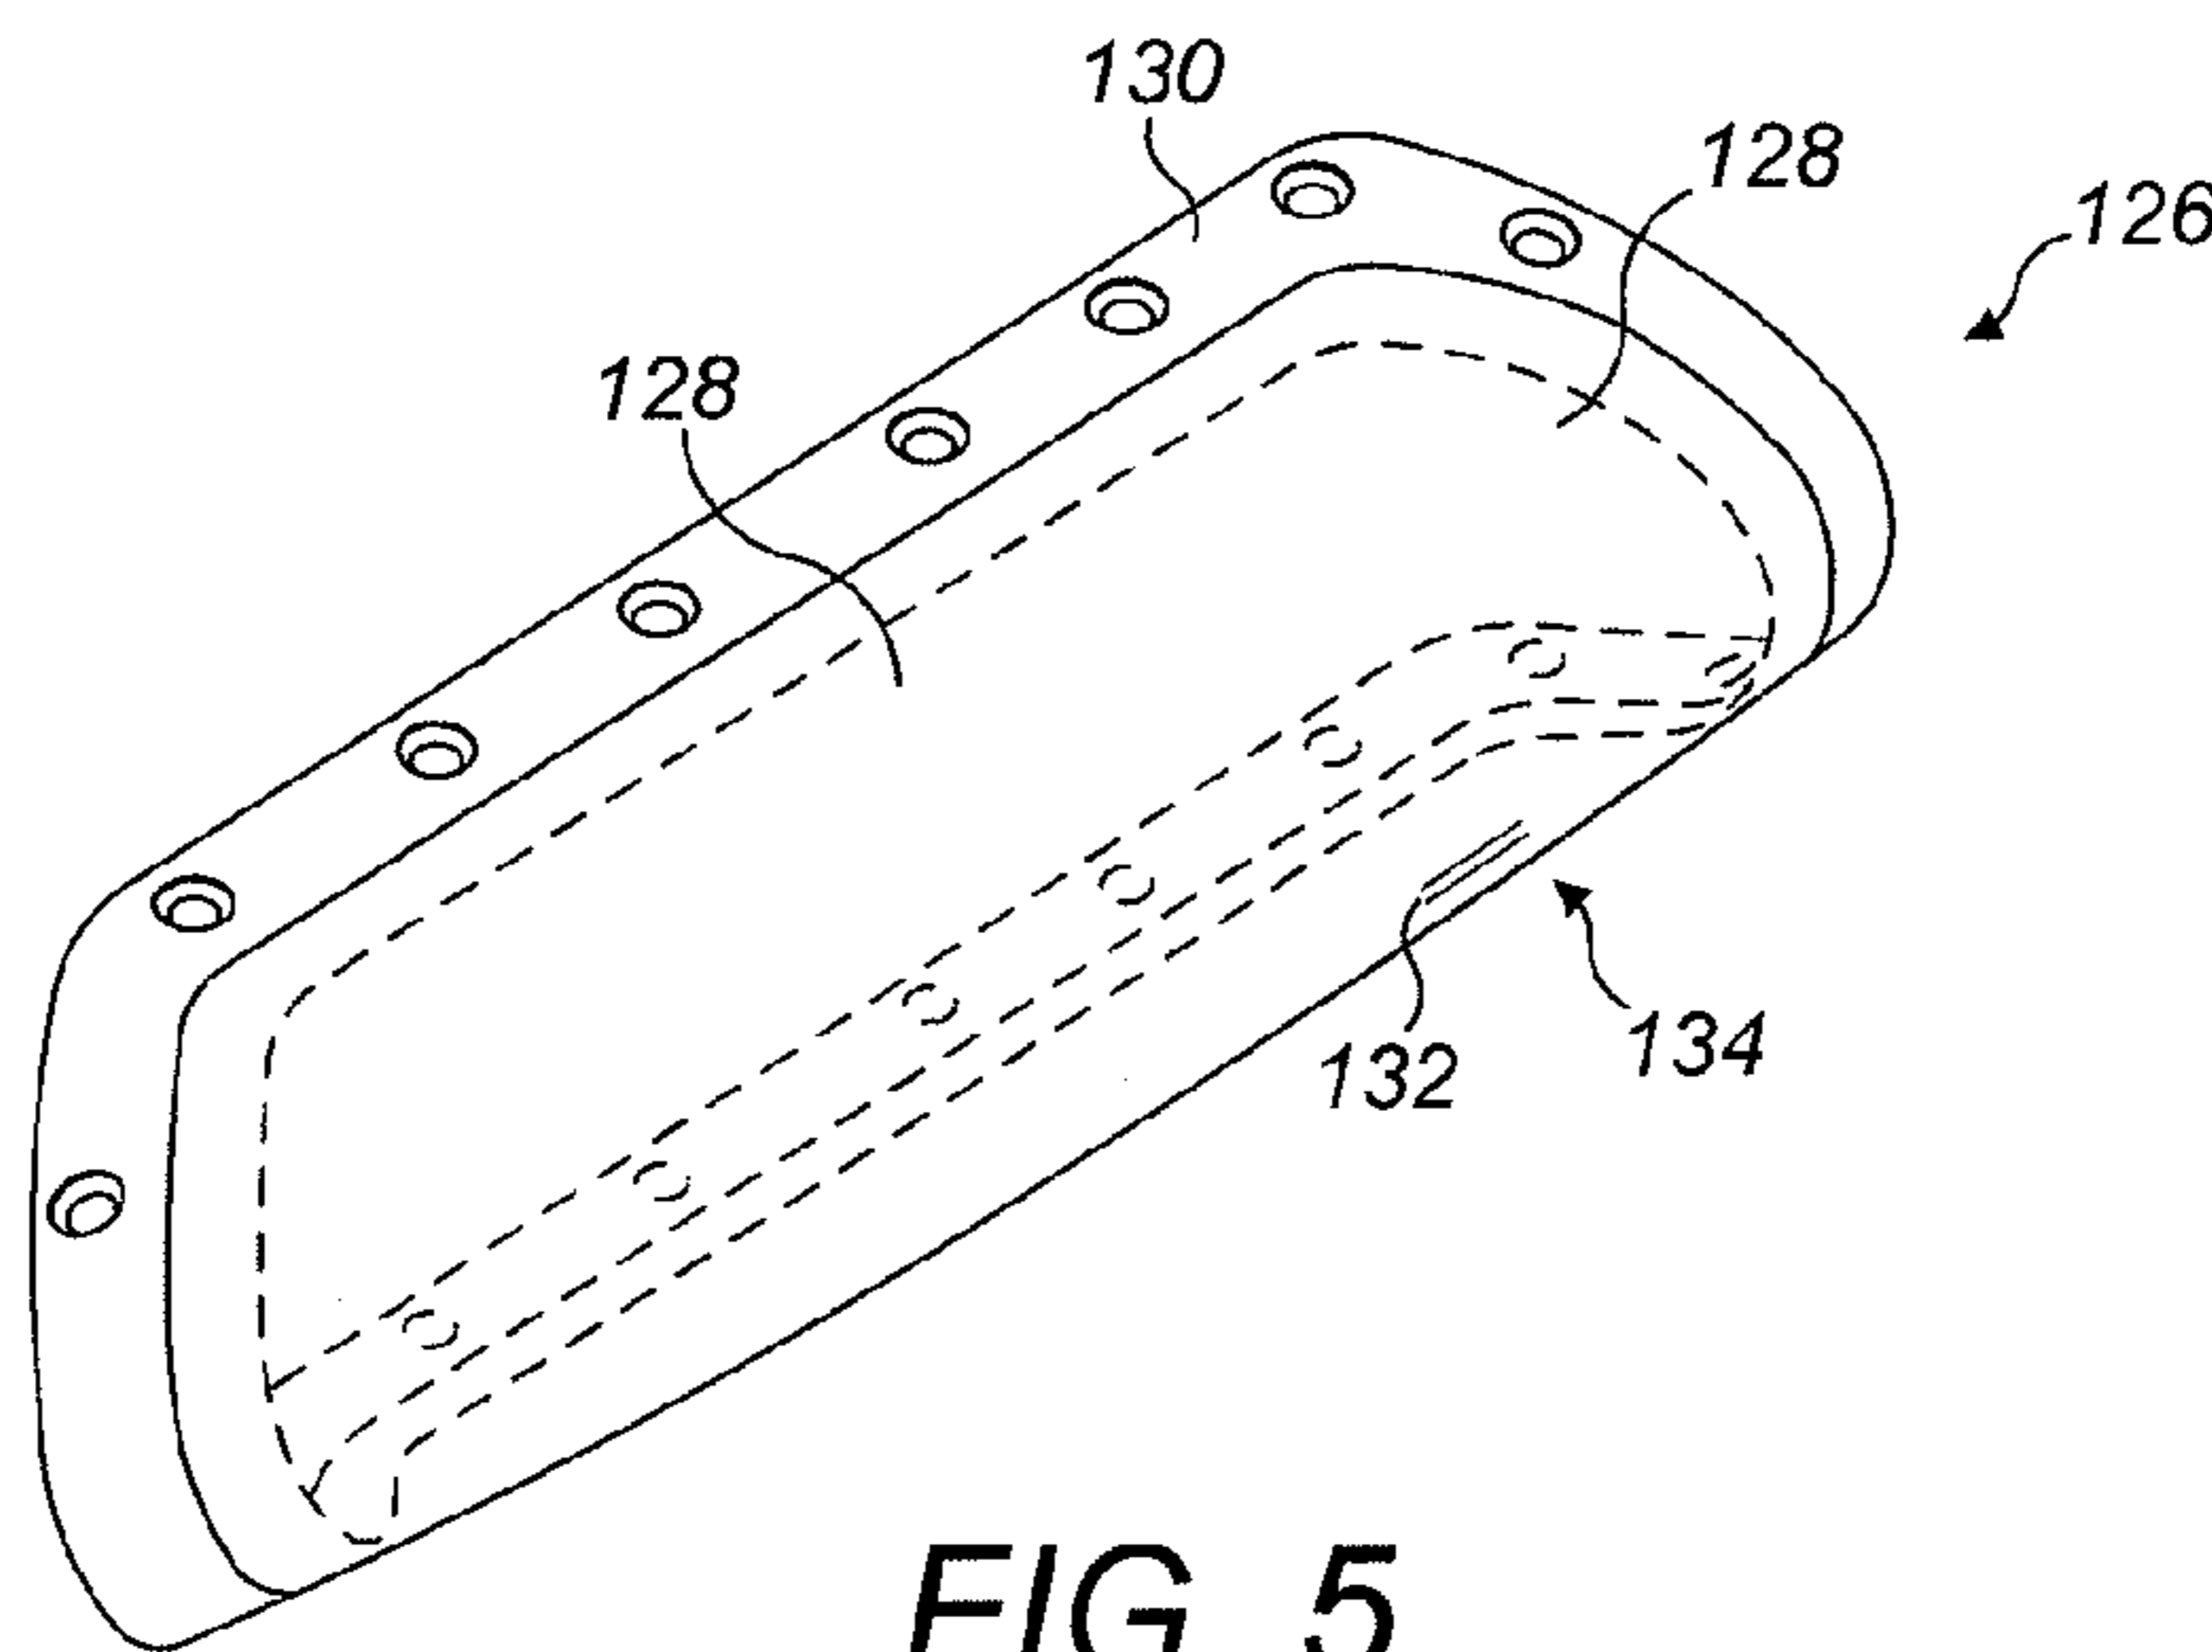
FIG. 5 is a view of an alternative glazing component comprising a wear indicator in accordance with the present invention.

Turning to FIG. **5**, a glazing component **126** comprises a transparent part **128** and a metal surround **130**. The glazing component **126** comprises a foremost point **132** where the erosion wear indicator **134** is located.
