(12) **United States Patent**
Dai

(10) **Patent No.:** **US 8,836,524 B2**
(45) **Date of Patent:** **Sep. 16, 2014**

(54) **DETECTING DEVICE AND BATTERY BOX USING THE SAME**

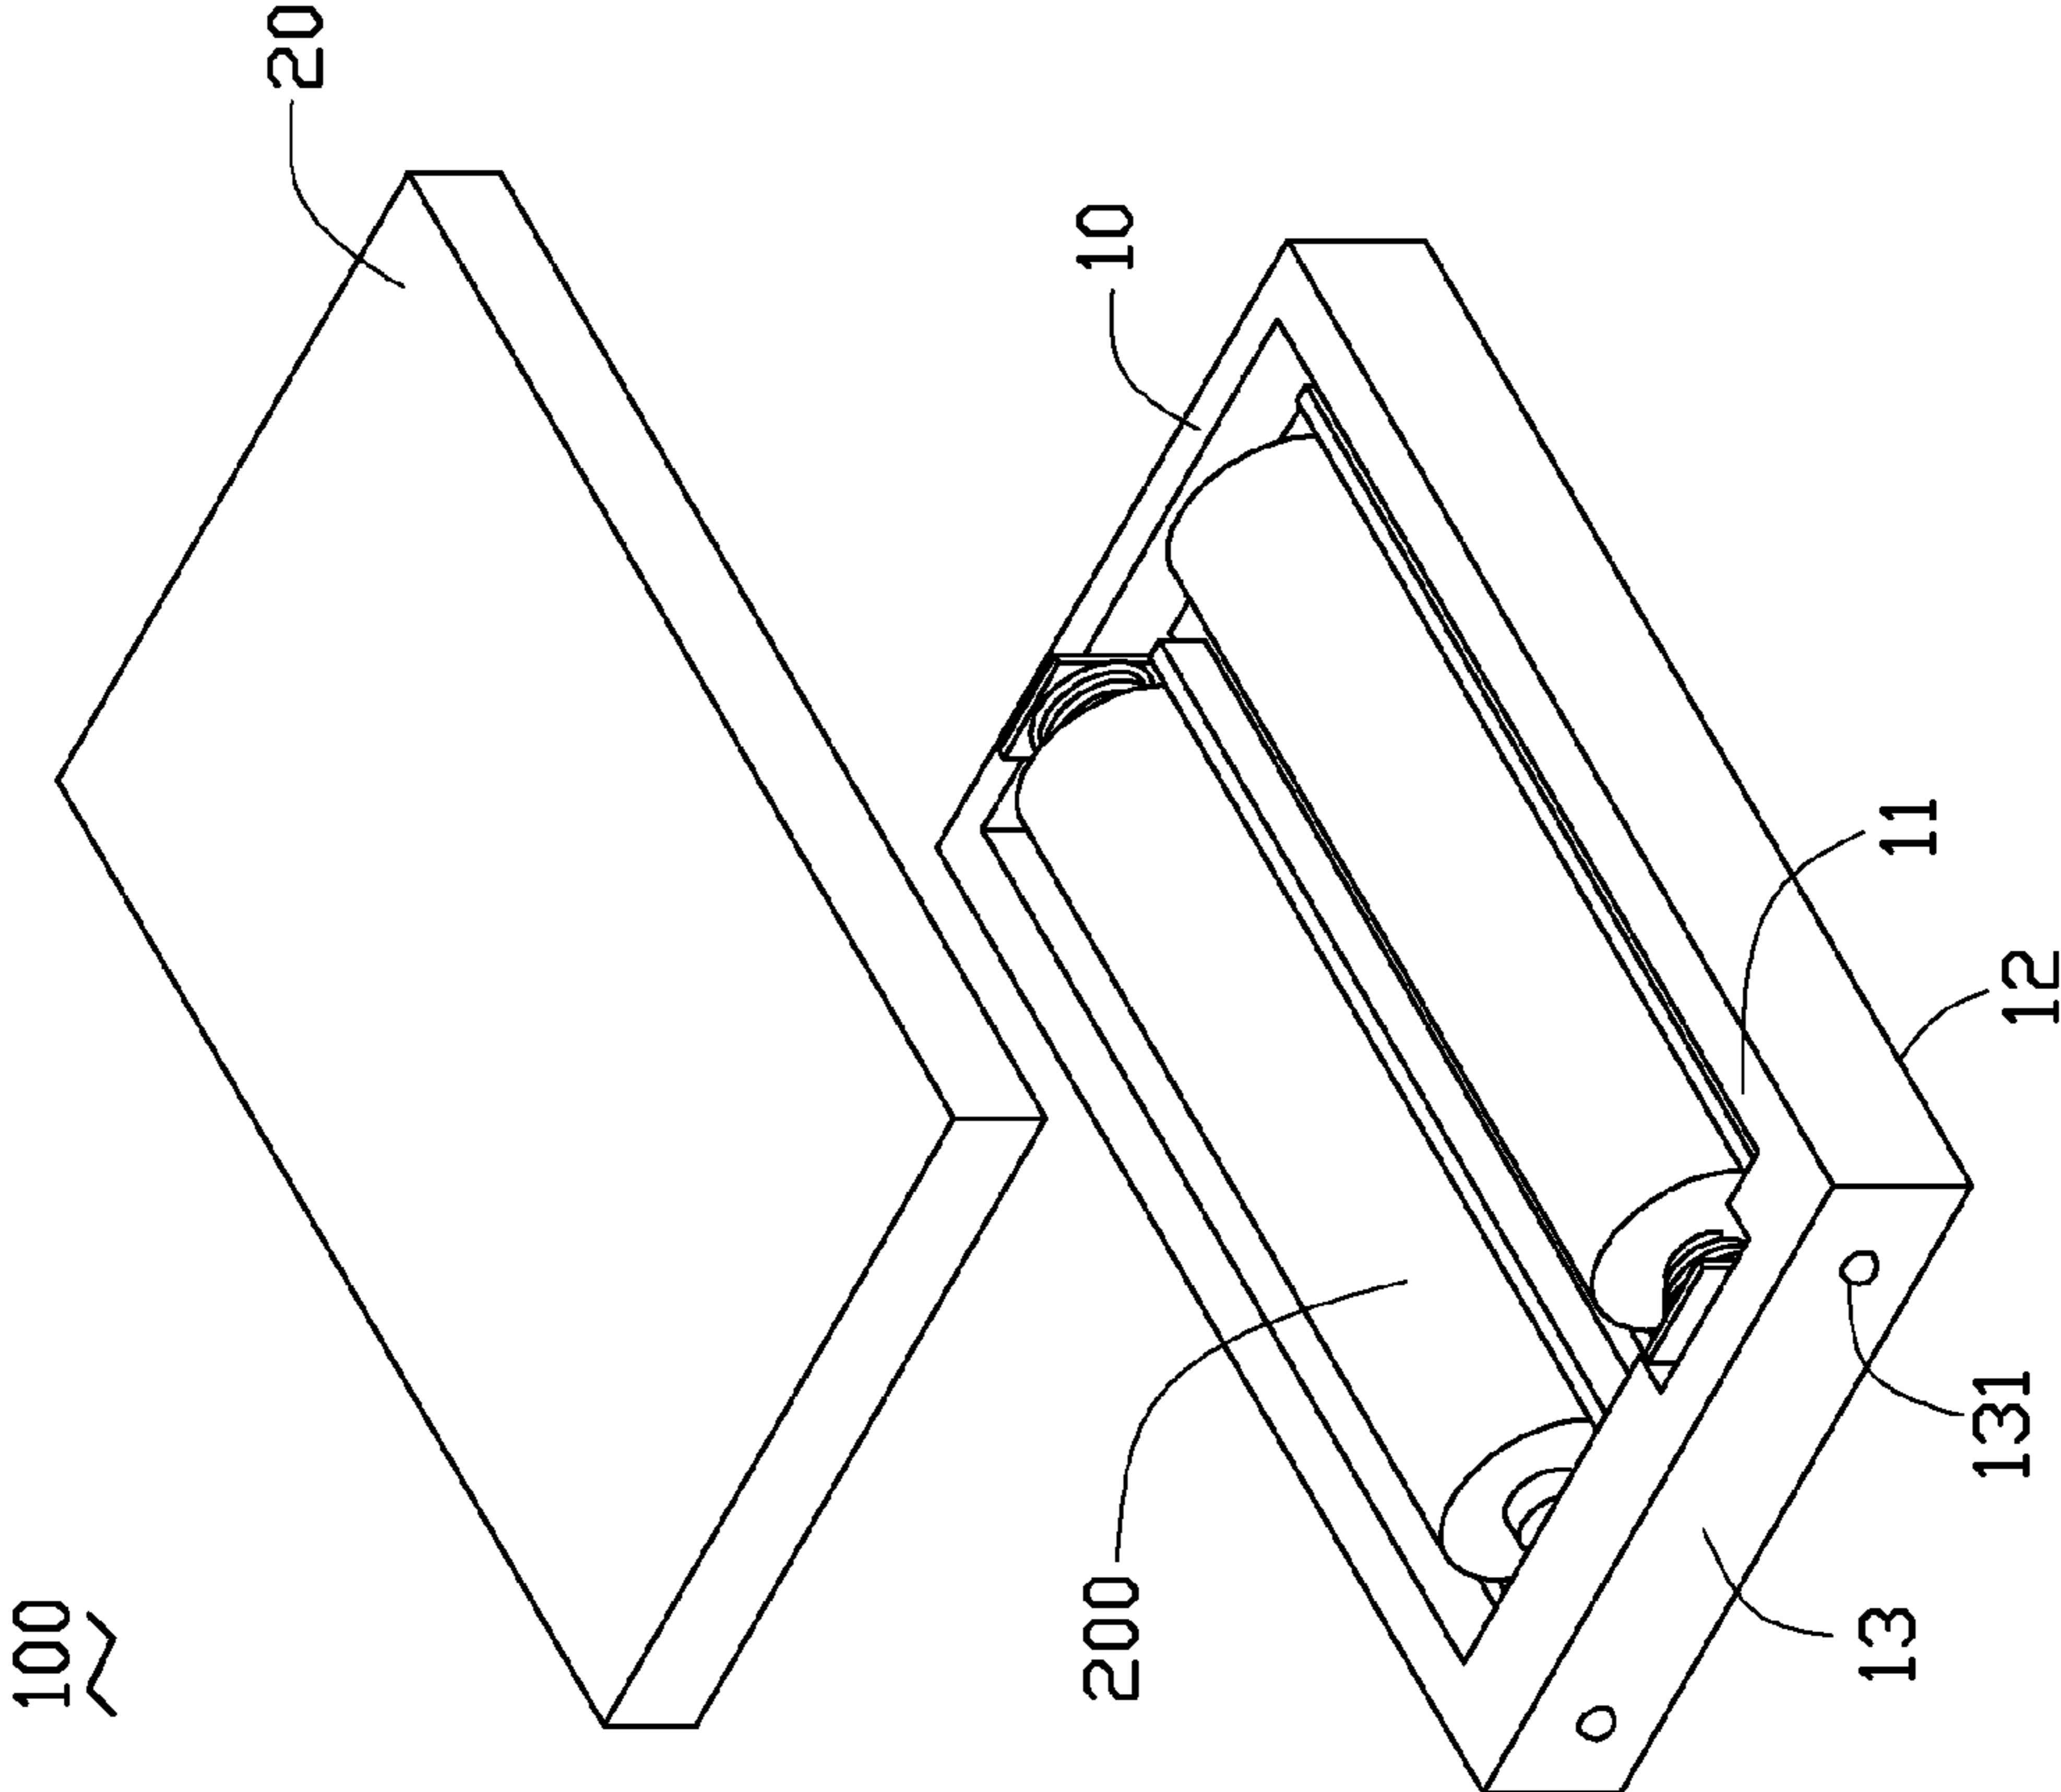
FIG. 1 is a perspective view showing a battery box in accordance with one embodiment, the battery box includes a detecting device.

Referring to FIGS. 1 and 2, a battery box 100 includes a main body 10, a lid 20, and a detecting device 30. The lid 20 is used for covering the main body 10 and to protect and contain at least one battery 200. The detecting device 30 is disposed on the main body 10 for detecting whether the battery 200 has a leak, and generating a leak warning signal to indicate that the battery 200 is leaking. In this embodiment, the battery 200 is a dry cell battery.

The main body 10 includes a first surface 11, a second surface 12, and a third surface 13. The first surface 11 and the second surface 12 are opposite to each other, and the third surface 13 perpendicularly connects the first surface 11 to the second surface 12. The main body 10 defines a pair of compartments 111 adjacent to each other in the first surface 11, and each of the compartments 111 is used for receiving one battery 200. Each of the compartments 111 is disposed with a first contact 112, a second contact 113, and a spring 114. When the battery 200 is mounted in the compartment 111, the first contact 112 is electrically connected to the positive terminal of the battery 200, and the second contact 113 is electrically connected to the negative terminal of the battery 200 through the spring 114. Therefore, the battery 200 can supply

The third surface 13 defines two through holes 131 respectively corresponding to the two compartments 111 and respectively communicating with the two compartments 111.

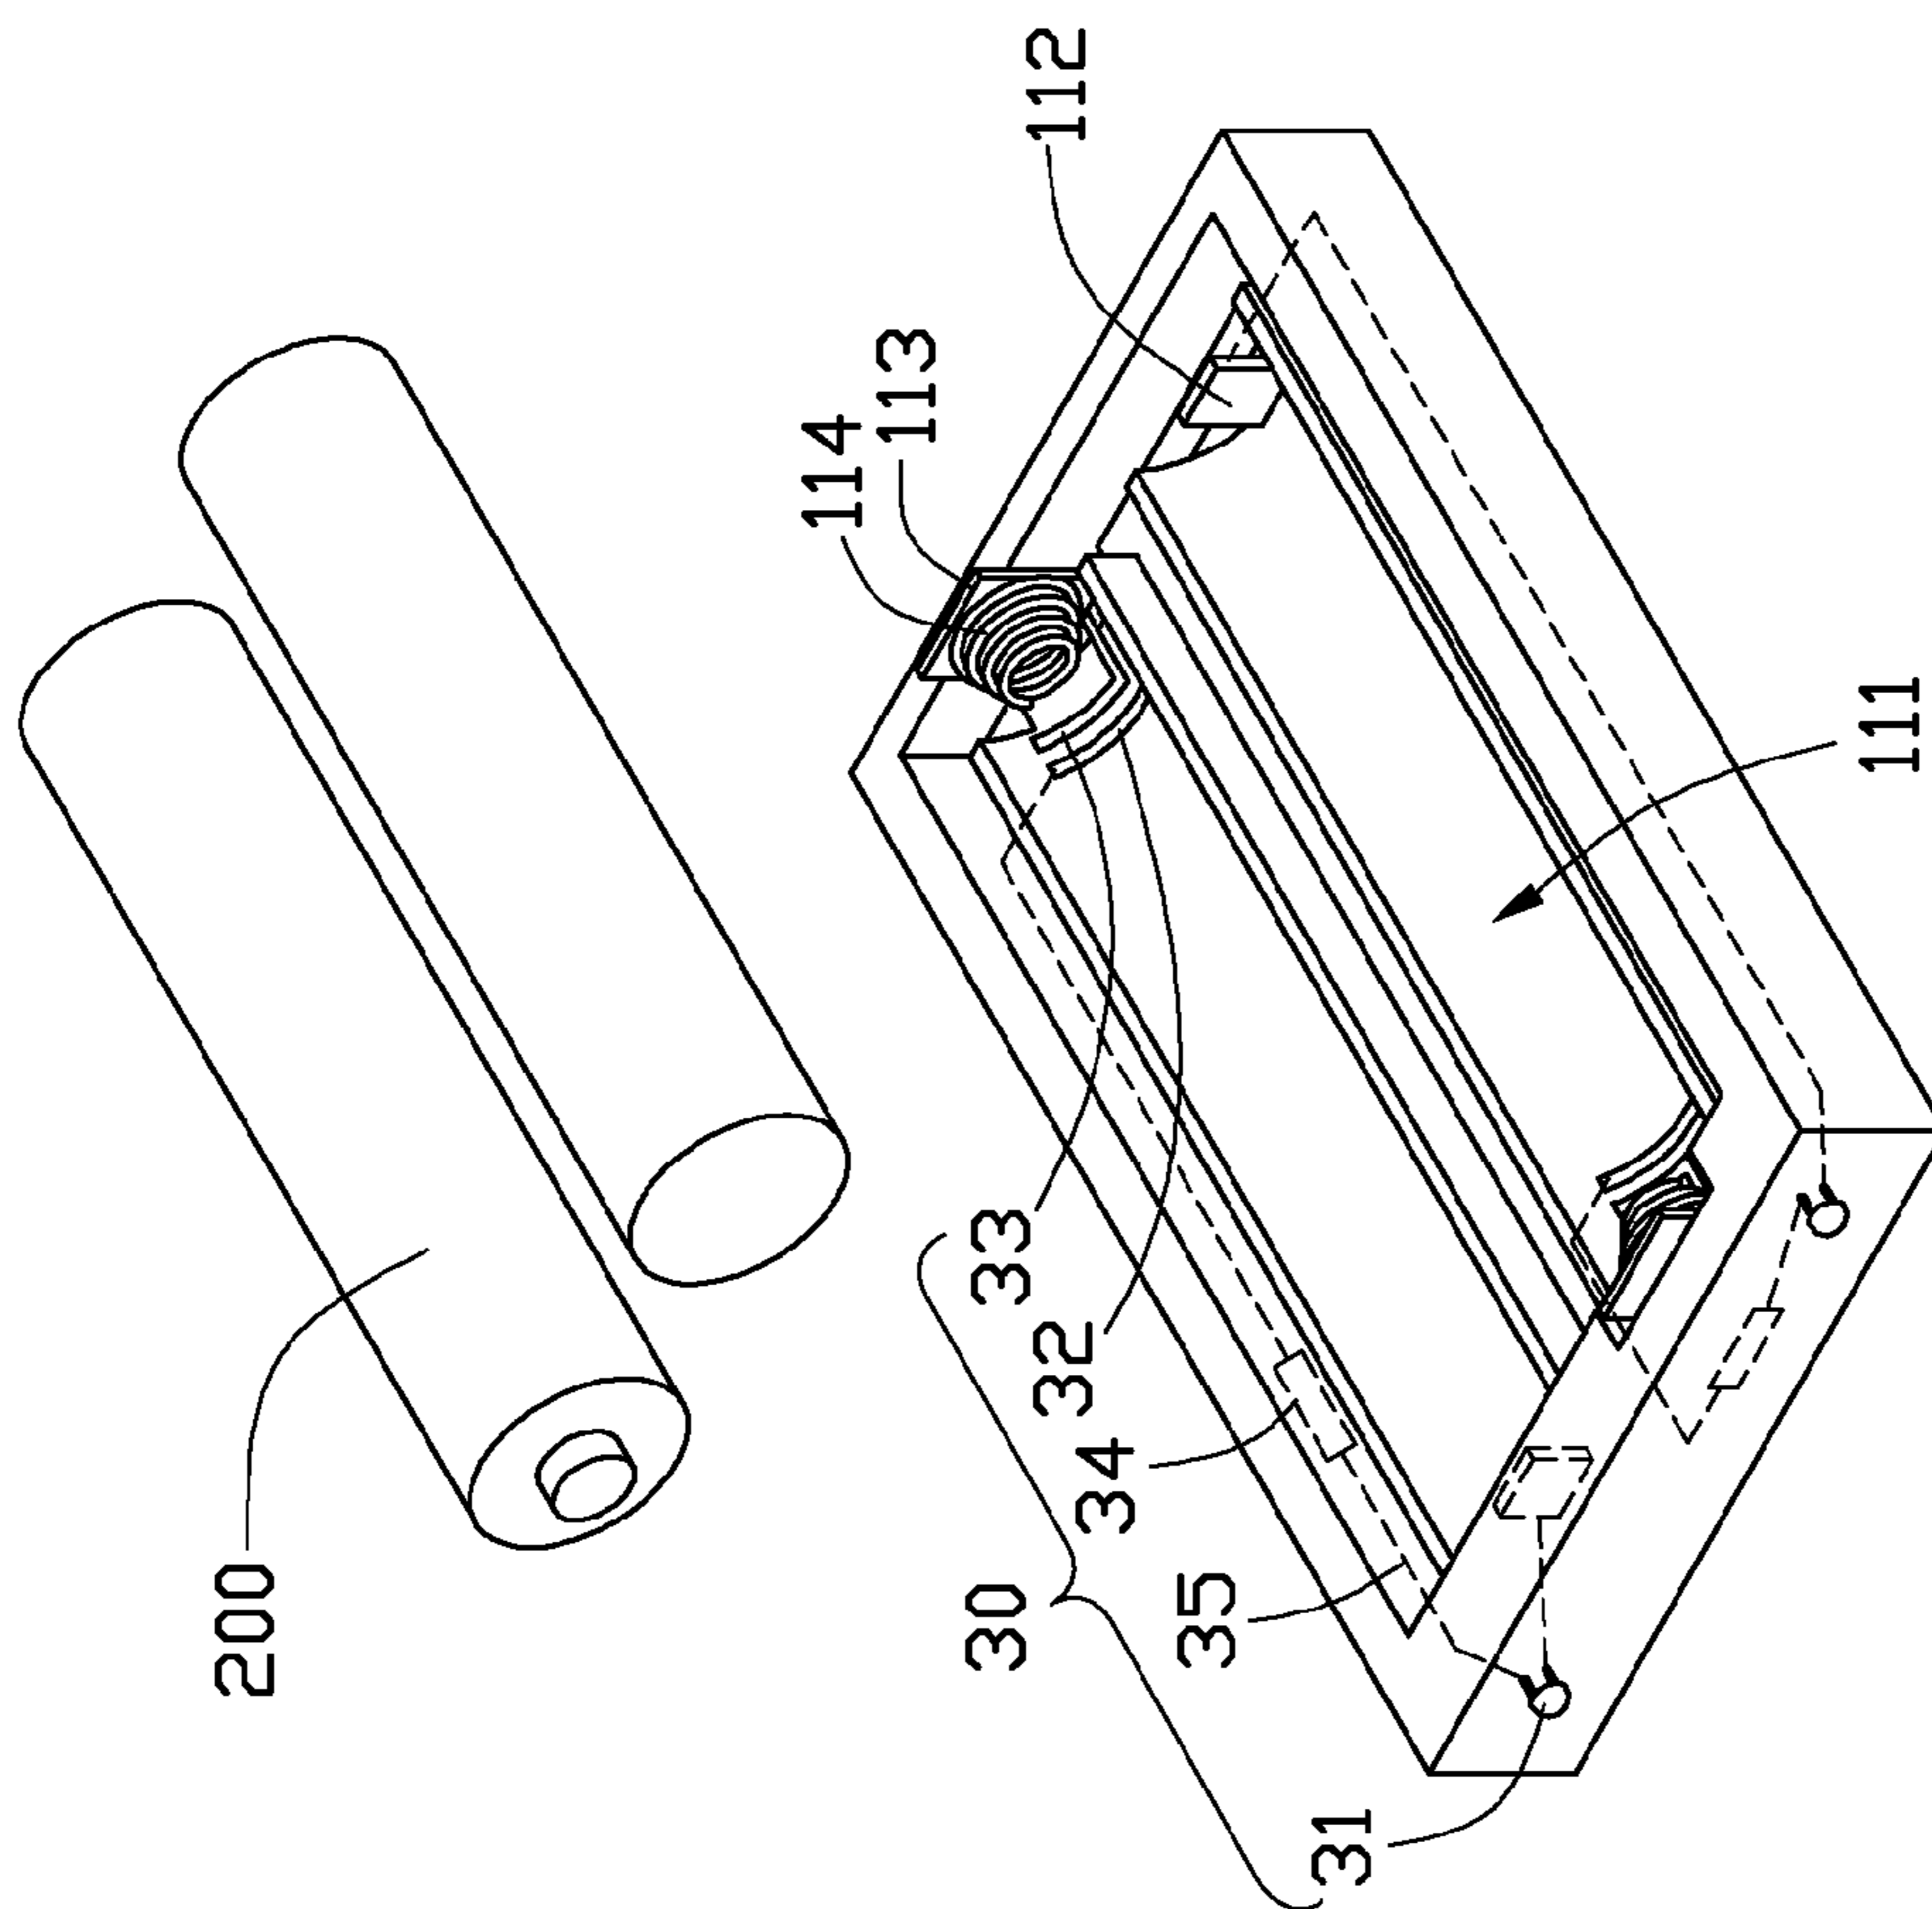
FIG. 2 is a schematic view showing the internal structure of the detecting device of FIG. 1.

Referring also to FIG. 3, there are two detecting devices 30, each of the detecting devices 30 includes a warning unit 31, a first conductor 32, a second conductor 33, a resistor 34, and a conducting wire 35. In this embodiment, the warning unit 31 is a light emitting diode (LED) 31, the LED 31 is disposed in the through hole 131 and protrudes from the battery box 100. The first conductor 32 and the second conductor 33 are disposed in the bottom surface of the compartments 111 respectively, and are apart from each other. The first conductor 32 and the second conductor 33 are adjacent to the second contact 113.

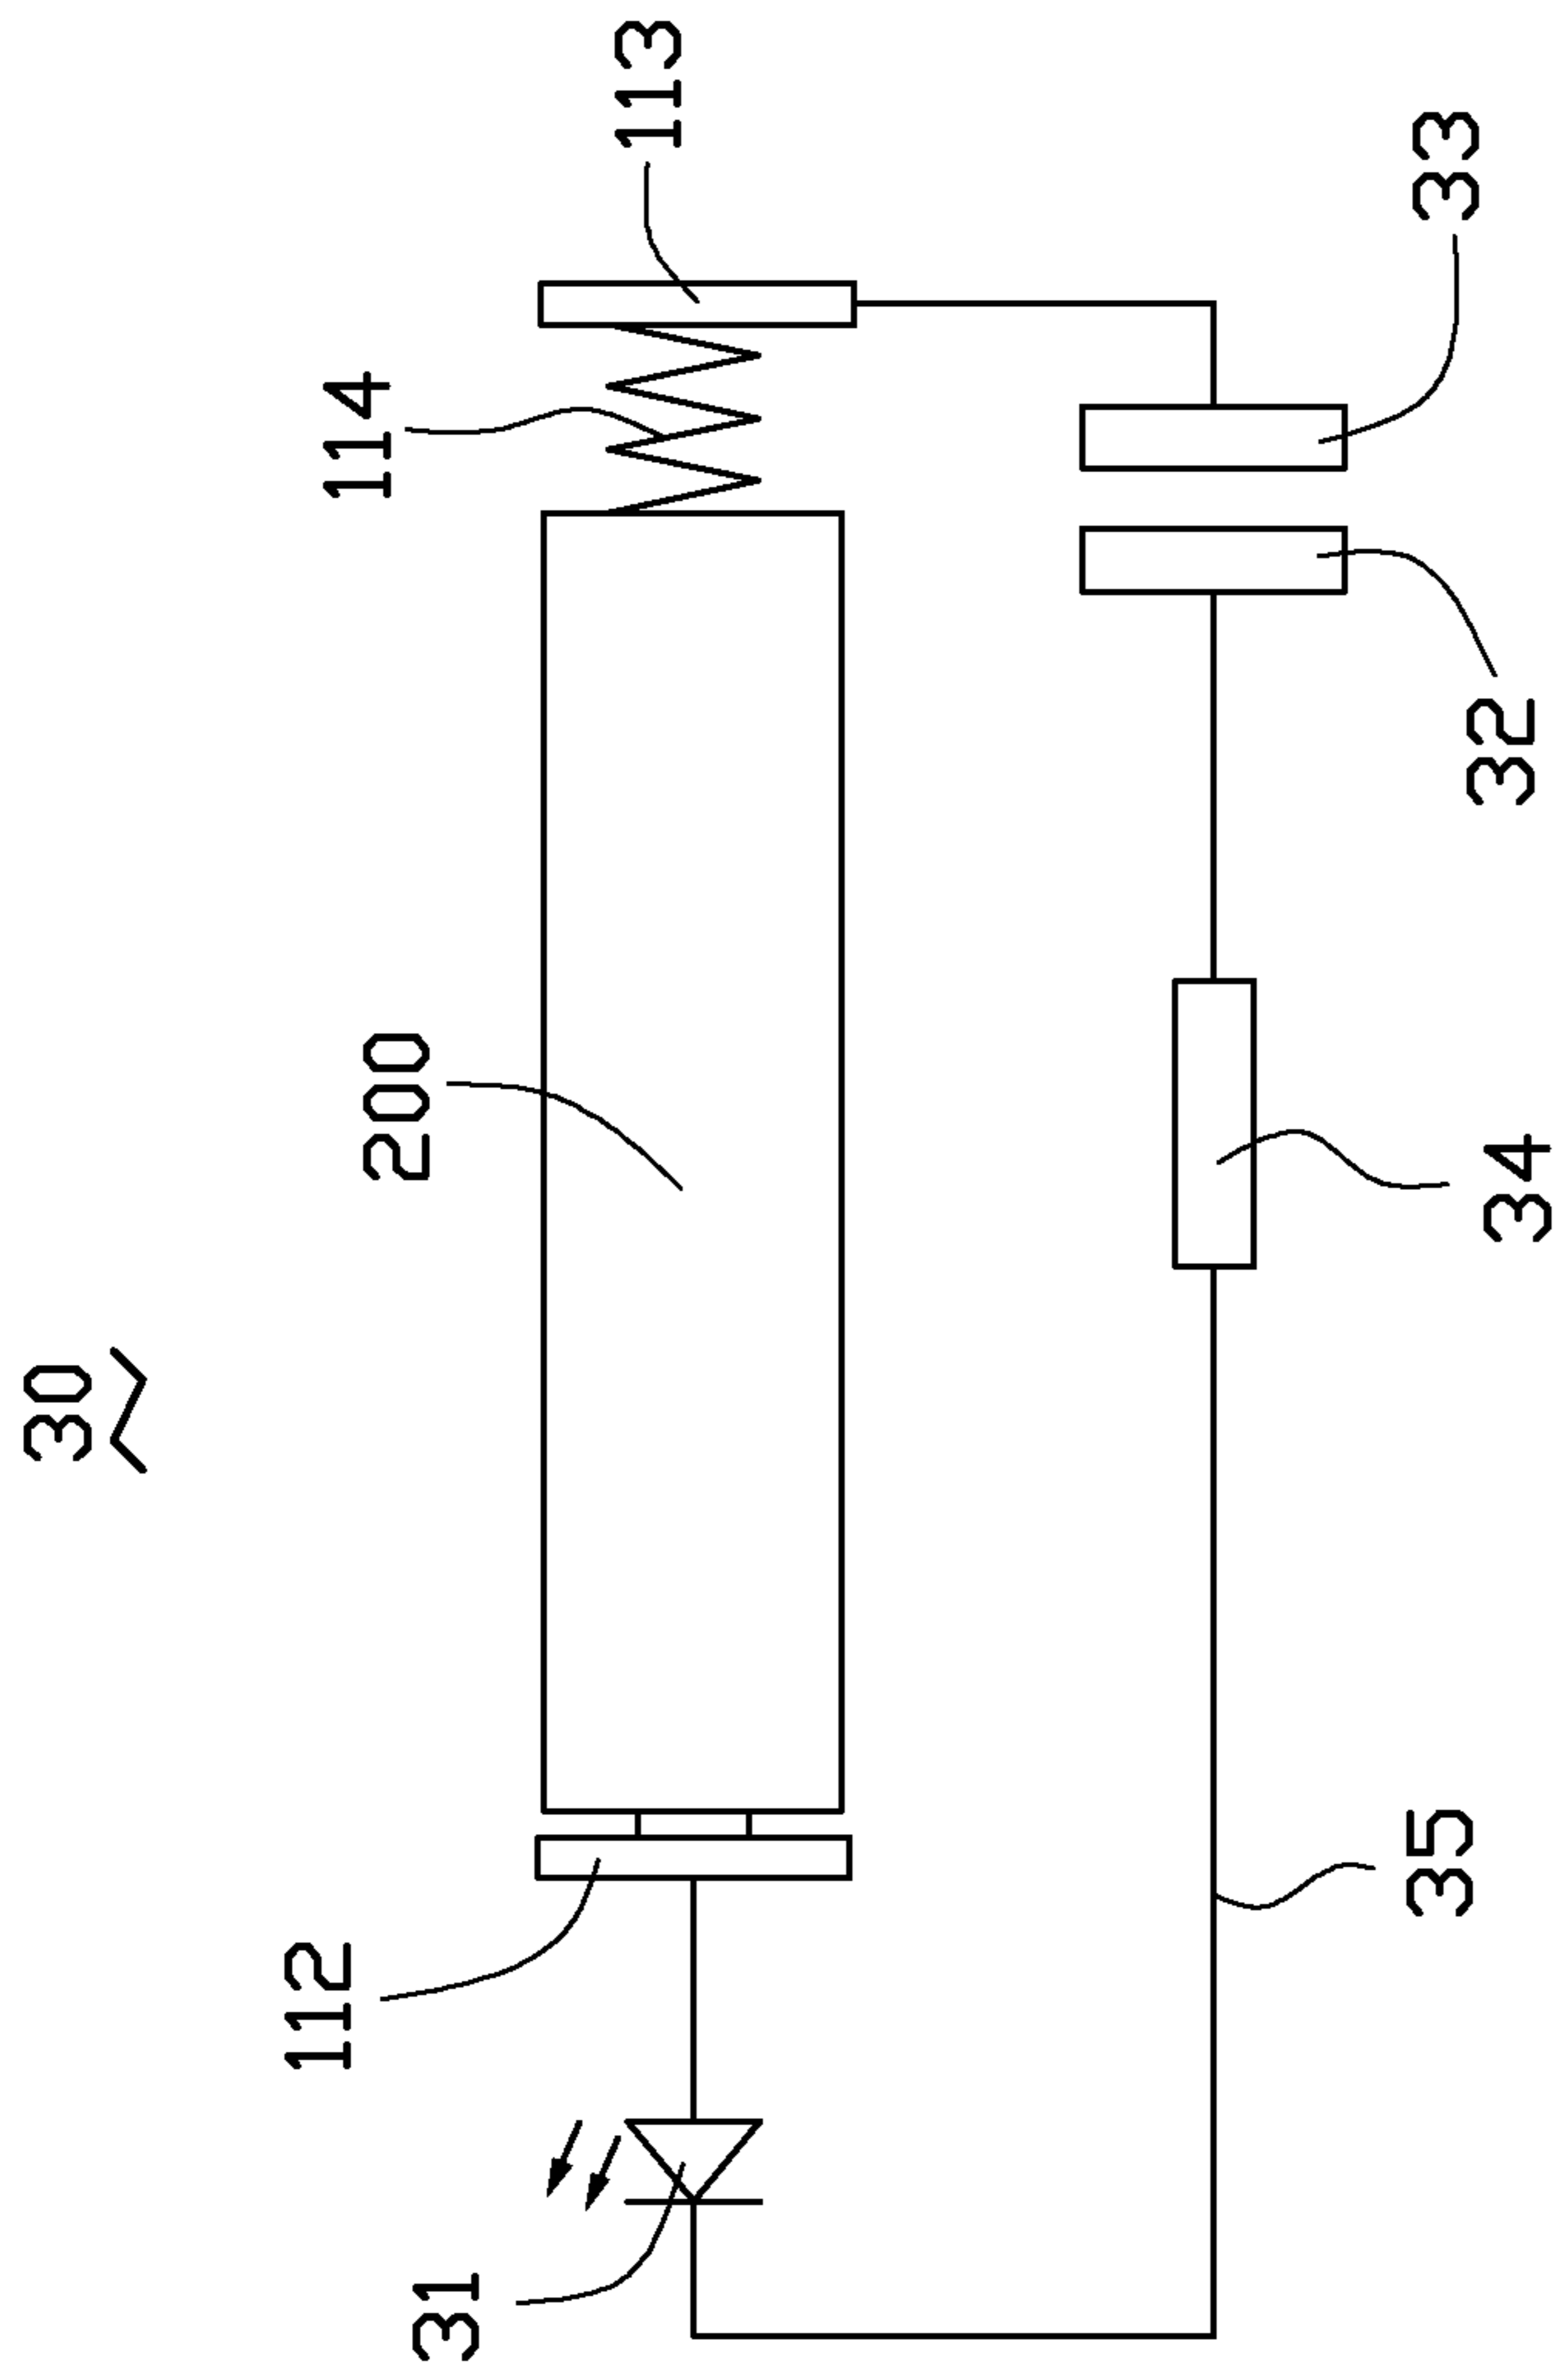
FIG. 3 is a circuit diagram of the detecting device of FIG. 1.

An anode of the LED 31 is electrically connected to the first contact 112 via the conductive wire 35, a cathode of the LED 31 is electrically connected to the first conductor 32 through the resistor 34. The second conductor 33 is electrically connected to the second contact 113. When electrolyte is leaked from the battery 200, the first conductor 32 will be electrically connected to the second conductor 33 through the leaked electrolyte, thus the LED 31 emits light to indicate that the battery 200 has a leak. When the electrolyte is not leaking from the battery 200, the first conductor 32 is not electrically connected to the second conductor 33, therefore the LED 31 will not emit light. In other embodiments, the first conductor 32 is electrically connected to the first contact 112 through the resistor 34, the warning unit 31 is connected between the second conductor 33 and the second contact 113; the warning unit 31 can be a speaker, so that when the electrolyte is leaked from the battery 200, the speaker 31 outputs a sound to indicate that the battery 200 has a leak.
