(10) **Patent No.:** **US 8,878,698 B2**  
(45) **Date of Patent:** **Nov. 4, 2014**

(54) **LIGHTNING STRIKE DETECTION**

(73) Assignee: **The Boeing Company**, Chicago, IL (US)

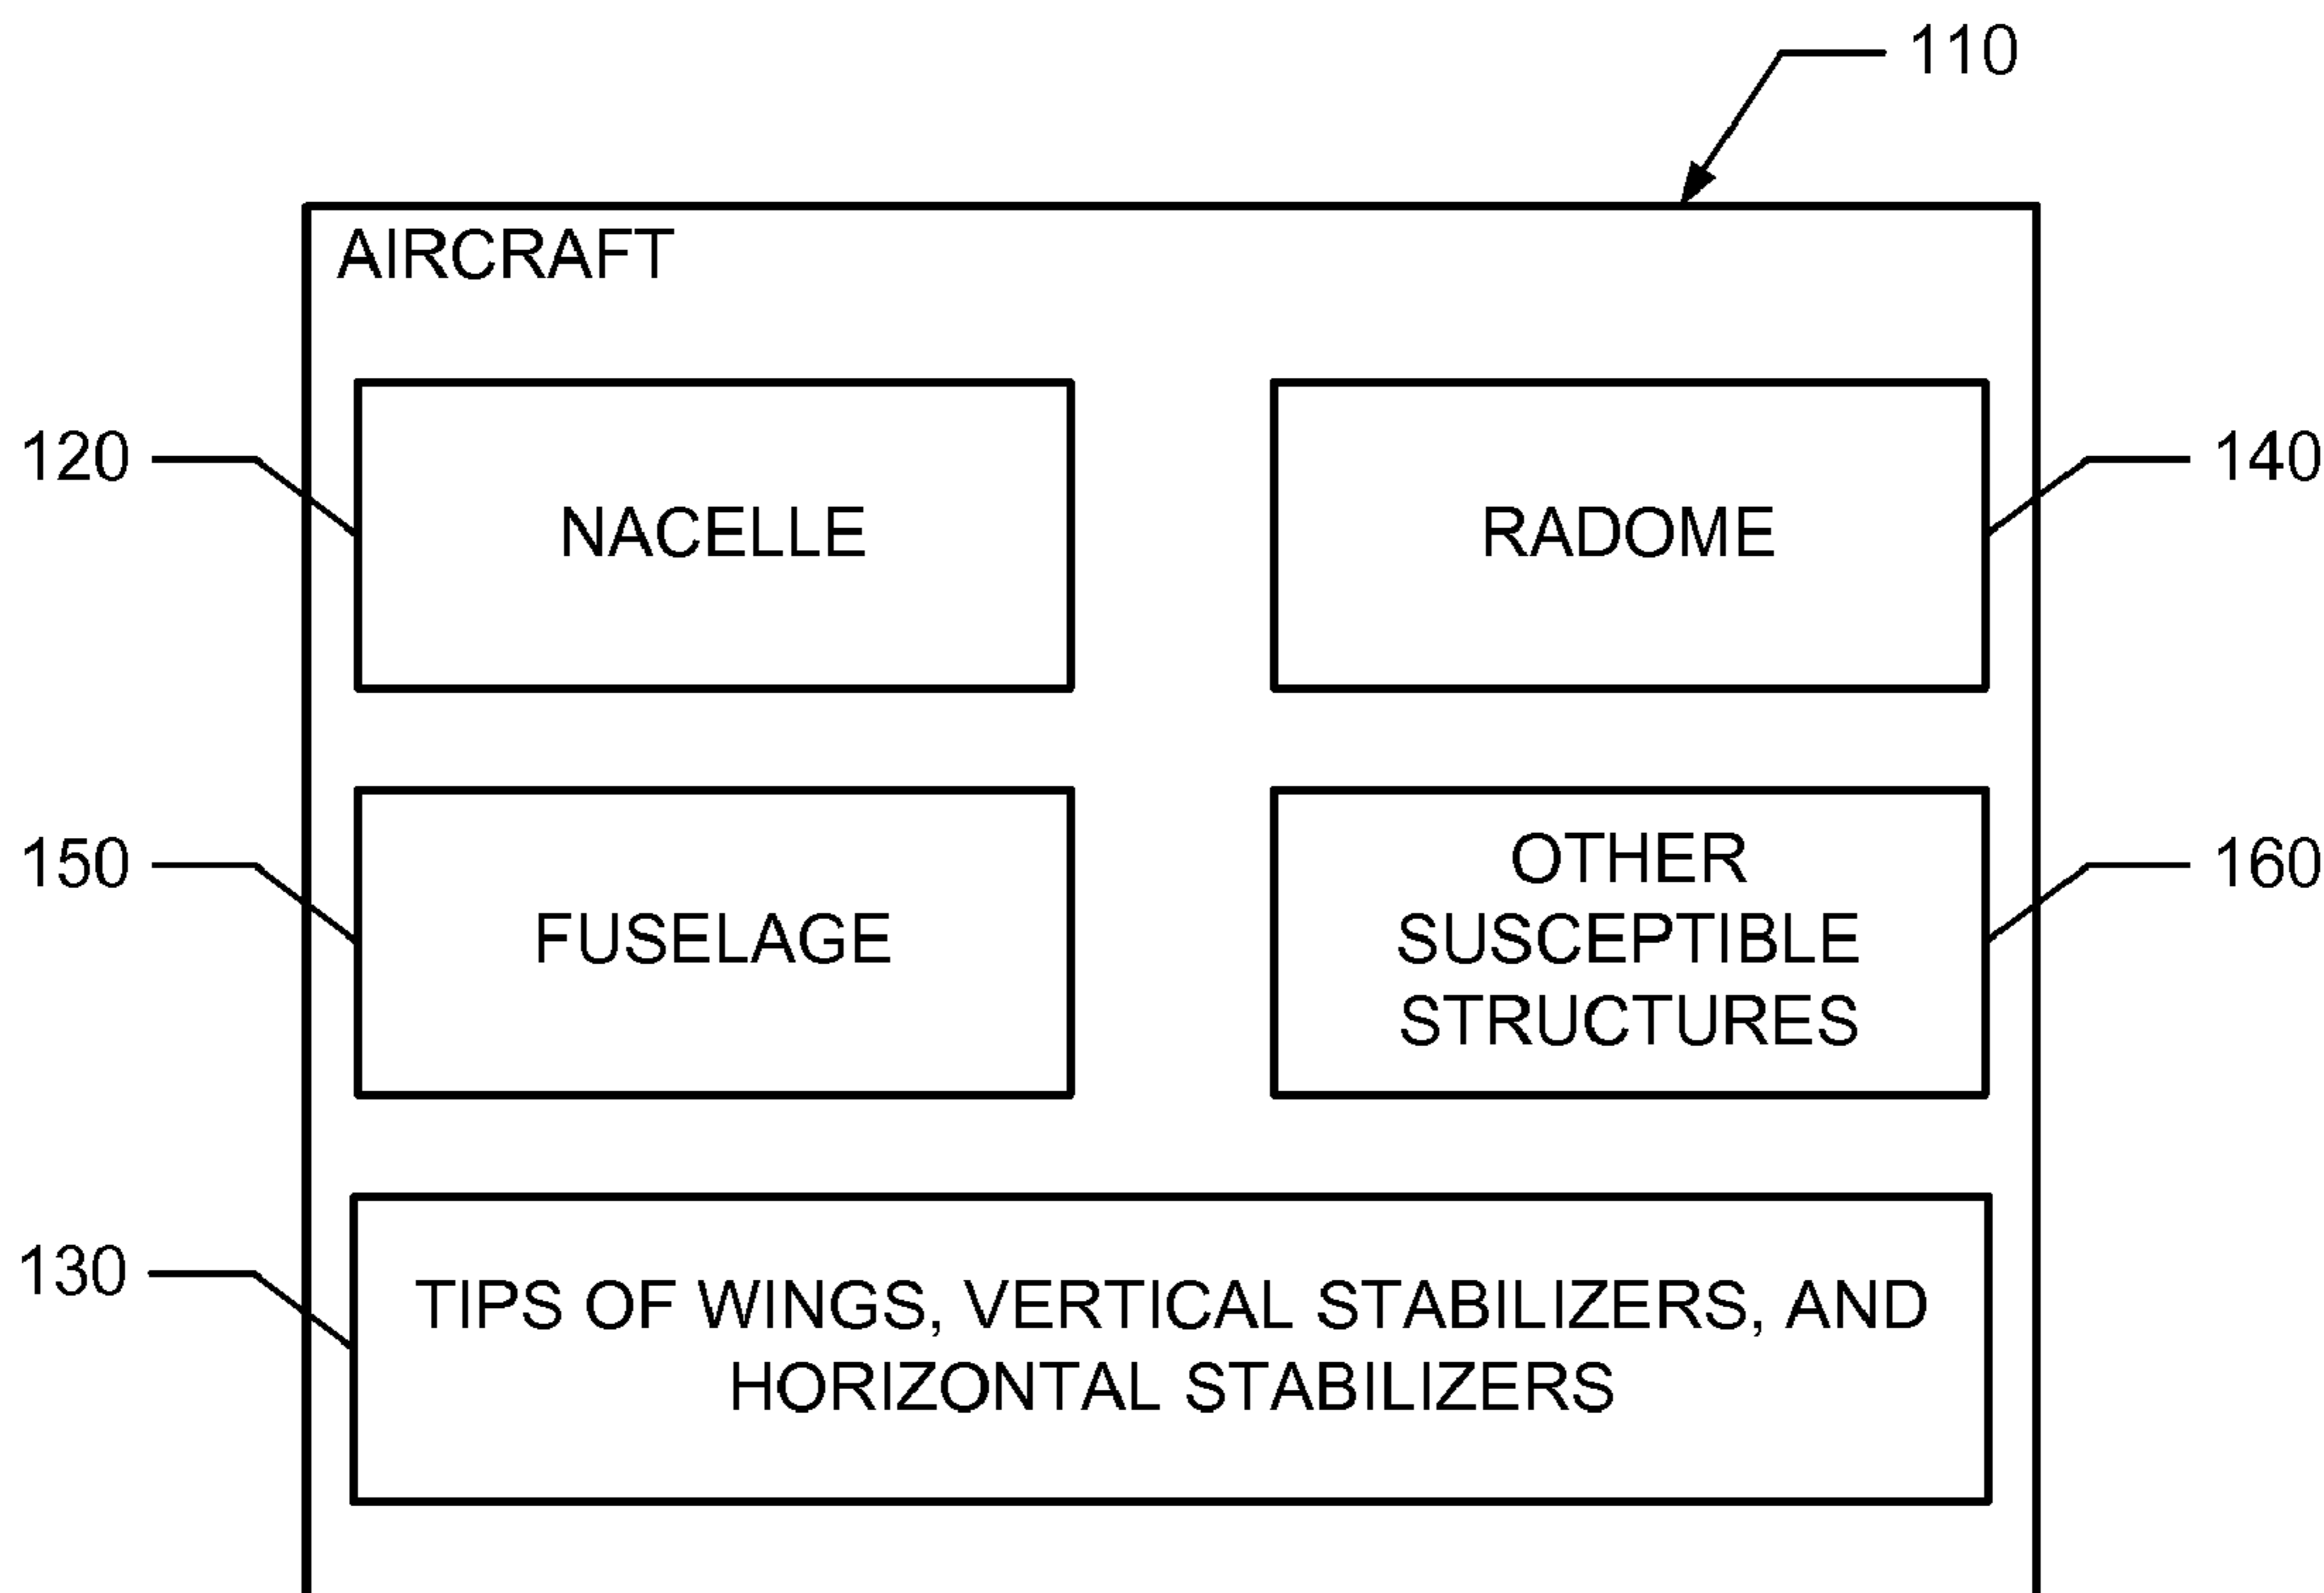
FIG. 1 is an illustration of an aircraft.

Reference is made to FIG. 1, which illustrates an aircraft 110 having a plurality of composite structures. Some composite structures may be made entirely from a composite material such as fiberglass or carbon fiber reinforced plastic (CFRP). Other structures might be a combination of composite materials and metals. For example, a composite structure might include composite material, metal fasteners, electrical bonding jumpers, and metal for lightning strike protection.

Some of the composite structures on the aircraft are more susceptible to lightning strikes than others. On a large commercial aircraft, some of the most susceptible structures include nacelles 120, tips 130 of wings and vertical and horizontal stabilizers, and radomes 140. The aircraft's fuselage 150 and other structures 160 might also be highly susceptible.

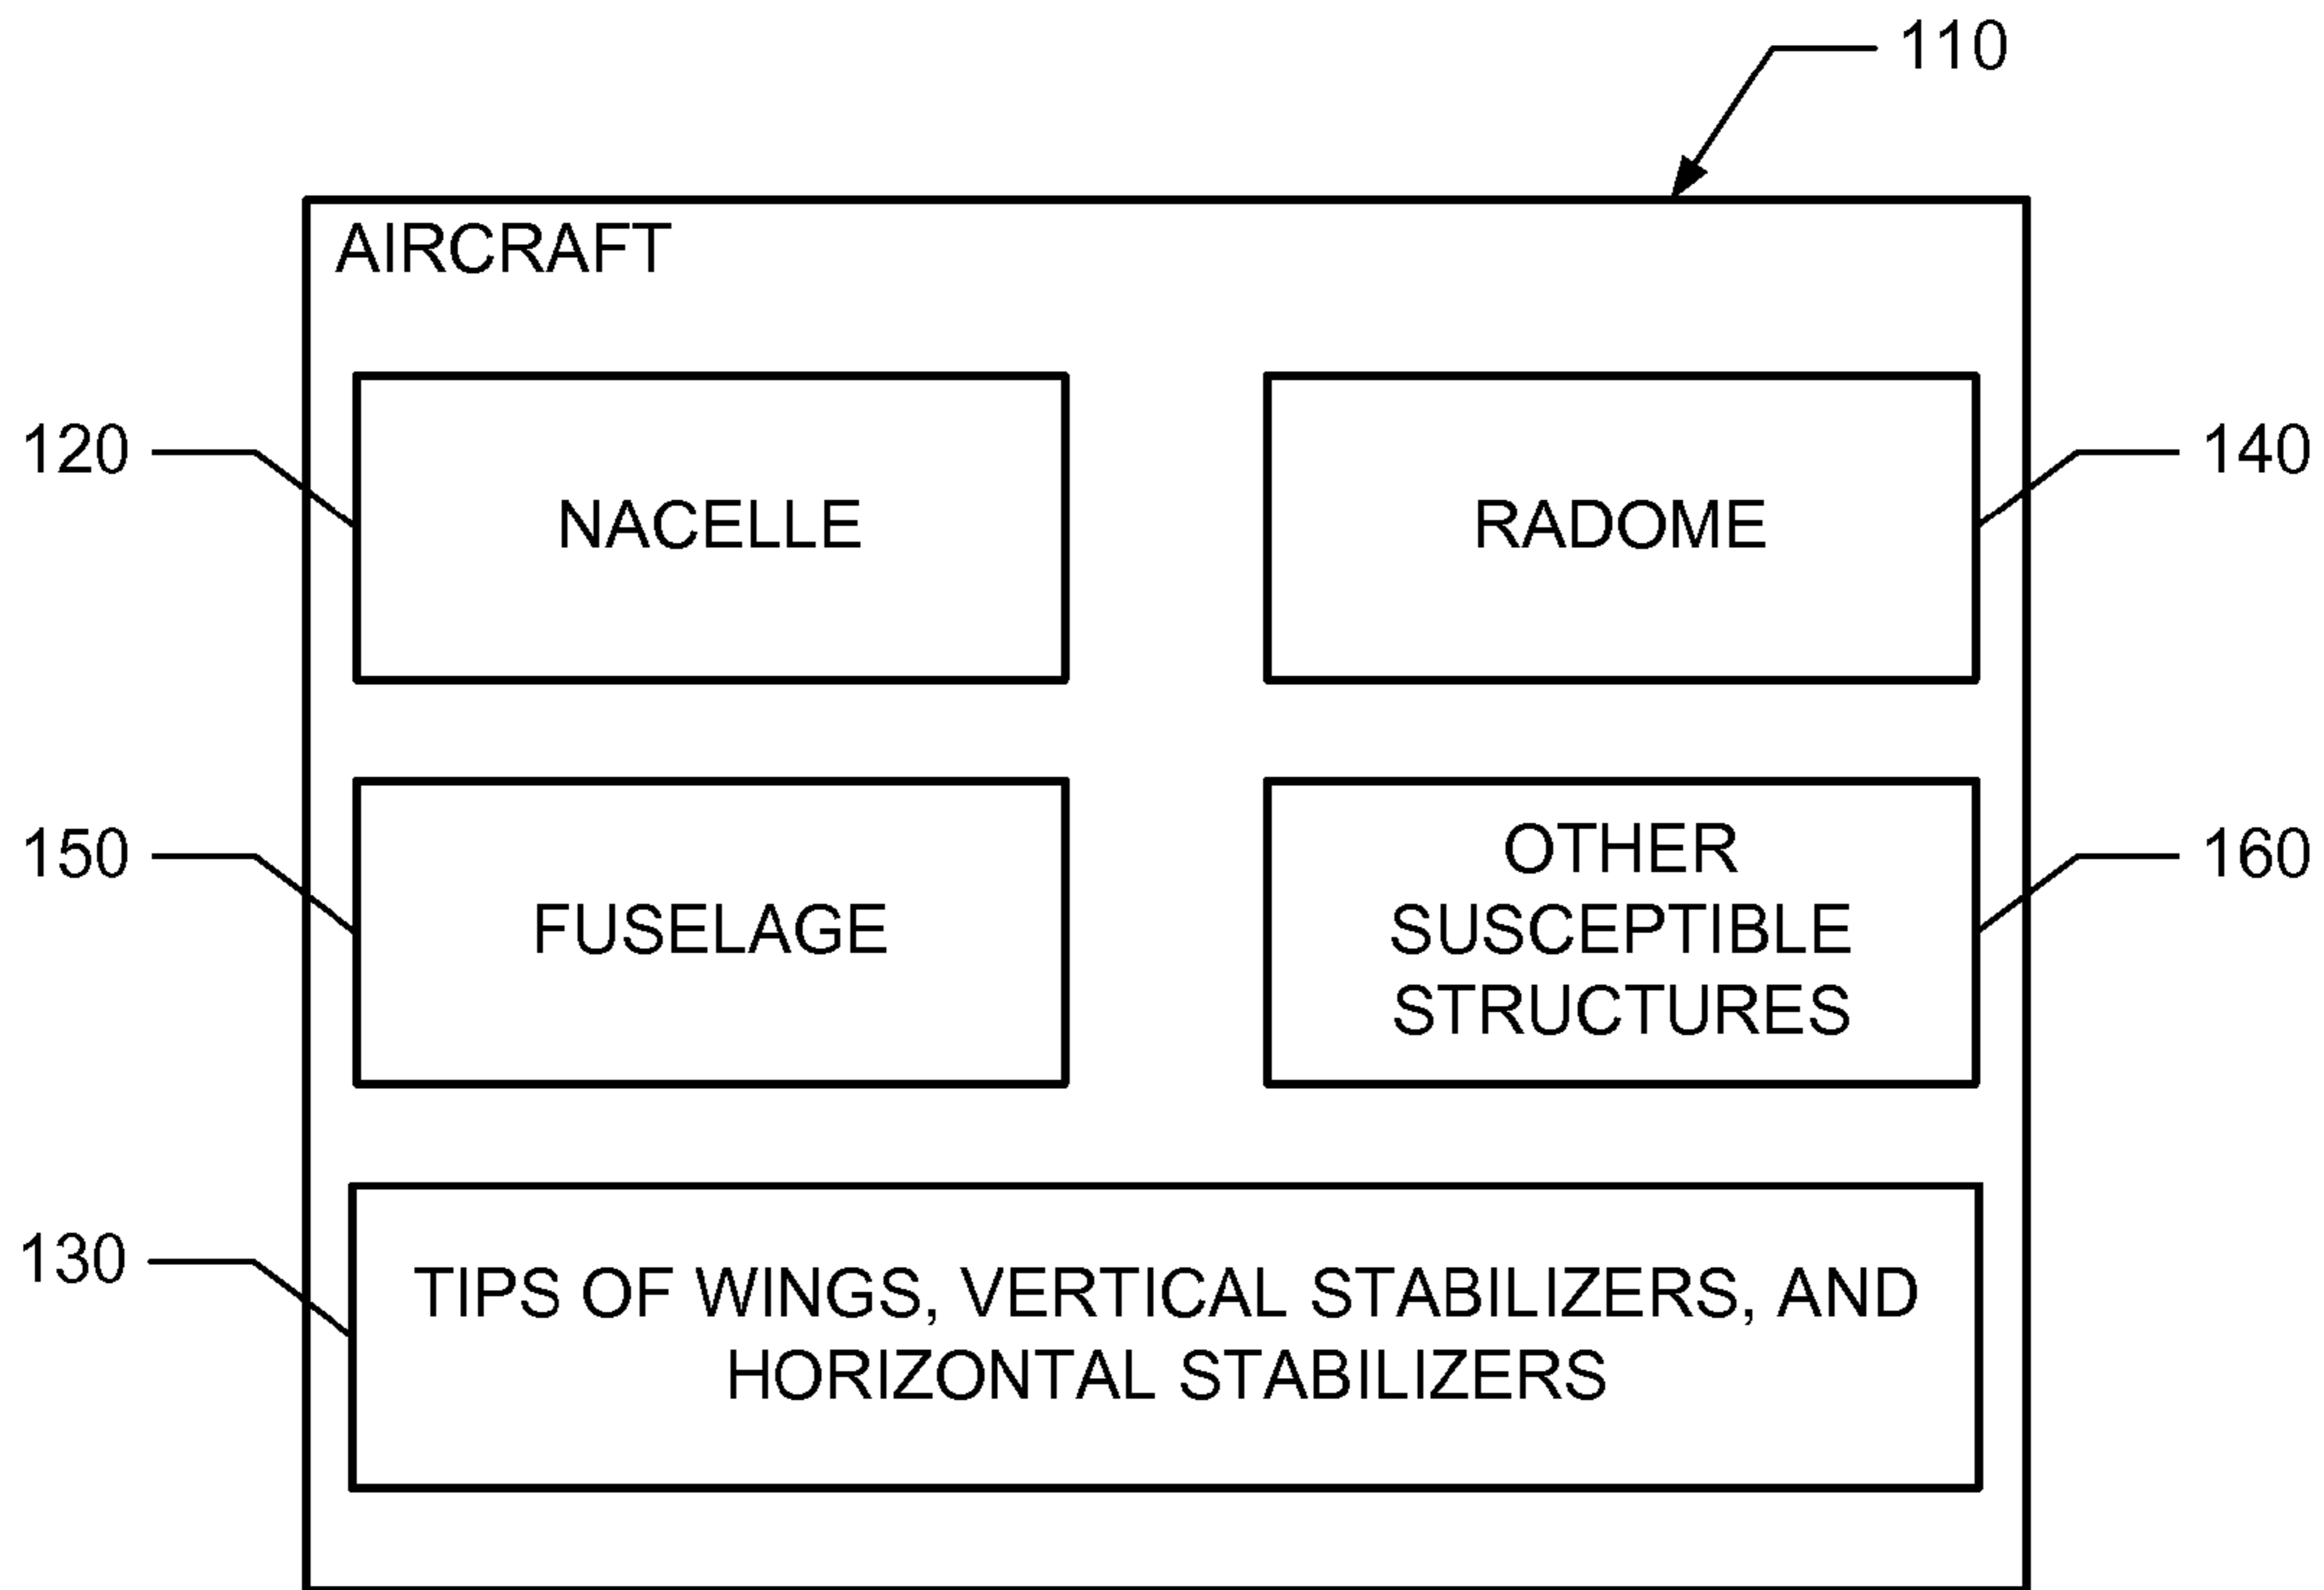
FIGS. 2a and 2b are illustrations of different patterns of communication devices for providing lightning strike detection coverage of an aircraft.

Reference is made to FIG. 2a, which illustrates a plurality of small lightweight pollable communications devices 220 for providing lightning strike detection coverage of a region 210 of a susceptible structure. Each device 220 is rendered inoperative if struck by lightning or proximate to a lightning strike. If during a thunderstorm one of the devices 220 is rendered inoperative, lightning current in the region 210 can be assumed. If a path of devices 220 is rendered inoperative, not only can lightning current in the region 210 be assumed, but a possible path of the current can be identified.

The devices 220 may be arranged in a pattern. A region 210 may be covered by devices 220 arranged in a grid pattern such as the grid pattern illustrated in FIG. 2a, or a radial pattern such as the radial pattern illustrated in FIG. 2b (the concentric circles in FIG. 2b are for reference only), or some other repeatable pattern. The pattern is not limited to a repeatable pattern. Irregular asymmetric or other non-repeatable "random" patterns may be used, for instance for installations which have high geometrical complexity or other surface constraints or where varying levels of coverage resolution are desired.

A region 210 may cover an entire structure or only a portion of a structure. For example, the grid pattern of FIG. 2a may be used to cover the tips of wings, while the radial pattern of FIG. 2b may be used to provide coverage for the tip of a radome (looking head-on towards the aircraft). More than one structure may be covered by the communication devices 220. Multiple regions of a structure may be covered by the communication devices 220. Structures that are susceptible to a lightning strike may be covered, and structures that are not susceptible to a lightning strike may also be covered.

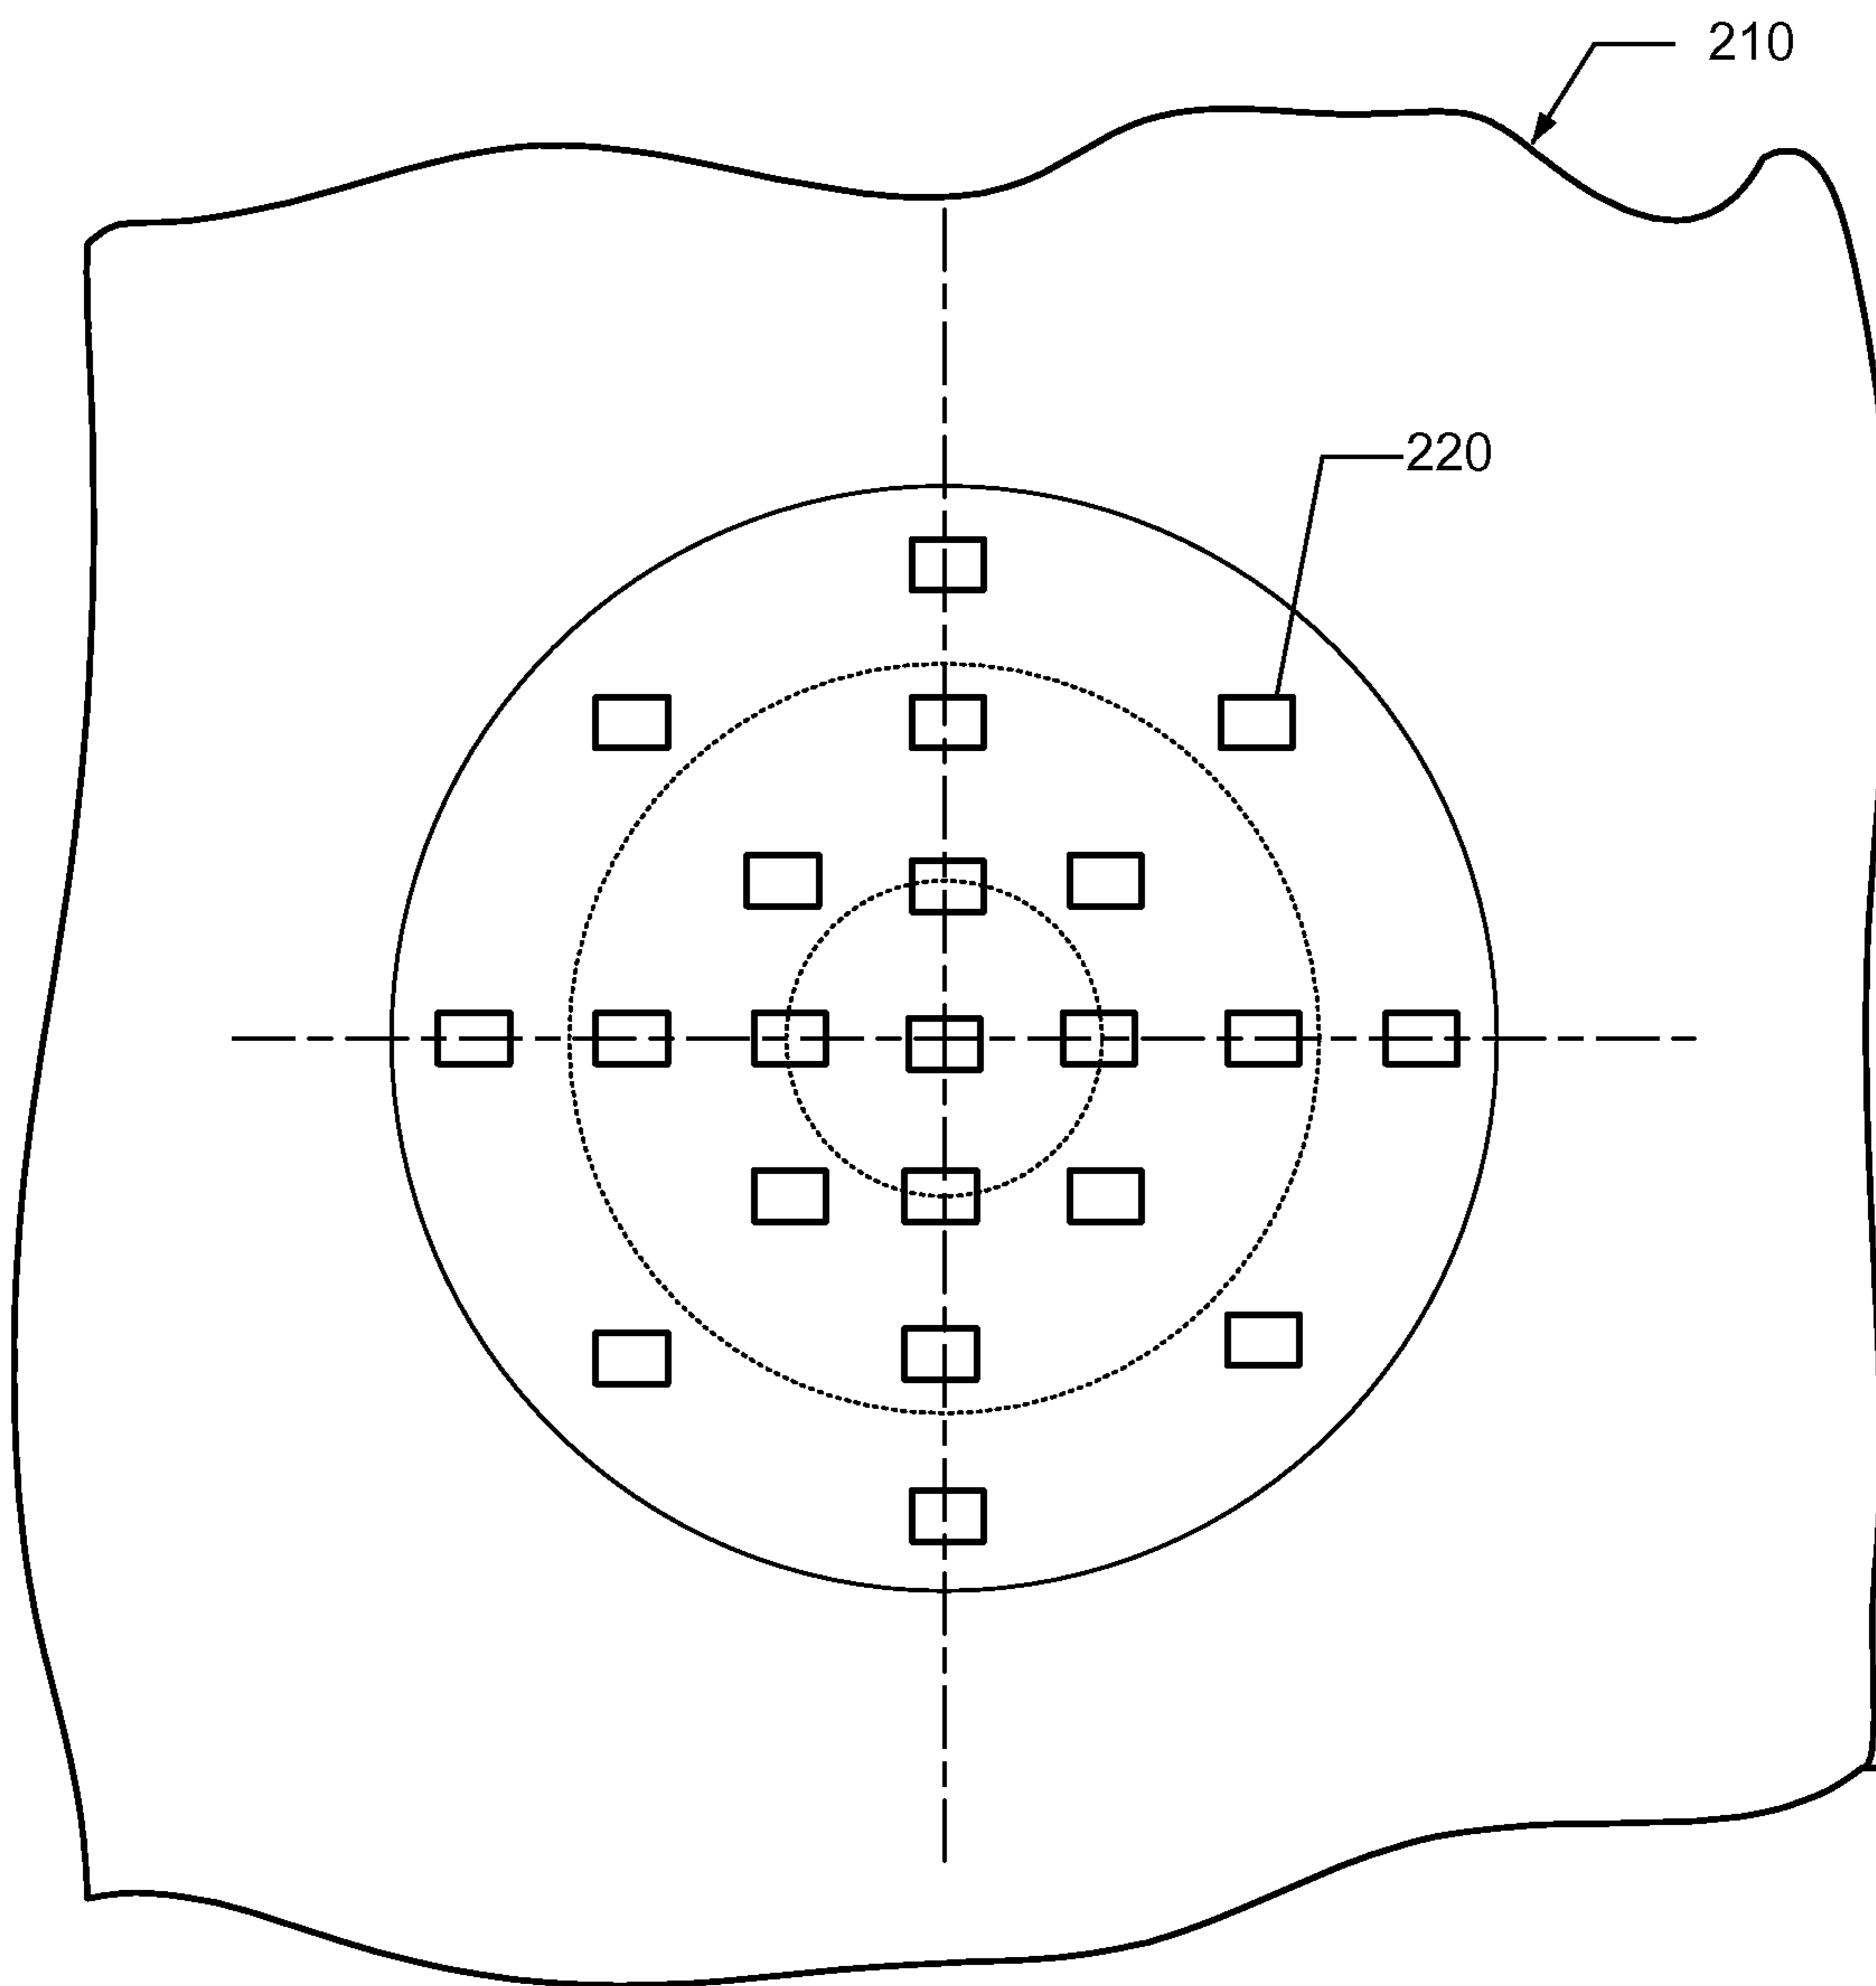
FIG. 3 is an illustration of a communication device that is surface mounted to an aircraft structure.

Reference is made to FIG. 3, which illustrates a wireless communication device **310** that is surface mounted to a structure (e.g., skin, structural spar, stringer) **320**. In some embodiments, a wireless device **310** may be attached to a structure **320** by a sealant, epoxy, or a pressure sensitive adhesive that is temperature-cured or light-cured. In some embodiments a wireless device **310** manufactured to a rigid substrate may be attached to a structural element **320** with fasteners. Such a fastener may be made of a non-conductive material (e.g., nylon), or it may be made of a conductive material (e.g., metal) but have a good conductive path away from it. In some embodiments, a wireless device **310** manufactured to a rigid or flexible substrate may be attached to a structure **320** with adhesive tape.

The mounting approaches of FIGS. **3-5** may be applied to a composite structure. The mounting approaches of FIGS. **3** and **5** may be applied to a metal structure.

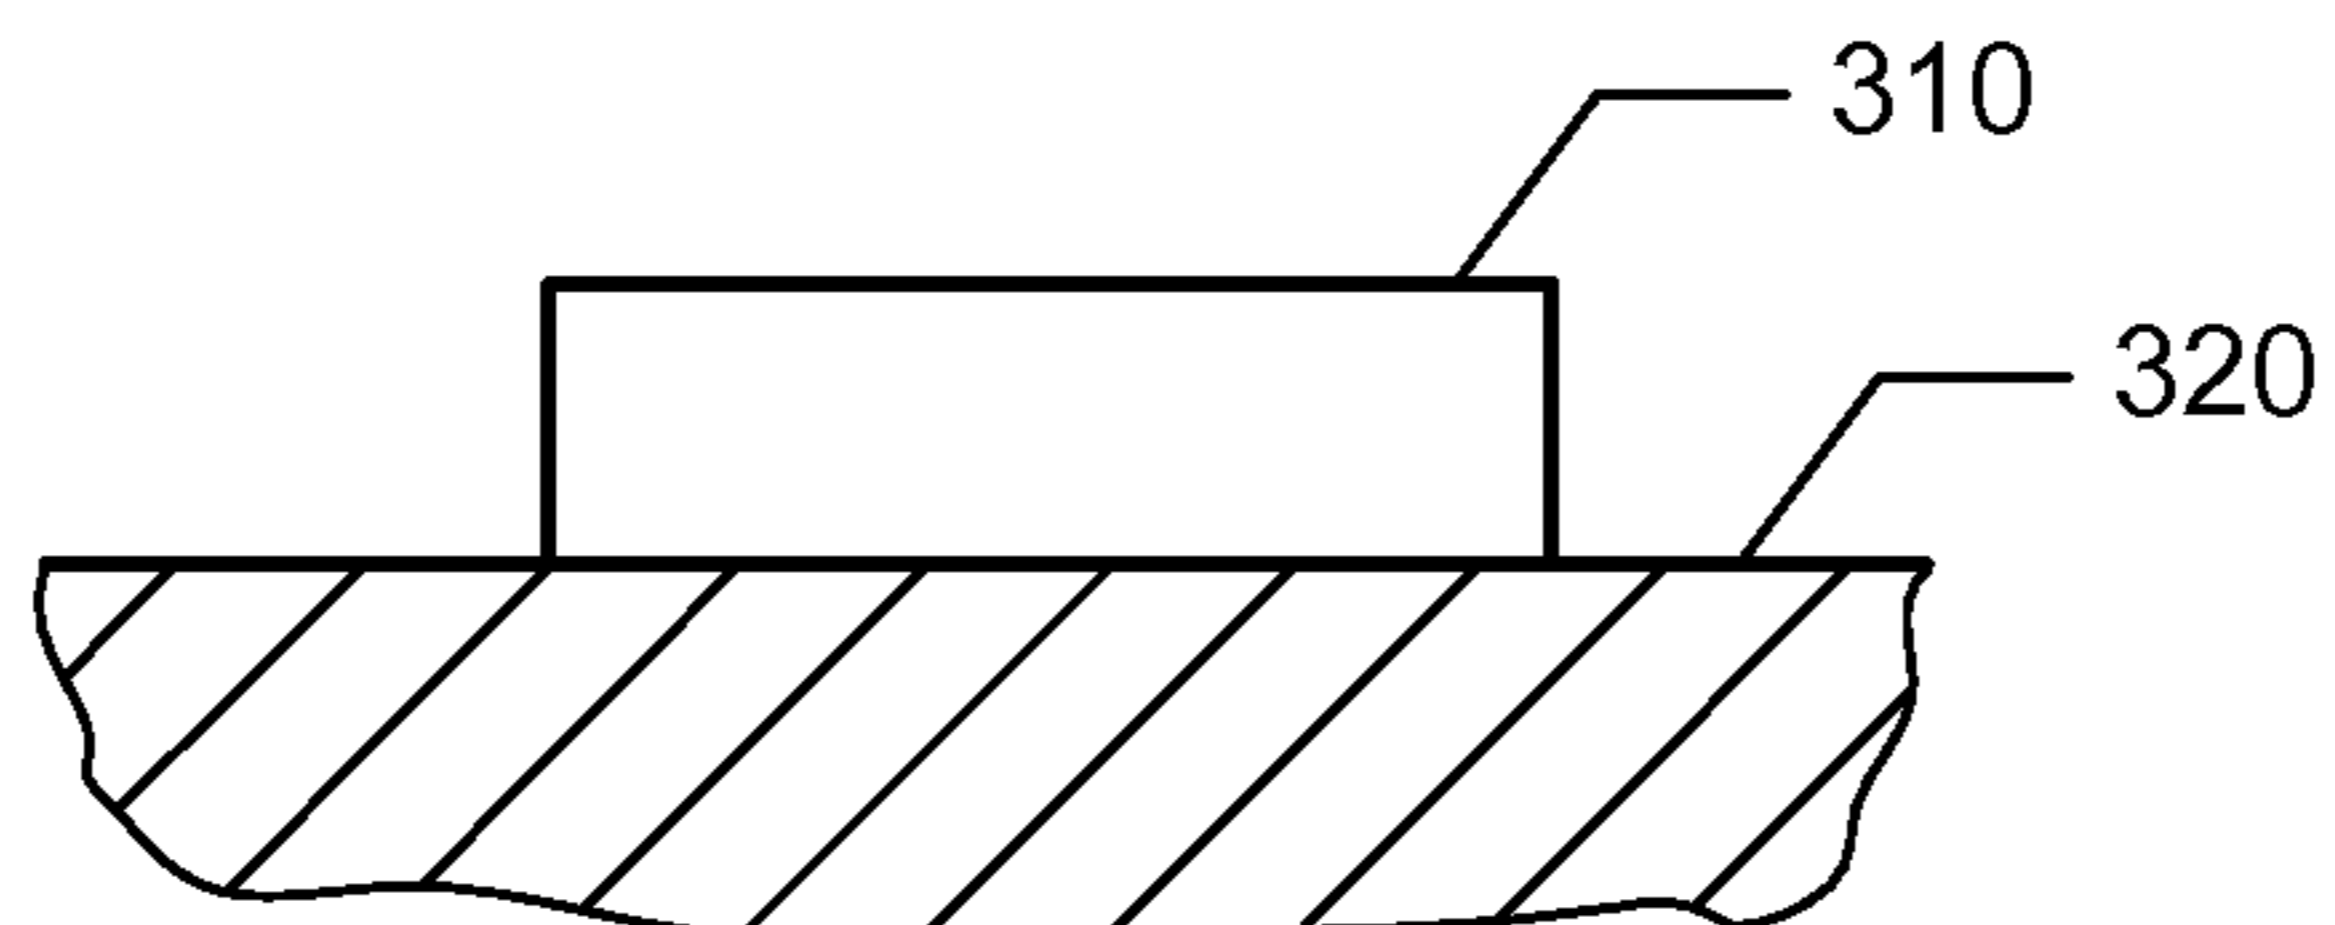
FIG. 4 is an illustration of a communication device that is embedded in an aircraft structure.

Reference is made to FIG. 4, which illustrates a wireless device such as an RFID tag **410** that is embedded in a composite structure such as a composite skin **420**. An RFID tag **410** having the geometry of a label, for instance, could be placed between layers (within the first few plies) of fiberglass, prior to curing the fiberglass. Such an RFID tag **410** can withstand a standard cure cycle. Tests have verified read/write capability of an RFID tag **410** following 220° F. autoclave fiberglass panel curing temperatures. Tests have also verified

that such an embedded RFID tag **410** would pass non-destructive inspection (NDI) testing (e.g., the tag **410** won't appear as a disbond or delamination).

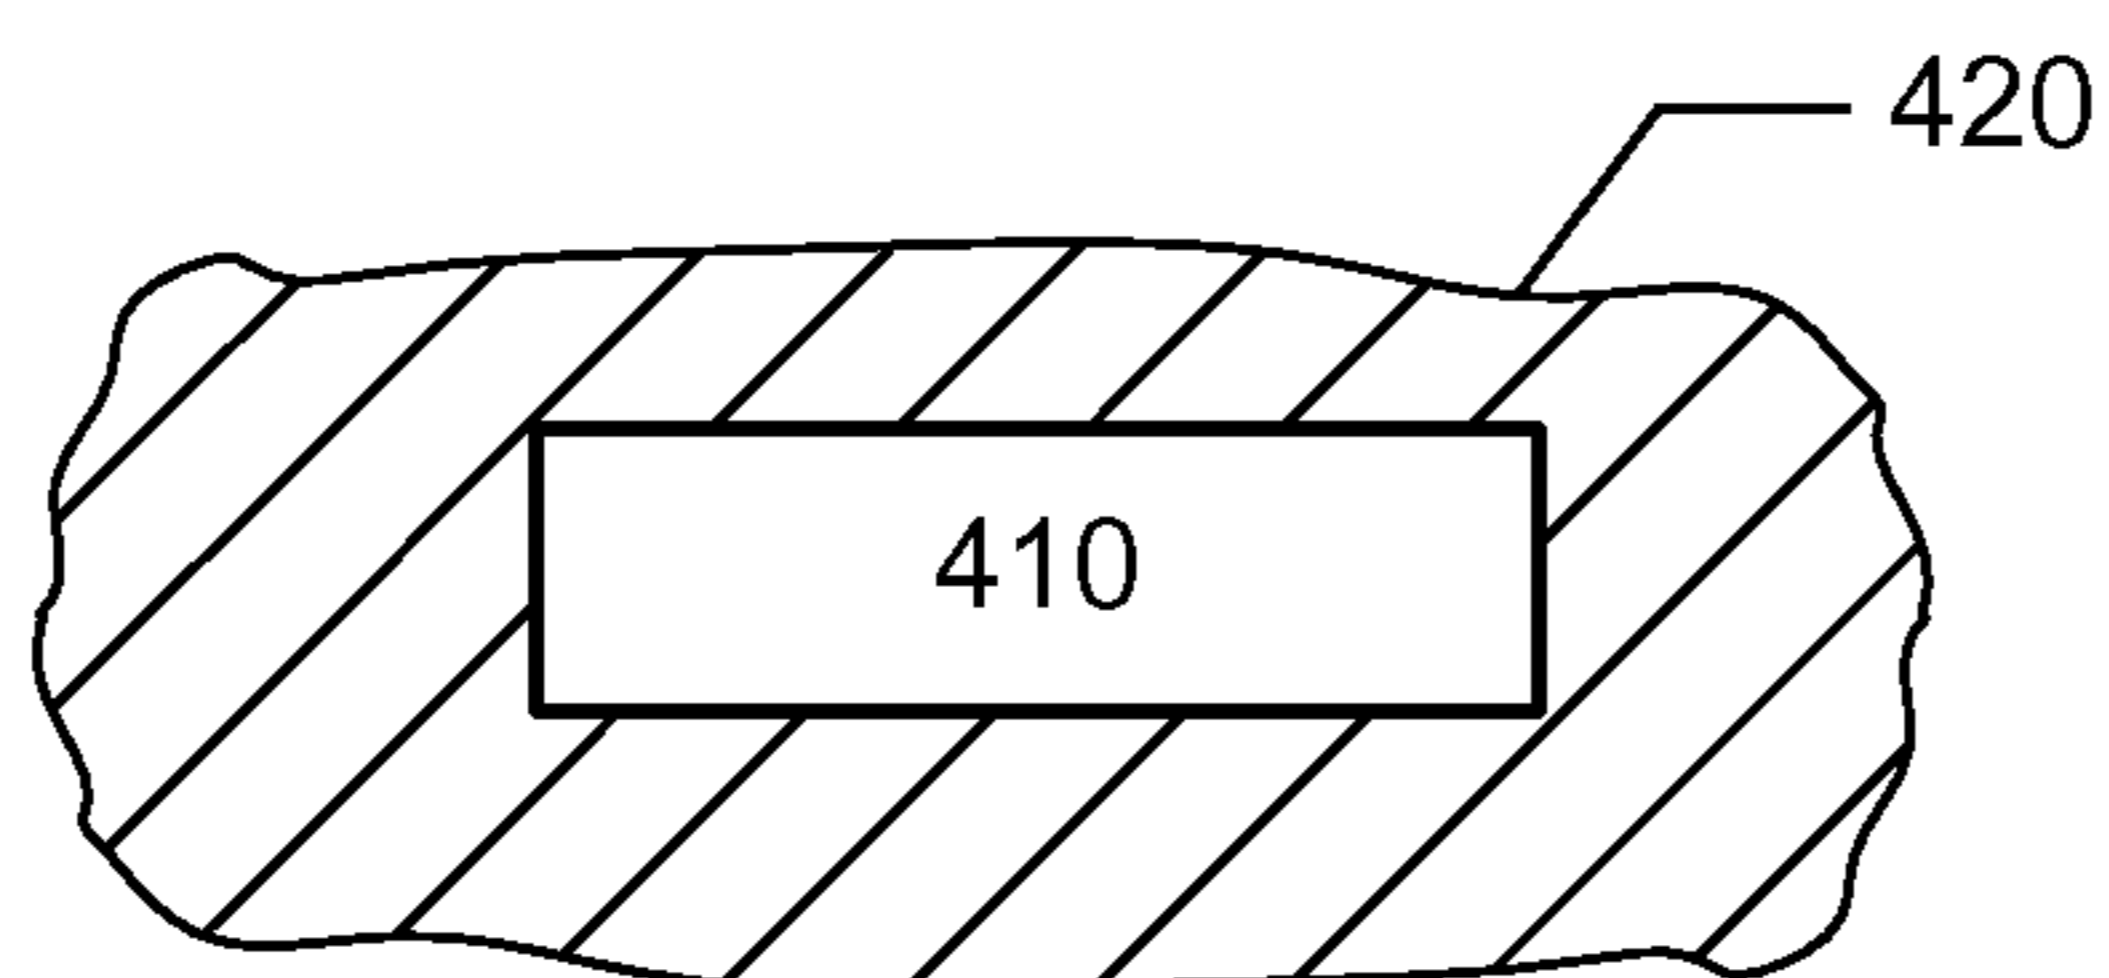
FIG. 5 is an illustration of a communication device carried by aircraft appliqué.

Reference is made to FIG. **5**, which illustrates a communication device **510** that is carried by appliqué **520**. Appliqué, which typically has a thickness between 2-4 mils, provides a protective coating for composite structures such as fuselage skin, and wing skin (in lieu of paints and other coatings). The wireless device **510** may be surface mounted to the appliqué **520**. The appliqué is then attached to a surface of a composite structure **530** using, for example, epoxy, sealant, pressure sensitive adhesive, temperature-cured adhesive, or light-cured adhesive.

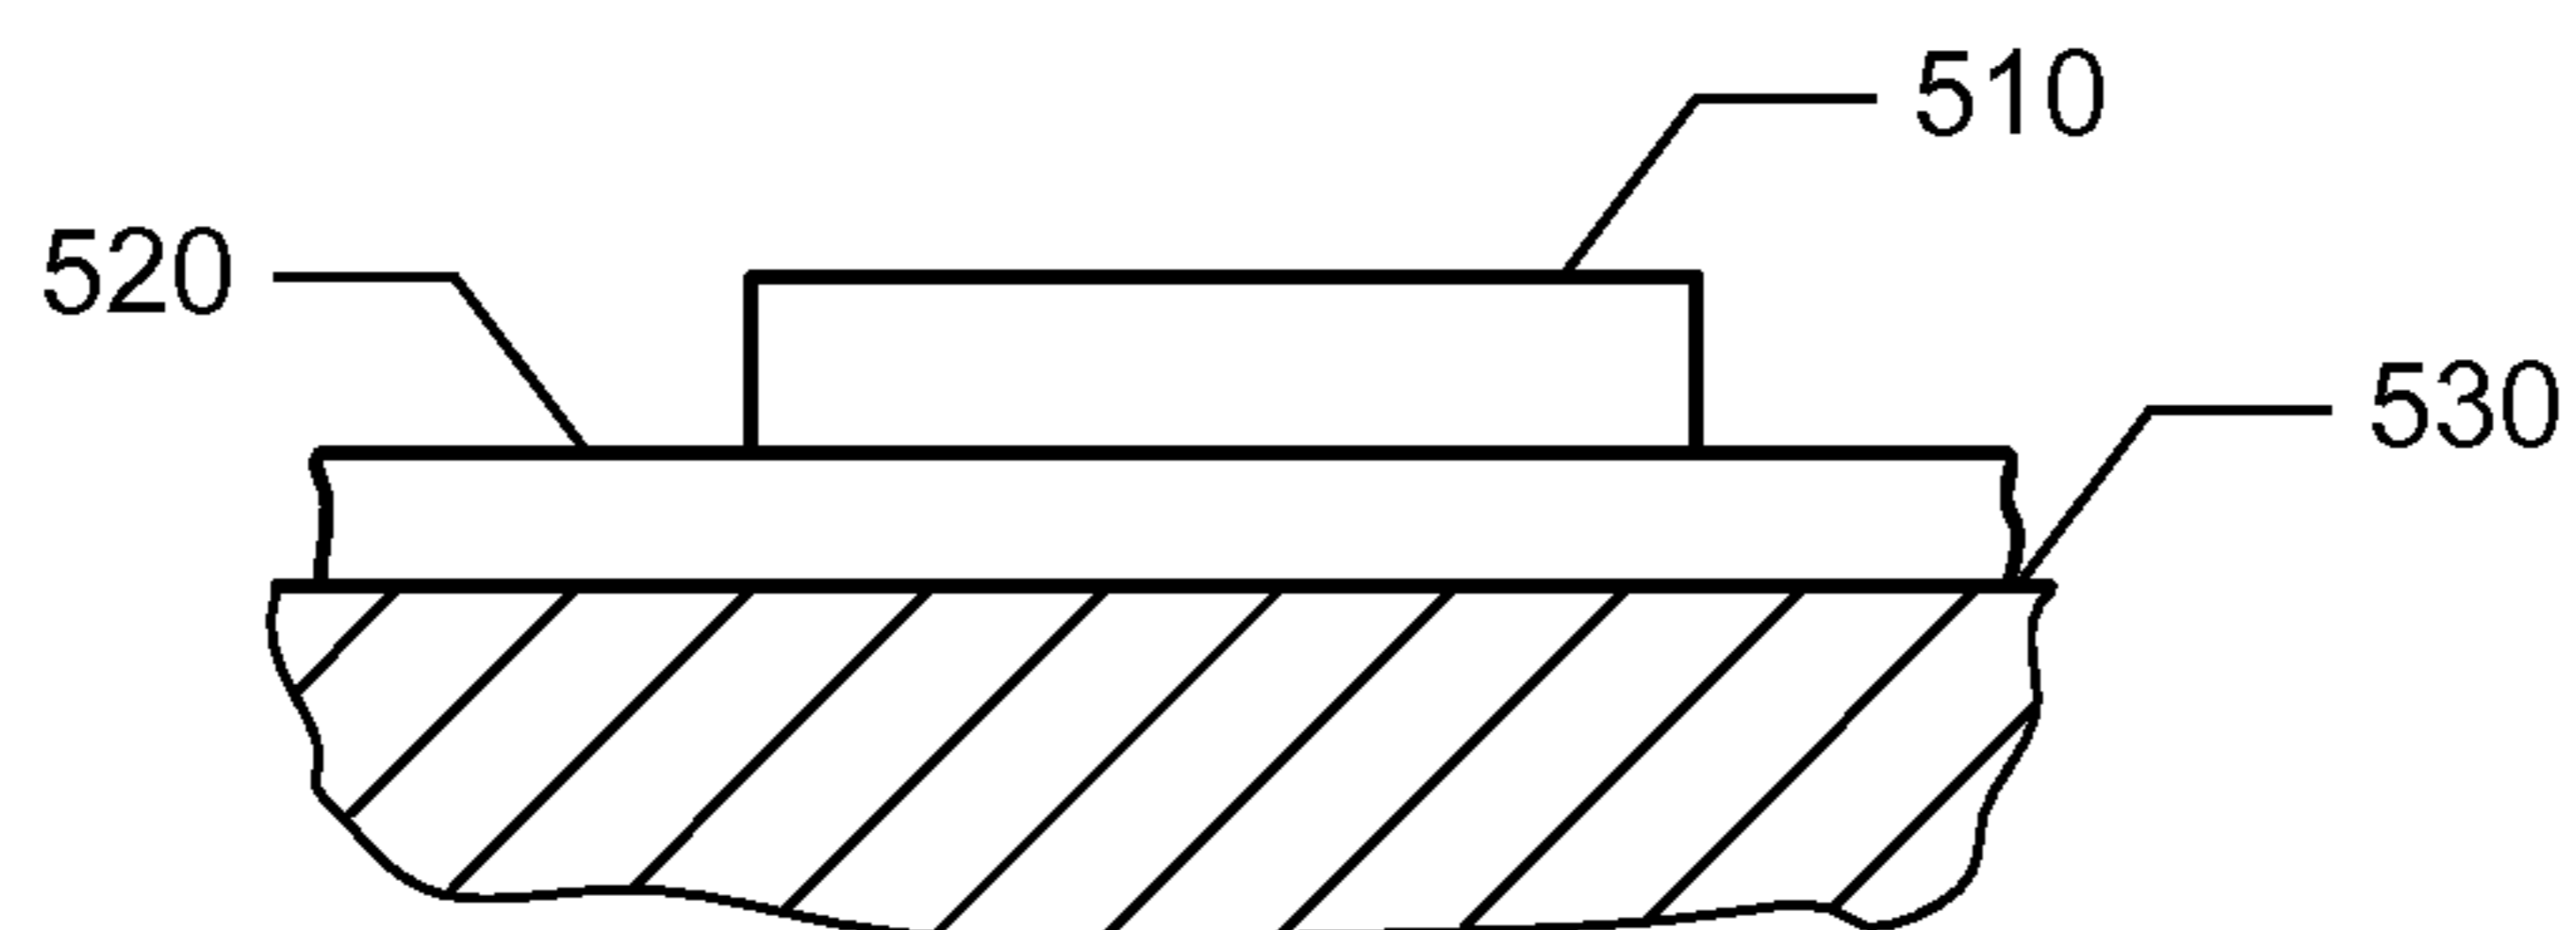
*FIG. 6*

FIG. 6 is an illustration of a method of detecting a lightning strike.

Reference is now made to FIG. **6**, which illustrates a method for assessing the structural health of an aircraft. At block **610**, polling is performed on a plurality of devices that cover a region of the aircraft. The polling can be performed periodically or in response to an event (e.g., a lightning strike), or both. All operative devices will respond to the polling by, for example, providing identification information.

At block **620**, inoperative devices are identified. That is, those devices not responding to the polling are identified.

At block **630**, locations of any inoperative devices are identified. The locations may be identified by accessing a lookup table of that returns a specific aircraft installation location in response to a unique device.

At block **640**, analysis of an affected region is performed to identify inspection zones. Inspection zones will be examined in greater detail by NDI. At a minimum, the analysis may indicate whether the region under test was struck by lightning. If multiple devices are inoperative, the analysis may also suggest a path followed by the current, where the lightning detached, magnitude of the lightning strike, etc. In some embodiments, the analysis may indicate whether LSP failed.

At block **650**, nondestructive inspection for damage caused by the lightning strike is performed on any inspection zones. For example, ultrasonic testing or infrared spectroscopy may be performed on an inspection zone.

Thus, the method of FIG. **6** allows NDI to be localized quickly, without any advance knowledge of the lightning strike. Very large areas of an aircraft structure do not have to be inspected, and specific indicators (e.g., areas containing surface pitting and paint damage) are far less likely to be missed.

The functions at block **610-640** may be performed in-flight. If the aircraft can perform in-flight NDI, the function at block **650** may also be performed in-flight. Lightning strike detection results may be sent to a computer that is on-board the aircraft, and/or it may be transmitted to a computer that is on the ground. If a lightning strike is detected, an appropriate action is taken. As a first example, a pilot is notified that the aircraft has been struck by lightning and the region that has been struck. If the aircraft can perform in-flight NDI, it could inspect any inspection zones and inform the pilot of any damage. A recommendation can then be made as to aborting or continuing the flight.

At block **660**, once the aircraft is on the ground, structural damage can be fully assessed, and damaged structures can be repaired. In addition, inoperative devices can be replaced by maintenance personnel. If an inoperative device was surface mounted, it can be removed, and a replacement device can be surface mounted to the same location. If an inoperative device is embedded, a replacement device can be surface mounted to the location over the inoperative device.
