(12) **United States Patent**
Berkebile et al.

(10) **Patent No.:** **US 8,904,635 B2**
(45) **Date of Patent:** **Dec. 9, 2014**

(54) **METHOD FOR SERVICING A TURBINE PART**

(73) Assignee: **General Electric Company**, Schenectady, NY (US)

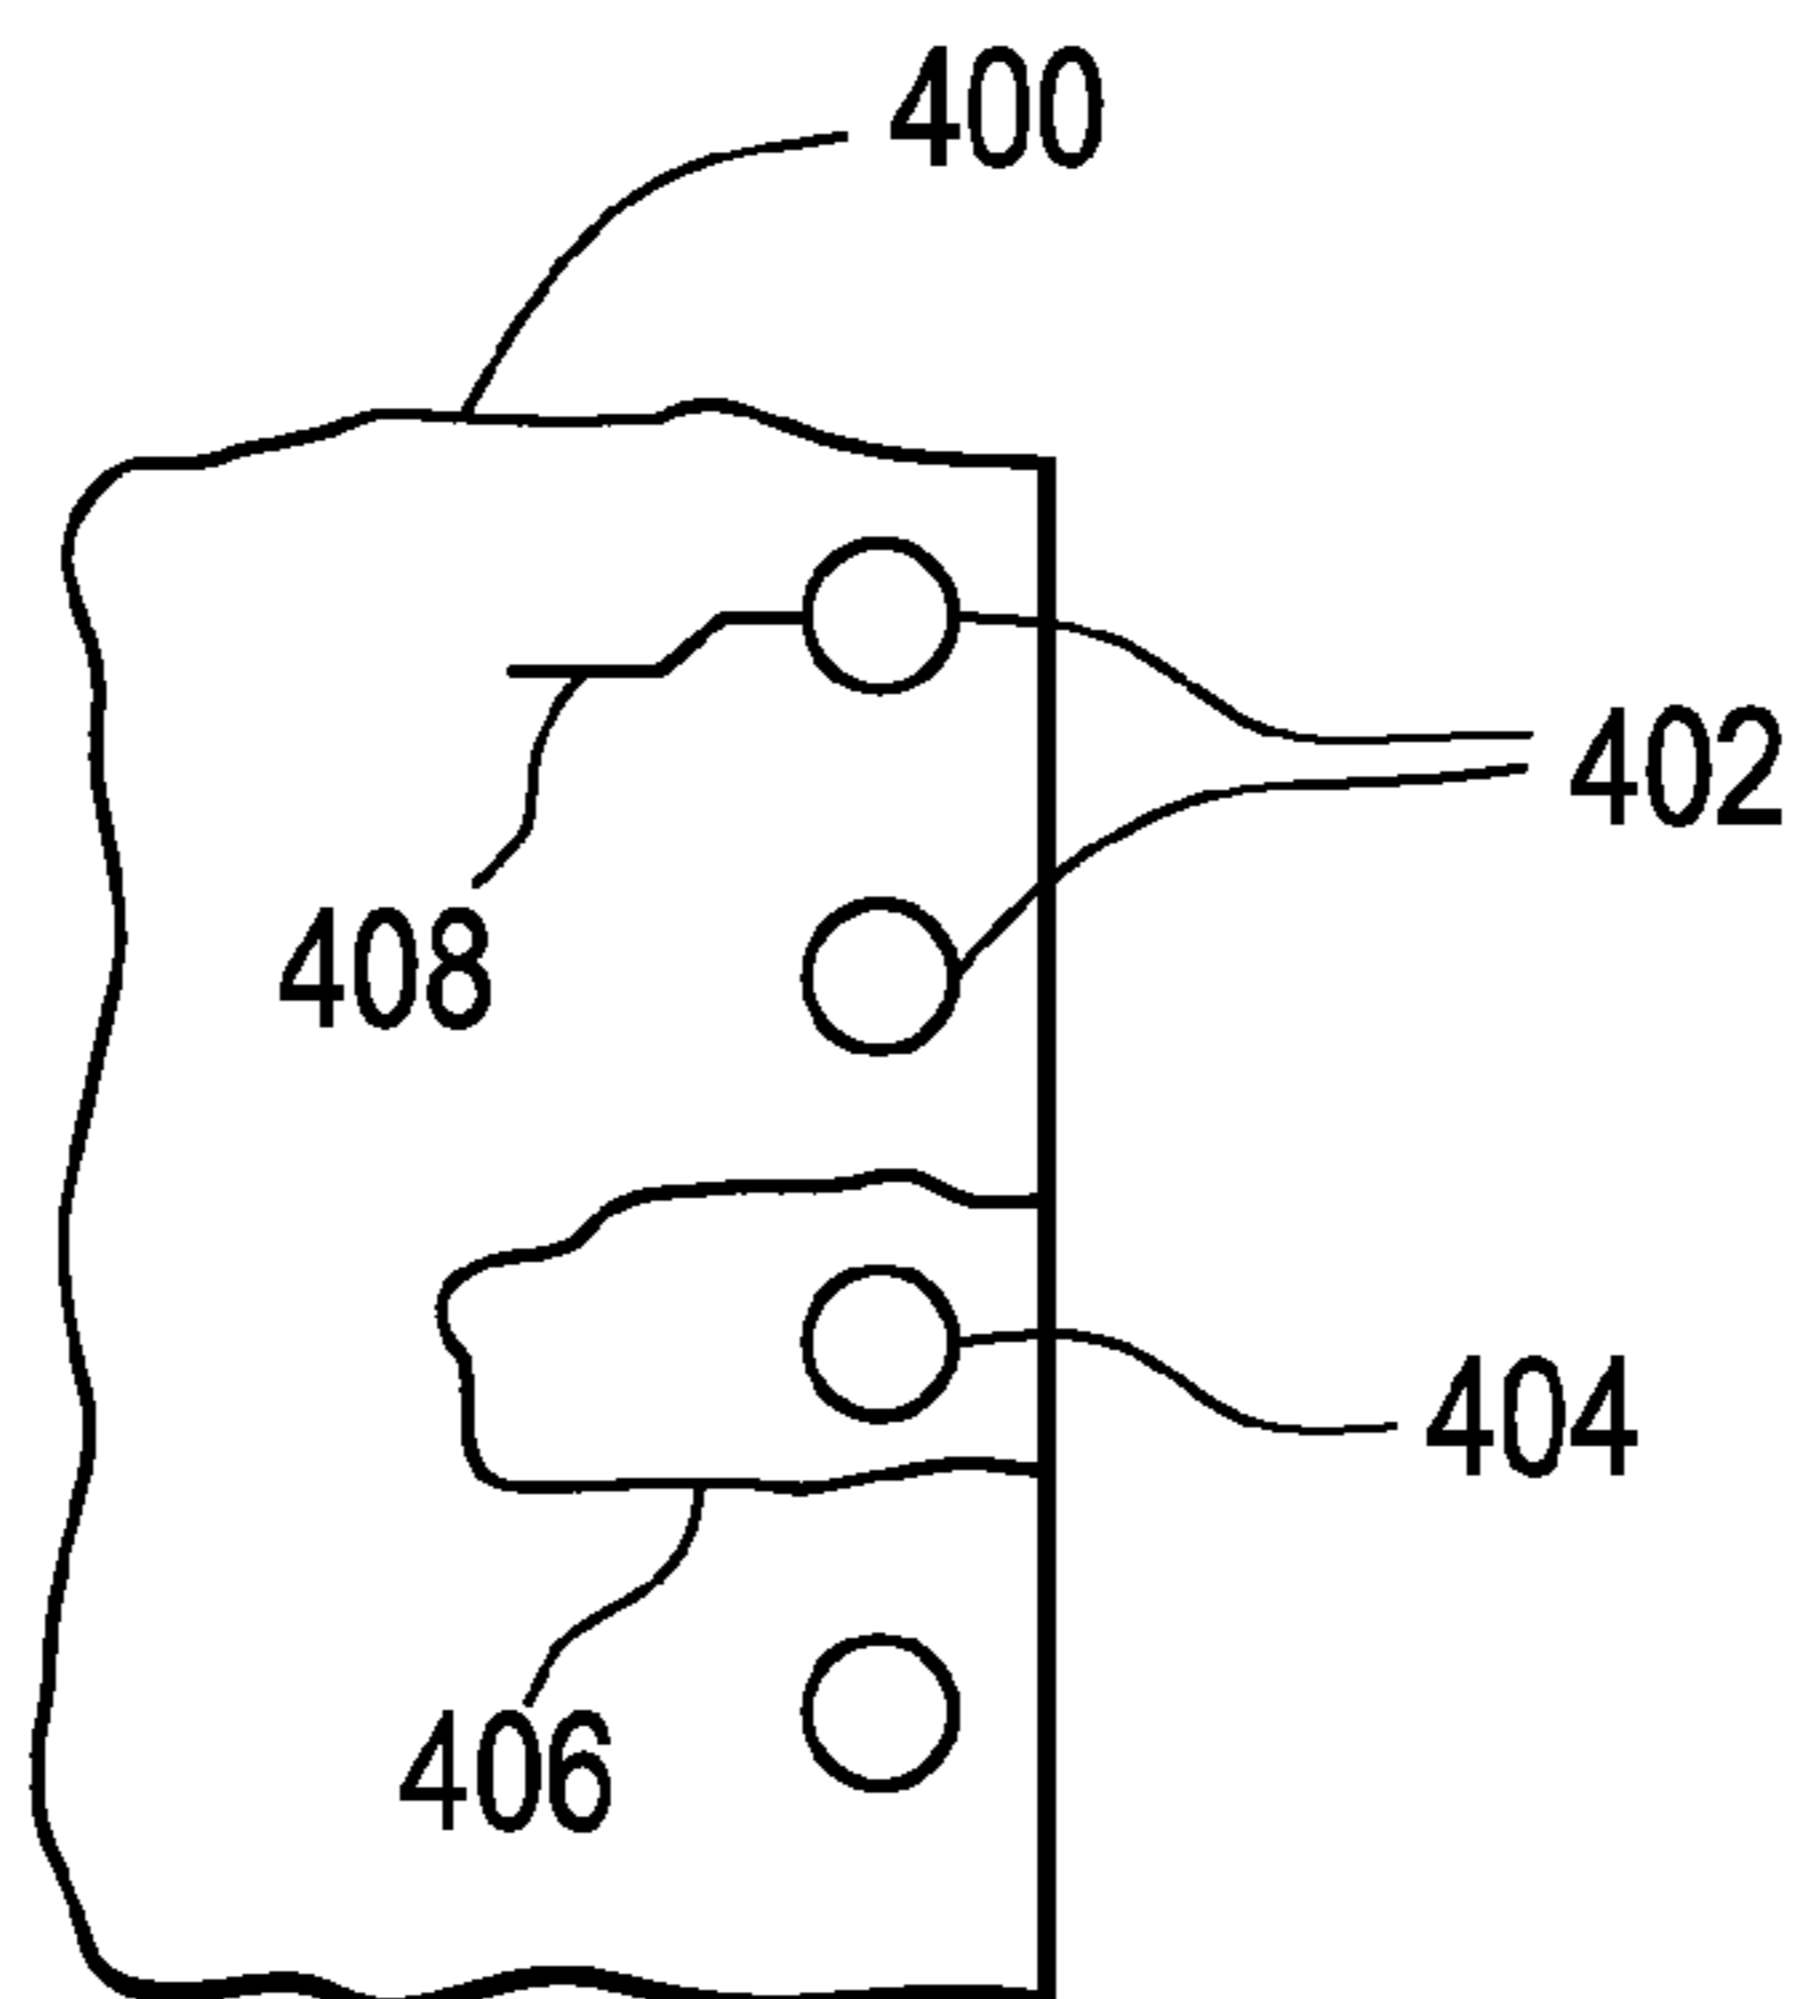
FIG. 4 is a top view of an embodiment of a combustion part that has been repaired.

FIG. 4 is a top view of an embodiment of a combustion part **400** that has been repaired using a pulsed laser welder. The combustion part **400** includes holes **402**, repaired hole **404**, weld area **406** and crack **408**. The repaired hole **404** shows the structure of the hole **404** that has been maintained after a pulsed laser weld has repaired a crack filled by the weld area **406**. The depicted weld area **406** shows the area after pulsed laser welding, where the weld forms a small pool, but does not fill hole **404**. Therefore, the hole **404** is capable of fluid flow without machining or drilling the hole before reinstalling in the turbine. Element **408** depicts an example of a crack that may be repaired by the pulsed laser welding method discussed above.
