(12) **United States Patent**
Berkebile et al.

(10) **Patent No.:** **US 8,904,635 B2**
(45) **Date of Patent:** **Dec. 9, 2014**

(54) **METHOD FOR SERVICING A TURBINE PART**

(73) Assignee: **General Electric Company**, Schenectady, NY (US)

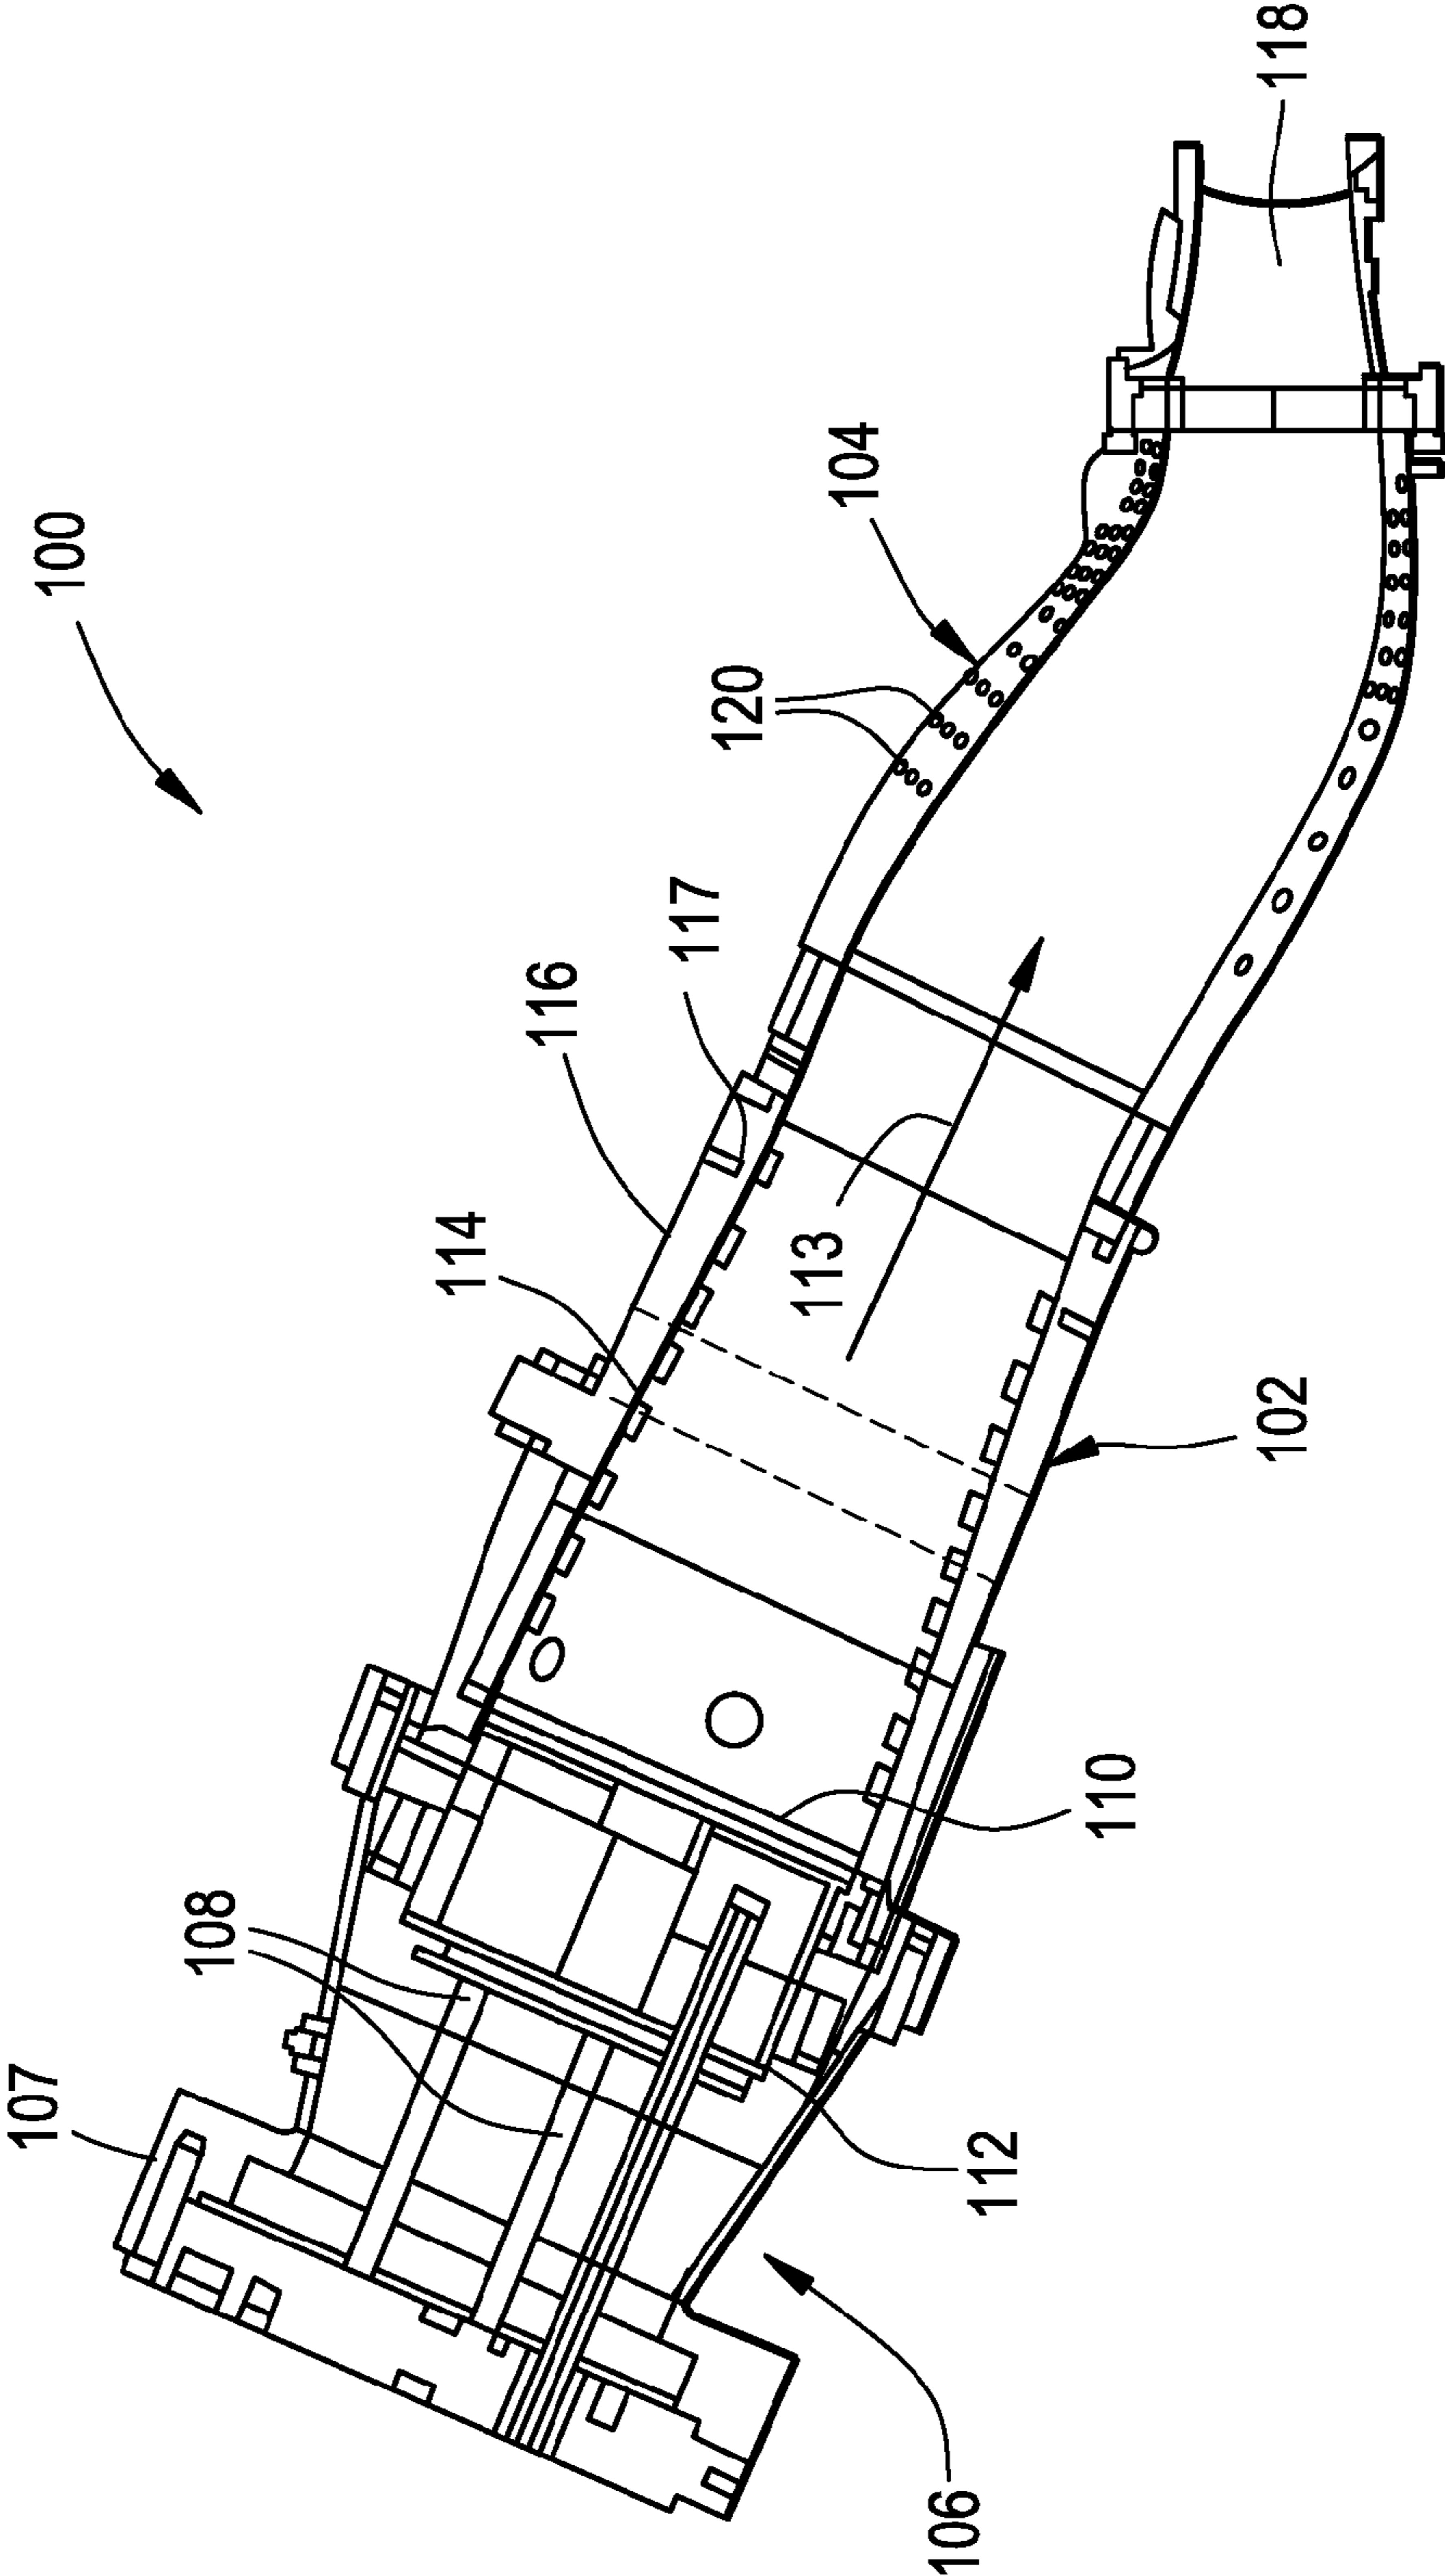
FIG. 1 is a sectional side view of an embodiment of gas turbine combustor;

FIG. 1 is a sectional side view of an embodiment of gas turbine combustor 100. The combustor 100 includes a combustion chamber 102, transition piece 104 and fuel nozzle assembly 106. The fuel nozzle assembly 106 includes an end cover 107, fuel nozzles 108, effusion plate 110 and combustion cap 112. The fuel nozzles 108 inject and mix a supply of fuel and a supply of compressed air into the combustion chamber 102, wherein the fuel-air mixture combusts to provide a hot gas flow downstream 113. The combustion chamber 102 includes a liner 114 positioned within a flow sleeve 116, wherein an air supply is directed through flow holes 117 in the liner 114 to provide air to the combustion chamber 102. The hot gas flows downstream 113 from combustion chamber through transition piece 104 to turbine 118. The transition piece 104 includes holes 120 configured to flow a cooling fluid, thereby cooling the transition piece 104.

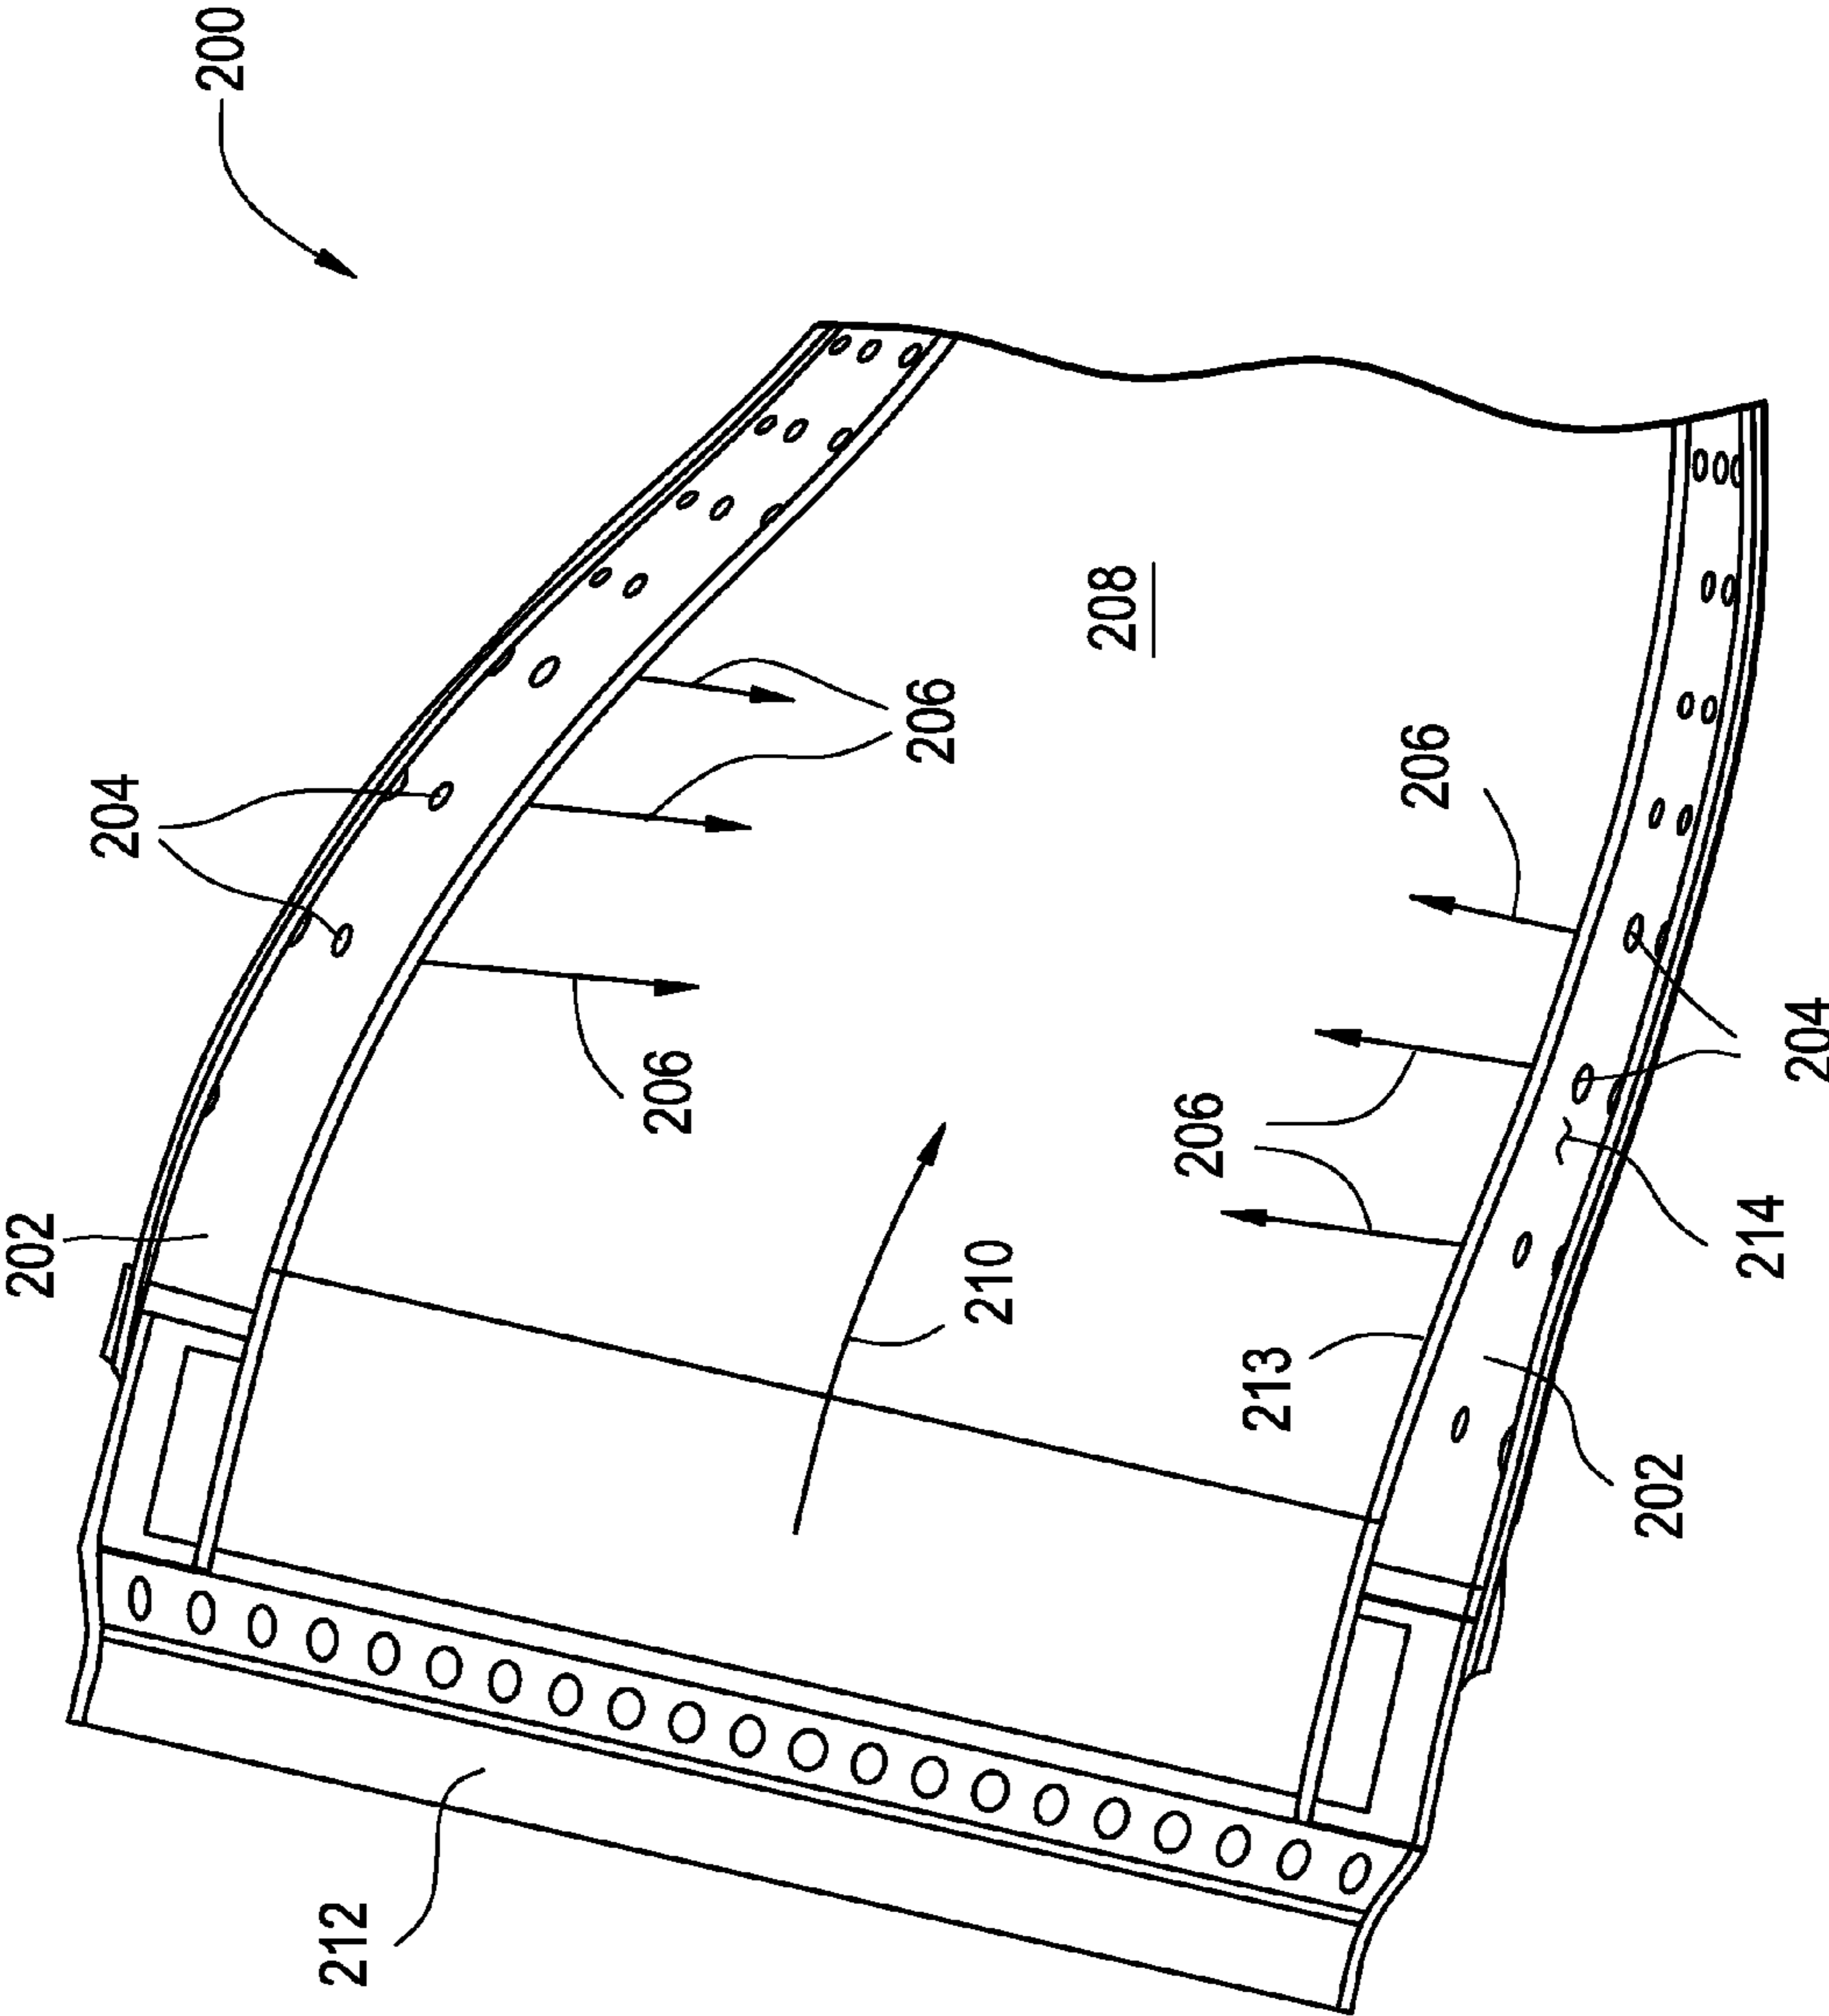
FIG. 2 is a sectional side view of an embodiment of a transition piece;

Referring now to FIG. 2, a sectional side view of an embodiment of a transition piece 200 is illustrated. The transition piece 200 includes a body 202 with holes 204 for flow of a cooling fluid 206 into a chamber 208. The cooling fluid 206 is configured cool the body 202 as a hot gas flow 210 flows into the chamber 208 from a combustor coupled to transition piece end 212. The holes 204 are a suitable structure or geometry, such as circles, hexagons or squares, to provide cooling fluid flow 206 that creates a film on body 202 to protect the body 202 as the hot gas 210 flows through the transition piece 200. The shape and size of the holes 204 are designed to improve cooling of the body 202 (also referred to as impingement sleeve). In an embodiment, the holes 204 are a circular structure with a diameter of about 0.5 to 3 millimeters, wherein the size and shape of the structure causes the cooling fluid 206 to diffuse in the chamber 208. In an embodiment, the body 202 comprises a steel alloy and the holes 204 are punched, drilled or otherwise formed in the body 202. The pulsed laser weld repair near the holes 204 does not substantially change the diameter of the holes 204, thereby enabling the cooling fluid to flow and produce the desired cooling in the turbine part, such as transition piece 200.

In addition, an exemplary transition piece 200 includes a thermal barrier coating 213 wherein the thermal barrier coating 213 is configured to provide a layer of protection to the transition piece 200 from the high temperatures caused by hot gas flow 210 within the transition piece 200. Further, thermal barrier coating 213 is disposed on a surface of the transition piece 200 wherein the thermal barrier coating 213 comprises a metal substrate, metallic bond coat, thermally grown oxide and ceramic topcoat. In embodiments, a structural flaw, such as a crack 214, may develop near holes 204. A pulsed laser welder may be used to fill the crack by precisely melting a filler material and the body 202 near the crack, wherein the pulsed laser weld repairs the crack 214 without affecting the nearby holes 204 and while maintaining the thermal barrier coating 213. This is due to the precision and short pulse width of pulsed laser weld focused on the small area of the crack 214. Thus, by intensely focusing short pulse width laser beams of the pulsed laser welder in a selected area, the pulsed laser welder provides a lower heat to the region of the body 202 near the crack 214, thereby protecting the holes 204 and thermal barrier coating 213. By precisely filling the crack 214

using the pulsed laser welder, the repair of the transition piece **200** is simplified and shortened due to the weld not affecting the structure of holes **204** and thermal barrier coating **213**.

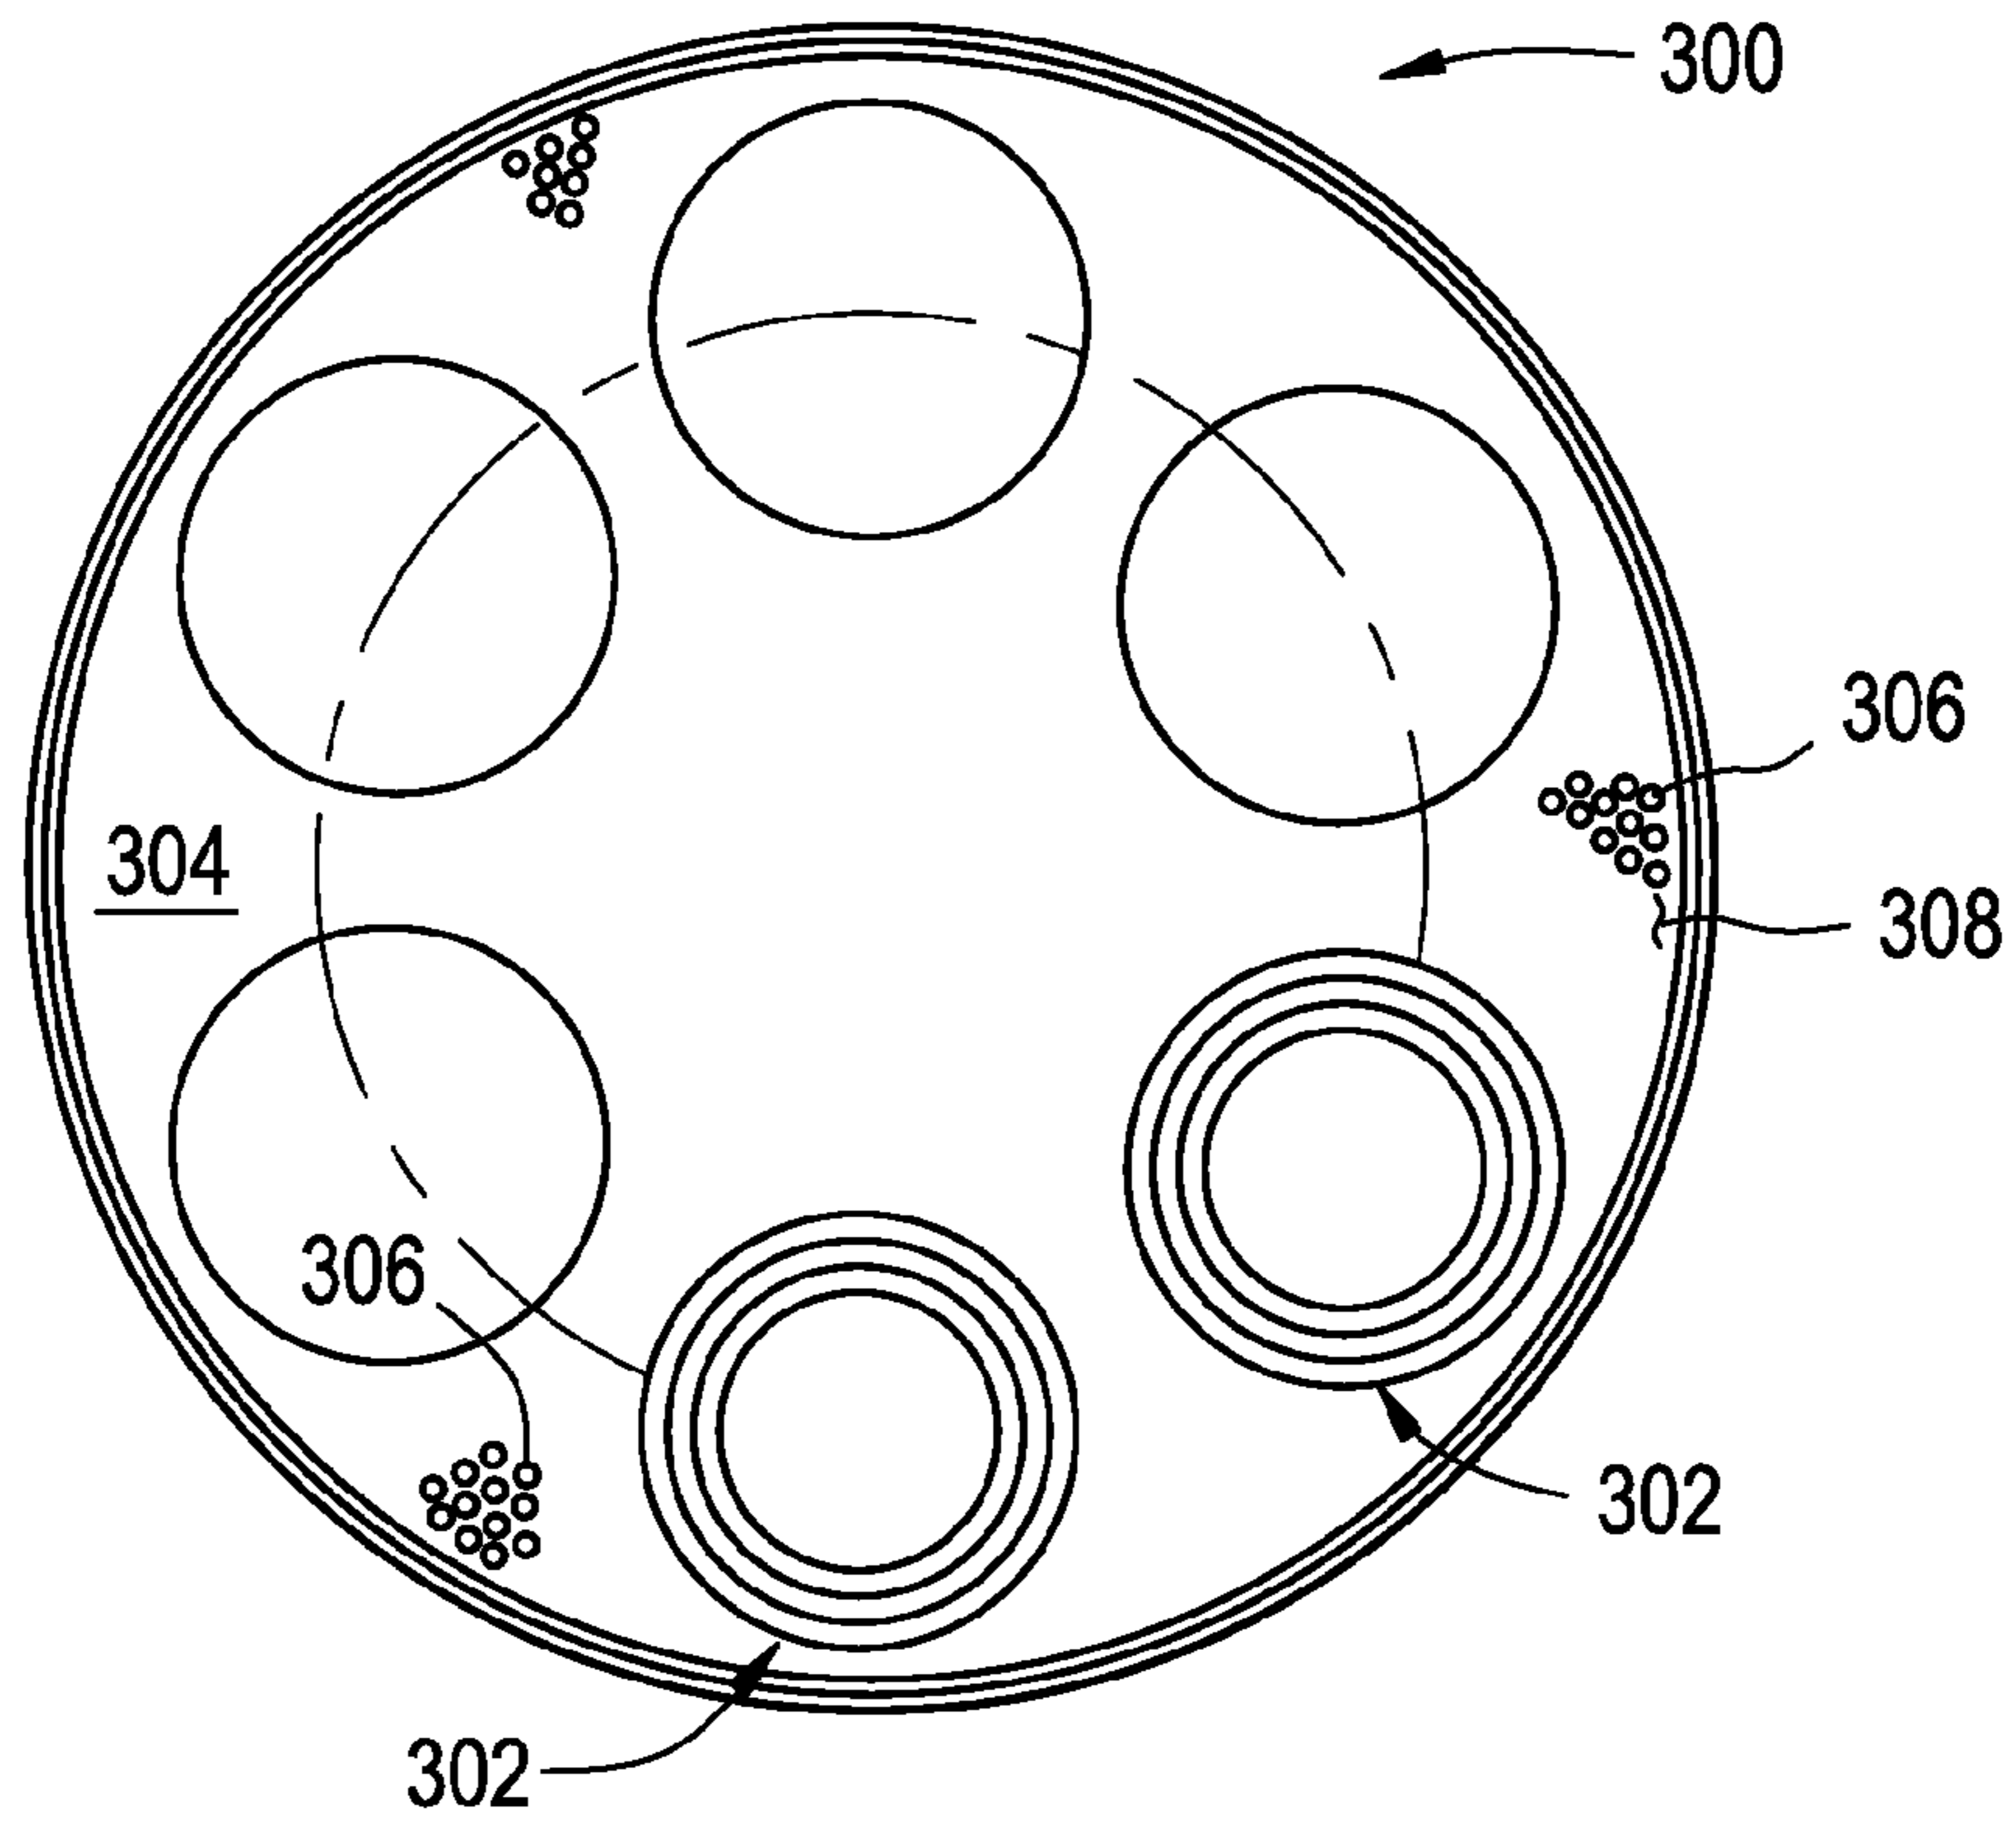
FIG. 3 is a top view of an embodiment of an effusion plate; and

FIG. 3 is a top view of an embodiment of an effusion plate **300**. In one embodiment, the effusion plate **300** is proximate to a downstream end of one or more fuel nozzles **302**. The effusion plate **300** includes a body **304** with a plurality of holes **306** for a flow of cooling fluid. In an aspect, the holes **306** are circular holes configured to enable a fluid flow through the holes **306** and causing a film of cooling fluid to develop on the body **304**, thereby cooling the body from the hot gas flow within the turbine. In aspects, the holes **306** may be any suitable structure, including but not limited to, circles, hexagons and squares. Over time, wear and tear may cause flaws, such as a crack **308**, to develop on the body **304** near the holes **306**. As discussed above, the crack **308** is repaired by a pulsed laser welder without affecting the structure of the holes. In an example, the effusion plate **300** is removed from the turbine and the crack **308** is pulsed laser welded while still attached to adjacent components, such as nozzles **302**, thereby eliminating disassembly and assembly steps of the repair process. The pulsed laser weld provides a precise and focused weld to fill the crack **308** without affecting regions near the weld. Specifically, the precise laser weld of the crack **308** does not affect a structure of the cooling fluid holes **306** and is performed while attached to fuel nozzles **302**. Thus, the crack **308** is repaired and operational without brazing or machining the body **304** or the holes **306** following the pulsed laser welding process. Accordingly, the repair process is simplified and shortened by utilizing pulsed laser welding to avoid several steps that are used in other repair processes.

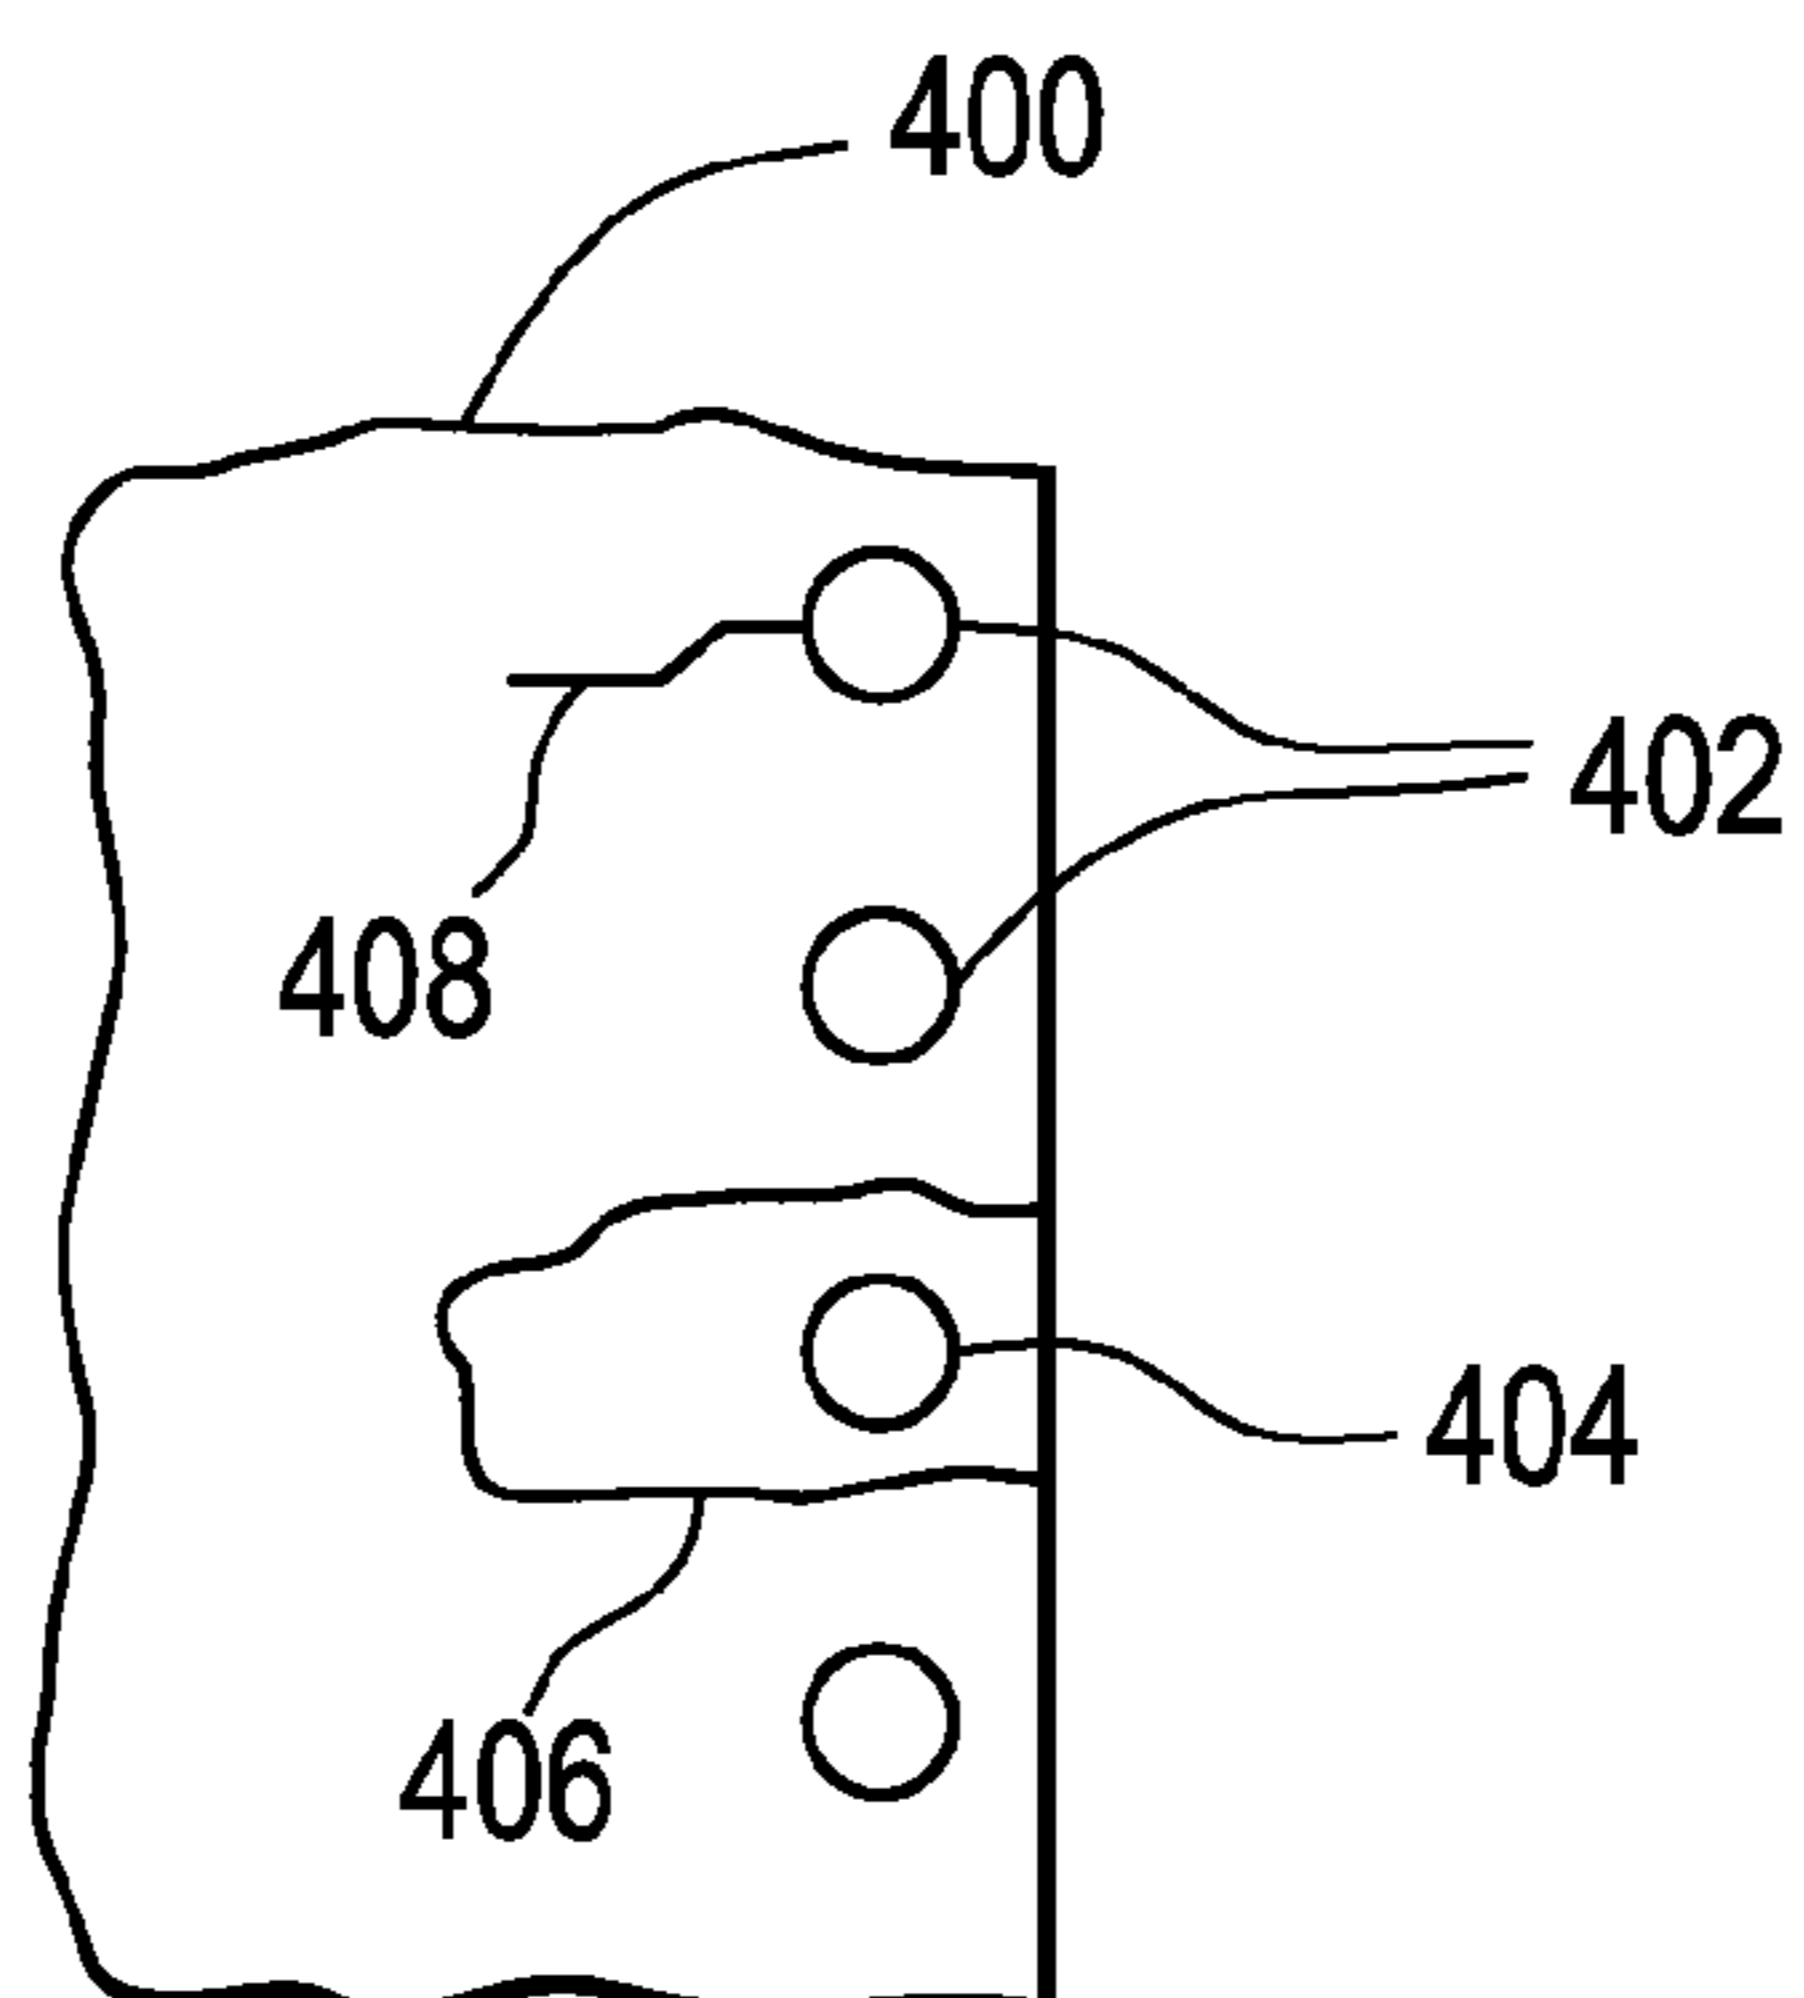
FIG. 4 is a top view of an embodiment of a combustion part that has been repaired.

FIG. 4 is a top view of an embodiment of a combustion part **400** that has been repaired using a pulsed laser welder. The combustion part **400** includes holes **402**, repaired hole **404**, weld area **406** and crack **408**. The repaired hole **404** shows the structure of the hole **404** that has been maintained after a pulsed laser weld has repaired a crack filled by the weld area **406**. The depicted weld area **406** shows the area after pulsed laser welding, where the weld forms a small pool, but does not fill hole **404**. Therefore, the hole **404** is capable of fluid flow without machining or drilling the hole before reinstalling in the turbine. Element **408** depicts an example of a crack that may be repaired by the pulsed laser welding method discussed above.
