(54) **FIRESHIELD FASTENER HOOD**
(75) Inventors: **Brian Kenneth Holland**, Lansing, MI (US); **William Bogue**, Hebron, CT (US)
(73) Assignee: **United Technologies Corporation**, Hartford, CT (US)

A fireshield fastener hood and method of bonding a cover to a substrate therefor.

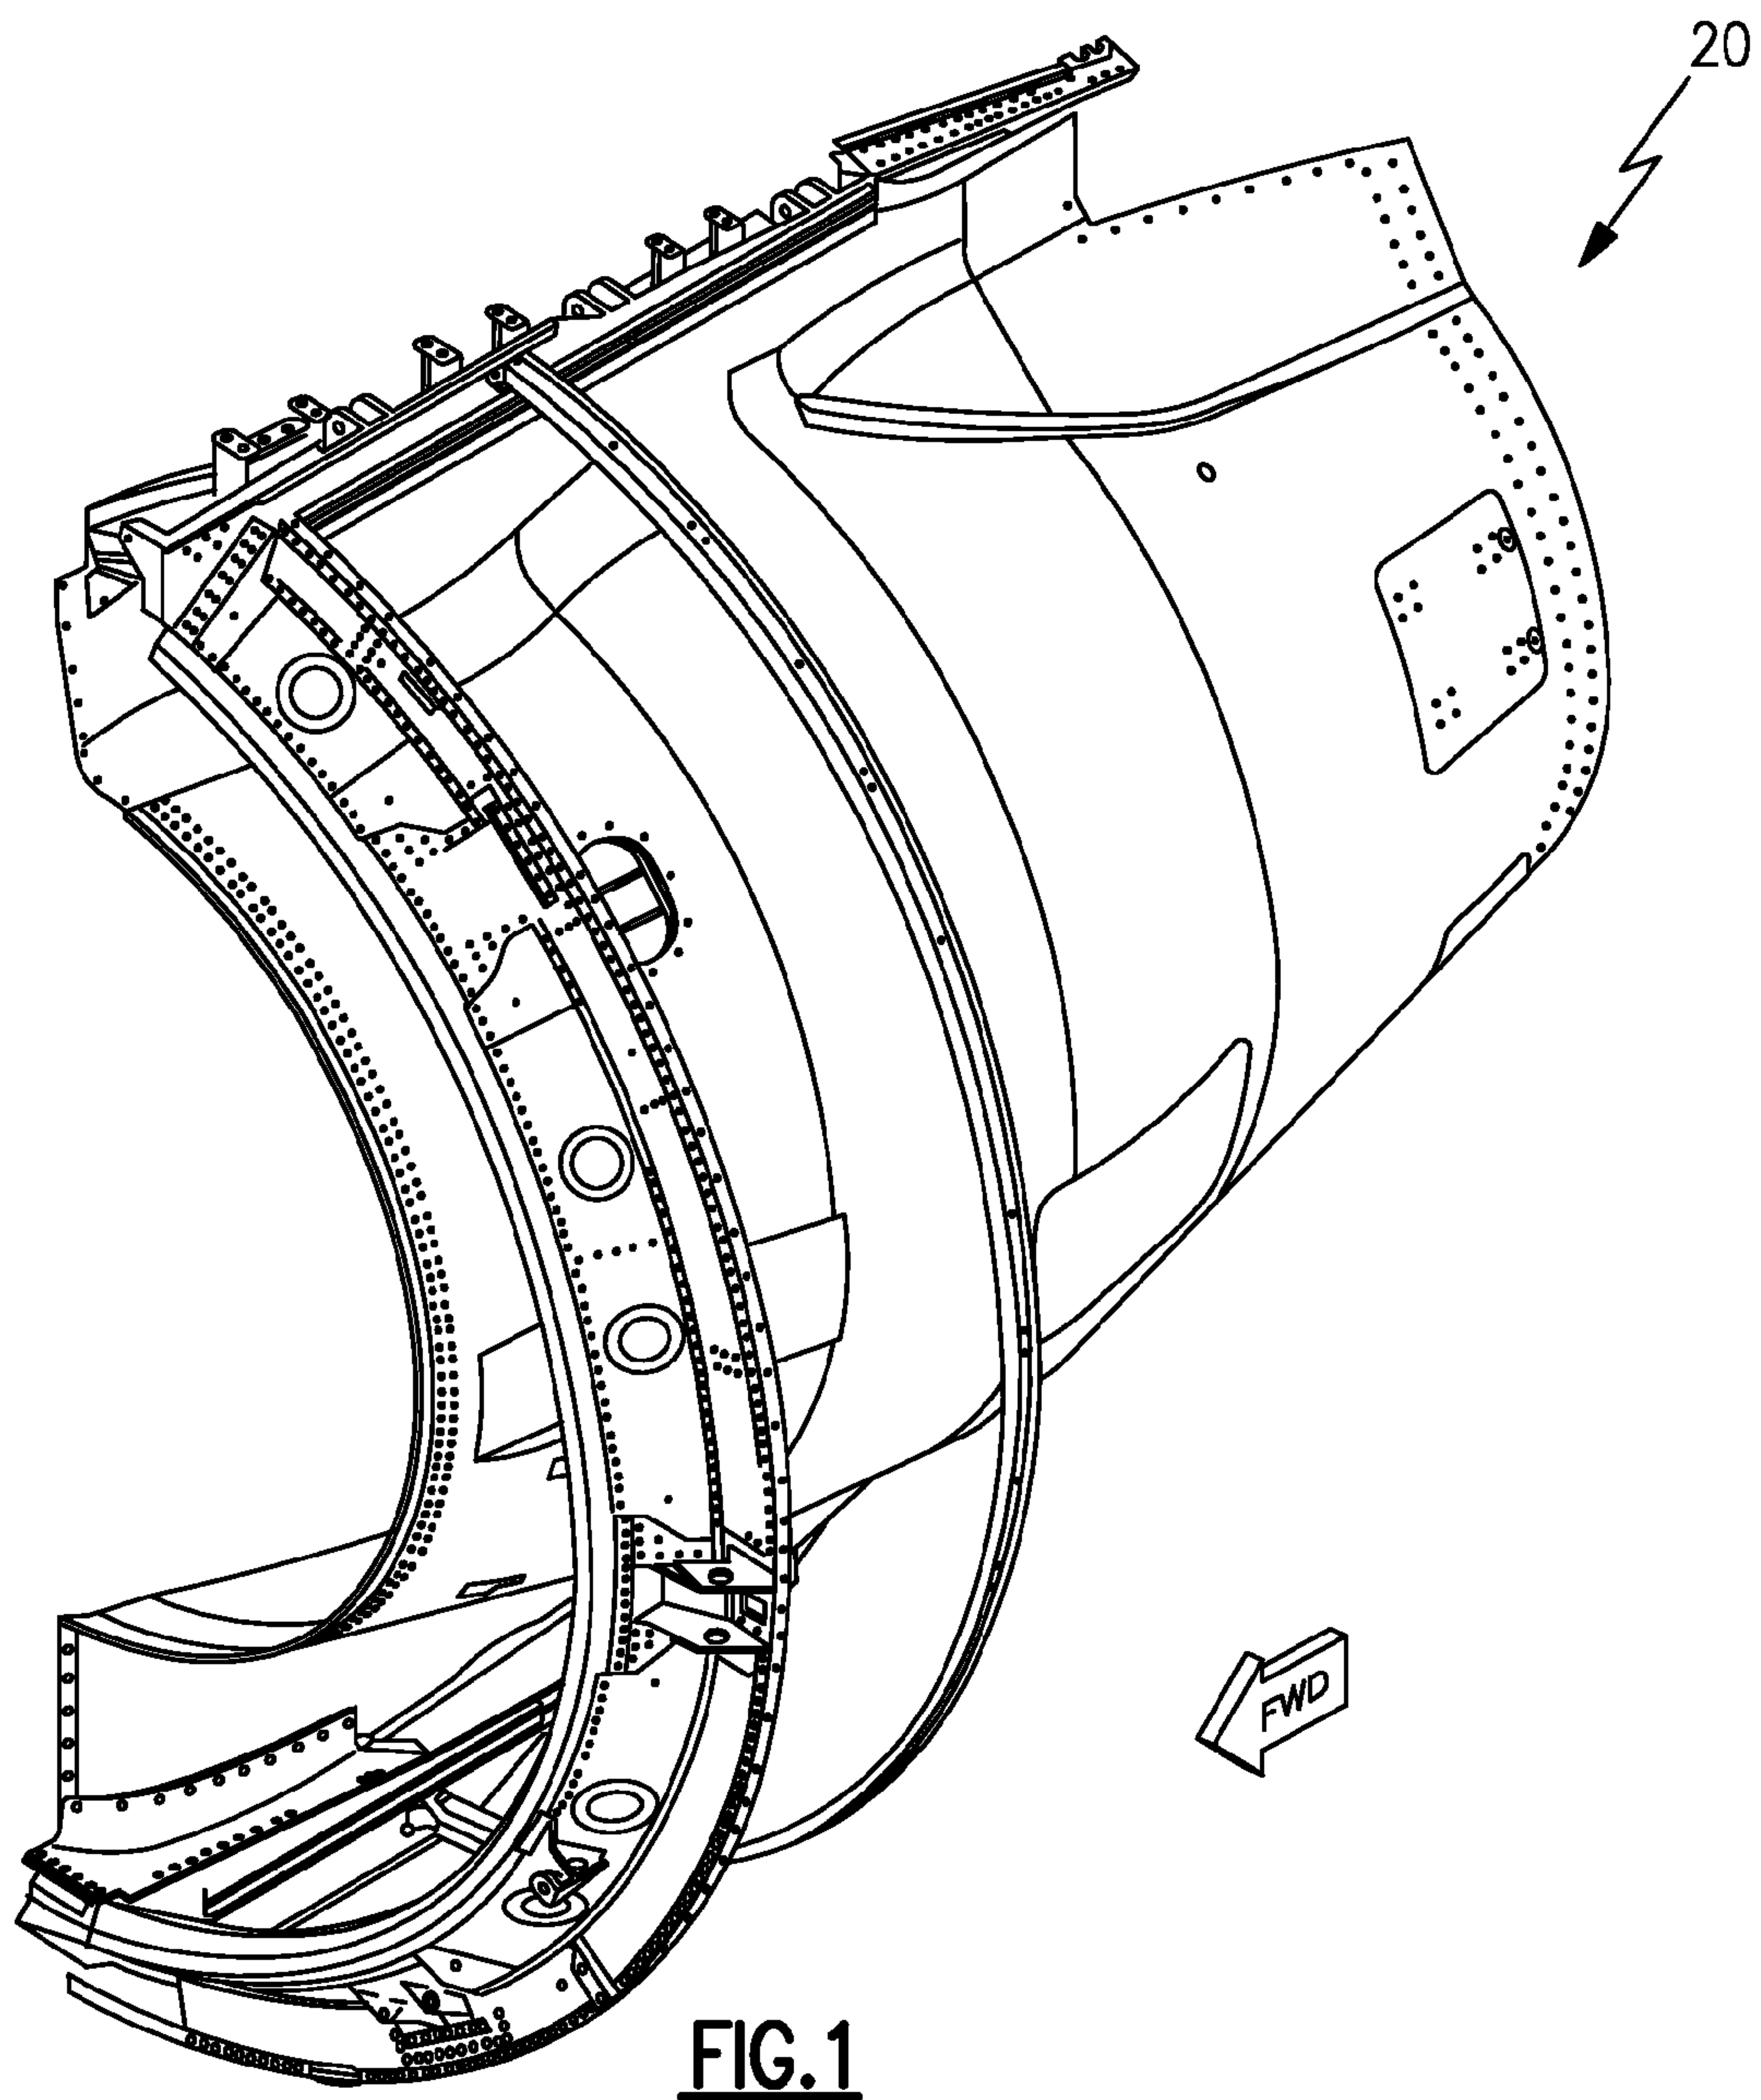
FIG. 1 IS A GENERAL PERSPECTIVE VIEW OF PART OF A NACELLE STRUCTURE FOR A GAS TURBINE ENGINE EMBODIMENT FOR USE WITH THE PRESENT DISCLOSURE;

FIG. 1 ILLUSTRATES A THRUST REVERSE CORE COWL PORTION OF A GAS TURBINE ENGINE NACELLE STRUCTURE 20. ALTHOUGH A NACELLE STRUCTURE 20 IS ILLUSTRATED IN THE DISCLOSED NON-LIMITING EMBODIMENT, IT SHOULD BE UNDERSTOOD THAT VARIOUS STRUCTURES WILL BENEFIT HEREFROM AND THE DISCLOSURE HEREIN SHOULD NOT BE LIMITED ONLY TO SUCH STRUCTURES.

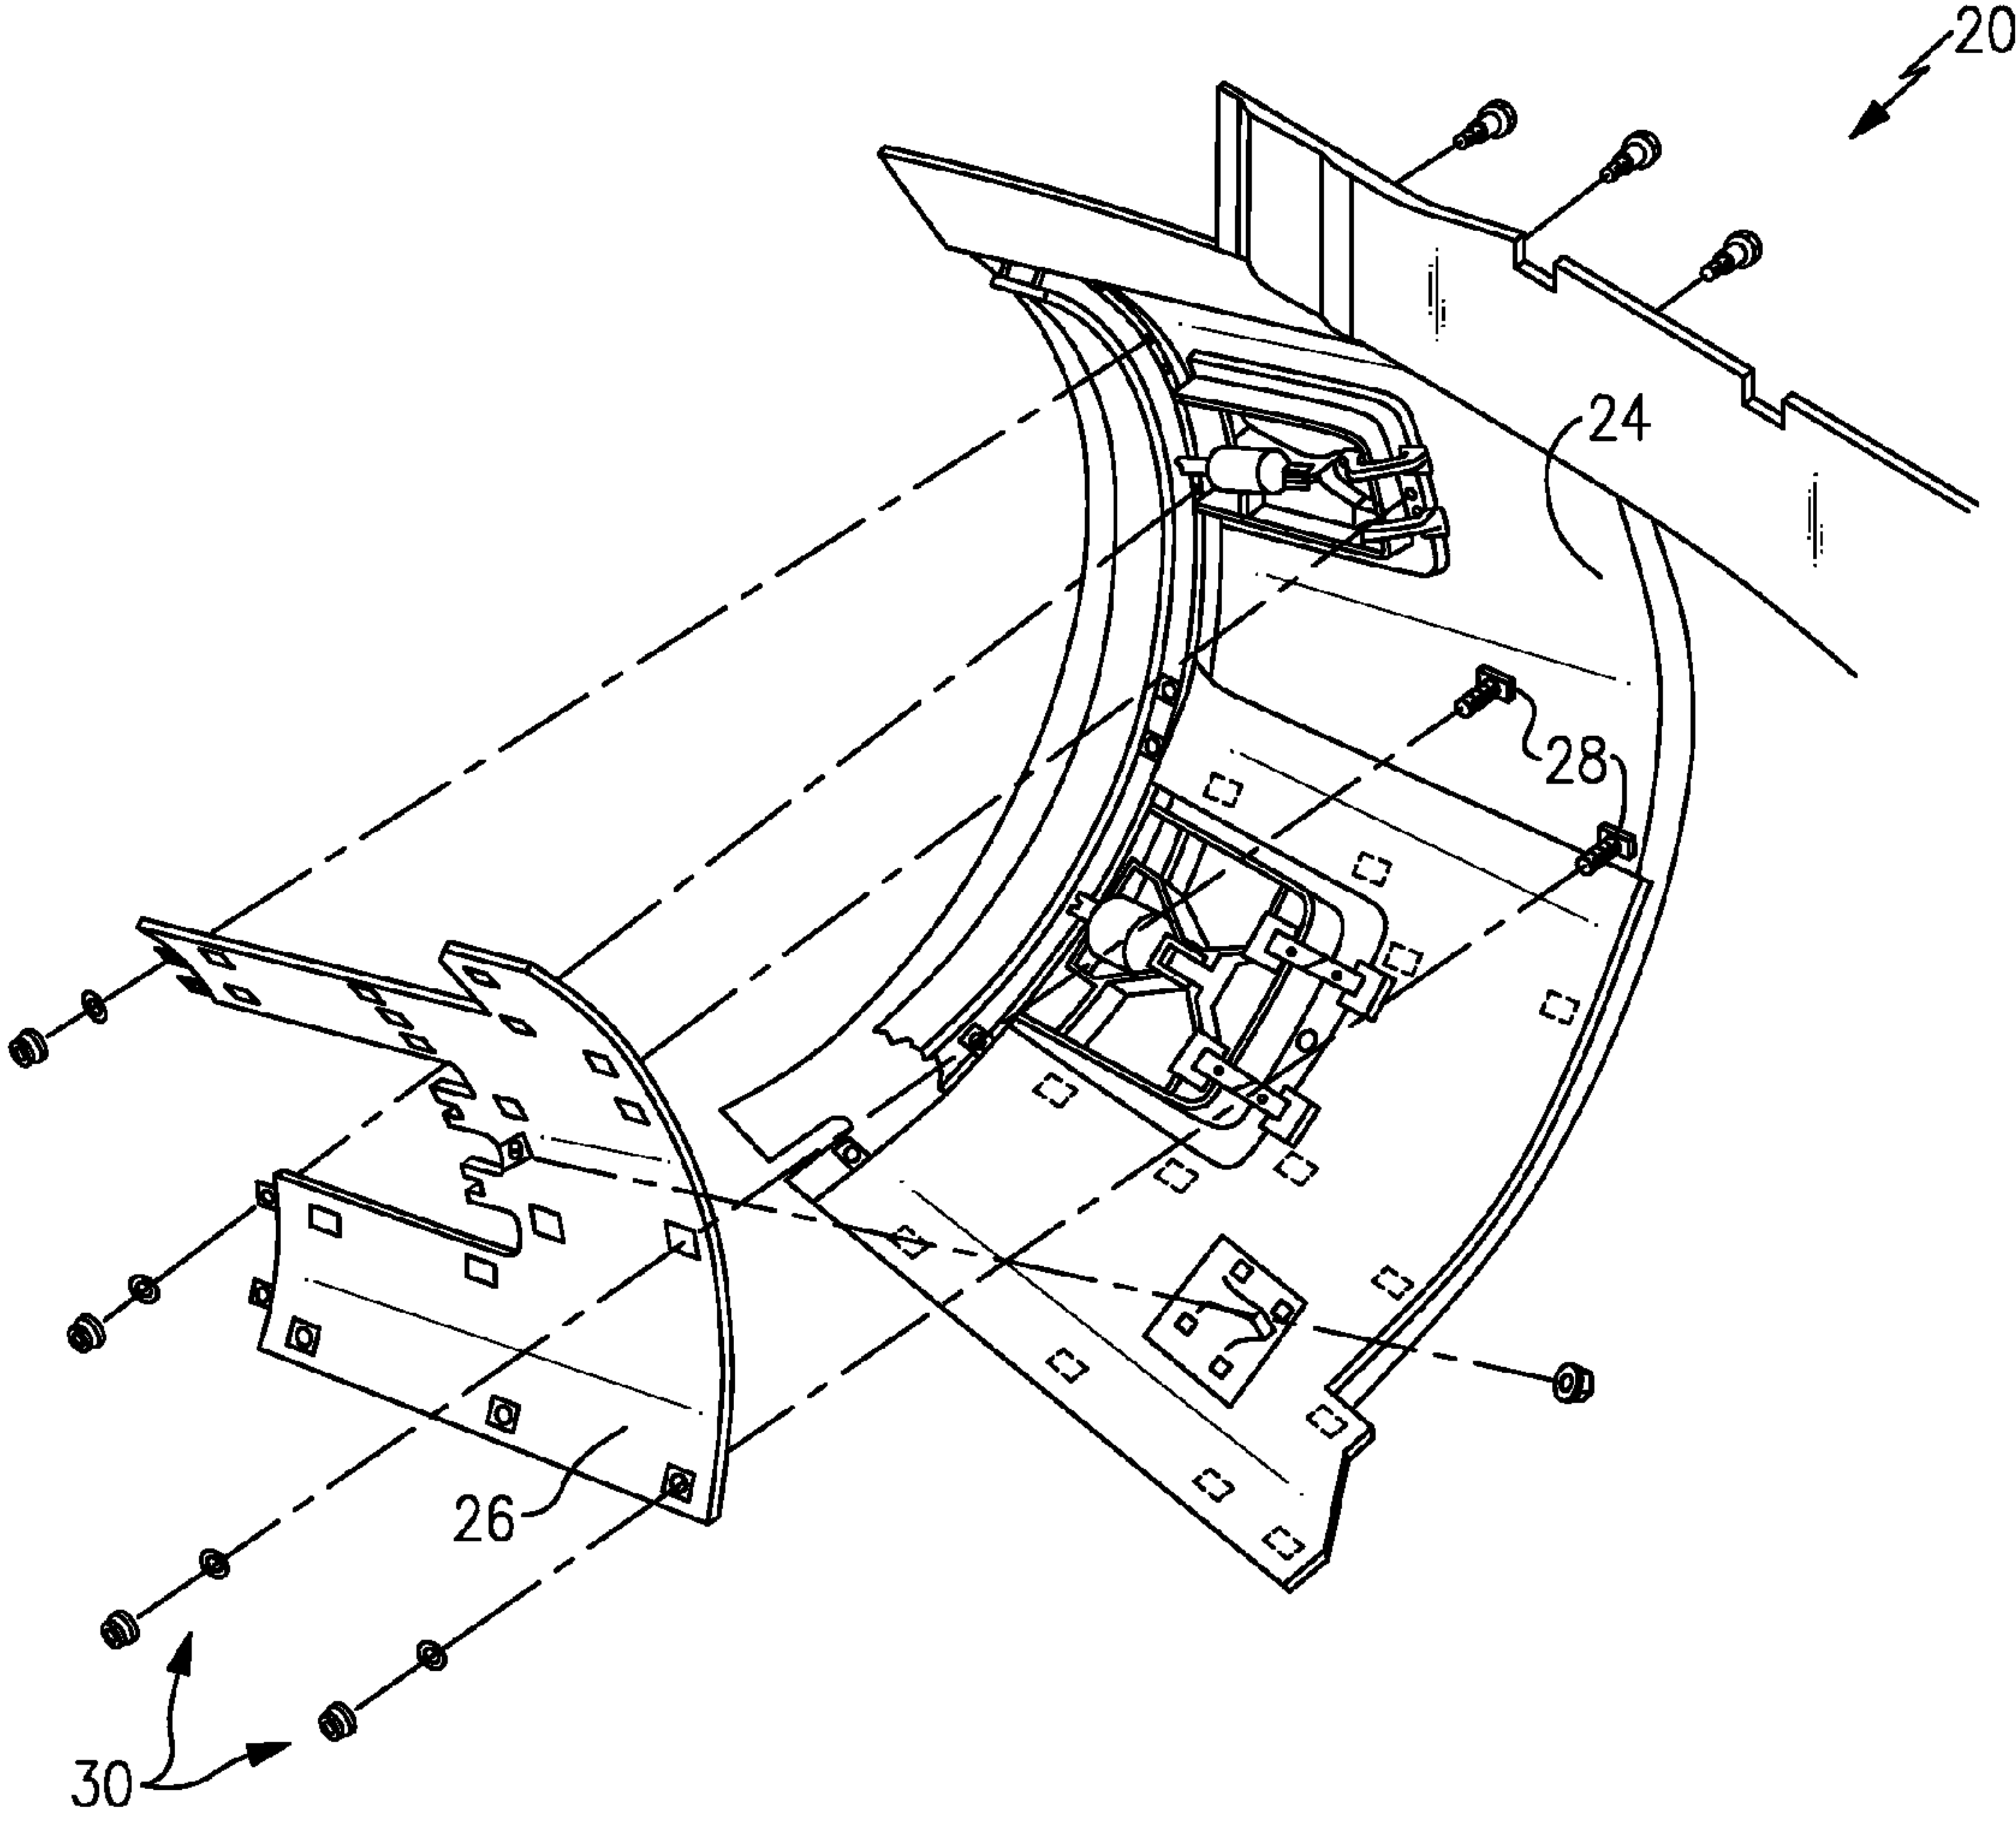
FIG.2

FIG. 2 IS AN EXPLODED VIEW OF A FIRESHIELD OF THE NACELLE STRUCTURE OF FIG. 1;

WITH REFERENCE TO FIG. 2, THE NACELLE STRUCTURE 20 GENERALLY INCLUDES AN INNER COWL SECTION 24 ONTO WHICH IS MOUNTED A FIRESHIELD 26. THE COWL SECTION 24 IS TYPICALLY MANUFACTURED FROM A CARBON FIBER OR LIGHT WEIGHT METALLIC MATERIAL SUCH AS AN ALUMINUM ALLOY WHICH MAY REQUIRE THE THERMAL PROTECTION OF THE FIRESHIELD 26 DURING NORMAL SERVICE OR IN THE ABNORMAL EVENT OF A FIRE IN THAT COMPARTMENT.

THE FIRESHIELD 26 IS MOUNTED TO A MULTIPLE OF STUDS 28 WHICH EXTEND FROM THE COWL SECTION 24. THE STUDS 28 EXTEND THROUGH THE FIRESHIELD 26 TO RECEIVE A FASTENER 30 SUCH AS A NUT TO RETAIN THE FIRESHIELD 26 TO THE COWL SECTION 24. THE EXTENDED STUD 28 AND FASTENER 30 ARE PROTECTED BY A MOVABLE FIRESHIELD FASTENER HOOD 32 (FIG. 3). ALTHOUGH A MOVABLE FIRESHIELD HOOD FOR A FASTENER IS DISCUSSED IN DETAIL HEREIN, IT SHOULD BE UNDERSTOOD THAT OTHER FIRESHIELD HOODS SUCH AS THAT FOR A HINGE 34 WILL ALSO BENEFIT HEREFROM.

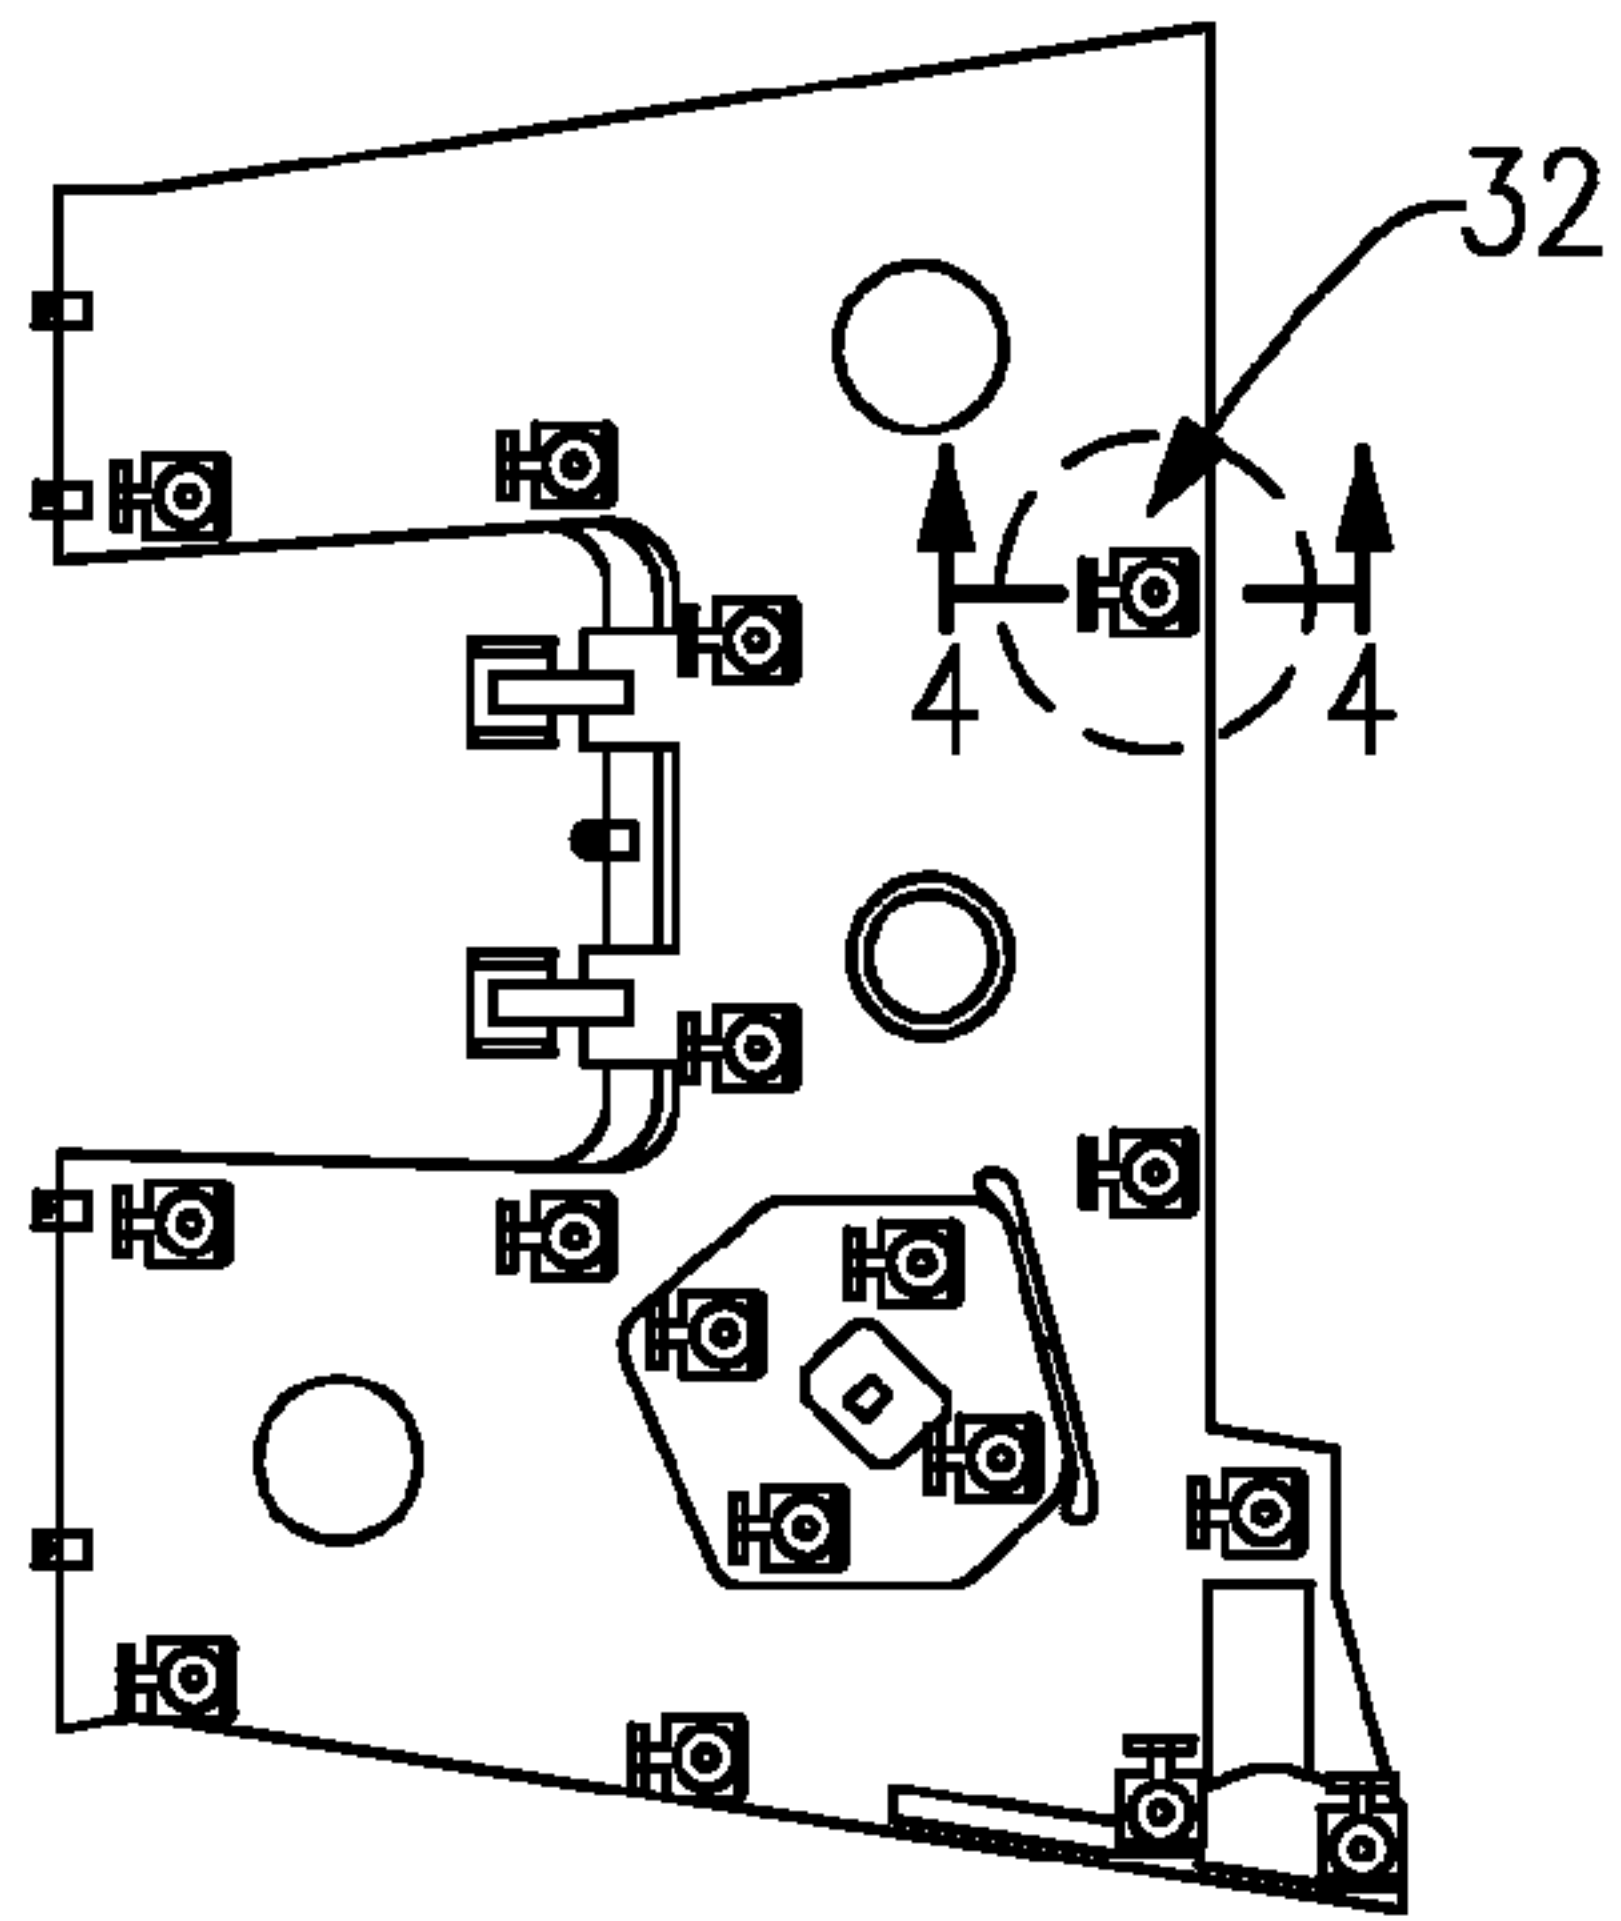
FIG. 3 IS AN INNER VIEW OF THE FIRESHIELD ILLUSTRATING A FIRESHIELD FASTENER HOOD

WITH REFERENCE TO FIG. 8, STEP 100 OF A MANUFACTURE OR REPAIR TO THE FIRESHIELD FASTENER HOOD 32 INCLUDES CLEANING THE REPAIR AREA OF THE FIRESHIELD FASTENER HOOD 32. THE CLEANING FACILITATES BONDING AND CRACK INSPECTION. THE REPAIR TO THE FIRESHIELD FASTENER HOOD 32 MAY BE PERFORMED WHILE THE FIRESHIELD FASTENER HOOD 32 IS MOUNTED TO THE FIRESHIELD 26 (FIG. 3).

In step 126, the replacement tab 40' is inserted into the retainer 50 (FIG. 3).

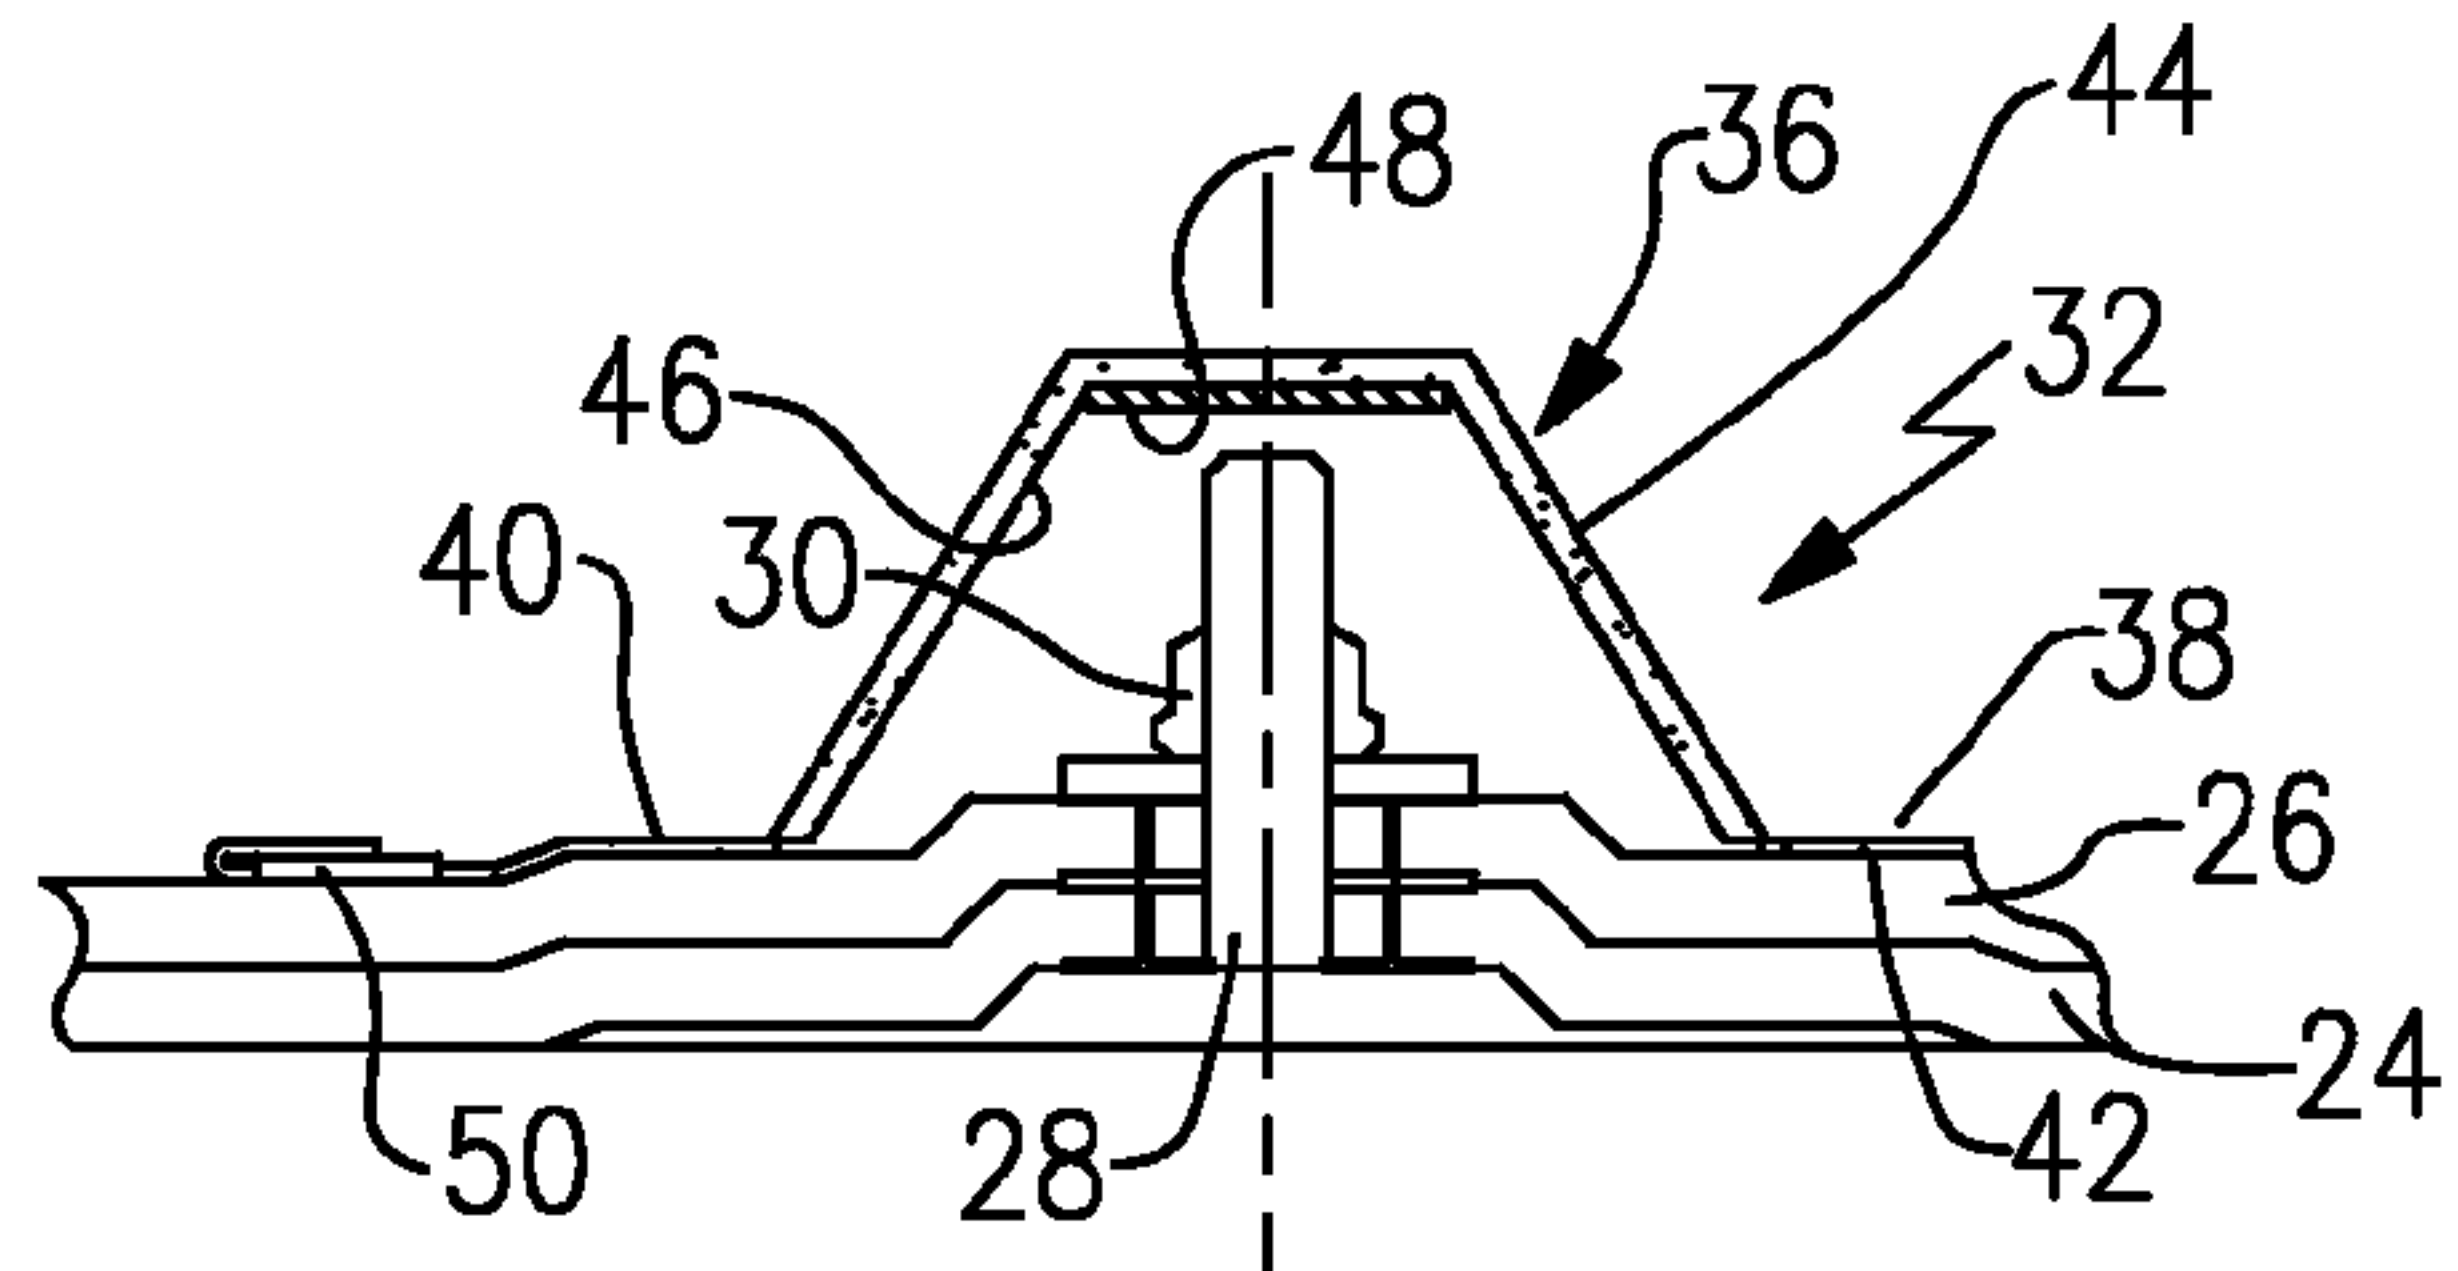
FIG. 4 IS A SECTIONAL VIEW OF THE FIRESHIELD FASTENER HOOD ATTACHED TO A FIRESHIELD MOUNTED TO THE NACELLE COWL;

WITH REFERENCE TO FIG. 4, THE FIRESHIELD FASTENER HOOD 32 GENERALLY INCLUDES A FRUSTRO-CONICAL HOOD 36 WHICH EXTENDS FROM A GENERALLY PLANAR PLATFORM 38 WHICH INCLUDES A TAB 40 AND A BENDABLE HINGE 42 (ALSO ILLUSTRATED IN FIG. 5). THE HOOD 36, PLATFORM 38, TAB 40 AND HINGE 42 MAY BE MANUFACTURED OF AN AISI 300 SERIES STAINLESS STEEL ALLOY SUBSTRATE 44 WHICH IS APPROXIMATELY 0.003 INCHES (0.0762 MM) THICK. A SILICONE LAYER 46 COATS THE INTERIOR OF THE HOOD 36 AND A POLYTETRAFLUOROETHYLENE DISK 48 IS MOUNTED TO THE APEX OF THE HOOD 36 TO PROTECT THE SILICONE LAYER 46 SHOULD THE RELATIVELY THIN SUBSTRATE 44 BE OVER-COMPRESSED TO MAKE INTIMATE CONTACT WITH THE STUD 28. IT SHOULD BE UNDERSTOOD THAT VARIOUS OTHER CONSTRUCTIONS MAY ALTERNATIVELY OR ADDITIONALLY BE PROVIDED AND THE FIRESHIELD FASTENER HOOD 32 MAY BE OF VARIOUS GEOMETRIES.

THE HINGE 42 IS A FOLDED SECTION OF THE SUBSTRATE 44 WHICH MAY BE TACK WELDED TO THE FIRESHIELD 26 TO PERMIT THE FIRESHIELD FASTENER HOOD 32 TO MOVE RELATIVE THERETO. THE TAB 40 EXTENDS FROM THE PLATFORM 38 FOR RECEIPT INTO A RETAINER 50 IN THE FIRESHIELD 26 TO CLOSE THE FIRESHIELD FASTENER HOOD 32 OVER THE STUD 28 AND FASTENER 30. TO ACCESS THE STUD 28 AND FASTENER 30, THE TAB 40 IS SLIPPED OUT FROM UNDER THE RETAINER 50 AND THE FIRESHIELD FASTENER HOOD 32 IS PIVOTED UPON THE HINGE 42.

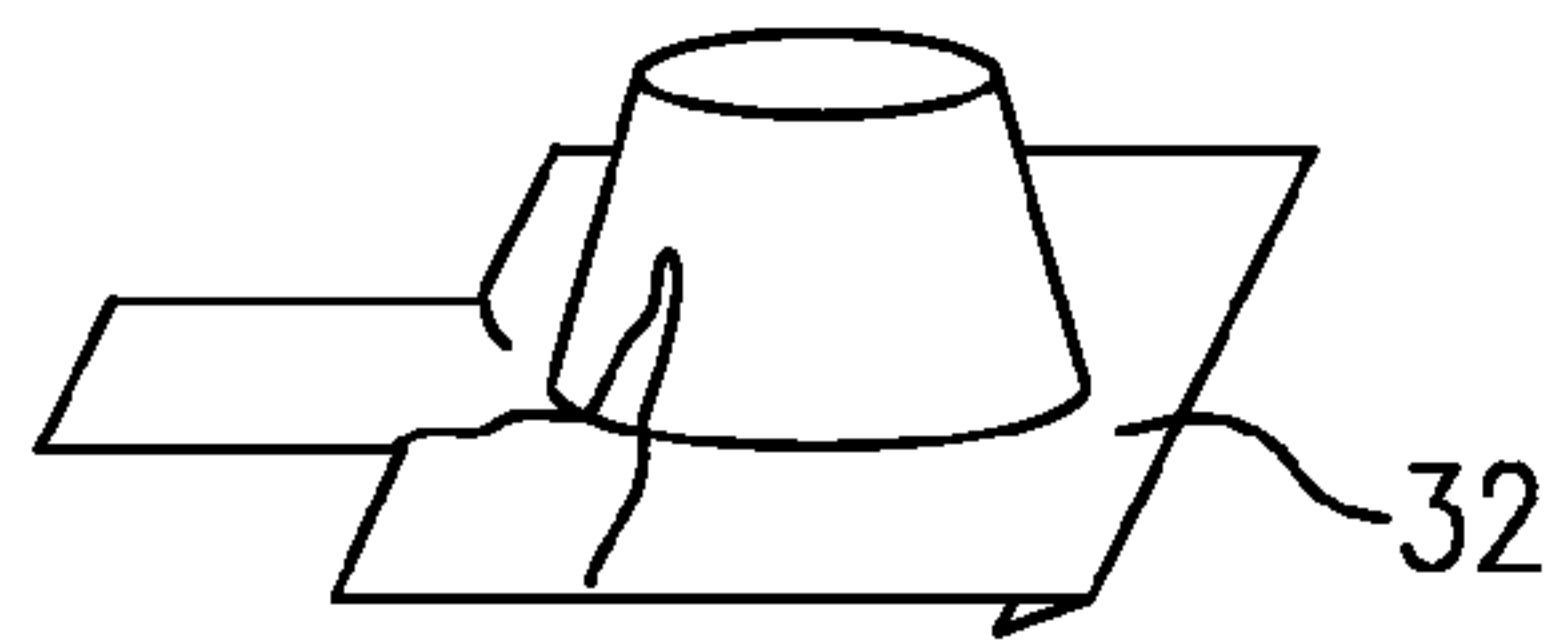
FIG. 6 IS A PERSPECTIVE VIEW OF THE FIRESHIELD FASTENER HOOD;

OFTENTIMES THE SUBSTRATE 44 MAY CRACK, TEAR, OR OTHERWISE BE DAMAGED IN A MANNER WHICH IS REPAIRABLE BY THE METHOD DISCLOSED HEREIN (FIG. 6). TYPICALLY, ACCEPTABLE CRACKS MAY BE LOCATED IN AN ARC OF APPROXIMATELY 170 DEGREES FROM THE CENTER OF THE HOOD 36 IN AN AREA ADJACENT TO THE TAB 40 (FIG. 7). IT SHOULD BE UNDERSTOOD THAT OTHER CRACK LOCATIONS MAY ALTERNATIVELY OR ADDITIONALLY ALLOWABLE.

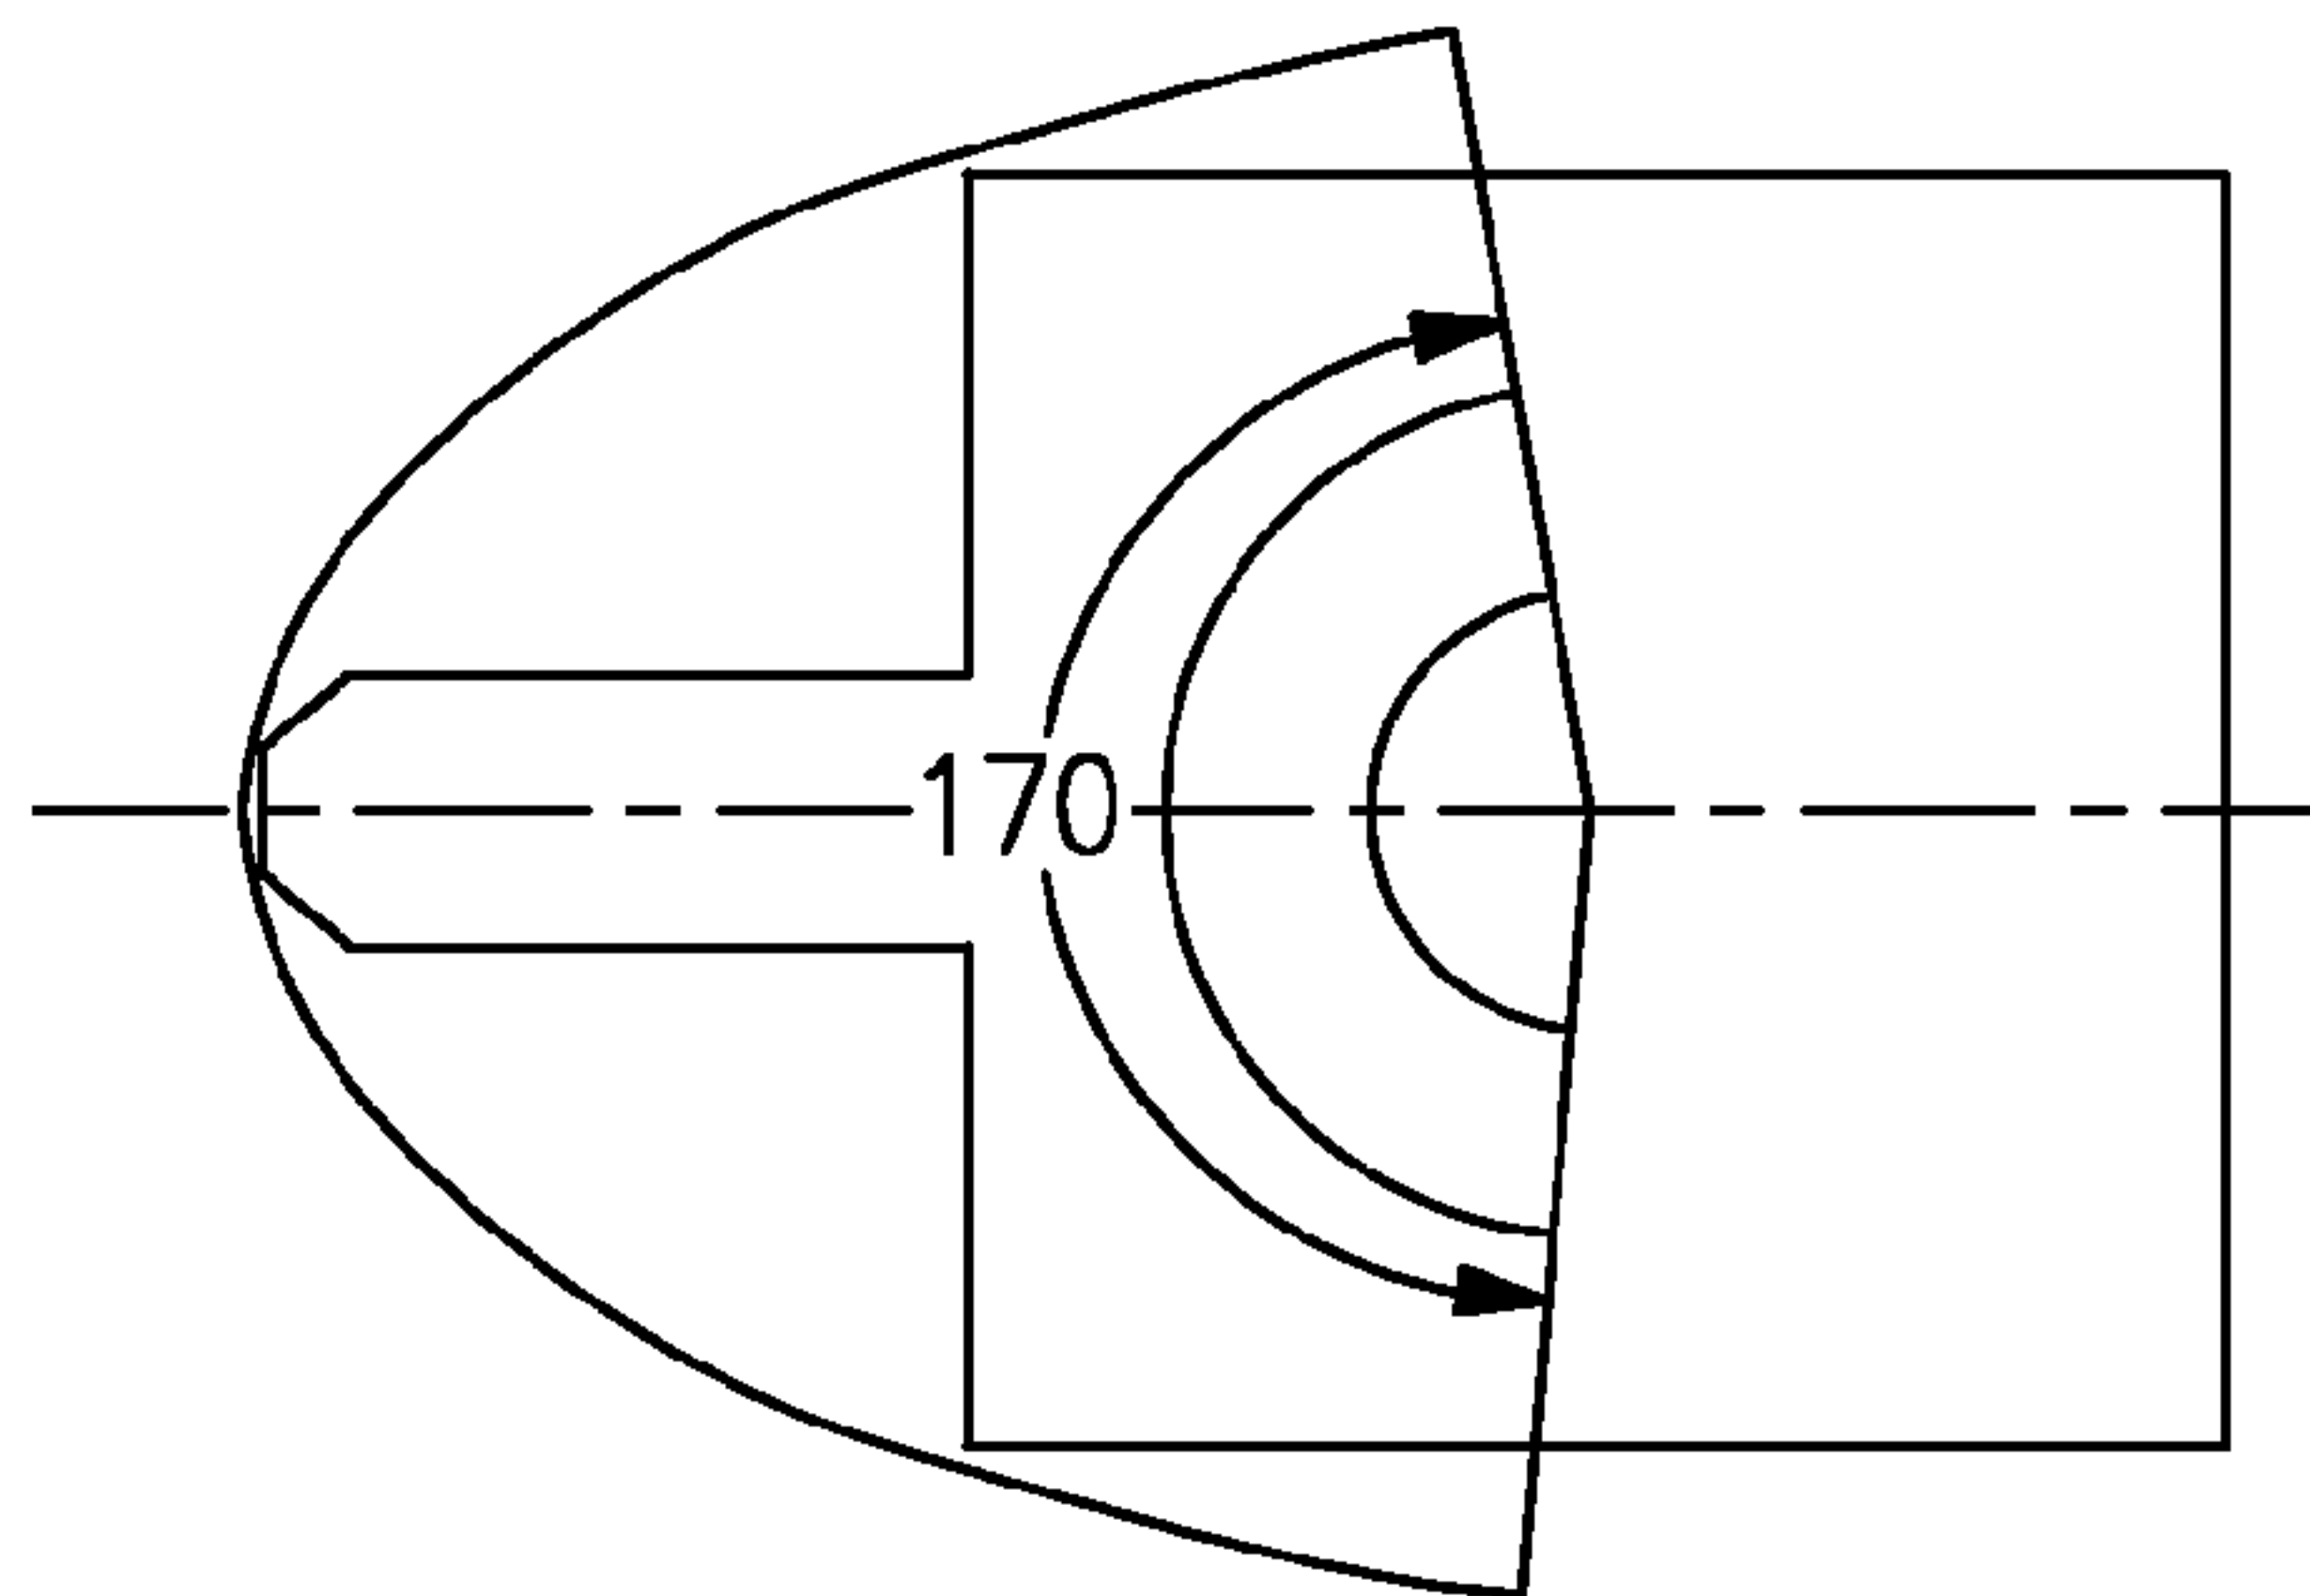
FIG. 7 IS A SCHEMATIC VIEW OF AN ALLOWABLE CRACK AREA IN THE FIRESHIELD FASTENER HOOD FOR A REPAIR THEREOF;

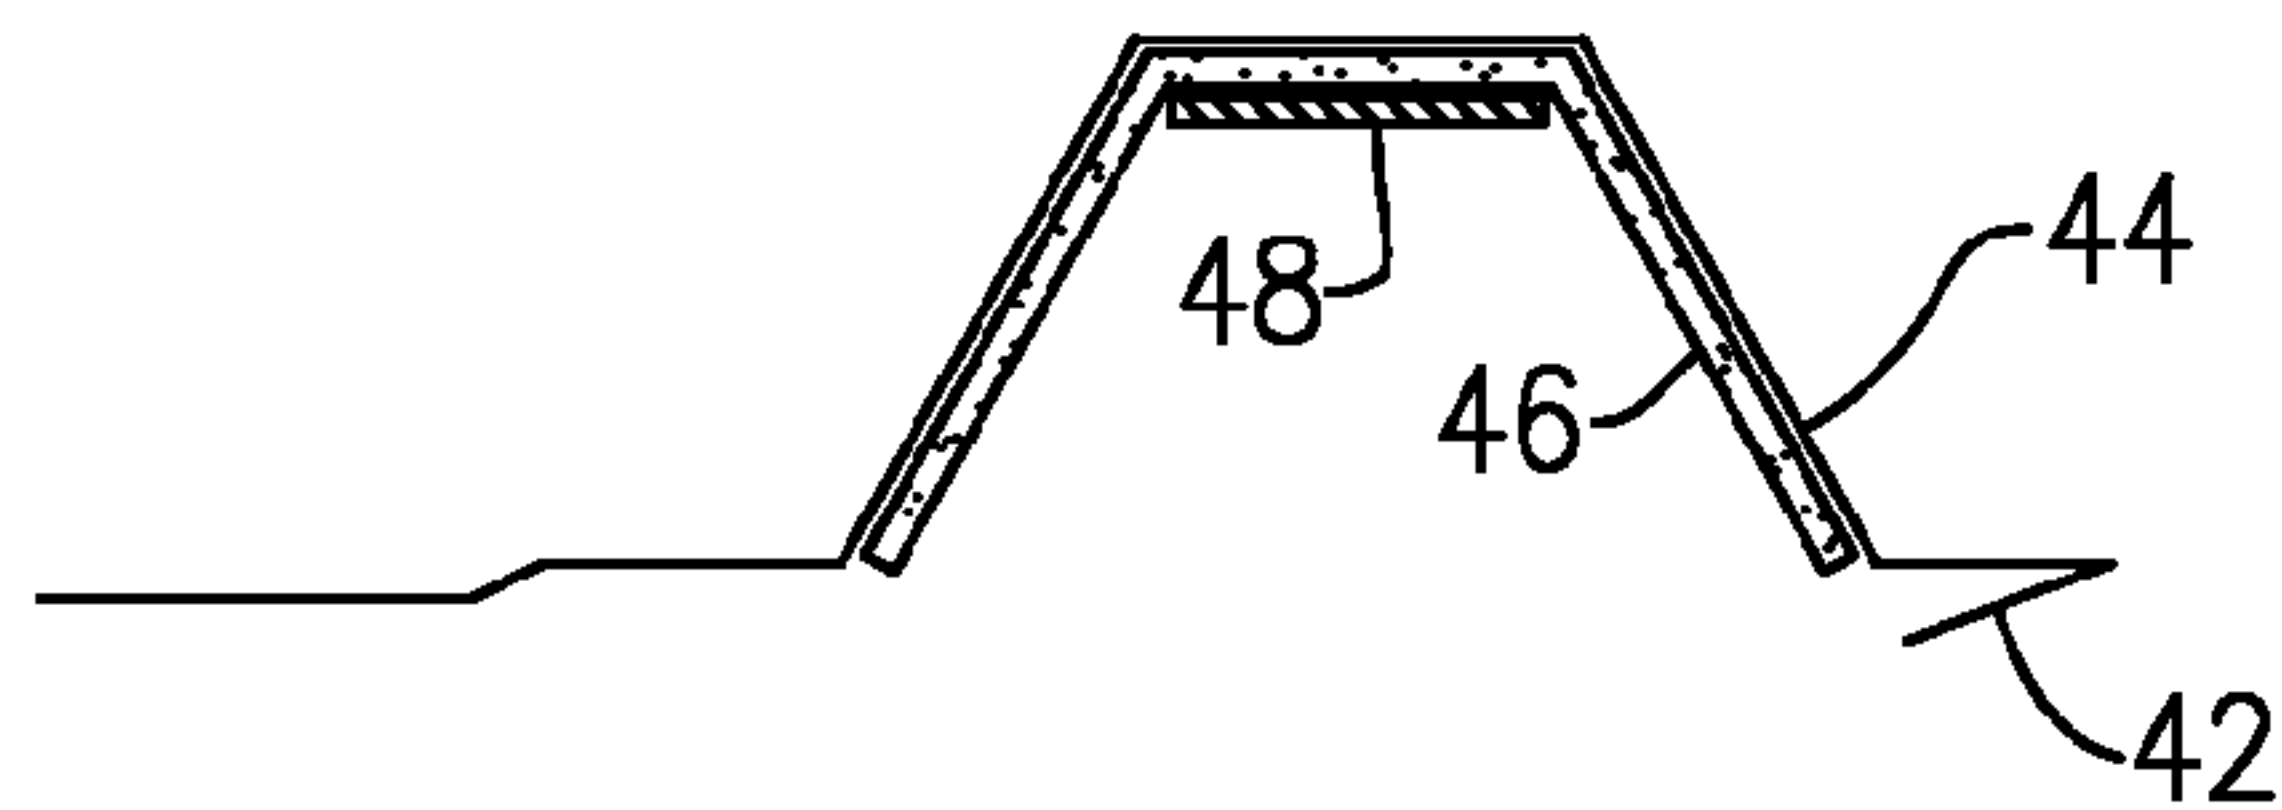
FIG. 5 IS A SECTIONAL VIEW OF THE FIRESHIELD FASTENER HOOD;
