(54) **FIRESHIELD FASTENER HOOD**
(75) Inventors: **Brian Kenneth Holland**, Lansing, MI (US); **William Bogue**, Hebron, CT (US)
(73) Assignee: **United Technologies Corporation**, Hartford, CT (US)

A fireshield fastener hood and method of bonding a cover to a substrate therefor.

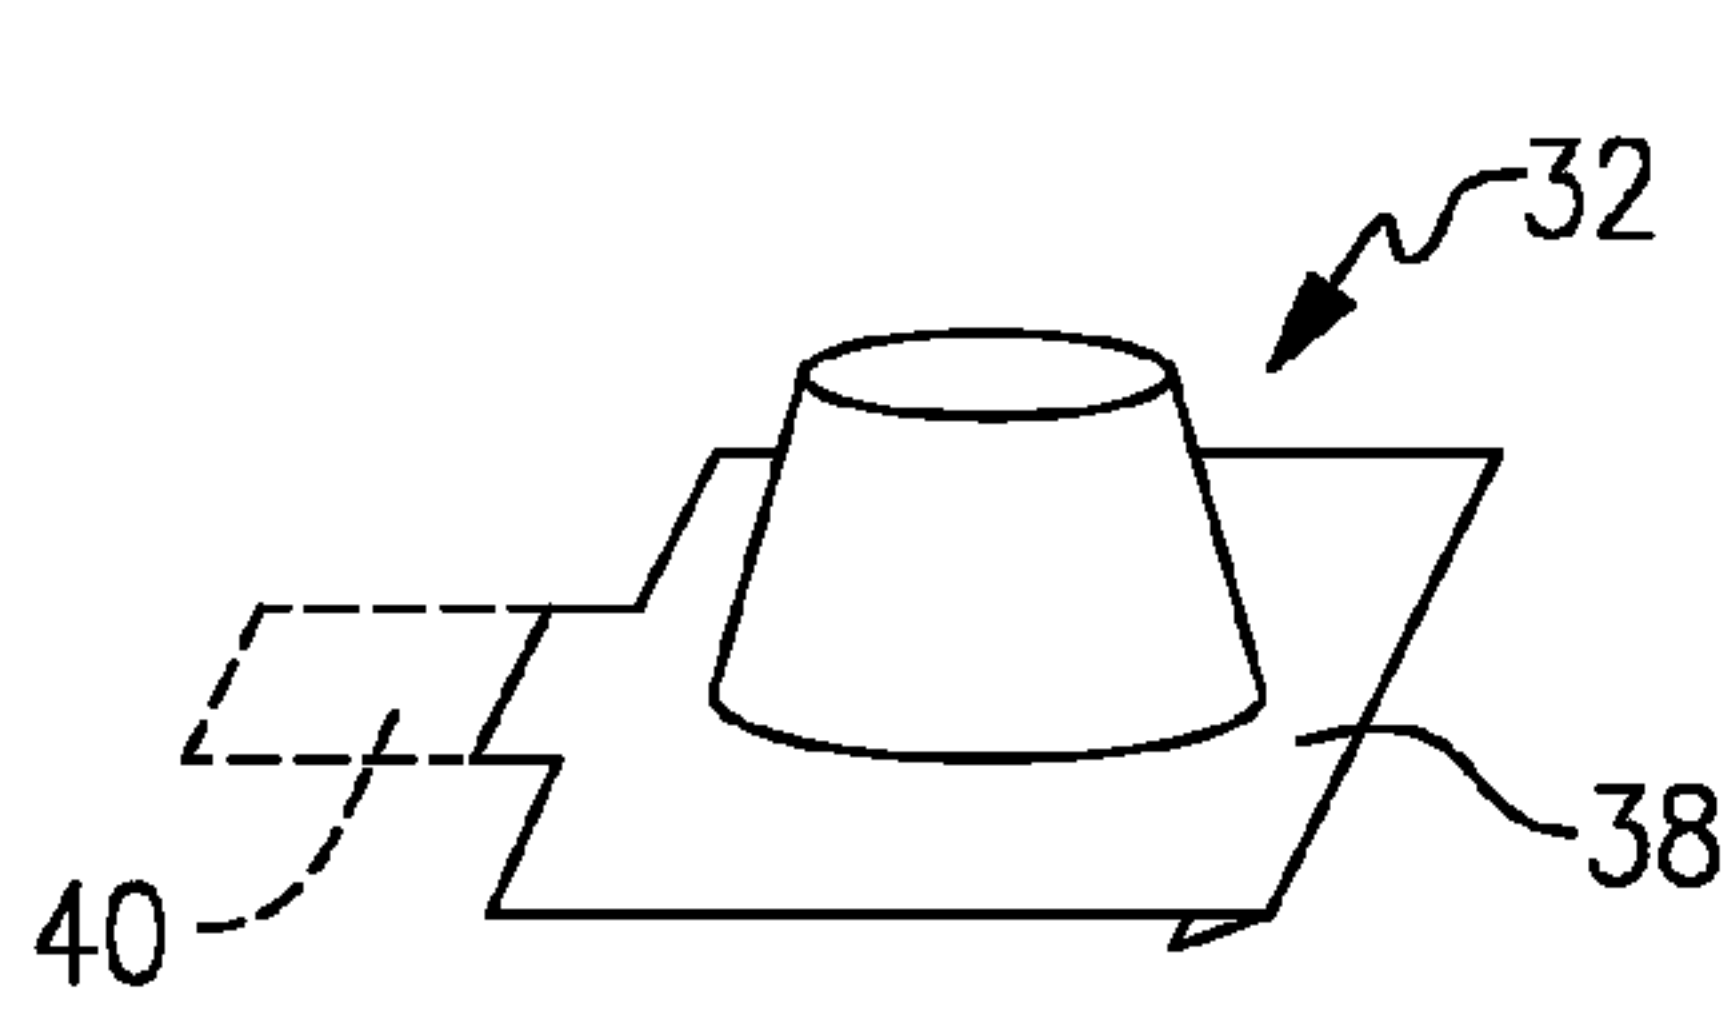
FIG. 9 IS A PERSPECTIVE VIEW OF THE FIRESHIELD FASTENER HOOD WITH A TAB CUT OFF;

STEP 102 OF THE REPAIR MAY INCLUDE REMOVAL OF THE TAB 40 (FIGS. 9 AND 10). THE TAB 40 MAY BE TRIMMED TO BE FROM 0 TO

0.3 inches (0-8 mm) from the platform 38. The tab removal may only be necessary where an extra thick tab 40 will not fit under retainer 50 or when tab 40 is damaged.

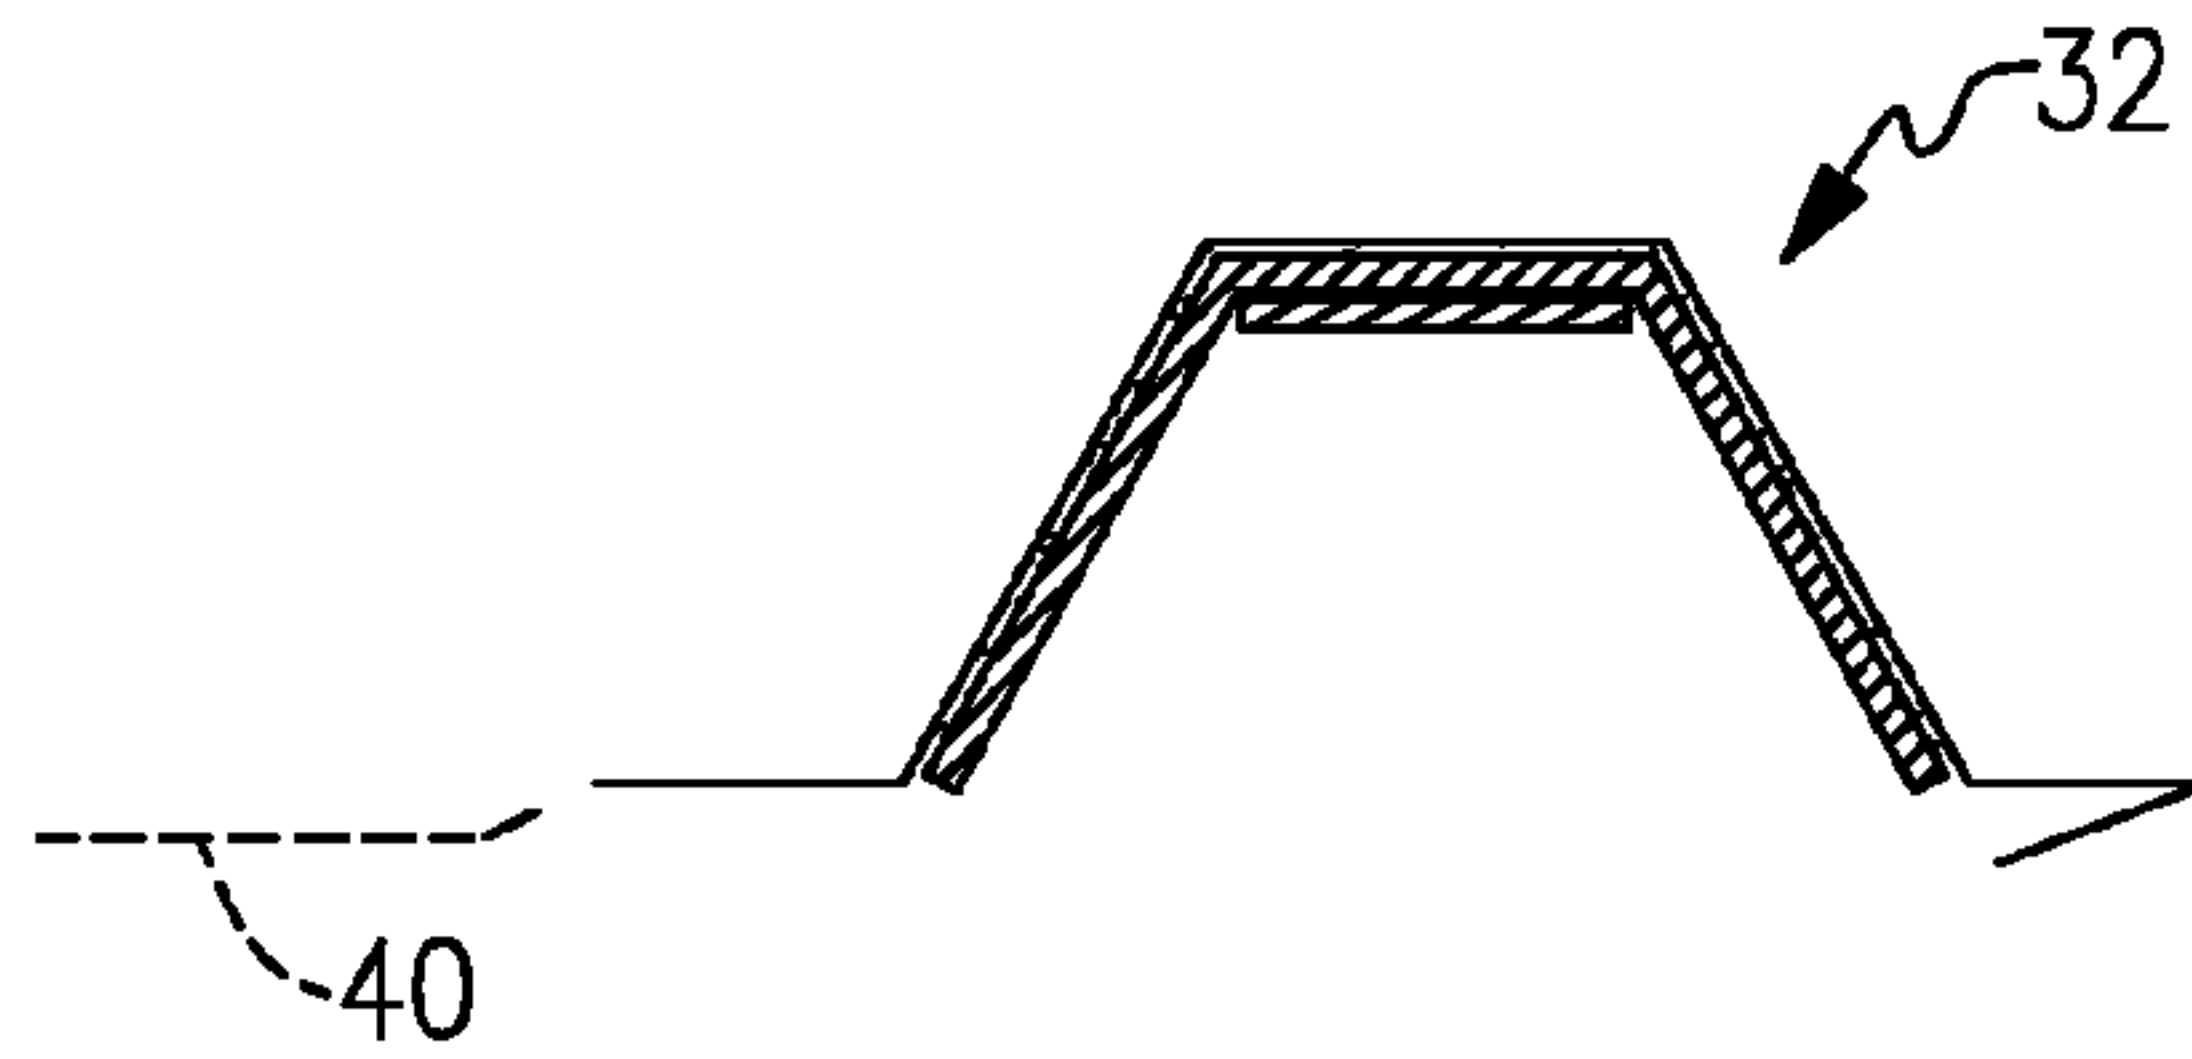
FIG. 10 IS A SECTIONAL VIEW OF THE FIRESHIELD FASTENER HOOD WITH THE TAB CUT OFF;

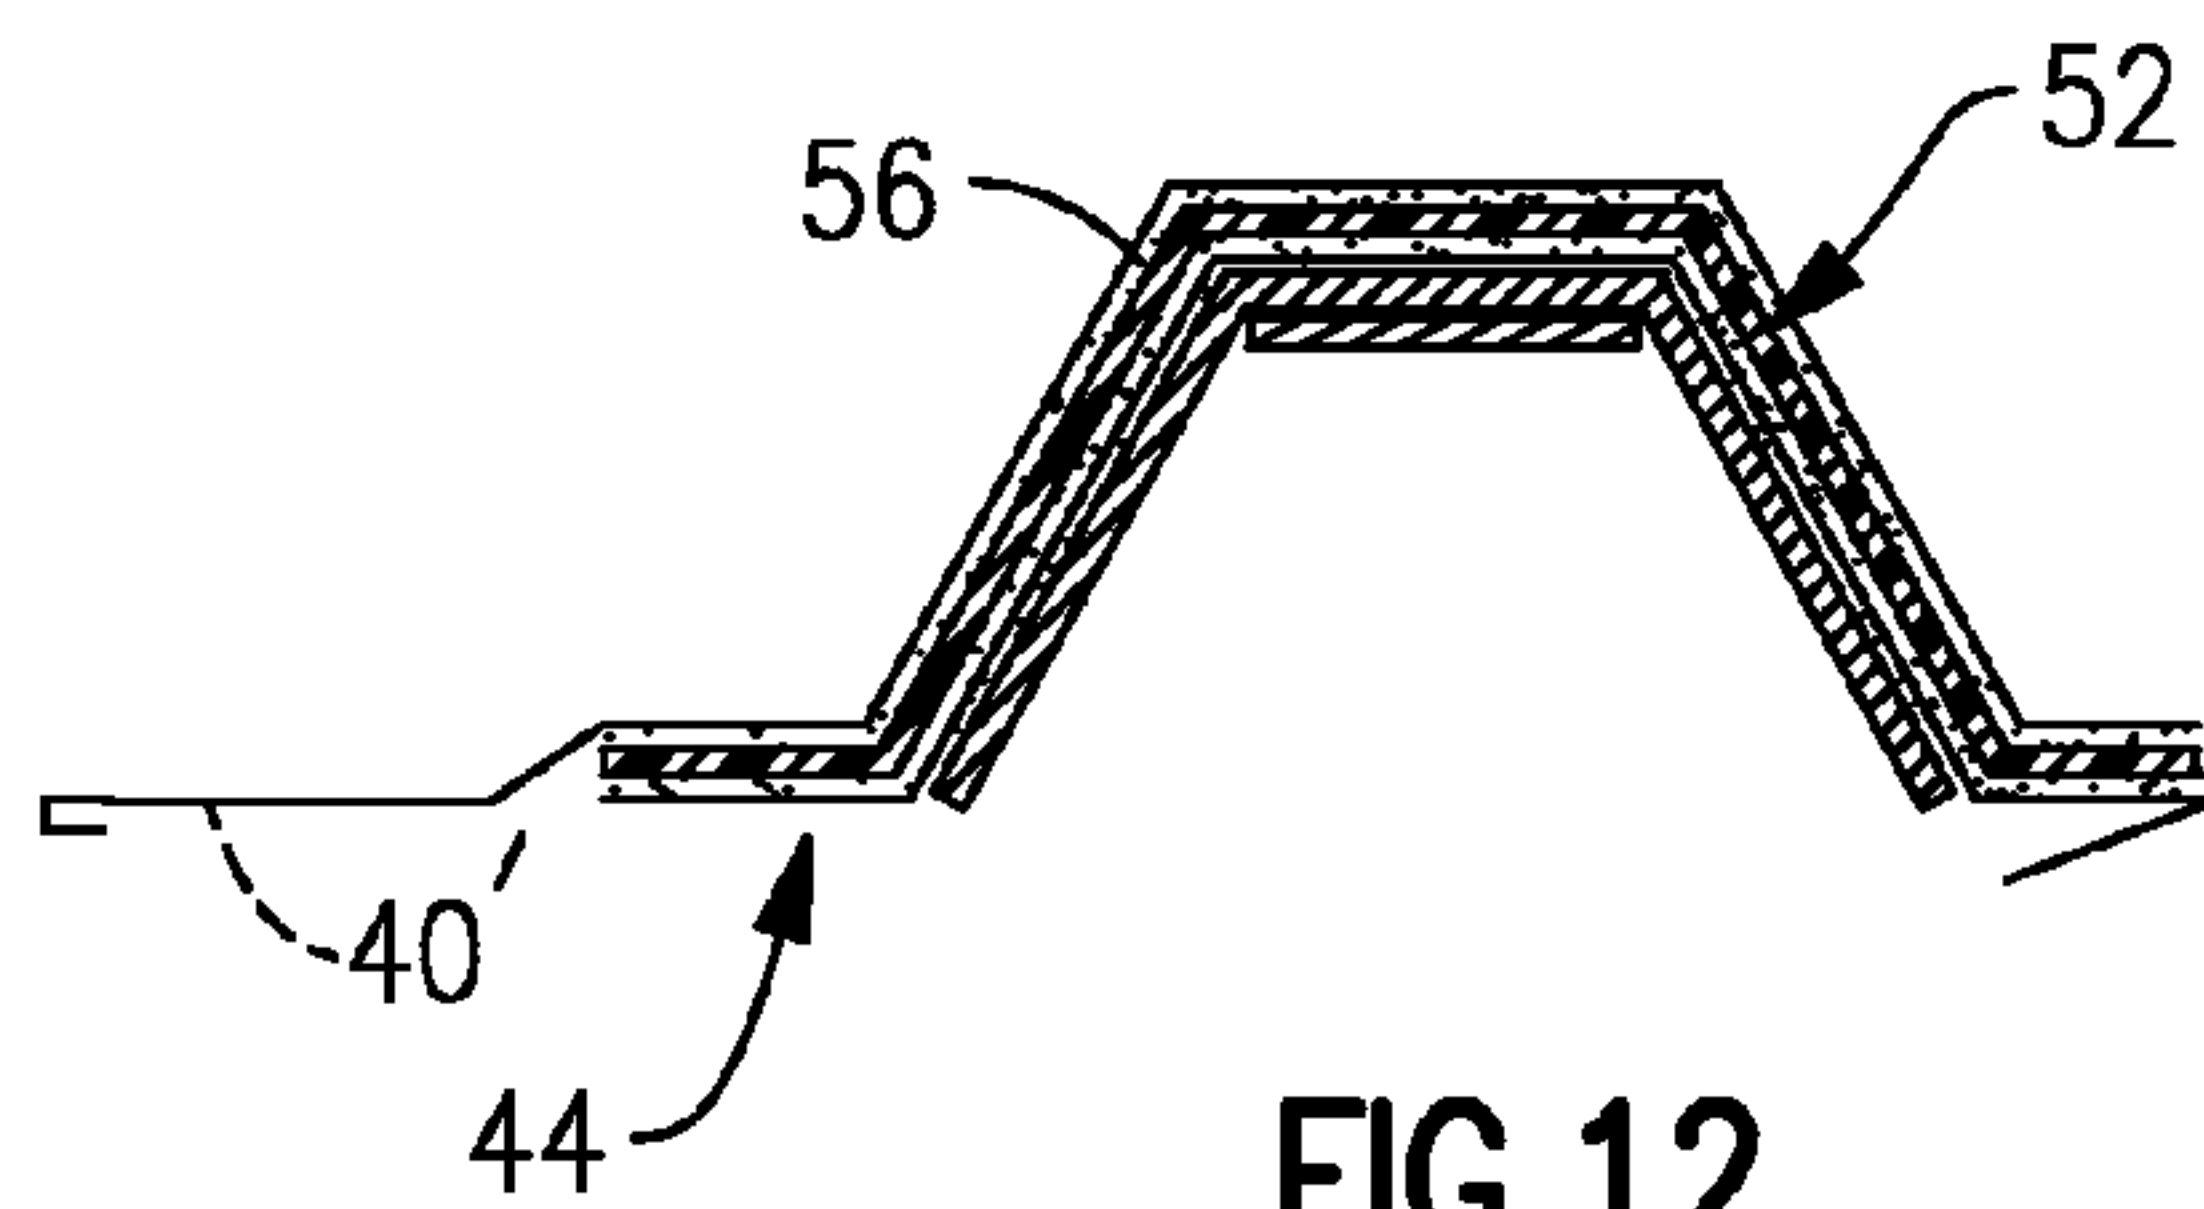
FIG. 12 IS A SECTIONAL VIEW OF THE FIRESHIELD FASTENER HOOD WITH A COVER MOUNTED THEREON;

With reference to FIG. 12, in step 114, a layer of sealant 56 is applied to the mating surface of the cover 52, and the substrate 44. The sealant 56 may be a thixotropic silicone paste firewall sealant such as DAPCO 18-4F manufactured by D Aircraft Products Inc. of California, USA.

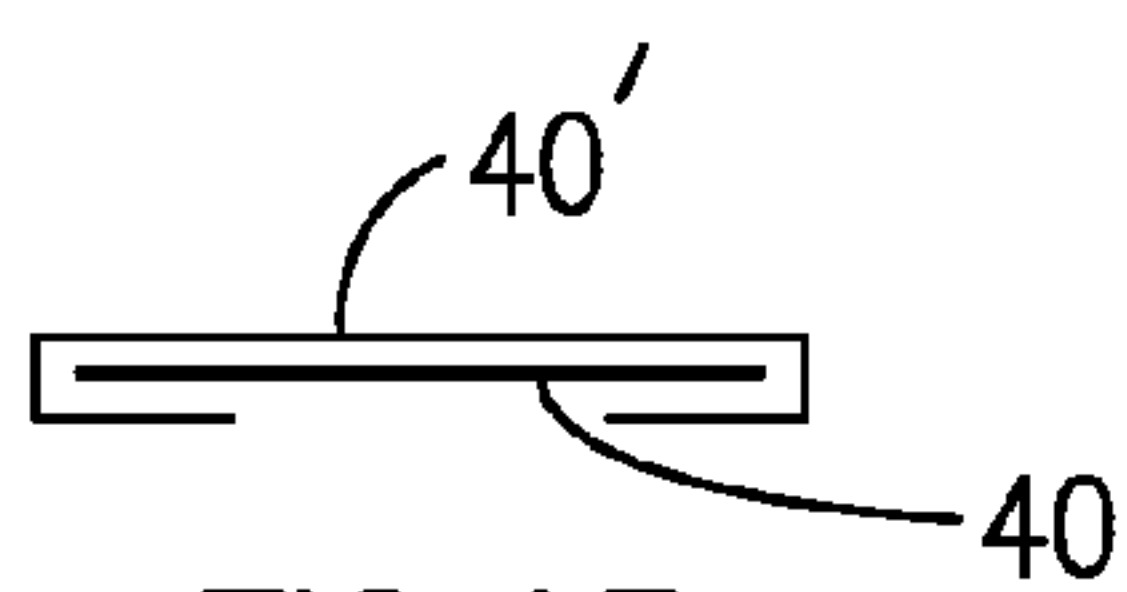
FIG. 13 IS A SECTIONAL VIEW OF A REPLACEMENT TAB TAKEN ALONG LINE 13-13 IN FIG. 11;

The cover 52 may be manufactured of an AISI 300 Series Stainless Steel alloy which is approximately the same thickness as the hood 32. That is, the cover 52 may be manufactured from a similar material as the substrate 44. The cover 52 may also form a replacement tab 40'. That is, the cover 52 forms a double layer of material over the hood 36 and the platform 38 but a single layer to define the replacement tab 40' as only a single layer thickness would fit within the retainer 50 (FIG. 12). The section of the cover 52 which forms the replacement tab 40' should be doubled over a minimum of 0.08 inches (2 mm) along the length of the replacement tab 40' to increase the strength to the replacement tab 40' (FIG. 13).

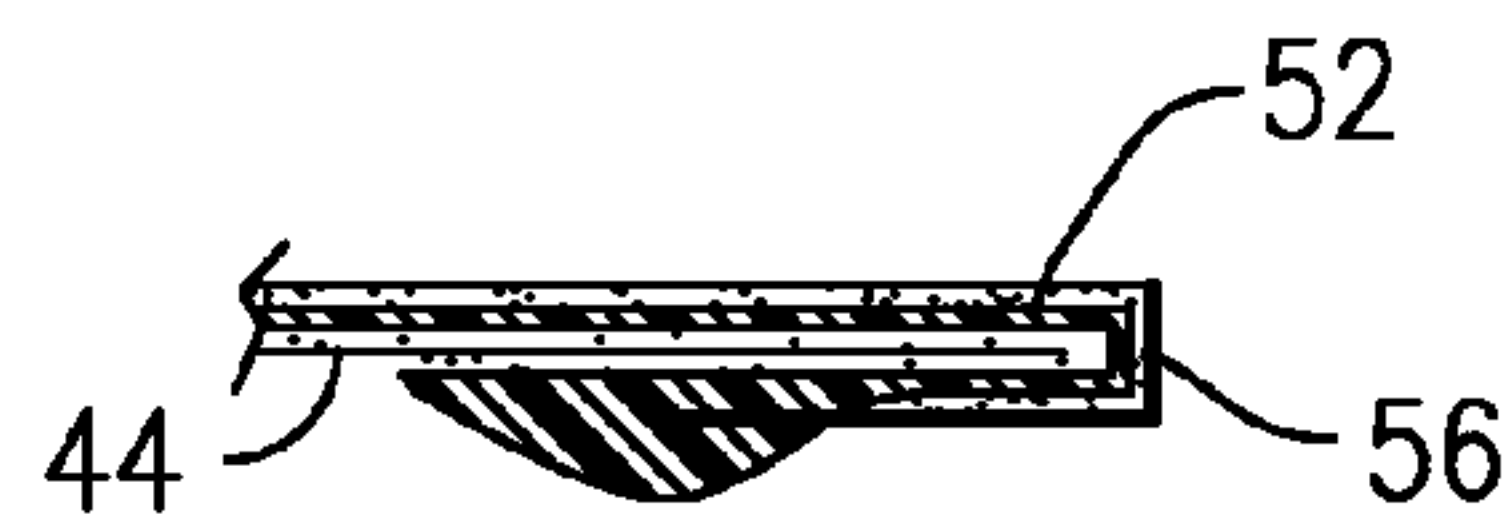
FIG. 14 IS AN EDGE VIEW OF THE FIRESHIELD FASTENER HOOD WITH A COVER ALONG LINE 14-14 IN FIG. 11; AND

Step 108 of the repair includes trimming the cover 52 to cover the substrate except the hinge 42. The trimming should include additional material to wrap around the edges. (FIG. 14). The cover 52 may be a maximum of 0.060 inches (10 mm) of the edge (FIG. 14). It is permissible to trim the replacement tab 40' of the cover 52 to width and length after bonding.

In step 116, the cover 52 is then pressed onto the layer of sealant 56 on the substrate 44. The cover 52 is wrapped over the edges of the substrate 44 (FIG. 14). It is permissible to dart the cover 52 at the edges where the cover 52 extends beyond the hood 36 before the edges are folded over the platform 38. A Radius of 0.06-0.25 inches (1.5-6.35 mm) may be formed between the platform 38 and the replacement tab 40' (FIG. 15). The radius also minimizes stress concentrations.

In step 120, the cover 52 is edge sealed (step 120). Sealant squeeze out is required all around the cover 52 (FIG. 14). The cover 52 is wrapped around the edge to a minimum of 0.2 inches (5 mm) and edge sealed in the sealant 56 (FIG. 14). The perimeter is to be fully encapsulated.

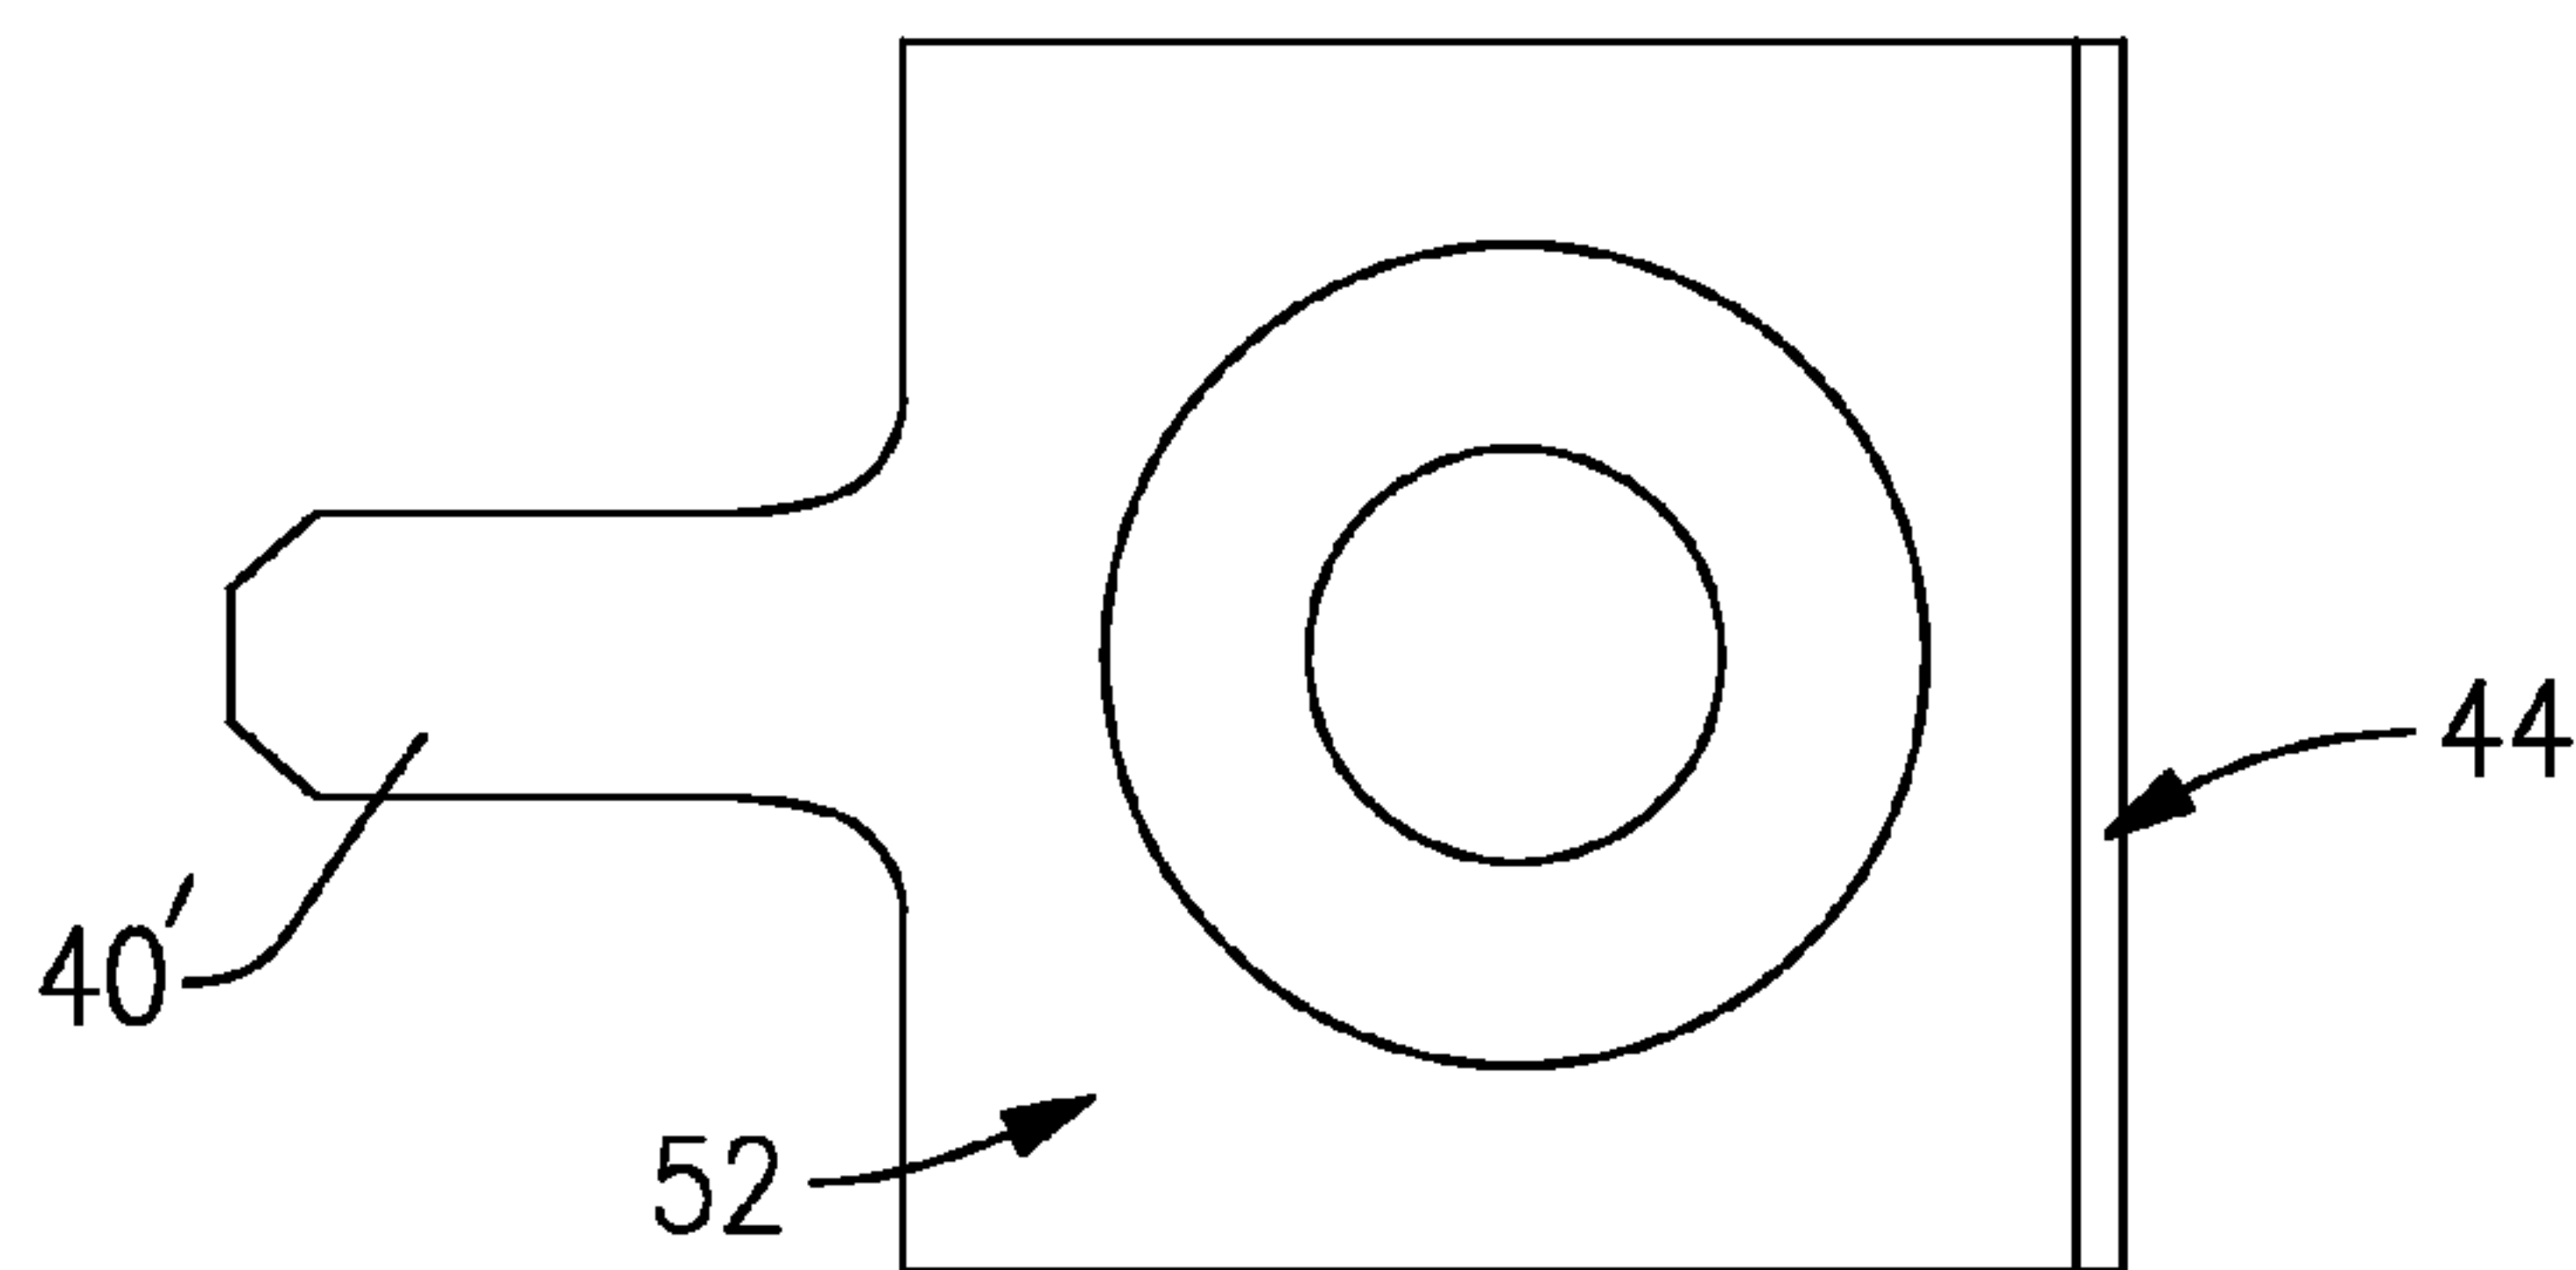
FIG. 15 IS A TOP VIEW OF THE FIRESHIELD FASTENER HOOD WITH THE COVER.
