(10) **Patent No.:** **US 8,916,011 B2**  
(45) **Date of Patent:** **Dec. 23, 2014**

(54) **FIRESHIELD FASTENER HOOD**

(73) Assignee: **United Technologies Corporation**,  
Hartford, CT (US)

A fireshield fastener hood and method of bonding a cover to  
a substrate therefor.

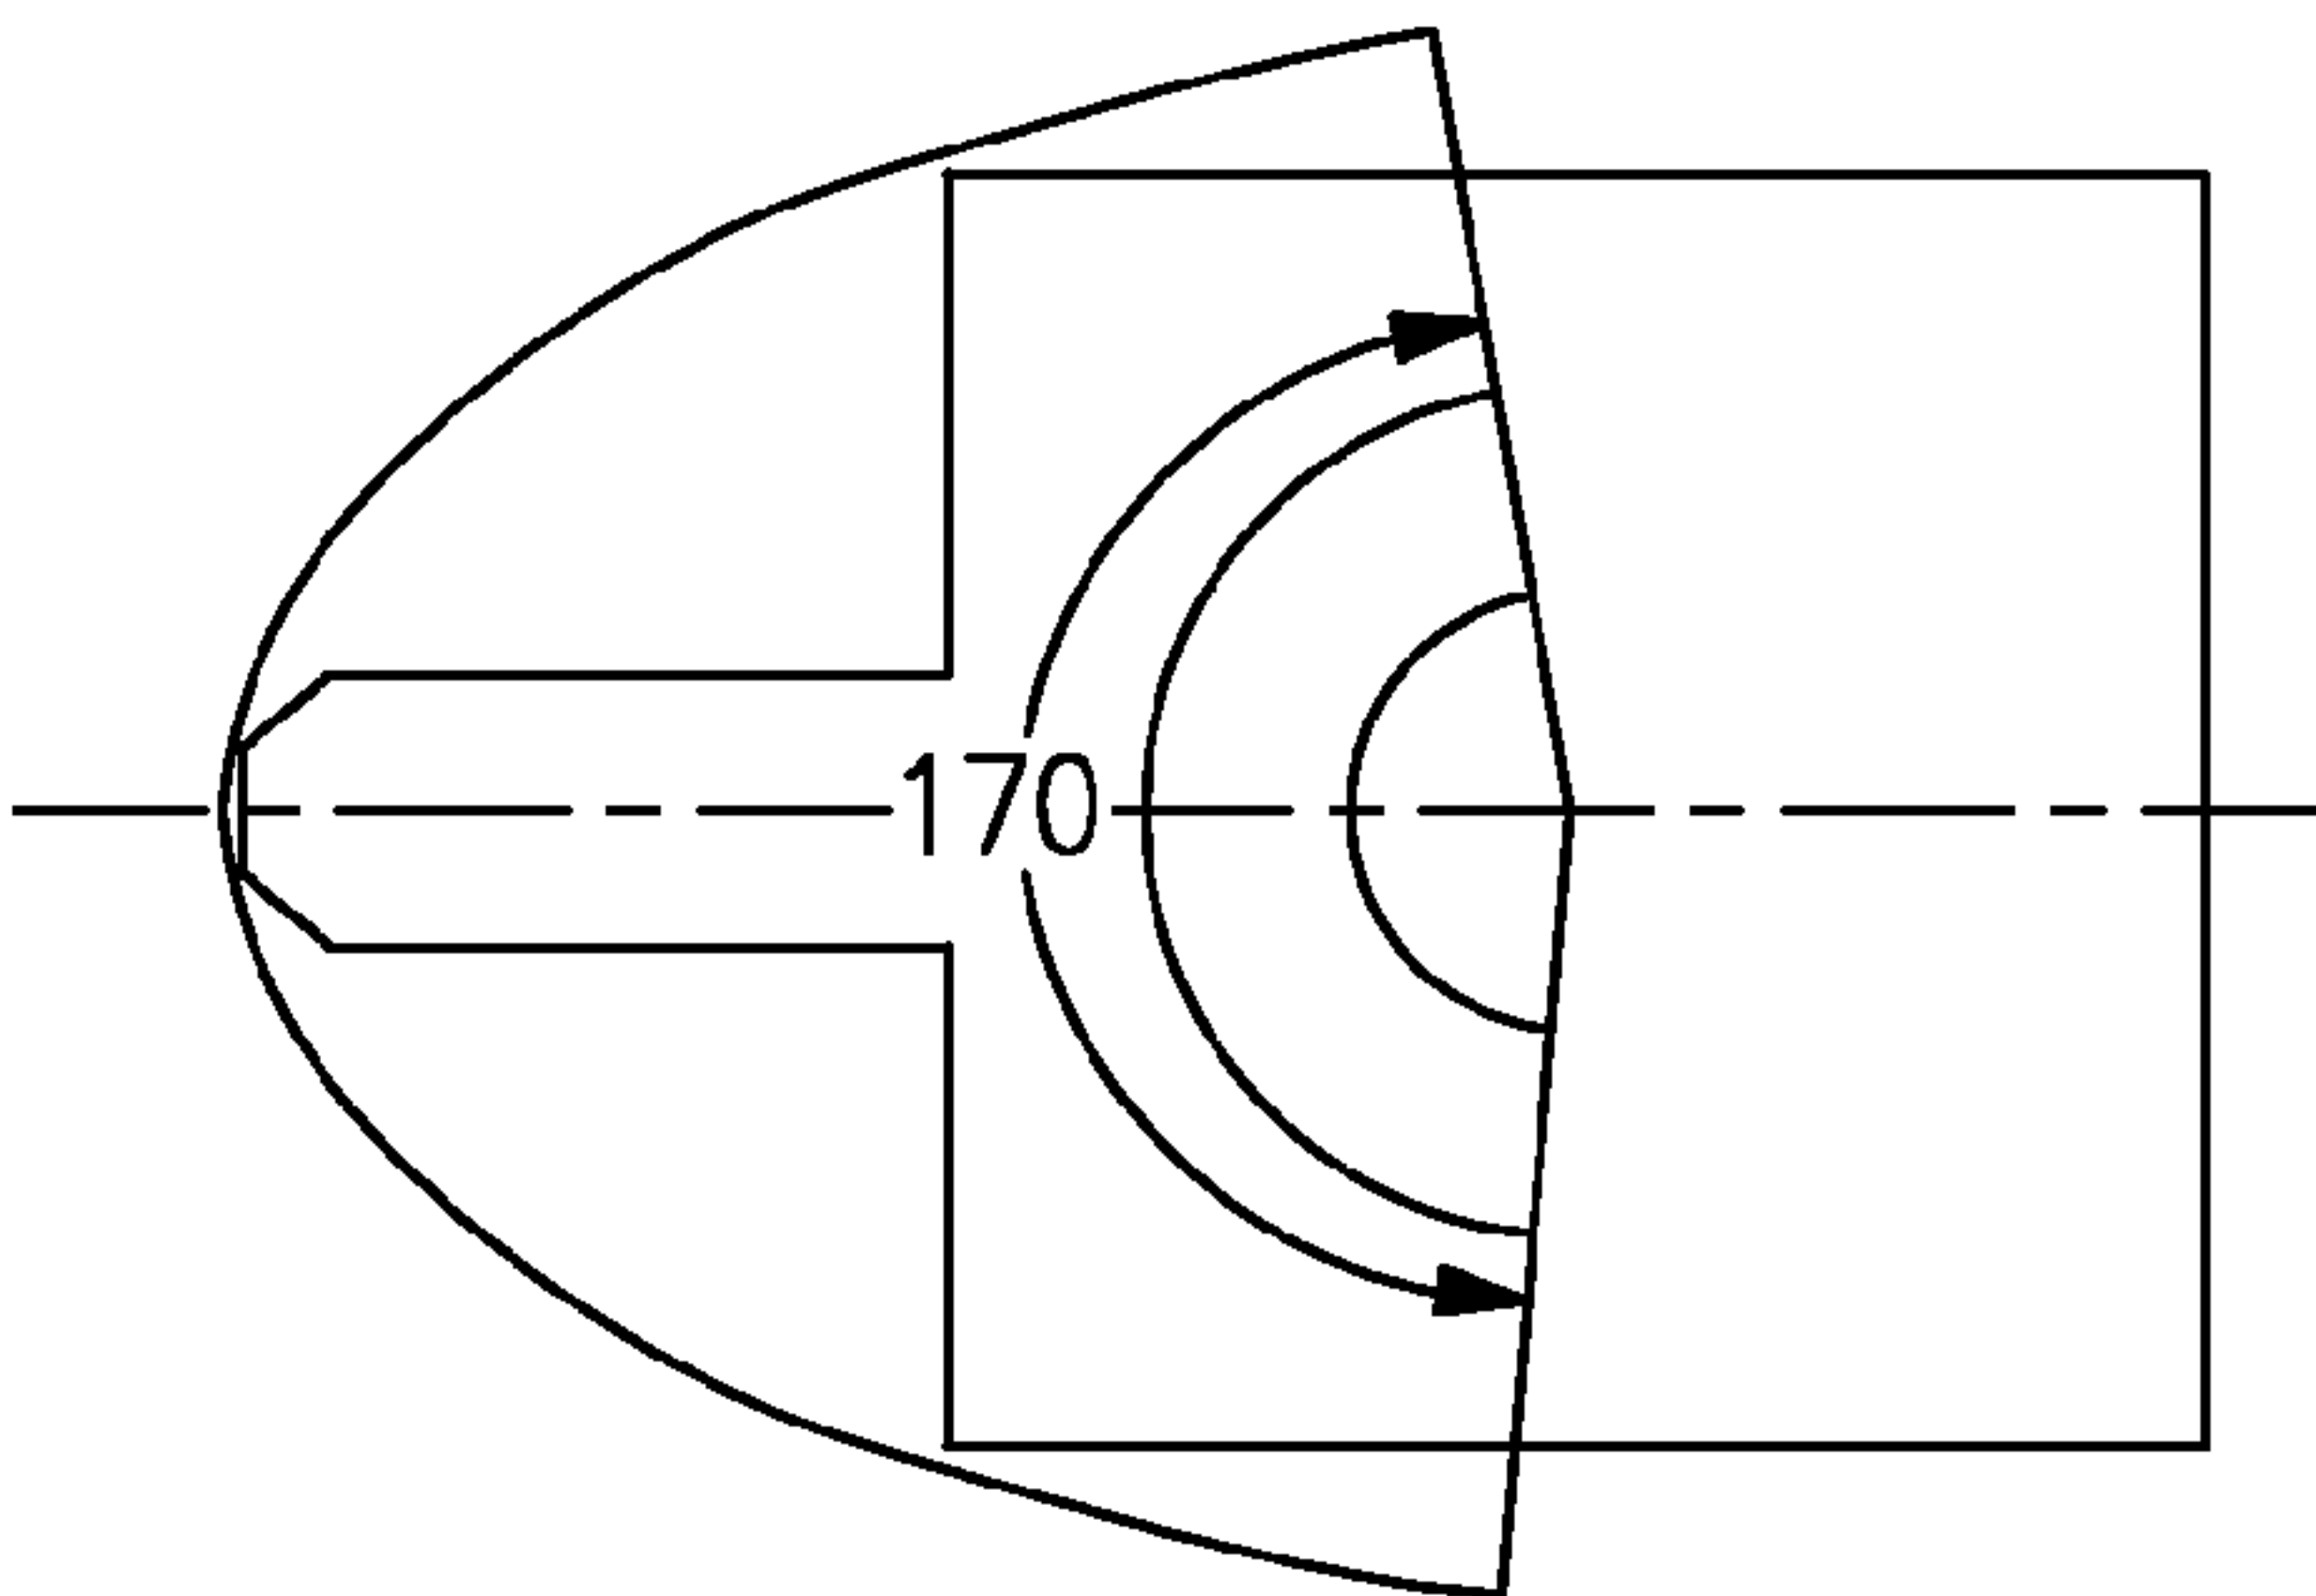
**FIG. 7**

FIG. 7 is a schematic view of an allowable crack area in the fireshield fastener hood for a repair thereof;

Oftentimes the substrate 44 may crack, tear, or otherwise be damaged in a manner which is repairable by the method disclosed herein (FIG. 6). Typically, acceptable cracks may be located in an arc of approximately 170 degrees from the center of the hood 36 in an area adjacent to the tab 40 (FIG. 7). It should be understood that other crack locations may alternatively or additionally allowable.

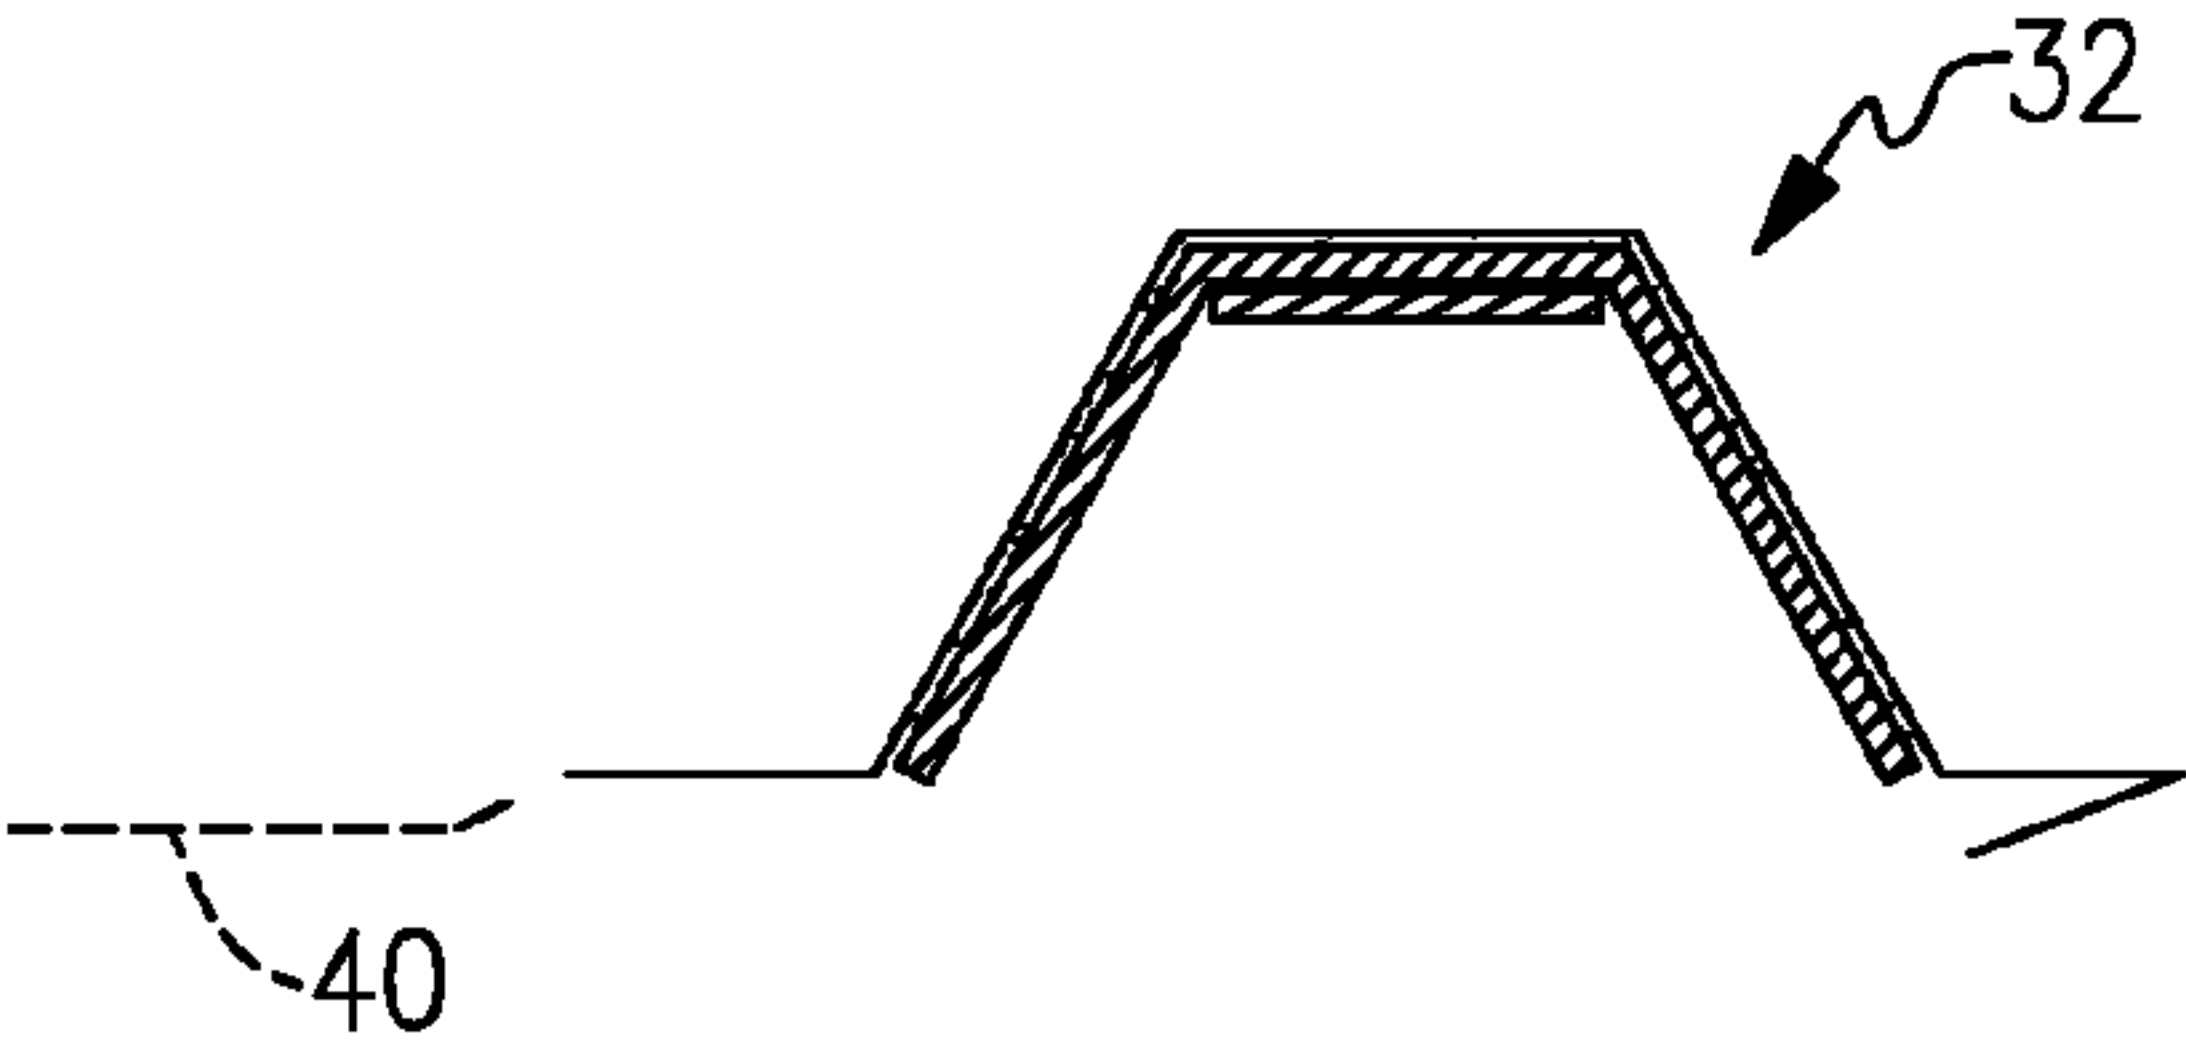
**FIG. 10**

FIG. 11 is a perspective view of the fireshield fastener hood with a cover mounted thereon;

With Reference to FIG. 11, a cover 52 is formed to match the contour of the substrate 44, hood 36 and platform 38 (Step 104). The cover 52 may be formed over a rigid tool which is generally of the contour of the hood 36 and the platform 38. It should be understood that a kit to perform the repair may include a preformed cover 52. The cover 52 should cover the entire contoured hood surface with sufficient material to allow trim. Folds and wrinkles are permitted, but the cover 52 must not have any cracks or tears.

The cover 52 may be manufactured of an AISI 300 Series Stainless Steel alloy which is approximately the same thickness as the hood 32. That is, the cover 52 may be manufactured from a similar material as the substrate 44. The cover 52 may also form a replacement tab 40'. That is, the cover 52 forms a double layer of material over the hood 36 and the platform 38 but a single layer to define the replacement tab 40' as only a single layer thickness would fit within the retainer 50 (FIG. 12). The section of the cover 52 which forms the replacement tab 40' should be doubled over a minimum of 0.08 inches (2 mm) along the length of the replacement tab 40 to increase the strength to the replacement tab 40' (FIG. 13).

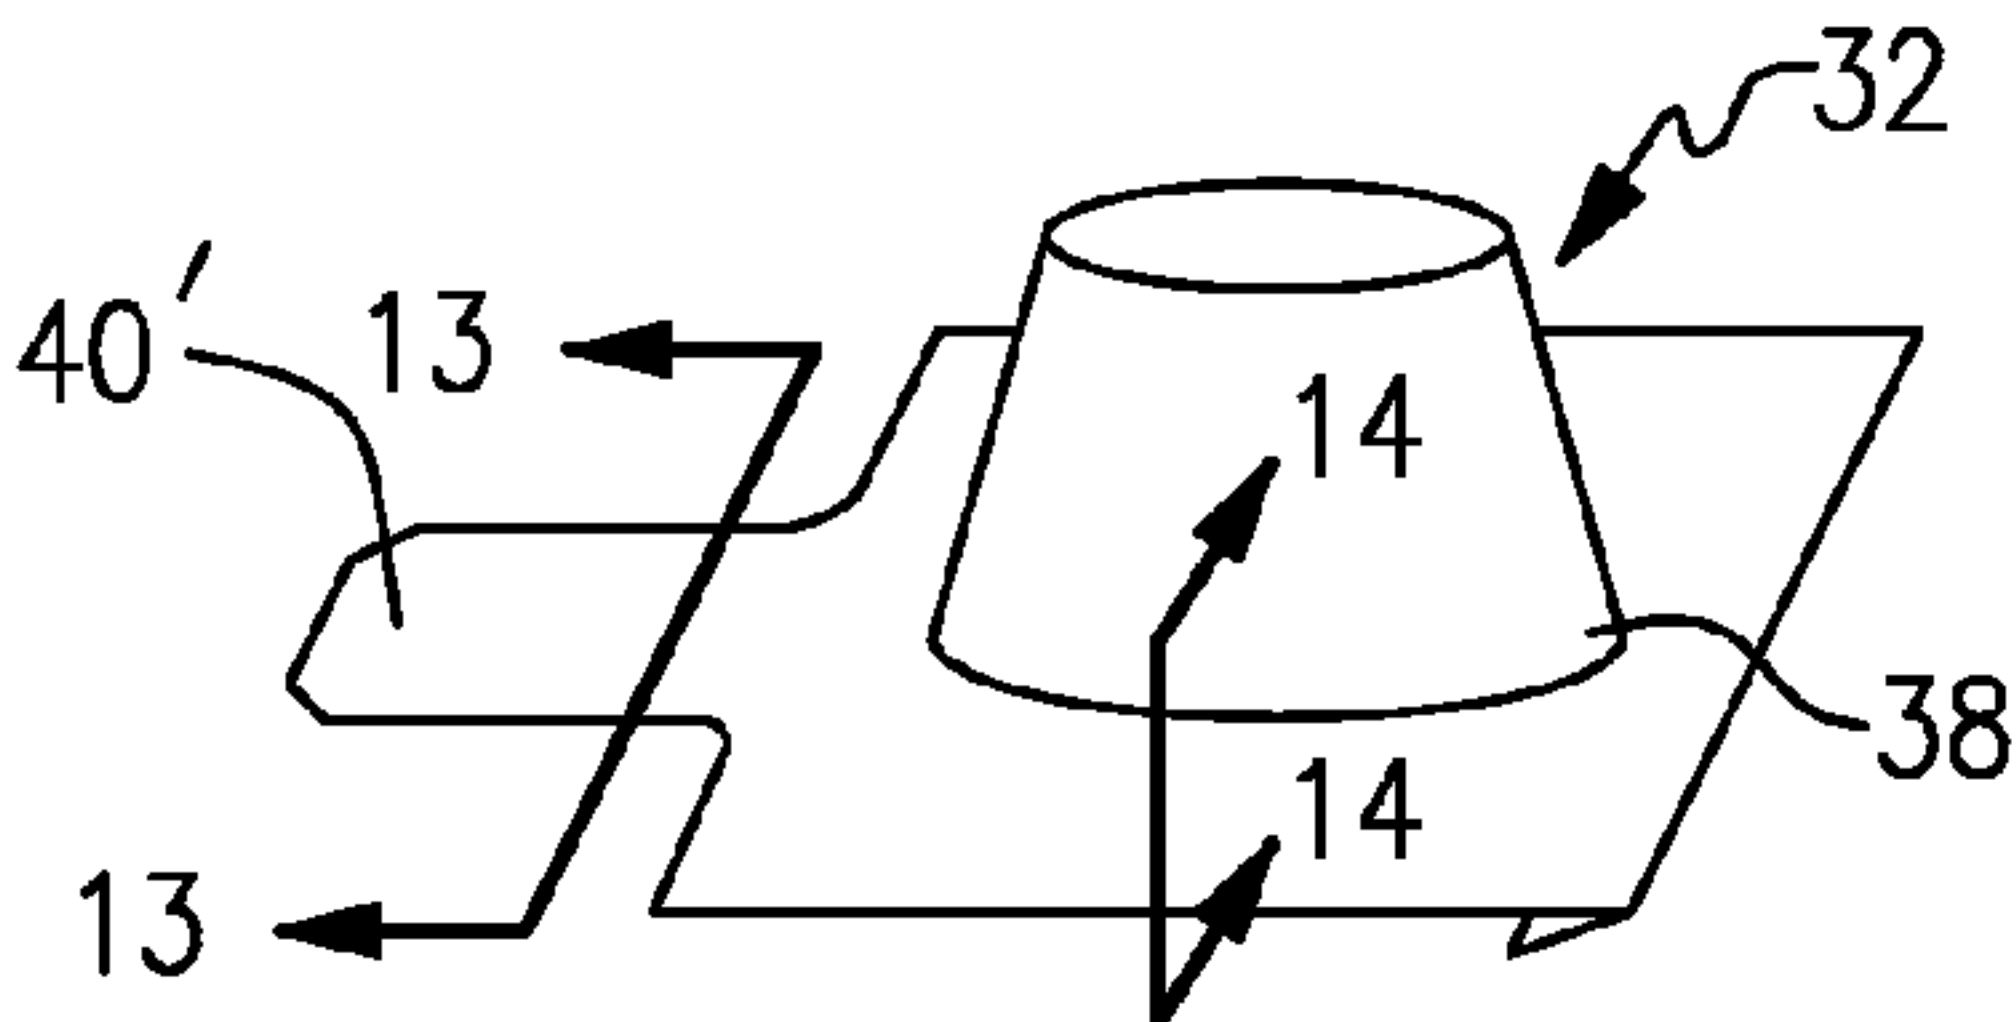
**FIG. 11**

FIG. 12 is a sectional view of the fireshield fastener hood with a cover mounted thereon;

With reference to FIG. 12, in step 114, a layer of sealant 56 is applied to the mating surface of the cover 52, and the substrate 44. The sealant 56 may be a thixotropic silicone paste firewall sealant such as DAPCO 18-4F manufactured by D Aircraft Products Inc. of California, USA.

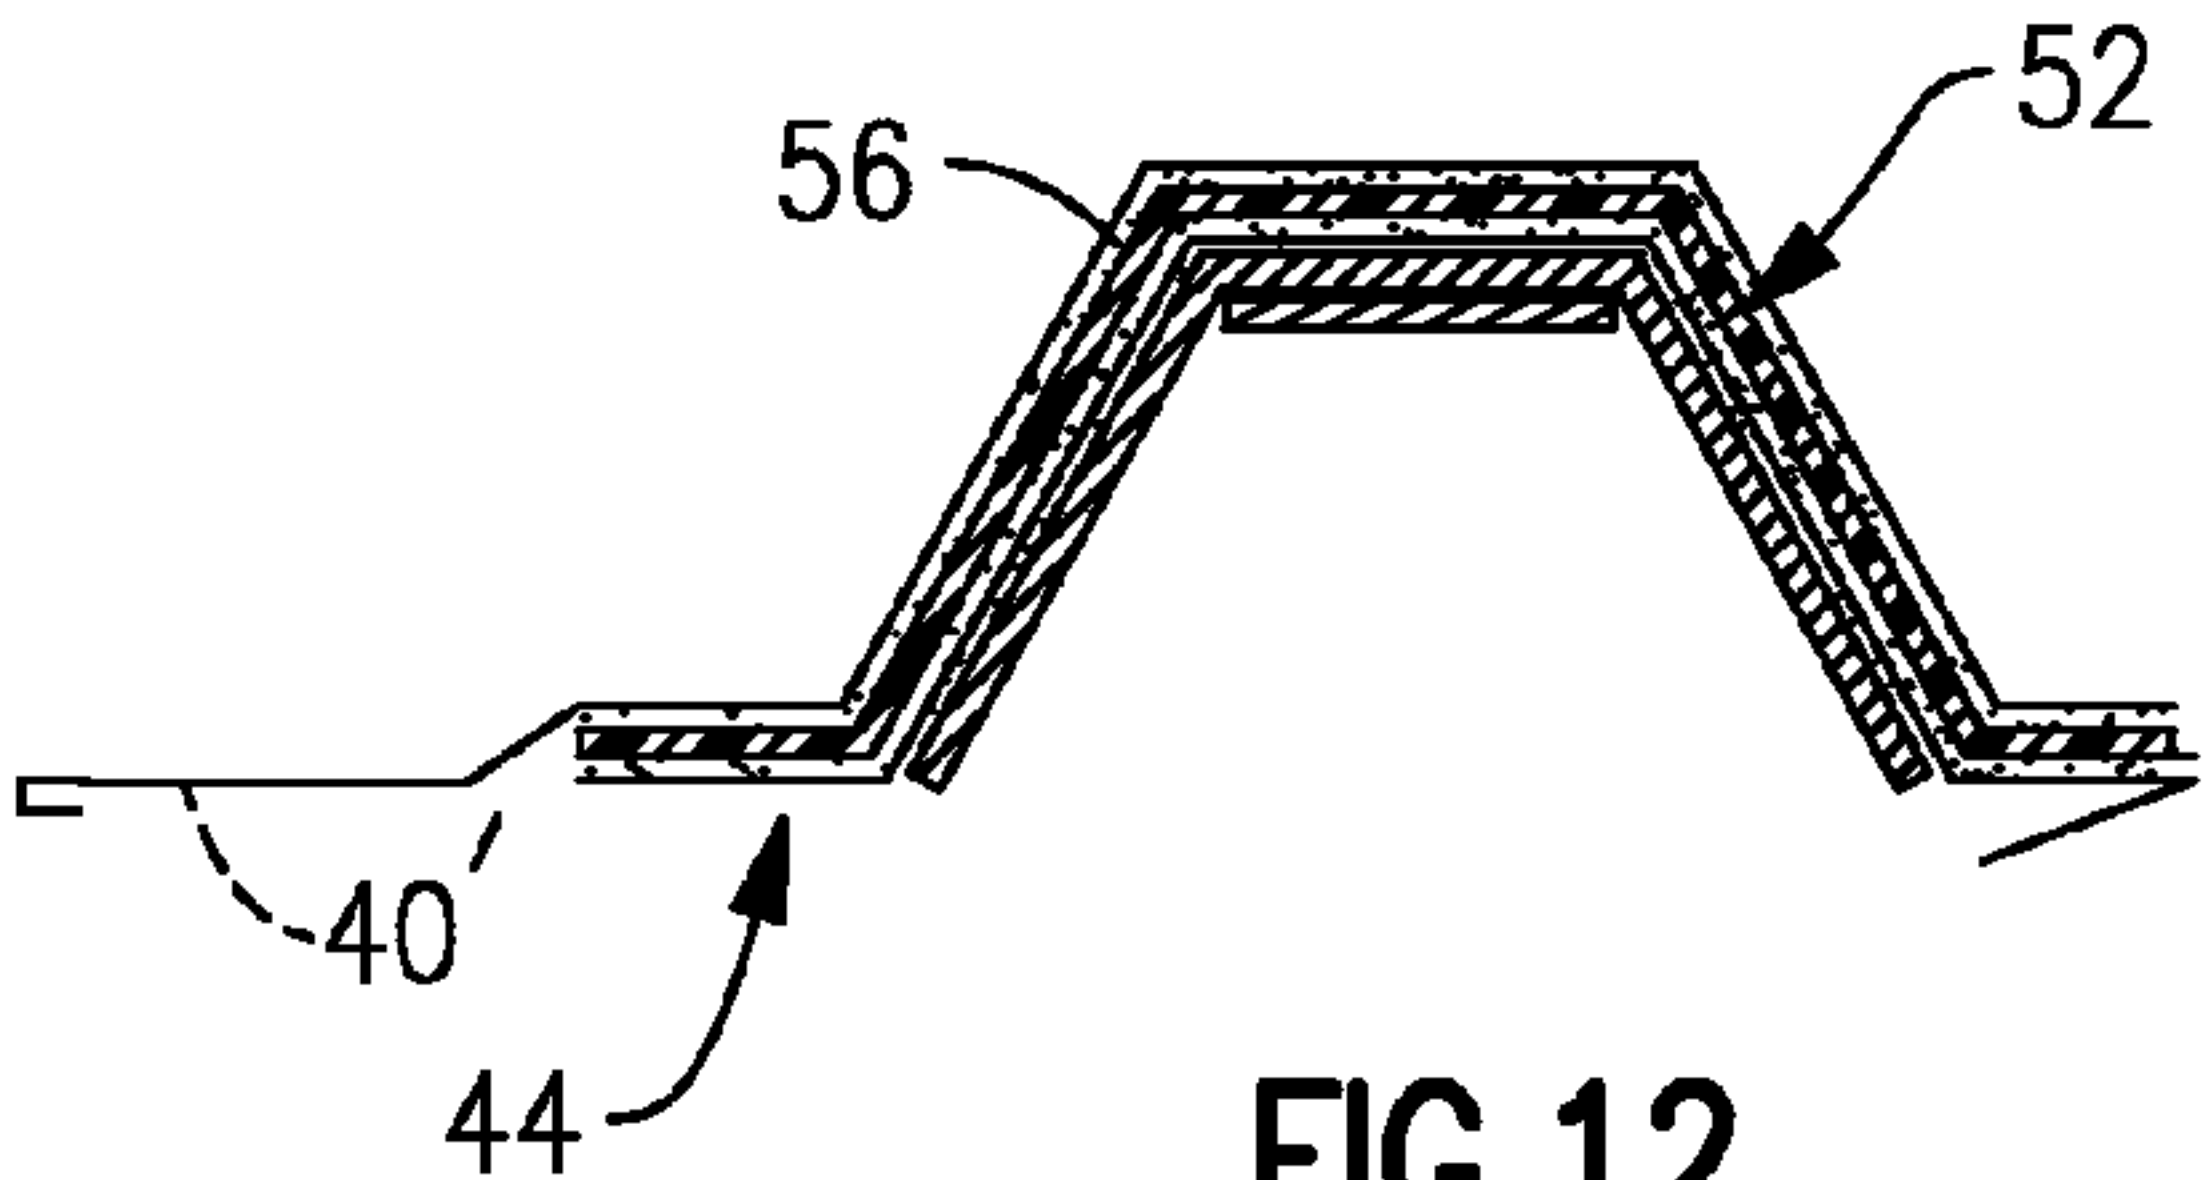
**FIG. 12**

FIG. 13 is a sectional view of a replacement tab taken along line 13-13 in FIG. 11;

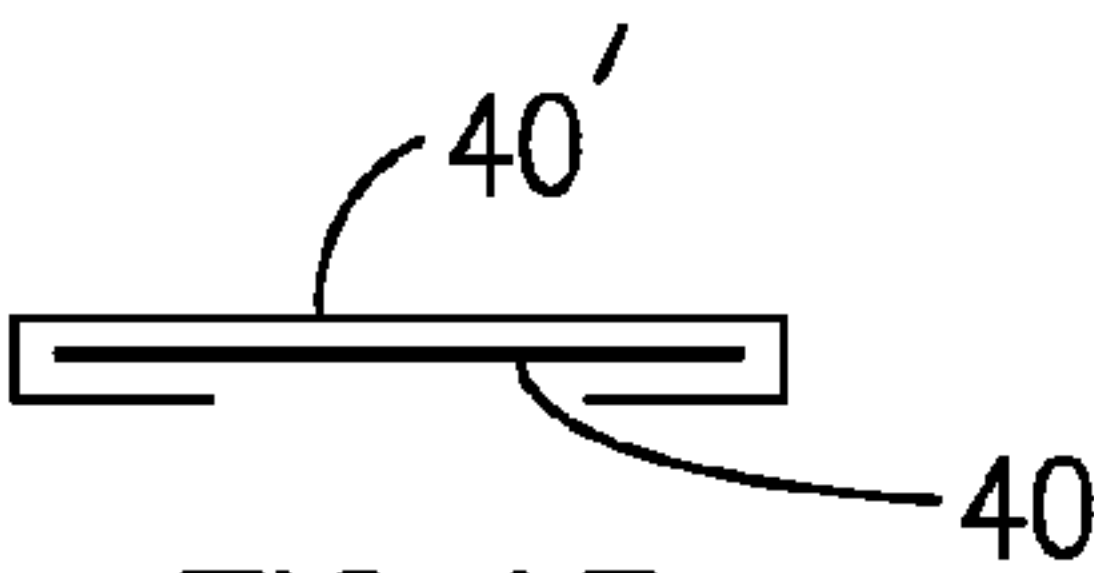
**FIG. 13**

FIG. 14 is an edge view of the fireshield fastener hood with a cover along line 14-14 in FIG. 11; and

Step 108 of the repair includes trimming the cover 52 to cover the substrate except the hinge 42. The trimming should include additional material to wrap around the edges. (FIG. 14). The cover 52 may be a maximum of 0.060 inches (10 mm) of the edge (FIG. 14). It is permissible to trim the replacement tab 40' of the cover 52 to width and length after bonding.

In step 116, the cover 52 is then pressed onto the layer of sealant 56 on the substrate 44. The cover 52 is wrapped over the edges of the substrate 44 (FIG. 14). It is permissible to dart the cover 52 at the edges where the cover 52 extends beyond the hood 36 before the edges are folded over the platform 38. A Radius of 0.06-0.25 inches (1.5-6.35 mm) may be formed between the platform 38 and the replacement tab 40' (FIG. 15). The radius also minimizes stress concentrations.

In step 120, the cover 52 is edge sealed (step 120). Sealant squeeze out is required all around the cover 52 (FIG. 14). The cover 52 is wrapped around the edge to a minimum of 0.2 inches (5 mm) and edge sealed in the sealant 56 (FIG. 14). The perimeter is to be fully encapsulated.

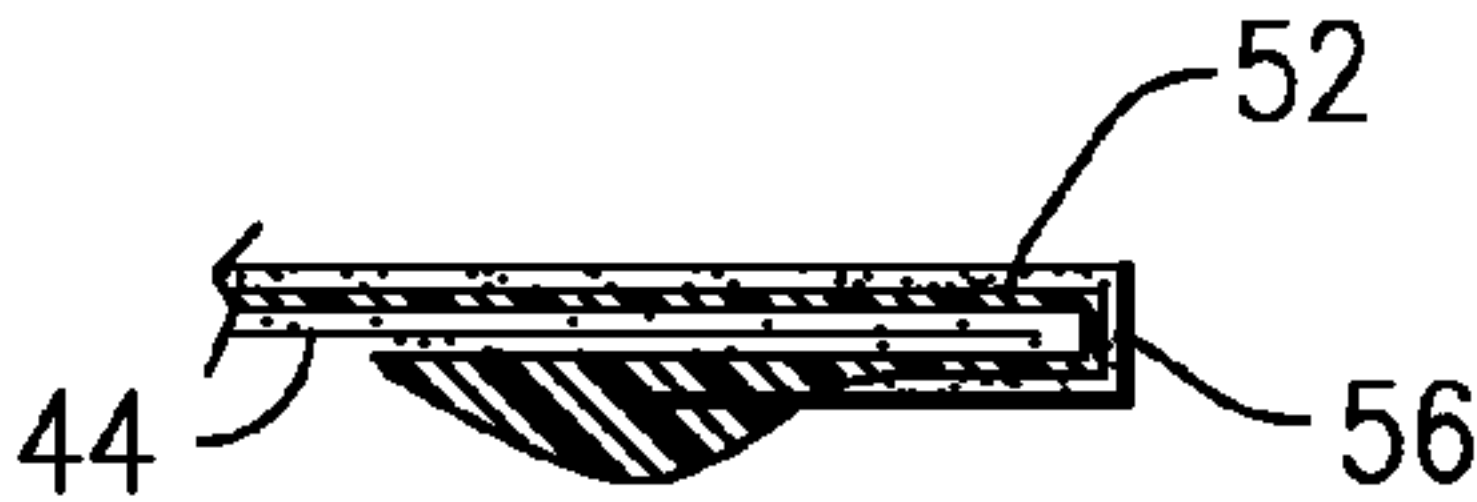
**FIG. 14**

FIG. 15 is a top view of the fireshield fastener hood with the cover.
