(10) **Patent No.:** **US 8,994,817 B2**
(45) **Date of Patent:** **Mar. 31, 2015**

(54) **INFRARED INSPECTION OF METALLIC WEB STRUCTURES**

(73) Assignees: **Michelin Recherche et Technique S.A.**, Granges-Paccot (CH); **Compagnie Generale des Etablissements Michelin**, Clermont-Ferrand (FR)

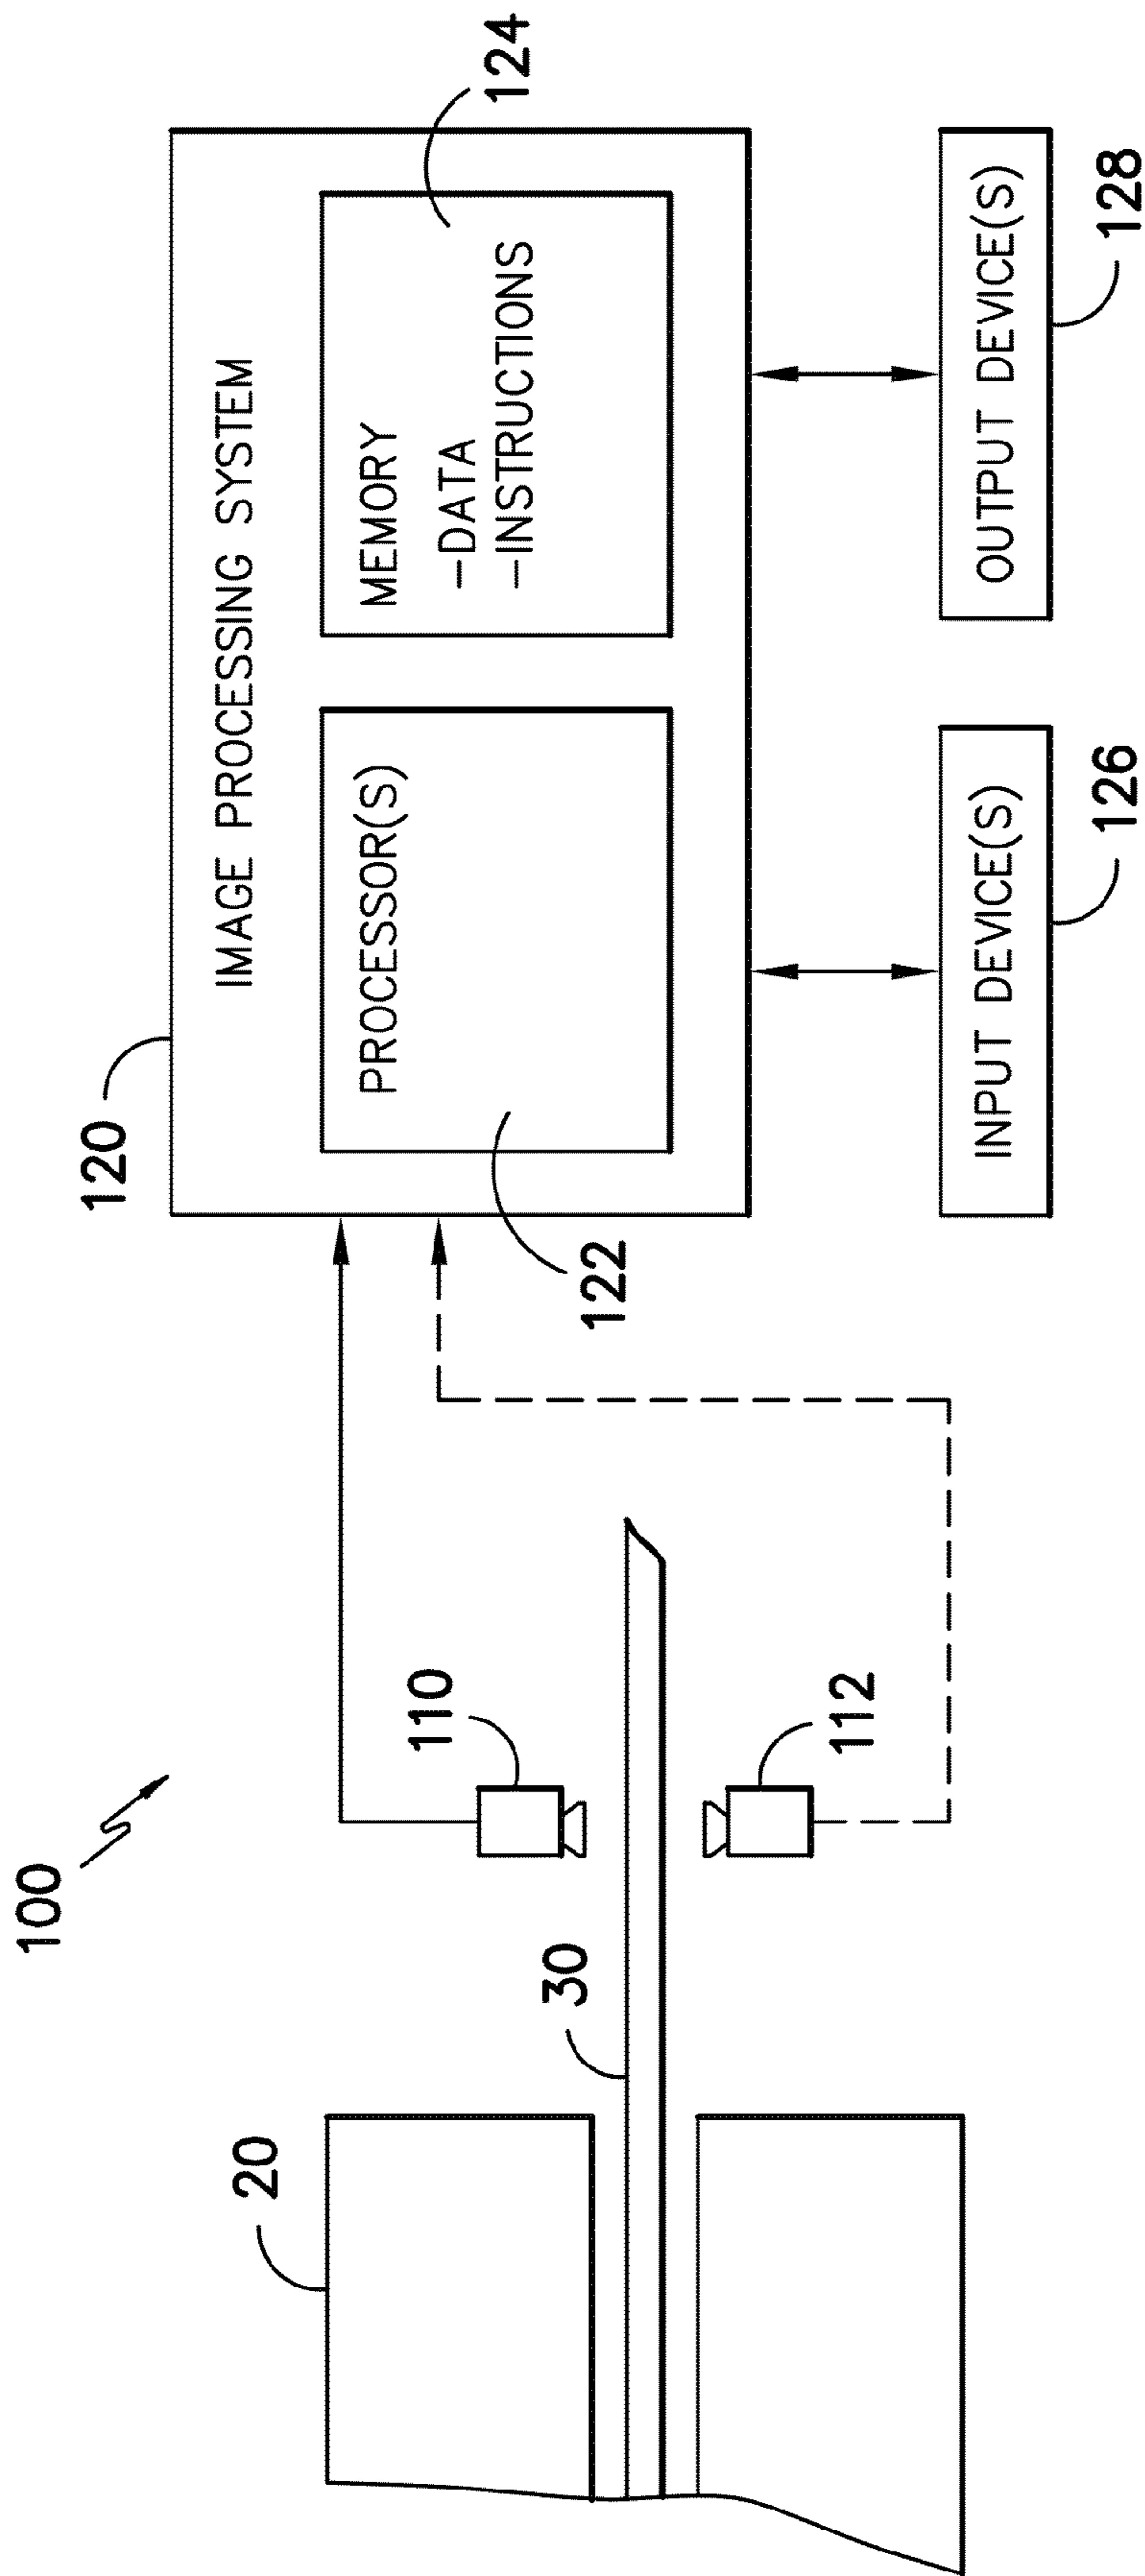
FIG. -1-

FIG. 1 provides a block diagram of a system for inspecting web structures according to an exemplary aspect of the present disclosure;

FIG. 1 illustrates a schematic overview of an exemplary system 100 for inspecting a web structure 30 as the web structure 30 leaves a calender 20. During the calendaring process, a ply of metallic cables is fed into the calender 20 using a cable guide. Layers of viscoelastic material, such as a rubber material, are heated and pressed onto the upper and lower surface of the metallic cables to form the web structure 30.

As shown in FIG. 1, an exemplary system 100 for detecting an anomaly in the web structure 30 includes a thermal imaging device 110 and an image processing system 120. The thermal imaging device 110 can include an infrared camera configured to capture thermal images of the web structure 30 as it leaves the calender 20. For instance, in a particular embodiment, the thermal imaging device can include infrared camera. The infrared camera can be a low resolution infrared camera (120x120) or a high resolution infrared camera. Those of ordinary skill in the art, using the disclosures provided herein, should understand that any thermal imaging device configured to capture data associated with the thermal properties of the web structure can be used without deviating from the scope of the present disclosure.

The thermal imaging device 110 is positioned to scan a first surface of the web structure 30 as the web structure 30 exits the calender 20. The thermal imaging device 110 captures thermal images of the web structure 30 as the web structure 30 leaves the calender 20. Optionally, the system 100 can include a second thermal imaging device 112 positioned to scan a second surface of the web structure 30 as the web structure 30 exits the calender 20. The thermal imaging device 110 should be positioned to scan the web structure 30 when the web structure 30 is still in a thermodynamic state after leaving the calender 20. For instance, in a particular embodiment, the thermal imaging device 110 is positioned to scan a portion of the web structure 30 within about five seconds or less after the portion of the web structure 30 leaves the calender 20.

Referring back to FIG. **1**, the thermal imaging device **110** can be configured to provide thermal images to an image processing system **120**. The image processing system **120** can be configured to control the thermal imaging device **110** to capture thermal images of the web structure **30** and can be further configured to analyze the thermal images for temperature differentials to locate anomalies in the web structure **30**. For instance, in a particular embodiment, the image processing system **120** can analyze pixel values associated with a plurality of pixels of the thermal image for the presence of a pixel value differential and compare the pixel value differential to a threshold value to detect the presence of an anomaly in the web structure **30**.
