(10) **Patent No.:** **US 9,004,589 B2**
(45) **Date of Patent:** **Apr. 14, 2015**

(54) **VIBRATORY ALERT PATCH**

(71) Applicant: **Toyota Boshoku America, Inc.**, Novi, MI (US)

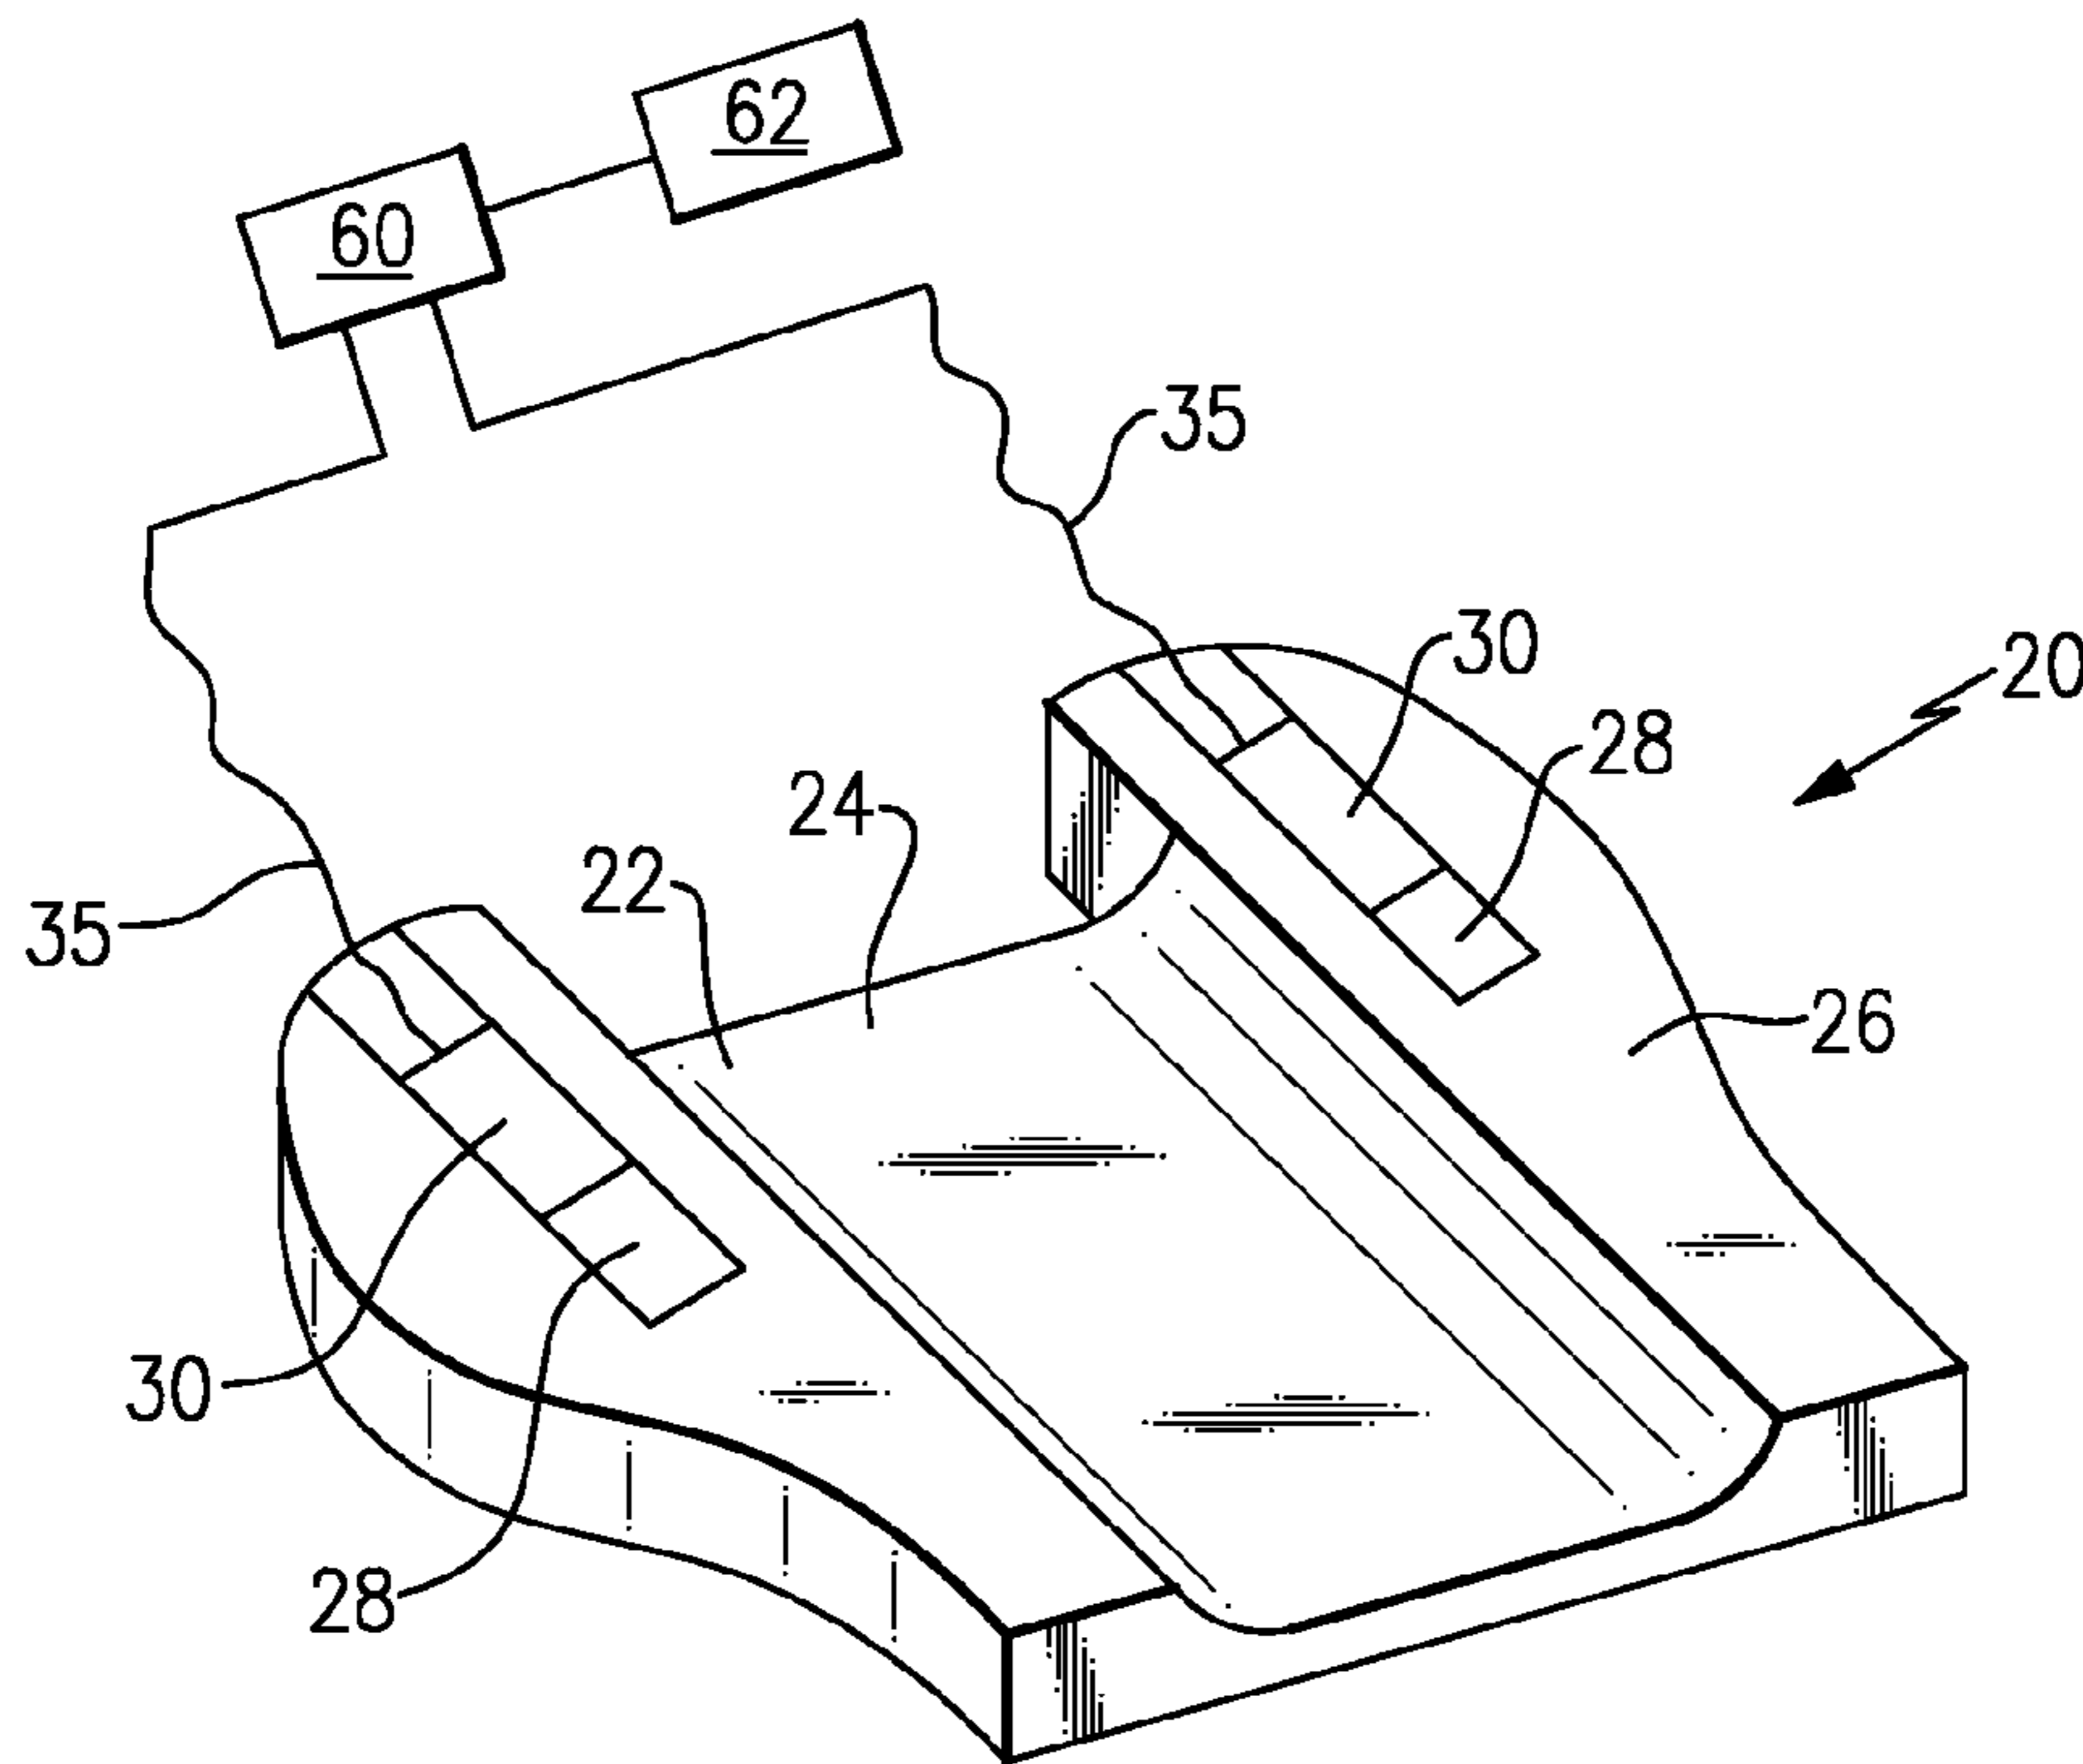
FIG. 1 illustrates a perspective view of a cushion of a vehicle seat;

FIG. 1 illustrates a cushion 20 of a vehicle seat 64. In one example, the vehicle seat 64 is a driver's seat. The cushion 20 is formed by a molding process and includes a seat portion 22 having a substantially flat upper surface 24 and two side bolsters 26 each located on one side of the seat portion 22. In one example, the cushion 20 is made of foam. In one example, the cushion 20 is made of polyurethane foam. The cushion 20 includes a pre-formed recess 28 formed during the molding process. In one example, each of the two side bolsters 26 include a pre-formed recess 28. A vibratory alert patch 30 that is a haptic motor is located on the cushion 20 in each of the pre-formed recesses 28.

Returning to FIG. 1, the wires **34** allow for communication between the vibratory alert patch **30** and a controller **60**. The controller **60** is also in communication with a sensor **62** that detects a road event. In one example, a road event occurs when the vehicle moves from its lane, another vehicle is approaching, a front collision occurs, or a rear collision occurs. When the sensor **62** detects a road event, a signal is sent to the controller **60**. The controller **60** then sends a signal to the vibratory alert patch **30** in response to the signal from the sensor **62**. In response to the signal from the controller **60**, the vibratory alert patch **30** vibrates on the cushion **20** to provide a tactile signal and feedback that can be felt by the driver to alert the driver of the road event. In one example, the vibratory alert patch **30** vibrates above 50 m/s^2 as measured at a seat-occupant interface at approximately 175 Hz. By spacing the transducer cells **32**, the sensing of vibrations can be increased.

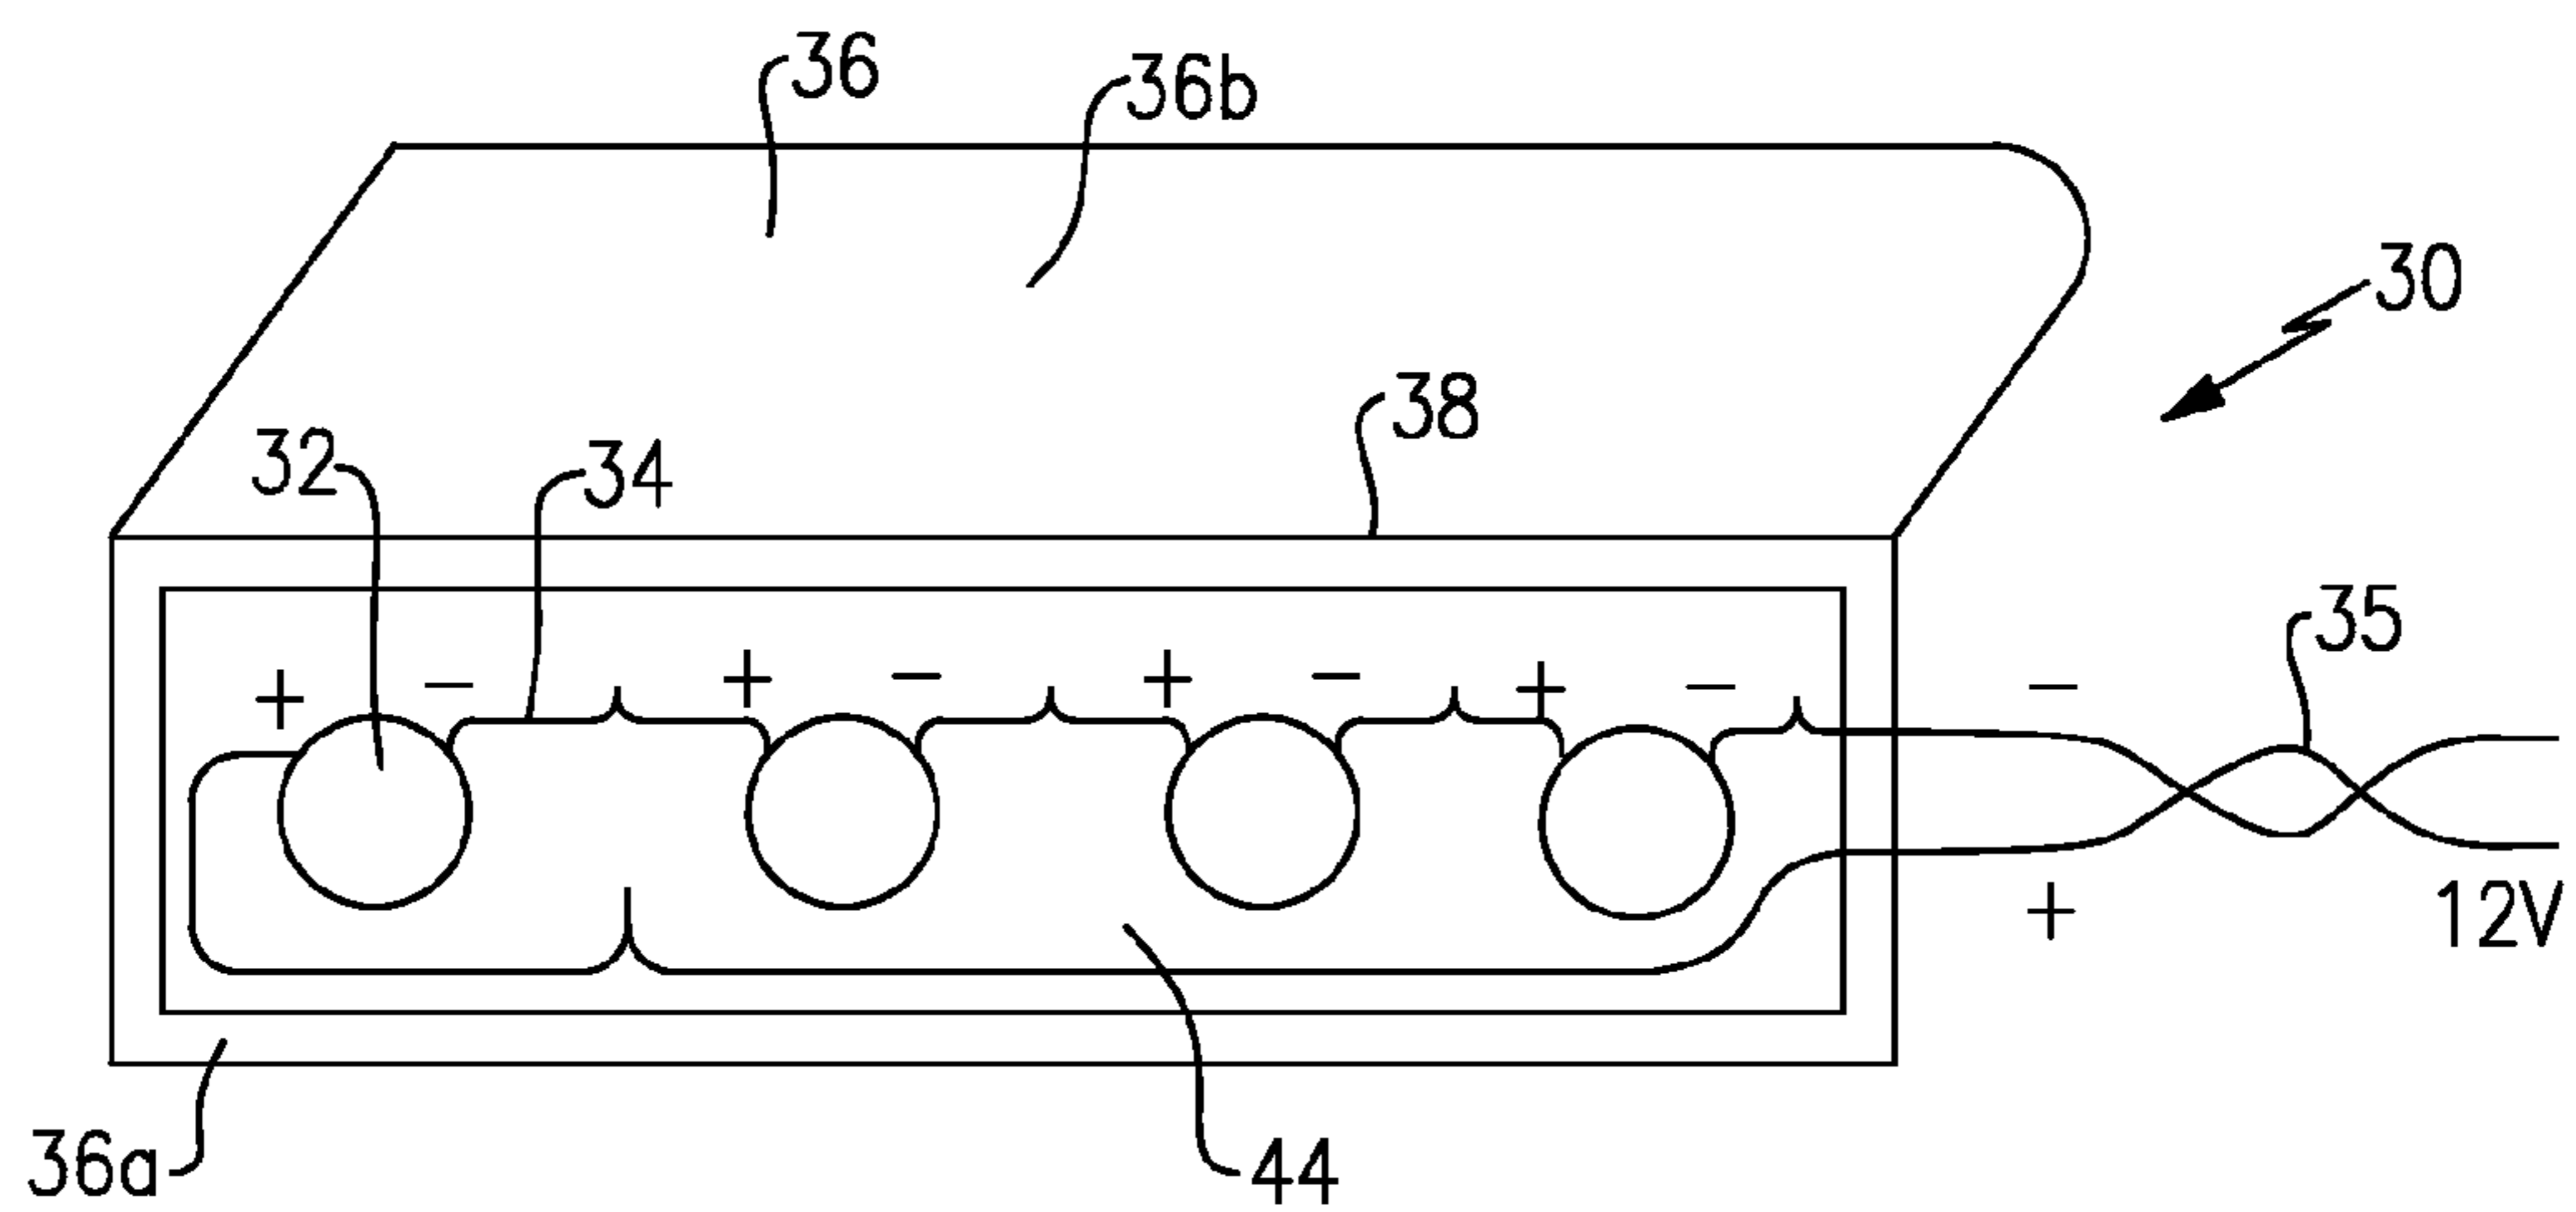
FIG. 2 illustrates internal components of a vibratory alert patch;

FIGS. 2 illustrates internal components of a haptic motor, for example a vibratory alert patch 30. The vibratory alert patch 30 includes an array of transducer cells 32. In one example, there are four transducer cells 32. In one example, the transducer cells 32 are each a Linear Resonant Actuator 25 (LRA). In one example, the transducer cells 32 are each coin style transducer cells. Although a Linear Resonant Actuator is illustrated and described, the transducer cells 32 can each be a vibration surface transducer cell or an eccentrically rotating mass (ERM) motor.

The transducer cells 32 each have a voltage rating of about 30
2 V RMS. The transducer cells 32 have the same phase and frequency, and the vibration from each of the transducer cells 32 is added to a total vibration applied on the seat surface. In one example, the transducer cells 32 have a high G force rating. In one example, the transducer cells 32 have a G force rating of about 1.4 G.

In one example, the transducer cells 32 are connected in series by wires 34 to achieve a desired vibration alert. In another example, the transducer cells 32 are connected in parallel by wires 34 to achieve a desired vibration alert. The transducer cells 32 can also be connected in both series and parallel by wires 34 to achieve a desired vibration alert. The transducer cells 32 employ AC voltage at a specific frequency to generate the vibration resonance.

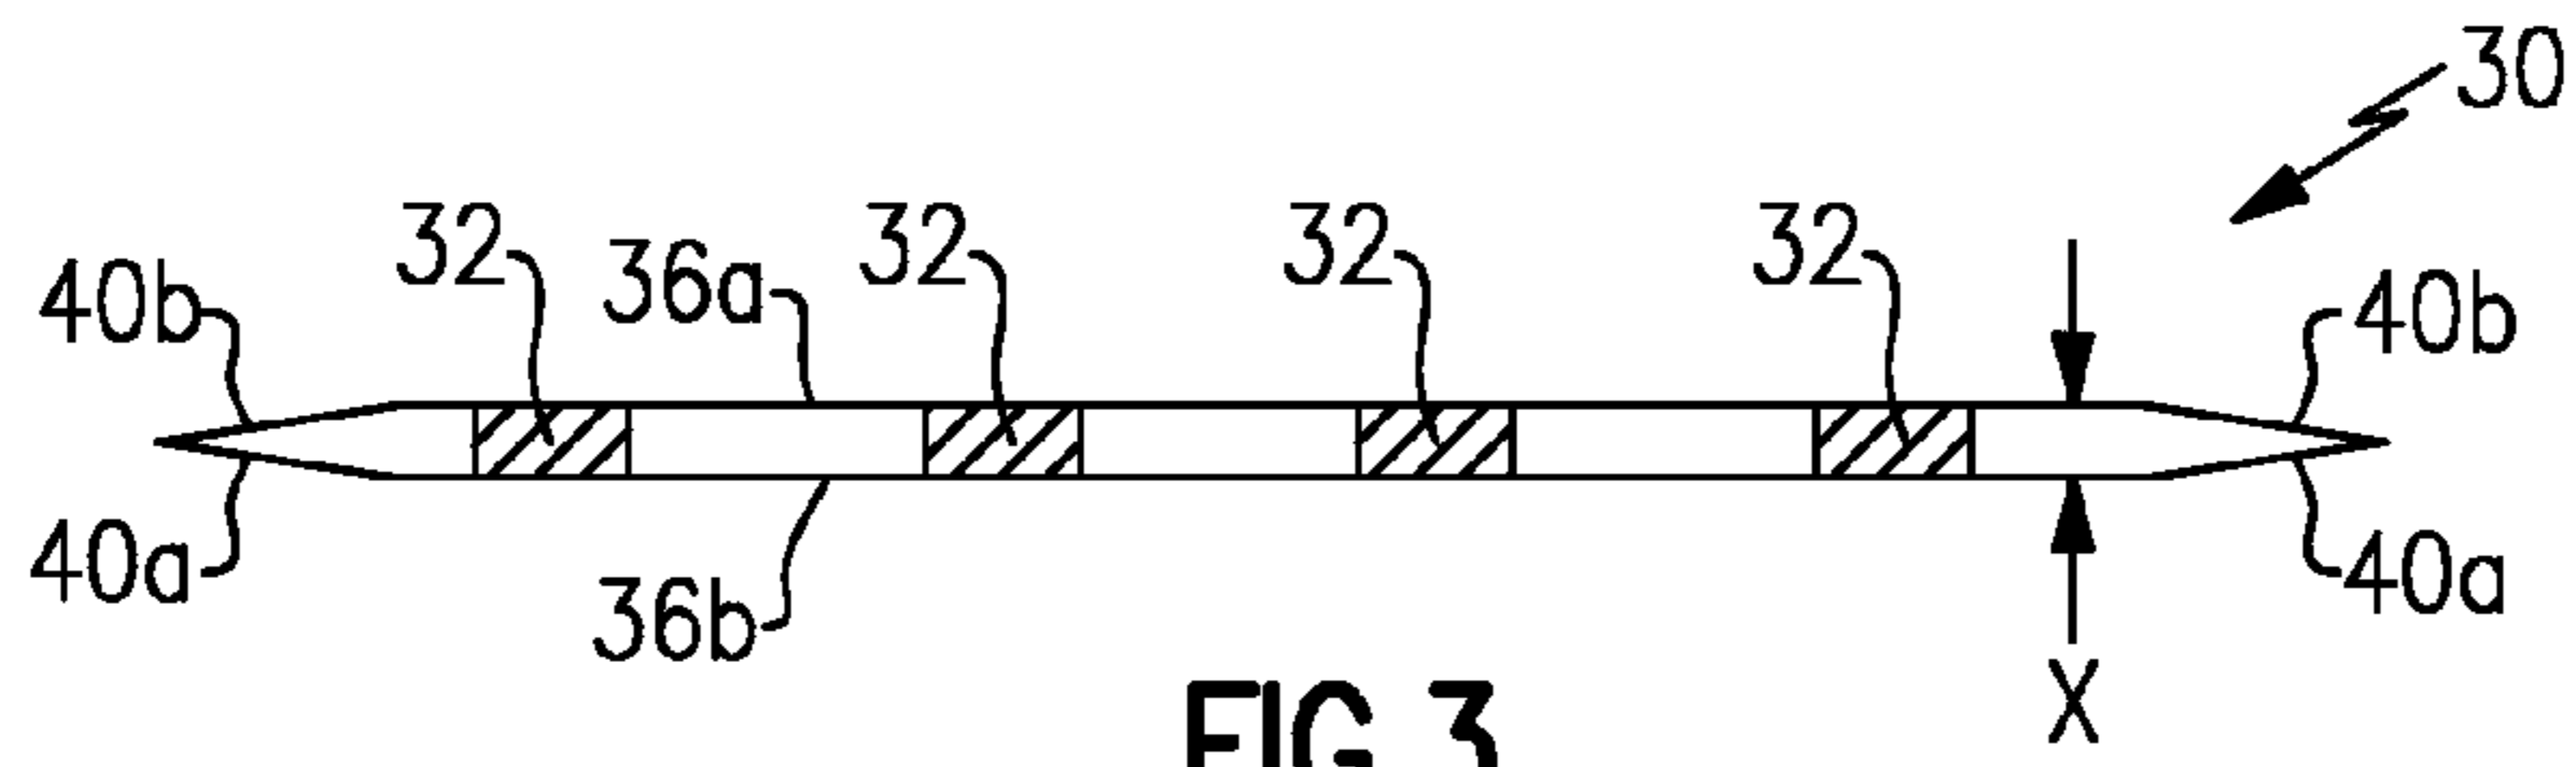
FIG. 3 illustrates a cross-sectional view of the vibratory 55
alert patch;

The transducer cells 32 are located between portions 36a and 36b of a piece of fabric 36. In one example, the piece of fabric 36 is polyester cloth. The piece of fabric 36 is folded along a fold 38 to define the portions 36a and 36b. As shown in FIG. 3, the portions 36a and 36b are secured to each by an adhesive to retain and completely encase the transducer cells 32 therebetween, as shown in FIG. 4. In one example, the adhesive is a polyester adhesive.

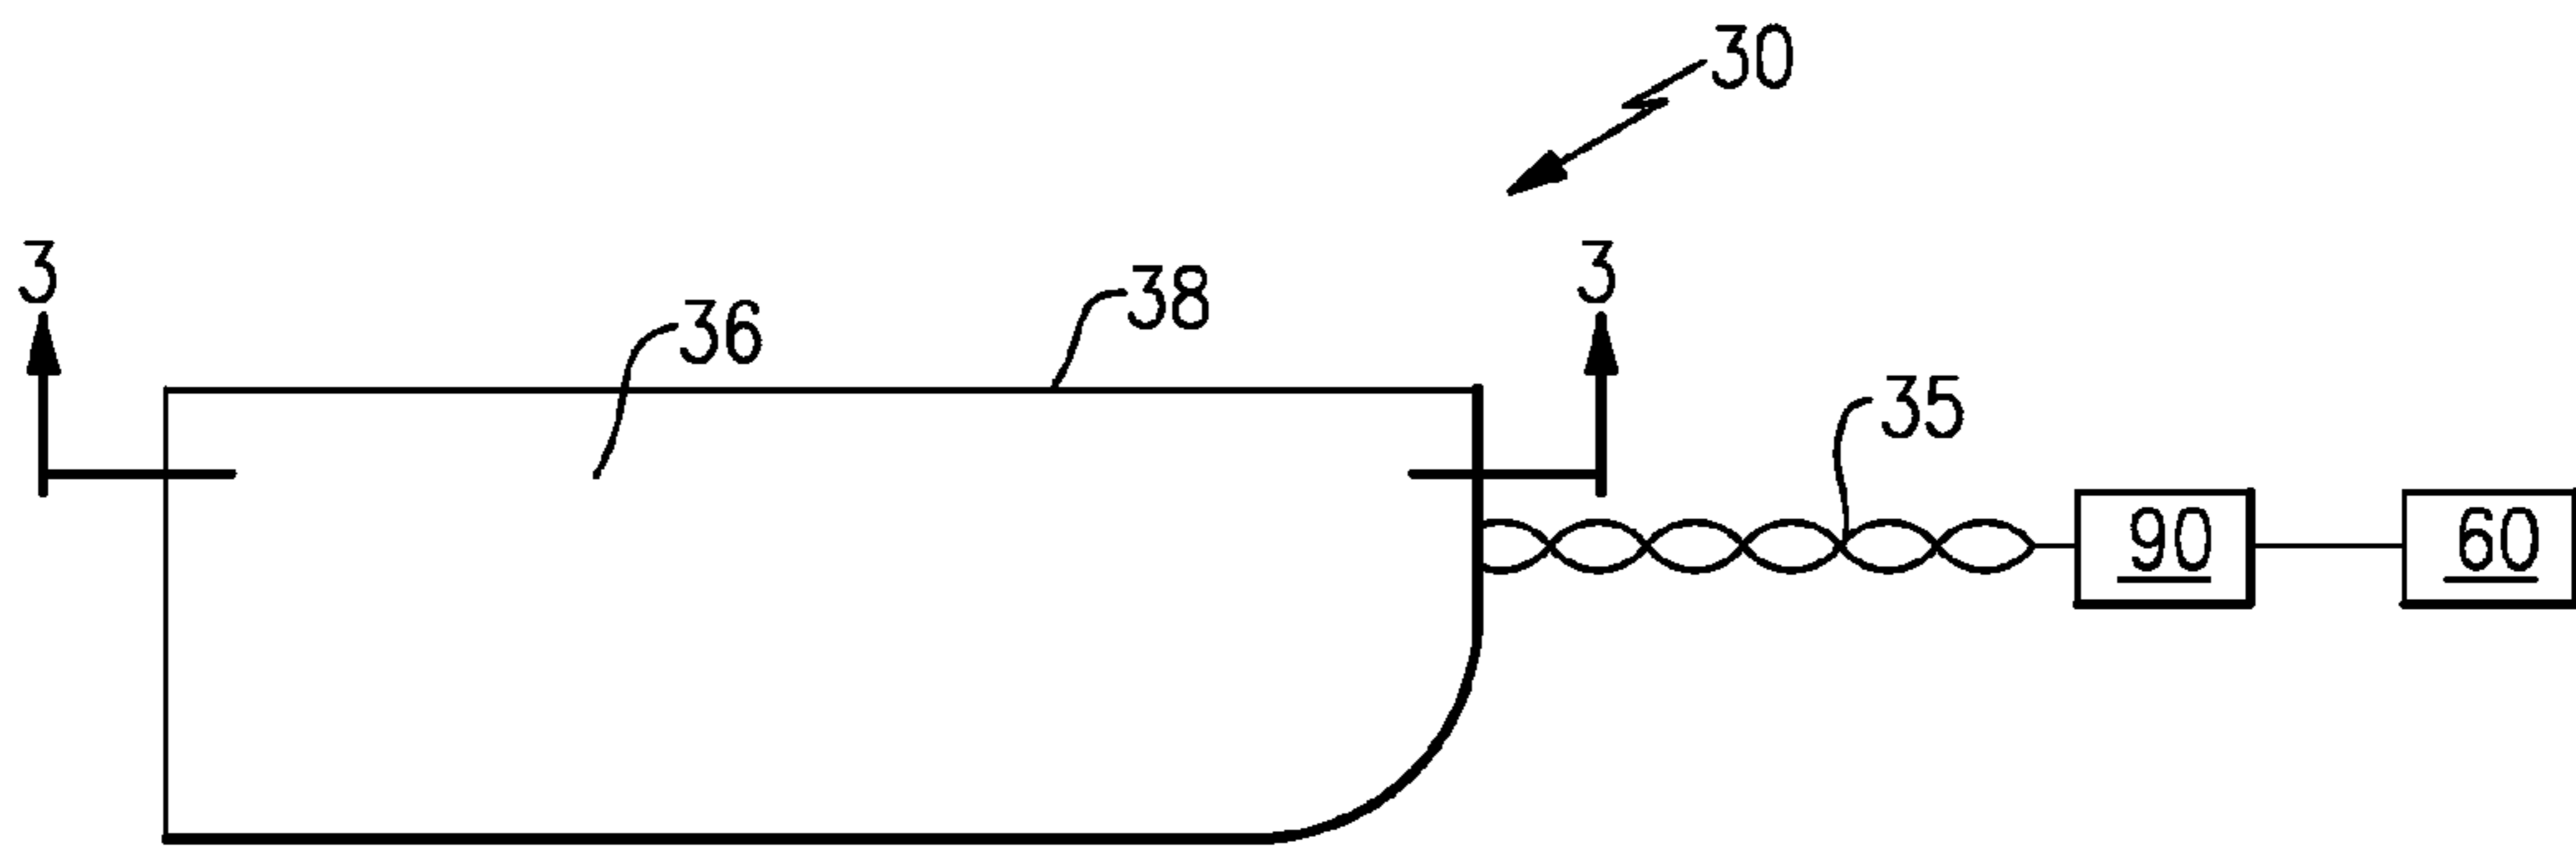
FIG. 4 illustrates a top view of a vibratory alert patch;

In another example, the signal from the controller **60** can be amplified by an optional amplifier **90** (shown in FIG. 4) to power multiple devices. In another example, controller **60** can send the signal at a less frequent interval to reduce the resonant vibration frequency.

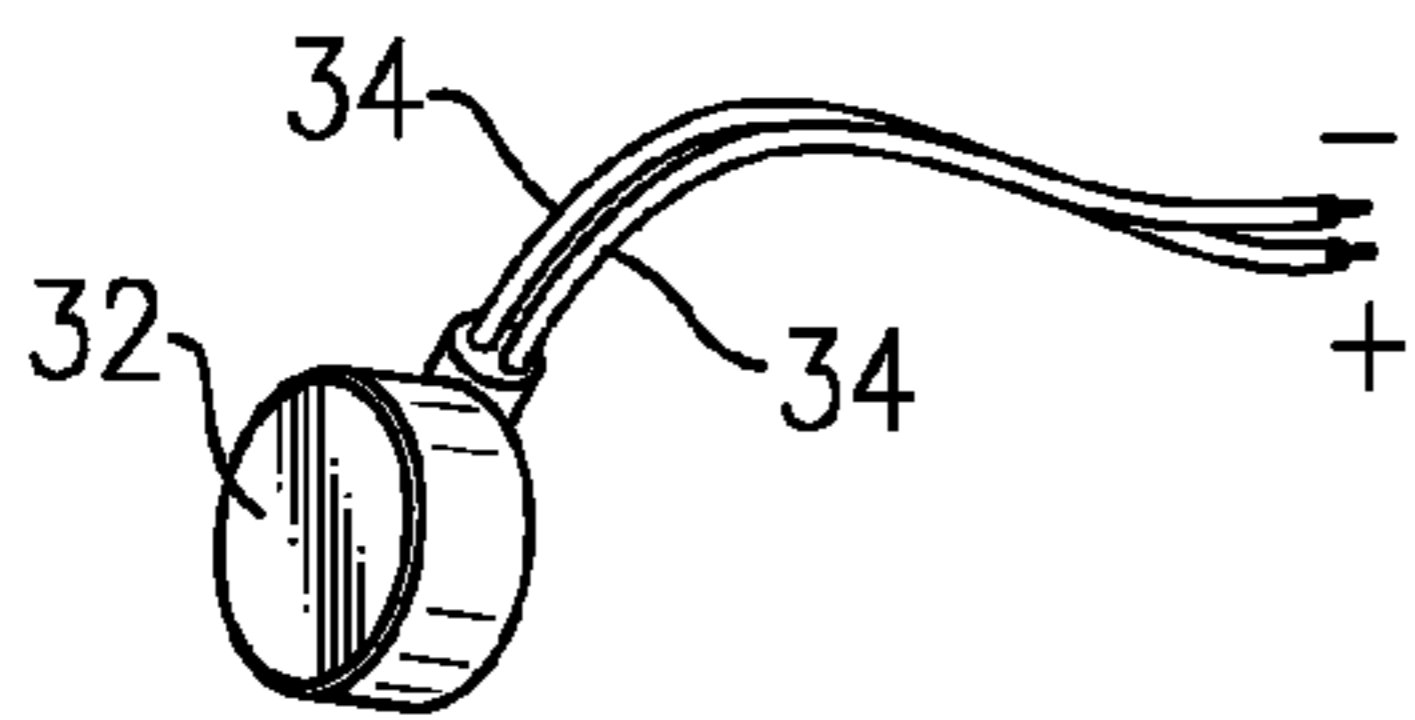
FIG. 5 illustrates a transducer cell of the vibratory alert patch;

In one example, each transducer cell **32** is a Precision Microdrives Precision Haptic Y-Axis Linear Resonant Actuator. FIG. 5 illustrates a Linear Resonant Actuator (LRA) including wires **34**.

In one example, each transducer cell **32**, or Linear Resonant Actuator of FIGS. 5 and 6 has the following parameters:

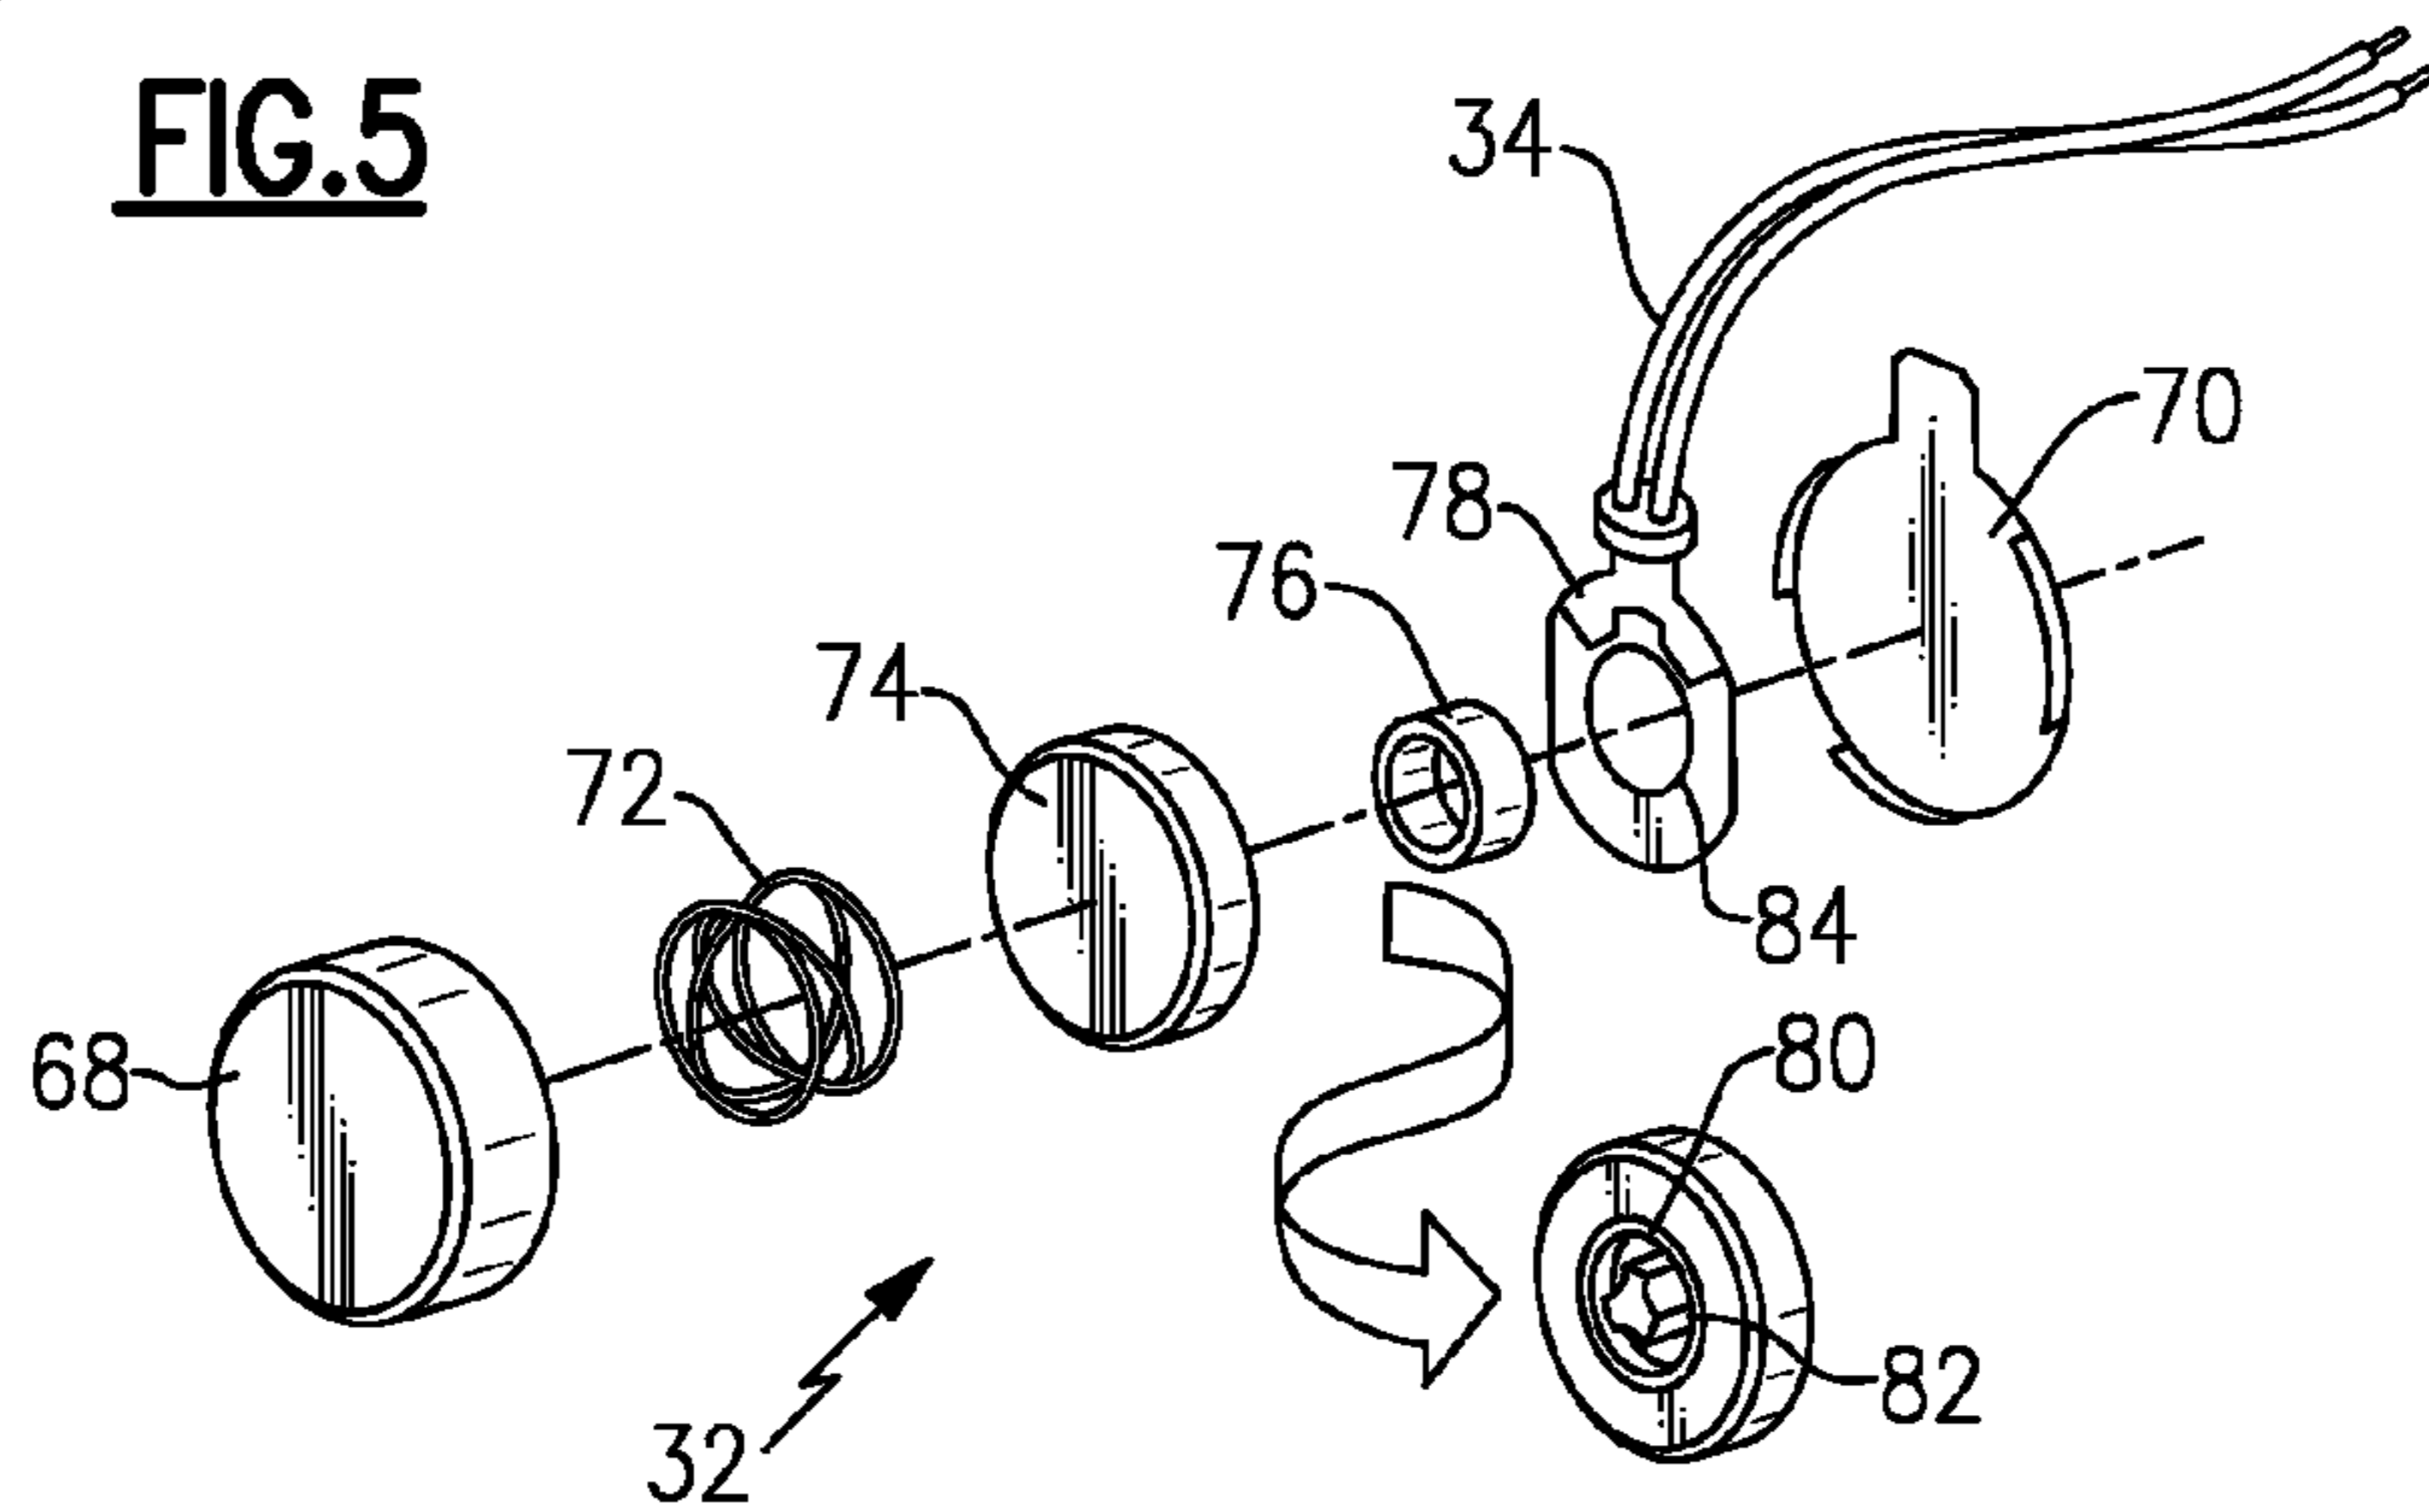
FIG. 6 illustrates an exploded view of the transducer cell of 60
FIG. 5;

FIG. 6 illustrates an exploded view of the transducer cell **32** of FIG. 5. The transducer cell **32** (the Linear Resonant Actuator) includes a motor cover **68** and a motor chassis **70** that define the external body of the transducer cell **32**. Contained within the motor cover **68** and the motor chassis **70** is a wave spring **72**, a moving mass **74**, a voice coil **76**, and a flexible printed circuit board **78** (PCB) to which the wires **34** are attached that includes an opening **84**. The voice coil **76** is received in the opening **84** of the printed circuit board **78**. The moving mass **74** includes a voice coil yoke **80** and a NeFeB Neodymium magnet **82**.

The Linear Resonant Actuator is driven by an AC signal through the wires **34**. Current driven through the voice coil **76** produces a magnetic field, which causes the NeFeB Neodymium magnet **82** in the moving mass **74** to react to the voice coil **76**, causing the moving mass **74** to move. The contact the wave spring **72** with the moving mass **74** creates a resonance effect that produces vibrations.

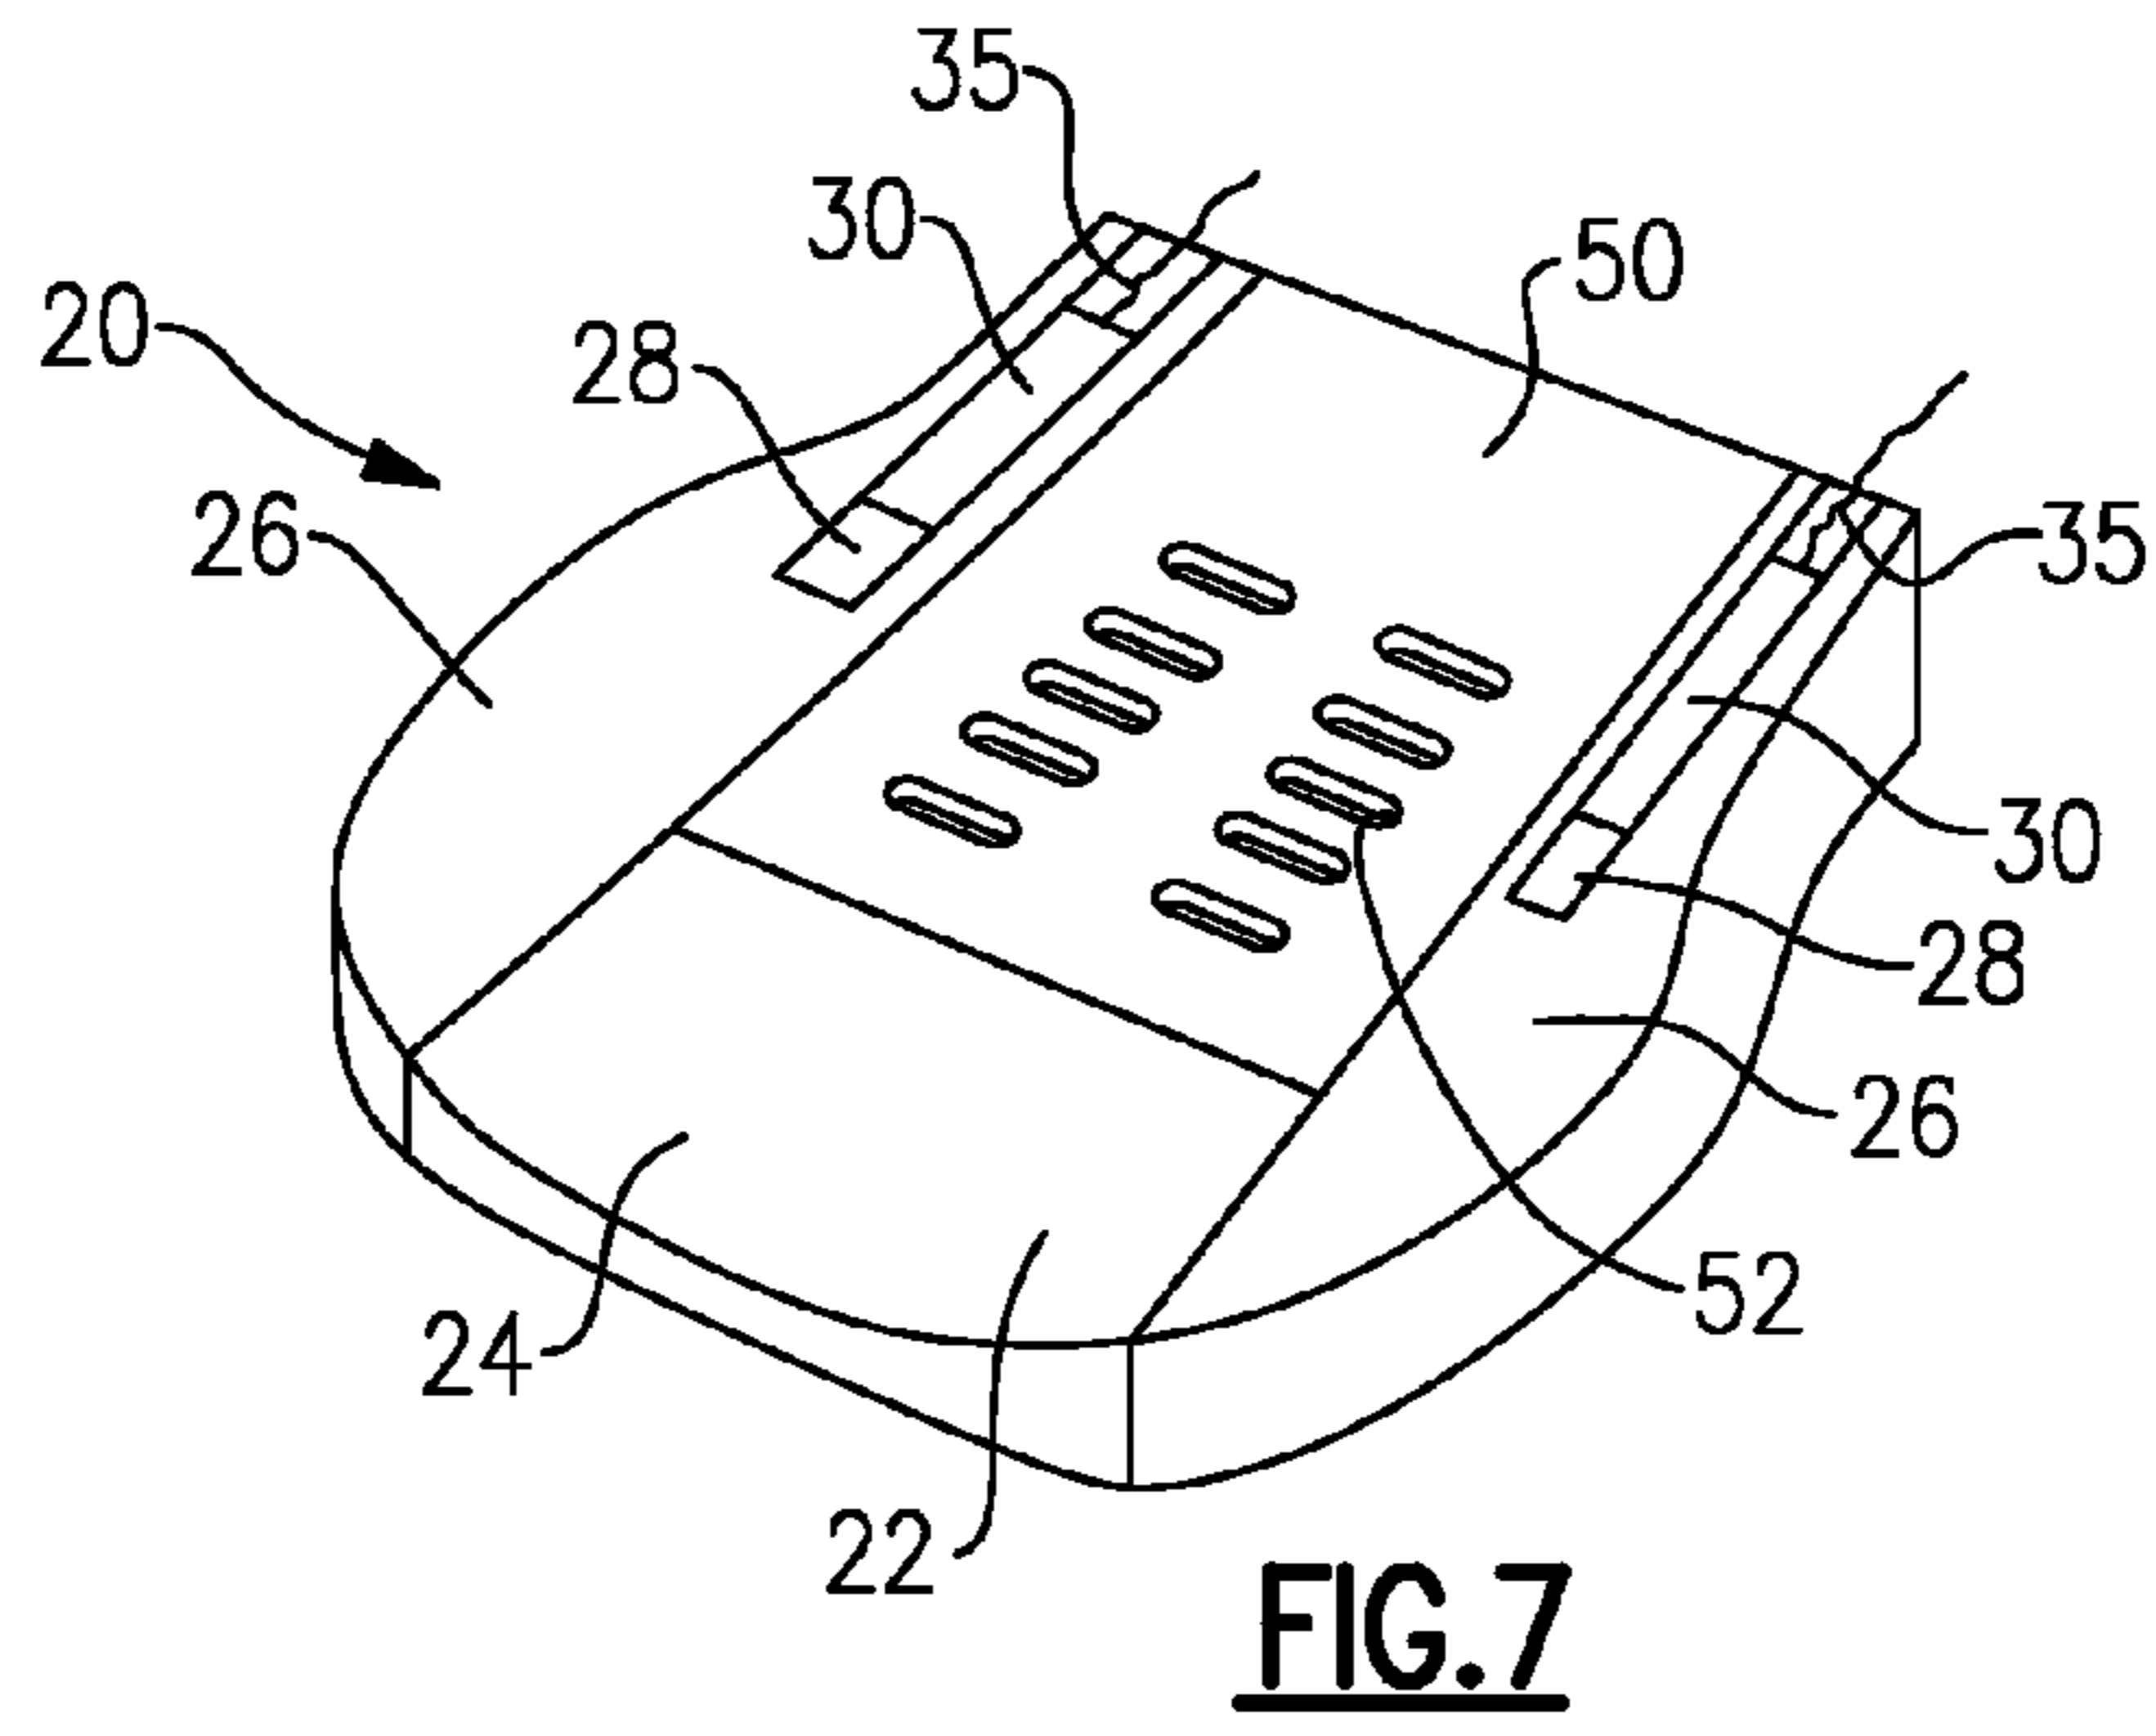
FIG. 7 illustrates a perspective view of the cushion with ventilation foam on an upper surface of the cushion;

FIG. 7 illustrates a perspective of the cushion **20** including two pre-formed recess **28** and a vibratory alert patch **30** located in each of the pre-formed recesses **28**. Although only two pre-formed recess **28** and two vibratory alert patches **30** are illustrated and described, any number of vibratory alert patches **30** can be positioned on the cushion **20** in any location or configuration. A mat **50** can be located over the flat upper surface **24** of the seat portion **22** of the cushion **20**. The mat **50** includes holes **52** that allow for ventilation. In one example, the mat **50** is made of polyester.
