(10) **Patent No.:** **US 9,004,589 B2**
(45) **Date of Patent:** **Apr. 14, 2015**

(54) **VIBRATORY ALERT PATCH**

(71) Applicant: **Toyota Boshoku America, Inc.**, Novi, MI (US)

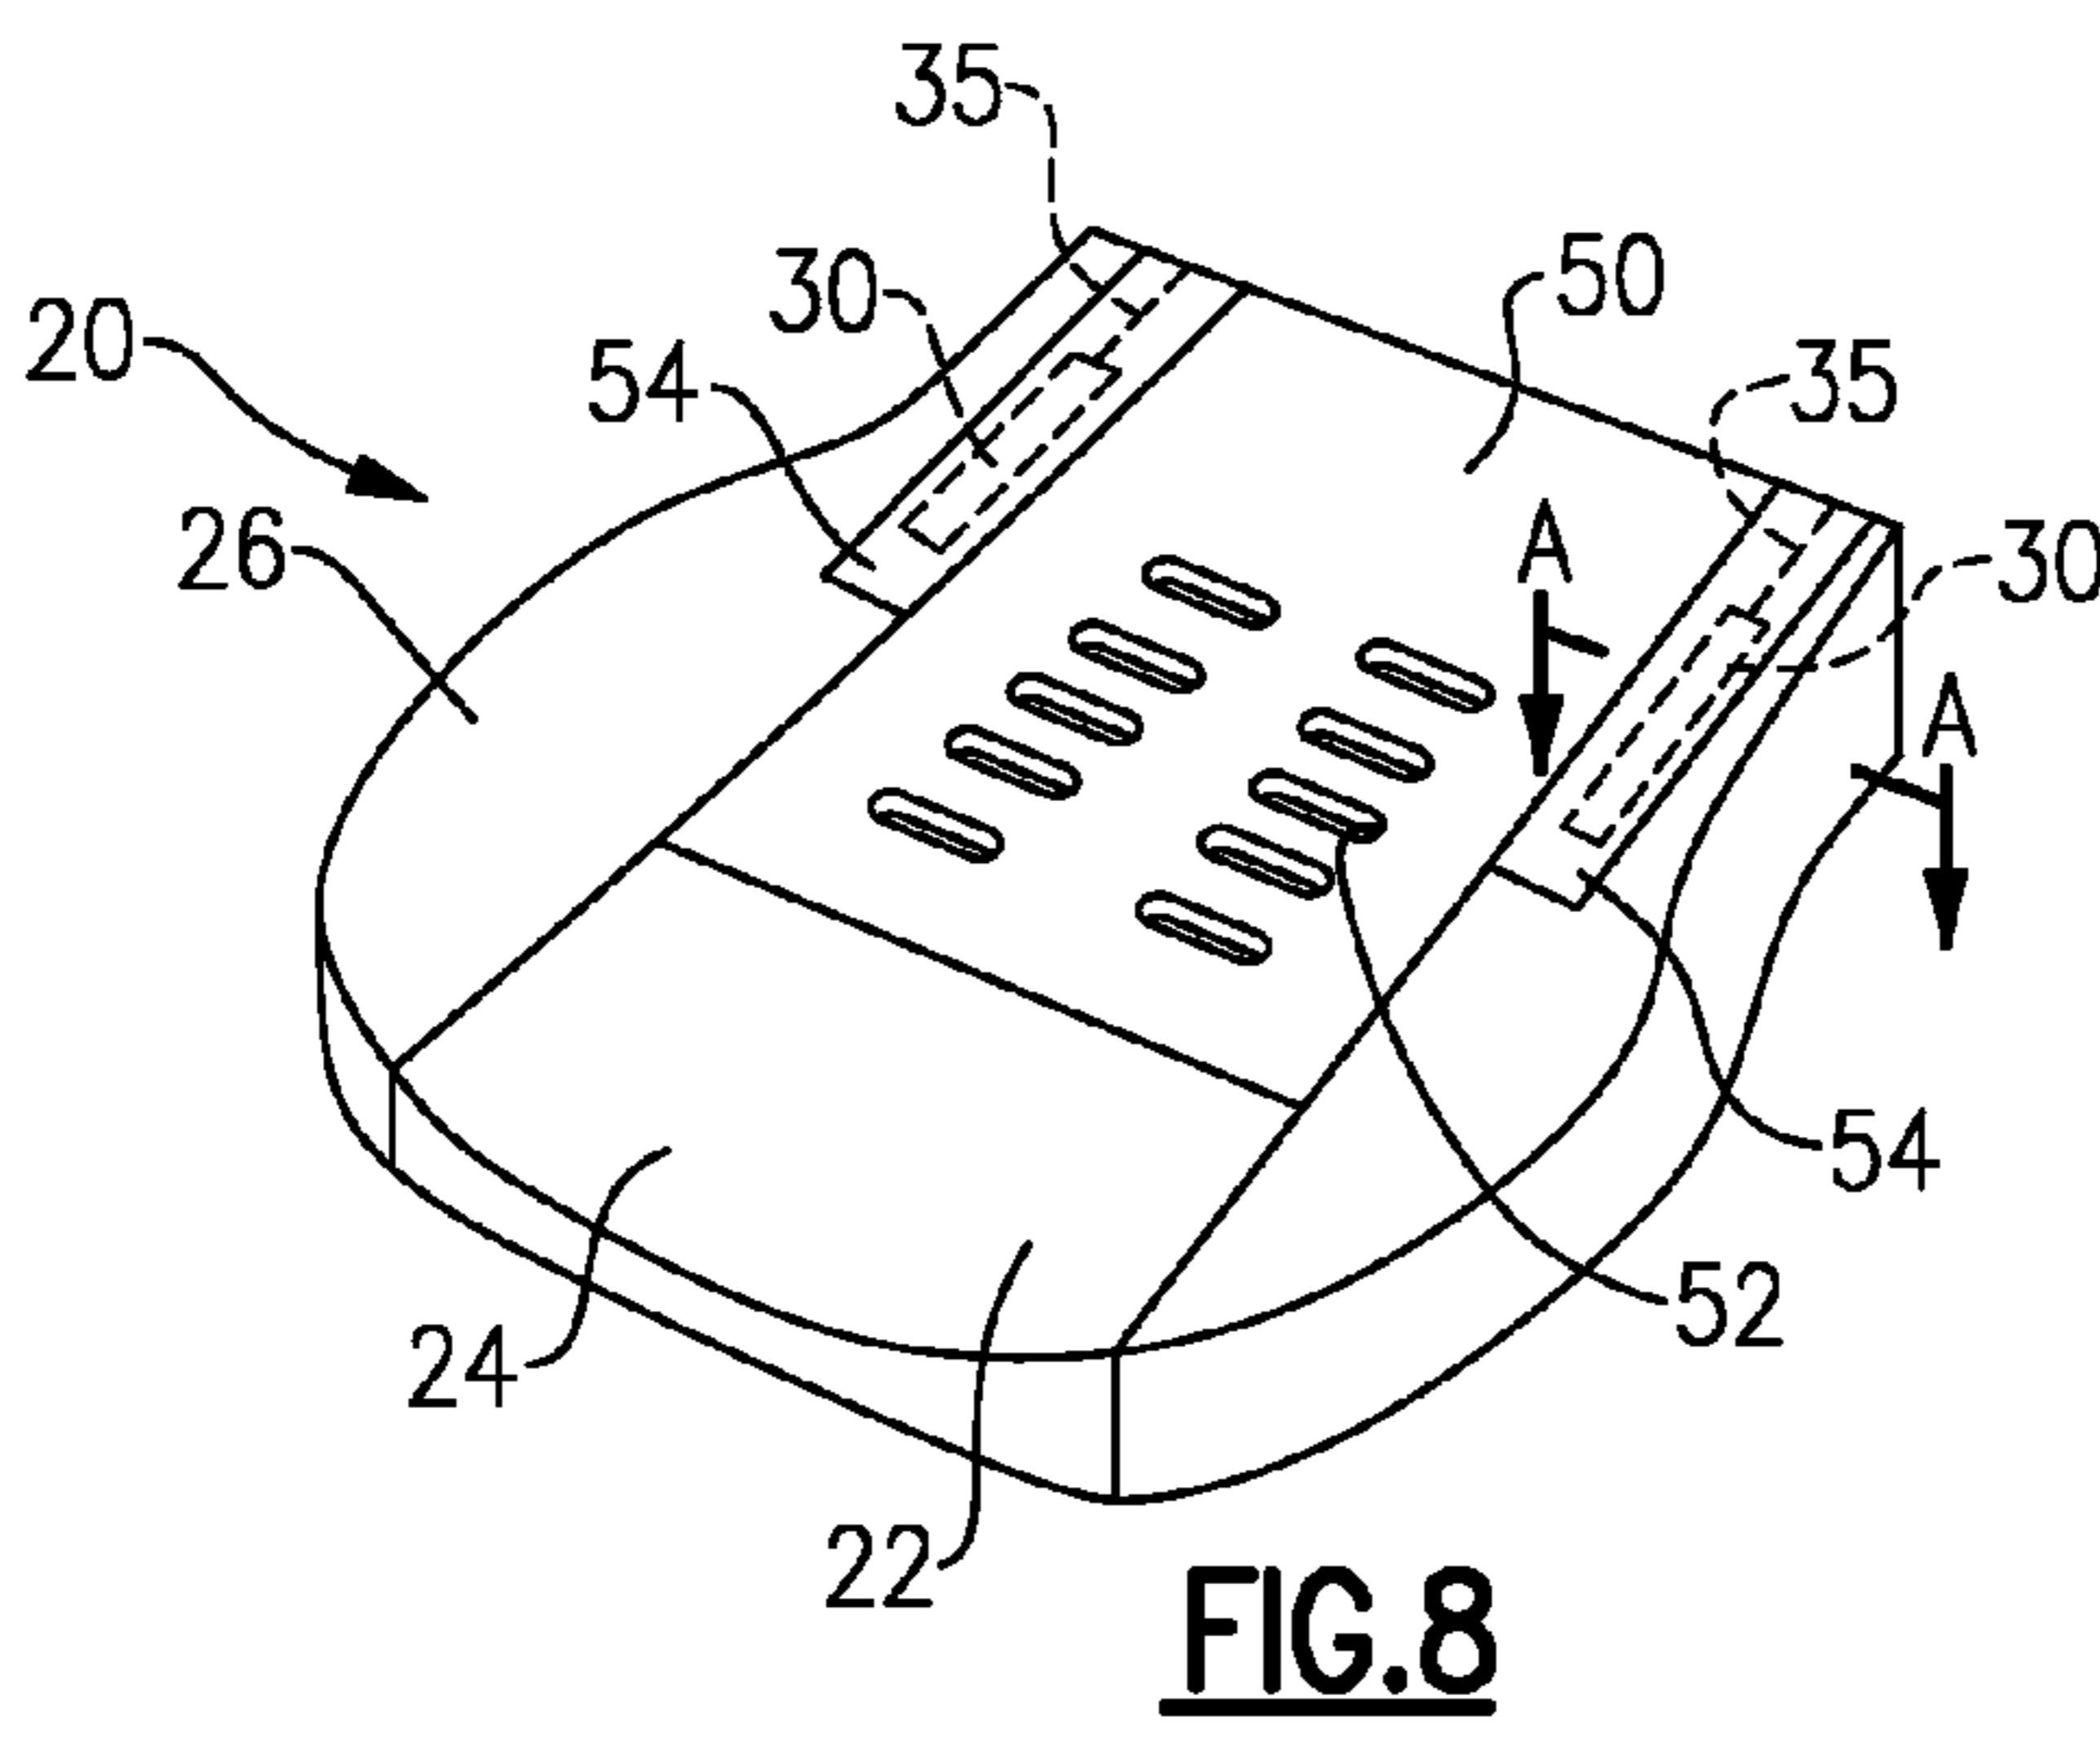
FIG. 8 illustrates a perspective view of foam placed over the vibratory alert patches;

FIG. 8 illustrates a perspective of the cushion **20** including a layer of foam **54** located over each of the two vibratory alert

patches **30** on an exterior surface of the cushion **20**. The layer of foam **54** provides additional cushioning to protect the two vibratory alert patches **30** and also prevents the two vibratory alert patches **30** from causing driver discomfort. In one example, each layer of foam **54** is made of polyurethane. In one example, the layer of foam **54** has a thickness of about $Y \pm 1$ mm. In one example, Y is 5. In another example, the two vibratory alert patches **30** are embedded in the cushion **20** during the molding process near an upper surface of the cushion **20**, and the layer of foam **54** is not needed.

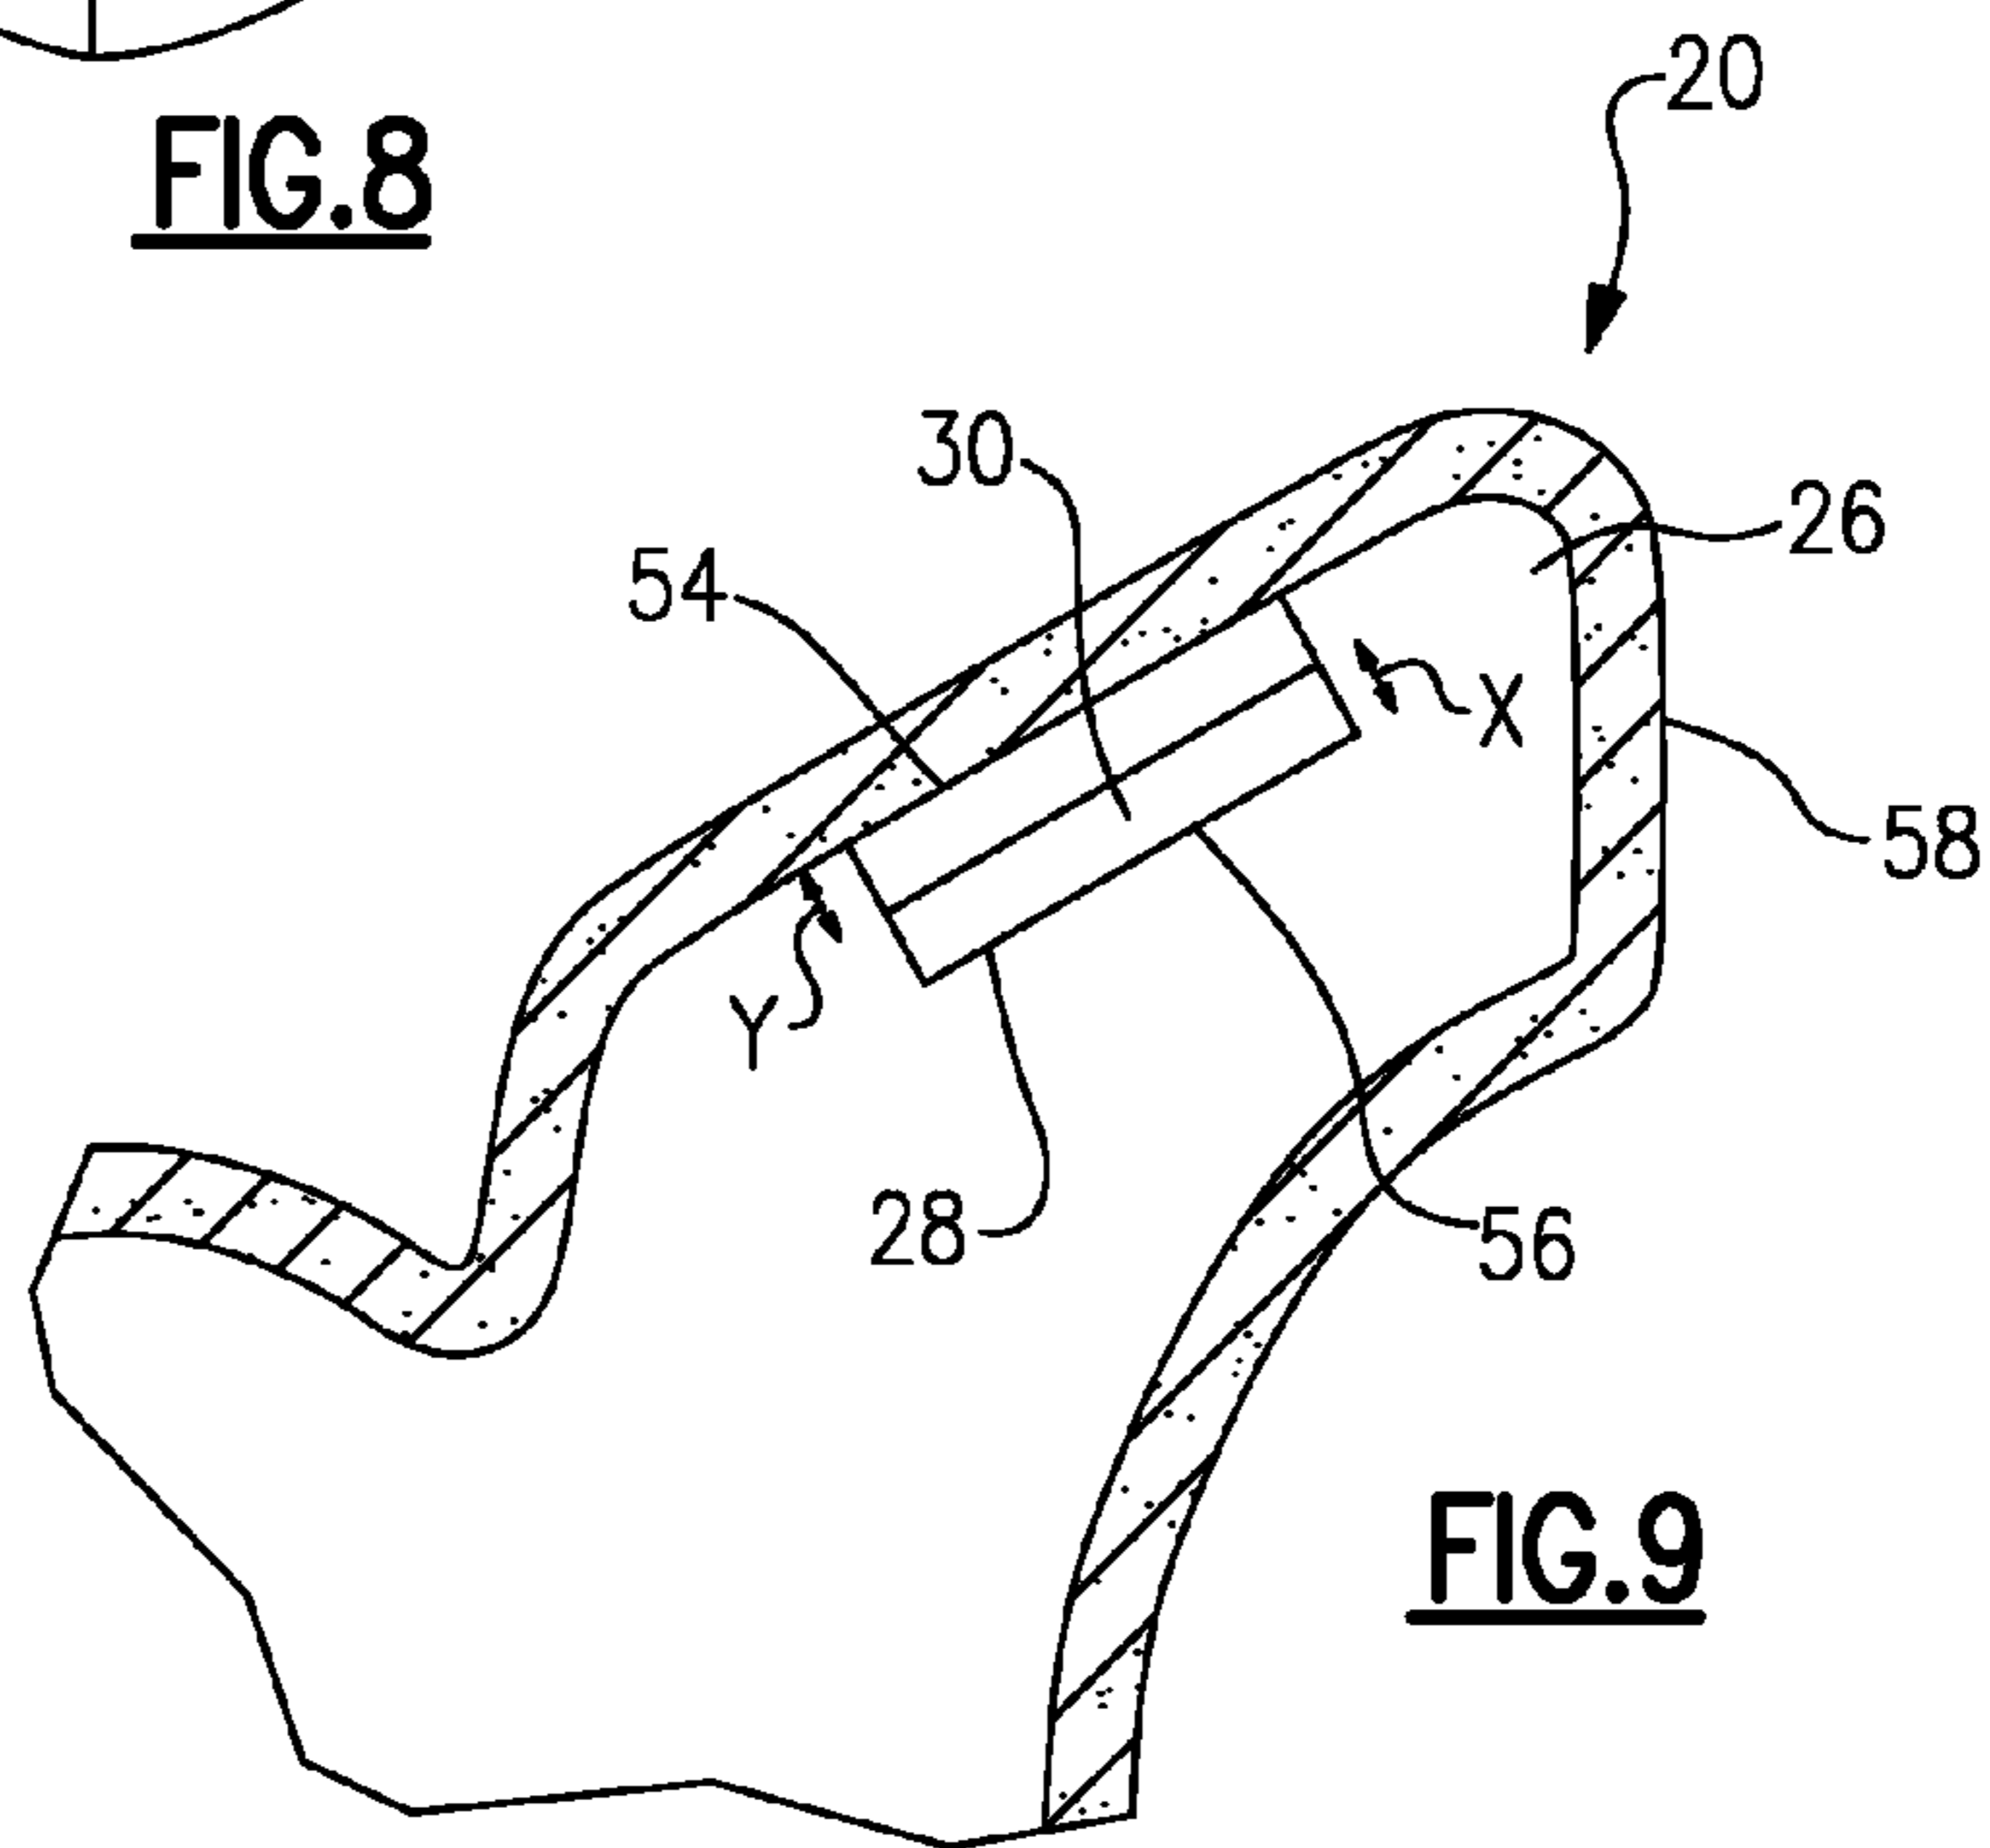
FIG. 9 illustrates a cross-sectional view of a side bolster of the cushion and the vibratory alert patch; and

FIG. 9 shows a cross-sectional view of a side bolster **26** of the cushion **20** taken along line A-A of FIG. 8. An adhesive **56** can be employed to secure the vibratory alert patches **30** in the pre-formed recess **26**. A trim cover **58** is located over the cushion **20** and provides an external surface of the vehicle seat **64** in which the driver sits while driving.

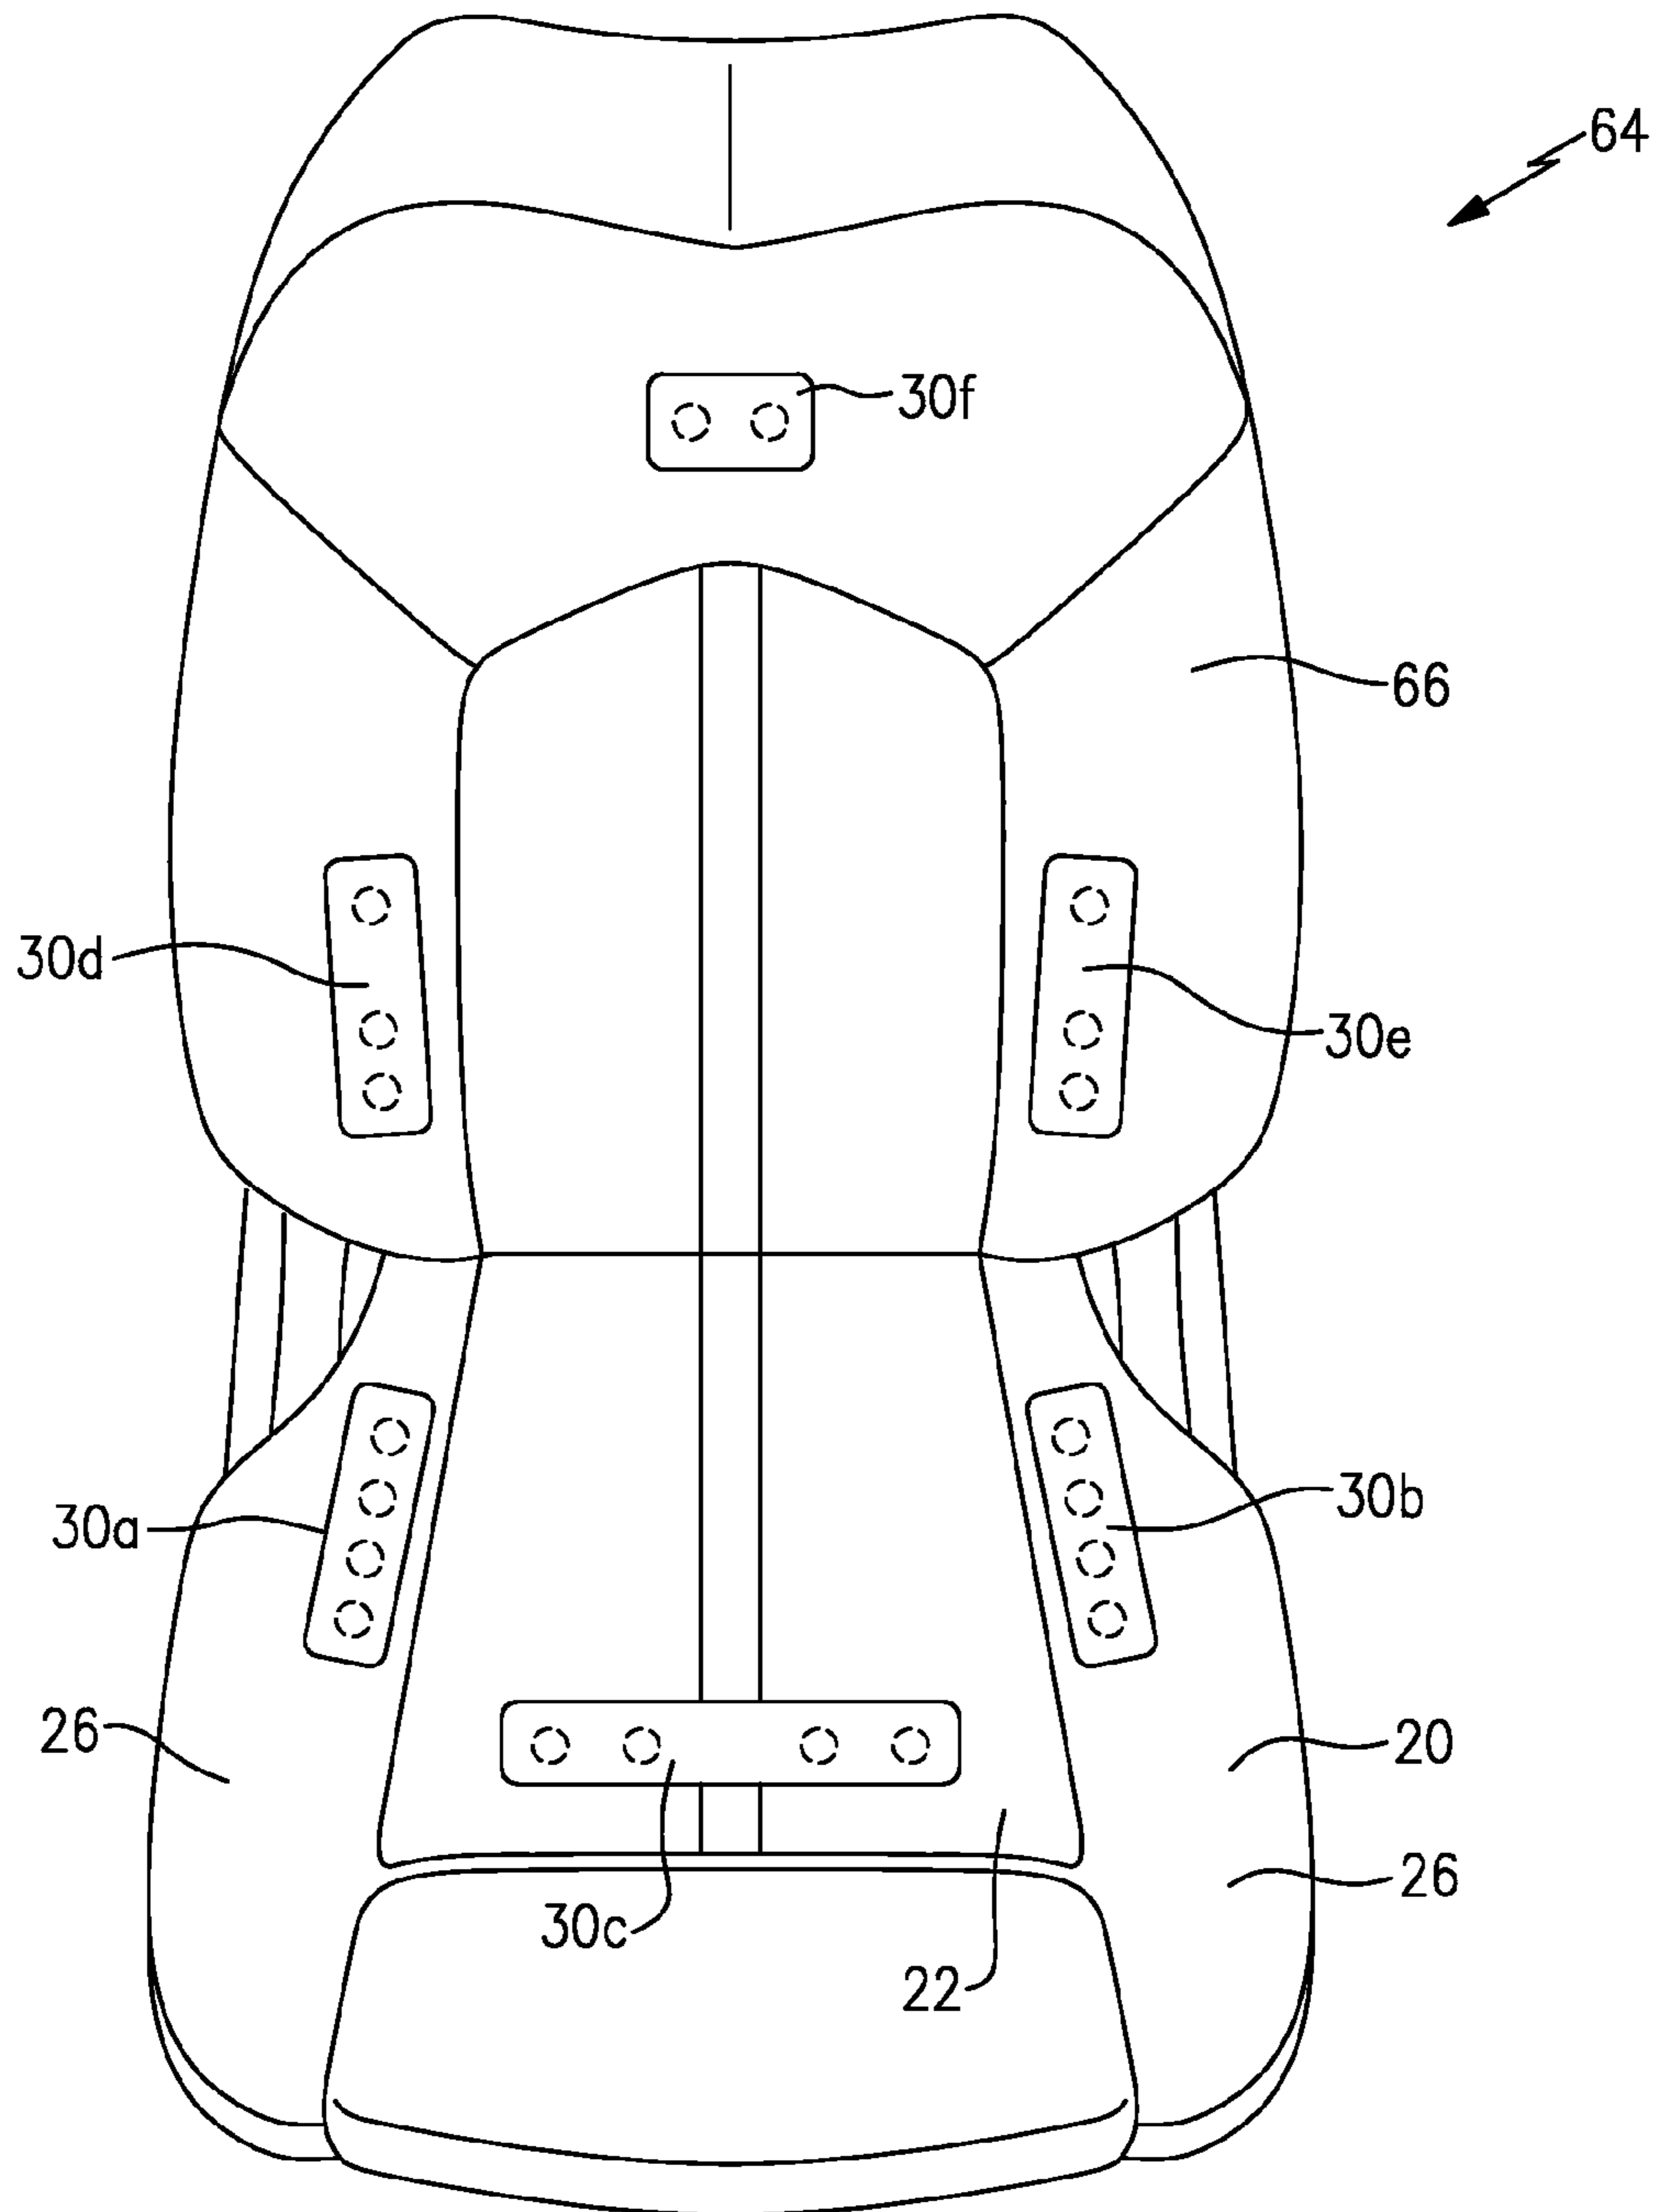
FIG. 10 illustrates a vehicle seat including an example configuration of vibratory alert patches.

FIG. 10 illustrate a vehicle seat **64** including the cushion **20** and a back rest **66** including six vibratory alert patches **30a**, **30b**, **30c**, **30d**, **30e** and **30f**. A vibratory alert patch **30a** and **30b** is each located on one of the two seat bolsters **26**. A vibratory alert patch **30c** is located over the seat portion **22** between the two seat bolsters **26**. Three vibratory alert patches **30d**, **30e** and **30f** are located on the back rest **66**. The vibratory alert patches **30d** and **30e** are aligned with the vibratory alert patches **30a** and **30b**, respectively, on the side bolsters **26**. The vibratory alert patch **30f** is aligned with the vibratory alert patch **30c**. FIG. 10 shows one example configuration or arrangements of vibratory alert patches **30**. However, the vibratory alert patches **30** can be located in any configuration.
