(10) **Patent No.:** **US 9,127,550 B2**
(45) **Date of Patent:** **Sep. 8, 2015**

(54) **TURBINE SUPERALLOY COMPONENT DEFECT REPAIR WITH LOW-TEMPERATURE CURING RESIN**

(73) Assignee: **Siemens Energy, Inc.**, Orlando, FL (US)

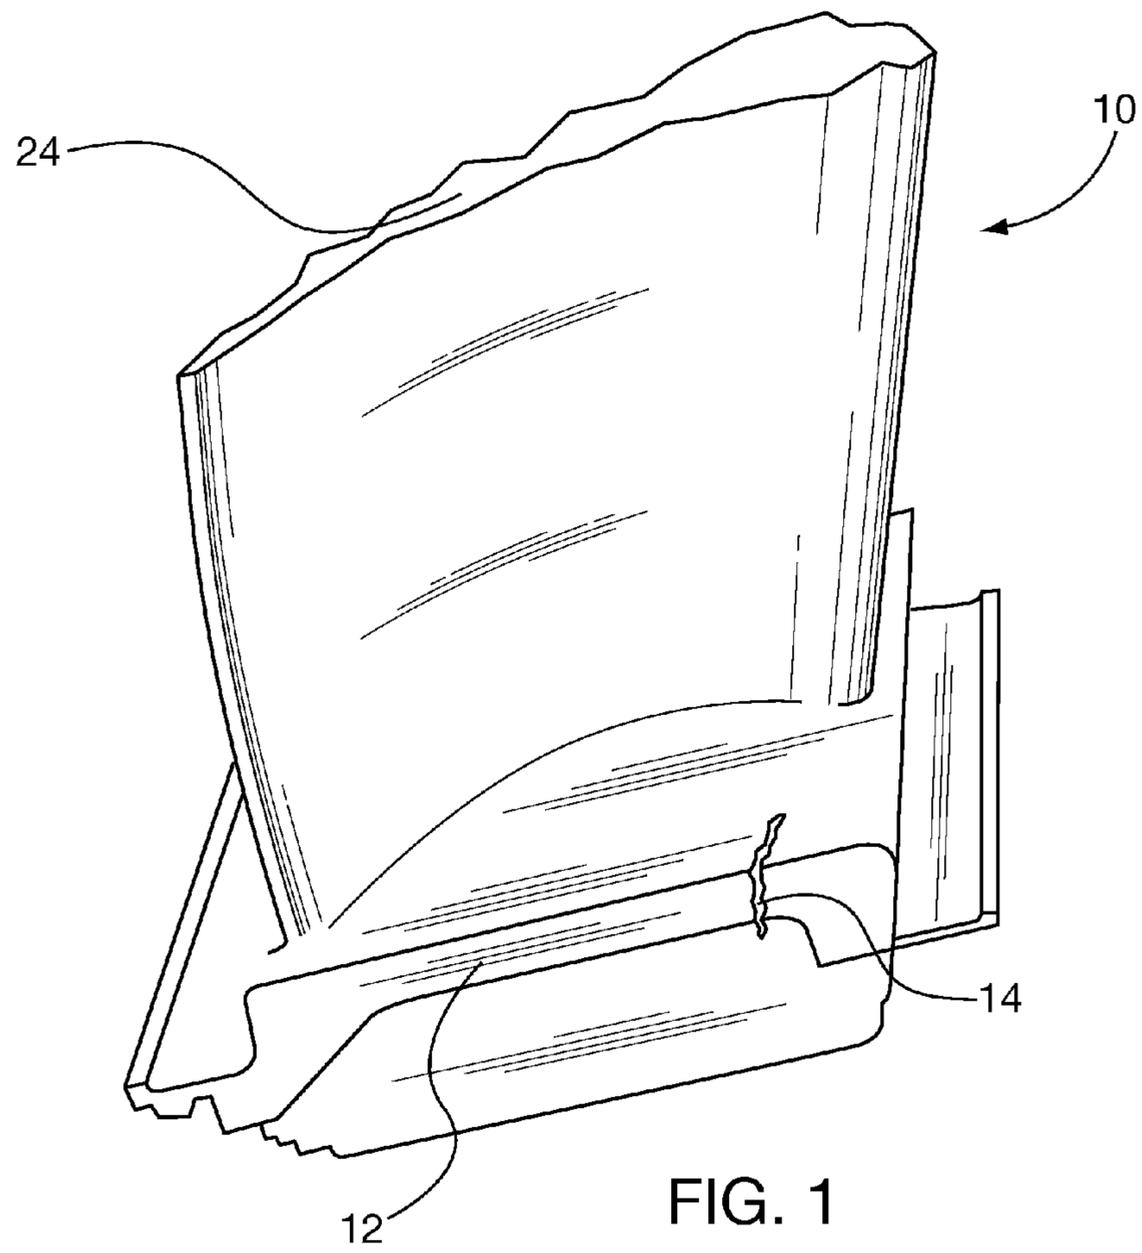
FIG. 1 shows a schematic elevational perspective view of a superalloy turbine blade component having a crack defect void;

FIG. 1 shows a known exemplary thermal barrier coated industrial gas turbine superalloy blade **10** having a blade root substrate **12** with a surface void or defect crack **14** that is a candidate for cosmetic repair, rather than structural repair. The goal of cosmetic repair is to restore a continuous surface in the defect zone within the blade’s dimensional specifications. The blade **10** is prepared for repair by stripping existing thermal barrier and other coatings, combustion contamination, etc. by known processes, leaving a clean substrate **12**. The crack defect is cleaned, but does not have to be excised from the substrate by grinding or other known metal removal methods, as is customarily done when performing brazing repairs. If the blade **10** has a defect within a previously brazed repair zone, the defect may be repaired with the methods of the present invention without removing the braze material.

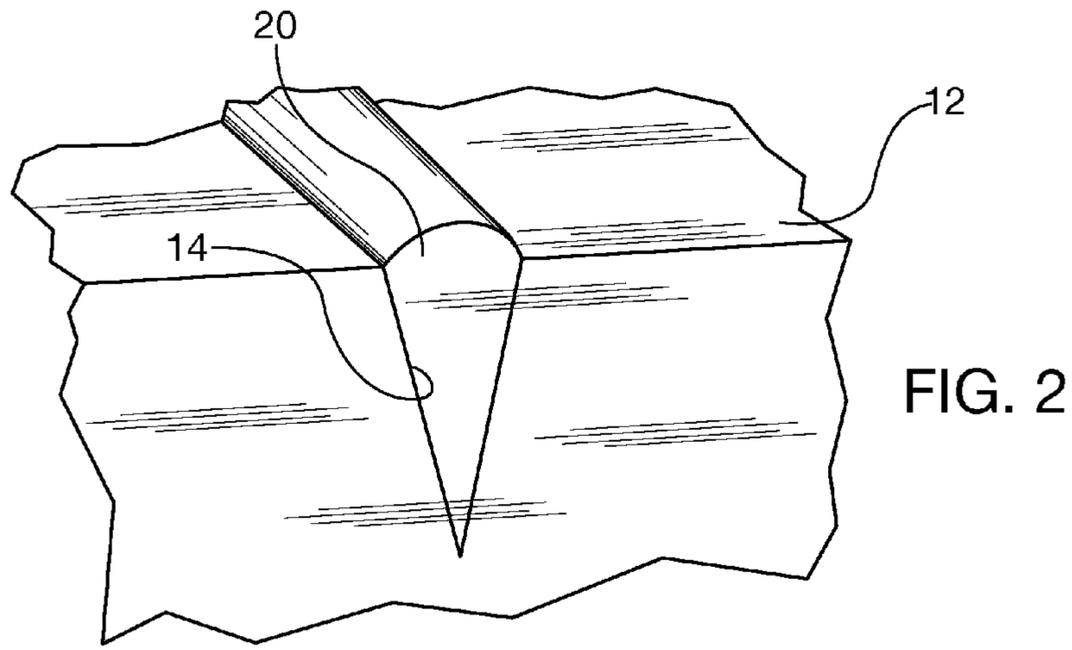
FIG. 2 shows an enlarged perspective view of the turbine blade defect of FIG. 1 filled with resin, in accordance with an embodiment of the present invention;

In FIG. 2, the crack defect **14** within the turbine blade substrate **12** is filled with a hardening resin filler **20**, again without the need to remove the crack defect from the substrate. Filler **20** can be applied with hand tools at ambient temperature and intentionally projects, or is “proud” of the substrate surface. After the filler **20** cures, it is ground flush with the substrate as shown in FIG. 3. In this way the filler **20** surface conforms with the surrounding substrate **20** dimensions and restores the repaired blade to dimensional specifications. When applied to the blade substrate **12**, the filler **20** is a pliable particle-filled resin putty or two-part epoxy-like

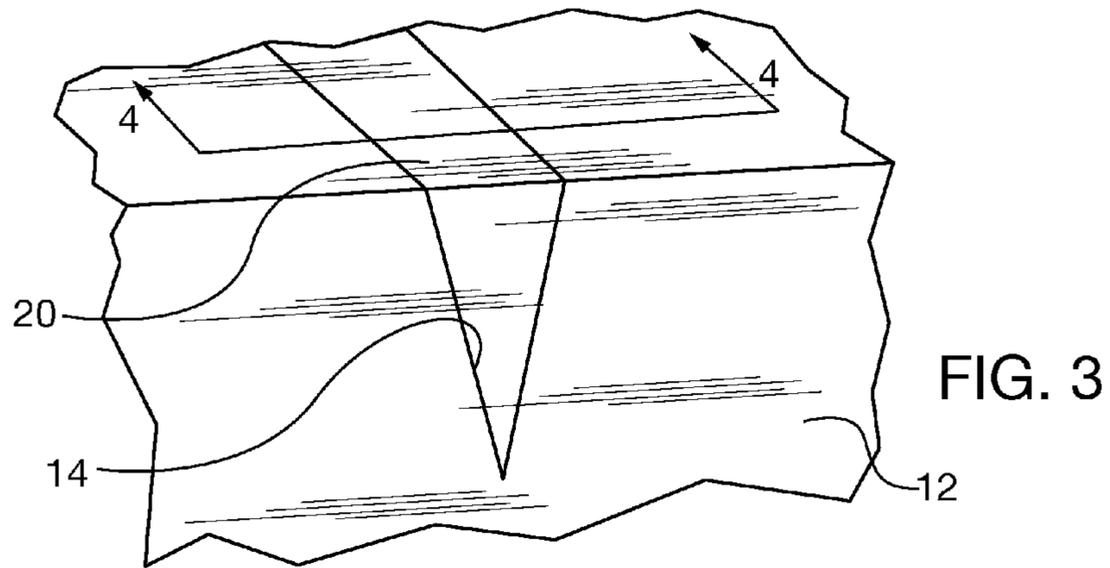
FIG. 3 shows an enlarged view of the turbine blade defect of FIG. 1, where the resin has been ground to conform it to the dimensional profile of the surrounding turbine blade substrate, in accordance with an embodiment of the present invention; and

After filler **20** curing and shaping to conform to the surrounding substrate **12** dimensional specifications the blade **10** or other superalloy component is prepared for application of a metallic bondcoat and thermal barrier coating using presently known methods. For example, the repaired blade **10**, including the now filled defect **14** may be grit blasted prior to application of the bond coating and thermal barrier coating layer. An exemplary repaired turbine blade **10** is shown in FIG. **4**, with a bond coating/thermal barrier coating **30** cov-

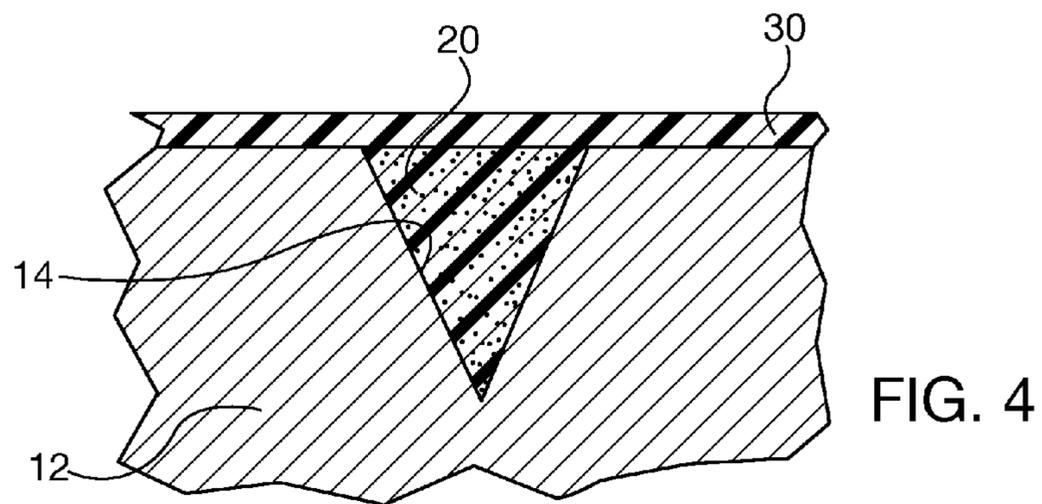
FIG. 4 is an elevational cross-sectional view taken along 4-4 of FIG. 3, showing a thermal barrier coating applied to the substrate and resin.

ering the substrate **12**, defect **14**, and the cured filler material **20**. The cured filler material **20** may also cover existing braze material on the substrate **12** (not shown) for better adhesion of bond coating and the thermal barrier coating **30**. As previously discussed, braze material often contains elements such as boron, phosphorous and/or silicon that do not promote bond coat or thermal barrier coating adhesion.
