(10) **Patent No.:** **US 9,346,349 B2**
(45) **Date of Patent:** **May 24, 2016**

(54) **SHUTTER ABNORMALITY NOTIFICATION APPARATUS FOR VARIABLE DUCT**

(71) Applicant: **Fuji Jukogyo Kabushiki Kaisha**, Tokyo (JP)

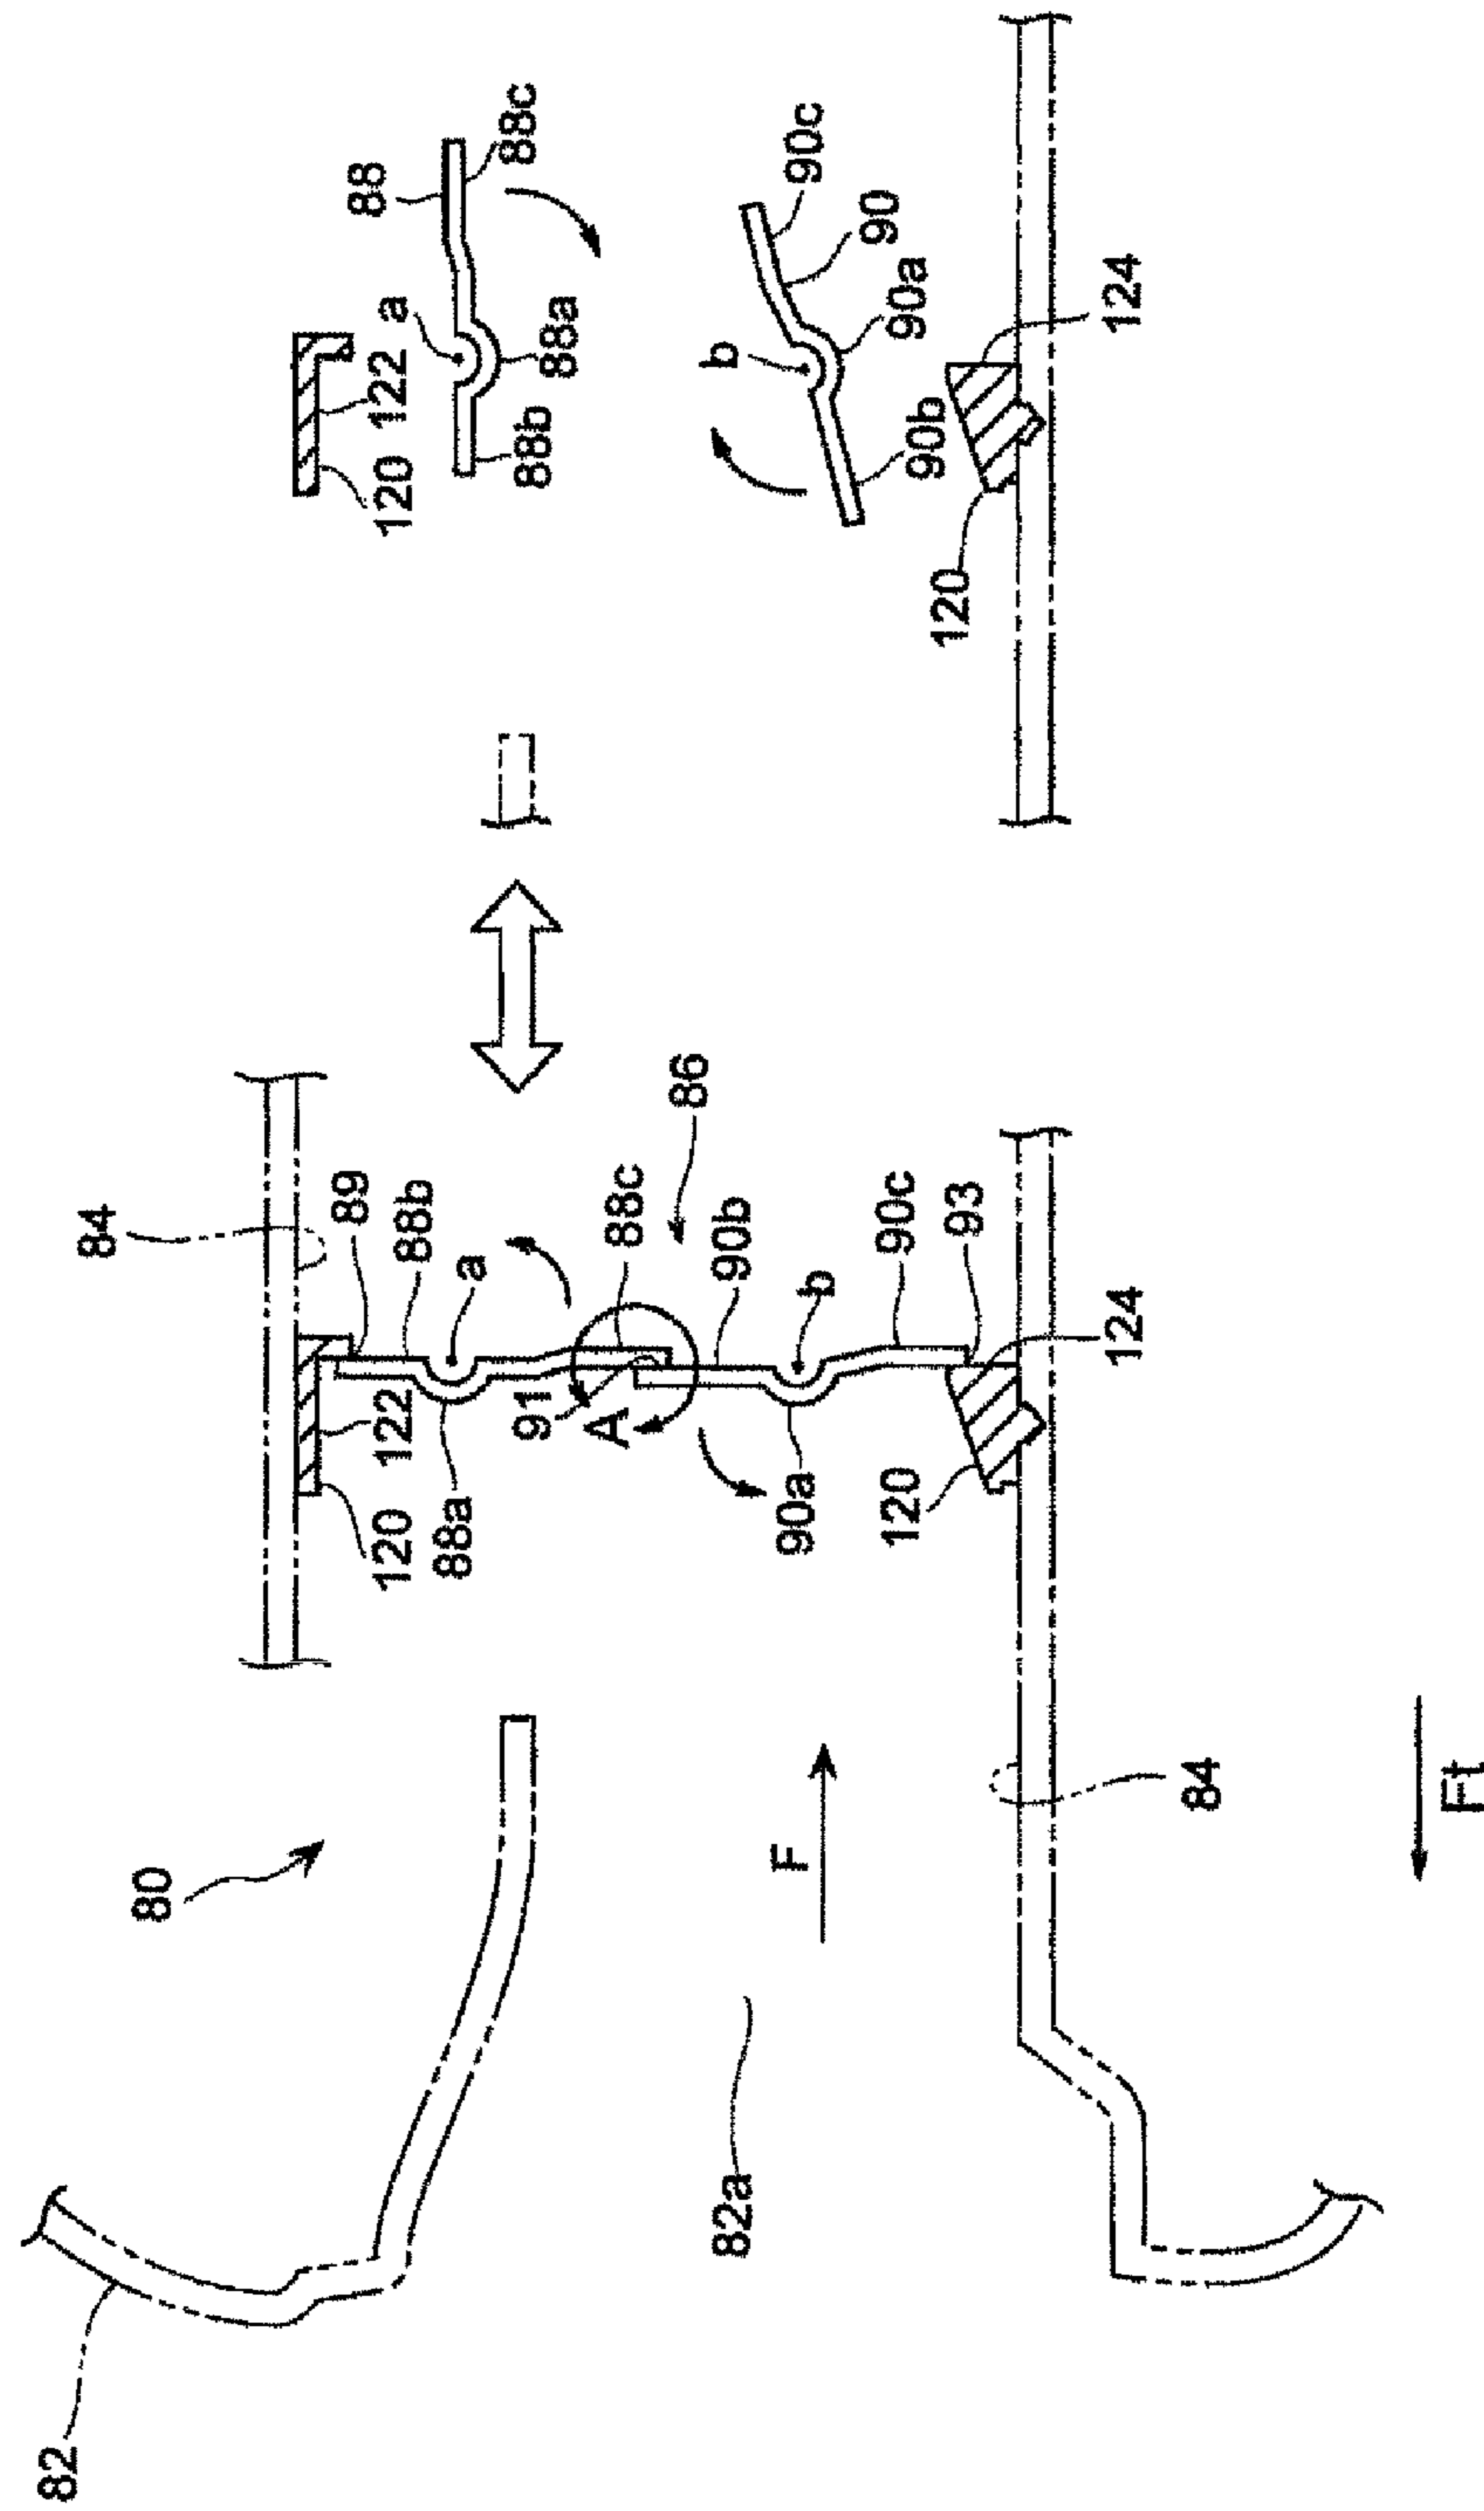
FIG. 3 is a view obtained by adding a main configuration of the shutter abnormality notification apparatus according to this implementation to the enlarged view of a portion A in FIG. 2;

As illustrated in FIG. 3, the electric circuit 20 has an electric contact in the contact portion (the duct seal 91) between the tip end of the lower fin 88c of the upper slat 88 and the tip end of the upper fin 90b of the lower slat 90 in the closed position. Hence, when the lower fin 88c of the upper slat 88 contacts the upper fin 90b of the lower slat 90, conduction is established in the circuit, and when the lower fin 88c of the upper slat 88 separates from the upper fin 90b of the lower slat 90, the circuit becomes non-conductive.

The heater **60**, as illustrated in FIG. 3, is a heater circuit having a heater portion **60a** on the tip end of the lower fin **88c** of the upper slat **88**. A switch **60b** is provided in the circuit. When the switch **60b** is connected, the heater **60** heats the duct seal **91** via the heater portion **60a**, and when the switch **60b** is disconnected, the heater **60** stops heating the duct seal **91**.

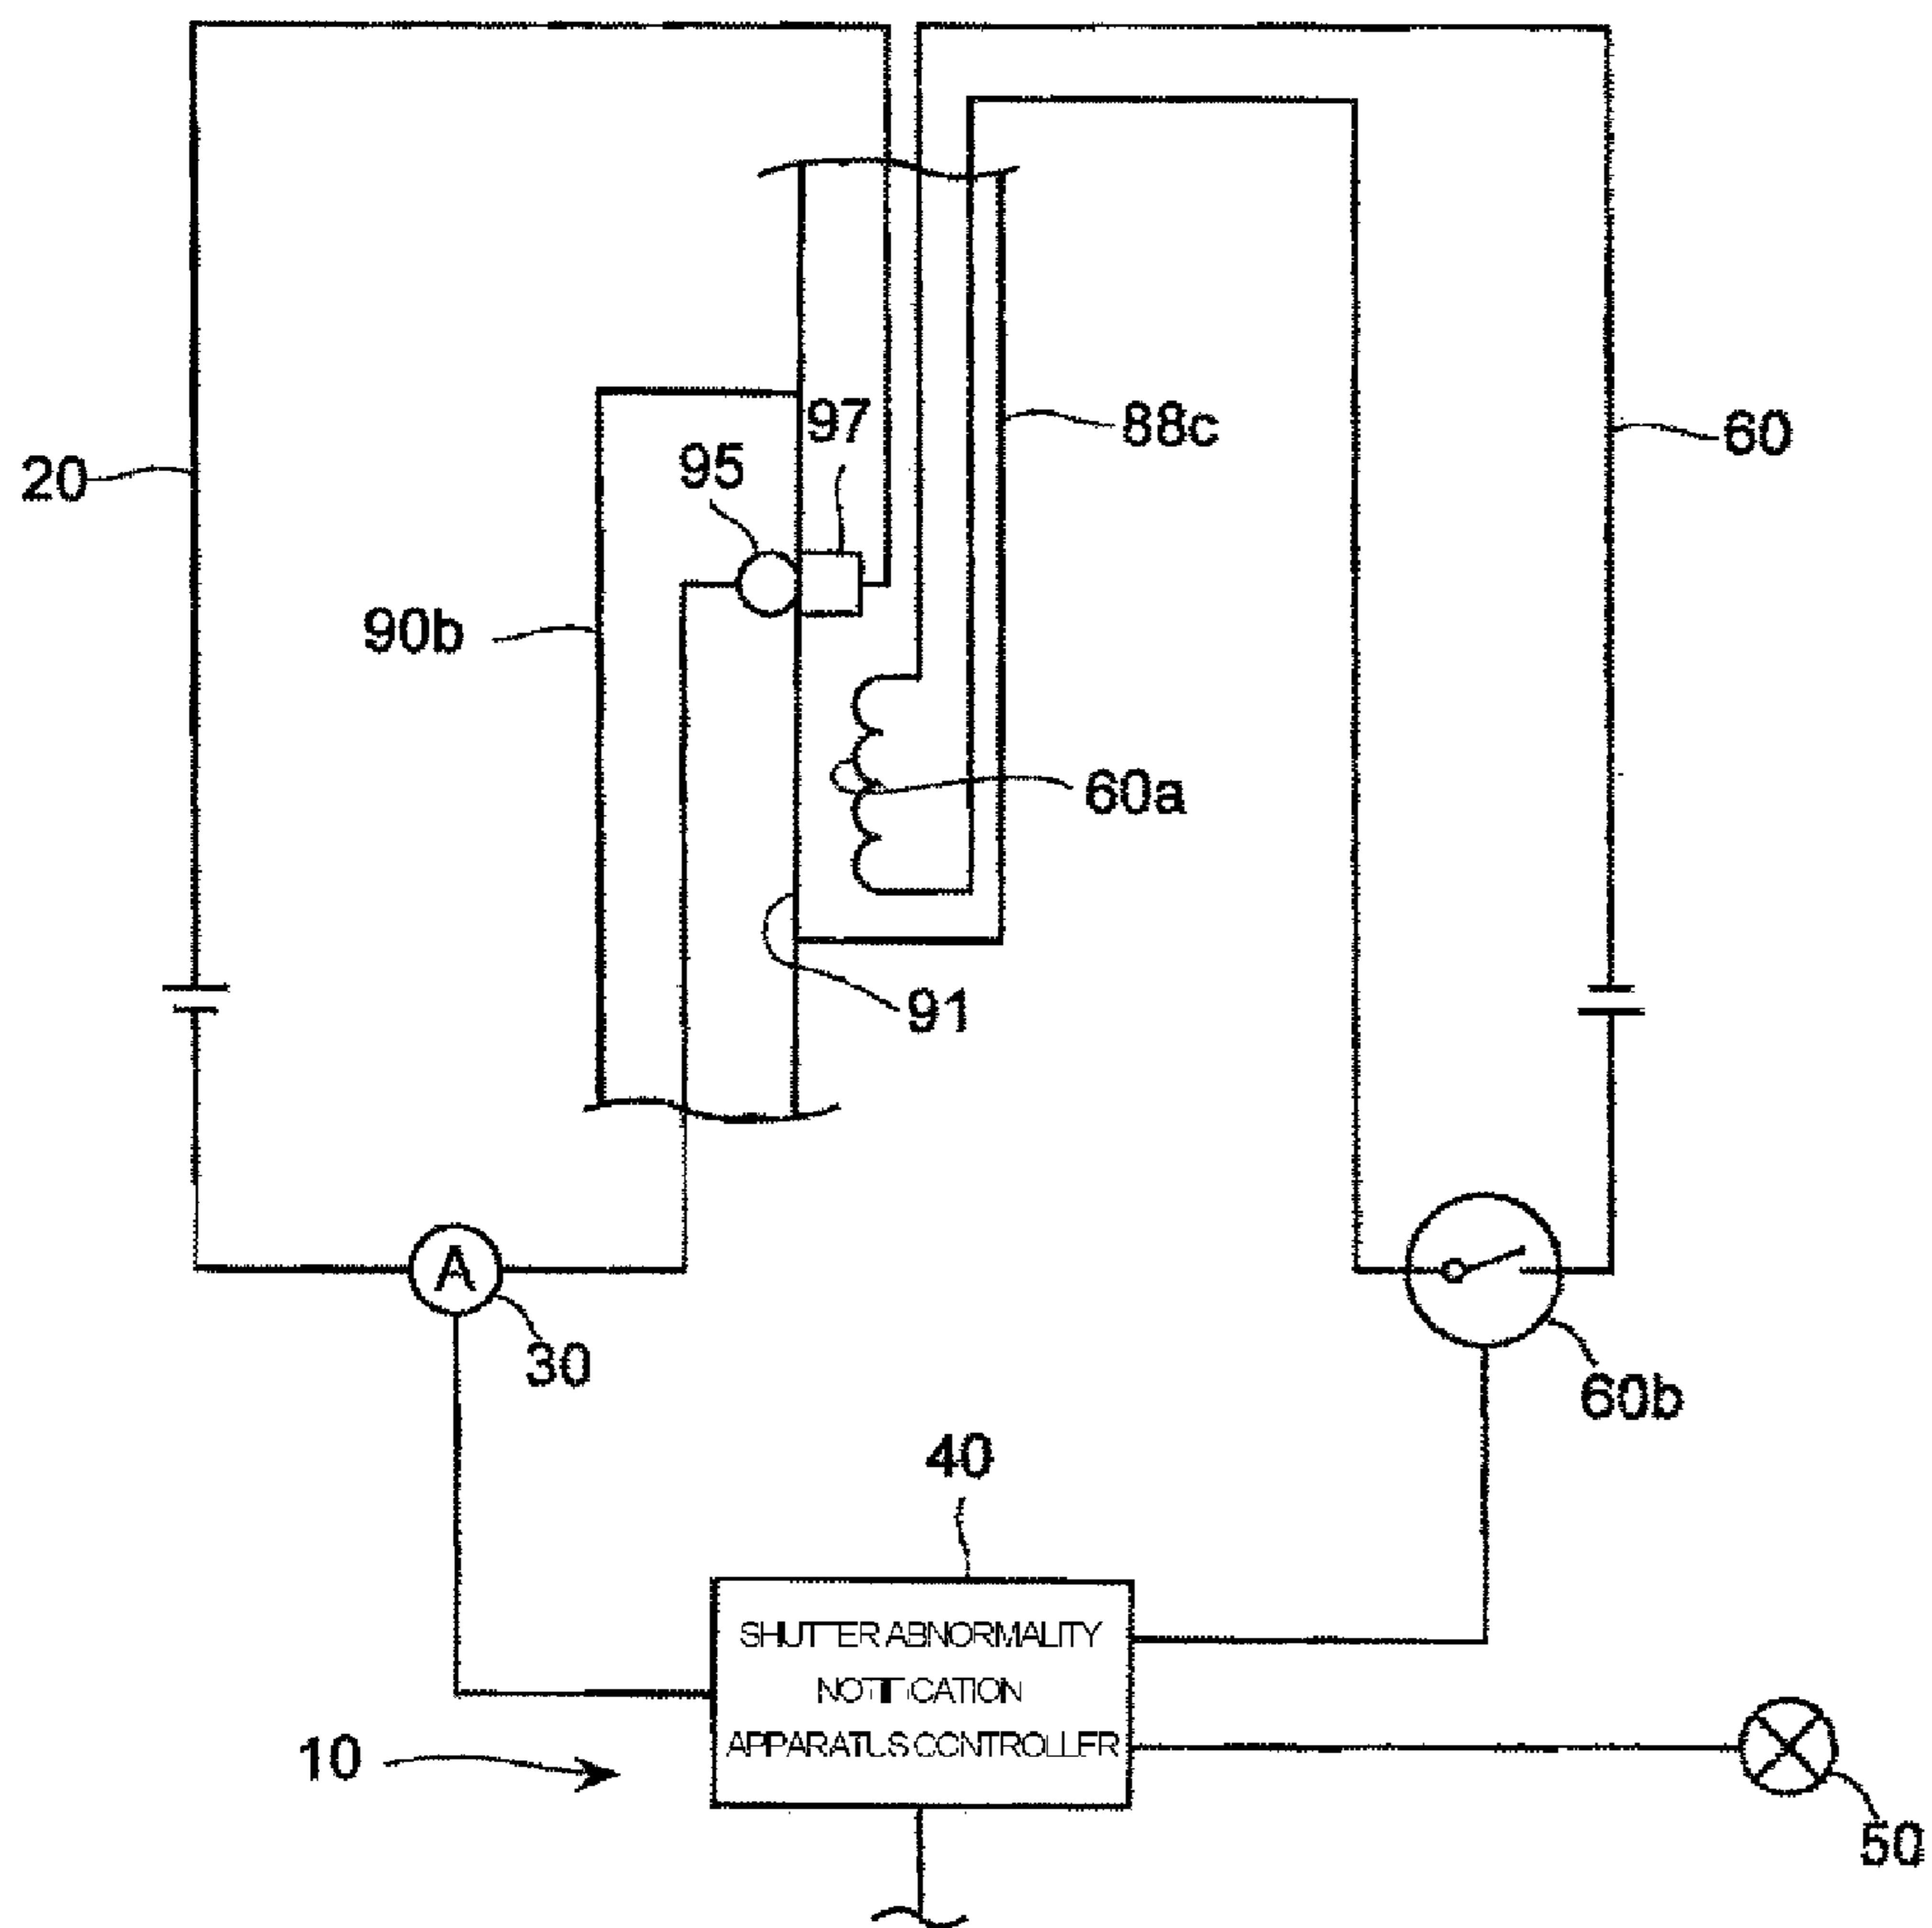
FIG. 4A

FIGS. 4A-4C are perspective views illustrating a conductive member and a conducting member provided in a shutter that is disposed in a duct seal of the shutter abnormality notification apparatus according to this implementation;

As illustrated in FIG. 4A, the electric contact in the duct seal 91 is a contact point between a metal conductive member 95 that has a rectangular shape when seen from above and is embedded in the tip end of the upper fin 90b of the lower slat 90 and a conducting member 97 constituted by a metal flat plate that has a substantially rectangular shape when seen from above and is embedded in a tip end surface of the lower fin 88c of the upper slat 88 so as to oppose the conductive member 95.

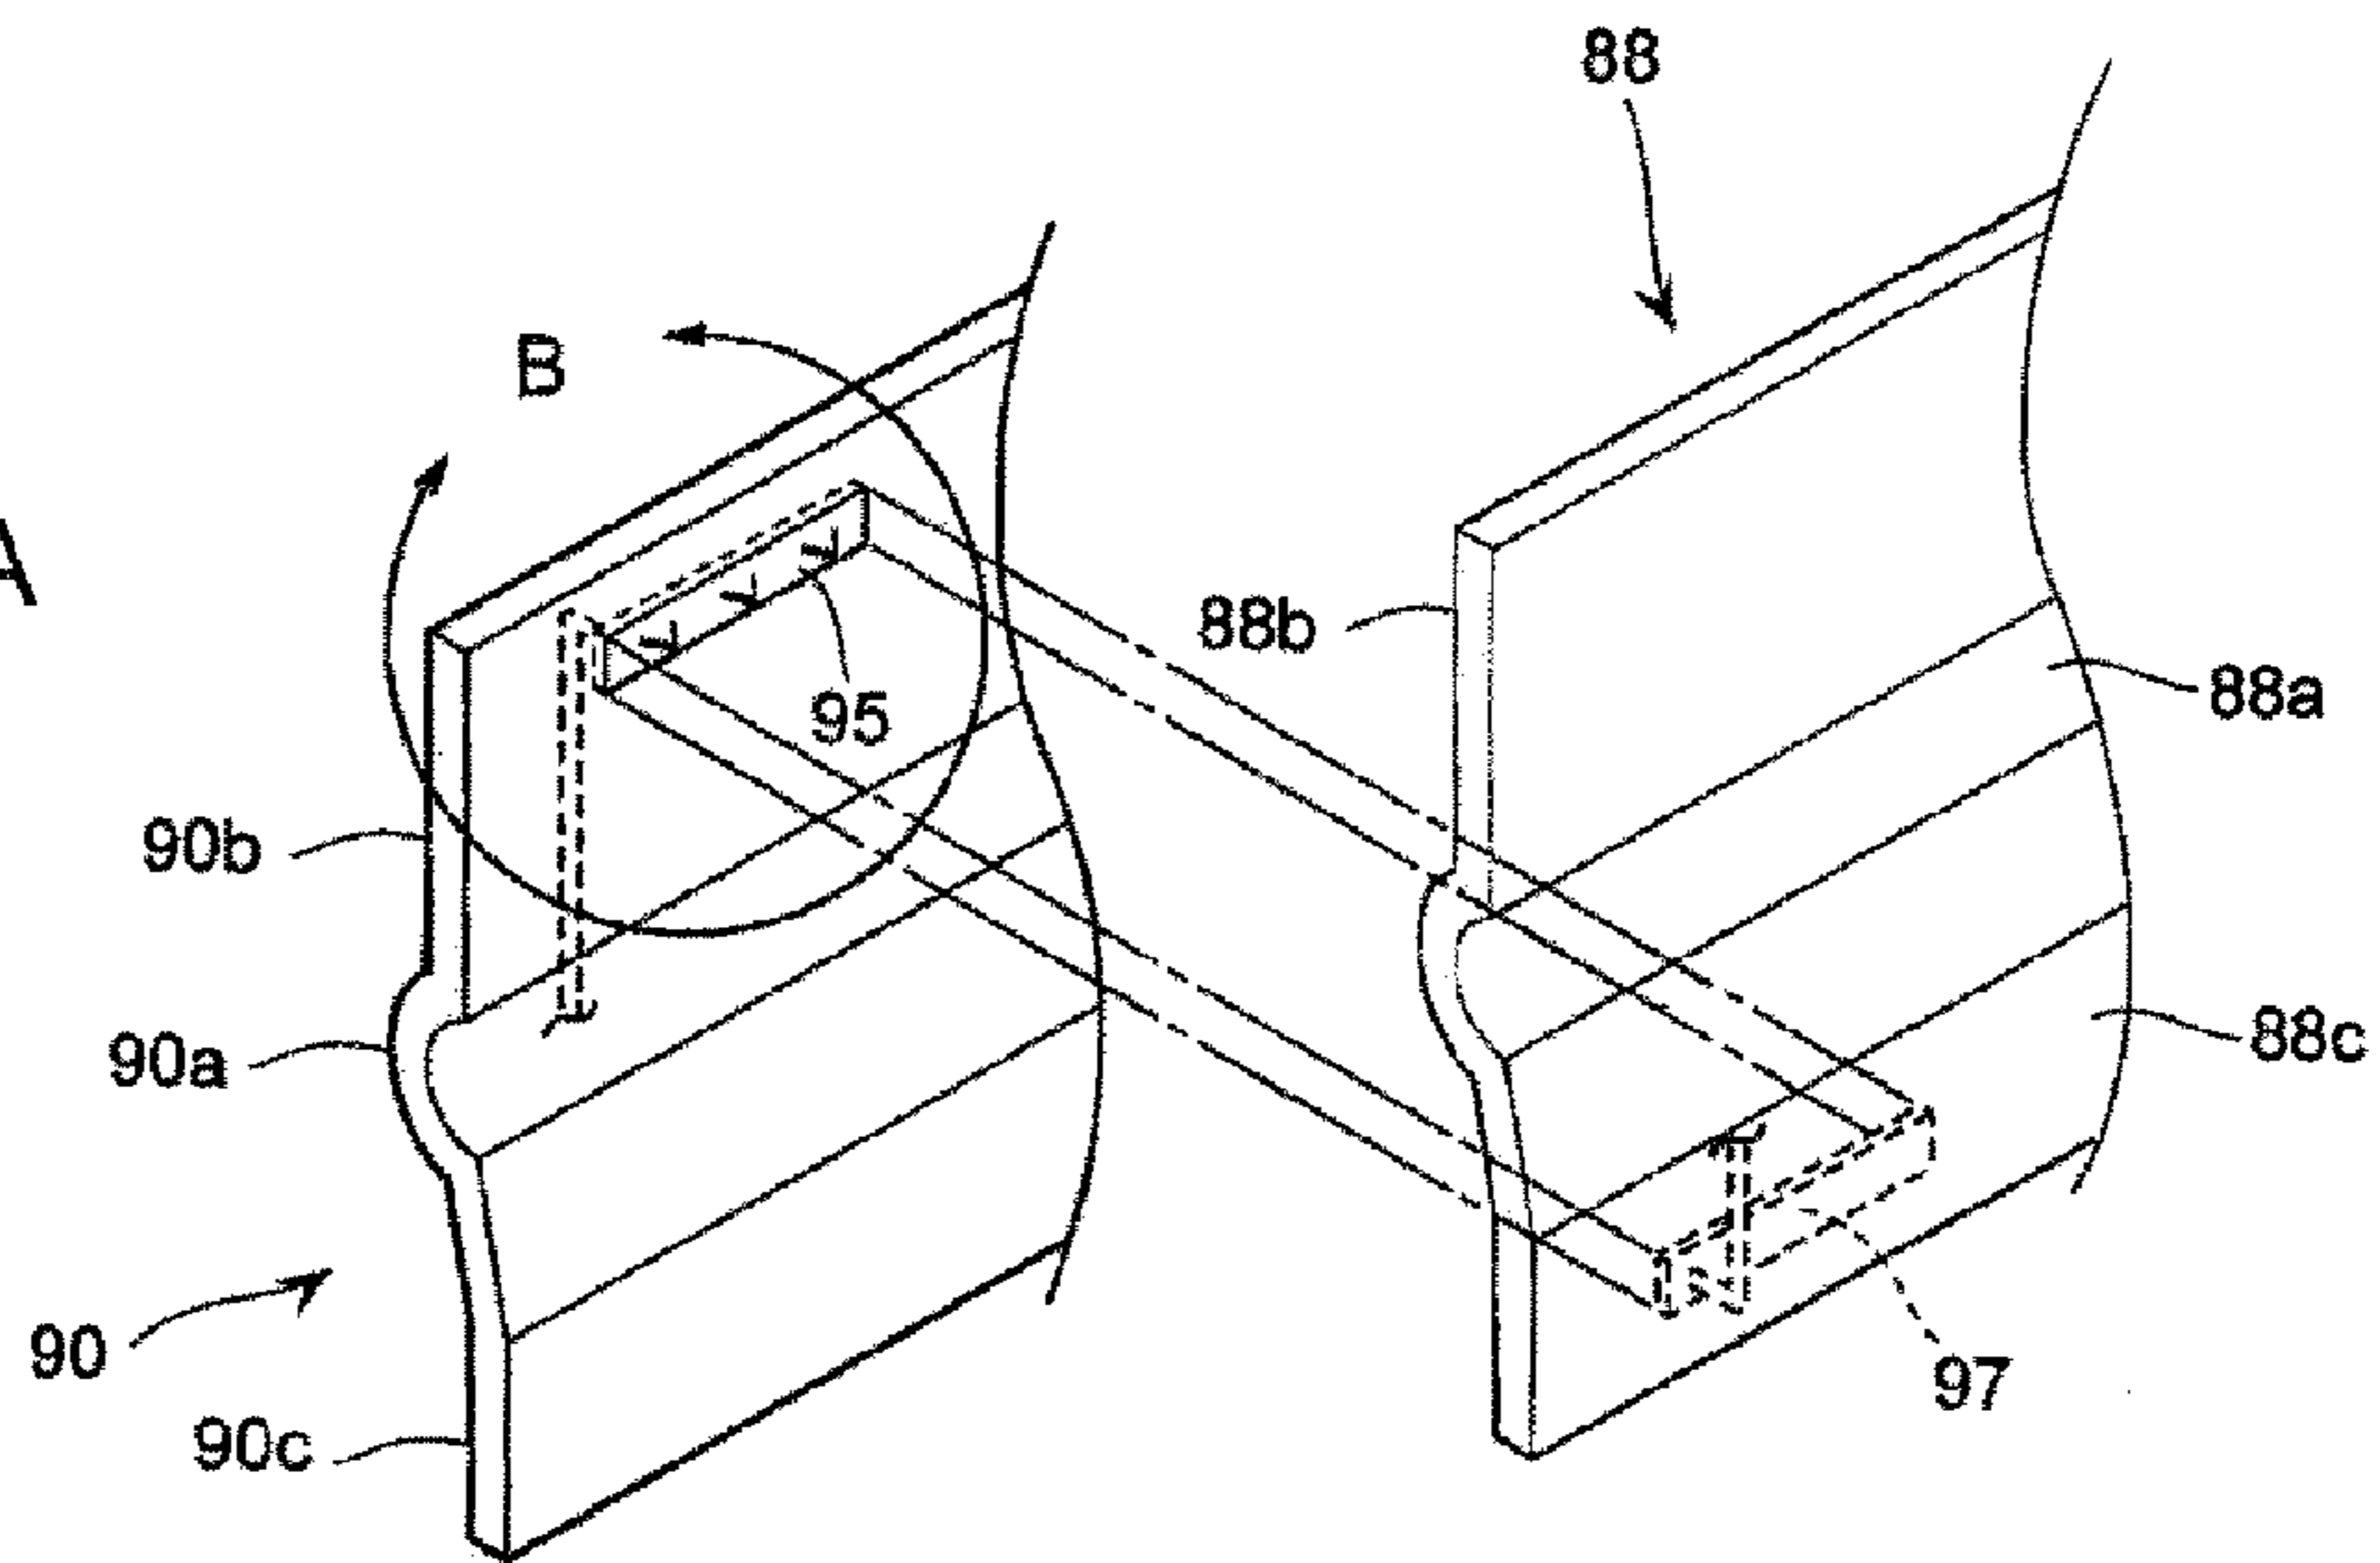
FIG. 4B

As illustrated in FIG. 4B, the conductive member 95 includes a plurality of cut and raised portions 95a, which are formed as projections having a predetermined elasticity. The cut and raised portions 95a undergo elastic deformation upon contact with the flat plate-shaped conducting member 97, and at the same time as electric contact is established, the upper fin 90b of the lower slat 90 and the lower fin 88c of the upper slat 88 come into surface contact such that the gap between the upper fin 90b of the lower slat 90 and the lower fin 88c of the upper slat 88 is sealed.

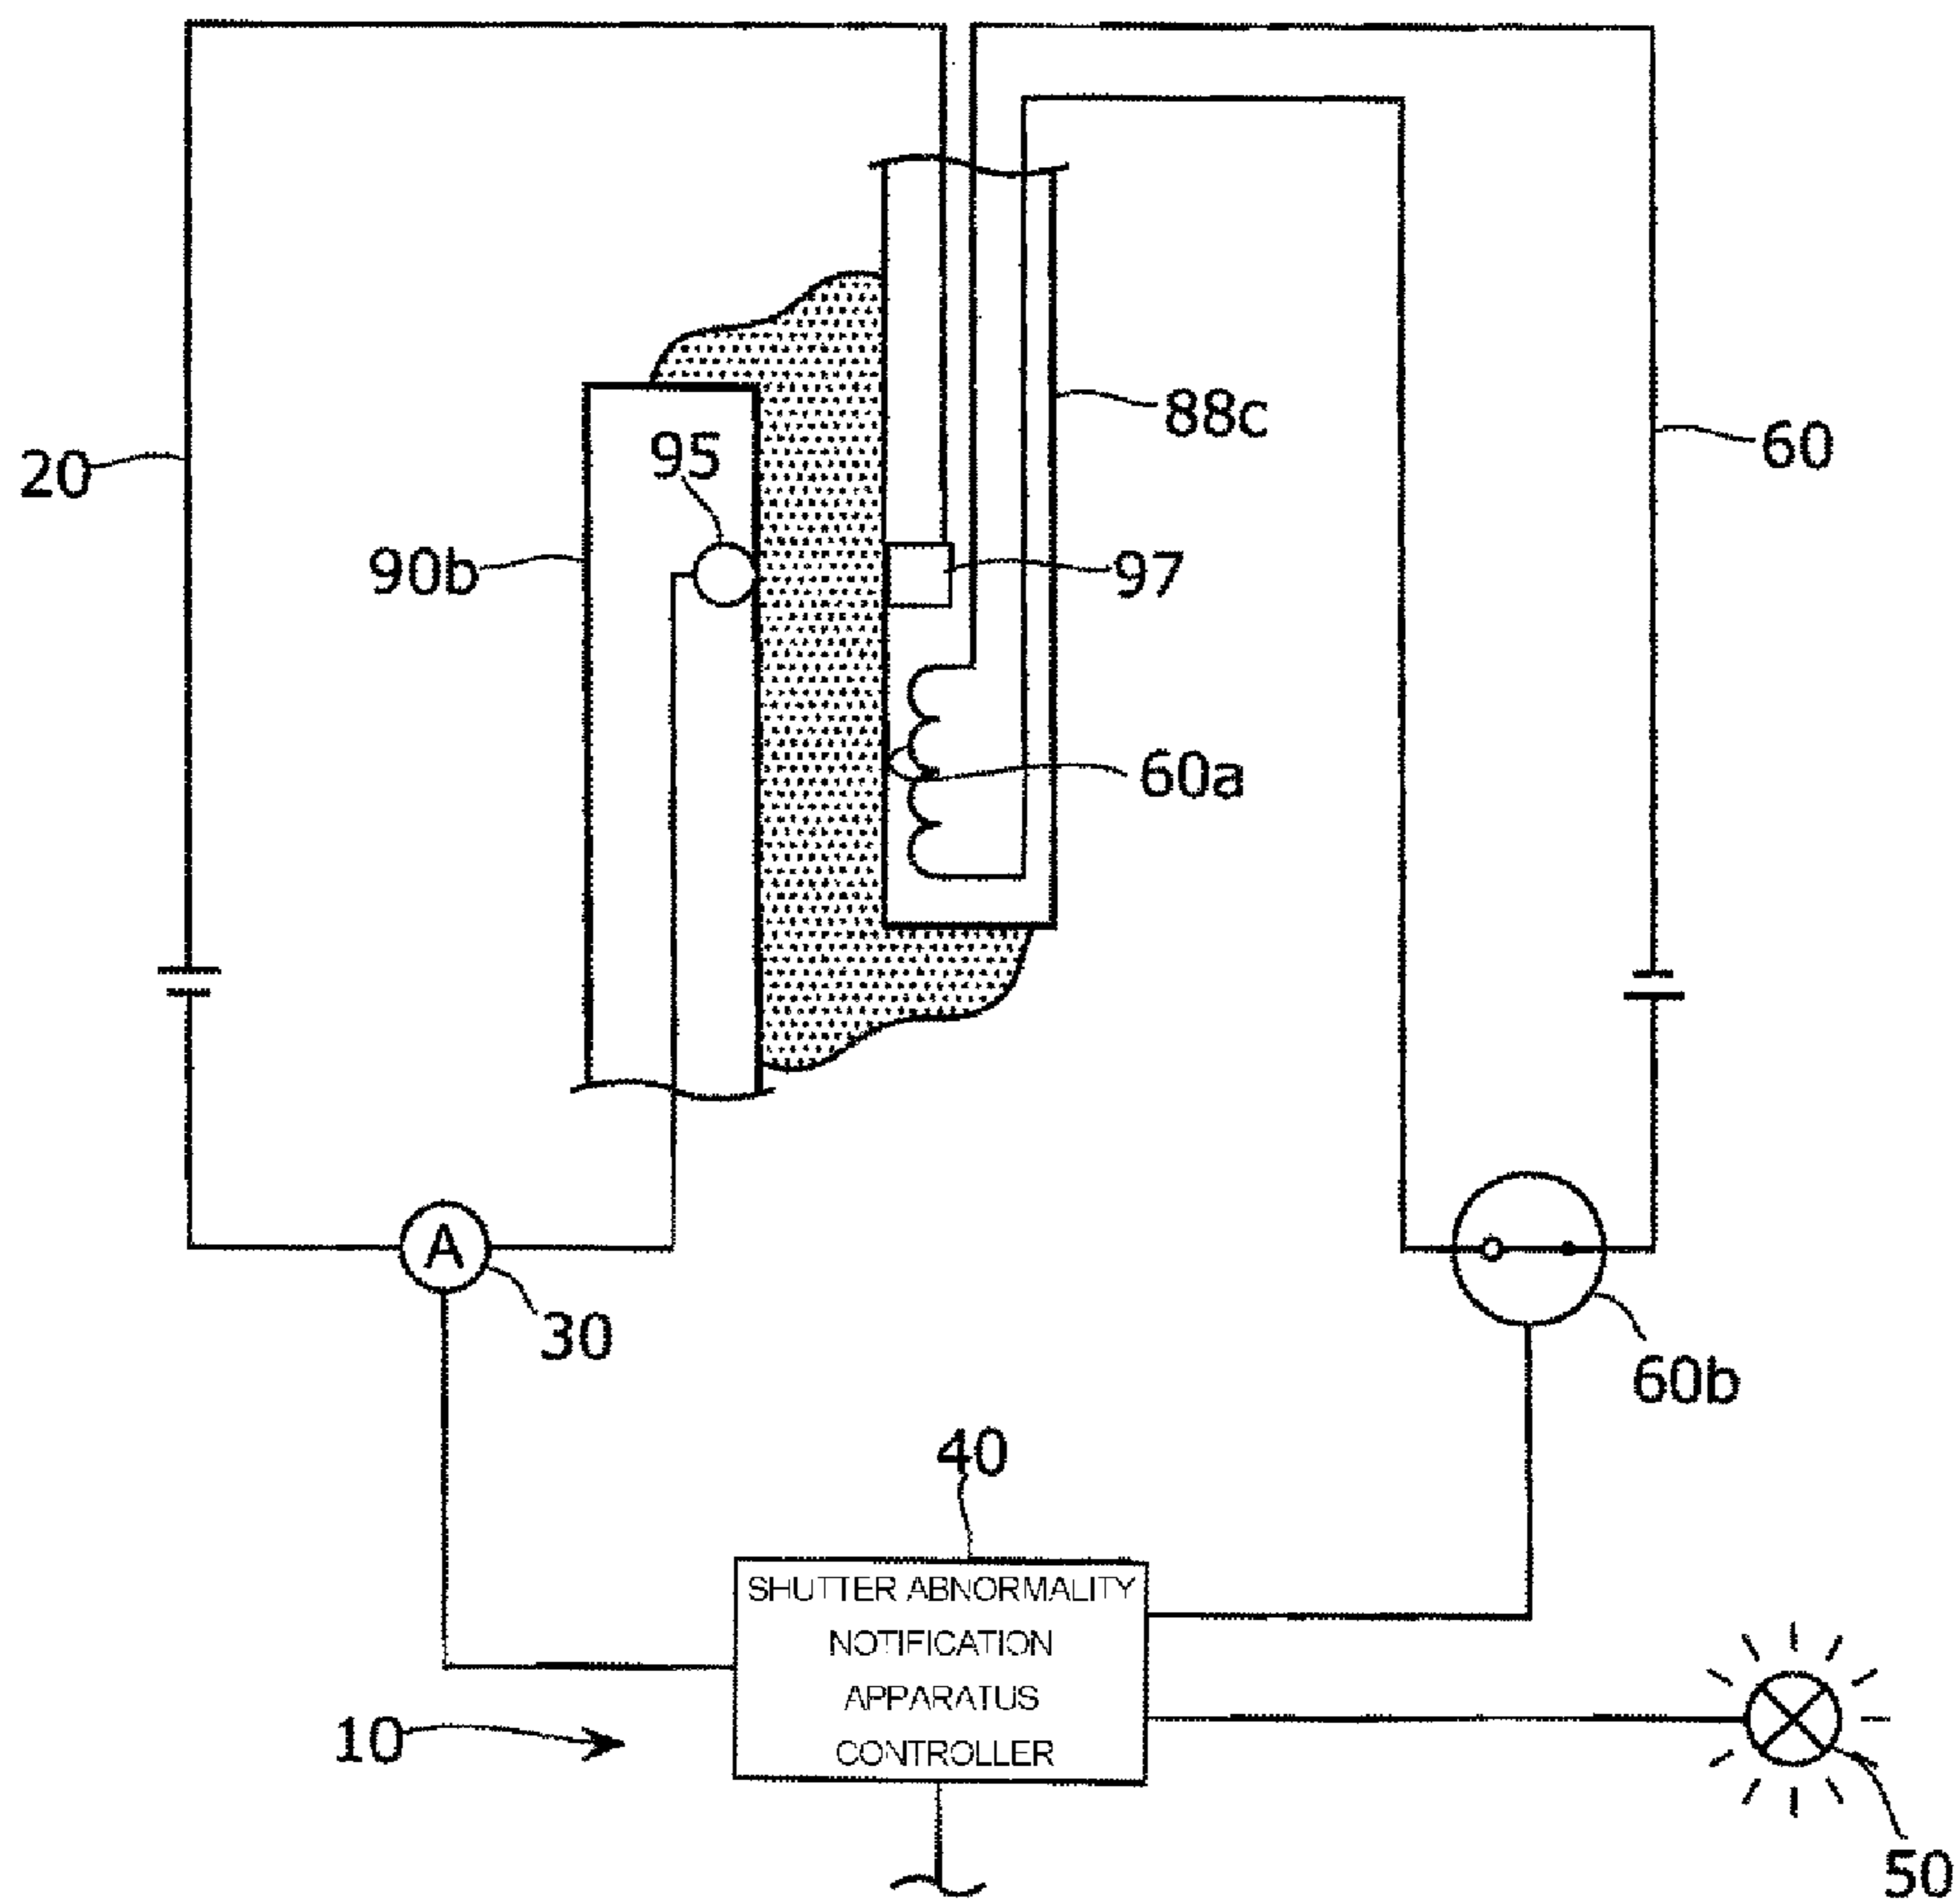
FIG. 7 is a front-rear direction sectional view of a vehicle front end, illustrating a variable duct in which a shutter abnormality notification apparatus according to a second implementation of the present invention is disposed; and

When the slat 140 is in a closed position, as illustrated in FIG. 7, a tip end of the upper fin 140b contacts the upper frame 122 and a tip end of the lower fin 140c contacts the lower frame 124. As a result, rotation of the slat 140 is restricted such that the duct 84 is blocked.
