(10) **Patent No.:** **US 9,403,244 B2**
(45) **Date of Patent:** **Aug. 2, 2016**

(54) **METHOD FOR REPAIRING AN ABRADABLE COATING OF A COMPRESSOR OF A GAS TURBINE**

(71) Applicant: **Rolls-Royce Deutschland Ltd & Co KG**, Blankenfelde-Mahlow (DE)

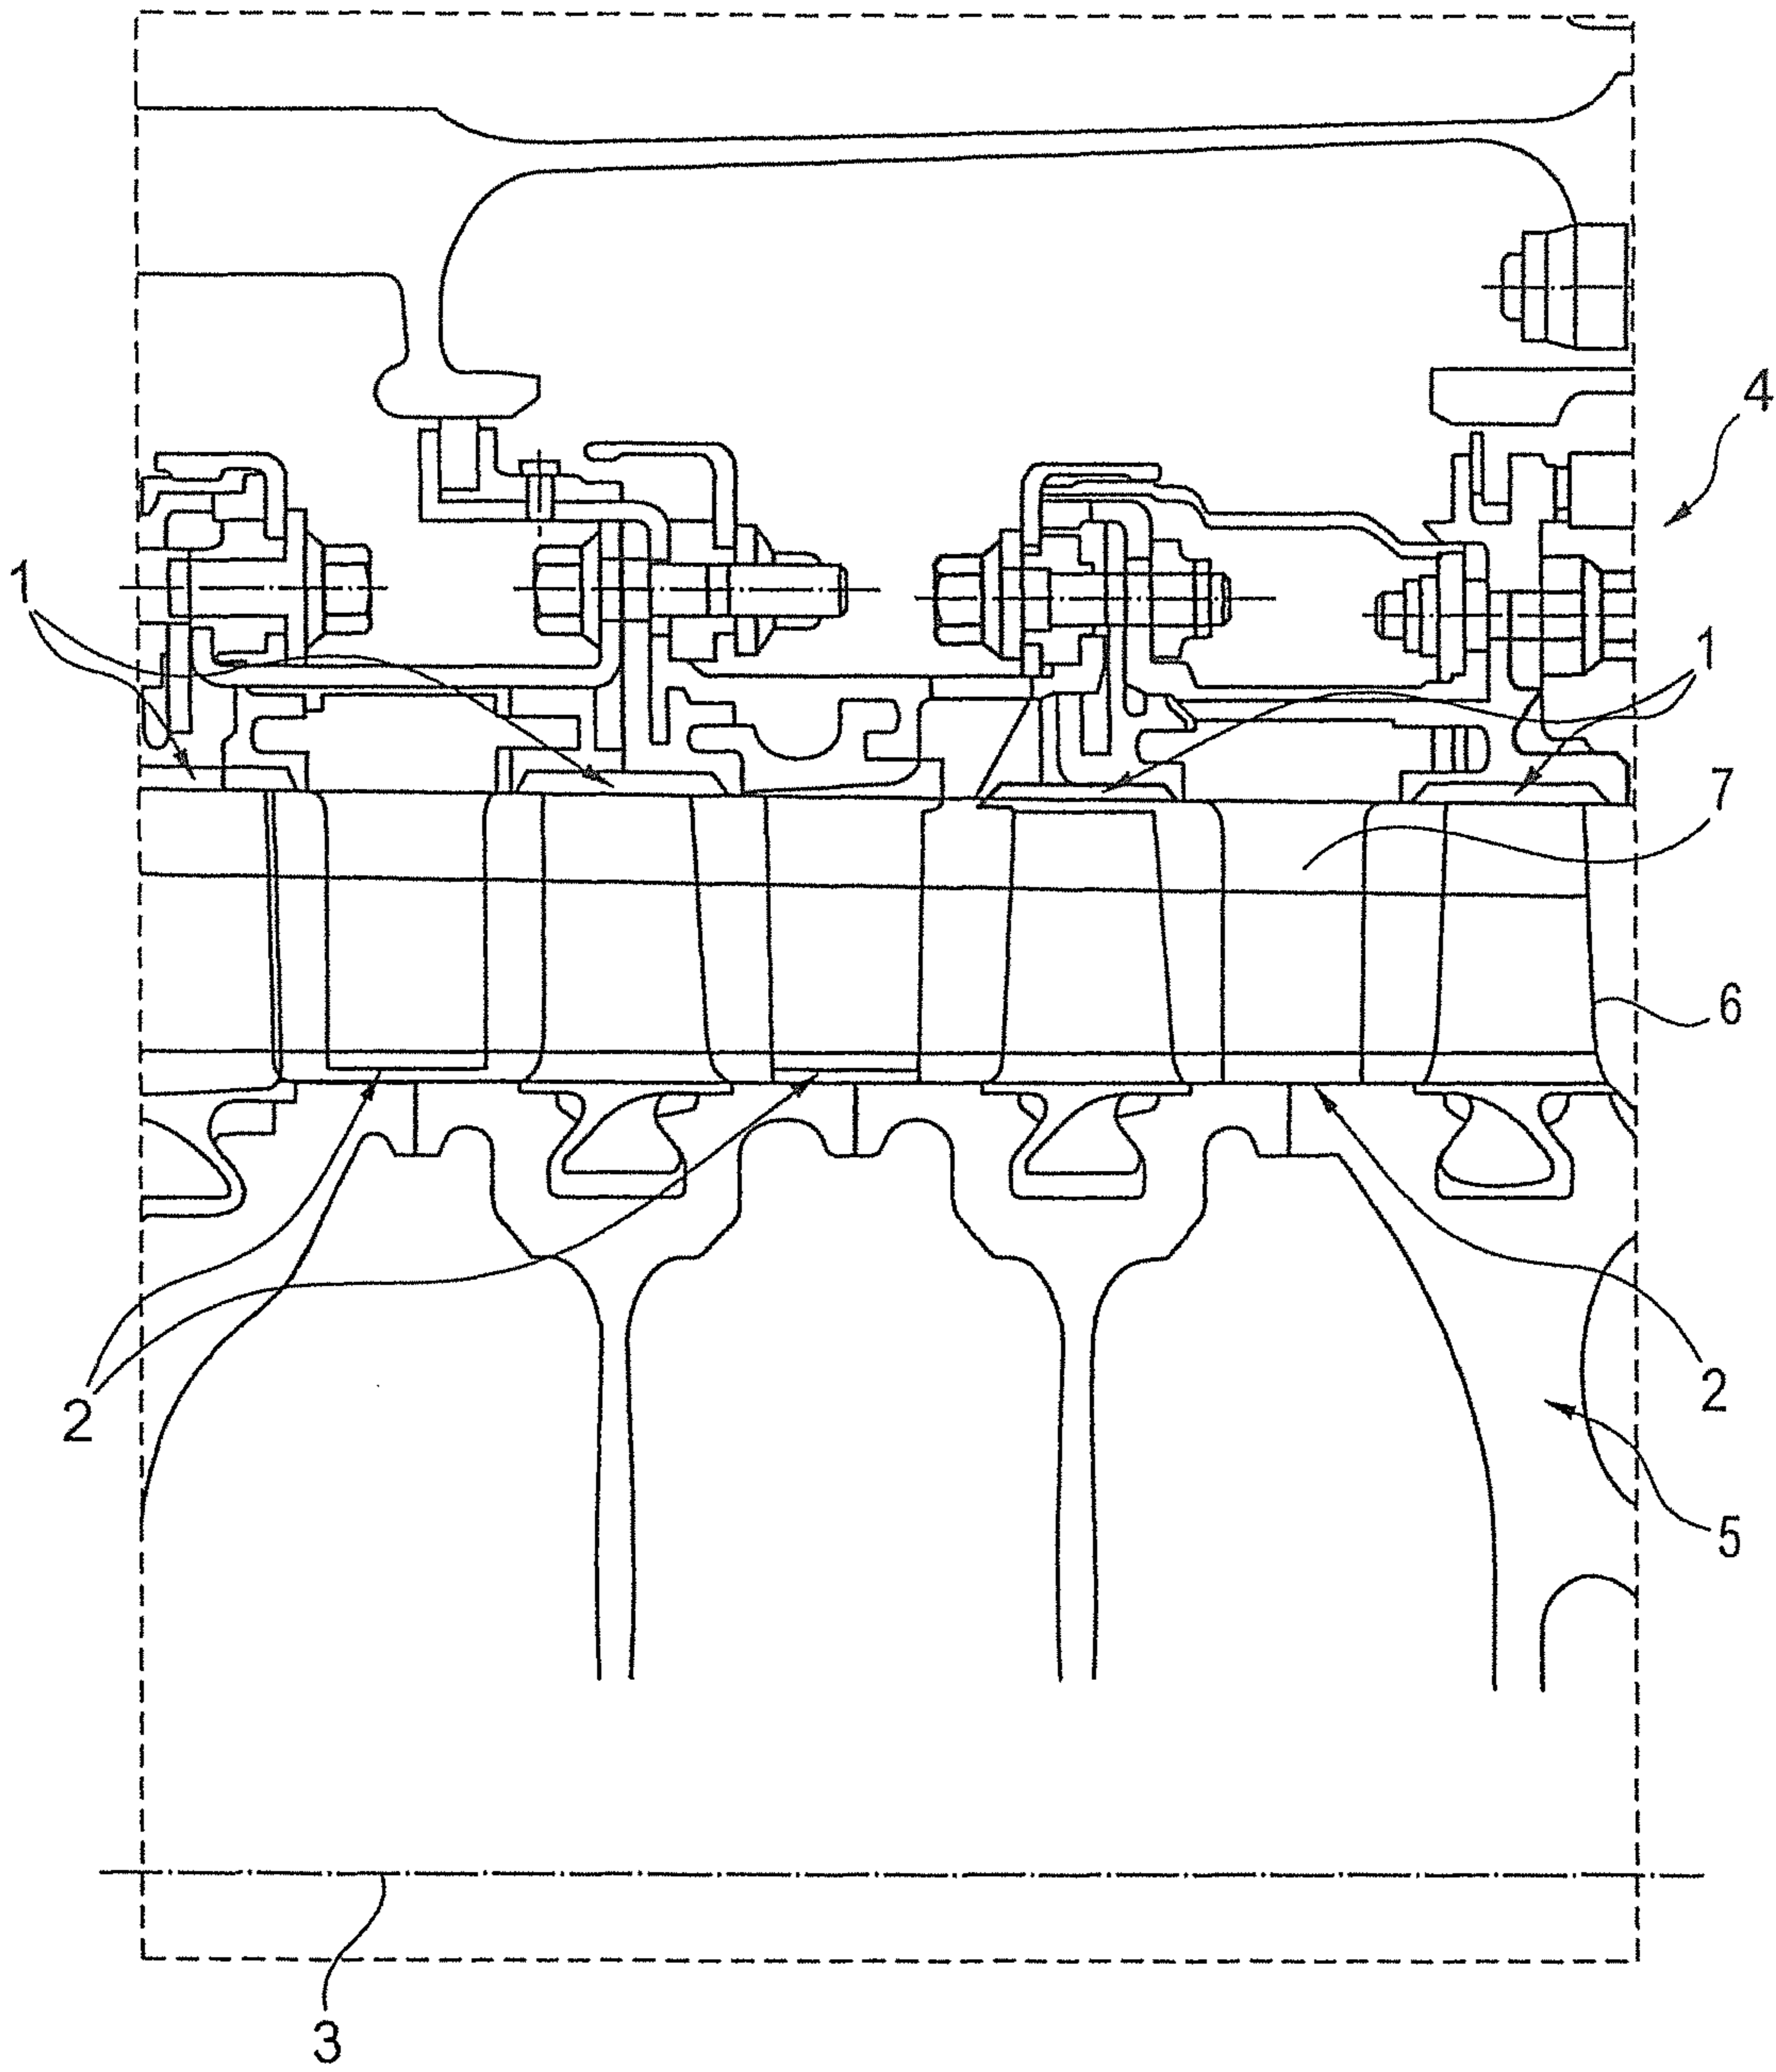
Fig. 1

FIG. 1 schematically shows a partial axial sectional view of a compressor of a gas turbine having abradable coatings,

FIG. 1 shows a machine axis 3 about which a rotor 5 of a compressor is rotatable inside a casing 4. The rotor includes, in the standard design of a compressor, several rotor blades 6 whose free ends are facing abradable coatings 1 of the compressor casing 4. By analogy, the compressor casing 4 includes stator vanes 7 whose free and radially inward-facing ends are facing abradable coatings 2 of the rotor 5 (compressor drum). The abradable coatings come into contact with the free ends of the blades/vanes 6, 7 in order to minimize the tip clearance, and thus permit abrasion during operation of the gas turbine, as is known from the state of the art.

The repair method in accordance with the invention is performed using at least one boroscope, which is inserted through suitable apertures of the casing into the area of the blades/vanes 6, 7.

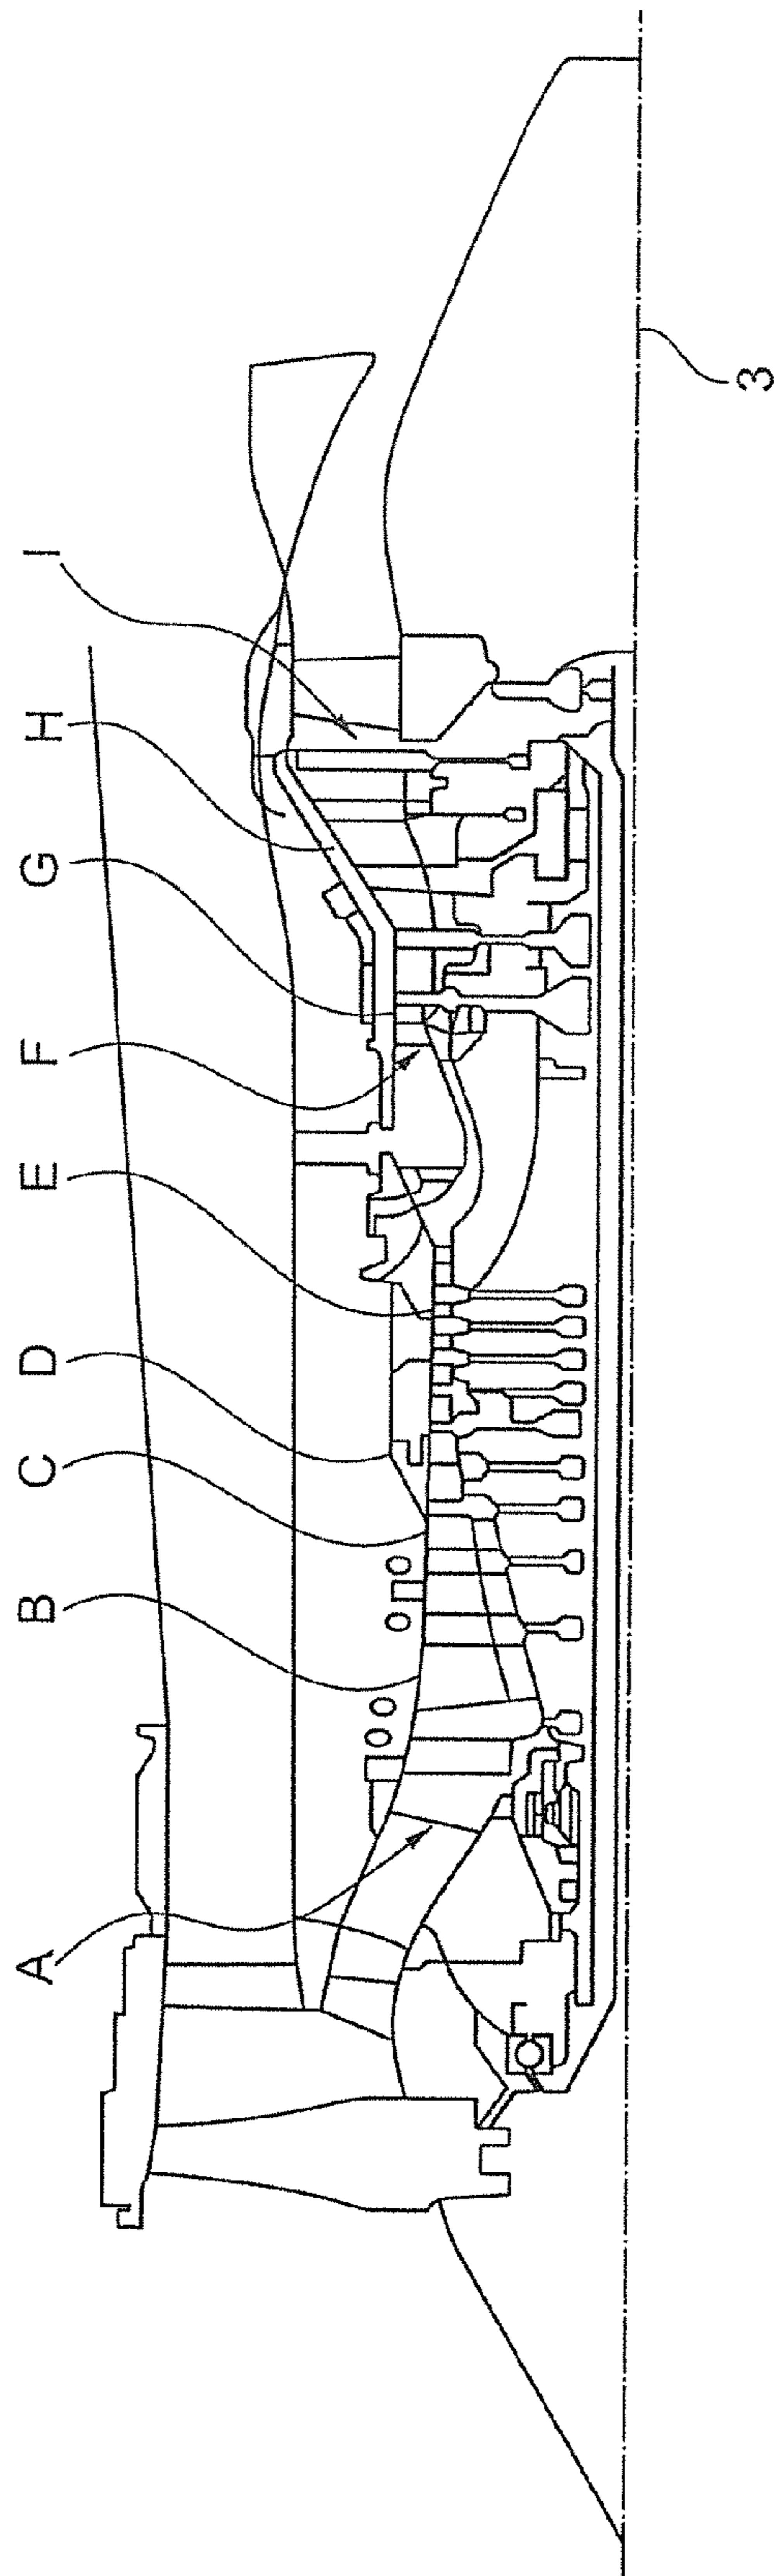
Fig. 2

FIG. 2 shows a schematic representation of a gas-turbine engine with accessibilities for boroscope work,

FIG. 2 schematically shows a partial axial sectional view of a gas-turbine engine with principal accessibilities for boroscope work. As can be seen here, access to a very wide range of areas of the gas-turbine engine is possible by the removal of attachments, by opening of access apertures and similar.

FIG. 2 shows the following elements/assemblies:

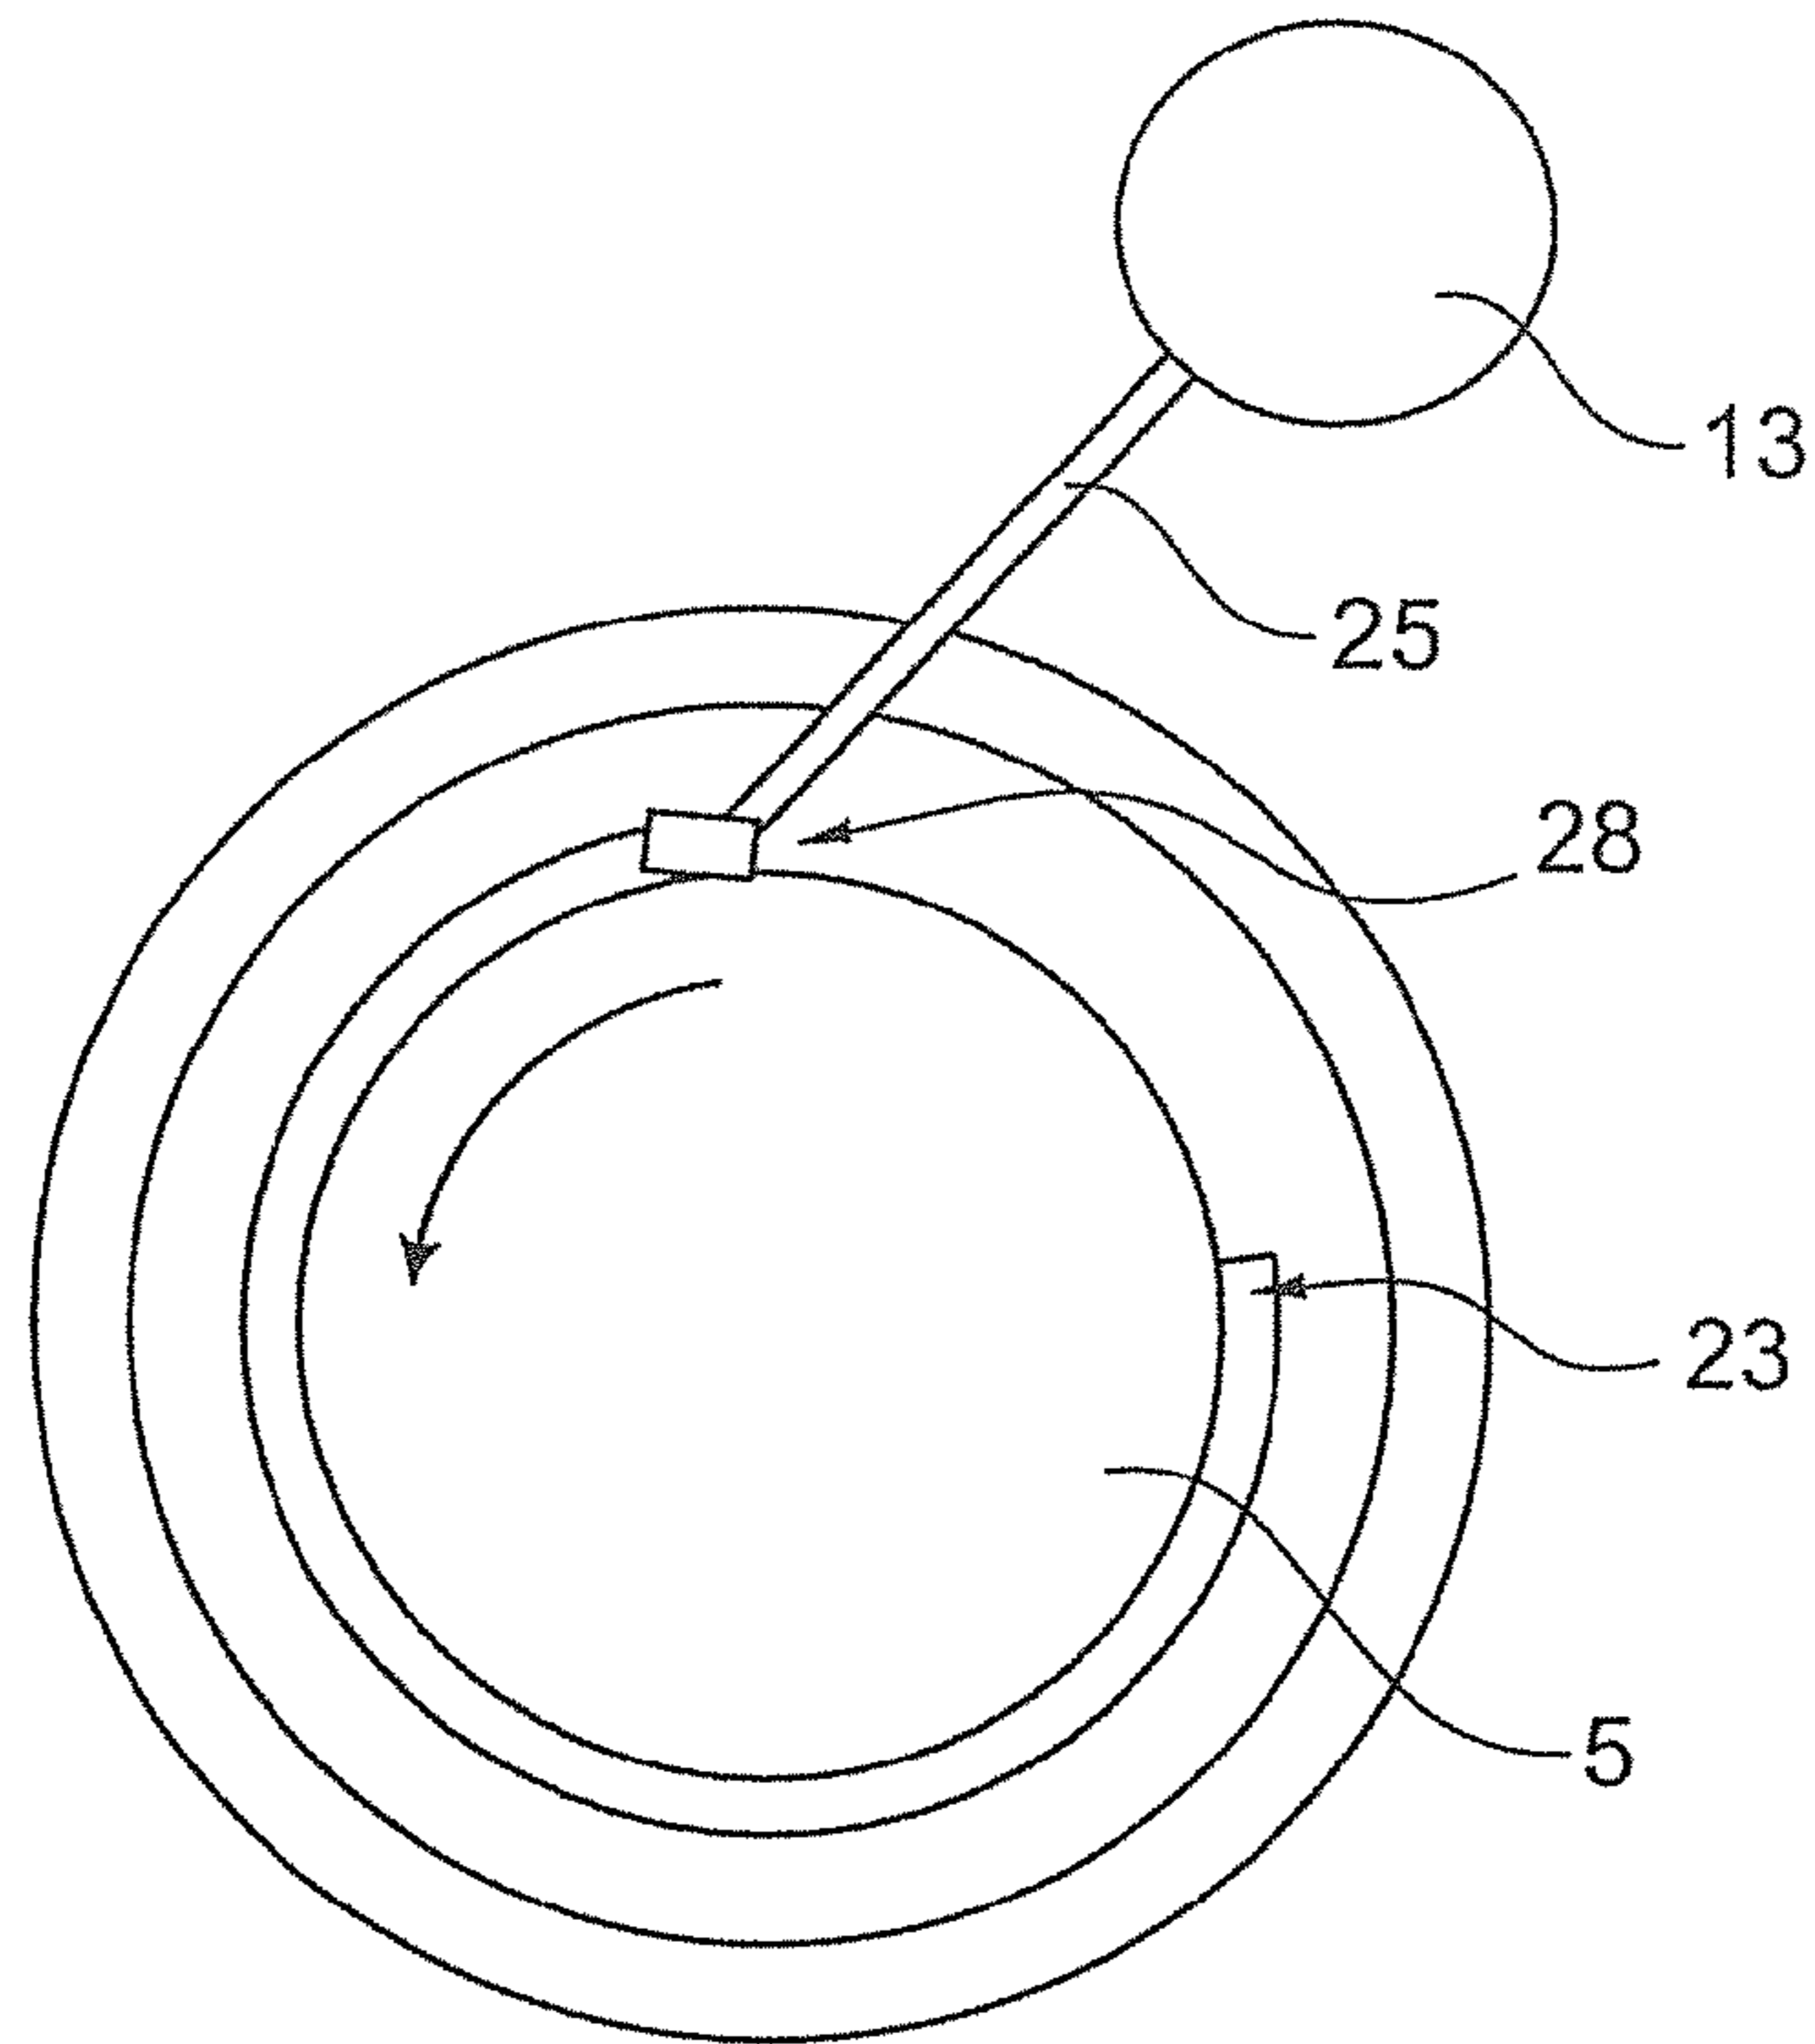
Fig. 6

FIG. 6 shows a simplified side view of the method in accordance with the present invention.

FIG. 6 shows in a greatly simplified representation the application of repair medium 23 onto a rotor 25 in a side view. It can be seen here that repair medium can be applied using the tool 25 in layers by rotating the rotor.

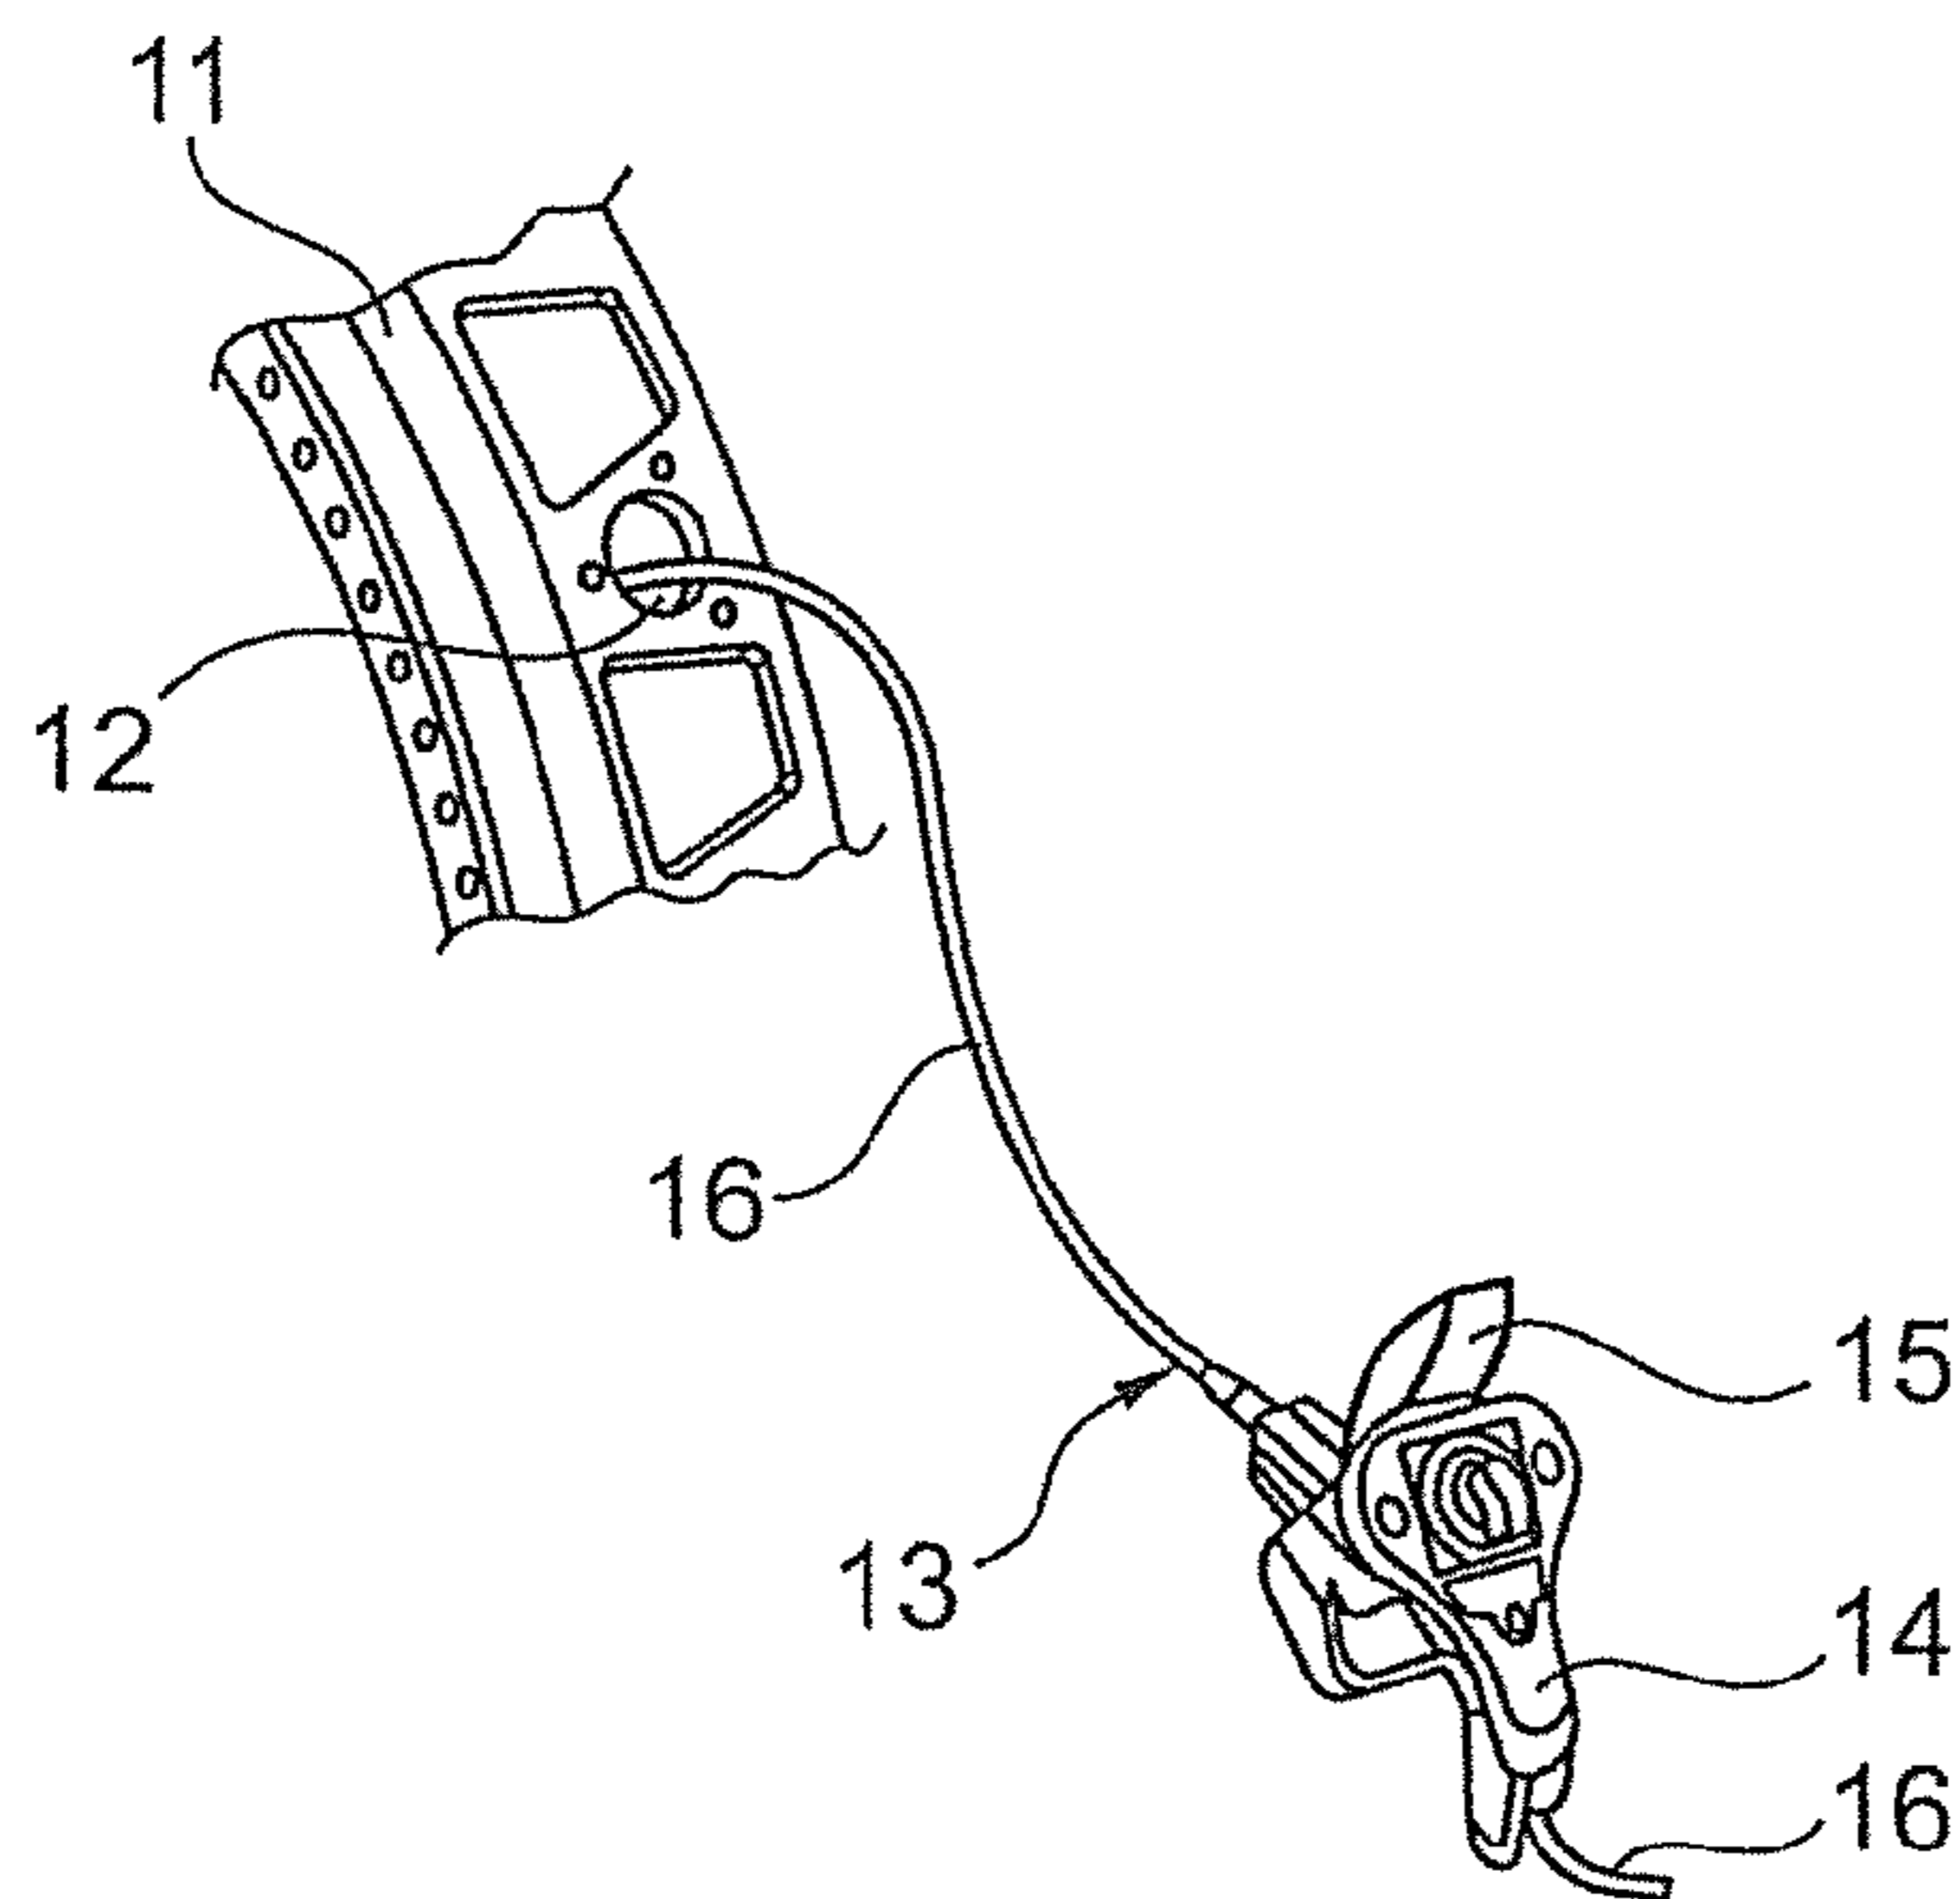
Fig. 3

FIG. 3 shows a simplified schematic representation of the use of various boroscope equipment and units,

25 FIG. 3 schematically shows the use of boroscope equipment in combination with the method in accordance with the invention. Here a part of a casing 11 is shown which is provided with a boroscope aperture 12 (access aperture). This can be provided by removal of a cover or by removal of a unit or similar. A manipulator 13 is introduced through the aperture 12 in order to remove and extract particles and/or to analyse them. A display and actuation unit, and/or the one control unit 14, permit by means of a monitor 15 checking and control of the work.

35 The manipulator 13 is linked to at least one hose 16 through which media can be supplied. The quantity of applied repair medium can be read off from a display. The control unit permits precise setting of the application speed.

It is understood that the representation in FIG. 3 shows the individual components and their mode of operation only in a very schematic form.

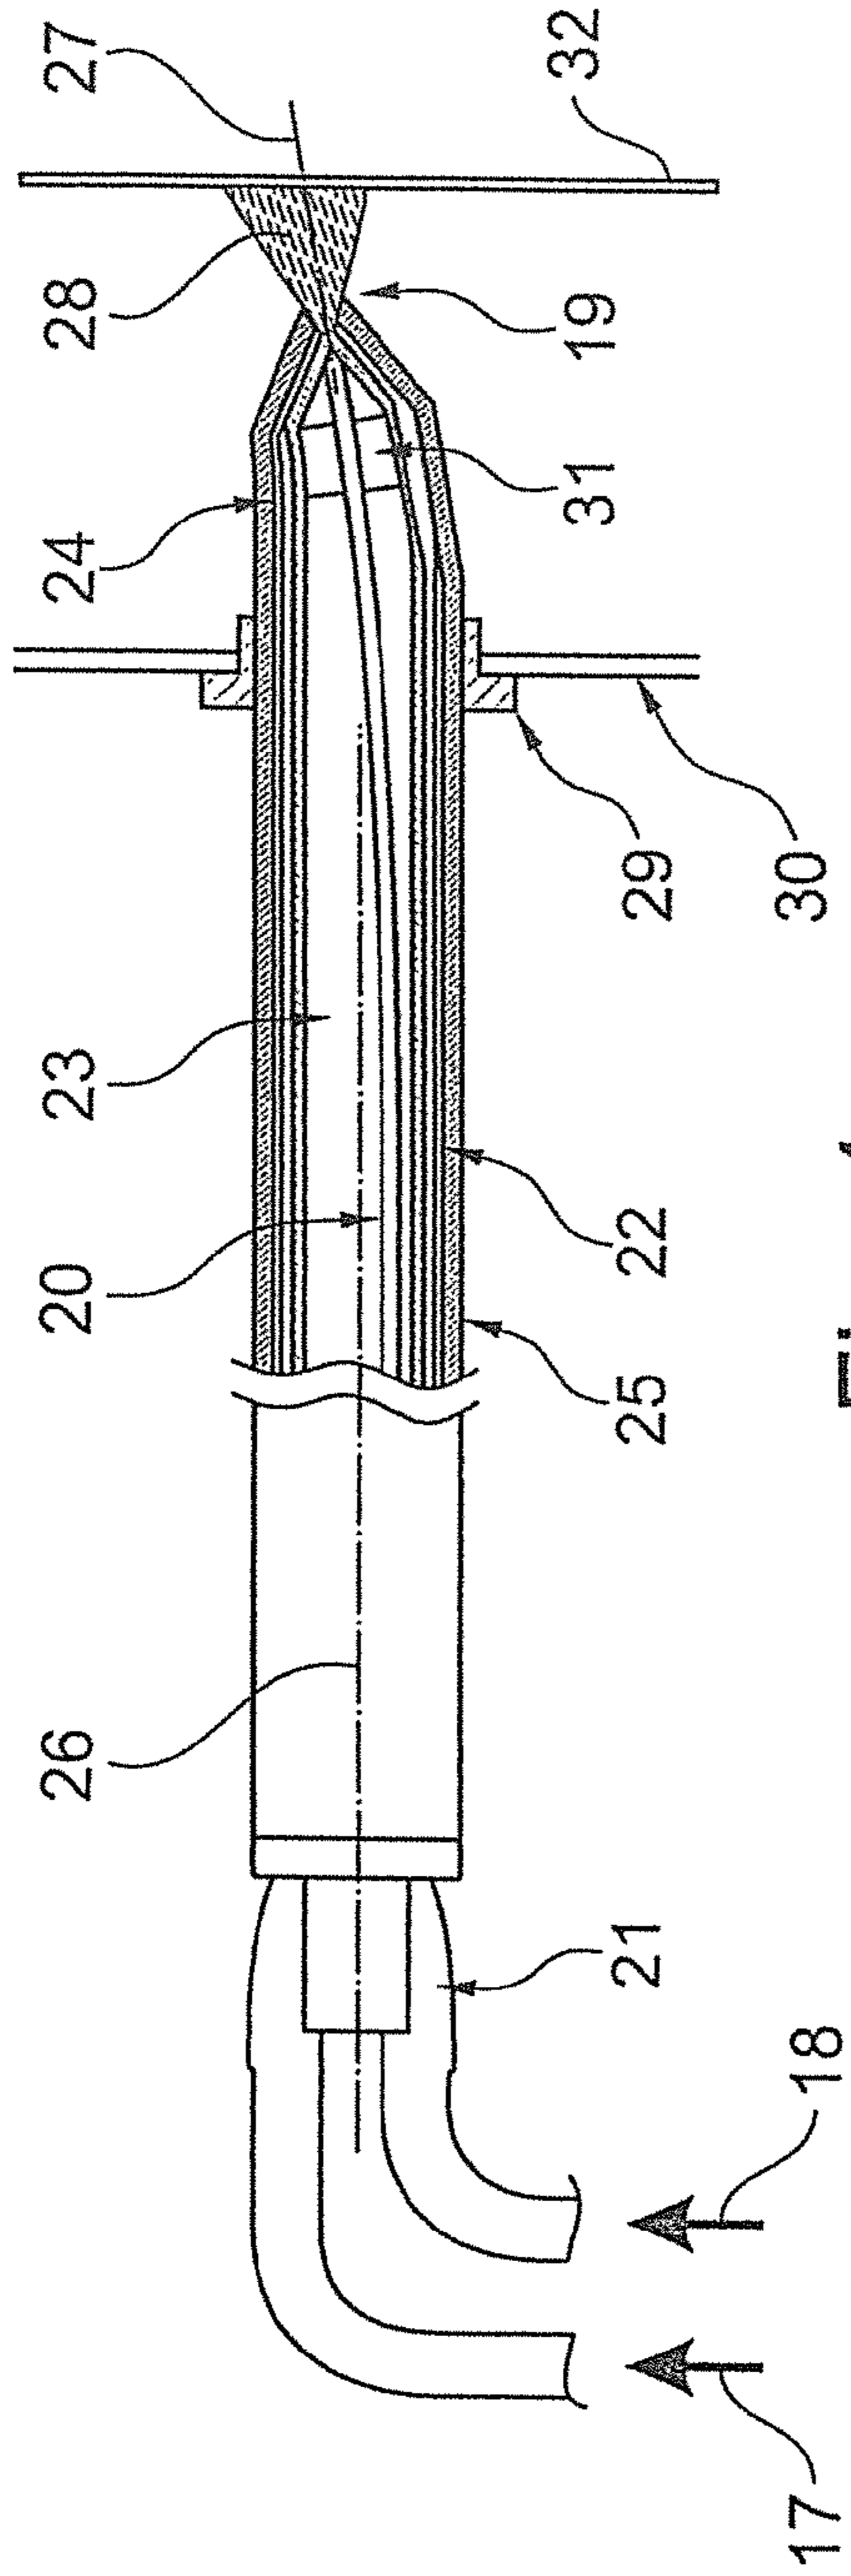
Fig. 4

FIG. 4 shows a simplified schematic representation of a coating tool,

FIG. 4 shows a simplified schematic representation of a coating tool 25 in accordance with the invention. In the rear part of the tool 25, a repair medium 17 and the compressed air 18 are supplied via hoses 16. The supplied quantity of the repair medium in a nozzle 19 is controlled using a needle 20 by means of an actuator 21.

The nozzle 9 is located on the front of the tool 25. The repair medium 23 and the compressed air 22 are mixed inside the nozzle 19. The nozzle 19 is angled by several degrees relative to the center axis 26 of the tool 25, such that the jet 28 can be directed by turning the tool. The process can be observed by means of glass fibers 24 with integrated lighting.

55 FIG. 4 shows that the repair tool has a substantially cylindrical body whose front end area is, as already mentioned, inclined at an angle to a center axis 26 of the tool 25. The reference numeral 27 shows the center axis of the nozzle 19, corresponding to the center axis of the front end area of the tool 25. By rotating the tool 25, the exit angle of the jet 28 can be altered, so that the area to be sprayed can be suitably selected.

65 FIG. 4 furthermore shows a guide bush 29, arranged in a recess of an outer casing 30 of the compressor and/or the flow duct and used for guidance of the tool 25. The reference numeral 32 indicates an inner casing of the compressor and/or of the flow duct, onto which repair medium 23 is applied by means of the jet 28.

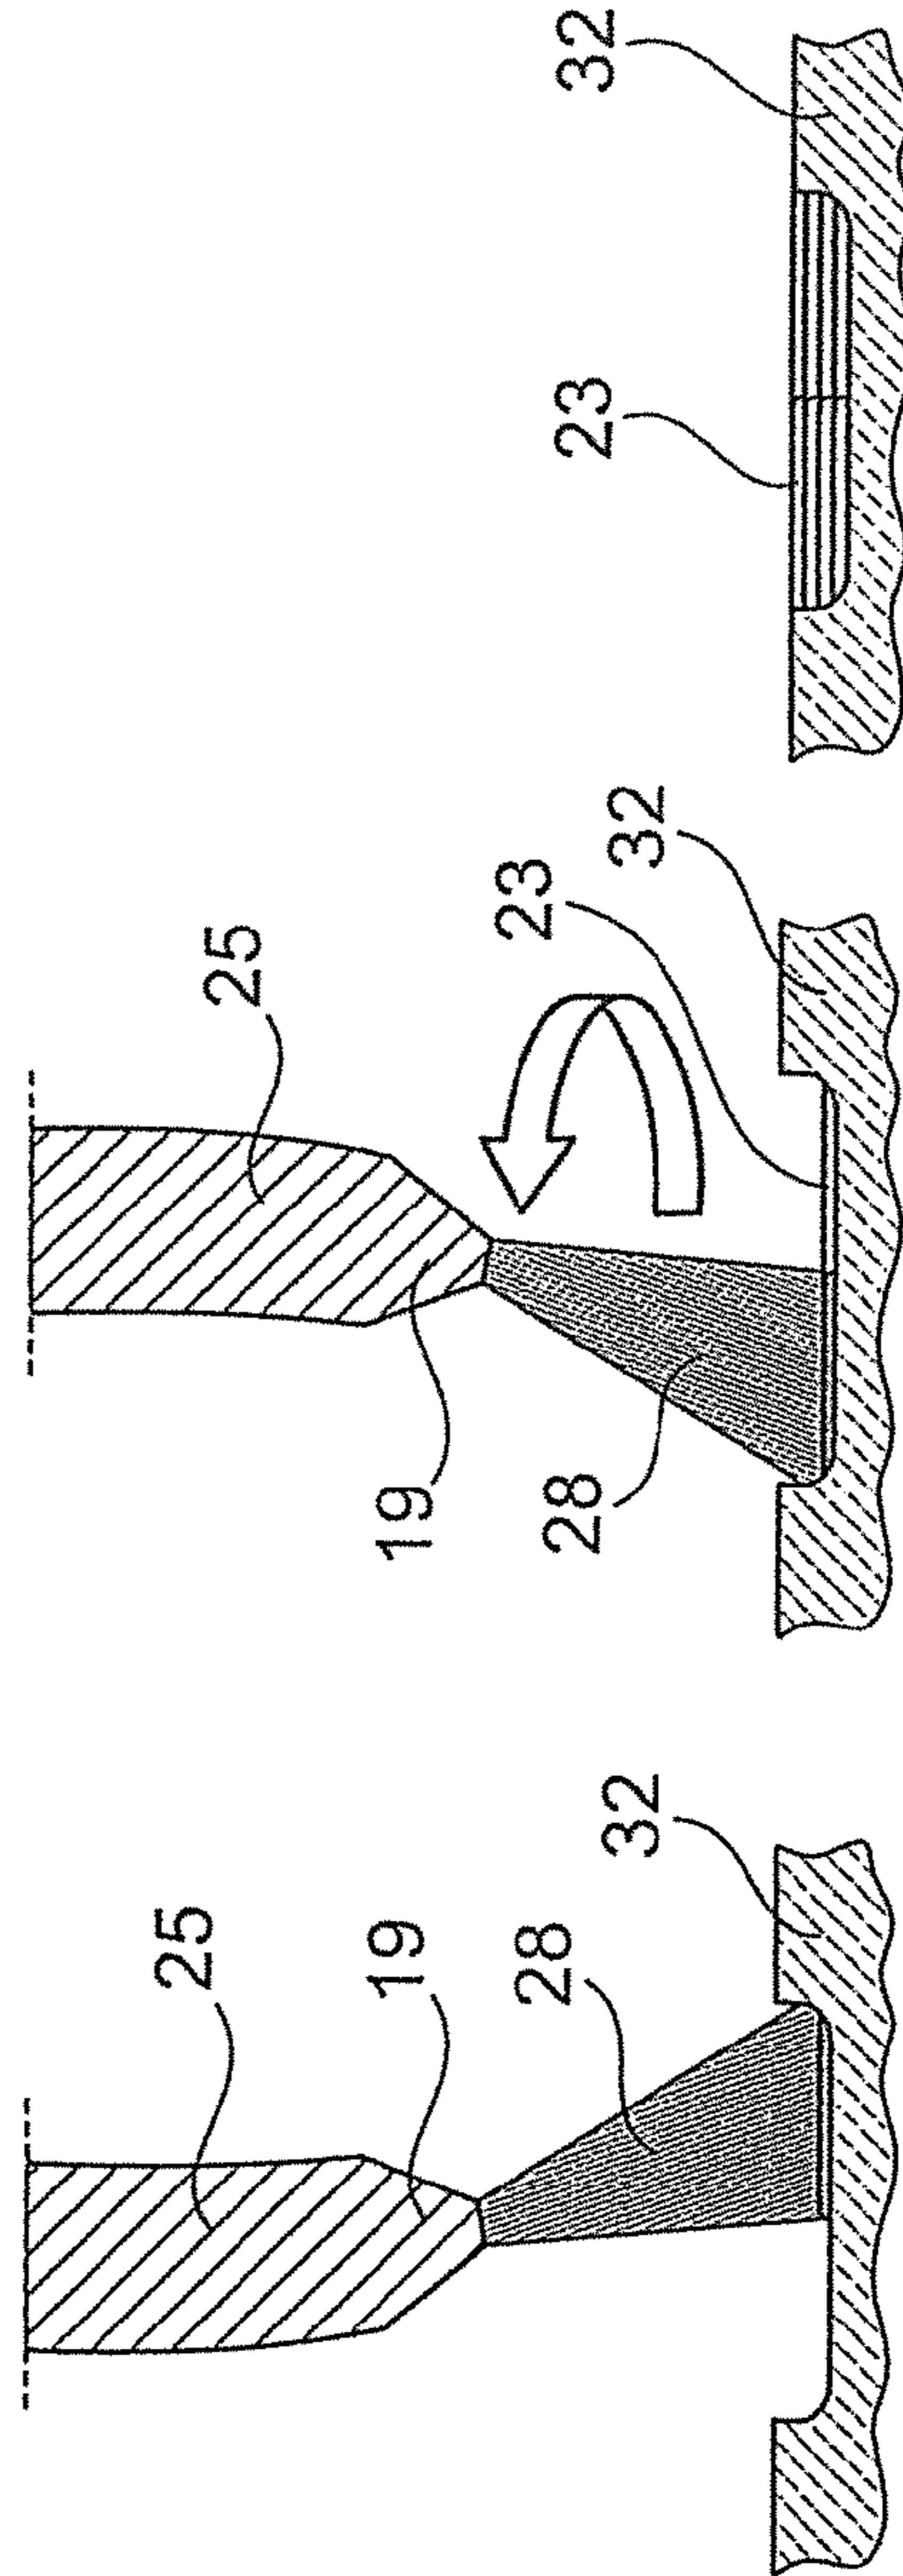
Fig. 5

FIG. 5 shows a functional principle of tool rotation for controlling the nozzle and the jet for applying several layers, and

FIG. 5 shows how the repair medium 23 is applied in thin layers next to and above one another. The left-hand half of FIG. 5 shows the application of a first layer by means of the jet 28. Once this has been applied, the next layer is applied as shown in the center of FIG. 5. The right-hand half of FIG. 5 shows the finished state, in which several individual layers of repair medium 23 have been applied to restore an abradable coating.
