US009403244B2

(54) **METHOD FOR REPAIRING AN ABRADABLE COATING OF A COMPRESSOR OF A GAS TURBINE**

(71) Applicant: **Rolls-Royce Deutschland Ltd & Co KG**, Blankenfelde-Mahlow (DE)

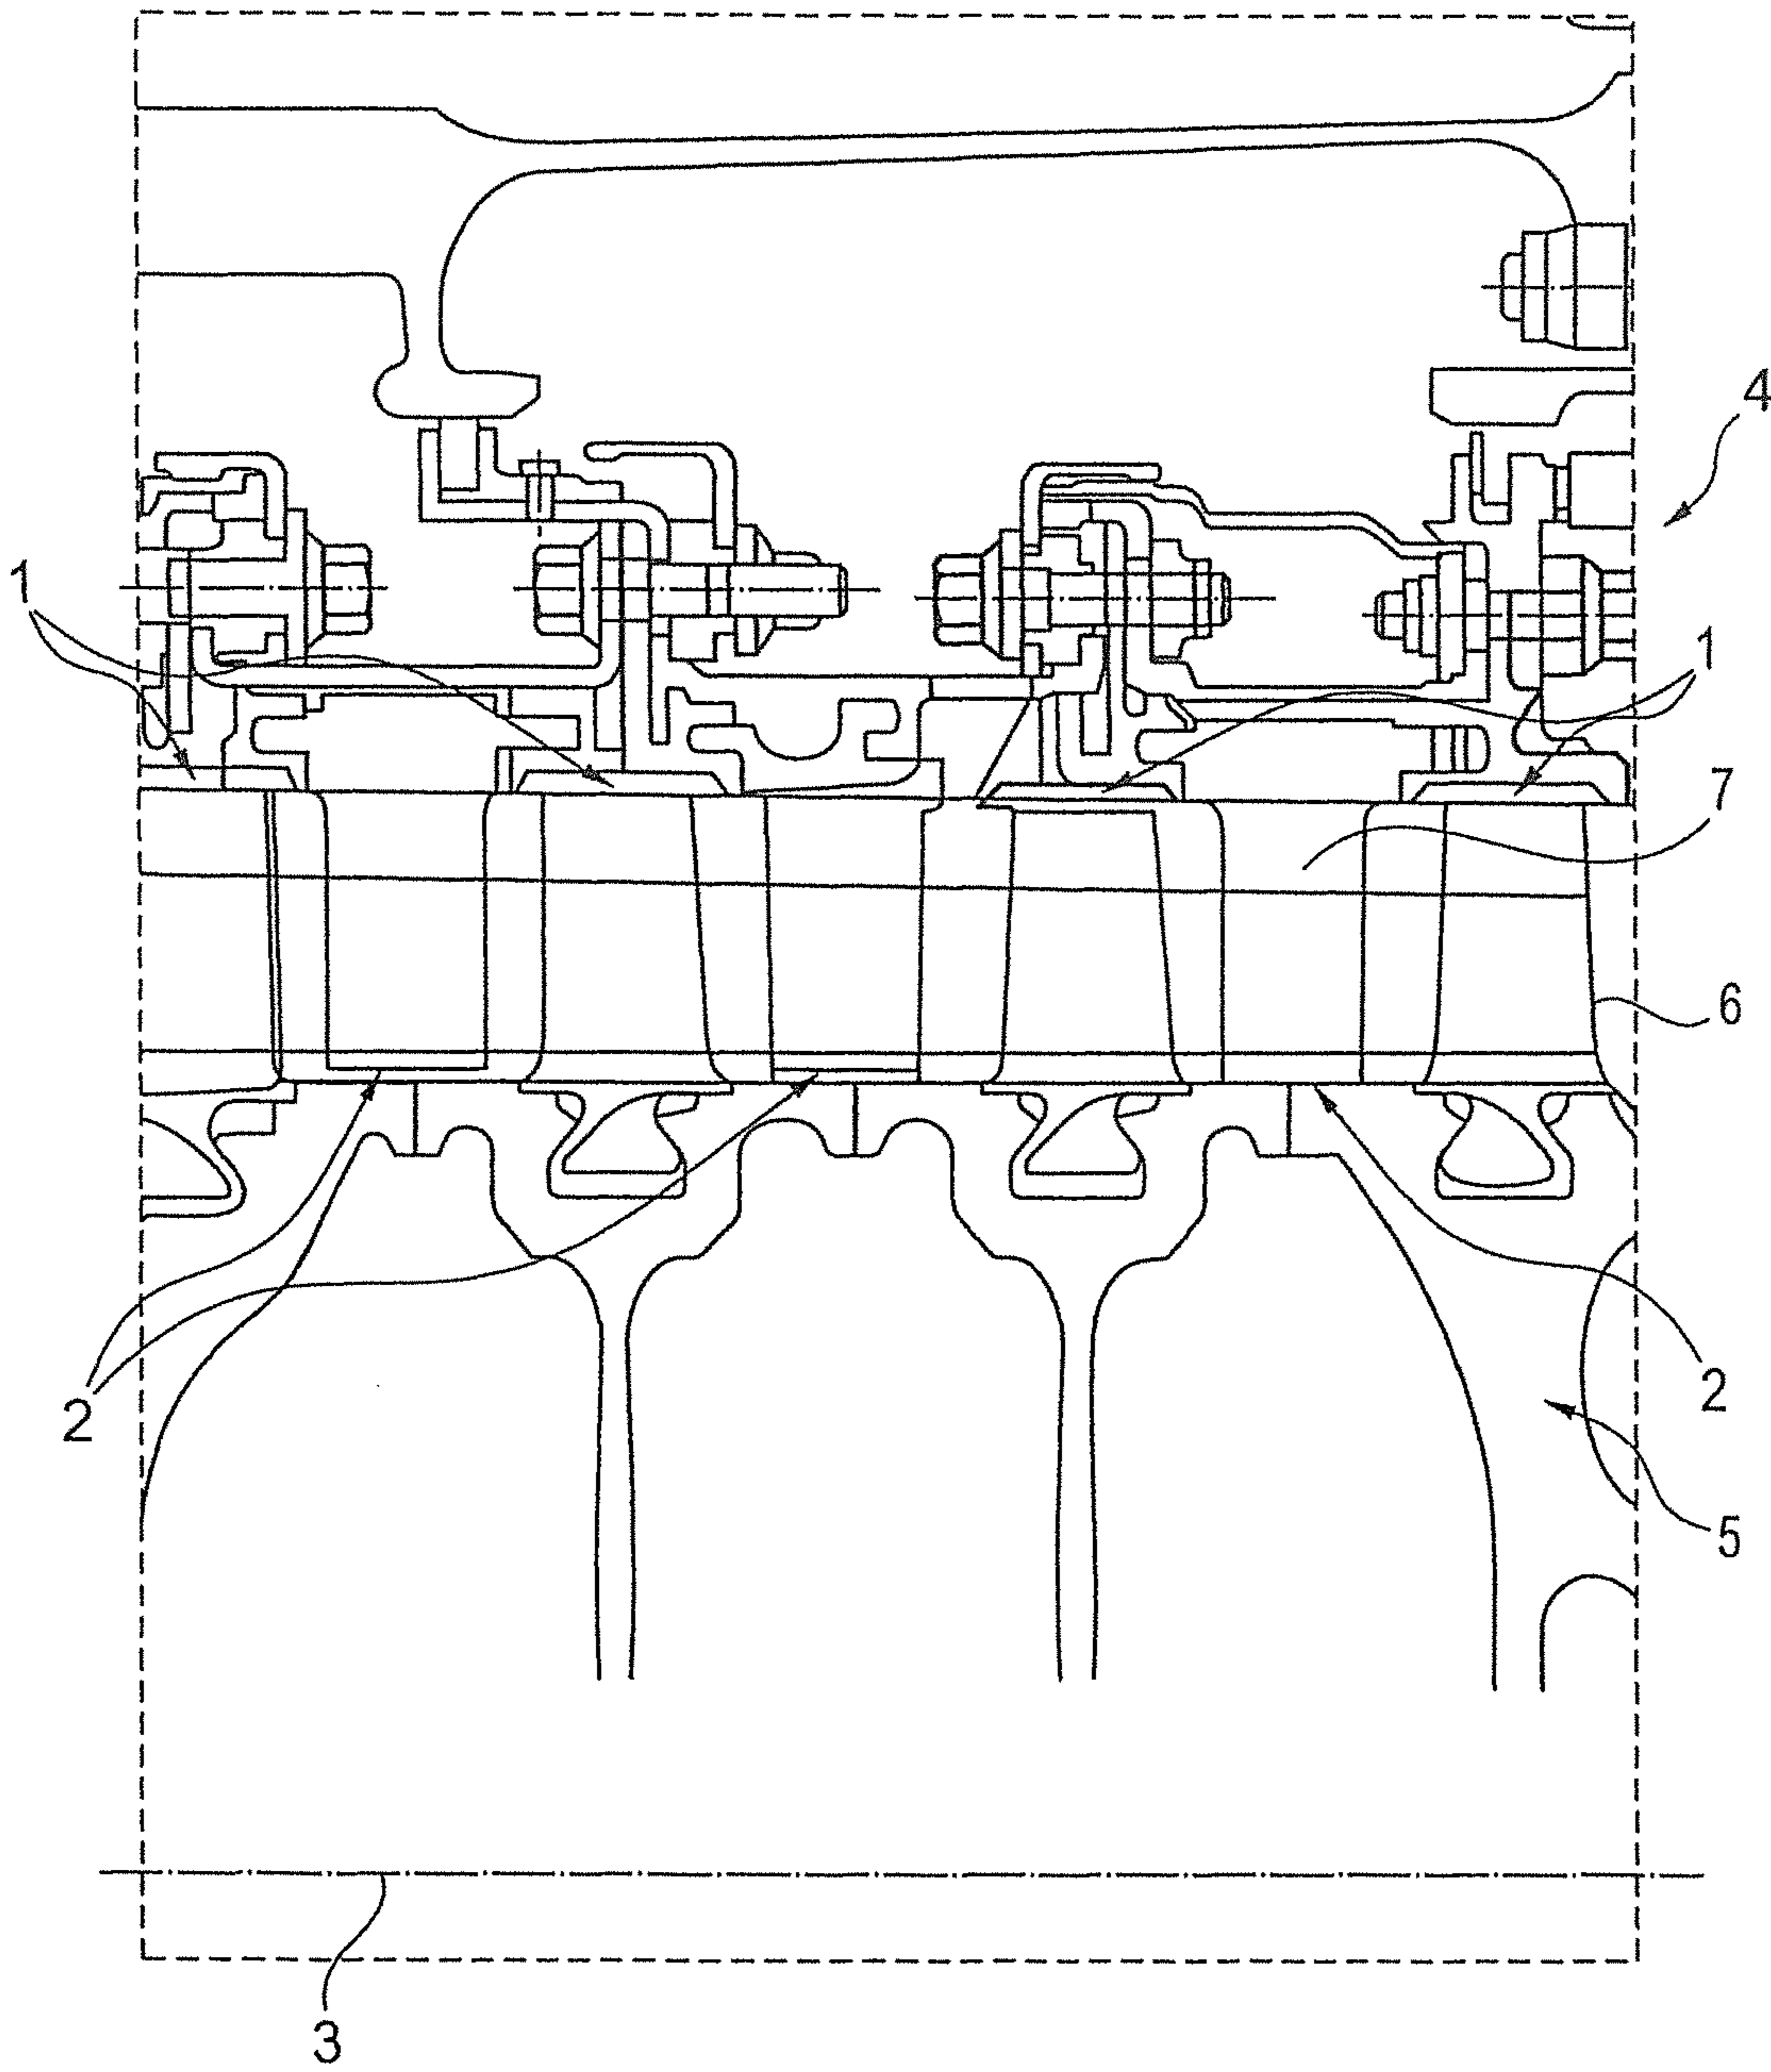
Fig. 1

FIG. 1 schematically shows a partial axial sectional view of a compressor of a gas turbine having abradable coatings,

FIG. 1 shows a machine axis 3 about which a rotor 5 of a compressor is rotatable inside a casing 4. The rotor includes, in the standard design of a compressor, several rotor blades 6 whose free ends are facing abradable coatings 1 of the compressor casing 4. By analogy, the compressor casing 4 includes stator vanes 7 whose free and radially inward-facing ends are facing abradable coatings 2 of the rotor 5 (compressor drum). The abradable coatings come into contact with the free ends of the blades/vanes 6, 7 in order to minimize the tip clearance, and thus permit abrasion during operation of the gas turbine, as is known from the state of the art.

The repair method in accordance with the invention is performed using at least one boroscope, which is inserted through suitable apertures of the casing into the area of the blades/vanes 6, 7.

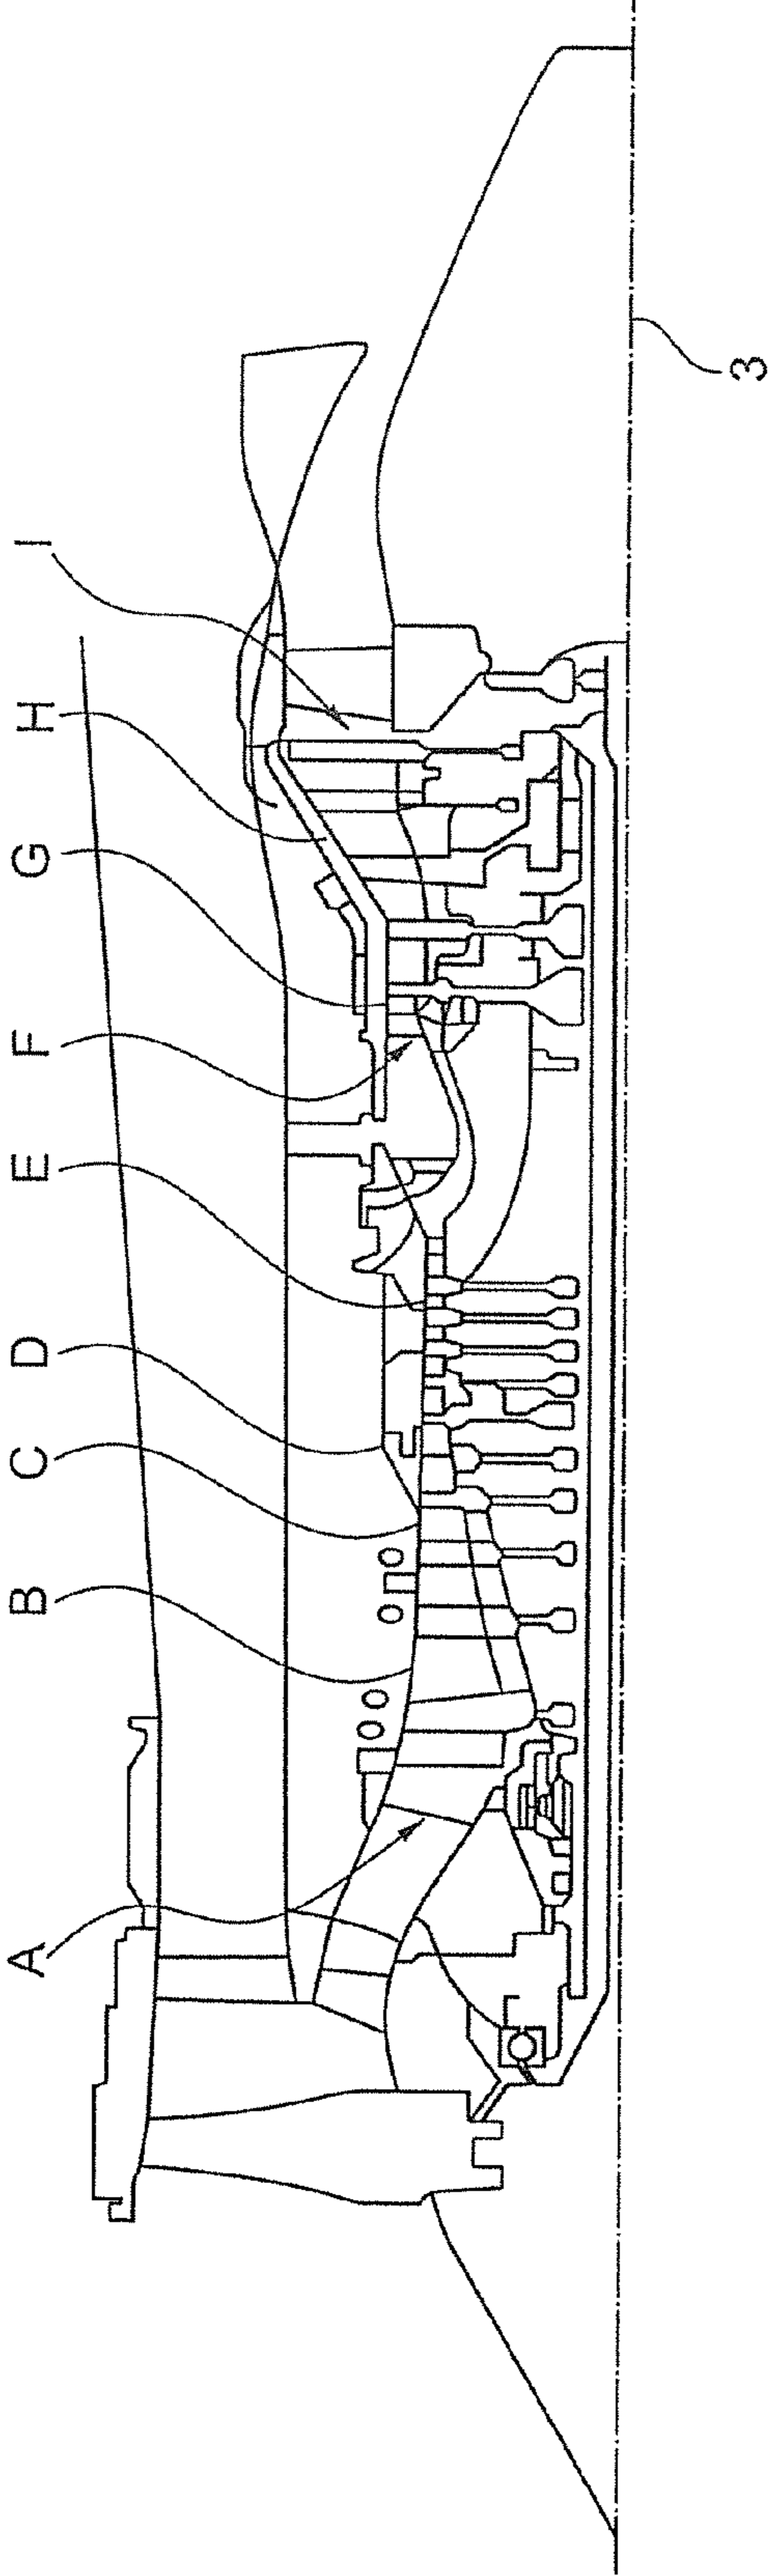
Fig. 2

FIG. 2 shows a schematic representation of a gas-turbine engine with accessibilities for boroscope work,

FIG. 2 schematically shows a partial axial sectional view of a gas-turbine engine with principal accessibilities for boroscope work. As can be seen here, access to a very wide range of areas of the gas-turbine engine is possible by the removal of attachments, by opening of access apertures and similar.

FIG. 2 shows the following elements/assemblies:

A High-pressure compressor rotor blades, stage 1, leading edge

B High-pressure compressor rotor blades, stage 1, trailing edge

E High-pressure compressor rotor blades, stage 9, trailing edge

F High-pressure turbine rotor blades, stage 1, leading edge
High-pressure turbine stator vanes, stage 1, combustion chamber

H High-pressure turbine rotor blades, stage 2, trailing edge

I Low-pressure turbine rotor blades, stage 2, trailing edge.

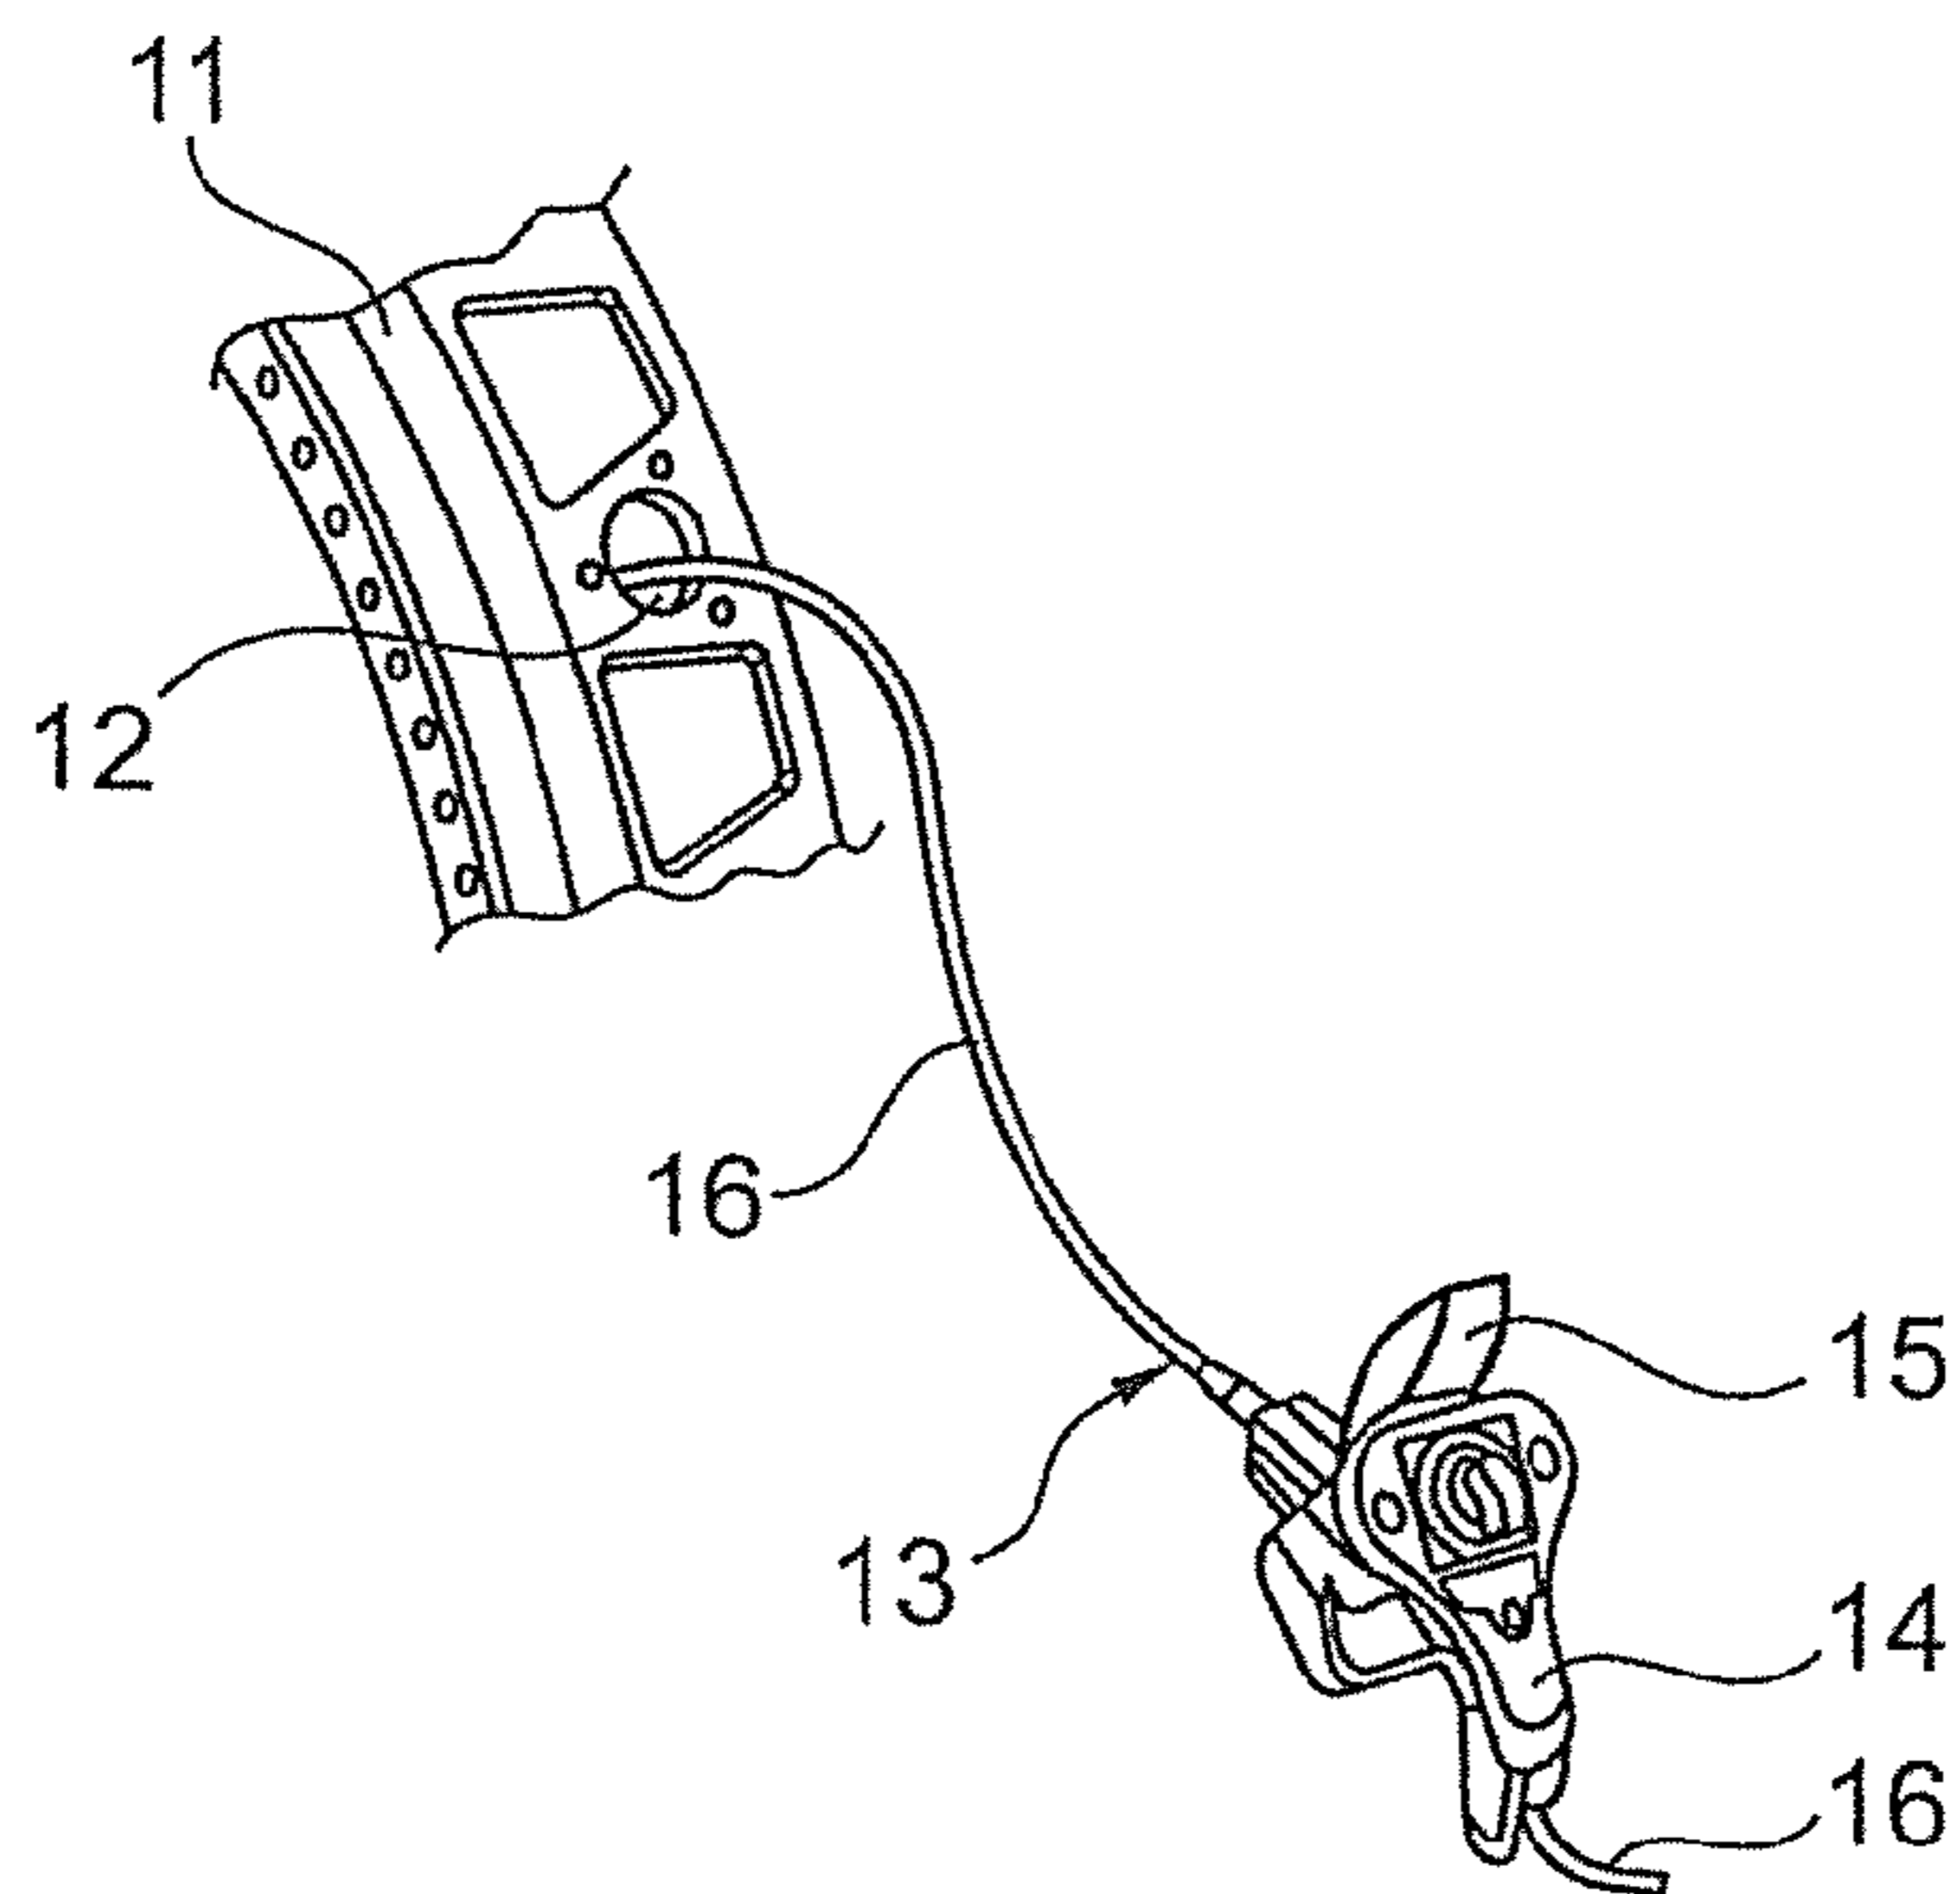
Fig. 3

FIG. 3 shows a simplified schematic representation of the use of various boroscope equipment and units,

25 FIG. 3 schematically shows the use of boroscope equipment in combination with the method in accordance with the invention. Here a part of a casing 11 is shown which is provided with a boroscope aperture 12 (access aperture). This can be provided by removal of a cover or by removal of a unit or similar. A manipulator 13 is introduced through the aperture 12 in order to remove and extract particles and/or to analyse them. A display and actuation unit, and/or the one control unit 14, permit by means of a monitor 15 checking and control of the work.

35 The manipulator 13 is linked to at least one hose 16 through which media can be supplied. The quantity of applied repair medium can be read off from a display. The control unit permits precise setting of the application speed.

It is understood that the representation in FIG. 3 shows the individual components and their mode of operation only in a very schematic form.

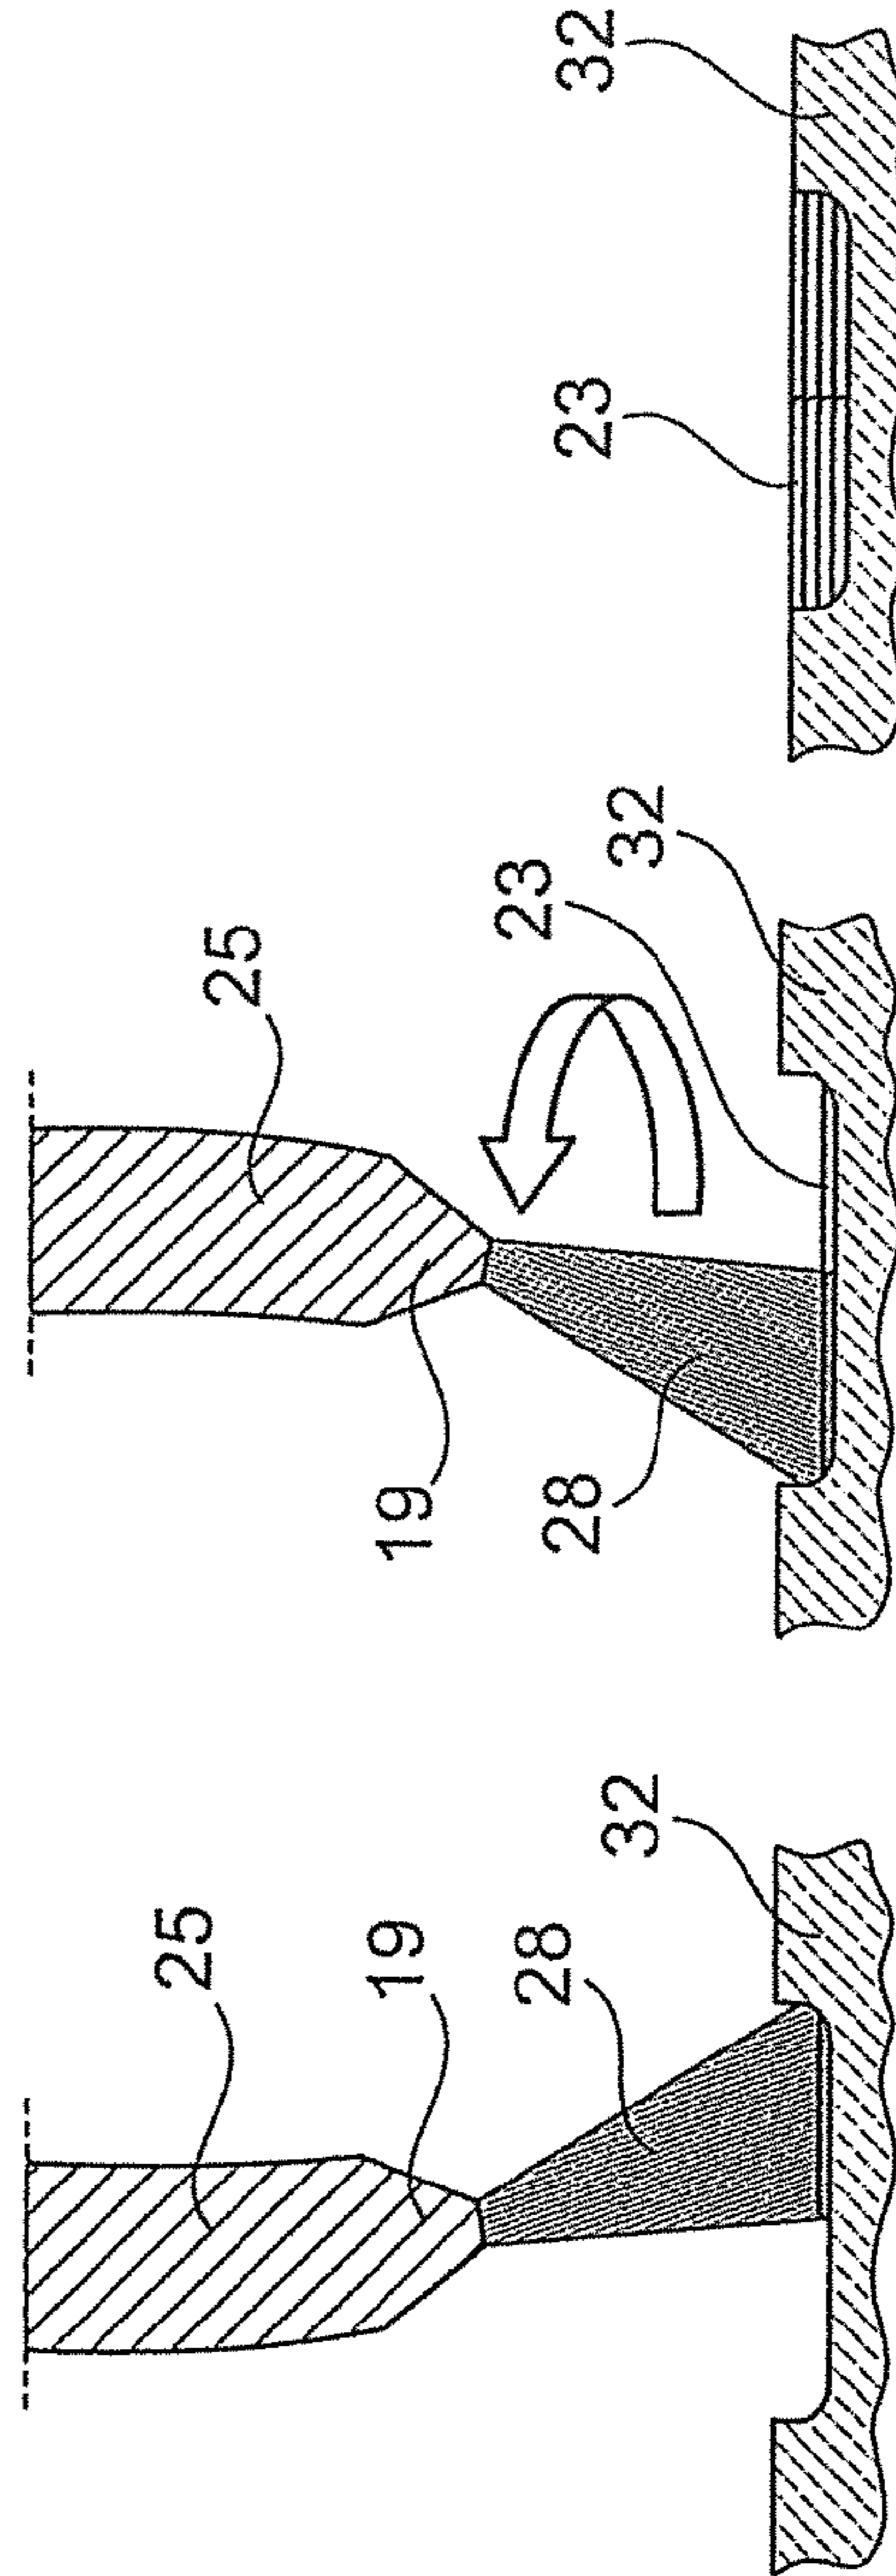
Fig. 5

FIG. 5 shows a functional principle of tool rotation for controlling the nozzle and the jet for applying several layers, and

FIG. 5 shows how the repair medium 23 is applied in thin layers next to and above one another. The left-hand half of FIG. 5 shows the application of a first layer by means of the jet 28. Once this has been applied, the next layer is applied as shown in the center of FIG. 5. The right-hand half of FIG. 5 shows the finished state, in which several individual layers of repair medium 23 have been applied to restore an abradable coating.
