(10) Patent No.: US 9,415,746 B1 (45) Date of Patent: Aug. 16, 2016

(54) VEHICLE SAFETY BELT BYPASS WARNING SYSTEM

(71) Applicant: INTERNATIONAL BUSINESS MACHINES CORPORATION,

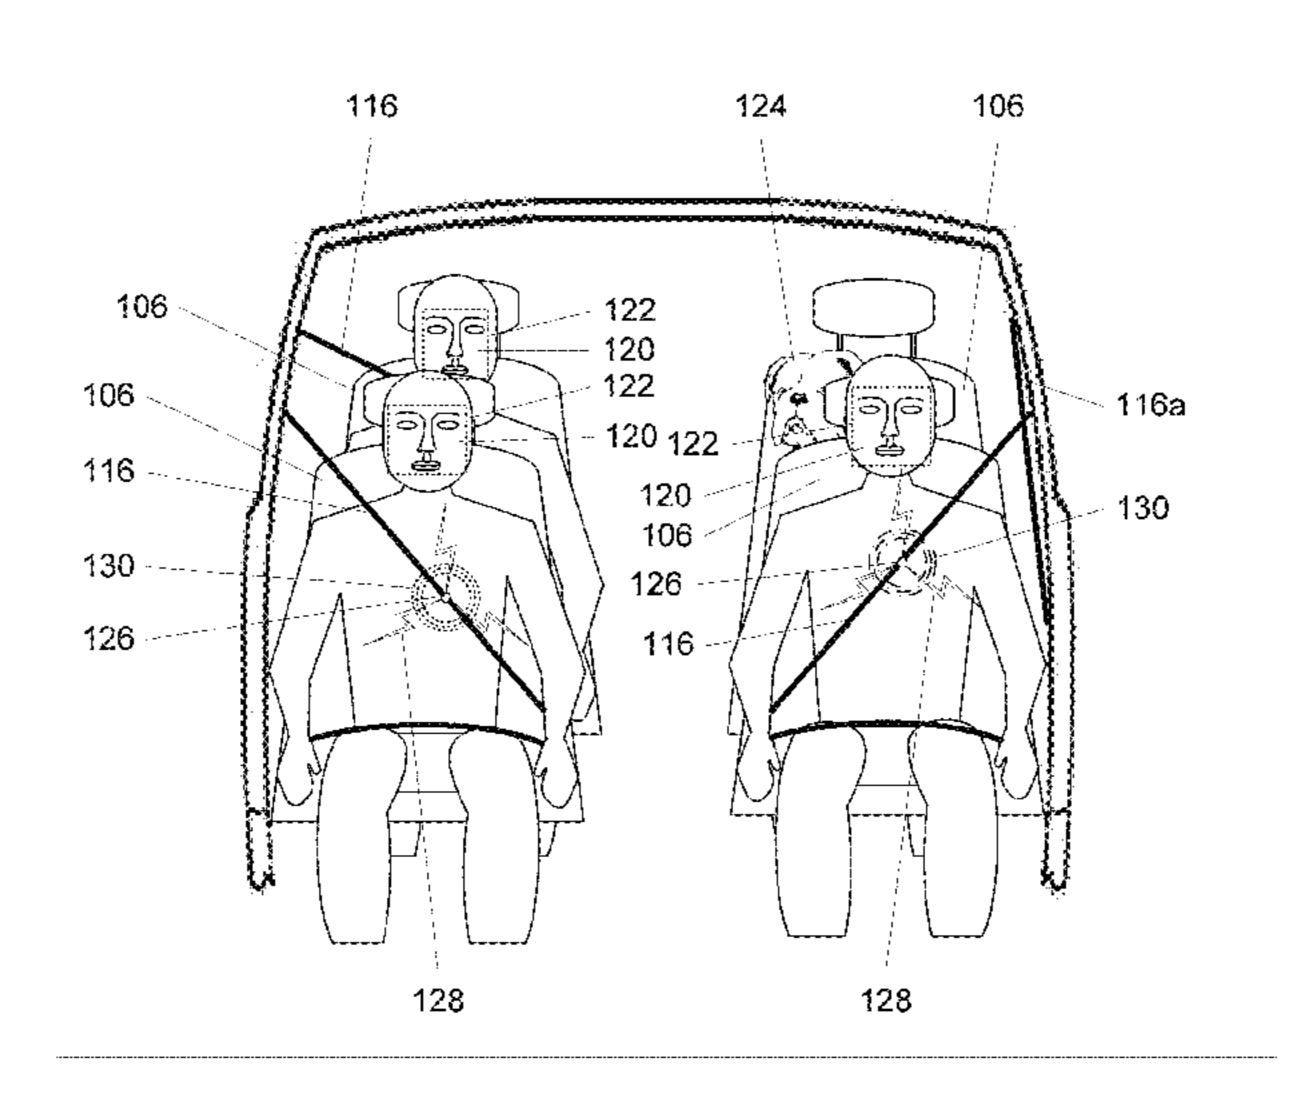
FIG. 1 illustrates, a simplified cutaway view of a portion of the interior of a vehicle 100 incorporating one example implementation of a safety belt bypass warning system as described herein.

As shown in FIG. 1, the system includes at least one video camera 102 located within the vehicle, for example, in the dashboard, binnacle, headliner, windshield frame, center console, etc. such that it has a field of view (between by the extreme lines 104a, 104b) encompassing the upper portion of at least two seats 106 within the vehicle 100.

FIG. 1 illustrates, a simplified cutaway view of a portion of the interior of a vehicle incorporating one example implementation of a safety belt bypass warning system as described herein;

Referring now to FIG. 1 and FIG. 2 in combination, the processor 112 running the face detection software 108 searches for faces in the vehicle within the field of view boundaries 104a, 104b of the video camera 102. The face detection software 108 program is a computer program that can detect a human face and differentiate it from the face of, for example, a dog. The program is implemented as a less 40 sophisticated version of facial recognition software because it need only recognize the existence of a human face, as opposed to being able to discern human features at a resolution sufficient to match them with other images to detect the same person.

Returning now to FIG. 1, the safety belt bypass warning system also includes at least one, and possibly more, IR receiver(s) 132 positioned within the vehicle 100, for example, in one or more of the dashboard, binnacle, rearview mirror or its mount, the sun visor mountings, A pillar, B-pillar, C-pillar, headliner, center console, etc. and directed towards at least one seat 106 such that the coded IR signal from at least one IR emitter output 126 of an occupied seat 106 can be received. The IR receiver(s) 132 are each enabled when an IR emitter output 126 is enabled.

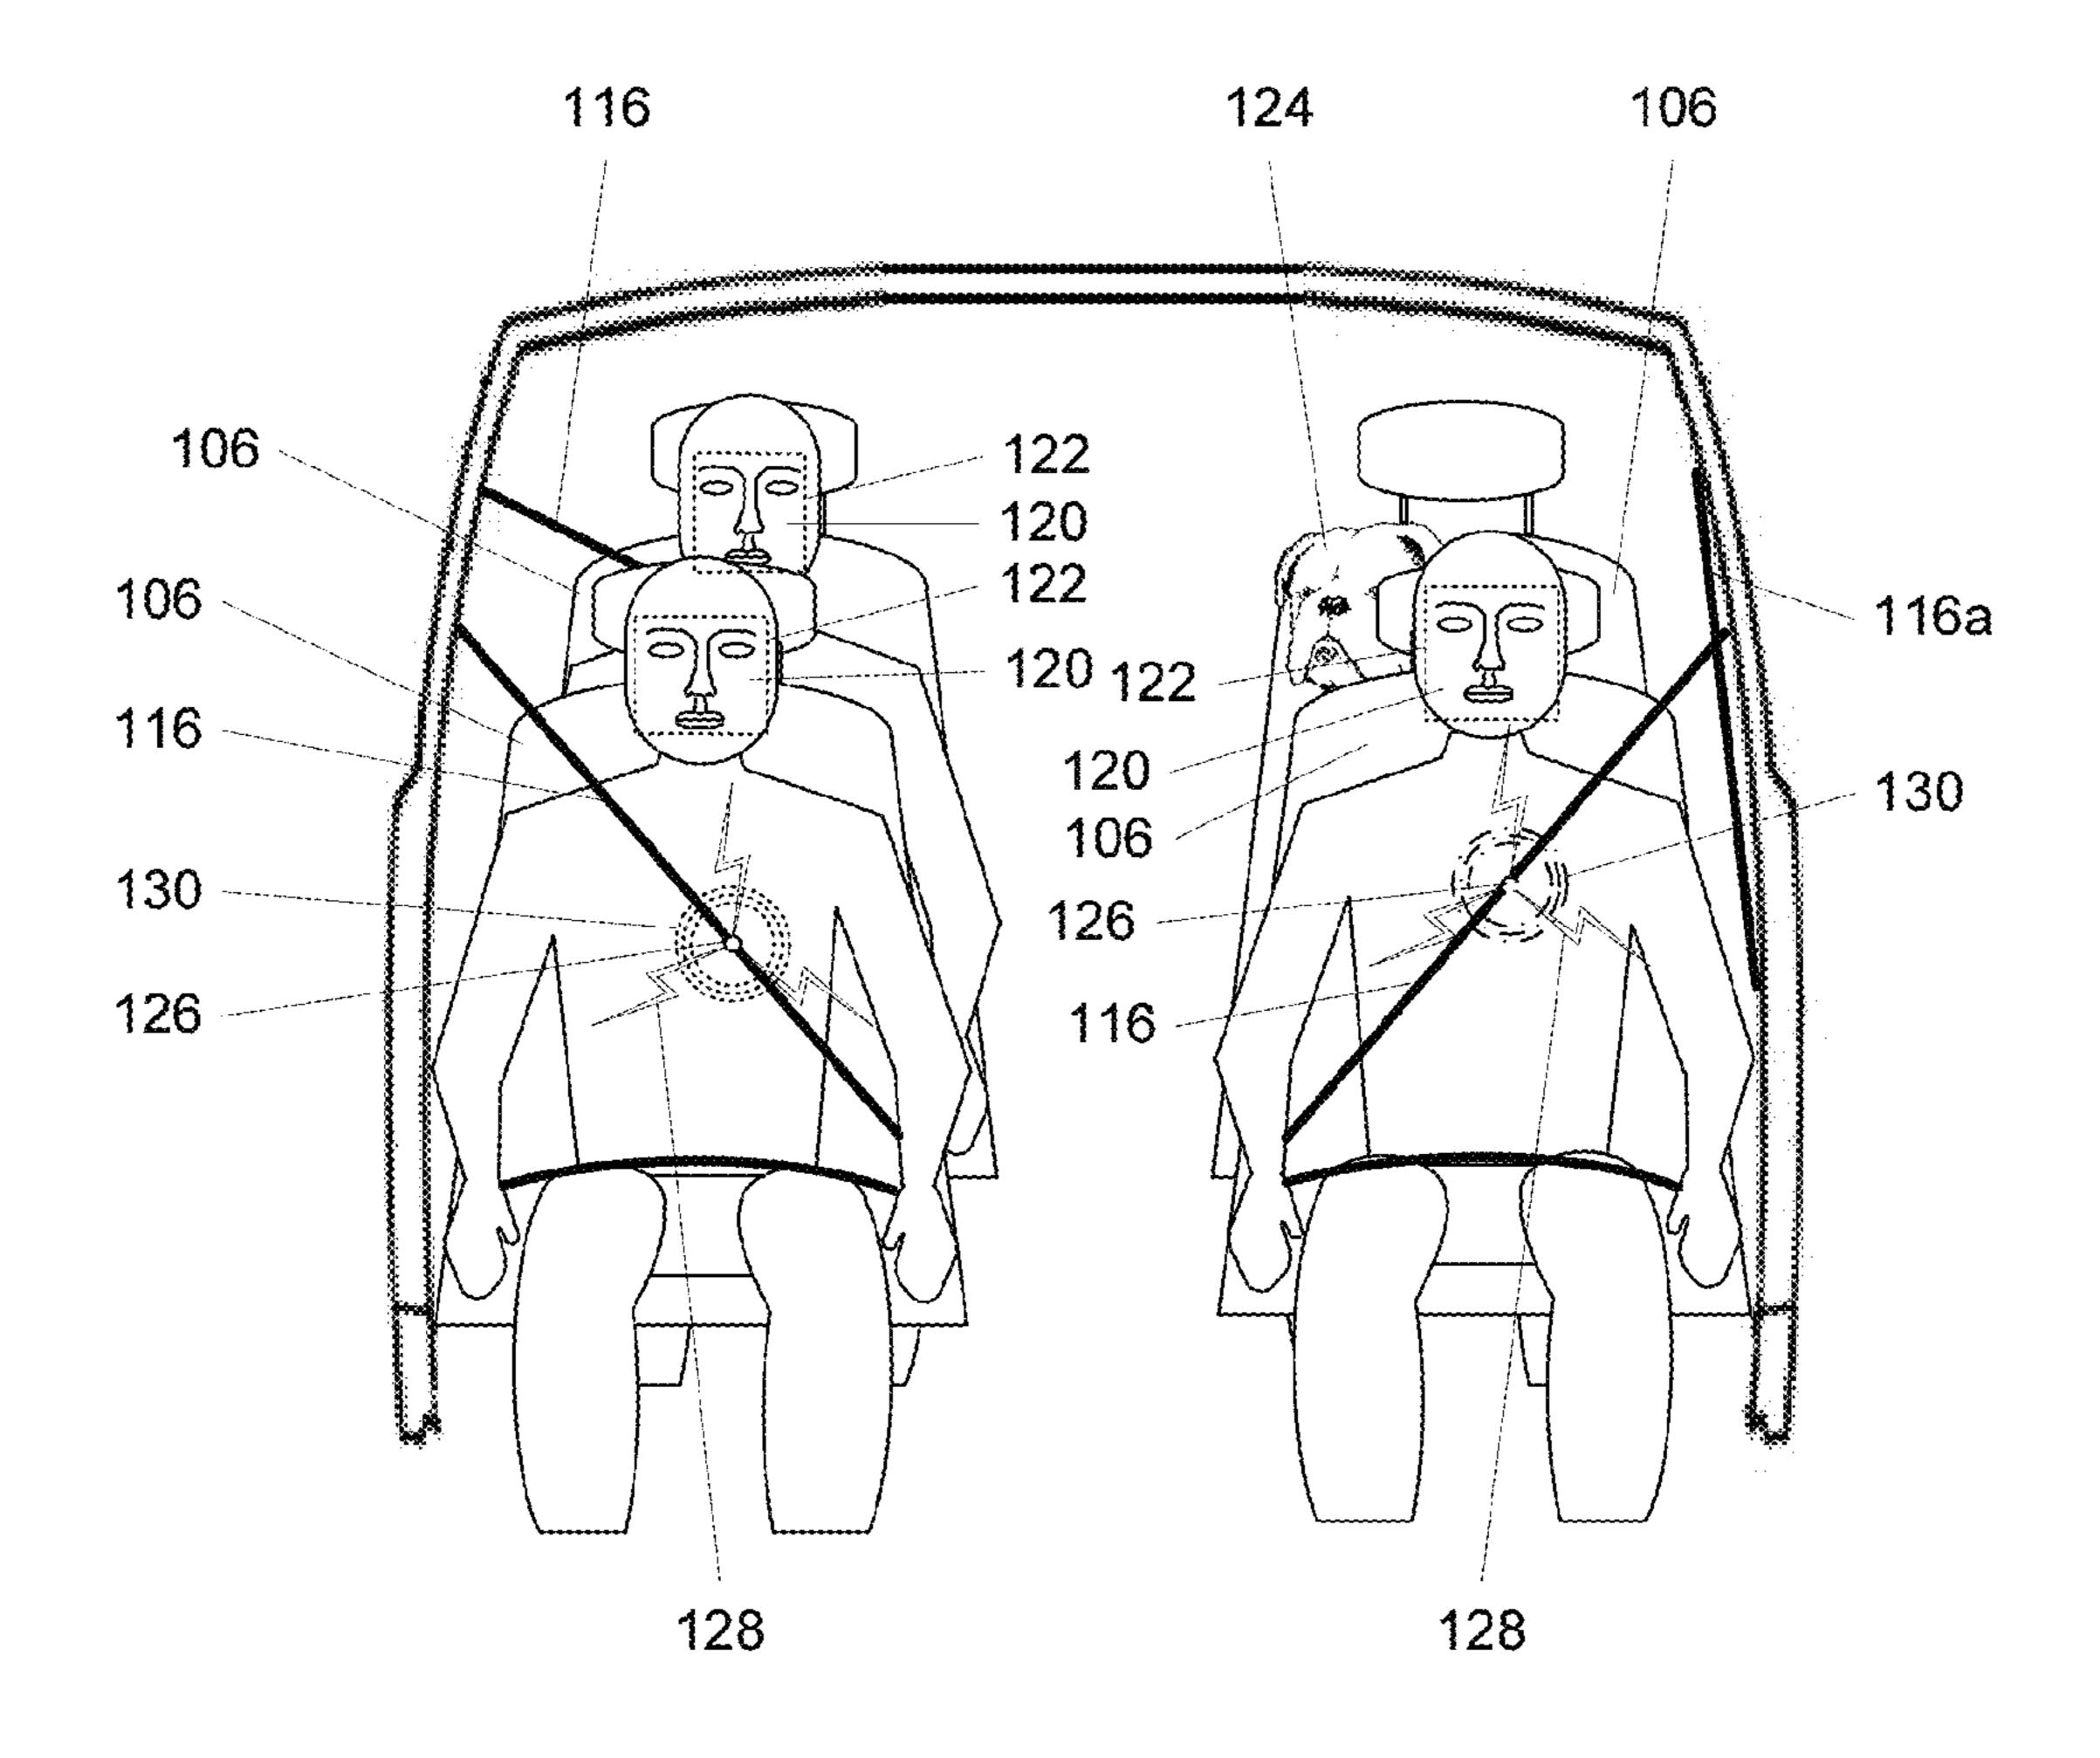
FIG. 2 illustrates, in simplified form, a cutaway view of a vehicle, viewed from the front of the vehicle;

FIG. 2 illustrates, in simplified form, a cutaway view of a 20 vehicle 100, viewed from the front of the vehicle 100. As shown in FIG. 2, the vehicle has four occupants.

As shown, using this approach, human faces 120 have been detected for three of the seats 106 within parts 122 of the field of view. In contrast, despite a heavy dog 124 being present behind the driver 126, since the face detection software 108 did not detect a human face, only the driver's seat, front 50 passenger seat and rear seat behind the front passenger seat are each considered an "occupied seat" for purposes of the safety belt bypass warning system as described herein.

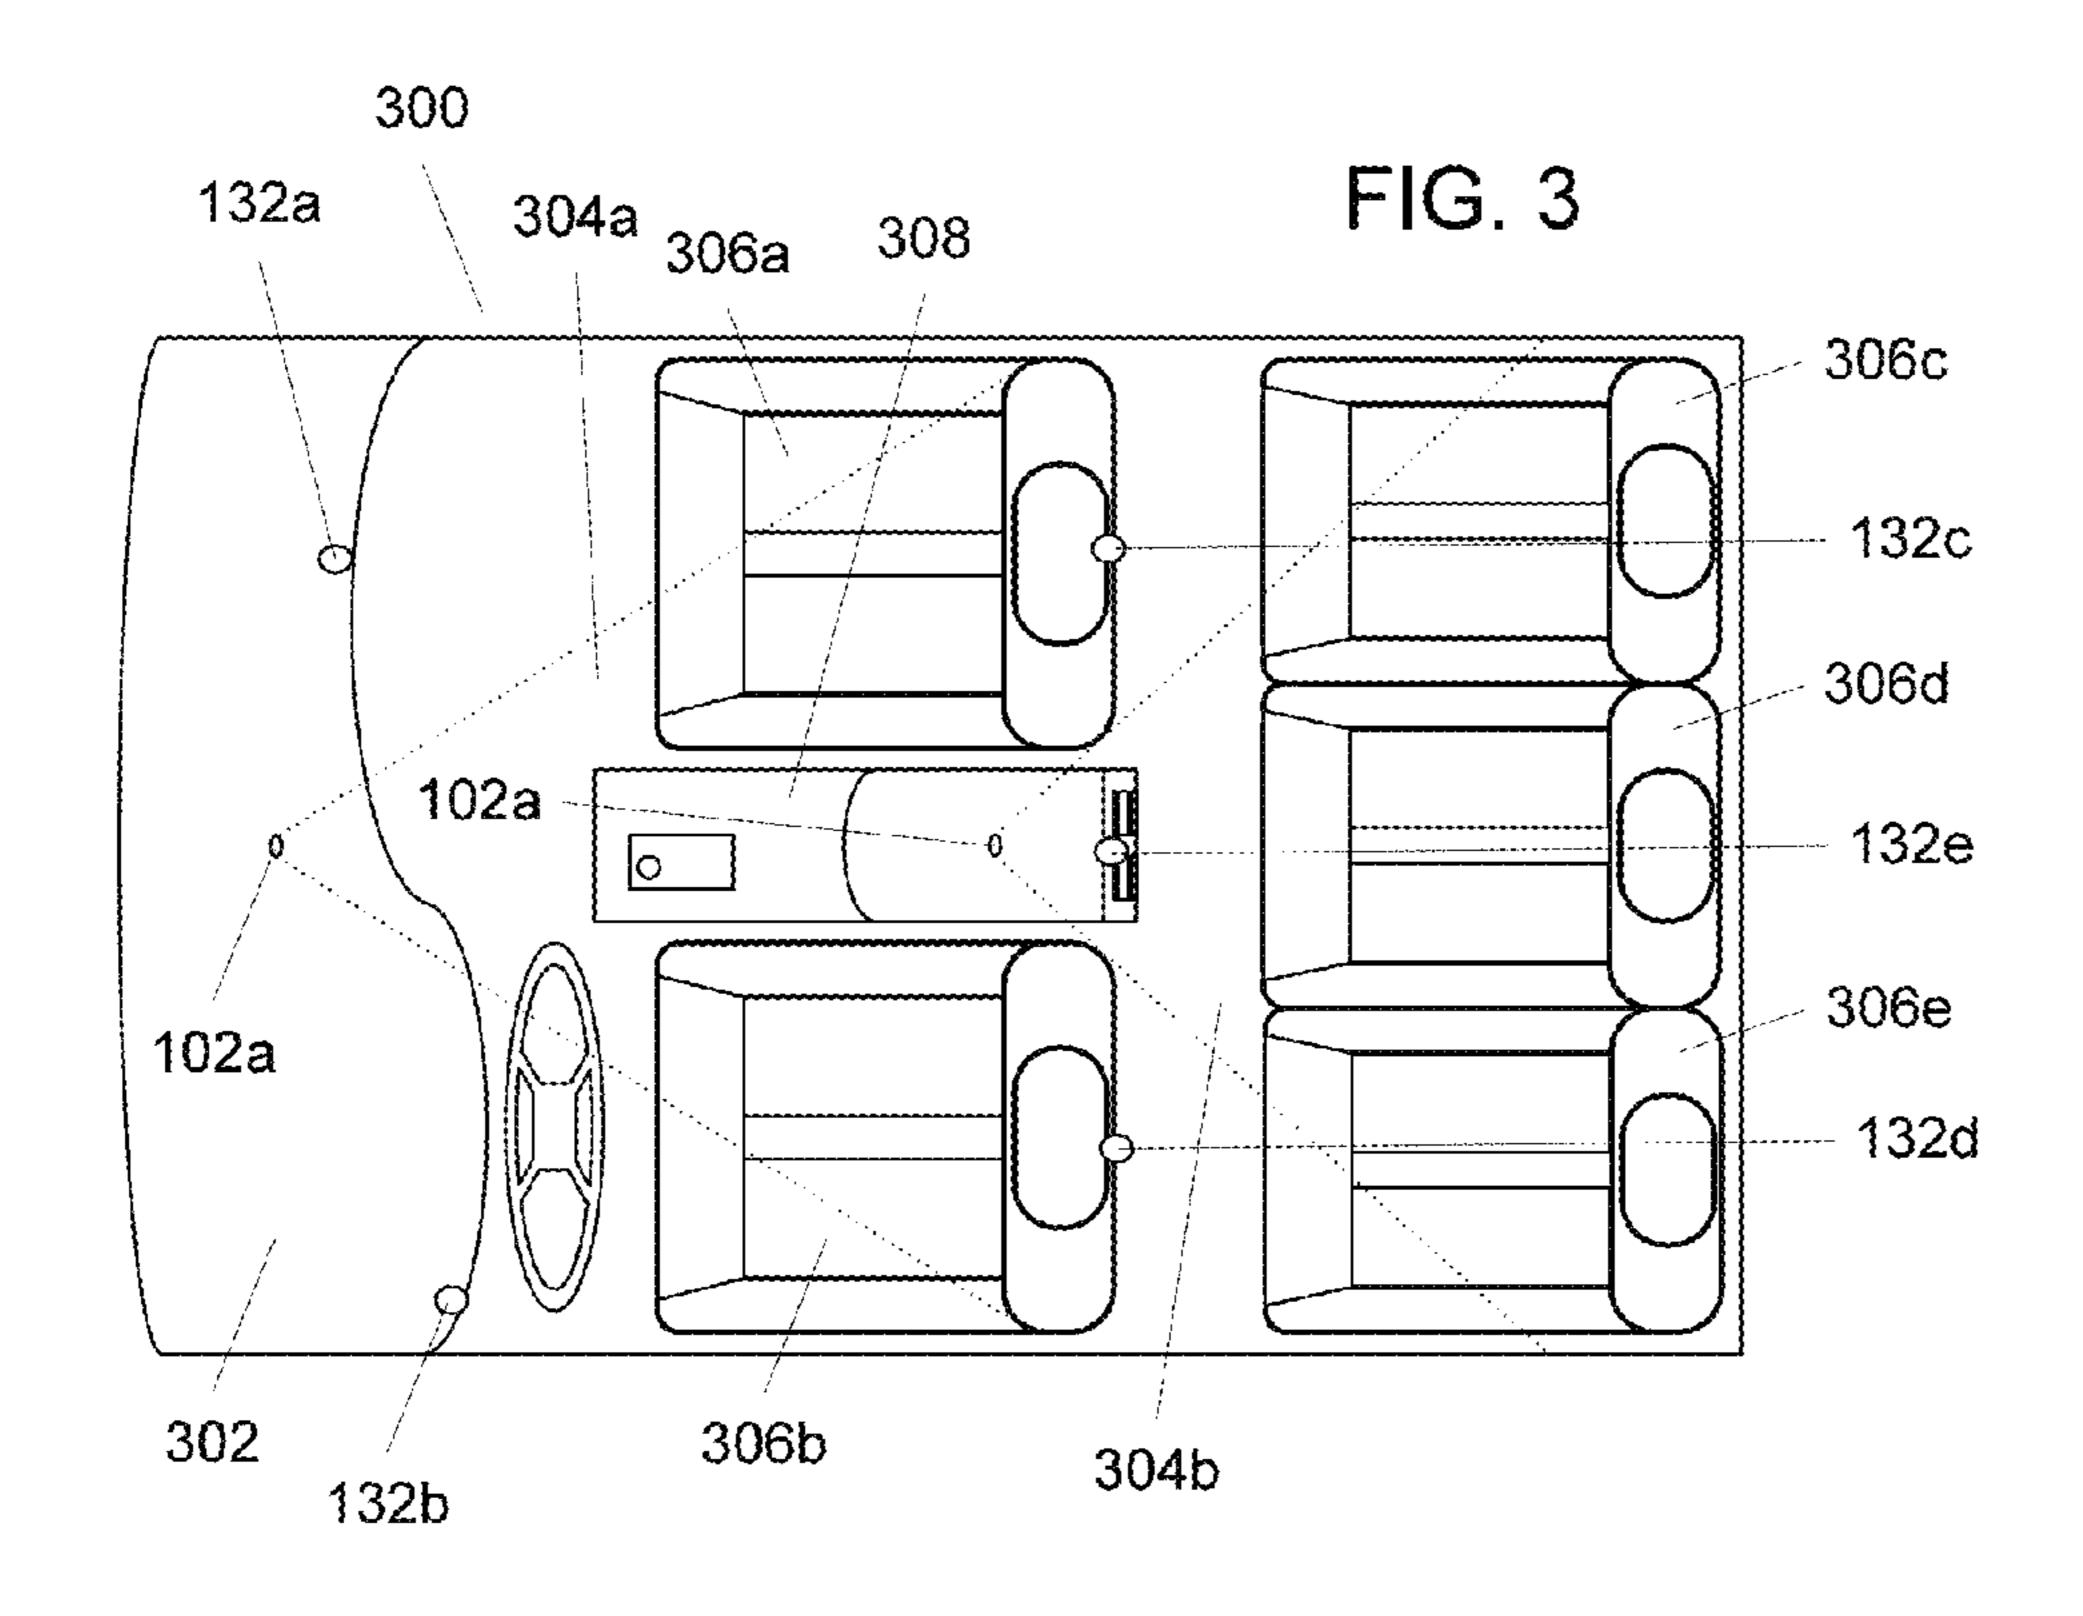
FIG. 3 illustrates, in simplified form, an overhead view of a vehicle interior showing one example placement for video camera(s) and IR receiver(s) as described herein;

FIG. 3 illustrates, in simplified form, an overhead view of a vehicle interior 300 showing one example placement for video camera(s) 102 and IR receiver(s) 132 as described 35 herein. As shown, in FIG. 3, a video camera 102a near the headliner (not shown) above the dashboard 302 has a field of view 304a (between the dotted lines) encompassing the two front seats 306a, 306b and the center seat 306d in the rear. The video camera 102b near the headliner (not shown) above the view 304b (between the dotted lines) encompassing all three back seats 306c, 306d, 306e.

There are also two IR receivers 132a, 132b on the dash-board 302, two IR receivers 132c, 132d in the back of the head 45 restraints of the front seats 306a, 306b, and one in the center console 308, each directed at an individual corresponding seat such that each will receive coded IR light pulses from one safety belt's IR emitter output(s) 126.

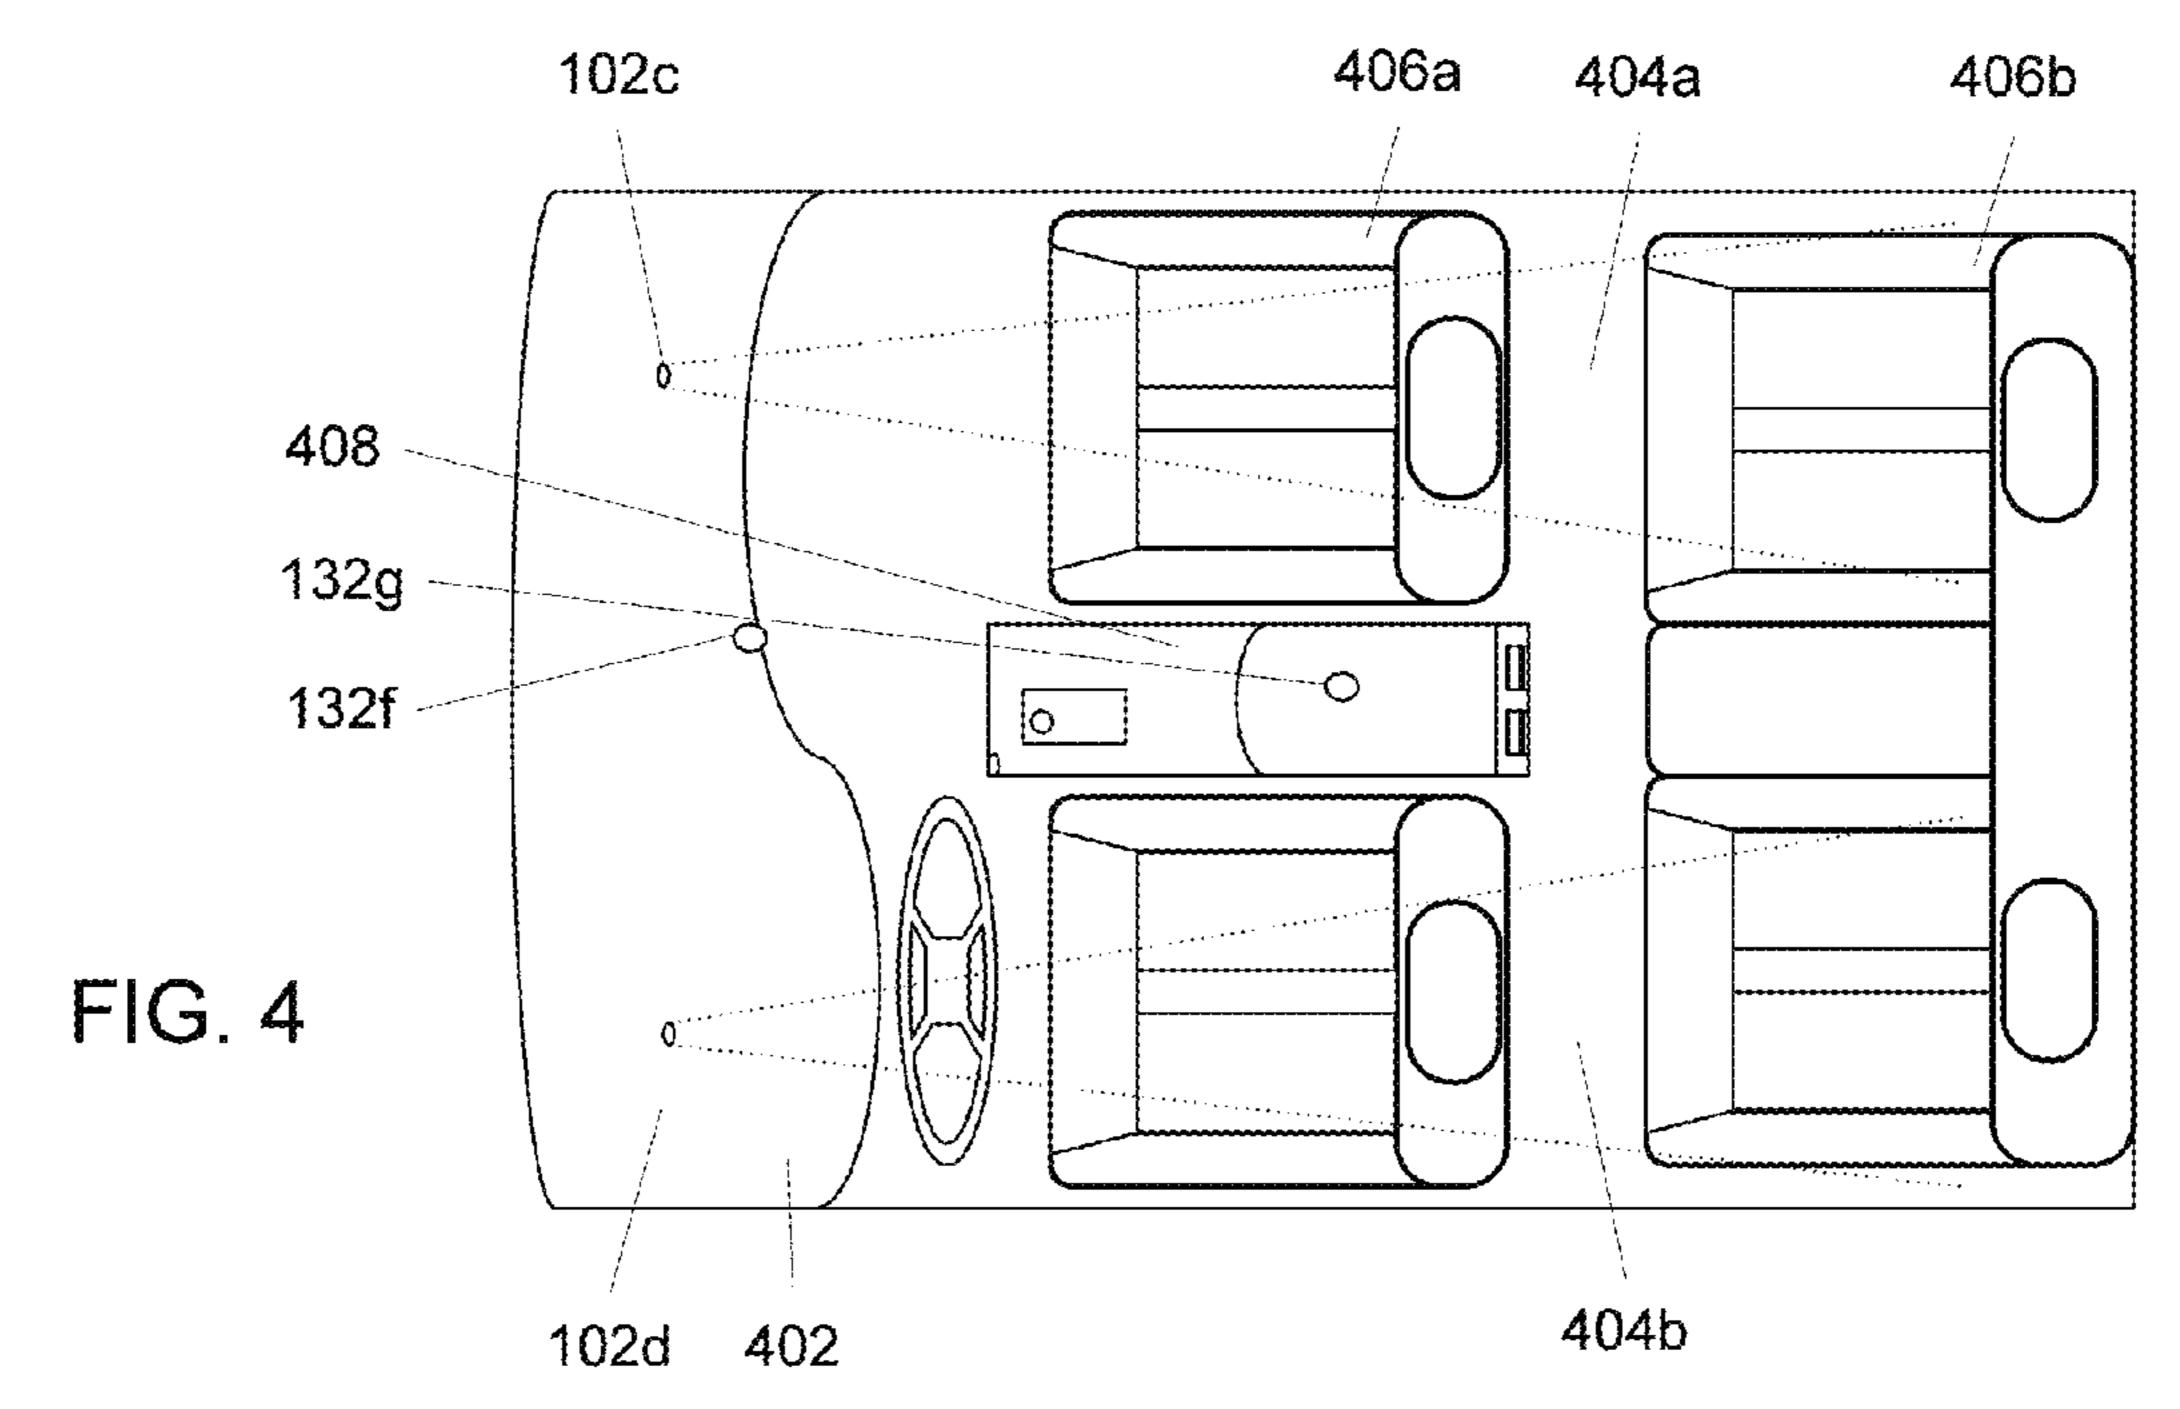
FIG. 4 illustrates, in simplified form, an overhead view of a vehicle interior showing another alternative example placement for video camera(s) and IR receiver(s) as described herein; and

FIG. 4 illustrates, in simplified form, an overhead view of a vehicle interior 400 showing another alternative example placement for video camera(s) 102 and IR receiver(s) 132 as described herein. As shown in FIG. 4, there are two video cameras 102c, 102d near the headliner (not shown) above the dashboard 402. Each video camera 102c, 102d has a field of 55 view 404a, 404b (between the respective dotted lines) that respectively encompass two seats, a front seat 406a and back seat 406b on the passenger side and a front seat 406c and back seat 406d on the driver's side.

There are also two IR receivers 132f, 132g located, for the front of the vehicle, near the rear-view mirror (not shown), so that it can receive coded IR light pulses from the IR emitter output(s) 126 from the safety belts of the front seats, and for the rear of the vehicle, above the center console near a central interior light, so that it can receive coded IR light pulses from 65 the IR emitter output(s) 126 of the safety belts of the two rear seats 406b, 406d.

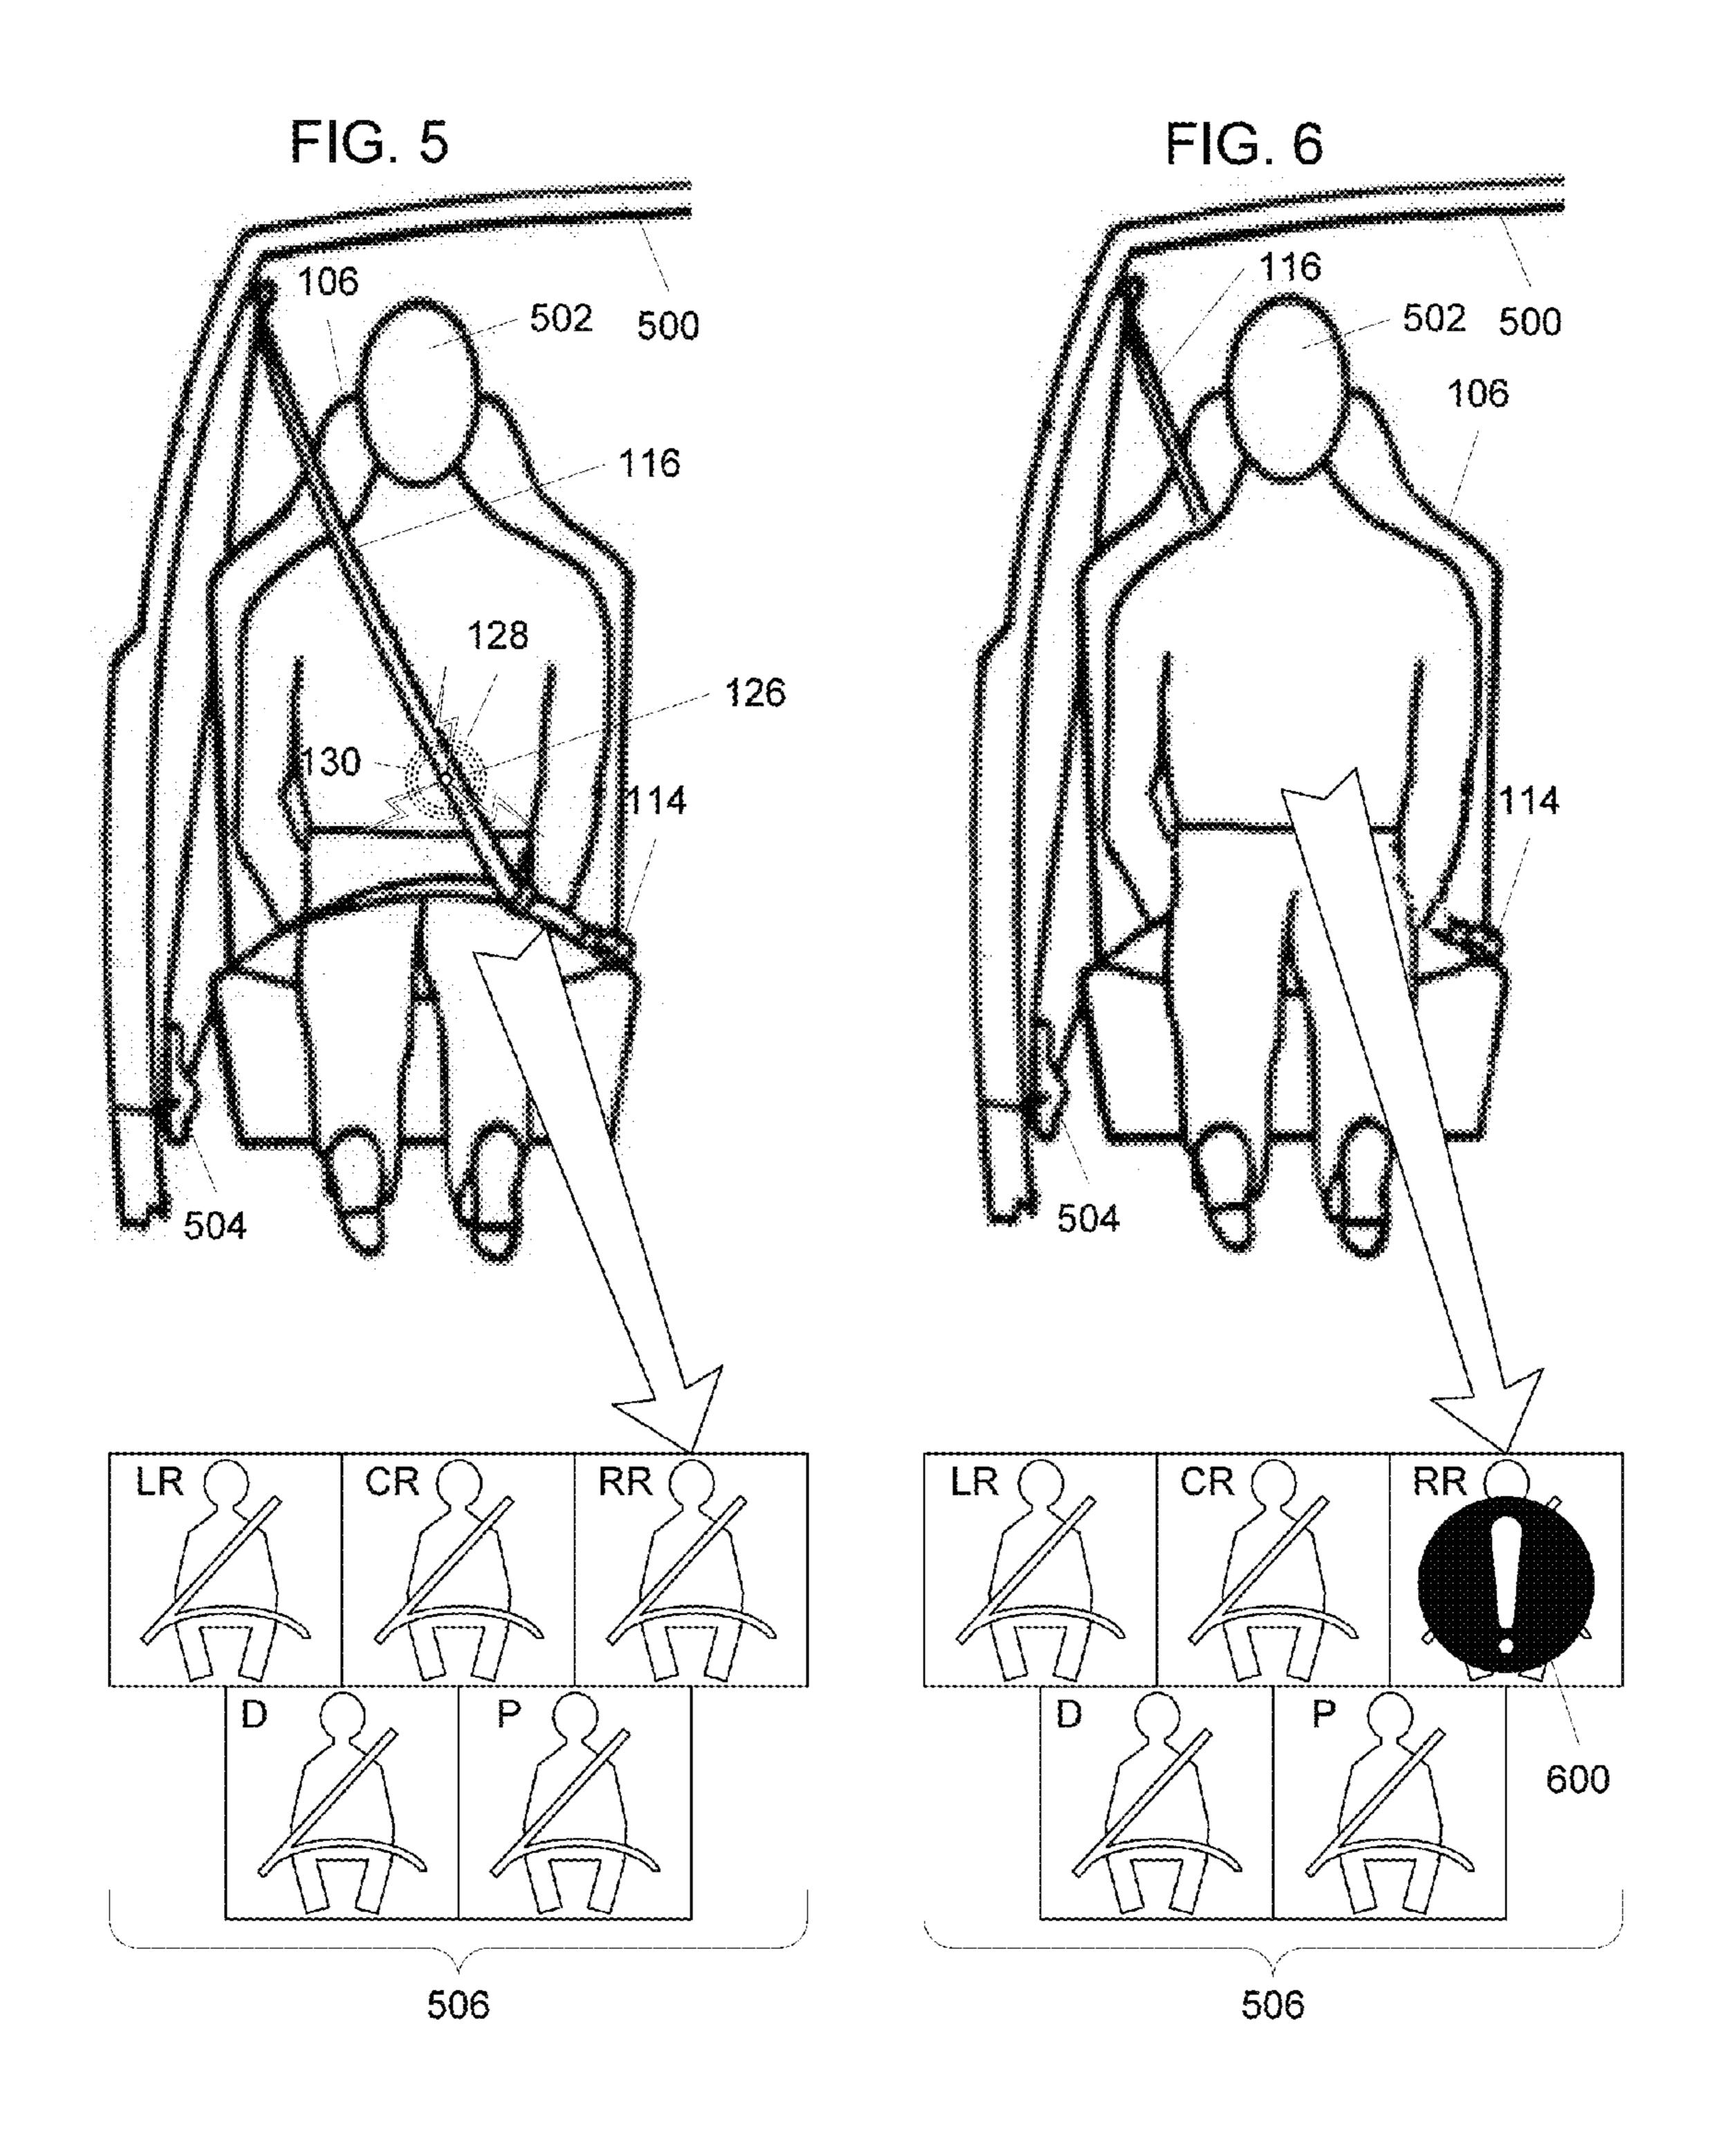
FIGS. 5-6 collectively illustrate, in simplified form, one example of safety belt bypass warning indication.

FIGS. **5-6** collectively illustrate, in simplified form, one example of safety belt bypass warning indication.

As shown in FIG. 5, a vehicle's 500 occupant 502 is seated in a seat 106 behind the passenger seat of the vehicle 500, has retracted their safety belt from the retractor 504 and is wearing their safety belt 116 properly. The ignition has already been engaged and the IR emitter output 126 is outputting its coded 128 light pulses 130. Since the coded 128 light pulses 130 were received by an IR receiver (not shown) and the processor (not shown) matched the corresponding coded electrical signal it received, none of the dashboard warning indicators 506 for the individual seats of the vehicle 500 have been triggered.

In contrast, as shown in FIG. 6, the vehicle's 500 occupant 502 is now seated in the same seat 106 of the vehicle 500 but latched the safety belt before sitting so that the safety belt engagement sensor circuit 114 indicates that the occupant 502 is wearing their safety belt 116. As a result, although the IR emitter output 126 is outputting its coded 128 light pulses 130, since it is behind and blocked by the occupant 502, the corresponding IR receiver in the vehicle 500 cannot receive them. As a result, the processor (not shown) does not receive the coded electrical signal for this occupied seat, so it triggers a warning indication 600 on the corresponding dashboard warning indicators 506 to indicate that the safety belt for that particular seat has been bypassed.
