US009581279B1

(54) **MULTI-LAYERED CONDUIT REPAIR SYSTEM**

A conduit repair liner includes at least two sheets of planar material that are connected to each other as pages of a book and coated with silica resin then closed against one another to form the conduit repair liner for wrapping around a carrier. The conduit repair liner includes a feature for removably affixing the conduit repair liner to the carrier during positioning within a failed conduit.

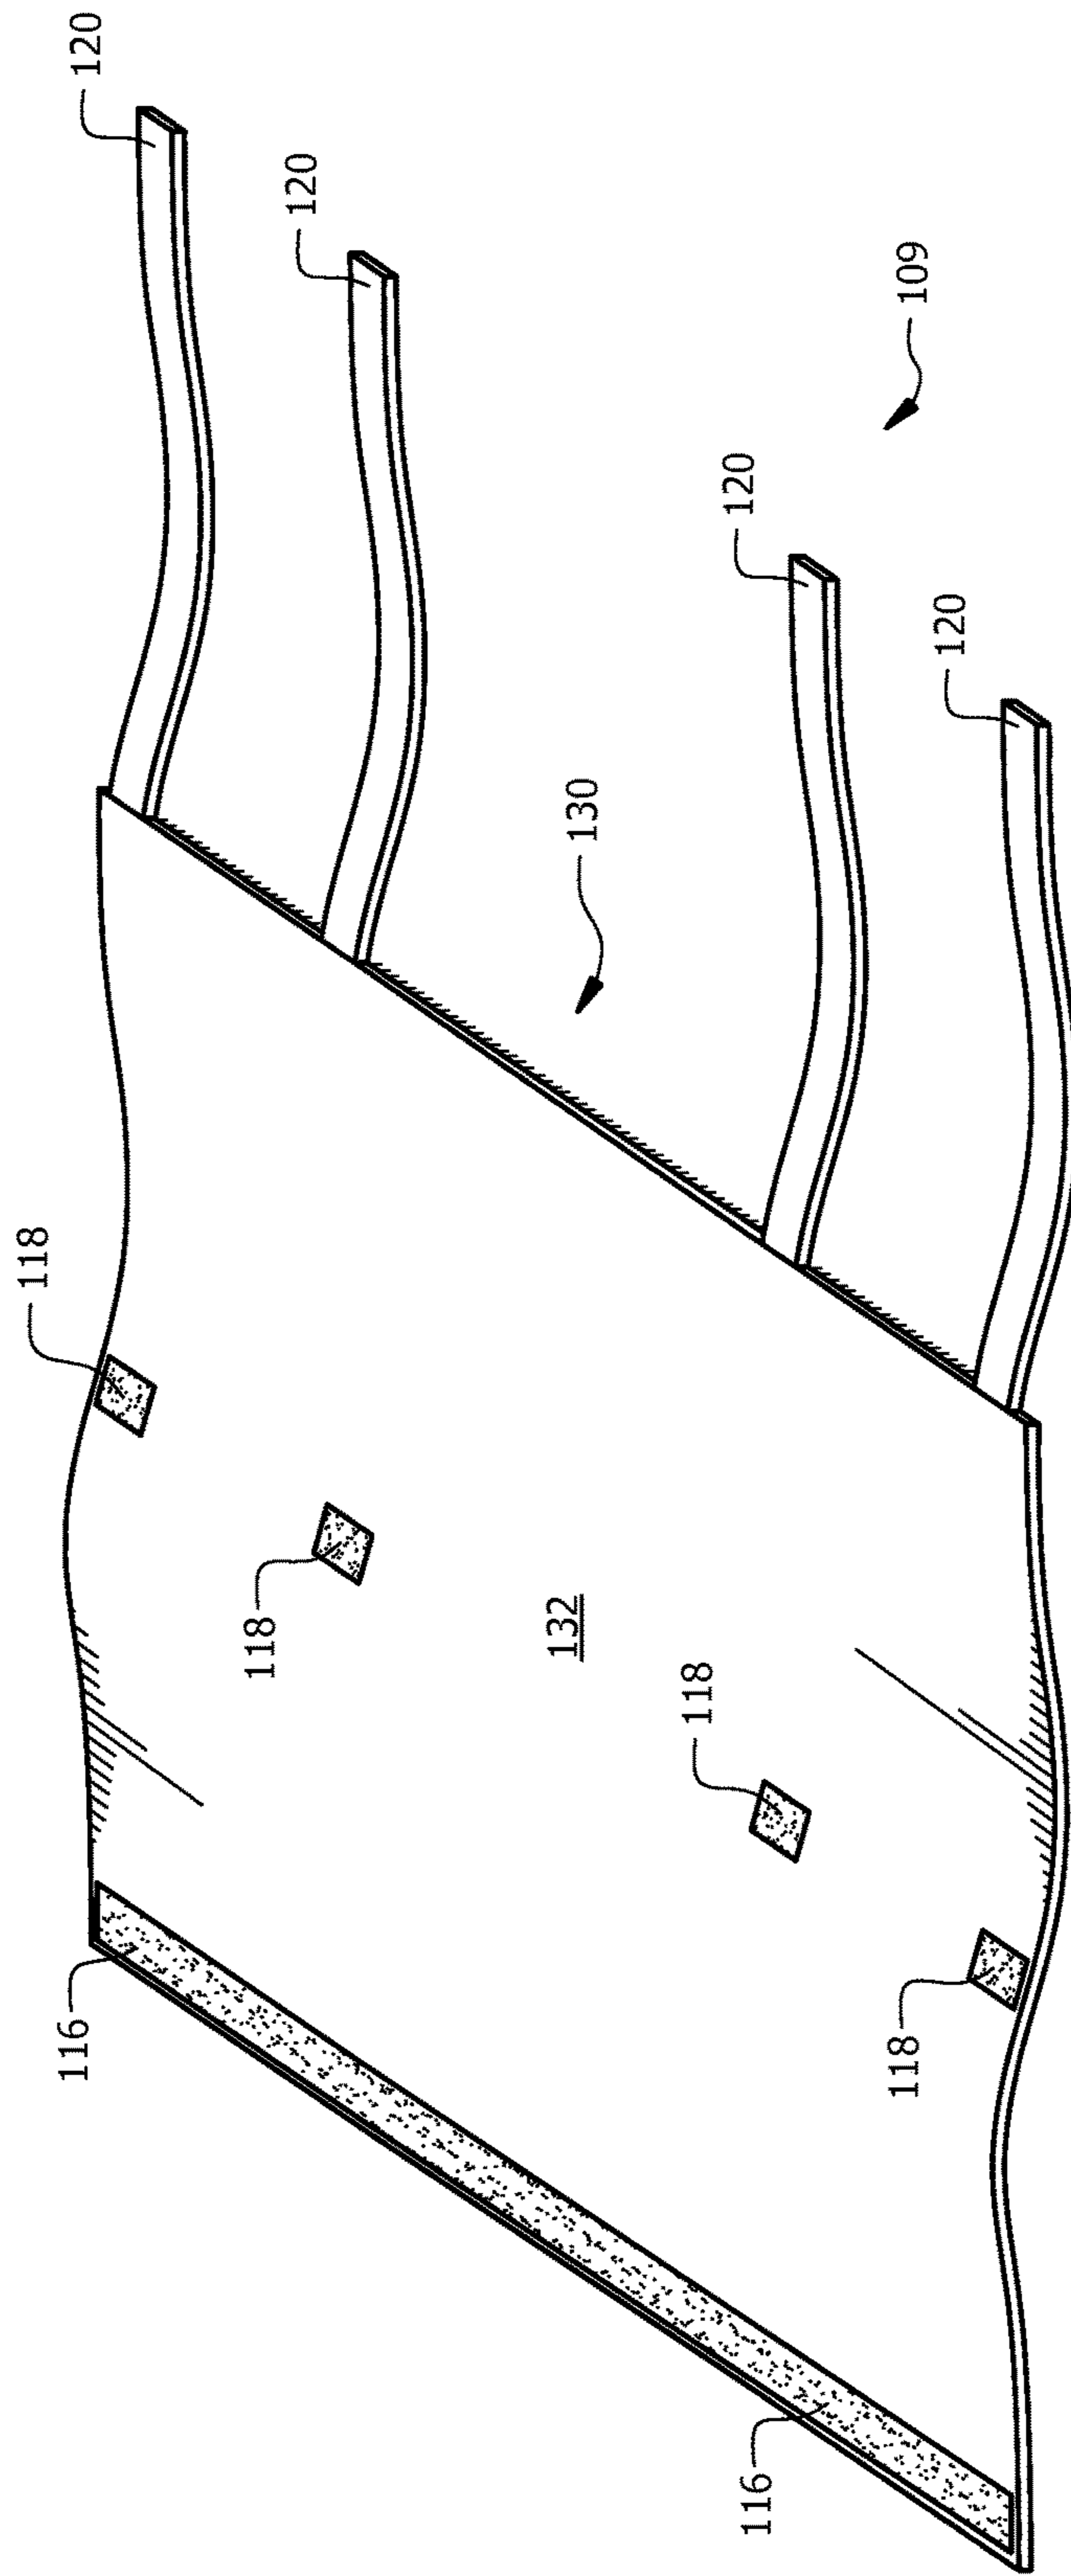
FIG. 1
(Prior Art)

FIG. 1 illustrates a perspective view of a conduit repair system liner of the prior art.

Referring to FIG. 1, an exemplary conduit repair liner 109 of the prior art is shown. Such a conduit repair liner 109 is used to repair pipe in situ, without requiring excavation around the pipe. Any type of pipe/plumbing is anticipated including PCV pipe, plastic pipe, iron pipe, copper pipe, etc.

This conduit repair liner 109 that is substantially planar and is made of materials that will soak up epoxy resin. This conduit repair system liner 109 has hook/loop material 116 at an end and a central section 130. The central section 130 typically comprises a material 132 that absorbs the resin, such as felt or felt and woven fiberglass, etc. In some liners 109 of the prior art, woven reinforcement material is included for added strength, for example, a layer of absor-

bent material such as felt, a layer of reinforcement material, and another layer absorbent material. Attached to this liner 109 are straps 120 that help to secure the liner 109 to a carrier similar to the carrier 80 shown in FIG. 9 after the liner 109 is saturated with epoxy resin. The straps 120 adhere to the hook and loop material patches 118 to hold the liner 109 to the carrier, but when the carrier is inflated, the bond of the hook and loop material breaks, permitting the liner 109 to expand outwardly to contact inner walls of the failed conduit 2 (see FIGS. 10A and 10B). Such a liner system 109 is sufficient for epoxy resin, but will not work well with silica resin, as silica resin does not readily absorb into the material used in this liner 30. As discussed prior, silica resin is desirable because it has a longer working time than epoxy resin.

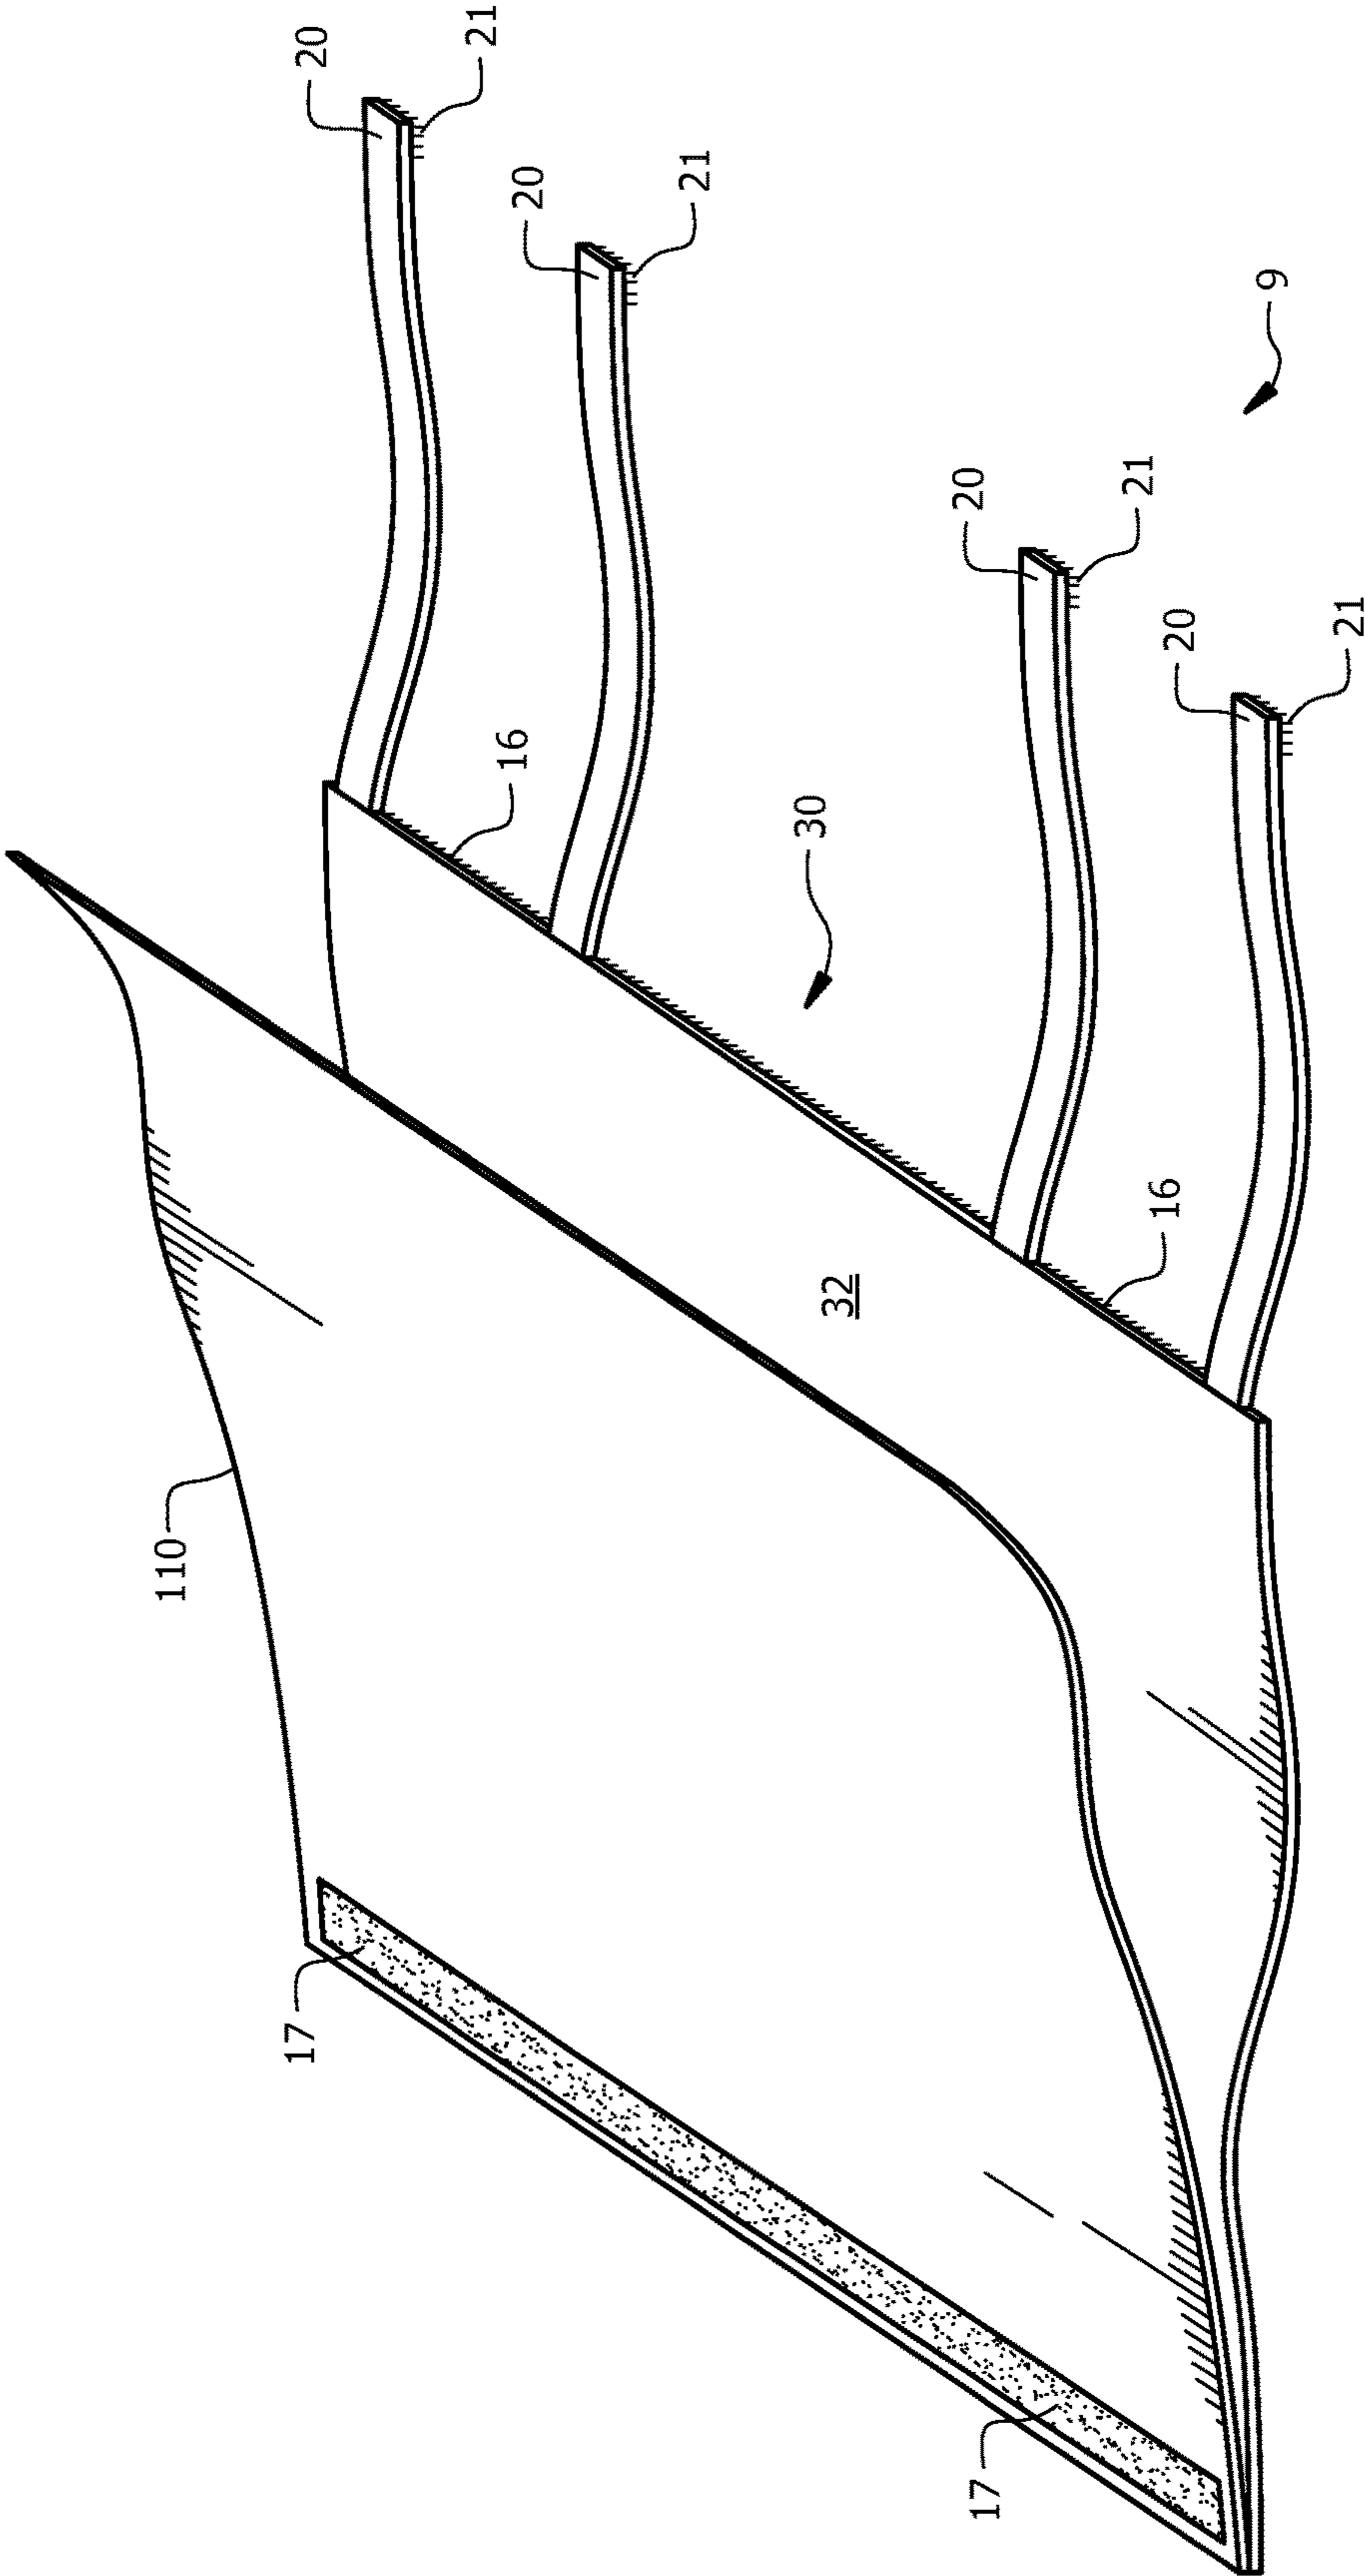
FIG. 2 illustrates a perspective view of a conduit repair system liner with two layers bound as a book along one edge.

Referring to FIG. 2 the conduit repair system liner 9 is shown in book form having two sheets of a planar material 30. A first sheet of planar material 32 is attached to the second sheet of planar material 110 along an edge. In this, the silica resin is applied to the sheets of planar material 32/110, the sheets of planar material 30 are closed (e.g. as a book is closed) and then the liner 9 is wrapped around the carrier 80 for insertion and repair of the failed conduit 2.

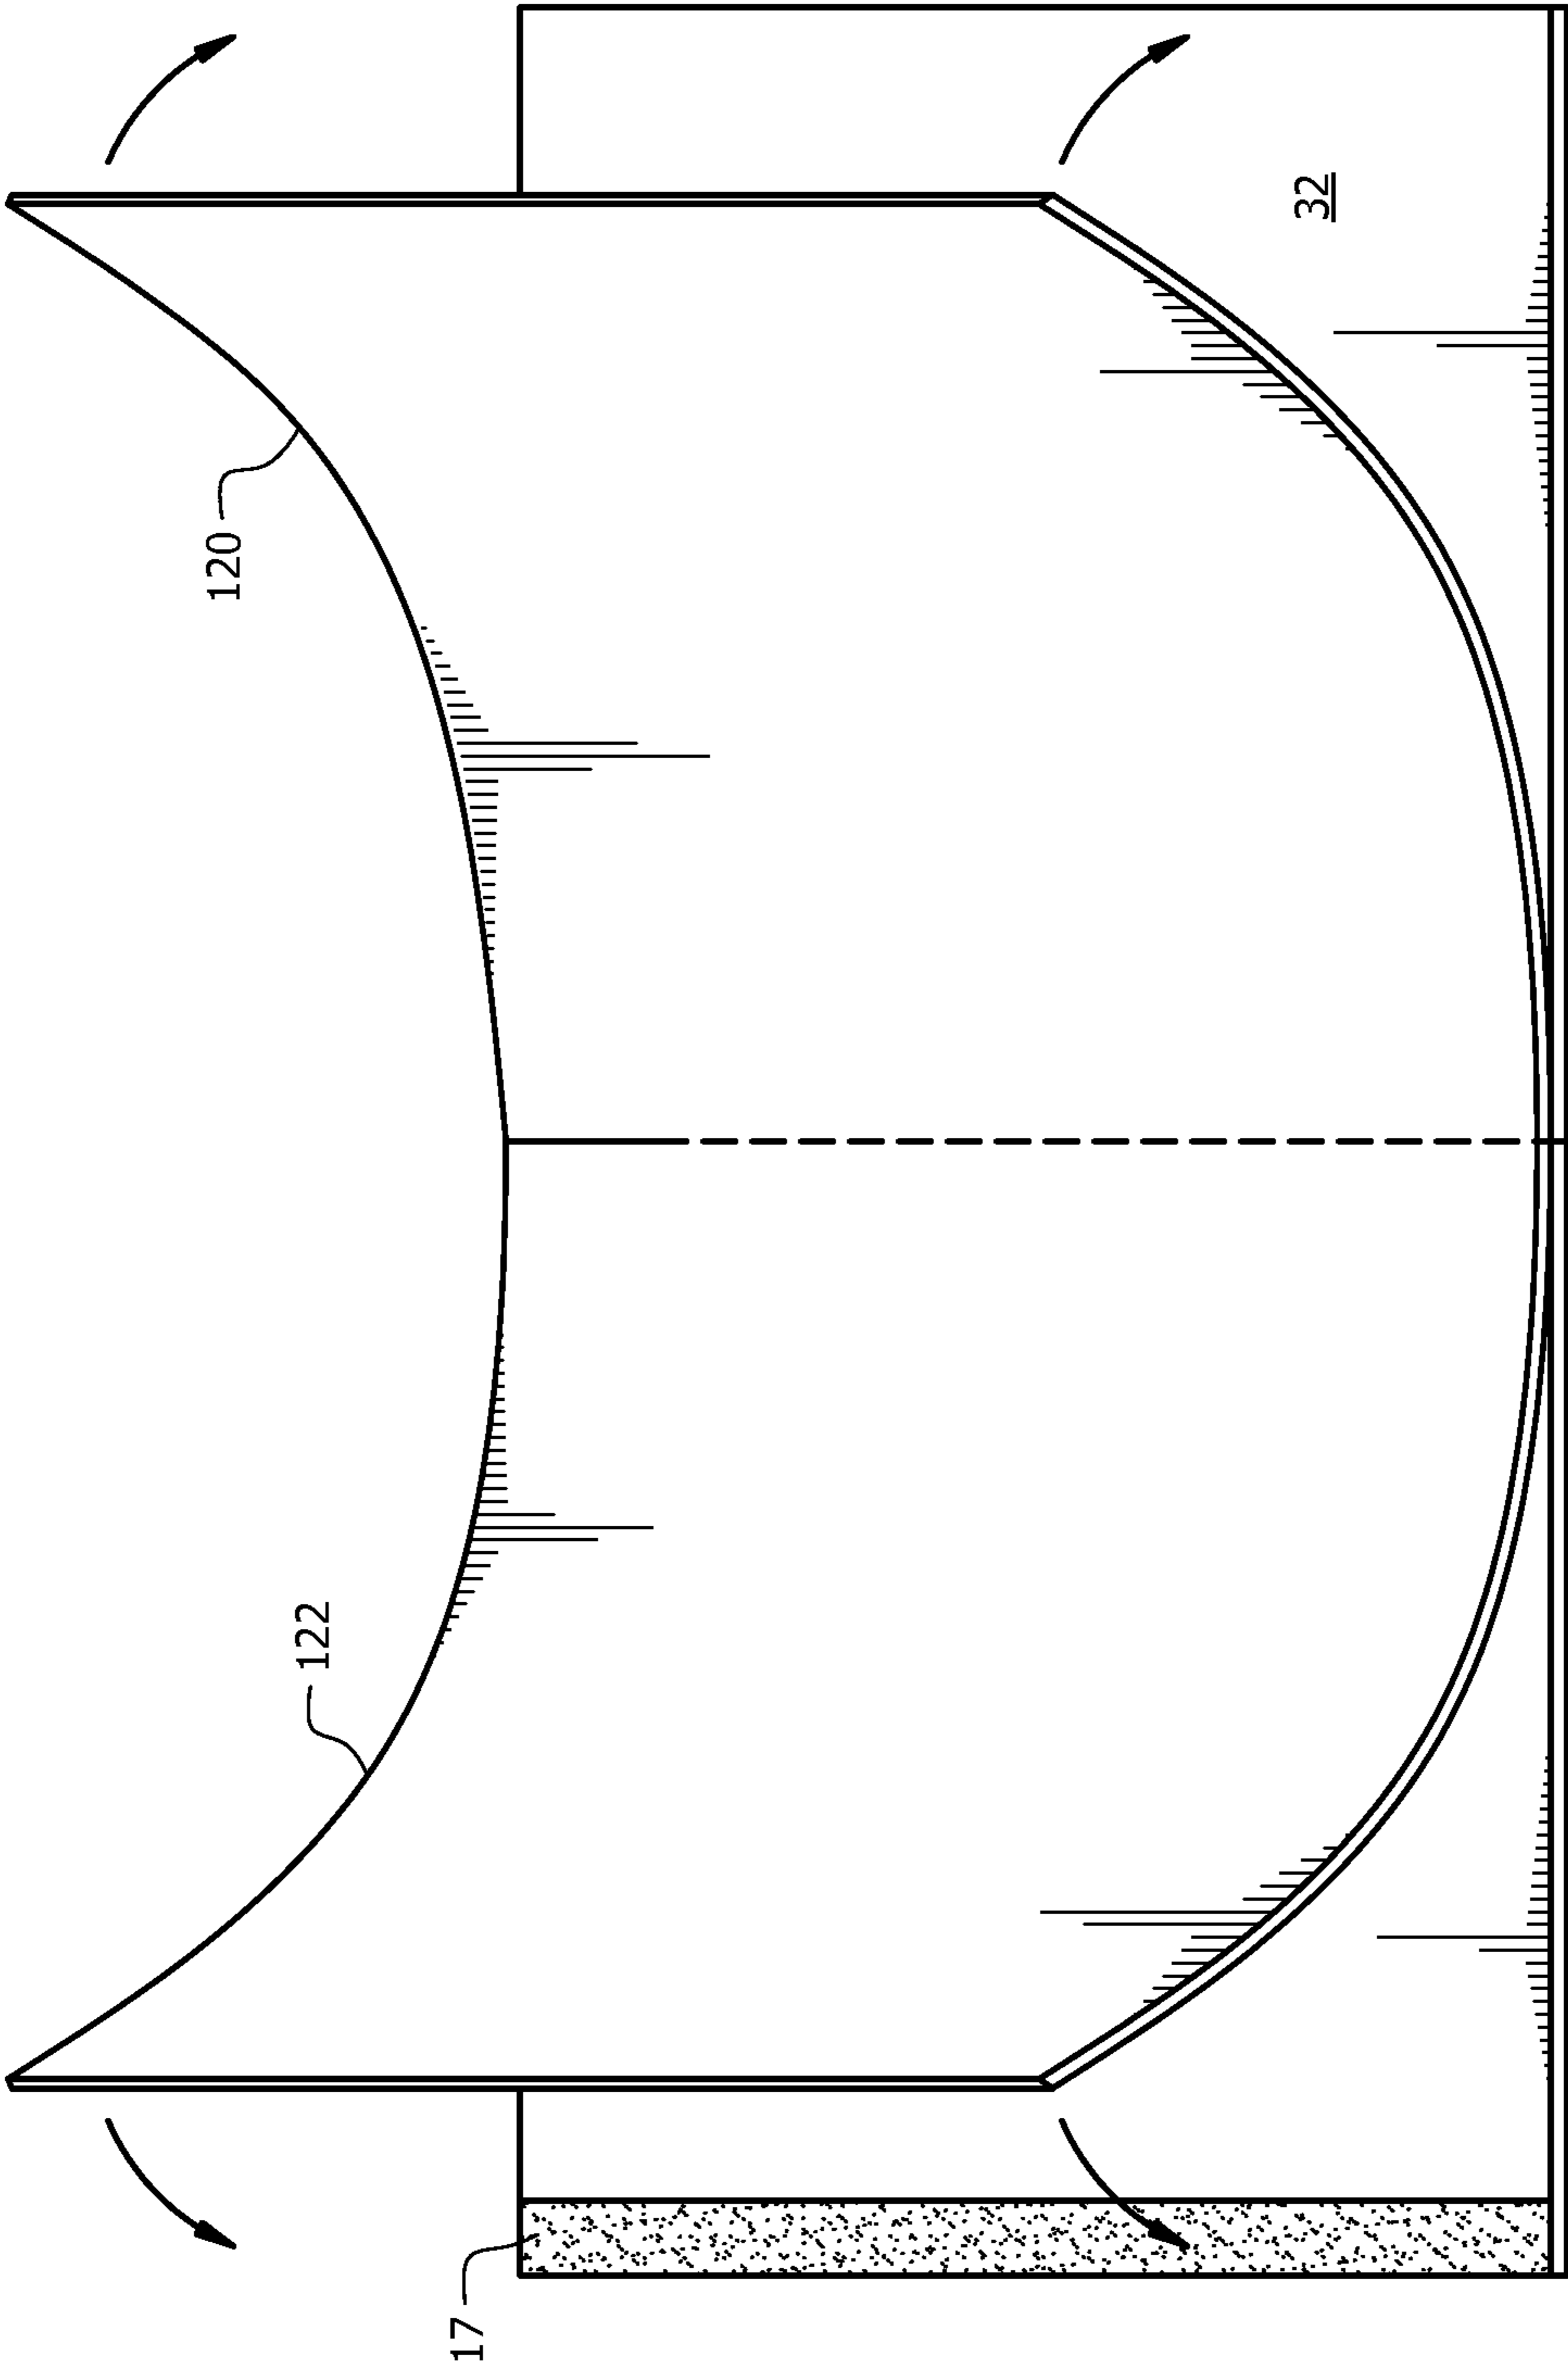
FIG. 3 illustrates a perspective view of the conduit repair system liner with two layers bound centrally along a center axis.

Referring to FIG. 3 the conduit repair system liner 9 is shown in book form having two sheets of a planar material 30. A first sheet of planar material 32 is attached to the second sheet of planar material 120 along a widthwise axis. In this, the silica resin is applied to the sheets of planar material 32/120, the sheets of planar material 30 are closed (e.g. as a book is closed) and then the liner 9 is wrapped around the carrier 80 for insertion and repair of the failed conduit 2.

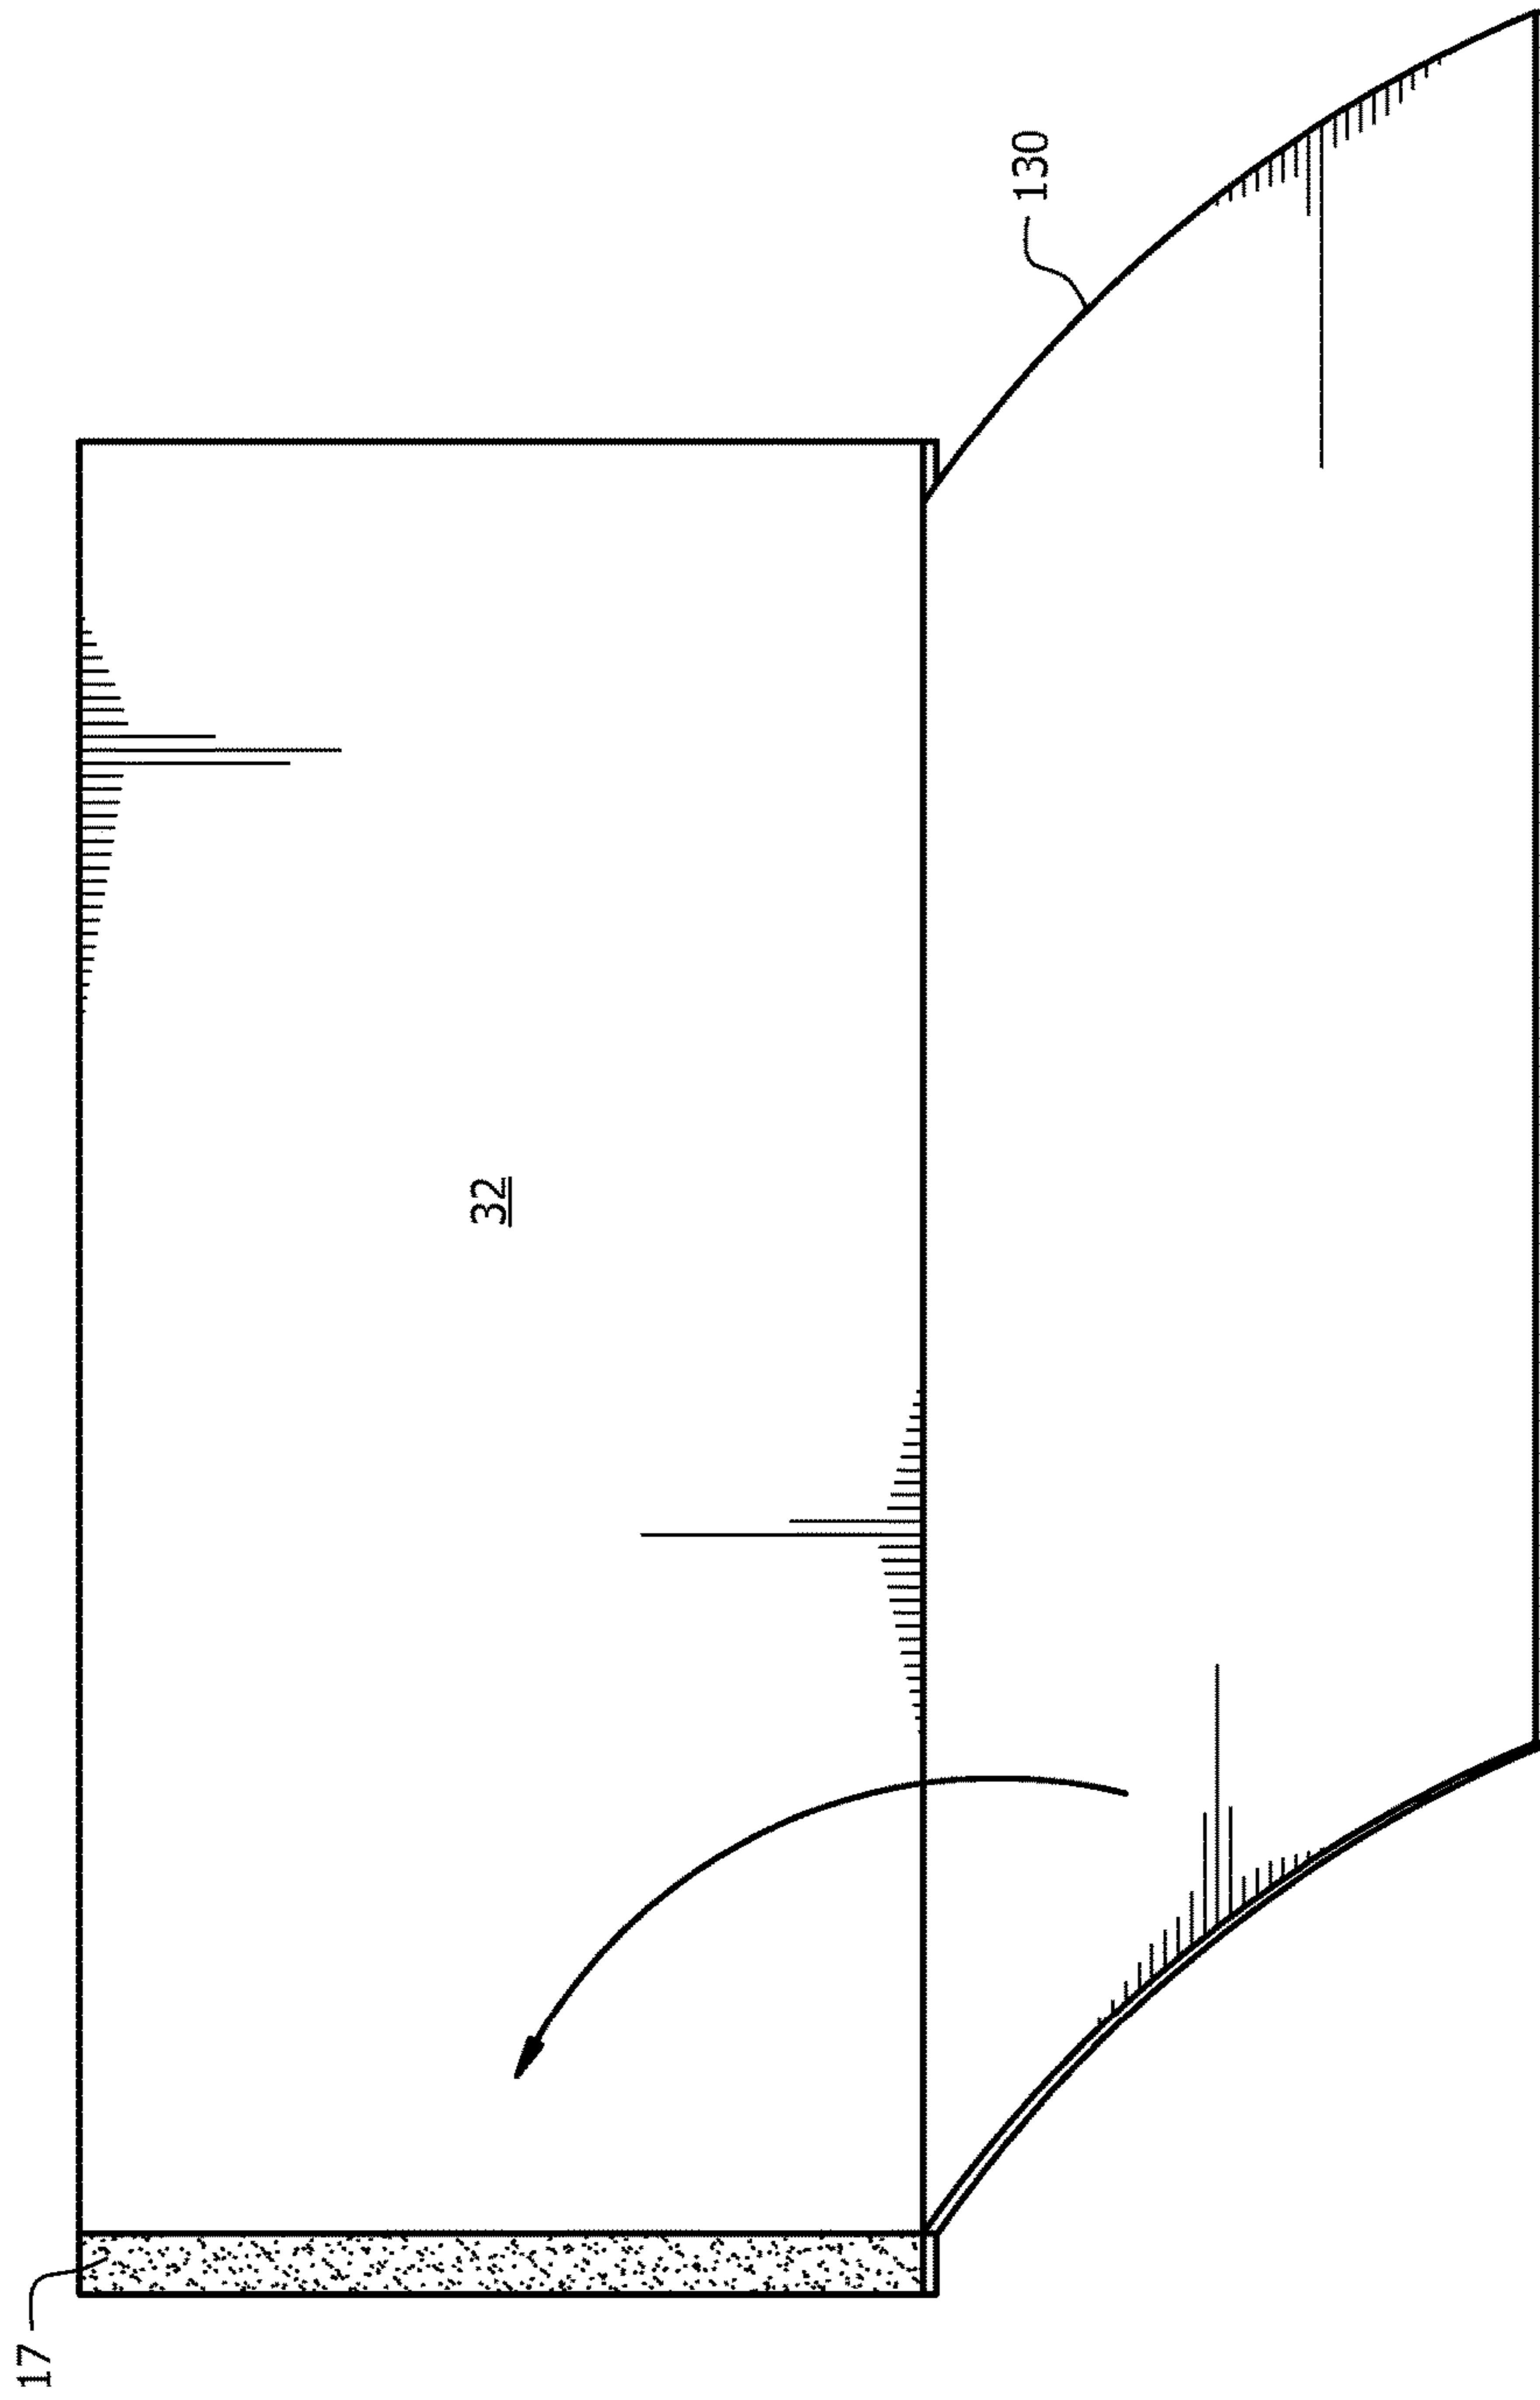
FIG. 4 illustrates a perspective view of the conduit repair system liner with two layers bound as a book along a different edge.

Referring to FIG. 4 the conduit repair system liner 9 is shown in book form having two sheets of a planar material 30. A first sheet of planar material 32 is attached to the second sheet of planar material 130 along a lengthwise edge. In this, the silica resin is applied to the sheets of planar material 32/130, the sheets of planar material 30 are closed

(e.g. as a book is closed) and then the liner 9 is wrapped around the carrier 80 for insertion and repair of the failed conduit 2.

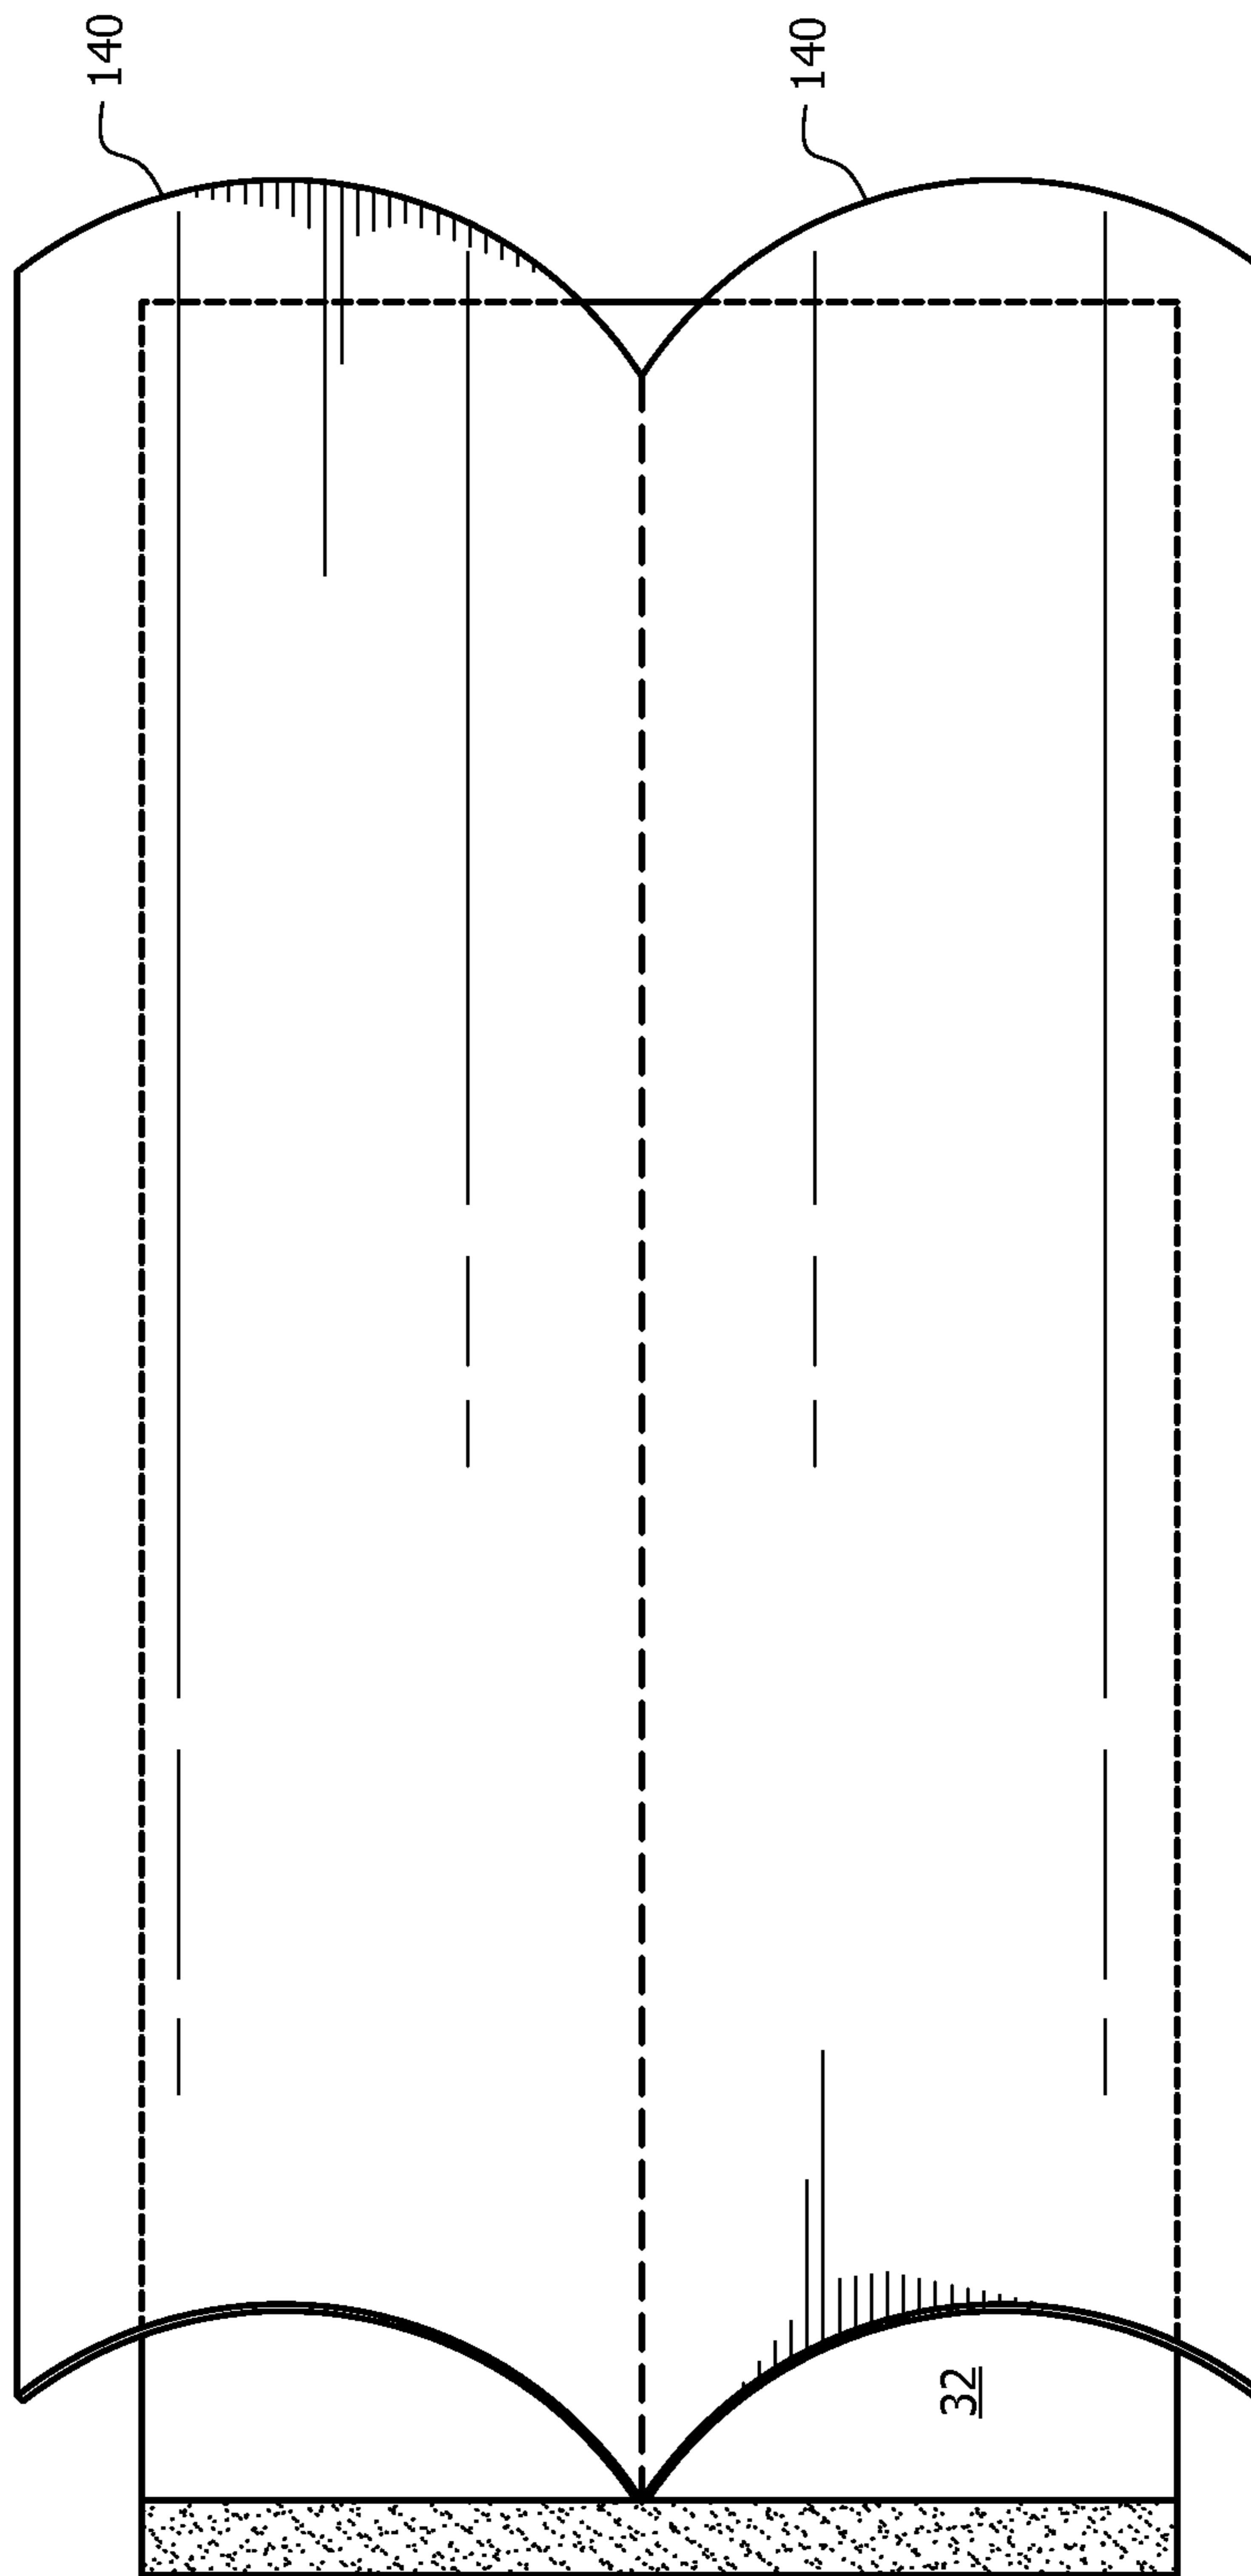
FIG. 5 illustrates a perspective view of the conduit repair system liner with two layers bound centrally along a second, center axis.

Referring to FIG. 5 the conduit repair system liner 9 is shown in book form having two sheets of a planar material 30. A first sheet of planar material 32 is attached to the second sheet of planar material 140 along a lengthwise axis. In this, the silica resin is applied to the sheets of planar material 32/140, the sheets of planar material 30 are closed (e.g. as a book is closed) and then the liner 9 is wrapped around the carrier 80 for insertion and repair of the failed conduit 2.

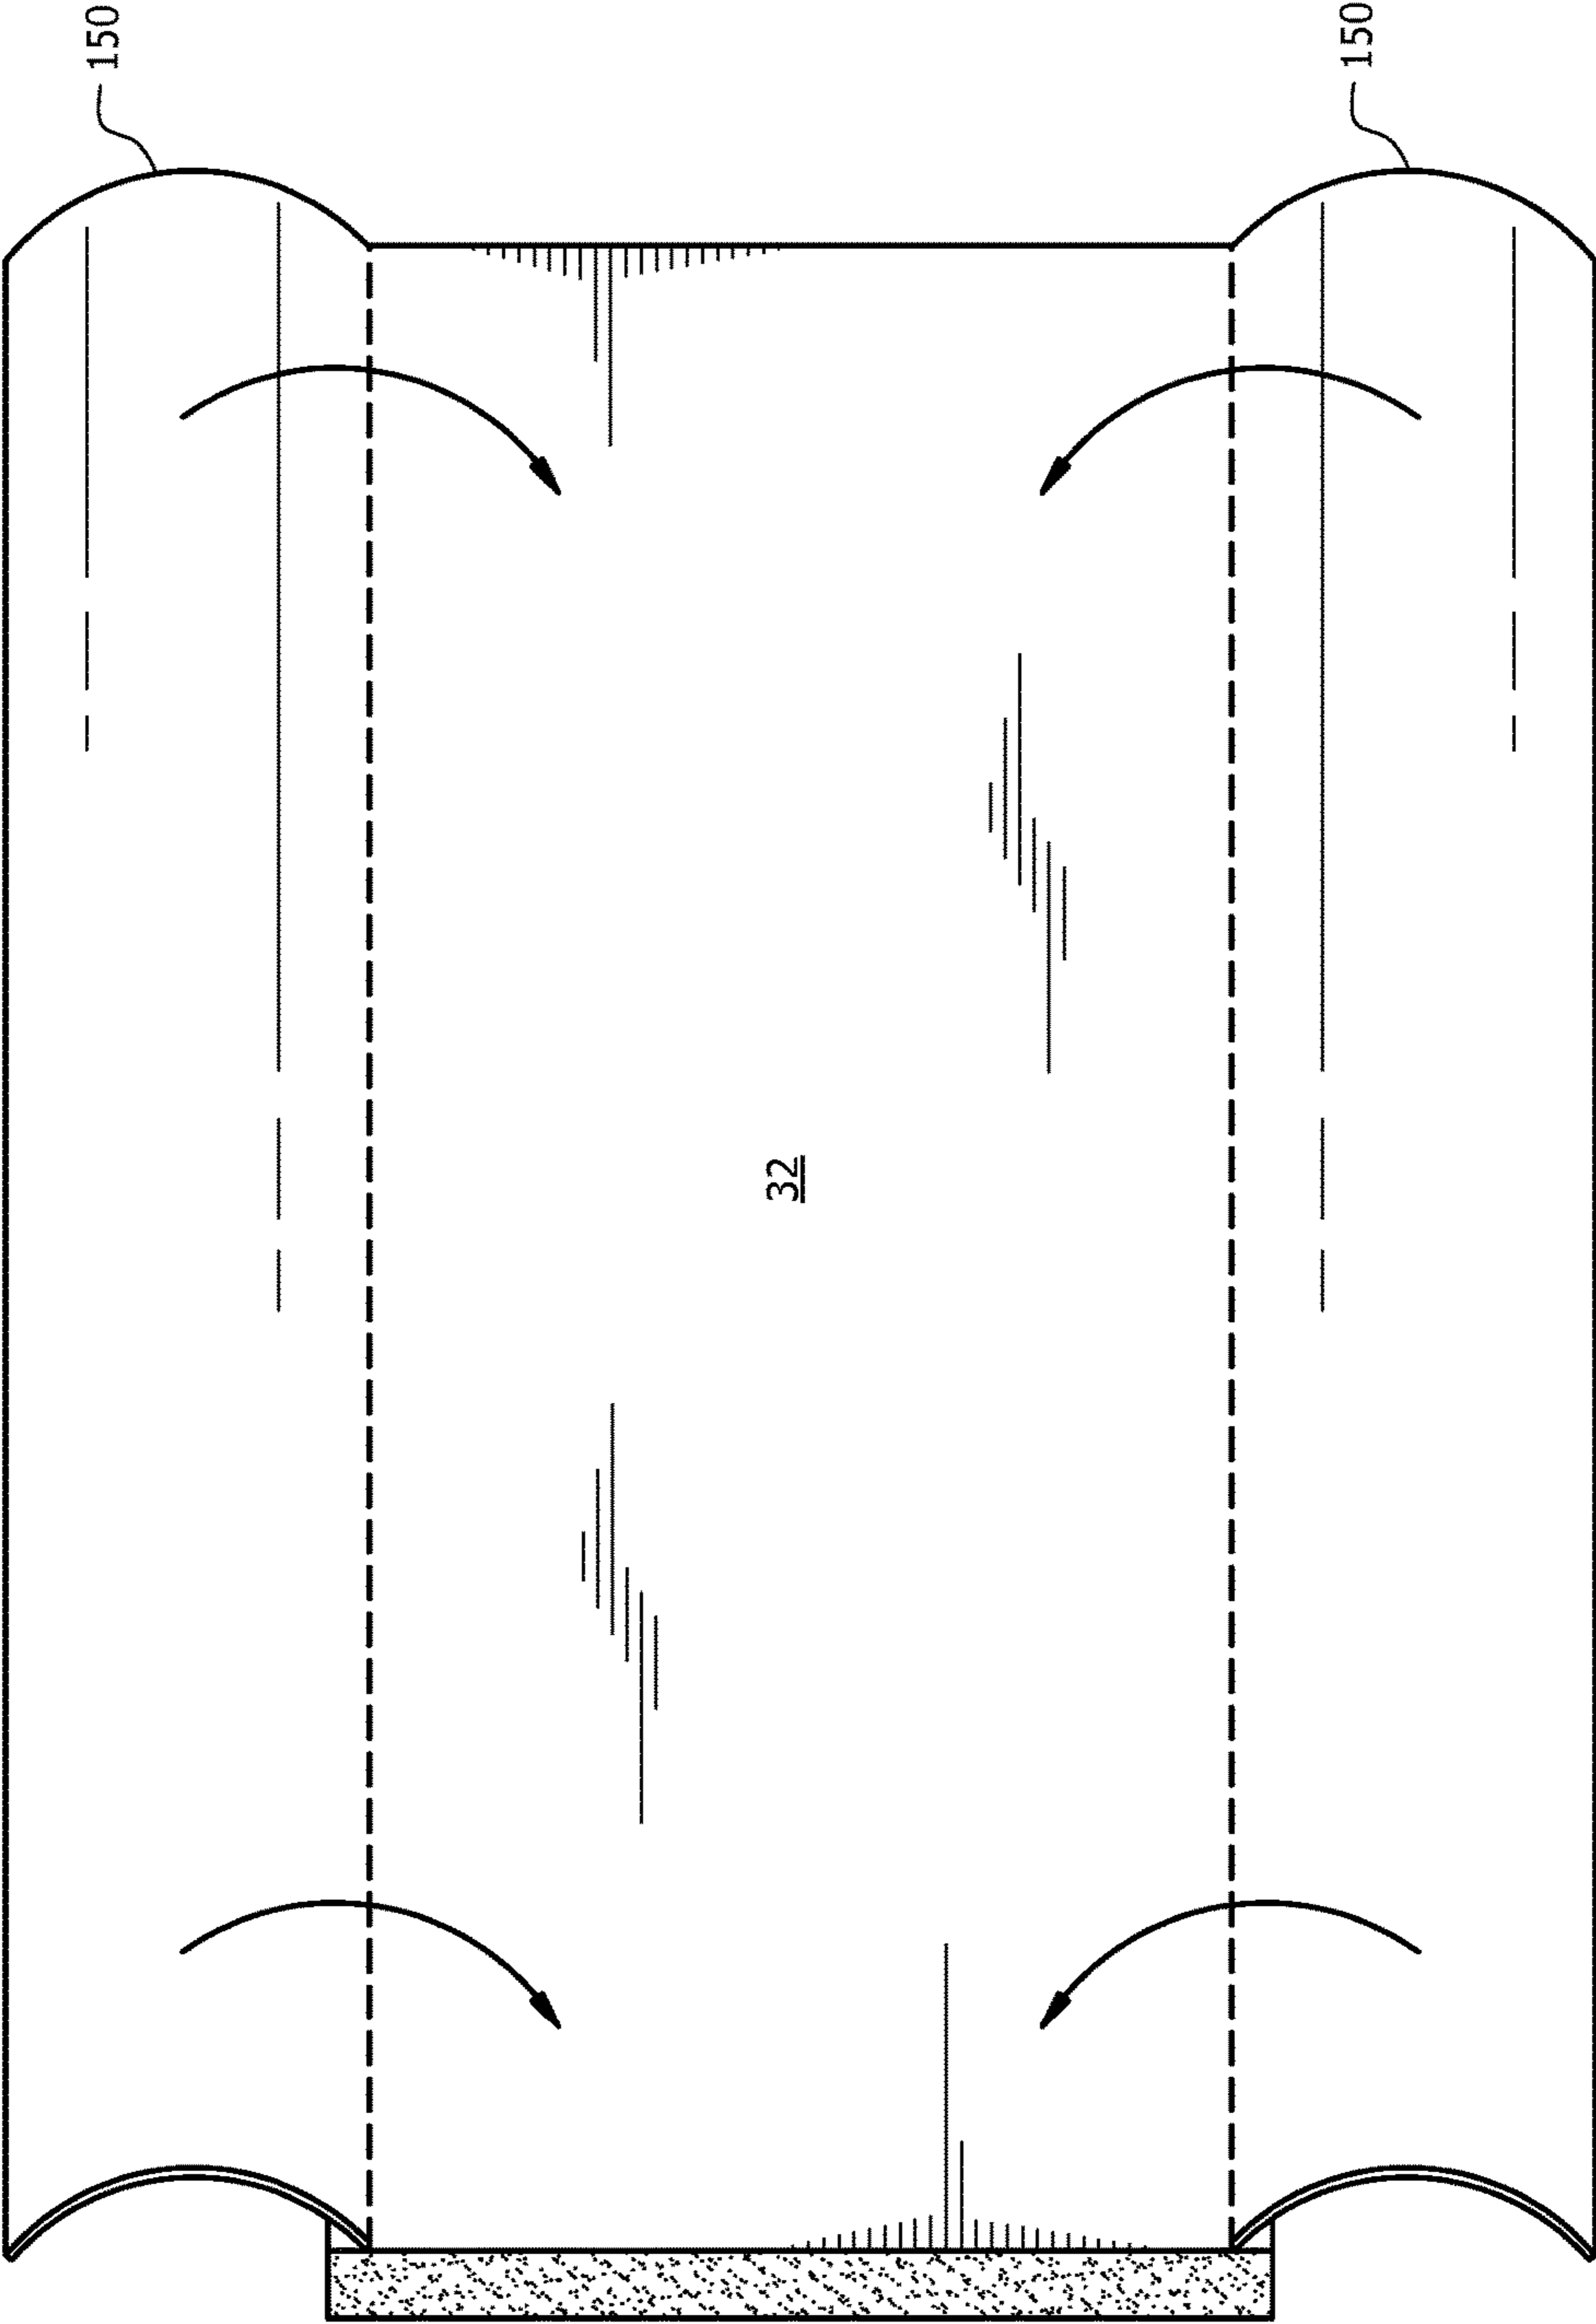
FIG. 6 illustrates a perspective view of the conduit repair system liner with two layers, the second layer in two sections bound along opposing edges.

Referring to FIG. 6 the conduit repair system liner 9 is shown in book form having two sheets of a planar material 30. A first sheet of planar material 32 is attached to half-sections of the second sheet of planar material 150 along two lengthwise edges. In this, the silica resin is applied to the sheets of planar material 32/150, the sheets of planar material 30 are closed (e.g. as a book is closed) and then the liner 9 is wrapped around the carrier 80 for insertion and repair of the failed conduit 2.
