US009581279B1

(54) **MULTI-LAYERED CONDUIT REPAIR SYSTEM**

A conduit repair liner includes at least two sheets of planar material that are connected to each other as pages of a book and coated with silica resin then closed against one another to form the conduit repair liner for wrapping around a carrier. The conduit repair liner includes a feature for removably affixing the conduit repair liner to the carrier during positioning within a failed conduit.

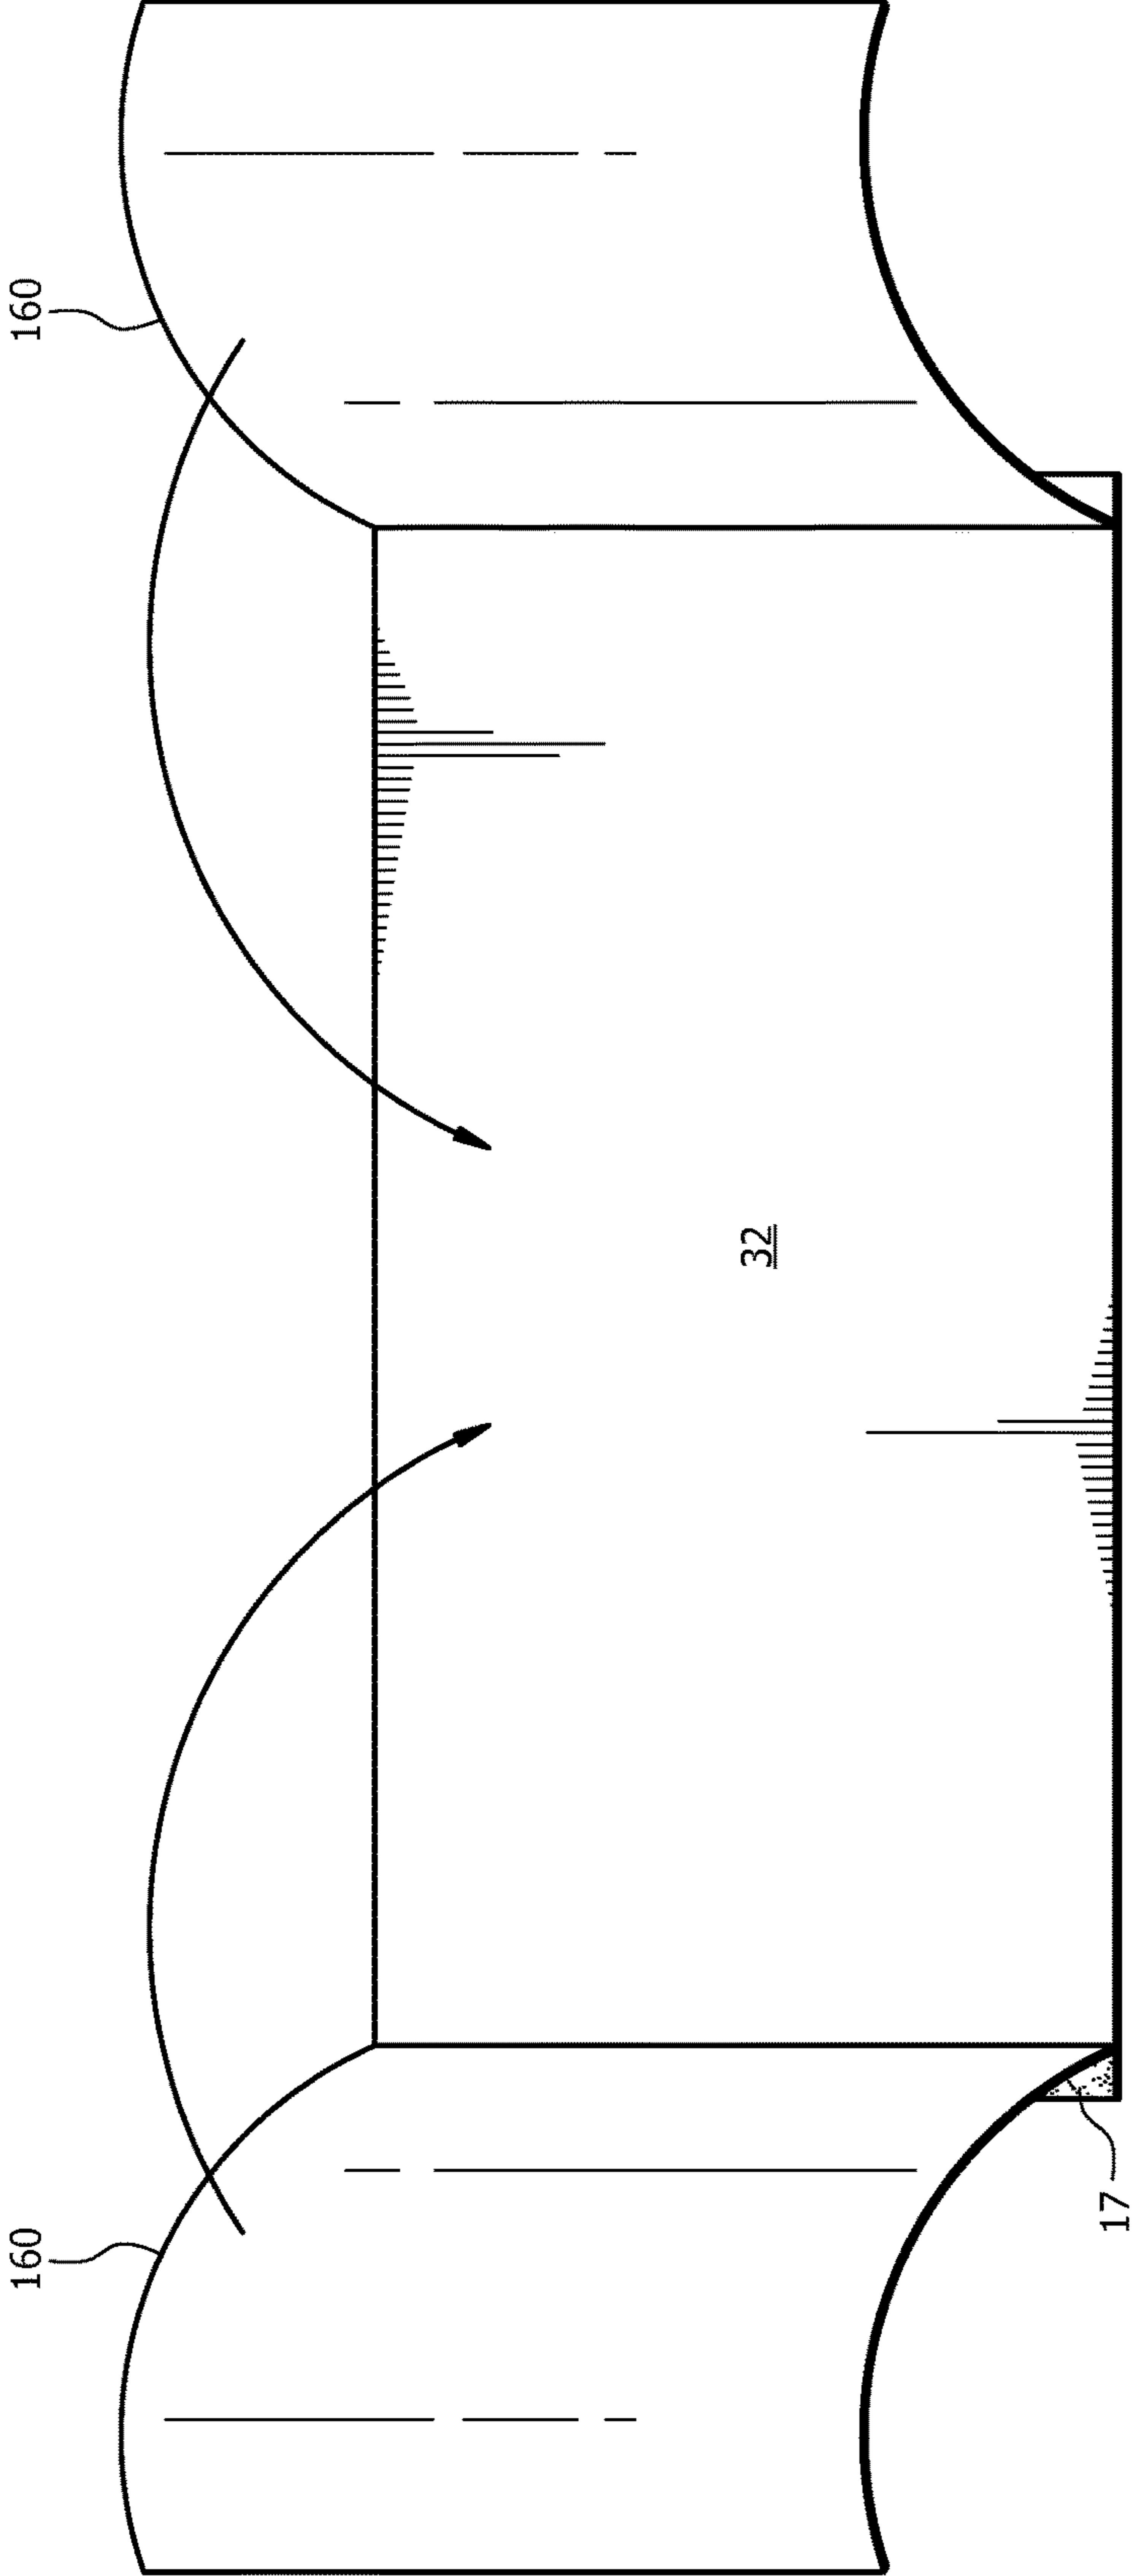
FIG. 7 illustrates a perspective view of the conduit repair system liner with two layers, the second layer in two sections bound along other opposing edges.

Referring to FIG. 7 the conduit repair system liner 9 is shown in book form having two sheets of a planar material 30. A first sheet of planar material 32 is attached to half-sections of the second sheet of planar material 160 along two widthwise edges. In this, the silica resin is applied to the sheets of planar material 32/160, the sheets of planar material 30 are closed (e.g. as a book is closed) and then the liner 9 is wrapped around the carrier 80 for insertion and repair of the failed conduit 2.

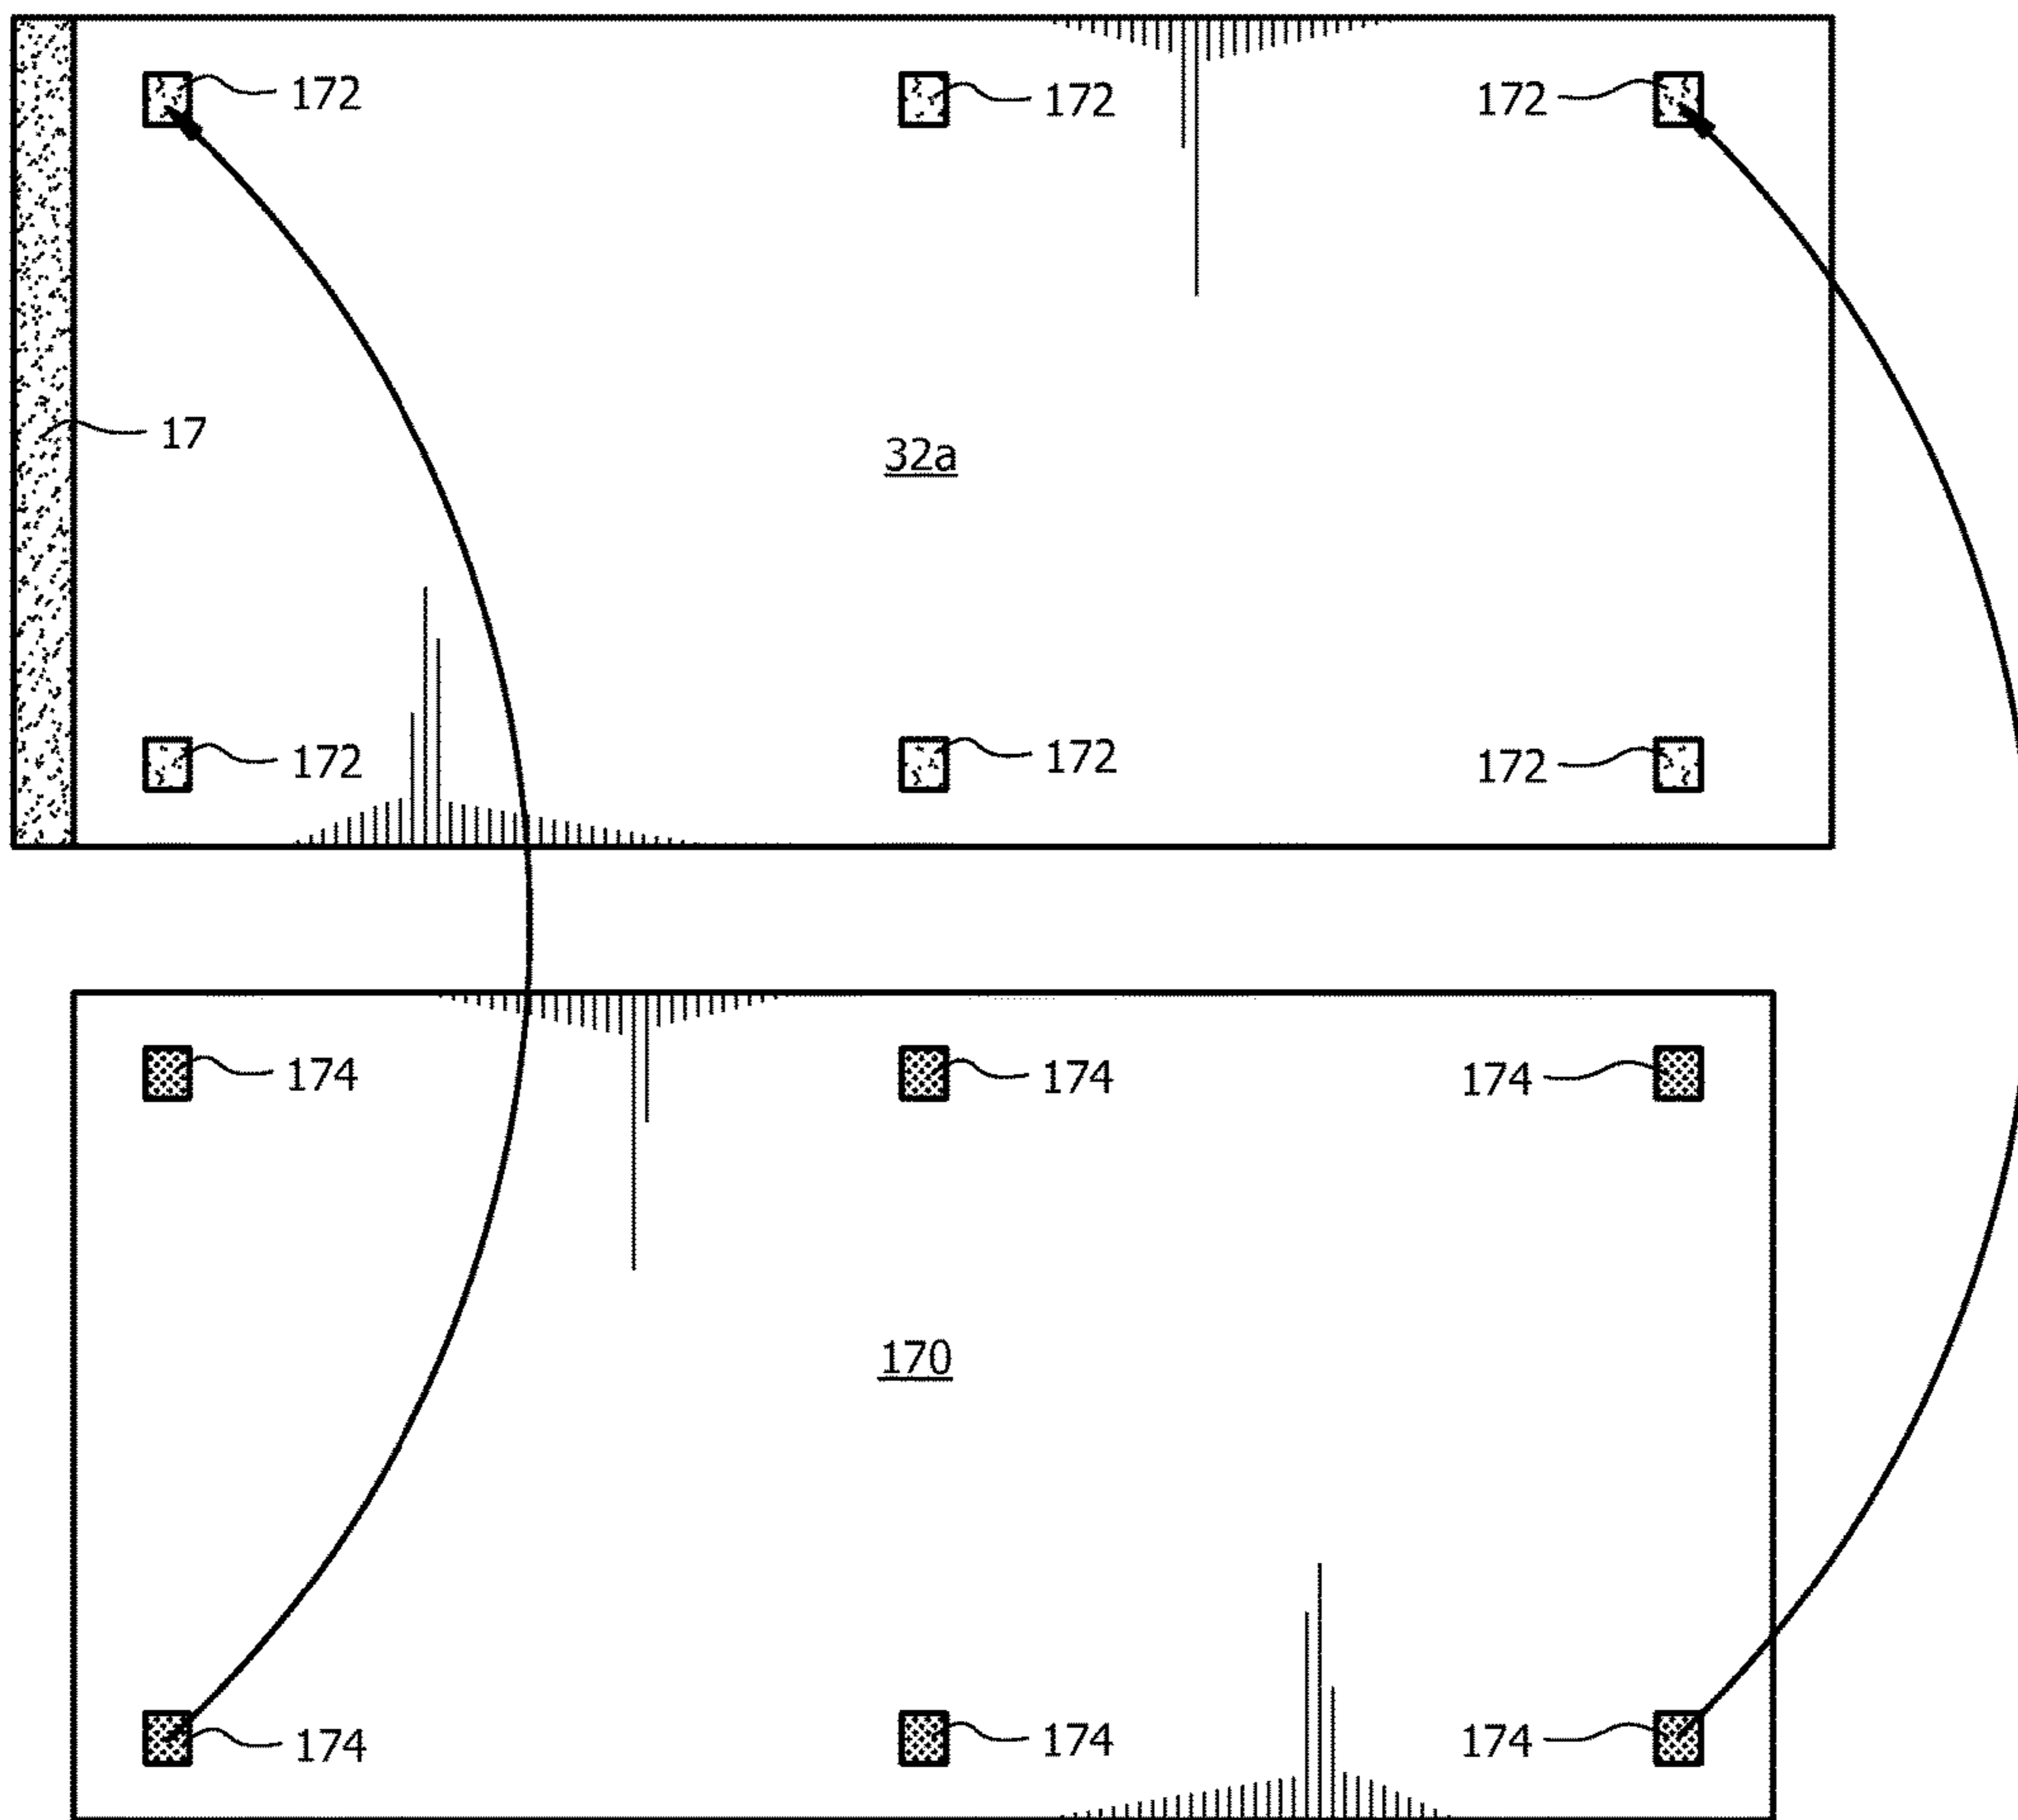
FIG. 8 illustrates a perspective view of the conduit repair system liner with two layers, the second layer being separate from the first layer, but attachable by hook and loop pads.

Referring to FIG. 8 the conduit repair system liner 9 is shown in book form having two sheets of a planar material 30. A first sheet of planar material 32 is separate from the second sheet of planar material 170. In this, the silica resin is applied to the sheets of planar material 32/170, then the sheets of planar material 30 are overlaid and connected by fasteners 172/174 (e.g., hook and loop material), and then the liner 9 is wrapped around the carrier 80 for insertion and repair of the failed conduit 2.

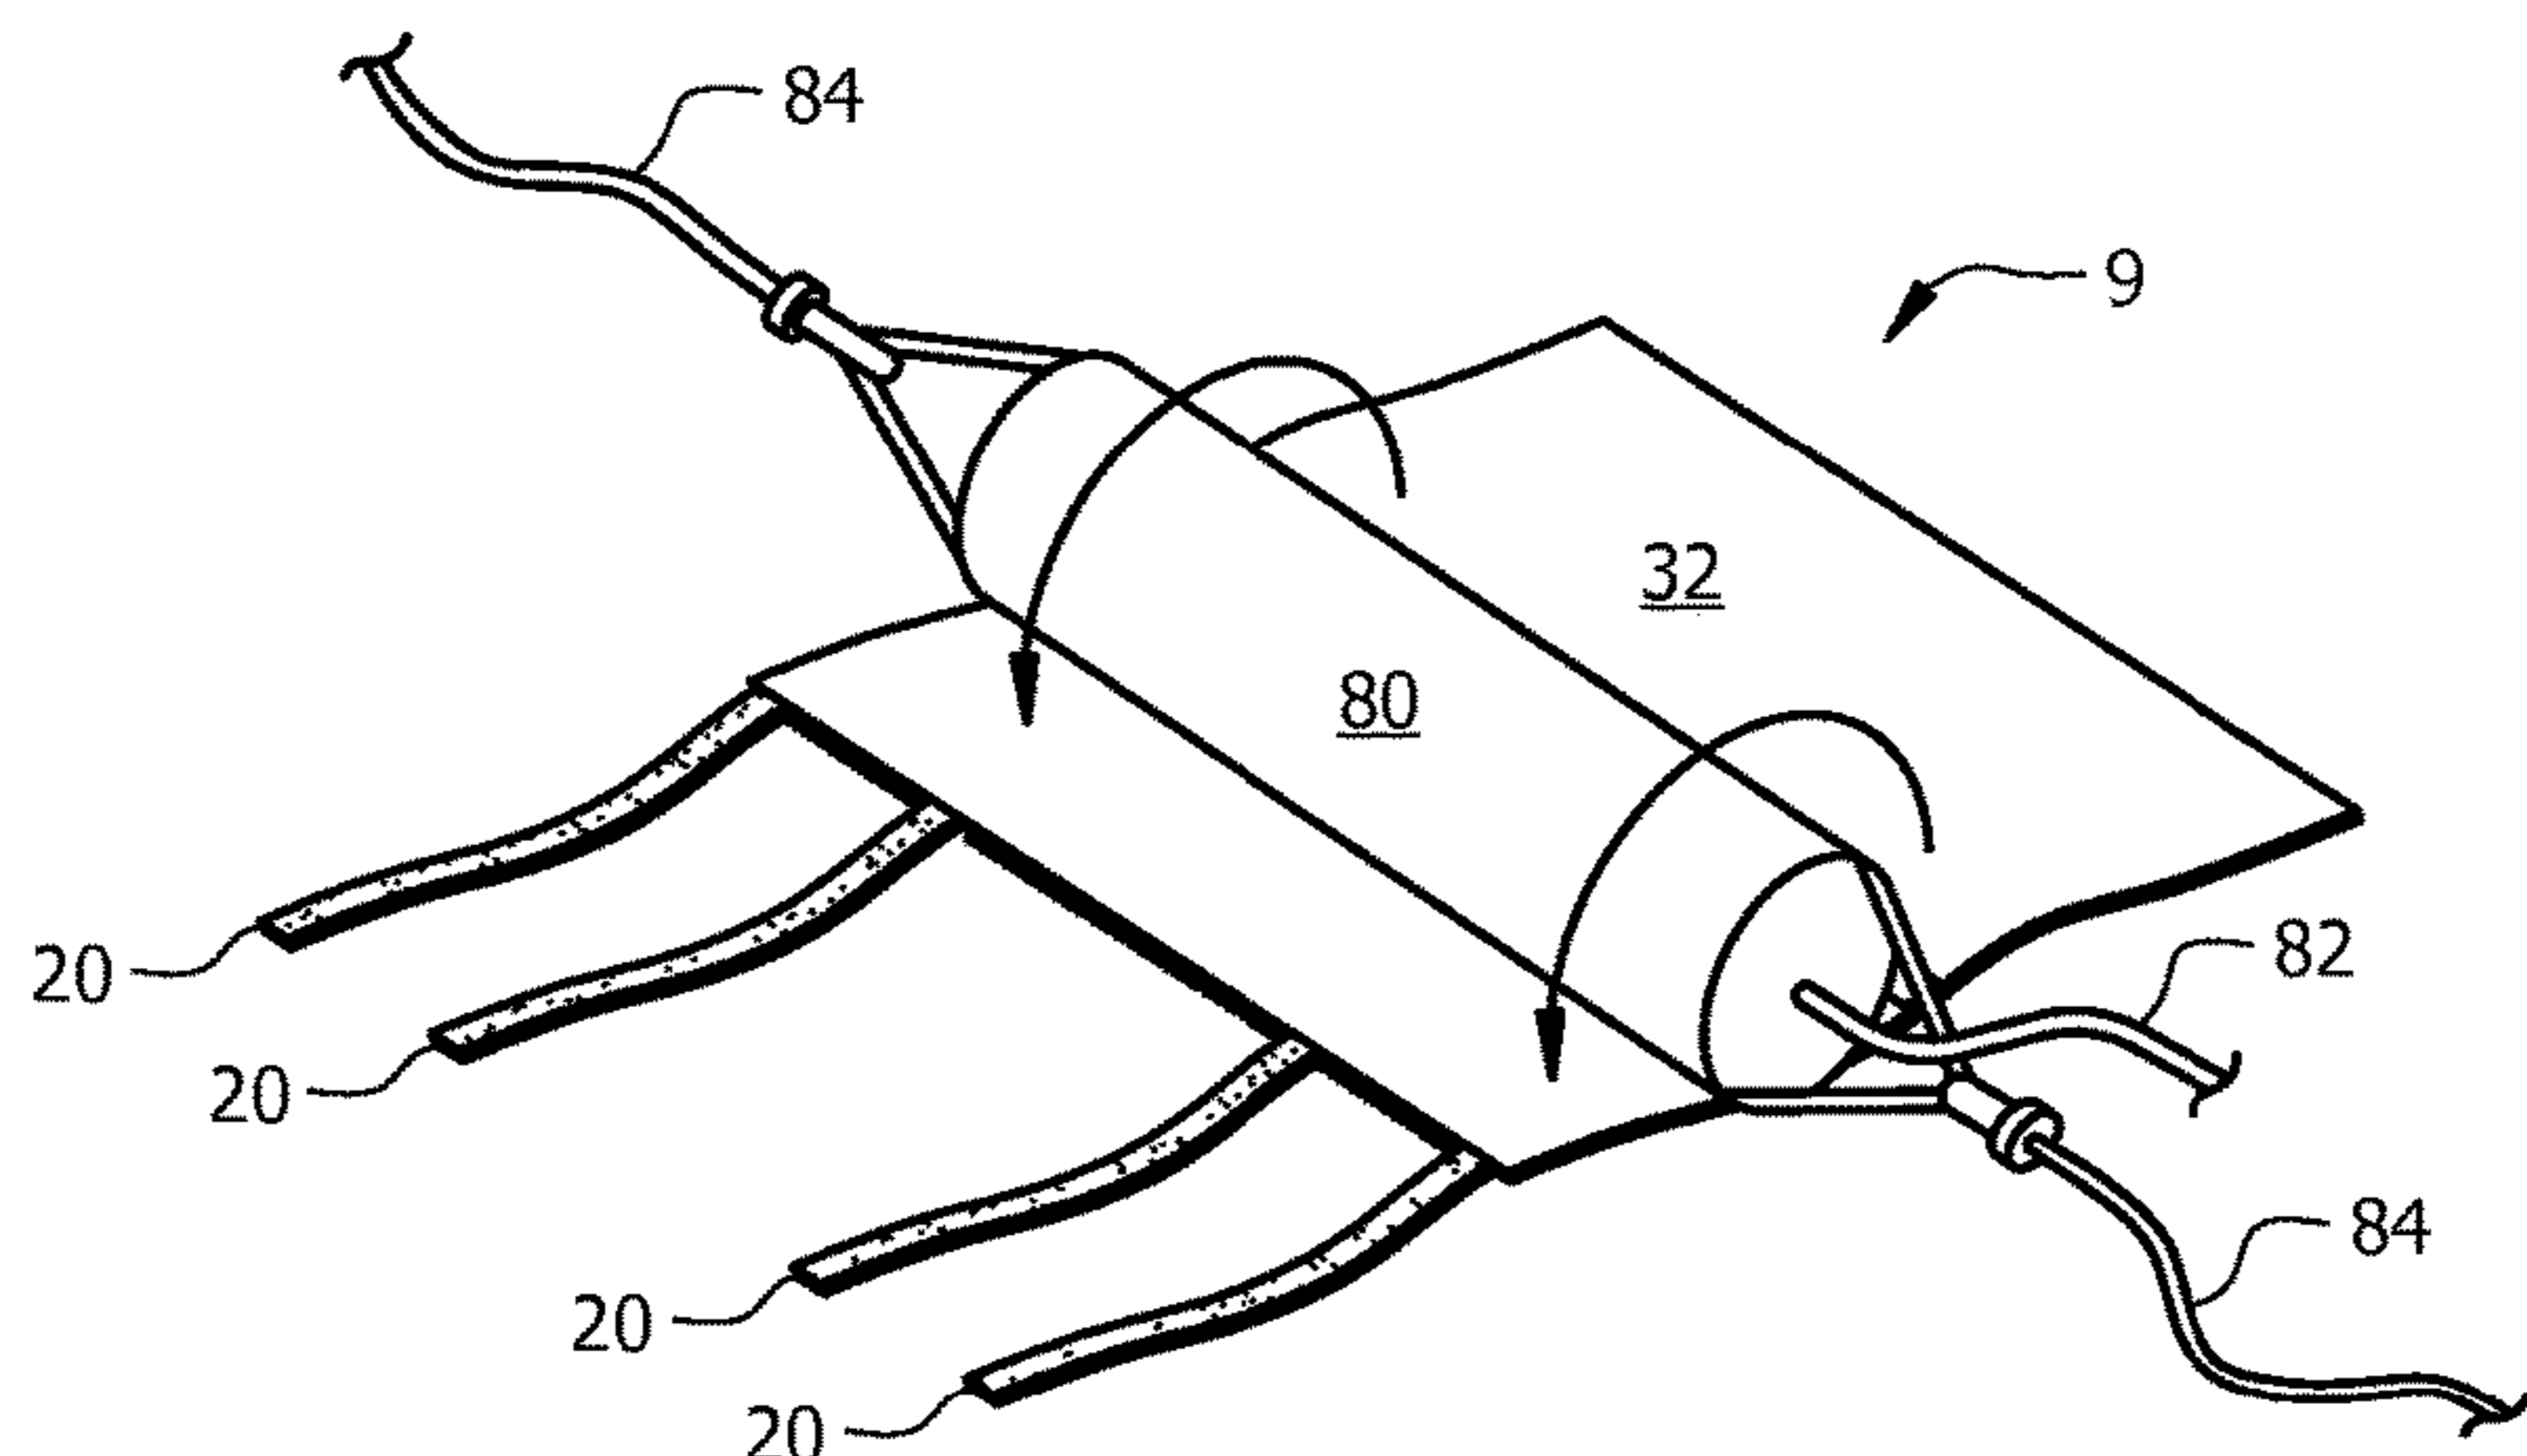
FIG. 9 illustrates a perspective view of the conduit repair system liner being impregnated in resin then wrapped around a deflated carrier.

As described, with any of the above examples, the sheets of the conduit repair system liner 9 are coated with silica resin 3 (see FIG. 10B) before installation into a failed conduit 2. In some methods of installation, the silica resin 3 is poured and spread over the sheets 30 of the conduit repair system liner 9, substantially covering such, for example, using a spreader (not shown). In some embodiments, the silica resin 3 is sprayed onto the conduit repair system liner 9. After the conduit repair system liner 9 is coated with the silica resin 3, the conduit repair system liner 9 is wrapped around a carrier 80 and secured using the one or more retaining straps 20 that are affixed to one or more attachment areas 18, thereby temporarily holding the conduit repair system liner 9 to the carrier 80. By whatever temporary retainment mechanism, it is preferred that the conduit repair system liner 9 be substantially covered with the silica resin 3.

The carrier 80 preferably includes positioning mechanisms 84 for moving the carrier 80 within the plumbing

failed conduit 2 and an inflation tube 82. The positioning mechanisms 84 are any device used to properly position the carrier 80 at the locale of the failure, including, but not limited to ropes, cables, push rods, etc. The method of installation of the conduit repair system liner 9 using the carrier 80 is shown in FIGS. 10A and 10B, though it is fully anticipated that the conduit repair system liner 9 be used with other types of carrier systems and using other methods that may or may not use the described carrier 80.

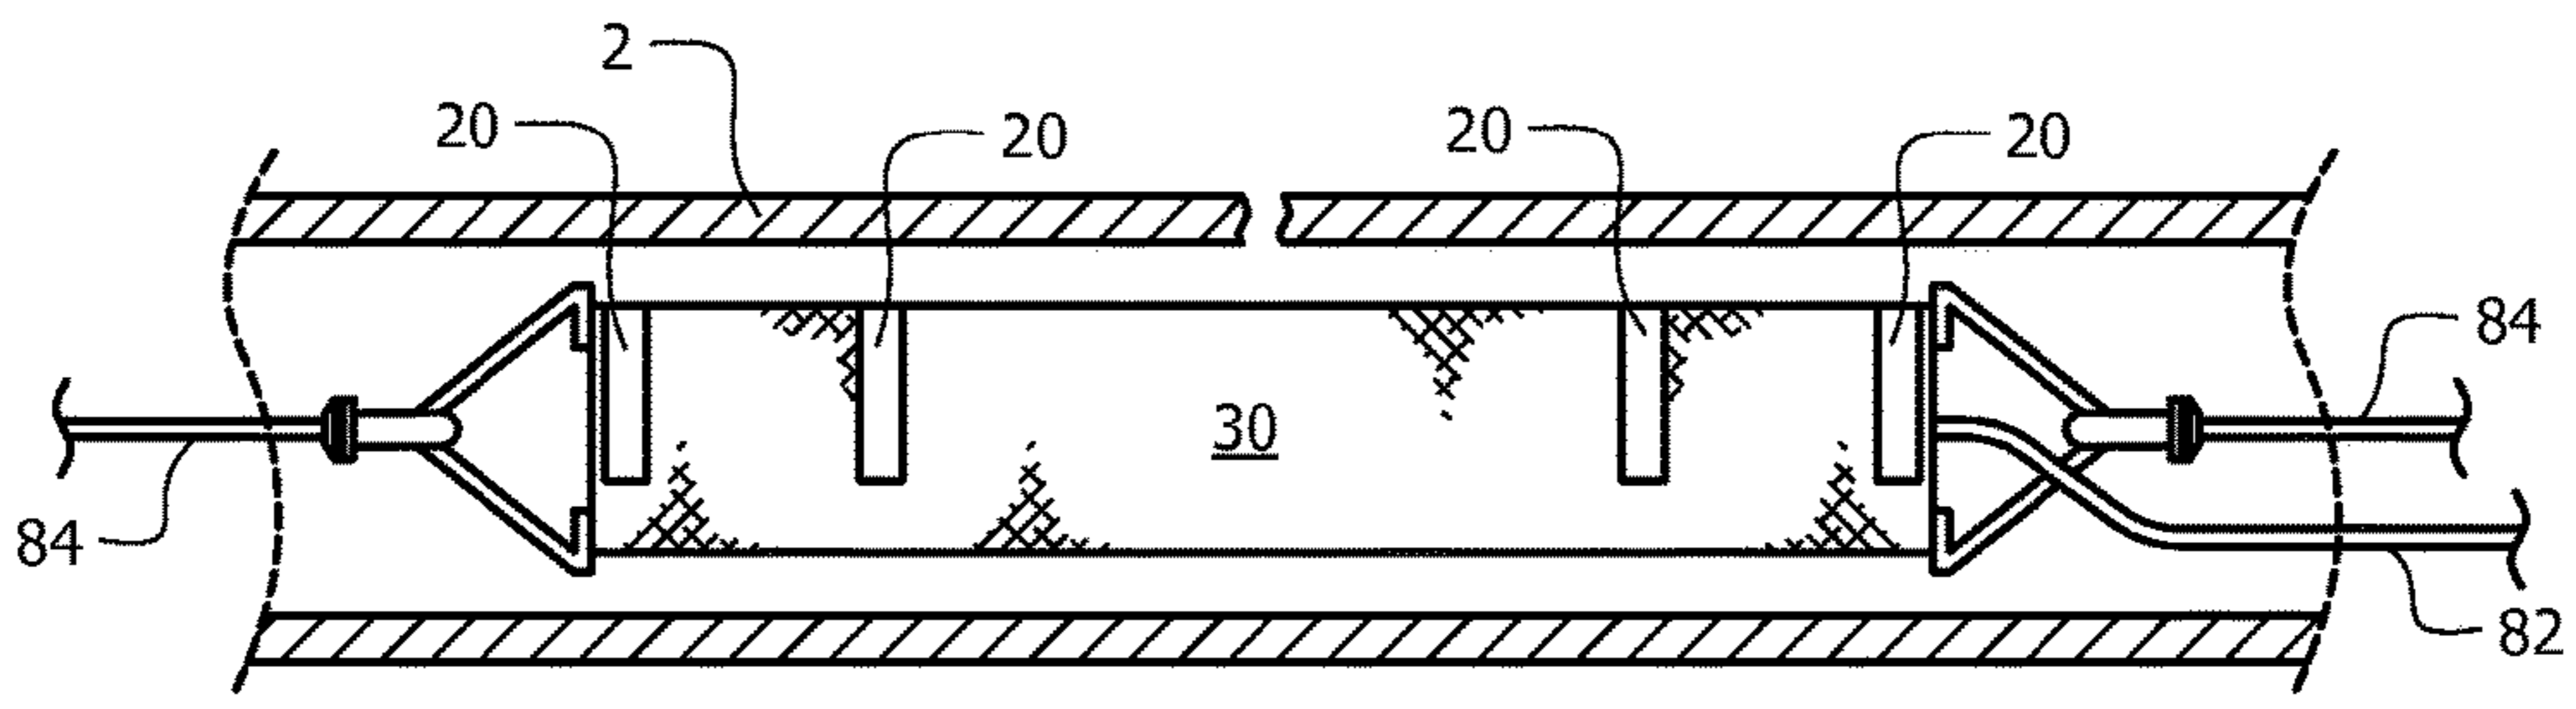
FIG. 10A illustrates a cross-sectional view of the conduit repair system liner wrapped around a deflated carrier and pulled into place within a conduit.

Referring to FIGS. 10A and 10B, views of the conduit repair system liner 9 during installation within a failed conduit 2. After the conduit repair system liner 9 is coated with silica resin 3, the conduit repair liner 9 is wrapped around the carrier 80. The conduit repair system liner 9 and the carrier 80 are positioned within the failed conduit 2 as shown in FIG. 10A, by, for example, pulling/pushing using the positioning lines 84. Note, that the method shown of positioning the conduit repair system liner 9 and the carrier 80 are examples as it is anticipated that the conduit repair system liner 9 functions with other methods of positioning, all of which are included here within. Note that there is a crack or leak in the failed conduit 2.

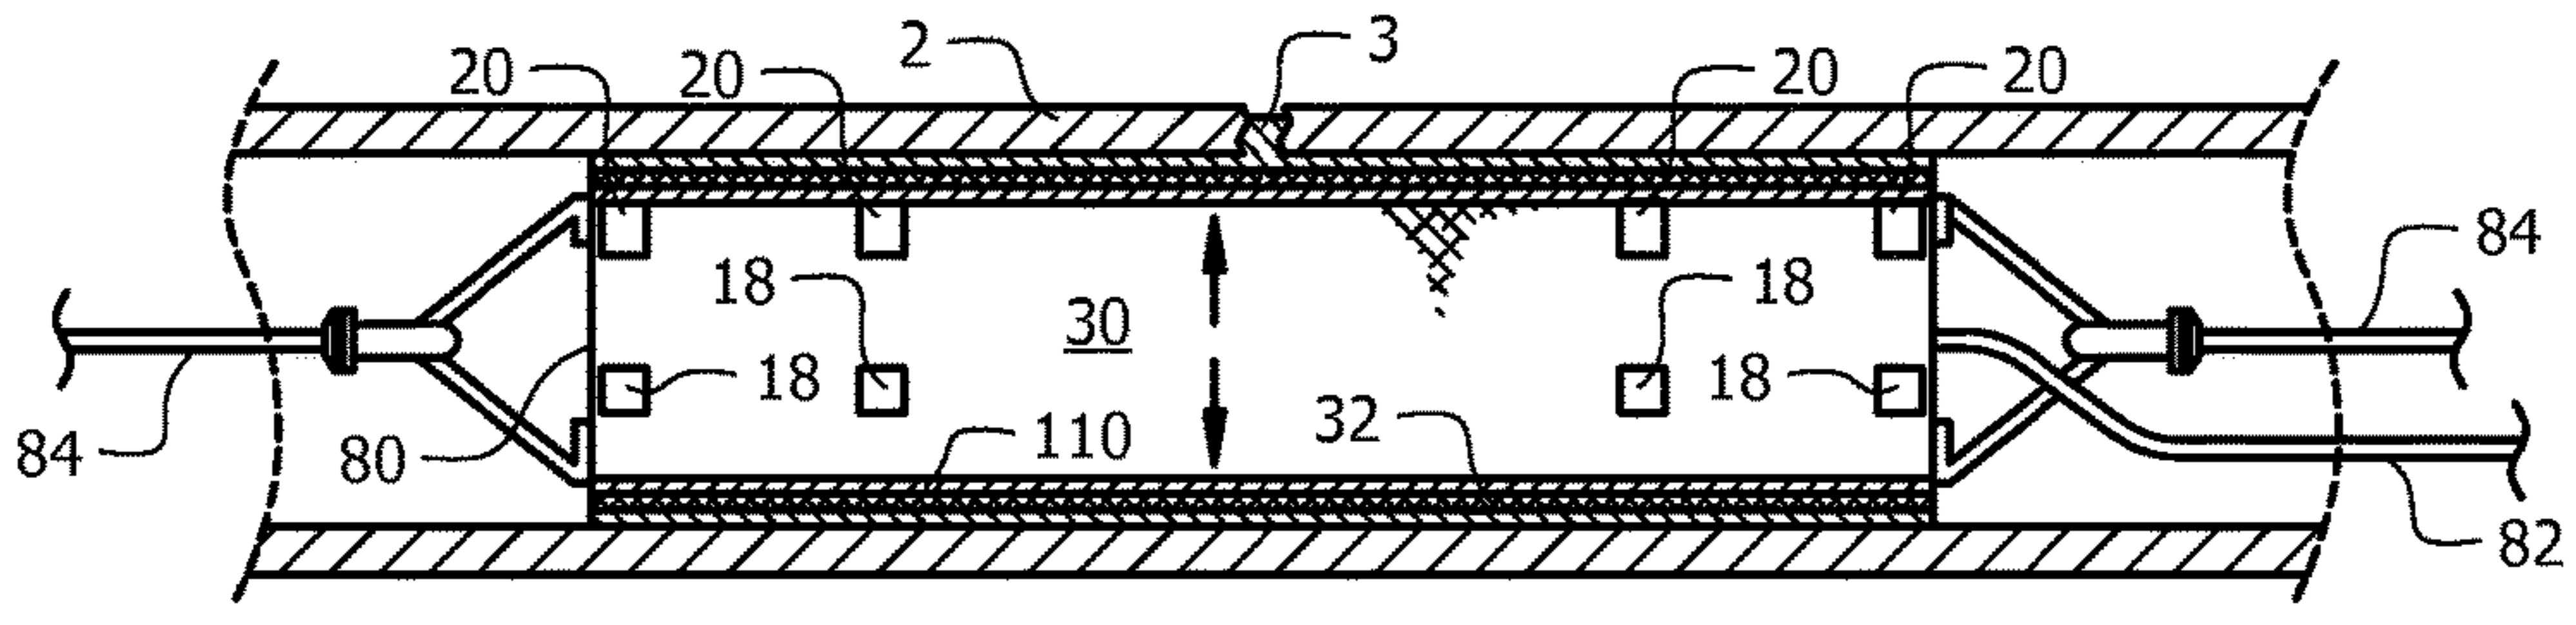
FIG. 10B illustrates a cross-sectional view of the conduit repair system liner wrapped around a now inflated carrier in place within the conduit.

Once the conduit repair system liner 9 and the carrier 80 are in position, the inflatable carrier 80 is inflated as shown in FIG. 10B. The inflation tube 82 expands the conduit repair system liner 9 and forces the conduit repair system liner 9 to stretch, overcoming the holding action of the removable fasteners 21/18 which are shown fastened in FIG. 10A and detached in FIG. 10B. The conduit repair system liner 9 and the silica resin 3 contacts the inside surface of the failed conduit 2. Note that some of the silica resin 3 has filled the crack in the failed conduit. Substantially the entire conduit repair system liner 9 (coated with the silica resin 3) rests against the inner walls of the failed conduit 2 in the area of the crack/leak. After or just before curing, the carrier 80 is deflated (or evacuated if necessary) and pulled out of the repair area of the failed conduit 2, leaving the conduit repair system liner 9 affixed to the inside walls of the failed conduit 2 (not shown). Once the failed conduit cures (sets), the failed conduit 2 has similar or superior structural support, as required by, for example, plumbing beneath roadways, etc.
