(10) **Patent No.:** **US 9,659,556 B1**
(45) **Date of Patent:** **May 23, 2017**

(54) **METHODS OF REPAIRING AN ACOUSTIC SANDWICH PANEL AND ACOUSTIC SANDWICH PANEL REPAIR KITS THEREFOR**

(71) Applicant: **The Boeing Company**, Chicago, IL (US)

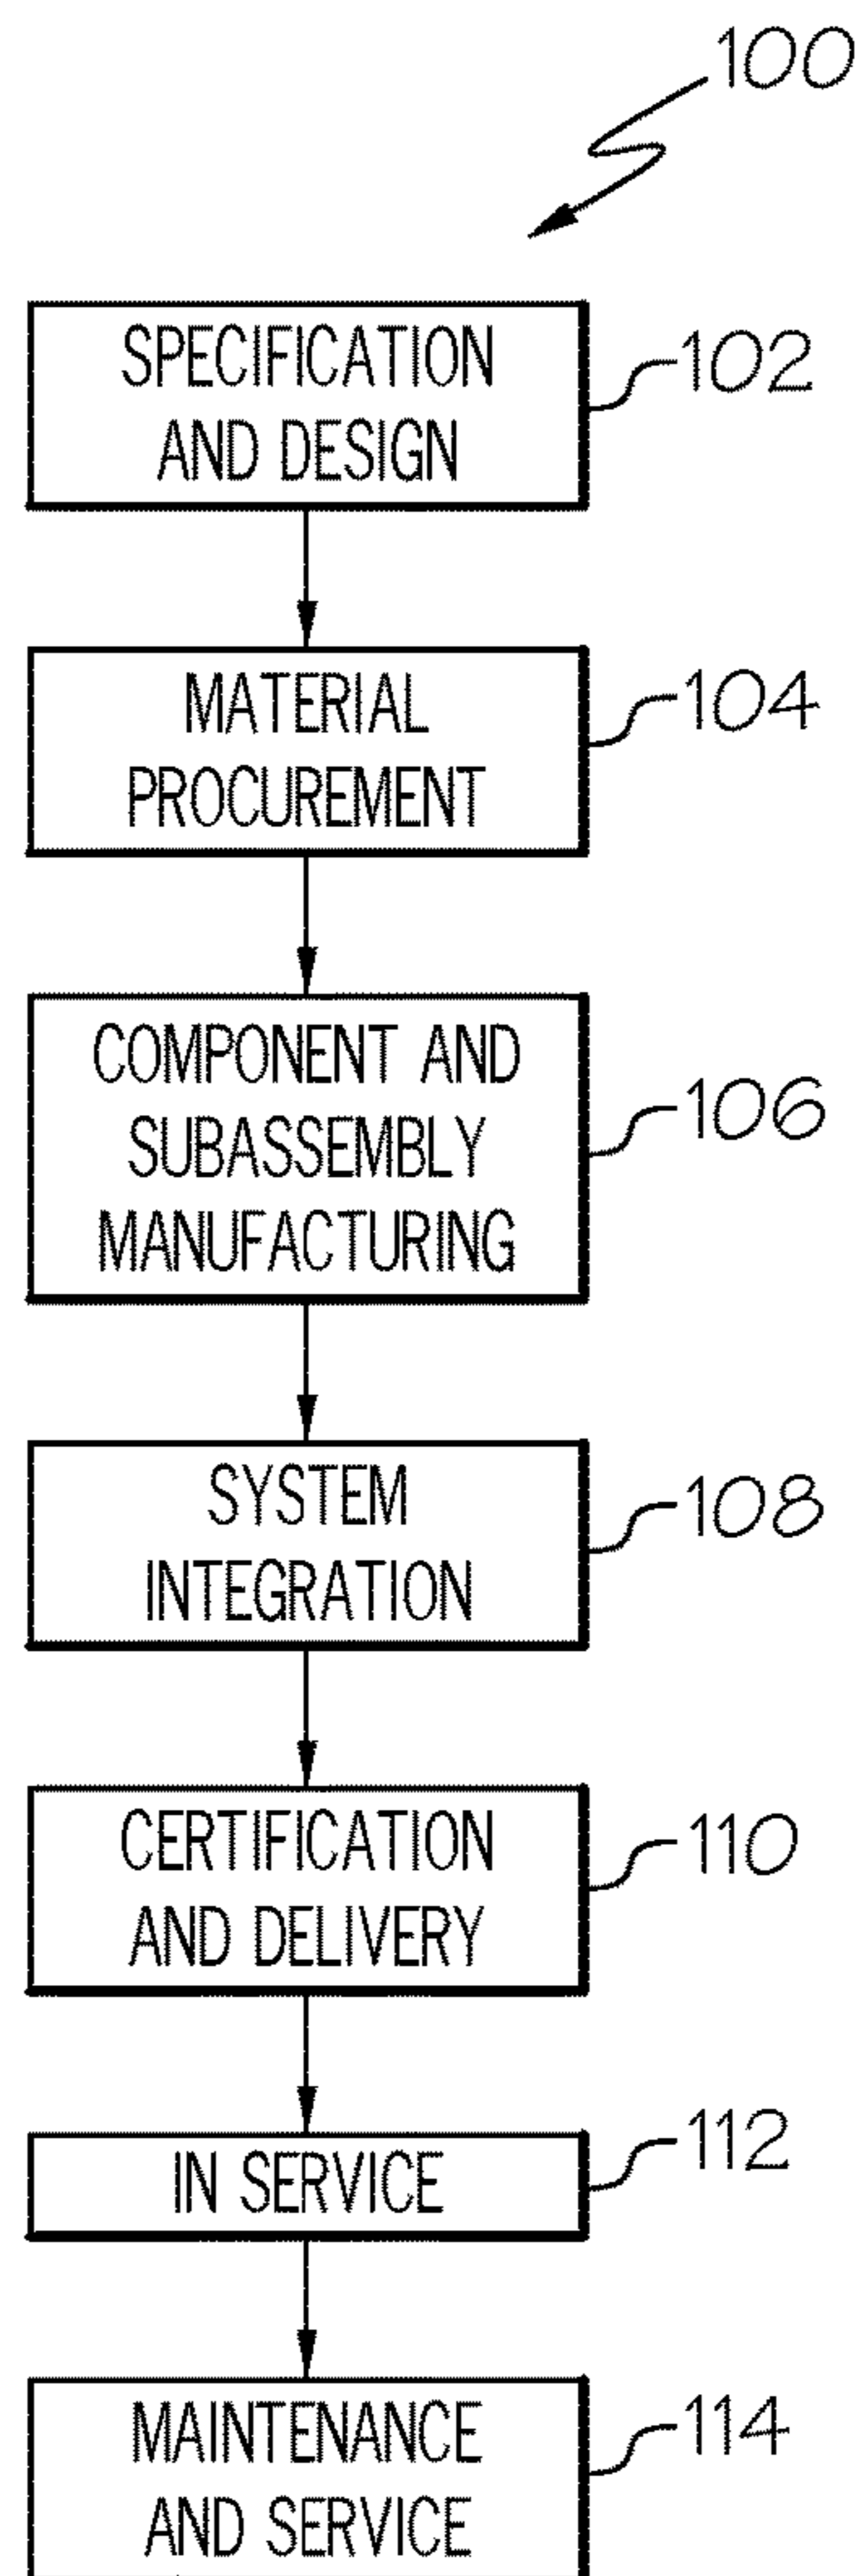
FIG. 1 is a flow diagram of an aircraft manufacturing and service methodology.

Examples of the present disclosure may be described in the context of an aircraft manufacturing and service method **100** as shown in FIG. **1** and an aircraft **200** as shown in FIG. **2**. During pre-production, the illustrative method **100** may include specification and design, as shown at block **102**, of the aircraft **200** and material procurement, as shown at block **104**. During production, component and subassembly manufacturing, as shown at block **106**, and system integration, as shown at block **108**, of the aircraft **200** may take place. Thereafter, the aircraft **200** may go through certification and delivery, as shown block **110**, to be placed in service, as shown at block **112**. While in service, the aircraft **200** may be scheduled for routine maintenance and service, as shown at block **114**. Routine maintenance and service may include modification, reconfiguration, refurbishment, etc. of one or more systems of the aircraft **200**.

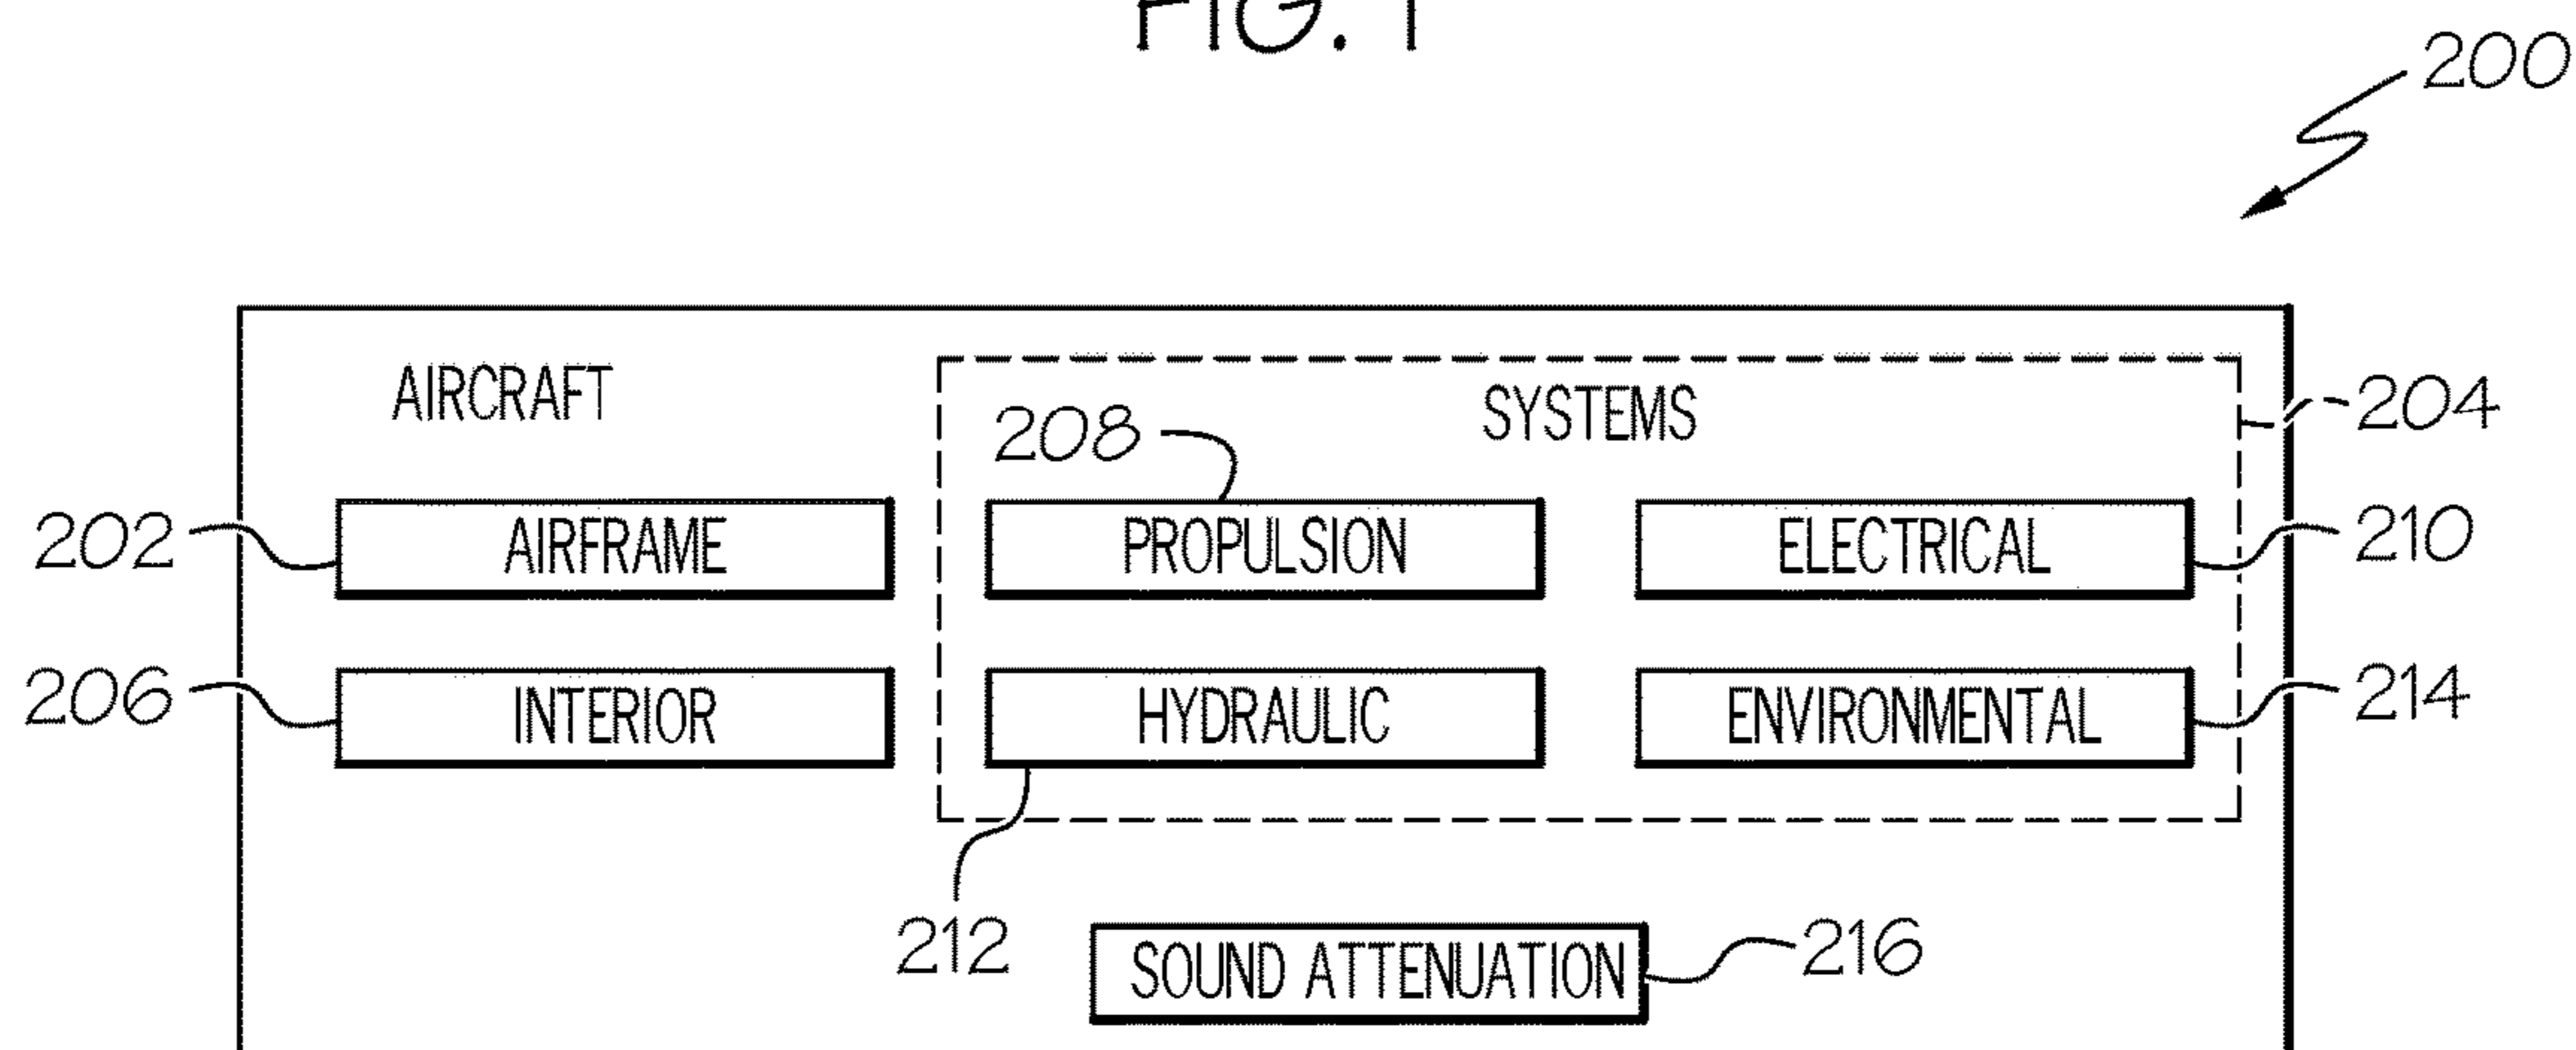
FIG. 2 is a block diagram of an aircraft.

As shown in FIG. **2**, the aircraft **200** produced by illustrative method **100** (FIG. **1**) may include an airframe **202** with a plurality of high-level systems **204** and an interior **206**. Examples of high-level systems **204** may include one or more of propulsion system **208**, electrical system **210**, hydraulic system **212**, environmental system **214**, and sound attenuation system **216**. Any number of other systems may be included. Although an aerospace example is shown, the principles disclosed herein may be applied to other industries, such as the automotive and marine industries. Accordingly, in addition to the aircraft **200**, the principles disclosed herein may apply to other vehicles (e.g., land vehicles, marine vehicles, space vehicles, etc.).

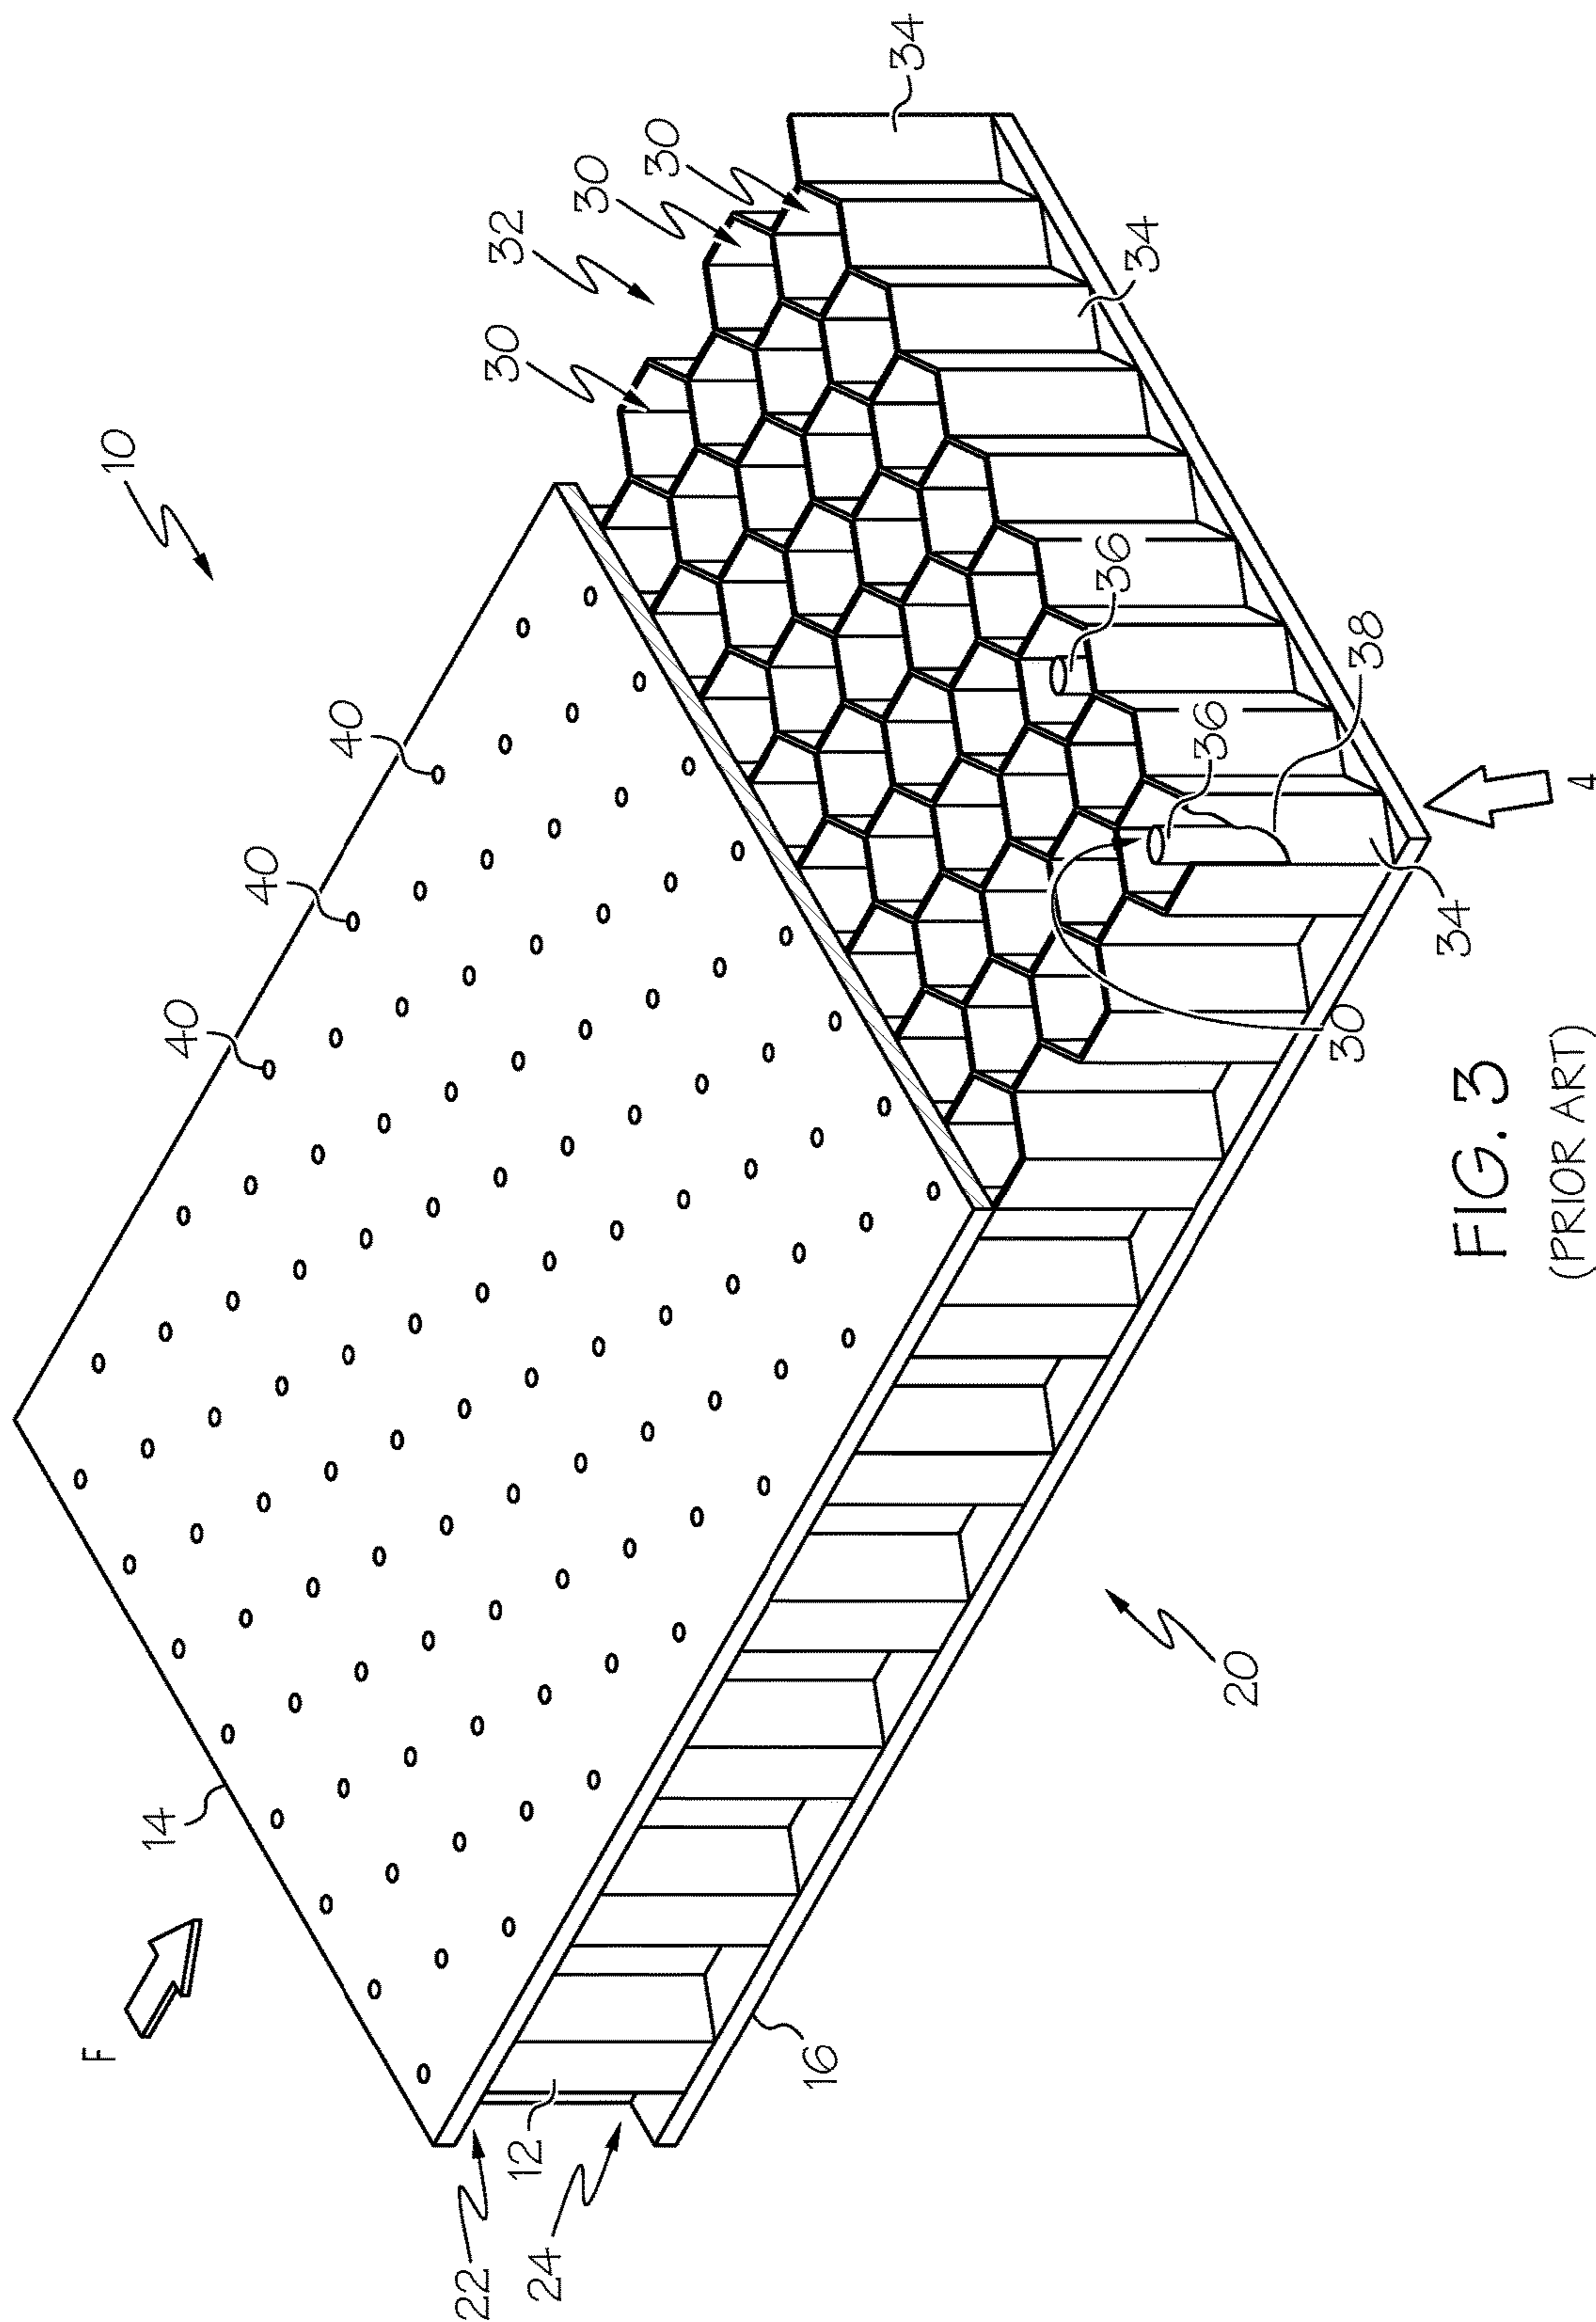
FIG. 3
(PRIOR ART)

FIG. 3 is a perspective view of a known acoustic sandwich panel including an acoustic core cell that has a damaged core cell wall in need of repair.

Referring to FIG. **3**, a known acoustic sandwich panel, generally designated **10**, may include a core **12**, a first liner sheet **14**, a second liner sheet **16** and a plurality of inserts **36**. The core **12**, the first liner sheet **14** and the second liner sheet **16** form a layered structure **20**, and the inserts **36** are positioned and housed within the core **12** of the layered

In one particular realization, the core **12** of the acoustic sandwich panel **10** may have a honeycomb structure **32** that includes an array of tightly packed acoustic core cells **34**, with each cell **34** of the honeycomb structure **32** defining an associated cavity **30** and cavity volume. The cells **34** of the honeycomb structure **32** may be tubular and may have a cross-sectional shape, such as hexagonal, square, rectangular, circular, ovular, or the like. The cavities **30** defined by the cells **34** of the honeycomb structure **32** may extend continuously through the core **12** from the first liner sheet **14** to the second liner sheet **16**.

The first liner sheet **14** of the acoustic sandwich panel **10** may be perforated. Specifically, the first liner sheet **14** may define a plurality of apertures **40** extending therethrough. Each aperture **40** of the first liner sheet **14** may provide fluid communication with an associated cavity **30** in the underlying core **12**. While a single aperture **40** per cavity **30** is shown in FIG. 1, in an alternative construction, two or more apertures **40** per cavity **30** may be formed in the first liner sheet **14**.

Thus, each aperture **40** may fluidly couple an associated cavity **30** with an airflow (designated with arrow F shown in FIG. 3) moving across the top side (as viewed looking at FIG. 3) of the acoustic sandwich panel **10**. Therefore, the fluid communication between the airflow F and the cavities **30** in the core **12** of the acoustic sandwich panel **10**—by way of the apertures **40** of the first liner sheet **14**—may allow the cavities **30** to function as Helmholtz resonators, thereby attenuating the sound of the airflow F.

For purposes of discussion, one of the acoustic core cells **34** (i.e., the core cell **34** located in the lower left corner of the perspective view of FIG. 3) of the acoustic sandwich panel **10** is shown with an example damaged core cell wall **38**. Various embodiments of repair methods and repair kits for repairing damaged walls, such as the damaged core cell wall **38** of the acoustic core cell **34** of the acoustic sandwich panel **10** shown in FIG. 3, are disclosed herein.

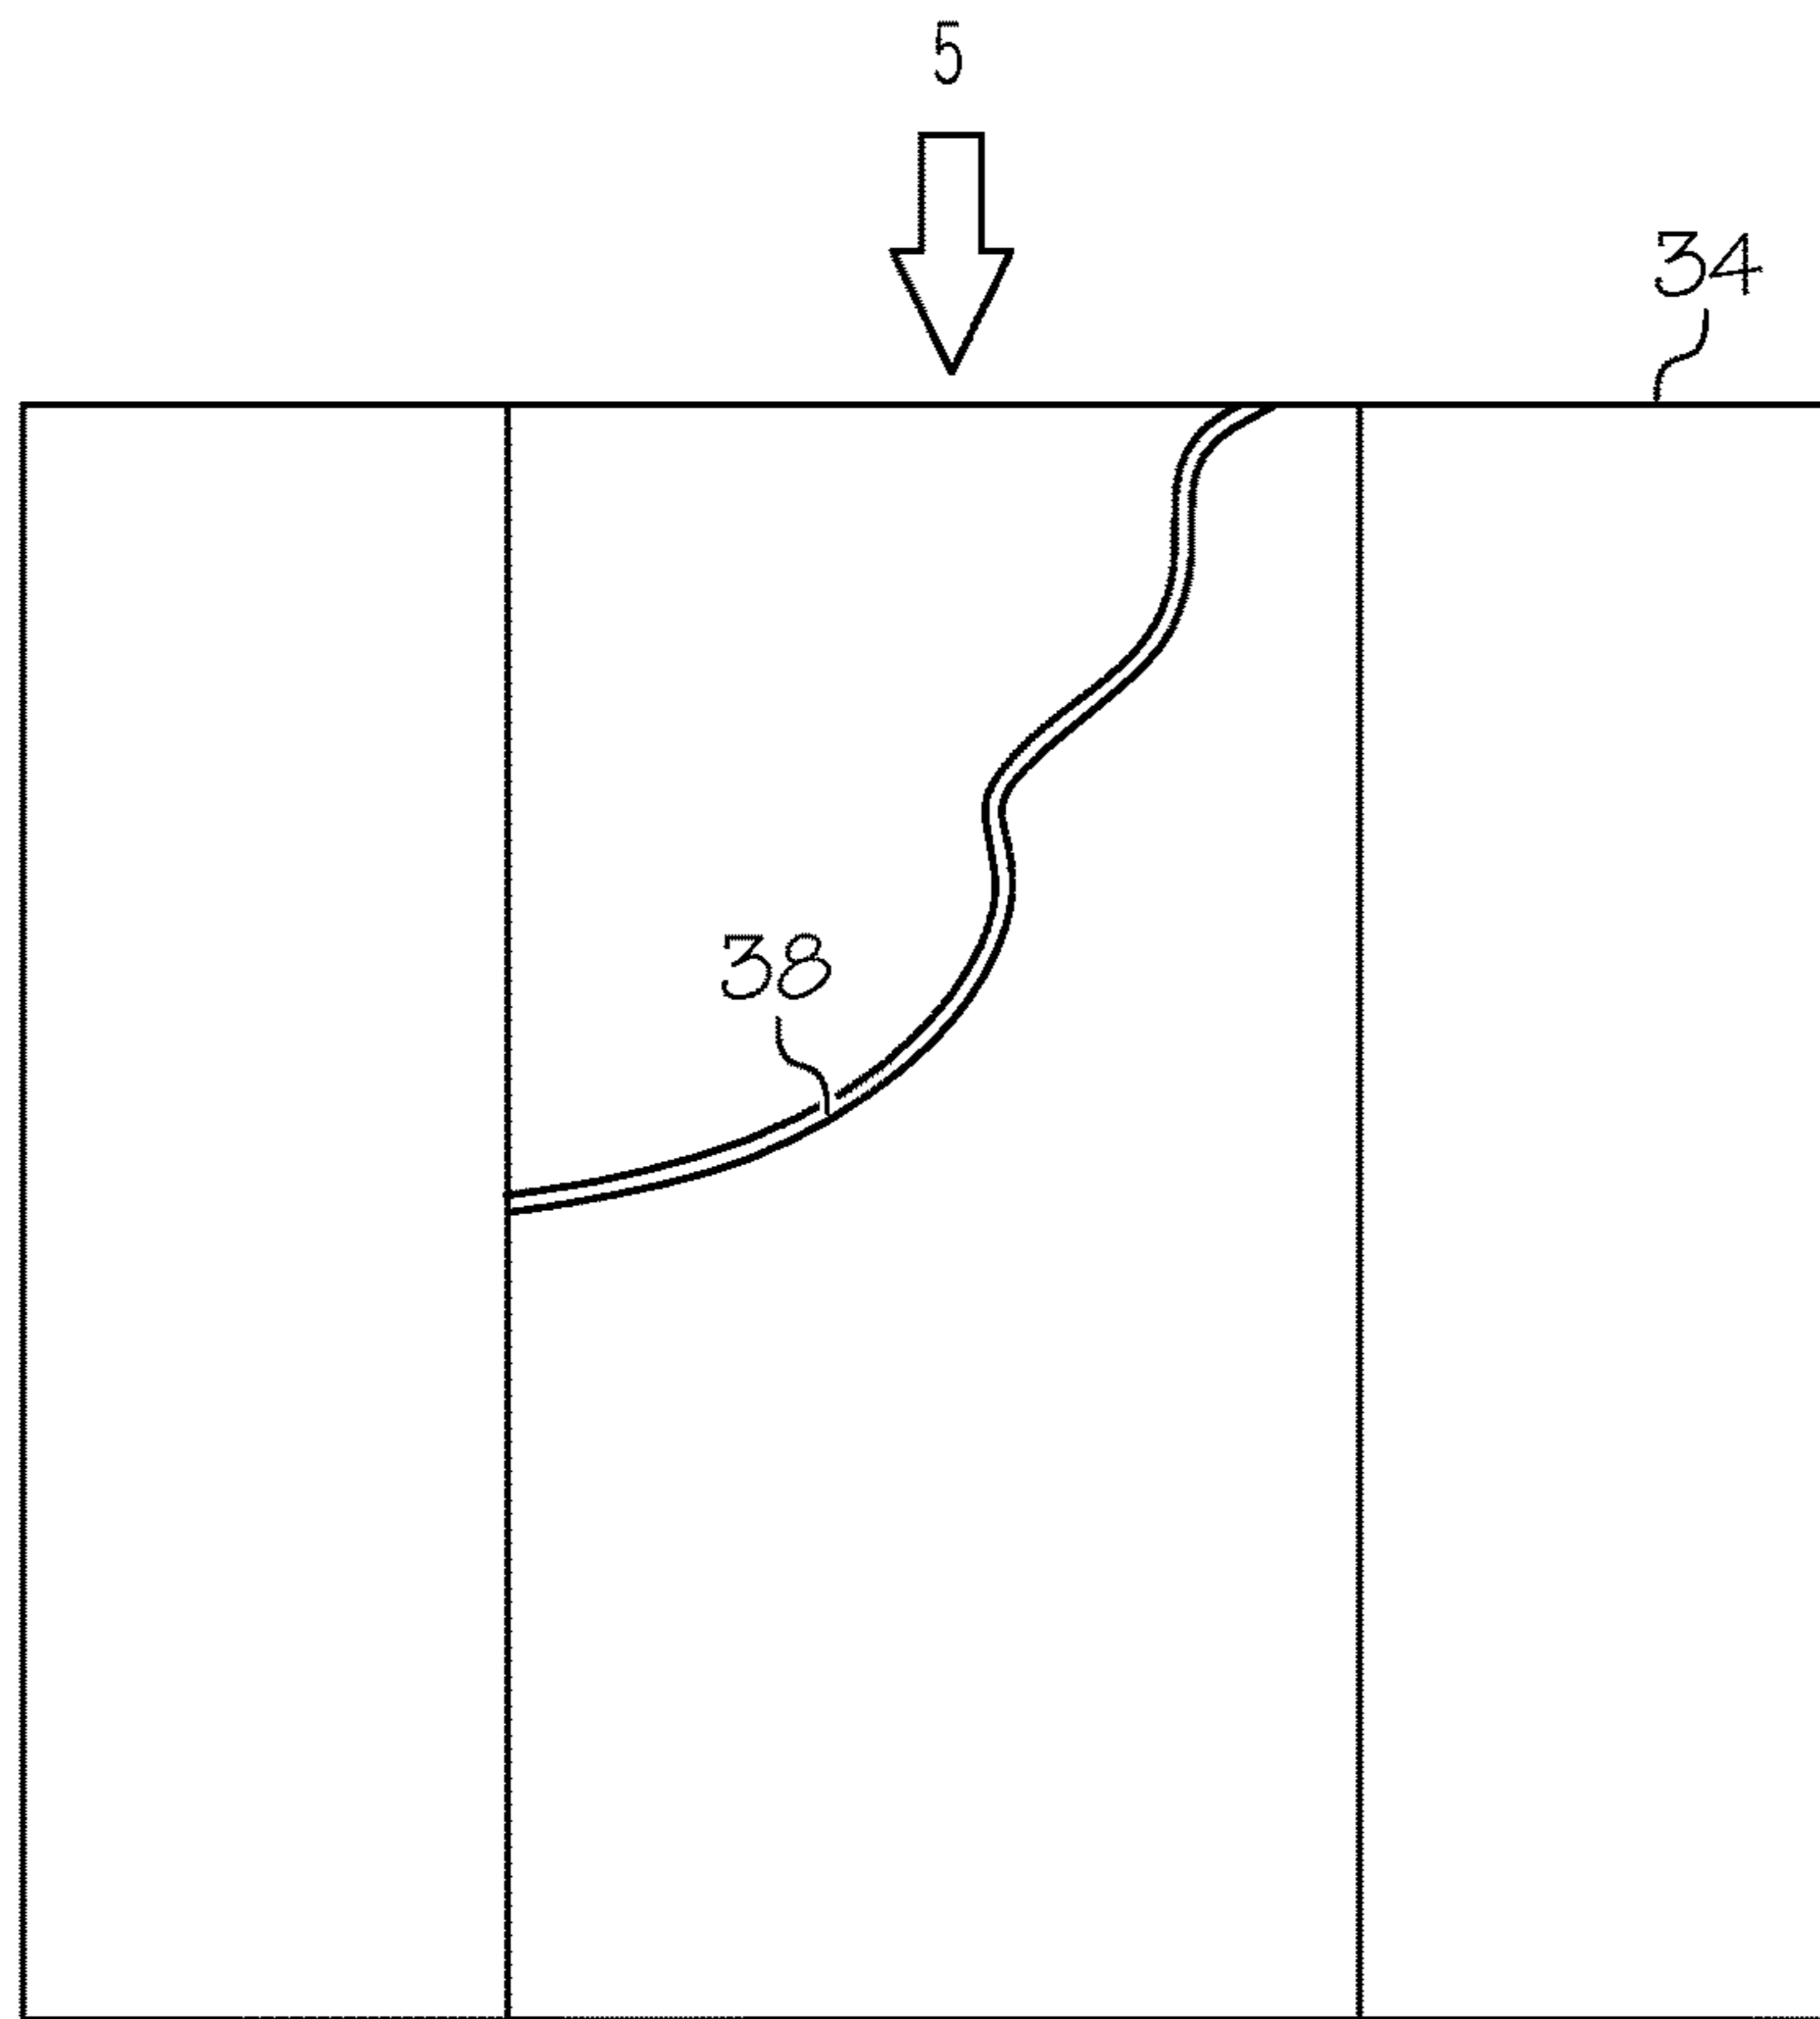
FIG. 4
(PRIOR ART)

FIG. 4 is a cross-sectional view, looking approximately in the direction of arrow 4 shown in FIG. 3, of the damaged core cell wall of FIG. 3.

Referring to FIG. 4, a cross-sectional view, looking approximately in the direction of arrow **4** shown in FIG. 3, of the damaged core cell wall **38** of FIG. 3 is shown. For clarity of discussion herein, the insert **36** in the cavity **30** of the acoustic core cell **34** shown in FIG. 3 is omitted from FIG. 4. Referring to FIG. 5, a top plan view, looking approximately in the direction of arrow **5** shown in FIG. 4, of the damaged core cell wall **38** of FIG. 4 is shown. As best shown in FIG. 4, the example damaged core cell wall **38** of the core cell **34** is in the form of a crack. This crack has the negative effect of reducing the effectiveness of the cavity **30** of the core cell **34** to function as a Helmholtz resonator and thereby reducing the sound attenuation capacity of the core cell **34**. Accordingly, it would be desirable to repair the damaged core cell wall **38** to restore the sound attenuation capacity of the core cell **34** and thereby restore the sound attenuation capacity of the acoustic sandwich panel **10** (FIG. 1).

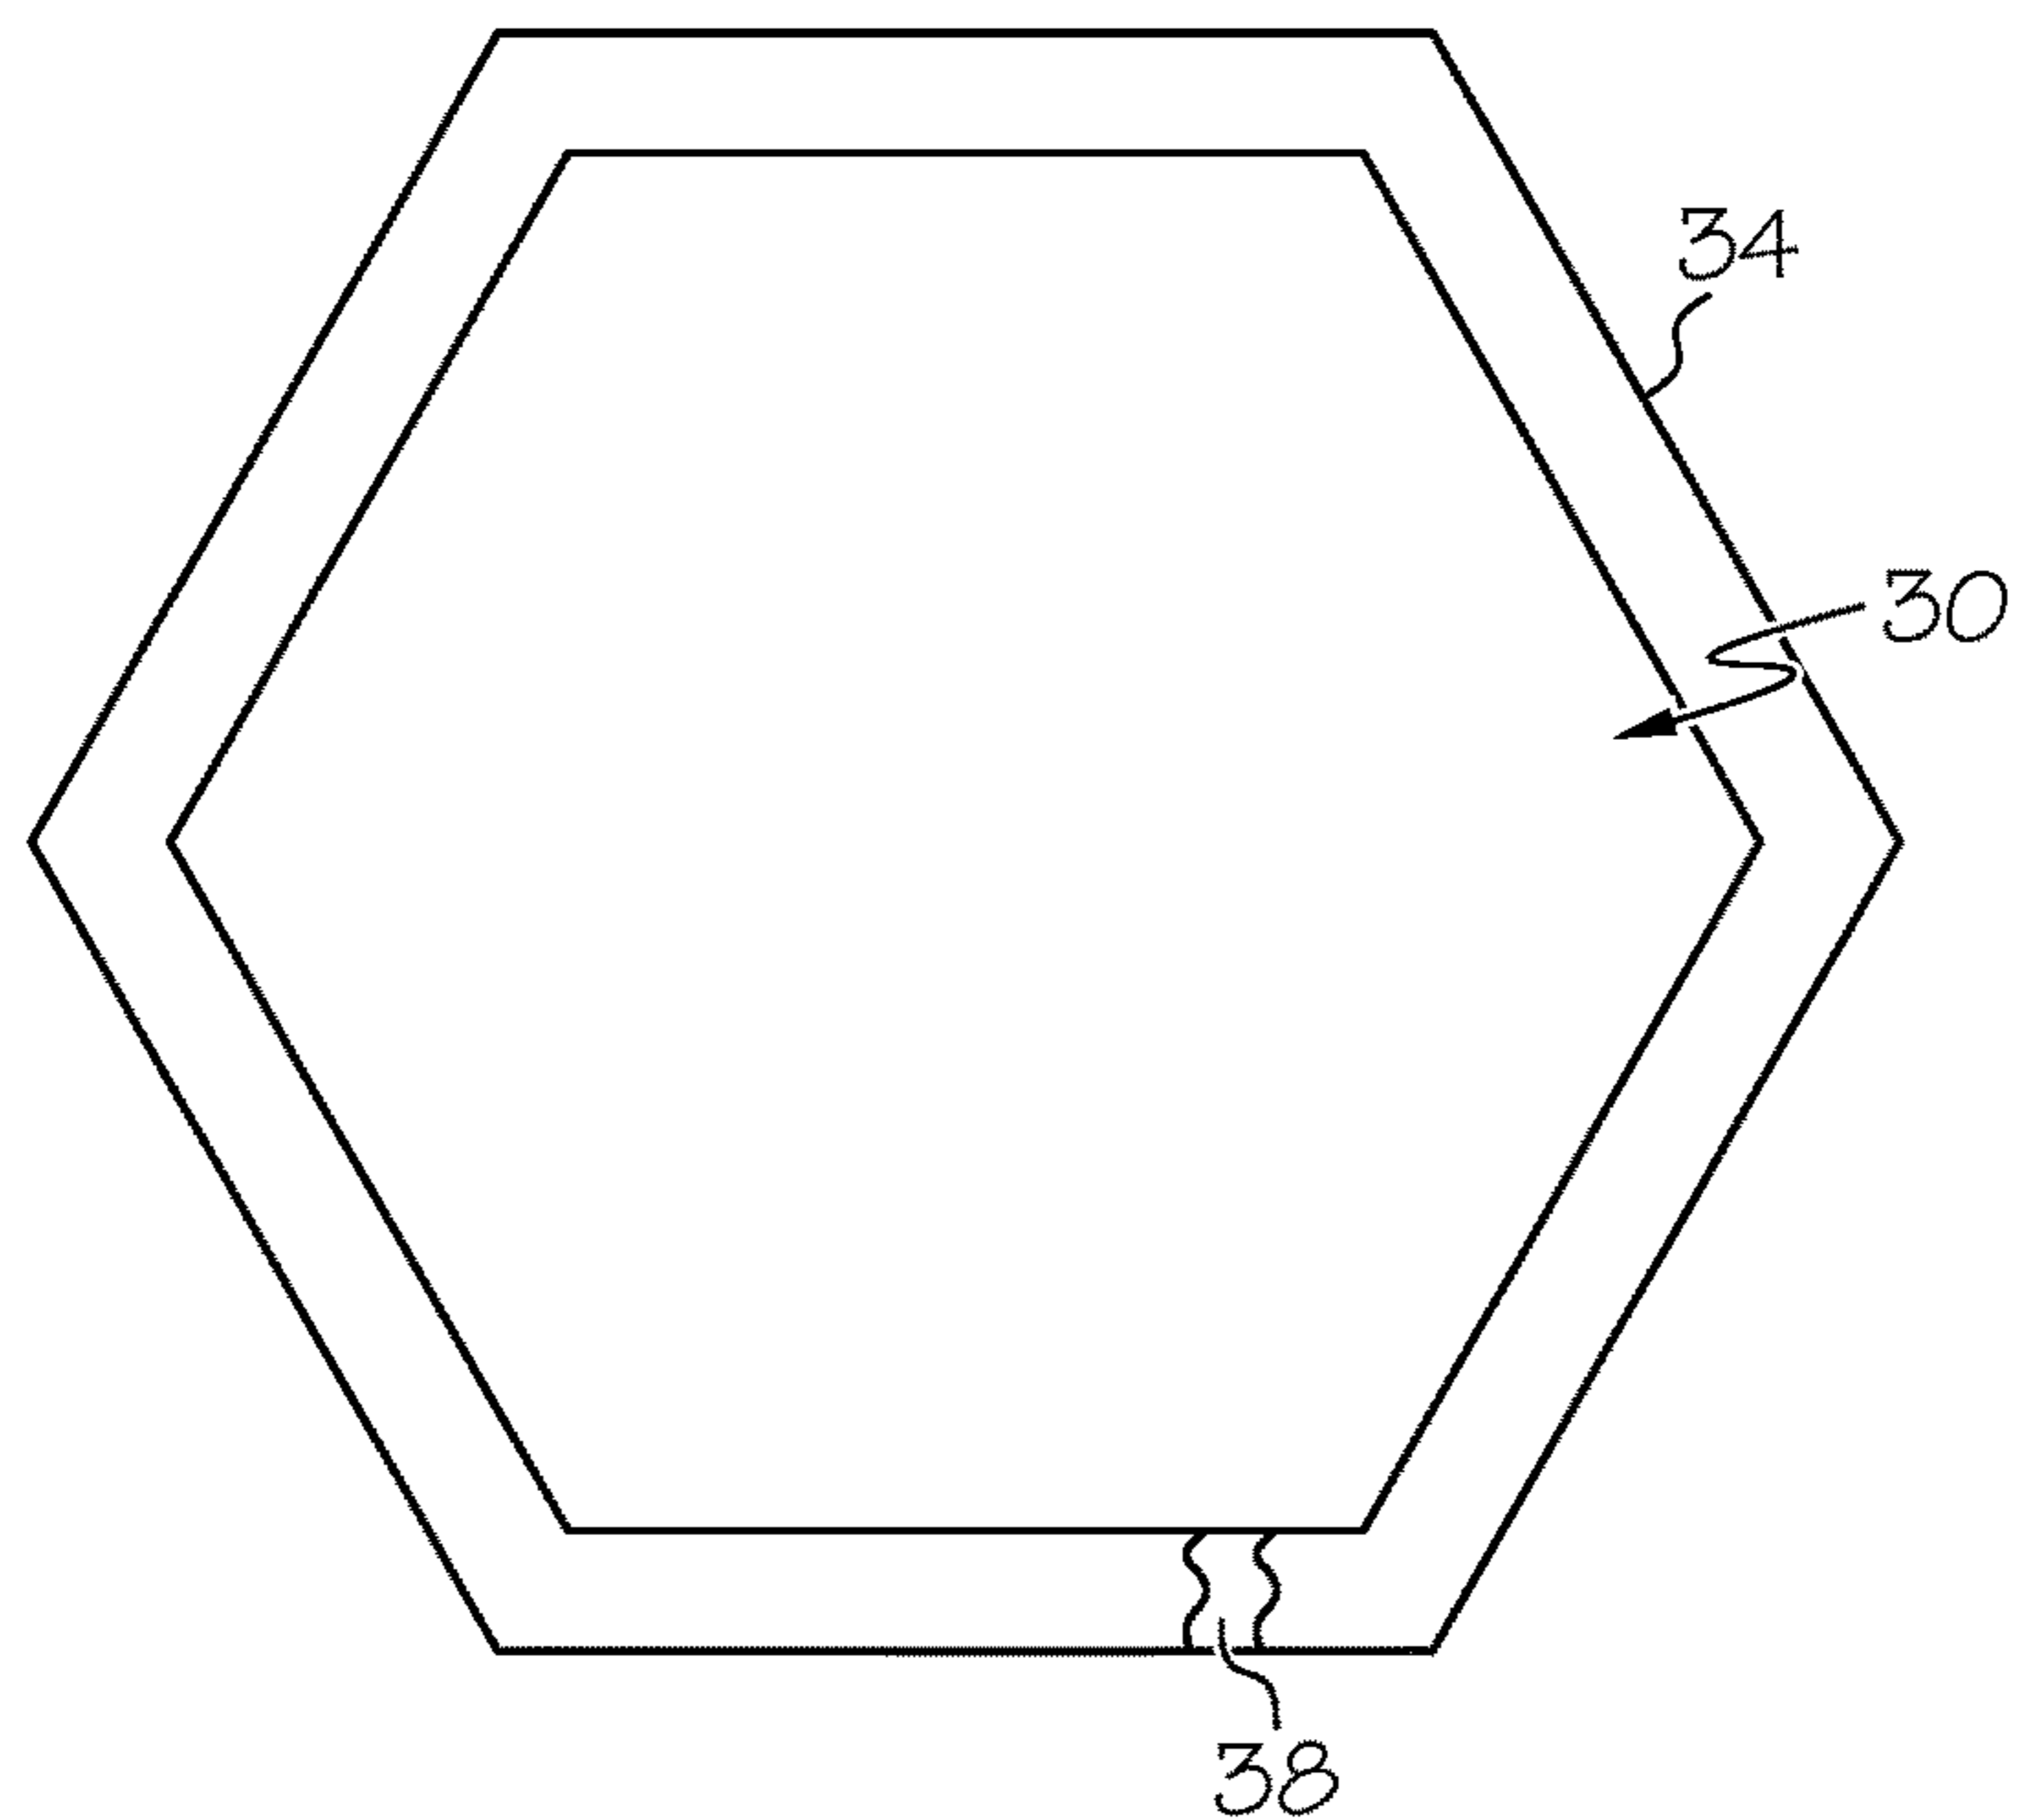
FIG. 5
(PRIOR ART)

FIG. 5 is a top plan view, looking approximately in the direction of arrow 5 shown in FIG. 4, of the damaged core cell wall of FIG. 4.

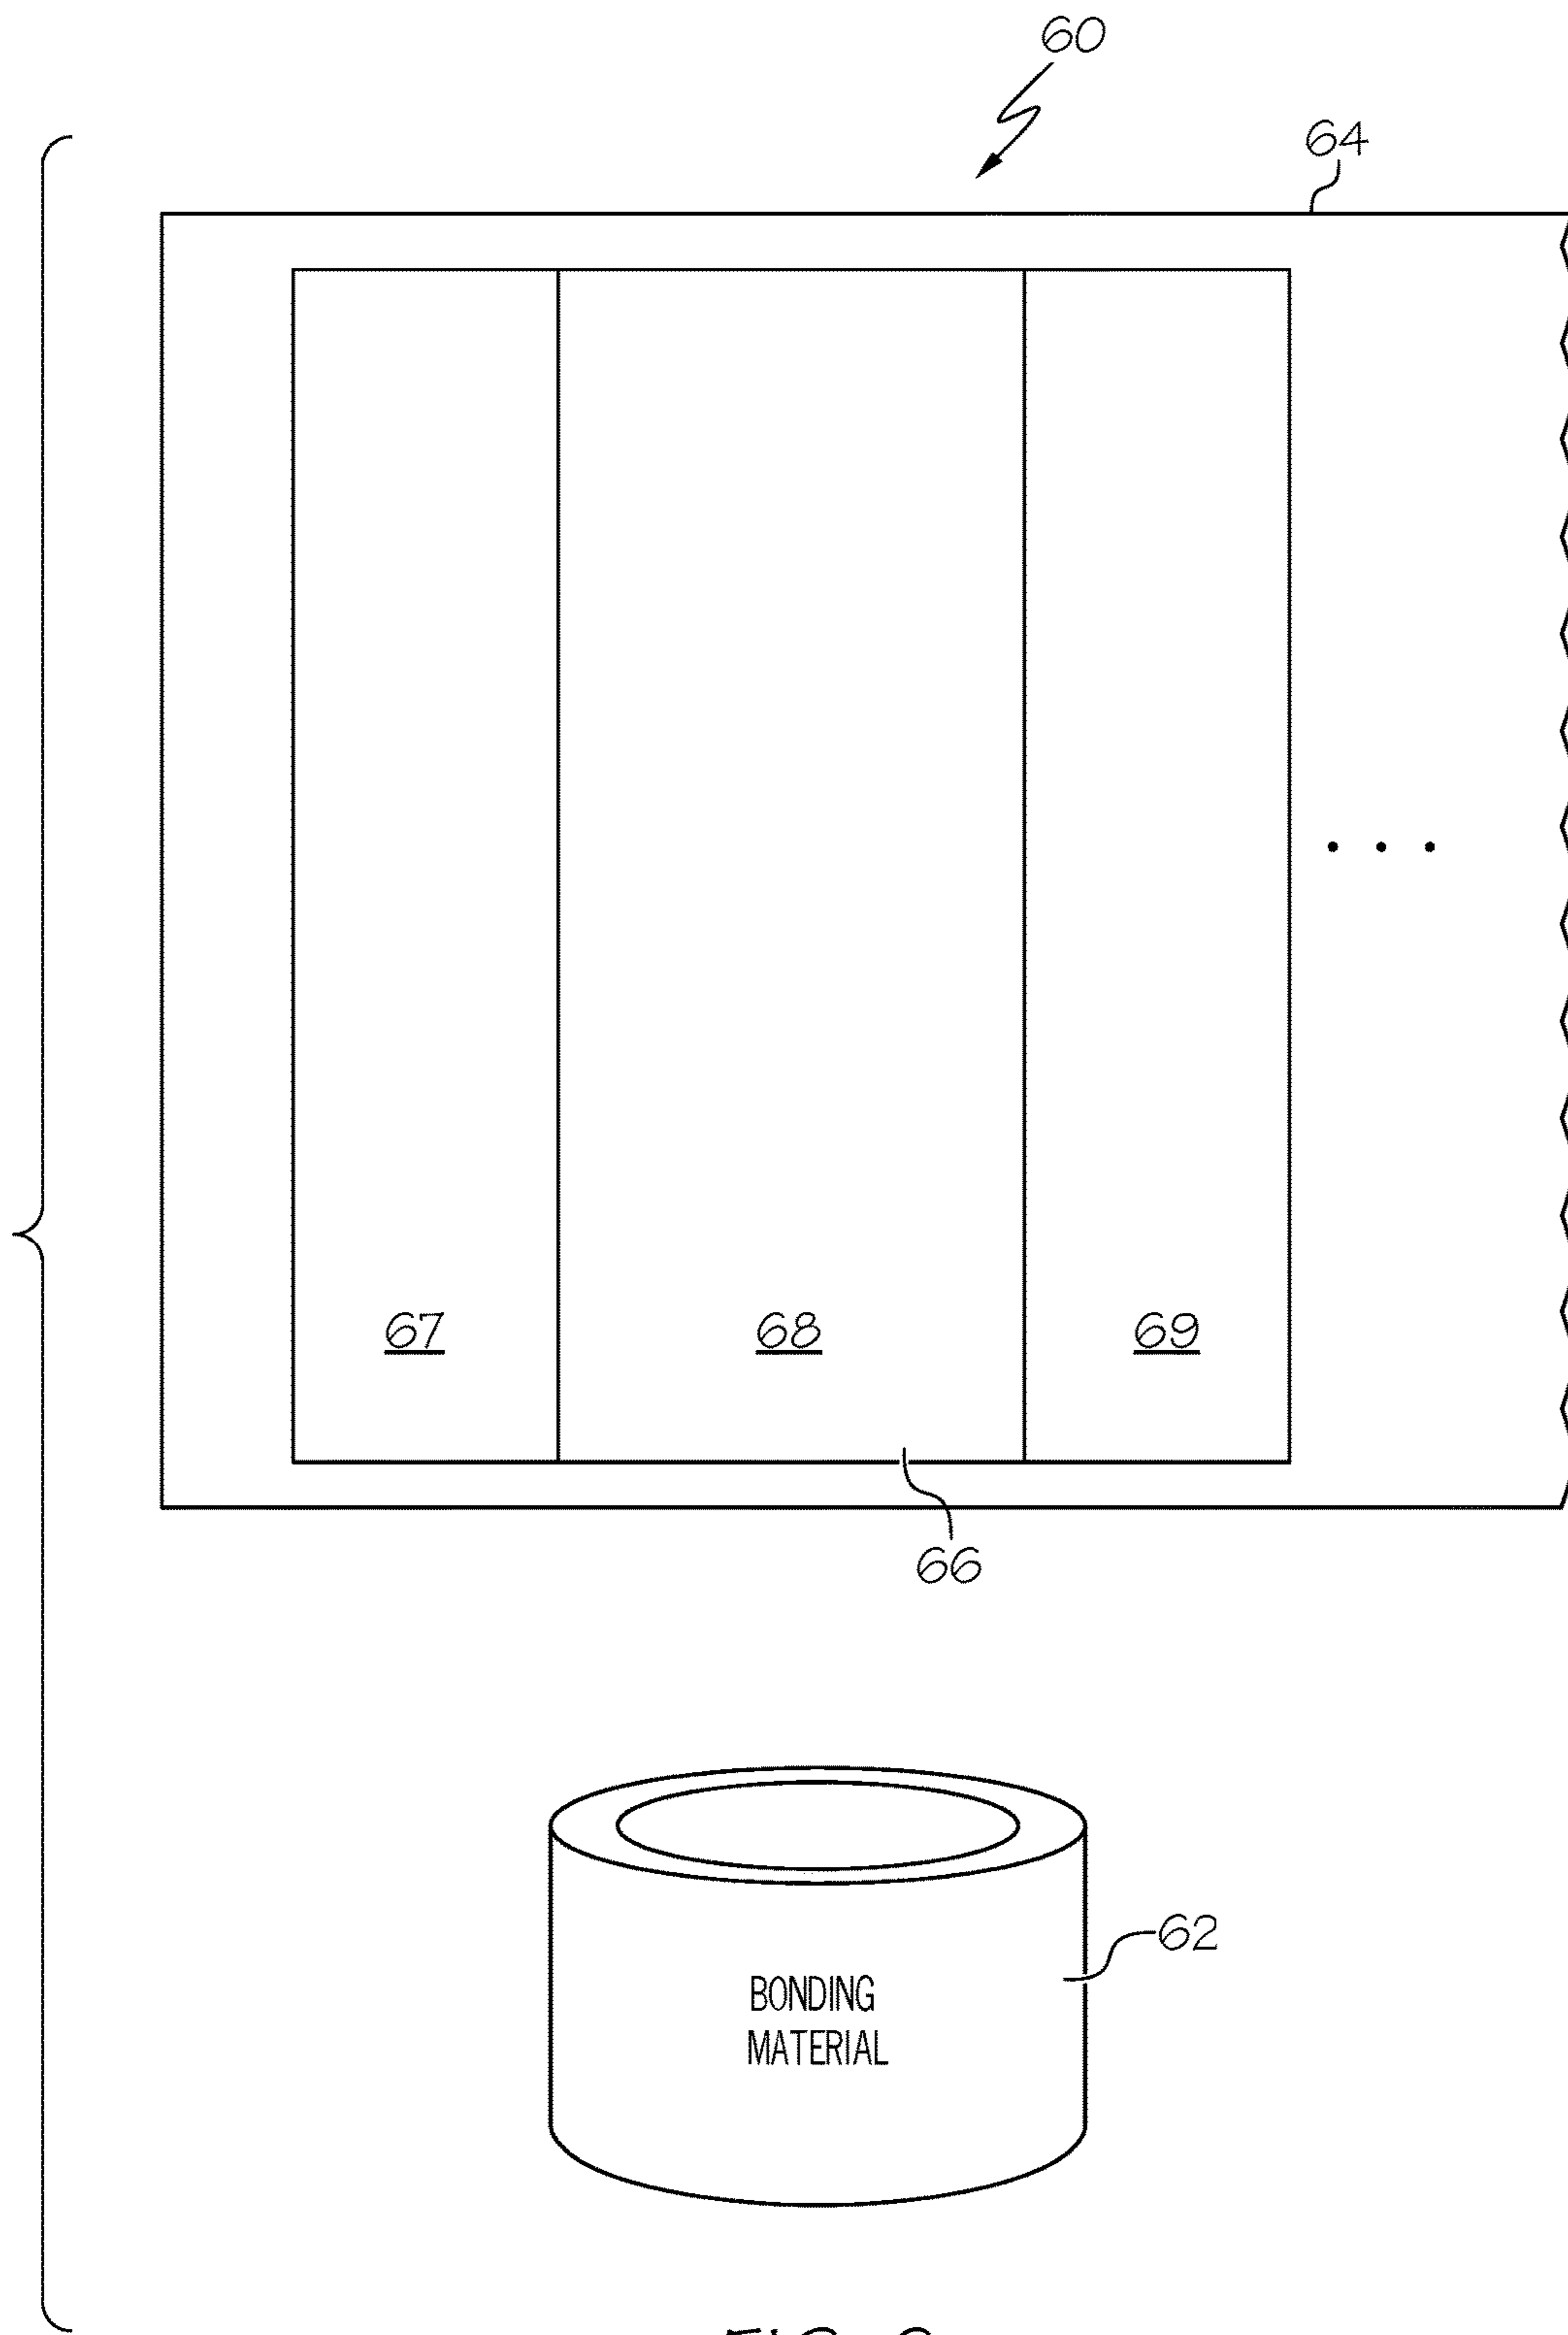
FIG. 6 is a perspective view of an acoustic sandwich panel repair kit constructed in accordance with an embodiment, which contains a bonding material and a ribbon of core repair splices for repairing the damaged core cell wall of FIGS. 3-5.

Referring to FIG. 6, a perspective view of an acoustic sandwich panel repair kit **60** constructed in accordance with an embodiment is shown. The acoustic sandwich panel repair kit **60** includes a container of bonding material **62** and a ribbon **64** of core repair splices **66** for repairing damaged walls, such as the damaged core cell wall **38** shown in FIGS. 3-5. The bonding material **62** may comprise an adhesive. In one implementation, an epoxy paste adhesive is used. An example epoxy paste adhesive is LOCTITE® EA 9394 AERO™ available from Henkel Corporation Aerospace located in Bay Point, Calif., U.S.A. In another implemen-

The ribbon **64** includes a plurality of core repair splices **66**, only one of which is shown in FIG. **6**. The ellipsis shown in FIG. **6** designates other one or more of core repair splices on the ribbon **64**. For simplicity and clarity of discussion, only the core repair splice **66** shown in FIG. **6** is described herein. The core repair splice **66** includes a plurality of surfaces shaped to conform to a number of damaged walls. More specifically, the plurality of surfaces includes a first flat surface **68**, a second flat surface **67** that is oblique to the first flat surface **68** at one edge of the first flat surface **68**, and a third flat surface **69** that is oblique to the first flat surface **68** at an opposite end edge of the first flat surface **68**.

Each of the panels **67**, **68**, **69** has a length or height (as viewed looking at FIG. **6**) that is greater than the distance between the first liner sheet **14** and the second liner **16** (FIG. **1**), for example. Each of the panels **67**, **68**, **69** has a width that is about the width of a core cell wall of a core cell, such as the width of the damaged core cell wall **38** of the core cell **34** shown in FIGS. **3-5**. The core repair splice **66** comprises material that is substantially the same or similar to the material of the damaged core cell wall **38**.
