(10) **Patent No.:** **US 9,659,556 B1**
(45) **Date of Patent:** **May 23, 2017**

(54) **METHODS OF REPAIRING AN ACOUSTIC SANDWICH PANEL AND ACOUSTIC SANDWICH PANEL REPAIR KITS THEREFOR**

(71) Applicant: **The Boeing Company**, Chicago, IL (US)

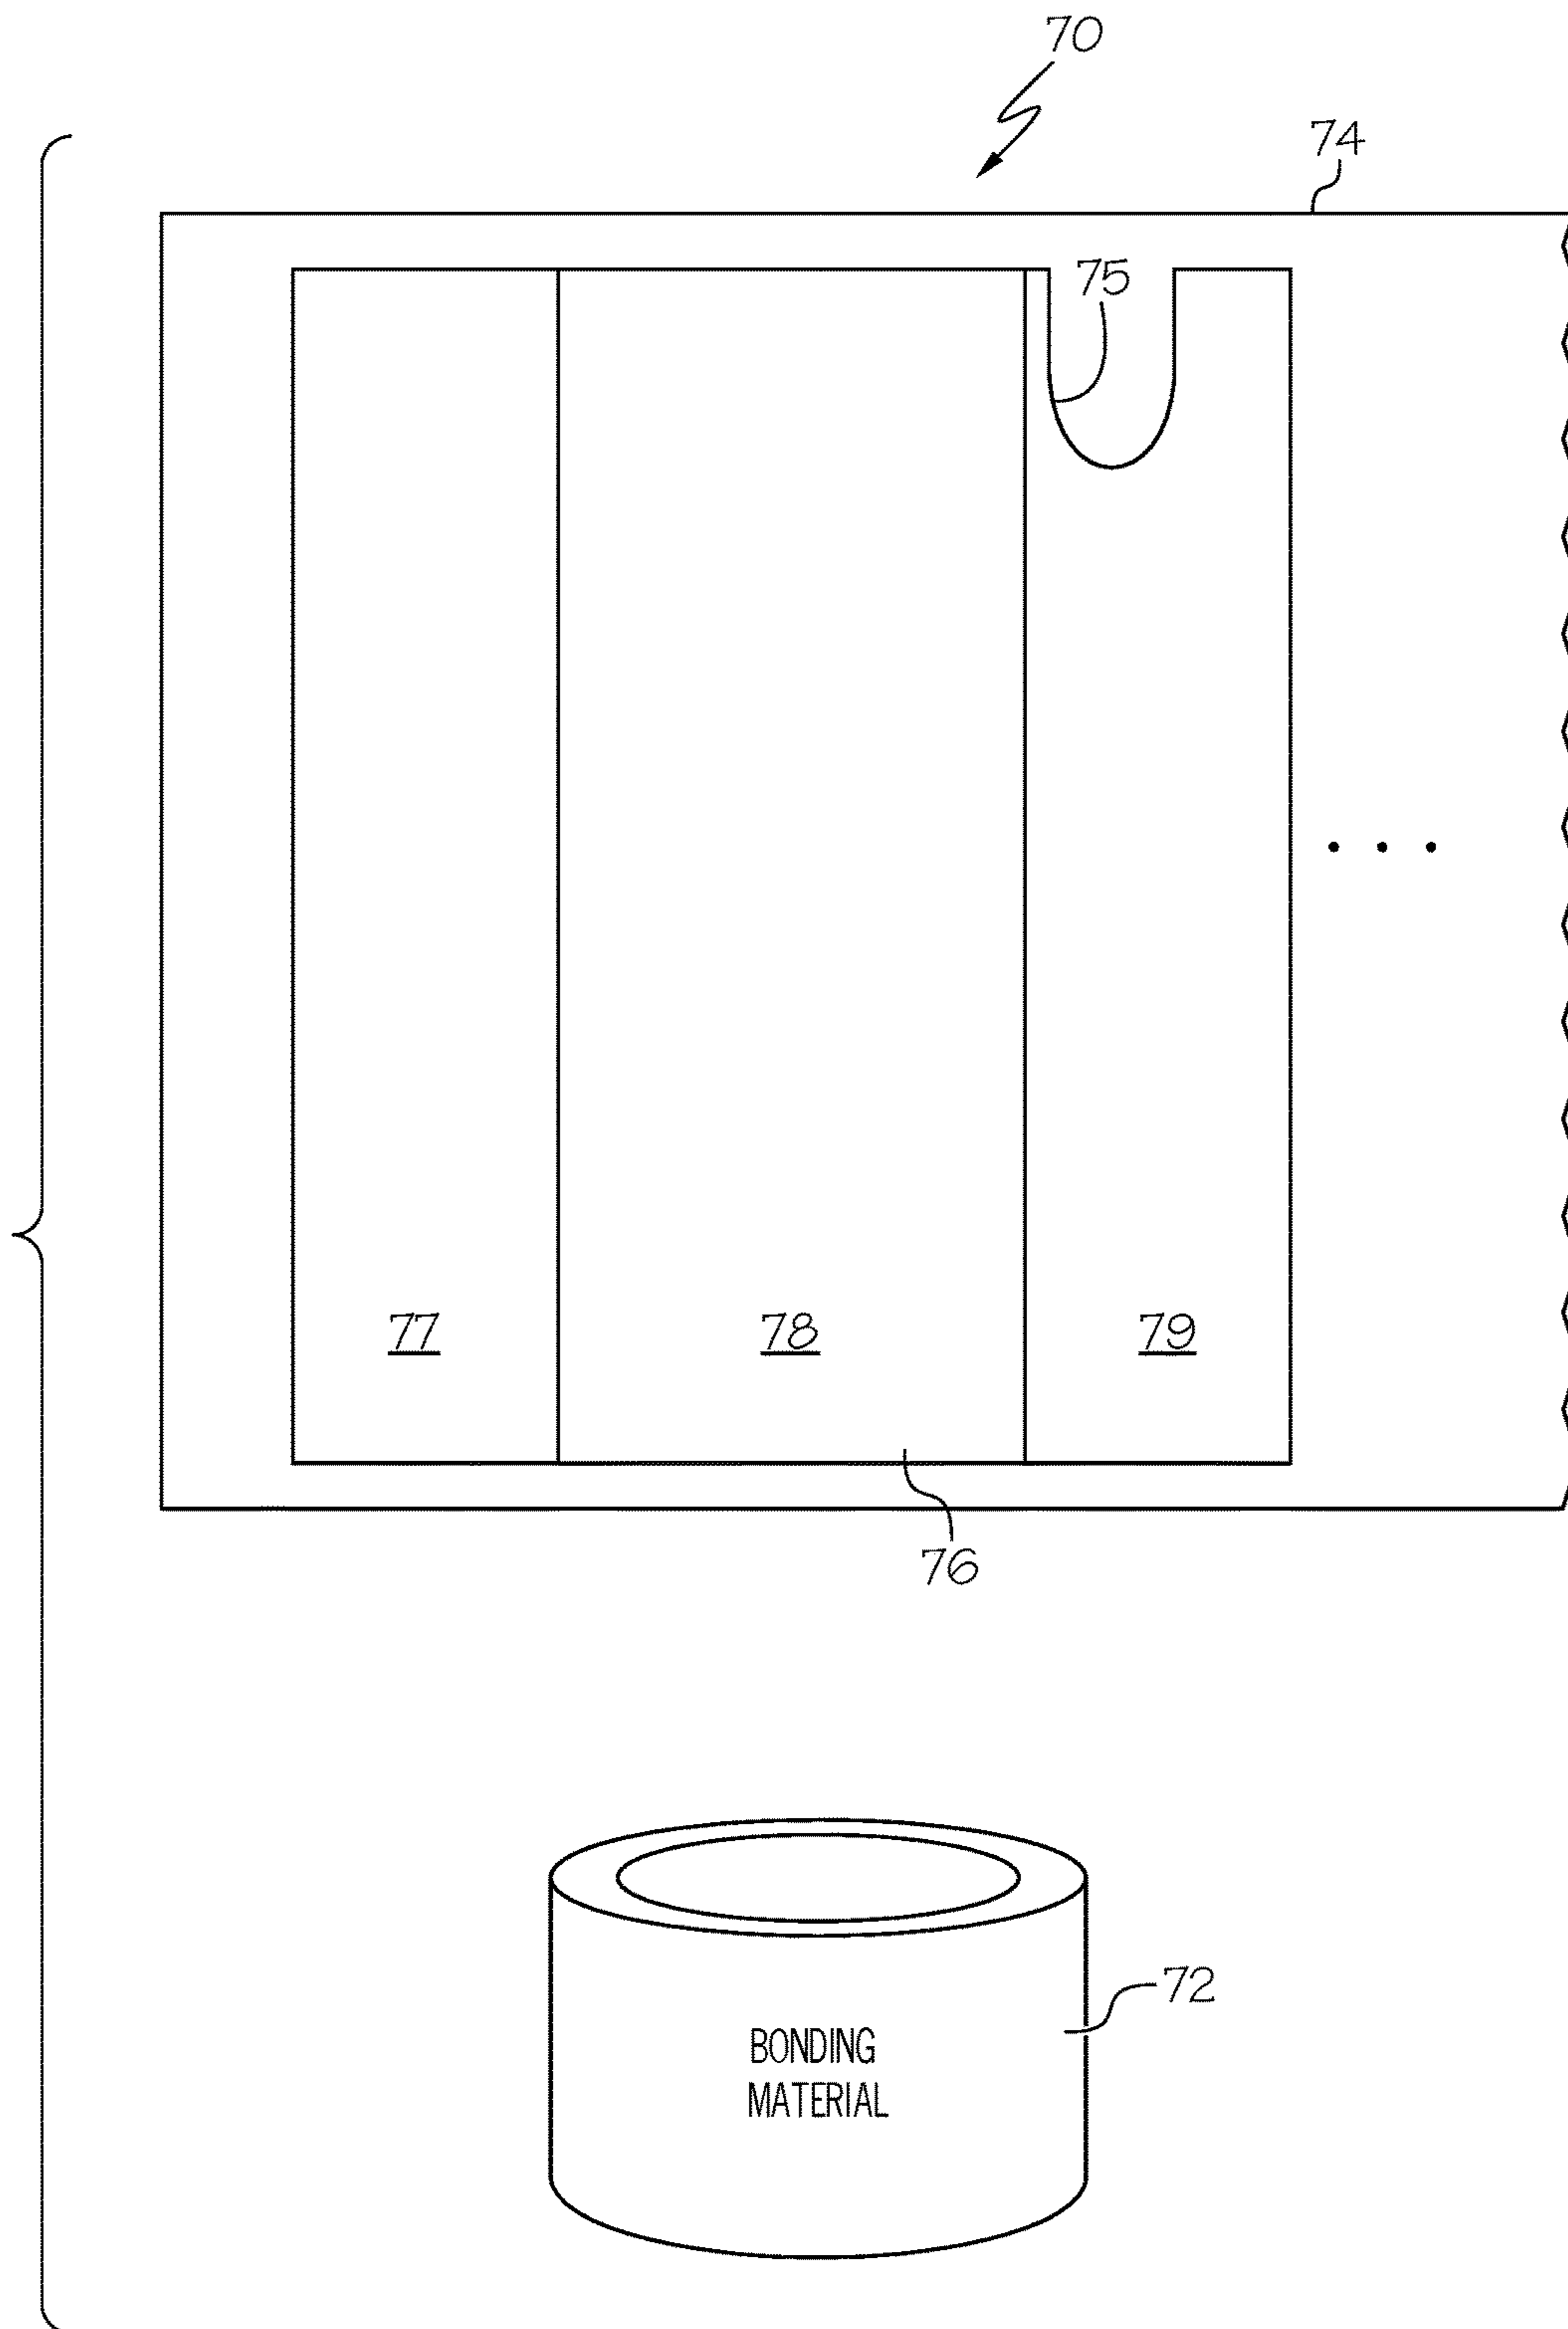
FIG. 7 is a perspective view similar to the perspective view of FIG. 6, and showing an acoustic sandwich panel repair kit constructed in accordance with another embodiment.

Referring to FIG. **7**, a perspective view similar to the perspective view of FIG. **6** is shown. FIG. **7** shows an acoustic sandwich panel repair kit **70** constructed in accordance with another embodiment. The acoustic sandwich panel repair kit **70** includes a container of bonding material **72** and a ribbon **74** of core repair splices **76** for repairing damaged walls. The bonding material **72** may comprise an adhesive. In one implementation, an epoxy paste adhesive is used. An example epoxy paste adhesive is LOCTITE® EA 9394 AERO™ available from Henkel Corporation Aerospace located in Bay Point, Calif., U.S.A. In another implementation, a high viscosity adhesive is used. Other implementations of bonding material **72** are possible.

The ribbon **74** includes a plurality of core repair splices **76**, only one of which is shown in FIG. **7**. The ellipsis shown in FIG. **7** designates other one or more of core repair splices on the ribbon **74**. For simplicity and clarity of discussion, only the core repair splice **76** shown in FIG. **7** is described herein. The core repair splice **76** includes a plurality of surfaces shaped to conform to a number of damaged walls. More specifically, the plurality of surfaces includes a first flat surface **78**, a second flat surface **77** that is oblique to the first flat surface **78** at one edge of the first flat surface **78**, and a third flat surface **79** that is oblique to the first flat surface **78** at an opposite end edge of the first flat surface **78**. Further, one or more of the three panels **77**, **78**, **79** may have one or more slots formed therein depending upon the need of the particular repair application. As shown in the example implementation of FIG. **7**, the panel **79** has one slot **75** formed at one end of the panel **79**. The slot **75** is provided for the purpose of water drainage.

Each of the panels **77**, **78**, **79** also has a length or height (as viewed looking at FIG. **7**) that is greater than the distance between liner sheets of the particular acoustic sandwich panel that is being repaired. Also, each of the panels **77**, **78**, **79** has a width that is about the width of a damaged core cell wall of an acoustic core cell of the acoustic sandwich panel that is being repaired. The core repair splice **76** comprises material that is substantially the same or similar to the material of a damaged core cell wall of an acoustic core cell of the acoustic sandwich panel that is being repaired.

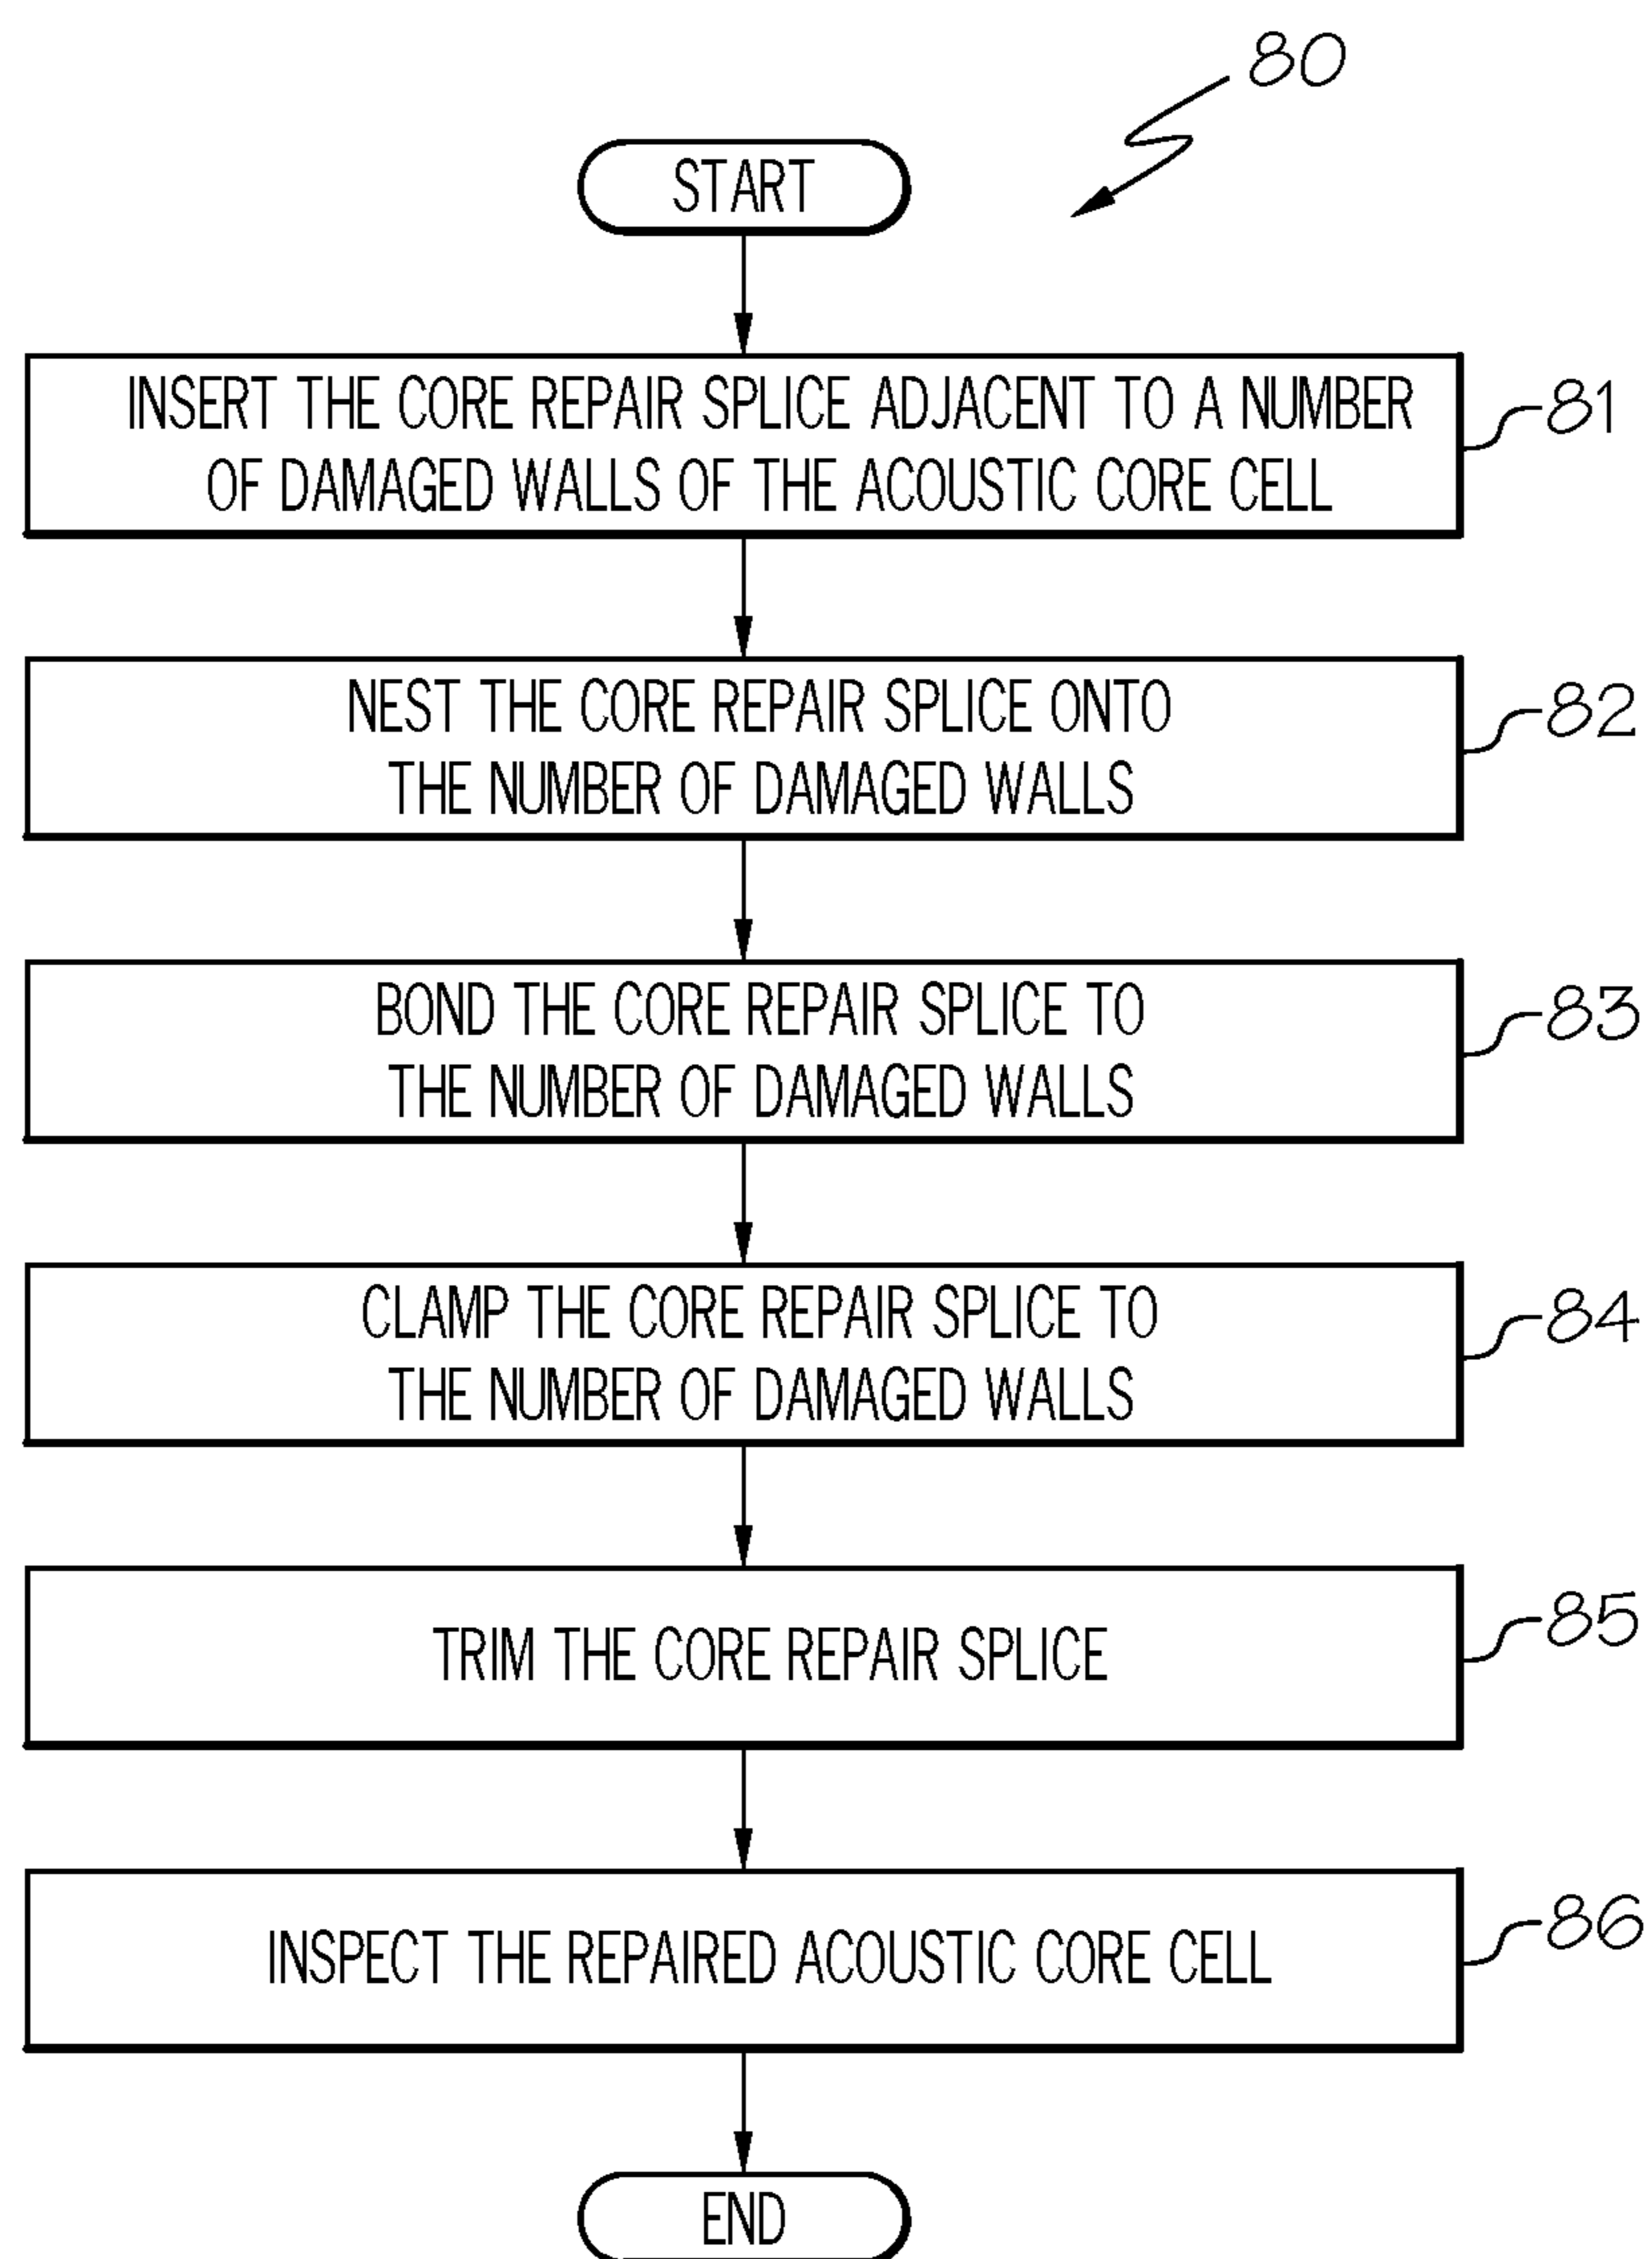
FIG. 8 is a flow diagram illustrating a method of repairing the damaged core cell wall of FIGS. 3-5 in accordance with an embodiment.

Referring to FIG. **8**, a flow diagram **80** is shown illustrating a method of repairing the damaged core cell wall **38** of FIGS. **3-5** using a core repair splice **66** of FIG. **6** in

In the flow diagram **80** of FIG. **8**, the core repair splice **66** is inserted adjacent to a number of damaged walls of the acoustic core cell **34** (block **81**). The core repair splice **66** is nested onto the number of damaged walls (block **82**). In the example implementation shown in FIG. **9**, the panel **68** of the core repair splice **66** is nested onto the damaged core cell wall **38**, and the other two panels **67**, **69** are nested onto walls adjacent to the damaged core cell wall **38**.

After the core repair splice **66** is bonded to the number of damaged walls, the core repair splice **66** is clamped to the number of damaged walls (block **84**). In one example implementation, one or more hair clips can be inserted into the cavity **30** to clamp the core repair splice **66** to the damaged core cell wall **38** when the bonding material **62** cures. In another implementation, one or more foam ear plugs can be inserted into the cavity **30** to clamp the core repair splice **66** to the damaged core cell wall **38** when the bonding material **62** cures. After the bonding material **62** cures and the one or more foam ear plugs or hair clips are removed.

After block **84**, the core repair splice **66** is trimmed (block **85**). In one implementation, the core repair splice **66** is trimmed such that the core repair splice **66** extends flush with a core surface of the acoustic core cell **34** when the trimmed core repair splice is bonded to the number of damaged walls. In another implementation, the core repair splice **66** is trimmed such that the core repair splice **66** extends beyond a core surface of the acoustic core cell when the trimmed core repair splice is bonded to the number of damaged walls. While the above description described the core repair splice **66** being trimmed after the core repair splice **66** is bonded to the number of damaged walls, it is conceivable that the core repair splice **66** be trimmed before the core repair splice **66** is inserted adjacent to the number of damaged walls. As a result, the repaired acoustic core cell **90** shown in FIG. **9** is provided and subsequently inspected to ensure quality of the repair (block **86**).

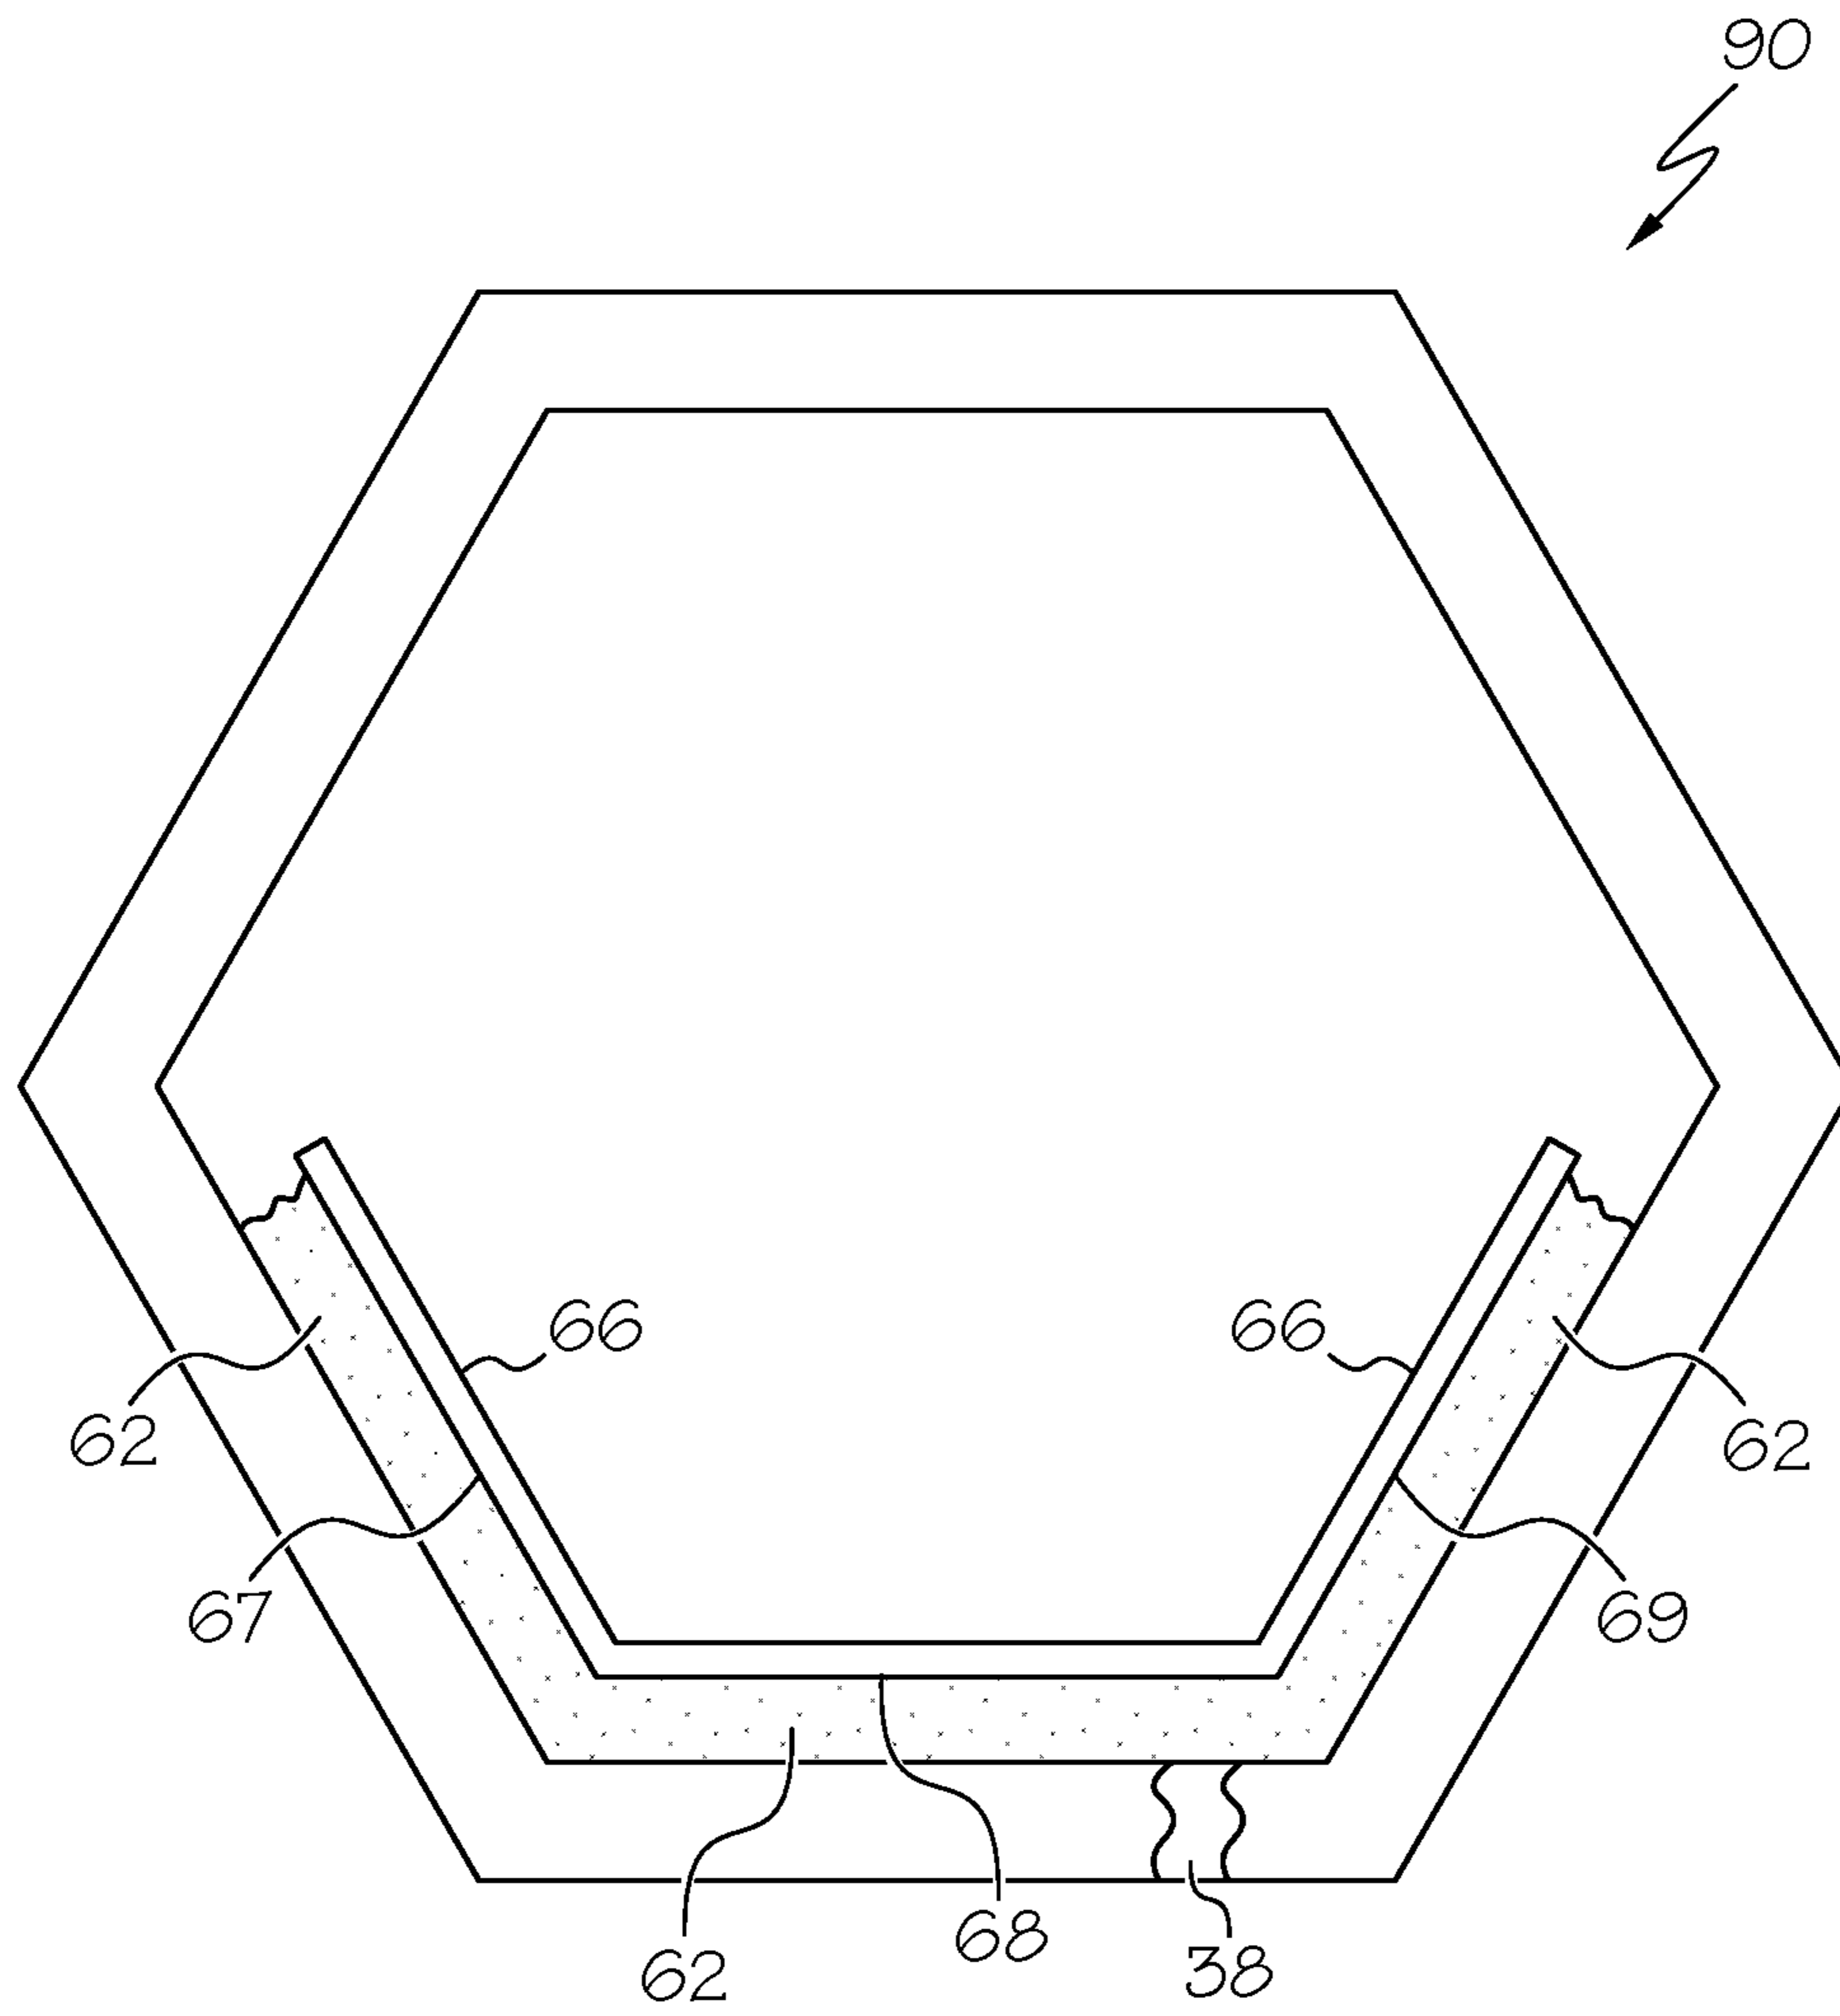
FIG. 9 is a top plan view similar to the top view of FIG. 5, and showing the damaged core cell wall of the acoustic core cell of FIGS. 3-5 repaired with the bonding material and a core repair splice of the repair kit of FIG. 6.

accordance with an embodiment. Referring to FIG. **9**, a top plan view similar to the top plan view of FIG. **5** is shown. More specifically, FIG. **9** shows the damaged core cell wall **38** of FIGS. **3-5** repaired with the bonding material **62** and a core repair splice **66** of the repair kit **60** of FIG. **6**. The repaired acoustic core cell is designated with reference numeral “**90**” in FIG. **9**. The acoustic sandwich panel repair method **80** and acoustic sandwich panel repair kits **60**, **70** disclosed herein may be employed according to FAA regulations. Specifications of FAA regulations for repairing acoustic sandwich panels are known and, therefore, will not be described.

The core repair splice **66** is then bonded to the number of damaged walls to repair the acoustic core cell **34** to provide the repaired acoustic core cell **90** (block **83**). As shown in FIG. **9**, the panels **67**, **68**, **69** are bonded with bonding material **62** to core cell walls including the damaged core cell wall **38**. It should be noted that the thickness of the bonding material **62** between the core repair splice **66** and the core cell walls including the damaged core cell wall **38** is shown exaggerated for purposes of illustration.

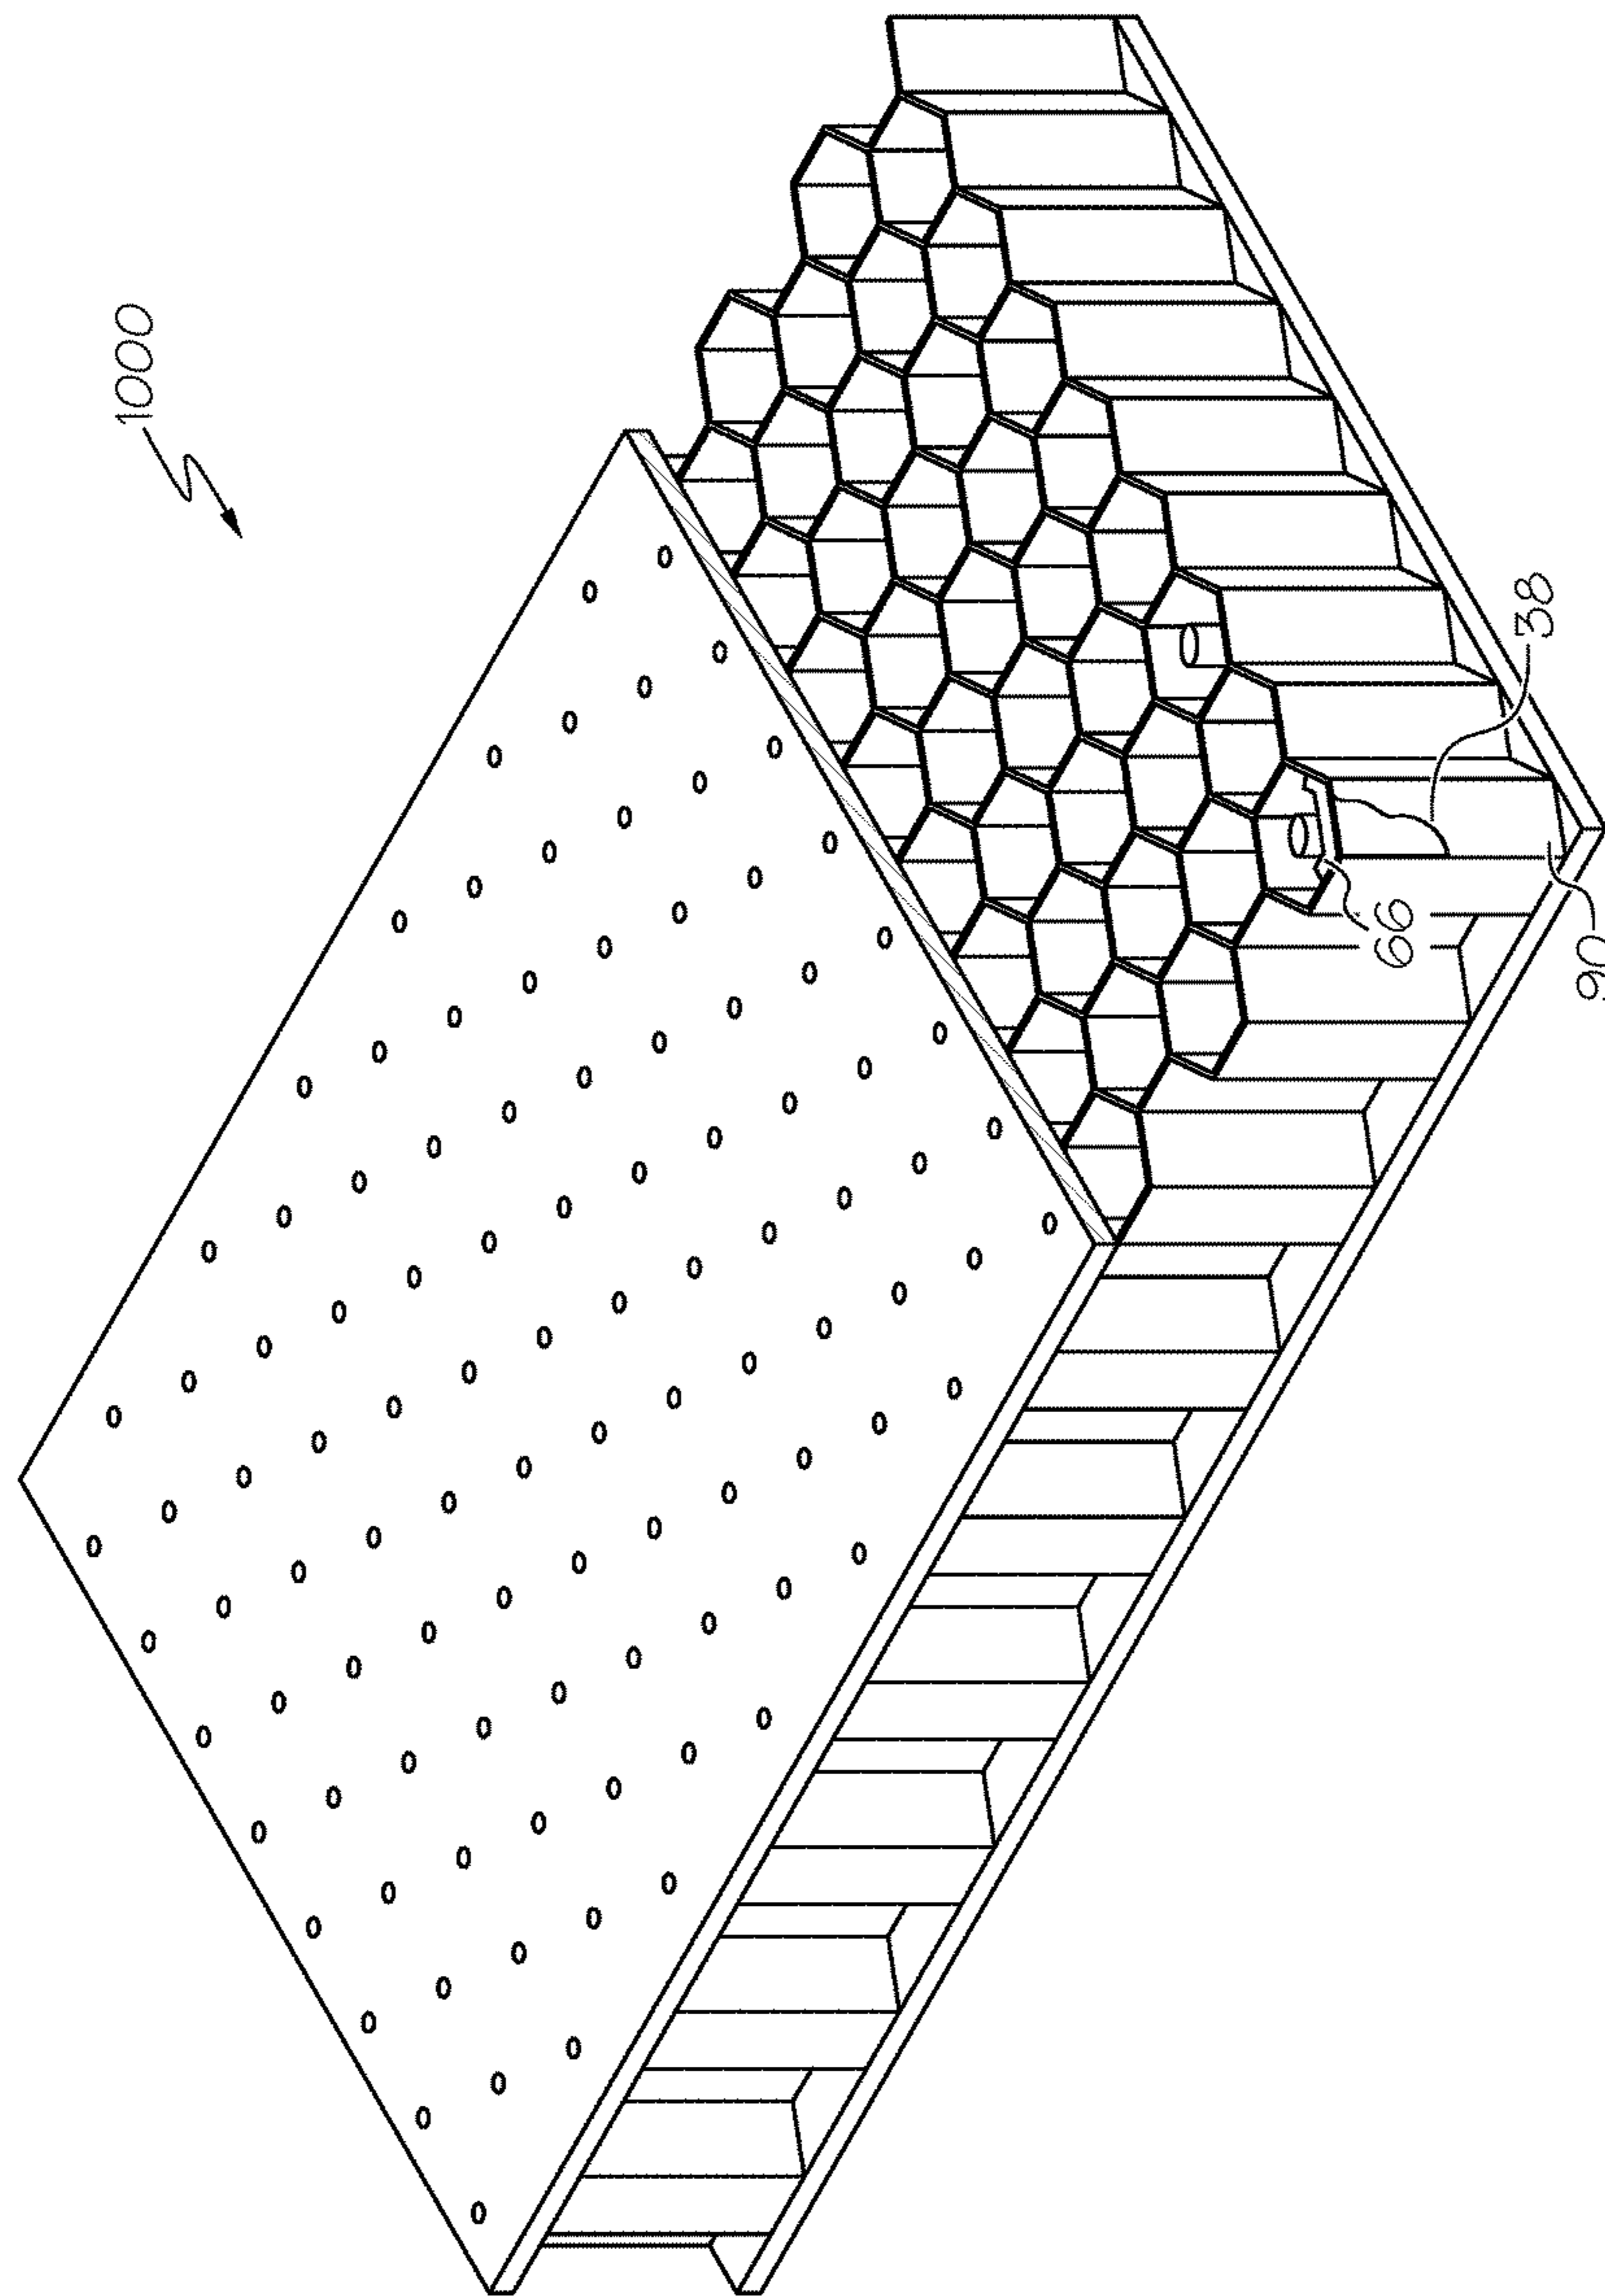
FIG. 10 is a perspective view similar to the perspective view of FIG. 3, and showing the repaired core cell wall of the acoustic core cell of FIG. 9 as part of repaired acoustic sandwich panel.

provide structural support and reinforcement for the damaged core cell wall **38** to thereby provide repaired acoustic core cell **90** (FIG. **9**) that is part of repaired acoustic sandwich panel **1000** shown in FIG. **10**.
